The Fleece Hotel, 19, 19A and 21 Westgate Street, Gloucester

Historic Building Investigation

Rebecca Lane

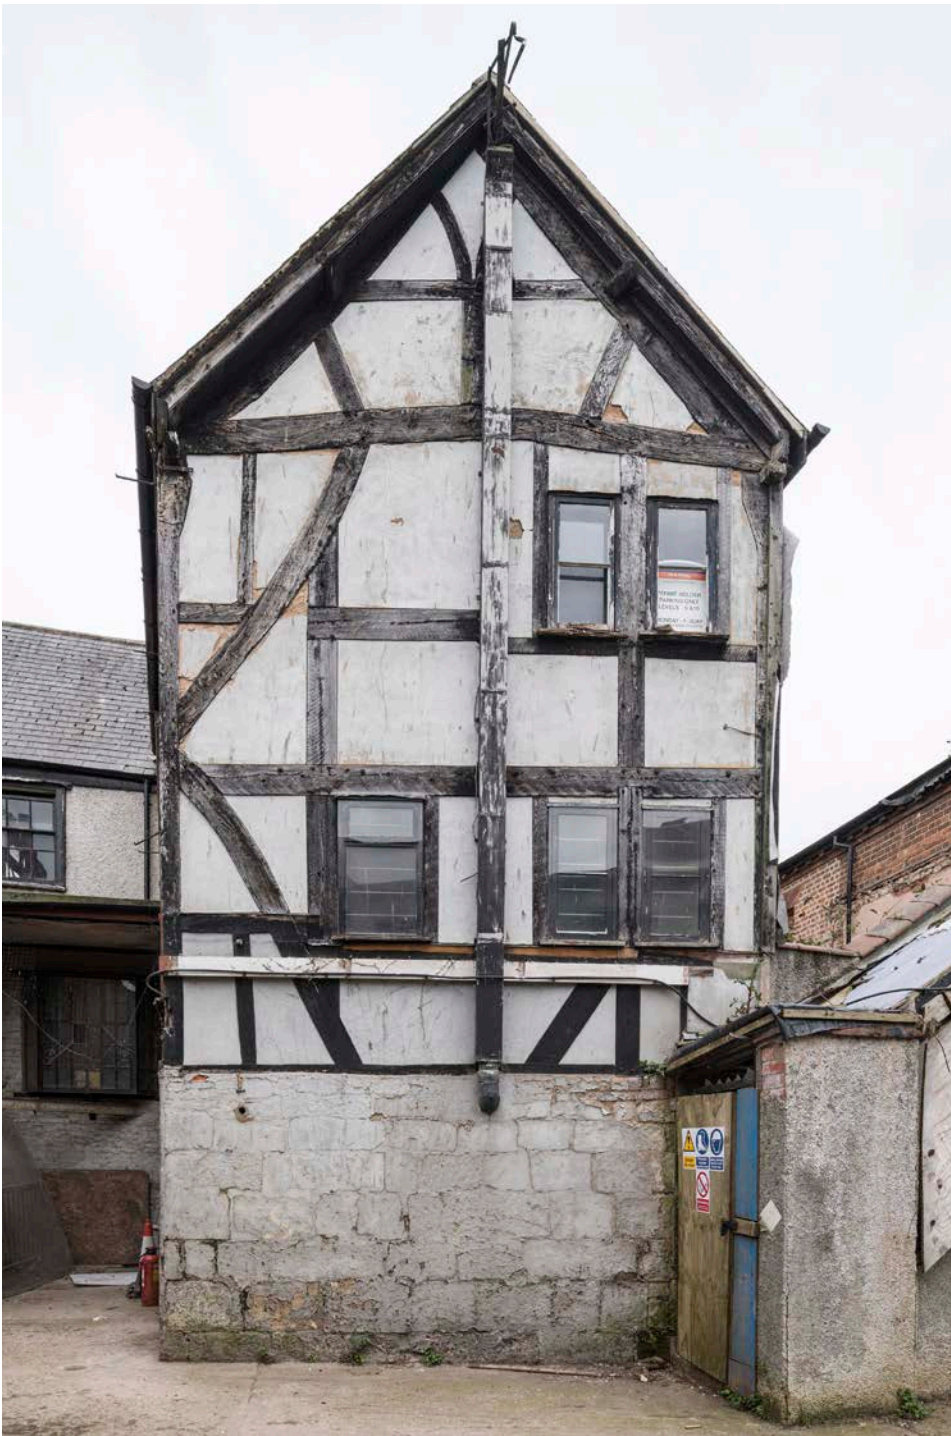
Figure 114: The south-west wing of the great inn range, west elevation, looking east. [Steve Baker © HEA DP325653]

The main element of the complex which can be dated, on stylistic evidence, to the 17th century is the two-bay three-storey range which is attached to the south end of the great inn range on its western side (Figure 114). The wing is formed of a stone plinth rising to approximately 2.2m, slightly higher than the height of the original undercroft above ground level. Above the plinth the range is timber-framed, although some of the extant framing is later replacement. The south wall is currently totally concealed externally by a protective membrane and so cannot fully be investigated at present, although some framing in this wall is visible from within the building.

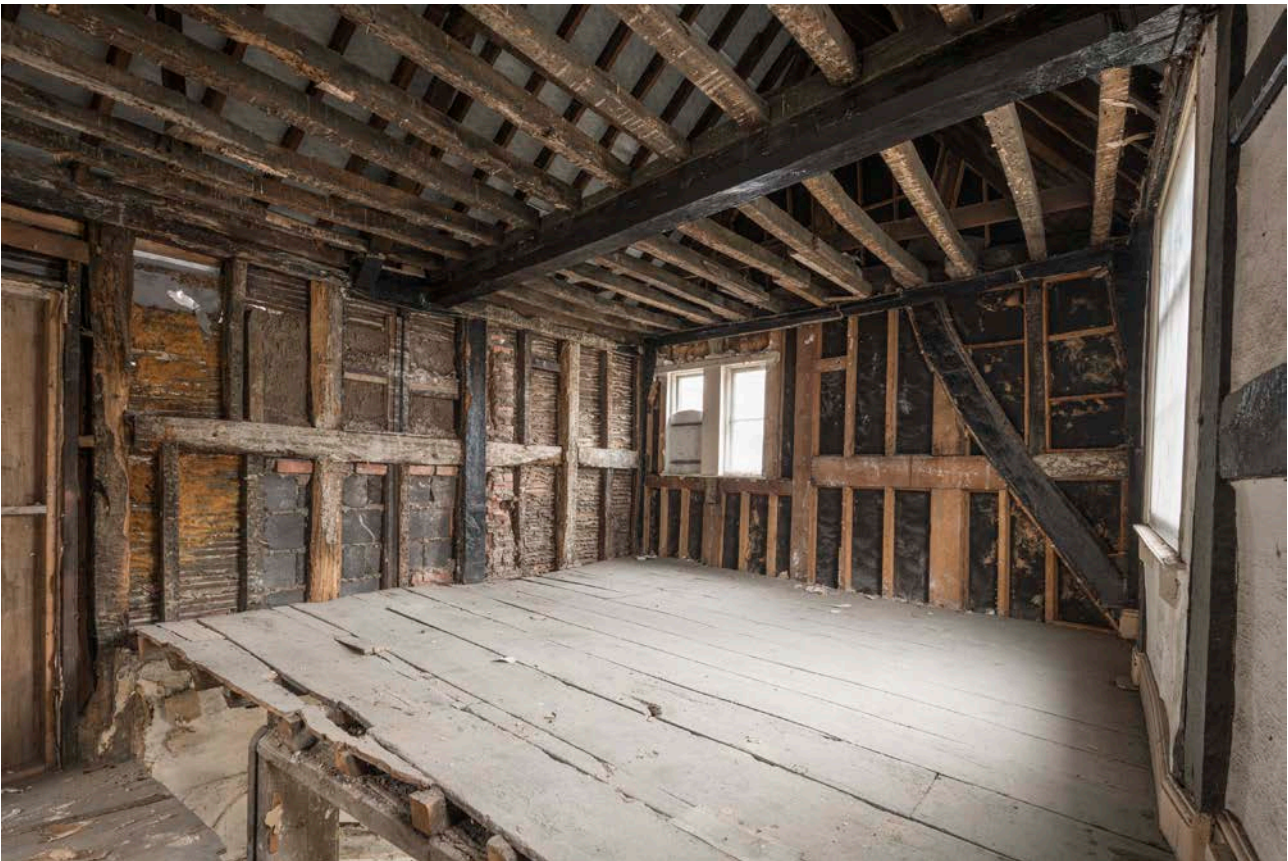
Figure 115: The south-west wing of the great inn range, internal arrangement at first-floor level, looking south-west. [Steve Baker © HEA DP325592]

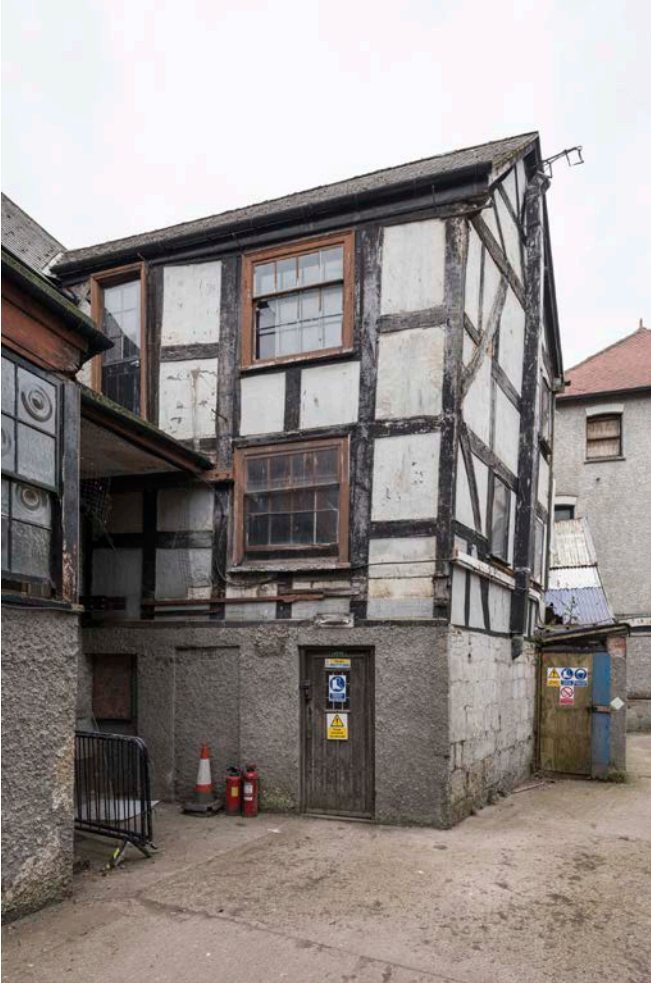
Figure 116: The south-west wing of the great inn range, north elevation, looking south.
[Steve Baker © HEA DP325654]

Although the range has seen later alteration and some renewal to its external timber frame, much of its original fabric survives, and further details can be inferred. The plinth of the range is formed of squared stone blocks to the west elevation. To the north the plinth level is rendered and has been extensively modified. Above the plinth the west elevation is formed of timber-framing (see Figure 114). This has been modified, but its original form can be reconstructed to a greater degree. Original elements surviving include the main posts, two large curved braces, possibly elements of a third brace, and much of the framing of the roof truss including tie beam collar and raking queen struts.

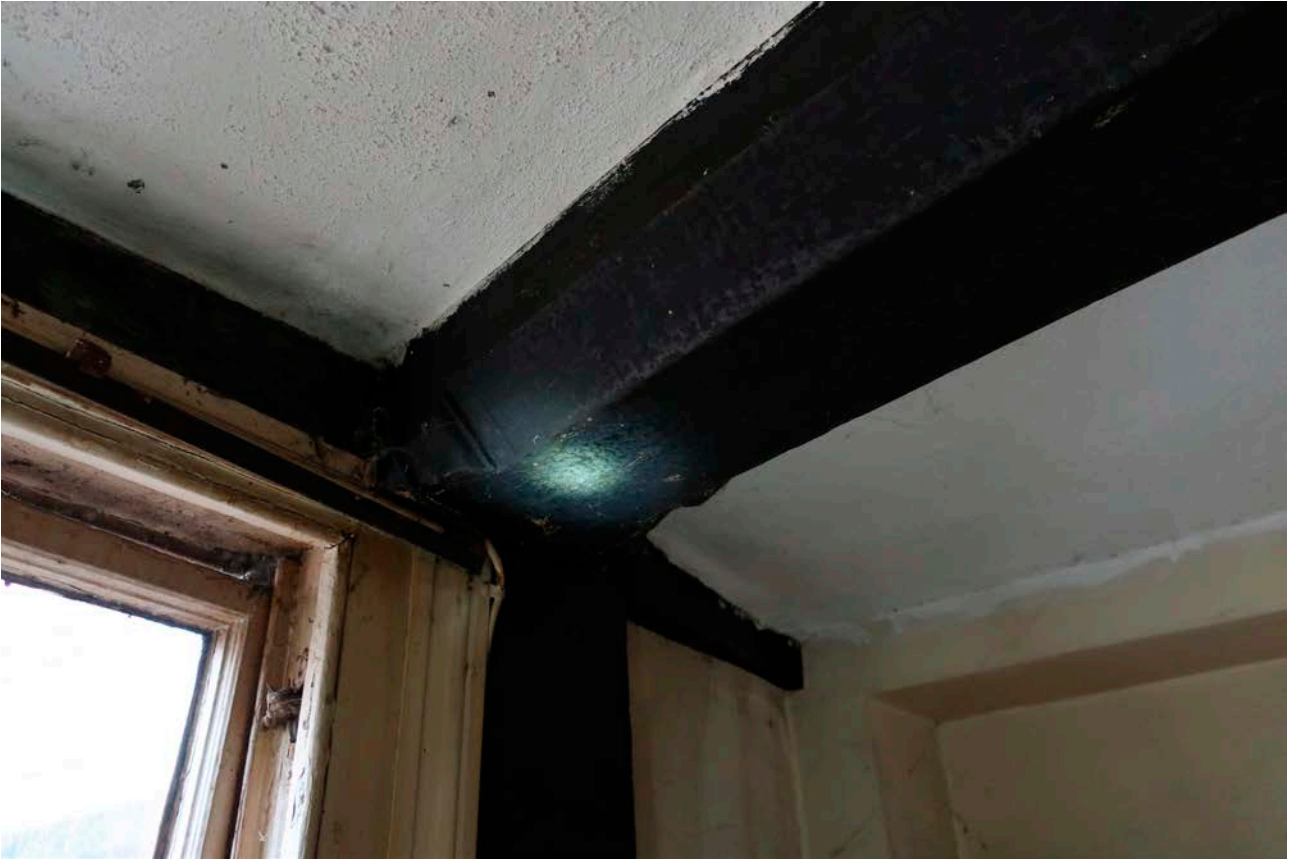
Figure 117: The cross beam at first-floor level in the south-west wing of the great inn range, looking north-east, showing chamfer stop detail. [Rebecca Lane © Historic England]

The interior of the building has been altered but some original features do survive, most notably the ceiling beams. The irregular plan form of the range appears to have necessitated some compromises in the internal structural arrangements to support the different floor levels. The main cross beam at each level runs parallel with the west elevation, but as this is not at right angles to the north and south elevations, the beams have had to be carefully designed to accommodate the angle where they meet the side walls. It is notable that the chamfer detailing is therefore staggered, so that both sides of each timber are stopped against the side walls despite their angled position within the range (Figure 117).

At first-floor level much of the framing in the north and west walls is visible and there is a further chamfered ceiling beam surviving, this time with a stepped and barred chamfer stop (see Figure 117). As mentioned above, the chamfer stops on either side of the beam have been off-set from each other, to accommodate the angle where it joins the side walls. The original access arrangement between the main range and wing at this level is unclear. The later arrangement was via a short flight of stairs from the landing adjacent to the ground-floor entrance point, and this may reflect the original design. At this level some of the framing of the south wall is also visible, including a post in the south-east corner and an angled brace (although this may not be original – a closer examination is required to confirm this).

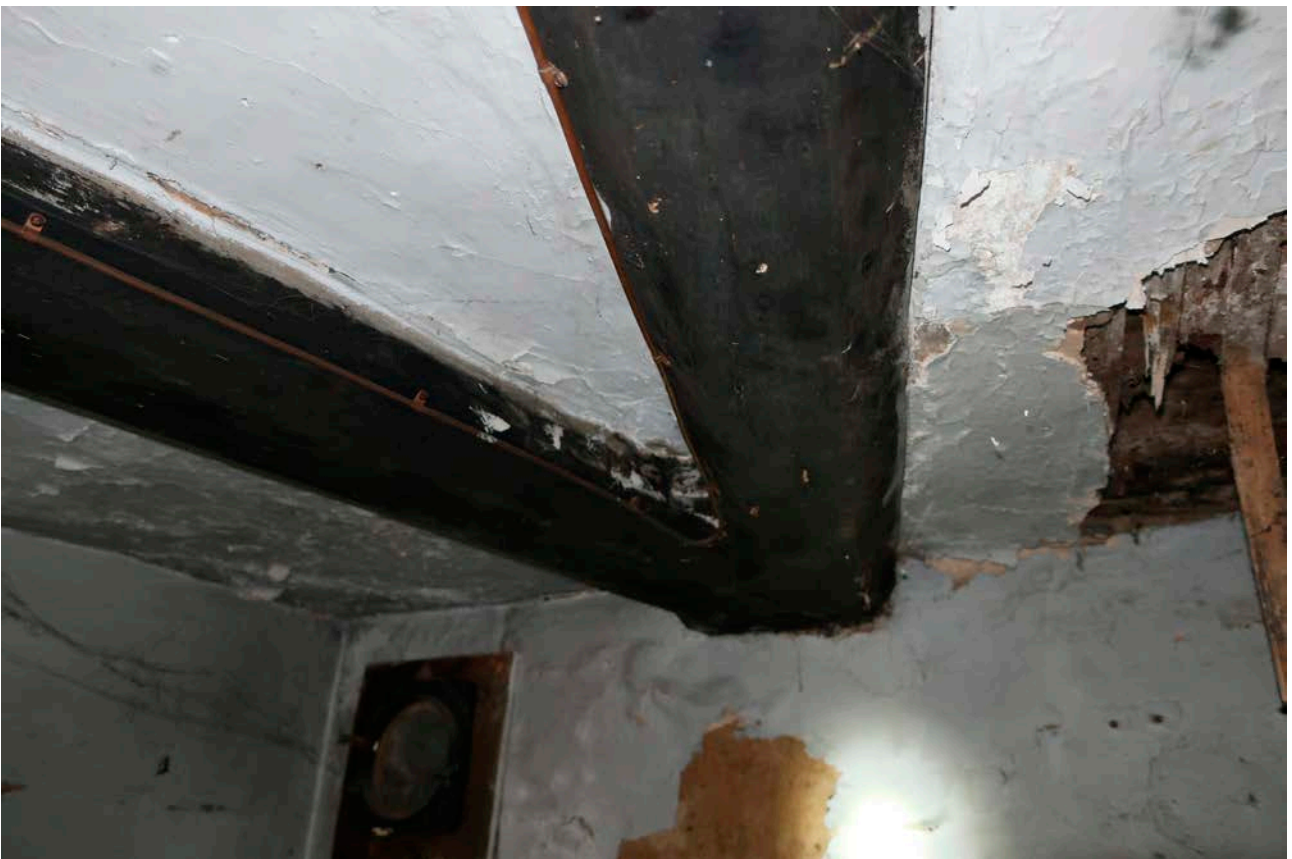
Figure 118: The irregular beam arrangement at ground-floor level in the south-west wing of the great inn range, looking south. [Rebecca Lane © Historic England]

Internally the ground floor of the range has been heavily altered to provide a boiler room and other services. The only original feature currently visible is a pair of chamfered ceiling beams. It is not clear if they are in situ, but the main beam spanning the range is on alignment with those above, so is probably in approximately its original position. It is chamfered but not stopped. A second chamfered beam is located next to this in the south wall, but does not run parallel to the main beam, instead being angled to run to the northern corner of the building (Figure 118). This form of diagonal beam is normally associated with a jettied arrangement, but it never seems to have been part of such an

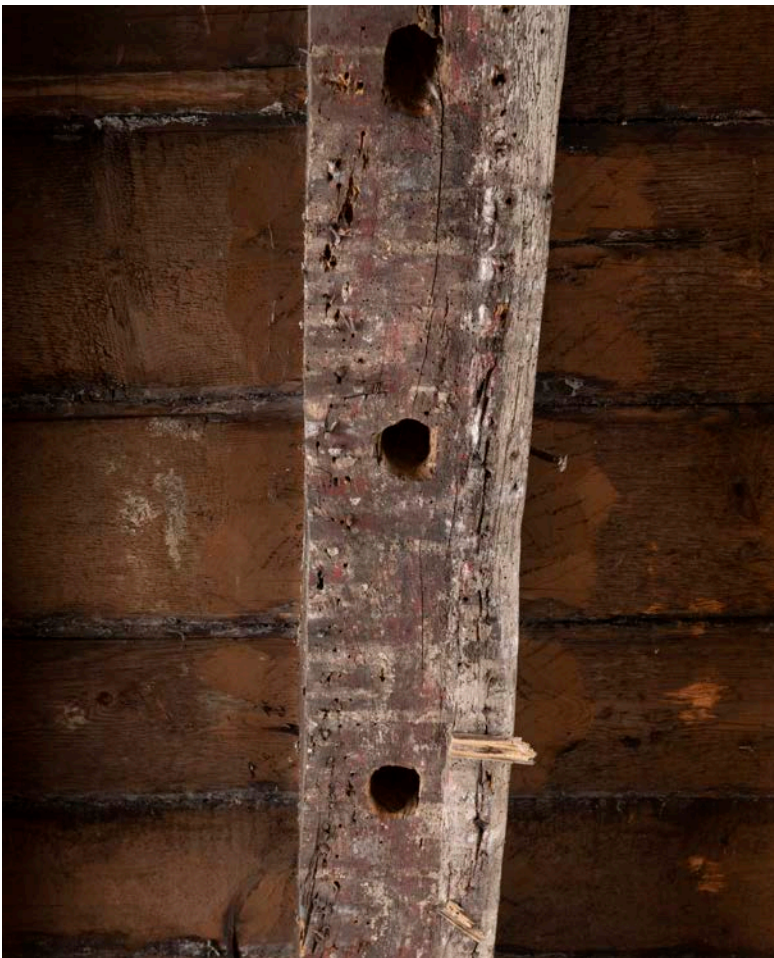
Figure 119: Evidence for an inserted partition in the south bay of the great inn range at ground-floor level, with stave holes inserted into an earlier joist. [James O. Davies © HEA DP435626]

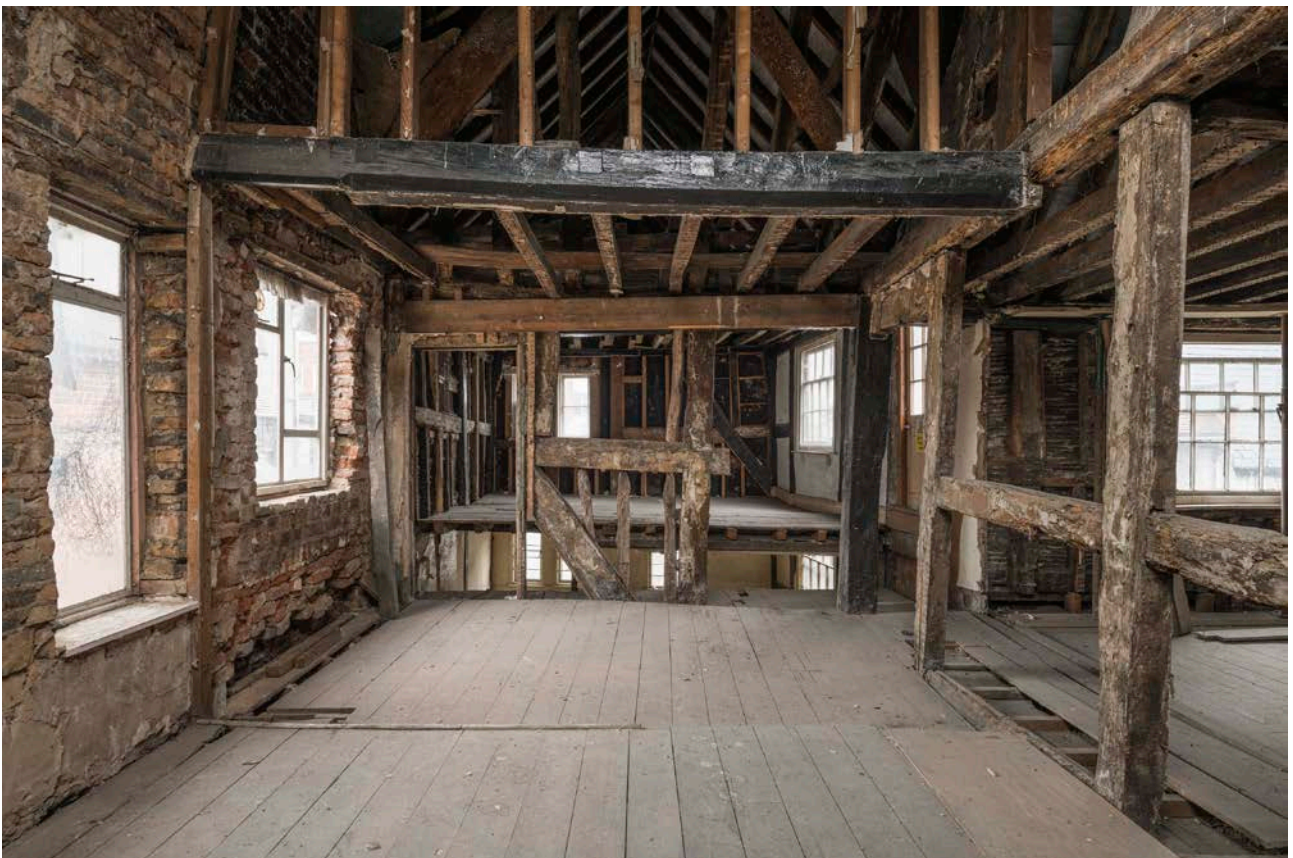
Figure 120: The inserted beam in the south bay of the great inn range at first-floor level, lapped onto the earlier partition to the north (right), looking west. Also showing the positions of the joists for the section of the ceiling which was later removed. [Steve Baker © HEA DP325590]

At first-floor level the insertion of the larger stair and the hearth appears associated with the insertion of a ceiling over the southern bay. Surviving of this arrangement is an inserted lateral beam, which runs from frame VI to the south wall, west of the centre of the bay (Figure 120). This has chamfered edges and stepped run out chamfer stops (Figure 121). Towards its southern end it has an off-set on its eastern side, where it would have run around the chimney breast (Figure 122). The chamfer stop on this side is correspondingly placed further north, so that it would have finished just north of the chimney. To the west of this inserted beam, the joists of the ceiling survive, but to the east they have been later removed, although the infilled mortices which originally housed them are visible on the eastern side of the beam. The other ends of these joists were most likely supported by a partition (since removed), which must have divided the western part of the space from the inserted stair to the east. The only evidence for this partition is a lap joint on the earlier partition of frame VI (Figure 123). It is likely that the eastern doorway in this partition was inserted at the same time, allowing access directly from the inserted stair into the larger room to the north.

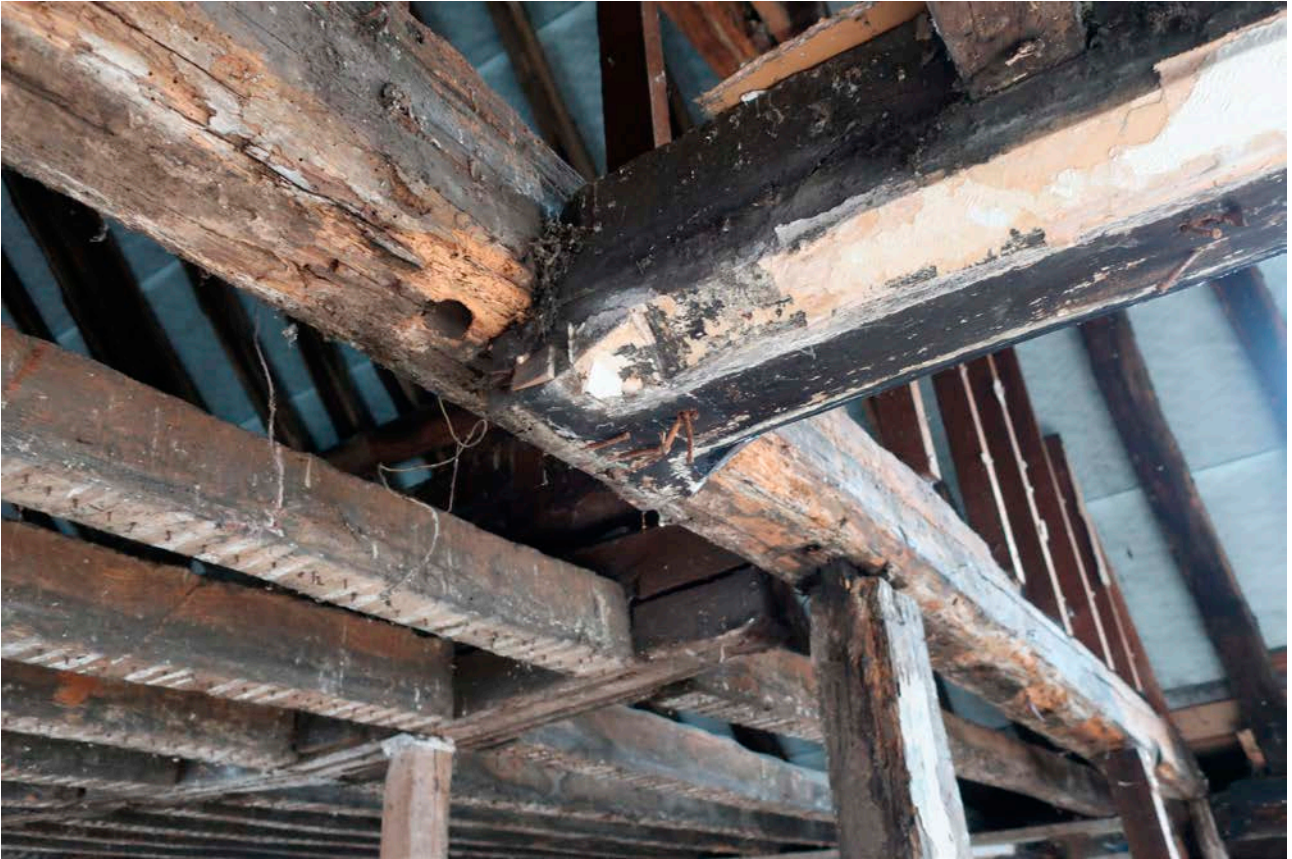
Figure 121: The northern end of the inserted beam in the south bay, looking north-east, showing the bar chamfer stop. [Rebecca Lane © Historic England]

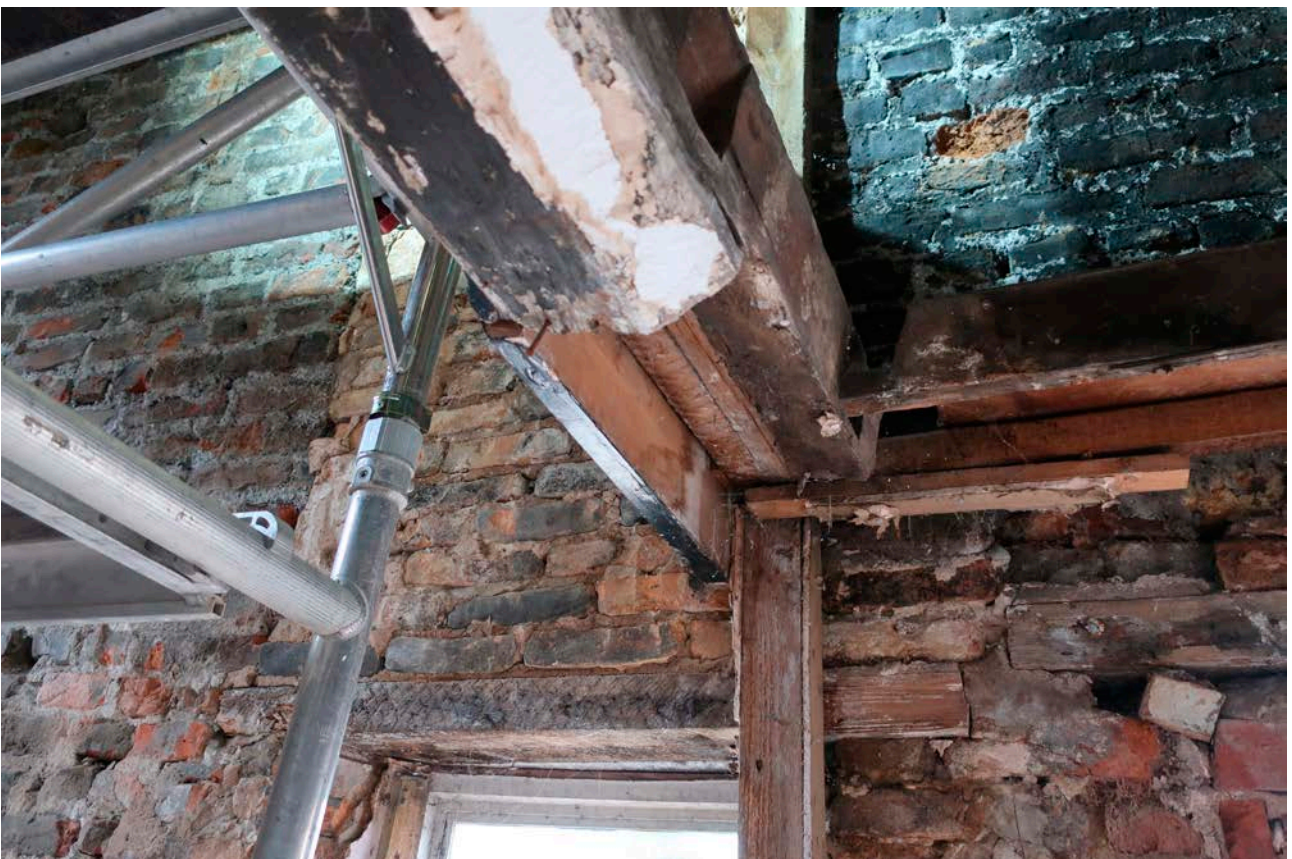
Figure 122: The southern end of the inserted beam in the south bay, looking south, showing the off set in the beam for the former chimney position. [Rebecca Lane © Historic England]

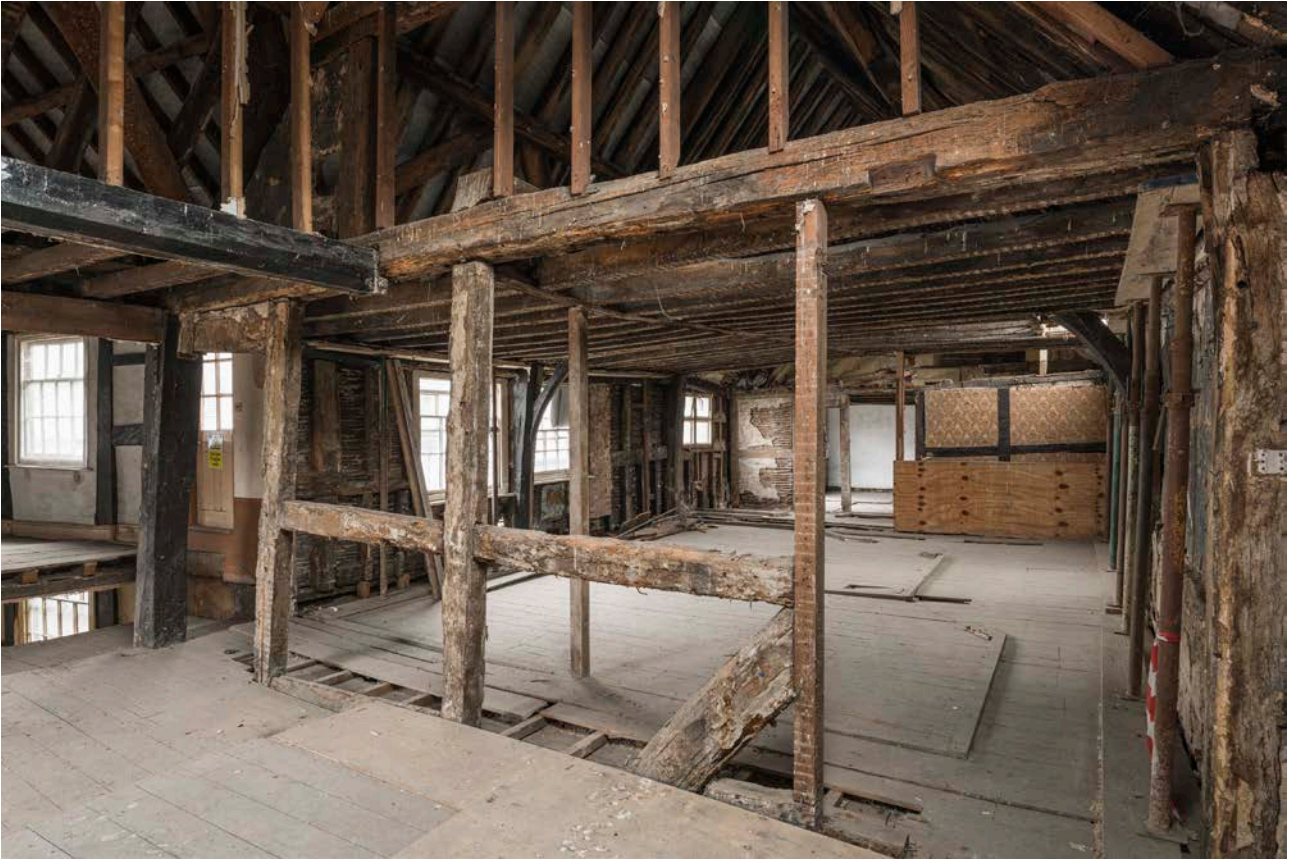
Figure 123: The south bay of the great inn range at first-floor level, looking north-west, showing the earlier partition with the later lap joint adjacent to the inserted doorway at the east end of the partition (the right-hand side of the photograph). [Steve Baker © HEA DP325594]

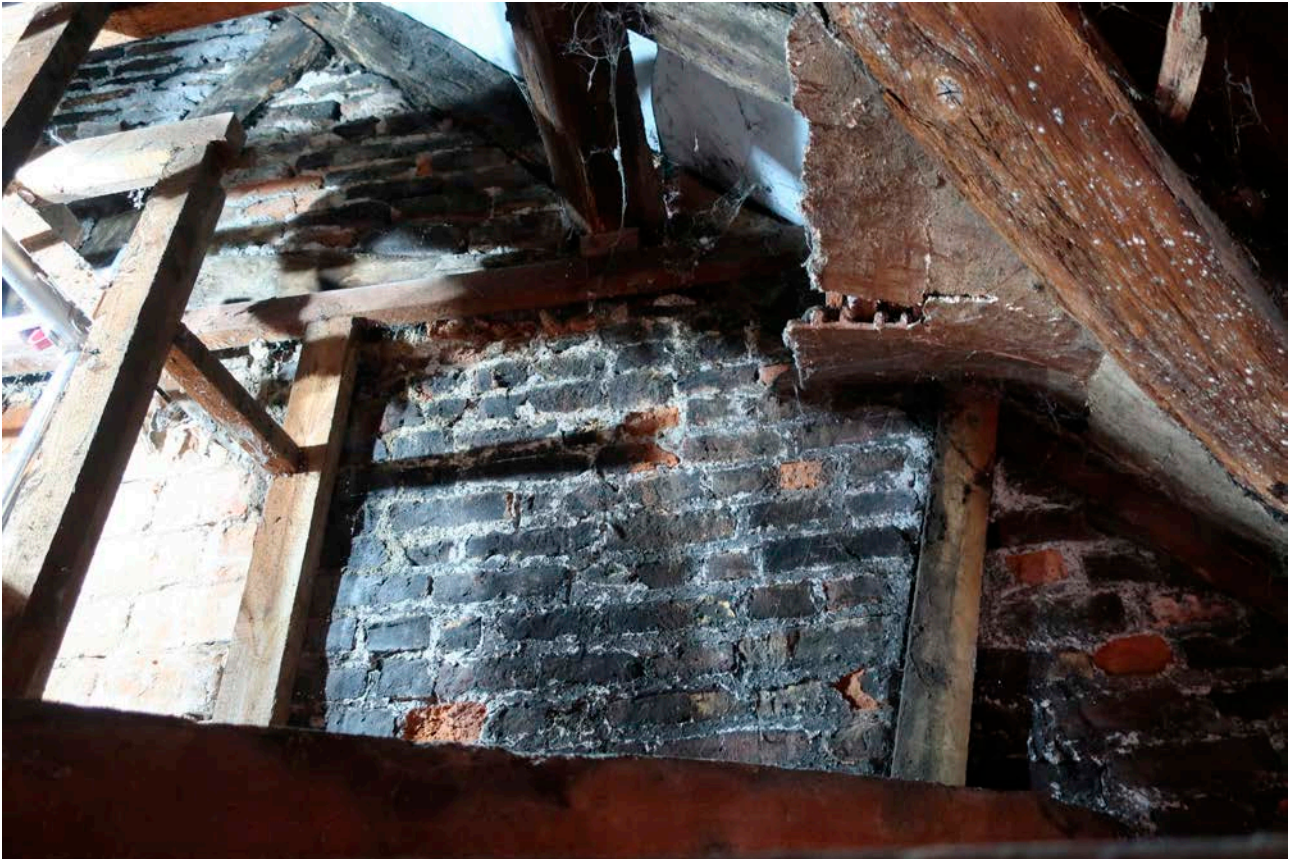
Figure 124: The south elevation of the great inn range at roof level, looking south, showing place bricks inserted around the original timber frame, blackened by soot from the adjacent chimney position. [Rebecca Lane © Historic England]

At attic level, there is evidence for a plaster ceiling structure, probably inserted as part of this phase. A partially collapsed fragment of this survives on the south side of the western elevation (Figure 124). Elsewhere its position is indicated by the nails which previously supported the laths of the ceiling – these can be seen on both the east and west sides running to a level above the original purlins. There must originally have been inserted timbers at this level, to create a flat ceiling, but these have been completely removed. A plaster ceiling at this level would have allowed the attic in this area to have been used as a room. The means of access is unclear but may have been via the stair to the east, which could have risen through to this further storey, although the headroom would have been restricted by the slope of the roof.

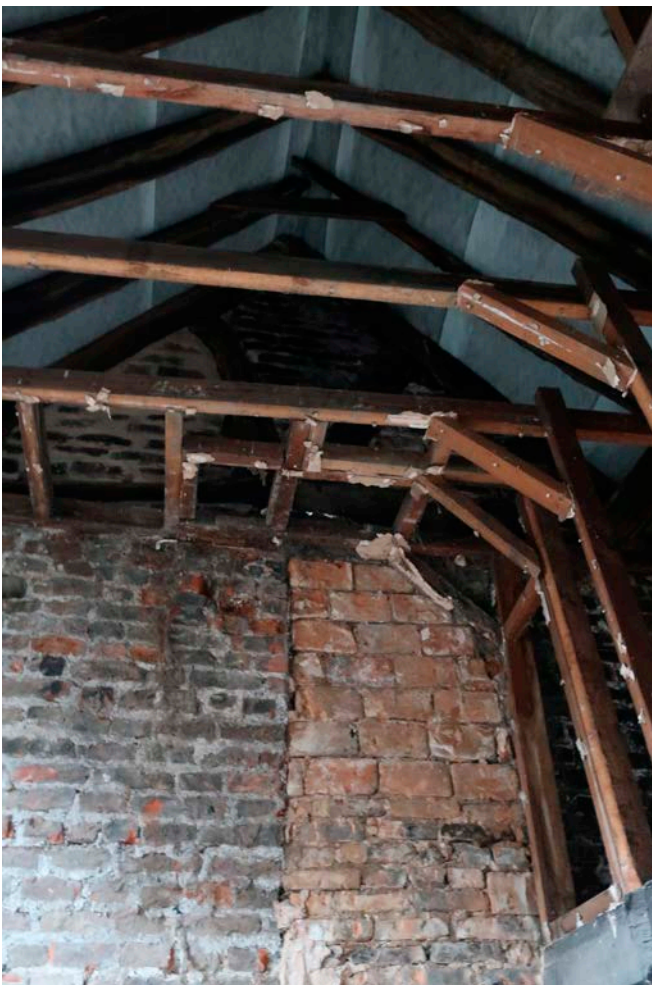
Figure 125: The south elevation of the great inn range at roof level, looking south-west showing the place bricks inserted into the eastern part of the elevation. [Rebecca Lane © Historic England]

As well as all of the alterations to the south bay, it is clear that the south elevation was also altered, although this was not necessarily done at the same time. At some point the original panels of the elevation were replaced with brick, which was used to infill around the surviving elements of the earlier main external frame. Although some areas of this brick have later been replaced, it appears to have been used consistently to infill most of the upper panels of the frame, between the surviving elements of the original tie beam, the collar and the associated struts (Figure 125 and see Figure 71). The brickwork is characterised by the use of place bricks (that is, poorer quality bricks which show evidence for their original setting out) with a thick mortar used between them which includes a significant amount of ash or charcoal visible as black inclusions. This brickwork extends across the elevation at high level, and down between the two truncated ends of the original tie beam. A high-level window position (infilled with later brick, laid on side) is evident, and presumably was designed to light the newly created attic room. Where the inserted chimney is likely to have run the brickwork appears to have been inserted from the south (i.e. from the exterior of the building) rather than from the interior as seems the case for the other panels. This created an uneven finish to the mortar within the building immediately adjacent to the chimney and suggests that the brickwork was inserted after the chimney – although both may have taken place in the 17th century. At first-floor level the brick has been much modified by later insertions, although the outline of the chimney position can tentatively be identified where there are signs of brickwork having been hacked back to the wall line.

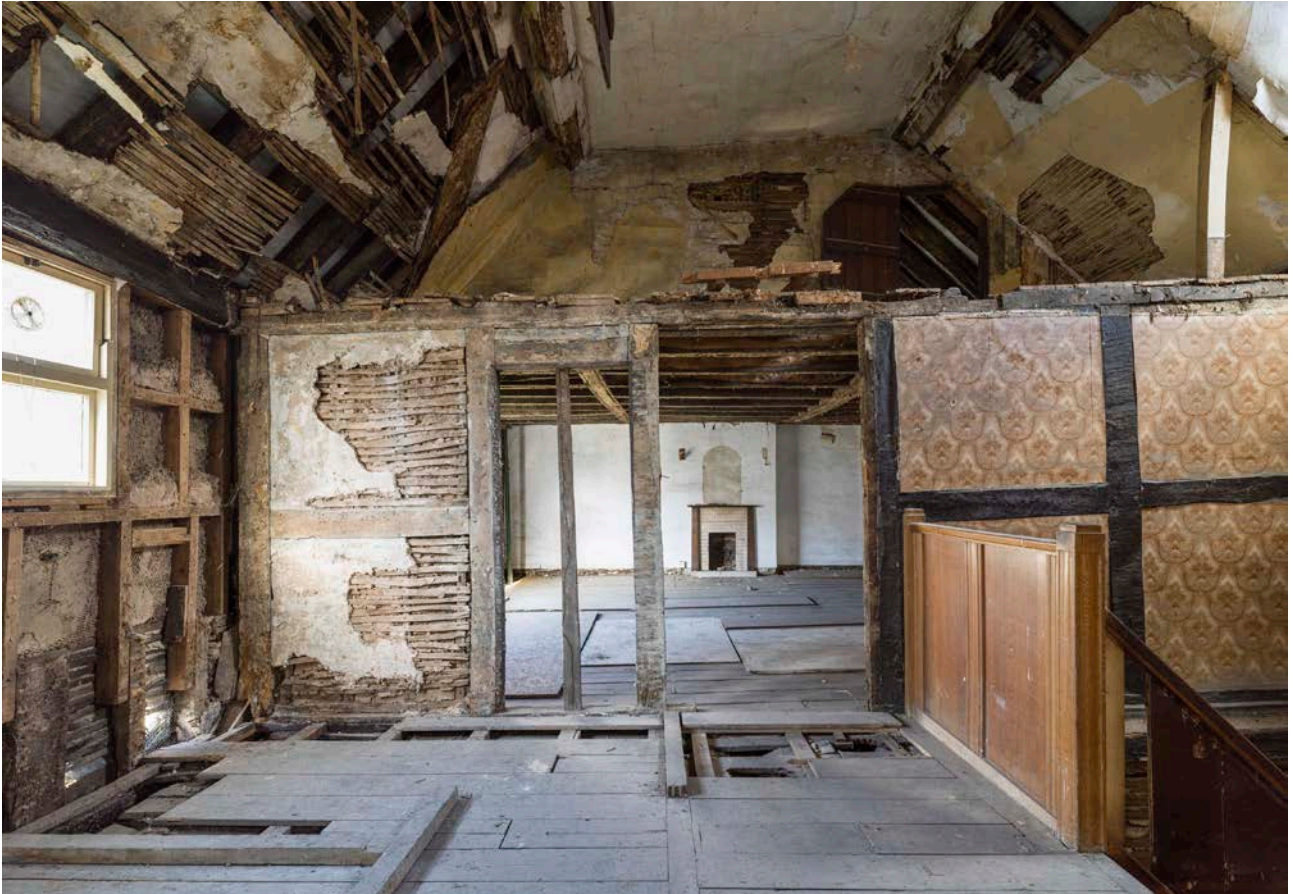
Figure 126: The ceiling inserted at collar level over the northern first-floor room of the great inn range, looking north, with the ceiling and the rafters plastered over. The partition shown below is part of the late 18th-century alterations at the site. [Steve Baker © HEA DP325625]

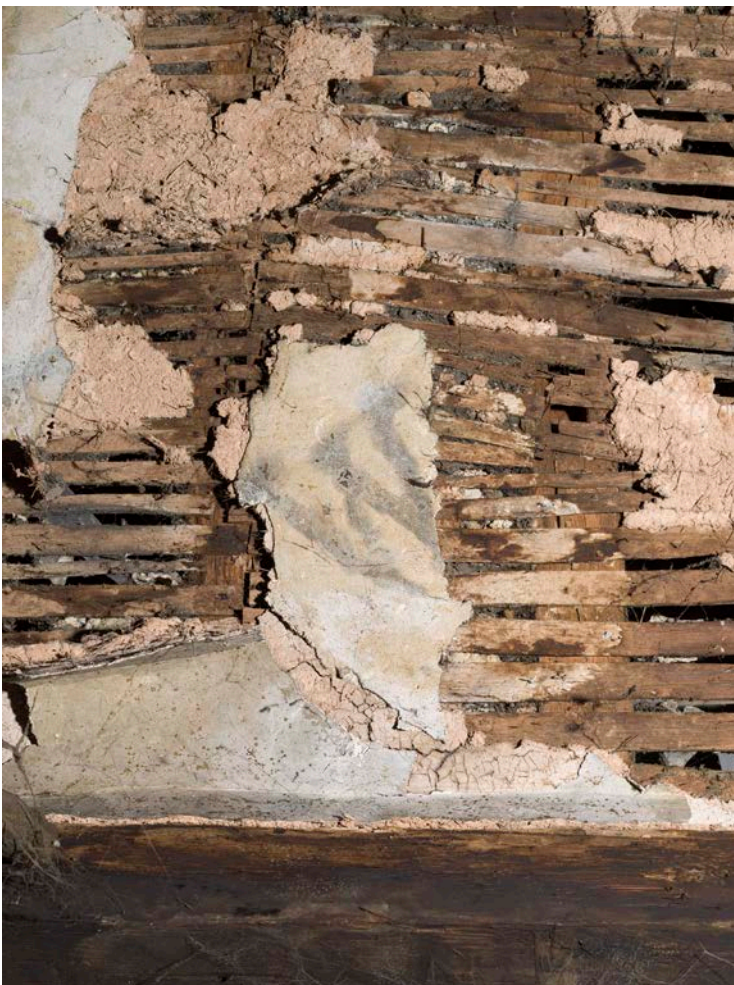
Figure 127: A fragment of the plaster ceiling over the northern first-floor room of the great inn range, showing a possible candle-marked 'W' (or 'M'). [Steve Baker © HEA DP325670]

At the northern end of the first floor of the main range, the two-bay room occupying bays B and C appears to have had a different form of ceiling inserted in the 17th century. Instead of a flat ceiling level with the tie beams, as in the central room immediately south of this, a series of timbers were inserted along the purlins at collar level (Figure 126). The sloping pitch of the roof below this, and the inserted ceiling, were lined with laths to support a plaster ceiling. There are faint traces of a decorative effect on the plaster of the ceiling, with a star pattern visible particularly at the southern end. It is not clear if this is contemporary with the insertion of the ceiling, however. Similarly a possible candle mark of an M or W in the western part of bay B is visible, but could date from a later period than the ceiling (Figure 127).

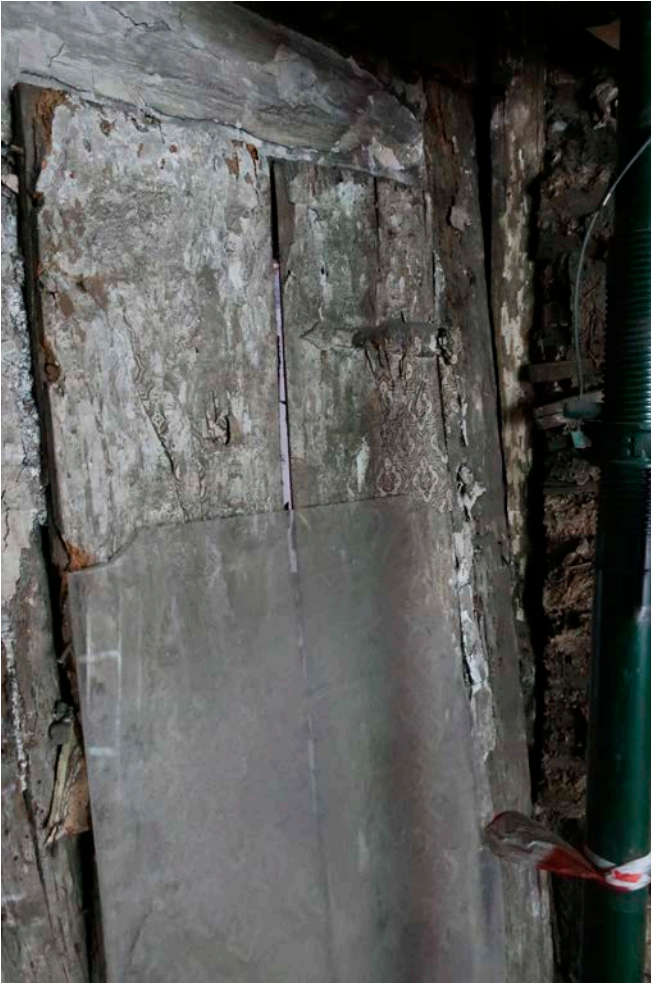
Figure 128: Detail of the inserted door in the south elevation of the street-front range at first-floor level, leading into the first floor of the west range, showing a 17th-century strapwork hinge, looking north-west. [Rebecca Lane © Historic England]

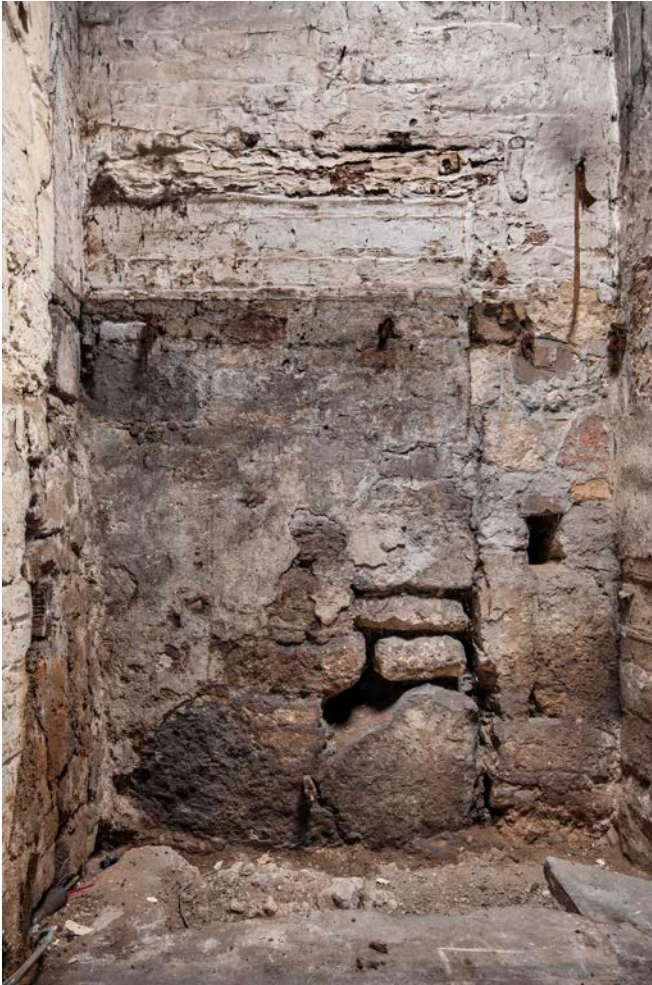
Figure 129: Inserted stone and brickwork at the north end of the undercroft of the great inn range, with the position of a doorway visible, with later stone infill, looking north. [James O. Davies © HEA DP435613]

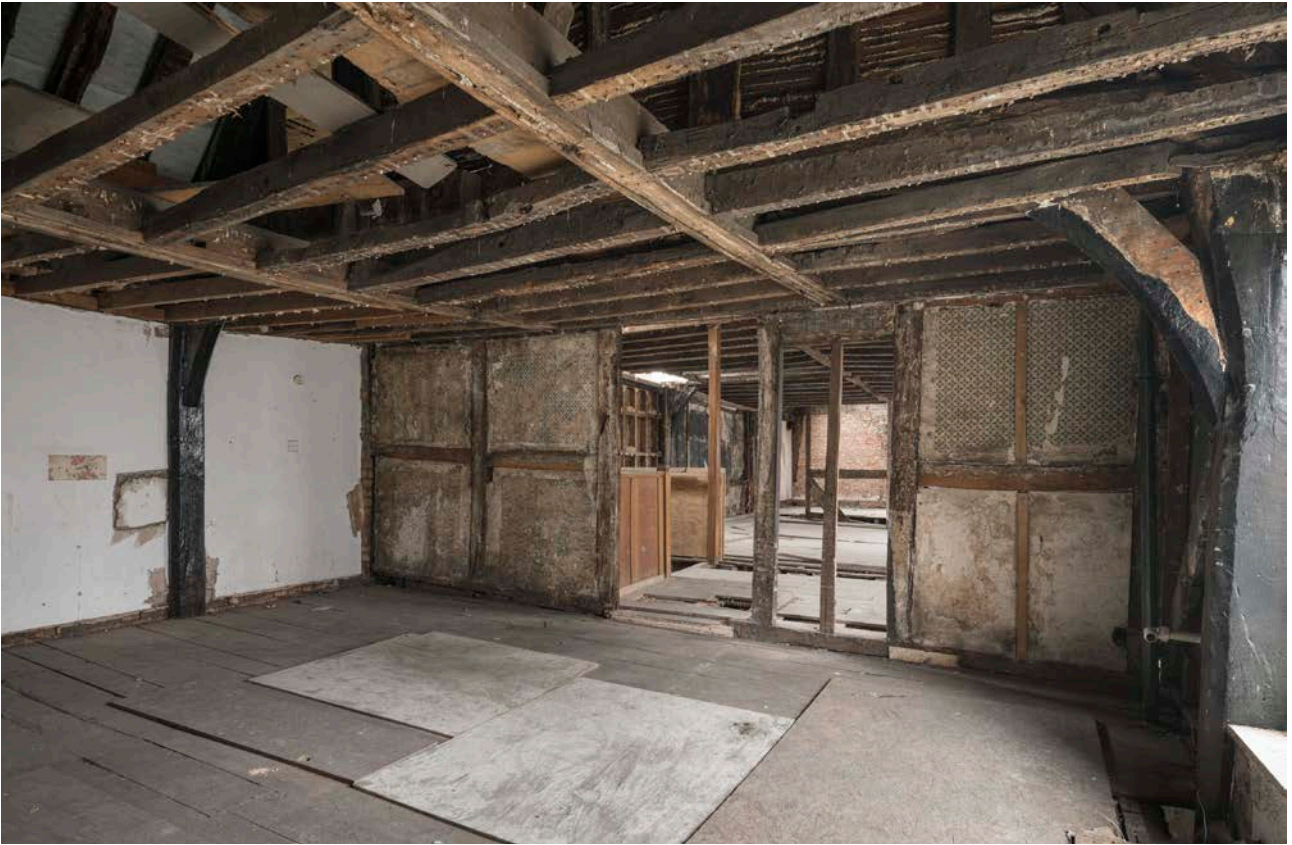
Figure 131: The inserted partition at the north end of the first-floor level in the great inn range, showing early wall paper on its northern face, looking south. [Steve Baker © HEA DP325596]

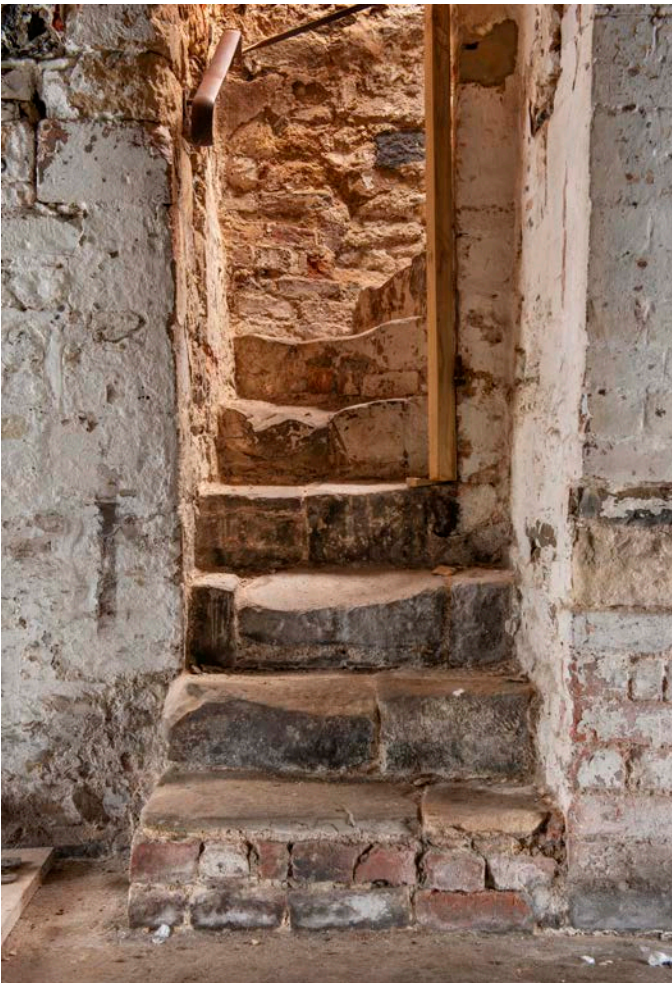
Figure 132: Inserted internal stair from the undercroft to the ground-floor level in the great inn range, looking east. [James O. Davies © HEA DP435619]

At first-floor level a partition was also inserted towards the south of the larger room (within bay C) on the same alignment as that at ground-floor level, creating a similar landing and circulation space which ran the full width of the range (Figure 131 and see Figure 126). As well as the partition, a flat ceiling was inserted, with the lateral beam resting on the new partition at its south end. It seems likely that the current stair arrangement was created as part of this, linking the ground- and first-floor corridors to improve circulation through the building, although much of the upper part of the stair has been later replaced. As part of this alteration the brick and stone stair which currently provides access between the cellar and the upper part of the range may also have been inserted (Figure 132).

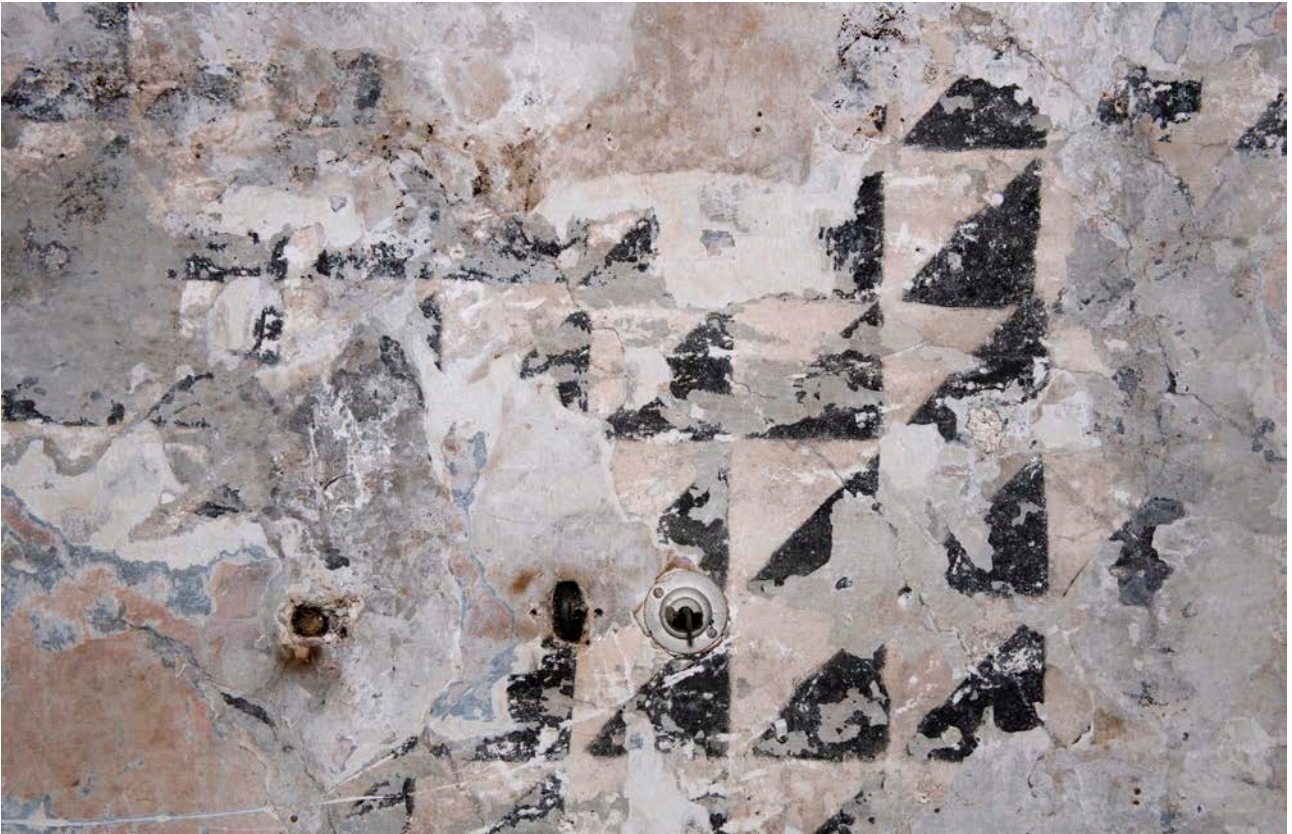
Figure 133: Diamond pattern decoration on the ground-floor ceiling of bay E (No. 21), possibly applied in the 18th century. [James O. Davies © HEA DP435655]

Alterations to other ranges which might have taken place in the 18th century are harder to trace. However, one notable element which has tentatively been ascribed an 18th century date is the decorative scheme visible in the ground- and first-floor levels of the street-front range, in what is now No. 21 (bay E). At ground-floor level there is a geometric pattern surviving on the ceiling of both parts of the bay (north and south of the cross beam which indicated the original partition line). Its presence on both sides of the cross beam probably indicates that by this date the shop and the room to its rear had been opened up to form a single, larger commercial space. The ceiling pattern comprises a series of black and white triangles with no other embellishment (Figure 133). This has been compared to
