The Fleece Hotel, 19, 19A and 21 Westgate Street, Gloucester

Historic Building Investigation

Rebecca Lane

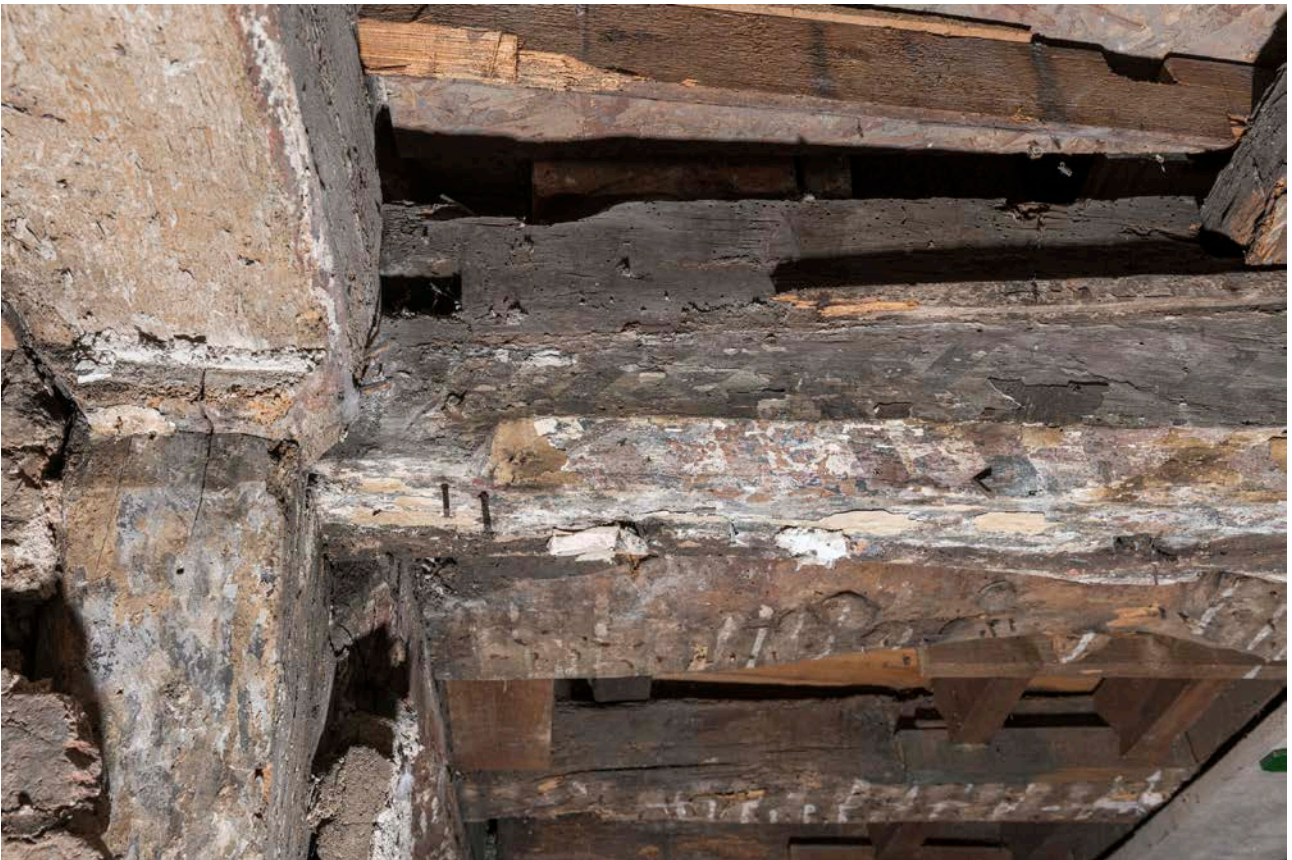
Figure 134: Black and white chevron pattern faintly visible on the timber beam and post of frame V, in bay E (No. 21), possibly applied at the same time as the pattern at ground-floor level, looking east. [Steve Baker © HEA DP325646]

other examples known to have been painted in the 18th century, although these are of a much higher status, and thus the survival of such a scheme in this type of premises is extremely rare.²⁴⁹ This may relate to a further geometric scheme visible in the room directly above this, on the western side of frame V at first-floor level (Figure 134). At this level there is a black and white chevron pattern running along the southern part of the cross rail which may continue down the side of the adjacent stud. The scheme overlays the earlier plain red painted onto the timbers, thought to date to the 16th century (see Phase Three above).²⁵⁰

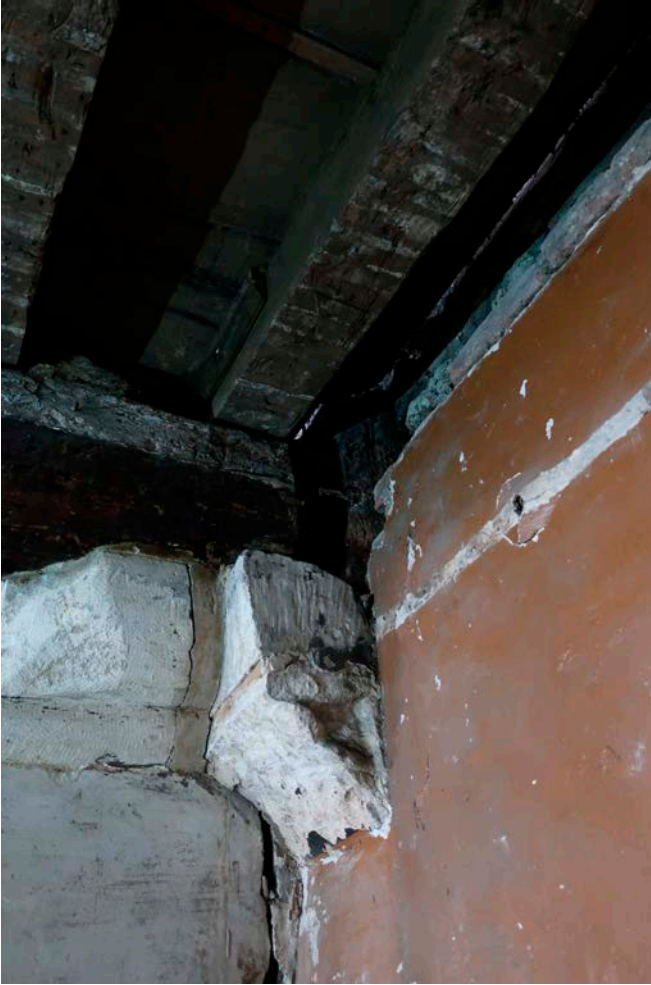
Figure 135: Inserted stone corbel with a sunk chamfer decoration on the side, supporting the earlier cross beam of frame V at ground-floor level in the great inn range, looking north-east. [Rebecca Lane © Historic England]

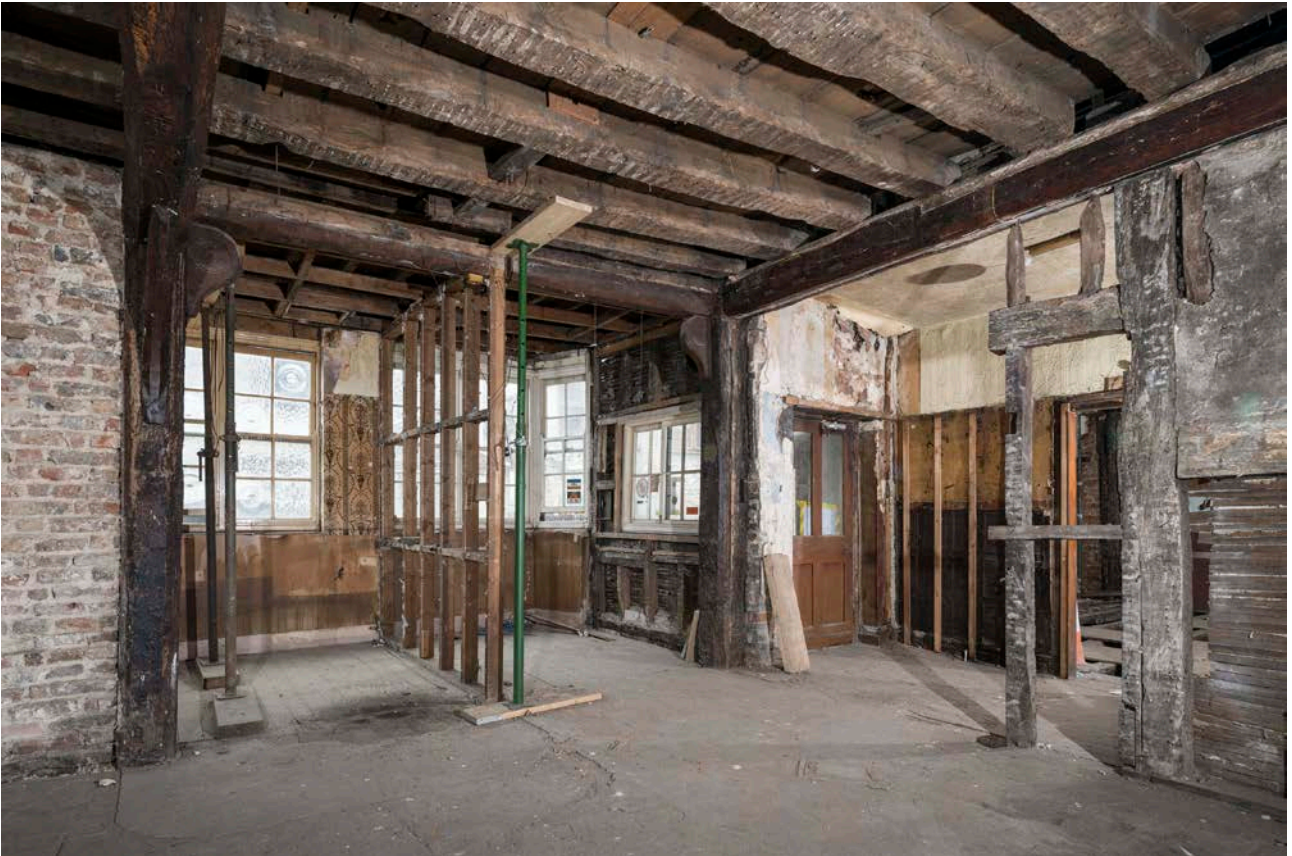
Figure 136: Inserted bay window in the central room at ground-floor level in the great inn range, looking north-west. [Steve Baker © HEA DP325603]

These alterations to the eastern wall of the range must have removed any original windows which might have sat on the eastern side at ground-floor level. It may have been this alteration which prompted the construction of a further bay window on the western side of the range, to try and increase the amount of natural light entering the ground-floor rooms from this side. It is possible that the large curving bay window was inserted in the north room in the 1770s (see Phase Five above). The other bay window, lighting the central two-bay room, may have been inserted as part of this 1800s phase. This is a further large, full-height bay, of similar overall scale to the curving bay to the north but built with a rectangular plan (Figure 136).

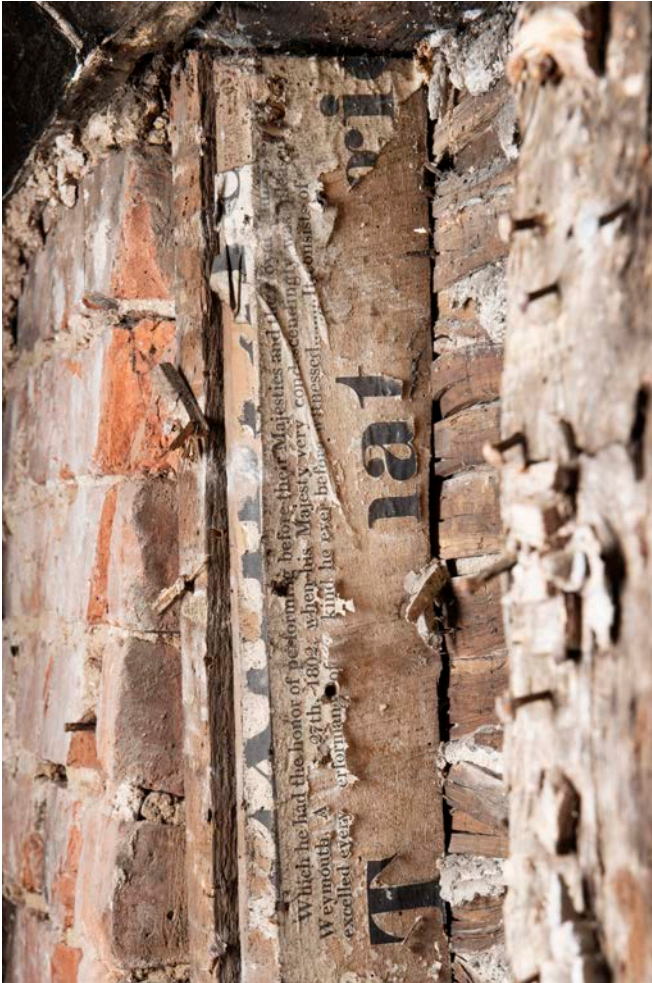
Figure 137: Inserted timber stud in the west elevation of the great inn range, with a section of a paper playbill attached to the side showing the date 1802. [James O. Davies © HEA DP435631]

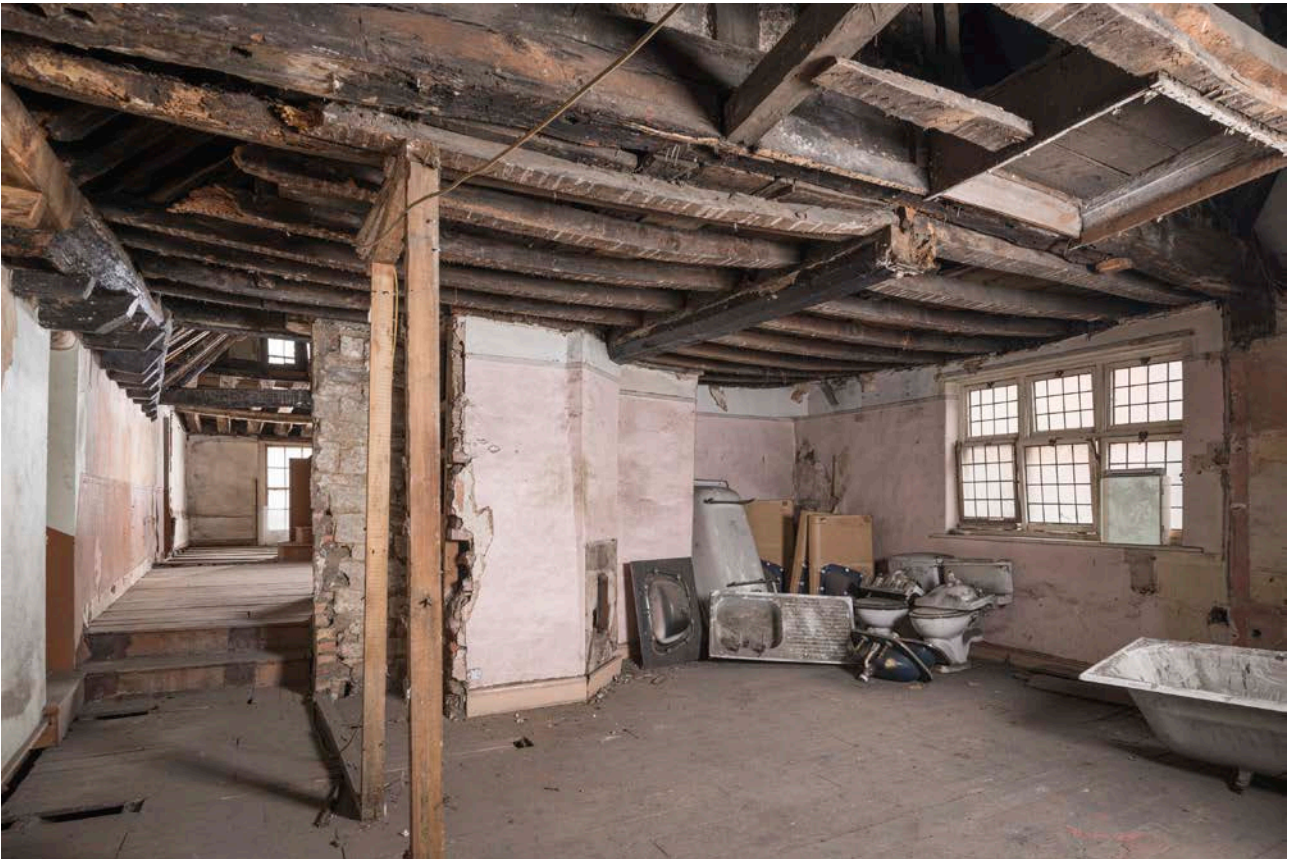
Figure 139: First-floor level in the west range, looking north-west, showing the rebuilt western wall of the range, with the earlier wall plate supported on timber brackets. [Steve Baker © HEA DP325610]

As part of the 1850 reconstruction of the adjacent property at No. 23 (see separate description in Appendix Two), it seems that the party wall between the two properties was completely replaced in brick. This saw the total removal of the original framing along the western side of the west range, although the original timber wall plate was left in situ. This was supported on a series of timber brackets projecting out from the brick wall (Figure 139).

It seems likely that the present stair in the smoke bay (bay D) was created as part of this phase, providing external access directly up to the first floor of the building, although this may have replaced an earlier stair in the same location. At first-floor level a corridor arrangement was created on the western side which ran the full length of the range and connected through to the street-front range, although again it is possible that this was an adaptation of an earlier arrangement within the west range (see Figure 139). In order to

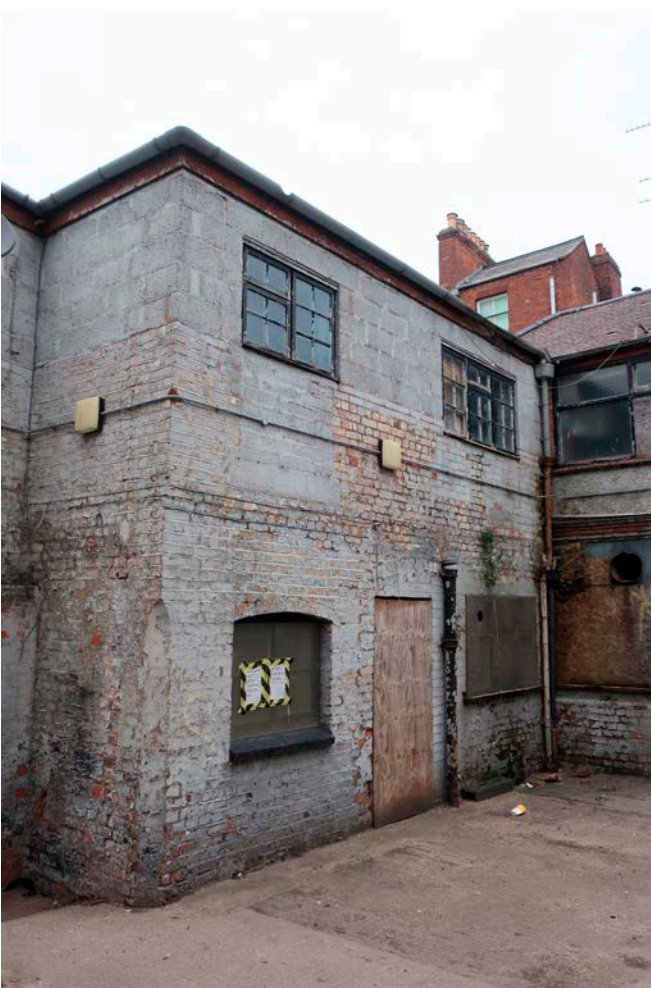
Figure 140: One of the stable or service ranges built south of the main Fleece complex, along the route in from Bull Lane, possibly reconstructed around 1874 and subsequently heightened in the 20th century, looking north-east. [Rebecca Lane © Historic England]

The fire recorded in the *Gloucester Journal* in 1874 apparently destroyed or damaged much of the rear area of the Fleece complex, south of the main three ranges. This appears to have necessitated the reconstruction of the southern ranges of the Fleece, which documentary evidence indicates were in use as stabling. The newspaper reports suggest that it also provided a skittle alley. It seems likely that the brick block surviving south of the Bull Lane entrance passageway originally dates to this phase, although it has been heavily altered and raised in the 20th century (Figure 140). Originally this appears to have been of one or one-and-a-half storeys and may have formed a stable with a loft over, or possibly some sort of ancillary storage in relation to the rest of the Fleece complex. Any other buildings reconstructed at this point have been removed by subsequent changes.

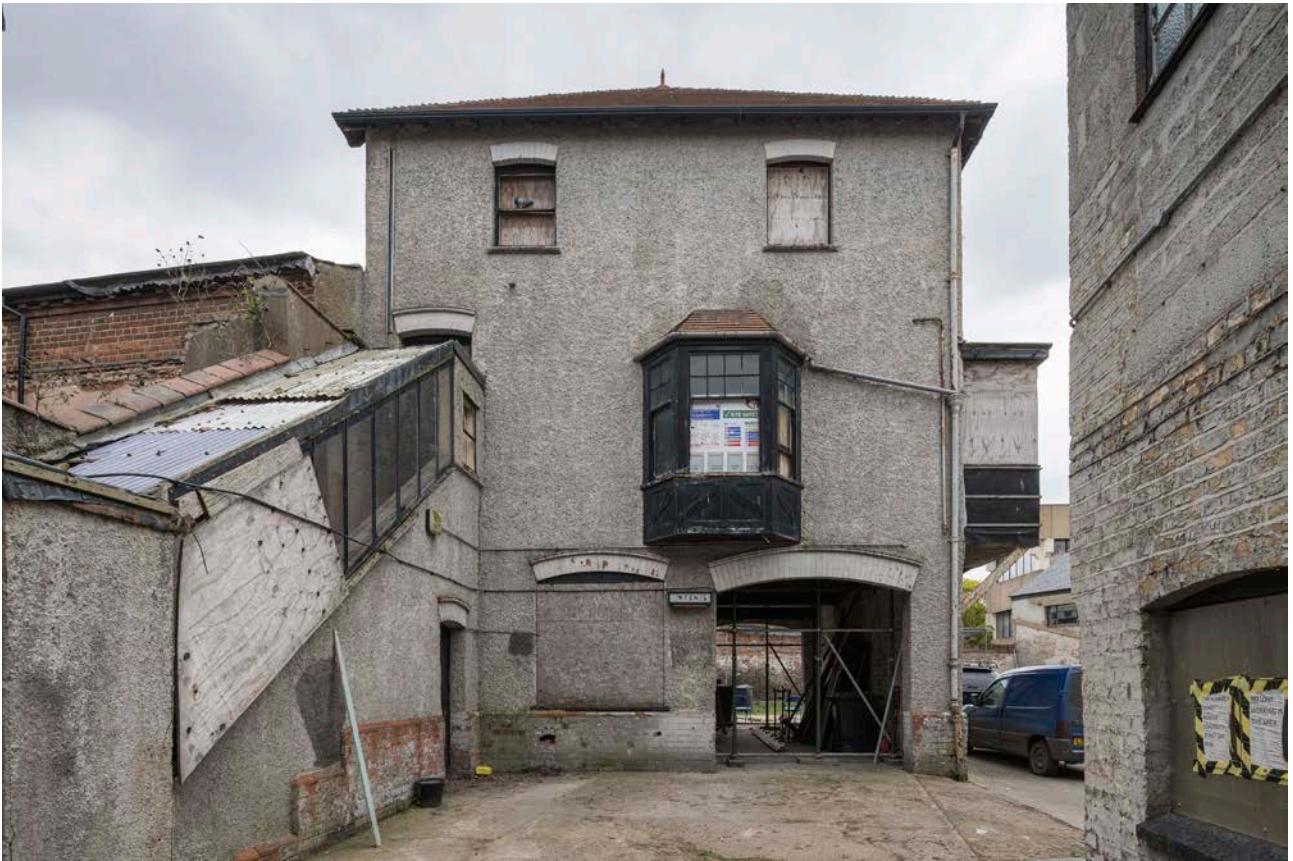
Figure 141: The north elevation of the garage building, constructed circa 1914, looking south. [Steve Baker © HEA DP325651]

The documentary evidence identifies a significant phase of restoration and alteration to the site which began in 1914 with the construction of the detached garage building to the south-west of the great inn range (Figure 141). This three-storey brick building replaced an earlier unit in roughly the same position, which appears to have provided a billiard room and other public spaces. The replacement building seems to have provided a garage bay with inspection pit at ground-floor level, with vehicle access via two large doorways in the north and south elevations. An external stair led to the main entrance to the building at first-floor level. The original plans suggest that the upper floors were intended to provide private accommodation, but by the time of the 1930s changes to the building (see below) the first floor was once again being used as a public space. It may be that it had a public use from the time of its reconstruction, reflecting the historic pattern of use rather than what was envisaged in the design drawings.

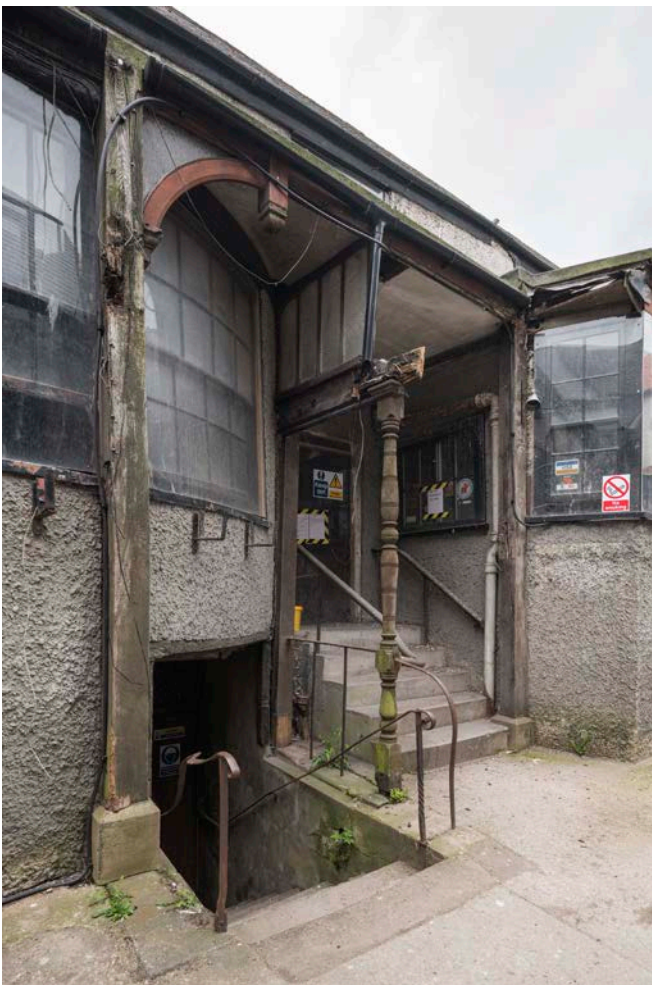
Figure 142: The entrance in the west elevation of the great inn range, looking south-east, showing elements of applied timberwork which was inserted in around 1919. [Steve Baker © HEA DP325656]

The documentary evidence indicates that as well as the construction of the garage block there was significant investment in the other buildings on the site – with plans surviving for the replacement of the shopfront at 19A, the recladding of the front of the building in applied timber-framing, and the creation of a timber Jacobean-style pediment (see Figures 16 and 19). At around the same time a similar historicisation of the great inn range took place, with a gallery created along the western side of the range, accessed via a doorway inserted into the north wall of the south-west wing at first-floor level (see Figure 15). Much of this work appears to have been superficial and has subsequently largely been lost; however, the remaining timbers forming the post at the base of the entrance steps and part of the associated archway over the cellar stairs appear to belong to this phase (Figure 142). To the south, the main structural intervention was the construction of a lean-to block onto the western part of the original southern end of the great inn range to house toilets and other services. Internally the plans indicate that a corridor arrangement was created along the eastern side of the range at first-floor level, and a bathroom inserted within the earlier landing space at the top of the stairs. These subdivisions have recently been stripped out.

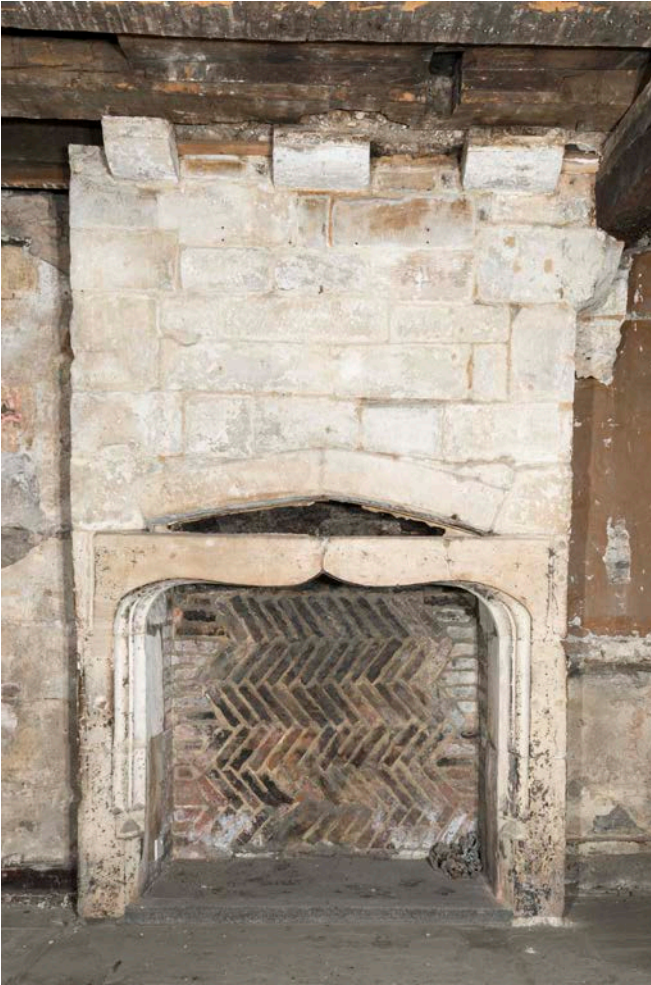
Figure 143: The stone chimney stack and fireplace inserted into the central ground-floor room of the great inn range, possibly also around 1919, looking east. [Steve Baker © HEA DP325623]

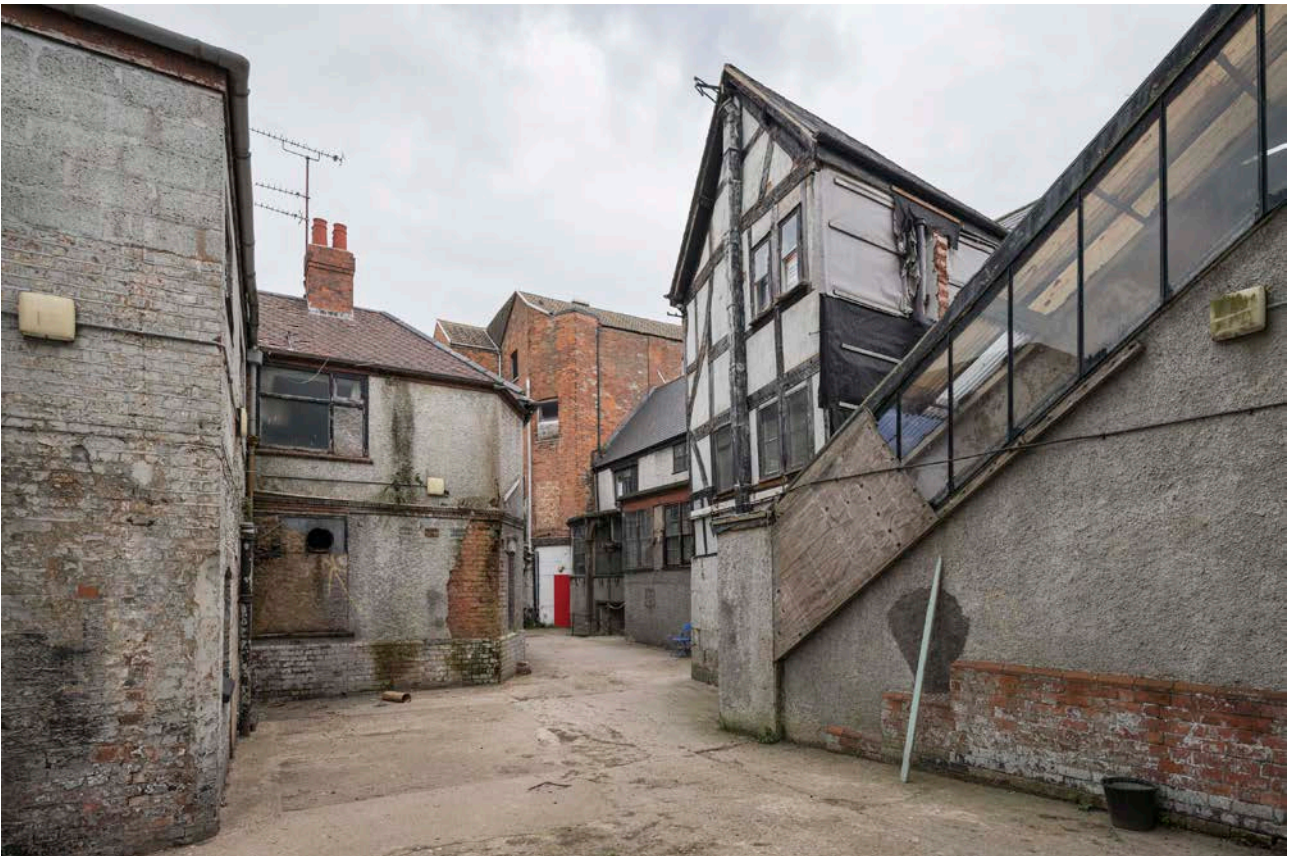
Figure 144: The courtyard of the Fleece, showing the brick building added at the southern end of the west range, added in the early 20th century, looking north-east. [Steve Baker © HEA DP325649]

Other features of this phase which do not have surviving planning records included the construction (or probably reconstruction) of a further building at the south end of the original west range. This section of the building appears to have already been in use as accommodation for the innkeeper in the 19th century, as indicated by the Goad mapping, which labelled the southern end of the west range as a dwelling (see Figure 12). The surviving bay, however, is formed of brick, with a moulded dentilated frieze between ground- and first-floor levels which matches that on the garage building of 1914 (Figure 144). It seems likely therefore that this bay was reconstructed at around the same time. It is shown with its present form (identifiable from the canted south-east corner) on the OS map of 1923 (see Figure 17). A plan for minor modifications to this area survives from the 1930s. This indicates that as constructed the building had provided a small kitchen and living room at ground-floor level with two bedrooms above. This area is currently inaccessible.

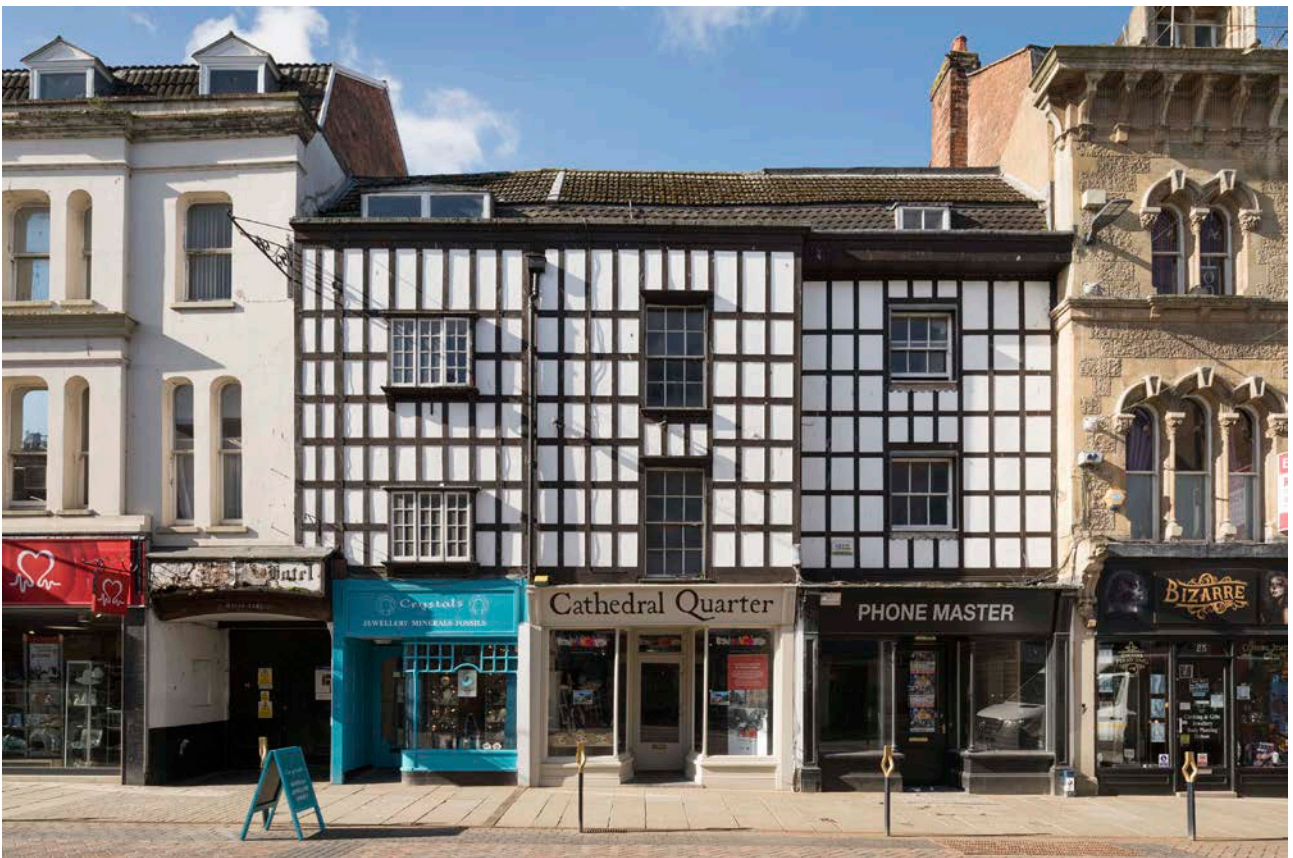
Figure 146: North elevation of the street-front range, fronting onto Westgate Street, showing the fake timber framing applied to no. 19A in the 1920s, and to Nos 21 and 23 probably in the 1970s, looking south. [Steve Baker © HEA DP325614]

The most visible alteration as part of this phase may have been the cladding of the whole of the façade of the street-front range with fake timber-framing (Figure 146). This completed the framing initially applied to No. 19A earlier in the 20th century, extending it across Nos 21 and 23.

No. 23 Westgate Street sits as part of a terrace of buildings on the south side of Westgate Street, flanked by the remainder of the street-front range of the Fleece to its east and by No. 25 to its west (see Figure 146). It runs on a narrow plot, orientated north to south, fronting onto Westgate Street to the north. To the south it is bounded by buildings which form part of the rear courtyard of the Fleece. This plot arrangement, including the rear courtyard and its access onto Bull Lane to the west, was established by the late 15th century and very likely reflects an arrangement that had existed from much earlier in the medieval period.

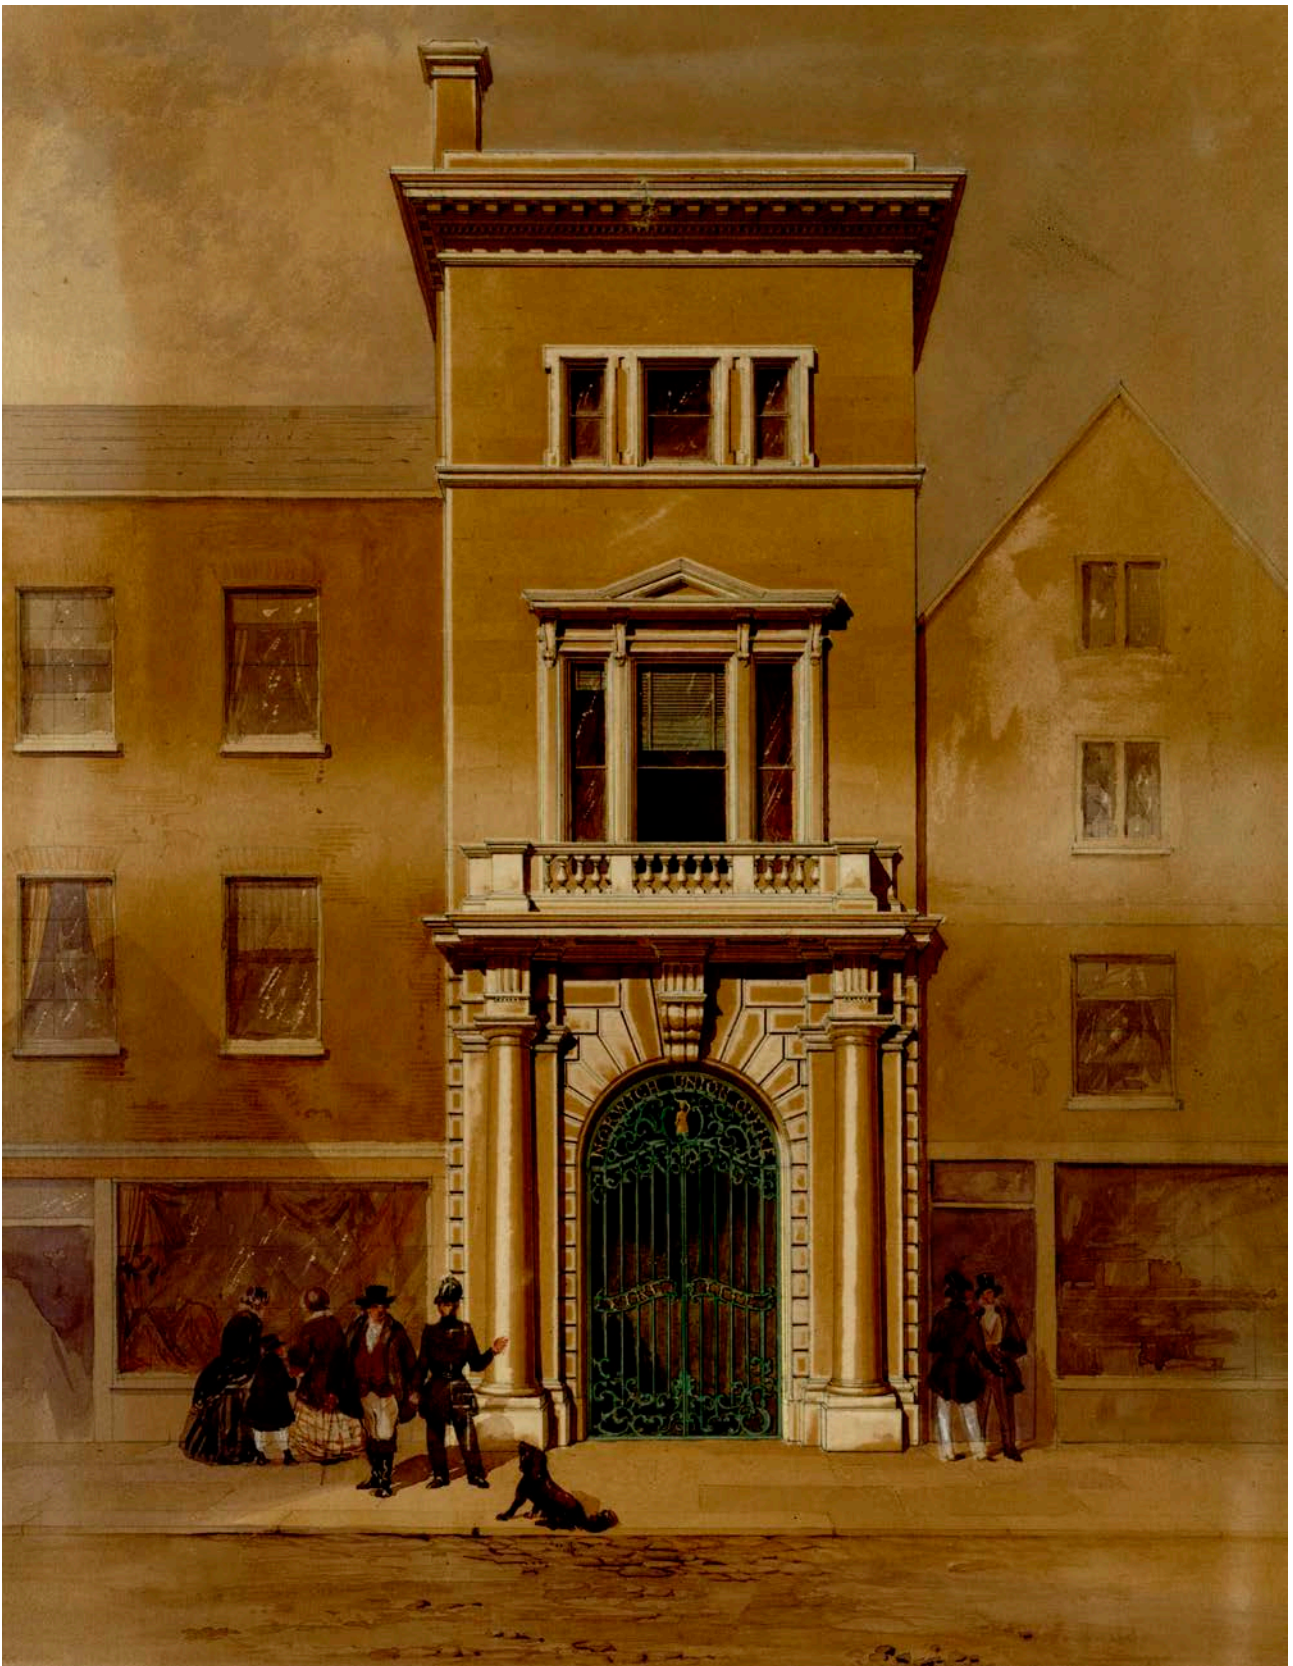
Figure 147: The north elevation of 23 Westgate Street, as designed by the Norwich Union Fire Insurance Company circa 1850. [© Aviva Archives NU5178. Reproduced with permission.]

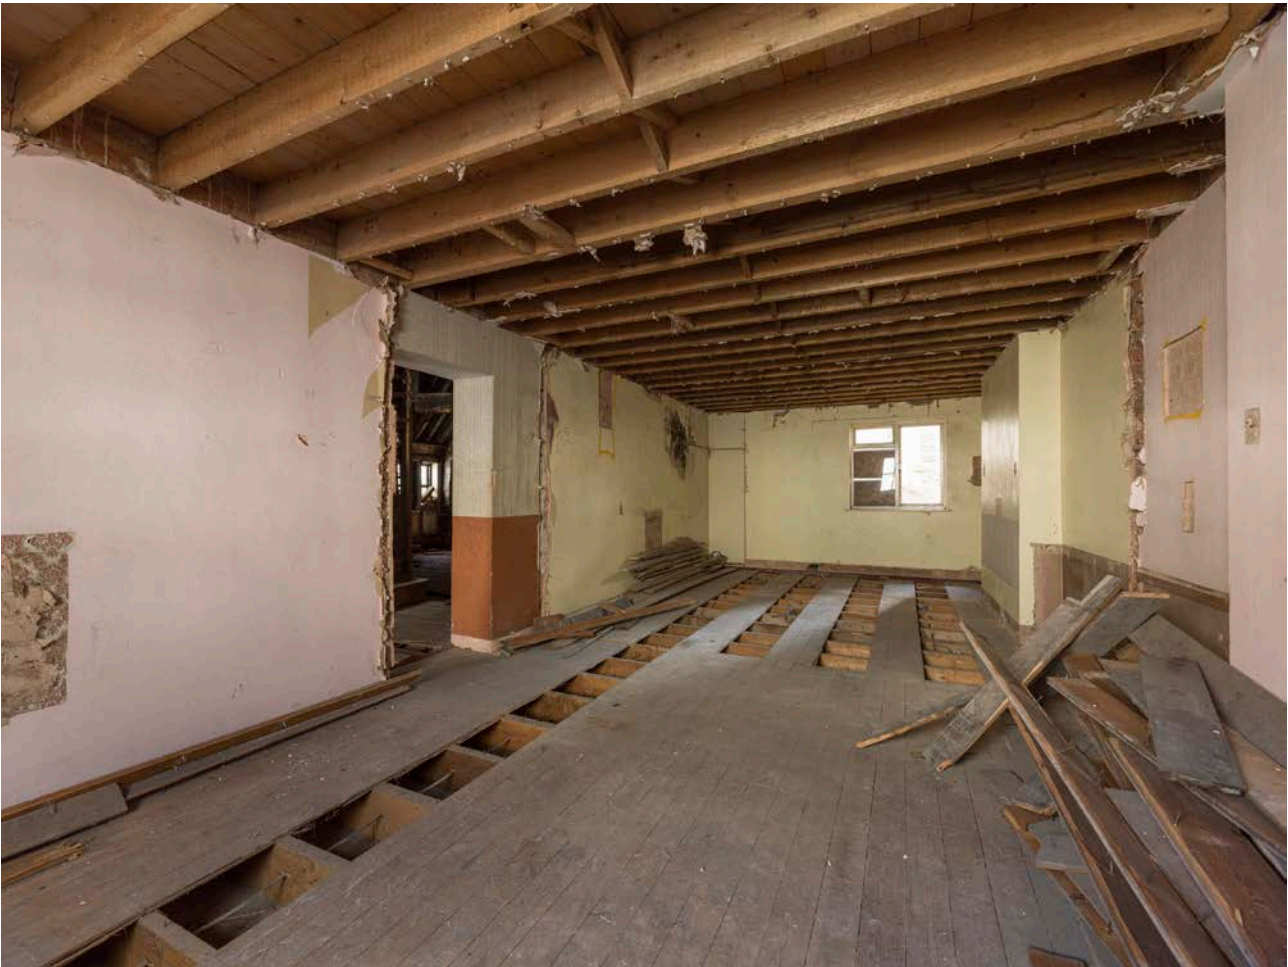
Figure 148: The first floor of No. 23, looking south-east, with floor levels as reconstructed in the 1970s. [Steve Baker © HEA DP325649]
