# 10 Church Street, Tewkesbury, Gloucestershire

## Historic Building Investigation

Johanna Roethe

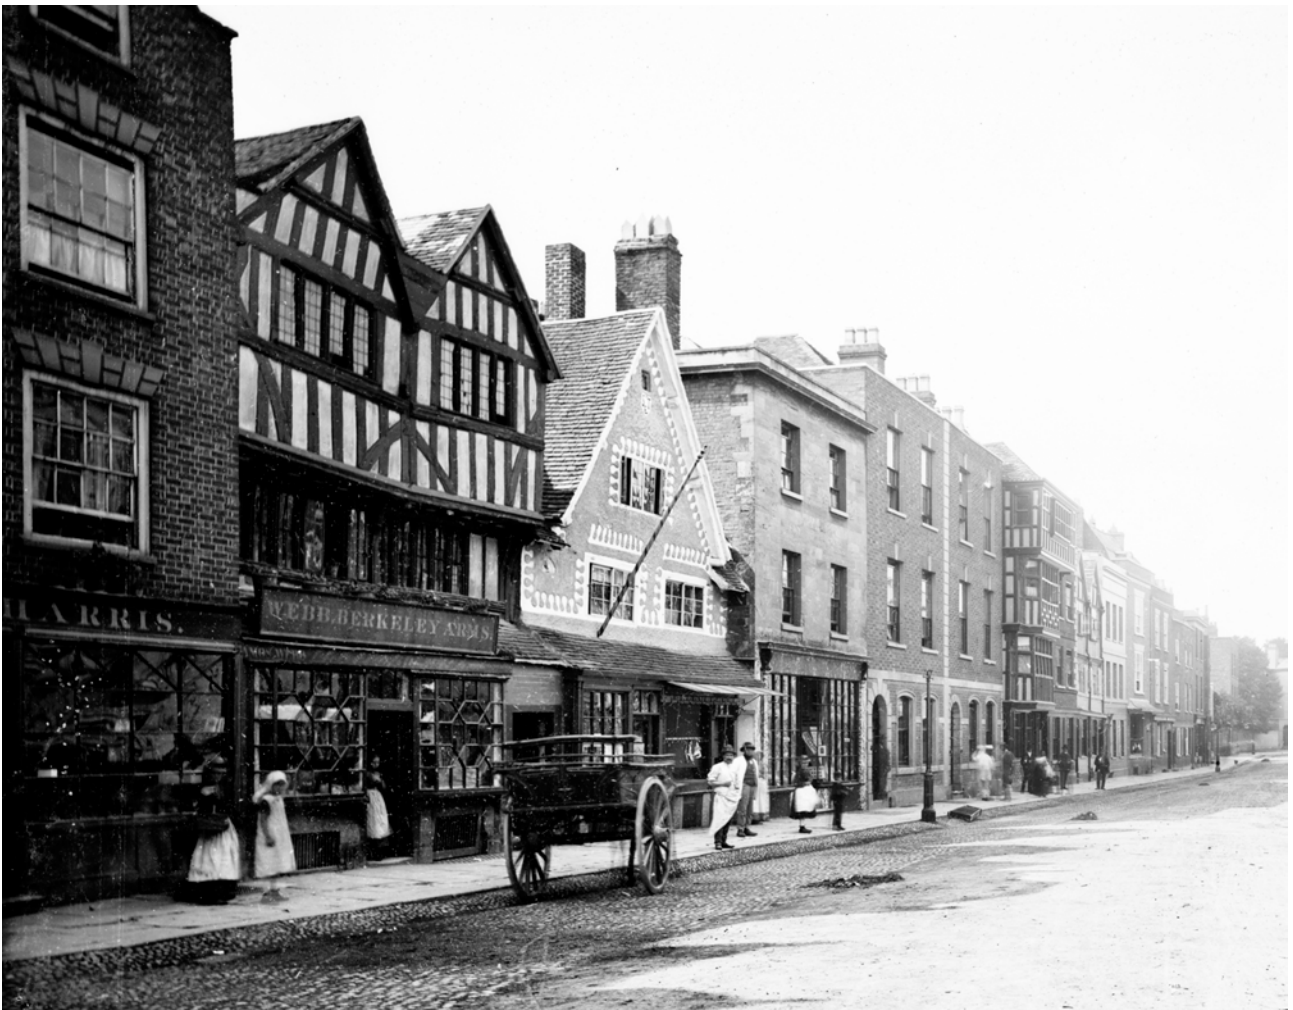
Figure 5: Detail of a photograph of Church Street looking south-west, taken before 1895 by Henry W. Taunt. 10 Church Street is the fourth house from the left. [Source: Historic England Archive, CC57/00312]

A photograph by Henry Taunt shows Church Street in the last quarter of the 19th century (Figure 5). It was taken some time before 1895, the year the adjacent property, 9 Church Street, was restored.<sup>51</sup> This photograph shows the surviving shopfront of 10 Church Street already in situ. It may have been installed for Mr Rossiter in the 1880s or Mr Alder in the early 1890s.

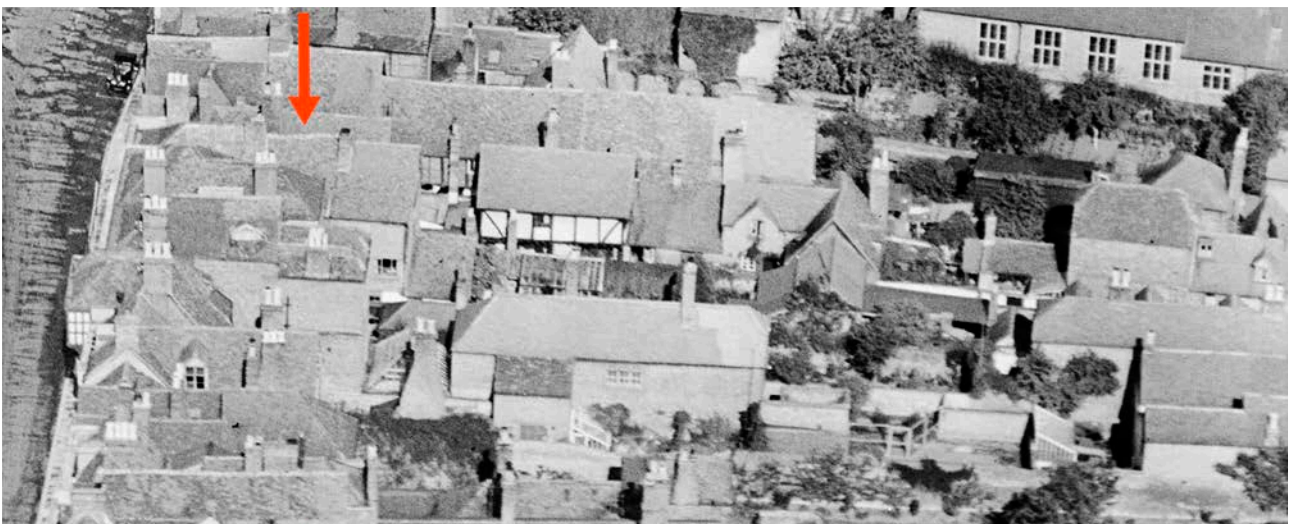
Figure 8: Detail of an aerial photograph taken in September 1928, with a red arrow indicating the roof of 10 Church Street. [© Historic England Archive. Aerofilms Collection, EPW023945]

A detail from an aerial photograph of September 1928 shows the roof line of 10 Church Street from the west (Figure 8). It shows the hipped roof to the north bay of the house, a chimney stack between the north and middle bays and another stack at the north end of the south bay. Behind the building was a short, one-storey extension with a pitched roof. In the garden to the south was what appears to be a greenhouse.

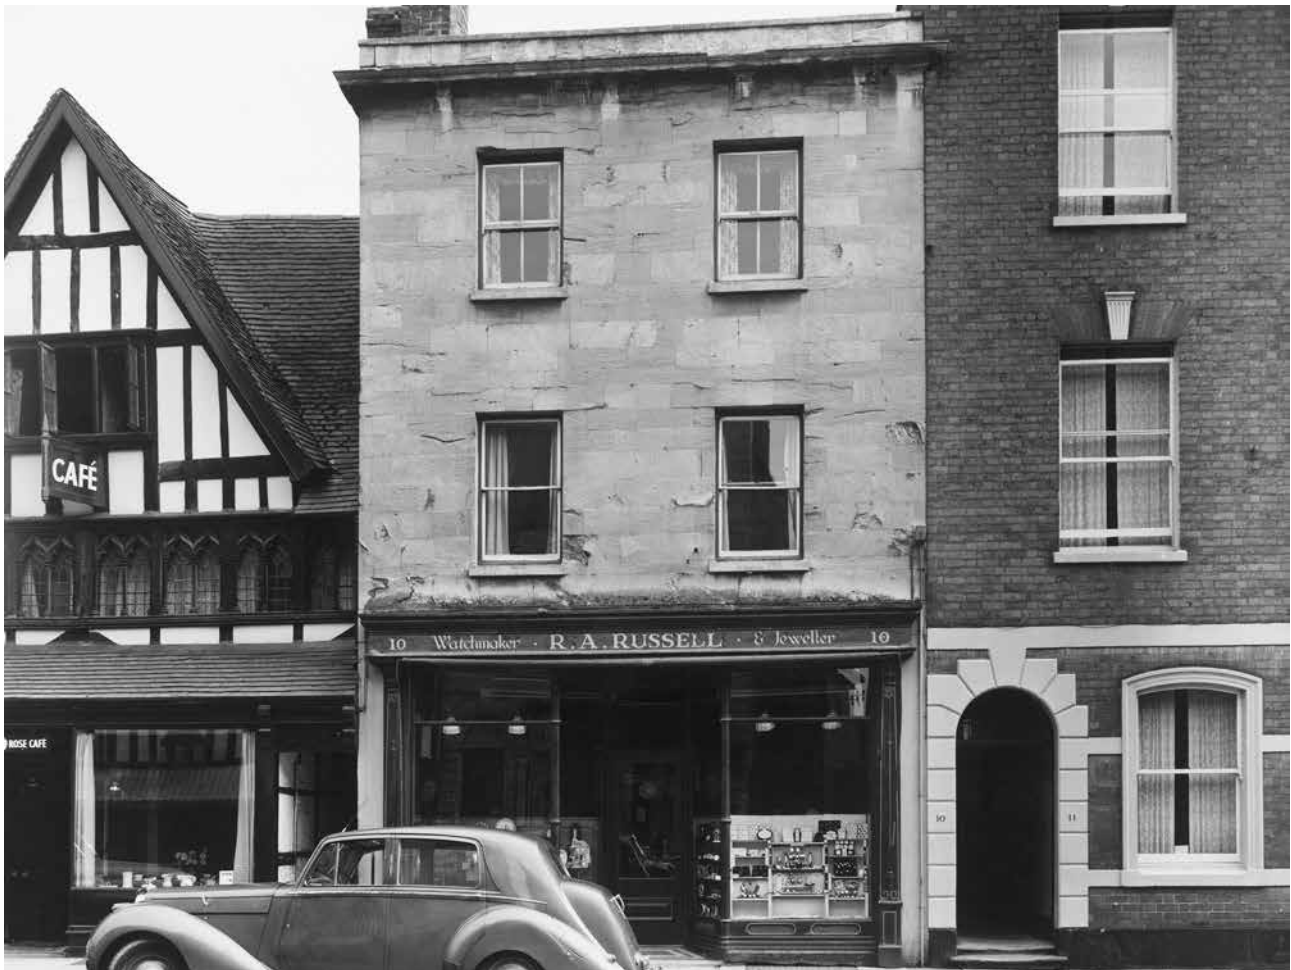
Figure 10: 10 Church Street in 1957. [Source: Historic England Archive, TEW01/01/X74794]

In 1952 the building was first added to the statutory list of buildings of special architectural or historic interest.<sup>73</sup> The following year the watchmaker Raymond Alfred Russell took out a seven-year lease of 10 Church Street.<sup>74</sup> A photograph of 1957 depicts the building during his time (Figure 10). It shows that the stonework of the upper storeys was in poor condition and that the cresting on top of the shopfront had been removed. The numbers '10' and '11' were painted on either side of the archway into Packer's Court, indicating that side access to 10 Church Street was still possible without needing to go through the shop.

Further minor alterations have been made since the 1950s and it is not always possible to assign a precise date. At some point after 1957 the stone of the front elevation, which had been in poor condition in 1957 (see Figure 10), was rendered and the design of the vents in the stallrisers altered from two per panel to one. The staircase in the south bay of the building, which leads from the ground to the first floor, was inserted (Figure 49). The plain design of the balusters and newel posts suggest a date in the second half of the 20th century.

At some point after 1957 the former door from Church Street to Packer's Court, which was formerly shared between 10 and 11 Church Street (see Figure 10), was fully incorporated into 11 Church Street. However, access to the court from 10 Church Street is still possible from the south. Between 1966 and 1983 the chimneystack at the north end of the south bay was completely removed, the roof of the rear extension changed to a flat roof, a canted projecting window installed in the south elevation at first-floor level and the second-floor south window widened (see Figures 11-13).

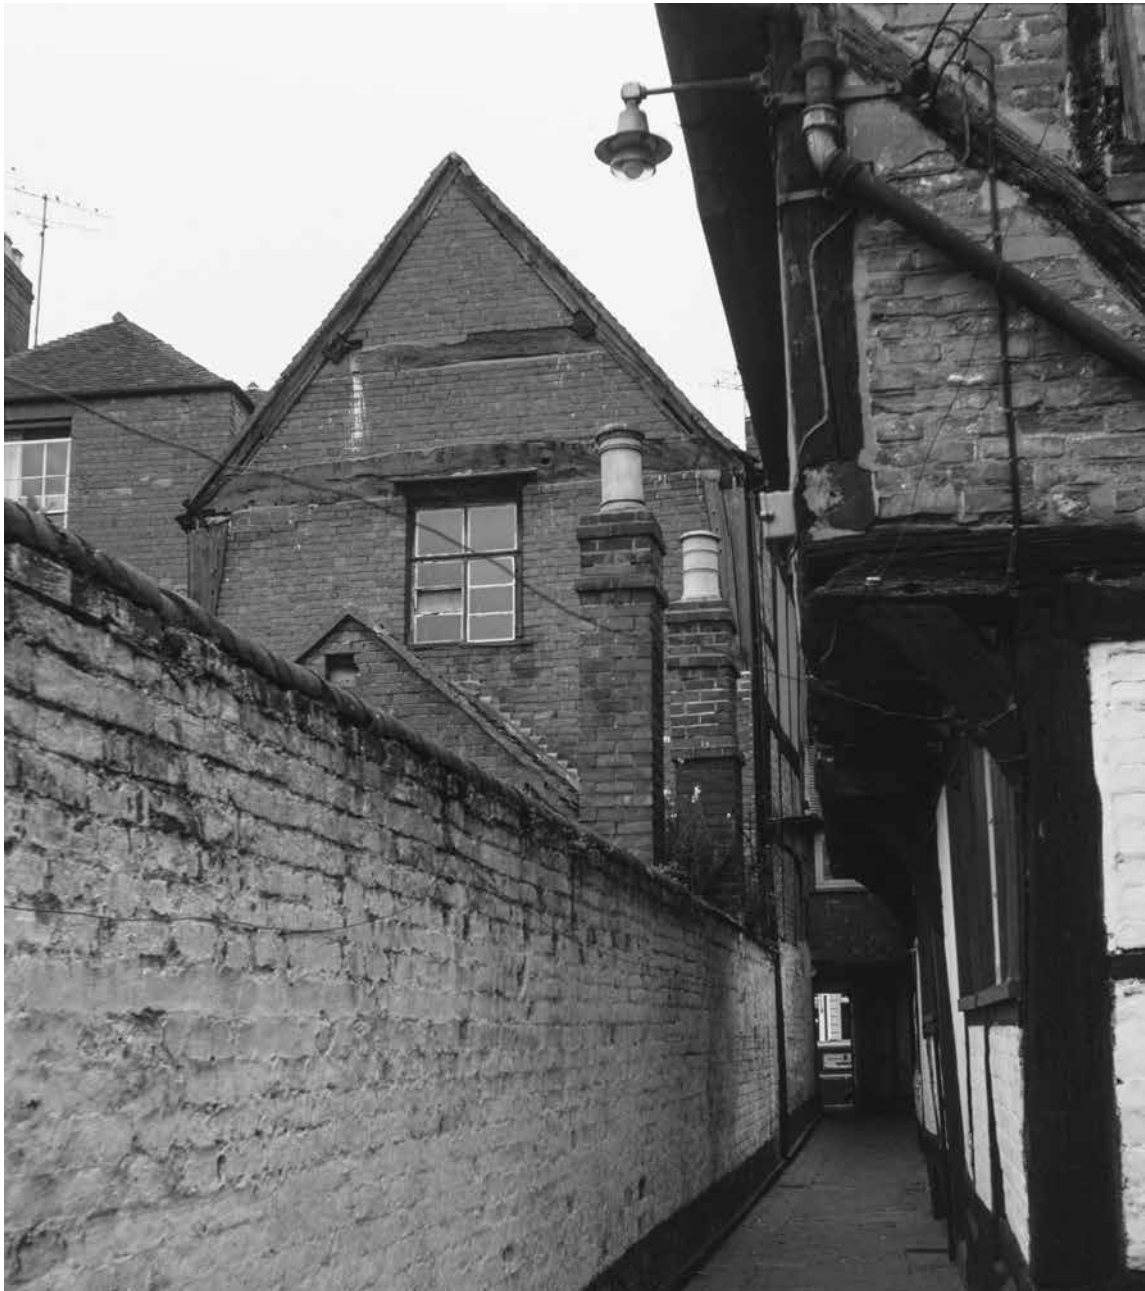
During his work for the Victoria County History volume for Tewkesbury in about 1966-8, Stanley Jones photographed the rear of 10 Church Street (Figure 11). It shows the south elevation without render and with a metal-framed second-floor window. A single-storey rear extension is shown with a pitched roof and there were two chimneystacks against the wall to Lilley's Alley.

Figure 11: Detail of a photograph taken by Stanley Jones in about 1966-8, showing the rear elevation of 10 Church Street from Lilley's Alley. [© Historic England Archive, SJC01/03/0010]

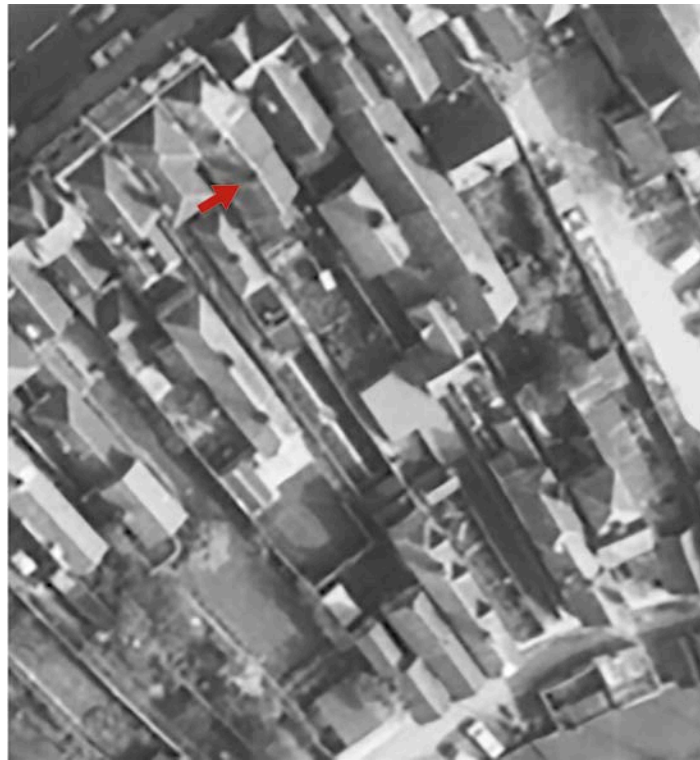
According to aerial photographs, the chimneystack at the north end of the south bay was removed between 1966 and 1983 (Figures 12 and 13). Also by 1983 the roof of the single-storey rear extension had been changed from a pitched to a flat roof and a projecting window installed on the floor above.

Figure 12: Detail from an aerial photograph taken on 21 April 1966, with a red arrow indicating the chimneystack in the south bay. [Historic England (Ordnance Survey photography), OS/66019/v/003]

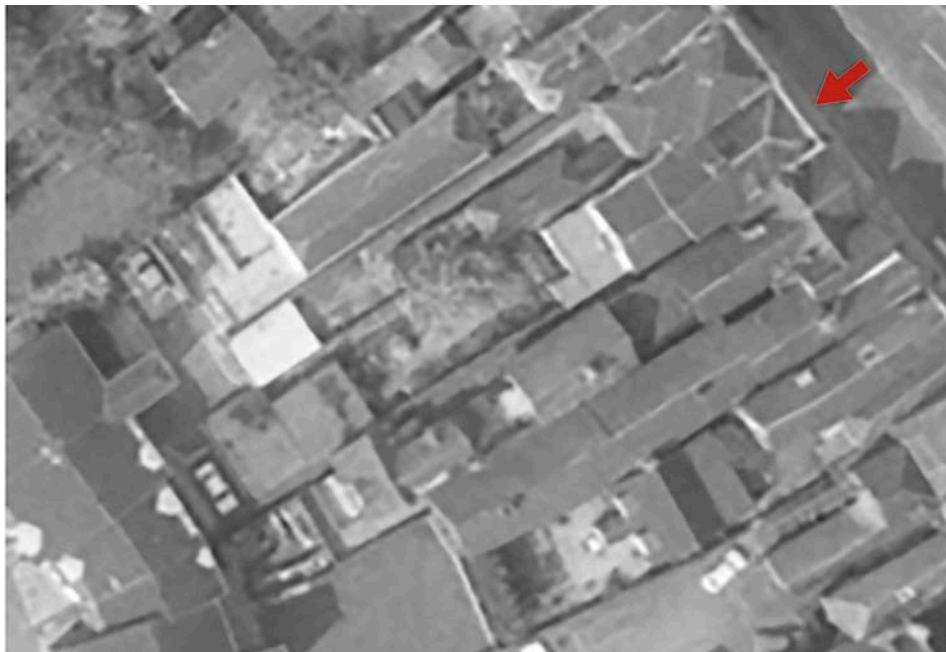
Figure 13: Detail from an aerial photograph taken on 14 May 1983, with a red arrow indicating the location of 10 Church Street. [© Crown copyright. Ordnance Survey, OS/83073/v/041]

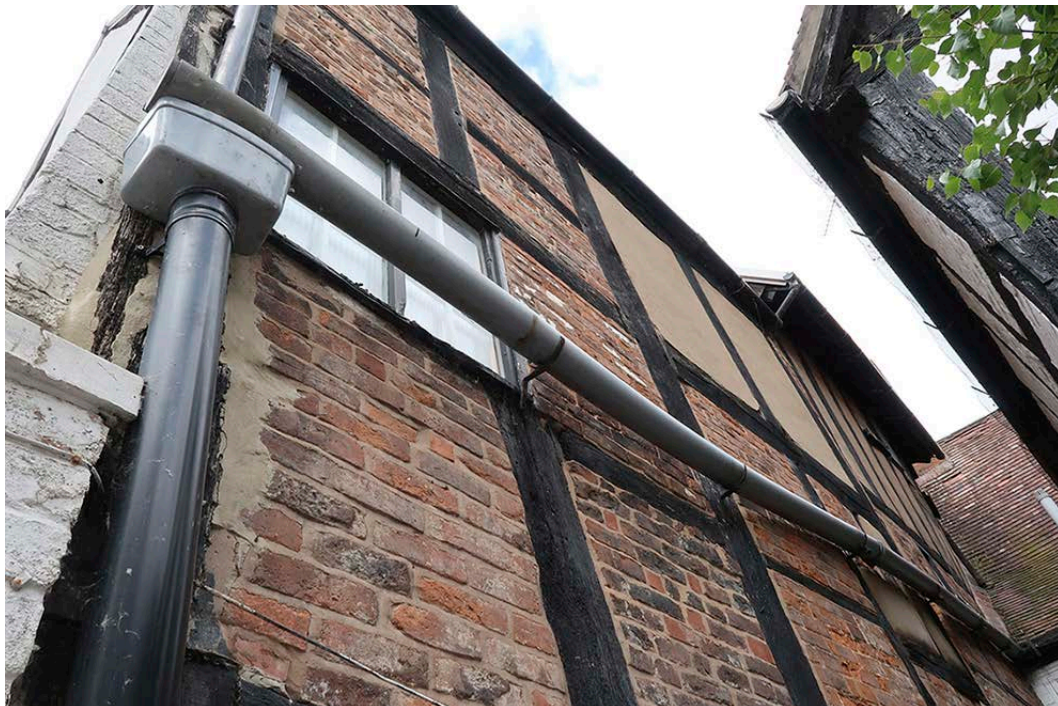
Figure 15: The east elevation of the south bay from Lilley's Alley. [Johanna Roethe © Historic England]

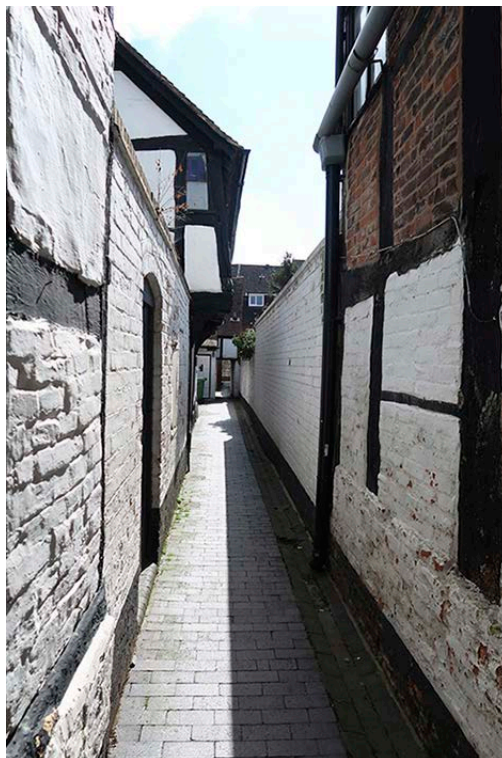
Figure 19: View of Lilley's Alley looking south, with part of the east elevation of 10 Church Street to the right. The east post of the southern pair of posts is just visible behind the downpipe. [Abigail Lloyd © Historic England]

The framing of the surviving bay comprises two pairs of posts, marking the south and north extent of the surviving framing. The northern posts are truncated, with that to the west visible at second-floor level (although it may survive further down) and that to the east surviving at first- and second-floor level. Originally however, it is likely that they would have risen the full height of the building. Of the southern pair of posts, the upper parts (at second-floor level) are visible both externally and internally. The western post of the southern pair survives internally at first-floor level as well (Figure 18). It appears to have a jowl or integral bracket perhaps to support a girding beam (although this has later been removed) but interpretation is hampered by the modern gloss paint on the timbers. The east post survives externally nearly to ground level (Figure 19). Both pairs of posts have jowled heads where they support the wall plates and the tie beams.

Between the posts on the east elevation, there is one central full-height stud rising from near the ground level to the wall plate (see Figures 15, 19). Again, it seems likely that this originally ran the full height of the building. Between these main structural elements, girding beams run at the floor levels, with further intermediate studs spanning the floor levels between these. There are also mid-rails on each floor level. Originally this must have created a regular box pattern arrangement, although some mid-rails have been removed, and others may have been inserted later. Internally, the full-height stud on the east wall has a carpenter's mark visible at first-floor level (within what is now the stairwell). This likely relates to the positioning of the stud within the bay (Figure 20). At second-floor level the three studs of the east wall are visible (Figure 21).

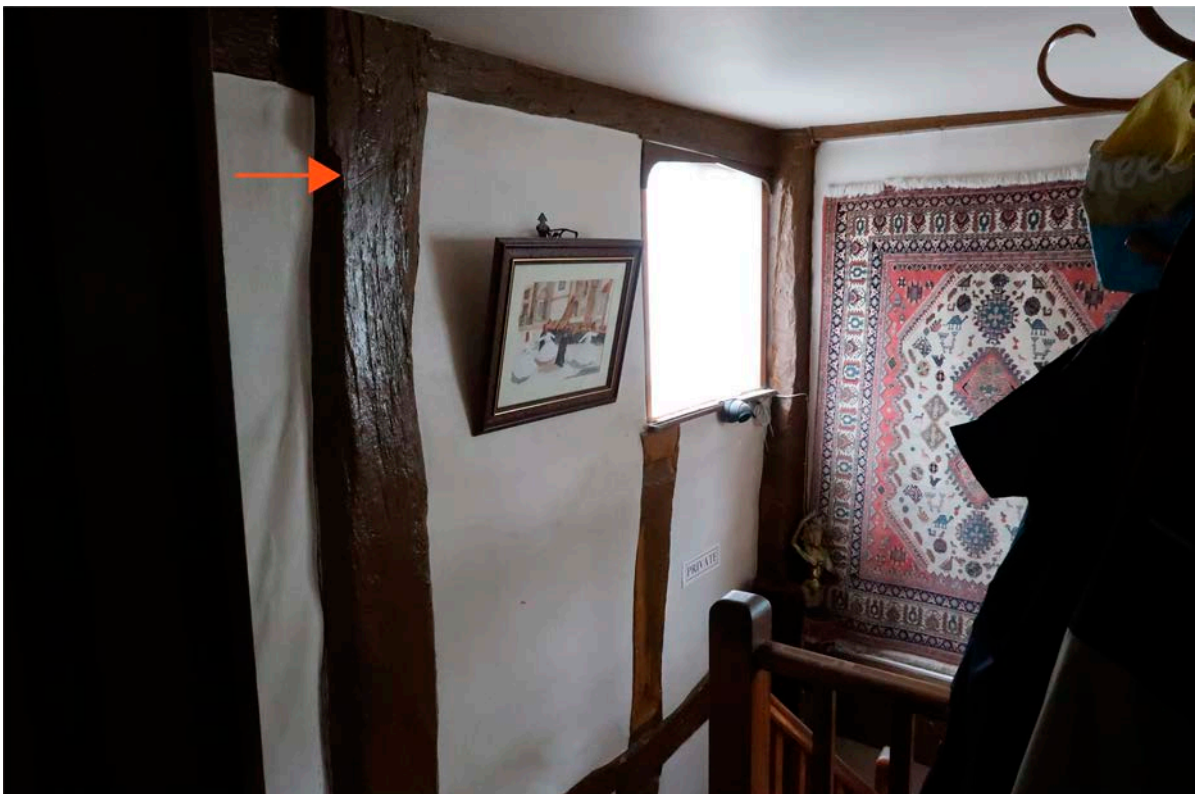
Figure 20: The south-east corner of the rear bay at first-floor level, with an arrow indicating the location of one of the carpenters' marks on the full-height stud. [Johanna Roethe © Historic England]

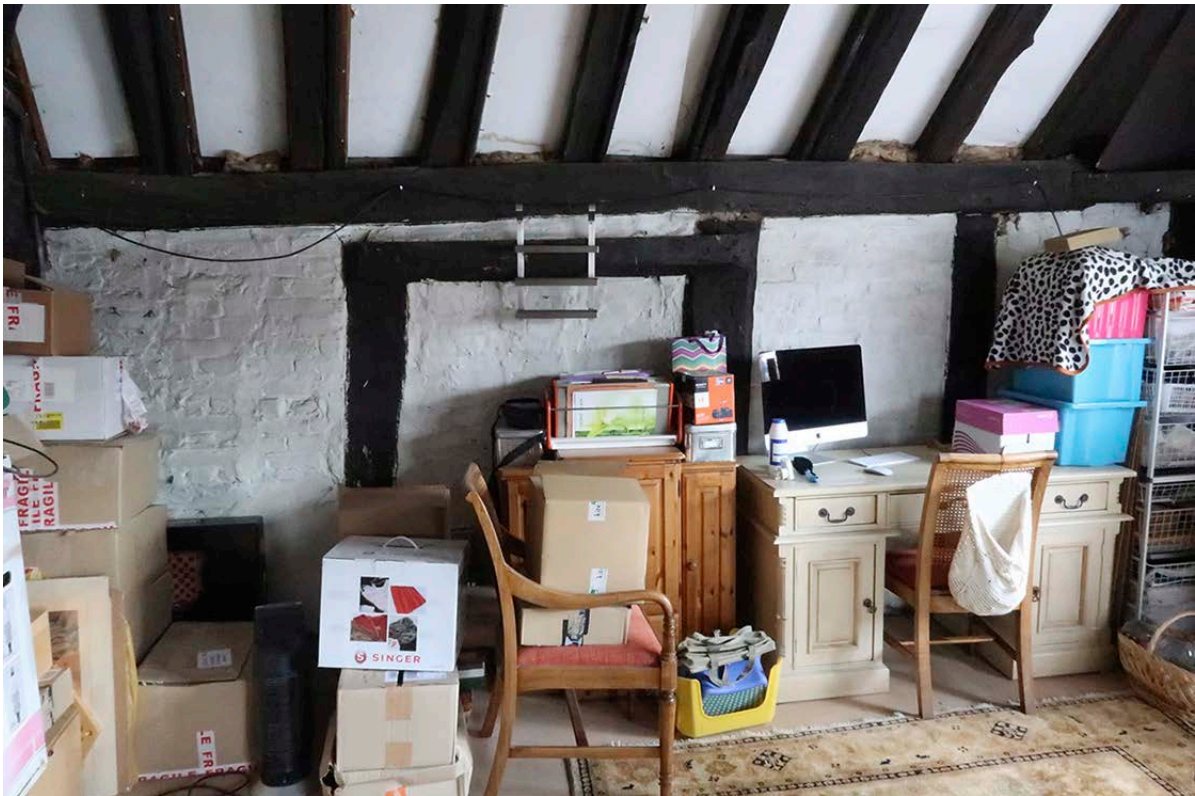
Figure 21: The east wall of the attic of the south bay, showing the three studs and wall plate (with a later horizontal timber lapped onto the inner side of two of the studs). [Johanna Roethe © Historic England]

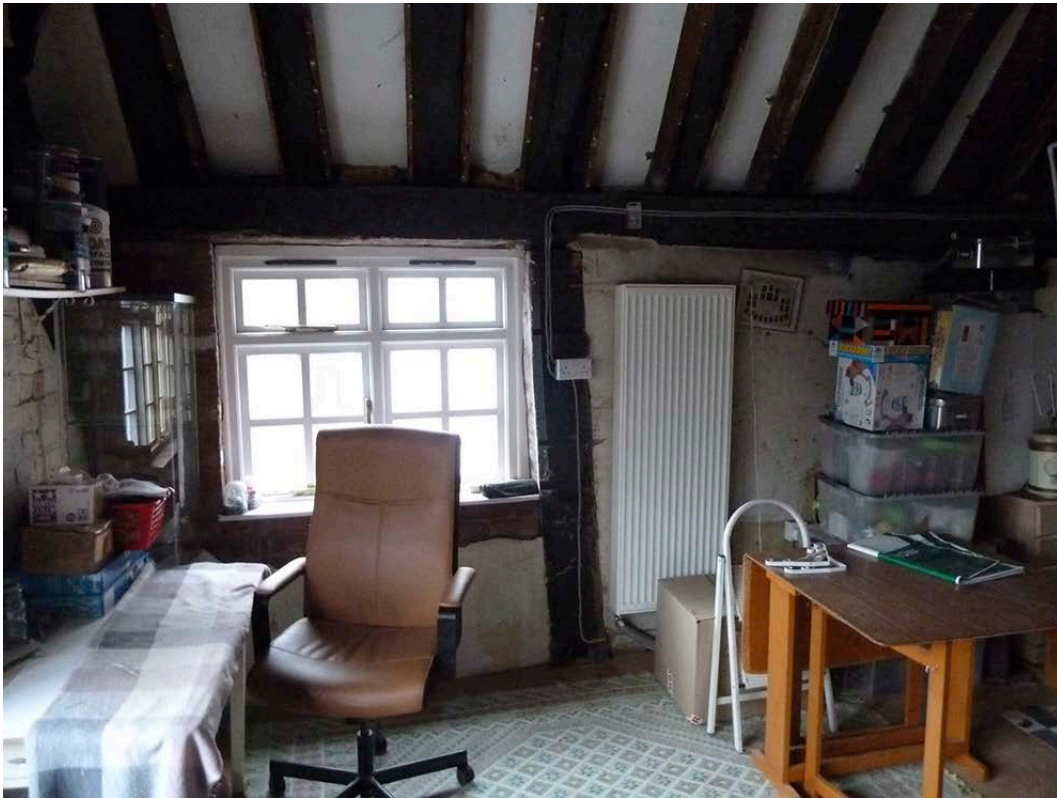
Figure 22: The west wall of the second floor of the south bay. [Johanna Roethe © Historic England]

On the second floor the west wall has one stud which is pegged into the wall plate (Figure 22). This has a chamfer on its southern edge with straight cut stops at the top and bottom – this might be taken to indicate a window position, but just to the south of the stud are two stave holes suggesting a solid wall with a wattle-and-daub partition (Figure 23). The reason for this chamfering is therefore unclear, although it may be that the stave holes are later insertions, to block an original window. There are peg holes in the wall plate for further studs to the north and south of this, equidistant between the stud and the posts to the north and south.

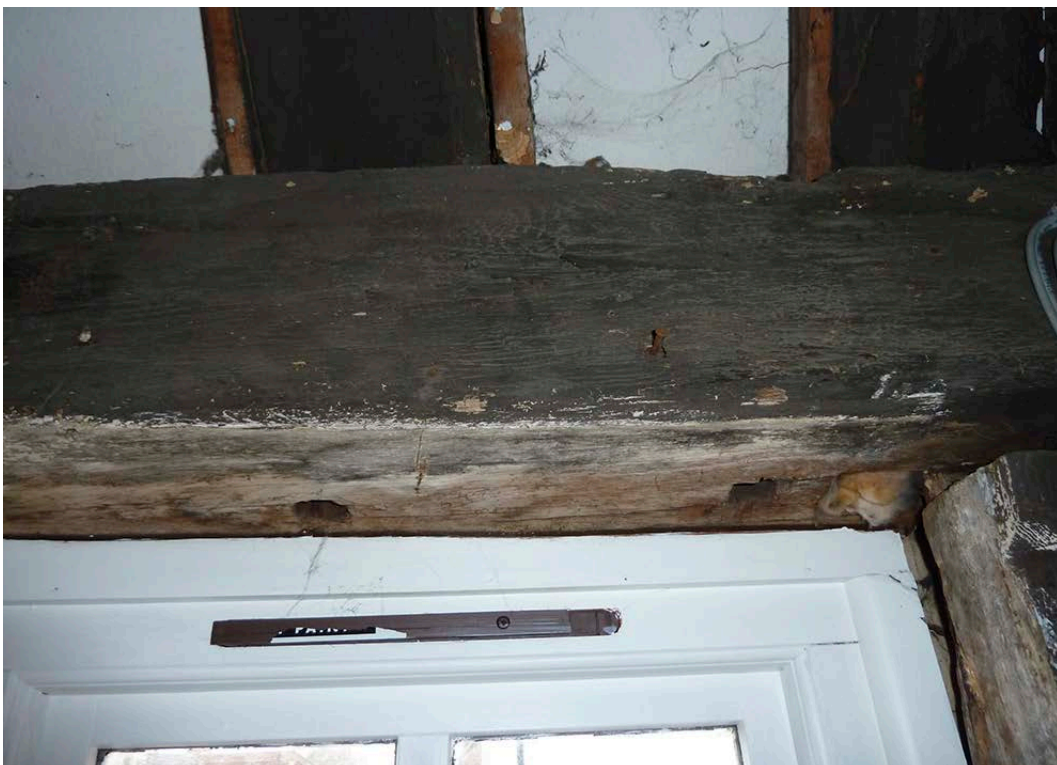
Figure 23: The underside of the wallplate in the west wall with the stave holes and the top chamfer of the adjacent stud (right). [Johanna Roethe © Historic England]

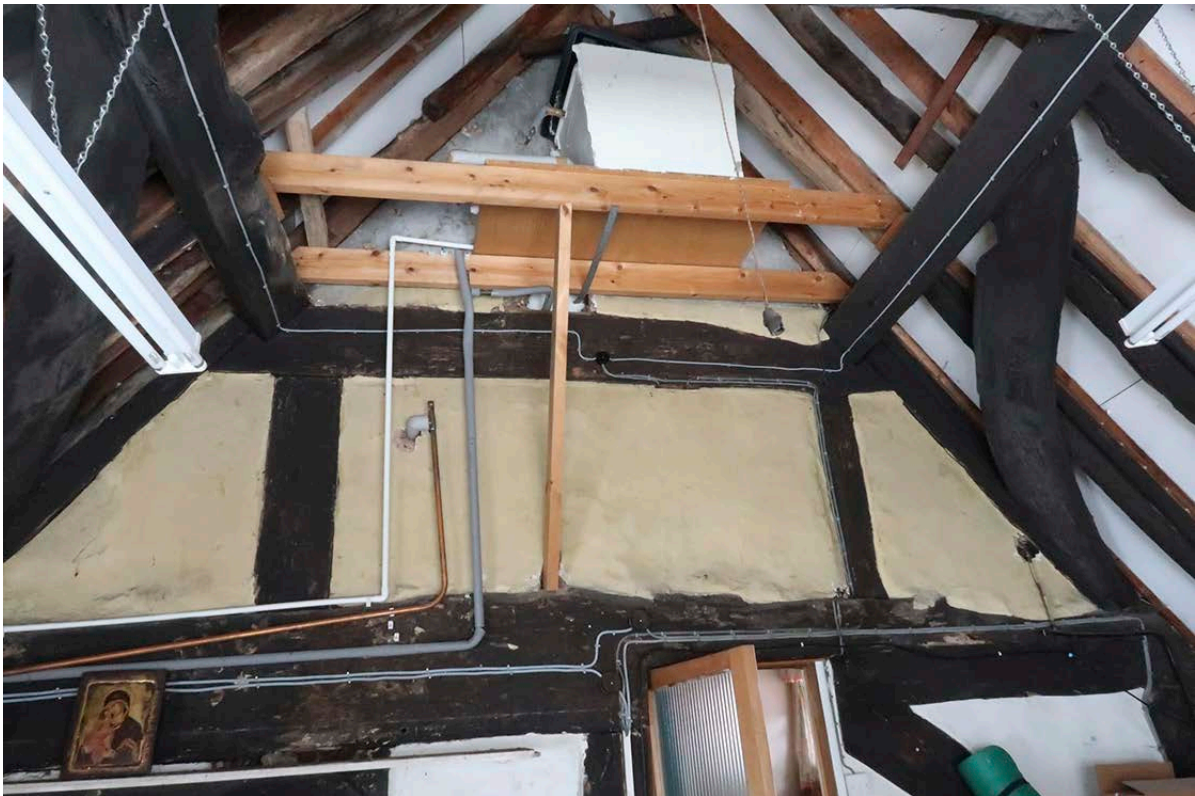
Figure 24: The upper part of the north truss of the south bay, seen from the south. [Johanna Roethe © Historic England]

Also during the 16th or 17th century a ceiling was inserted into the second-floor room of the southern building. The roof was ceiled at collar height (see Figures 24, 26, 28). This ceiling was still in situ during the 1940s, when it is shown in a sketch, which explains the lack of staining on the upper part of the roof, but has been removed since.<sup>98</sup>

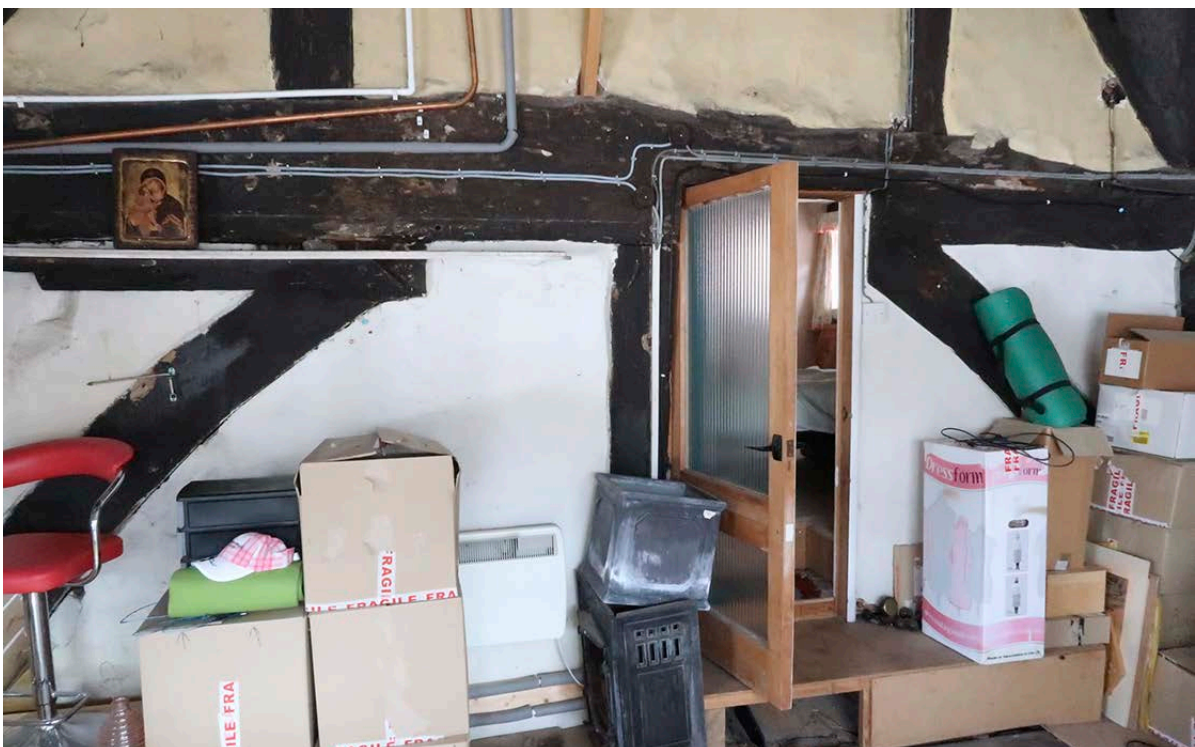
Figure 25: The lower part of the north frame of the south bay, seen from the south. [Johanna Roethe © Historic England]

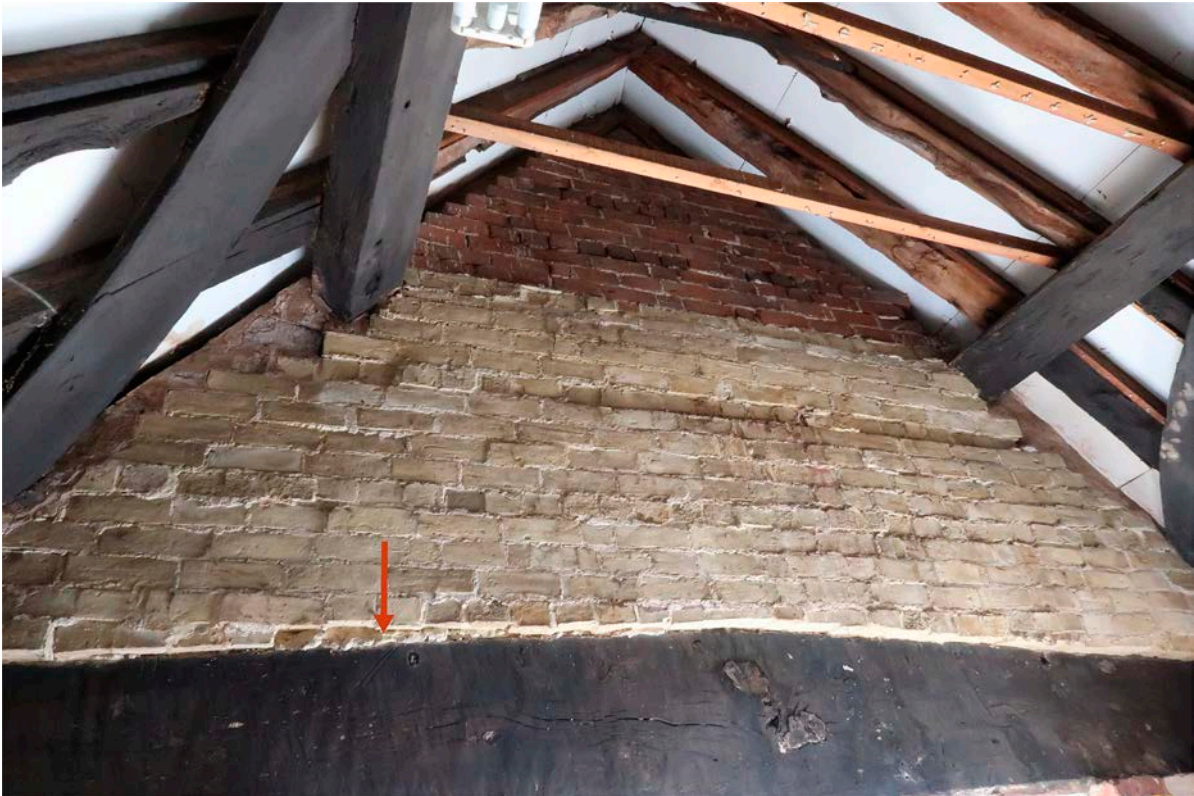
Figure 26: The upper part of the south truss of the south bay. The red arrow indicates the location of the carpenter's mark to the left of a peg hole. [Johanna Roethe © Historic England]

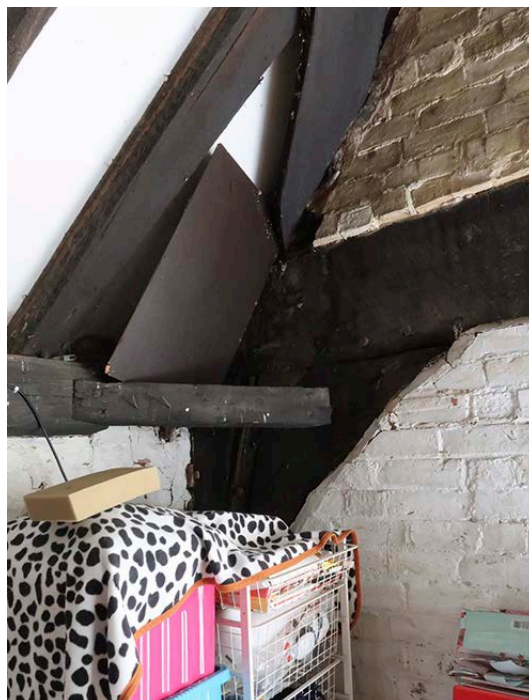
Figure 27: The knee brace in the south-east corner of the south bay (with a later timber infilling the corner between the brace, the post and the tie beam, and a further later timber spanning the corner between the wall plate and the brace). [Johanna Roethe © Historic England]

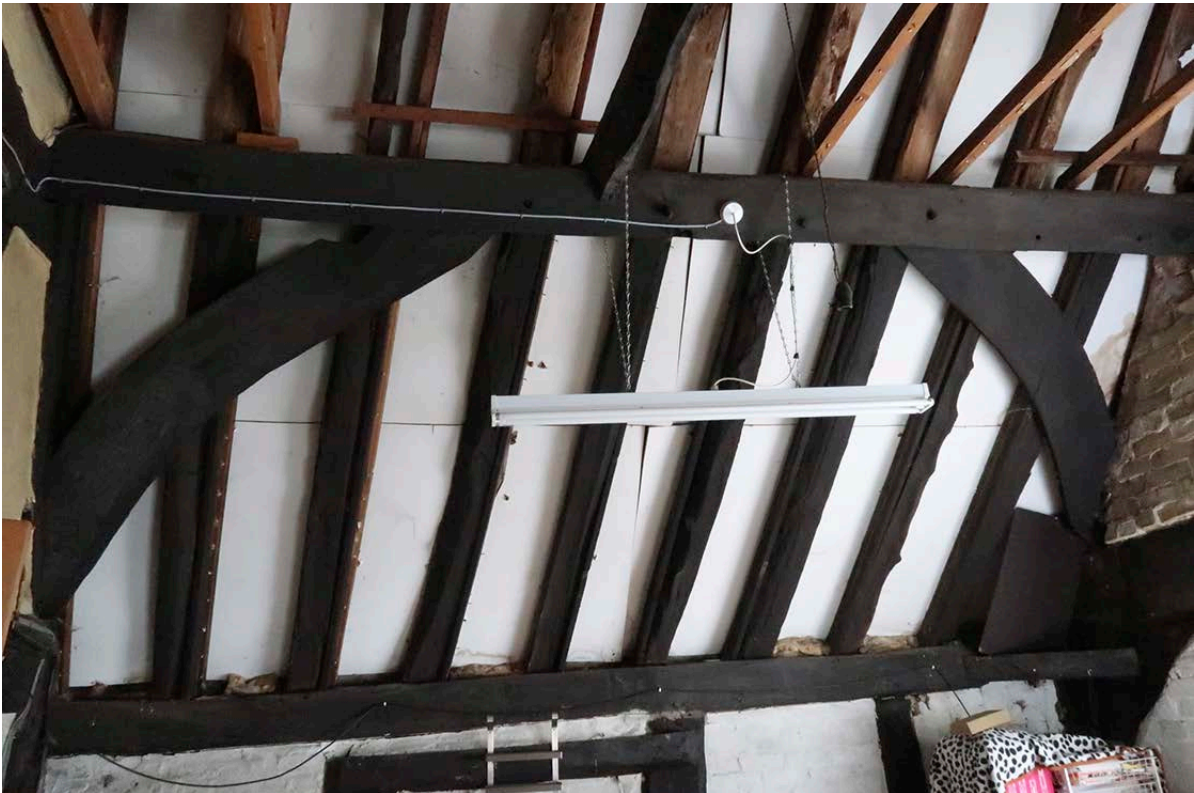
Between the north and south trusses a single row of purlins run, clasped between the collars and the principal rafters at either end. These are supported by a single tier of curved wind braces (Figure 28). Several rafters below the purlin on the west side have individual carpenter's marks (Figure 29), probably to indicate their position within the bay. The original arrangement of the north and south frames at ground- and first-floor level is unclear as the lower sections have been completely replaced, although the possible jowl in the west post of the south frame at first-floor level (as described above) suggests a pattern of cross beams at the floor levels.

Figure 28: The windbraces on the east side of the south roof. [Johanna Roethe © Historic England]

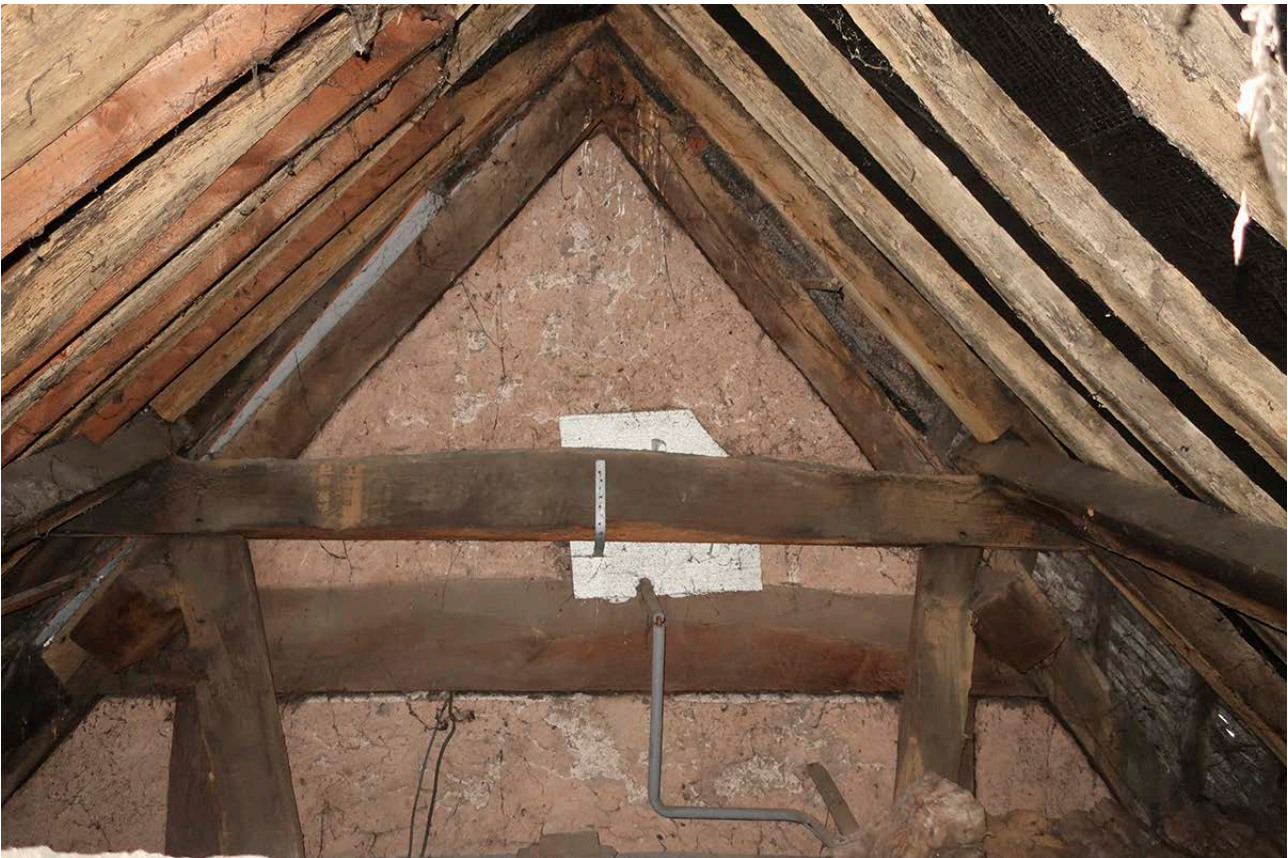
Figure 30: The closed north truss of the south bay seen from the north, with the open south truss of the middle bay in front of it. [Rebecca Lane © Historic England]

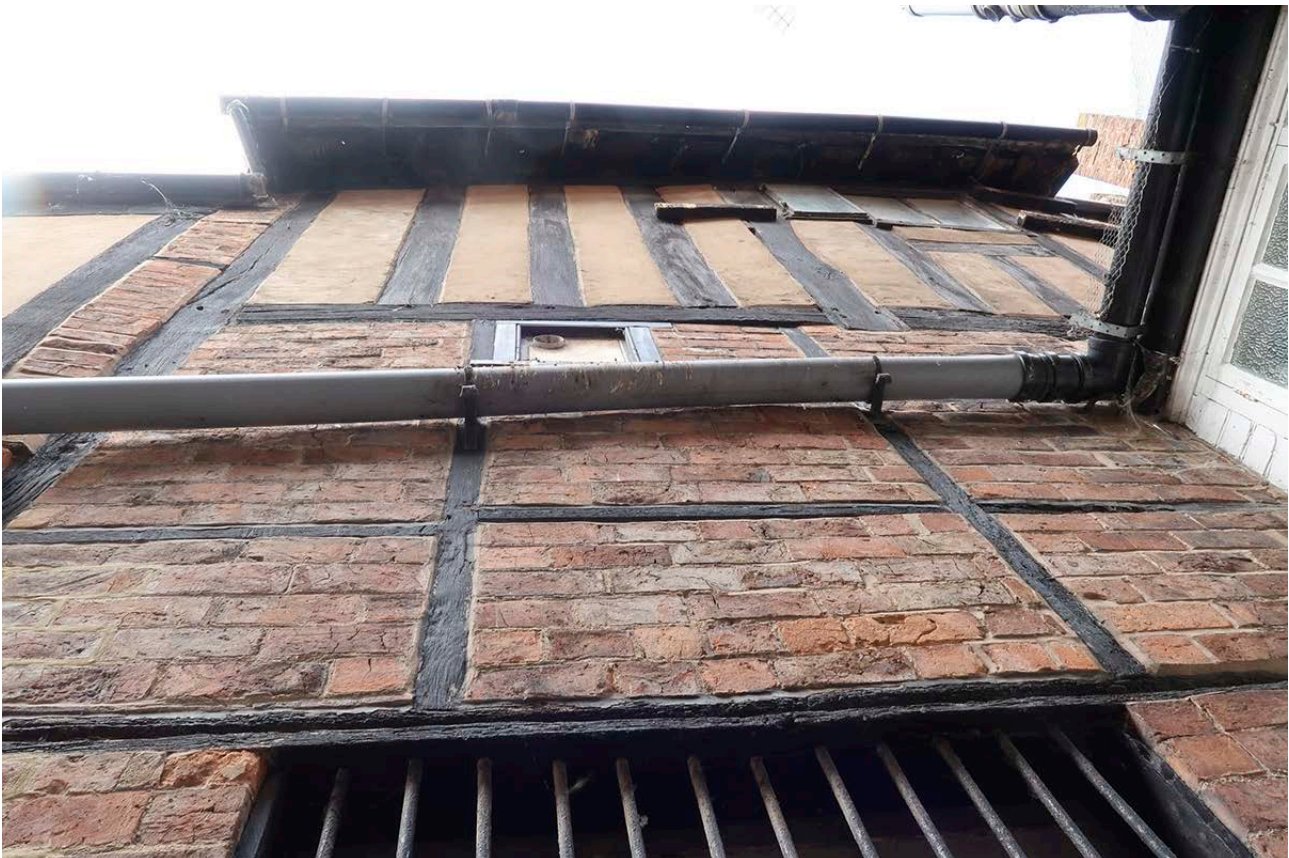
Figure 31: The close studding of the second floor of the middle bay. [Johanna Roethe © Historic England]

In 1998 the rear extension was replaced by a larger extension of the same width. Other recent repairs include the partial replacement of one post in the east elevation (see Figure 16) and repairs to the roof over the north bay.<sup>99</sup> A small, pegged timber window was inserted at first-floor level in the east elevation of the middle bay (see Figure 31).

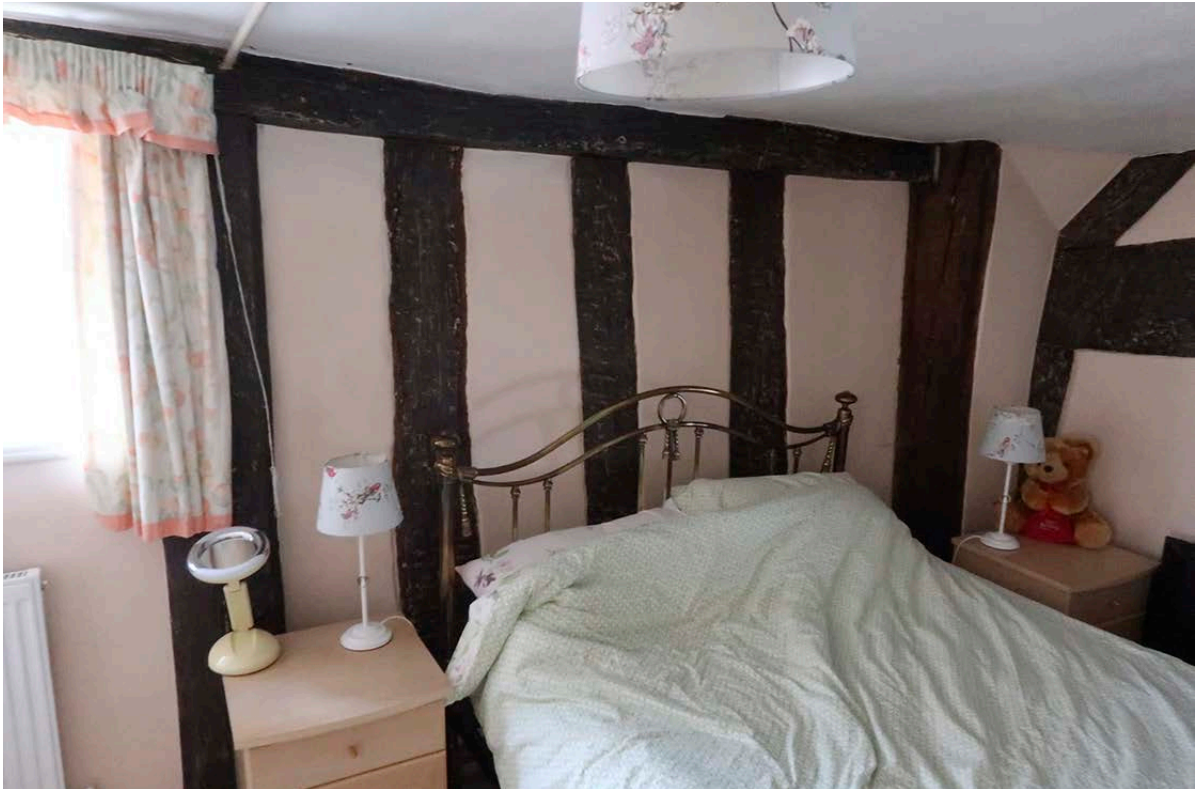
Figure 32: Close studding in the west wall of the middle bay at second-floor level. [Johanna Roethe © Historic England]

To the south, the southern frame is not visible at ground- or first-floor level. At second-floor level it is open with the junction between this bay and the truss to the south visible (Figure 32). The east post is exposed at second-floor level and there is no evidence of any original closed elements on this, perhaps indicating that, as survives at roof level, the abutting of this frame against the building to the south meant it was left open, to create a slightly larger space. Of the northern frame some elements survive, mainly at second-floor level, including curved braces at the west and east rising from the posts to the tie beam near the corner posts. On the east side the brace is visible within a cupboard on the second floor and a larger area of the west end of the framing is visible (Figure 33). There is also one central pegged strut visible running down from the tiebeam, with an area of associated daub (Figures 34 and 35). This indicates that, as originally constructed, the southern bay of this building was divided from the bays to the north at this level. The north face of the truss has taper burn marks to the post, mid-rail and brace on the west side (Figure 36).

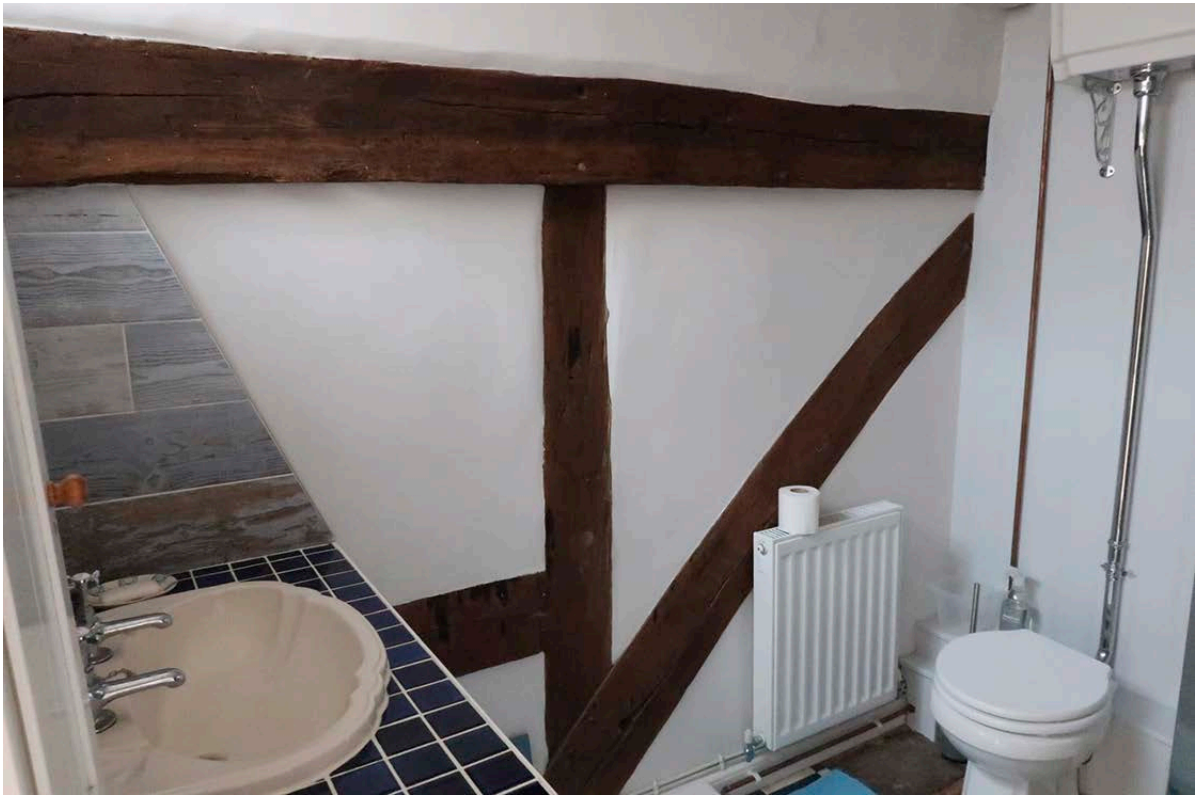
Figure 33: The west brace of the north truss of the middle bay, seen from the north. [Johanna Roethe © Historic England]

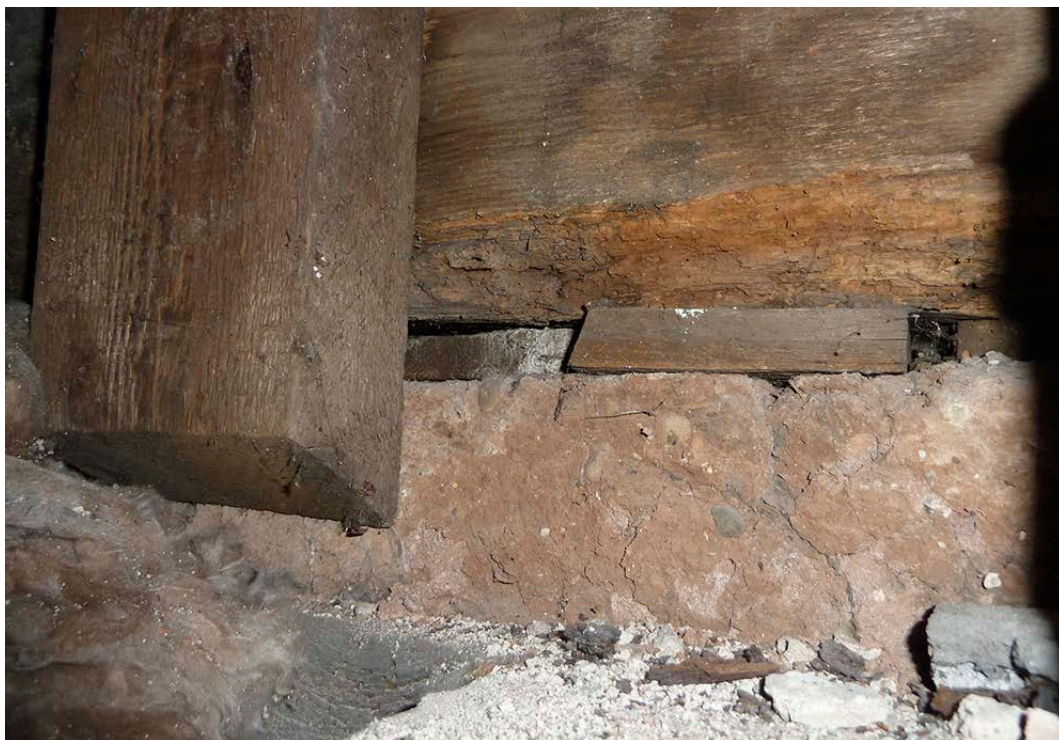
Figure 34: Remnant of daub below the tiebeam of the north truss in the middle bay. [Johanna Roethe © Historic England]
