# 10 Church Street, Tewkesbury, Gloucestershire

## Historic Building Investigation

Johanna Roethe

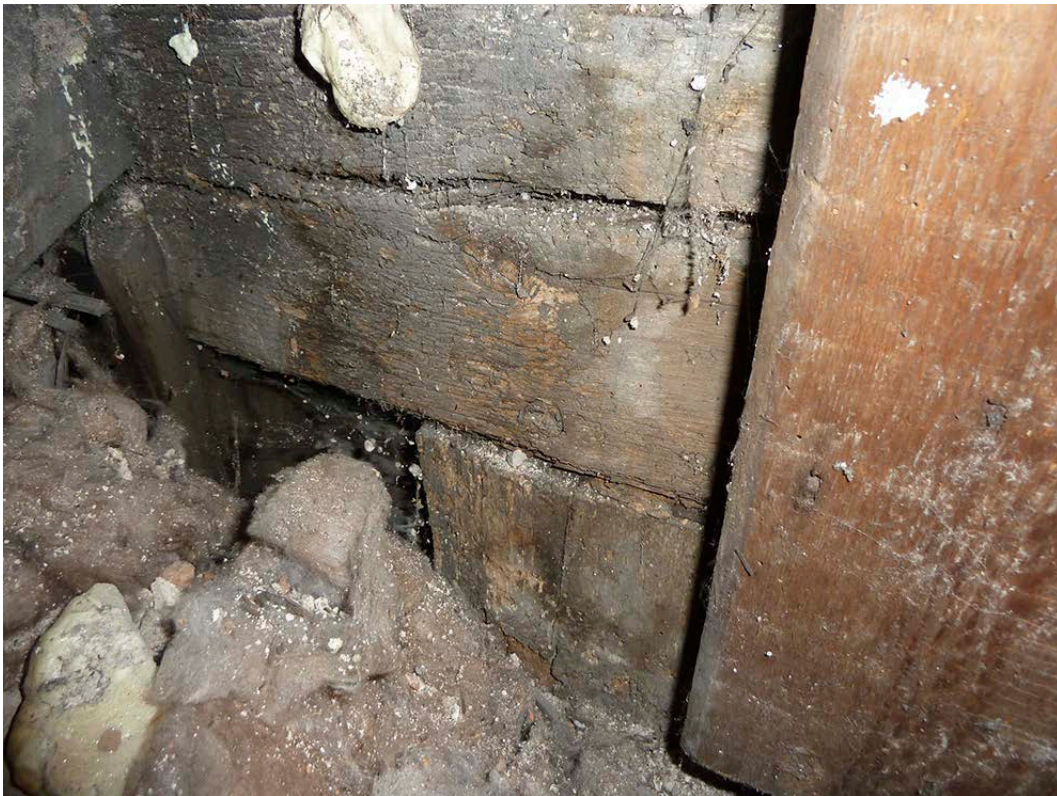
Figure 35: A pegged timber (centre bottom) below the tiebeam of the north truss of the middle bay. [Johanna Roethe © Historic England]

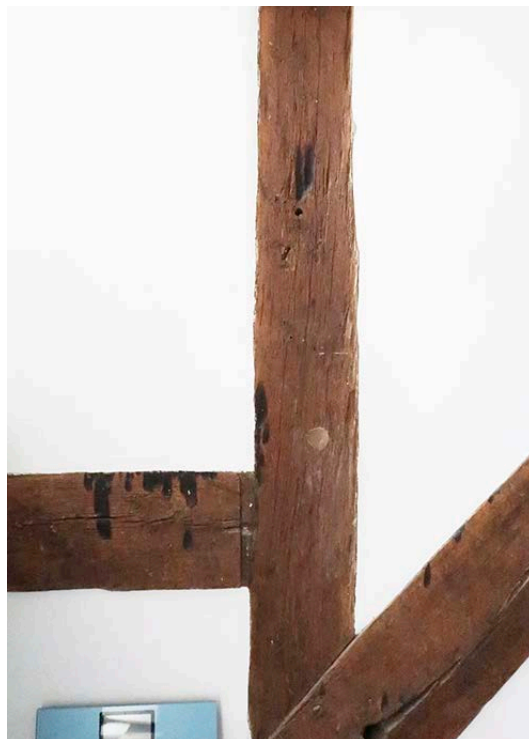
Figure 36: The taper burn marks on the north truss of the middle bay. [Johanna Roethe © Historic England]

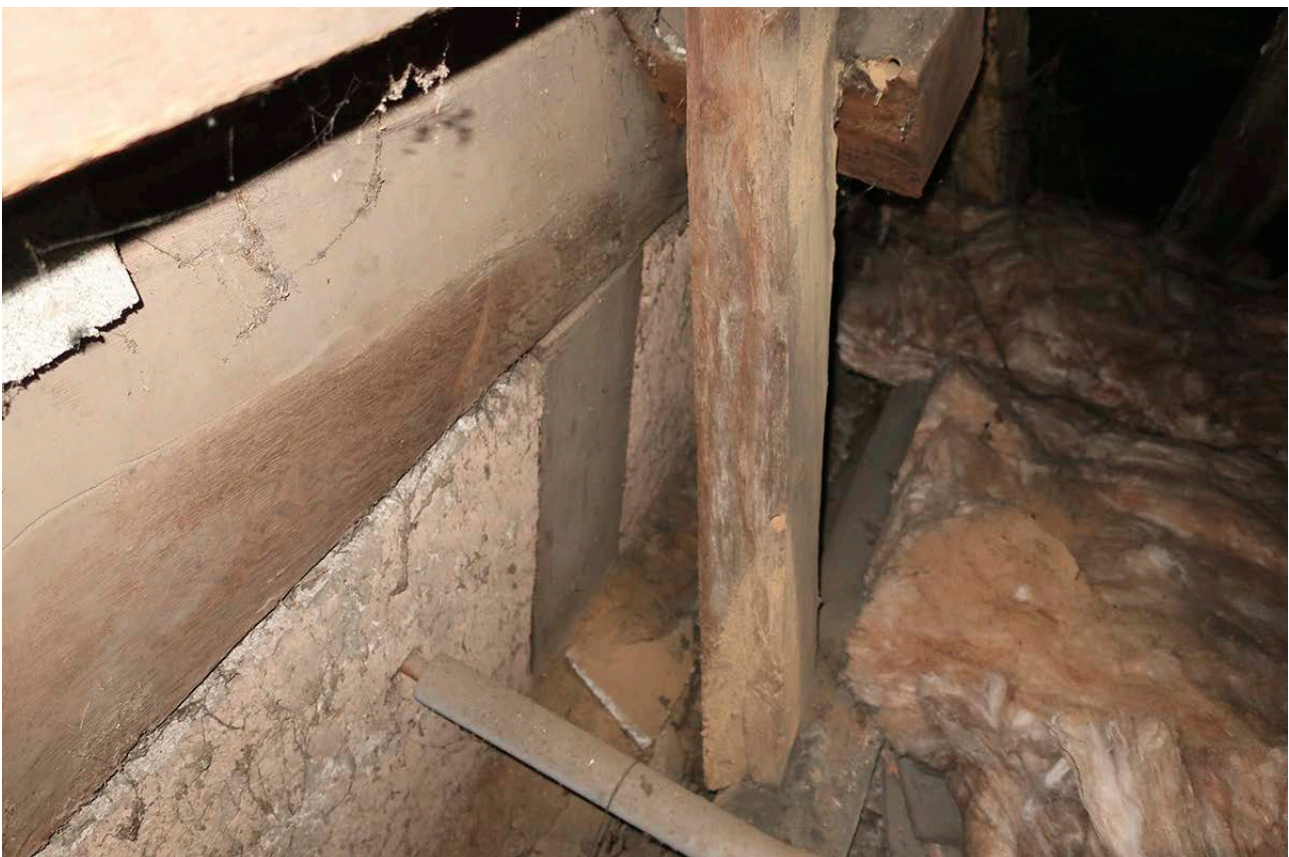
Figure 37: The west strut of the south truss of the middle bay. [Rebecca Lane © Historic England]

As discussed above, the roof of this building was built up against the roof of the building to the south. The southern truss of the range is therefore open, with no indication of stave holes or any other sign that it was designed to be closed. The slightly irregular arrangement of the truss was designed to accommodate its position adjacent to a pre-existing roof. The raking queen struts were placed in such a way to accommodate the projecting purlins of the south roof. The west strut is not framed properly into the tiebeam but is lapped onto the edge of the beam, although it is pegged, and its position corresponds to the comparable strut on the other side (Figure 37). It seems likely that this was adjusted after the truss was framed, to accommodate the projecting purlin of the southern roof.

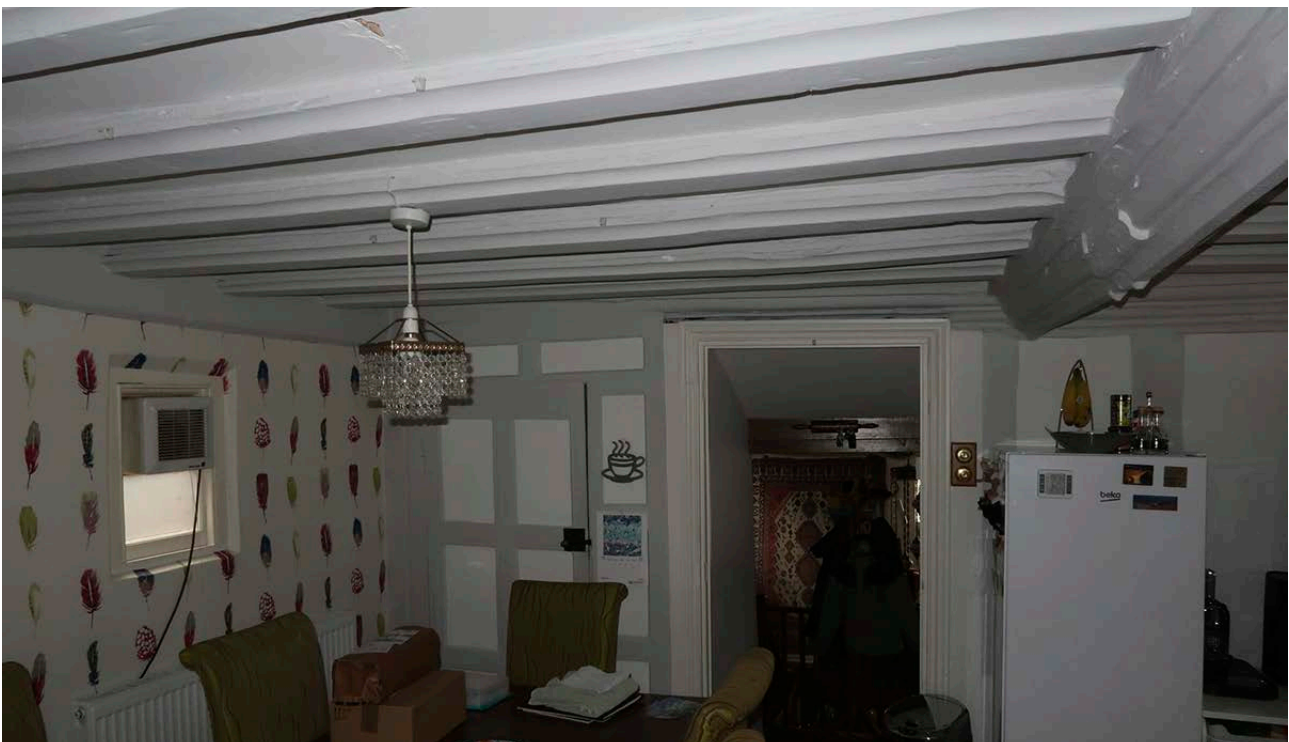
Figure 38: The first-floor ceiling in the middle bay, looking south. [Johanna Roethe © Historic England]

The height of the surviving part of this building strongly suggests it was always storeyed and did not include any open hall, with the ceilings on the first and second floor forming part of the same construction phase as the roof. There is no evidence of the original layout at ground-floor level, as the space has been opened out to the shop to the north. It has two chamfered ceiling beams which have scrolled stops to the south but not at the north end. A third beam in this space has a pattern of crenellation. All three beams appear to be *ex situ* and were probably imported from elsewhere in the 20th century. On the first floor is a full-width room with a decorative ceiling of moulded timbers, with hollow-chamfered joists and a moulded axial beam with hollow mouldings either side of a quarter round moulding, all interspersed with fillets (Figure 38). This moulding is of a type which is consistent with a 15th-century date. Linda Hall has recorded a ceiling beam of a similar profile in Kent with a slightly later date of 1507.<sup>94</sup> The decorative ceiling on the first floor has evidence that it was truncated. At the south end the axial ceiling beam abuts a similarly moulded transverse beam which is part of a stud partition. But at the north end of the room there is only a flimsy partition and no similarly moulded transverse beam, suggesting the ceiling might have originally continued further north.

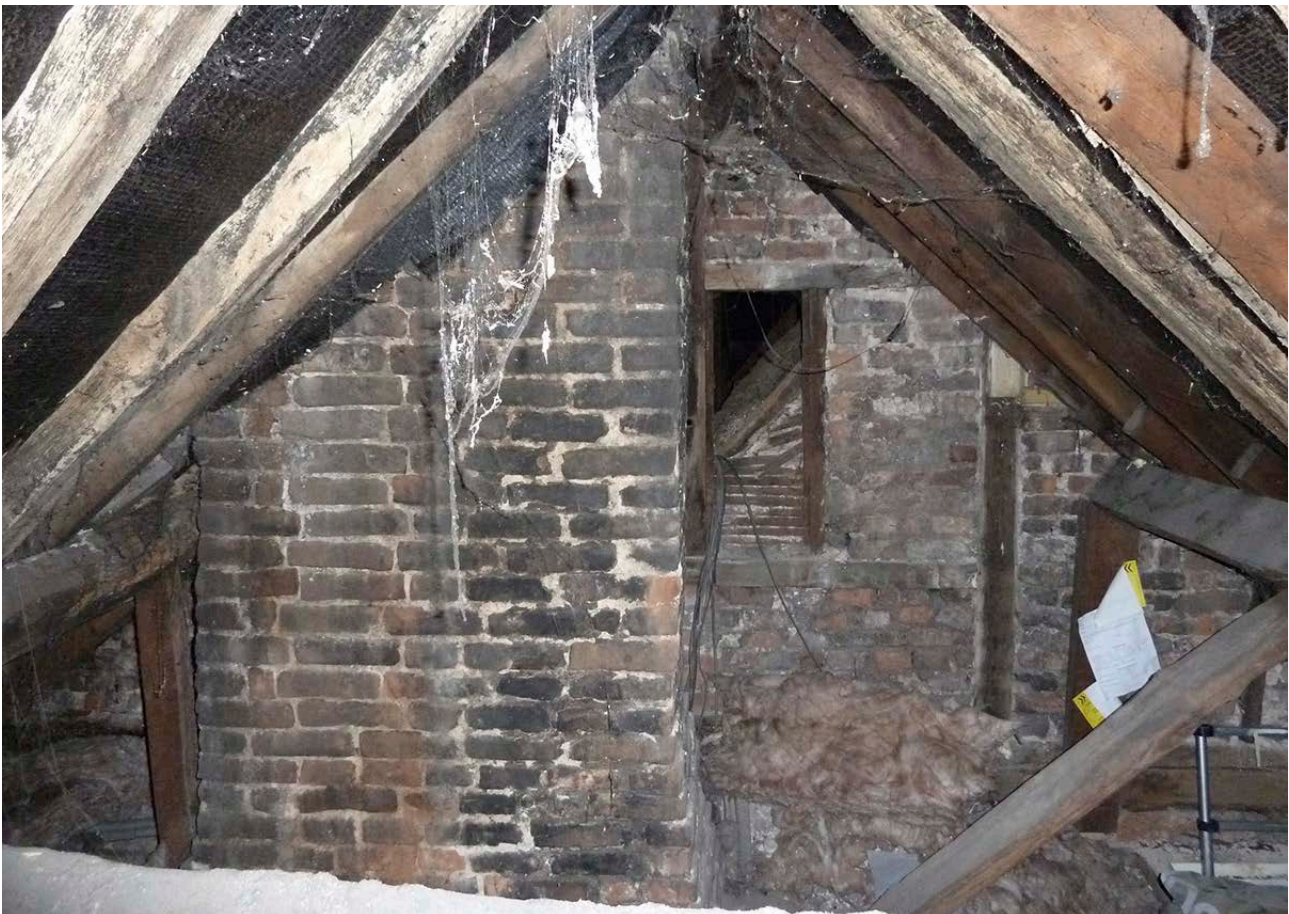
Figure 40: The chimneystack at the north end of the roofspace of the middle bay. [Johanna Roethe © Historic England]

Probably in the 17th century, a large brick chimneystack was inserted in the southern bay of the front building, now sitting at the north end of the middle bay (Figure 40). The bricks are of a size typical for bricks produced in the 17th century. The chimneystack probably served fireplaces on either side of the wall as it projects today on both sides of the wall on the first and second floors. In the cellar the stack has a base of stone to the north side and brick coving to the south (Figure 41). It is not clear if the chimneystack in the south bay shown on the 1928 aerial photograph was inserted at the same time. It has since been removed and no details about its construction or date survive.

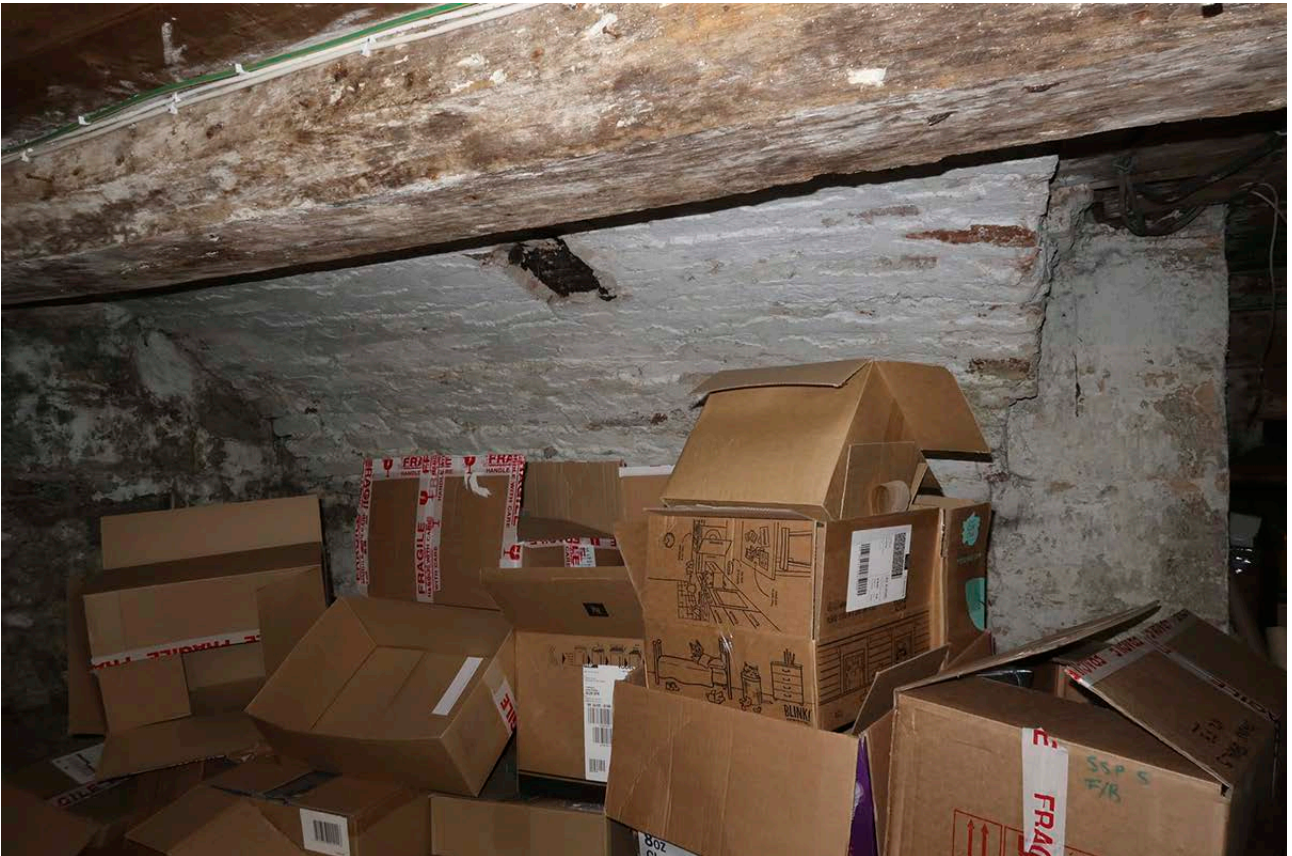
Figure 41: The brick coving on the south side of the chimneystack in the cellar. [Johanna Roethe © Historic England]

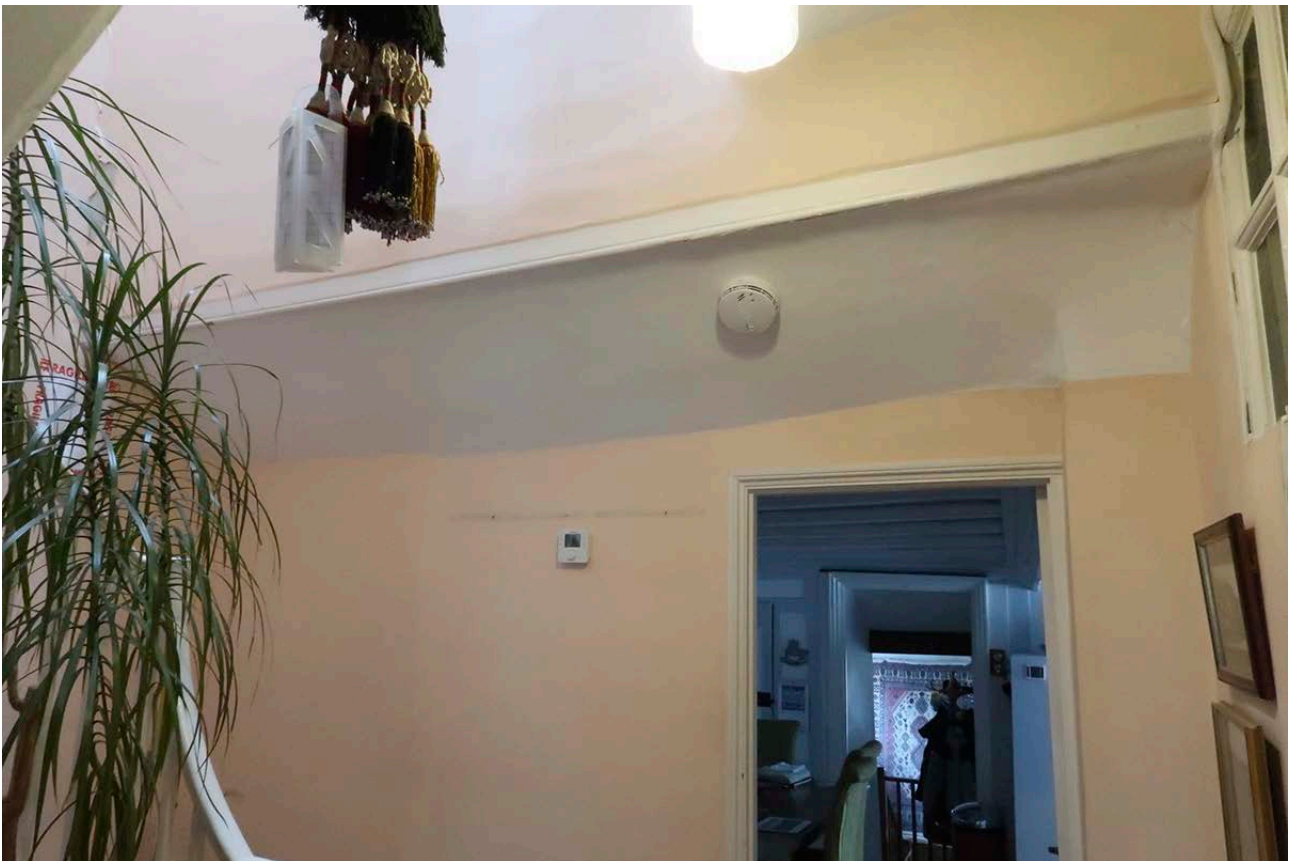
Figure 42: The truncated north end of the floor structure of the middle bay, seen from the stairwell in the front bay at first-floor level. [Johanna Roethe © Historic England]

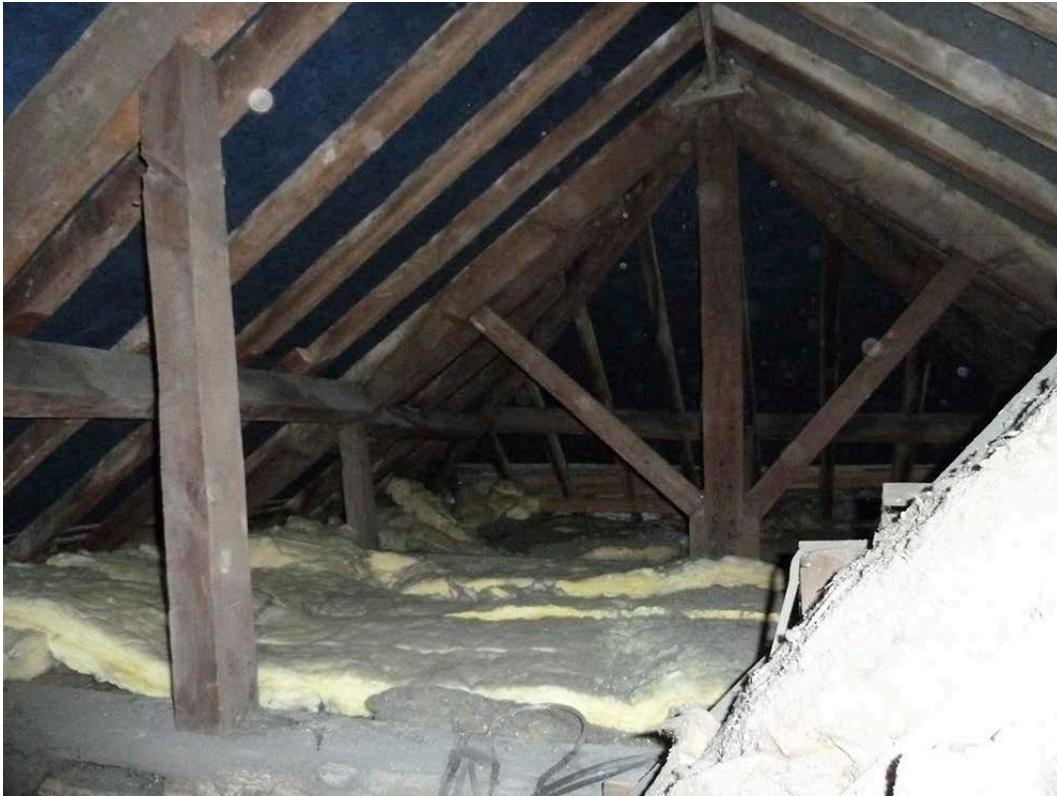
Figure 43: The king-post truss in the roof of the north bay, looking north. [Johanna Roethe © Historic England]

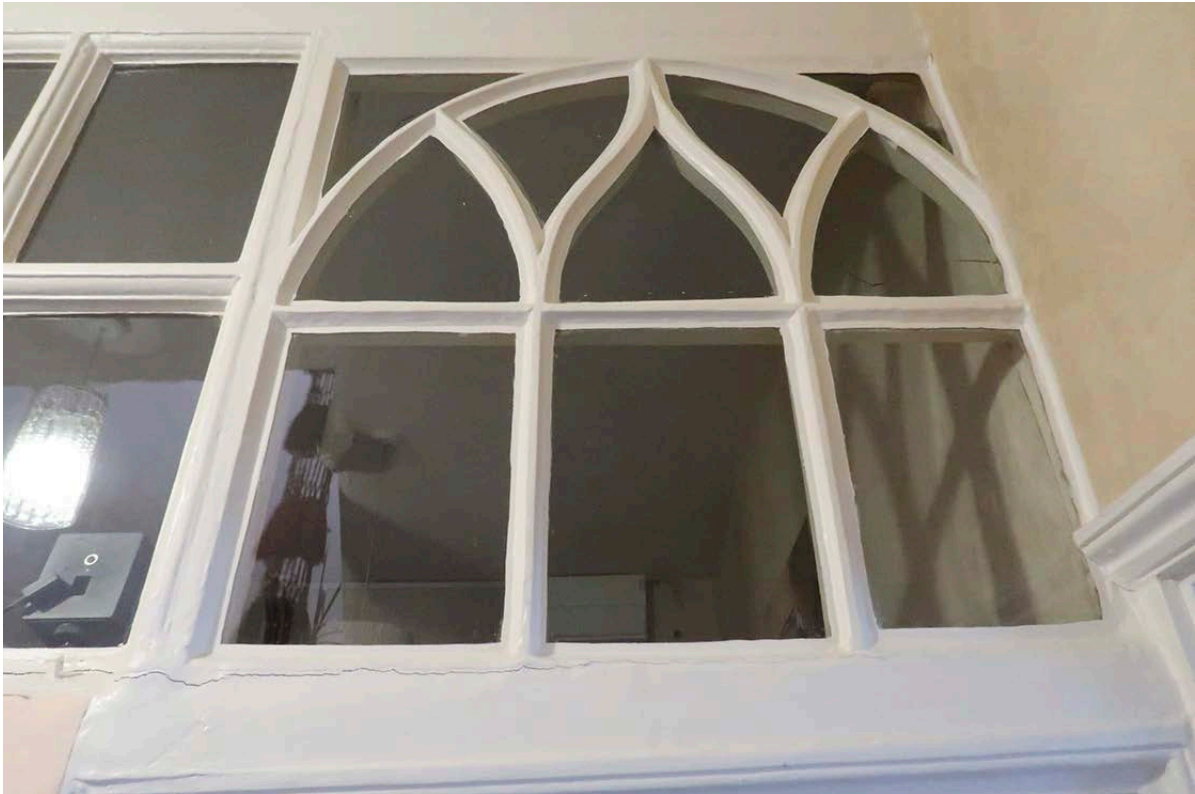
Figure 45: The fanlight on the first-floor landing of the north bay. [Johanna Roethe © Historic England]

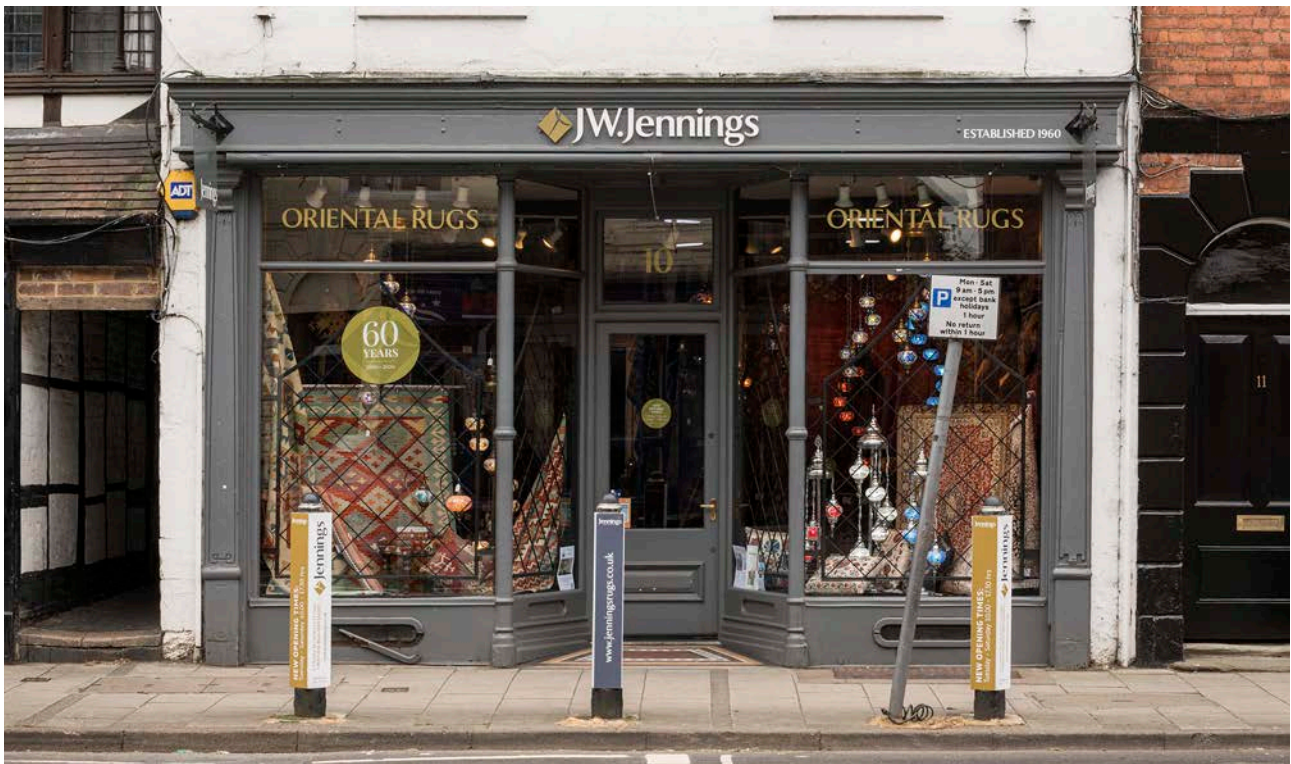
Figure 46: The late 19th-century shopfront in 2023. [Steven Baker © Historic England, DP325768]

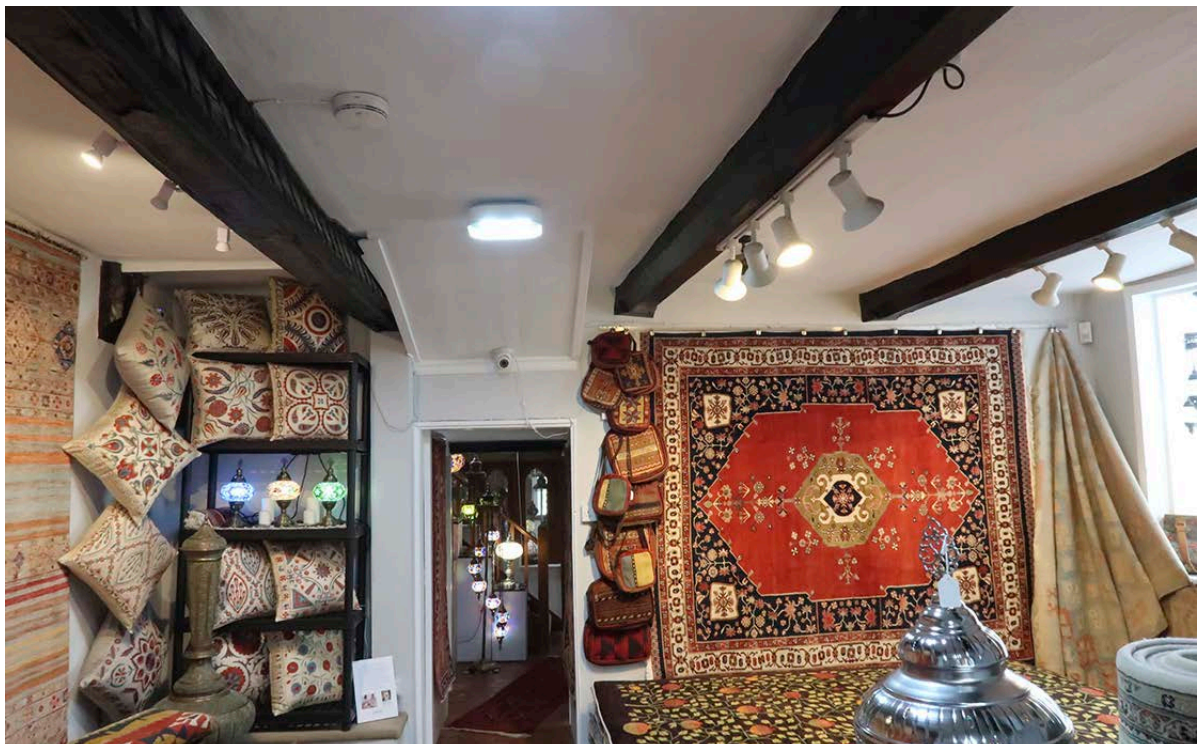
Figure 47: The ground-floor room in the middle bay, looking south. The crenellated beam is to the left and the two chamfered beams to the right. [Johanna Roethe © Historic England]

Since the early 20th century there have been a number of incremental alterations. The antique dealer Leonard T. Crow seems the most likely candidate to have enlarged the shop at the front of the building by removing the partition to the side entrance corridor and also the partitions in the middle bay on the ground floor (see Figure 6). Probably as part of these alterations three historic ceiling beams were introduced to the ground-floor space of the middle bay. Two are chamfered beams with scrolled stops to the south but not at the north end, and a third beam has a pattern of crenellation (Figure 47).

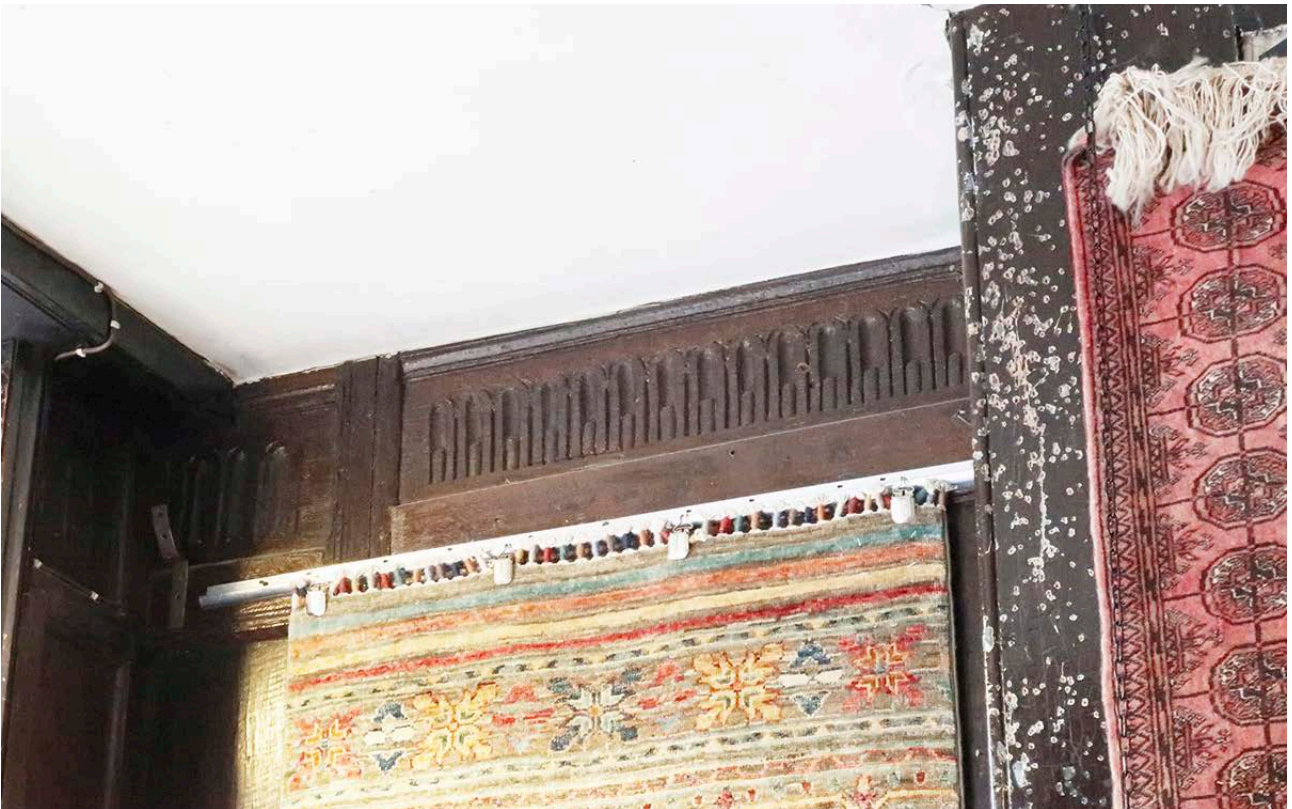
Figure 48: Mismatched arcading patterns in the frieze to the left of the chimneybreast in the north bay at ground-floor level. [Johanna Roethe © Historic England]

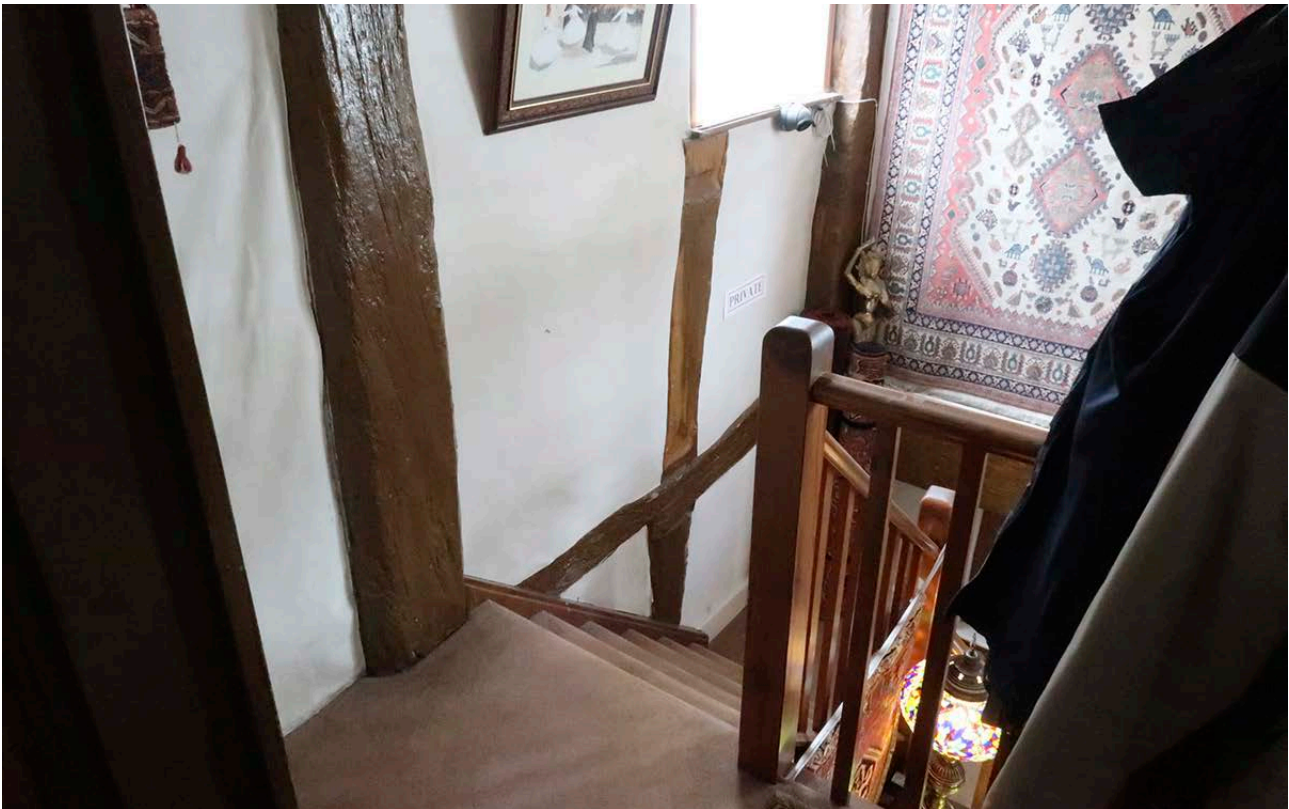
Figure 49: The staircase in the south bay, seen from the first floor. [Johanna Roethe © Historic England]

Further minor alterations have been made since the 1950s and it is not always possible to assign a precise date. At some point after 1957 the stone of the front elevation, which had been in poor condition in 1957 (see Figure 10), was rendered and the design of the vents in the stallrisers altered from two per panel to one. The staircase in the south bay of the building, which leads from the ground to the first floor, was inserted (Figure 49). The plain design of the balusters and newel posts suggest a date in the second half of the 20th century.
