# Church Tower 100m North of the Church of St John Shenstone Lichfield Staffordshire

Tree-ring Dating of Oak Timbers

Alison Arnold, Robert Howard, and Cathy Tyers

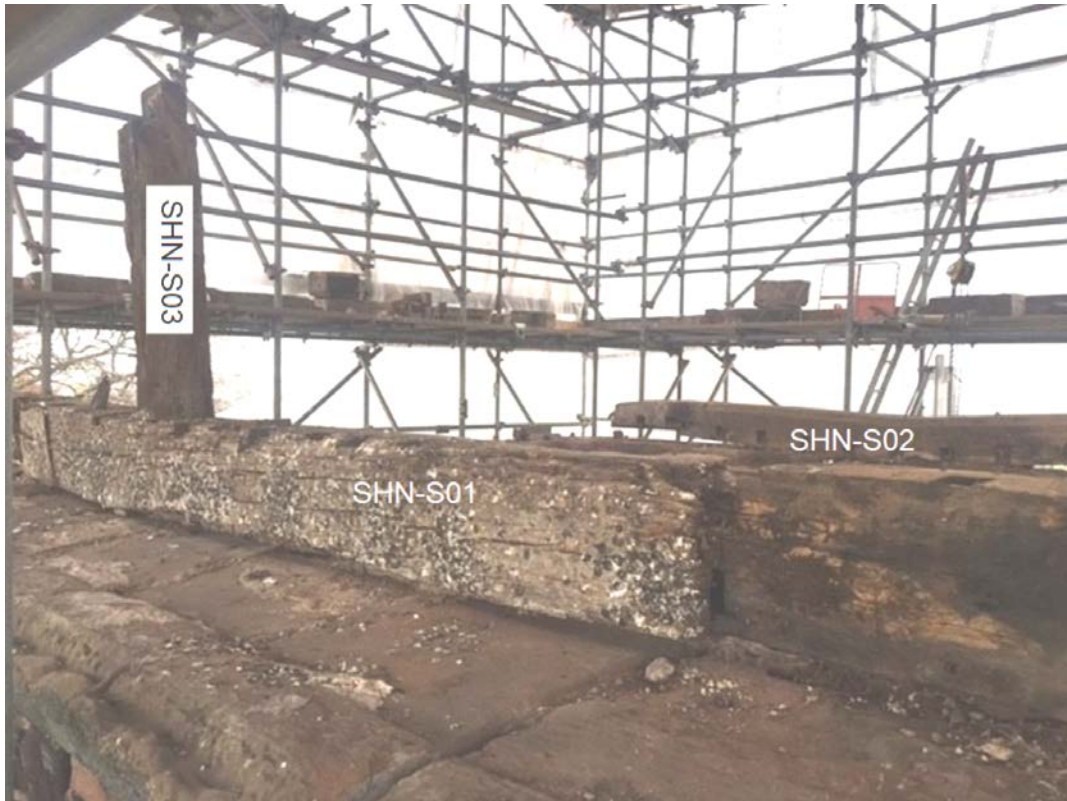
*Figure 2: Floor/roof beams, north beam with in-situ joist (standing upright) in foreground; samples SHN-S01–SHN-S03 (samples SHN-S04 and SHN-S05 cut off tenons not shown), photograph taken from the north-west (Photograph: Alison Arnold)*

Thirty-two oak timbers (*Quercus* spp) from this tower have been sampled with each being given the code SHN-S and numbered 01–32. Two main floor beams, which may also have acted as tiebeams for the roof, were sampled by coring; sliced samples were taken from a joist still morticed into one of the beams and tenons lodged in two mortices. Seven sliced samples were taken from timbers retrieved from a skip and 20 sliced samples from a pile of timbers adjacent to the tower; some of these were obviously parts of a bellframe as they were still partially articulated whilst others were individual timbers. Further details relating to all samples can be found in Table 1. Photographs were taken of timbers sampled (Figs 2–4) with the exception of the two cut off tenons.

All five of the samples taken from *in situ* timbers of this roof/floor frame have been successfully dated, only two of which have the heartwood/sapwood boundary. The two samples taken from the main beams have similar heartwood/sapwood boundary ring dates, suggestive of a single felling. The combined average heartwood/sapwood boundary ring of these two samples is AD 1692, allowing an estimated felling date to be calculated for the two timbers represented to within the range AD 1708–32. This felling date range allows for sample SHN-S01 having a last-measured ring date of AD 1707, with incomplete sapwood.

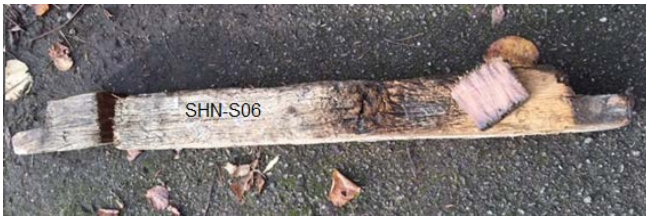
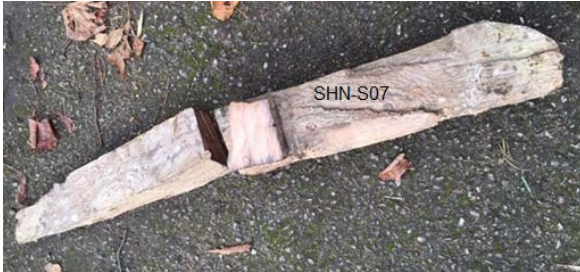
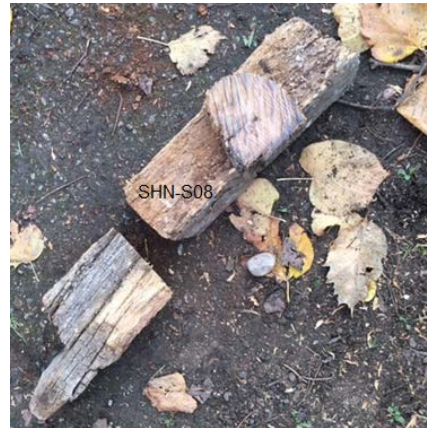
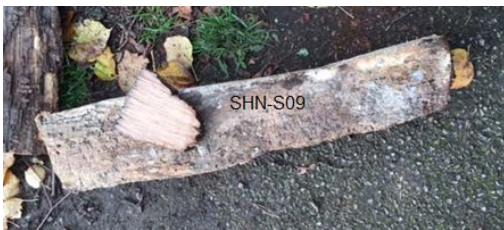
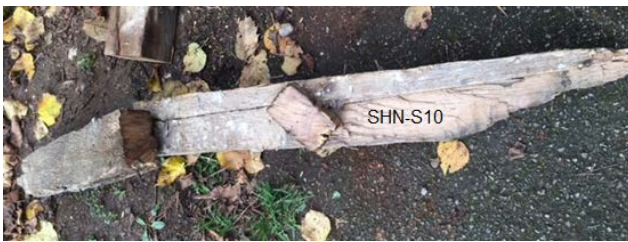
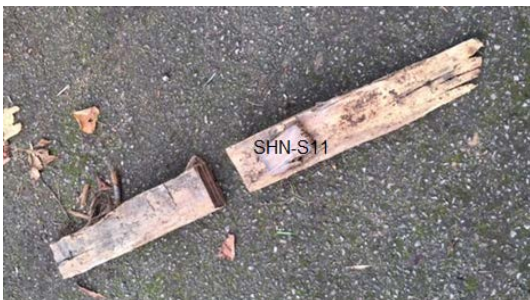
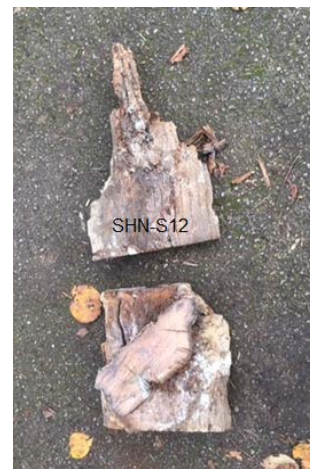
Figure 3: Photographs of samples taken from timbers retrieved from a skip, SHN-S06–12 (Photograph: Alison Arnold)

Sample SHN-S11, from one of the timbers retrieved from the skip, has also been dated. This sample has a last-measured ring date of AD 1456 but without the heartwood/sapwood boundary ring the timber represented has a *terminus post quem* date for felling of AD 1471.

The potentially earliest timbers identified during this research are the two joists and one of the timbers retrieved from the skip, which is also possibly a joist (Fig 3). These all have *terminus post quem* dates for felling in the second half of the fifteenth century. However, it is not possible to know how heavily these were trimmed during conversion from tree to timber element and hence, whether they may represent the inner portions of much longer-lived trees. It may be that they were felled at the same time as the third joist but as that sample also only has a *terminus post quem* for felling date (of AD 1535) this could also be any time from the mid-sixteenth century. However, it is unlikely that they were felled at the same time as the main beams they were jointed into, which have a felling date in the range AD 1708–32, as this would mean the joists were derived from trees in excess of 300 years old. Whilst this is possible it is unlikely. The felling date range obtained for the main beams raises the possibility that they could belong to the works known to have been undertaken on the chancel and ‘elsewhere’ in the church in, or about, AD 1723.

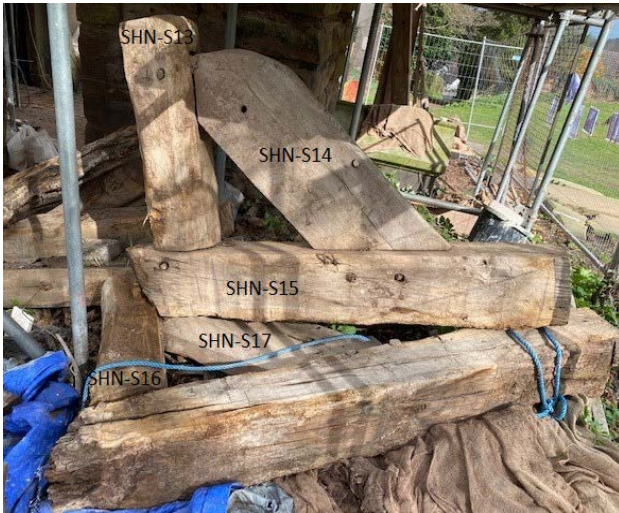
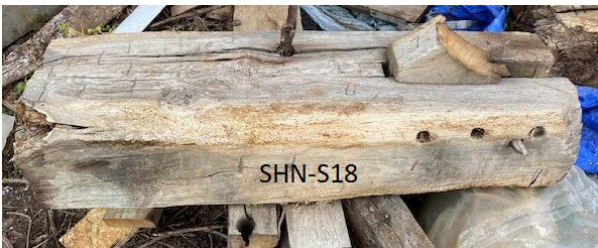
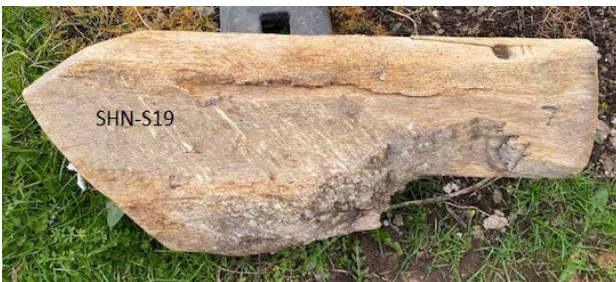
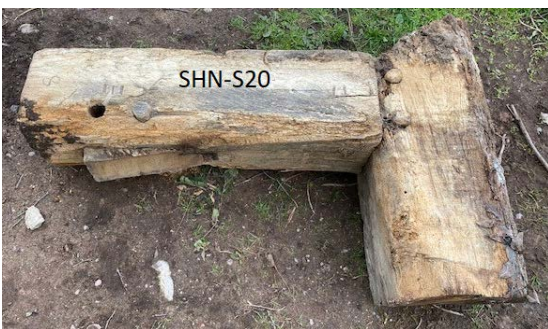
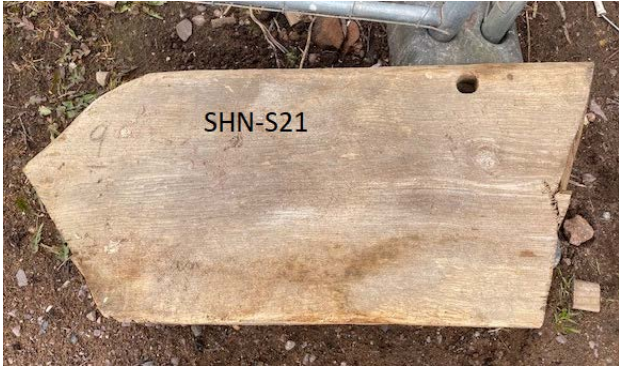
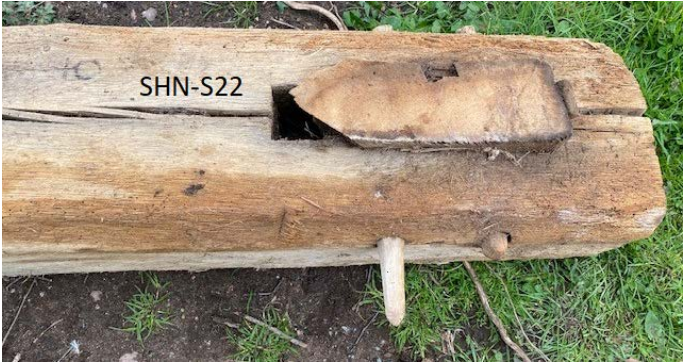
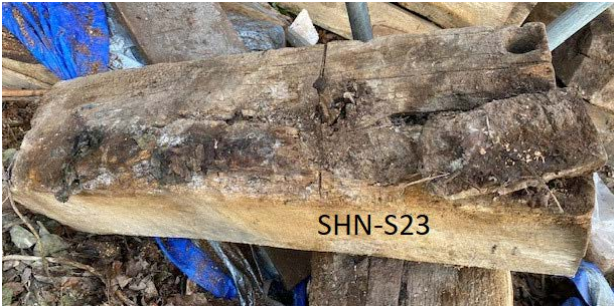
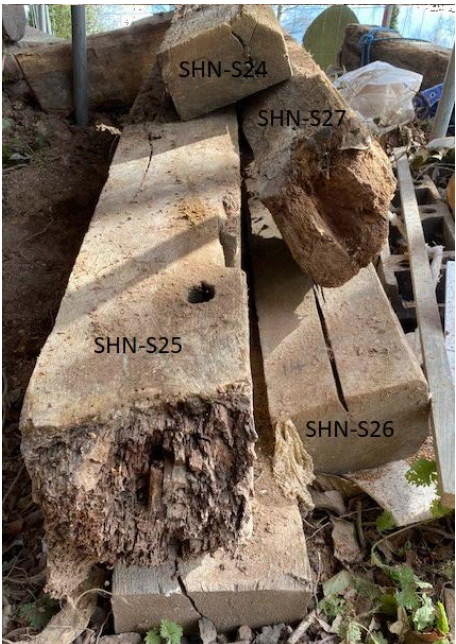
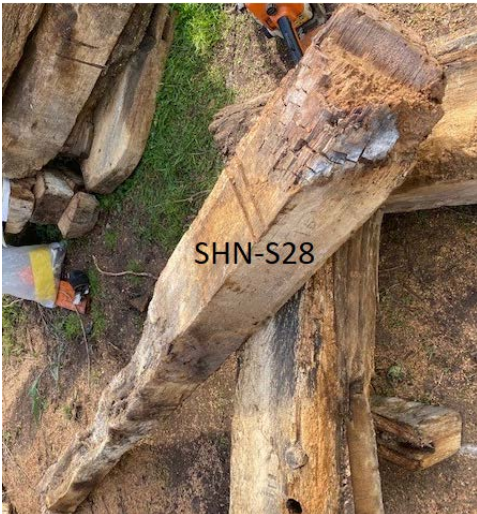
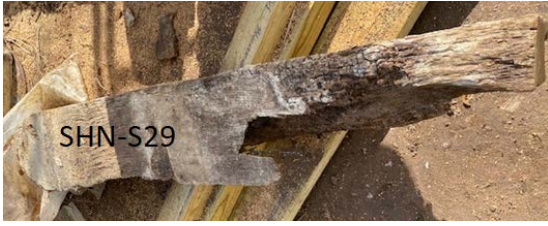
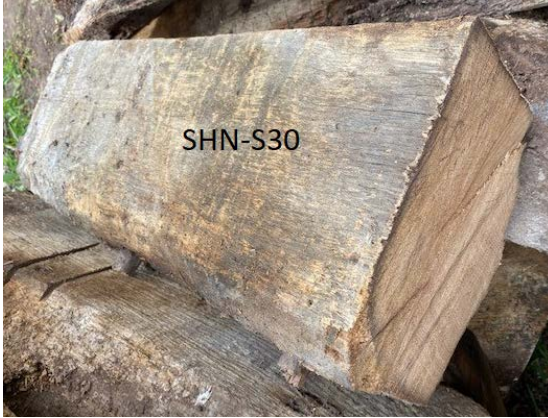
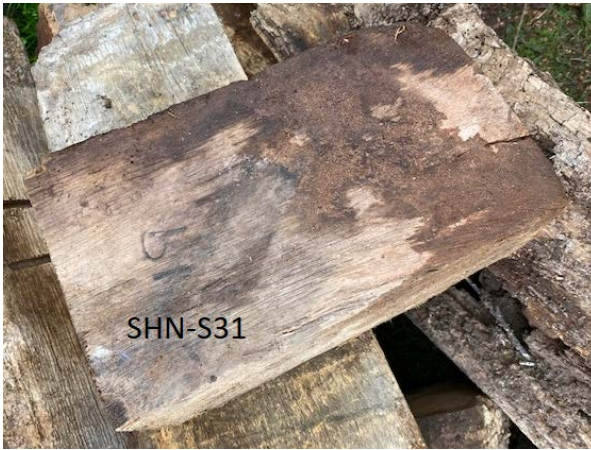
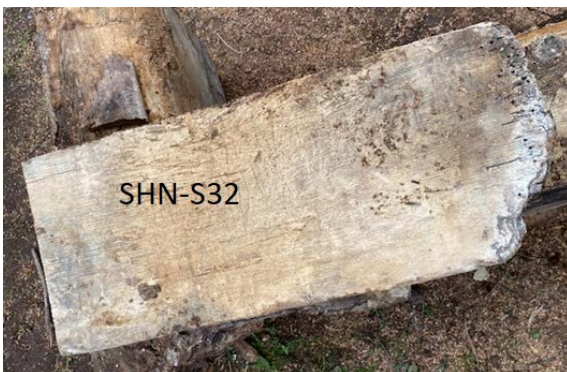
*Figure 4: Photographs of sampled bellframe and associated timbers, samples SHN-S13–32 (Photograph: Alison Arnold)*

Fifteen of the samples taken from the bellframe or loose timbers that appear associated with it, have been dated, seven of which retain complete sapwood.

Three samples, SHN-S24, SHN-S28, and SHN-S30 all have the last-measured ring date of AD 1625. When looked at under the microscope it is possible to see that the last ring has both spring and summer growth cells demonstrating that the timbers represented were felled in the winter of AD 1625/6. Six of the other dated samples group with these three samples at the high value of  $t = 13.3$ , which one would usually expect to signify the timbers represented were either cut from the same tree or from trees growing in relatively close proximity to one another. Hence all nine timbers represented are likely to have been derived from a tree, or trees, felled in the winter of AD 1625/6.

Three other samples with complete sapwood, SHN-S16, SHN-S20, and SHN-S22, have the slightly later last-ring date of AD 1633. Again, when looked at under the microscope both the spring and summer cells of this final ring are present, determining that the three timbers (all posts) were felled in the winter of AD 1633/4. These three samples, and that taken from the fourth post (SHN-S13), group at a minimum value of  $t = 11.6$ , again suggesting that these four timbers were either cut from the same tree or from trees growing in relatively close proximity to each other. Hence, all four posts have the same felling date of winter AD 1633/34.

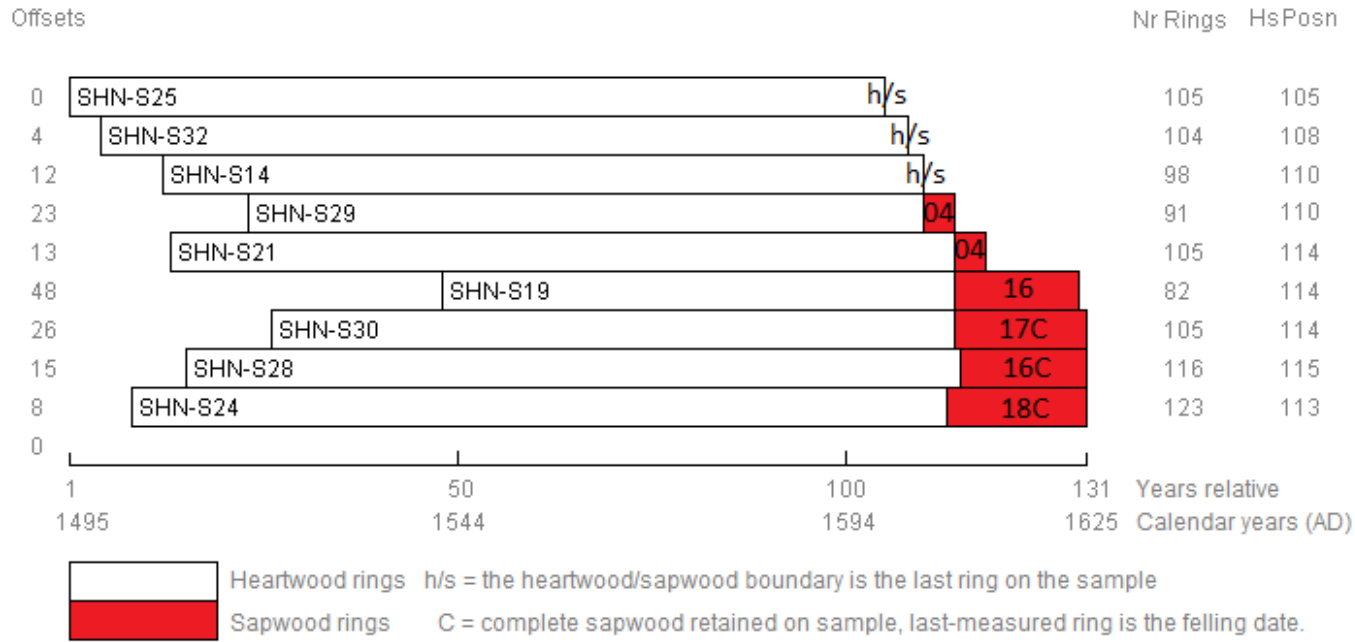
Figure 6: Bar diagram of samples in site sequence SHNSSQ02

Nine samples matched each other at a minimum value of  $t = 13.3$  and were combined at the relevant offset position to form SHNSSQ02, a site sequence of 131 rings (Fig 6). This site sequence was compared against a series of relevant reference chronologies for oak where it was found to match consistently and securely at a first-ring date of AD 1495 and a last-measured ring date of AD 1625. The evidence for this dating is given in Table 3.

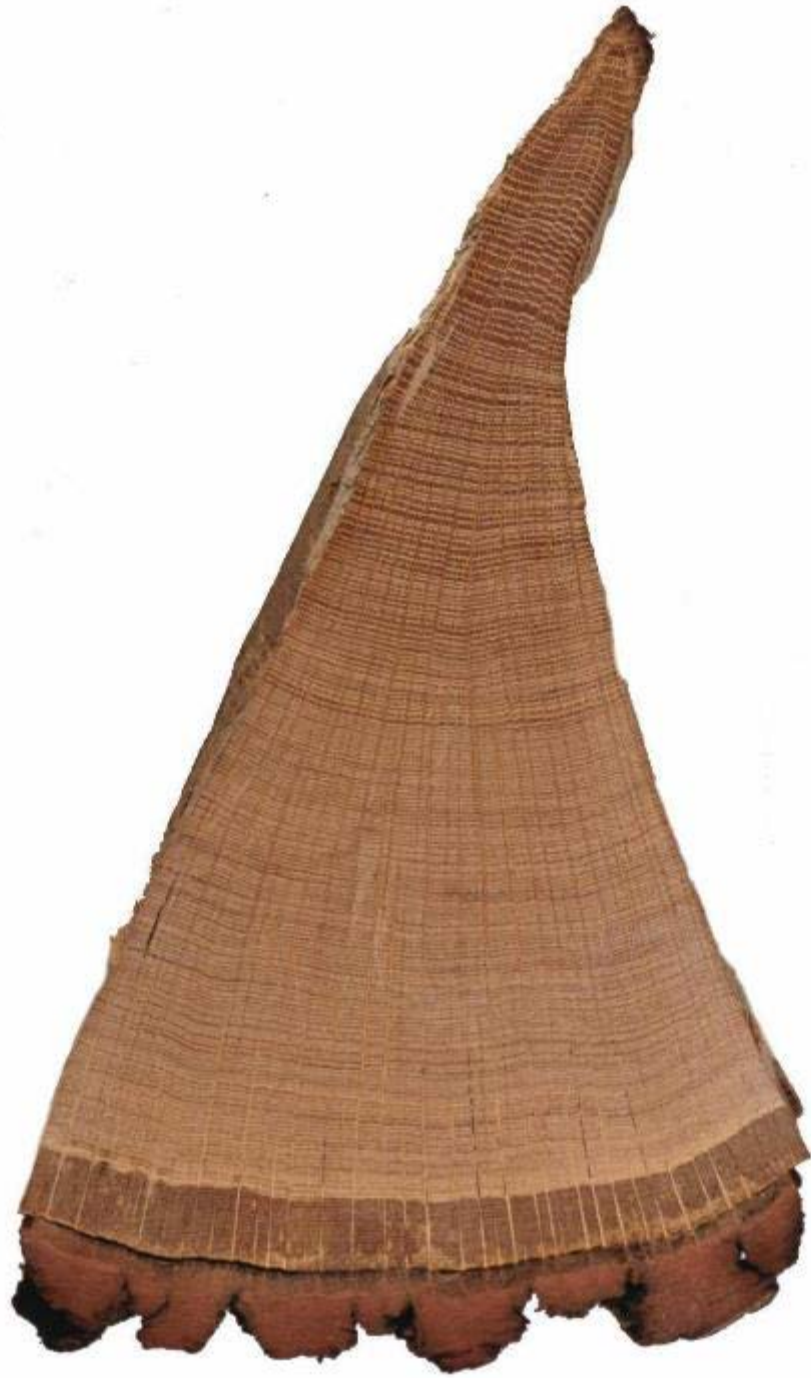
*Figure A1: A wedge of oak from a tree felled in 1976. It shows the annual growth rings, one for each year from the innermost ring to the last ring on the outside just inside the bark. The year of each ring can be determined by counting back from the outside ring, which grew in 1976*

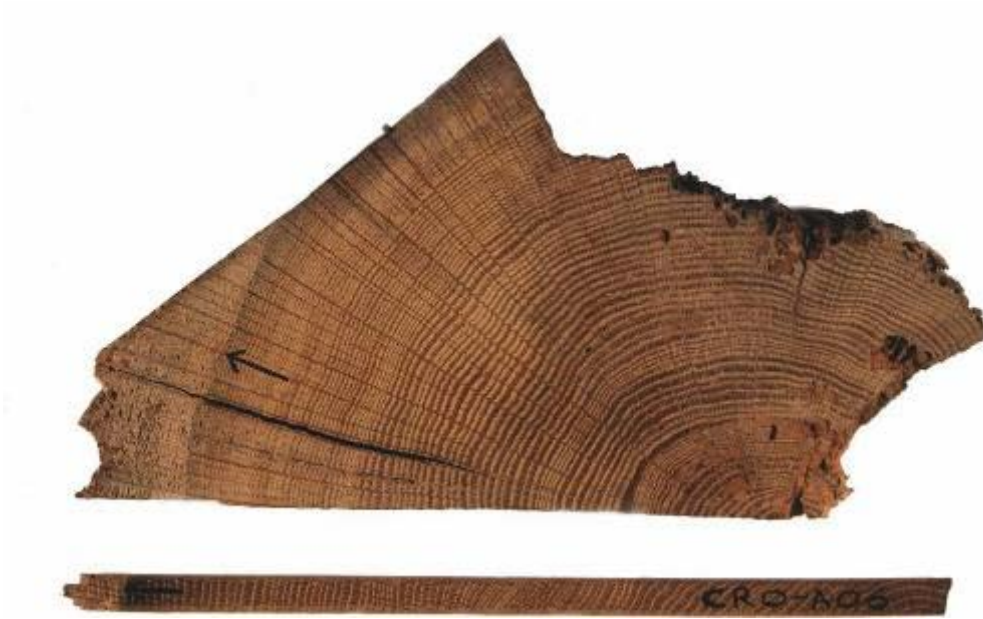
Figure A2: Cross-section of a rafter, showing sapwood rings in the left-hand corner, the arrow points to the heartwood/sapwood boundary (H/S); and a core with sapwood; again the arrow is pointing to the H/S. The core is about the size of a pencil

Quite often some, though not all, of the original outer rings are missing on a timber. The outer rings on an oak, called sapwood rings, are usually lighter than the inner rings, the heartwood, and so are relatively easy to identify. For example, sapwood can be seen in the corner of the rafter and at the outer end of the core in Figure A2, both indicated by arrows. More importantly for dendrochronology, the sapwood is relatively soft and so liable to insect attack and wear and tear. The builder, therefore, may remove some of the sapwood for precisely these reasons. Nevertheless, if at least some of the sapwood rings are left on a sample, we will know that not too many rings have been lost since felling so that the date of the last ring on the sample is only a few years before the date of the original last ring on the tree, and so to the date of felling.

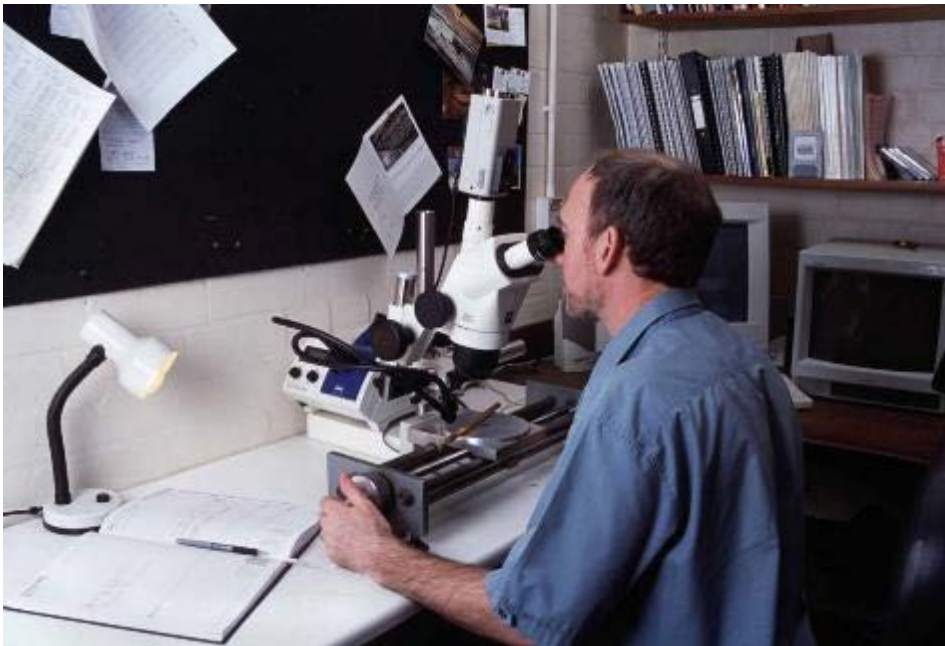
Figure A3: Measuring ring widths under a microscope. The microscope is fixed while the sample is on a moving platform. The total sequence of widths is measured twice to ensure that an error has not been made. This type of apparatus is needed to process a large number of samples on a regular basis

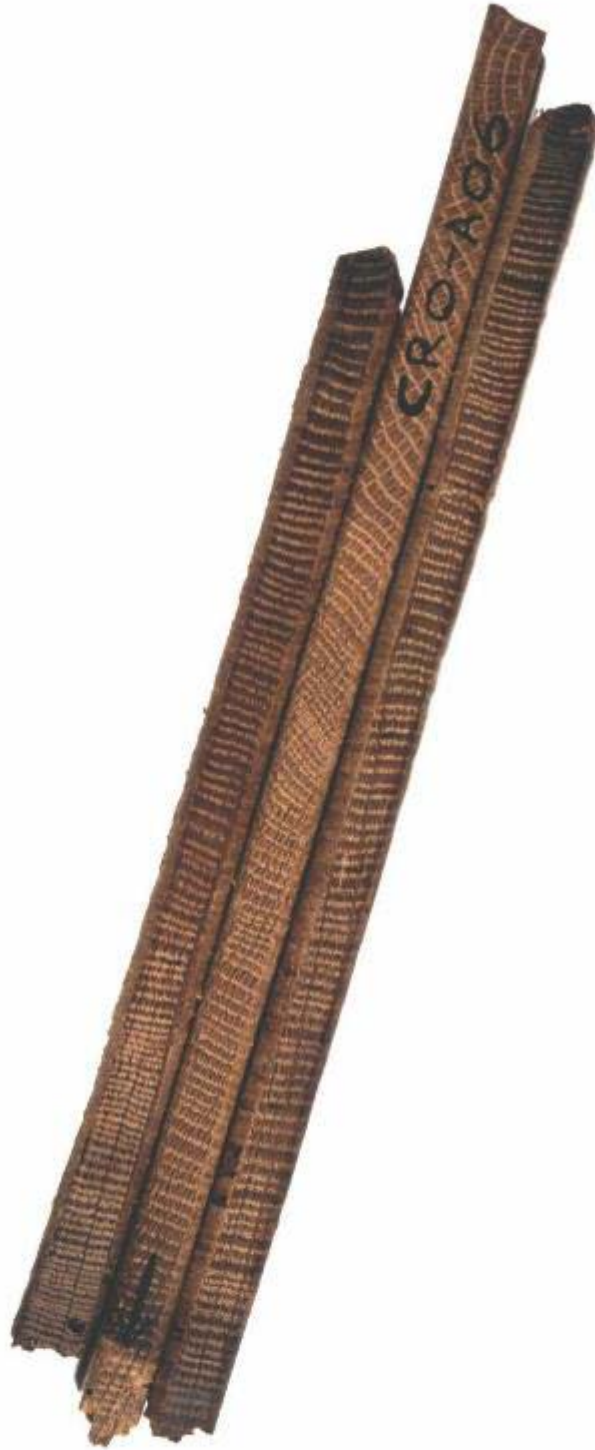
*Figure A4: Three cores from timbers in a building. They come from trees growing at the same time. Notice that, although the sequences of widths look similar, they are not identical. This is typical*
