81-2 Barton Street and 1-3 Mason's Court, Tewkesbury, Gloucestershire

Historic Building Assessment

Rebecca Lane and Johanna Roethe

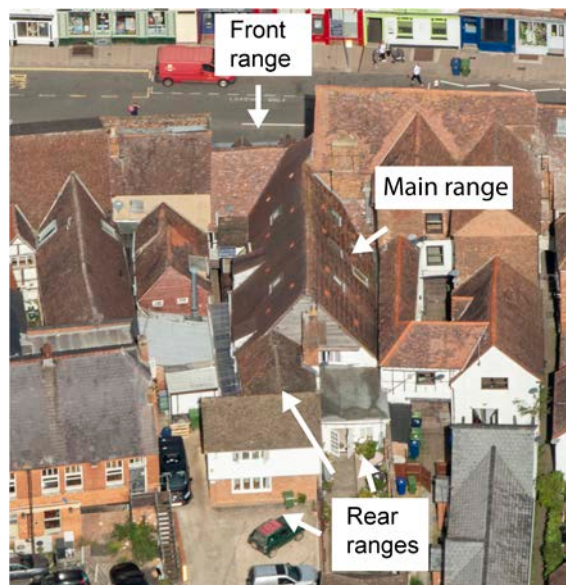
Figure 2: Detail of an aerial photograph of 2021, looking north, annotated to indicate the different elements of 81-2 Barton Street. [Damian Grady © Historic England Archive, 35126_011]

The building consists today of three different parts (Figure 2). There is a front range facing the street of two storeys and attic (numbered as 81-2 Barton Street on the ground floor and 3a and 3b Mason's Court on the upper floors); a tall gabled main range to the rear (2 Mason's Court and incorporating parts of 1 and 3b Mason's Court) and a south range (part of 1 Mason's Court) comprising two gabled, two-storey ranges to the south-west and one flat-roofed, single-storey range to the south-east.

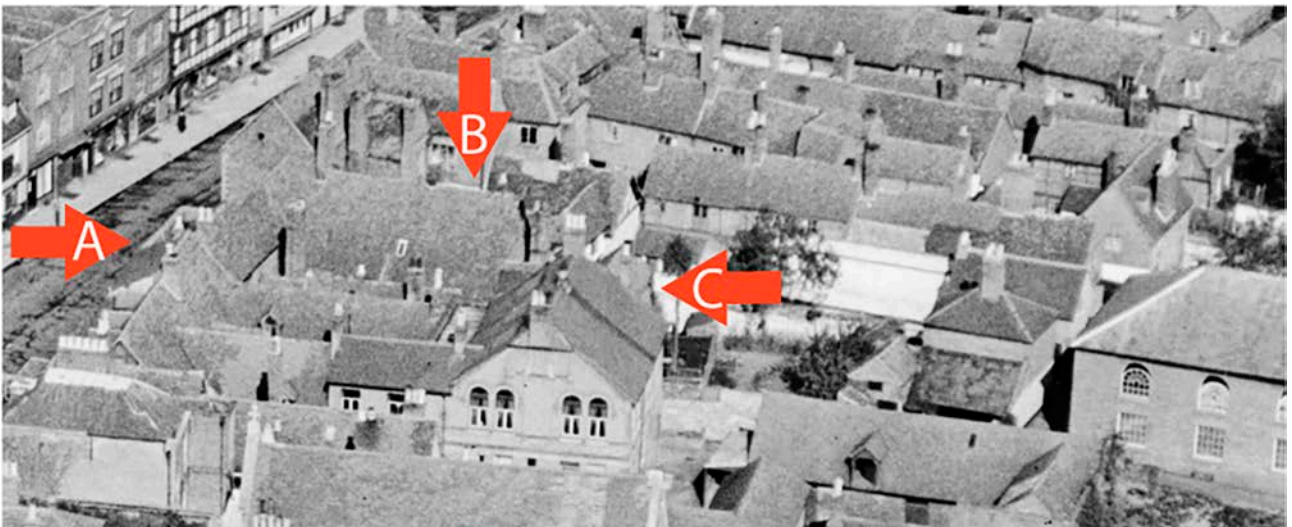
Figure 8: Detail from an aerial photograph taken in September 1928, with arrows indicating the front range to Barton Street (arrow A), the tall roof of the main range (arrow B) and the small rear range in Mason's Court (arrow C). [© Historic England Archive. Aerofilms Collection, EPW023945]

An aerial photograph taken in 1928 shows the large roof of the main range to the rear, with what appear to be small rooflights and two chimneystacks, one at the north end of the roof ridge and one near the middle (Figure 8). There were also two dormer windows on the west slope of the roof of the main range.

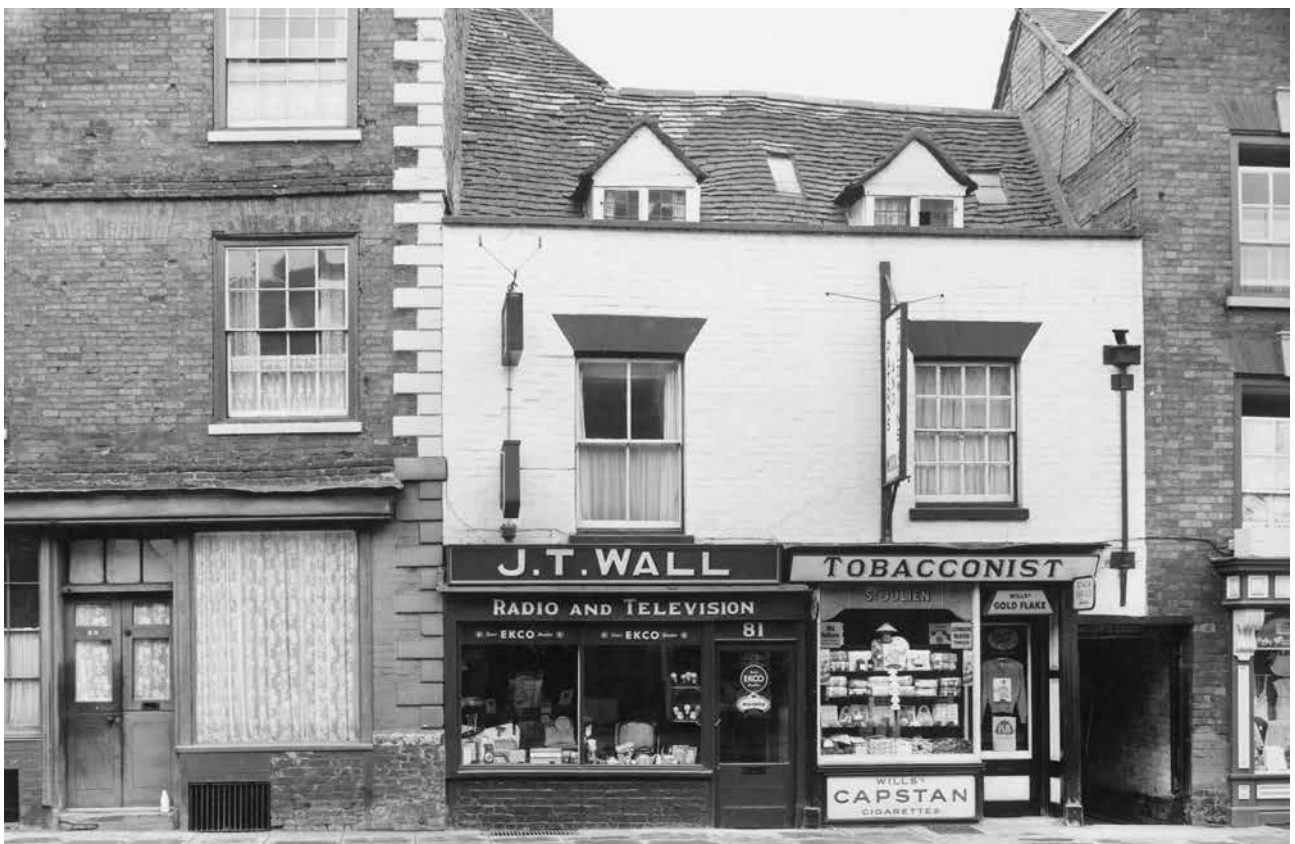
Figure 9: Photograph of 81-2 Barton Street in 1957. [Source: Historic England Archive, TEW01/01/X69722]

A photograph taken in 1957 shows the street elevation with the two shopfronts (Figure 9). By that date 82 Barton Street was a wool shop but had retained the tobacconist signage of the shopfront, amplified by a projecting sign on the first floor with the lettering 'Patons and Baldwins Wools'. The fascias of the two shops had been aligned by then but the shop window of 82 Barton Street was still taller than that of no. 81. Each shop

had projecting signs on the first floor and above the entrance to the alleyway was a lead downpipe with hopper. The attic had two dormer windows and two rooflights. The roof ridge to the street front range was largely as now, consisting of a gable roof parallel with the street, which near its eastern end rises in line with the roof pitch of the main range. The brickwork of the front elevation had been painted.

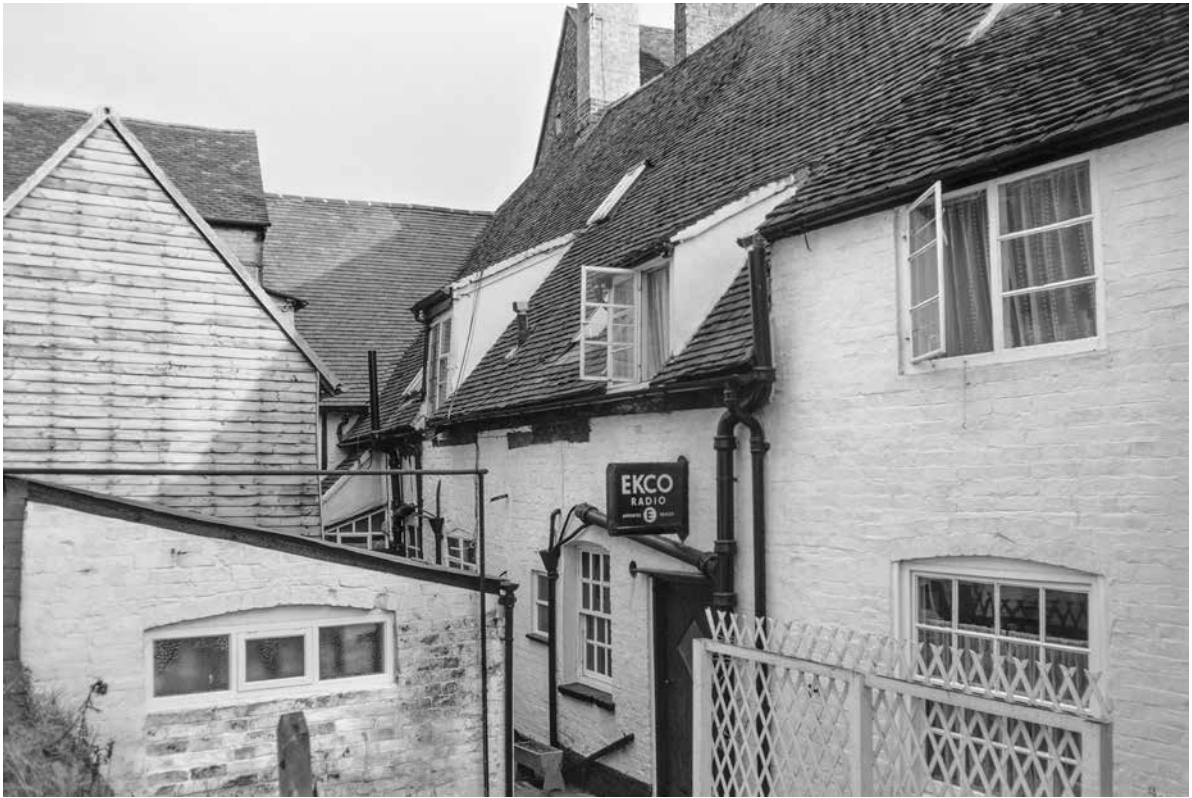
Figure 11: 1960s photograph by Stanley R. Jones, showing the west elevation of the main range (centre) and the south-west rear range (right). [© Historic England Archive, SJC01/03/0013]

During his visits in the 1960s and 1970s, Jones took a limited number of photographs, which form a valuable record of the site prior to alterations in the 1970s (see Appendix 1). Two exterior photographs show the west elevation of the main range facing the alleyway (Figure 11). By that date there was a chimneystack near the north gable of the main range, with possibly a second one just to the west. Most images show the interior of the upper part of the main range, which was then still largely undivided, apart from partitions forming attic rooms in the northern part of the main range (Figures 12-14). They also show extensive smoke-blackening, particularly on the closed frame 1 (see Figure 13). In 1973 the list entry for 81-2 Barton Street was updated but the full findings of Jones's work were only added to the list description in the 1994 revision when the building was upgraded to Grade II*.¹⁰⁴

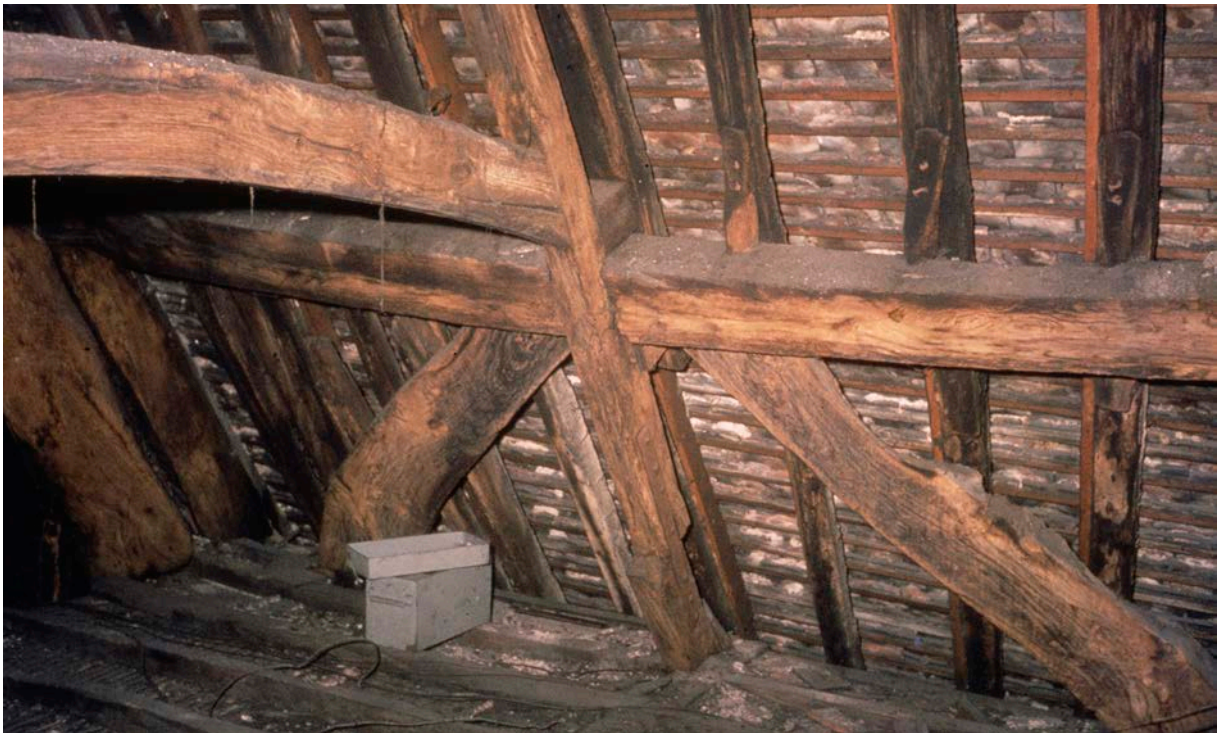
Figure 12: 1960s photograph by Stanley R. Jones, showing part of the two southern bays of the building, including the truss over the solar (bays C and D either side of the east end of frame 4). [© Historic England Archive, SJC01/03/0003]

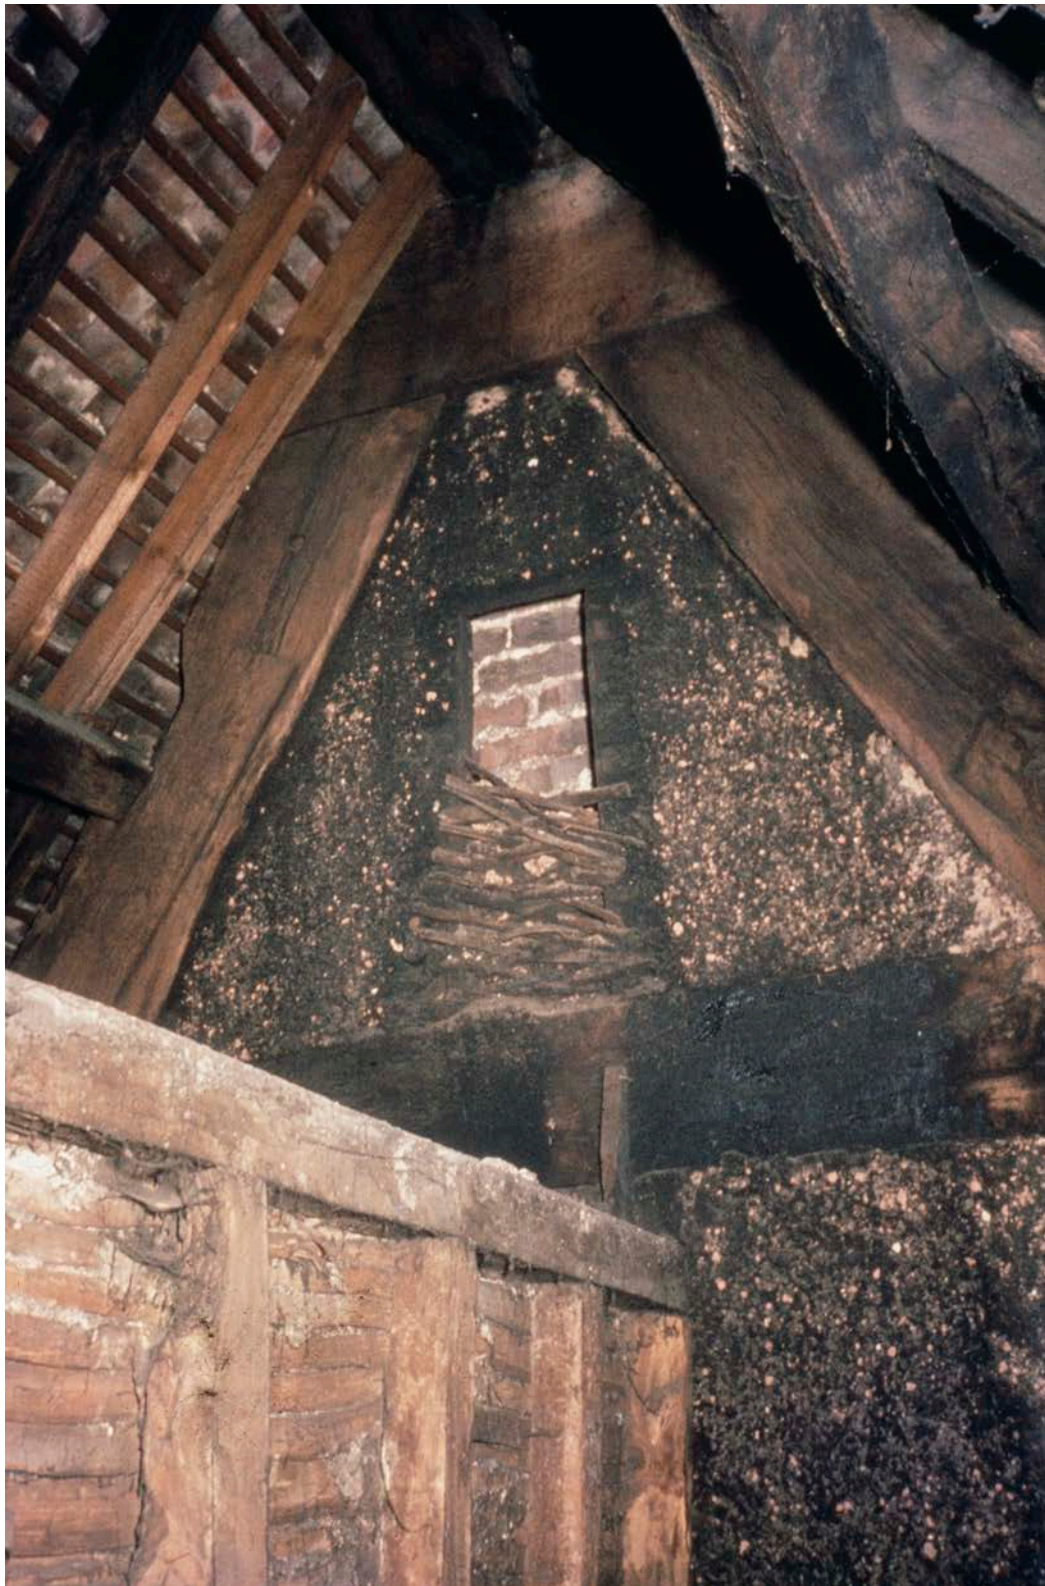
Figure 13: 1960s photograph by Stanley R. Jones showing the smoke-blackened south face of the northernmost frame (frame 1), with the lath-and-plaster attic in the foreground. [© Historic England Archive, SJC01/03/0008]

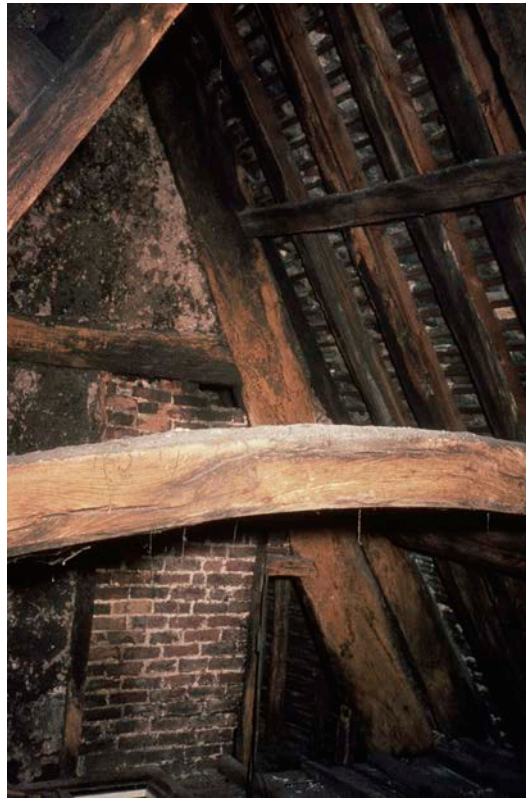
Figure 14: 1960s photograph by Stanley R. Jones showing the smoke-blackened south face of the partition between the hall and solar (frame 3) with the collar of the open frame over the solar (frame 4) in the foreground. The brick is part of a later chimneystack. [© Historic England Archive, SJC01/03/0006]

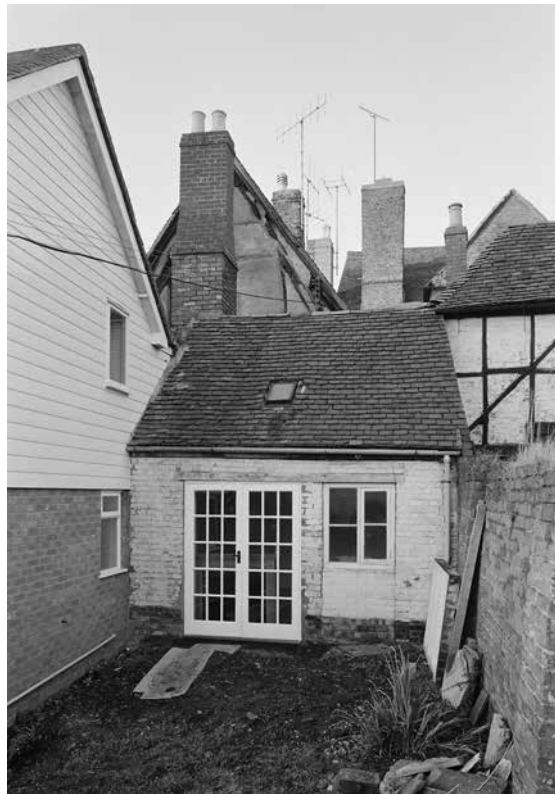
Figure 18: The single-storey range to the rear of the main range and the newly rebuilt south-west range (left) in a photograph by Dennis Evans of December 1971. [© Crown Copyright. Historic England Archive, BB72/00613]

In 1970 Mr Wall, the owner of 81-2 Barton Street, received planning permission for 'alterations and extension to existing premises to provide lounge with bedroom over'.¹¹⁸ No further details are known but it seems likely that this relates to the rebuilding of the south-west range to the south of the main range, which is now part of 1 Mason's Court. By 1971, when it is shown in photographs, the south-west range which slightly projects into the alleyway had been rebuilt (Figure 18).

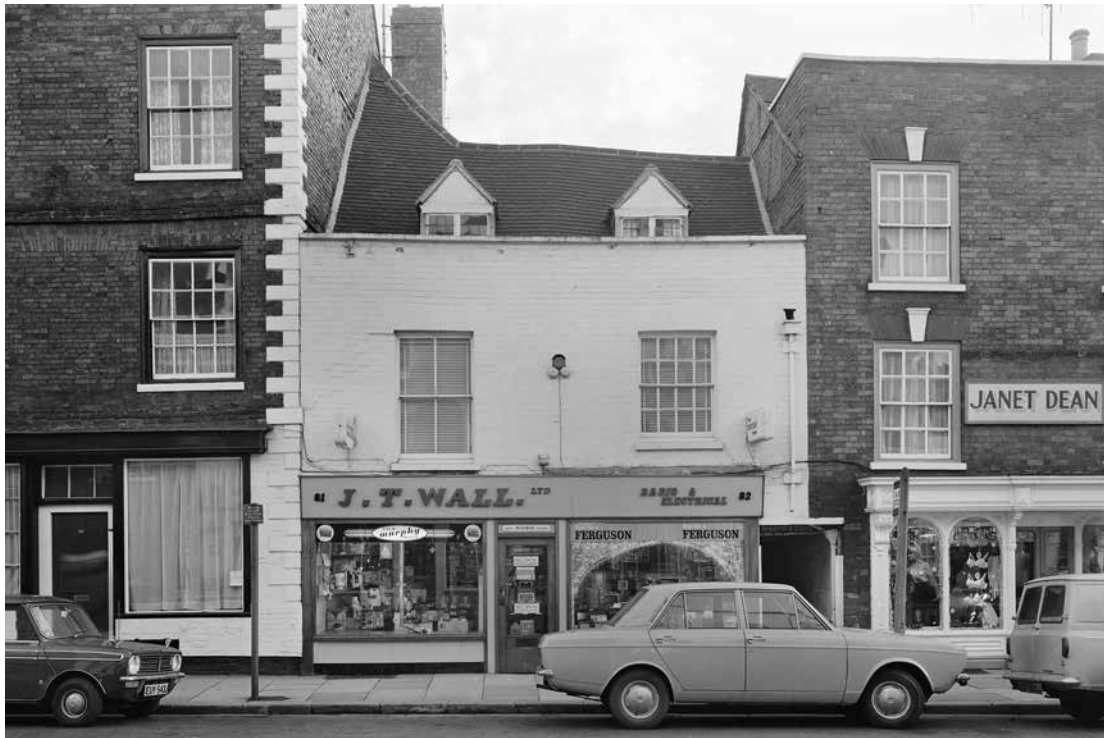
Figure 19: The shopfront at 81-2 Barton Street in a photograph by Dennis Evans of December 1971. [© Crown Copyright. Historic England Archive, BB72/00610]

In December 1971 Dennis Evans, a photographer from the RCHME, visited the building and took 24 photographs (see Appendix 3).¹¹⁹ It is likely that further planned alterations to the listed building prompted his visit. However, as is obvious from his photographs some alterations had already taken place by then, including the retiling of the roof of the front range (Figure 19).

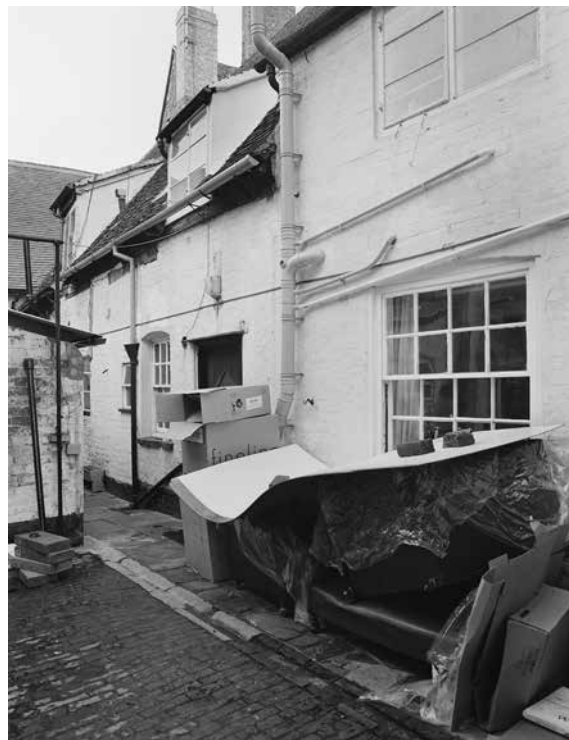
Figure 20: The west elevation of the main range (left) and the rear range (right) in a photograph by Dennis Evans of December 1971. [© Crown Copyright. Historic England Archive, BB72/00612]

Other photographs show part of the west elevation towards the alleyway (Figure 20) and the interior of the two first-floor rooms over the shop (now flat 3a Mason's Court). But the main focus of the photographic recording was the main range, which was then partly in residential use. In particular he focused on recording the visible cruck blades (Figure 21). Evans's images also show the collar and arch brace of the open hall's intermediate frame (frame 2) which was still partly encased by attic subdivisions in the roof space (Figure 22).

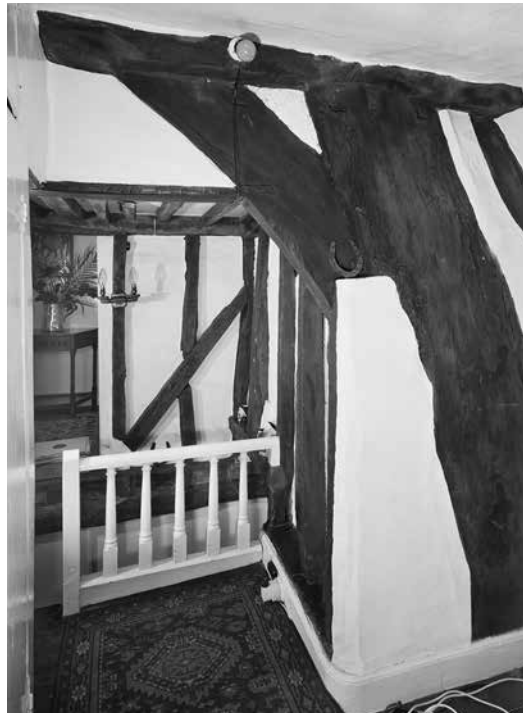
Figure 21: View from the front range at first-floor level with the north side of frame 1 of the main range in the foreground right. Photograph taken by Dennis Evans of December 1971. [© Crown Copyright. Historic England Archive, BB72/00615]

The main staircase in the main range was at its north end, just east of the entrance from the alleyway, and provided access to all floors of the main range and front range, including the cellar and attic (see Figure 21). A secondary stair was in the eastern room in the second bay from the north of the main range and connected the ground and first floors.

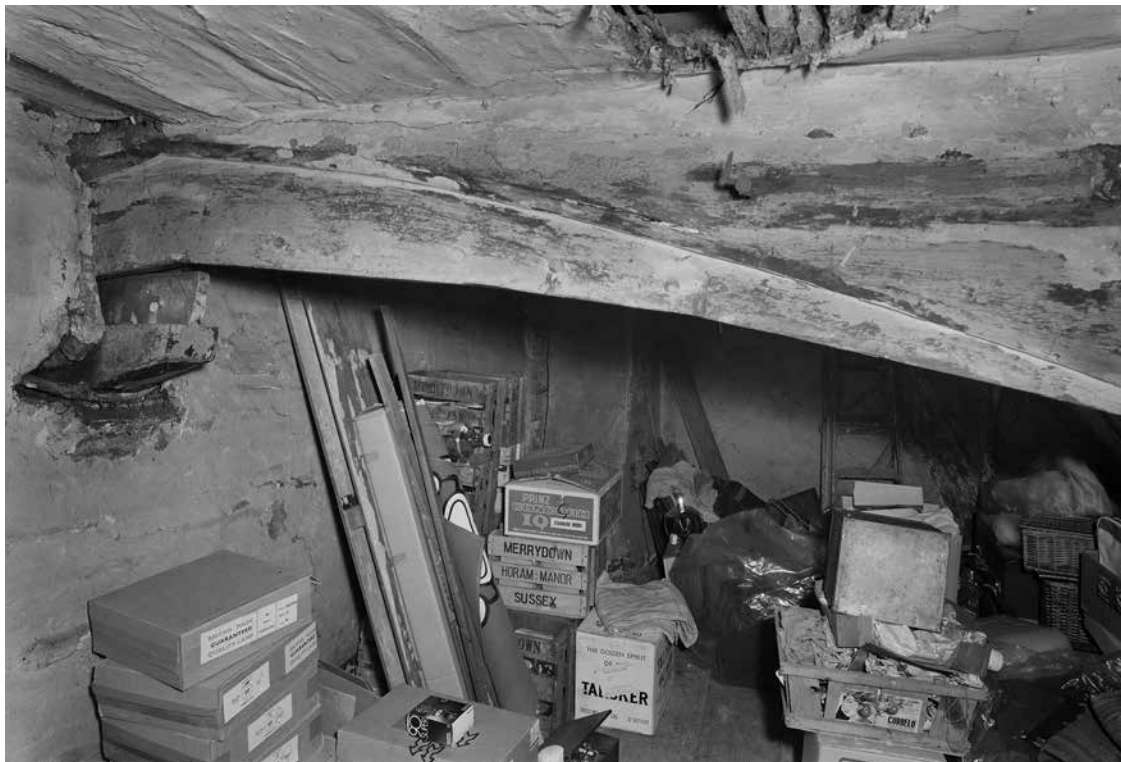
Figure 22: The collar of frame 2 with the partially-surviving arch brace to the east (left), photographed by Dennis Evans in December 1971. [© Crown Copyright. Historic England Archive, BB72/00629]

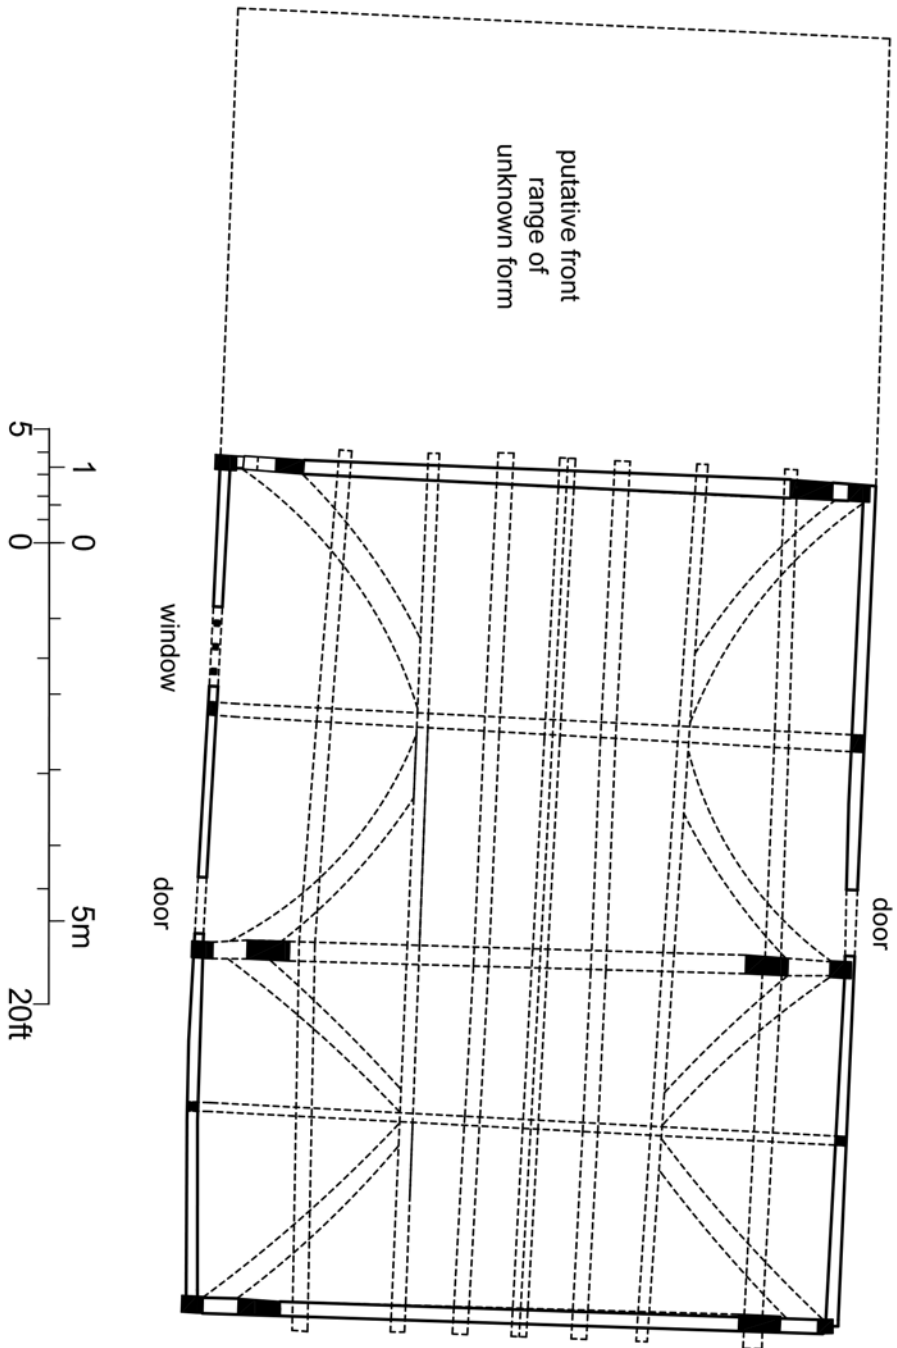
Figure 30: Reconstruction of the original plan (based on the existing first-floor plan) with reflected roof plan (scale 1:100). The solid lines denote wall lines and the dashed lines overhead features. [© Historic England]

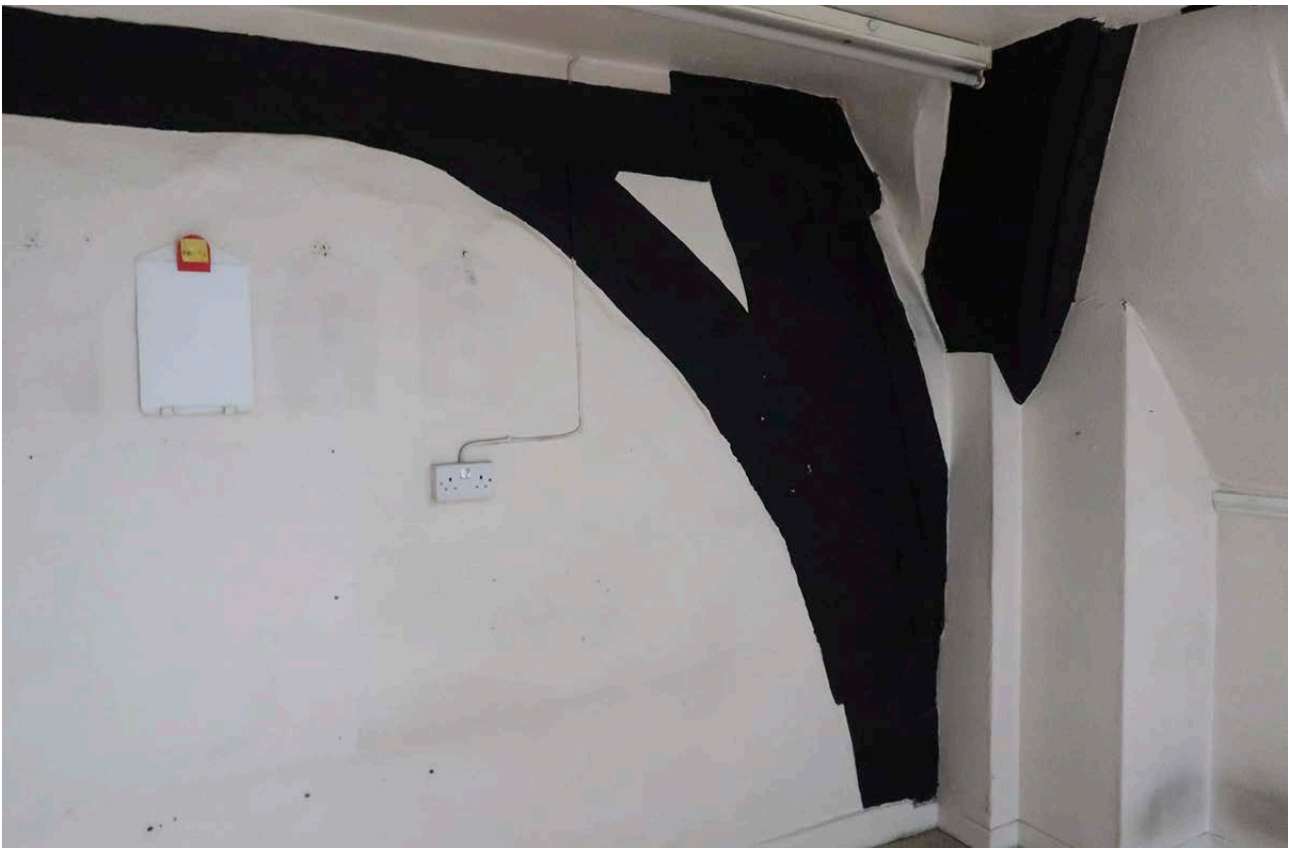
Figure 32: The south side of the east blade of frame 1 at the present first-floor level, showing from left to right the lower collar, arch brace, east cruck blade and windbrace. [Johanna Roethe © Historic England]

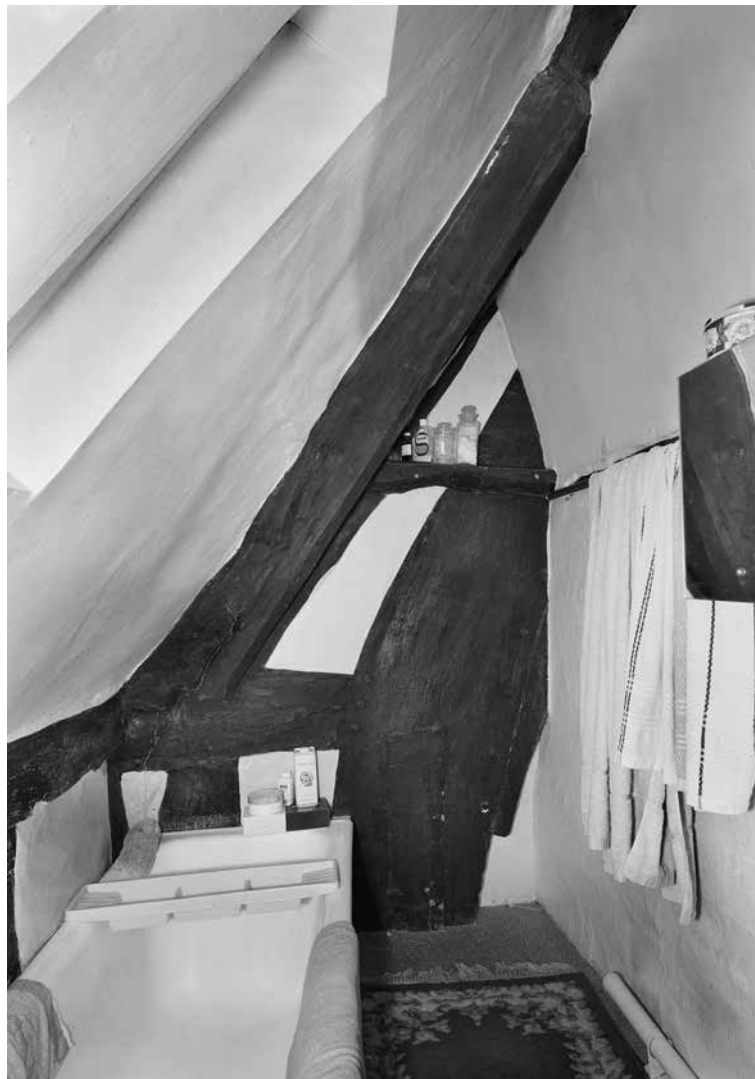
In the 1960s Jones saw evidence for a cruck spur running from the west blade of frame 1 to the wall plate, and this was photographed by the RCHME in 1971 (Figure 33). This photograph shows the spur tenoned into the outer edge of the western cruck blade, fixed with three pegs. Although there are some later timbers partially obscuring the original arrangement in the photograph, it appears that the spur is supported by a cruck stud, which sat slightly inwards from the outer end of the spur and the wall plate. Pegging for the joint between the stud and the spur is visible. The wall plate itself also appears to have been in situ at this stage, and to be seated on the outer edge of the cruck spur, although it is not clear how it was jointed to it. Just visible rising from the top of the cruck spur is a packing piece (or secondary rafter) designed to support the purlins. Jones did not appear to have noted the position of any tiebeam, nor is one shown in the photograph. However, neither he nor the later photographer appear to have seen the lower part of the frame.

Figure 33: The south side of the west blade of frame 1, at the modern first-floor level, photographed in 1971. [© Crown Copyright. Historic England Archive, bb72/00622]

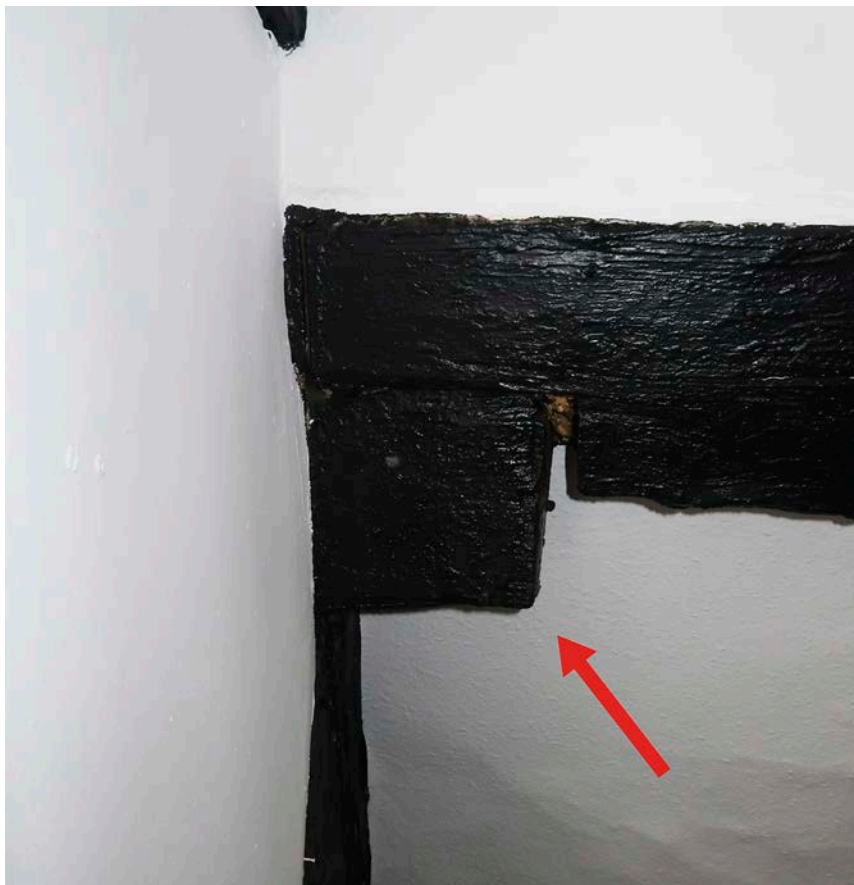
Figure 34: The north side of the west end of frame 1, seen from the second-floor flat in the later front range and looking west. The arrow indicates the projecting central purlin, with a later timber scarfed onto its northern end. [Johanna Roethe © Historic England]

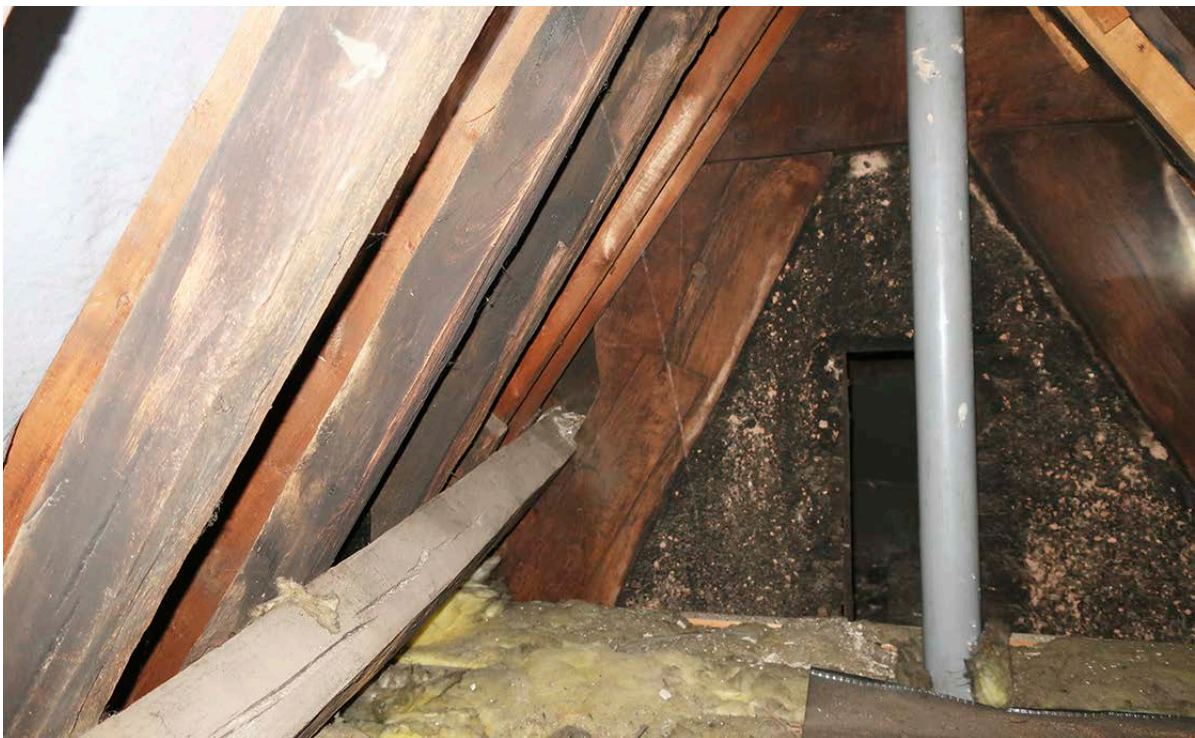
Figure 36: The roof space in bay A with the upper purlin on the west side. [Rebecca Lane © Historic England]

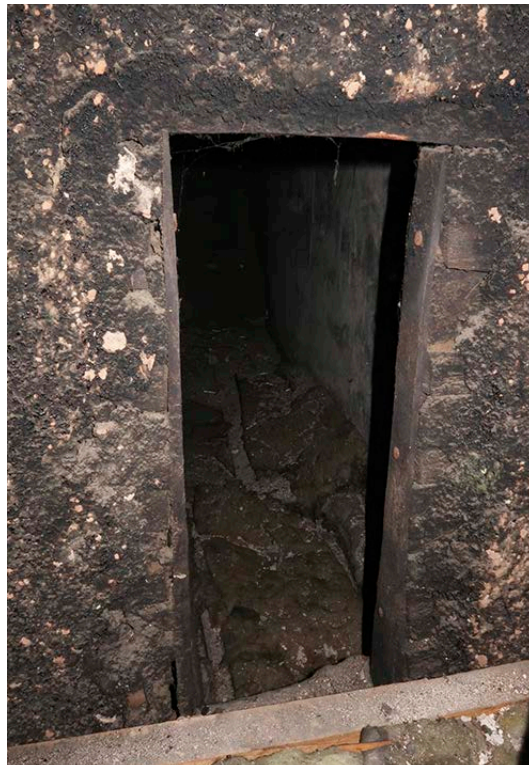
Figure 37: The south side of the apex of frame 1 with the smoke vent. [Johanna Roethe © Historic England]

The main evidence for this frame having been originally the northern extent of the main range survives in the upper part of the frame, in the form of a smoke vent. Just below its apex, frame 1 retains a smoke-blackened panel formed of studs supported by the upper collar and running into the saddle and the blades at their upper ends. These are mostly concealed by the plaster finish, but where it has fallen away (particularly on the northern face) they can still be observed. Where it can be observed, the inner face of the panel can be seen to be formed of thin slivers of timber, placed horizontally, which must be nailed or fixed onto the studs behind (Figure 37). At the centre of the panel is an oblong opening (see Figures 13, 16, 36, 37). This is carefully framed within the panel, directly above the upper collar, and between two studs.

The construction of the additional bay (or any larger structure it formed part of) would have rendered the original smoke vent in the north gable end of the main range useless, as the smoke would have fed into the roof over the later structure. This may have led to the modification of this opening. As already noted in Phase One, there is evidence for a later timber frame inserted within the opening, nailed to the original staves (see Figure 37). The nails have flat and circular heads.

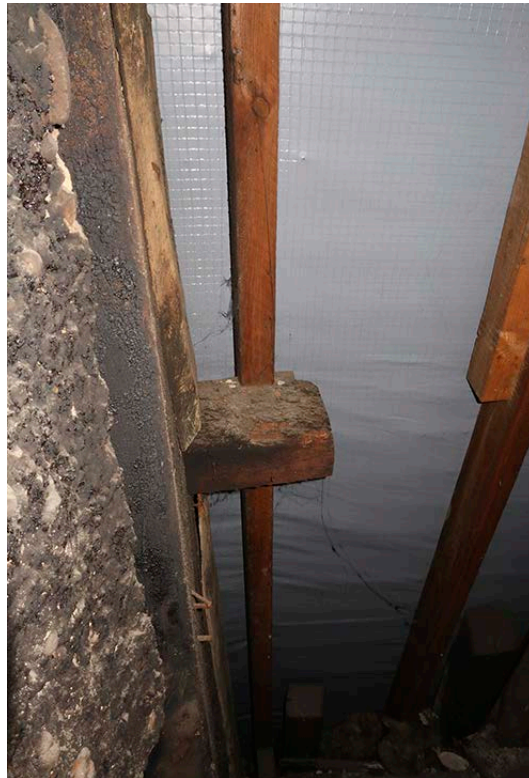
Figure 38: The west end of the north side of frame 1, with smoke blackening to the infill panel and the west cruck blade. [Johanna Roethe © Historic England]

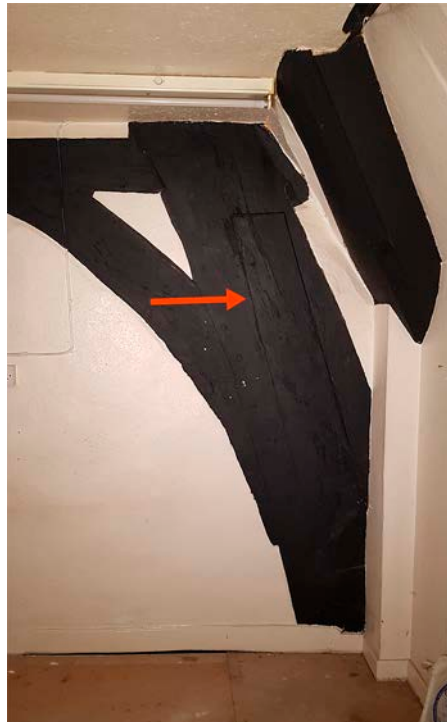
Figure 39: The south side of the east blade of frame 1 at collar level (now first-floor level), with the shallow cut-out indicated by a red arrow. [Abigail Lloyd © Historic England]

Both cruck blades of frame 1 have shallow inlay or patch infills on their south face. Stanley Jones speculated that these were where a flaw in the timber was cut out to a shallow depth and a timber piece inserted. The infills are smoke blackened to the same degree as the rest of the blades, suggesting these were repairs undertaken by the original carpenter while preparing the cruck blades for construction. Of the various patches that Jones observed, three are still visible, all on the south side of frame 1: one on the east blade at what is now first-floor level, where the patch infill is missing (Figure 39), one in situ patch infill on the west blade in the roof space (Figure 40) and a third on the east blade in the roof space, which is also missing its infill (Figure 41). The last two areas of infills are not at the same height (Figure 42). According to Stanley Jones's drawings these two continued further down the blade but this area is not currently visible (see Figure 16).

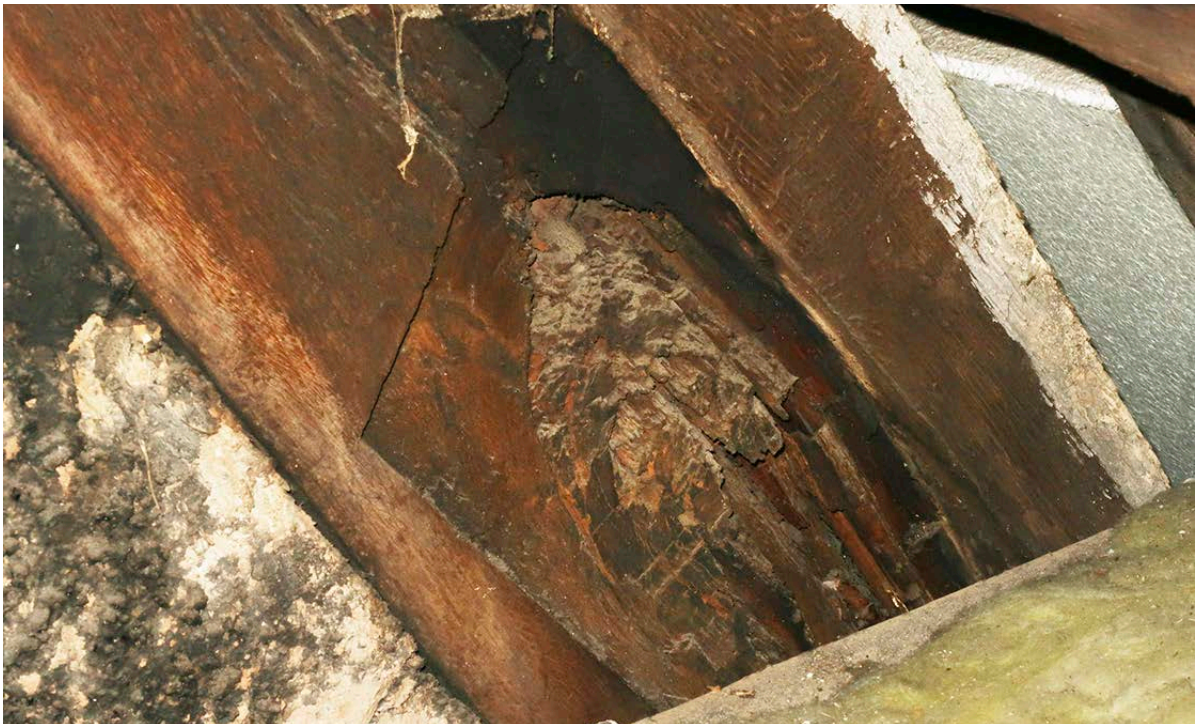
Figure 41: The missing patch infill in the east blade of frame 1 near the apex. [Johanna Roethe © Historic England]

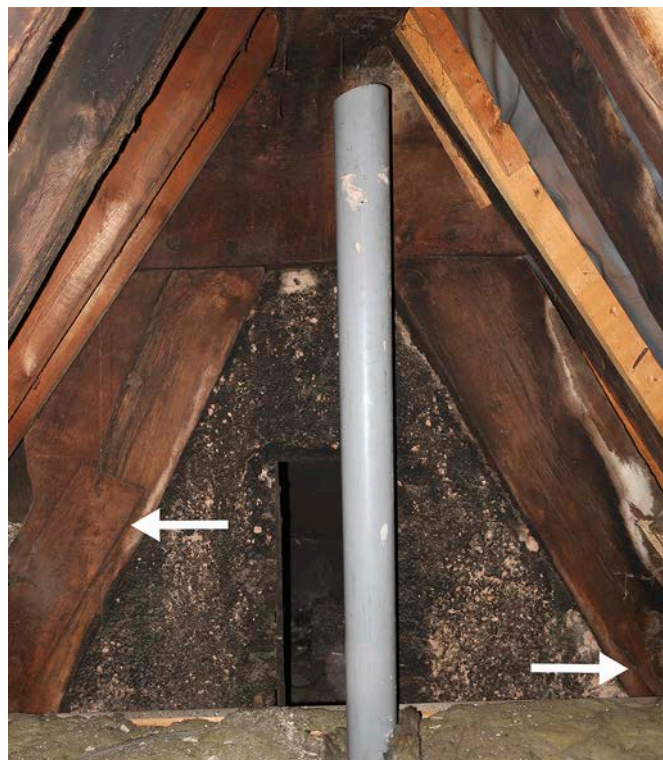
Figure 42: The south side of the apex of frame 1 with white arrows indicating the visible patch infills in the cruck blades. [Rebecca Lane © Historic England]

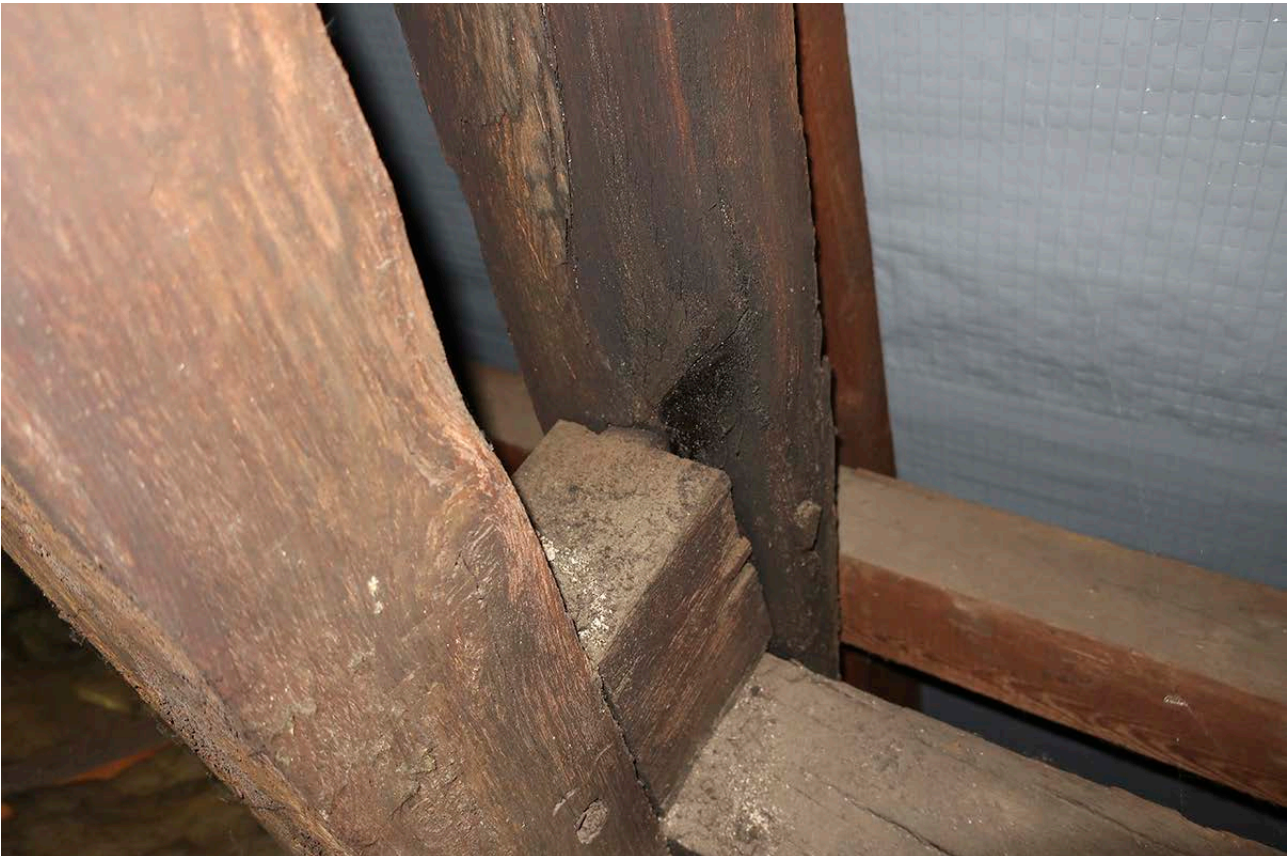
Figure 45: Detail of frame 2, showing the pegged spacer above the upper purlin. [Rebecca Lane © Historic England]

The upper and central purlins can both still be seen. Both purlins which are still visible are not fixed to the rafters themselves, but instead have small squared cleats or spacer blocks to either side, which are pegged into both purlins (Figure 45). This arrangement was presumably designed to minimise the movement of the purlins up or down, although the lack of fixing on the purlins themselves has still allowed significant later movement of the members.

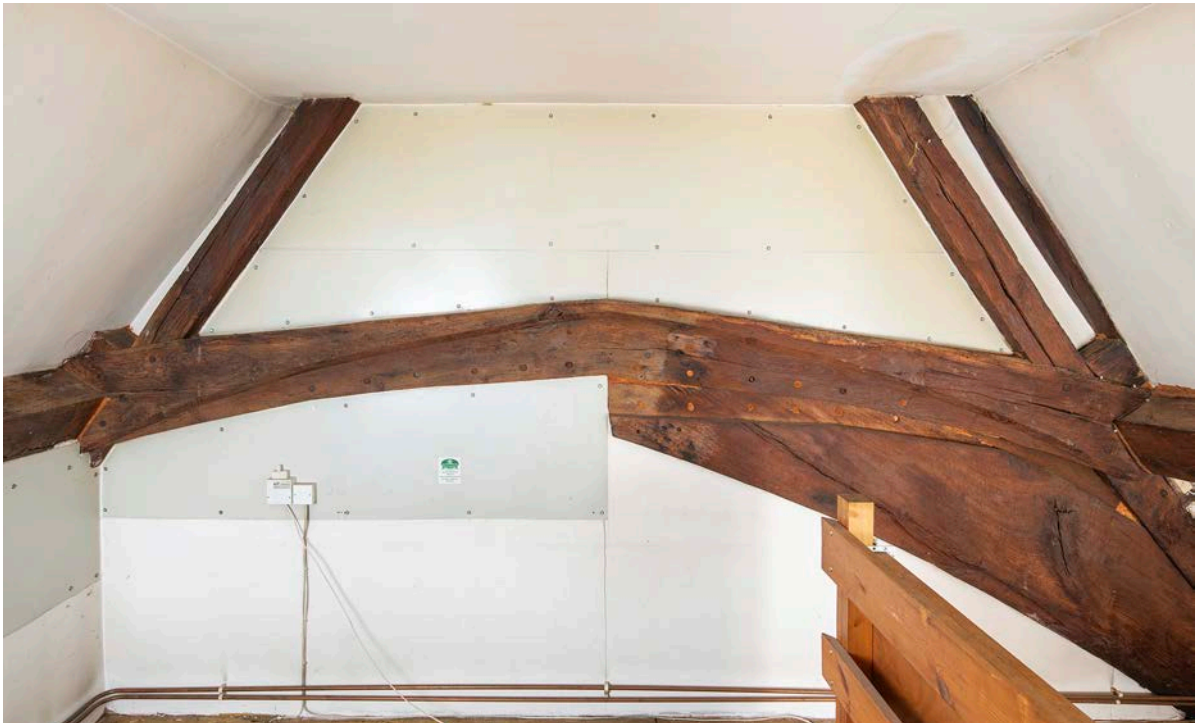
Figure 46: The south side of frame 2 at collar level (now second-floor level). [Steven Baker © Historic England Archive, DP325782]

Frame 2 has a collar which is tenoned into the inner rafter, but also rests on the central purlin to either side with a birdsmouth junction (Figures 46, 47). It was supported by two arch braces, although the western brace has later been removed. Both of these were originally tenoned into the principal rafters at their outer edges and into the collar above, with broad tenons pegged by rows of five widely spaced pegs. The collar above is slightly cambered, but this angle is emphasised by an offset on the face of the collar with a chamfered edge, which continues the line of the inner rafter, running with a slight curve from the base of the collar at its outer edges to a point just below the apex towards the centre. The area below the offset is flush with the arch braces. The surviving east brace has dropped out of its mortice revealing much of the tenon.

The roof space above the ceiling in bays A and B was seemingly not fully utilised, although one upper arch brace of frame 2 was removed for a low-ceiled lath-and-plaster attic room which may date from this period or later (see Figures 22 and 46).

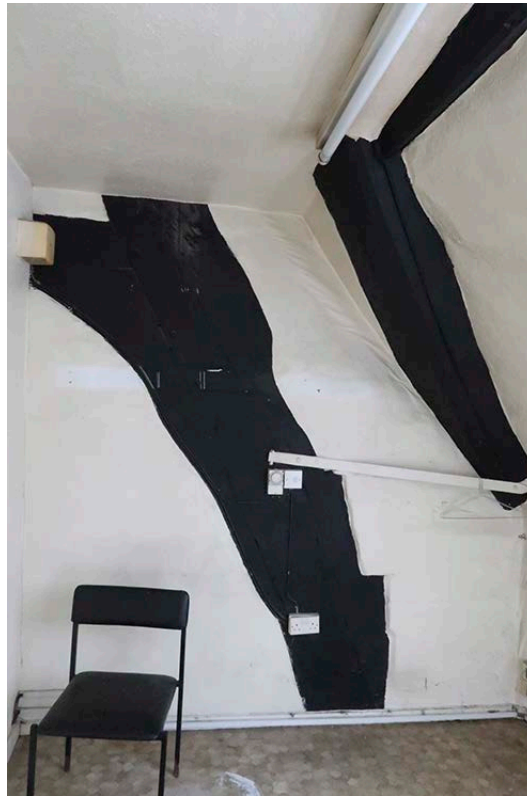
Figure 49: The north face of the west blade of frame 3, at the level of the lower collar (now first-floor level). [Johanna Roethe © Historic England]

Although the overall form of the collars is similar to frame 1, the form of the braces supporting the lower collar is slightly different (see Figures 16 and 48). Whereas in frame 1 the brace was an arch brace, here it is a shorter brace, which also engages into the corner (Figure 49). The reason for this difference is unclear. Both frames 1 and 3 were closed frames, so it does not appear to relate to any functional difference.
