81-2 Barton Street and 1-3 Mason's Court, Tewkesbury, Gloucestershire

Historic Building Assessment

Rebecca Lane and Johanna Roethe

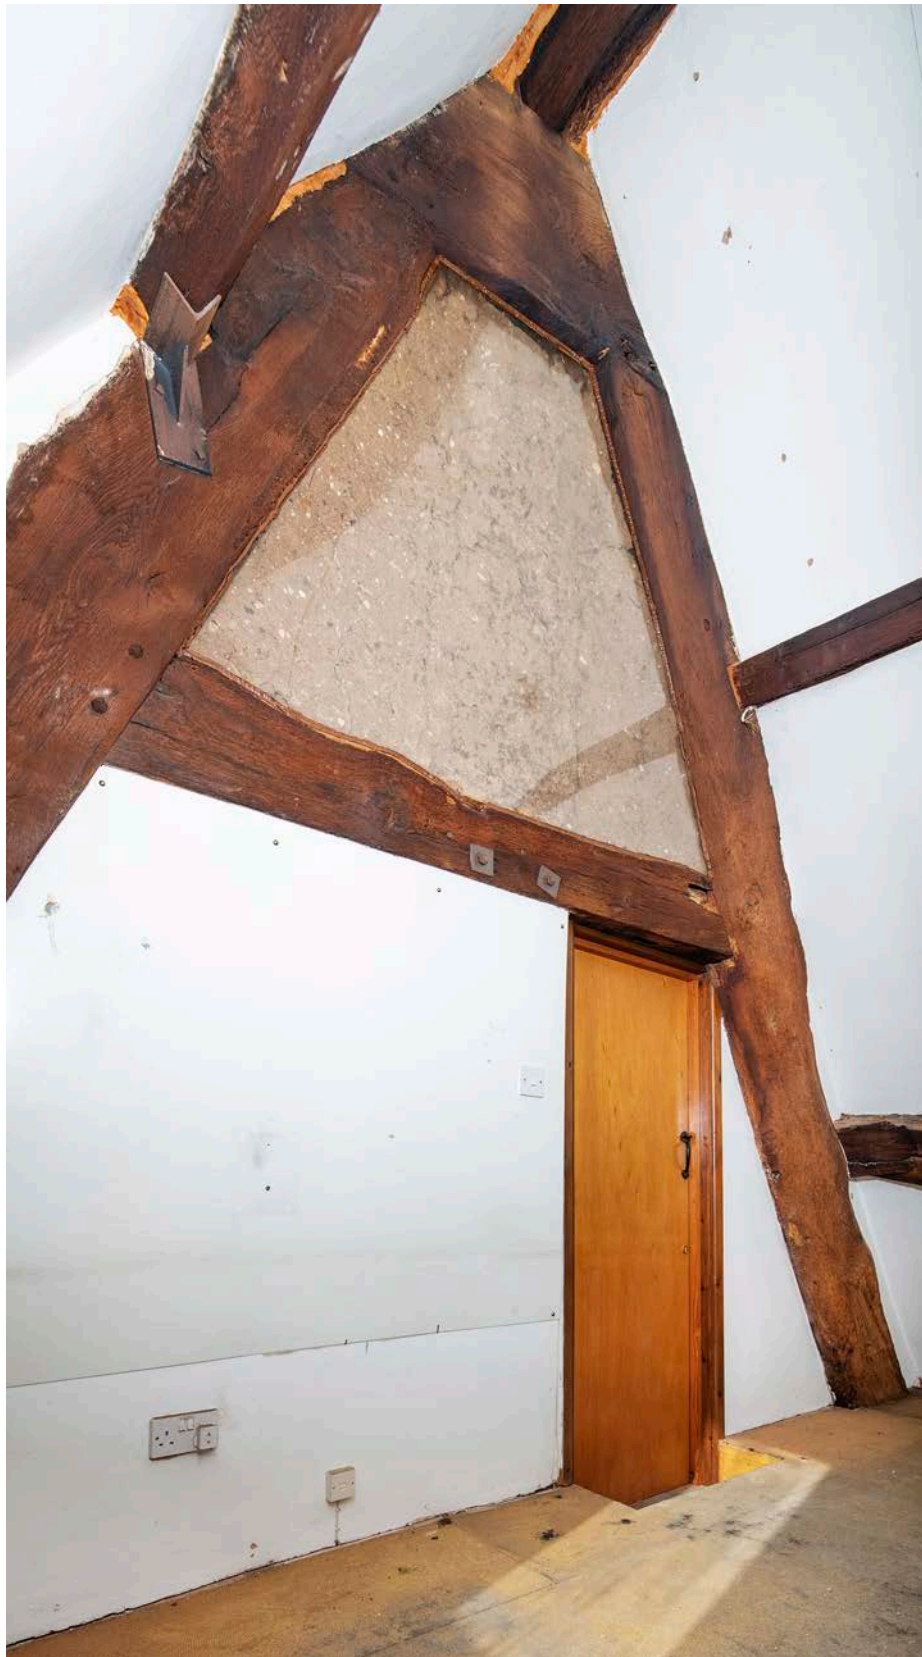
Figure 50: The south side of the apex of frame 3. [Steven Baker © Historic England Archive, DP325786]

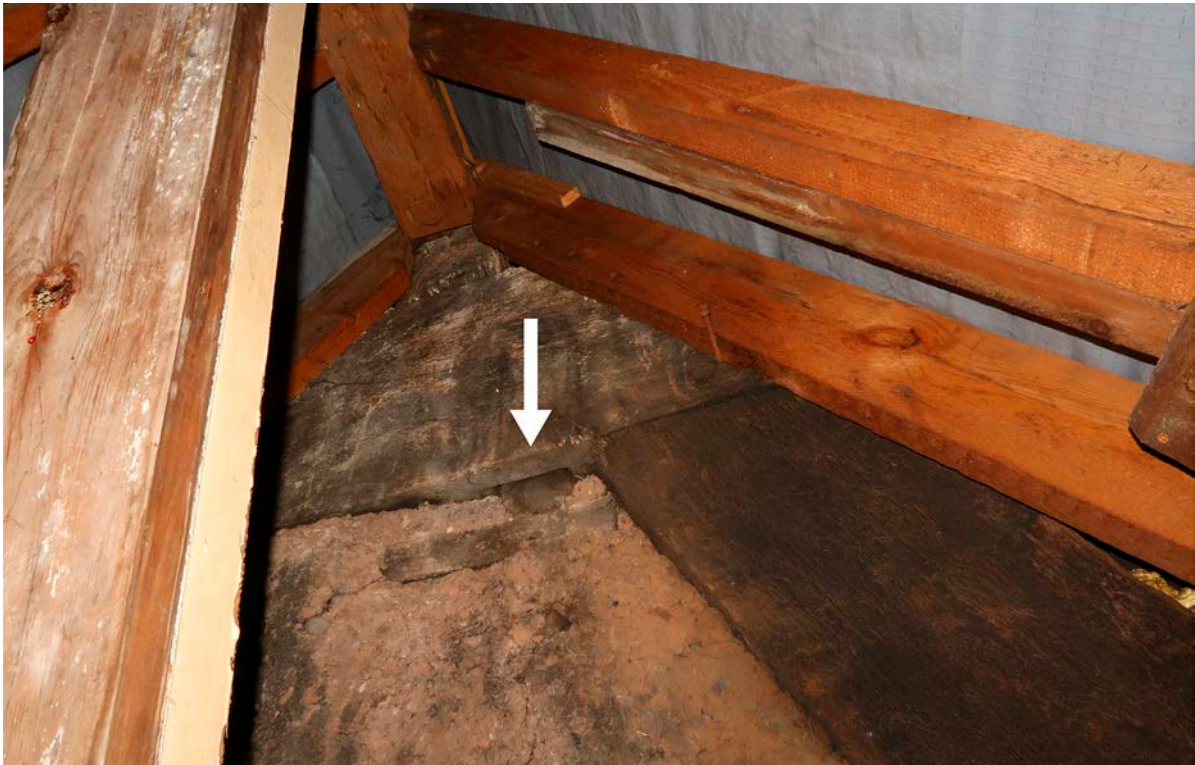
Figure 51: The north side of the apex of frame 3 with an arrow indicating a mortise with stave. [Johanna Roethe © Historic England]

There are clear indications that frame 3 was always closed. An original partition panel survives between the upper collar and the saddle (Figure 50). There are mortices in the underside of the saddle with staves running down (Figure 51). There is also an empty mortice visible in the underside of the upper collar, suggesting that the frame was also closed below this (Figure 52). There are marks on the underside of the collar, above the modern door opening, which may be laying out marks relating to the position of the stud in the mortice (see Figure 52).

Towards the apex of frame 3, where it is not coated in later paint, the north side of the frame is clearly smoke blackened from the open hall (see Figure 51). Stanley Jones's photograph of the south side also showed smoke blackening on the upper parts of the timbers, and the infill panels, which has since been cleaned from the panel above the upper collar (see Figure 14). Some smoke blackening is still visible on the timbers on the south side, however, particularly towards the apex on the saddle (see Figure 50).

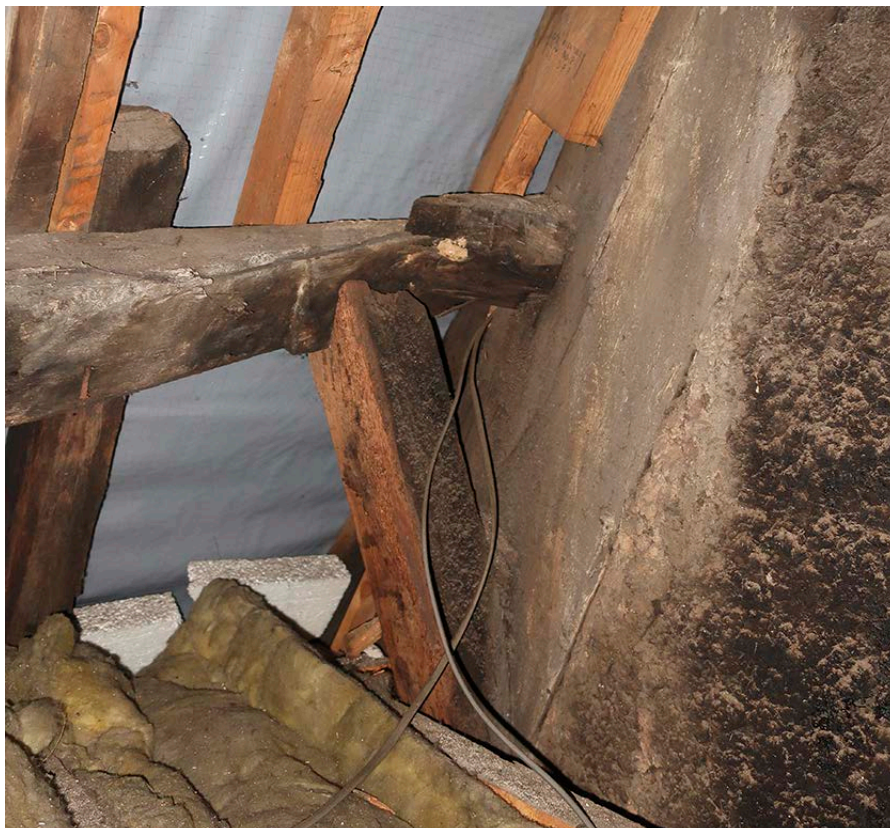
Figure 53: The splayed and tabled scarf joint in the upper purlin on the east side just north of frame 3 in bay B. [Rebecca Lane © Historic England]

As with frame 1, only the upper and central purlins are fully visible, and again they are trenched into the back of the cruck blades (with a halved lap joint). Both the central purlins and the upper purlin on the east side have through splayed and tabled scarf joints just north of frame 3; that is where the scarf joint is angled but with a step in it, which helped to prevent the two timbers moving apart (Figure 53). The ridge piece also has a scarf within bay B and close to frame 3. This appears to be a simple splayed scarf (Figure 54) although this may be the result of later modification as the southern part of the ridge was removed in the late 20th century (Figure 55). According to Stanley Jones's drawing of the west elevation, the wall plate on the western side has a through splayed and tabled scarf joint just south of frame 3 (see Figure 31).

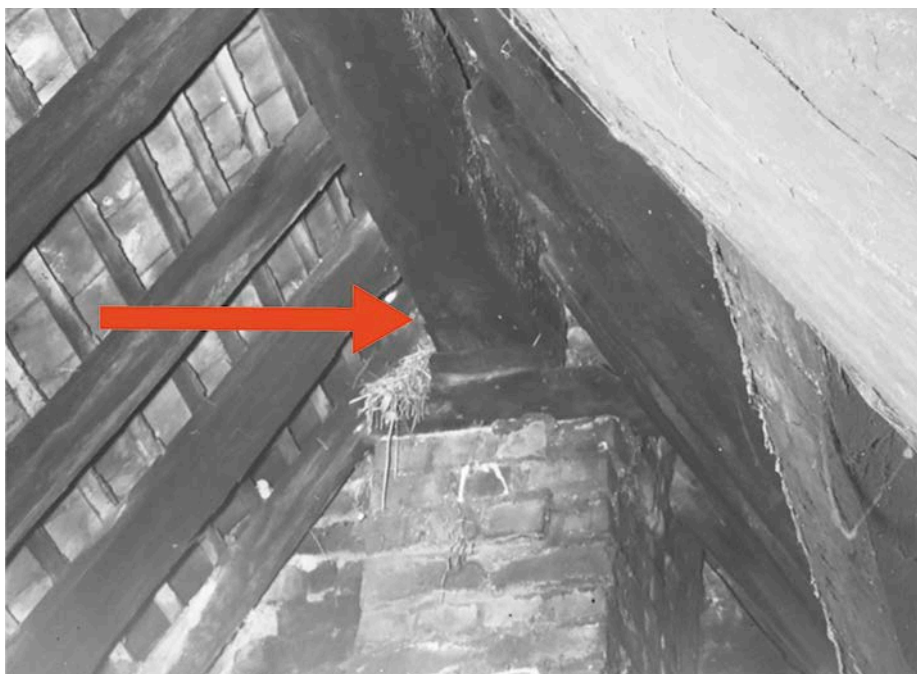
Figure 55: Detail of a photograph taken by Dennis Evans in December 1971, showing the chimneystack just north of frame 3. The arrow indicates the then still intact splayed scarf of the ridge piece. [© Crown Copyright. Historic England Archive, BB72/00632]

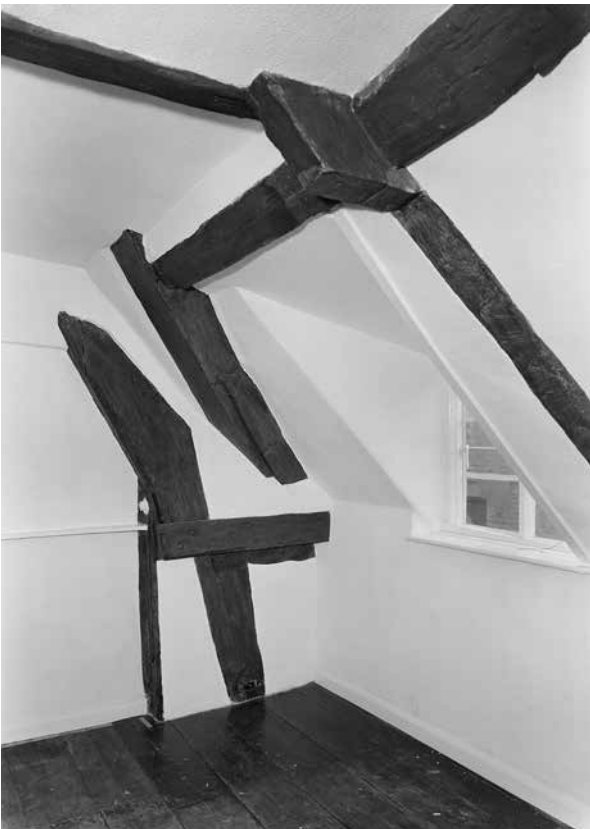
Figure 56: The west side of bays C and D at first-floor level in 1971 with frame 5 at centre left, with a windbrace rising from it, and the truncated inner rafter of frame 4 at centre top. [© Crown Copyright. Historic England Archive, BB72/00624]

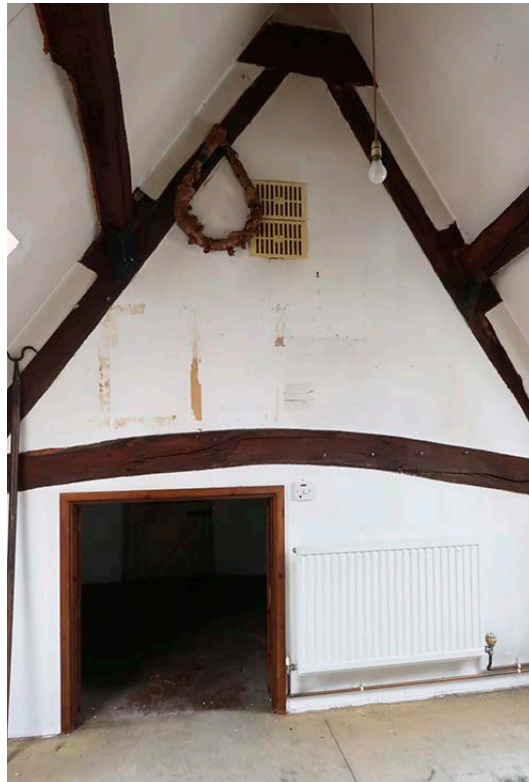
Figure 57: The upper part of the north side of frame 4, at what is now second-floor level. [Johanna Roethe © Historic England]

Frame 4, the intermediate frame in the southern two bays, was an open frame which took a similar overall form to frame 2, although it was less elaborate (see Figures 12, 14). It again had a compound arrangement, with inner and outer rafters, with the three tiers of purlins running between them. The upper two purlin levels are still visible, as are the same spacers (or squared cleats) to either side of each purlin. Few timbers relating to this frame are visible at lower level. The inner rafter has been truncated on the west side just below the modern second-floor level (Figure 56). At the present second-floor level there is a cambered and chamfered collar (Figure 57). Unlike frame 2 it appears never to have had any arch braces, making it simpler in its overall form. The north side has one run-out stop at the east end (Figure 58); the stop at the west end is obscured by plaster. The collar's south side is also chamfered but its stops are also obscured by later plaster below. There are no obvious signs of closure at this level and it is likely that this was part of the two-bay solar in bays C and D, which would have been open to the roof.

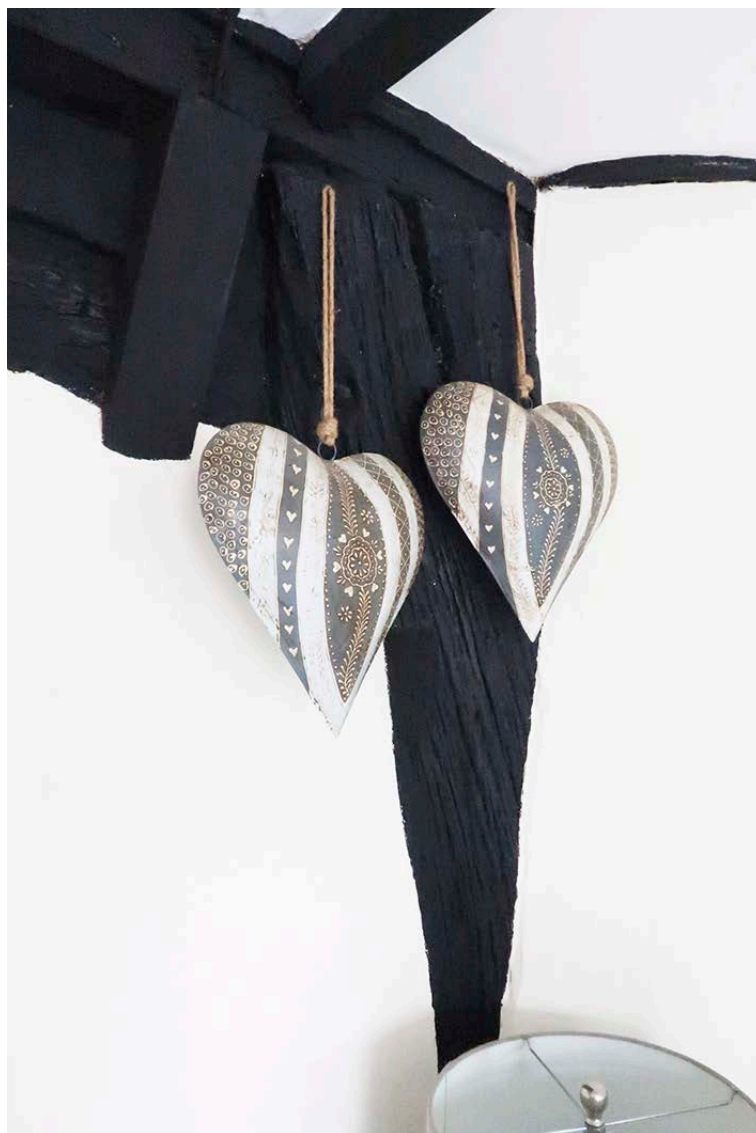
Figure 59: The lower part of the south side of the east blade of frame 5, with later ceiling timbers and bracket. [Johanna Roethe © Historic England]

Frame 5 is another cruck frame with two collars. The only visible part at ground-floor level is the eastern cruck blade (Figure 59). Both cruck blades are chamfered from where they are visible at lower level to the level of the upper collar where the chamfer ends in a run-out stop (Figures 60 and 61). Jones indicates that for this frame the upper part of both cruck blades is scarfed into the lower sections, an arrangement sometimes seen with cruck blades, and presumably indicating that it was not possible to source timbers of the right size and form to create a third pair. This junction is not currently visible, but such an arrangement would explain the thinner scantling of the blades as visible at towards their apex (Figures 62 and 63). Despite this the apex form corresponds to those to frames 1 and 3, with a saddle supporting the square ridge piece (Figure 64).

The frame had both upper and lower collars. The upper collar is chamfered with run-out stops (see Figure 61). The lower collar is still visible (at current first-floor level, above the south window) and is not chamfered (Figure 65). It is double pegged into the cruck blade and thus appears to be original. As Jones observed neither collar appears to have had any bracing, unlike frames 1 and 3. Instead he suggests an arrangement of vertical and horizontal studs within each panel (see Figure 62). This arrangement is consistent with this frame having always been a closed frame and marking the southern extent of the building. This suggestion is confirmed by several visible surviving mortices in the underside of the upper collar which appear to be for the staves of the partition, as they are not pegged (Figure 66). Heavy weathering on the south side of the frame, where it can be observed within the later extension, appears to confirm the fact that frame 5 marked the end of the building (see Figure 59).

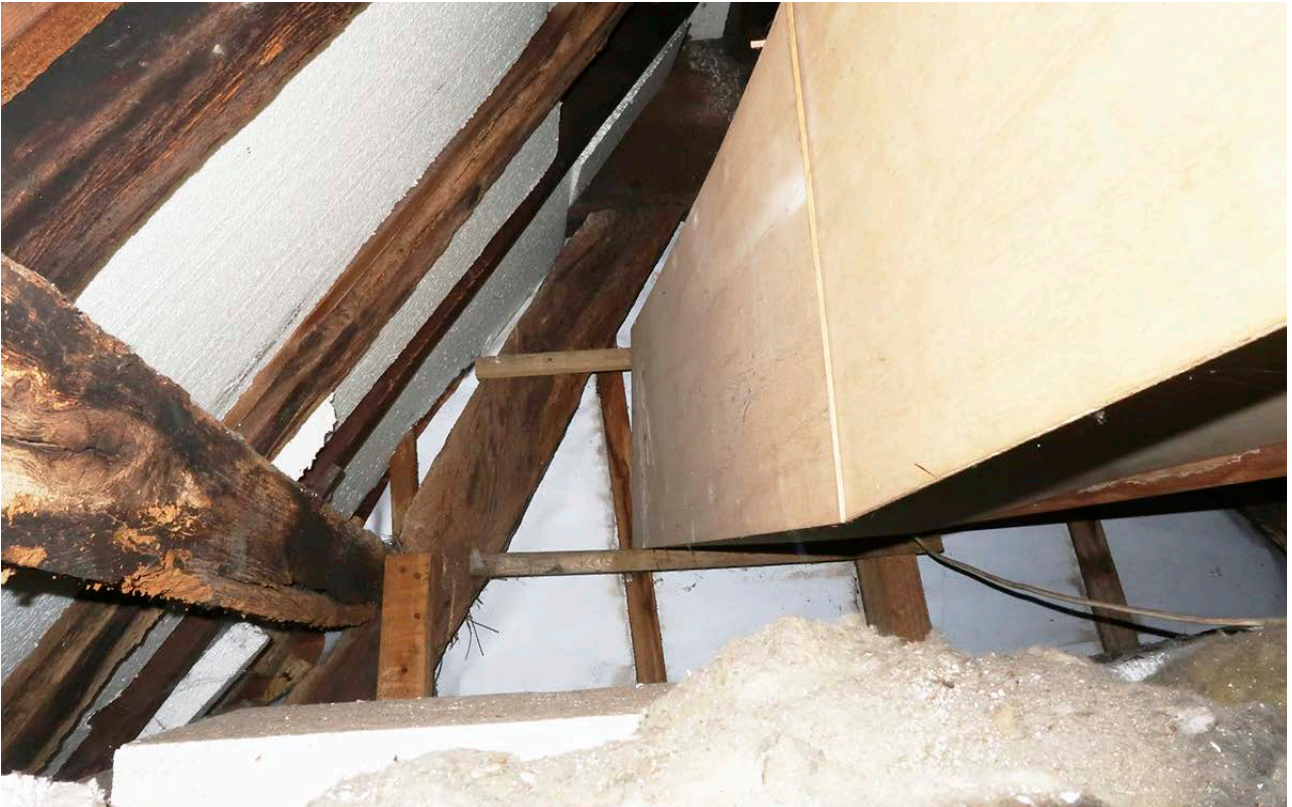
Figure 64: The upper part of the north side of frame 5 with the saddle (top centre) and the upper purlin (left) trenched onto the eastern cruck blade. [Johanna Roethe © Historic England]

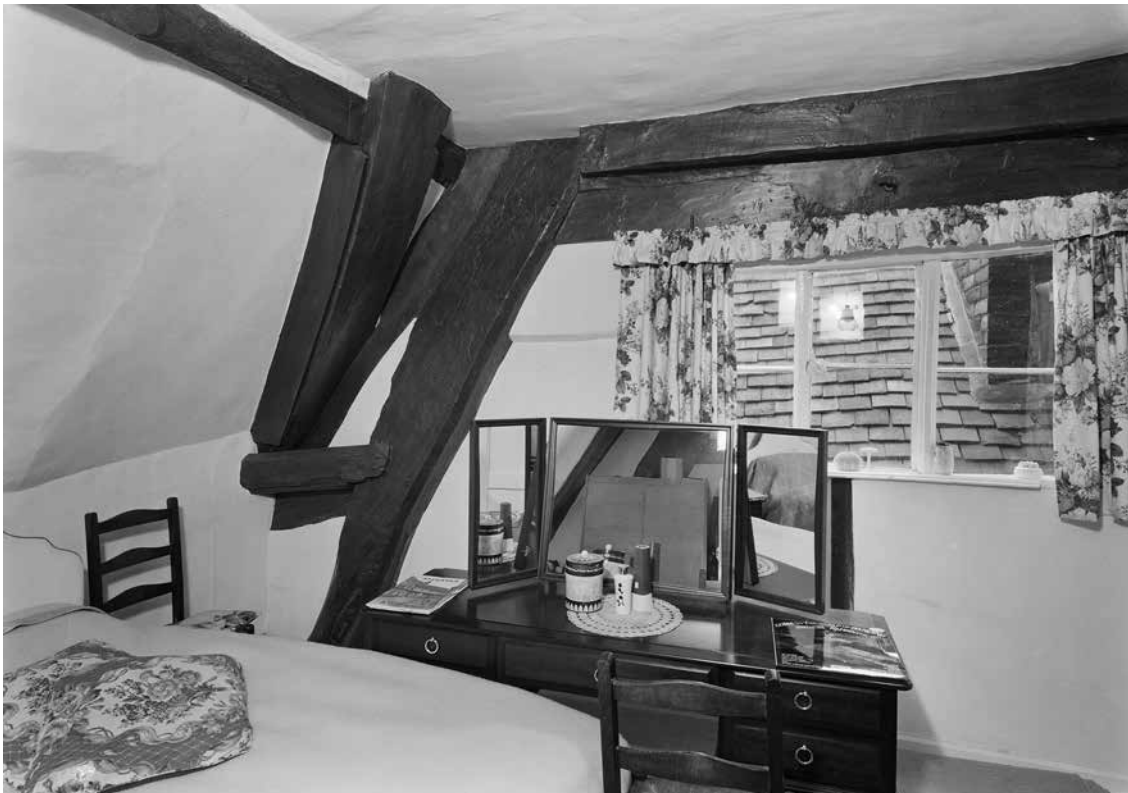
Figure 65: A 1971 photograph showing the north side of the east blade of frame 5 and the lower collar over the window. [© Crown Copyright. Historic England Archive, bb72/00626]

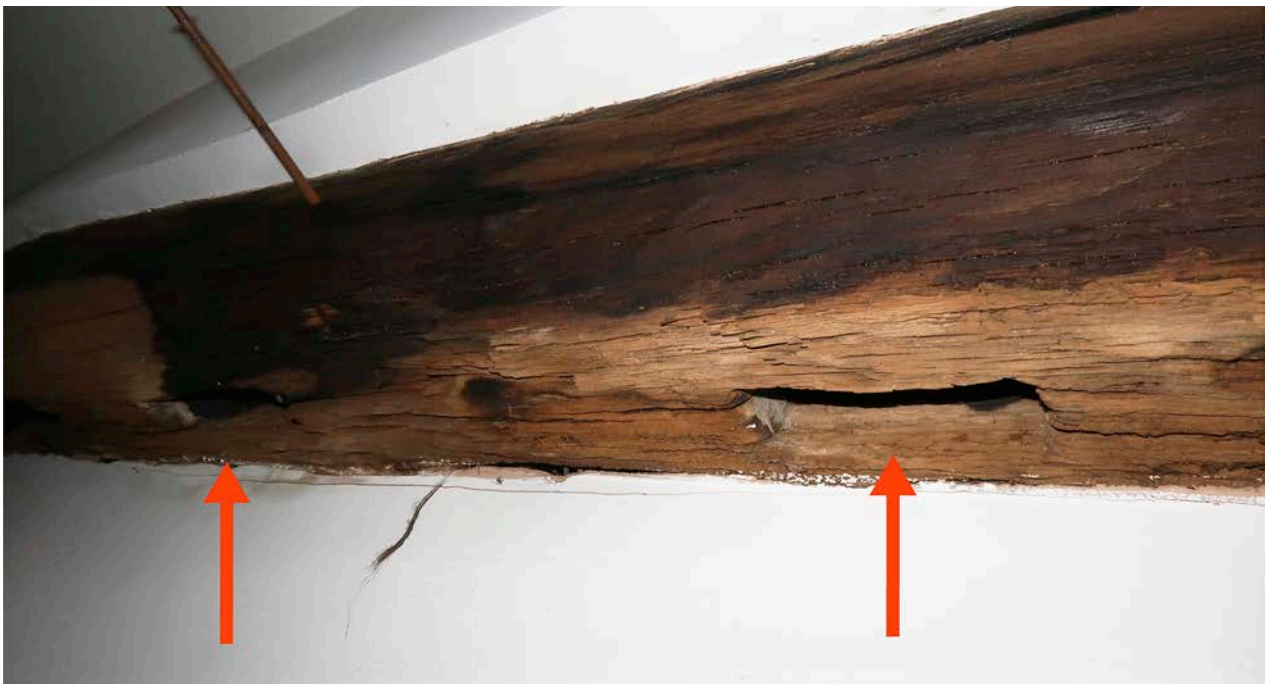
Figure 66: Two empty mortices (indicated by red arrows) for staves in the upper collar of frame 5. [Johanna Roethe © Historic England]

There is inconclusive evidence of smoke blackening or scorching on the upper collar (see Figure 66). It is possible this comes from the same source as the smoke blackening seen on the south side of frame 3, but in fact it looks less like smoke blackening, and more the result of scorching of the timber, possibly from a minor fire. It is possible that this is the effect of partial cleaning of the timber though, so at the moment this is inconclusive.

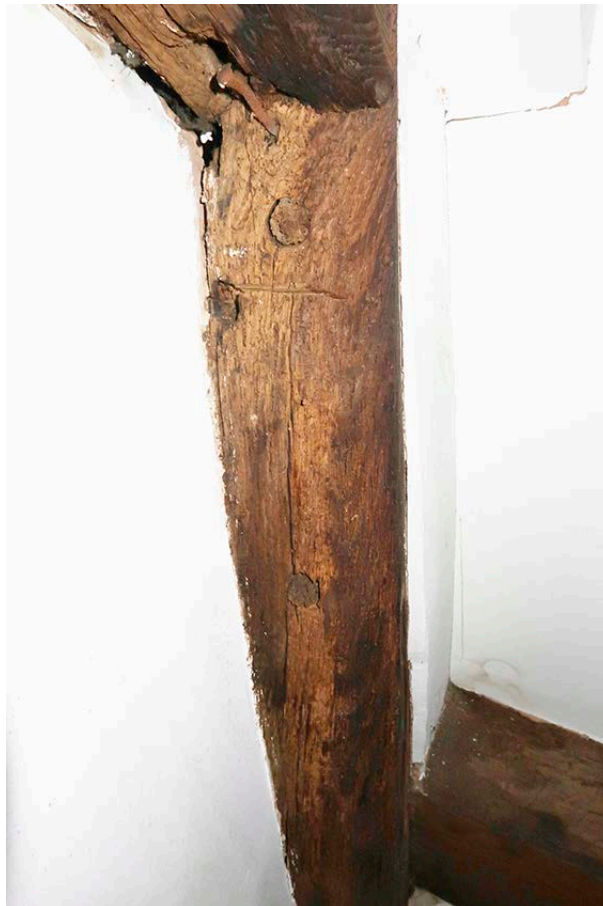
Figure 67: Three peg holes in the west cruck blade, two immediately below the collar and a further hole approximately 30cm below this. [Johanna Roethe © Historic England]

The inner face of the western cruck blade of frame 5 just below the upper collar has a series of peg holes (Figure 67). These could be interpreted as holes to receive the wattles of the infill to the panel, but elsewhere in the range the original infill arrangement does not seem to have used such wattles (see description above). It is possible that this frame utilised a slightly different infill form, or that the peg holes relate to a later feature.

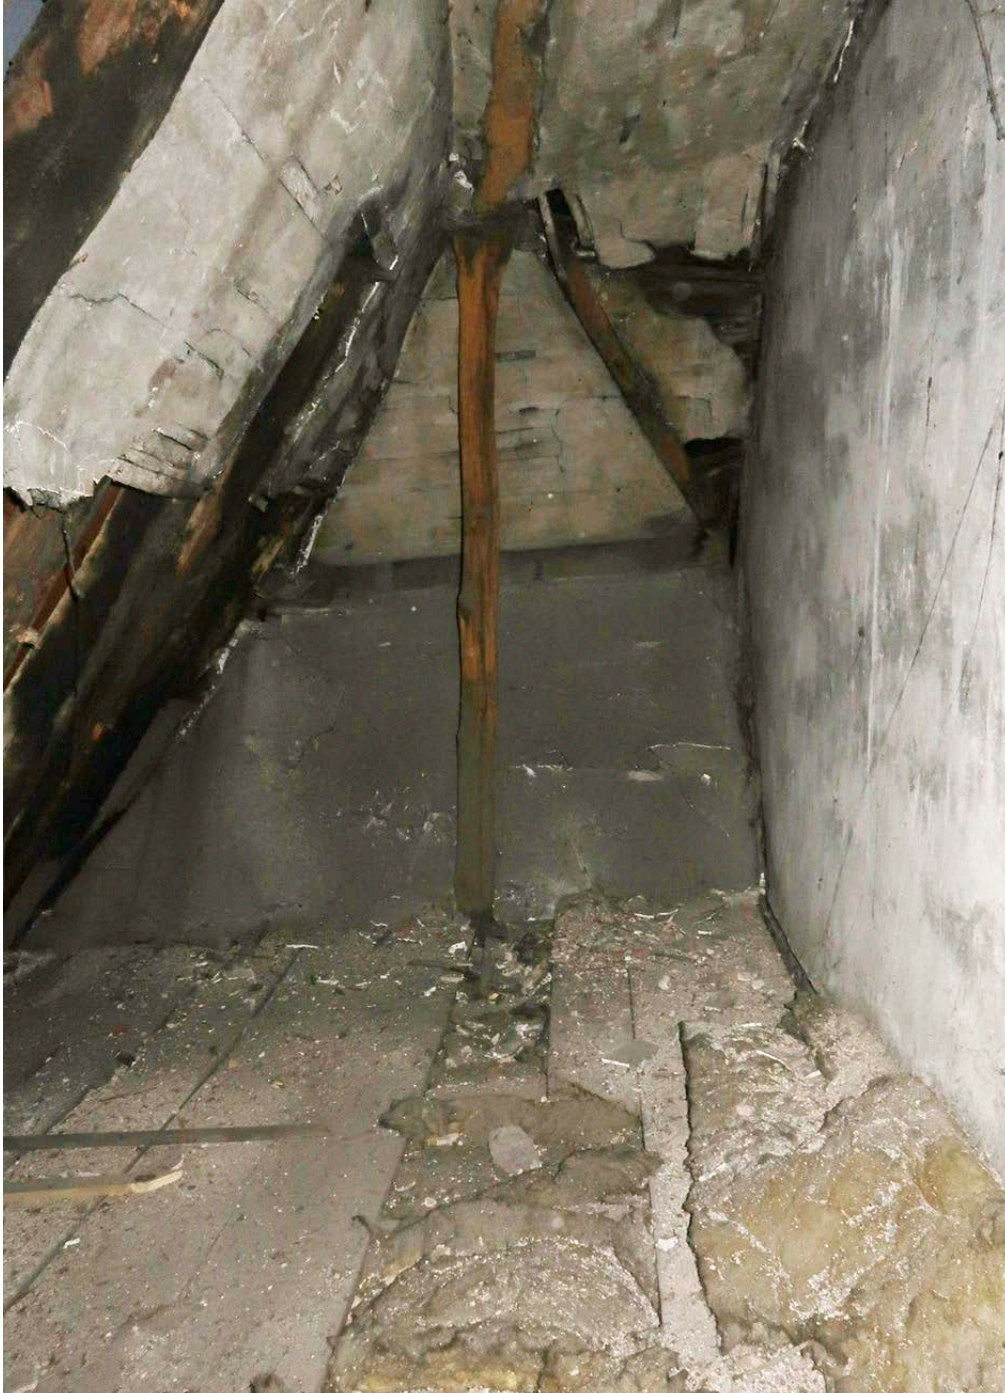
Figure 68: The inside of the additional roof space above the east end of the front range, looking north. The flat plaster wall to the right is the side of the adjoining building, 78-80 Barton Street. [Johanna Roethe © Historic England]

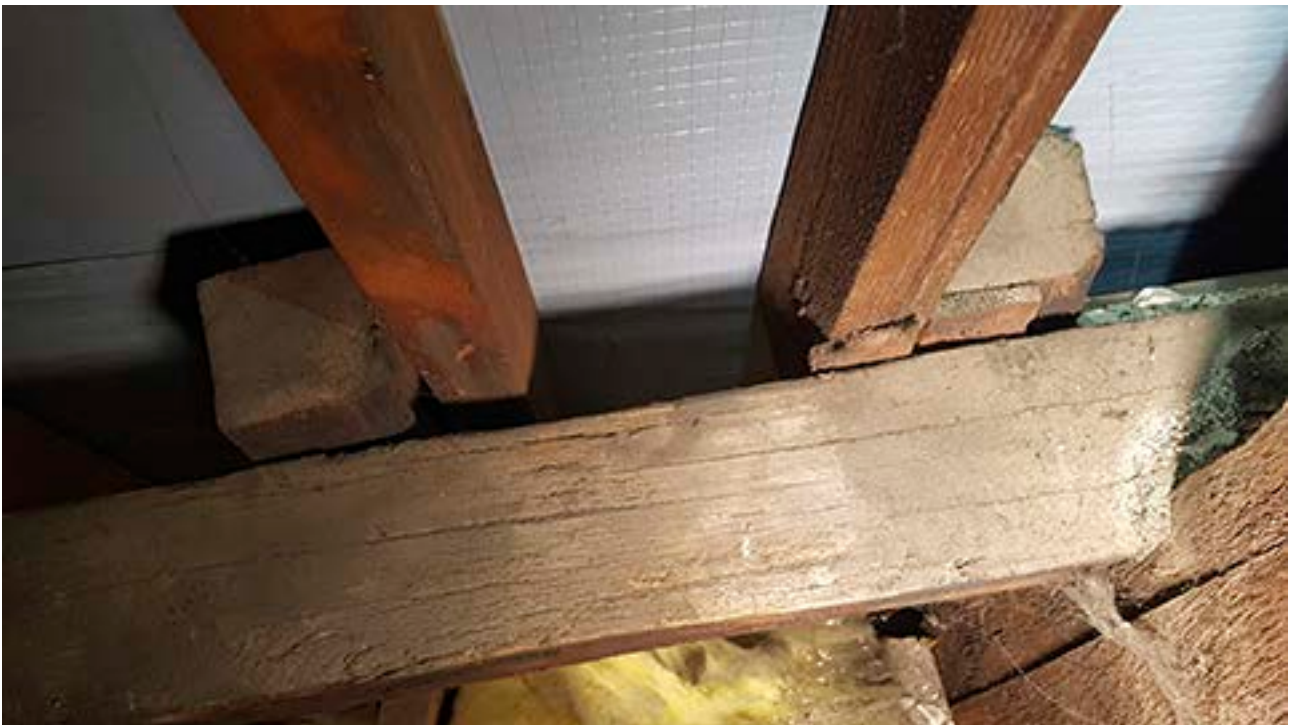
Figure 69: Two truncated common rafters on the west side of bay A, just south of frame 1 (right), with the upper purlin in the foreground and modern rafters behind. [Abigail Lloyd © Historic England]

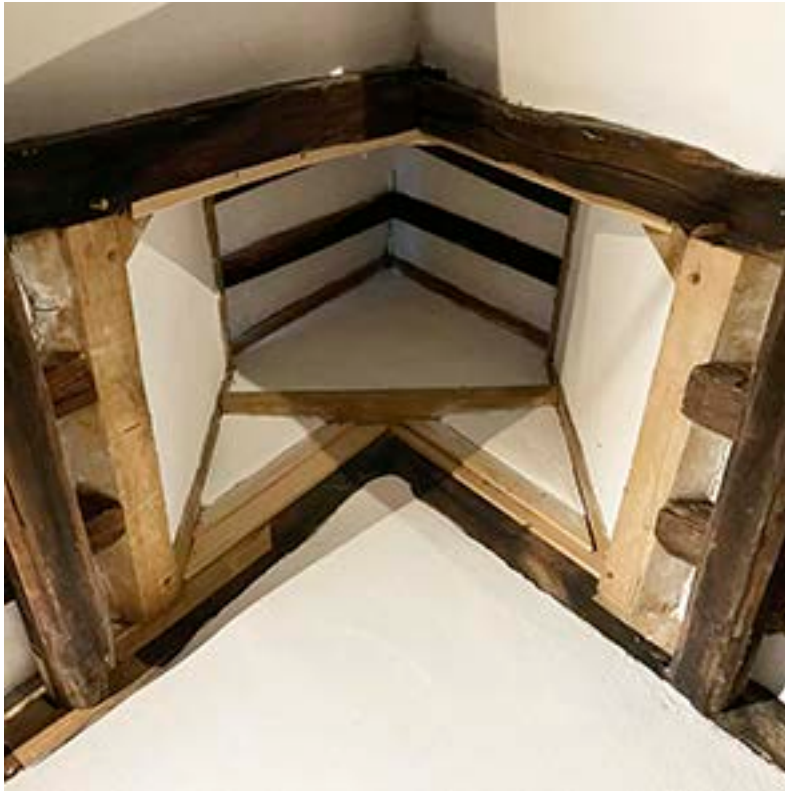
Figure 70: The reconstructed smoke louvre in a rear wing of the Royal Hop Pole Hotel in Tewkesbury. [Rebecca Lane © Historic England]

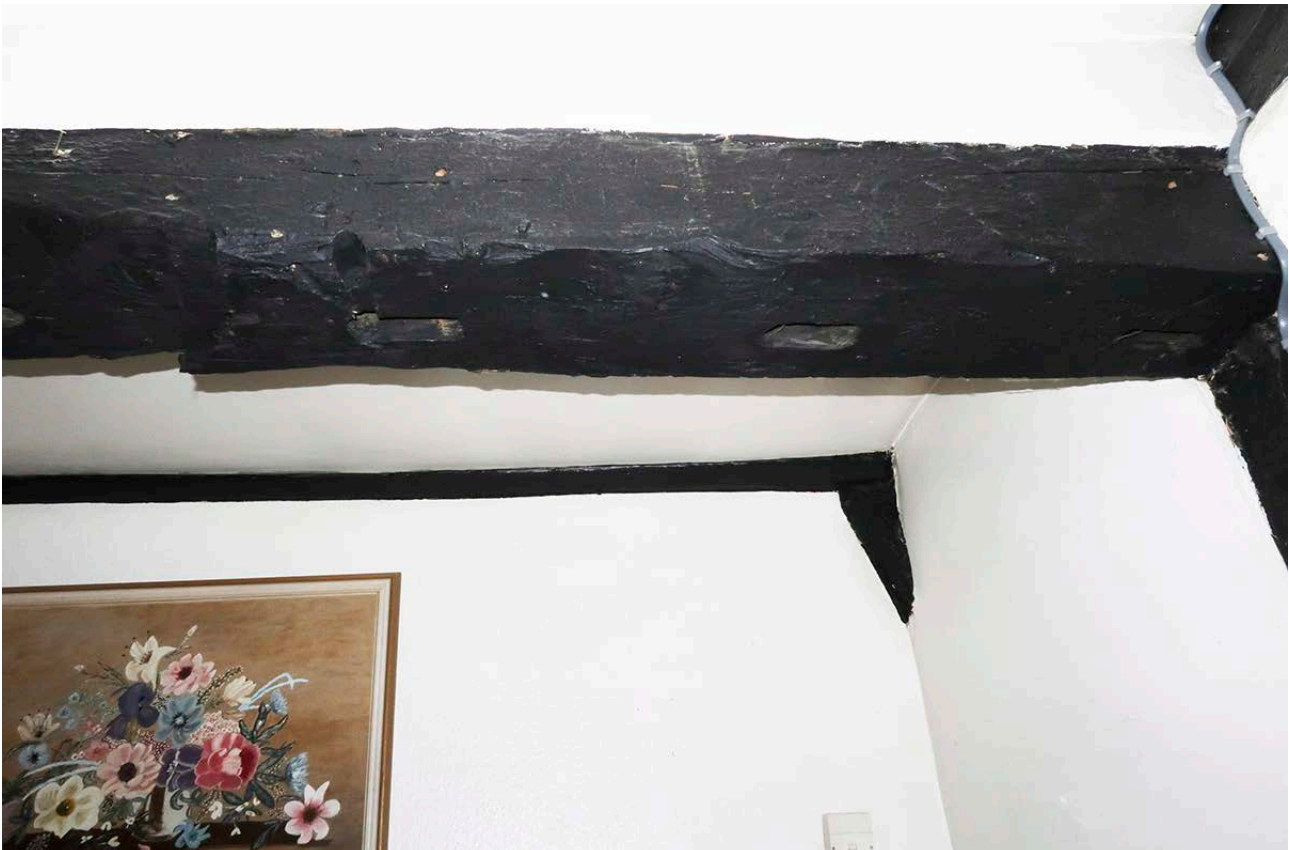
Figure 71: The former wall plate at the rear (south) of the east bay at first-floor level. The timber behind may be part of frame 1 of the main range. [Johanna Roethe © Historic England]

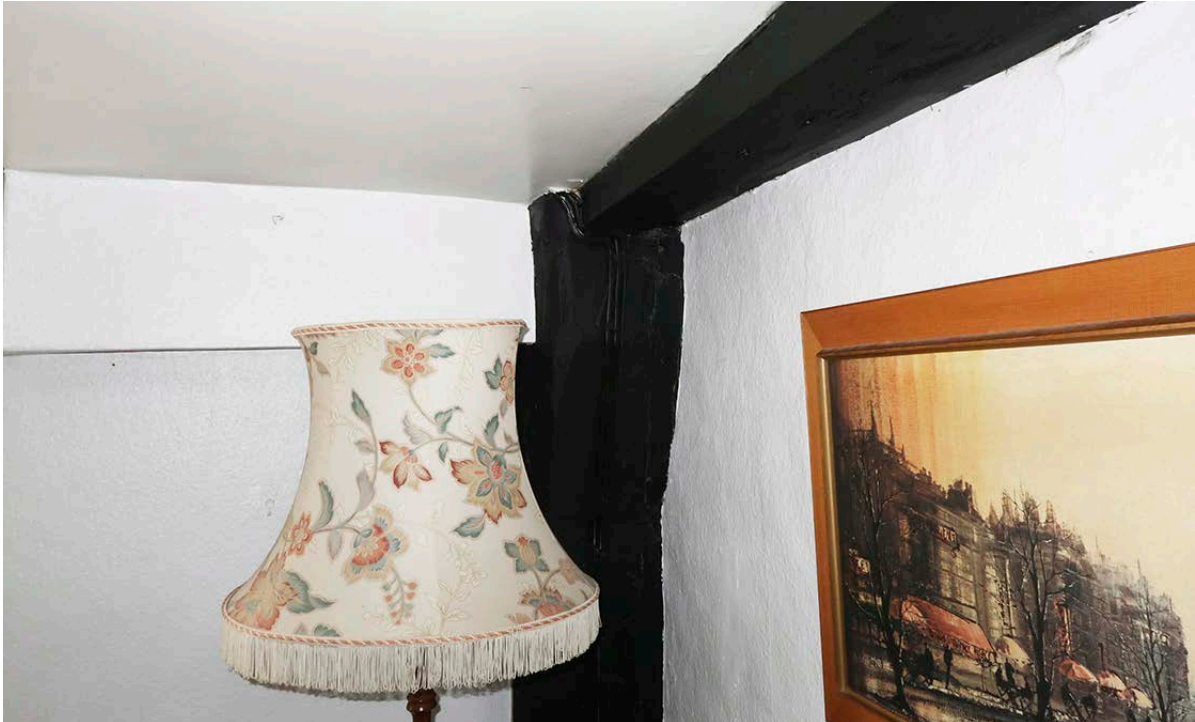
Figure 73: The jowled corner post at the north-east corner of the front range, at first-floor level. [Johanna Roethe © Historic England]

The framing of the front range comprised three pairs of posts defining the two bays. Of the eastern pair of posts, only the jowled post to the north is visible at first-floor level (Figure 73). The southern one may survive hidden within the walling. Both posts of the central cross frame are visible; that to the north is jowled, the southern has a splayed head (Figures 74 and 75). Of the western pair, only the south post is visible. Externally, this is the only original timber among reset timbers on the south elevation but inside it

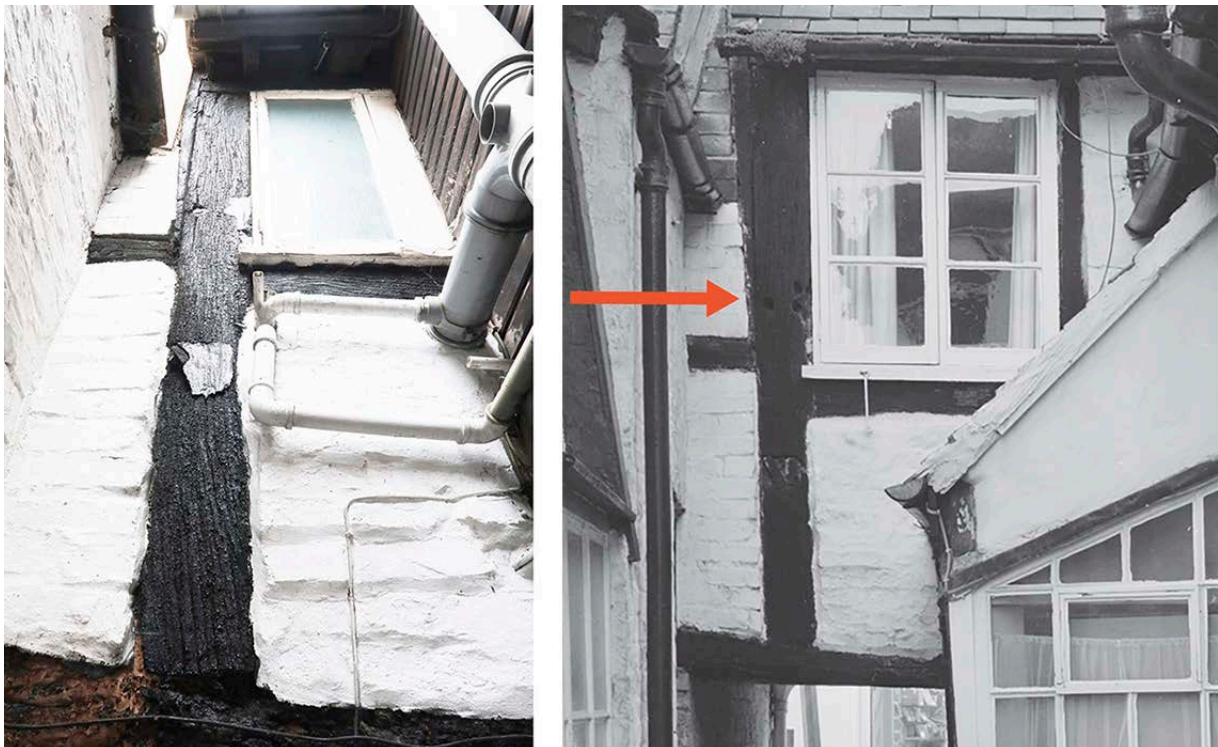
Figure 76: The south-west post, above the passageway [Johanna Roethe © Historic England] and a detail of a photograph of 1971 with an arrow pointing out the empty peg holes in the post. [© Crown Copyright. Historic England Archive, BB72/00611].

is clear that this is the original post as it is pegged into the tiebeam (Figure 76). Today, it is partly obscured internally (Figure 77) but a photograph of 1971 clearly shows that it has a jowl.¹⁴⁶

There is tentative evidence that the front range may have continued at least one bay further to the west. Externally, the south-west post has several large empty peg holes, which are now partly covered but which are clearly visible on a historic photograph (see Figure 76). There are two peg holes on the east side and one to the west. The peg holes on the western side suggest a further rail running westwards from this post. It is therefore possible that the building continued for at least another bay to the west.

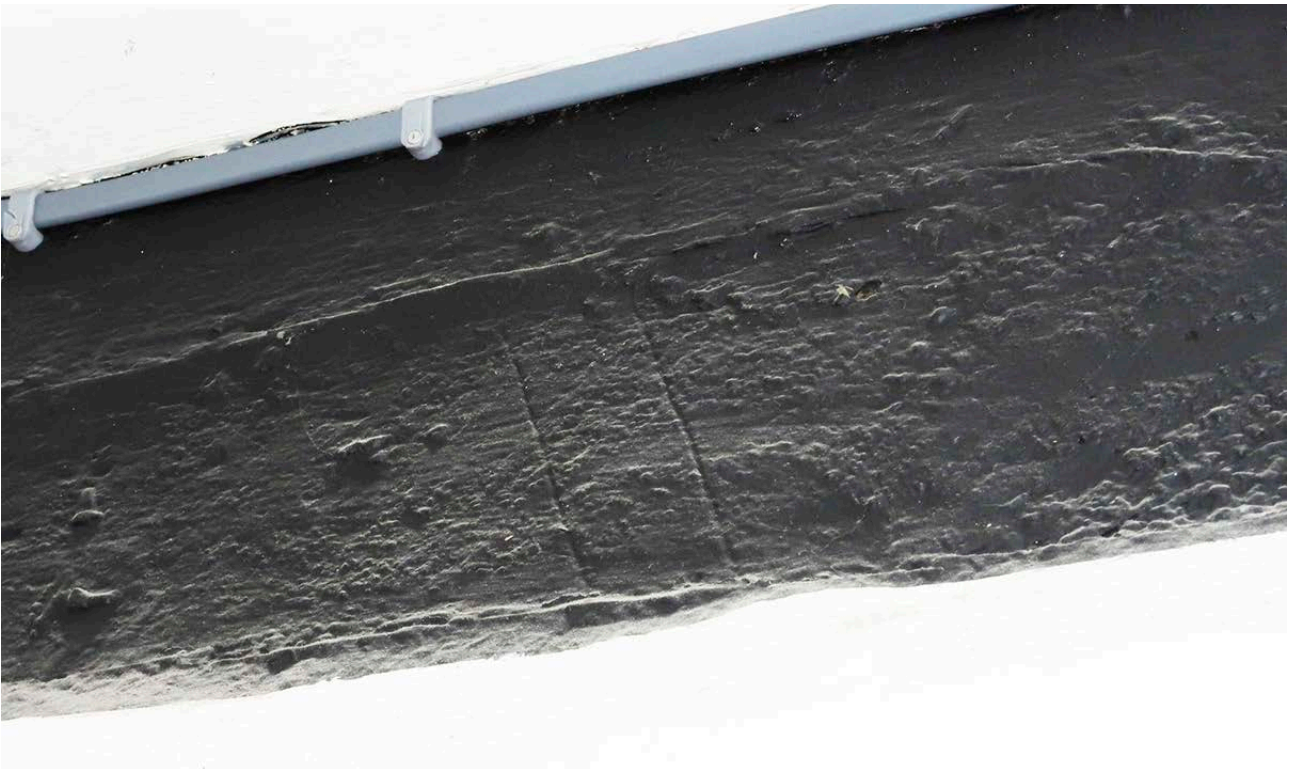
Figure 78: A scribed carpenter's mark (II for two) on the central tiebeam at the present first-floor level. [Johanna Roethe © Historic England]

Each pair of posts supports a tiebeam. The tiebeams have scribed carpenters' marks, to aid in the assembly of the framing. Crucially the fact that the marks are scribed rather than chiselled is often an indication of a relatively early date.¹⁴⁷ There is a 'II' (two) on the central tiebeam (Figure 78) and a 'III' on the west tiebeam of the west gable end (see Figure 77). Presumably there is a 'I' on the eastern tiebeam although this is not visible within the present building. This suggests the tiebeams were numbered east to west, and indicates that there were no further frames east of the surviving east frame. The western tiebeam also has scotching marks, that is shallow angled scoops, which are thought to have aided the raising of the timber frame (see Figure 77).

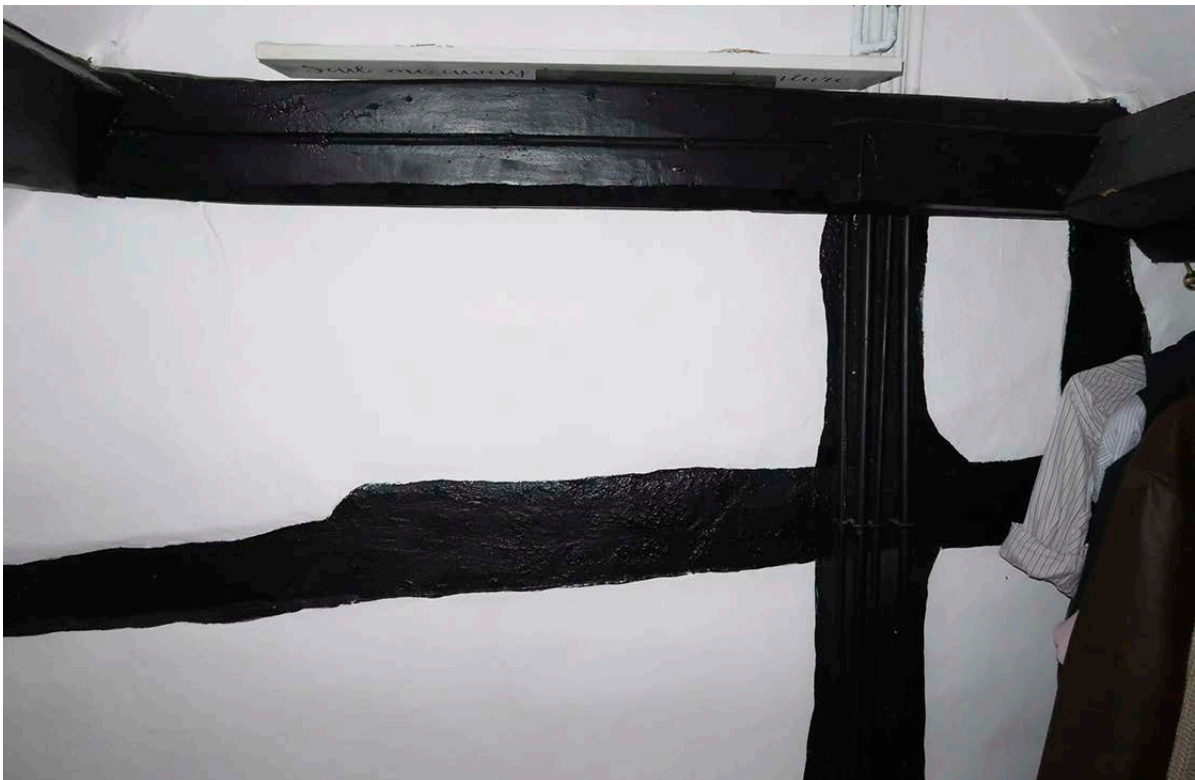
Figure 80: The west truss in the attic of the front range. [Johanna Roethe © Historic England]

Above the wall plates and tiebeams, the form of the roof trusses is unclear, as these elements have been lost or concealed. The western truss has a surviving collar, but there is no pegging visible, so it is not clear what form the truss took (Figure 80). A single row of purlins on both sides of the roof are still visible however, as are some of the common rafters. The purlins indicate that originally the roof had windbraces, which were all later removed, as their empty peg holes remain in the purlins and one empty mortice is visible in the south principal rafter of truss 1 (Figures 81 and 82).

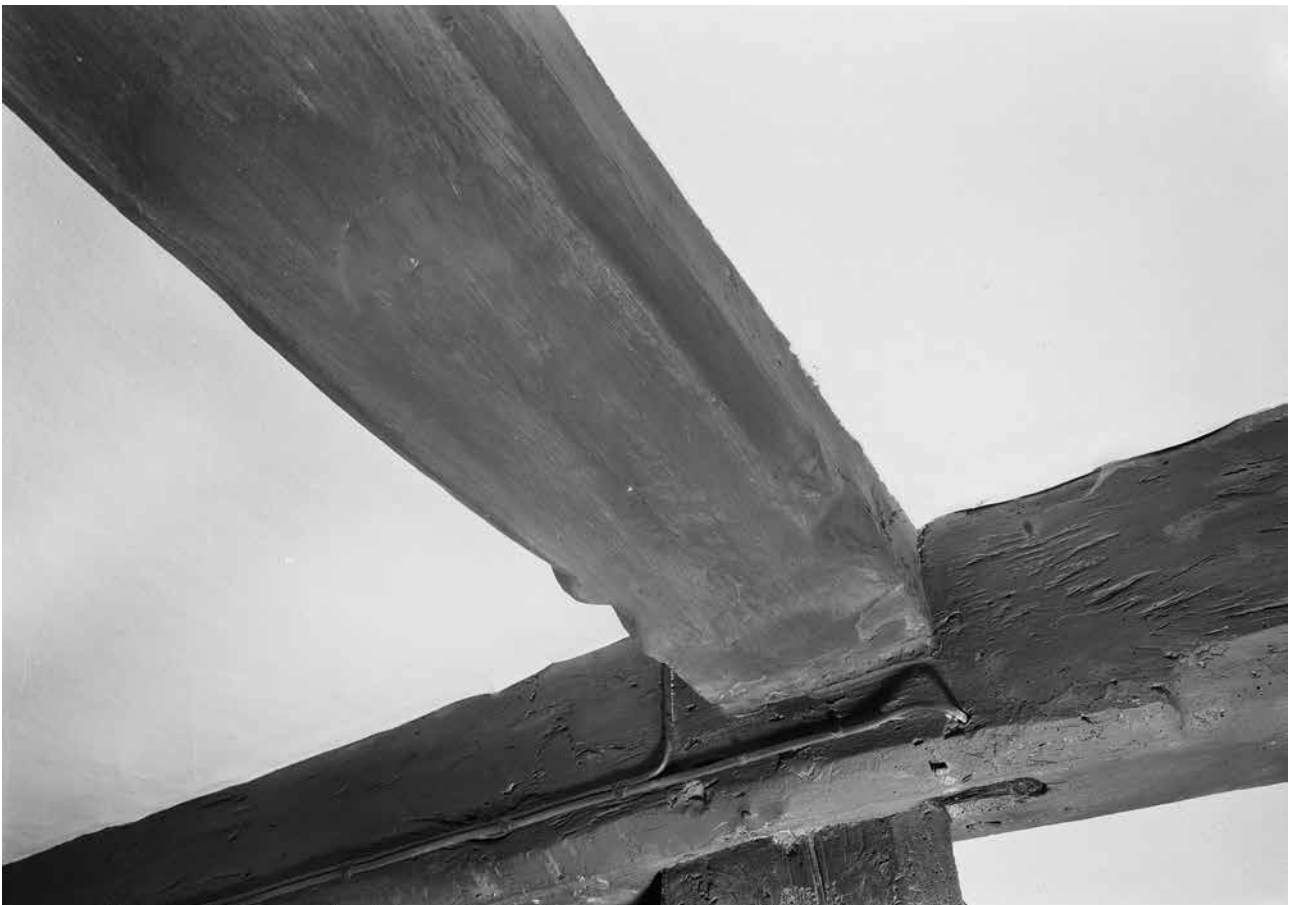
Figure 83: The ceiling beam in the west bay with a jewel stop and the large mortice for the original central stud, with later infill (bottom) in 1971. [© Crown Copyright. Historic England Archive, bb72/00619]

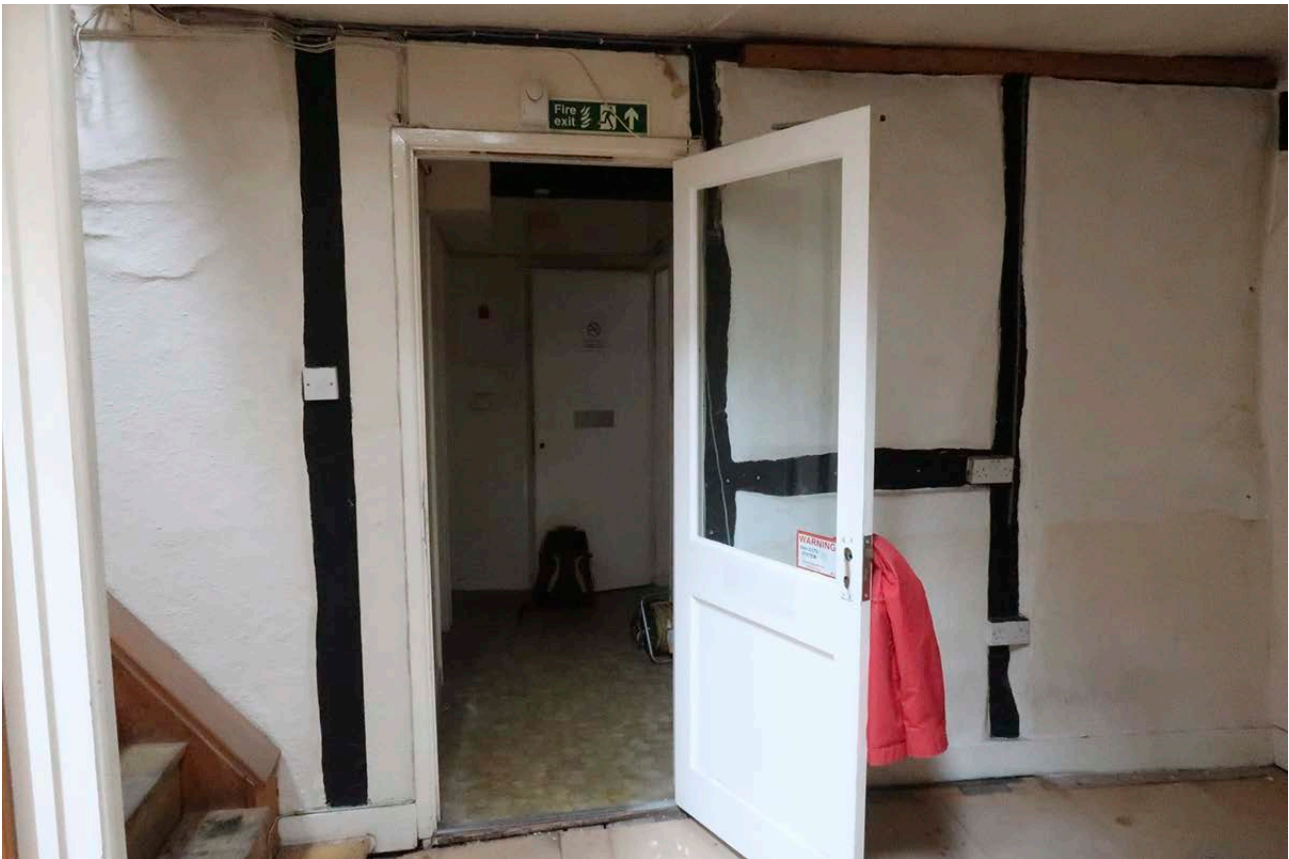
Figure 84: East side of the timber-framed partition in Bay A. [Johanna Roethe © Historic England]

Within the main range a ceiled first floor was inserted in the open hall in bays A and B and the interior was subdivided by timber-framed partitions. Surviving features in the main range which belong to this phase include a pegged timber-framed partition which extends axially between frames 1 and 3 on the first floor (Figure 84) splitting the space into east and west rooms. It is unclear how these were accessed as the present doorway appears later, but there may well have been an arrangement where one room led off the other. It seems likely that when the partition was created the rooms were also ceiled over, creating an attic or separate roof space above, as otherwise the partition between the rooms would have to have risen to the apex of the roof structure. The ceiling structure is now largely concealed. It is likely that the other areas of the building saw further such sub-division, but much of the evidence for this is now covered.
