81-2 Barton Street and 1-3 Mason's Court, Tewkesbury, Gloucestershire

Historic Building Assessment

Rebecca Lane and Johanna Roethe

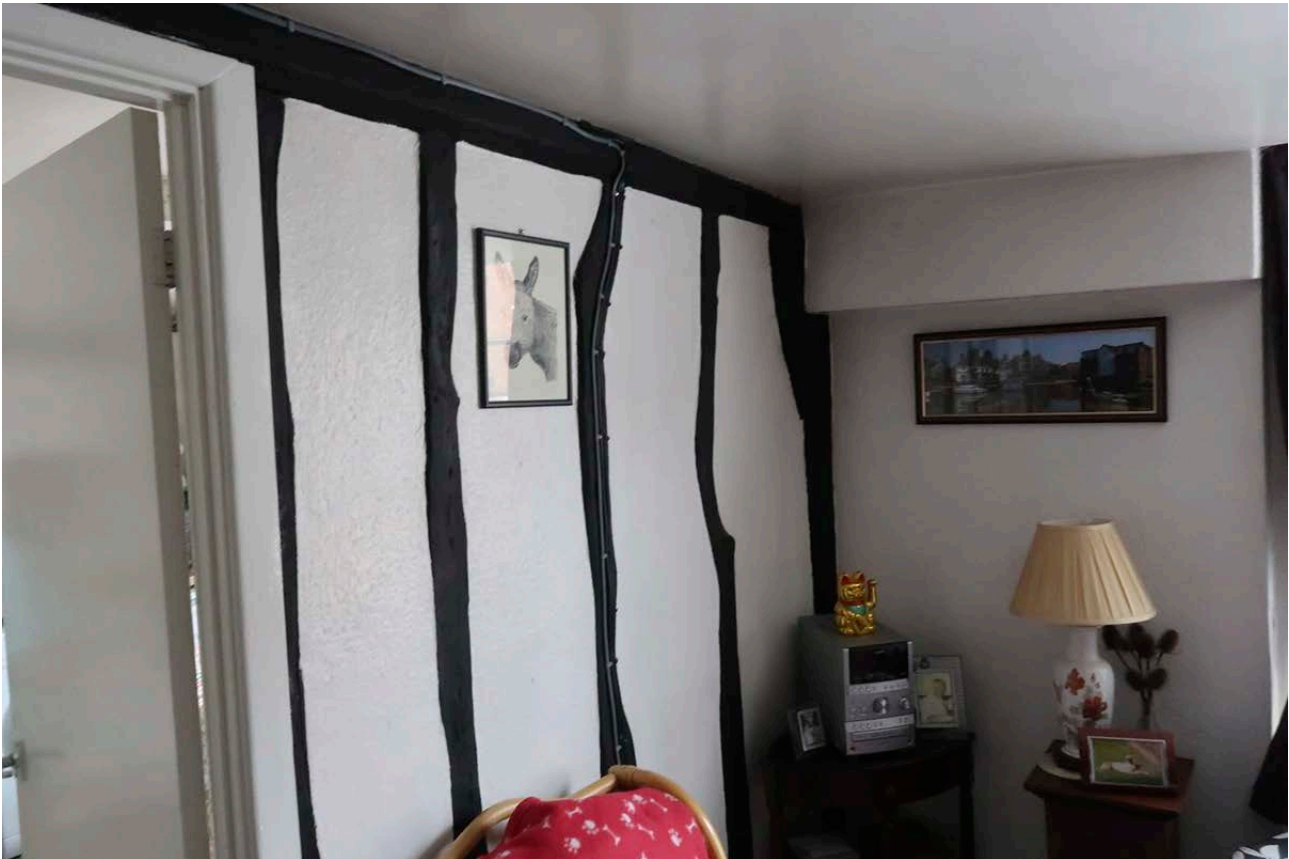
Figure 85: The 17th-century timber stud partition and the original central jowled post in the east room on the first floor of the front range. [Johanna Roethe © Historic England]

A similar process can be seen in terms of the alterations to the front range. It seems likely that if there was an open hall in the rear part of the front range's east bay it was floored and ceiled. There is also evidence of subdivision in the front range as part of this phase. This may relate to the use of the property as two separate shops by this phase, with separate domestic accommodation above – which was certainly the case in subsequent centuries (see below). The first floor of the front range was divided into two bays by a timber stud partition on the line of the central cross frame with no evidence of a 17th-century doorway between the two first-floor rooms (Figure 85). The studs are set into a sill plate. Although the first-floor ceiling in the front range is currently covered in modern plaster, a photograph from the 1970s shows an axial beam in the west bay (see Figure 83), which has a chamfered edge and a chamfer stop with a jewel stop form, with a run-out stop with notch, which is a form of chamfer stop associated with the 17th century.

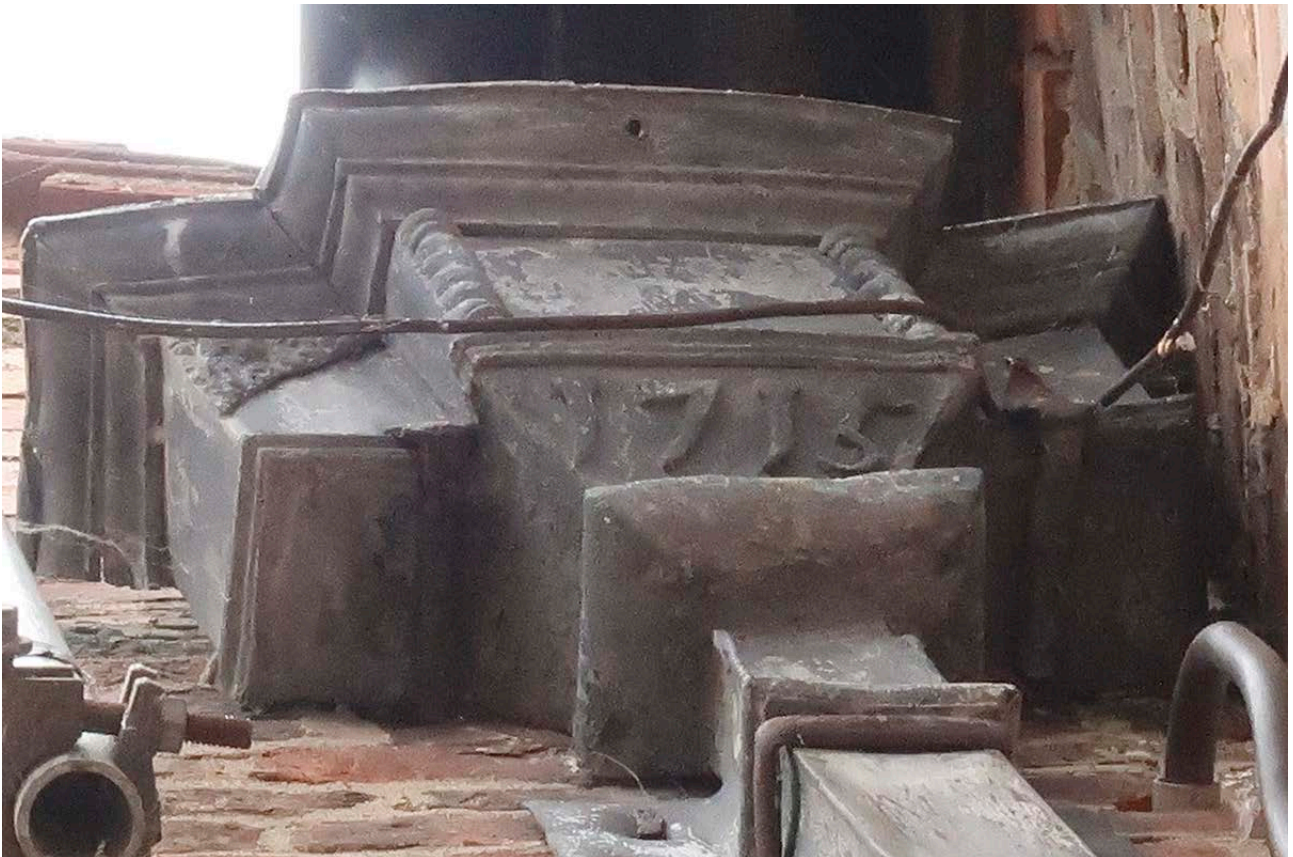
Figure 86: The lead hopper with the date '1715' at the rear of the front range of 78-80 Barton Street. [Johanna Roethe © Historic England]

The neighbouring property, 78-80 Barton Street, was in use as an inn by the 1660 (see discussion above) and appears to have been rebuilt for inn use in around 1715. This caused several alterations to the front range and main range of nos 81-2. The inn's name at the time is unknown; it was later known as the Maidenhead (by the 1770s) and the Star & Garter (by the 1790s). The date of 1715 can be found on a lead rainwater hopper at the rear of the front range of nos 78-80 (Figure 86). While this is not reliable evidence in itself, as rainwater goods are often renewed or replaced, it is consistent with the early Georgian style of the street elevation (see Figure 9), particularly the corner quoins and the wide plat bands dividing the storeys which can also be found in other

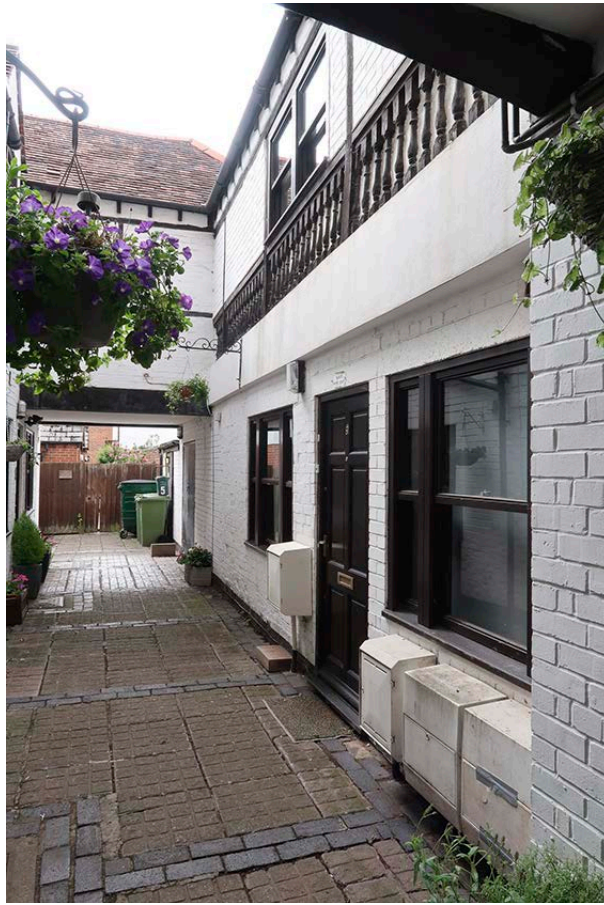
Figure 87: The south (left) and west (right) ranges of the former inn's courtyard. [Johanna Roethe © Historic England]

early 18th-century buildings in Tewkesbury, like 77 Church Street.¹⁴⁸ The west side of the oblong courtyard behind the front range of nos 78-80 has a first-floor timber balustrade (Figure 87). The form of the turned, vase-shaped balusters matches the profiles common in the late 17th and early 18th centuries.¹⁴⁹ As reconstructed, nos 78-80 was formed of a three-storey brick range fronting the street, with a central entrance leading to a courtyard to the rear. The courtyard was flanked by east and west courtyard ranges which ran back from the front range. These were two storeys in height.

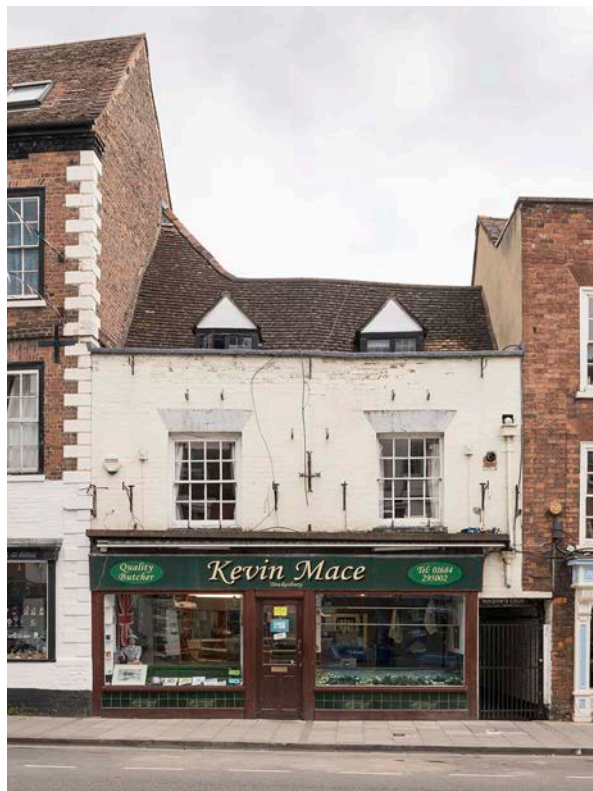
Figure 89: The north elevation of the front range in 2023. [Steven Baker © Historic England Archive, DP325781]

Like many other buildings in Tewkesbury, the front range of 81-82 Barton Street was refronted in brick in the 18th or early 19th century to modernise its appearance.¹⁵⁰ Of this refronting only the upper floor survives, with brick laid in English bond and two windows with flat arches of rubbed bricks (Figure 89). Until about 1978 the two windows were of different height (see Figure 9) which suggests the extent to which elements of the building might have been modernised separately given the divided tenancy of the front range. The parapet of the brick front rises above the roofline of the building, a common feature which is designed to give the building the impression of larger, more classical proportions. If the front range originally had a jetty (as suggested by Jones), this may have been underbuilt at the same time.

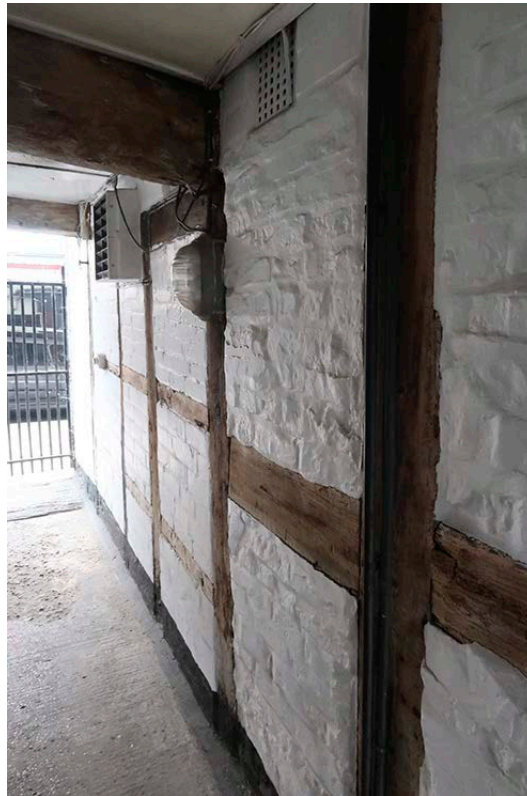
Figure 90: The west wall of the ground floor of the front range from Mason's Court, looking north-east. [Johanna Roethe © Historic England]

The west wall of the front range inside the alley was probably also rebuilt in brick at the time (Figure 90). The wall incorporates six vertical timbers (posts or studs) and several horizontal rails. None of the timbers are pegged into each other and they are likely reused, possibly from the timber-framing of the original west wall. The beam to which the sign 'Mason's Court' is attached is clearly reused as it has a redundant groove and peg holes.

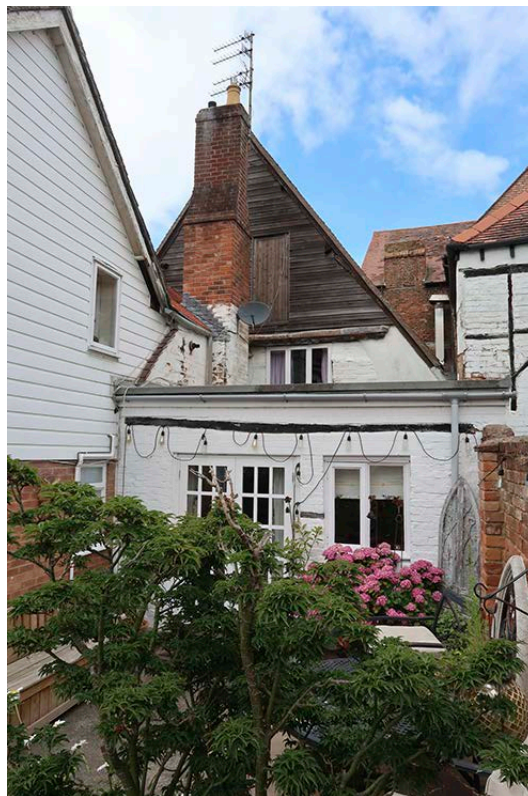
Figure 92: The flat-roofed, single-storey range to the south-east of the main range (centre) and to the left the 1970s rebuilding of the third 19th-century range. [Johanna Roethe © Historic England]

Probably shortly after this first addition, a second, single-storey range was built in east of the earlier extension and south of the main range (Figure 92). Originally with a pitched, tiled roof, the only visible elevation has been much altered (see Figure 18). Although evidence for this extension's date is slim, its small scale suggest that it is a piecemeal infill of the angle between the main range and the earlier extension. A third range was built to the south-west of this. As it was replaced in 1970s and no historic photographs are known, its construction date is unknown but, based on map evidence, must have been before 1883 (see Figure 91).

By 1970-1 there had also been changes to the south of the main range. The earlier south-west range, shown on the 1883 map (see Figure 91) was replaced by a two-storey cottage (see Figures 18 and 92). This now forms part of 1 Mason's Court. In 1971 the south elevation of the single-storey range to the east of this was altered with the installation of new, two-leaf French doors (see Figure 18). Its pitched roof was replaced by a flat roof soon after.

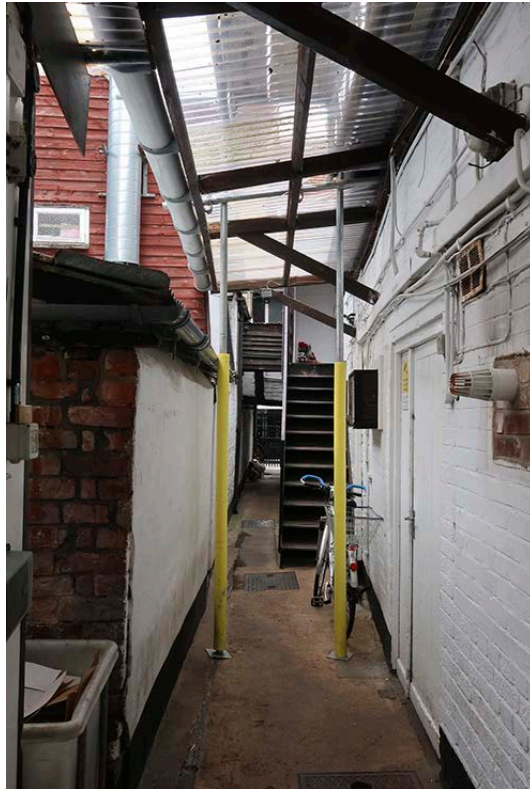
Figure 93: The alleyway, looking north towards the metal staircase installed in the 1970s-80s. The main range is to the right. [Johanna Roethe © Historic England]

The upper floors of the front range were converted to two flats, with a new internal staircase from the first to the second floor. A new metal external staircase was built in the corner of the front range and the main range, leading up to a first-floor landing for the two flats in the front range and the first floor of the main range (Figure 93). The walls of the cellar under the front range were lined with concrete blocks. Instead of the cellar being accessed from inside the ground floor of the main range as was previously the case, a new cellar stair was constructed in the alleyway, under the metal staircase.

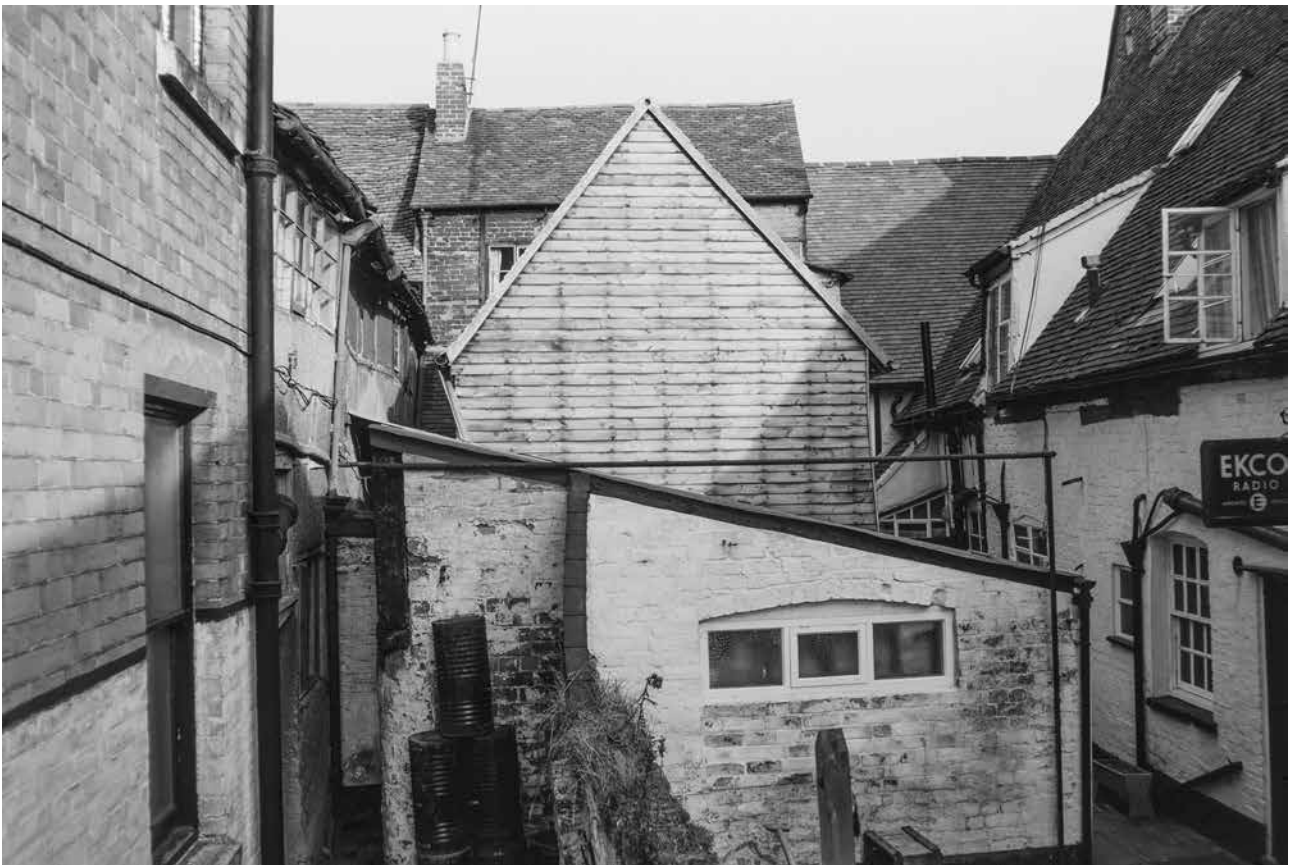
Figure Appendix 1.1: The rear (south) of 83 Barton Street (centre), with the alleyway and the west elevation of the main range at 81-2 Barton Street to the right. [© Historic England Archive, SJC01/03/0012]

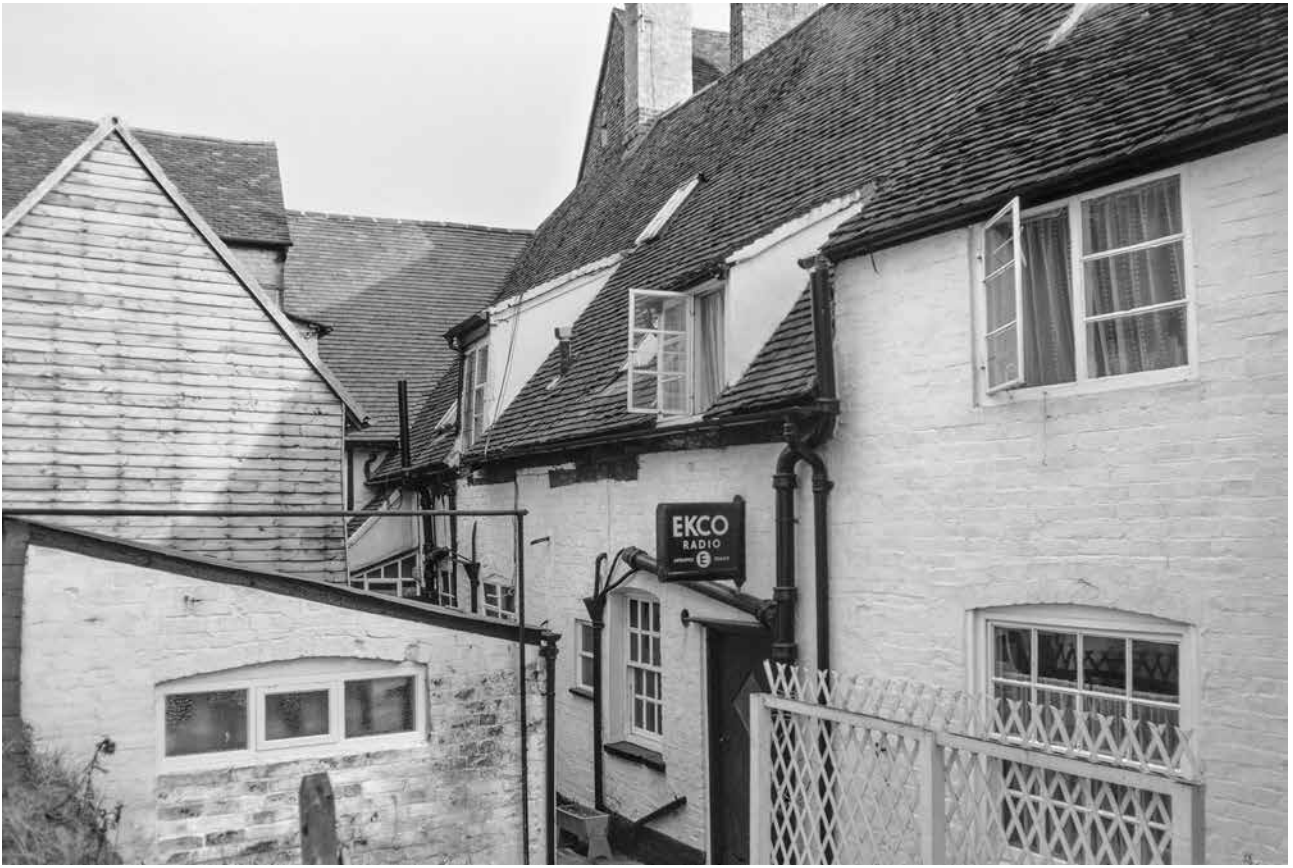
Figure Appendix 1.2: The rear (south) of 83 Barton Street to the left and Mason's Court and the west elevation of 81-2 Barton Street to the right. [© Historic England Archive, SJC01/03/0013]

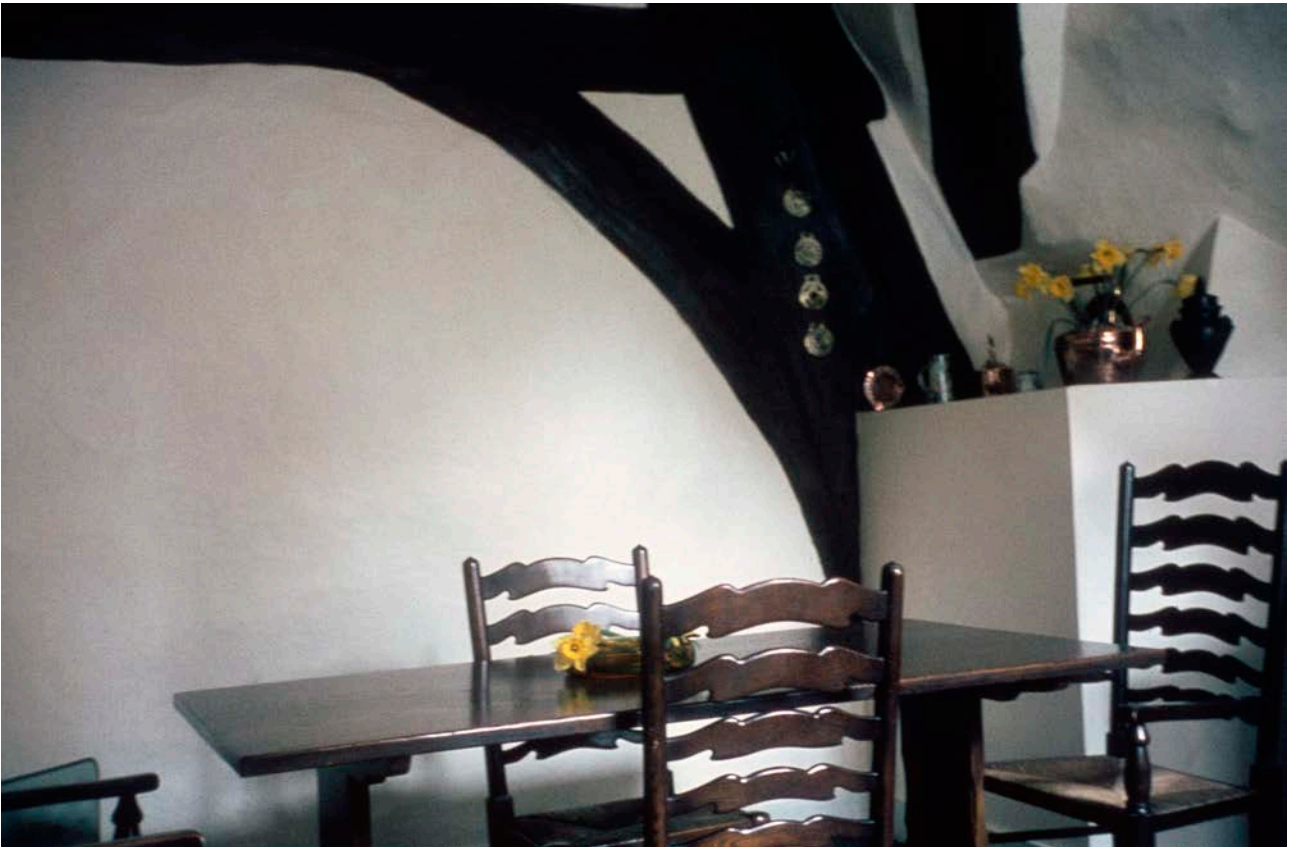
Figure Appendix 1.3: The south side of the east blade of frame 1, at collar level (now first-floor level). [© Historic England Archive, SJC01/03/0001]

Both cruck blades of frame 1 have shallow inlay or patch infills on their south face. Stanley Jones speculated that these were where a flaw in the timber was cut out to a shallow depth and a timber piece inserted. The infills are smoke blackened to the same degree as the rest of the blades, suggesting these were repairs undertaken by the original carpenter while preparing the cruck blades for construction. Of the various patches that Jones observed, three are still visible, all on the south side of frame 1: one on the east blade at what is now first-floor level, where the patch infill is missing (Figure 39), one in situ patch infill on the west blade in the roof space (Figure 40) and a third on the east blade in the roof space, which is also missing its infill (Figure 41). The last two areas of infills are not at the same height (Figure 42). According to Stanley Jones's drawings these two continued further down the blade but this area is not currently visible (see Figure 16).

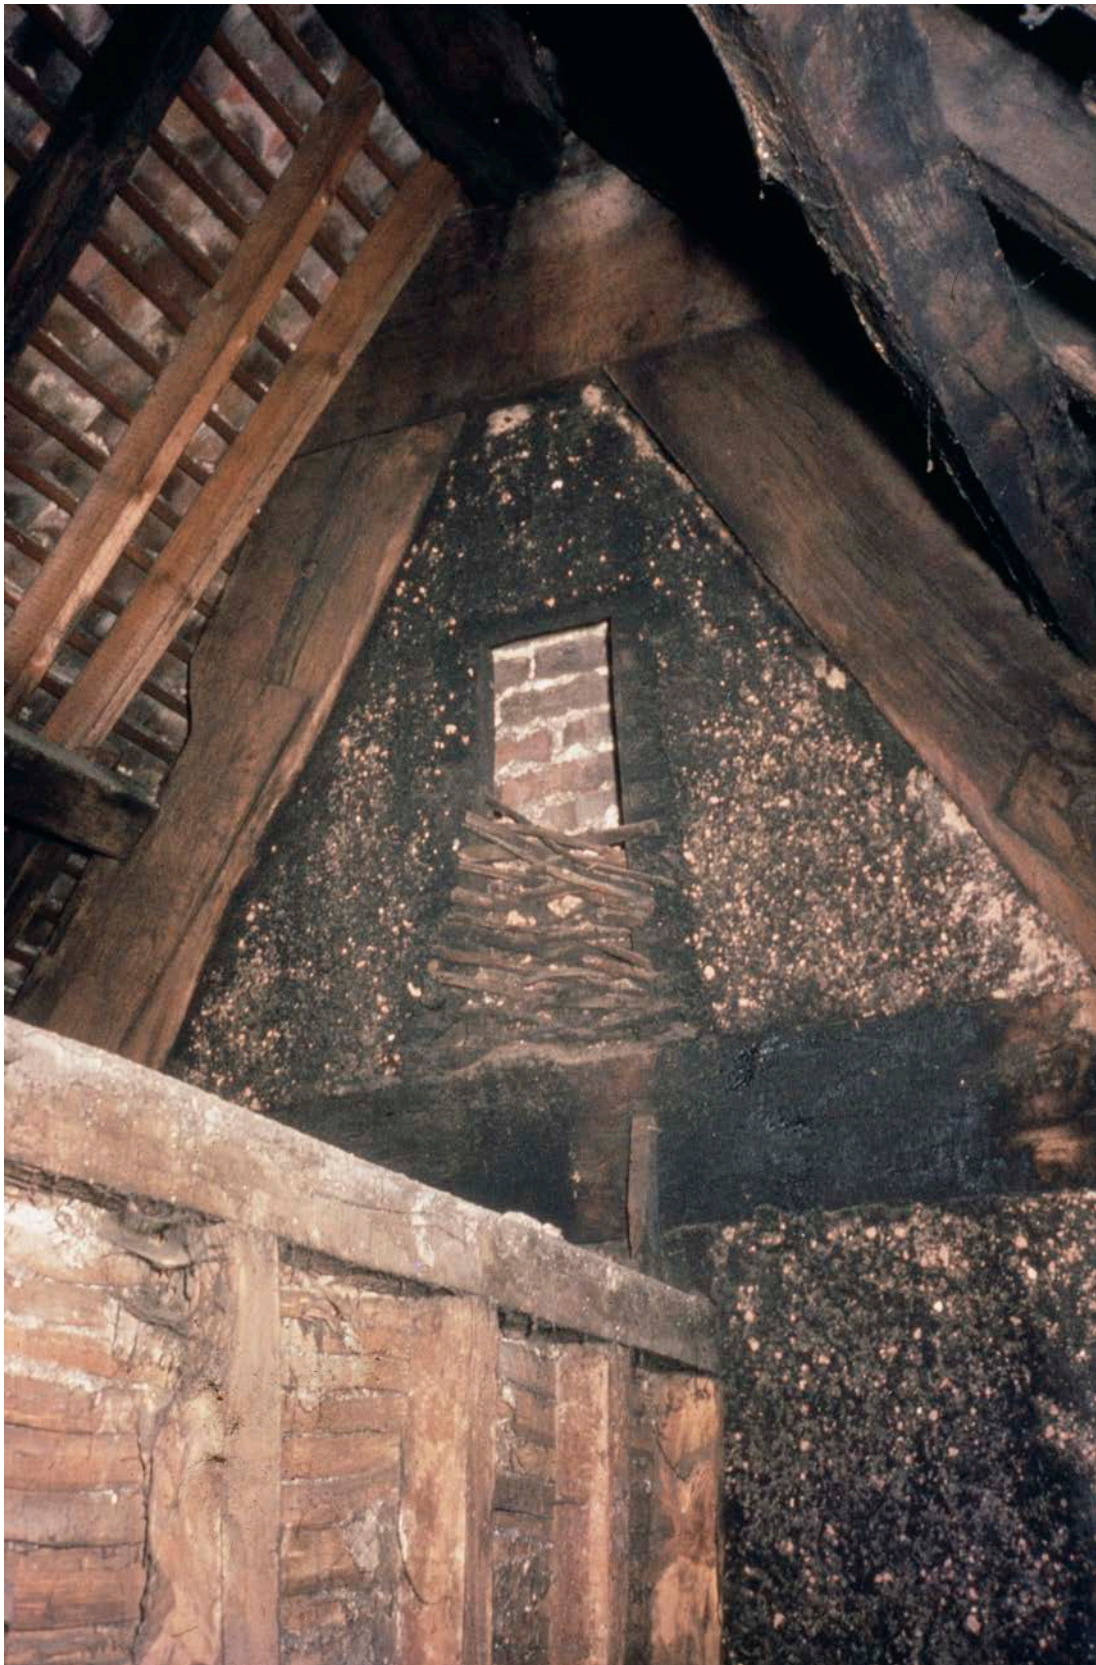
Figure Appendix 1.4: The south side of frame 1, with the smoke vent. To the left is the inserted partial attic. [© Historic England Archive, SJC01/03/0008]

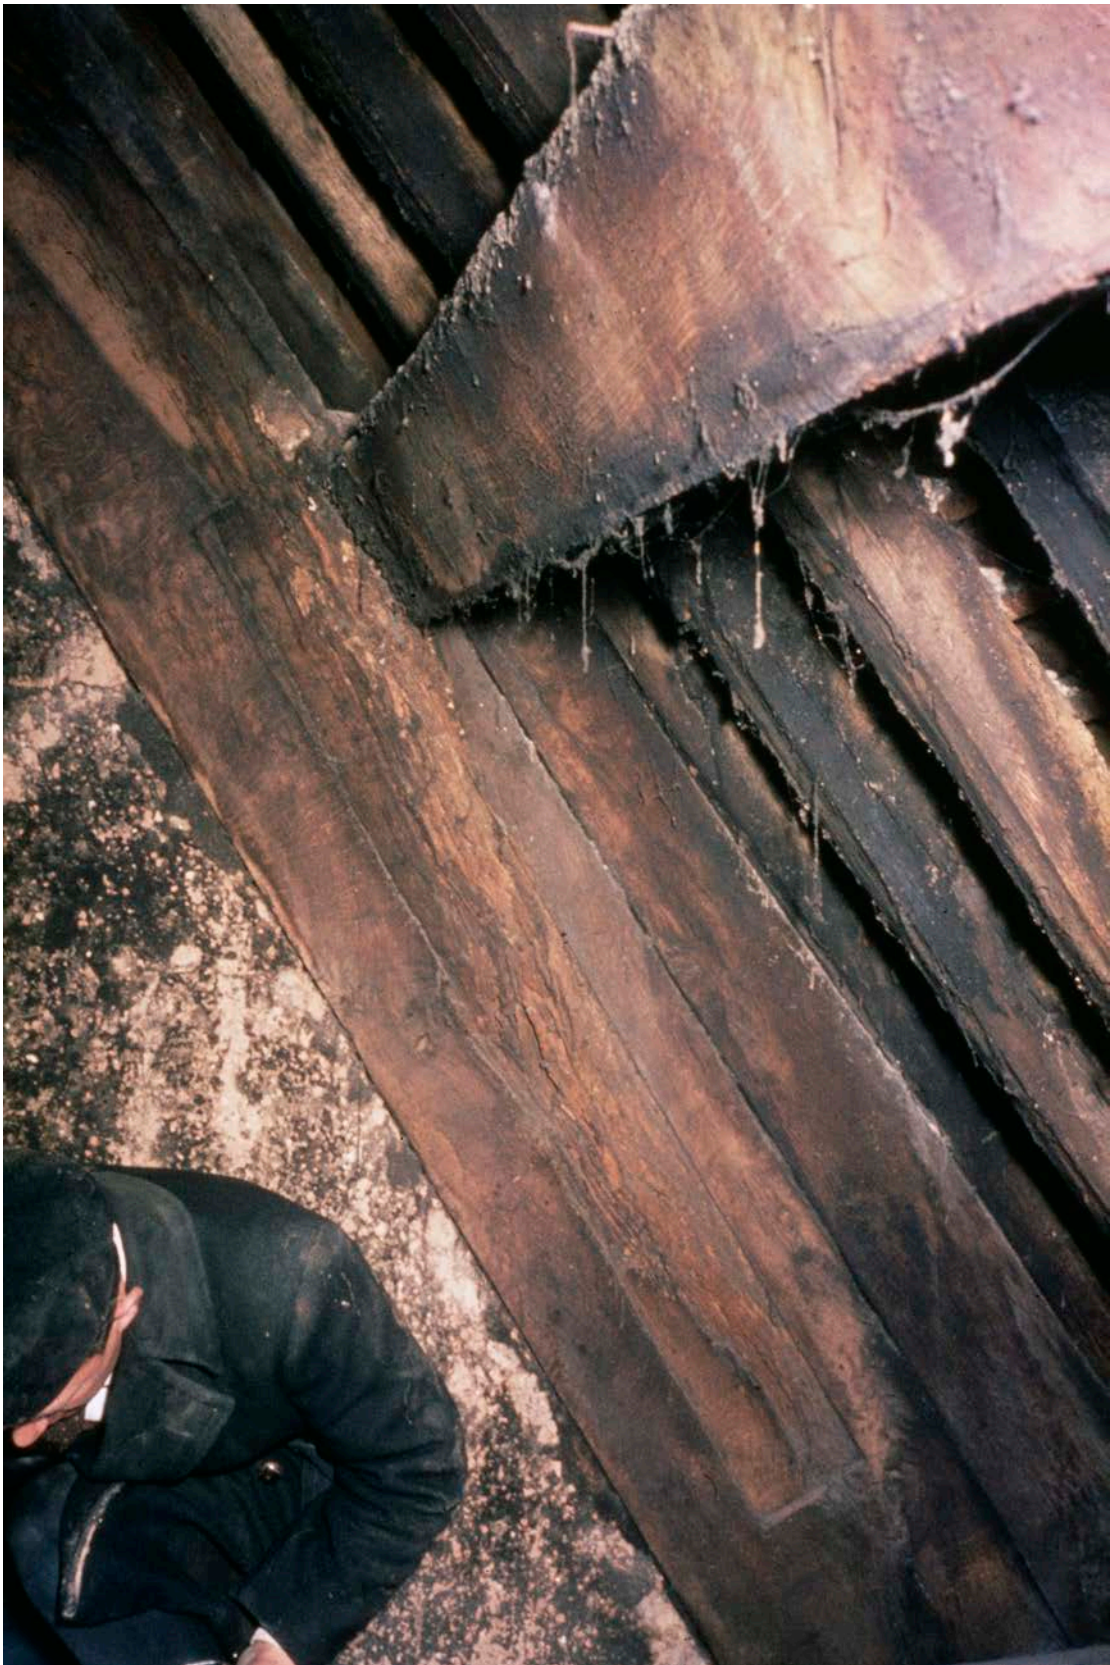
Figure Appendix 1.5: Detail of the east blade of frame 1 in the roof space, with a long, shallow cut out. [© Historic England Archive, SJC01/03/0004]

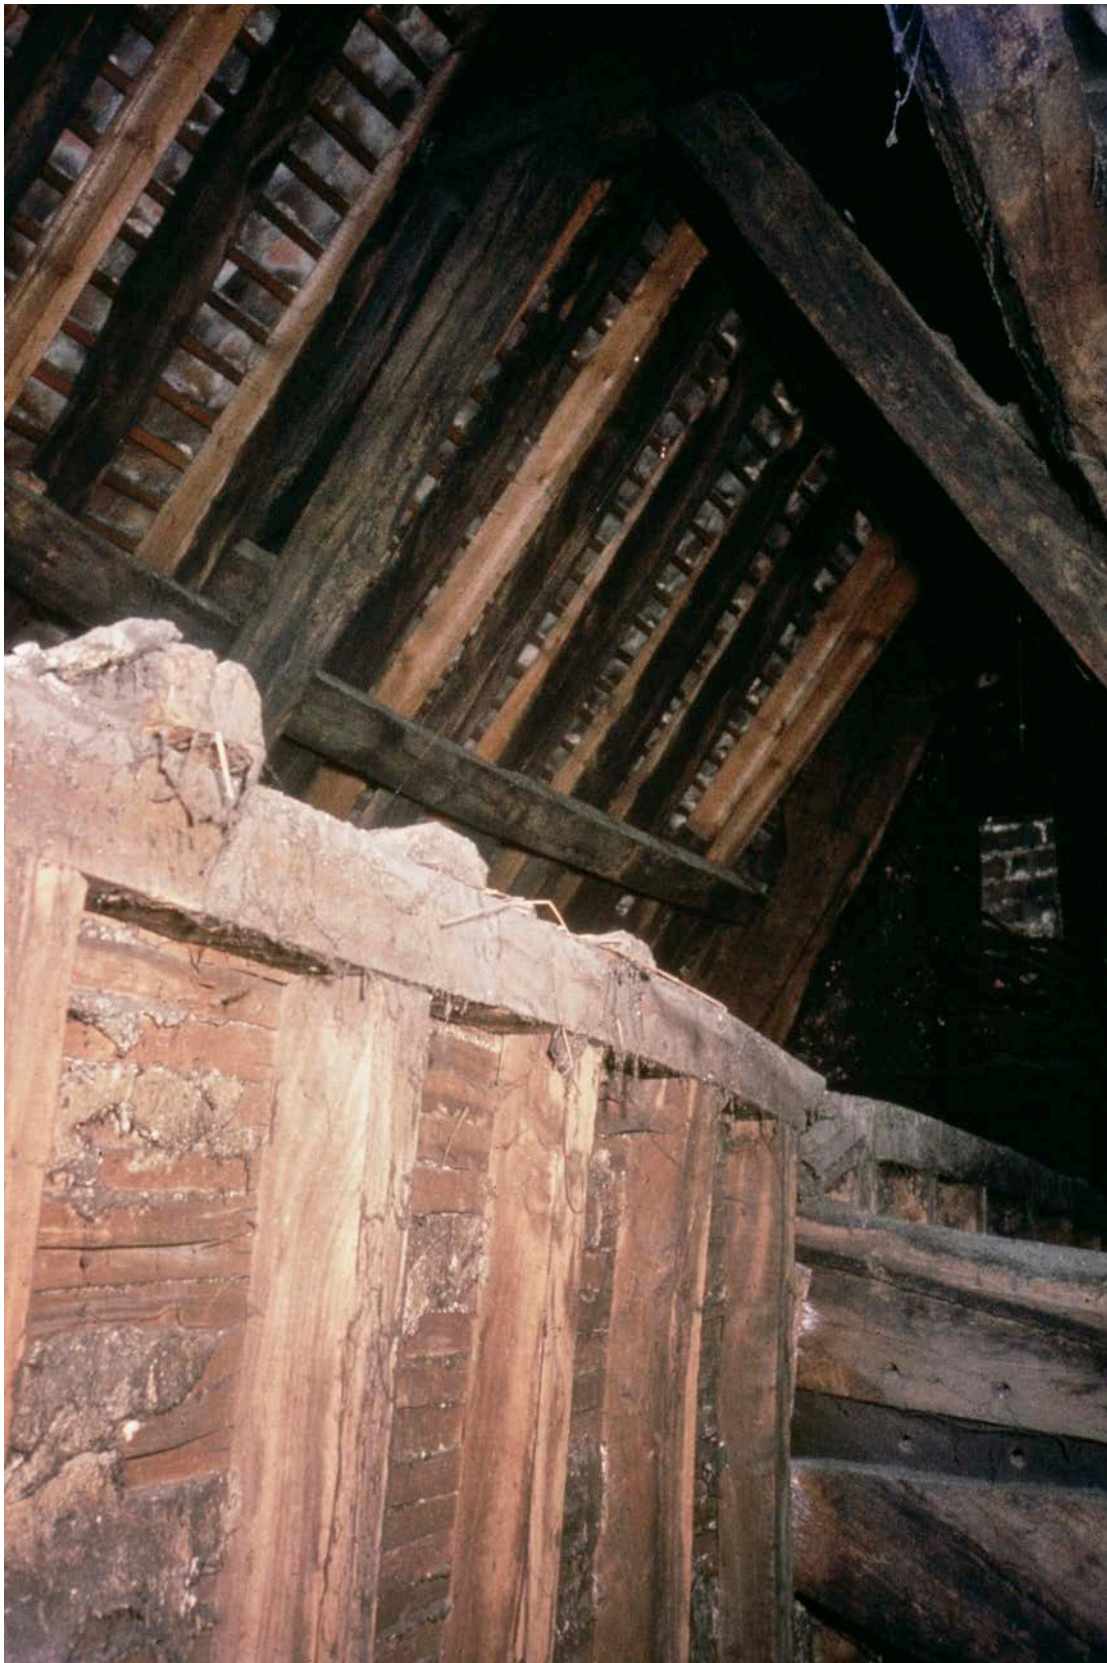
Figure Appendix 1.6: The south side of frame 2 in the middle distance, with frame 1 in the background. In the left foreground is the inserted partial attic. In the right foreground is the collar with arch brace of frame 2. [© Historic England Archive, SJC01/03/0007]

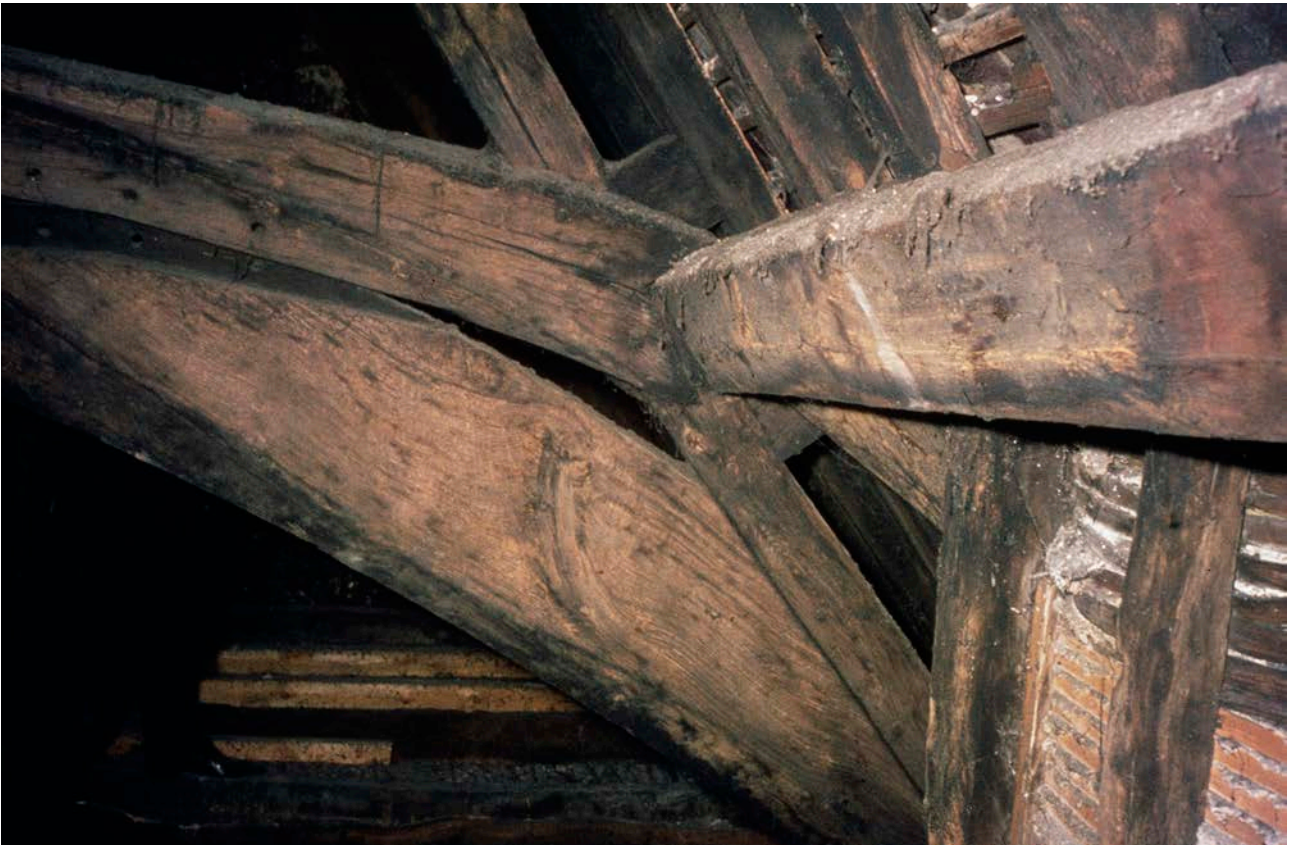
Figure Appendix 1.7: Detail of the birdsmouth joint of the collar and eastern central purlin of frame 2. [© Historic England Archive, SJC01/03/0005]

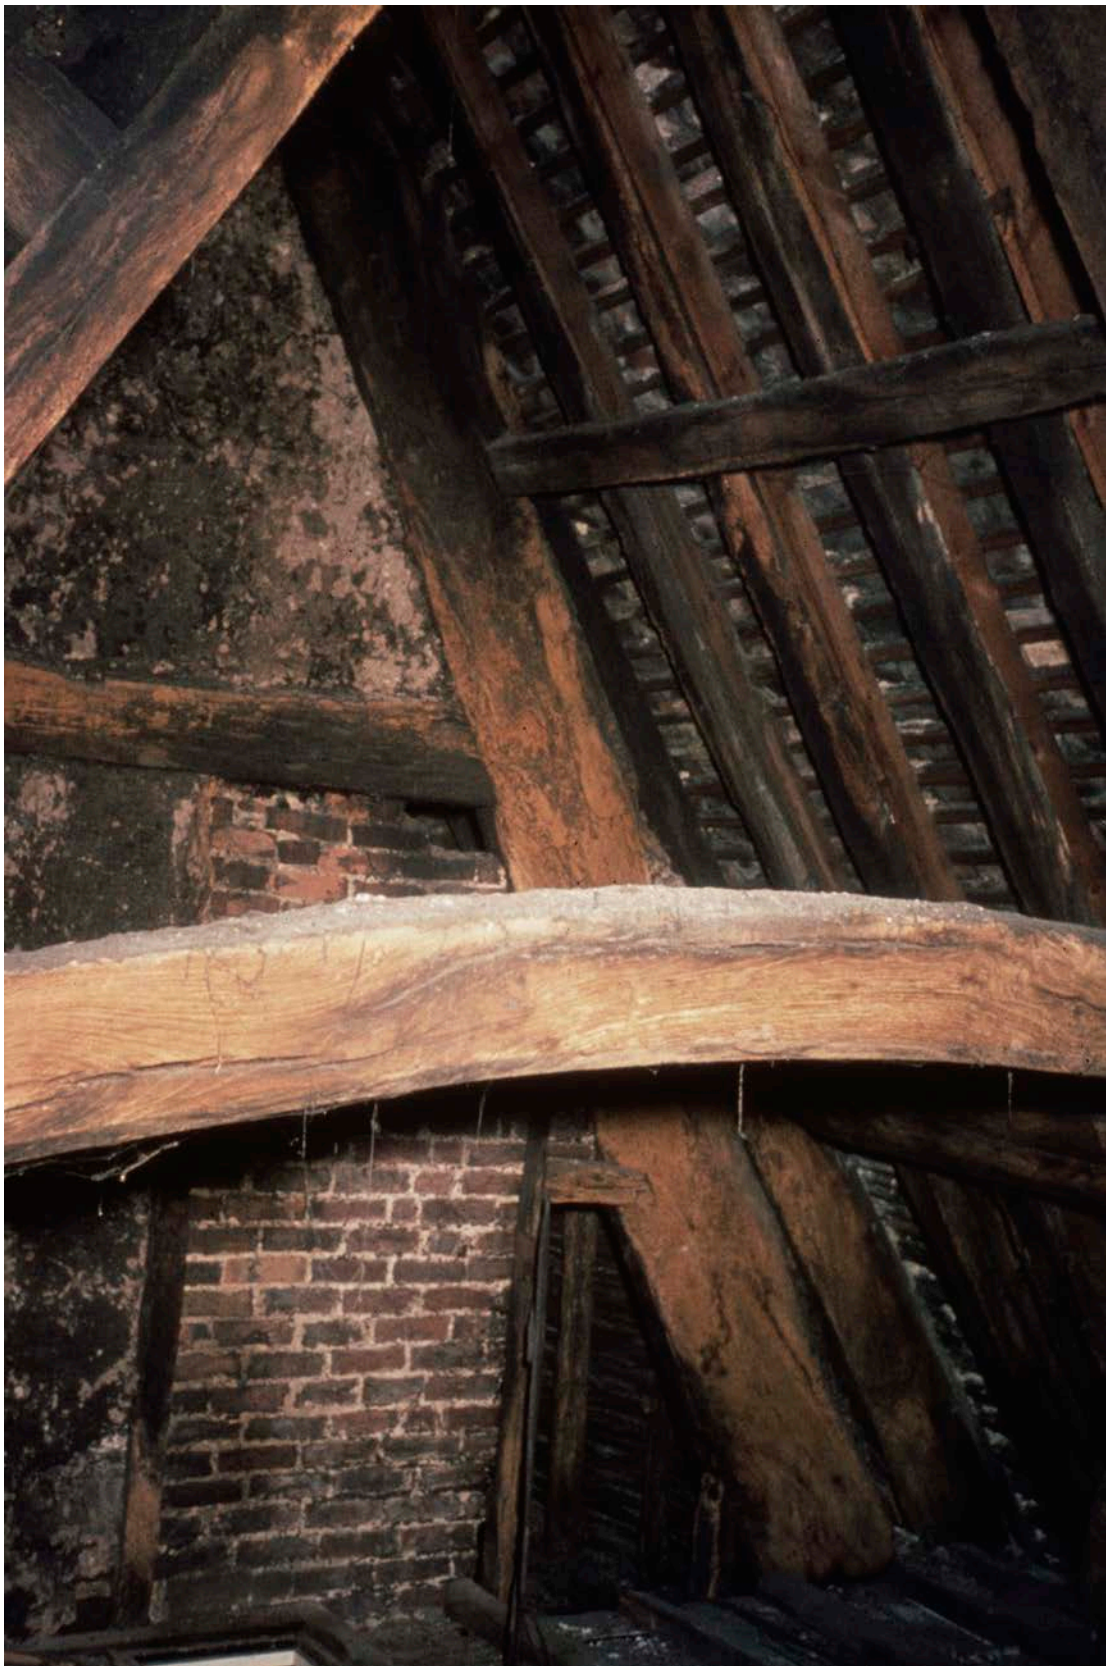
Figure Appendix 1.8: The collar of frame 4 in the foreground and the south side of frame 3 in the background. [© Historic England Archive, SJC01/03/0008]

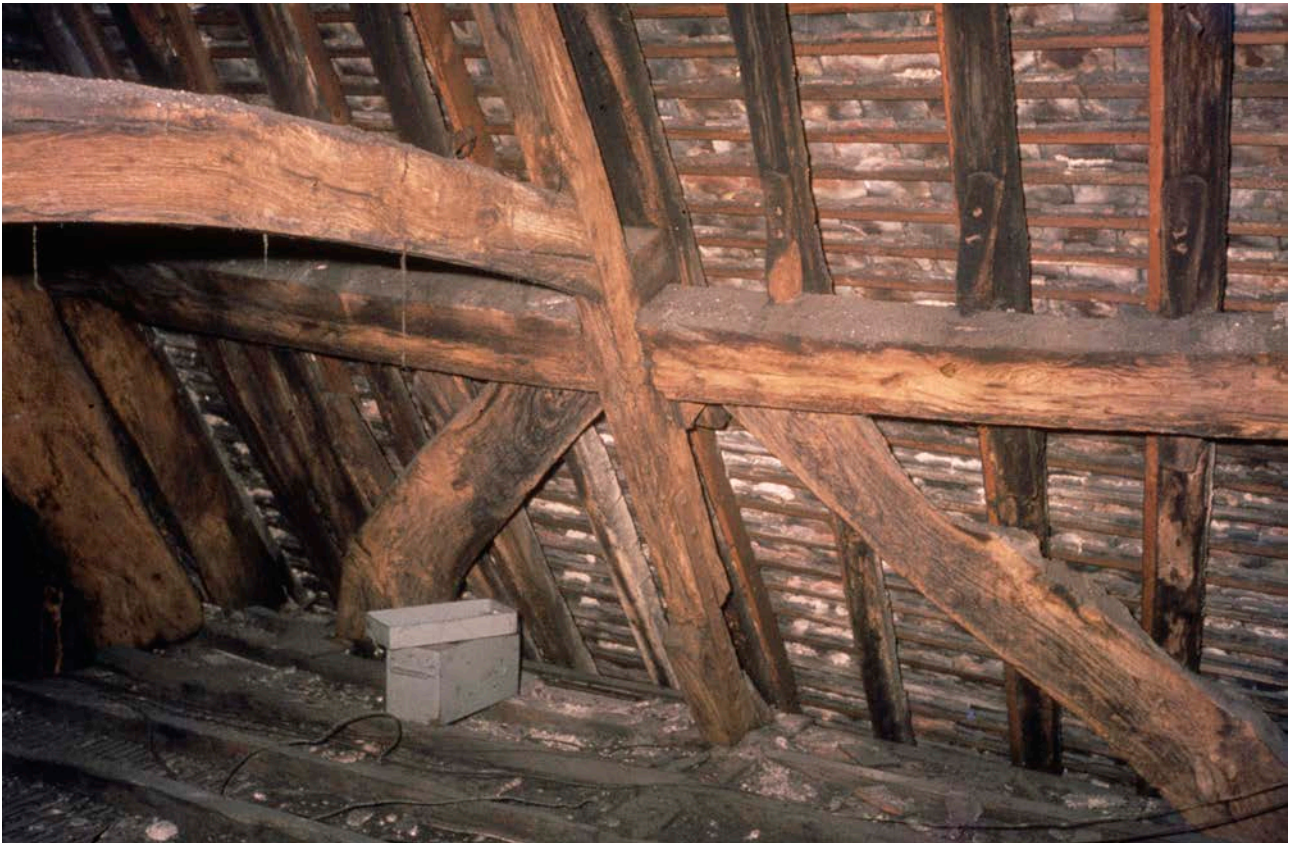
Figure Appendix 1.9: The collar of frame 4 (top left) and the eastern central purlin and windbraces in bays C and D. [© Historic England Archive, SJC01/03/0003]

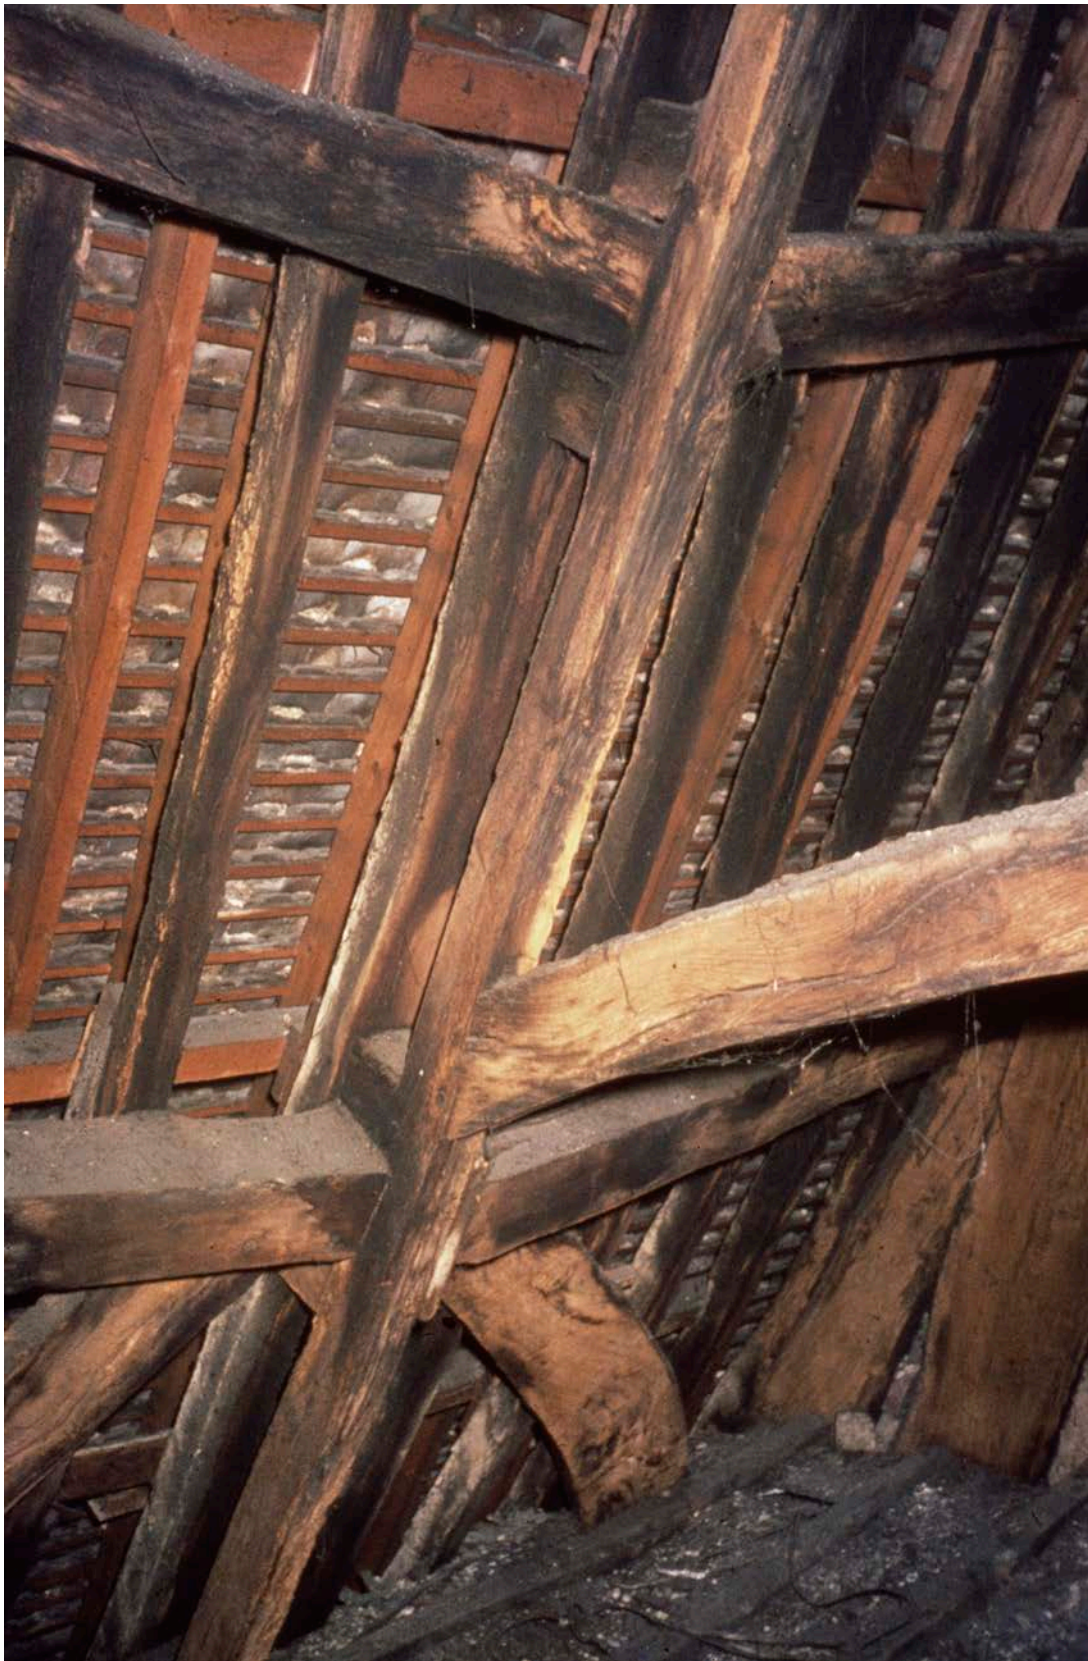
Figure Appendix 1.10: The collar of frame 4 (centre right) and the western central purlin and windbraces in bays C and D. [© Historic England Archive, SJC01/03/0008]

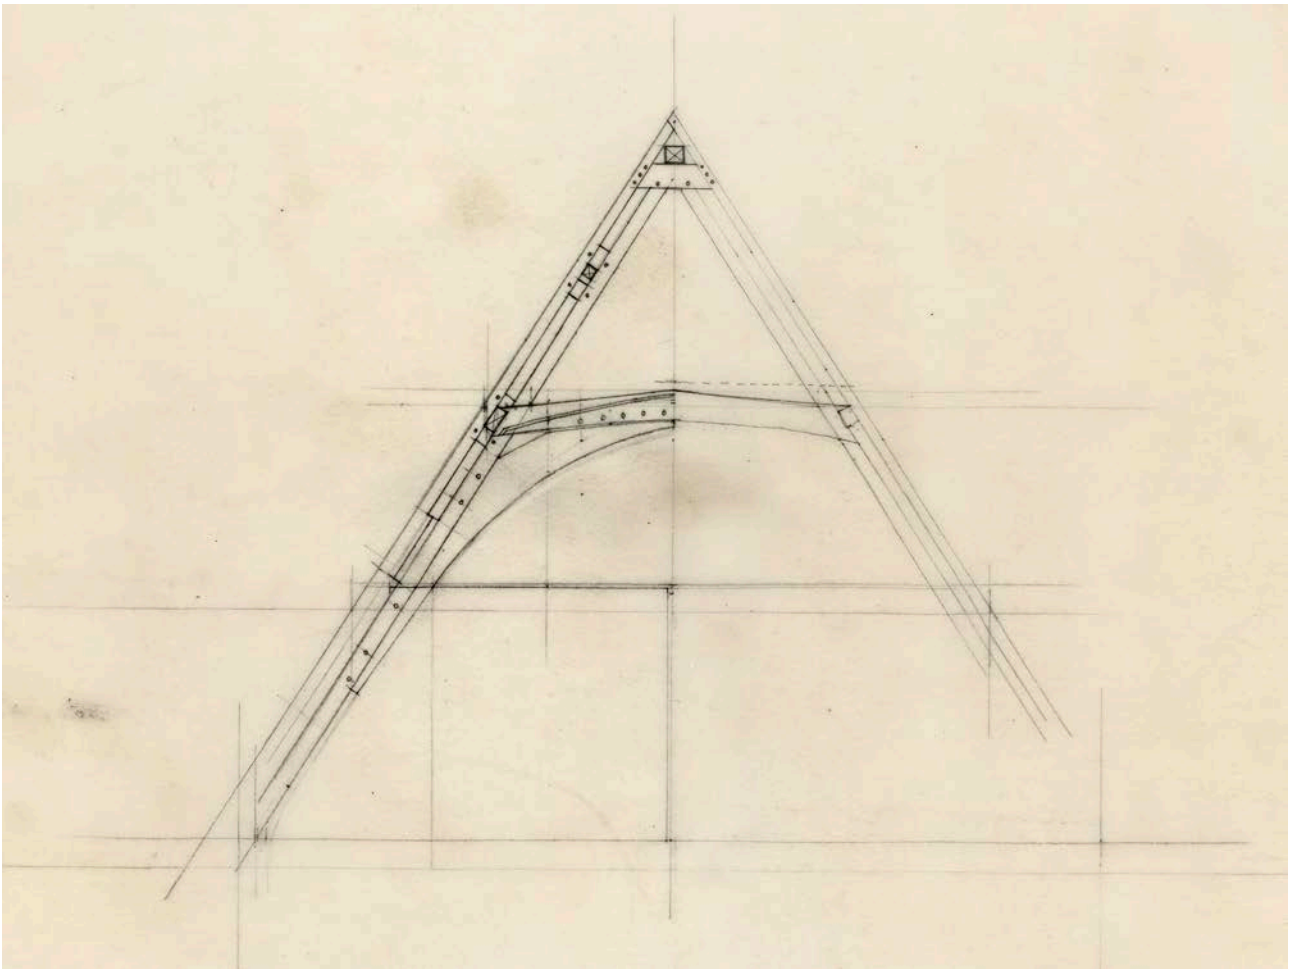
Figure Appendix 2.10: Partial elevation of the upper part of frame 2, north side. [© Historic England Archive, SJC01/01/001/11]
