81-2 Barton Street and 1-3 Mason's Court, Tewkesbury, Gloucestershire

Historic Building Assessment

Rebecca Lane and Johanna Roethe

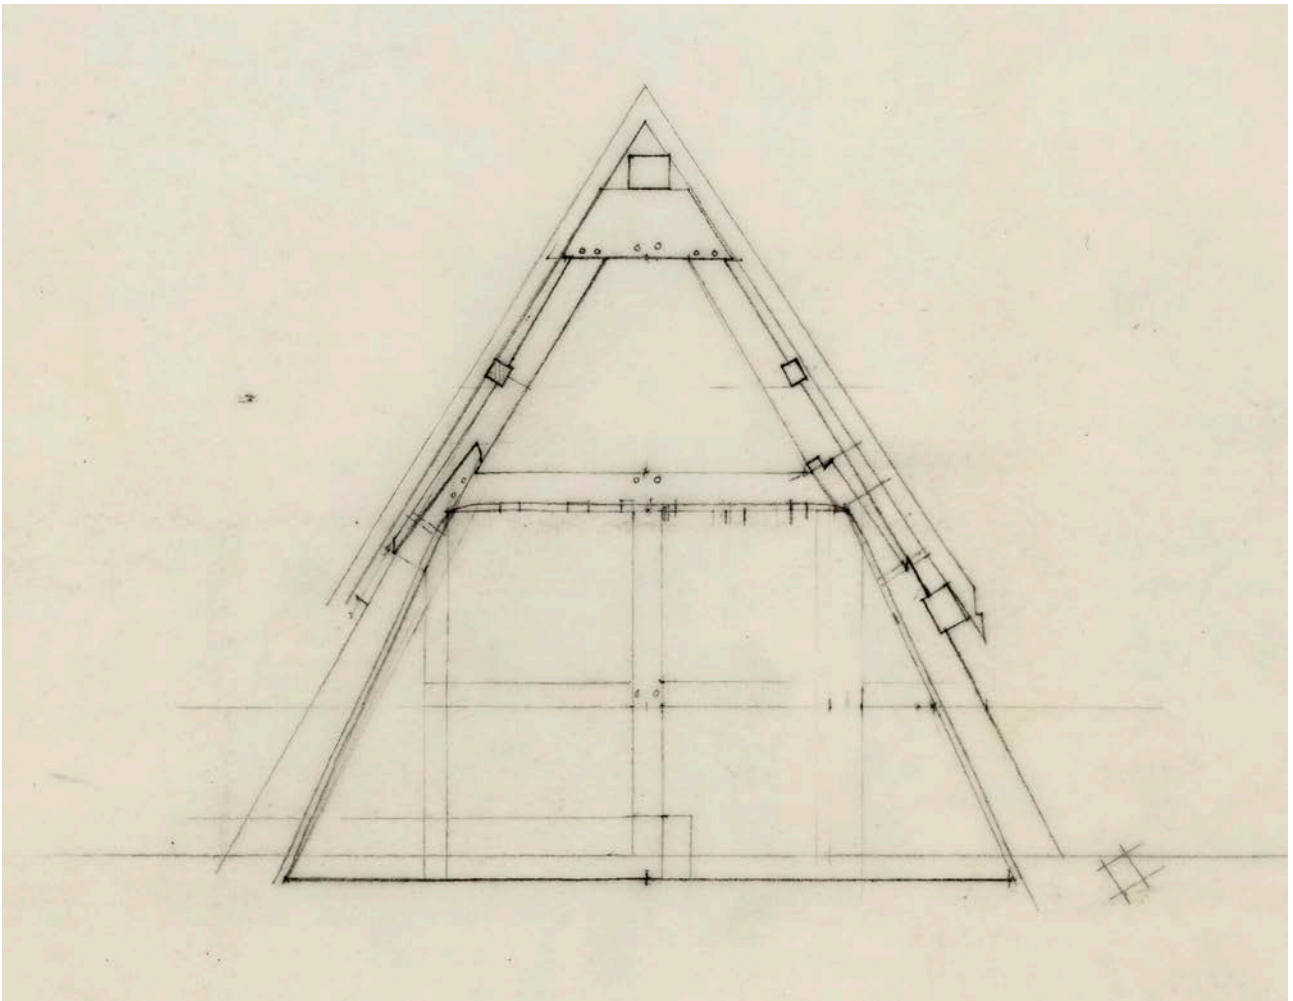
Figure Appendix 2.15: Elevation of the north side of frame 5 above first-floor level. [© Historic England Archive, SJC01/01/001/13]

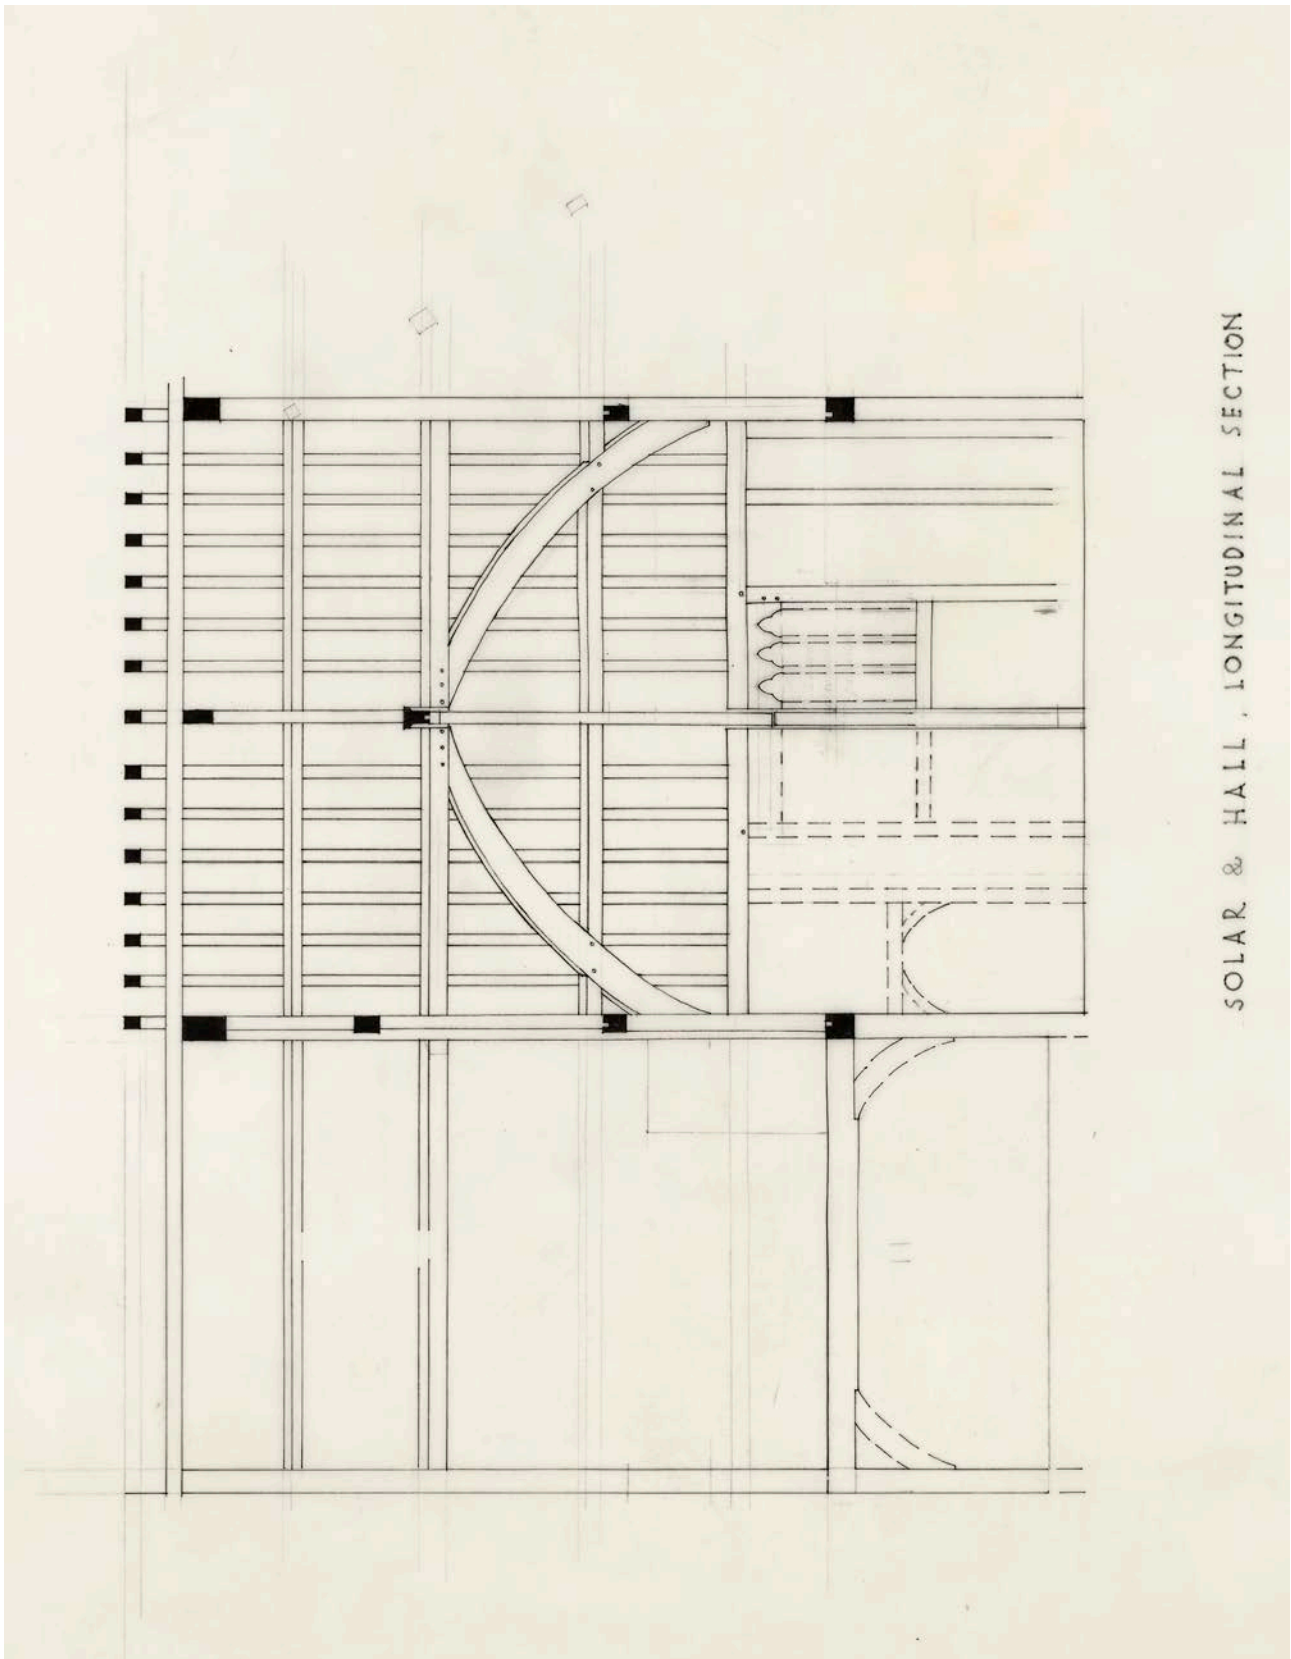
Figure Appendix 2.16: Longitudinal section of the main range, showing the west side. North is at the top of this page. [© Historic England Archive, SJC01/01/001/05]

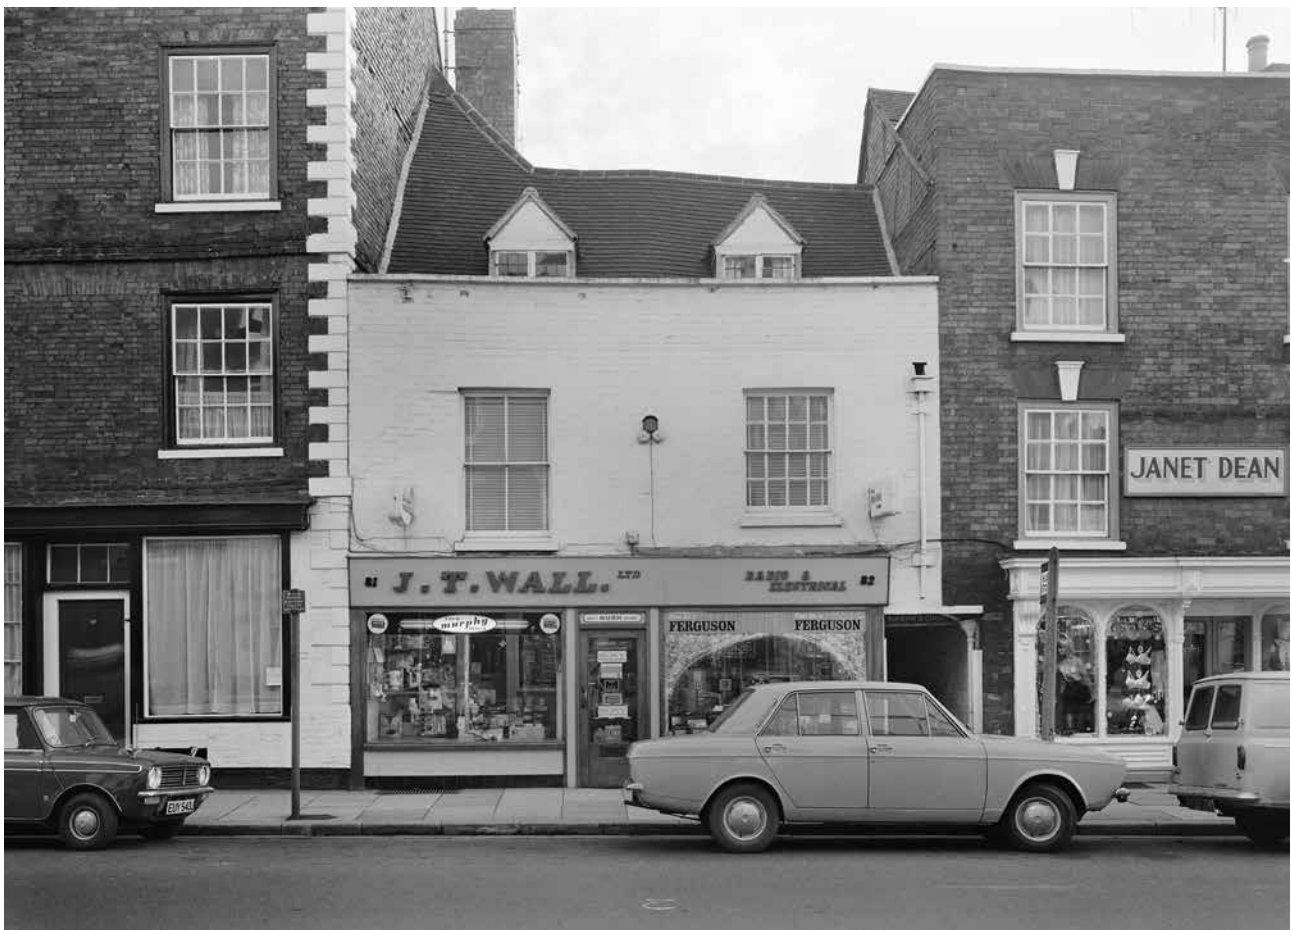
Figure Appendix 3.2: The north elevation of 81-2 Barton Street. [© Crown Copyright. Historic England Archive, bb72/00610]

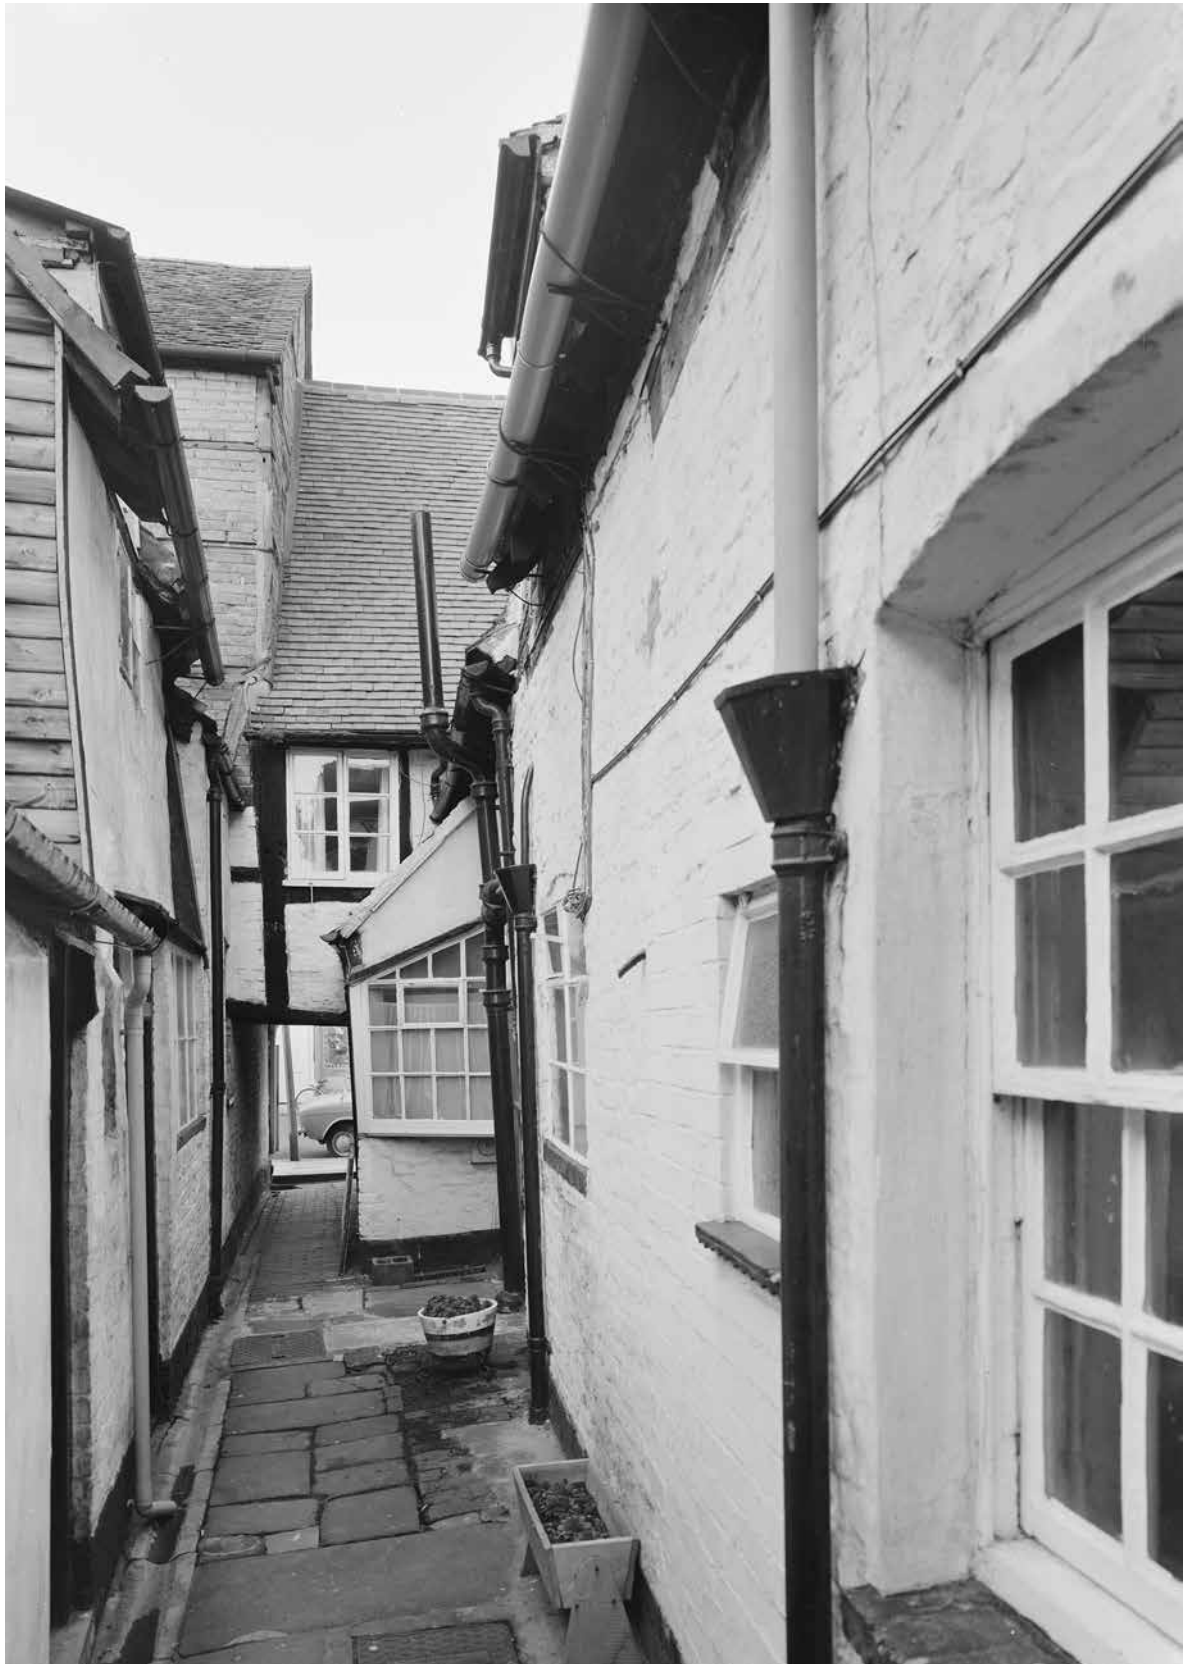
Figure Appendix 3.3: A view along the alleyway, looking north, with the main range to the right. [© Crown Copyright. Historic England Archive, bb72/00611]

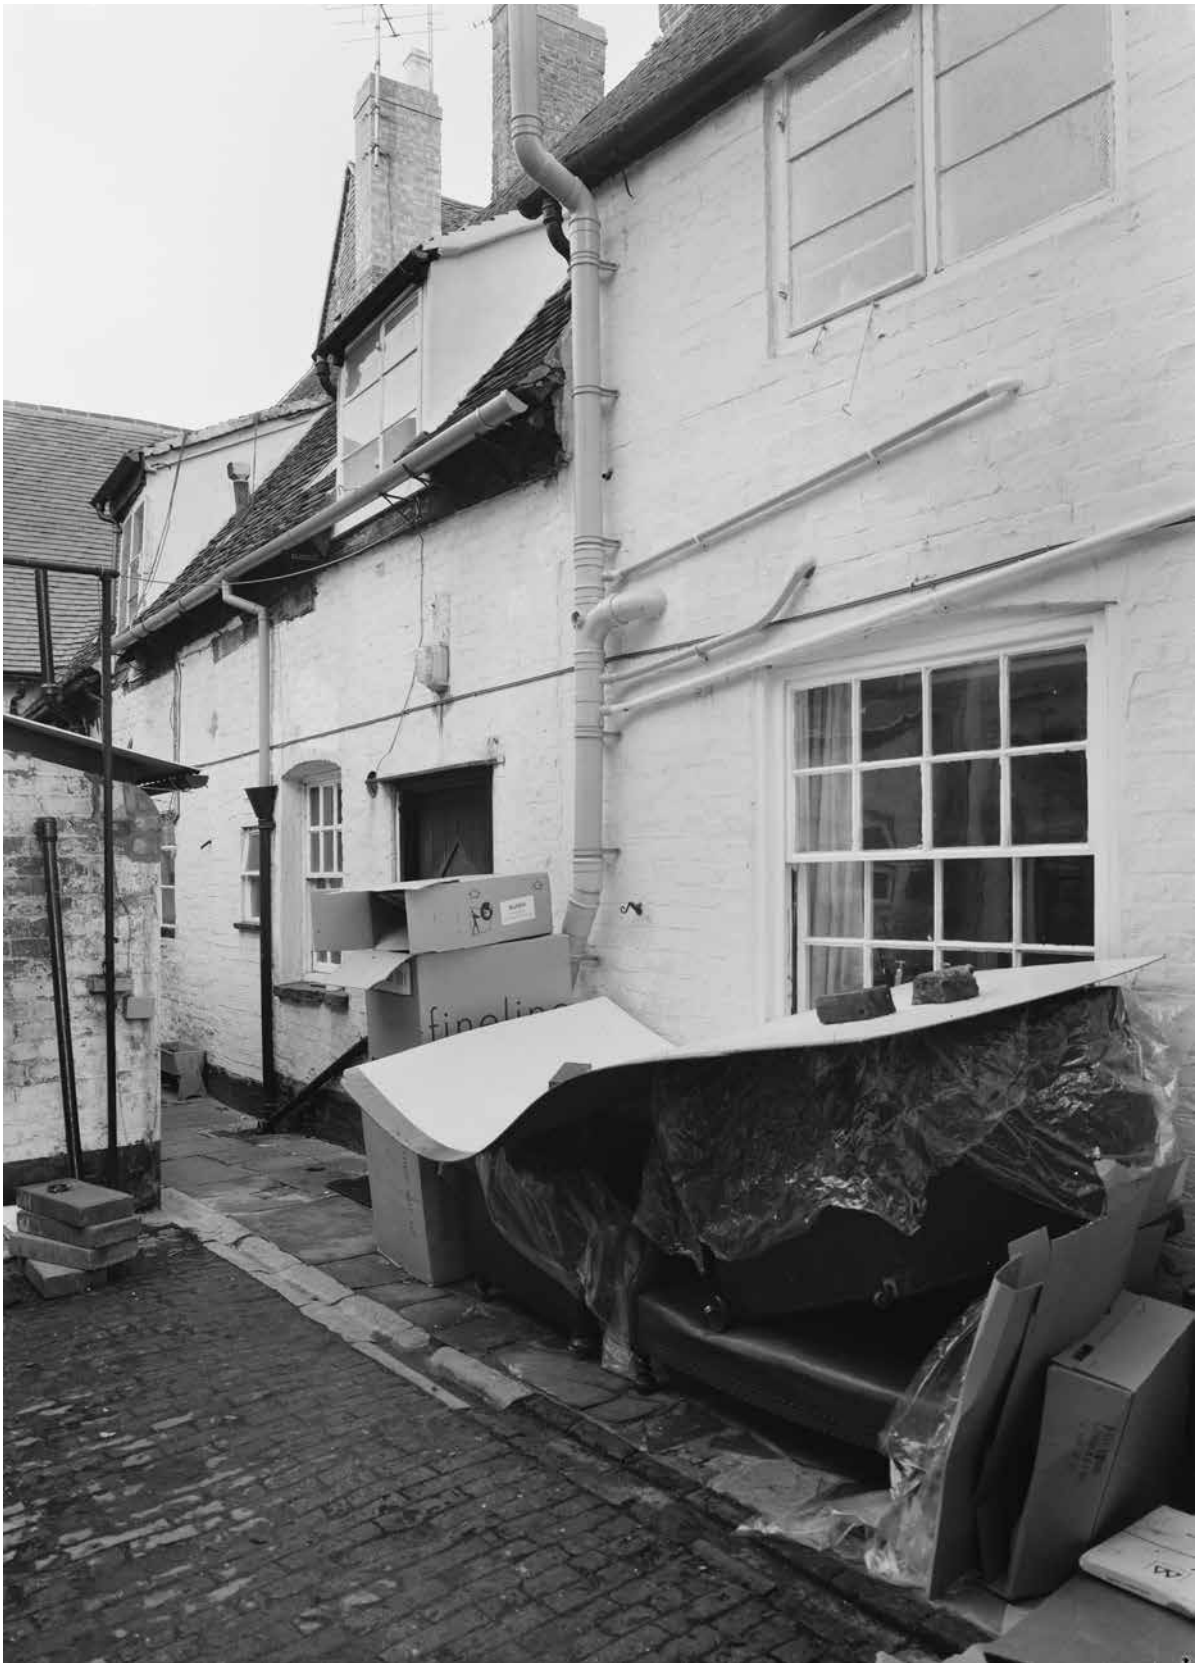
Figure Appendix 3.4: Looking north-east from the alleyway, with the main range at the centre and the 19th-century range to the right. [© Crown Copyright. Historic England Archive, bb72/00612]

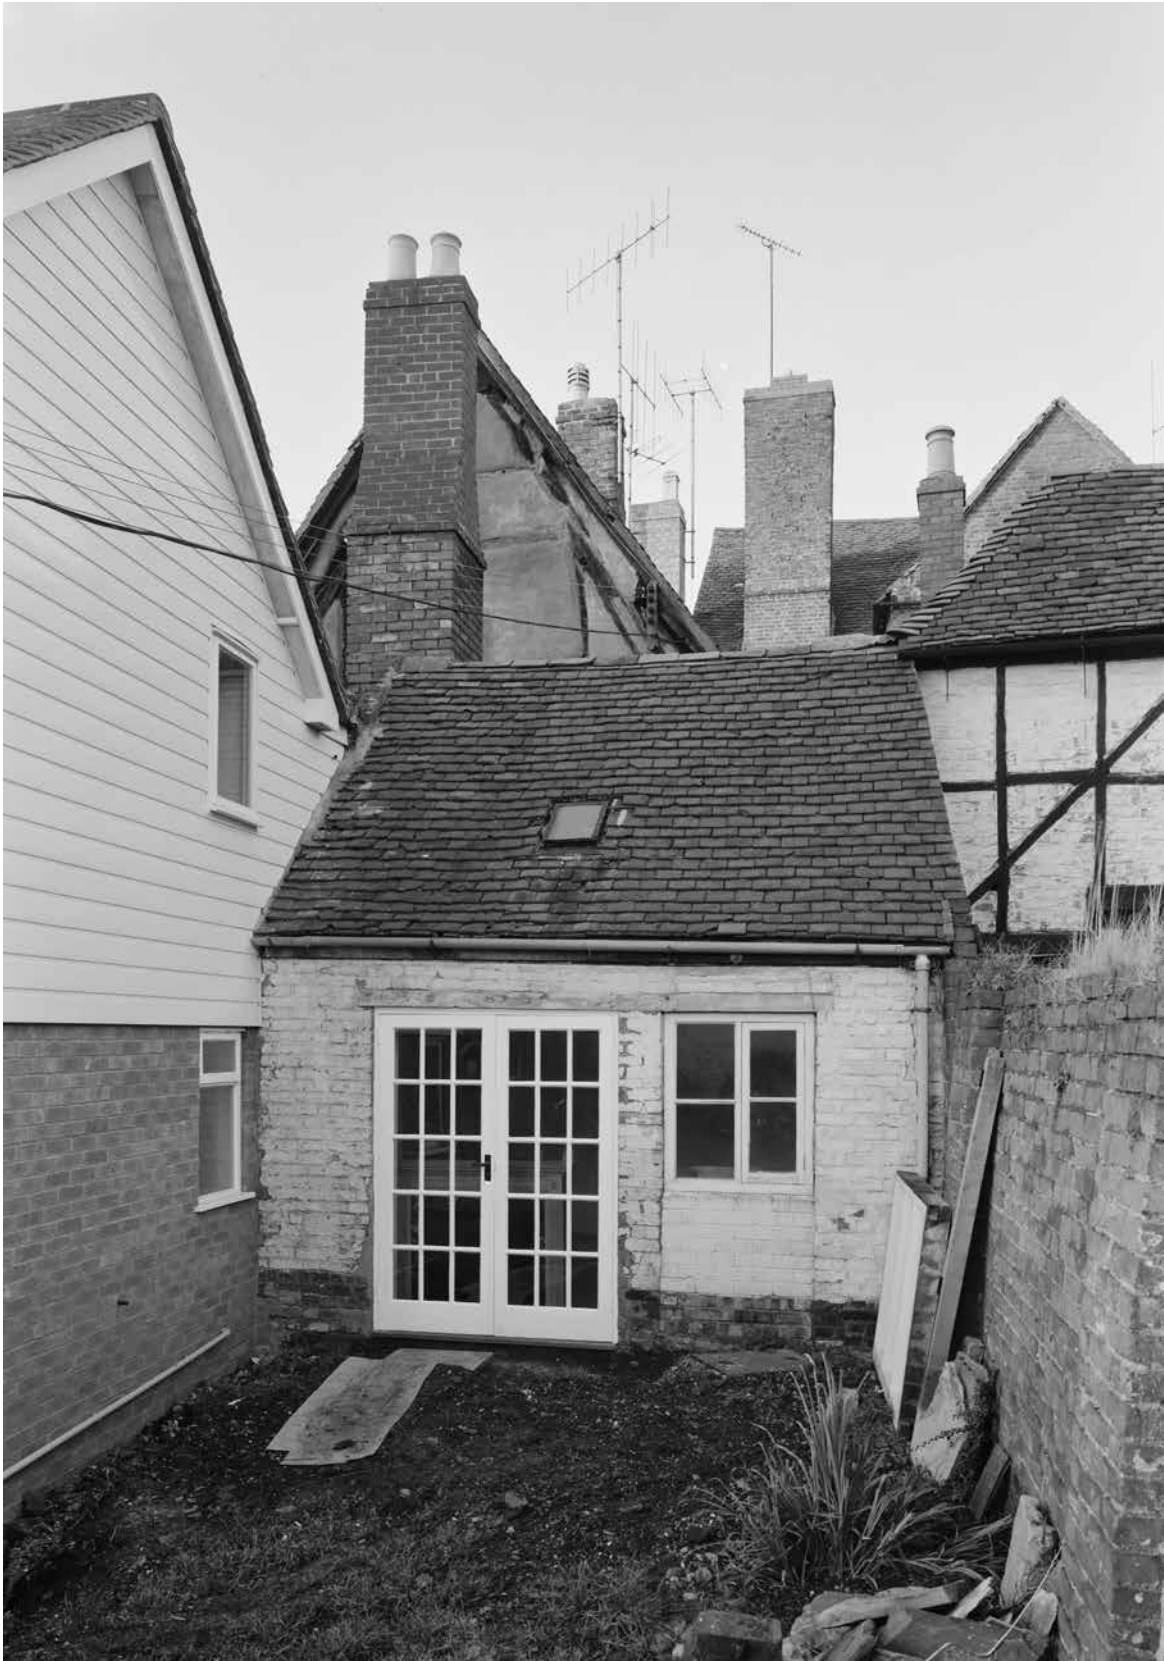
Figure Appendix 3.5: Looking north from the south end of the plot towards the south gable (left of centre) of the main range. In the foreground are a 1970s range (left) and a single-storey 19th-century range (centre). [© Crown Copyright. Historic England Archive, bb72/00613]

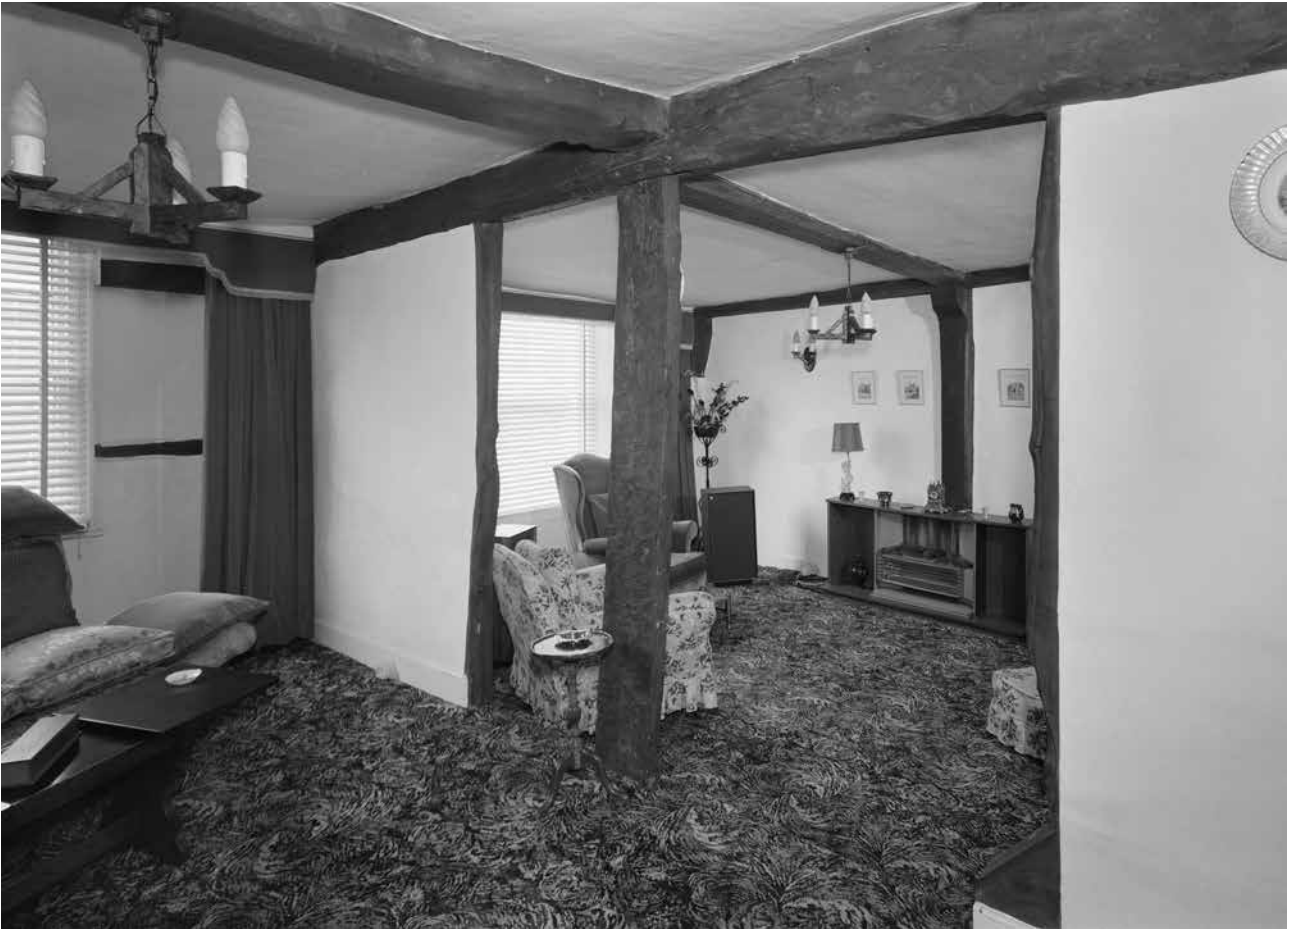
Figure Appendix 3.6: The first floor of the front range, looking north-east. [© Crown Copyright. Historic England Archive, bb72/00617]

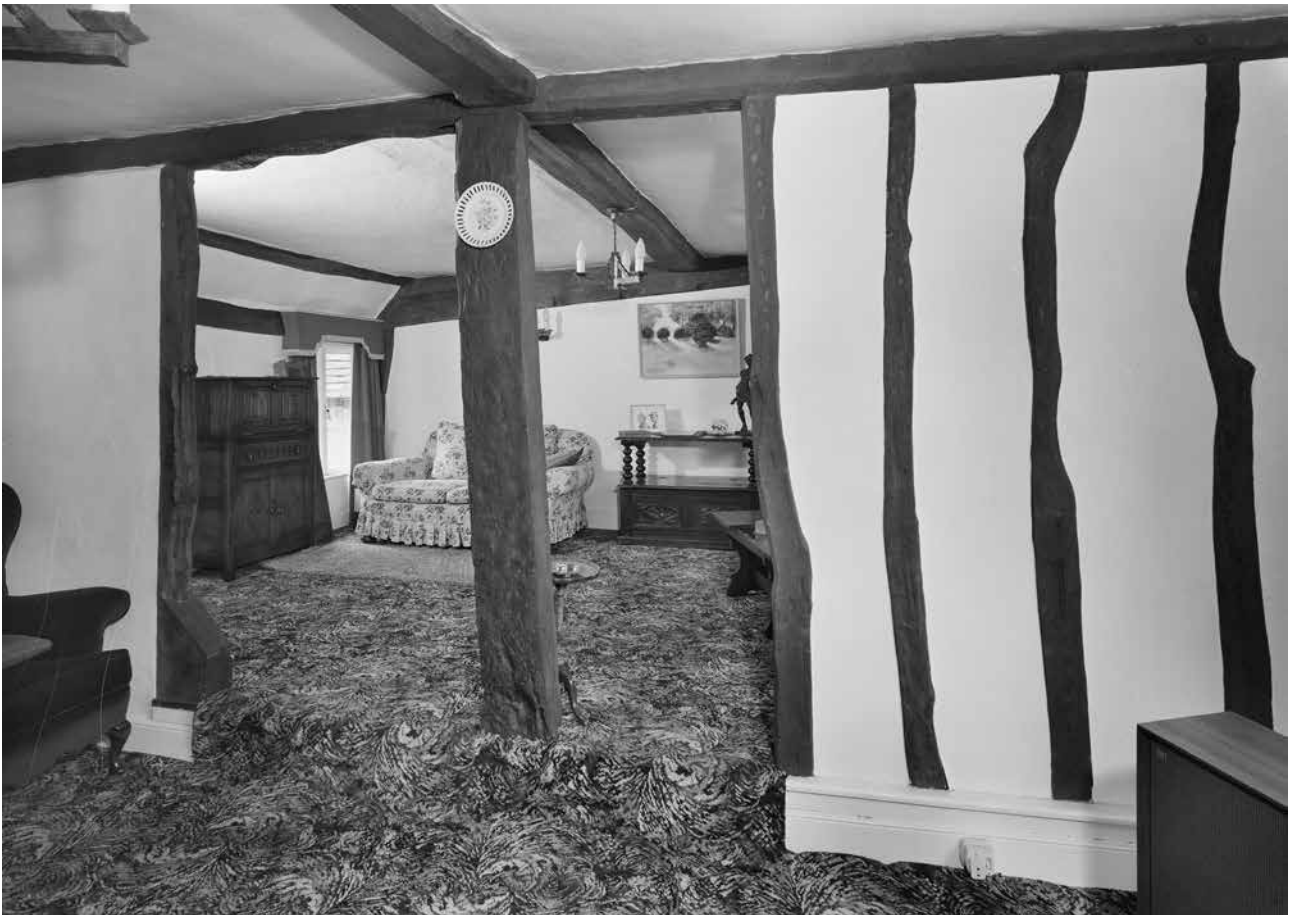
Figure Appendix 3.7: The first floor of the front range, looking south-west. [© Crown Copyright. Historic England Archive, bb72/00618]

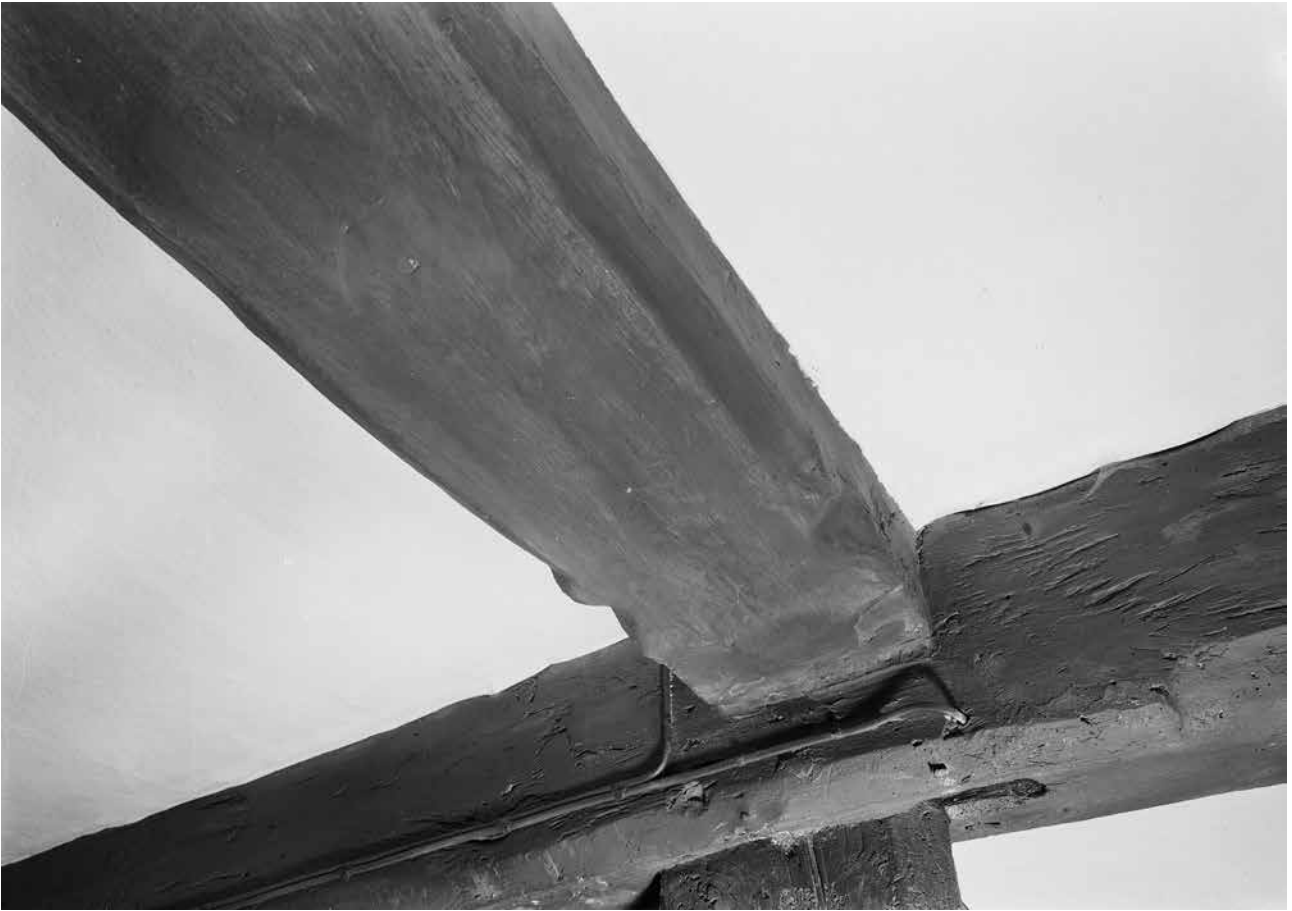
Figure Appendix 3.8: Detail of the chamfer stops of the axial beam in the west bay of the front range at first-floor level. [© Crown Copyright. Historic England Archive, bb72/00619]

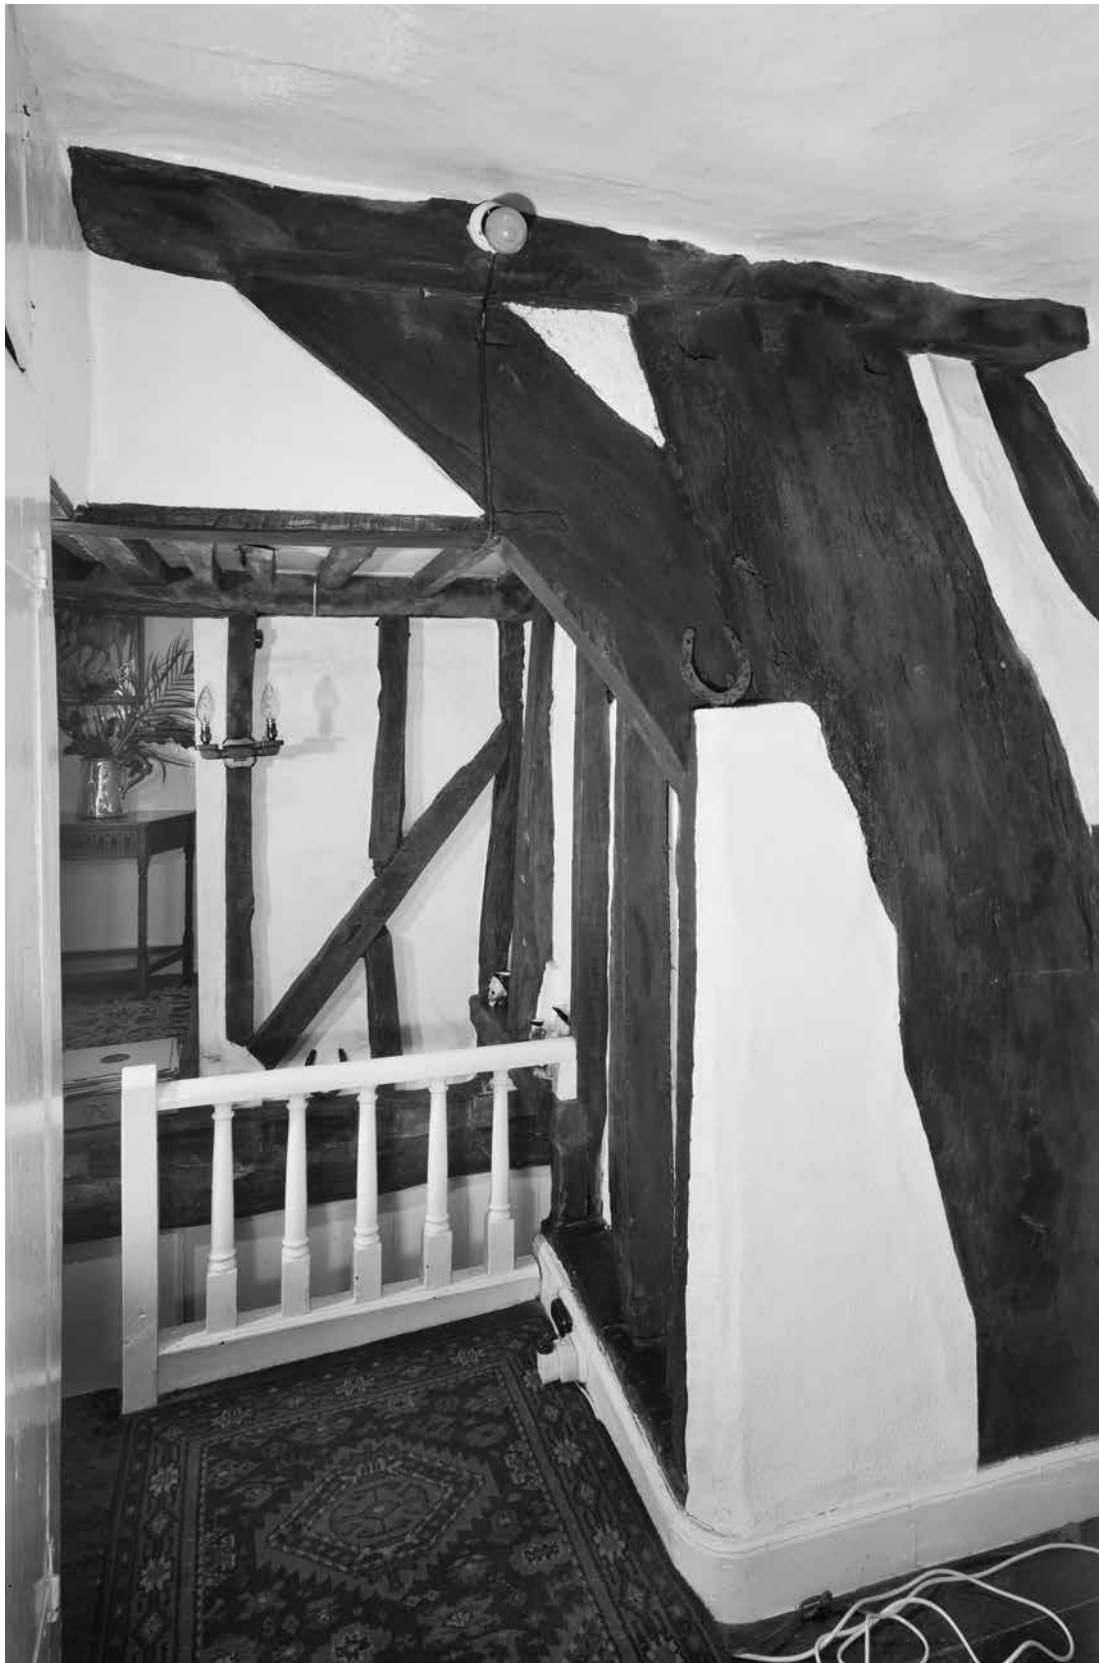
Figure Appendix 3.9: The north side of the west blade of the main range's frame 1, seen from the first floor of the front range. [© Crown Copyright. Historic England Archive, bb72/00615]

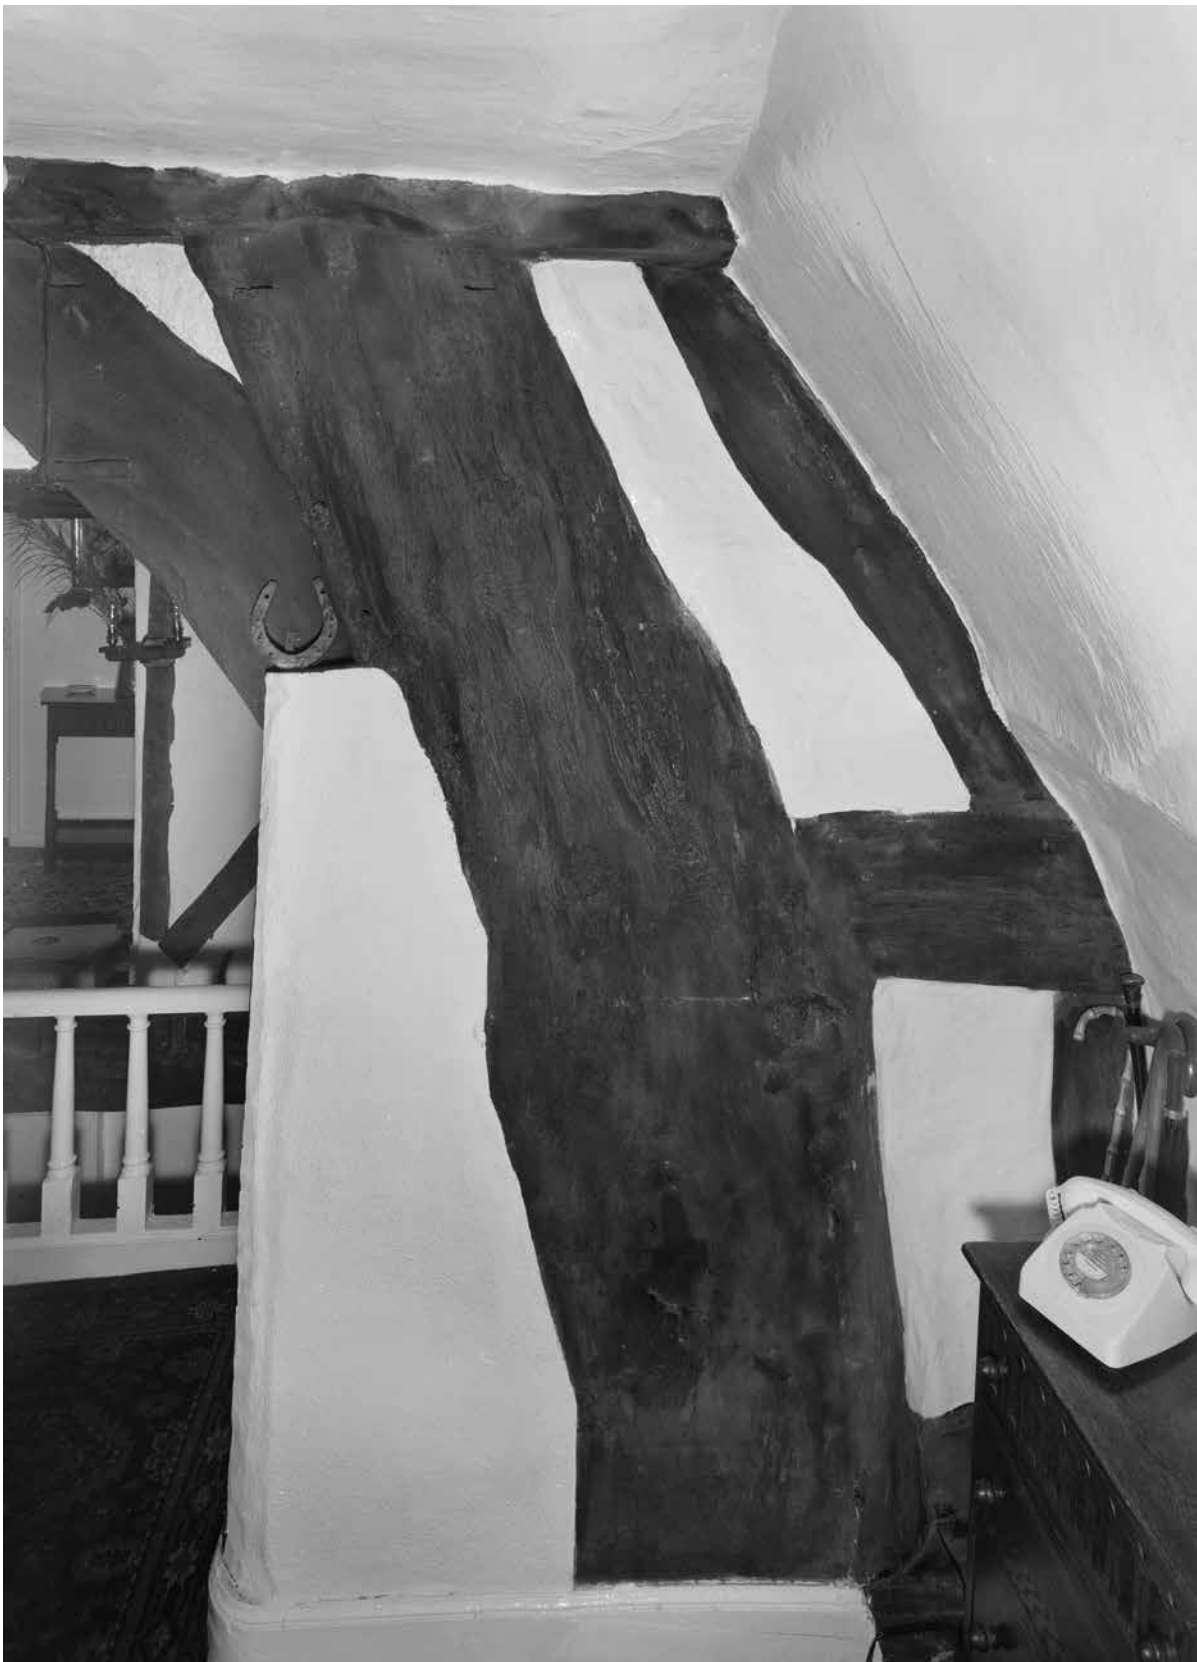
Figure Appendix 3.10: The north side of the west blade of the main range's frame 1, seen from the first floor of the front range. [© Crown Copyright. Historic England Archive, bb72/00616]

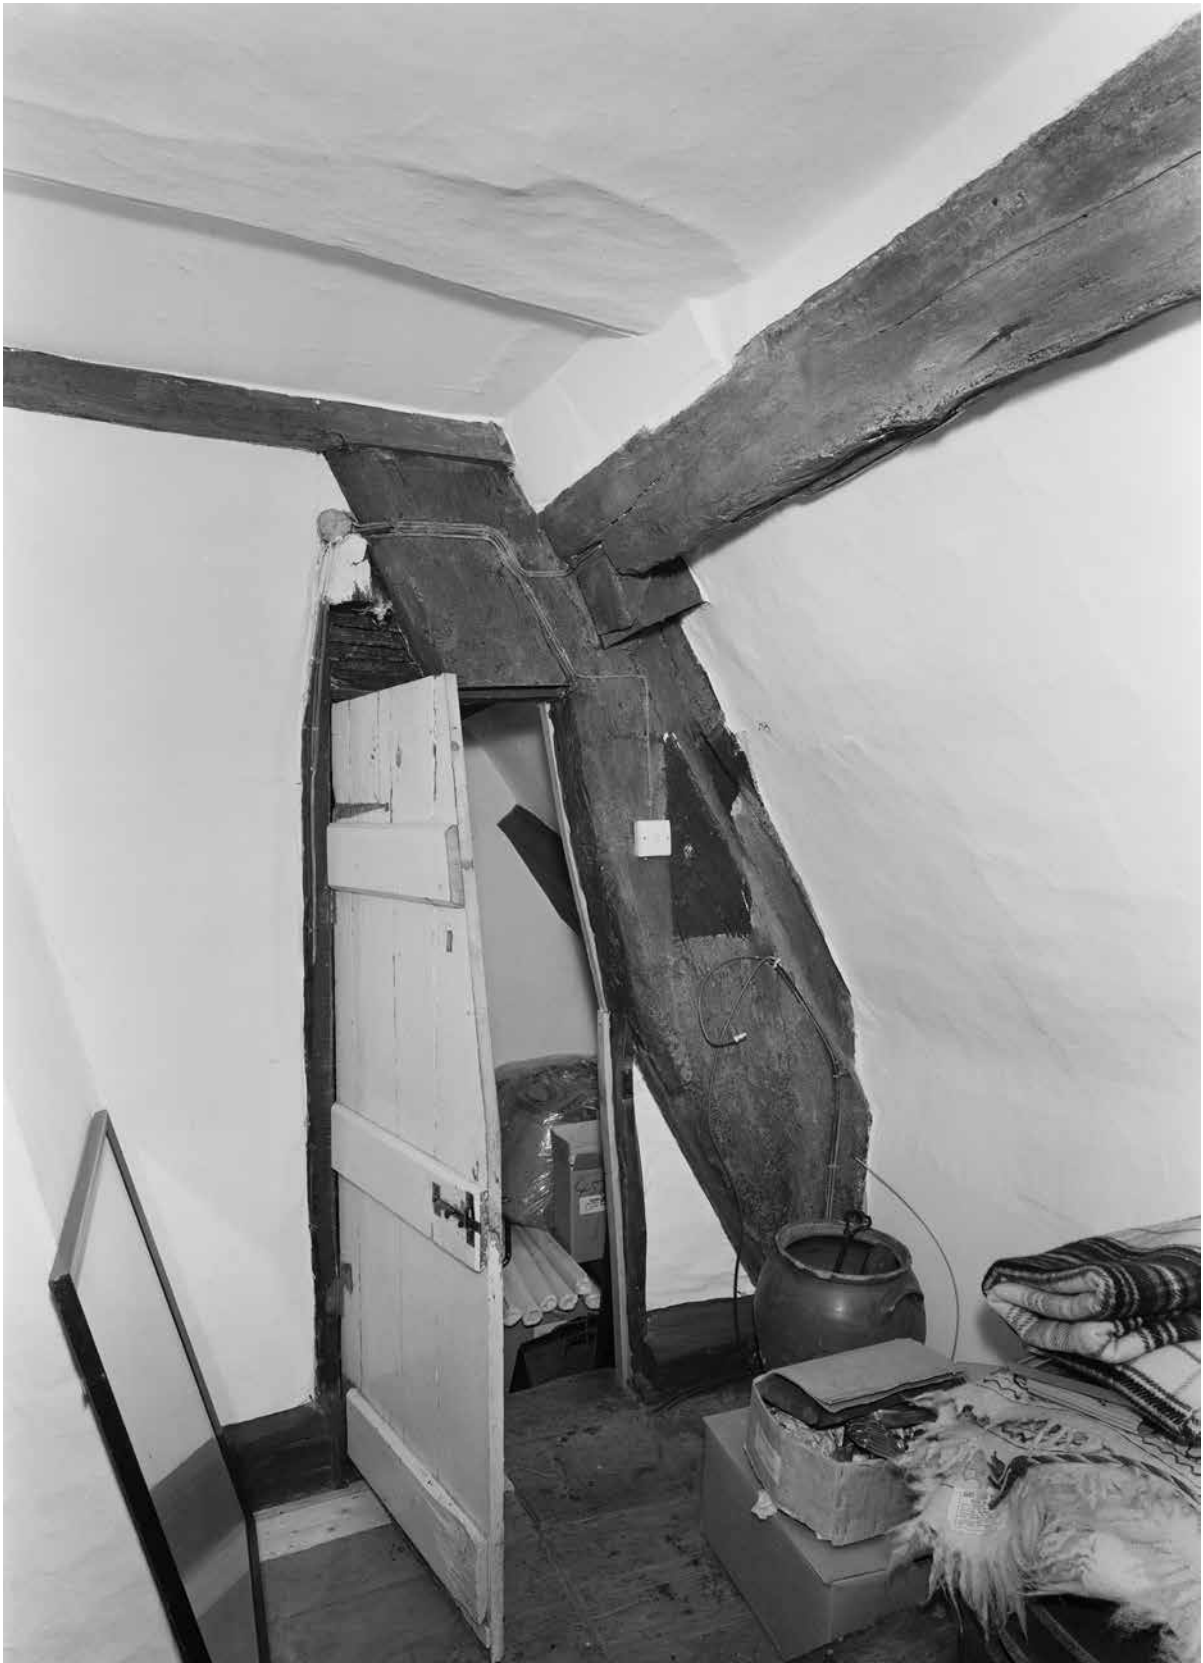
Figure Appendix 3.11: The north side of the west blade of the main range's frame 1, seen from the second floor of the front range. [© Crown Copyright. Historic England Archive, bb72/00628]

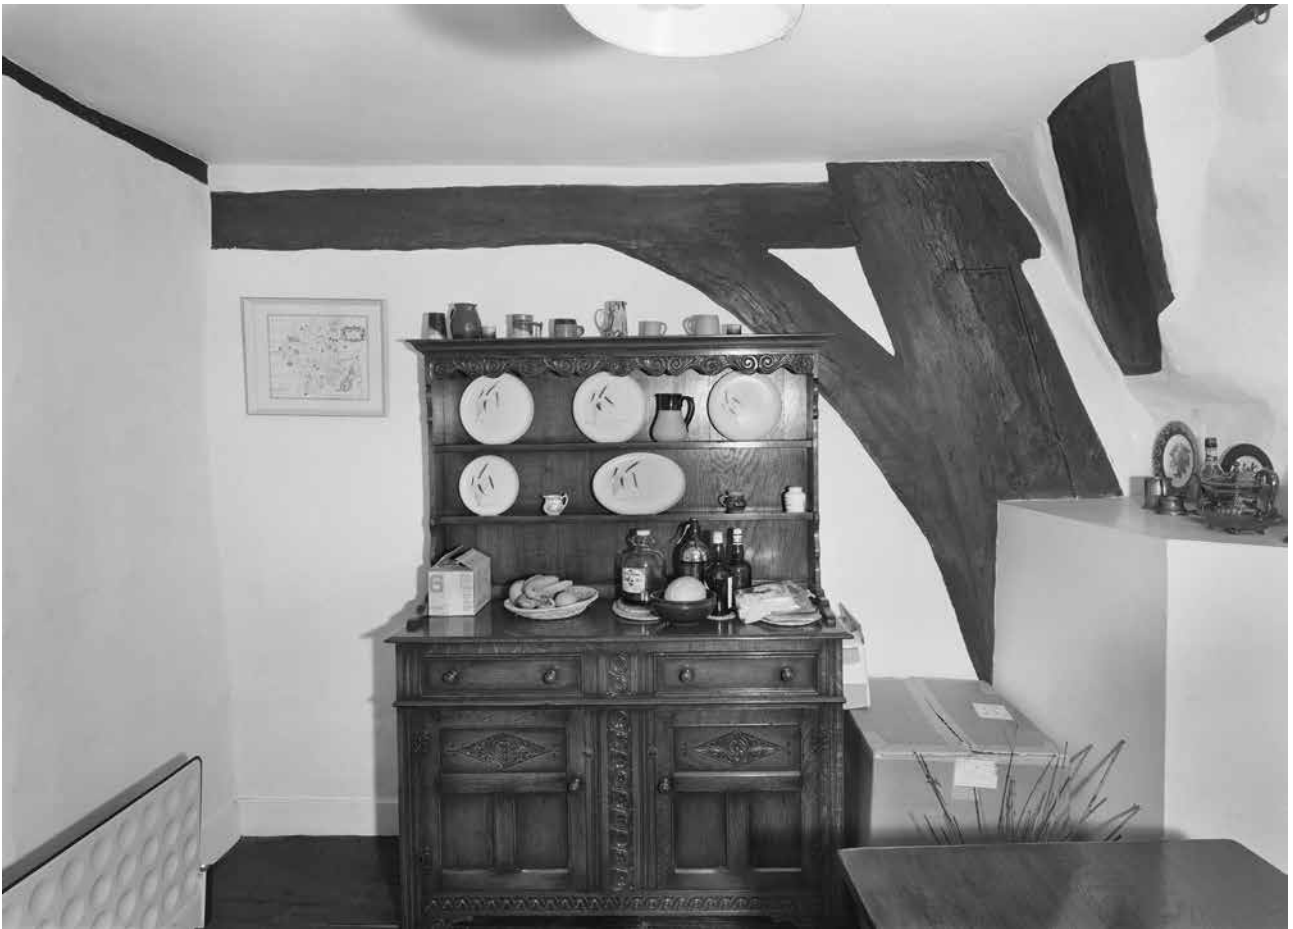
Figure Appendix 3.12: The south side of the east blade of the main range's frame 1, at first-floor level. [© Crown Copyright. Historic England Archive, bb72/00621]
