81-2 Barton Street and 1-3 Mason's Court, Tewkesbury, Gloucestershire

Historic Building Assessment

Rebecca Lane and Johanna Roethe

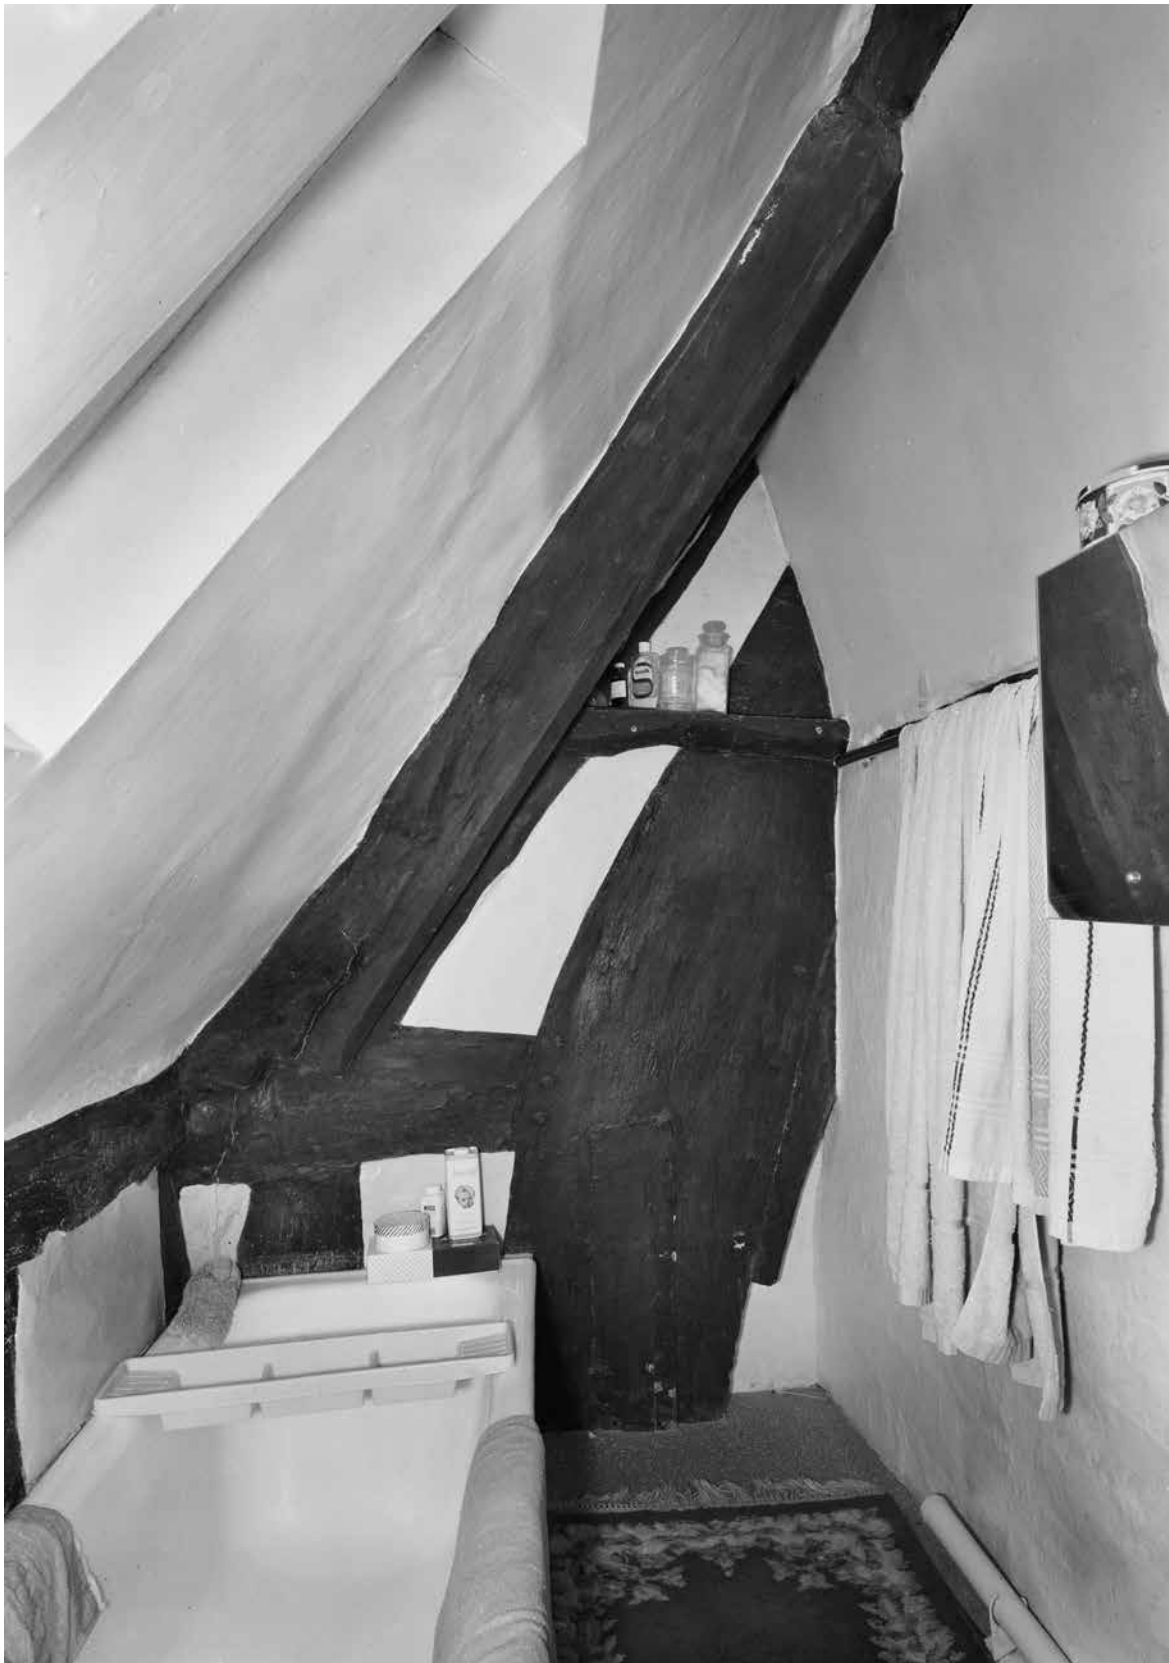
Figure Appendix 3.13: The south side of the west blade of the main range's frame 1, at first-floor level. [© Crown Copyright. Historic England Archive, bb72/00622]

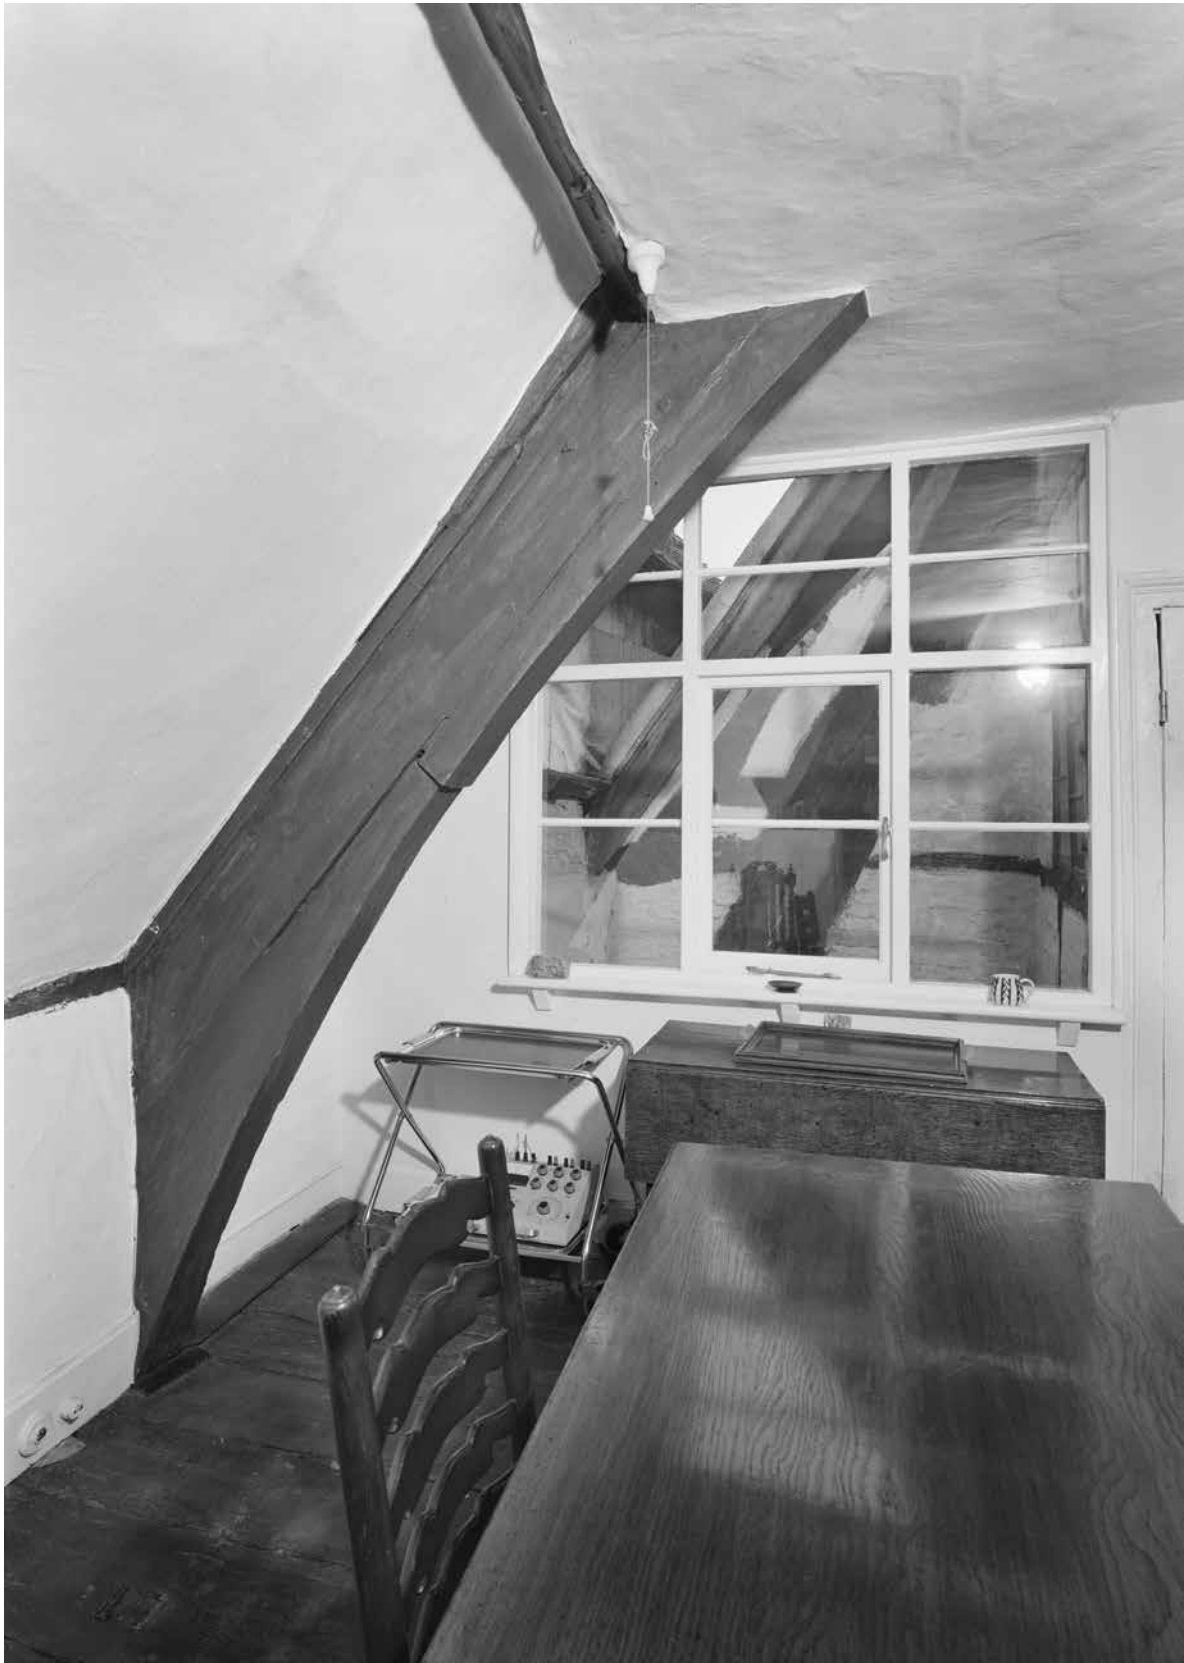
Figure Appendix 3.14: The north side of the east blade of the main range's frame 2, at first-floor level. Behind (south of) the frame is the 18th-century lightwell and frame 3. [© Crown Copyright. Historic England Archive, bb72/00620]

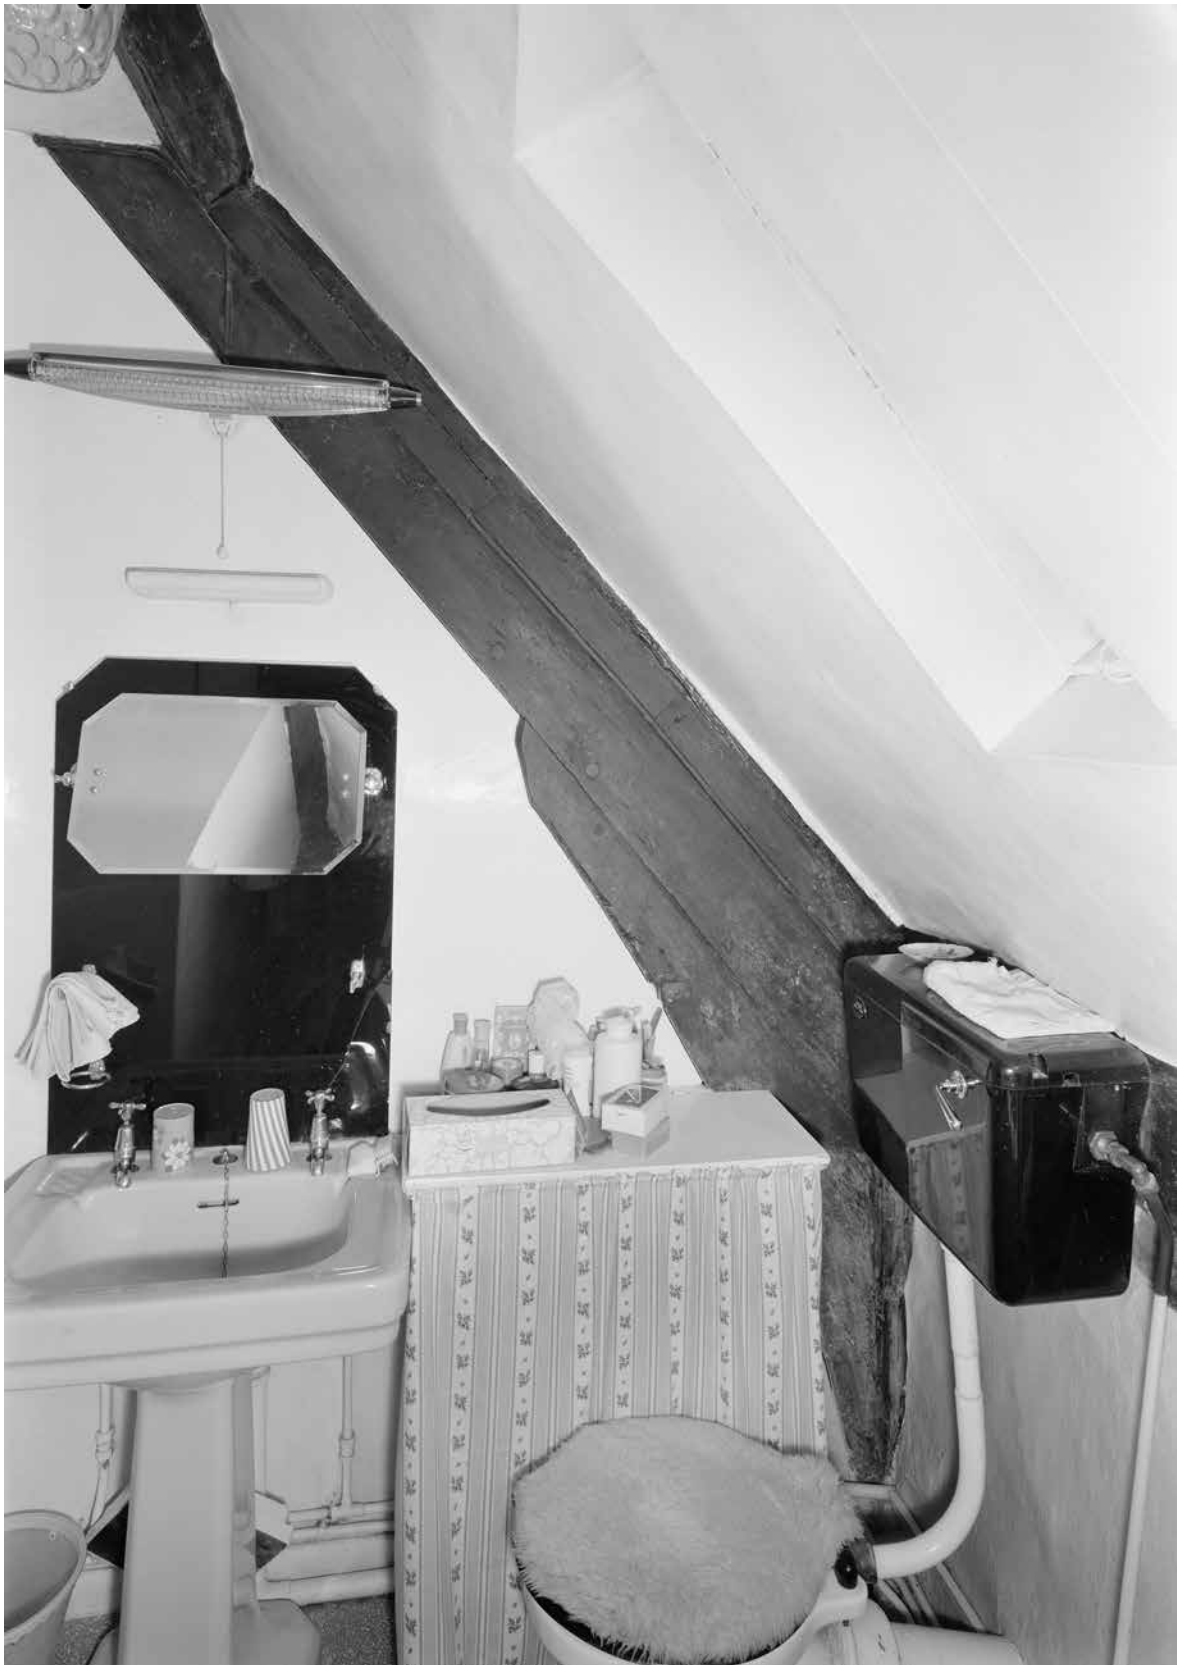
Figure Appendix 3.15: The north side of the west blade of the main range's frame 2, at first-floor level. [© Crown Copyright. Historic England Archive, bb72/00623]

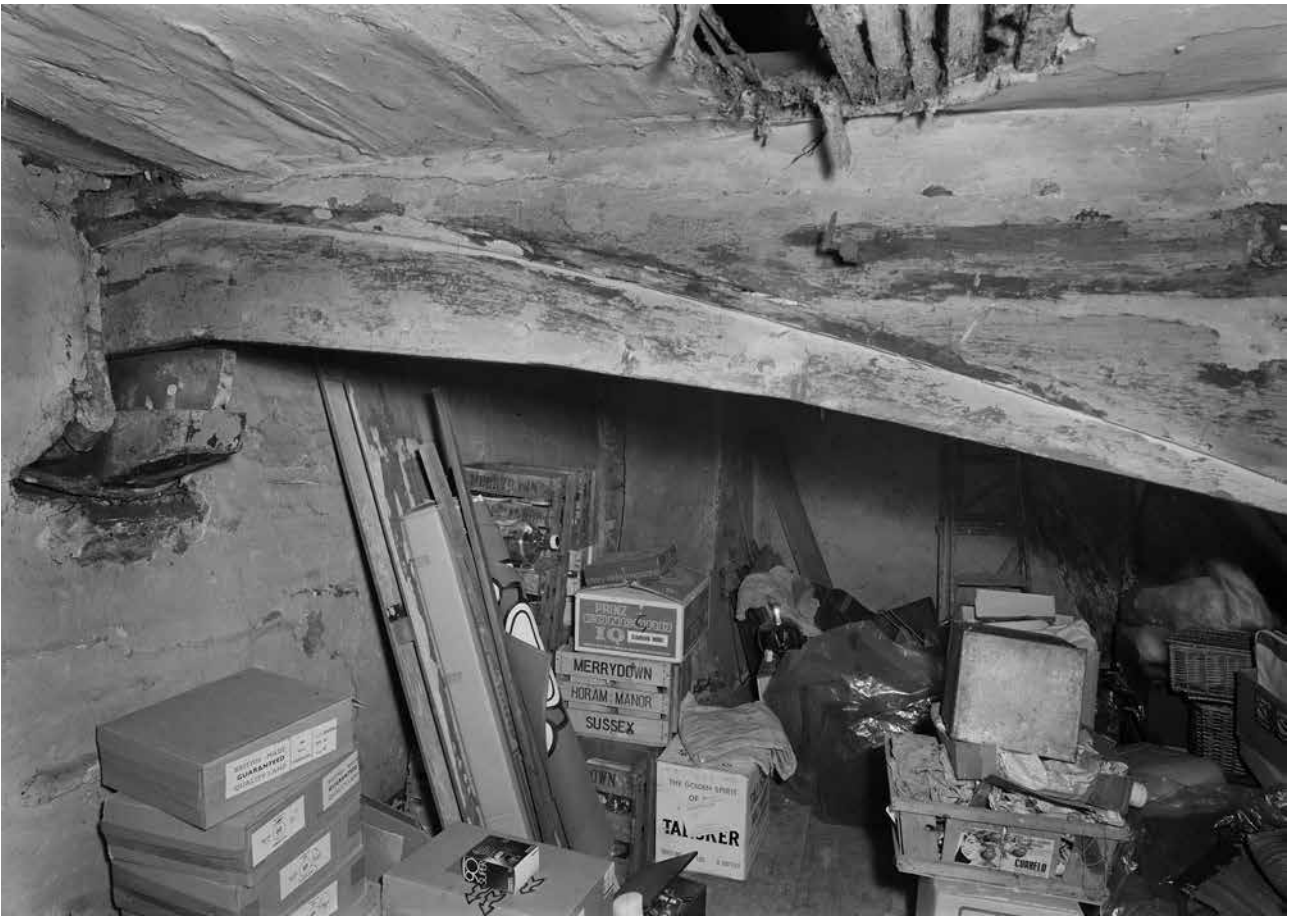
Figure Appendix 3.16: The west end of the collar of frame 2 (south side), at what was then attic level and is now the second floor. The surviving arch brace is embedded in the later wall to the left. [© Crown Copyright. Historic England Archive, bb72/00629]

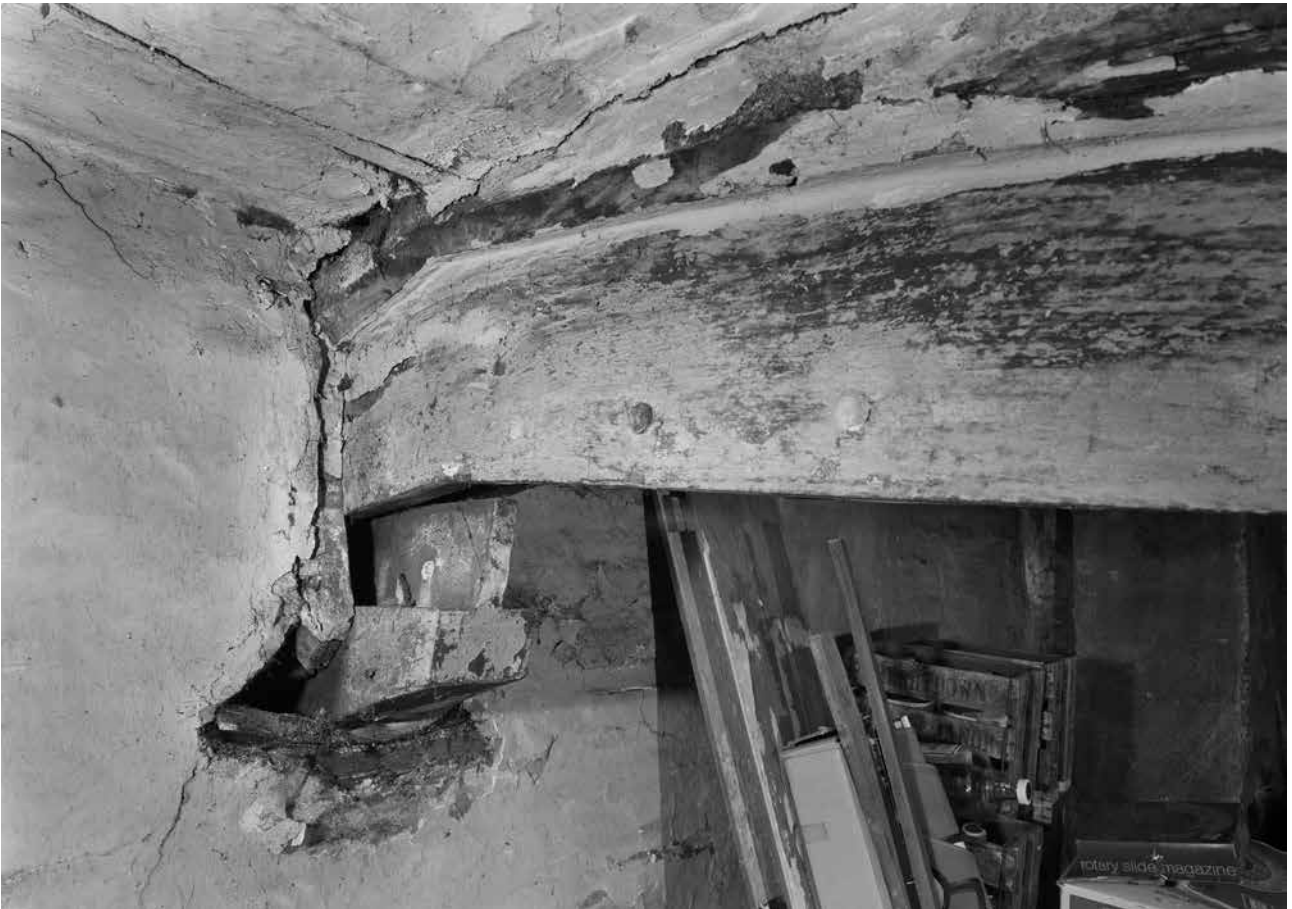
Figure Appendix 3.17: Close-up of the collar and surviving arch brace of frame 2. [© Crown Copyright. Historic England Archive, bb72/00630]

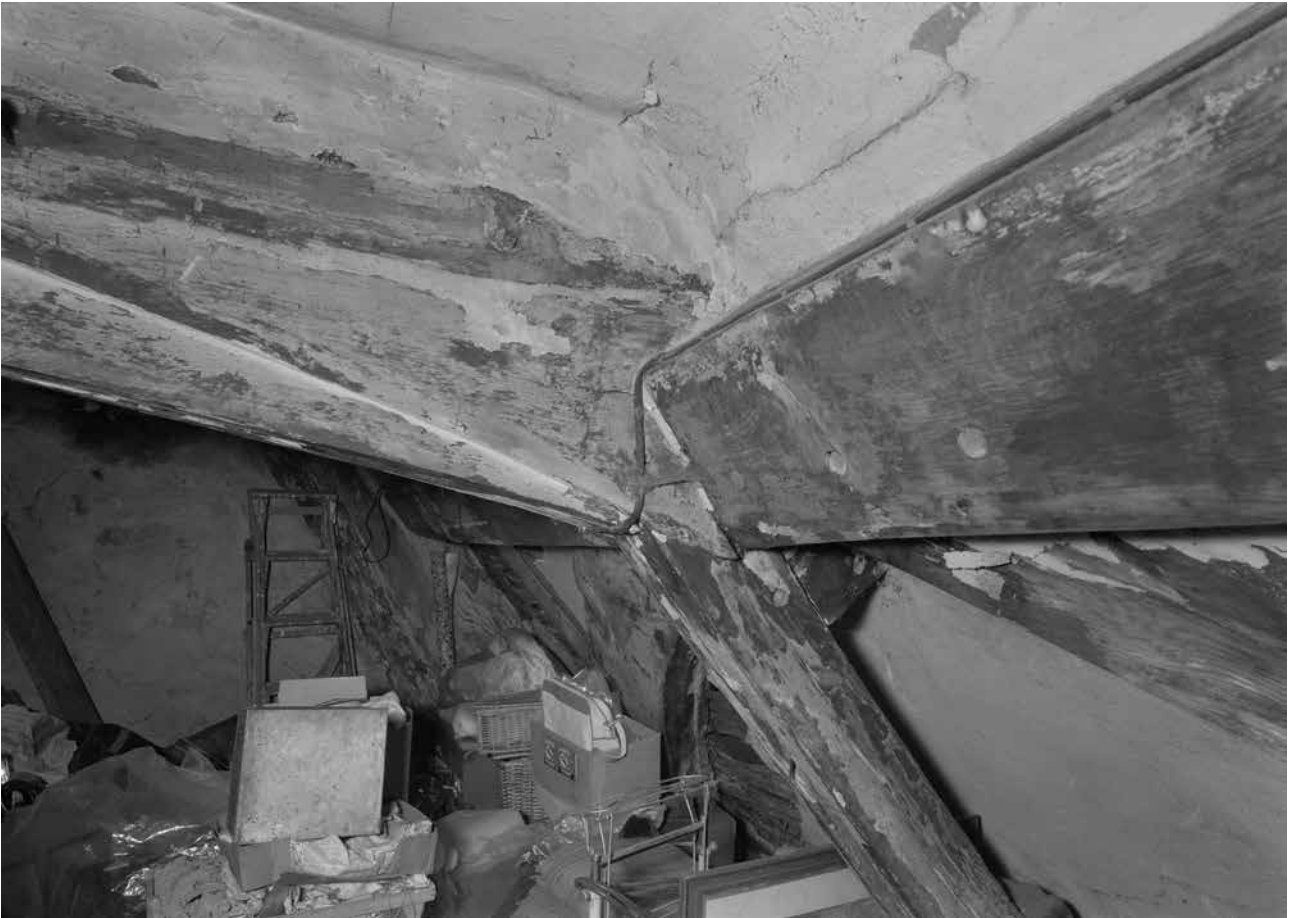
Figure Appendix 3.18: Detail of the birdsmouth joint of the collar and central purlin of frame 2. [© Crown Copyright. Historic England Archive, bb72/00631]

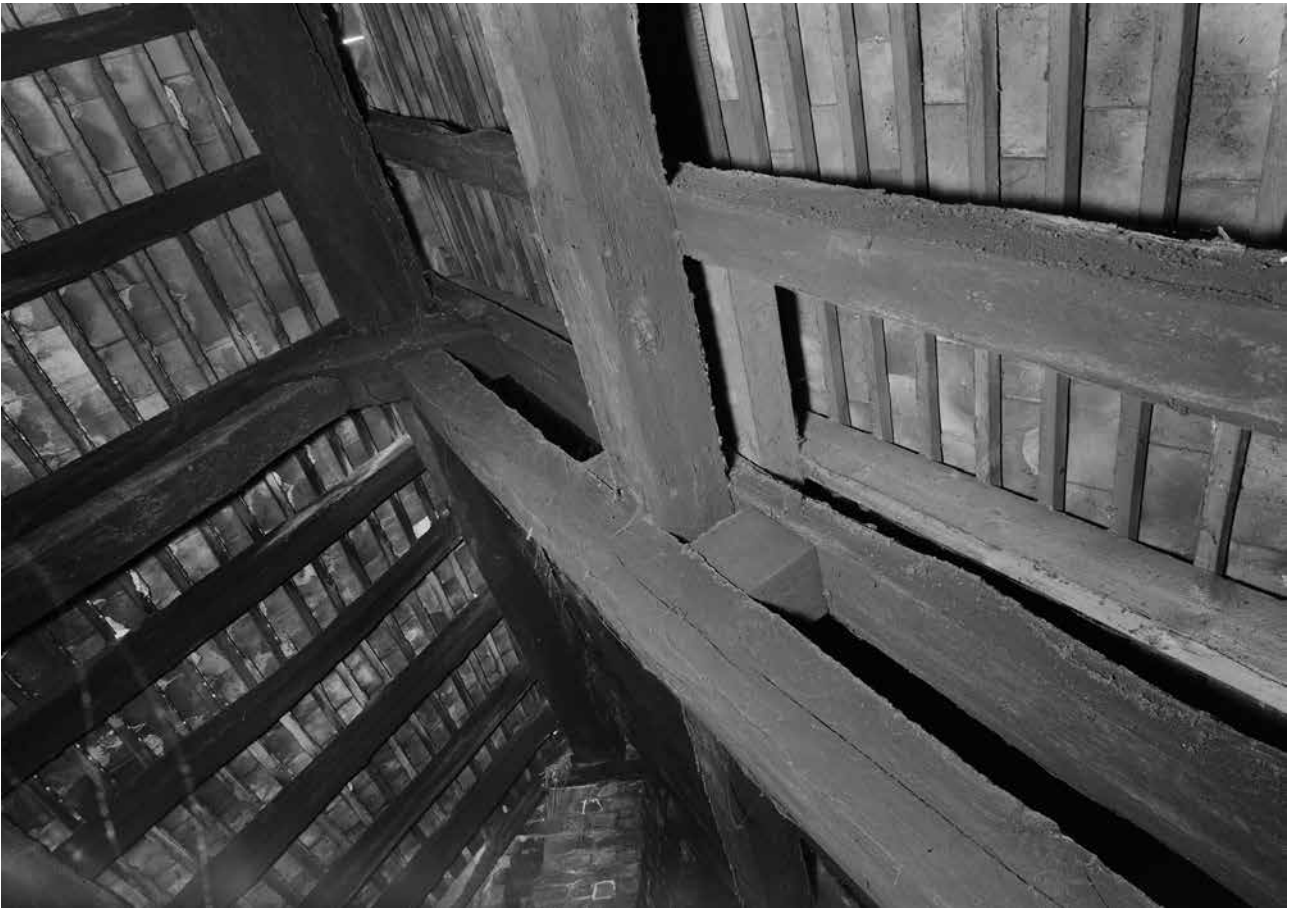
Figure Appendix 3.19: The north side of the main range's frame 2 in the roof space, looking south. In the background is the chimneystack set against frame 3. [© Crown Copyright. Historic England Archive, bb72/00632]

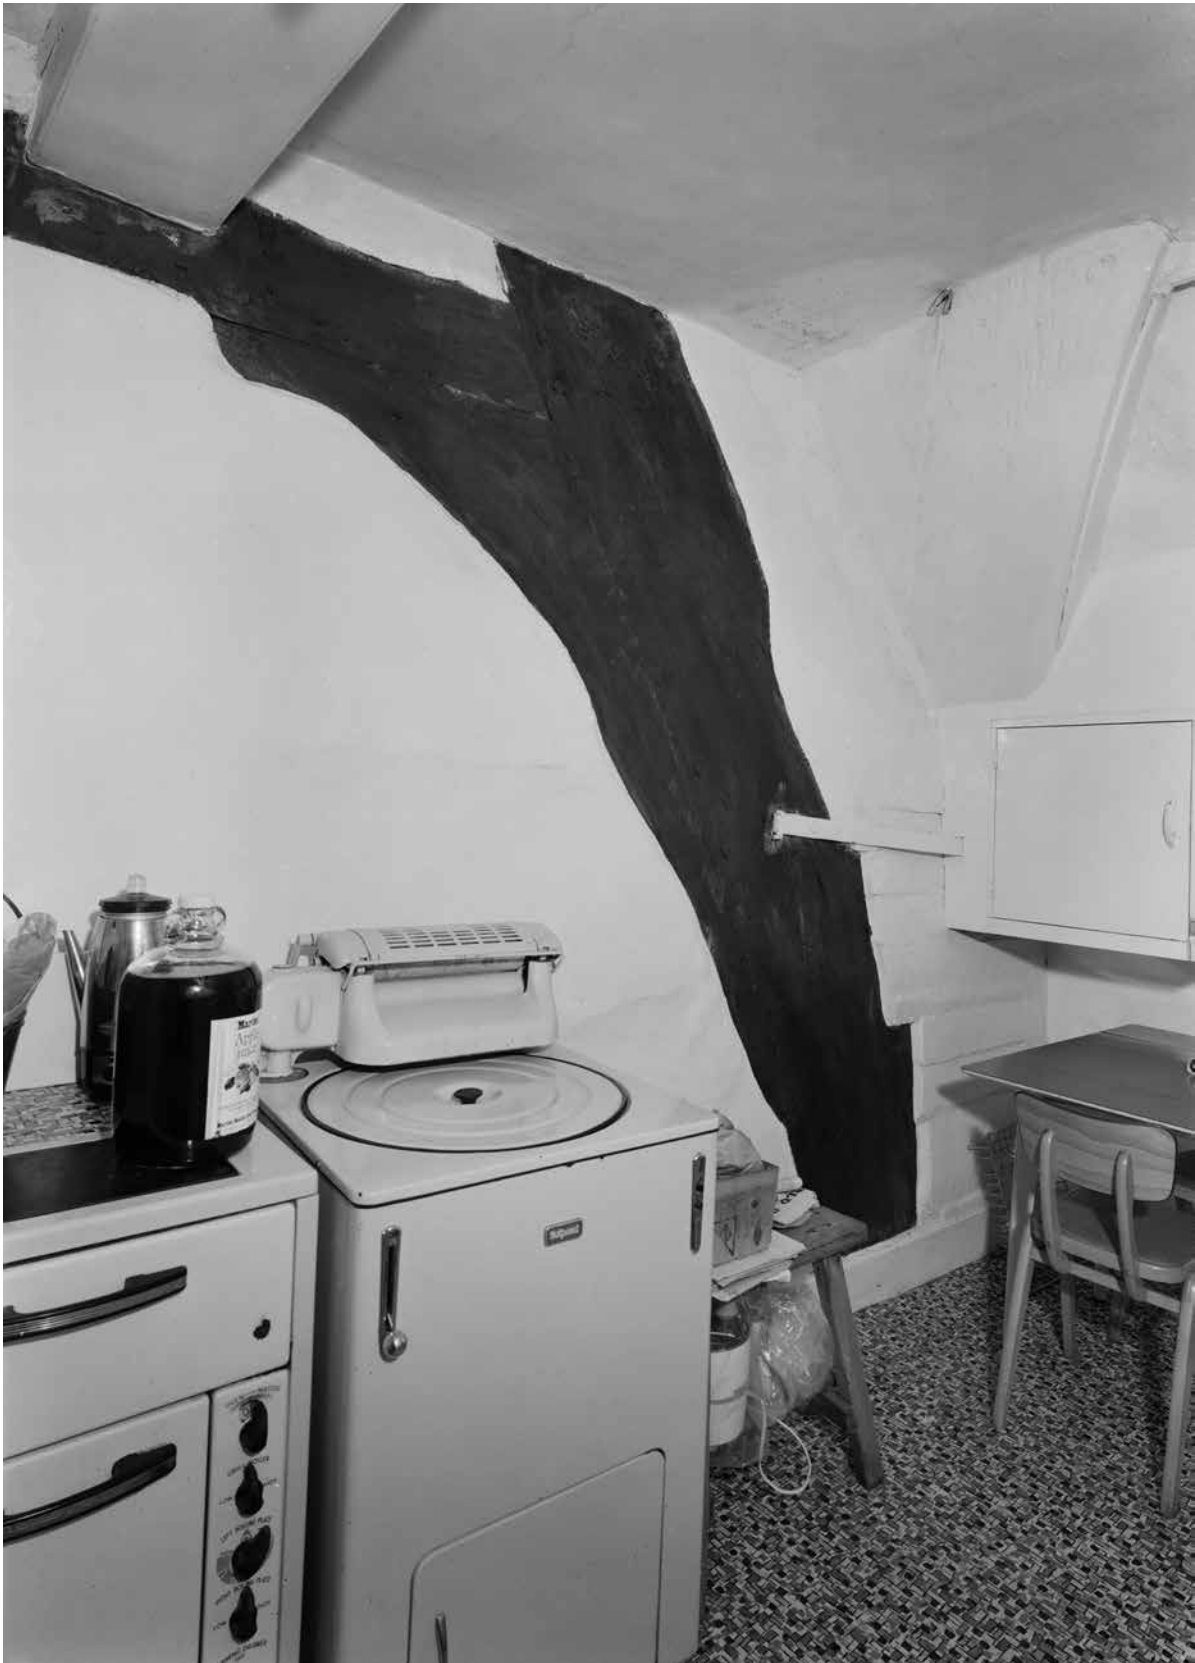
Figure Appendix 3.20: The north side of the west blade of the main range's frame 3, at first-floor level. [© Crown Copyright. Historic England Archive, bb72/00627]

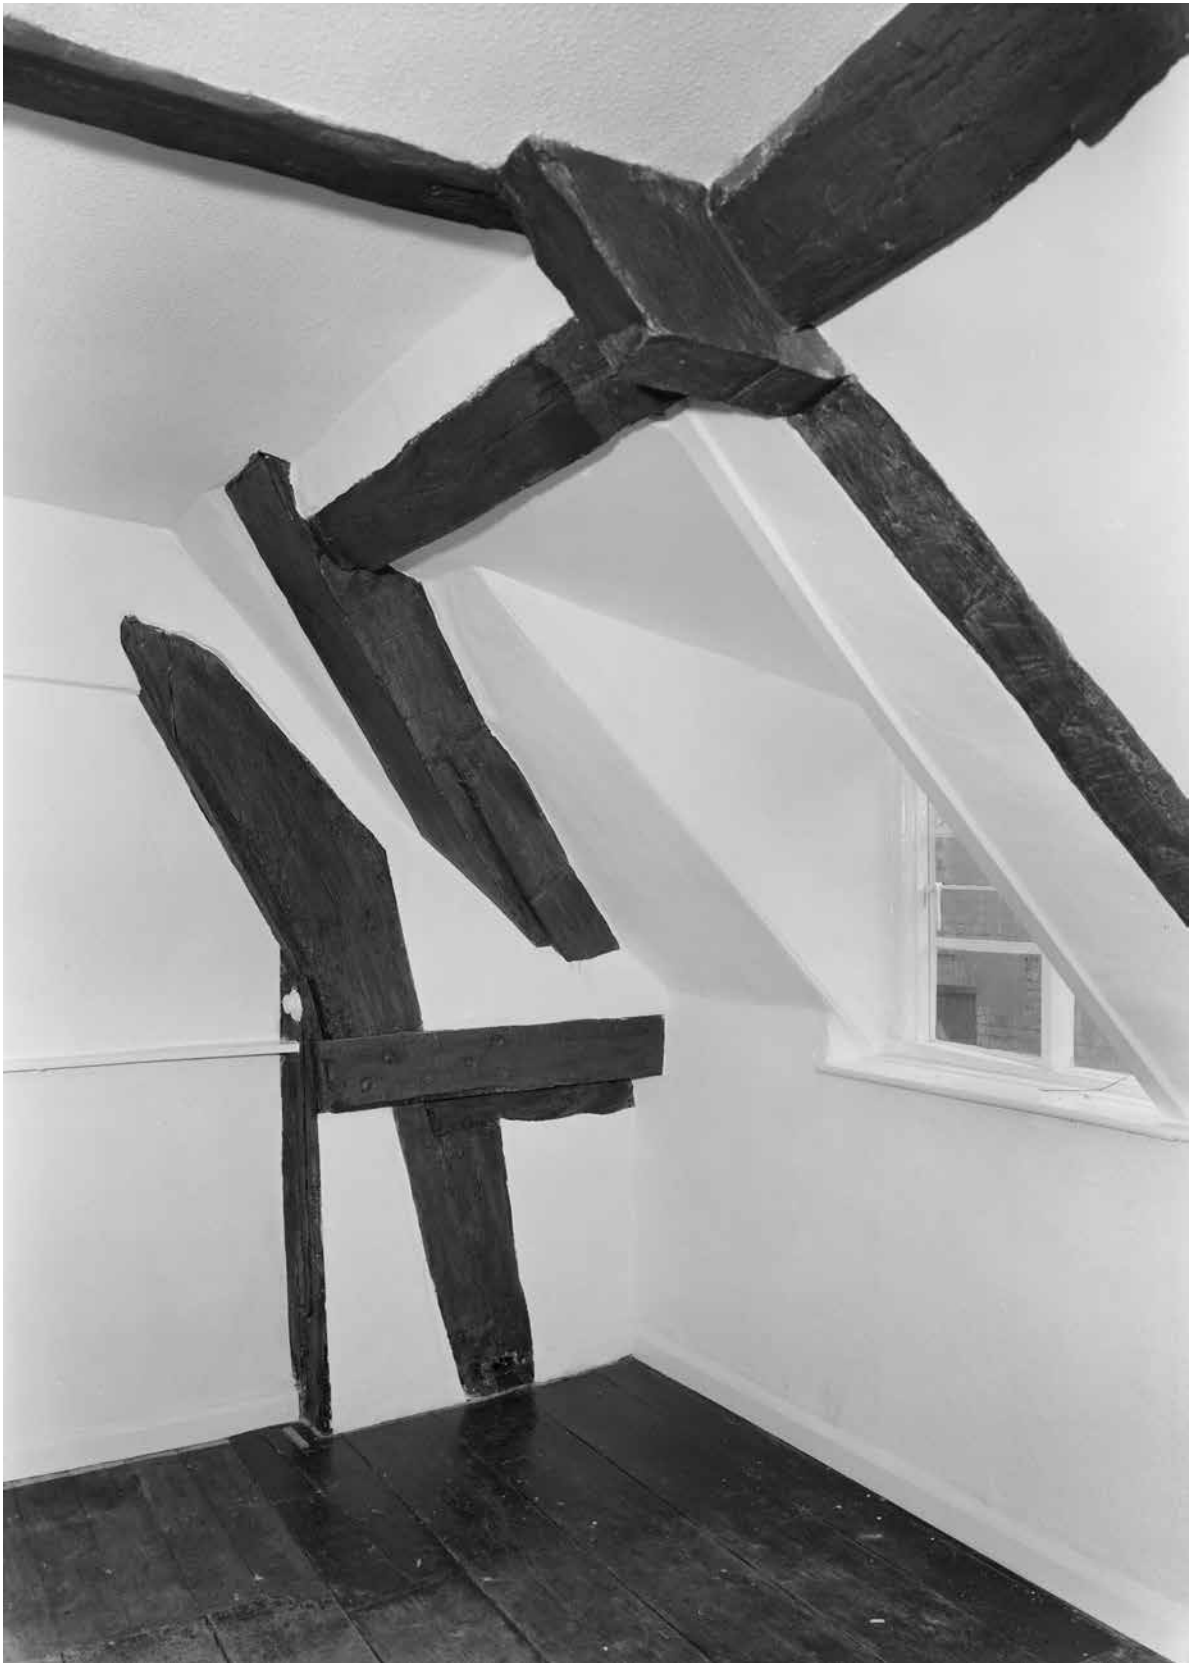
Figure Appendix 3.21: The west side of frames 4 (right) and 5 (left) at first-floor level and looking south. [© Crown Copyright. Historic England Archive, bb72/00624]

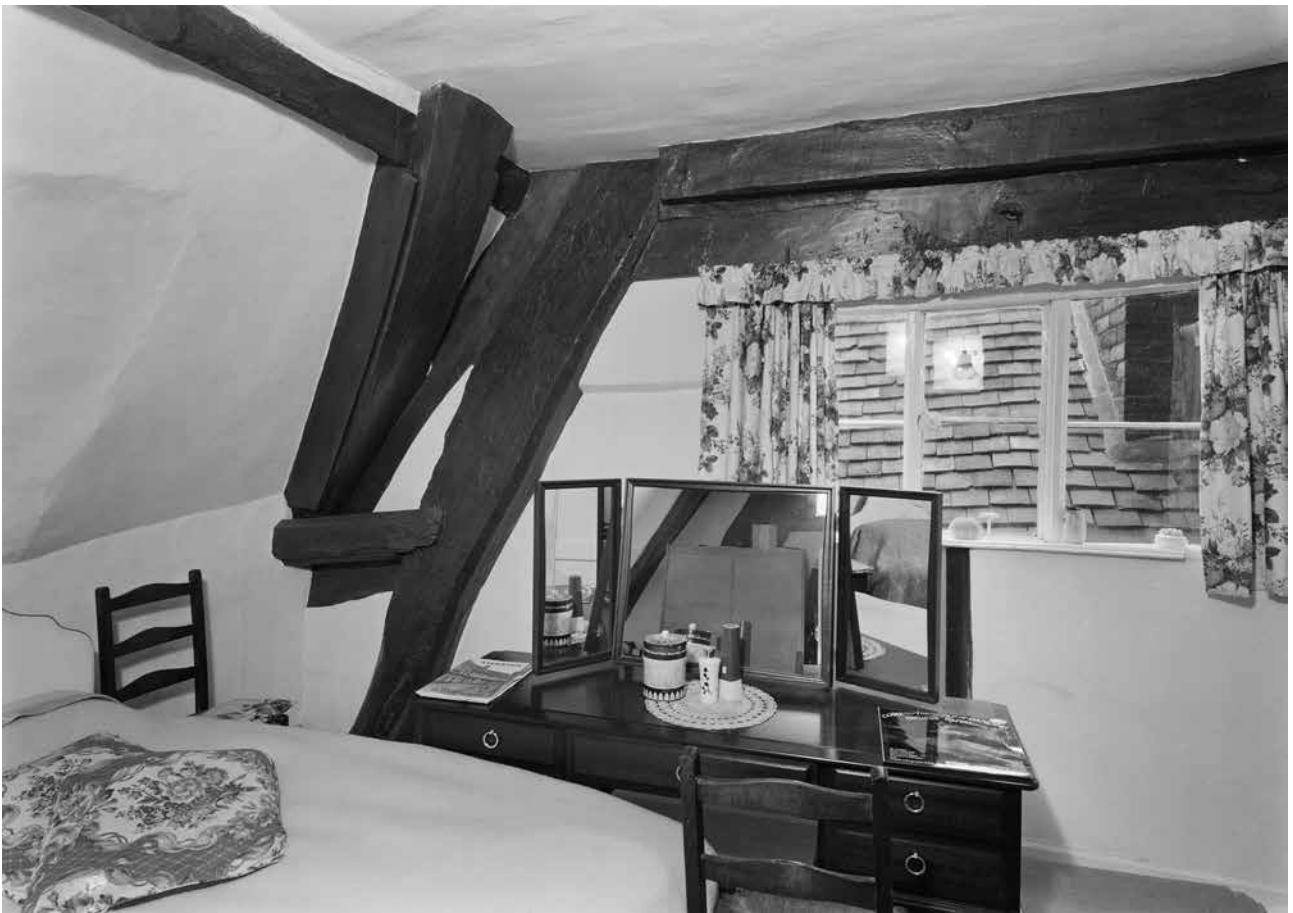
Figure Appendix 3.23: The north side of the east blade of the main range's frame 5, at first-floor level. [© Crown Copyright. Historic England Archive, bb72/00626]

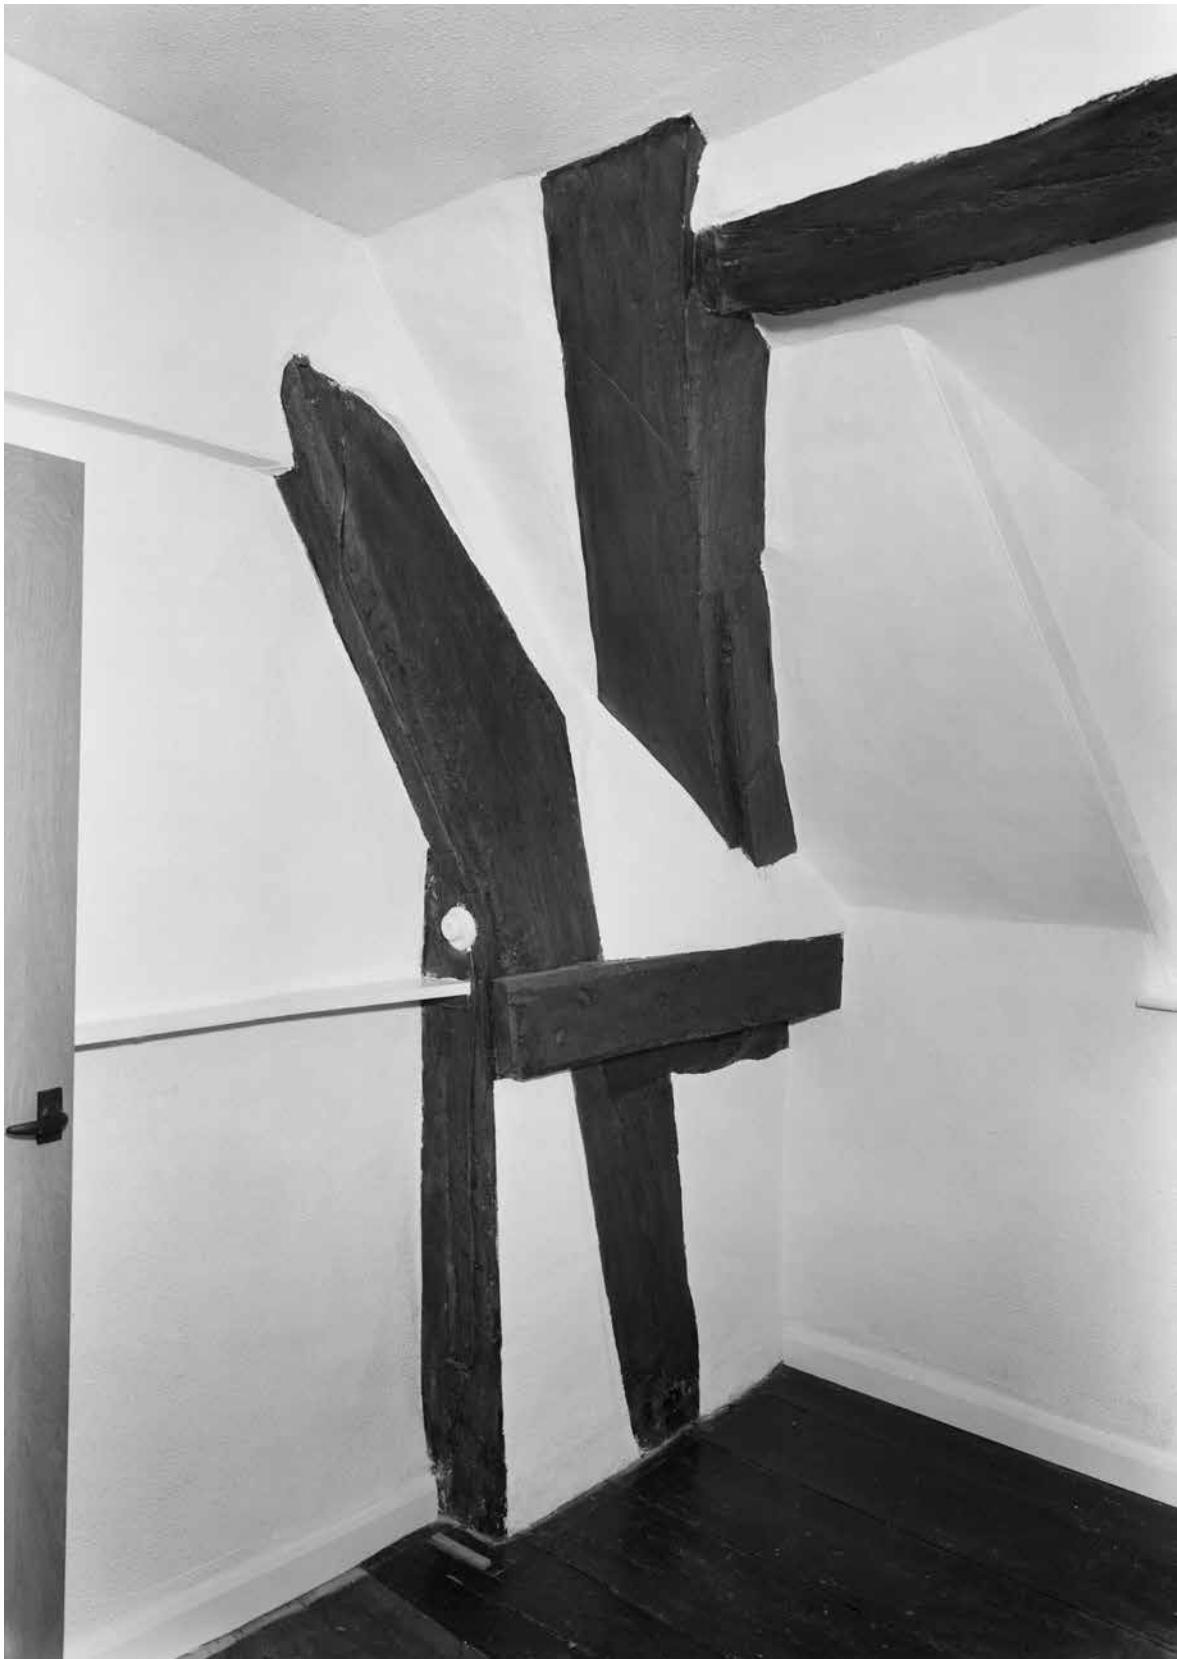
Figure Appendix 3.24: The north side of the west blade of the main range's frame 5, at second-floor level. [© Crown Copyright. Historic England Archive, bb72/00625]
