BELMOUNT HAWKSHEAD, CUMBRIA

Architectural Survey Report

ARCHITECTURAL SURVEY REPORT
NBR INDEX NO. 99130
NGR: SD 3519 9930

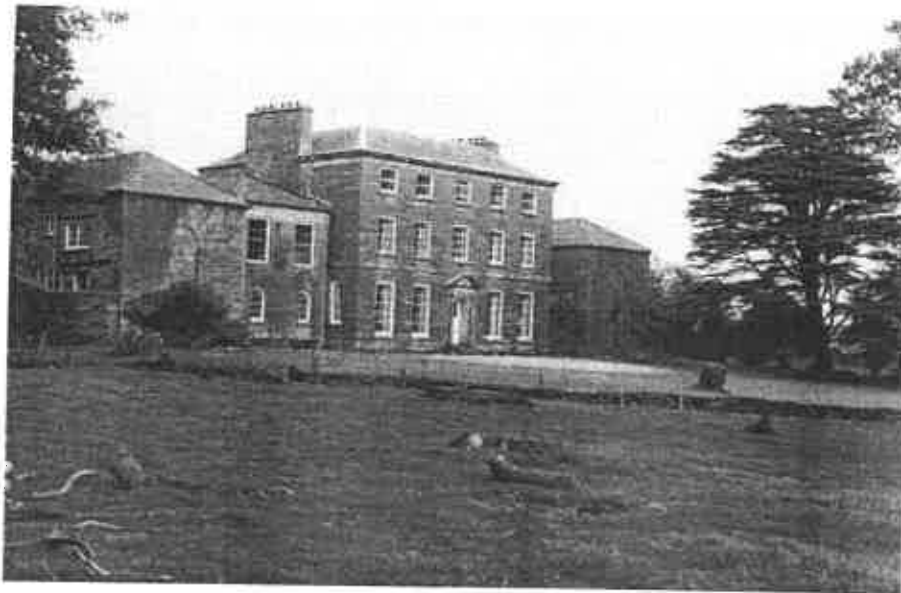
Fig.4 Front elevation of Belmount. (National Trust)

The main block at Belmount, the house, is symmetrical in appearance and has restrained classical detailing (Fig.4). It is built to a double-pile plan with a central

projecting stair bay at the rear, is three storeys high over a basement, and has a hipped slate roof with large grouped chimneystacks in the centre of its east and west side walls. The walls are of local slate rubble with ashlar detailing, the quality of the stonework diminishing round the house as less publicly visible elevations were reached. The front elevation is built of relatively well-squared, coursed slate, as is that part of the west wall in front of the west link block, the area above and behind it being plastered (see below). The rear wall is of poor, roughly-shaped rubble, with some larger quoins at the corners (Fig.5), and the east side wall is of the

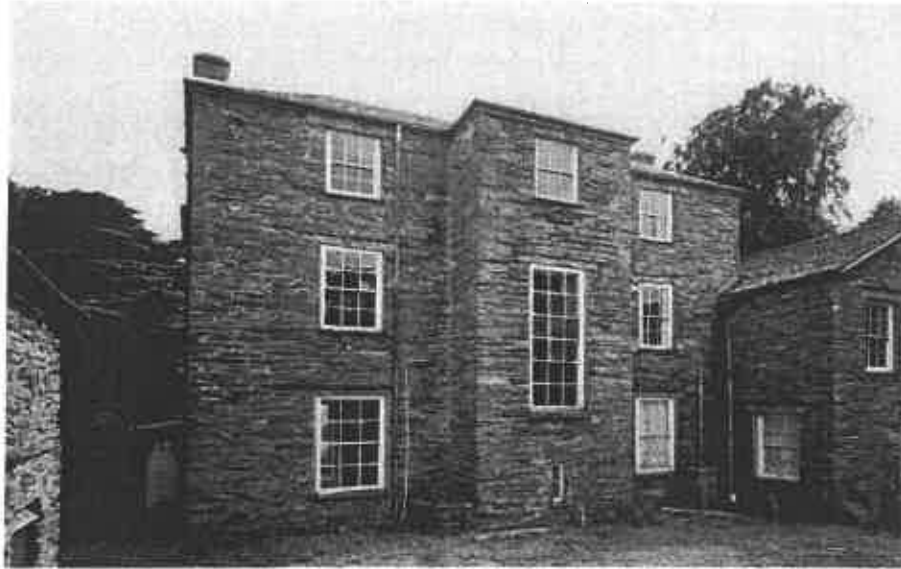
Fig.5 Rear of main block. (NMR: BB007277)

poorest stonework, with occasional projecting throughstones. The front and west return walls were the two walls visible on the approach to the house from the main drive, and the better quality masonry, together with the use of stone arches over the windows, suggests that the stonework was intended to be seen. The poorer-quality stonework on the rear and east side walls bears no traces of having been plastered to protect it from the weather either, and here the windows have timber lintels. However, these walls may have been plastered. Plaster scored to simulate ashlar survives on the west side wall within the heightened first floor of the west link block. The grey of the surviving plaster is similar in tone to the slate, although the scoring into ashlar blocks is at odds with the dimensions of the squared slate stonework. The lack of plaster on the exposed masonry above the roof of the heightened west link block indicates that it has been thoroughly removed here, and shows that it is not possible to know unequivocally whether or not some or all of the other walls were plastered. If the front elevation was included in this treatment, despite its squared stonework, then the stone arches over the windows could be structural, used because of the relatively larger area of glazing in this wall than in any other wall of the main block.

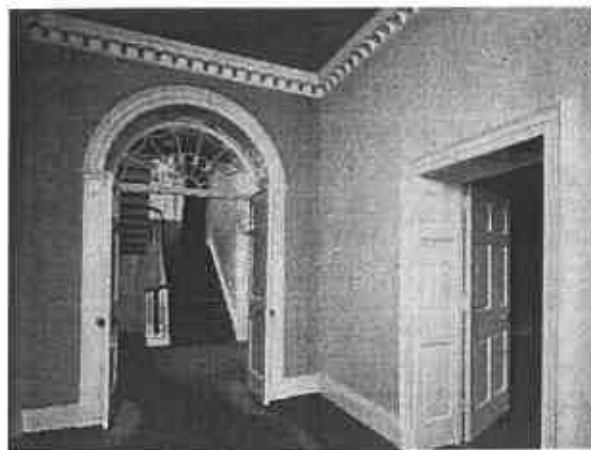
Fig.6 Entrance hall looking through to the main stair hall. (NMR: BB007285)

The entrance hall, which acted purely as a circulation space, has an enriched cornice with acanthus-leaf modillions (Fig.6). Two opposing doorways lead into the front reception rooms. Between the entrance hall and the main stair hall is a wide, round-headed opening incorporating a fanlight with wooden glazing bars. The enriched archivolt on both sides of this fanlight are original, as are the sunk-panelled reveals and soffit, but saw marks to the reveals suggest that the skirting of the entrance hall

originally stopped flush with the opening. The projecting wooden pilasters to the entrance hall, which appear to be applied over the top of the skirting, are likely to be late 20th-century in date, like the double doors which now close what would originally have been an open archway into the stair hall.

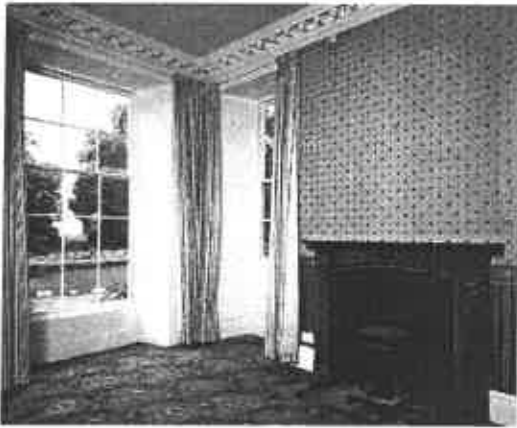
Fig.7 West front room on ground floor, possible drawing room. (NMR: BB007289)

The functions of the ground-floor rooms are unknown, although those at the front of the house, which are larger and more highly decorated than those at the rear, are likely to have been the dining and drawing rooms. The smaller west room, with its windows overlooking both the drive and the prospect from the house, may have been the drawing room (Fig.7), the larger east room being used for dining (Fig.8).

The west front room has an enriched modillioned cornice (Fig.10). The narrower walk-in window in the west wall is unaltered but the two windows in the front elevation were deepened in the early 19th century. All three windows retain their original fielded-panel reveals and soffits and the west window is also panelled beneath the window. Both the window and door architraves are early 19th-century replacements: the doorway from the entrance hall has the more elaborate original architrave to the front, while the doorway opening onto the back stair hall has the simpler quarter-round architrave to its exterior. This room also has a mid 19th-century marble chimneypiece, probably replacing one of the original timber ones noted above.

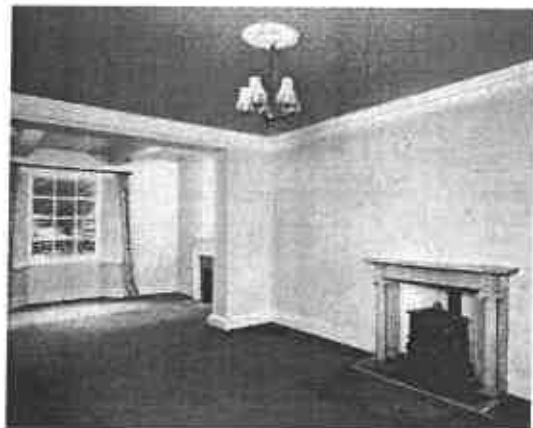
Fig.8 East front room on ground floor, possible dining room, looking through to east rear room. (NMR: BB007286)

The east front room, which has an enriched cornice (Fig.9), is the largest room on the ground floor. It was originally reached from both the entrance hall and the main stair hall, but the latter doorway is now blocked. Only the doorway off the entrance hall retains its original architrave, which is identical on both sides. The room is lit by two windows in the front wall which were deepened in the early 19th century; both have lost their shutters but retain the original fielded-panels to the soffits. The fireplace in the centre of the east wall has lost its original chimneypiece, replaced by a mid 19th-century marble one, but one of the two timber chimneypieces presently stored in the west wing is likely to have been original to this room.⁵¹ Both timber fireplaces are of similar dimensions to the original timber chimneypiece in the east

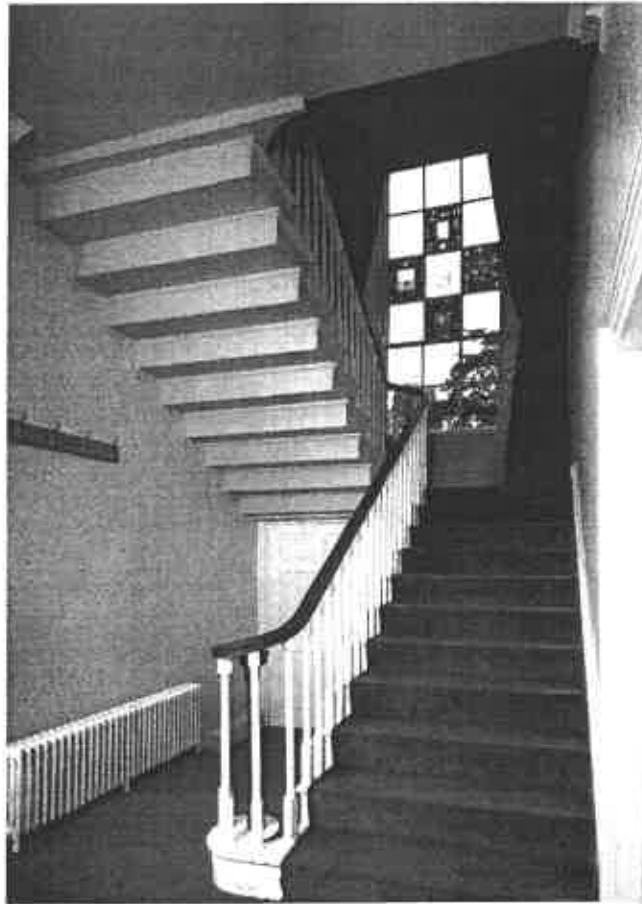
Fig.12 Main staircase to rear of the entrance hall, rising from the ground floor to the first floor (NMR: BB007291)

The main staircase in the house rises only to the first floor (Fig.12). It is of dog-leg form, its half landing occupying the projecting rear bay, and is lit by a tall stair window. The staircase is of timber and is of false cantilever construction with two column balusters per tread and a swept moulded handrail rising from a heavier

turned newel. Beneath the half-landing, on the ground floor, is a closet which was originally unlit. The ceiling over the ground floor of the main stair hall has a small ceiling rose and the same enriched cornice as the entrance hall, while the first-floor landing has a cornice enriched by acanthus leaf modillions and pellets. The staircase ceiling is decorated with Adamesque plasterwork comprising a central rose, within an oval with an outer border of ribbon bows, floral garlands and drops, and incorporating the busts of a male and a female figure, no doubt of Mr Brathwaite and his wife (Fig.13). The stair window has fielded-panel reveals and soffit; the stained glass in the upper sash was inserted in the mid 19th century.

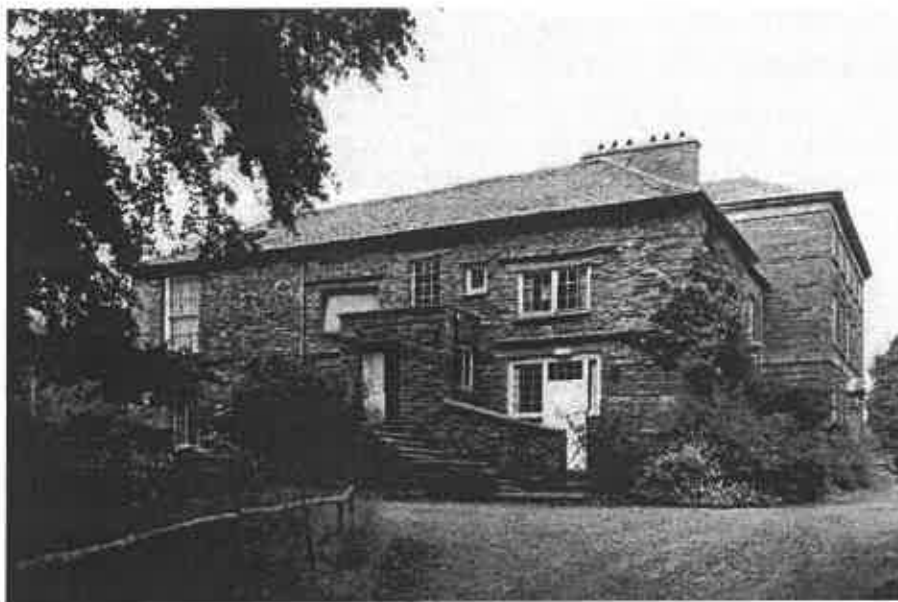
Fig.15 West side elevation of the west wing. (NMR: BB007275)

The west side elevation of the wing has a confused appearance due to the insertion in the mid 19th century of two unequally-sized windows at its north end and the addition of an external porch (Fig.15), the latter not shown on the 1847-48

Ordnance Survey map. At the south end this elevation has two wide windows on the ground floor with two similar windows above them, all with slate sills and heavy roughly-squared timber lintels under slate drip courses, with a taller stair window between. The first-floor south window retains a Yorkshire sash frame, which may be original; the frames in the other windows have been replaced. The ground-floor south window has had a doorway cut through part of it, some slates on the north side of the doorway cut with a stone-saw, indicating that it was originally just a window. There is no evidence to confirm whether there was originally an external doorway in this wall. The rear, north, wall has three slit vents at first-floor level and four square nesting holes with slate perching ledges above them, close to the wallhead. It is unclear whether this wall originally had a window because that on the ground-floor appears inserted, while blocking indicates that what is now a

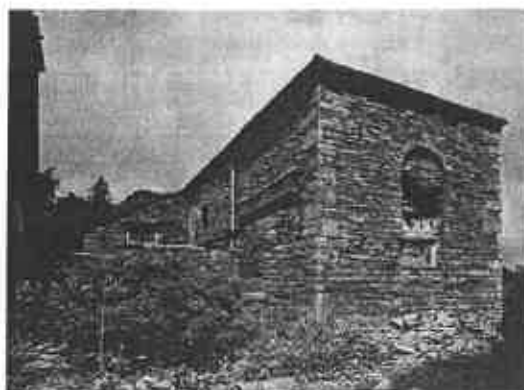
*Fig.16 Front elevation of the east wing.
(NMR: BB007280)*

The two-storey east wing, one bay wide and an irregular rectangle in plan, is built of slate rubble which is more regularly coursed across the single-bay front elevation than elsewhere. It has substantial quoins at all corners and a hipped, slate roof. The front elevation, built to mirror that of the west wing, has a tall, blind, round-headed recess which has an inserted window at its base and has now also lost much of its rubble facing (Fig.16). The head of the recess has rubble voussoirs, every other opening in the wing, apart

from a late garage door, having a timber lintel under a slate drip course.

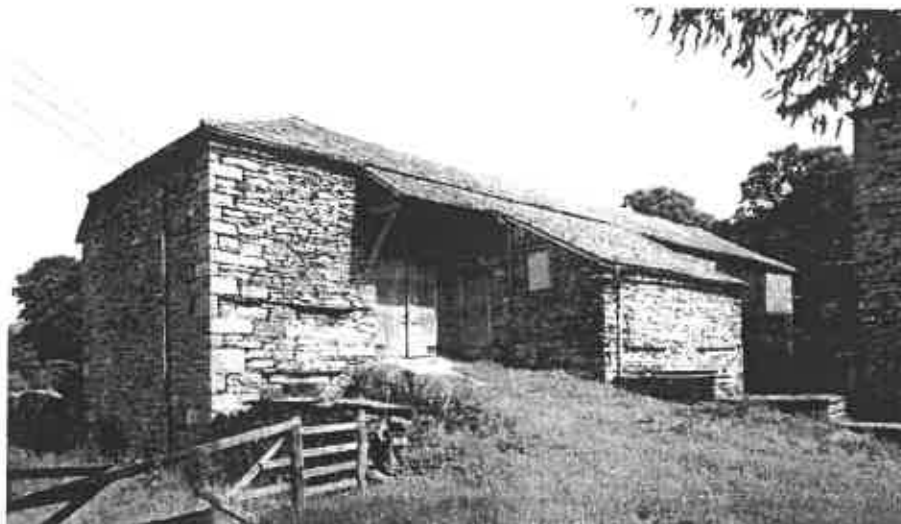
*Fig.17 West elevation of east wing showing ramp to first-floor threshing barn.
(NMR: BB007282)*

The east wing was built as a bank barn, in origin a type of farm building which combined a conventional threshing barn, approached by a ramp, at an upper level with rooms such as cartsheds, stables, cow-byres and loose boxes at a lower level (Fig.17). Bank barns were built on farms, particularly in Cumbria and certain other

upland areas, to take advantage of sloping land which allowed for compactness and economical combining of a variety of uses.⁵⁶ The incorporation of one in the formal layout of a small country house, where it served domestic as well as agricultural purposes within the constraints of a polite front elevation, is of particular interest. The ground floor of the narrower south part of the east wing appears originally to have contained, from south to north, a tack room, coach house and an open carriageway, with in succession a store, cartshed and byre in the wider north part. Overall there was a threshing barn reached from a ramp which rose up to the wide door close to the north end of the west wall. Bank barns were usually built either along the slope or at right angles to it, but at Belmont the site was almost level, and the versatility which this offered was exploited to the full. The rooms in the south part of the ground floor, whose use was related to the domestic life of the house, opened from the side facing it, whereas the northern rooms, the store excepted, which served the agricultural needs of the estate, opened from the side away from the house. The ramp up to the barn was, however, for convenience of access, towards the house.

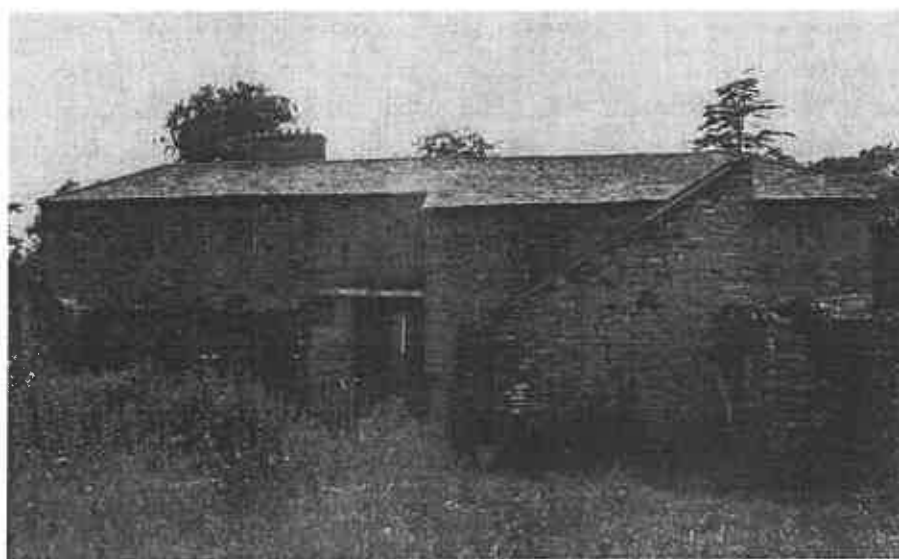
Fig.18 The east elevation of the east wing showing slit and square vents in the barn wall. (NMR: MF 000223/20)

The barn which occupies the whole of the first floor of the east wing has a threshing floor close to its north end with a wide west door and an opposing narrow winnowing door. The west door, approached by an external ramp, has renewed double doors which open outwards and is protected by a canopy with an original braced timber support surviving on its north side but not on the south where it has been lost to an extension. The older ledge and batten winnowing door opens inwards, the opening being precariously high above the level of the yard outside. The walls of the barn have a mixture of slit and square vents (Fig.18), and the roof

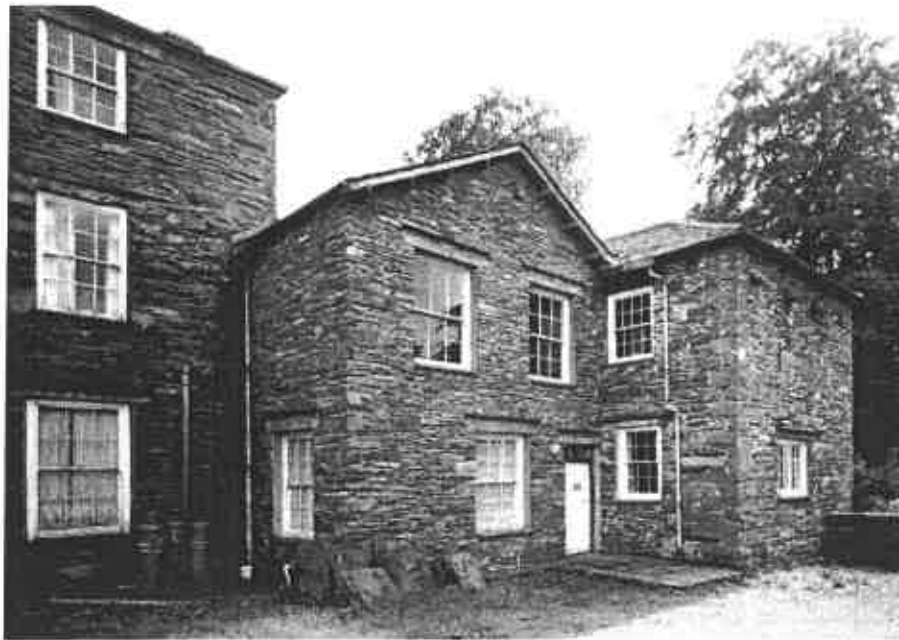
*Fig.19 Extended west link block projecting beyond the rear of the main block.
(NMR: BB007278)*

The alterations to the west link block involved raising it to two storeys and doubling its depth to beyond the rear of the original house (Fig.19). It clearly butts against

the rear of the main block, and at first-floor level its slate rubble wall butts against the east side wall of the original west wing, a doorway obscuring the junction at ground-floor level. The front elevation of the link block is now rendered, obscuring evidence of the heightening and it has a modern roof, hipped to the front and gabled to the rear. The two small-paned sash windows on the first floor of the front elevation have thin, square-cut stone sills, and horned hung-sash frames with thin glazing bars. The rear elevation has a centrally-placed ground-floor window with a doorway on the west side, and two first-floor windows. The single ground-floor window in the east side return wall must be an insertion because there was once a single-storey lean-to built against the wall. The lean-to appears to be shown on the 1888 Ordnance Survey map, and is also present on the 1979 plan (Fig.28), although it was not there when the National Trust photographed Belmont in 1985.⁵⁷ All the windows in the rear and east side walls have small-pane, horned hung-sashes with thin glazing bars, slate sills and drip courses above squared timber lintels. Slates have been nailed over the lintels to protect them from the weather, and the slate sills to the ground-floor windows are thicker than those above, and are cut with a chamfer.

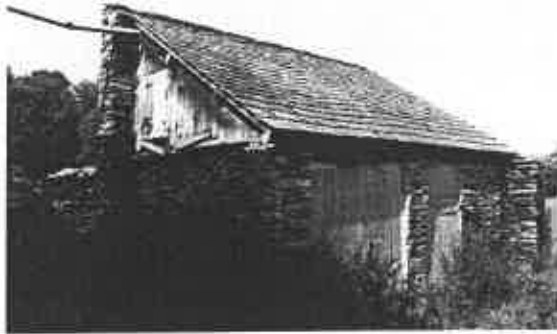
*Fig.22 The combined coach house and cart shed built to the east of the east wing.
(NMR: MF000223/19)*

The coach house and cartshed displaced from the east wing appear to have been replaced by a new free-standing building, erected east of the east wing, which is shown on the 1847-8 map (Fig.22). Its front elevation is in line with the northern edge of the carriageway through the wing through which the coaches passed. The

combined coach house and cartshed, of unconventional form, is a rectangular, single-storeyed structure built of coursed slate rubble. It has a single-pitch slate roof which descends from the tall rear north wall to the lower, two-bay wide front elevation which has a square pier at its west end, another in the centre, and timber lintels over the two bays. The wider east bay may originally have been the coach house, perhaps divided from the west bay by a partition which has since been lost since the west wall of the building originally appears to have been open, in contrast to the east wall (Fig.23). The roof is carried on two trusses, in the centre and at the
