Tonedale Mill and Tone Works, Wellington, Somerset: an archaeological landscape assessment of the water management system

**TONEDALE MILL AND TONE WORKS,
WELLINGTON, SOMERSET**

**An archaeological landscape assessment of the water
management system**

2024

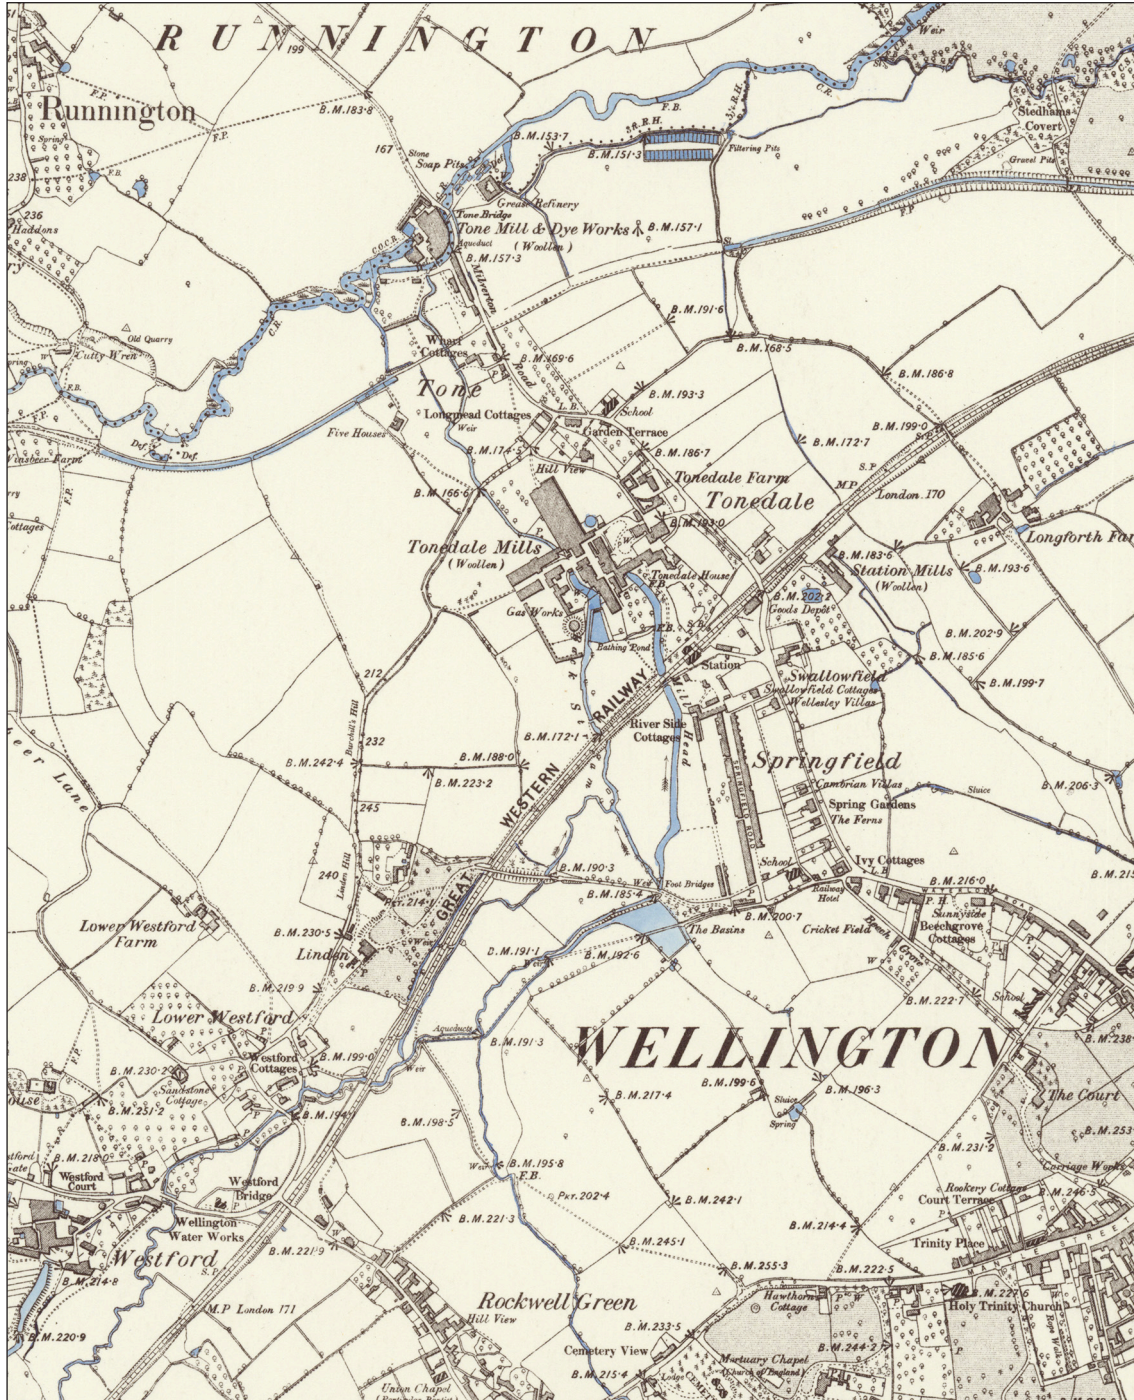
Figure 3: Extract from the 6-inch OS map of 1888 showing the full study area, with the waterways helpfully coloured in blue. Not reproduced at scale. [Somerset. Sheet LXXVIII. NE. Surveyed: 1887, Published: 1888. Reproduced with the permission of the National Library of Scotland]

The business, along with its buildings and water management infrastructure, continued to expand throughout the 19th century (Fig. 3). During the Boer War (1899-1902), the company made khaki cloth for military uniforms, receiving an order for 1.5 million yards, to be made at a rate of 4,000 yards a week to meet the War Office need for new inconspicuous uniforms. They also became well known for producing puttees, cloth bindings worn on soldiers' lower legs for weather protection and to prevent debris and mud entering short boots. They supplied 70,000 pairs a week to the army in the 1914-18 war (Thorne 1972, 29-30).

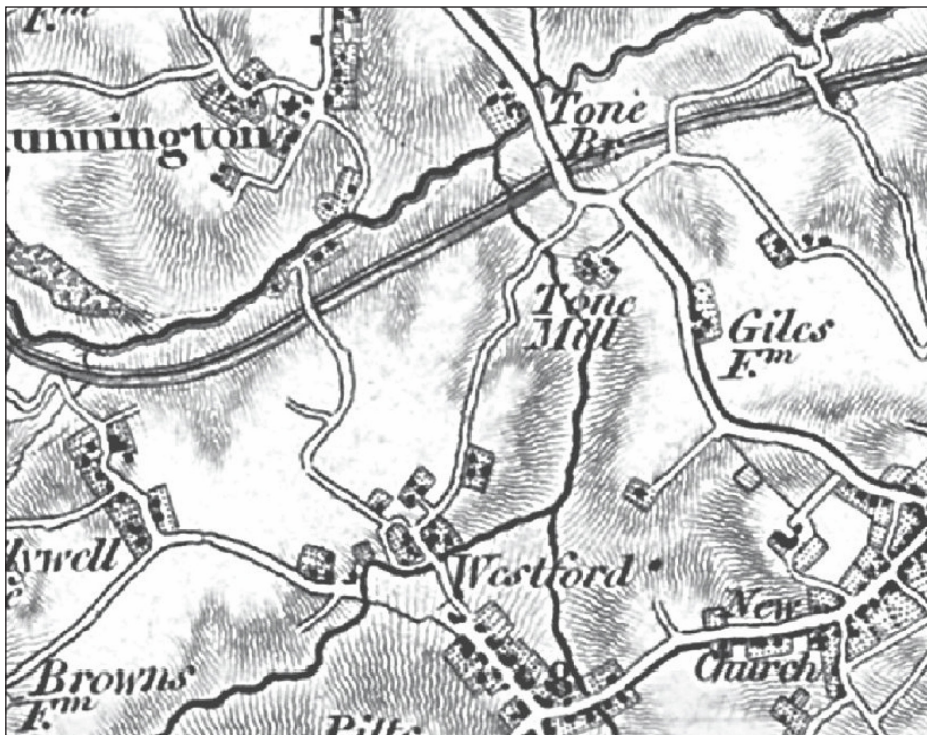
Figure 6: Extract from OS 1-inch map (1809-1820) showing 'Tone Mill' and watercourses leading northwards to it. Note this map version is an official OS revision of the original, modified to include the route of the Grand Western Canal. Not reproduced at scale. [© and database right Crown Copyright and Landmark Information Group Ltd (All rights reserved 2023). Licence numbers 000394 and TP0024]

The Ordnance Survey (OS) 1-inch drawings for Wellington, published in 1802 and surveyed prior to the completion of Thomas Fox's work on the mill, provide the earliest map evidence for the watercourses at Tonedale (Fig. 6). The Westford Stream and Rockwell Green Stream are shown converging south of 'Tone Mill', however, the amount of detail they include is limited by their depiction scale. No leat leading to the mill is shown, nor any tailrace exiting from it.

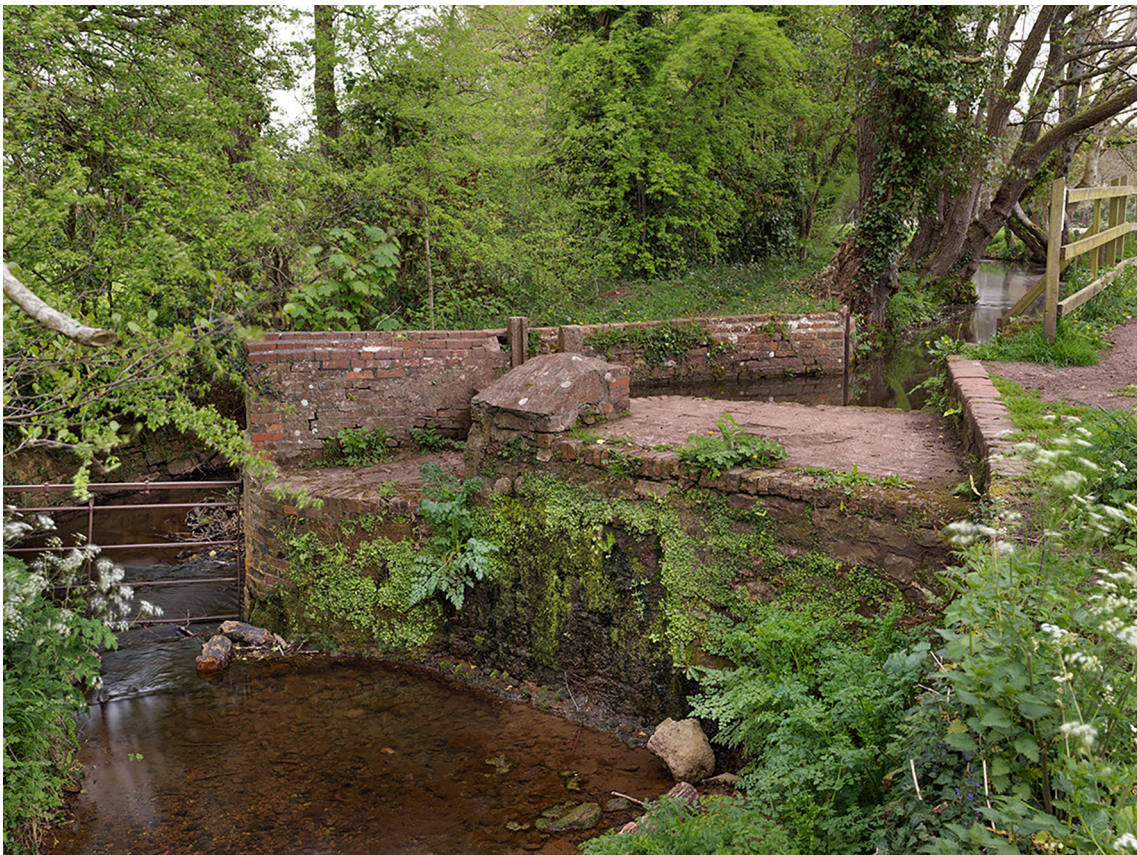
Figure 11: The Waterfall Weir [25], looking east, April 2022 [James O. Davies © Historic England Archive, DP347739]

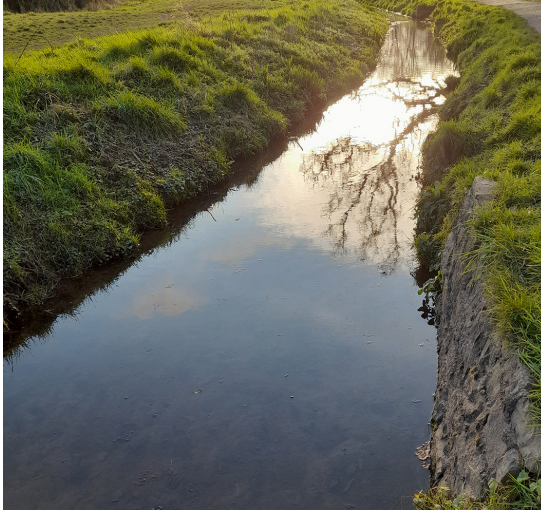
Figure 12: Leat [10], which leads to the Waterfall Weir, looking south-west away from the weir, January 2022 [Nicky Smith © Historic England]

It may have been at this time that the Basins' supply leat was altered to its present layout, a change which occurred at some stage between 1839 and 1888. The narrow channel [22] on the tithe map was replaced by a new leat [10] south of the stream (as mentioned above). A sluice [9] at its entrance could be opened to allow water to be sent along the channel when the Basins were filling. Alternatively, when the Basins were emptying, water could be directed to flow through the parallel continuation of the Westford Stream [19], which had a double sluice [17] at its entrance. The new leat [10] had to cross the Rockwell Green Stream but, according to local sources, Thomas Fox did not have the legal right to stop the flow of water from the Rockwell Green Stream. This problem was solved by sinking an old ship's boiler to carry the leat beneath it (Thorne 1973, 71). The leat [10] passes through the boiler or 'siphon' [13] and re-emerges on the other side of the Rockwell Green Stream. It then rejoins the original system at the Waterfall Weir [25], thus by-passing a loop in the meandering course of the Rockwell Green Stream (Fig. 12).

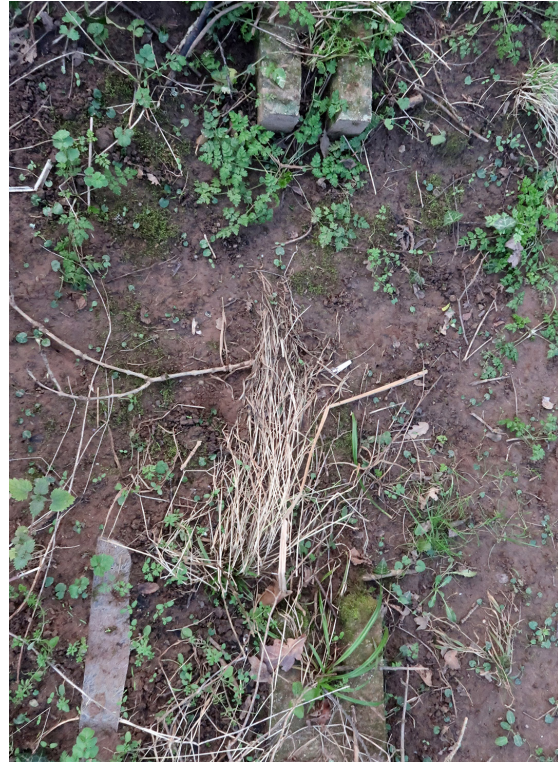
Figure 13: The buried remains of a sluice gate [20] on the Westford Stream at its confluence with the Rockwell Green Stream, January 2022 [Johanna Roethe © Historic England]

A watercourse [19] which serves as a continuation of the Westford Stream joins the Rockwell Green Stream immediately north of the siphon [13], at which point the embedded remains of a concrete sluice gate [20] were noted during field examination in January 2022 (Fig. 13). This sluice would have controlled the flow

of water from the watercourse into the Rockwell Green Stream, allowing it to be contained when stream levels were low. Feature 19 survives as a dry channel today, following flood alleviation work upstream (*see* 3.2.3 below). Today a reduced flow of water enters the siphon from a brick channel taken off a modern sluice [4] on the Rockwell Green Stream (Taunton Deane Borough Council 2006; McCluskey 2022).

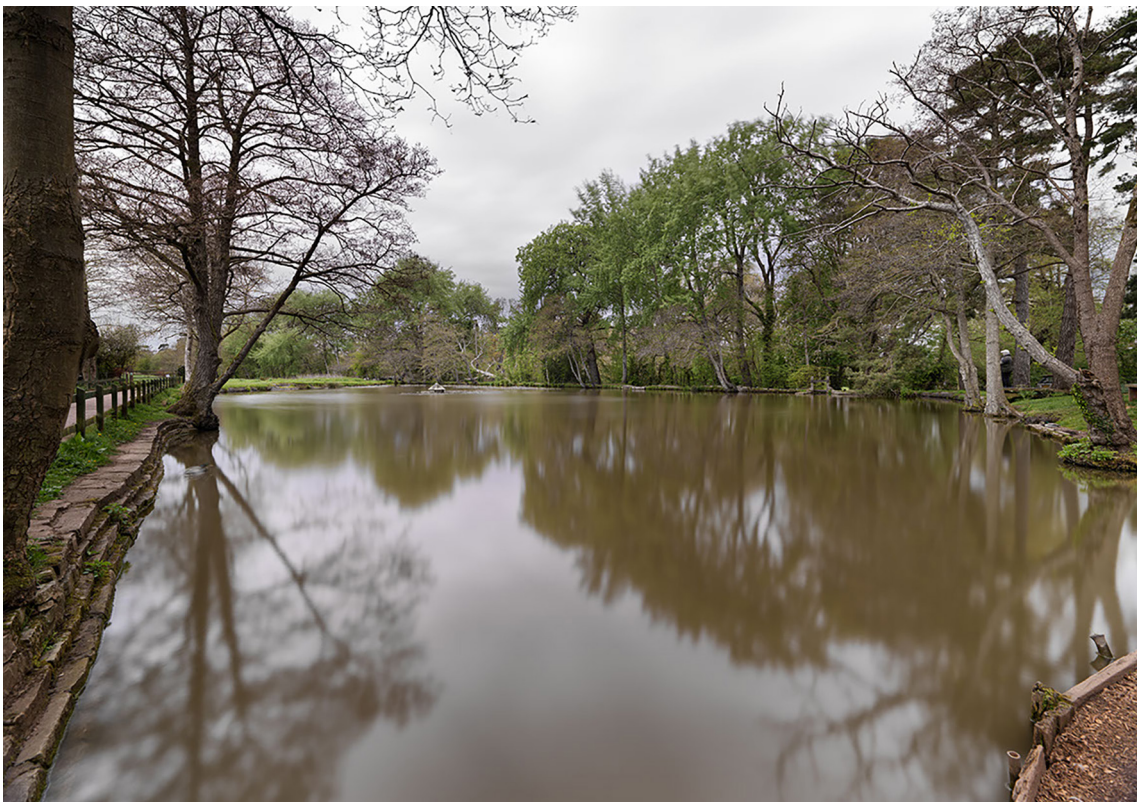
Figure 15: General view of the northern water basin [37], looking west, April 2022 [James O. Davies © Historic England Archive, DP347733]

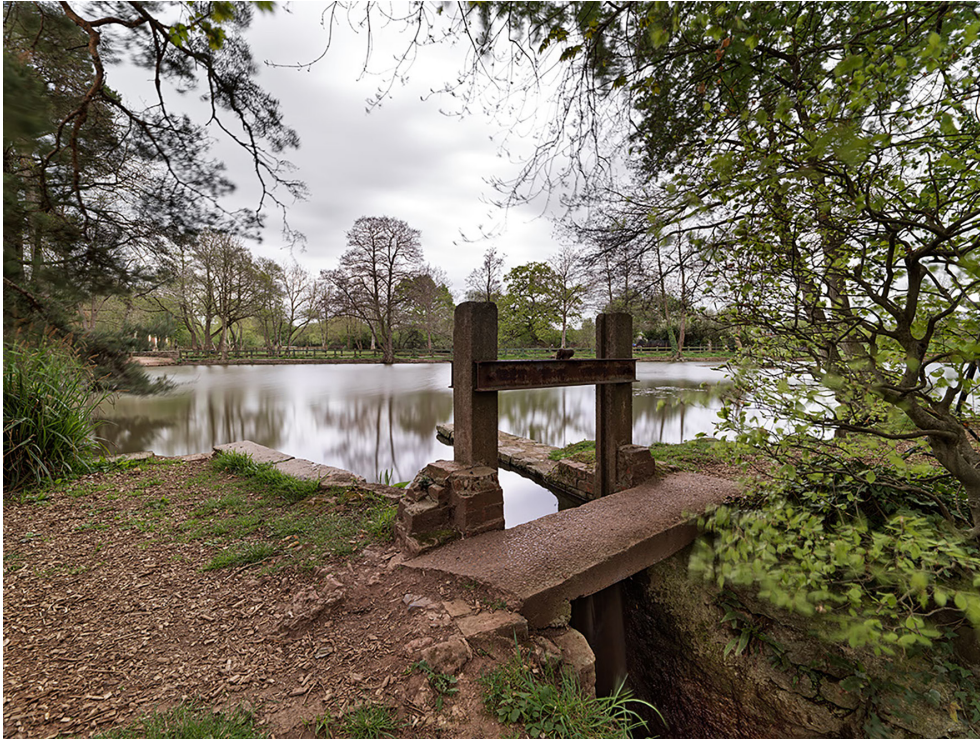
Figure 16: Outflow sluice [36] in the northern water basin, looking south-west, April 2022 [James O. Davies © Historic England Archive, DP347736]

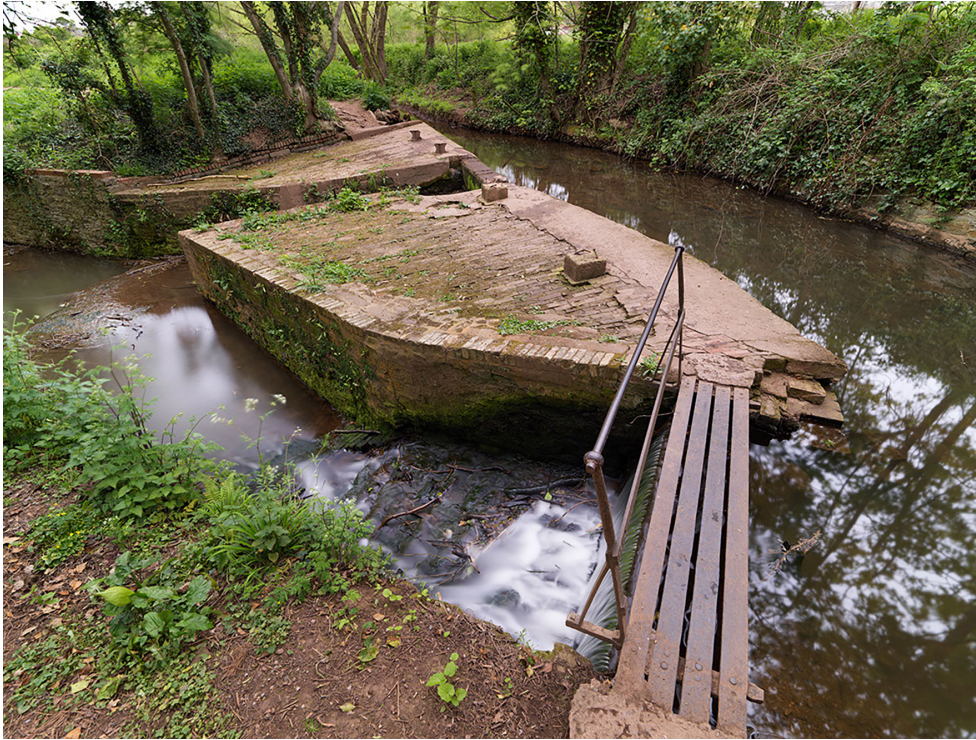
Figure 18: The weir below the Basins [30], with sluice [28] and footbridge [29] in the foreground, looking east, April 2022 [James O. Davies © Historic England Archive, DP347730]

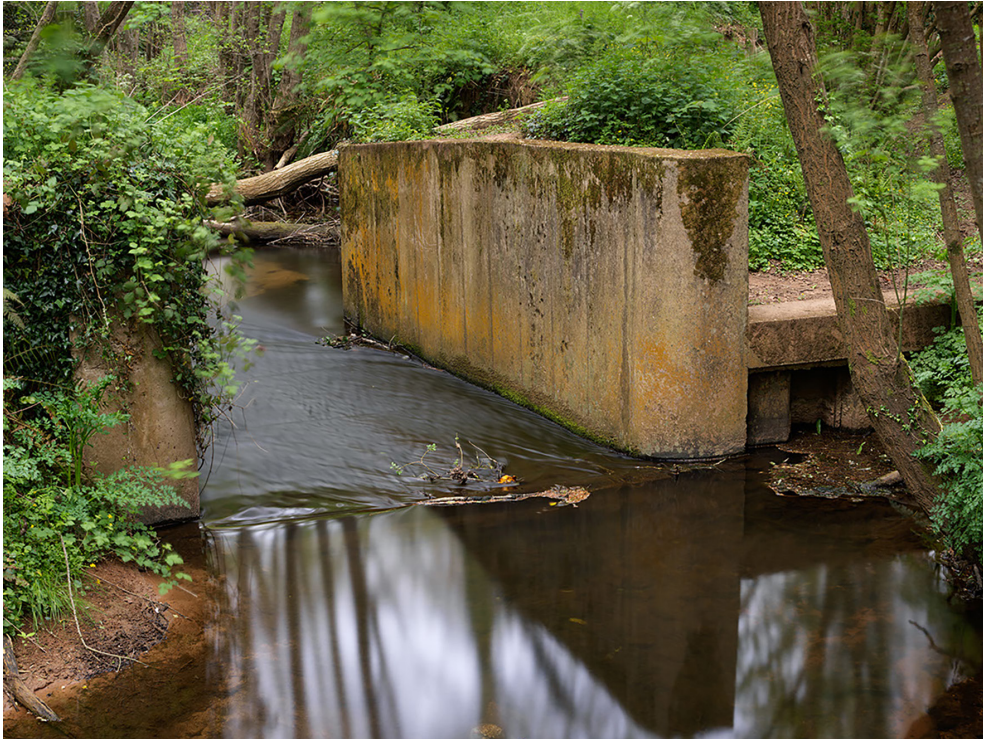
Figure 19: Concrete weir [8] built as part of flood alleviation work in the 1990s, looking north-east, April 2022 [James O. Davies © Historic England Archive, DP347750]

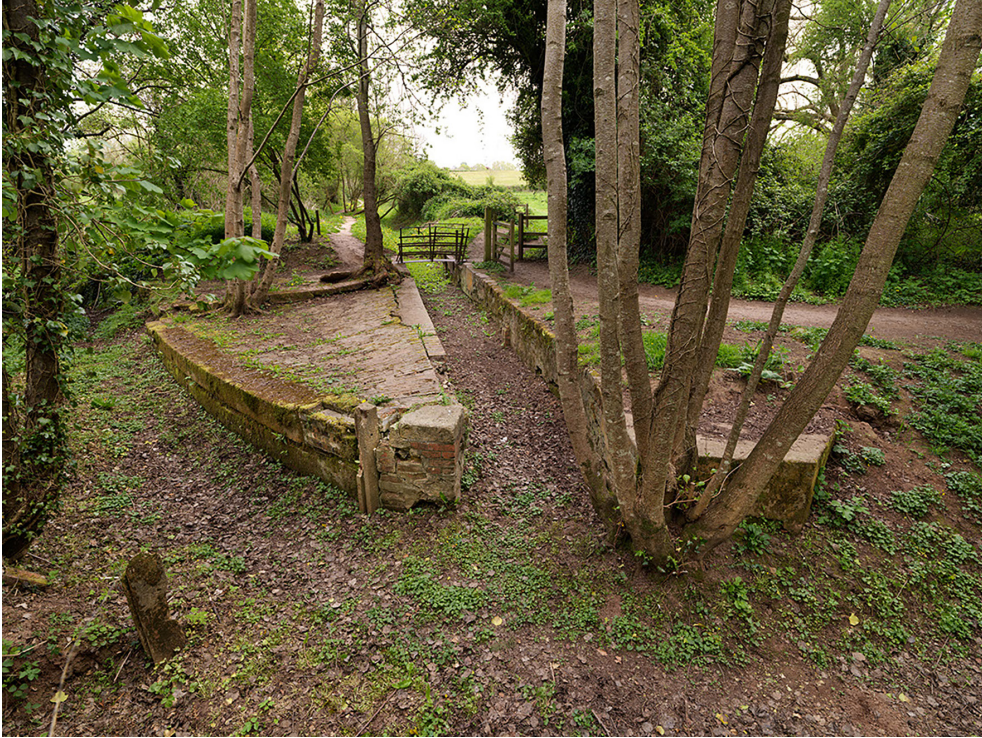
Figure 21: Dry channels [10 (right) and 19 (left)] following the flood alleviation work, looking east, April 2022 [James O. Davies © Historic England Archive, DP347755]

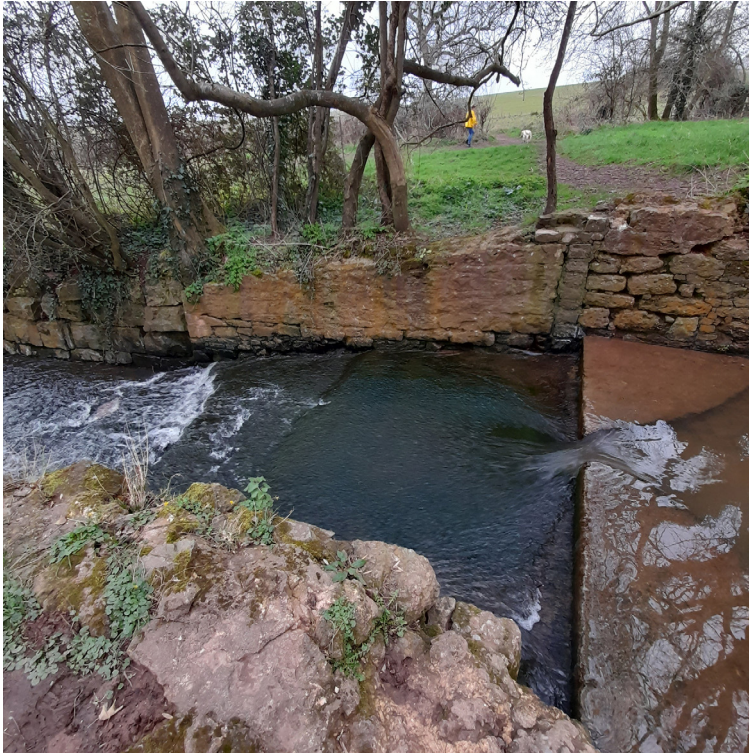
Figure 23: The weir at Oaken Ground [3], looking east, March 2022 [Nicky Smith © Historic England]

Further south, at Oaken Ground, a weir [3] is situated on a sharp double bend in the Rockwell Green Stream. This weir was depicted in detail on the OS Town Plan (1888) (Fig. 22), and the Wellington tithe map shows a head of water at the same location indicating that a weir was already in place here by 1839. Its purpose is uncertain. It may pre-date the Fox Brothers' system, but it has been substantially rebuilt to include a notched concrete section at its head, probably as part of the flood alleviation work, from which water flows down over three broad steps (Fig. 23).

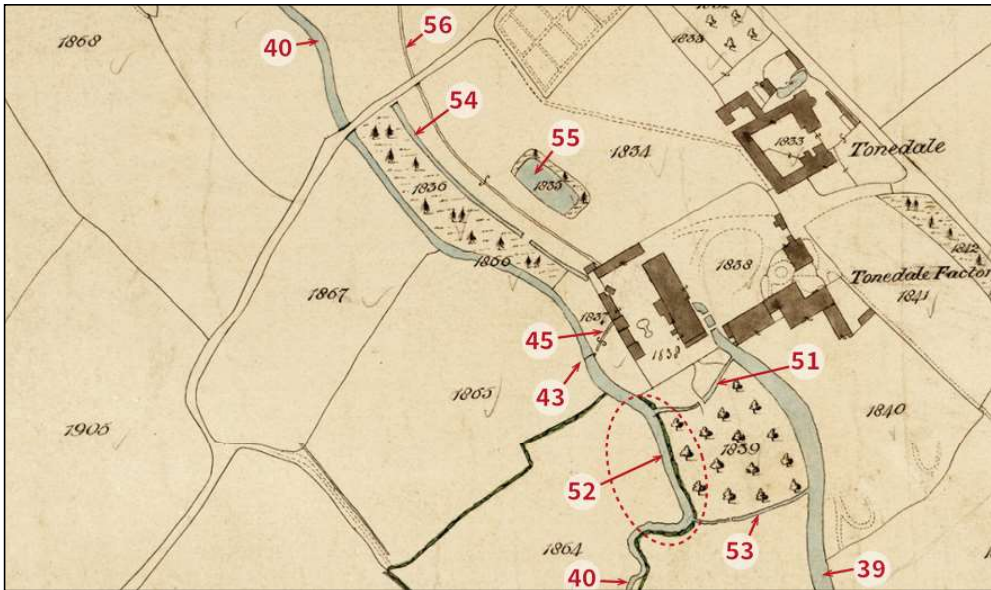
Figure 24: Extract from the 1839 Wellington tithe map, showing Tonedale Mill and its watercourse connections. Not reproduced at scale. [SHC D/D/rt/M/367, accessed via the 'Know Your Place' website, reproduced with kind permission of the South West Heritage Trust]

The Wellington tithe map shows the open channel of the Mill Head [39], wider than the other watercourses, approaching Tonedale Mill from the south and turning sharply to enter the mill's eastern side (Fig. 24). The tailrace channel exited the wheel pit at a lower level; it is shown on the tithe map re-emerging as an open channel [54] at the north-western corner of the building complex and continuing as far as Burchills Hill, from which point it was culverted. Two cross channels to the south of the mill [51 and 53] connect the Mill Head with the Back Stream [40].

After passing through the wheel chamber, the culverted tailrace flowed at a lower level and re-emerged as the westernmost of two channels [54] shown exiting the mill complex's northern boundary on the 1839 tithe map (*see* Figs. 24 and 29). A small building straddled its projected course a short distance south-east of this exit point and followed its alignment, indicating that it used the watercourse. The function of the building is not known, but the OS 1:500 Town Plan shows that it was replaced with new buildings before 1887 (*see* Fig. 25). Both channels [54 and 56] were likely to have been culverted when large weaving sheds were built at the northern edge of the factory complex in the late-19th century.

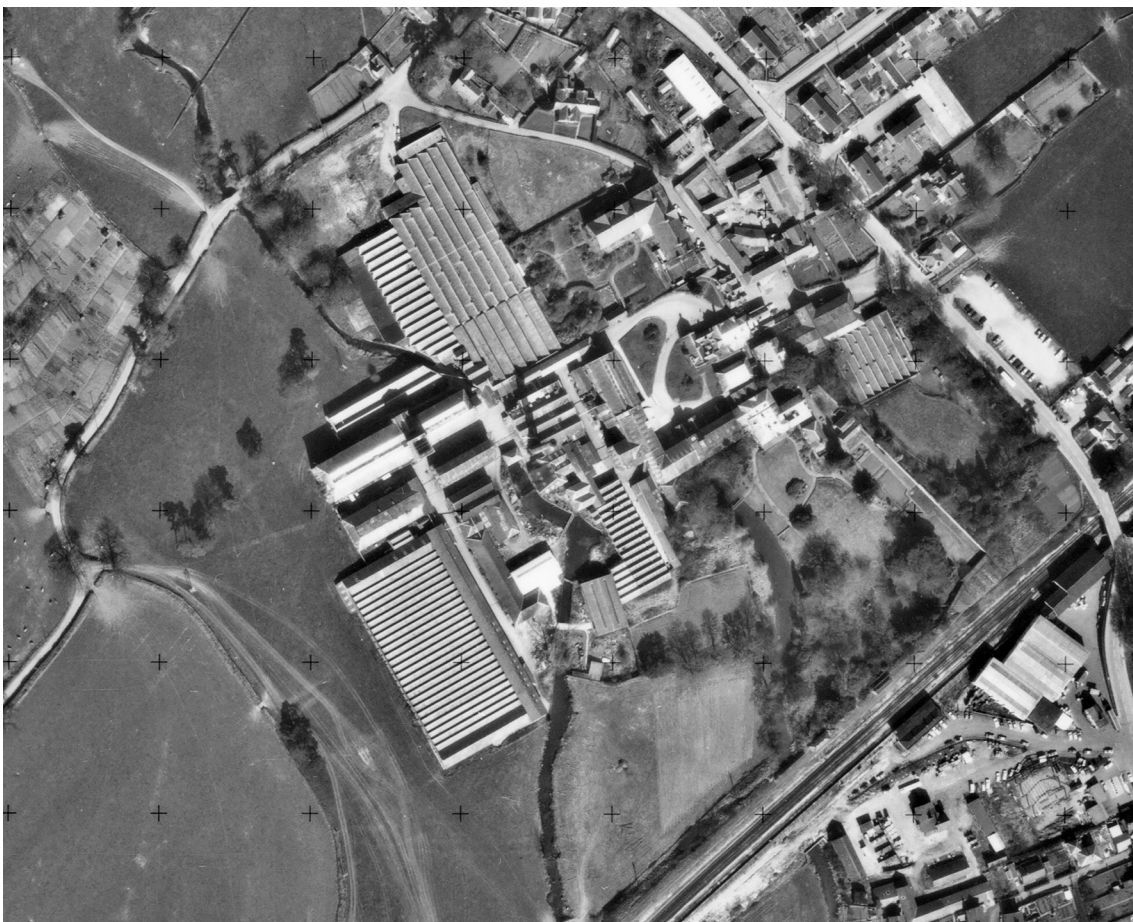
Figure 27: Tonedale Mill in 1973, with north at the top. The course of the Back Stream (left/west) and Mill Head (right/east) can be seen flowing from the south up into the mill complex. Note the purposefully widened stretch of the Mill Head as it passes through the large garden on the south side of Tonedale House. [OS/73039_006 29-MAR-1973 © Crown copyright. Historic England (OS Photography)]

As the factory developed the watercourses shown on the tithe map appear to have been retained and culverted beneath new buildings (Fig. 25). The OS 1:500 Town Plan of 1888 shows detail of the southern cross-channel [53], including a sluice with a footbridge, three weirs across it and its eastern end culverted by this date (Fig. 26). Its most obvious function would have been as an overflow channel for the Mill Head, but it also appears to have been landscaped for aesthetic purposes since it skirts part of the southern boundary of the large garden at the rear (south) of Tonedale House. The Mill Head [39], ponded along the western side of the main part of the garden, also doubled up as an ornamental feature (Figs 27 and 28).

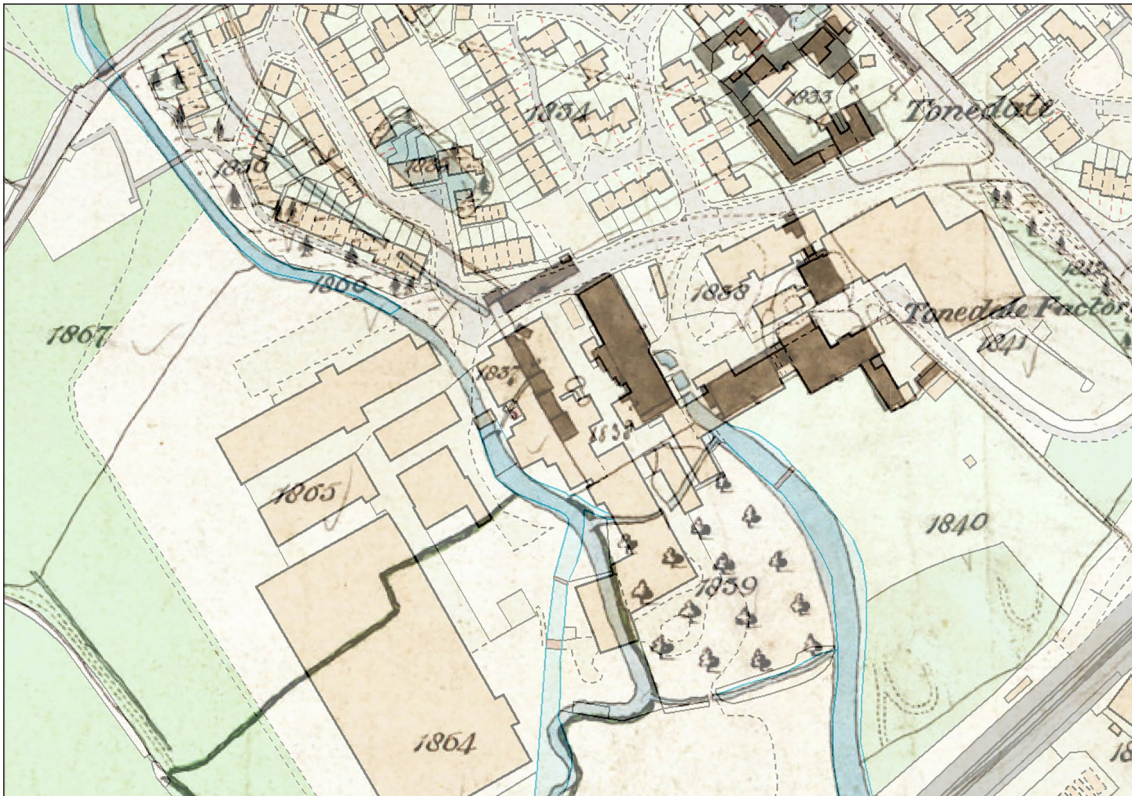
Figure 29: Earlier routes of water features through Tonedale Mill, illustrated by overlaying the 1839 Wellington tithe map on the modern OS Mastermap data. Cross-channel [51] can be seen connecting the two main watercourses immediately south of the early factory buildings. The former distinct bend in the Back Stream [52] (bottom centre) had been straightened by 1888, and most of the other features were culverted as the site developed and expanded. Not reproduced at scale. [Background mapping © Crown Copyright and database right 2023. All rights reserved. Ordnance Survey Licence number 100024900 © Historic England | overlay source: SHC D/D/rt/M/367, accessed via the 'Know Your Place' website, reproduced with kind permission of the South West Heritage Trust]

The northern cross-channel [51] was retained beneath buildings and corresponds with 'culvert B' in the report on the blacksmith's waterwheel (Craven 2007, 4) (*see* Fig. 35). An outlet into the Back Stream coincides precisely with its exit point on the georeferenced tithe map (Fig. 29). This channel probably served as an overflow for discharging water from the Mill Head into the Back Stream, but it may have had additional uses, perhaps providing water for processes or boosting the flow in the Back Stream which powered the blacksmith's waterwheel (*see* below). The channel drops steeply as it enters the east side of the mill (*see* Fig. 4, beneath the south-west end of building B), raising the possibility that there could have been an additional waterwheel.

Upstream from the blacksmith's waterwheel, changes were made to the Back Stream at some point between 1839 and 1888 (*see* Fig. 29). A sharp bend was removed to accommodate a bathing pool [41] (*see* Fig. 25), a valuable amenity for the Fox Brothers' workers, prior to the availability of domestic baths and showers. A probable reference to the pool occurs on 19 June 1877, when the company received a request to allow the 'bathing place' to be used by the residents of the town 'at hours not wanted by our people' (Williams n.d. b). Similar bathing facilities were provided by the Elworthy family in their mill pond at Westford Mill. The 1:2500 OS map sequence shows that the bathing pool at Tonedale Mill was filled in at some stage between 1930 and 1964. Its site was covered by a woollen waste store (Hagen and Fox 2000, 37). The pool may have doubled up as a storage pond, perhaps a back-up supply for the blacksmith's waterwheel.

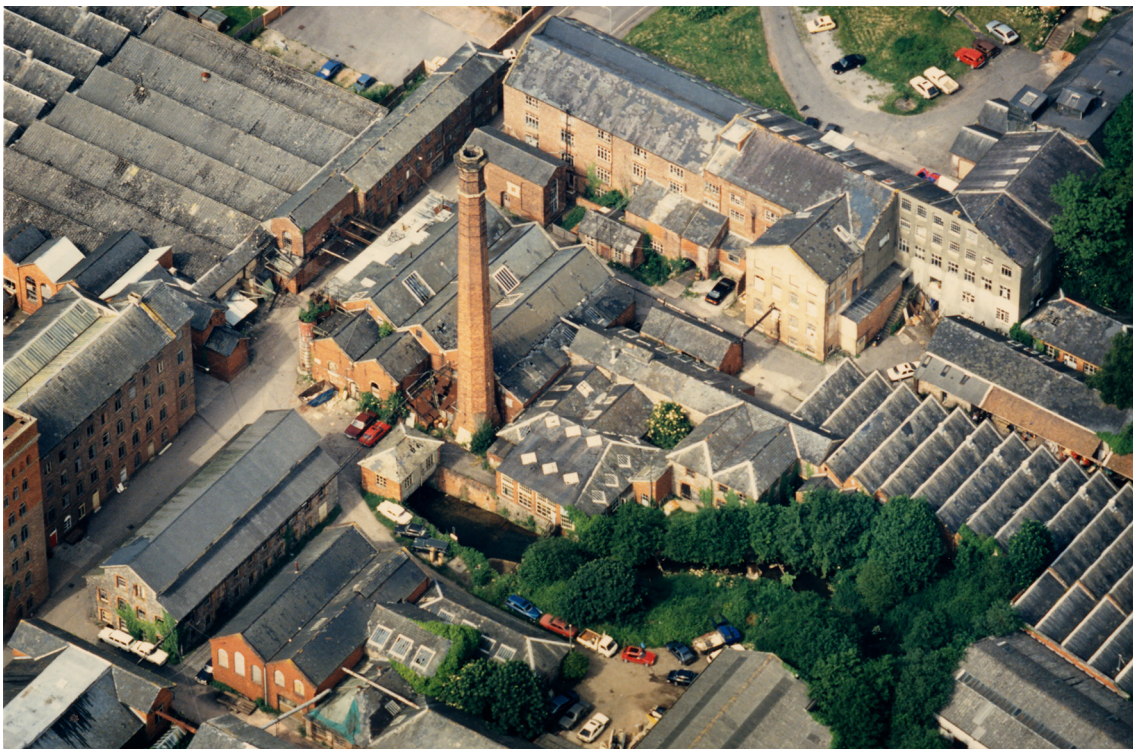
Figure 32: The centre of Tonedale Mill in 1993, looking north-east, with the Back Stream visible entering the mill complex, west (in front) of the chimney. [NMR 4893_22 22-JUN-1993 © Crown copyright. Historic England Archive]

The Back Stream [40] is the only other major watercourse flowing into and through Tonedale Mill (Figs 32, 33 and 34). It follows its approximate natural course through the factory, though canalised. The tithe map shows it in 1839, prior to the mill's expansion, when it passed to the west of the small building complex (see Figs 7, 24 and 29). From a weir [43] on the Back Stream a small channel [45] flowed into the westernmost mill building, entering the building where a weir and sluices are shown on late-19th century maps (see Figs 24 and 25). These buildings were later used for wool scouring, drying, steam plant and maintenance facilities. The stream was thus being used either for power, processes or both by this date. By 1888 the factory buildings had been extended and the Back Stream was partially culverted, flowing beneath a yard and the eastern end of the mills built in 1863-73 (see Fig. 29).

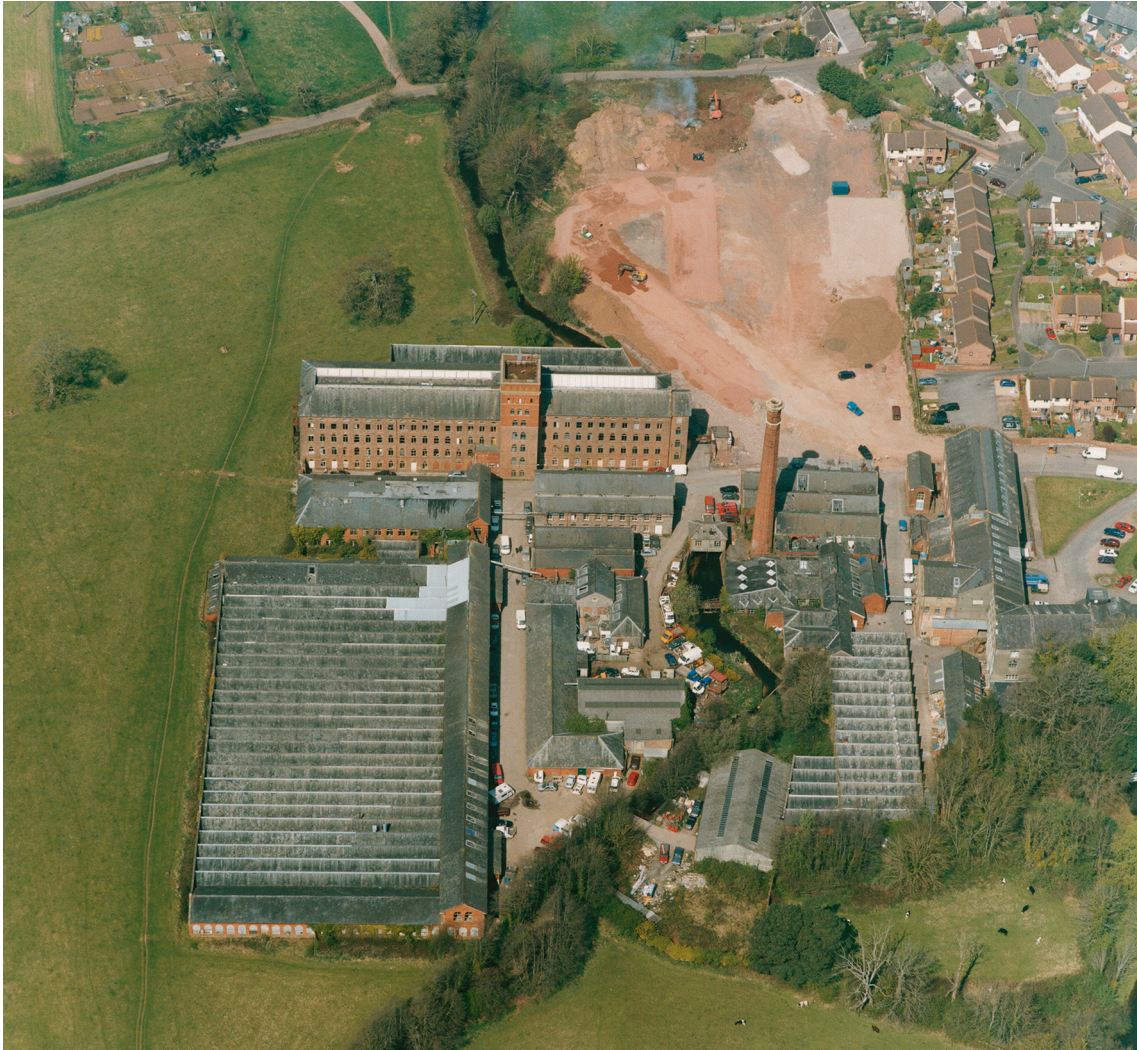
Figure 33: Tonedale Mill in 2003 following closure, looking north-west, with the Back Stream visible entering the mill complex (centre foreground). The northern part of the mill has been demolished and the site cleared for development. [NMR 23057_11 16-APR-2003 © Crown copyright. Historic England Archive]

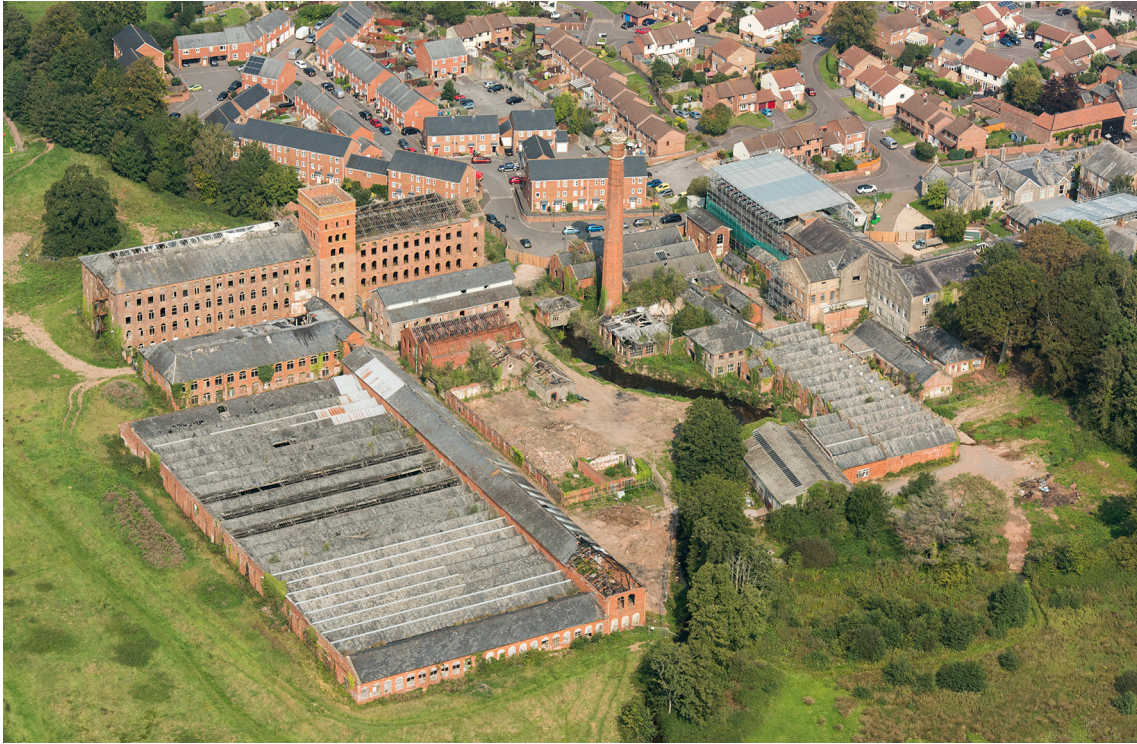
Figure 34: Tonedale Mills in 2020 in a derelict state, looking north, with new housing constructed on the northern part of the mill site which had been cleared in the early 2000s. [NMR 33912_029 16-SEP-2020 © Crown copyright. Historic England Archive]

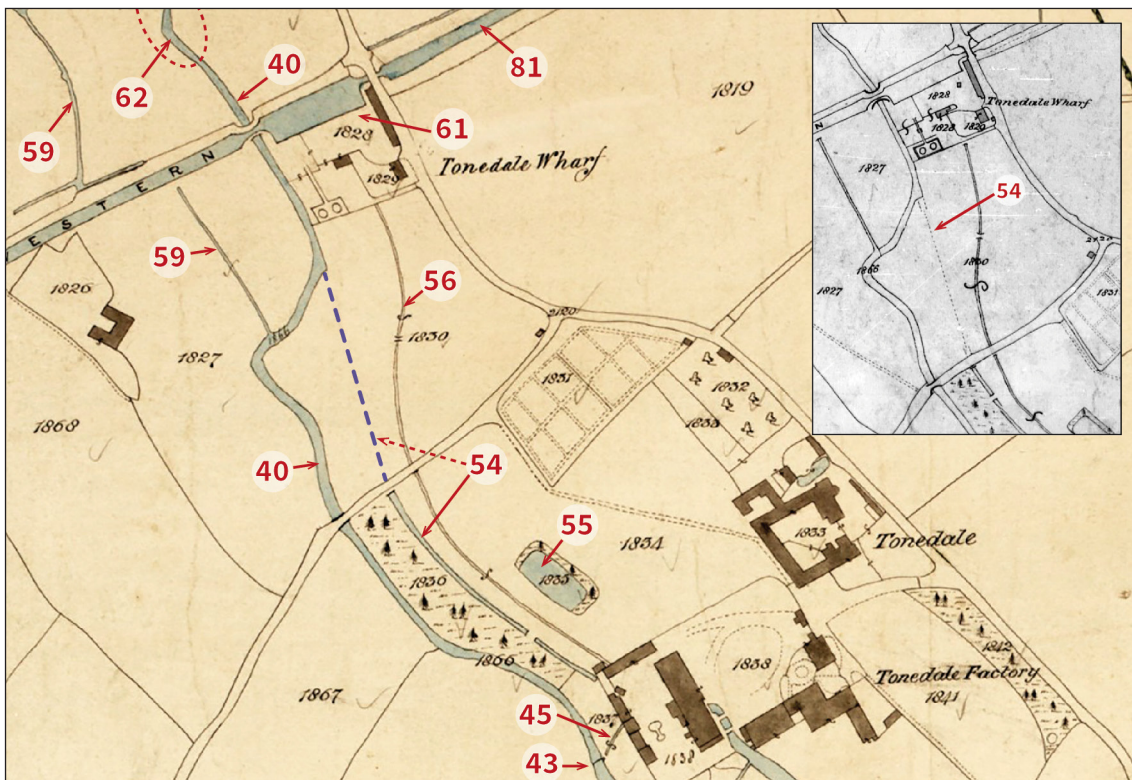
Figure 36: Extract from the Wellington tithe map of 1839. The postulated continued course of the tailrace [54] has been added as a dashed blue line and can be seen depicted on an alternative copy of the tithe map, shown as an inset. Parallel to its east is the narrow channel [56] from Tonedale Mill to the wharf and former pond [55], and to the west the Back Stream [40]. Not reproduced at scale. [main map SHC D/D/rt/M/367, accessed via the 'Know Your Place' website, reproduced with kind permission of the South West Heritage Trust; inset map © Crown copyright images reproduced courtesy of The National Archives]

The 1839 Wellington tithe map shows Tonedale Mill's tailrace [54] leading northwards for approximately 150m and then ending abruptly on the southern side of Burchill's Hill, where it presumably entered a culvert (Fig. 36). Its projected course northwards passed through 'Tonedale Three Corner Close', a pasture field in the possession of Henry Fox. The reason for it being taken underground here was presumably to enhance its gradient and so improve the flow of water away from the mill. If the course of the open part of the channel shown on the map is projected directly northwards it leads to a prominent spur visible on the east side of the Back Stream, which may have been where the tailrace entered the Back Stream.

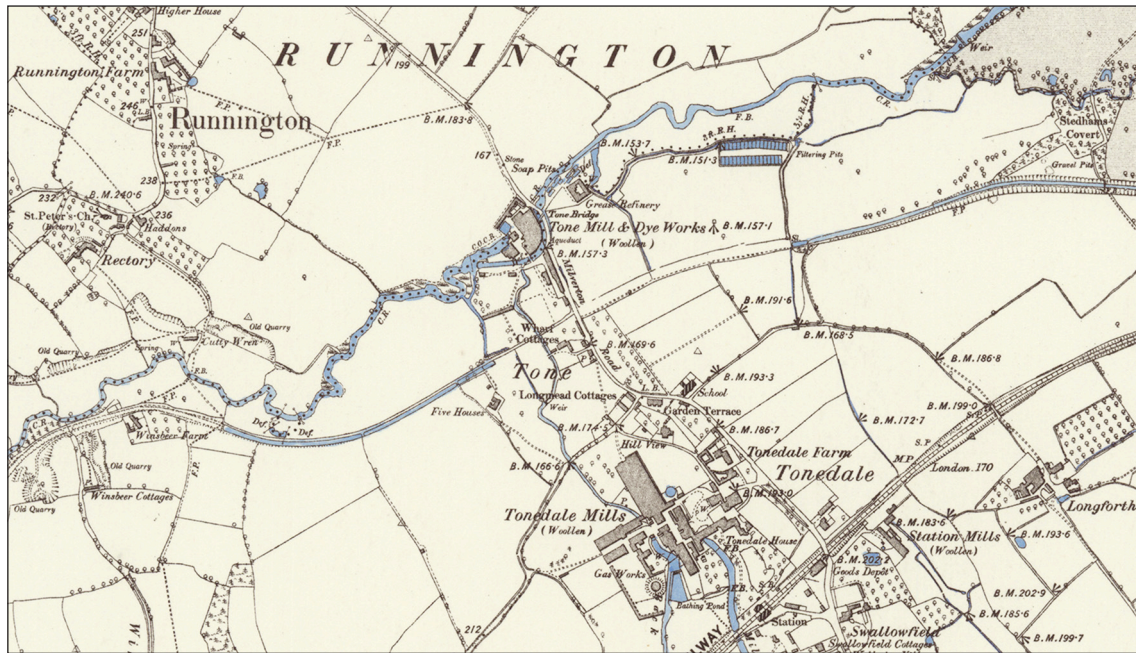
Figure 37: Extract from the coloured 1888 OS 25-inch map showing that while some sections of the Grand Western Canal remained in water, it had already been infilled between Tone Works and Tonedale Mill. Tonedale Wharf is no longer labelled, but the wharf cottages remain. Note also the dotted line of the parish boundary. Not reproduced at scale. [Reproduced with the permission of the National Library of Scotland]

Ordnance Survey map editions from 1888 show that much of the canal's course past the factories was already filled in by this date and that Tonedale Wharf was no longer extant (Fig. 37). A bridge carrying the Milverton Road over the canal was demolished in 1869 (HER 39870) and an aqueduct (HER 39872) taking the canal over the Back Stream has been taken down and replaced with a later structure. However, the canal's former route through Tone and Wellington survives fossilised in the line of the field boundaries and as a series of paths, including the West Dean Way long distance footpath. The traces of a stretch of the canal can be seen as a slight earthwork extending east-north-east along the present field boundary between the sewage treatment works at Tone and the corner of Stedhams Covert further east (see Fig. B4).

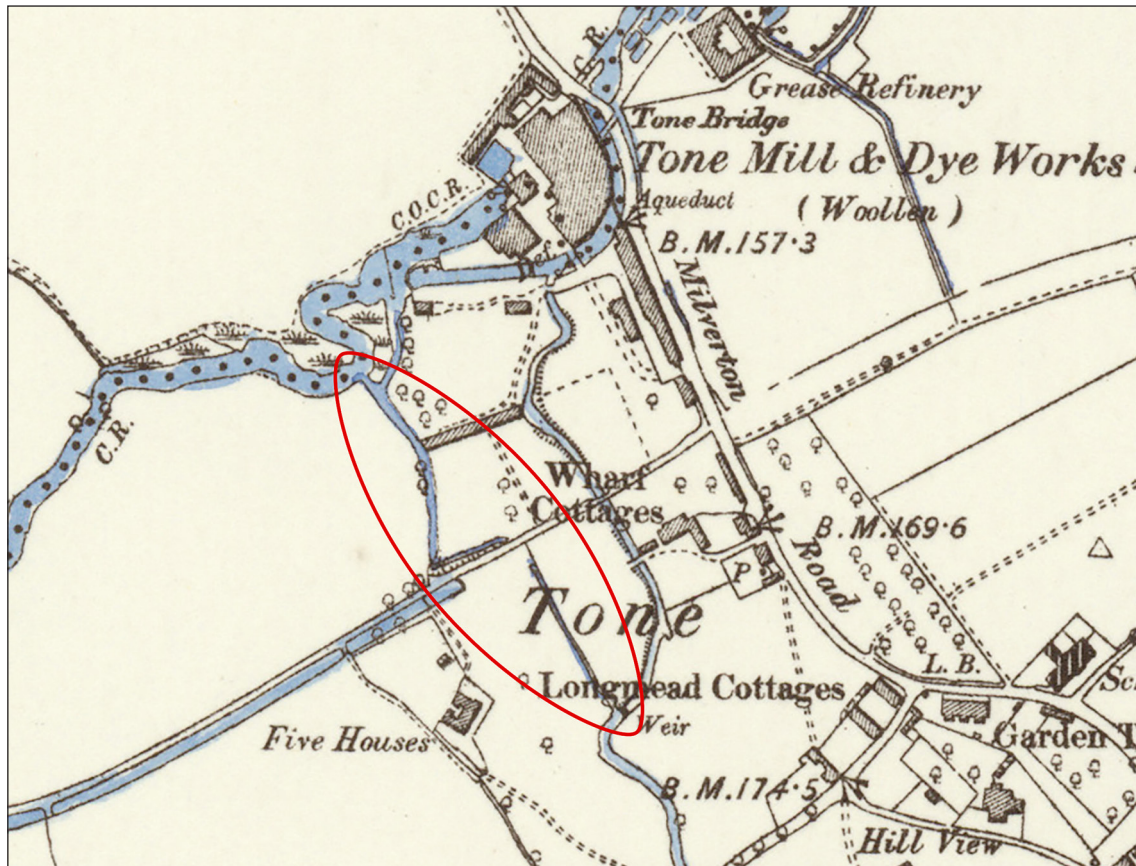
Figure 38: Channel [59] leading south-east from the River Tone to the Grand Western Canal [81] and continuing south to a weir [57] on the Back Stream. Depicted on the 1888 OS 6-inch map, highlighted here by the red oval. Not reproduced at scale. [Reproduced with the permission of the National Library of Scotland]

The Grand Western Canal's construction does not appear to have had any major effect on the mills' water management systems. A small channel [59], shown on

the tithe map flowing south-east from the River Tone, making a dog-leg east to pass under the canal, and continuing south to a weir [57] on the Back Stream, was possibly a feeder channel connected with the canal by a sluice [58] (Fig. 38, and see Fig. 36). This channel was still extant on the OS 25-inch map of 1904, but it had been filled in or culverted by the subsequent edition in 1930.

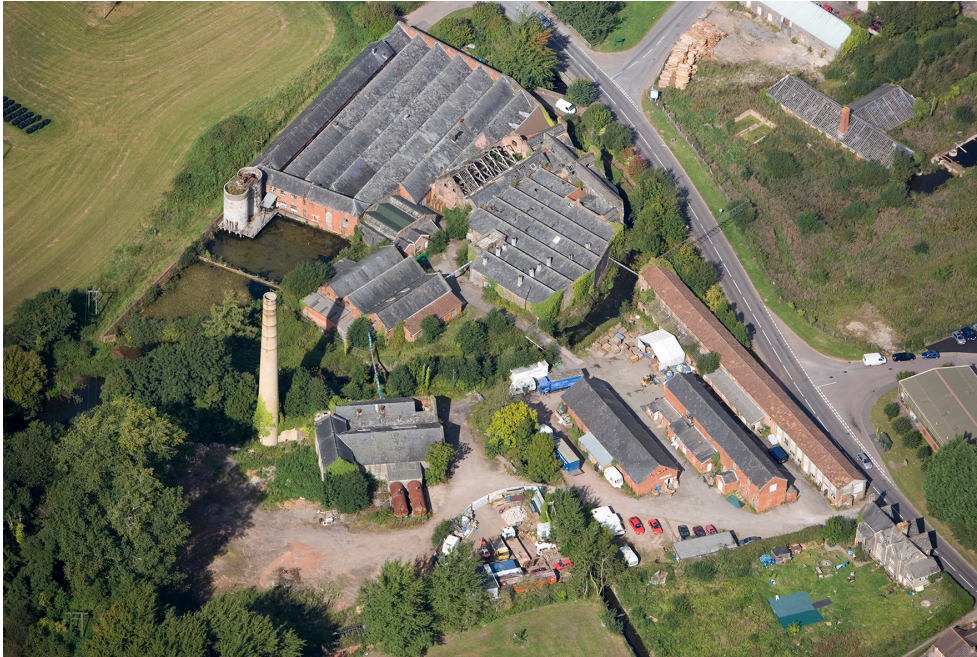
Figure 44: Tone Works in 2007, looking north with the main mill site overgrown and derelict. [HEA 24720_029 18-SEP-2007 © Crown copyright. Historic England Archive]

Close to this, between the former canal and the river, directly west of Tone Works, aerial photographs and historic OS maps from the early to mid-20th century indicate the ground had become increasingly waterlogged and a large pond appeared in the 1940s [80] (Fig. 43, and *see* Fig. 42). It is not entirely clear if this is constructed or natural, perhaps resulting from water displaced by the diversion or infilling of nearby watercourses. A field visit undertaken in late January 2022, found it to now be more amorphous in shape than the OS depiction, with conjoined areas of boggy ground. This area has become increasingly overgrown with reeds and surrounded by trees through the last two decades. This pattern of vegetation encroachment was also seen around the main complex (Fig. 44).
