Tonedale Mill and Tone Works, Wellington, Somerset: an archaeological landscape assessment of the water management system

**TONEDALE MILL AND TONE WORKS,
WELLINGTON, SOMERSET**

**An archaeological landscape assessment of the water
management system**

2024

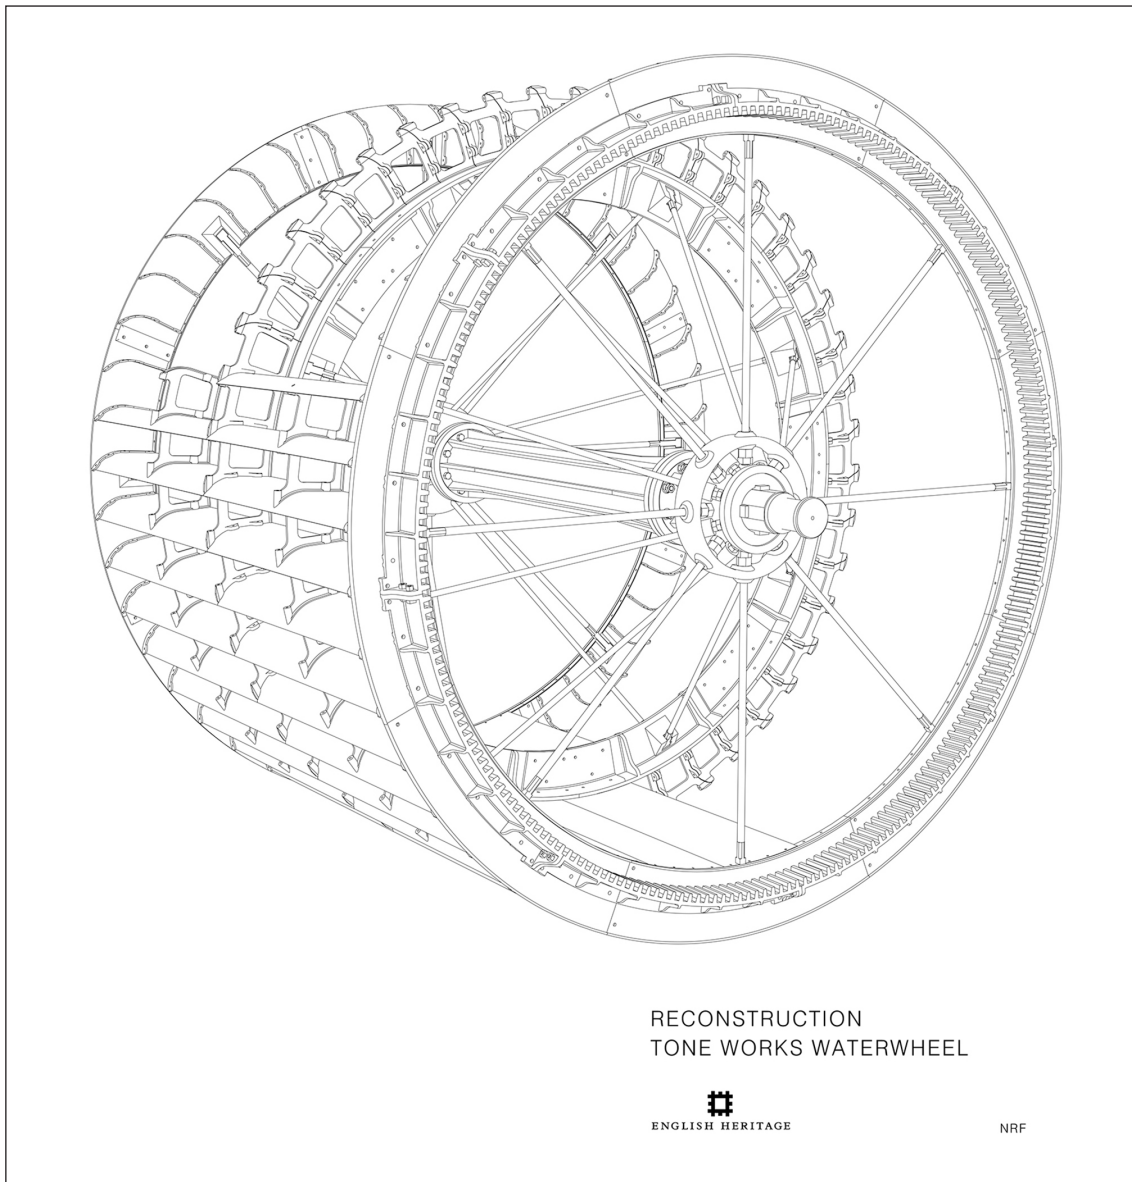
Figure 45: Reconstruction drawing of the waterwheel [72] at Tone Works, produced as part of English Heritage’s architectural survey and investigation of the mill buildings in the early 1990s. [© Historic England]

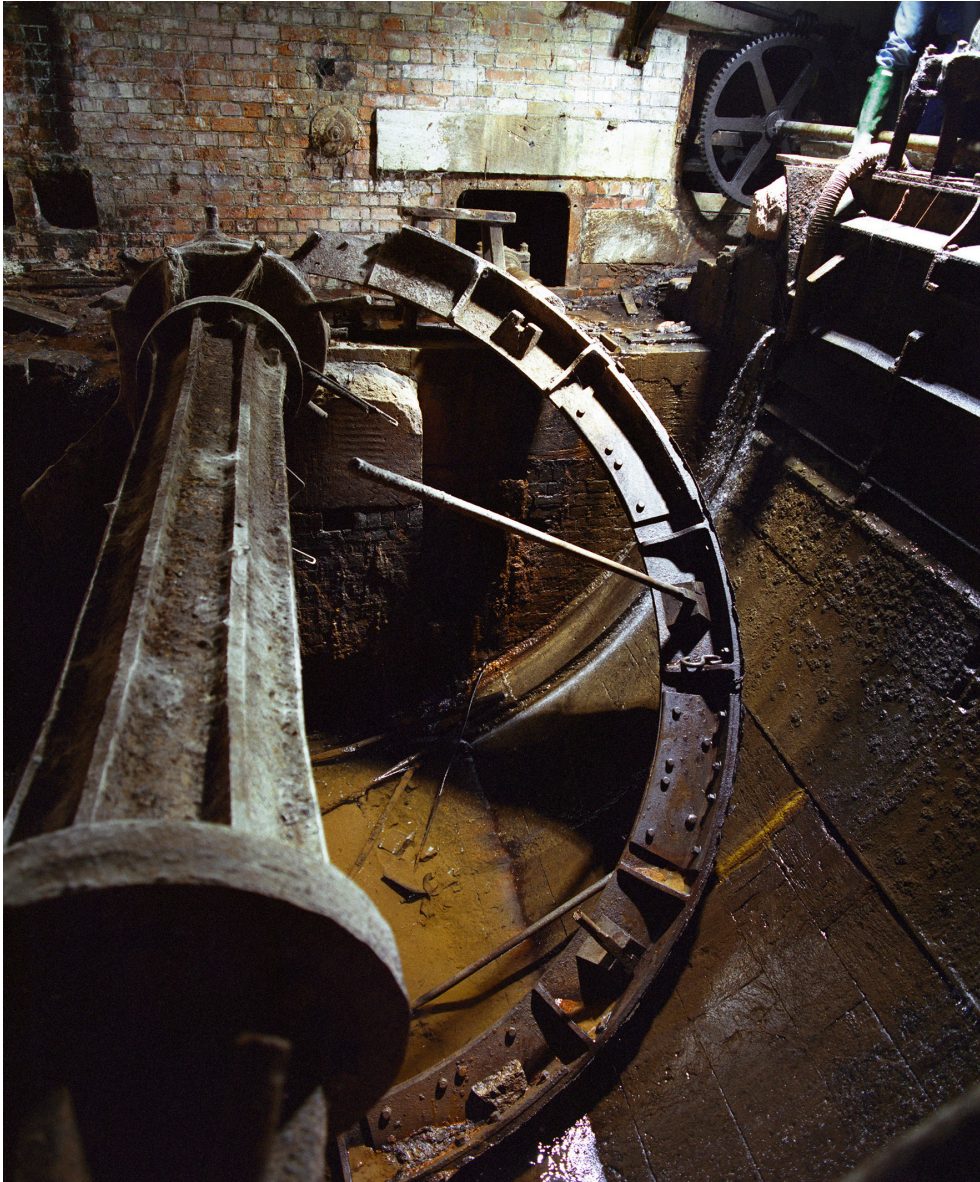
Figure 46: The waterwheel and pit [72] at Tone Works, photographed in October 1995 [Peter Williams © Crown copyright. Historic England, AA96/00684]

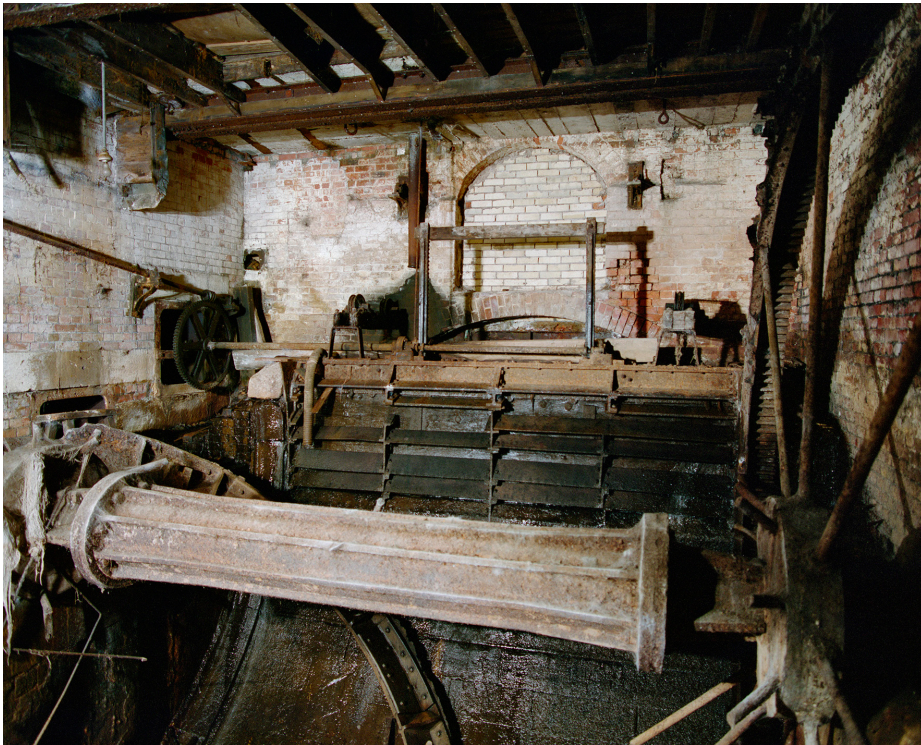
Figure 48: The wheel pit [72], photographed in October 1995. [Peter Williams © Crown copyright. Historic England, AA96/00682]

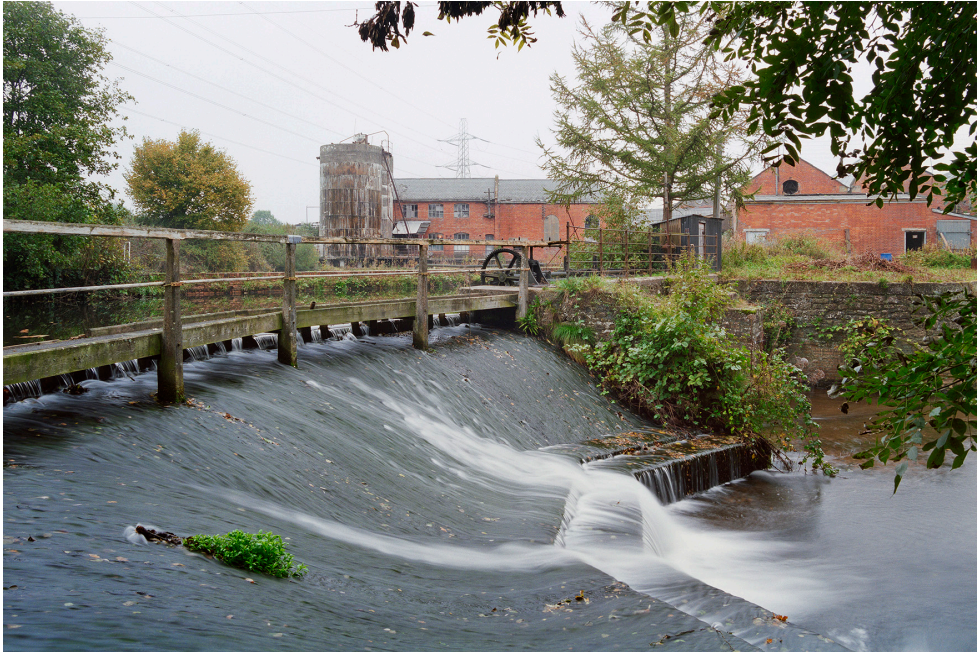
Figure 49: The weir at Tone Works [65], built in 1871, photographed in October 1995 [Peter Williams © Crown copyright. Historic England, AA96/00646]

The weir of 1871 would have replaced an earlier 'ware' nearby, mentioned in 1752 (Jessop 2007, 6). It is stone-built, to a curved plan composed of four angled straight sections crossed by a wooden footbridge (now in disrepair). Water drops some 2m from its ridge and then passes over two lower steps. Its eastern end has a large double by-pass sluice of red brick. This is believed to be contemporary with the rest of the weir and served as an overflow to allow flood water to be diverted to the south of the factory. The sluice has a central brick pier with a pair of cast-iron rack and pinion shutters to either side. These were originally controlled by separate hand wheels on pedestals at the ends of the sluices, but later a gearbox mechanism was added to the east, probably electrically powered. This was in working condition when examined by English Heritage (Williams 2007b, 39-40). No sluice gates survive, but the sides have grooved concrete posts for the insertion of stop boards. Construction of the weir did not significantly raise the head of water and its main purpose was to improve the site's flood defences (Williams 2007b, 39).

The most significant alteration to the watercourses at Tone Works was carried out in 1871, when part of the bend in the river where the factory stands was removed to alleviate flooding. The western side of the bend close to the factory was replaced by a new east-west straight cut to its south [63], which re-joined the river near its confluence with the Back Stream (compare Figs 40 and 41). The work was recorded in the company's accounts, which state that £915:14:09 was spent on 'A new cut at Tone Works' (Jessop 2007, 6). The new arrangement shows clearly on maps from the 1888 OS editions onwards, but the original course remains fossilised in the line of the parish boundary (see Figs 41 and 42). This layout, which survives today, did not radically alter the supply to the waterwheel. A new weir [65] diverted the main flow of the river into the cut while the remaining part of the old river channel continued as the headrace, newly lined with brick retaining walls (Fig. 49). The entrance to the headrace does not have a sluice today, though its sides

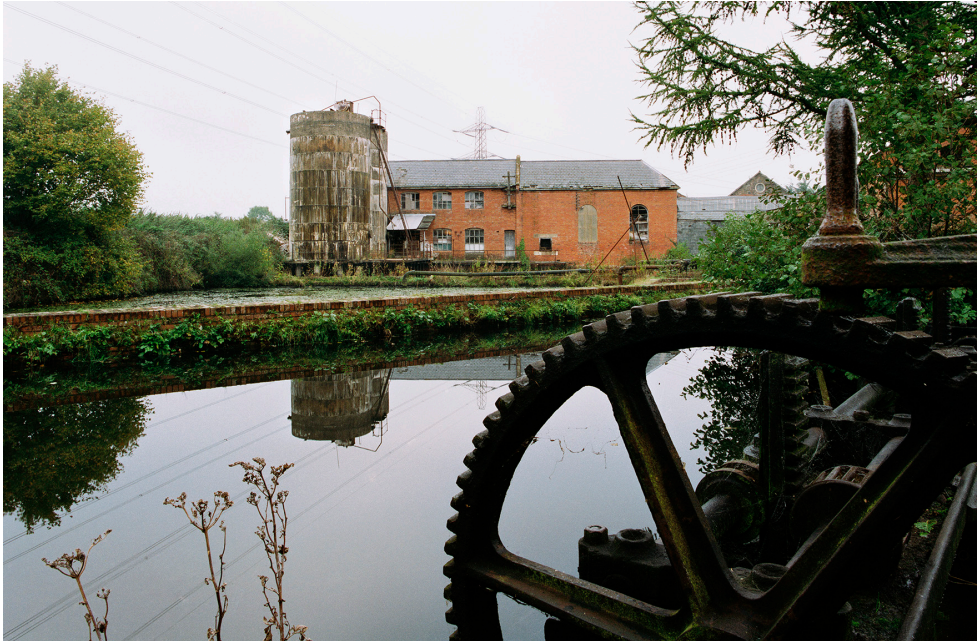
Figure 51: The headrace at Tone Works [73] (foreground), with the soft water reservoir of the early 1890s [71] and the pair of concrete lime soda water softening towers dating from 1914 beyond, looking north-east, October 1995 [Peter Williams © Crown copyright. Historic England, AA96/00645]

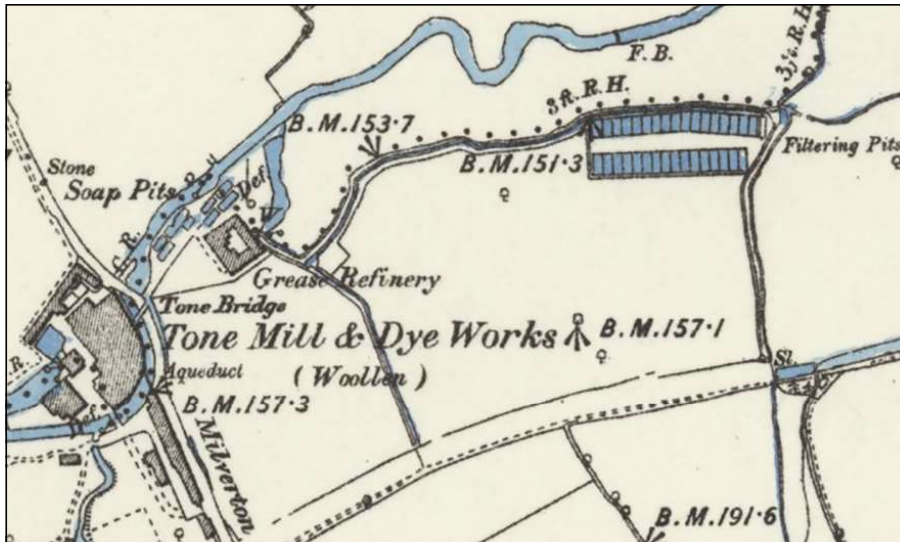
Figure 53: Extract from the coloured 1888 OS 25-inch map showing Tone Works ('Tone Mill & Dye Works') and adjacent grease works ('Grease Refinery') with its rectangular 'Soap Pits' for lanolin extraction and a channel taking wastewater to two rows of 'Filtering Pits' to the far east of the site. Not reproduced at scale. [Reproduced with the permission of the National Library of Scotland]

This initial grease works was demolished in 1882 after a flood caused oil to float into its furnace and catch fire (Fox 1933, 8). It was replaced, by 1887, with a larger grease works (HER 19940) [77], built east of the Milverton Road (B3187) in Tone. It was arranged around a central courtyard and had ten 'soap pits' [76] adjacent to it (Fig. 53, and *see* Figs 41 and 50). Pipes and aqueducts carried wastewater to

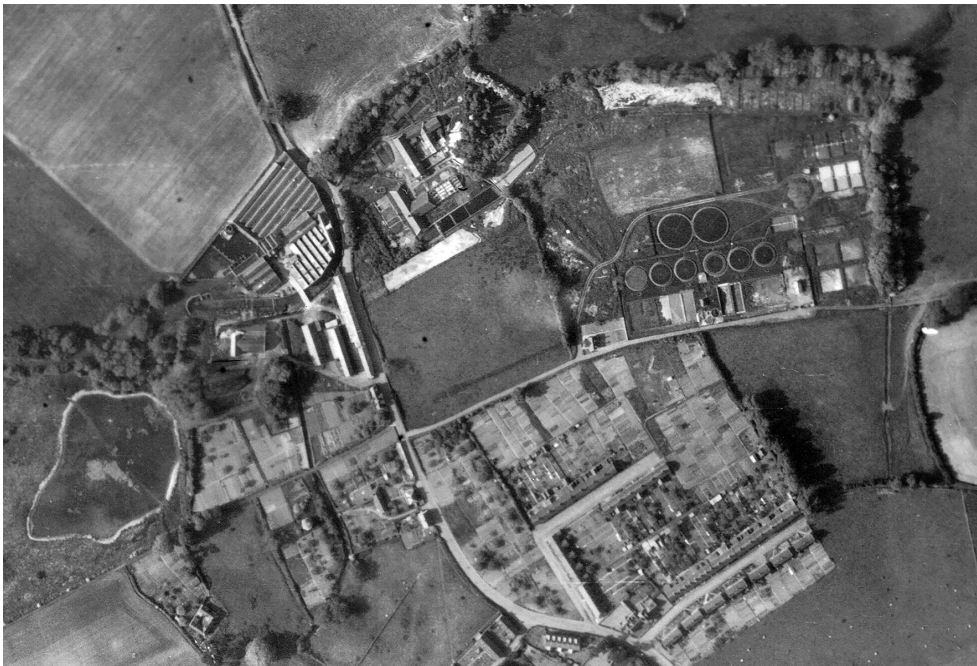
Figure 56: Vertical view of Tone Works in 1946, with north at the top. The finishing and dyeworks on the west (left) of the road and the grease works with its rectangular settling tanks to the east (right). The later sewage works is located to the south and south-east. [RAF/3GTUD/UK/207/ PT1 5001 13-MAY-1946 Historic England Archive (RAF Photography)]

Later developments coincided with tighter restrictions on river pollution introduced in the 20th century. Settling pits were replaced with tanks and sludge beds were created in the 1940s and 1950s (Figs 56 and 57). Effluent was treated with aluminium to form a sludge that was pumped onto adjoining land (Williams 2007c). However, in later years water discharged from the factory contained a high percentage of chromium and Ministry of Defence specification cloth was heavily mothproofed, producing poisonous effluent (Williams 2007c).

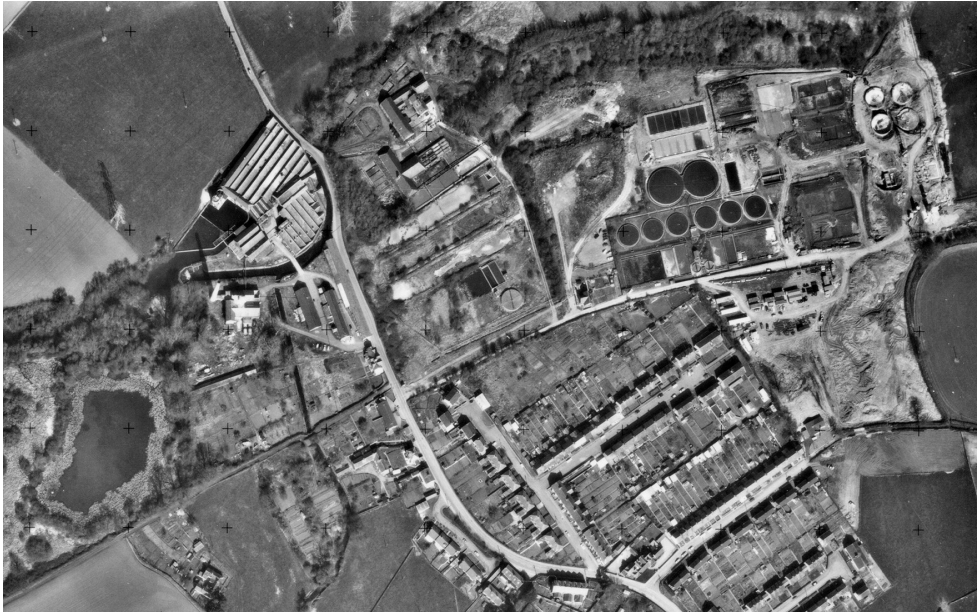
Figure 57: Tone Works in 1973, with north at the top. Additional long settling tanks now occupy the formerly open area to the south of the grease works (centre) and, east (right) of this, the later sewage works with its settling tanks have expanded. [OS/73039 006 29-MAR-1973 Historic England (OS Photography)]

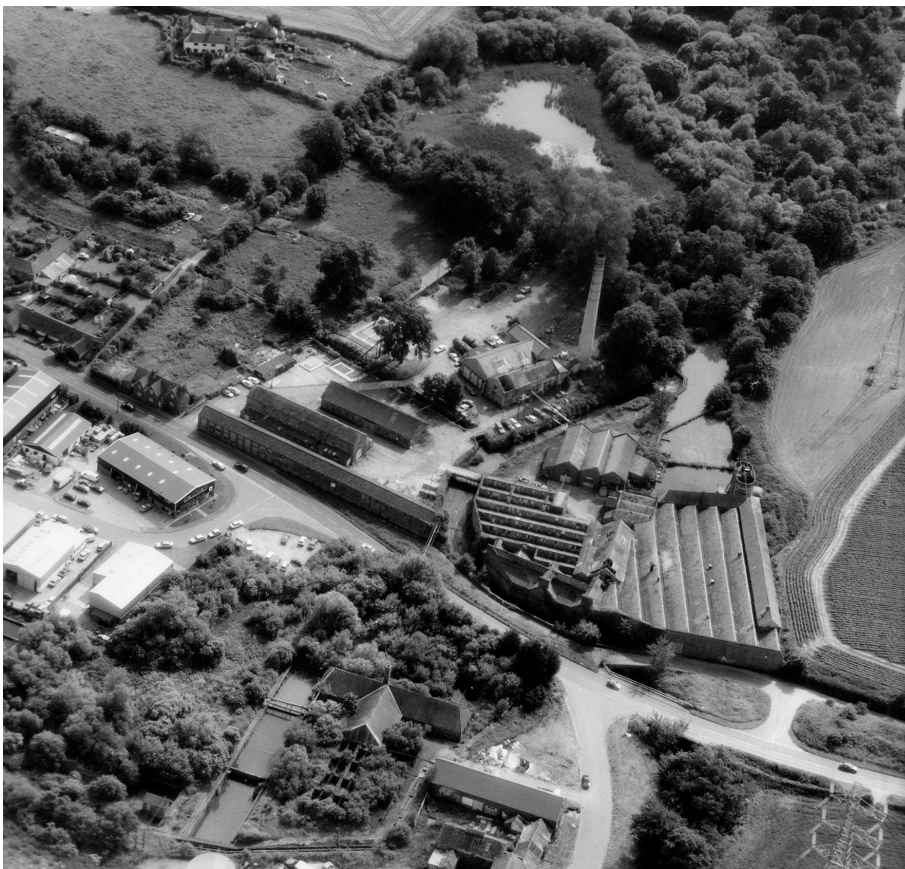
Figure 58: Tone Works in 1993, looking east, with the already overgrown grease works in the foreground. [ST1221/351 22-JUN-1993 © Crown copyright. Historic England Archive]

The facilities were enlarged again in the 1950s to 1960s, following another change in the law controlling river pollution, but were becoming run down in the 1970s as the woollen trade began to decline (Stainer 2014, 3). Oblique aerial photographs taken in the 1990s and early 2000s show the area around the buildings and ponds of the grease works site becoming gradually more overgrown (Figs 58 and 59).

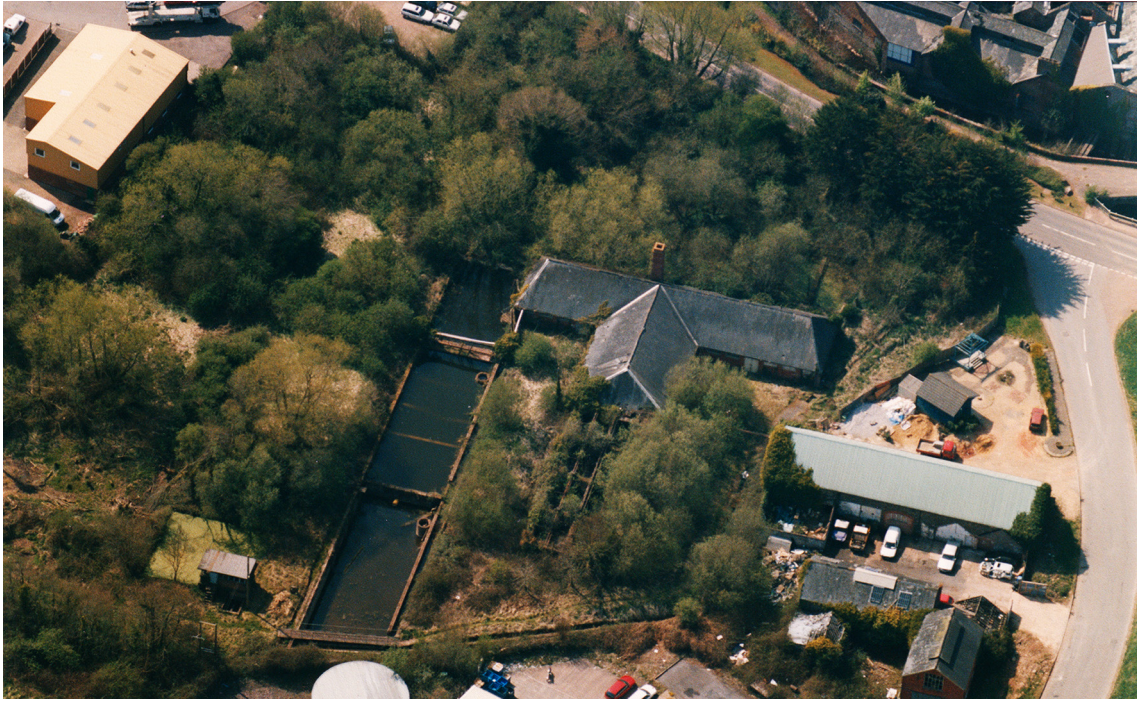
Figure 59: Aerial view of the overgrown site of the grease works buildings and ponds as they were in 2003, looking east towards the Tone Works across the Milverton Road. [ST1221_83 16-APR-2003 © Crown copyright. Historic England Archive]

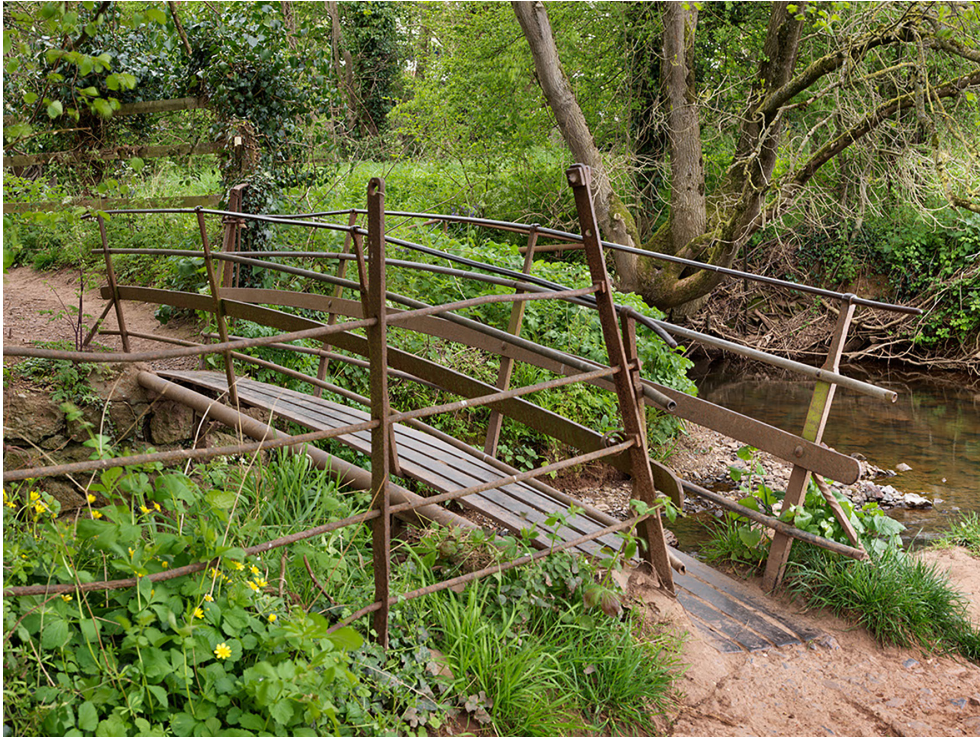
Figure 61: Blacksmith bridge [2] at Oaken Ground, bearing the date 1831 (not visible in this image), viewed from the south-east [James O. Davies © Historic England Archive, DP347762]

Narrow footbridges, primarily ‘blacksmith bridges’, were provided to cross the watercourses at various points. These strong but lightweight blacksmith-made pedestrian bridges were built from readily available wrought iron bar and rod, manufactured for use in estate fencing of the type seen in the surrounding area. Local historian R. L. Thorne, who was active in the 20th century, reported meeting a man at the Basins who claimed that his grandfather, a blacksmith at Tonedale Mill, had made the iron footbridges and had put a date on the one at Oaken Ground [2] (Fig. 61). Thorne checked up on the man’s story and found it to be largely correct,

though he reports the date as being 1838 (Thorne 1973, 72). The date on the extant bridge is 1831 – incised on the inner side of the handrail on the north side (Fig. 62) –, but it may otherwise be a plausible account. A series of similar bridges are found in the wider area around the factories, but the bridge at Oaken Ground is the only example shown on the Wellington tithe map (1839). By 1888, when the 1:500 OS Town Plan was produced, many other footbridges had been added. The other surviving examples do not have dates, but they are all similar in design to the bridge of 1831, albeit probably slightly later.

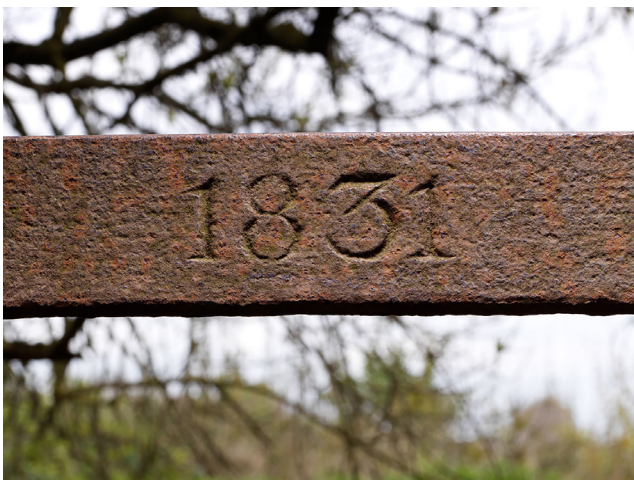
Figure 62: Detail of blacksmith bridge [2] showing the incised date of 1831 on the inner side of the handrail on the north side [James O. Davies © Historic England Archive, DP347760]

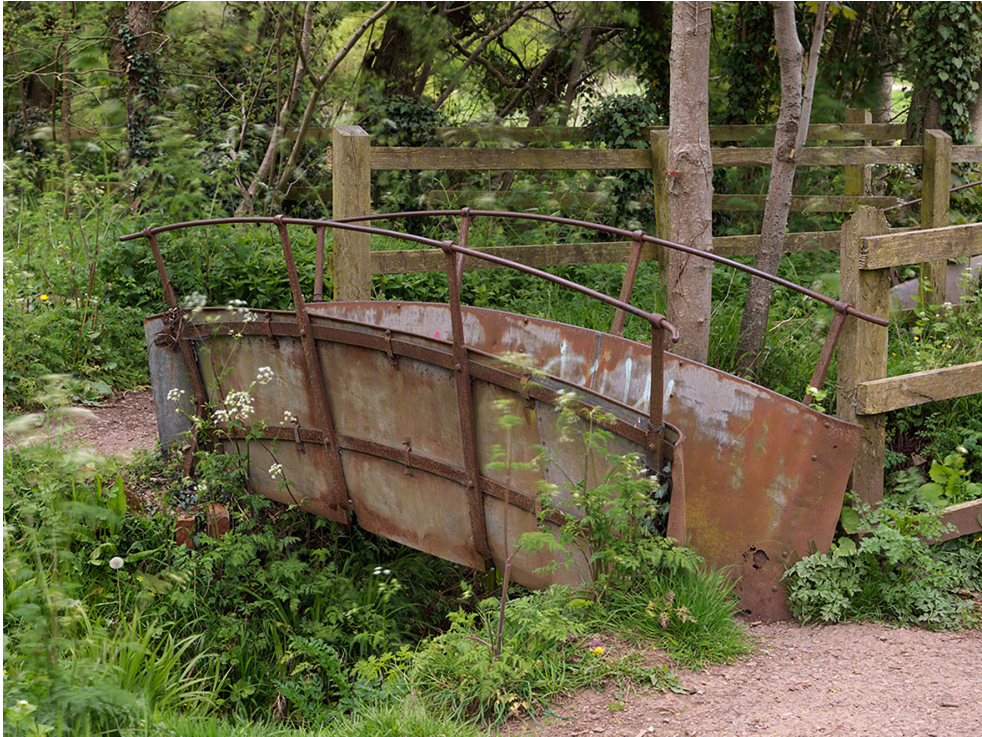
Figure 63: Blacksmith bridge [14] at the siphon, viewed from the north-west [James O. Davies © Historic England Archive, DP347740]

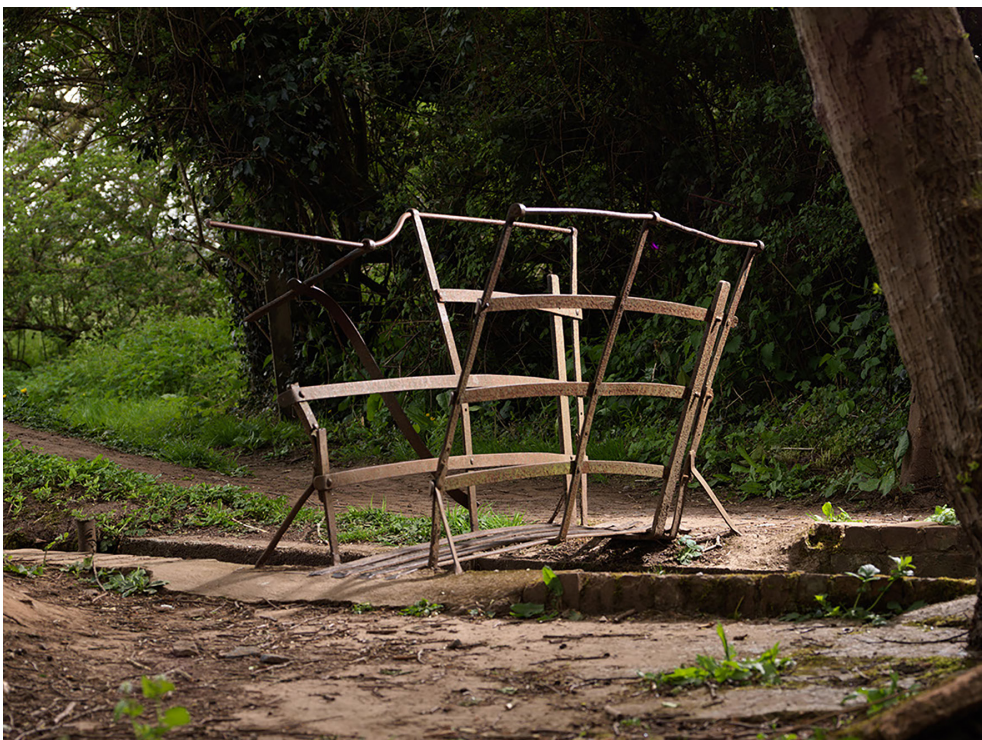
Figure 64: Blacksmith bridge [18], now crossing dry leaf [10], viewed from the north-west [James O. Davies © Historic England Archive, DP347752]

Six blacksmith bridges remain in situ in the open space south of Tonedale Mill, including the example at Oaken Ground [2]. Two cross the watercourses at the siphon – one over the Rockwell Green Stream [14] (Fig. 63), and the other [12] over the Basins' supply leat [10]. Another [18] crosses the dry leat close to the flood alleviation weir, while a larger bridge [15] spans the Westford Stream. At the weir north of (downstream/below) the Basins a single bridge [29] (*see* cover image and Fig. 18) survives out of three noted in 1980 when the site was visited by members of the Somerset Industrial Archaeology Society (SIAS). One of the two removed bridges [32 and 34] was donated to Rockwell Green Primary School in 1995 (HER 36840). Nineteenth-century OS maps depict further footbridges crossing the factories' waterways, some of which were almost certainly blacksmith bridges

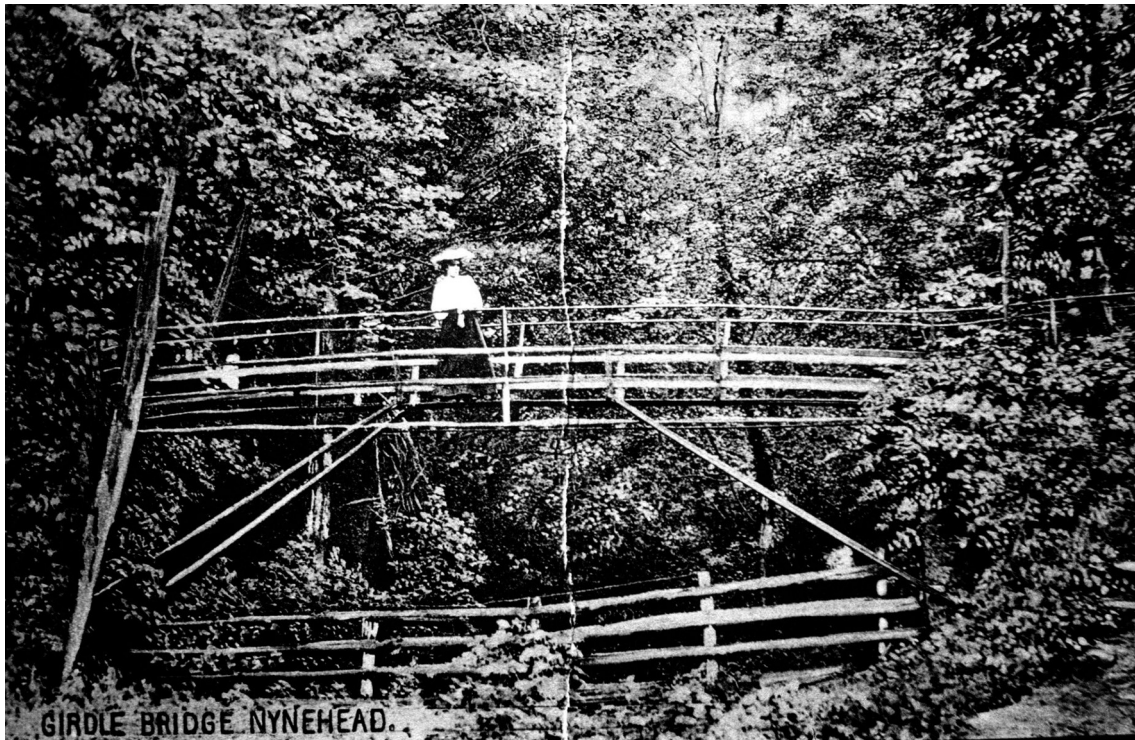
Figure 65: Studholme or 'Girdle' Bridge, Nynehead (HER 36838), featured on a postcard of 1907. [Reproduced with the permission of Somerset HER, item 55429]

Further blacksmith bridges (HER 36837 and HER 36838) crossed, or still cross, watercourses in the wider landscape around Wellington. One of these (HER 36838) was a larger bridge, at Nynehead, east of Tone Works, named 'Studholme Bridge' or 'Girdle Bridge'. It was designed and made by Wellington iron founder William Bishop in 1869 (HER 44406). Bishop had established himself as a blacksmith and bell hanger in North Street in 1837 and later developed his business as the North Street Iron and Brass Foundry and Machine Manufactory (HER 36462). Photographs of Studholme Bridge were made into postcards in around 1907 and 1926 (Fig. 65). By 1980 the bridge had been abandoned and it has since been removed for safekeeping and possible reinstatement by its owner (HER 36838).

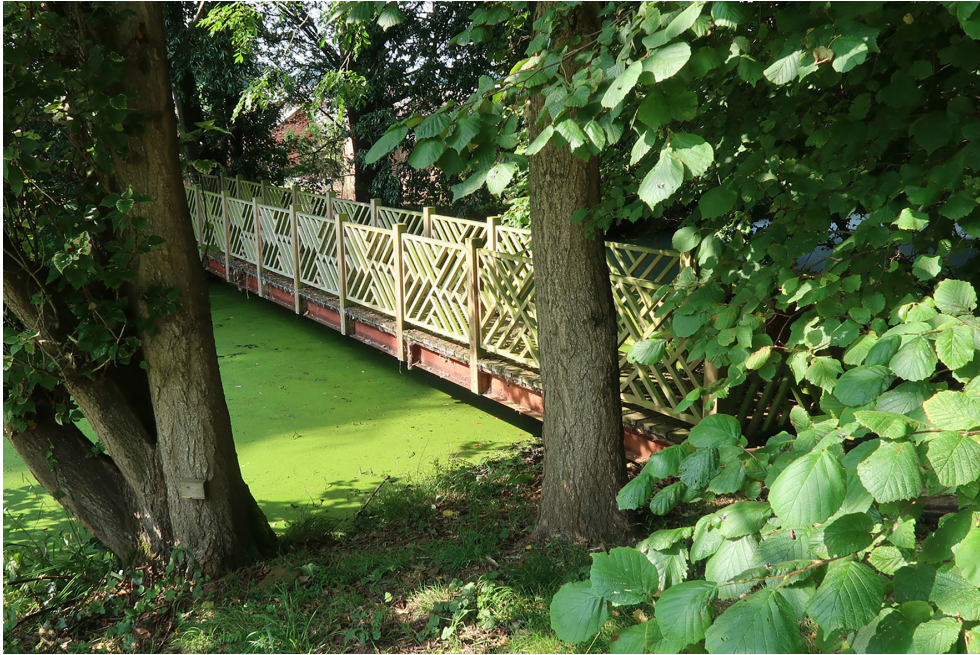
Figure 66: Ornamental footbridge [50] crossing the Mill Head in the gardens of Tonedale House, September 2021 [Johanna Roethe © Historic England]

In contrast to the iron blacksmiths' bridges, an ornamental footbridge [50], with a timber deck and a decorative wooden parapet supported on metal girders, currently crosses the Mill Head, providing access between the garden at Tonedale House and the factory buildings west of the Mill Head at Tonedale Mill (Fig. 66). This bridge post-dates the tithe map of 1839, which shows the factory buildings in their early stages of development and no bridge in this position. A footbridge was present in this location by 1888 when the 1:500 OS Town Plan of the area was published (*see* Fig. 25), but the current bridge is likely to be a later replacement.
