39-41 Westgate Street, Gloucester

Historic Building Investigation

Historic Buildings Investigation

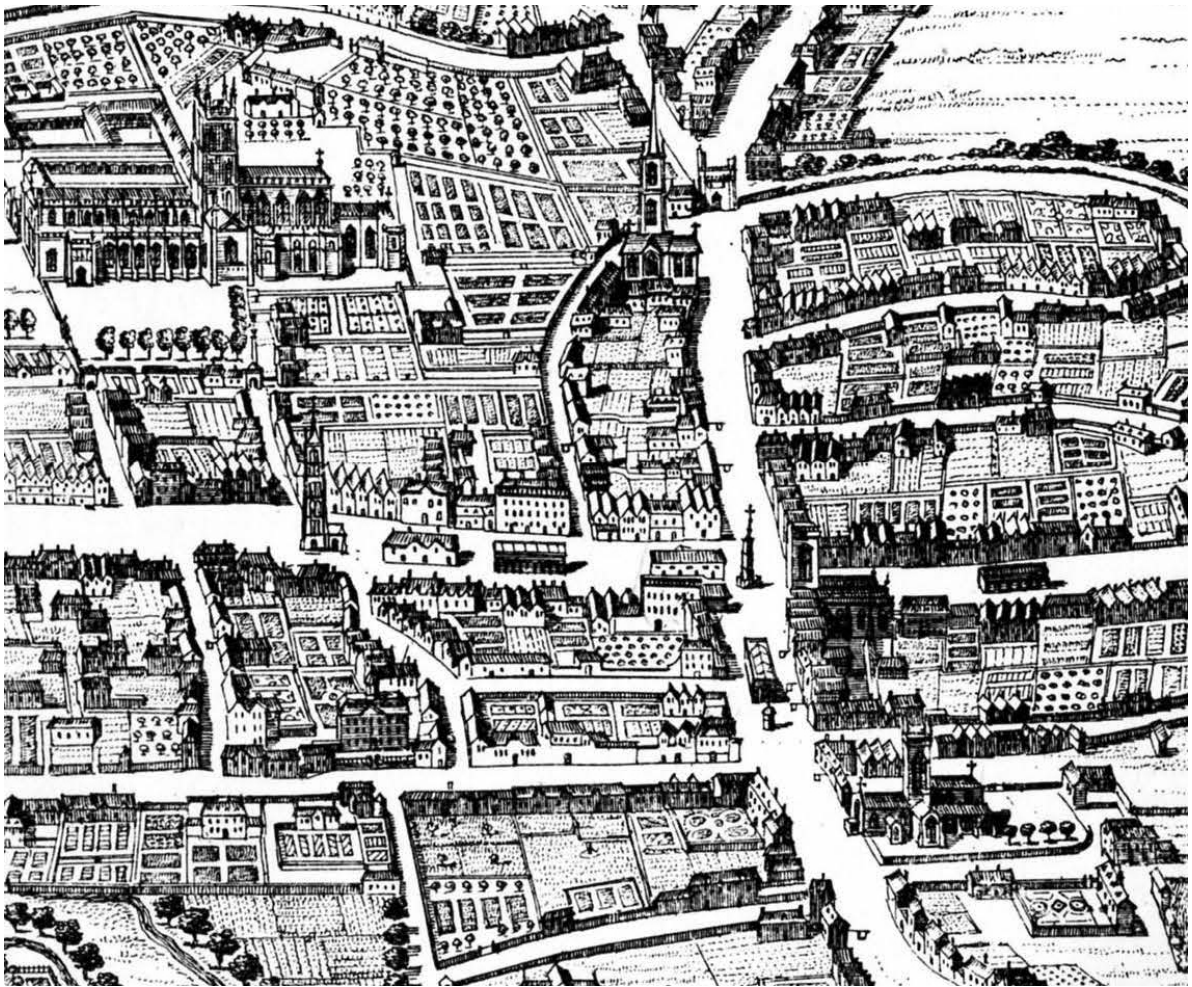
Figure 3: Detail from Johannes Kip's 1712 Prospect of Gloucester. Westgate Street is identifiable with the tower of Holy Trinity standing and the King's Board shown as a building with a ground-floor arcade. [Image reproduced with the permission of Gloucestershire Archaeology and Gloucester Civic Trust.]

On Johannes Kip's 1712 engraving of Gloucester, the plot of Nos 39-41 is identifiable by the position of Bull Lane, which is clearly shown running south from Westgate Street (Figure 3). Although somewhat stylised, the drawing indicates an irregular series of buildings running along Westgate Street and returning down Bull Lane, suggesting the extent to which Bull Lane was built up by this date. To the rear (south) there was an area shown as open ground, in common with other plots along Westgate Street.

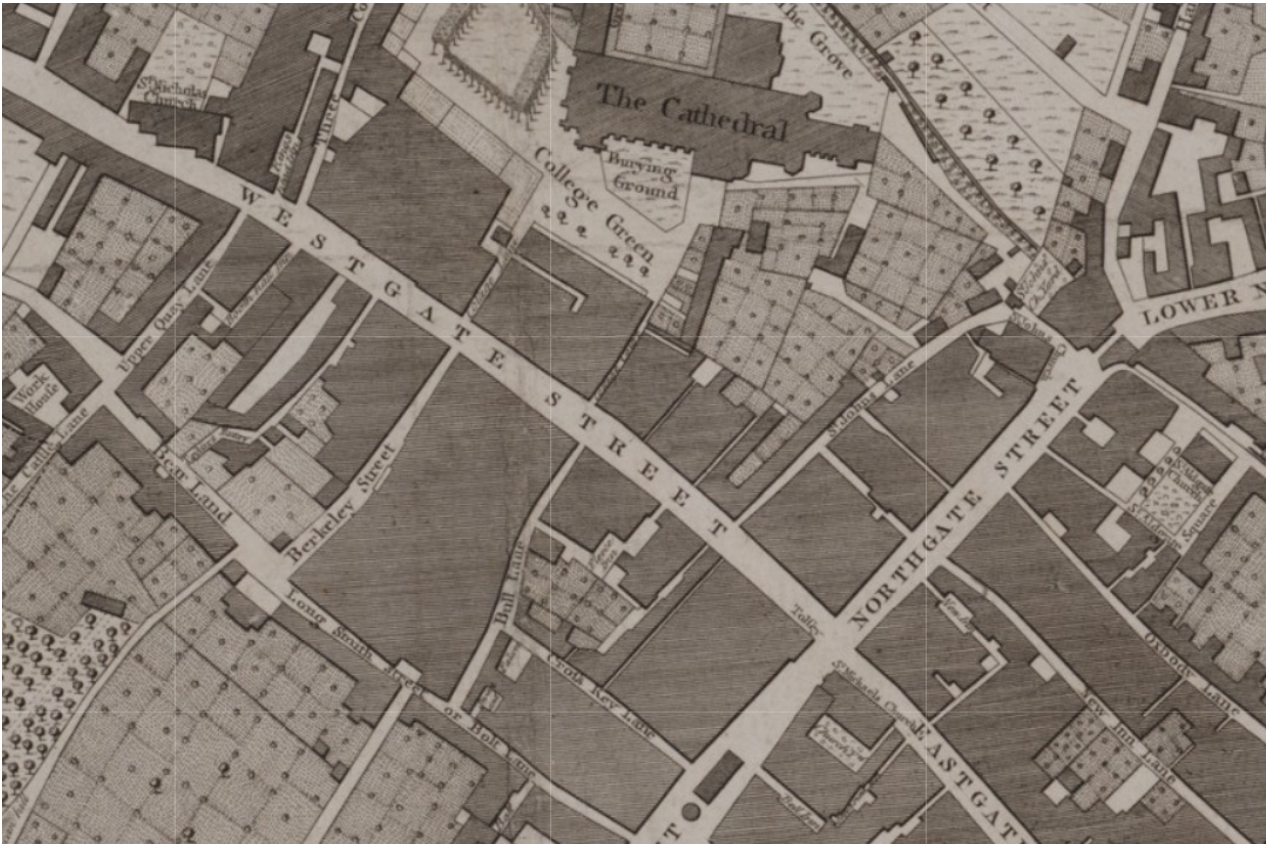
Figure 4: Detail from the 1780 Hall and Pinnell map of Gloucester showing the site of 39-41 Westgate Street. [Know Your Place. Reproduced with the permission of Gloucestershire Archives]

In the late 18th century a series of maps depicted the layout of Gloucester, with two editions of Hall & Pinnell's map (1780 and 1796) (Figure 4) followed by a further map of 1805 by Cole and Roper. While some prominent building arrangements (for example, that of the Fleece Inn further east on Westgate Street) are individually identifiable, most of the properties along the main streets are shown as undifferentiated blocks, with no detail of the tenement arrangements. The position of 39-41 Westgate Street is identifiable due to the depiction of Bull Lane immediately to the east, but no detail of the form of the buildings was provided.

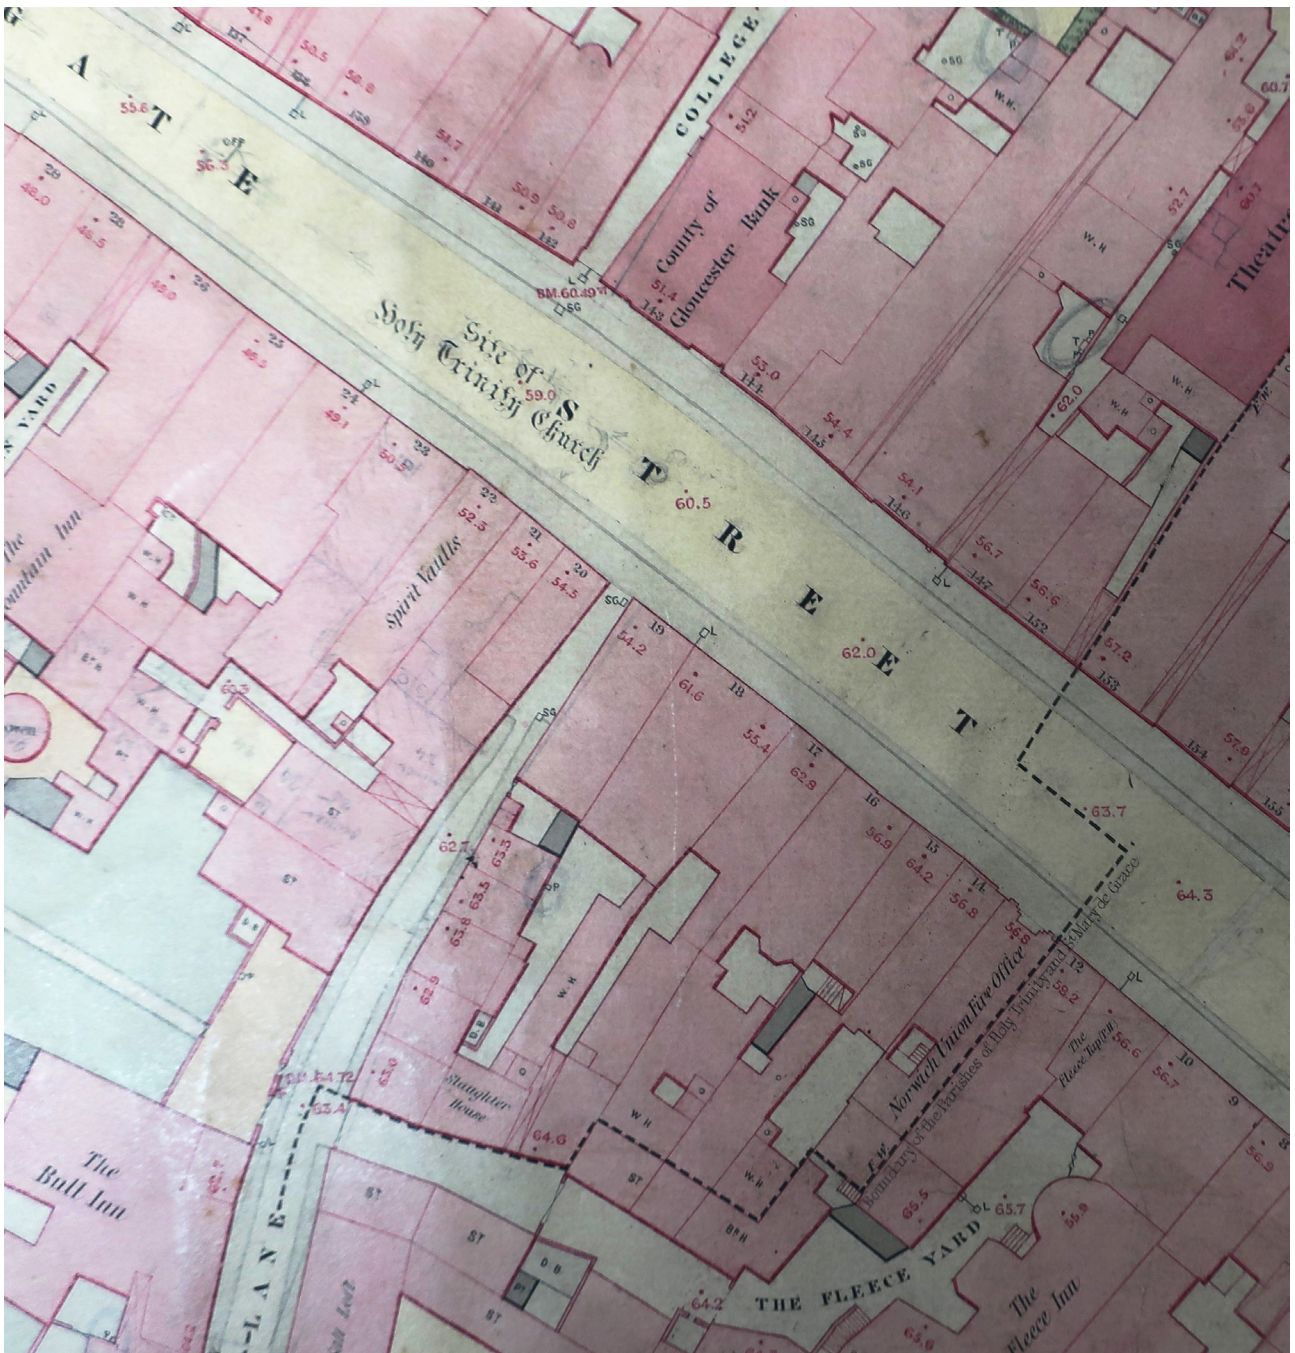
Figure 9: Detail from the 1852 Board of Health map of Gloucester, showing the footprint of Nos 39 and 41, including later pencil marks possibly indicating sub-division of No. 39. [Reproduced with the permission of Gloucestershire Archives: GBR/L10/1/2]

The 1852 Board of Health map of the city shows the two plots in slightly different form to those shown on the survey drawings of the 1830s and 1840s.⁵⁰ The widths of the two frontages appear the same, and No. 39 appears to have the same plot length. However, No. 41 is shown as having become part of a much larger block which extended southwards for the full extent of the original property boundary, and extended eastwards behind No. 39 onto Bull Lane (Figure 9). The extent to which separate tenements might

By 1852 the Board of Health map indicates that the whole of the rear courtyard behind No. 41 had been infilled, as had the side passageway along the side of the 17th-century rear range (see Figure 9). This must have necessitated demolition of the earlier outbuilding. The mapping in fact suggests that this infill block wrapped around the rear (south) side of No. 39 and ran up to Bull Lane, although it seems likely that this area was in fact subdivided. It is difficult to be certain about the exact form this extension took, as much of it appears to have been subsequently removed, but it certainly indicates a significant

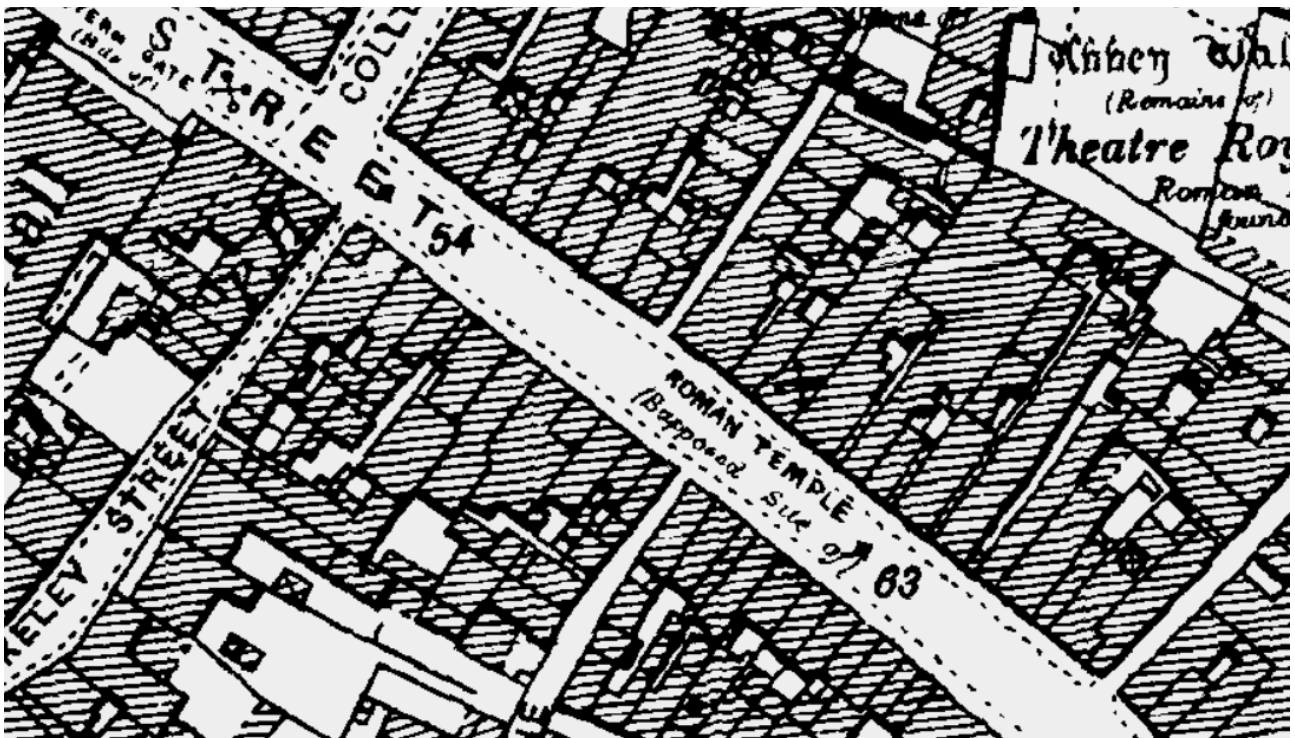
Figure 11: 1:2,500 Ordnance Survey map of 1902 showing the layout of 39-41 Westgate Street. [© and database right Crown Copyright and Landmark Information Group Ltd (All rights reserved 2024.) Licence numbers 000394 and TP0024]

The 1884 Ordnance Survey (OS) Town Plan shows the layout of the two properties some 30 years after the Board of Health map, and appears to confirm the subdivision of No. 39 into a rear property along Bull Lane and the front property (Figure 10). In fact it perhaps suggests that the properties which had been shown merged together on the 1852 map were subdivided into three. The 1886 1st edition OS map shows the same tripartite arrangement, but by the time of the 1902 2nd edition map, it seems to be subdivided into two (Figure 11).

The 1902 edition of the OS map suggests that by this time any clear subdivision in No. 39 had been removed, which is perhaps also confirmed by the 1891 and 1901 census returns, with only one household listed at the property (see Figure 11). If the subdivision of the property seen on the 1884 map does correspond with the two households listed in the 1881 census, it seems it was relatively brief.

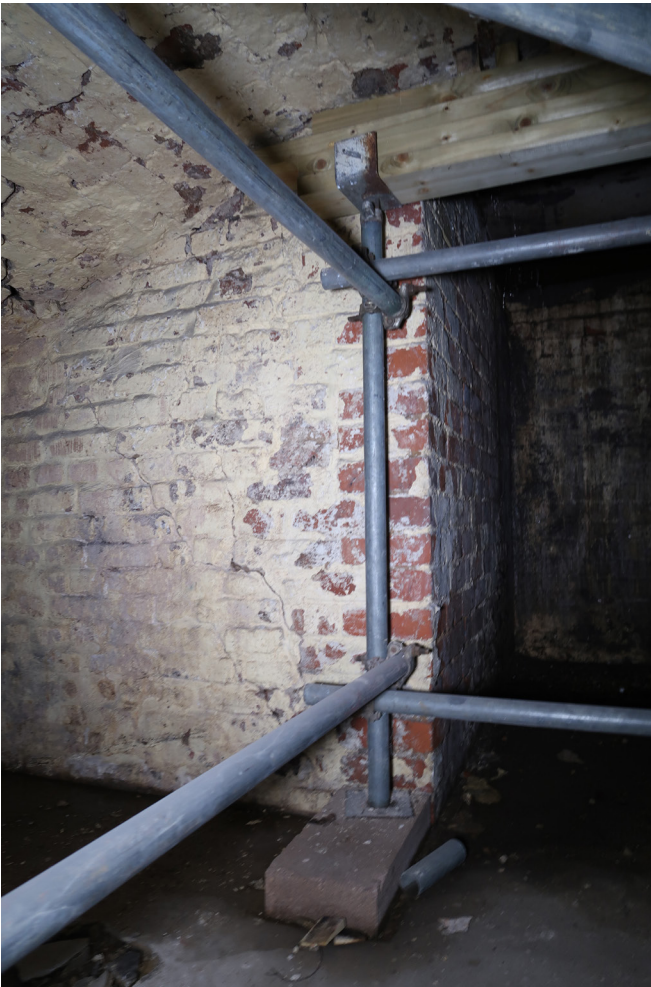
Figure 15: The cellar under No. 39, showing north wall with segmental-arch vaulted ceiling, looking north-west. [Abigail Lloyd © Historic England]

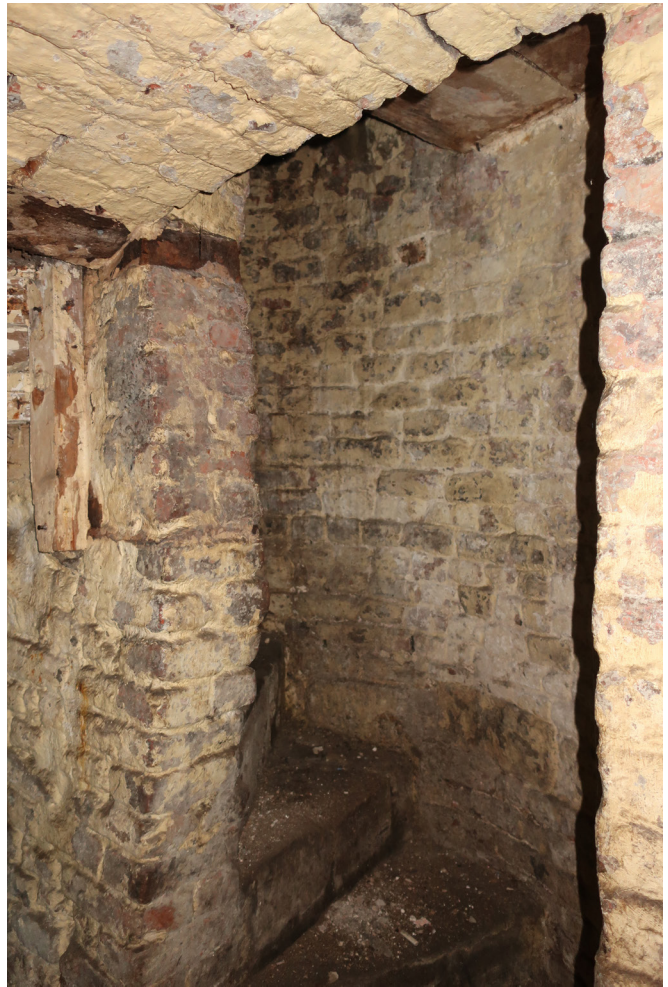
Figure 16: Brick stair rising from cellar to the rear of No. 39, looking south-east. [Rebecca Lane © Historic England]

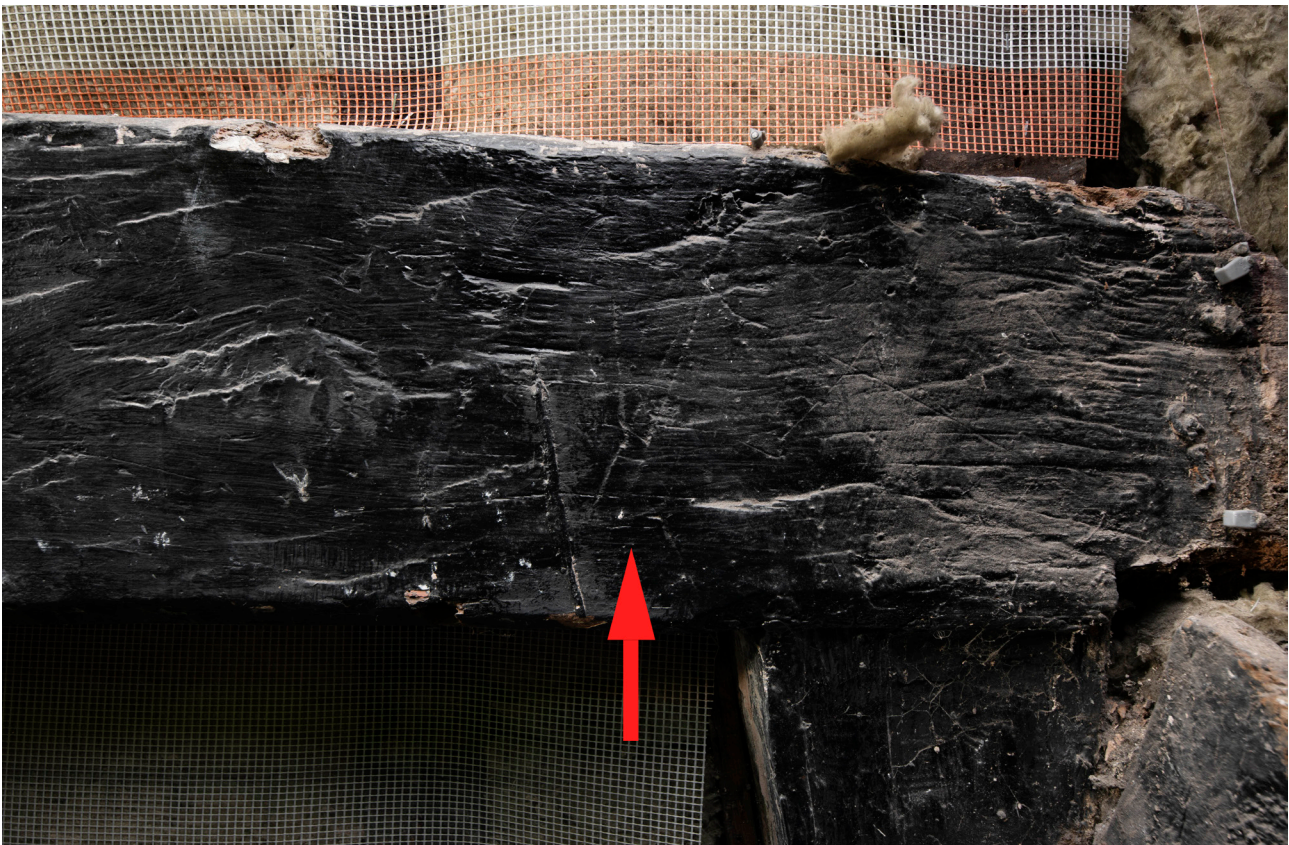
Figure 17: Carpenter's mark on the western side of the central frame of the front range (Frame B), looking east. [James O. Davies © HEA DP435493]

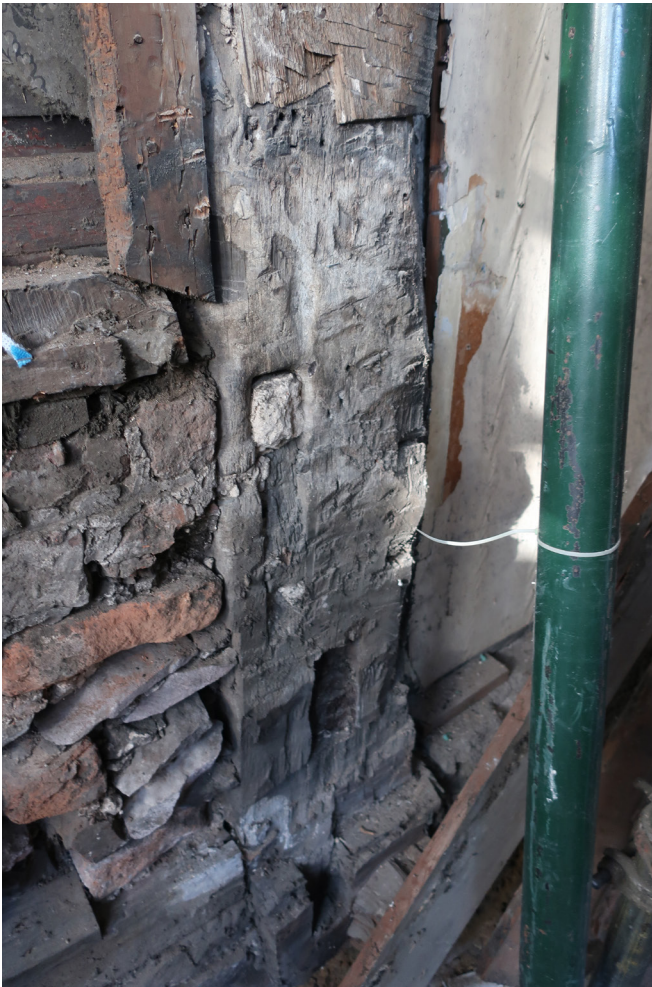
Figure 19: The north post of the central frame (frame B), surviving at ground-floor level in the partition between Nos 39 and 41, looking east. [Rebecca Lane © Historic England]

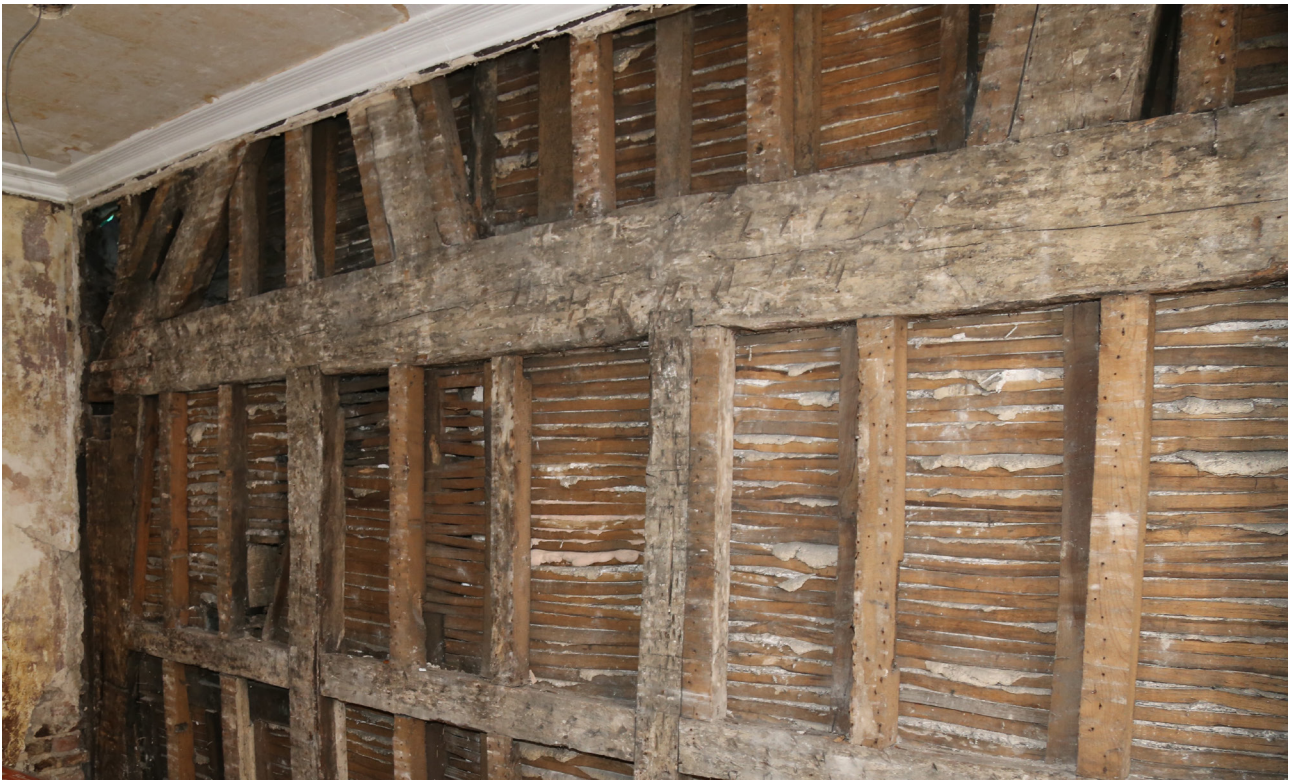
Figure 21: The central frame, showing the junction of the tie beam and principal rafter at the northern end, with a redundant mortice for a wind brace, looking west.[© Andrea Kirkham. Reproduced with permission]

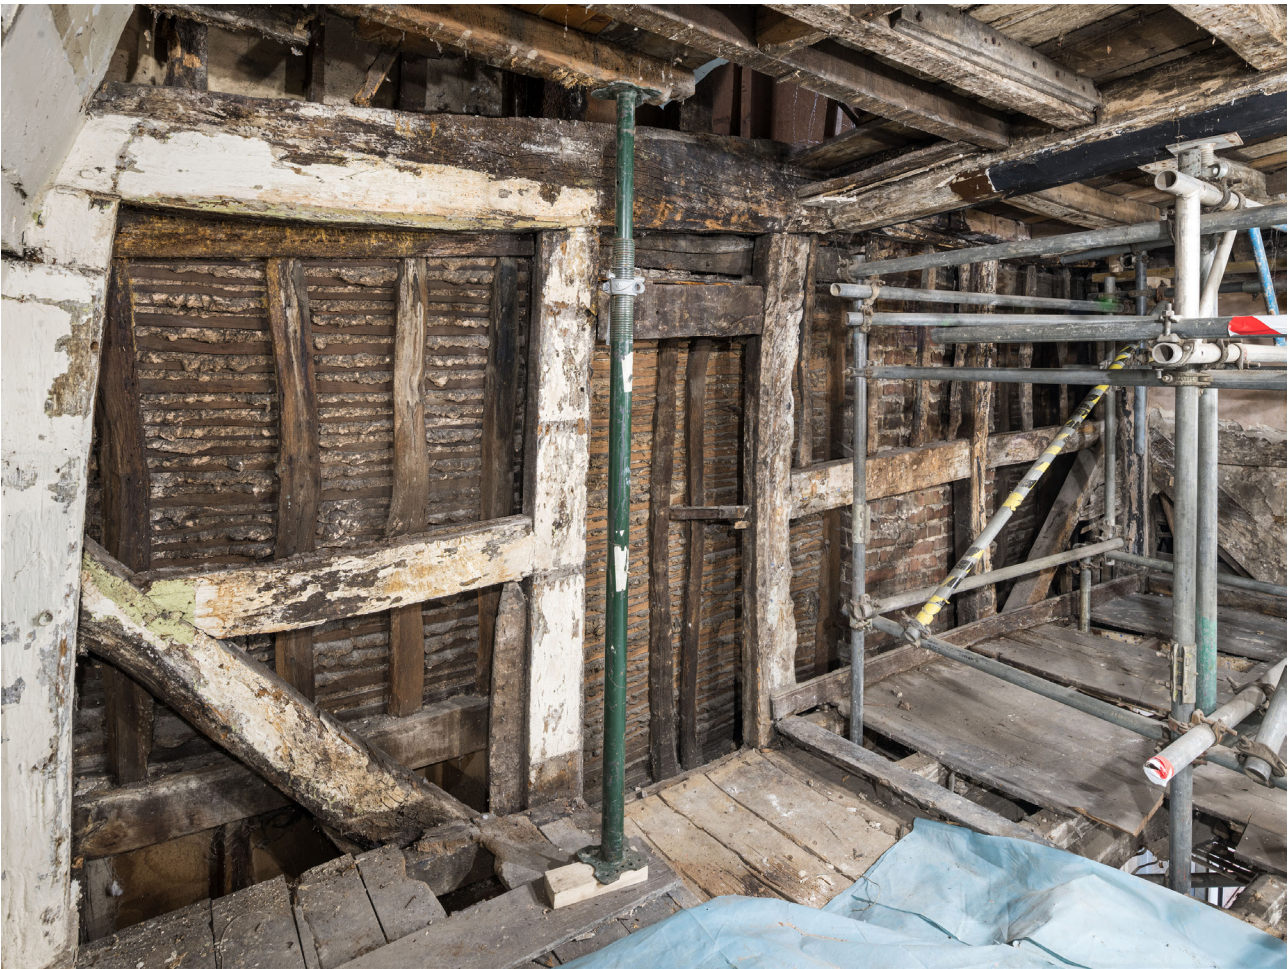
Figure 23: The western frame (Frame C) showing the surviving original framework at first-floor level, looking north-west. [Steve Baker © HEA DP325697]

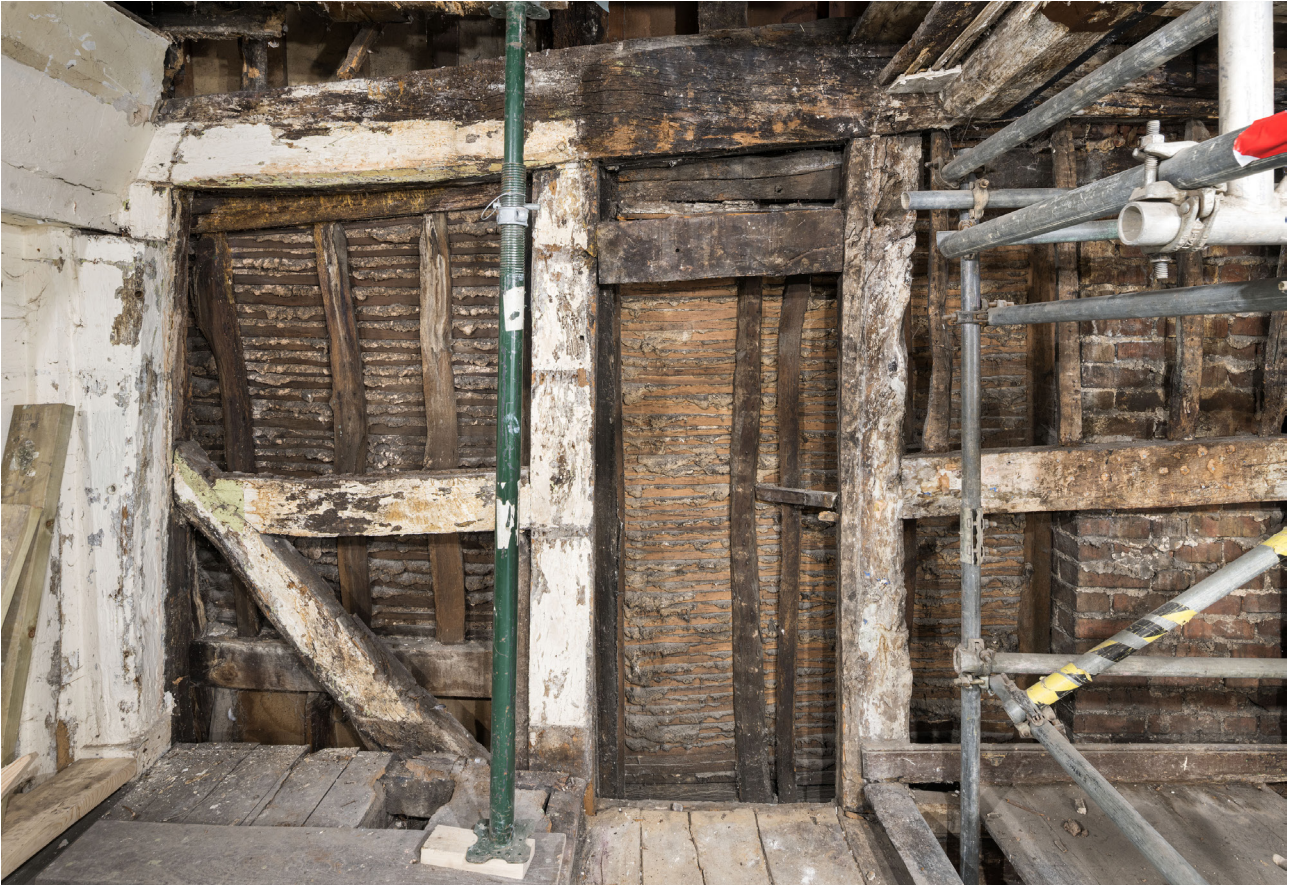
Figure 24: The southern section of the western frame (Frame C), showing the original doorway opening at first-floor level, looking west. [Steve Baker © HEA DP325698]

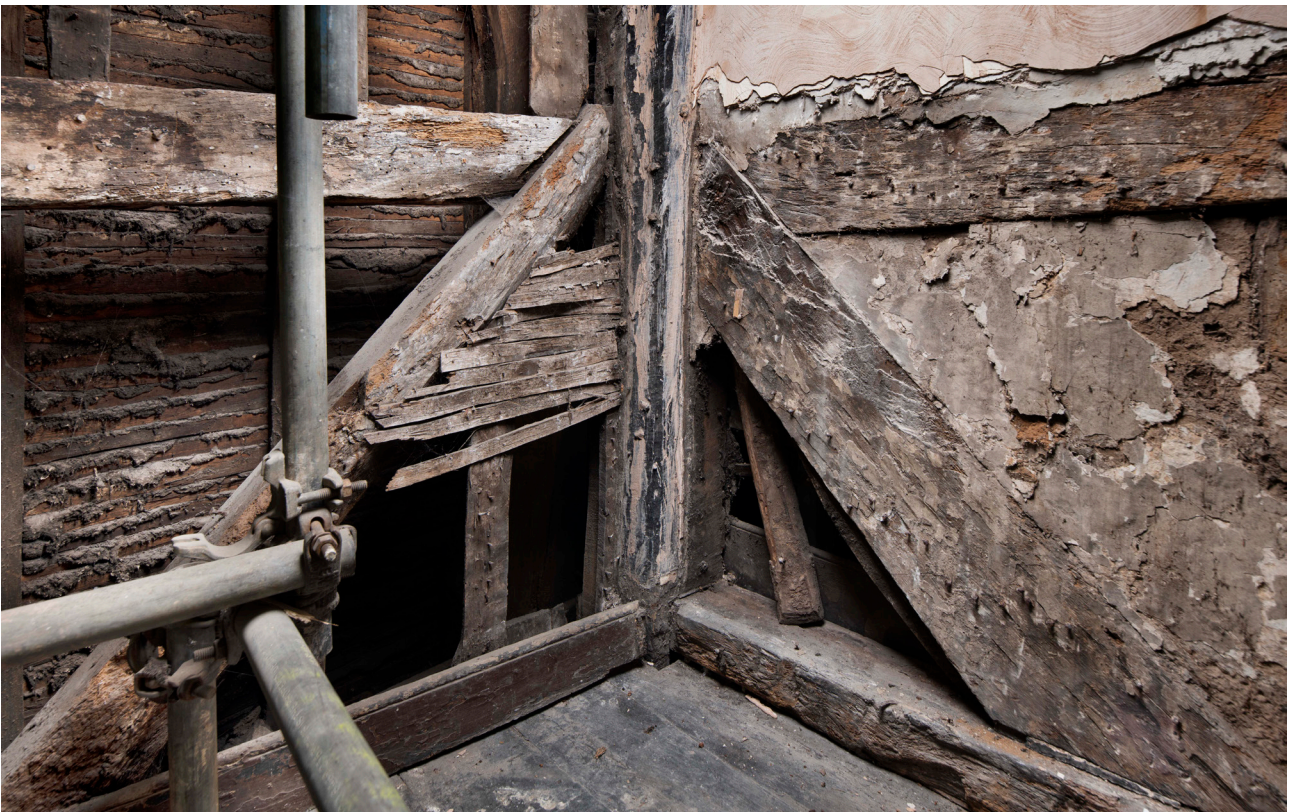
Figure 25: The corner brace at the north end of the western frame (Frame C), with the brace on the north elevation also shown, looking north-west. [James O. Davies © HEA DP435496]

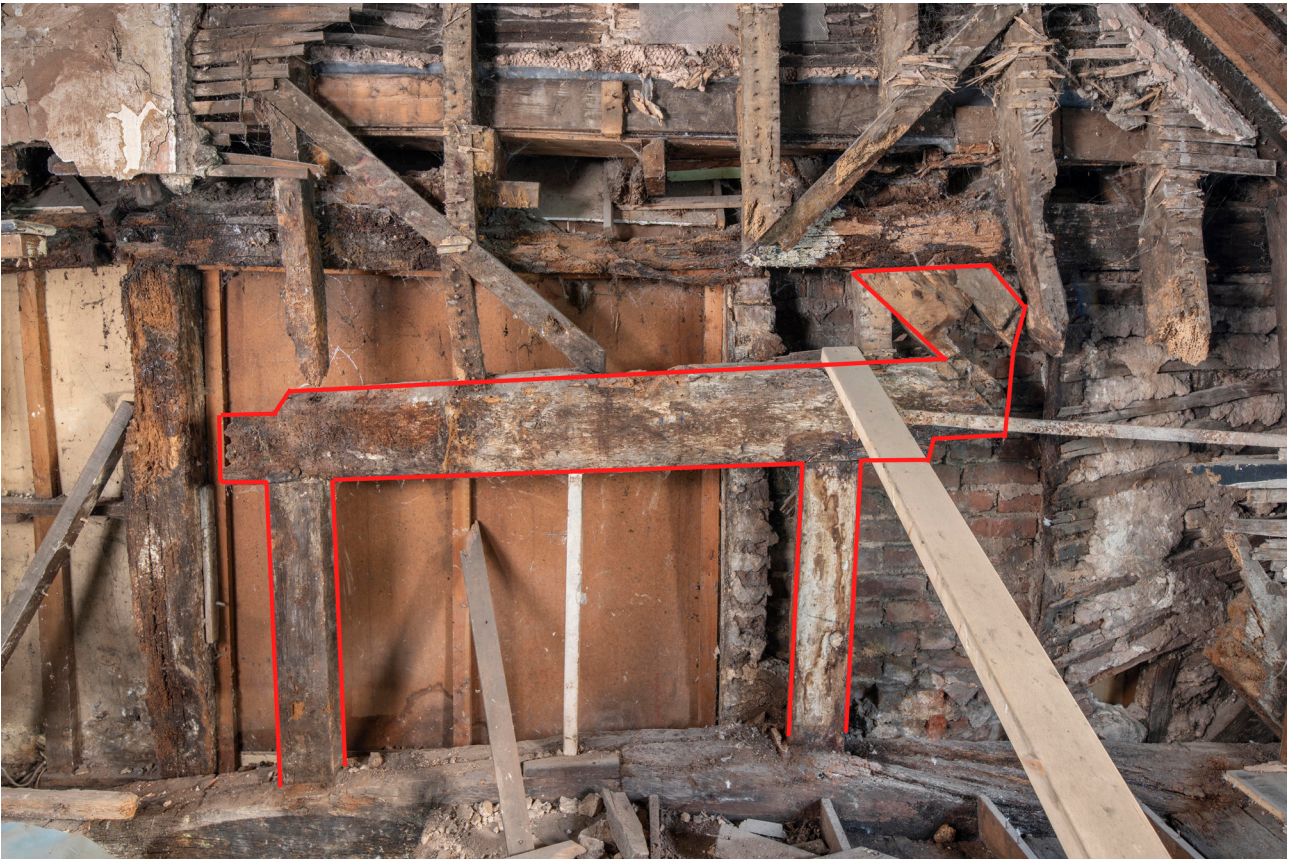
Figure 26: The surviving elements of the roof truss of frame C, with collar, two queen struts and part of the principal rafter outlined in red, looking west. [James O. Davies © HEA DP435502]

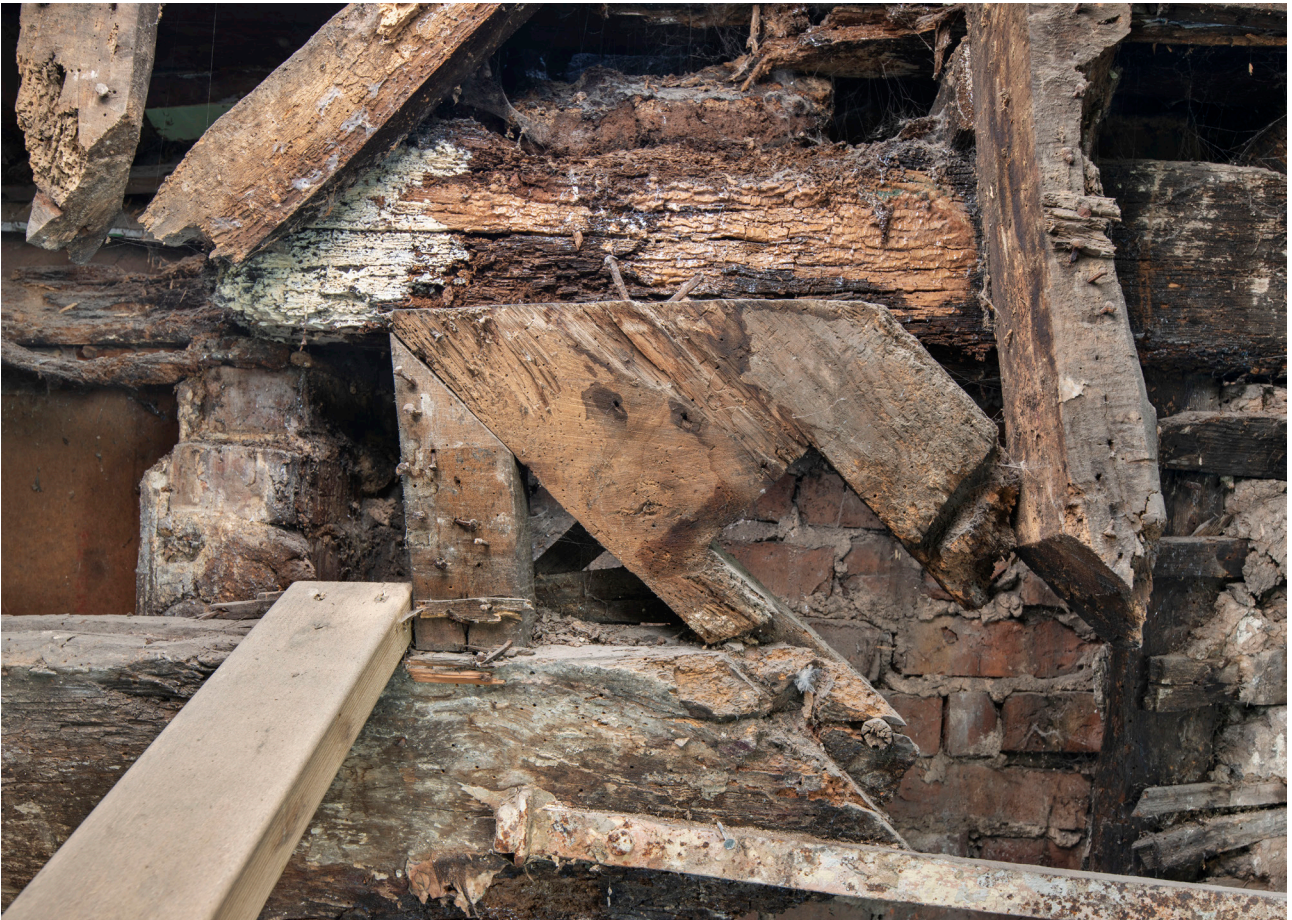
Figure 27: The small section of the surviving north principal rafter where it meets the surviving collar, with a redundant mortice for the purlin, looking west. [James O. Davies © HEA DP435503]

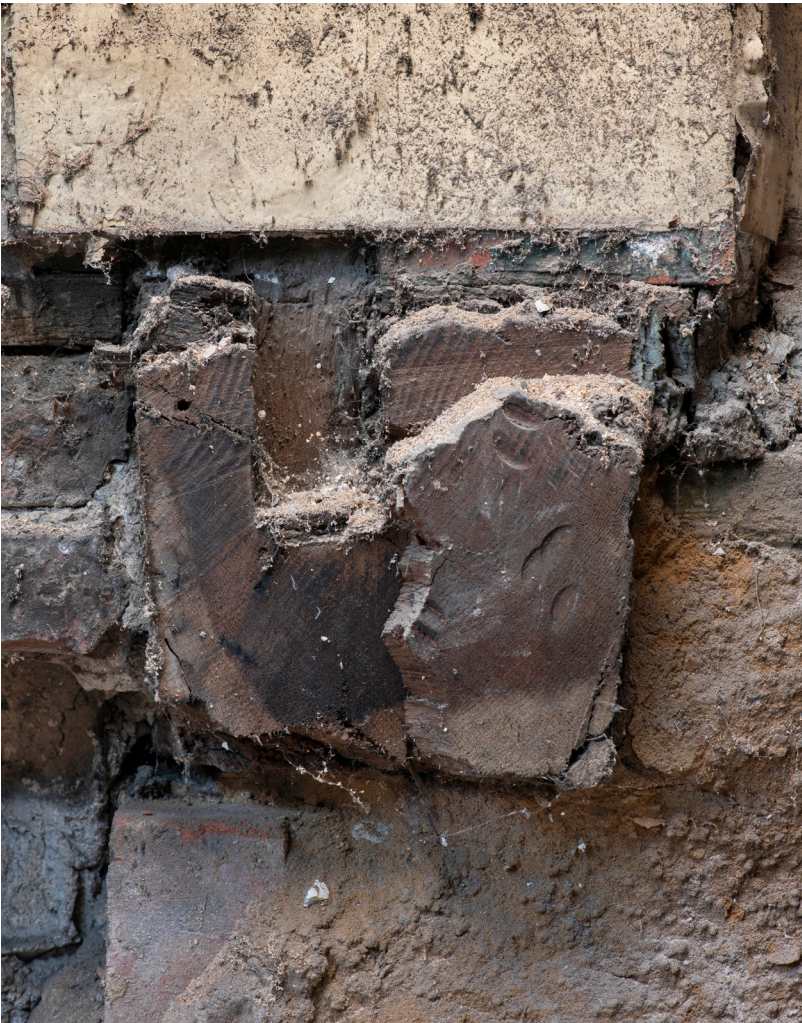
Figure 29: Sawn off end of the sill beam of the north elevation, visible from the western bay (now No. 41), looking east. [James O. Davies © HEA DP435523]

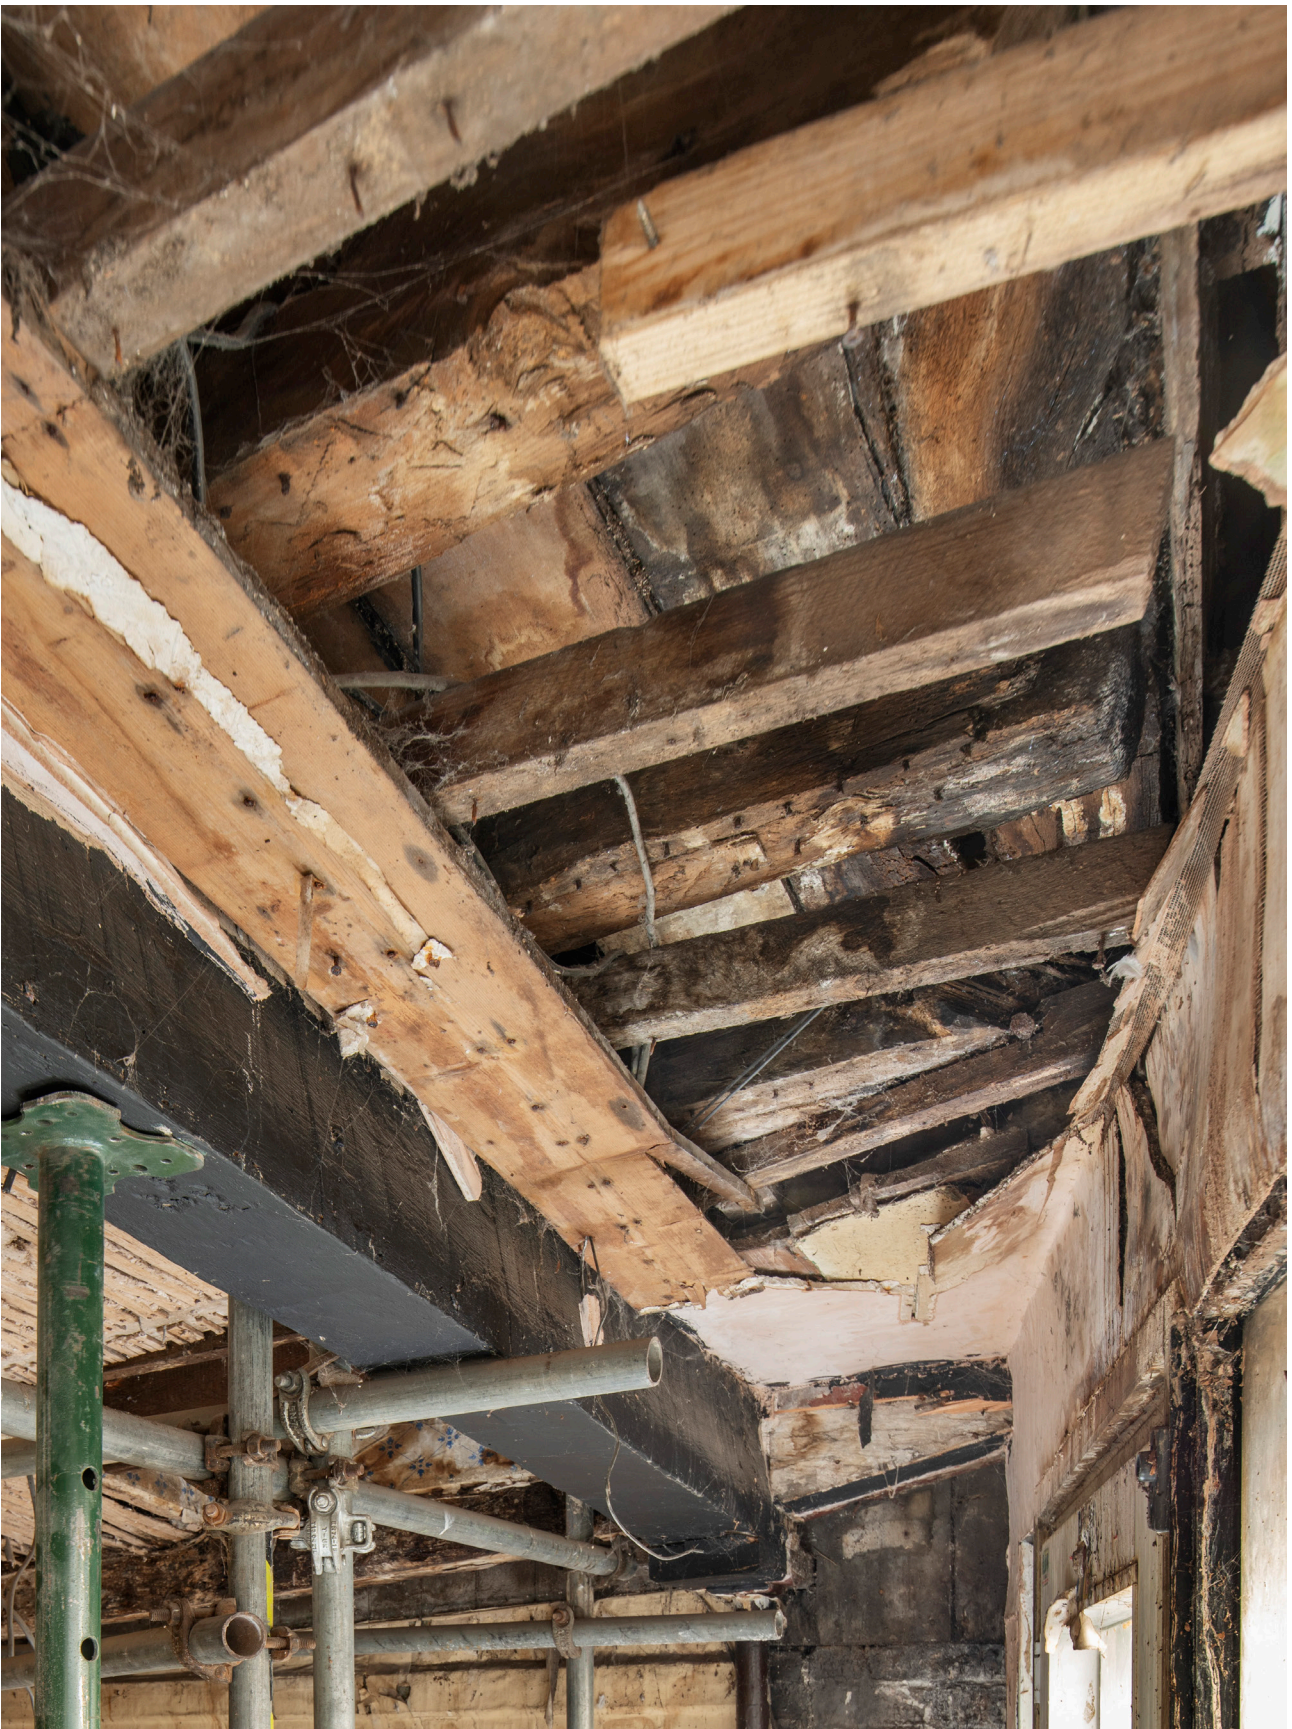
Figure 30: The jetty bressummer (painted black) and projecting joists, now within the front area of the western bay (No. 41), looking west. [James O. Davies © HEA DP435521]

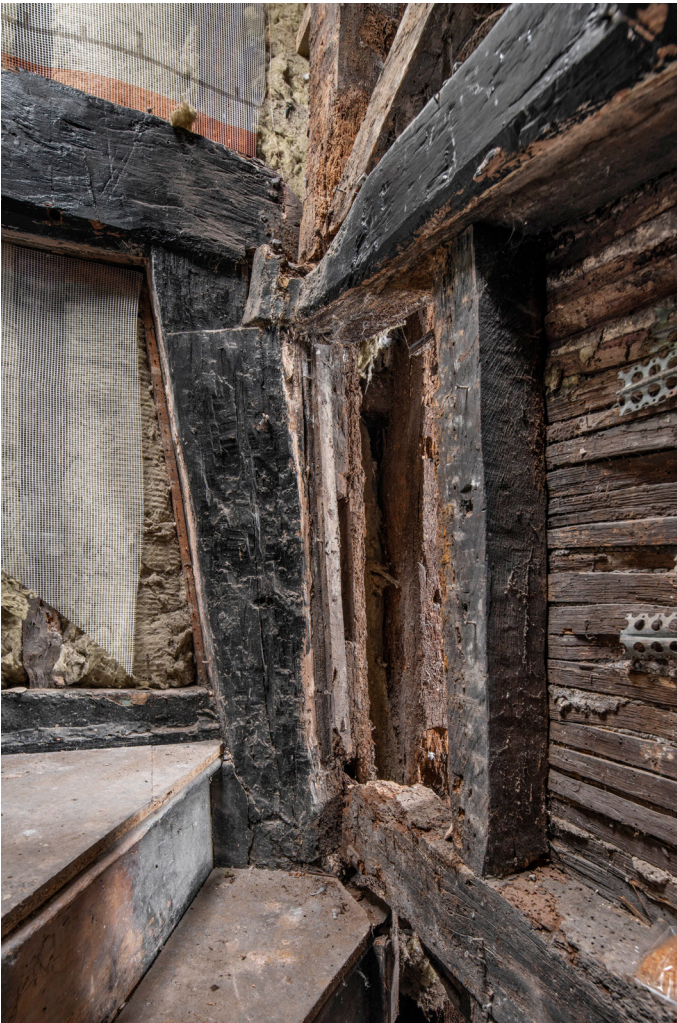
Figure 31: The south post of the central frame, showing redundant mortice for an up-brace, with later framing of the south elevation now projecting from it, looking south-east. [James O. Davies © HEA DP435492]

On the south elevation the west bay has been much more substantially altered, with much of the timber framing replaced, probably when the additional range to the rear was added (see Phase Four). At ground-floor level the frame of this elevation is now open, with no indication of the original framing arrangement visible. It is likely that originally there was a doorway opening in the elevation, facilitating access to the rear yard. At first-floor level there is some surviving evidence for the original form of the frame, despite the later alterations. The residual joint on the top of both the southern posts of the cross frames shows the original line of the wall plate, but the original timber has been replaced with a later, thinner timber (Figure 31). A short section of the mid-rail survives jointed into the

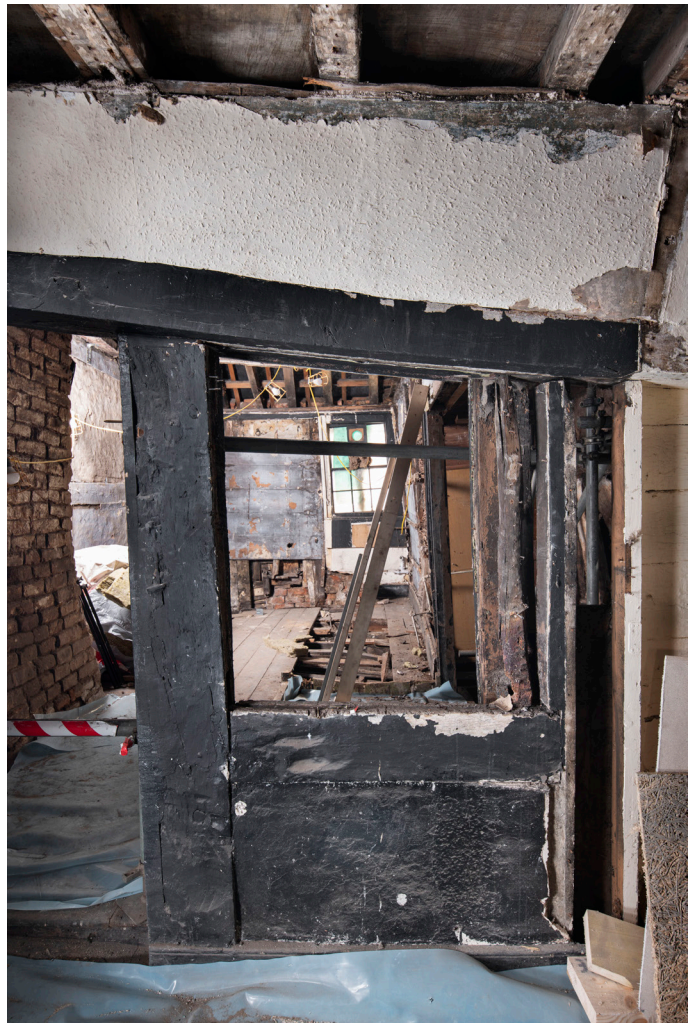
Figure 32: The later framing at the west end of the south elevation (No. 41), showing an original vertical stud reused in the elevation, looking south. [James O. Davies © HEA DP435491]

Apart from the south-east corner of the bay, the remainder of the south elevation has been replaced (Figure 32). One full-height stud, surviving towards the centre of the bay, may be a reused early timber, but it is not in its original position, as it has no mortices for a mid-rail at the right level for the elevation. It is likely that the original arrangement of the walling was similar to the front elevation, with two full-height studs running down from the wall plate and a mid-rail running in between.

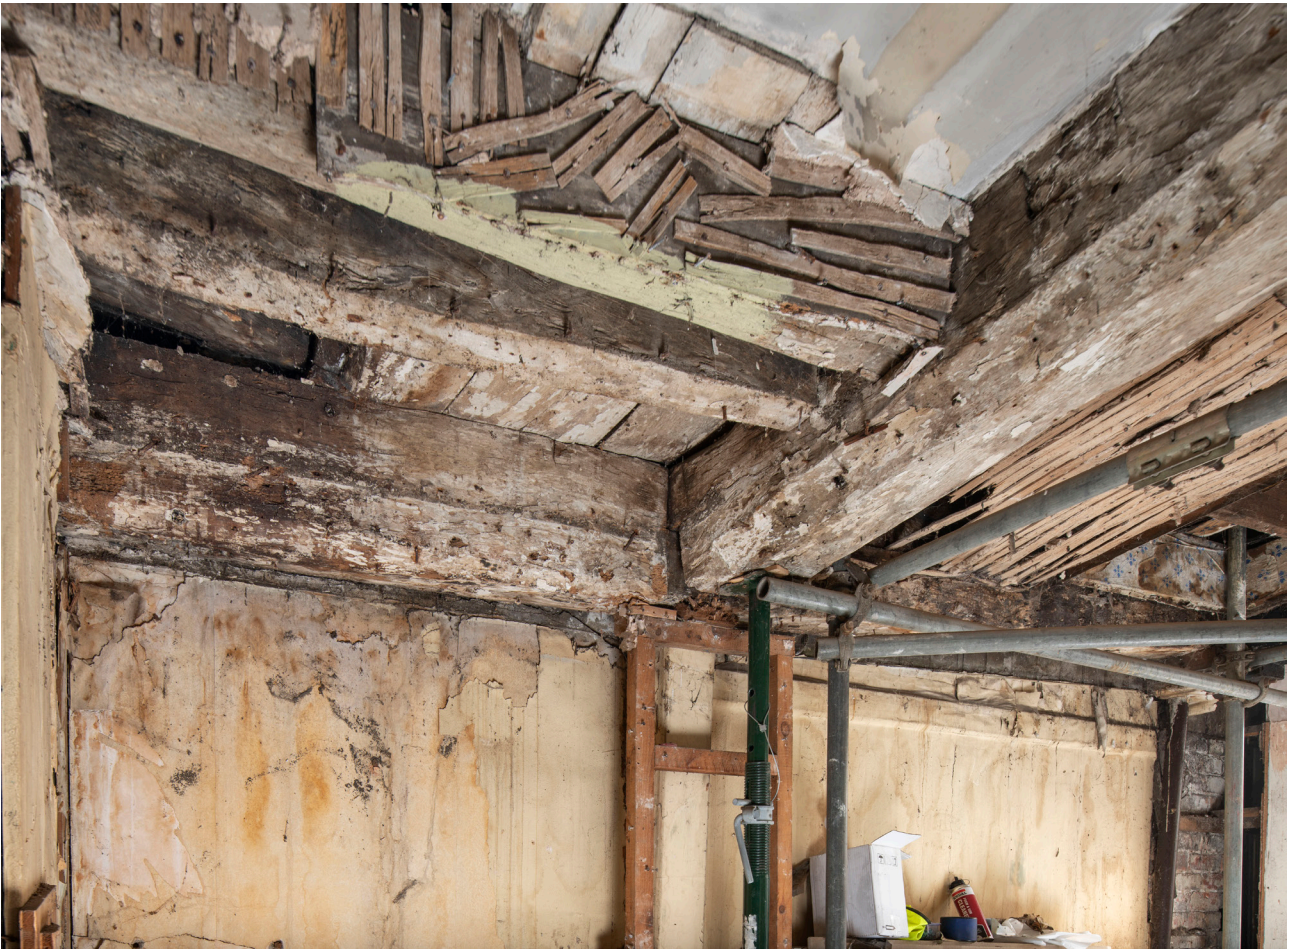
Figure 33: The main longitudinal beam in the western bay (No 41), where it meets the western frame (Frame C), showing simple chamfer moulding and straight-cut chamfer stop, looking north-west. [James O. Davies © HEA DP435518]

Within the western bay (now No. 41), a significant amount of the original ceiling arrangements remains at both levels. At ground-floor level a longitudinal beam runs across the bay supporting the floor joists. To the north the joists are original and run out to form the jetty. To the south the joists have been replaced at a later date. The beam is chamfered, with straight-cut stops (Figure 33). At first-floor level a similar lateral beam survives, with the same chamfer arrangement, although the stop is slightly different – apparently with a stepped form (although later damage has made the overall form less clear; Figure 34). This indicates that as built the first floor was ceiled over, to form a further room at second-floor level within the roof space. Initially this second-floor room must have been a relatively restricted space, as the original lower roof level would not have provided much head room, but it would have been sufficient for use for a sleeping chamber or for storage. The original arrangement of the central truss, with two raking queen struts rather than a queen strut and collar arrangement, would also have facilitated access between the two bays at this level (see above).
