39-41 Westgate Street, Gloucester

Historic Building Investigation

Historic Buildings Investigation

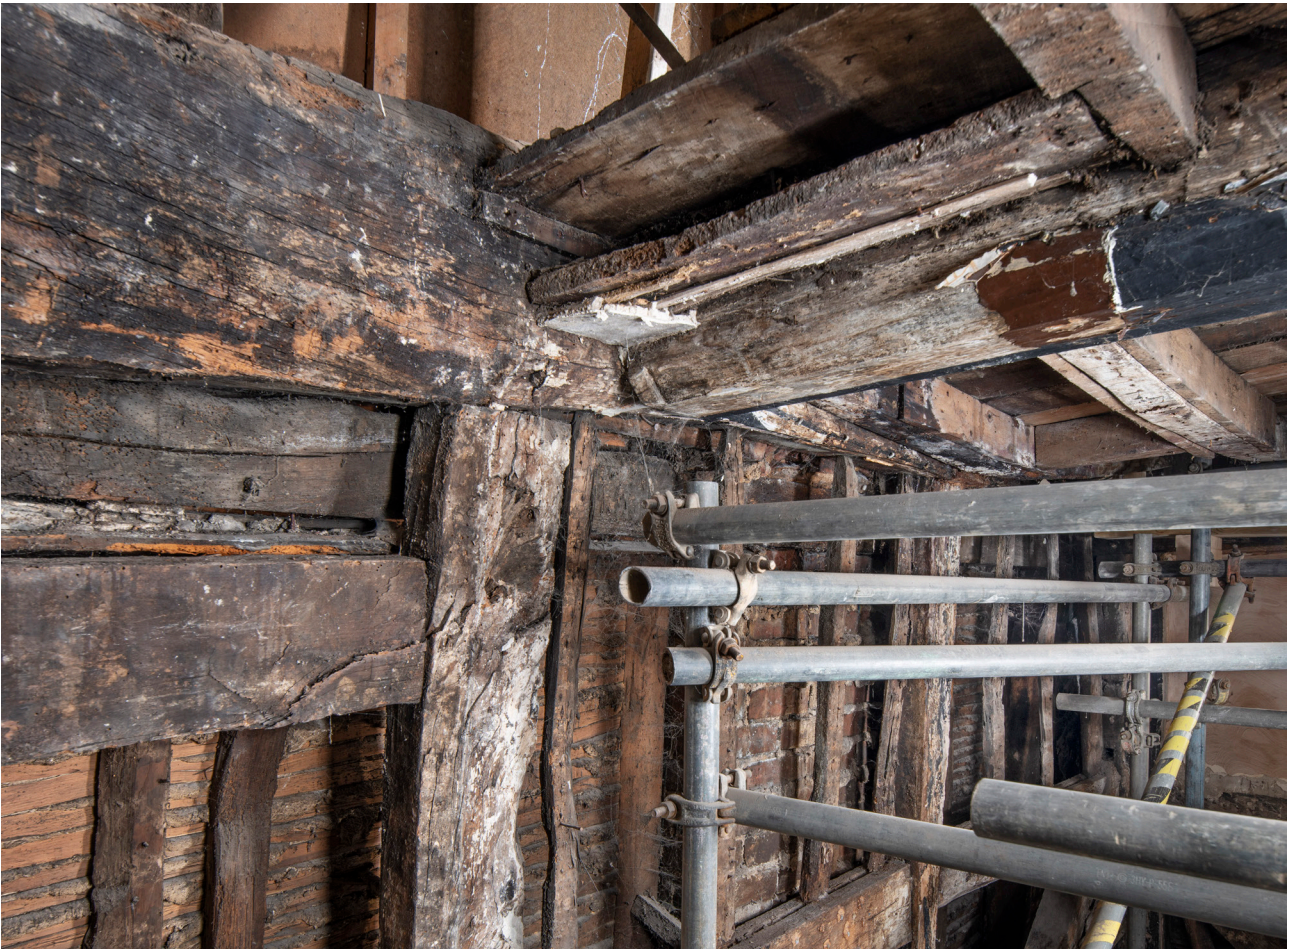
Figure 34: The ceiling arrangement at first-floor level in the western bay (No. 41), showing chamfer moulding to main beam with a stepped chamfer stop. [James O. Davies © HEA DP435495]

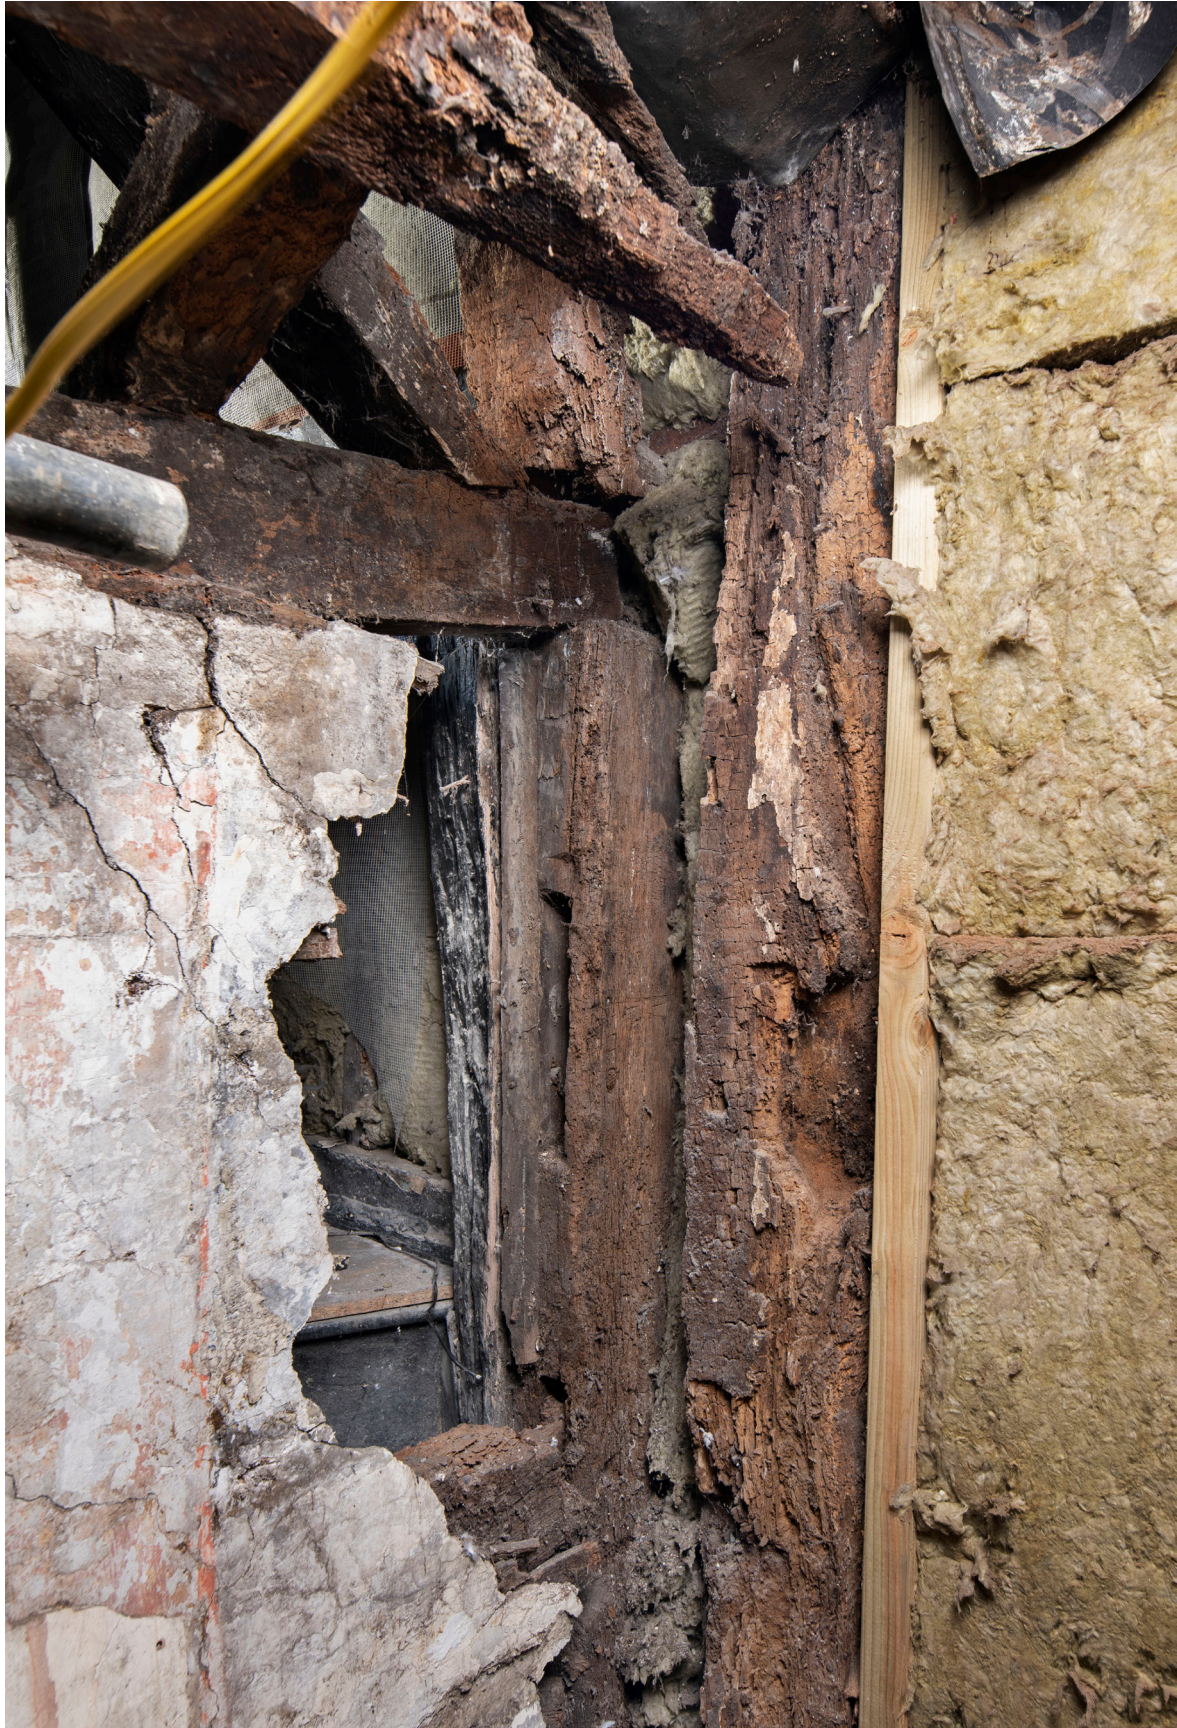
Figure 35: The south post of the central frame of the front range (Frame B), and the west post of the north frame of the rear range of No. 39 (Frame D), showing the later post butting up against the earlier one, looking north-east. [James O. Davies © HEA DP435485]

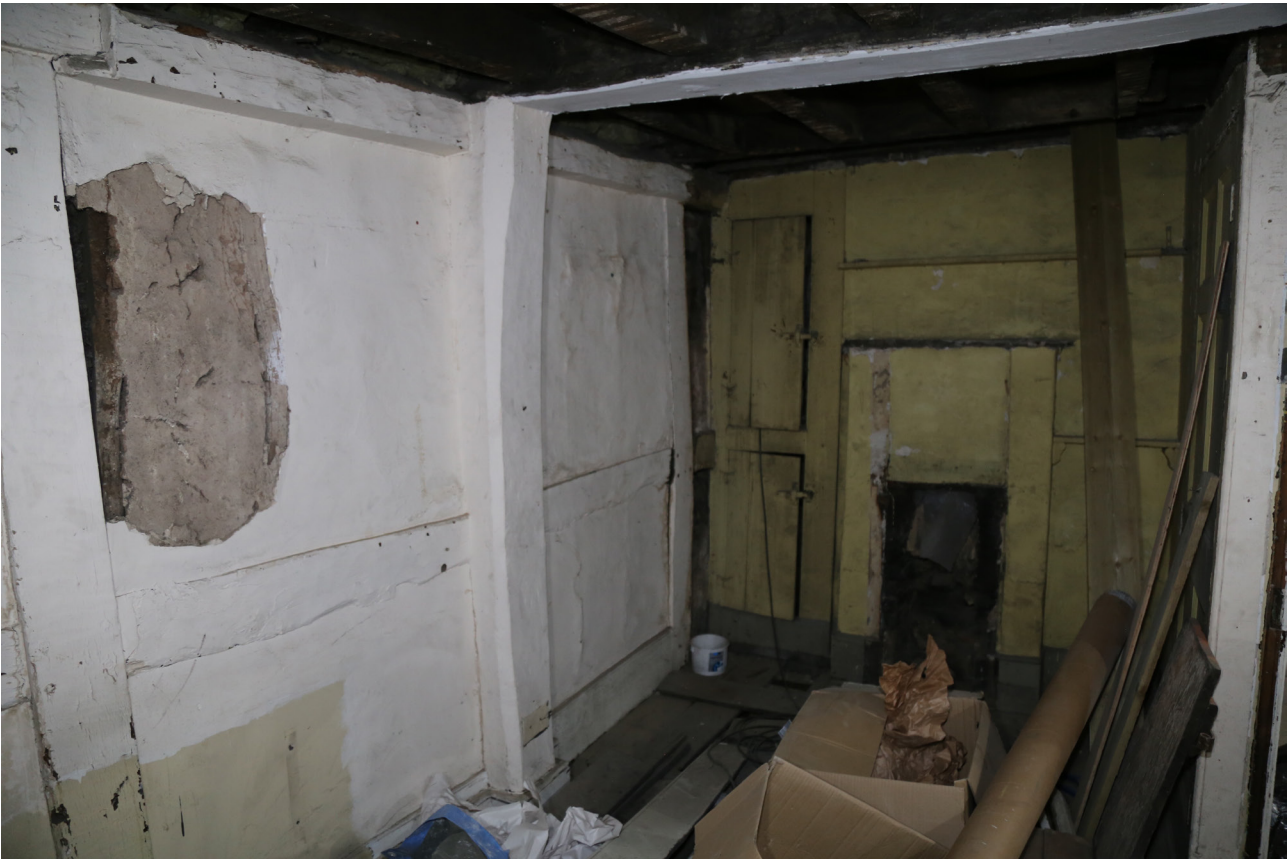
Figure 36: The west post of the central frame (Frame E) of the rear range of No. 39, also showing the box framing of the west wall of the range, and the later inserted chimney stack in the northern bay of the range, looking north-west. [© Andrea Kirkham. Reproduced with permission]

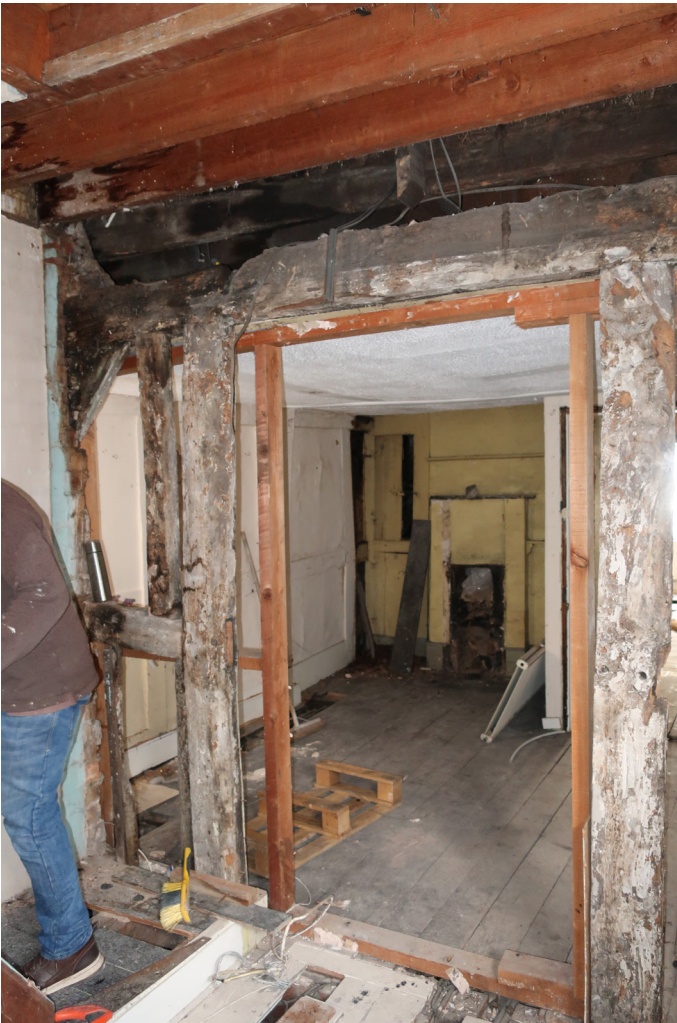
Figure 38: The southern frame of the rear range of No. 39, showing surviving framing at first-floor level, looking north-west. [Rebecca Lane © Historic England]

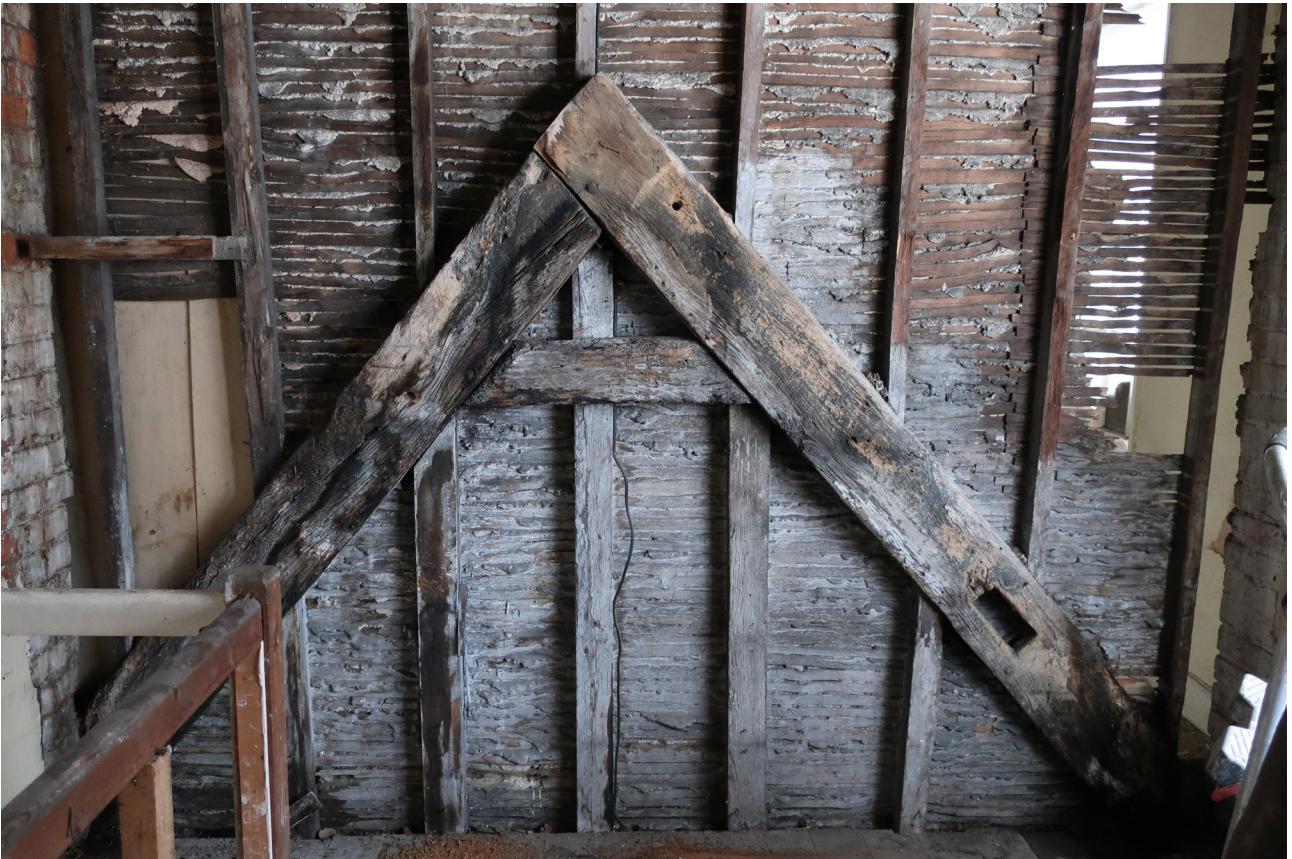
Figure 39: The upper part of the roof truss of the southern frame of the rear range of No. 39, looking north. [Rebecca Lane © Historic England]

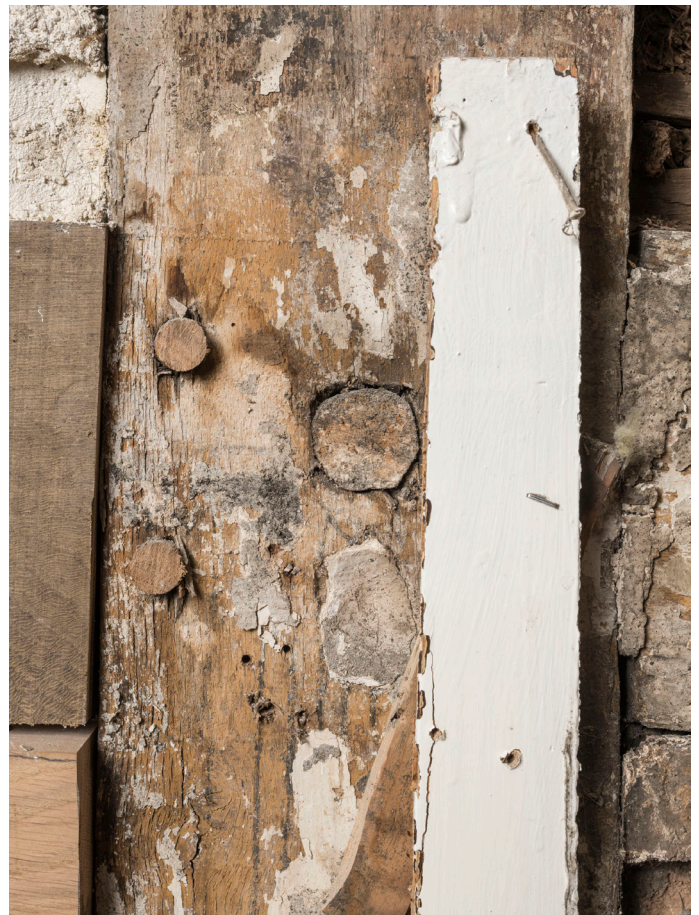
Figure 40: Face-peg on the timber frame of the east elevation of the rear range of No. 39, possibly to support original shelving, looking east. [Steve Baker © HEA DP464273]

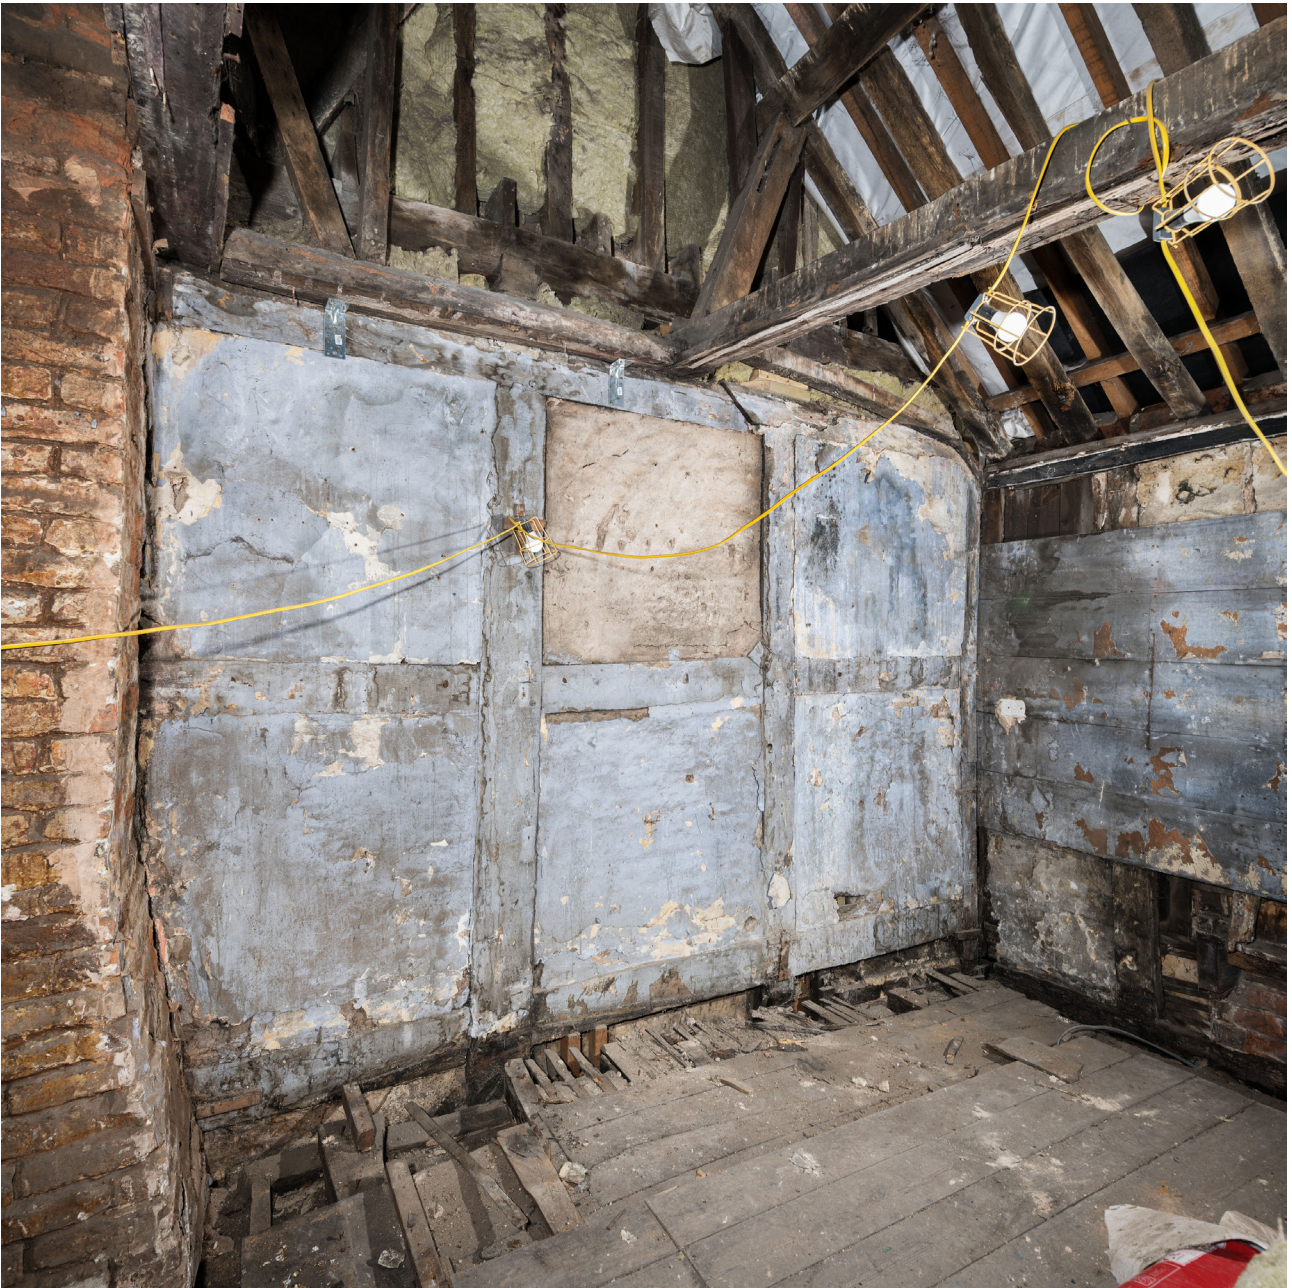
Figure 41: Framing of the west wall of the rear range of No. 39 (from within No. 41) showing box-frame form, looking south-east. [Steve Baker © HEA DP325694].

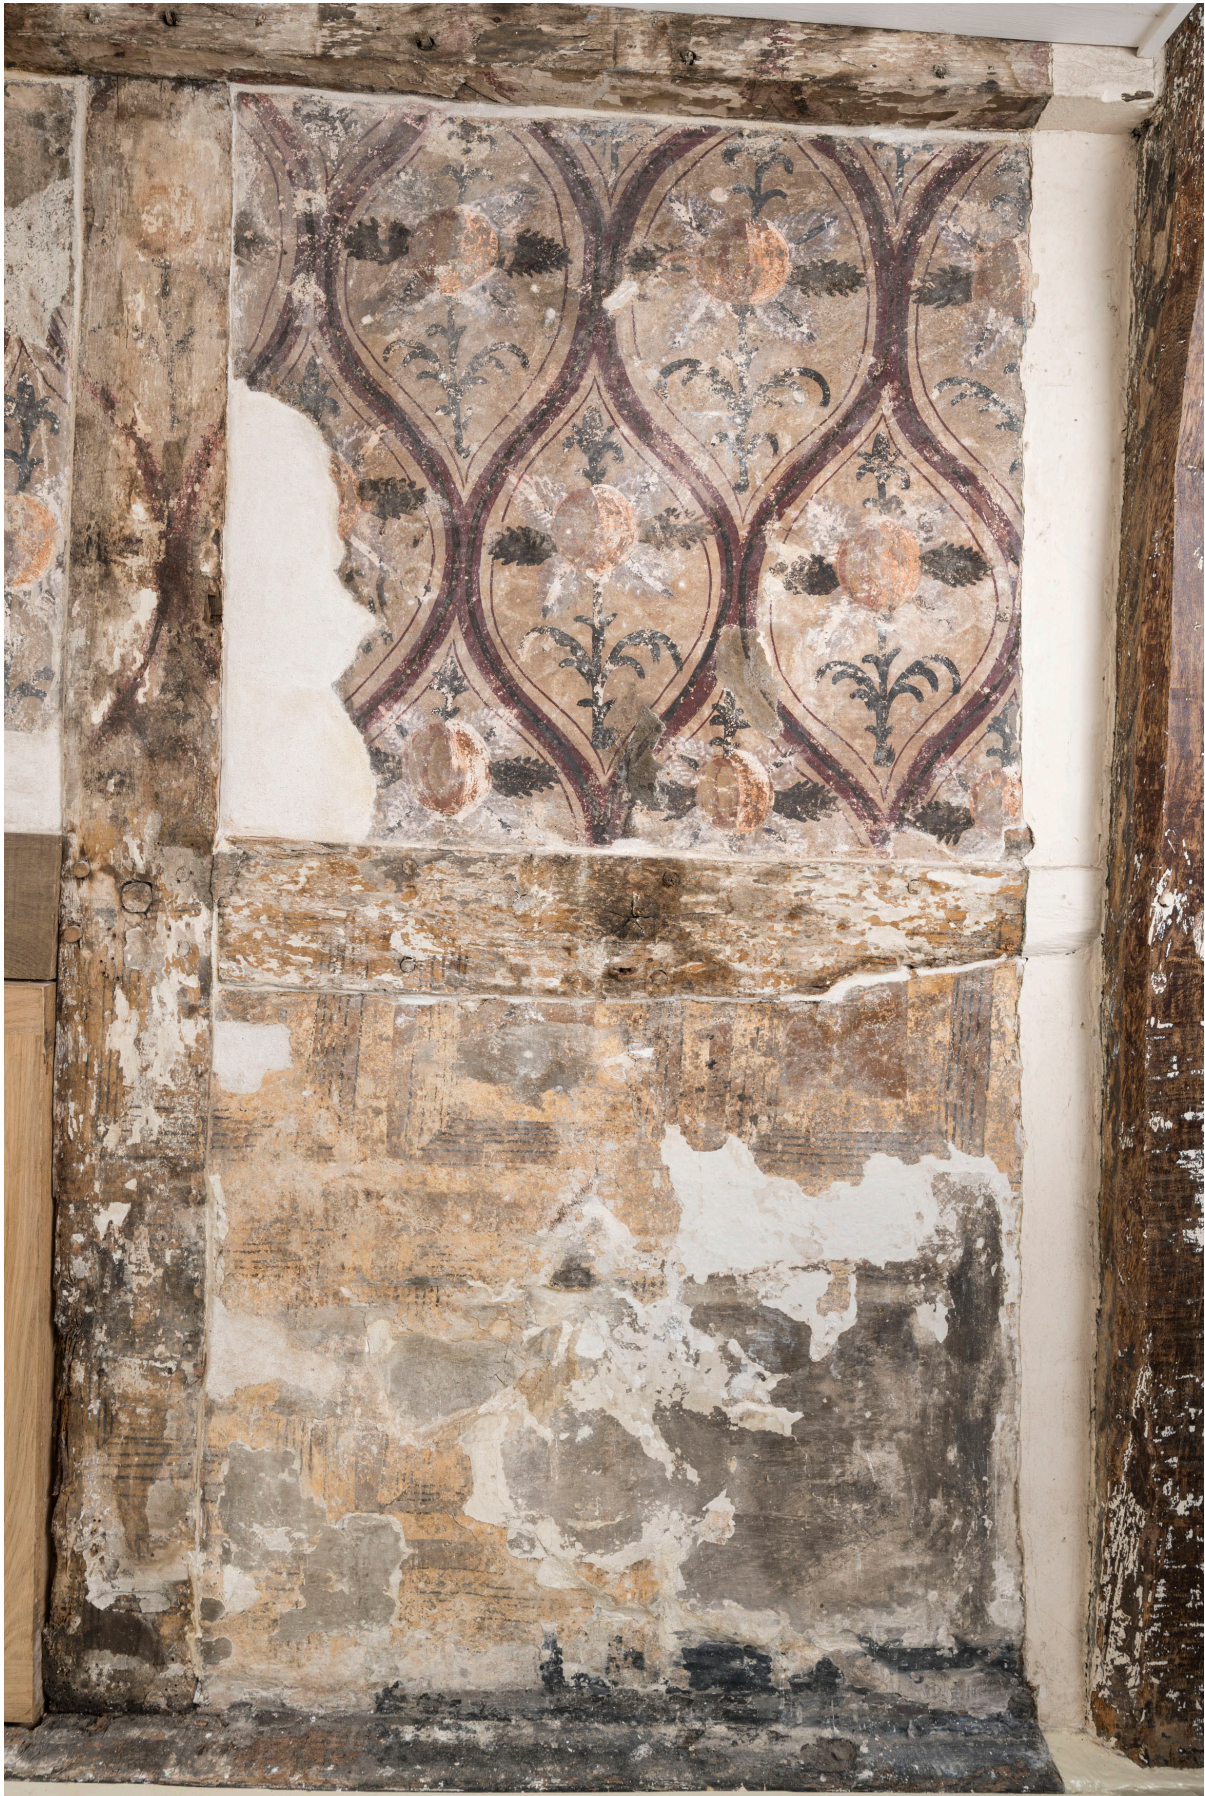
Figure 43: Painted wall scheme on the east elevation of the rear range, showing the imitation panelling on the bottom half and the lattice work above. [Steve Baker © HEA DP464281]

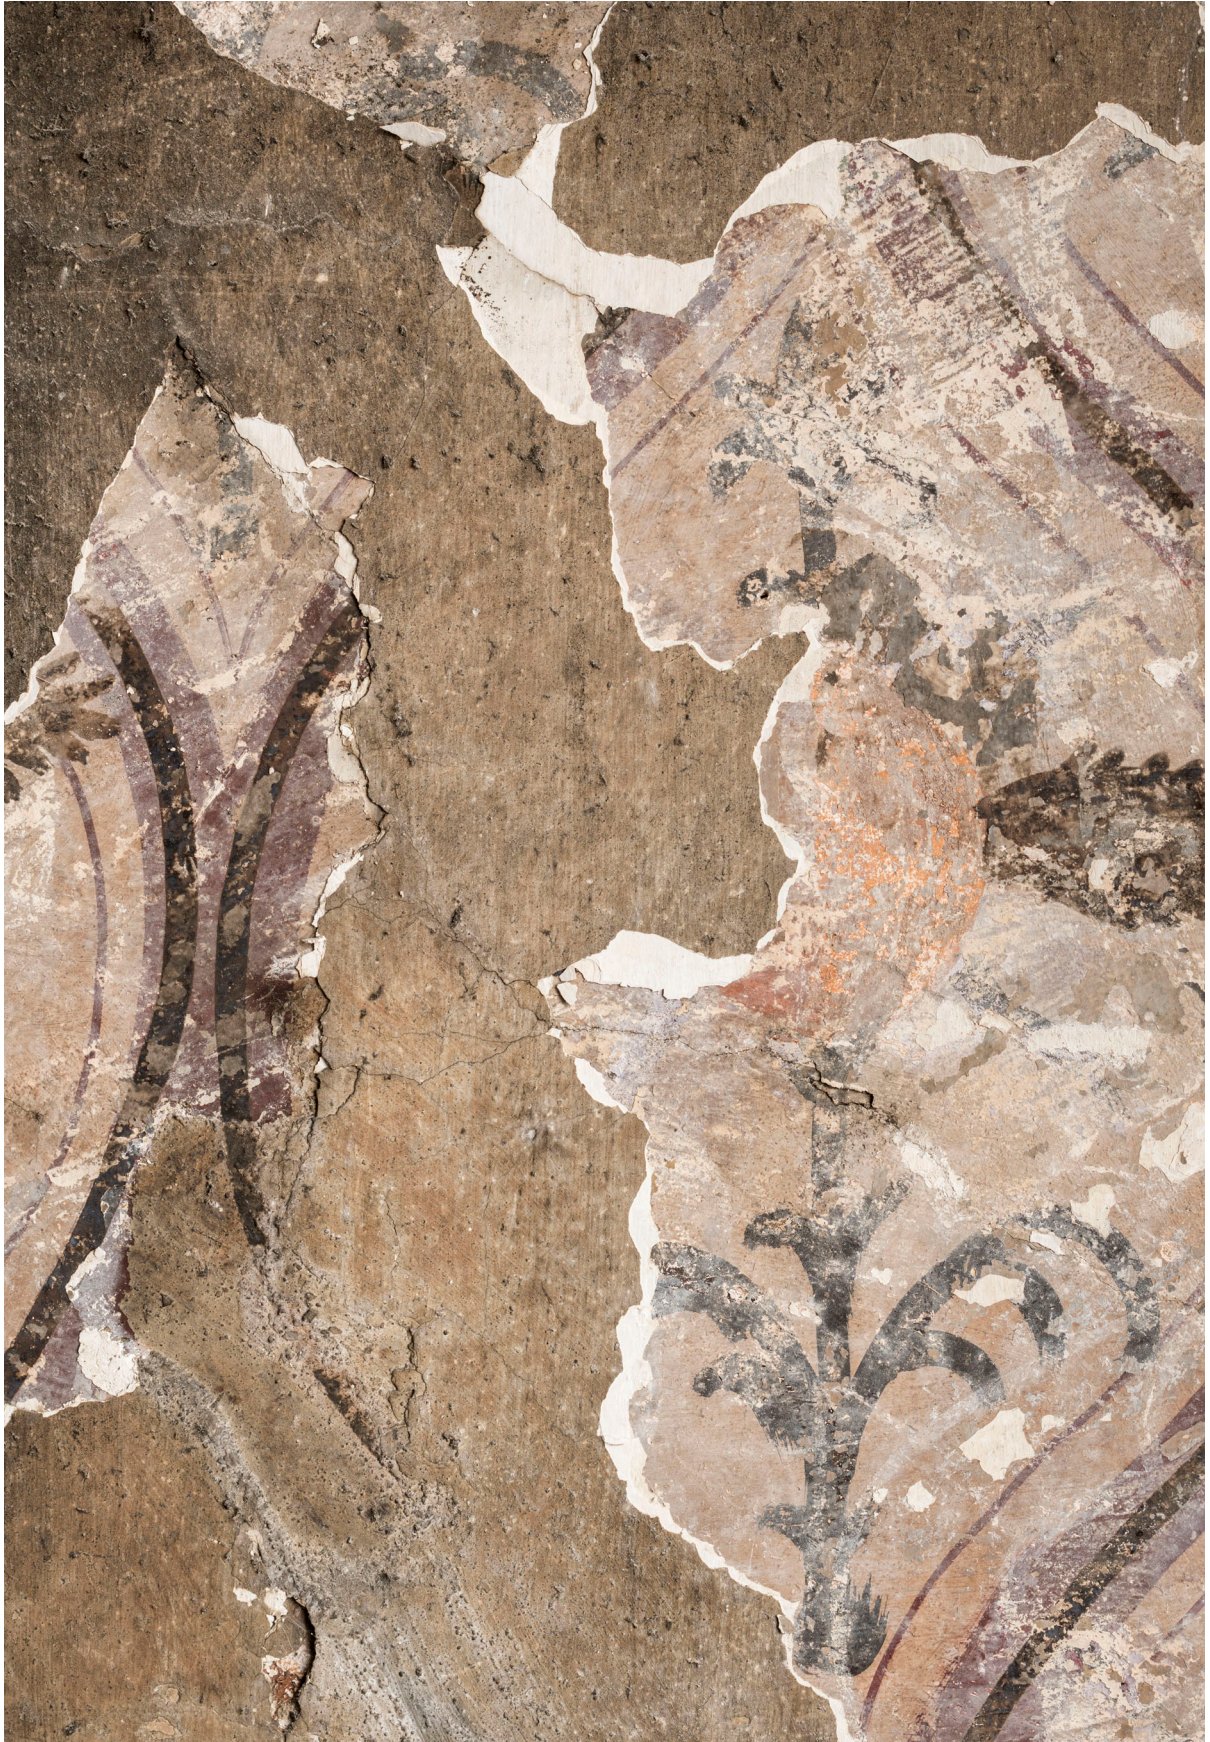
Figure 44: Detail of the scheme of late 16th century wall painting on the east elevation of the rear range of No. 39, showing the red lattice work with floral motif within. [Steve Baker © HEA DP464269]

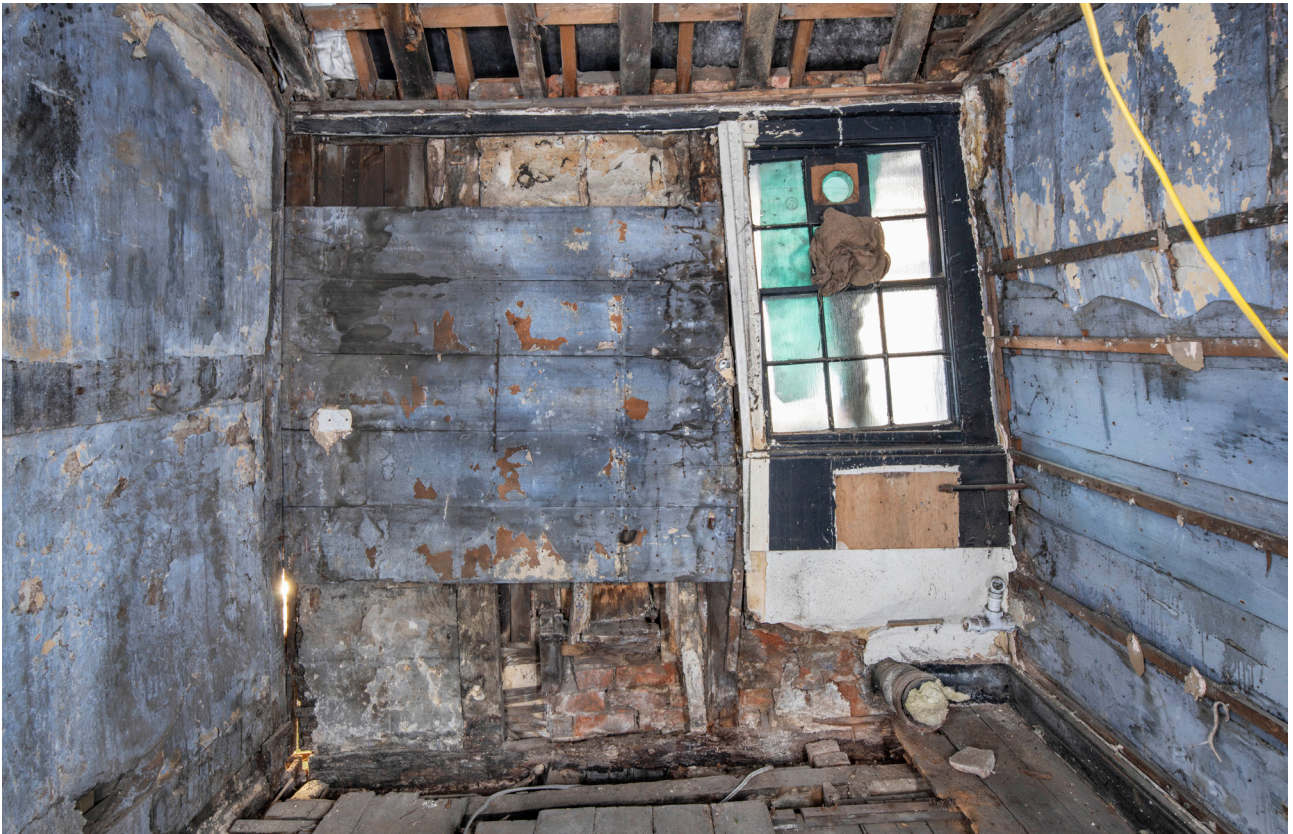
Figure 45: South elevation of the rear range of No. 41, showing framing and later timber boarding, looking south. [James O. Davies © HEA DP435478]

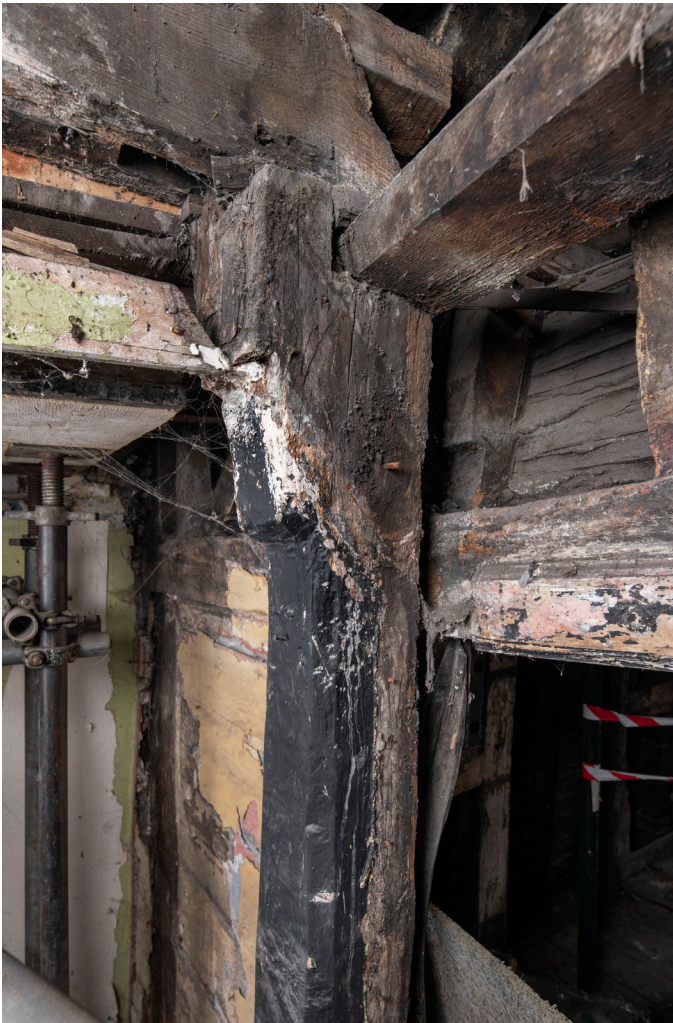
Figure 47: North post of the west elevation of the rear range of No. 41 (Frame G) showing the form of the jowl, which is typical of the 17th century, looking north-west. [James O. Davies © HEA DP435486]

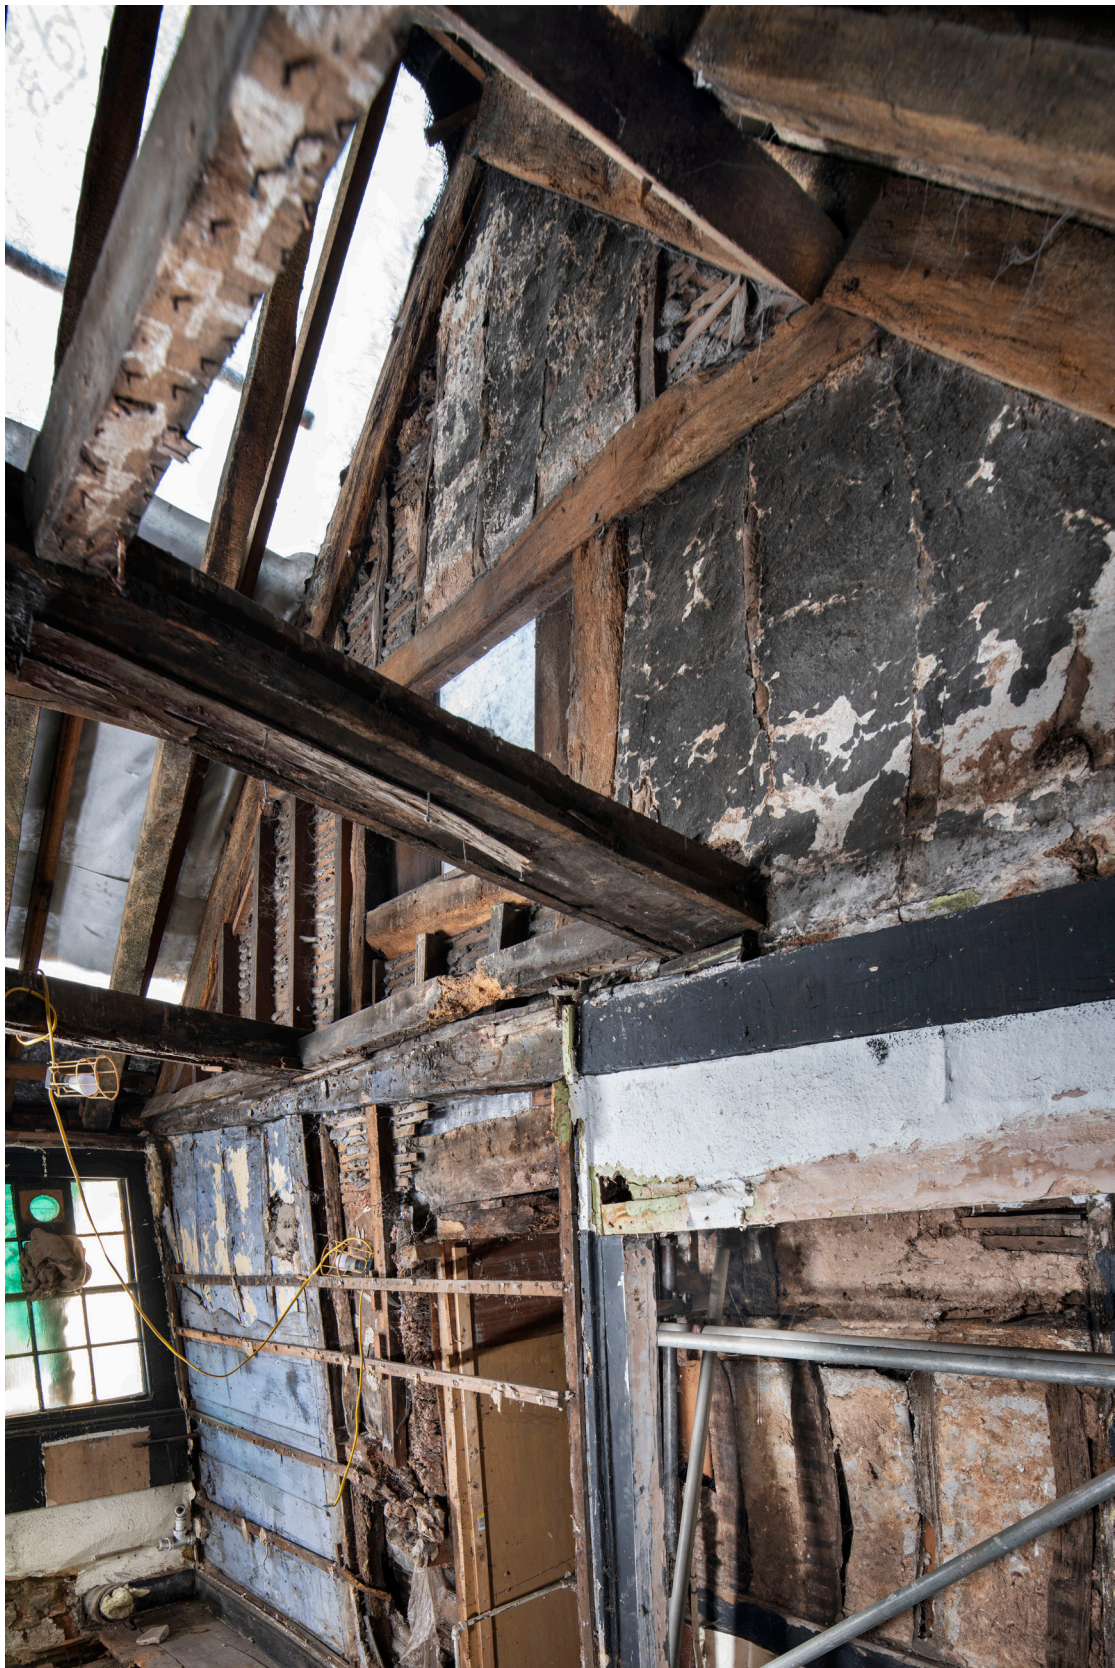
Figure 48: The gable end of the west elevation of the rear range of No. 41 (Frame G), looking south-west. [James O. Davies © HEA DP435488]

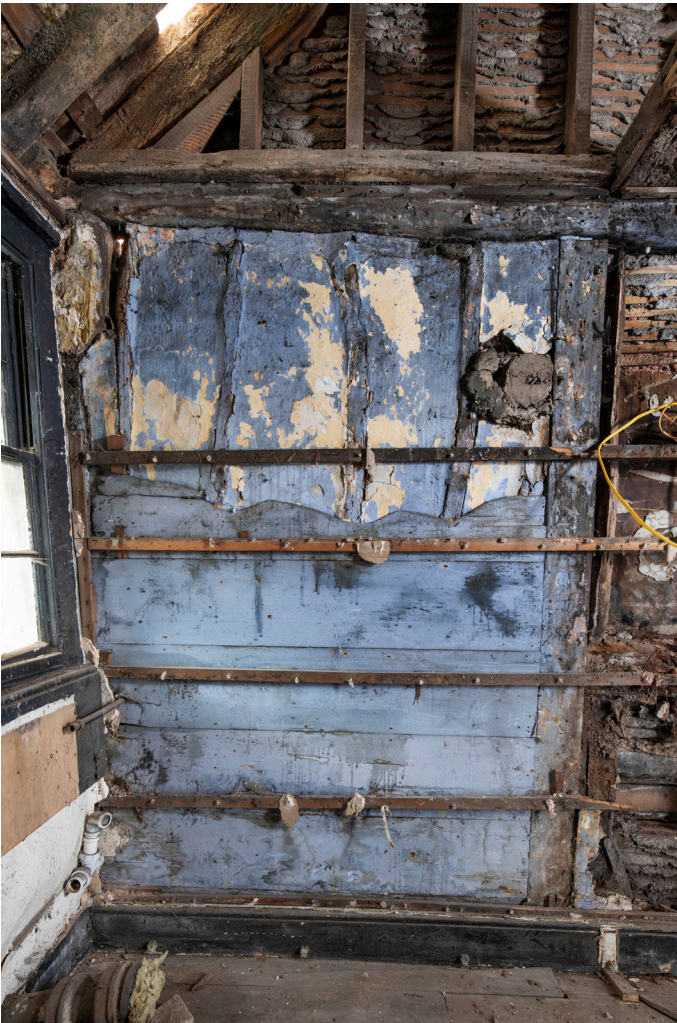
Figure 49: The south end of the west elevation of the rear range of No. 41 (Frame G), showing the original timber infill below the tie beam (partly hidden by later boarding) looking west. [James O. Davies © HEA DP435480]

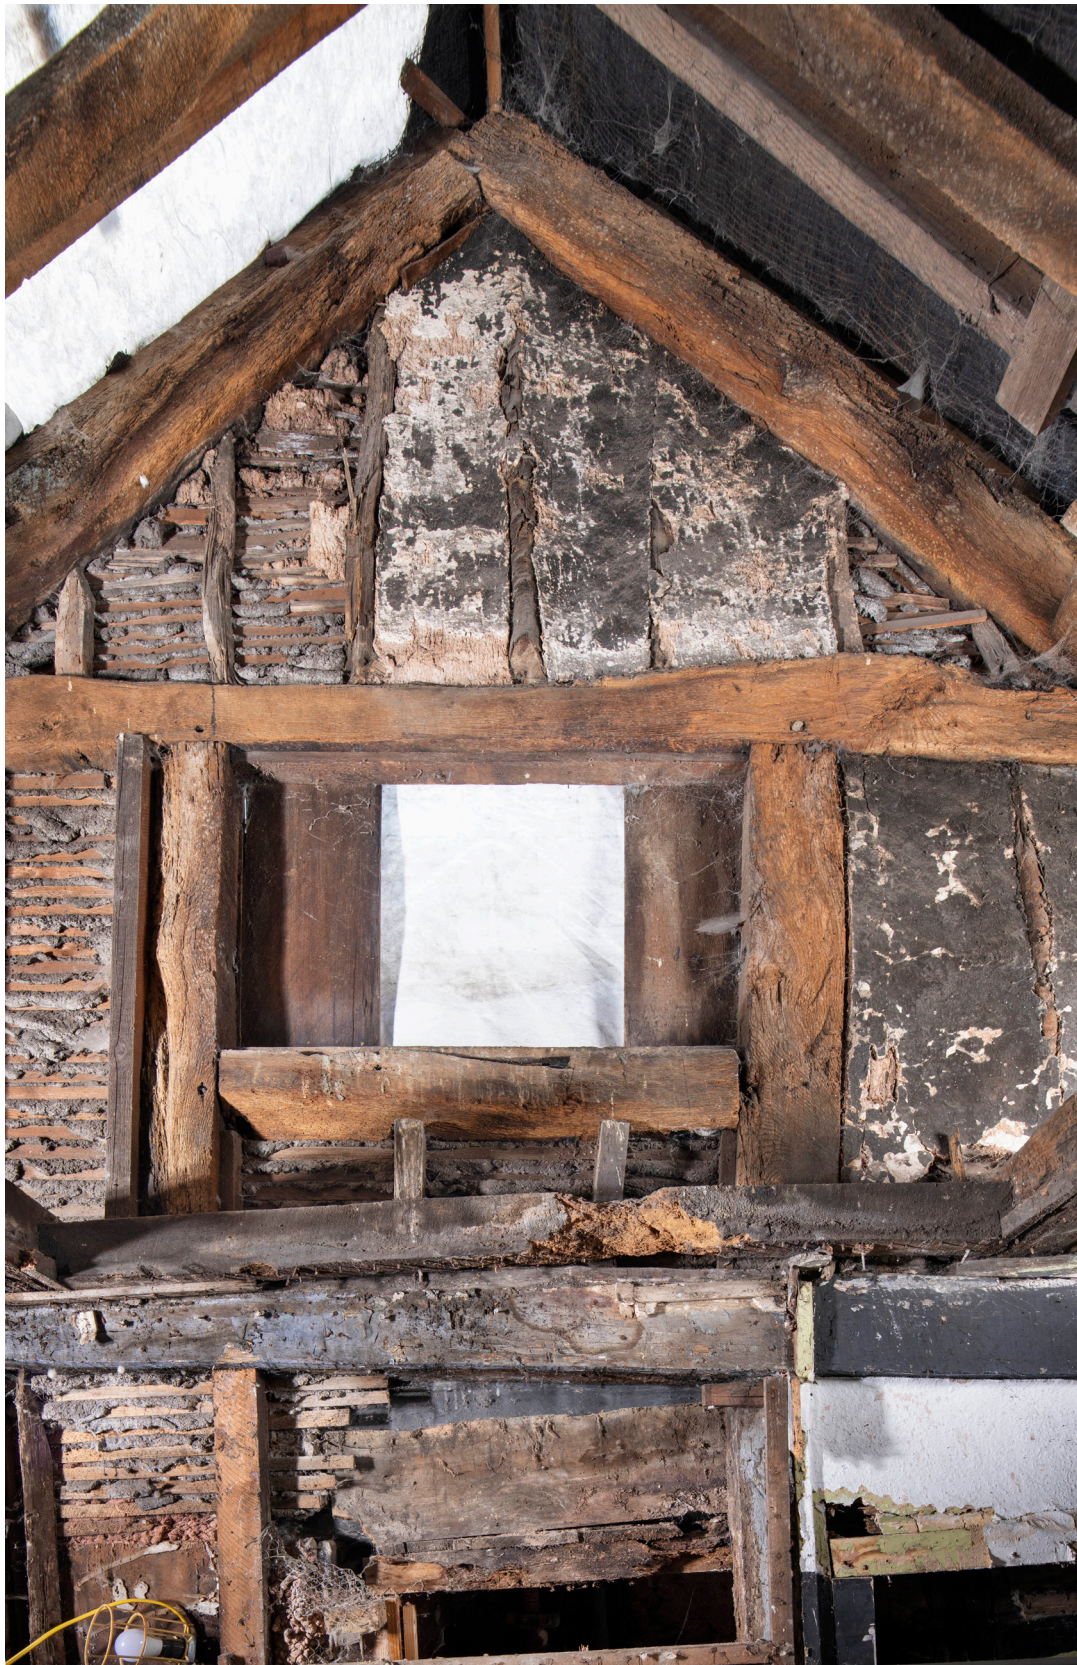
Figure 50: The gable end of the west elevation of the rear range of No. 41, showing the central window opening and original infill panels with staves to either side, looking west. [James O. Davies © HEA DP435482]

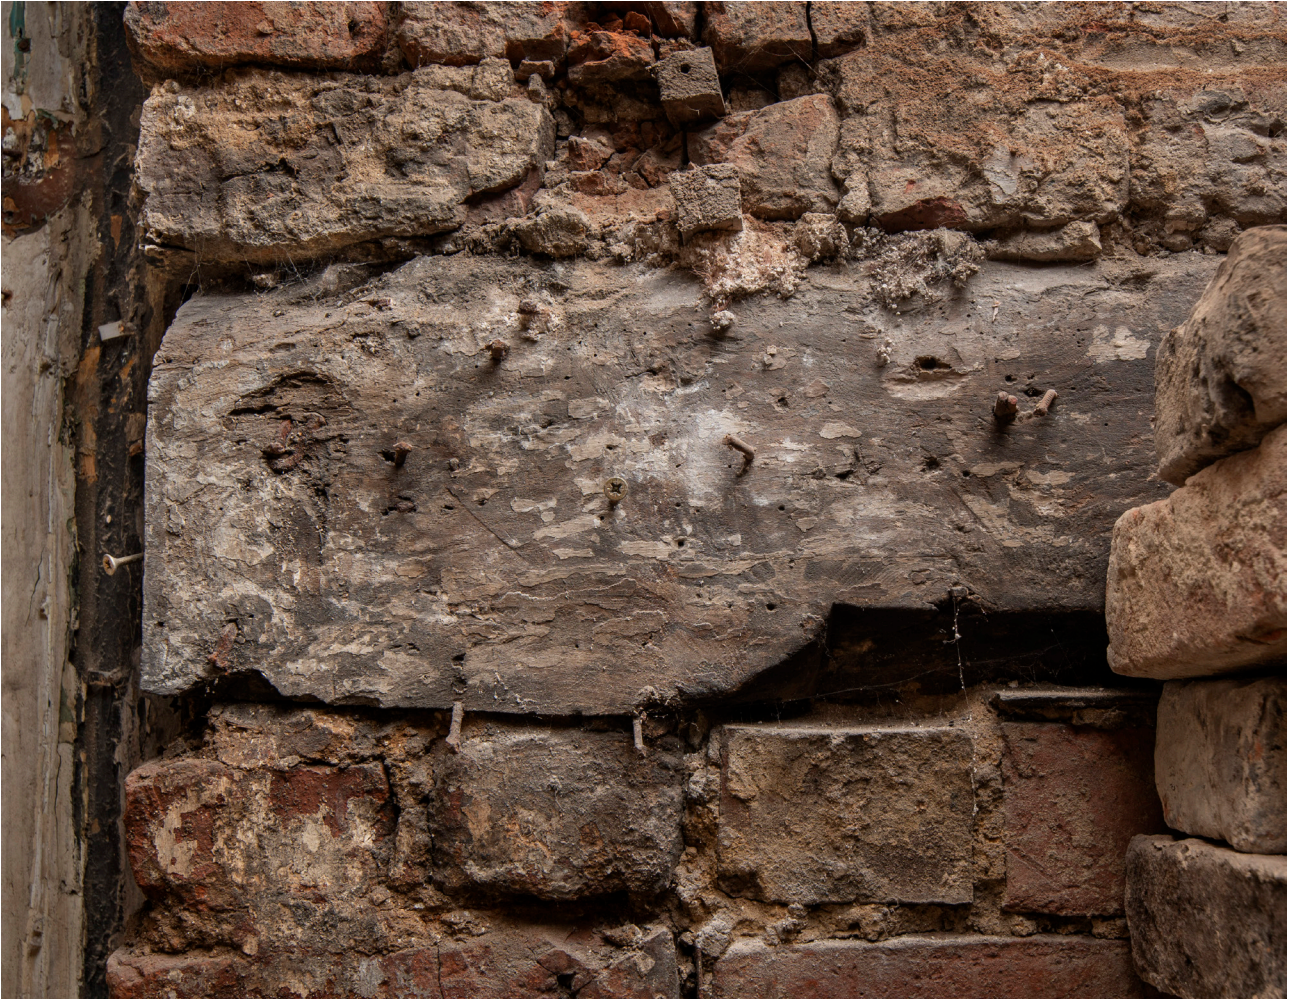
Figure 51: The south end of the cut-down fireplace bressummer, reused in the later fireplace, with an ogee chamfer stop visible at its south end. [James O. Davies © HEA DP435515]

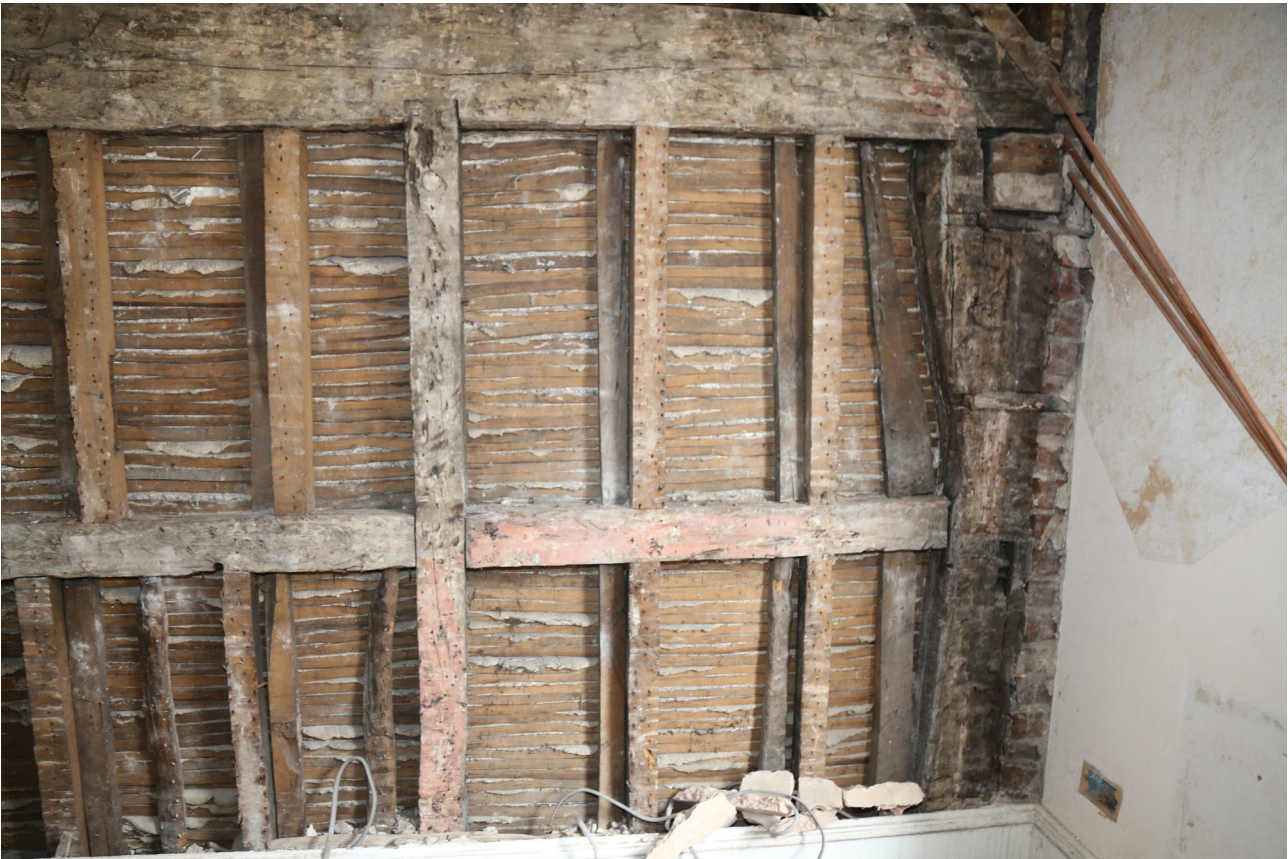
Figure 52: The north end of the central frame of the front range (Frame B), showing later framing lapped onto the original tie beam, looking west. [© Andrea Kirkham. Reproduced with permission]

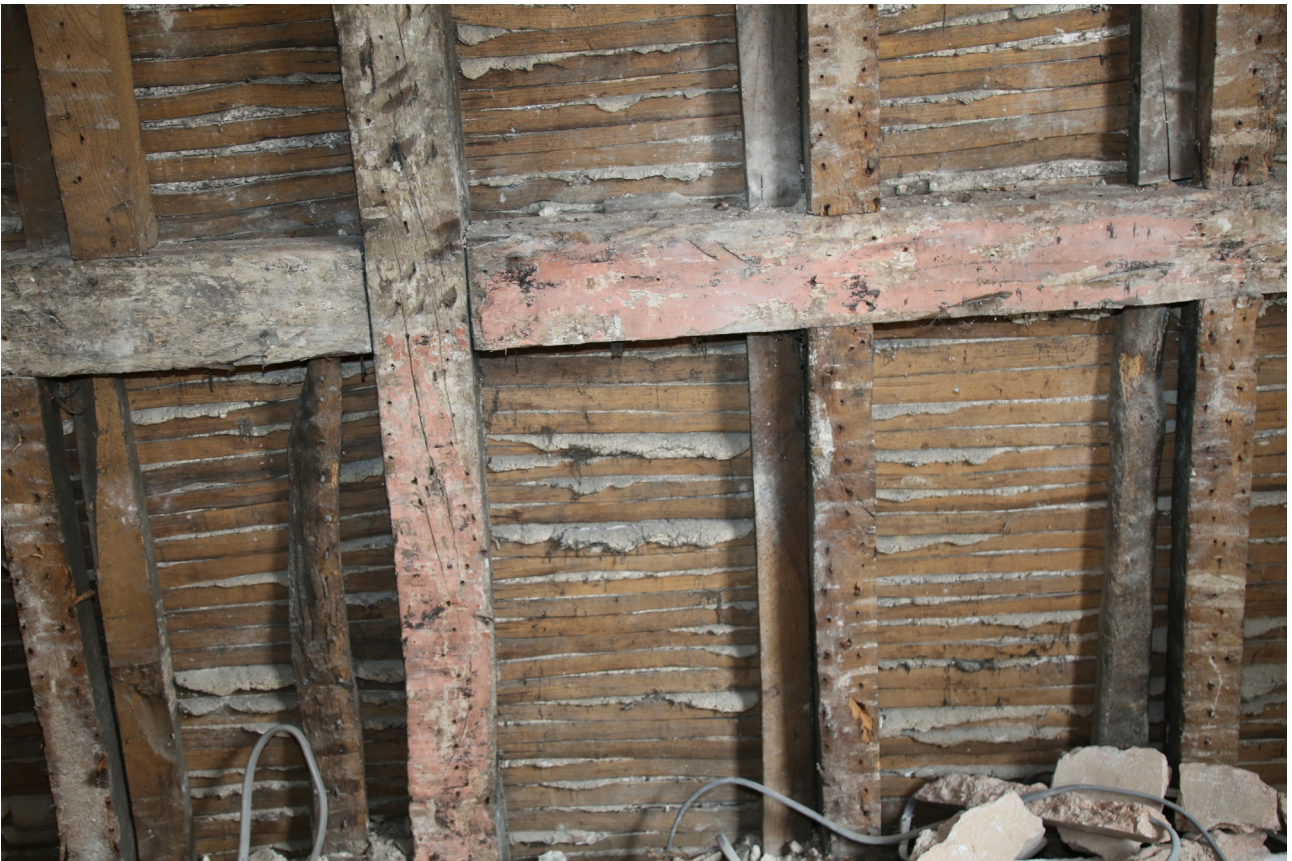
Figure 53: Detail of the later framework inserted into the central frame of the front range (frame B), showing pink paint on the timbers, looking west. [© Andrea Kirkham. Reproduced with permission]
