39-41 Westgate Street, Gloucester

Historic Building Investigation

Historic Buildings Investigation

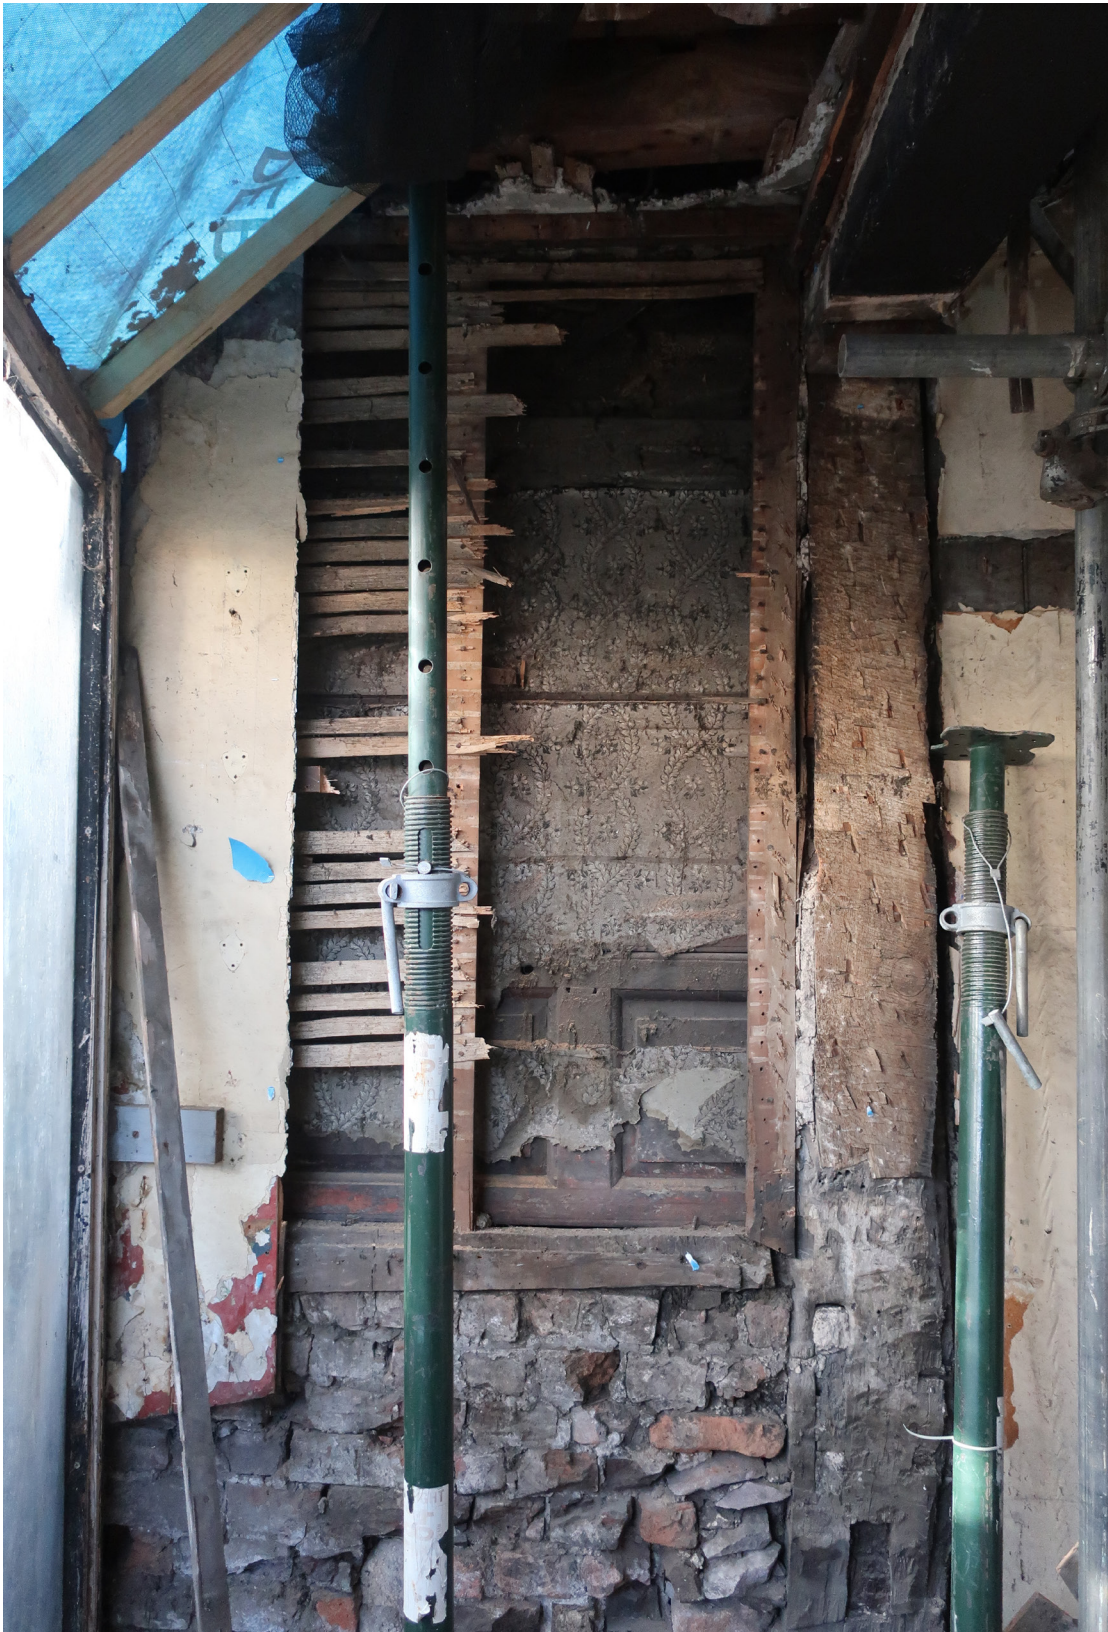
Figure 54: Timber panelling, possibly window shutters, used as part of the underbuilding of the jetty of the front range, now forming the partition between Nos 39 and 41, looking east. [Rebecca Lane © Historic England]

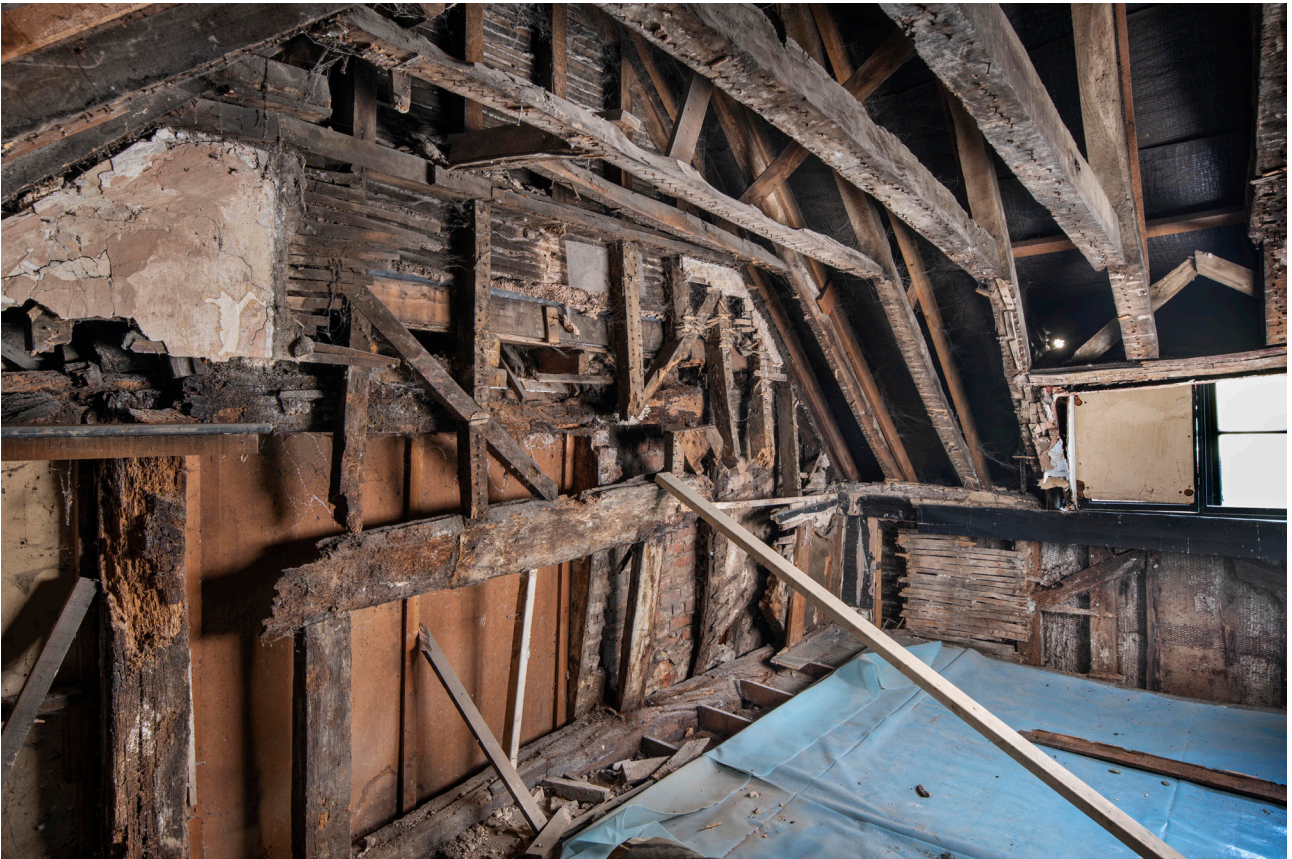
Figure 55: Raised roof over the western bay of the front range (No. 41) showing the later timbers inserted around the original gable-end framework, looking north-west. [James O. Davies © HEA DP435500]

The accommodation of this arrangement to the eastern side of the bay, where it shared a truss with No. 39, makes it seem likely that the alteration took place with an associated raising of the roofline over No. 39 – as otherwise the arrangement would have been hard to reconcile along the shared truss line. It may have been, therefore, that No. 39 had the same raised roof arrangement prior to the complete replacement of the east bay of the front range in the early 19th century. The raising was achieved by using short vertical studs, of relatively thin scantling, resting on the timbers of the earlier wall frames and cross frames. To the north and south these run along the tops of the earlier wall plate positions. It seems to have been at this point that the south wall plate of this bay was replaced with the surviving timber of thinner scantling running between the posts of the trusses to either side. The original wall plate in fact appears to have been reused at the top of the raised section of wall, providing the south wall plate for the new roof (Figure 56). As well as the vertical studs, diagonal bracing was also used along these upper sections of walling to provide additional structural strengthening. To the west the raised gable height incorporated elements of the original truss, but also used other reused timber to support a higher gable roof line (see Figures 26 and 55). Much of this arrangement has been lost in subsequent modification. The arrangement to the east has been subsequently replaced in the reconstruction of the east bay (No. 39; see Phase Six below).

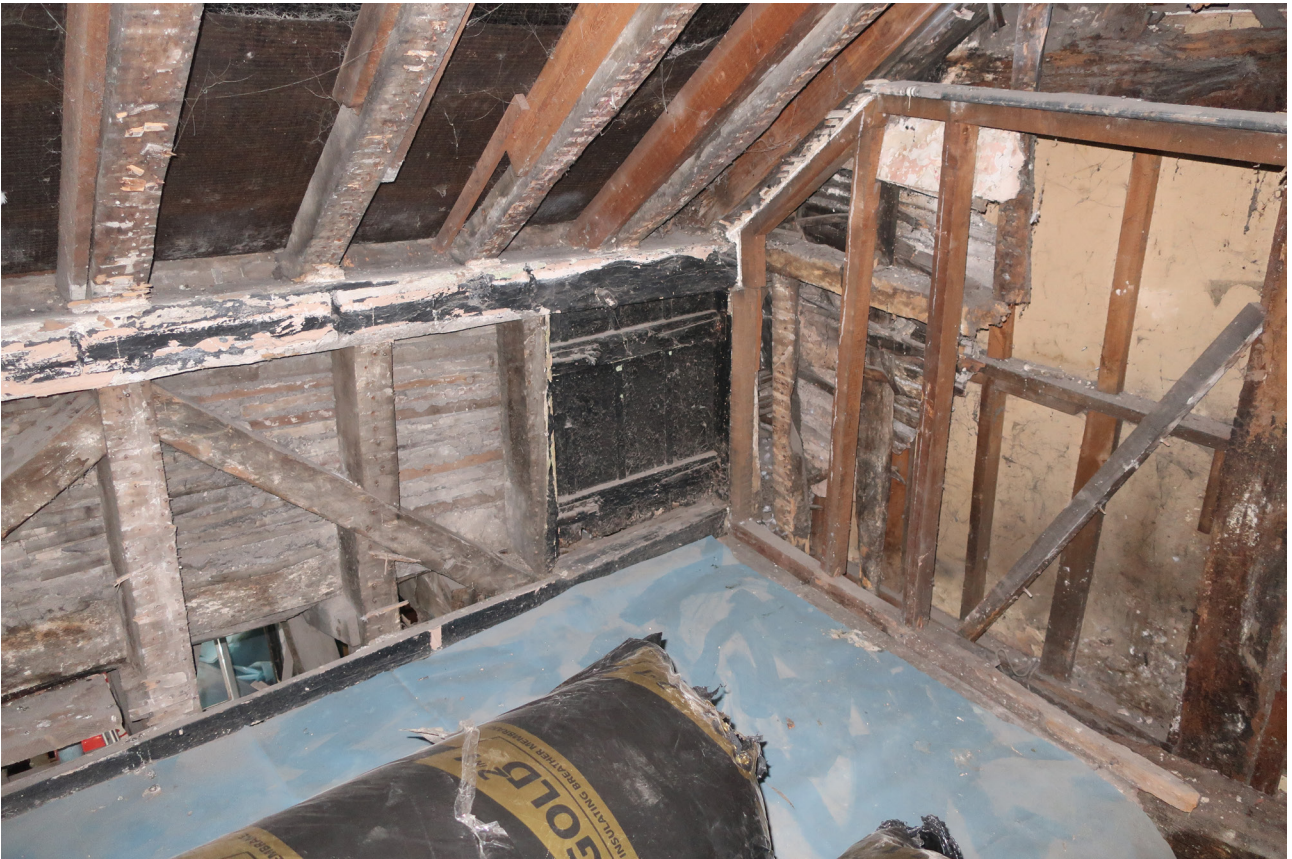
Figure 56: Raised wall line of the south elevation of the west bay of the front range (No. 41) showing the use of later timbers, and the reuse of the original wall plate at a higher level, looking south-west. [Rebecca Lane © Historic England]

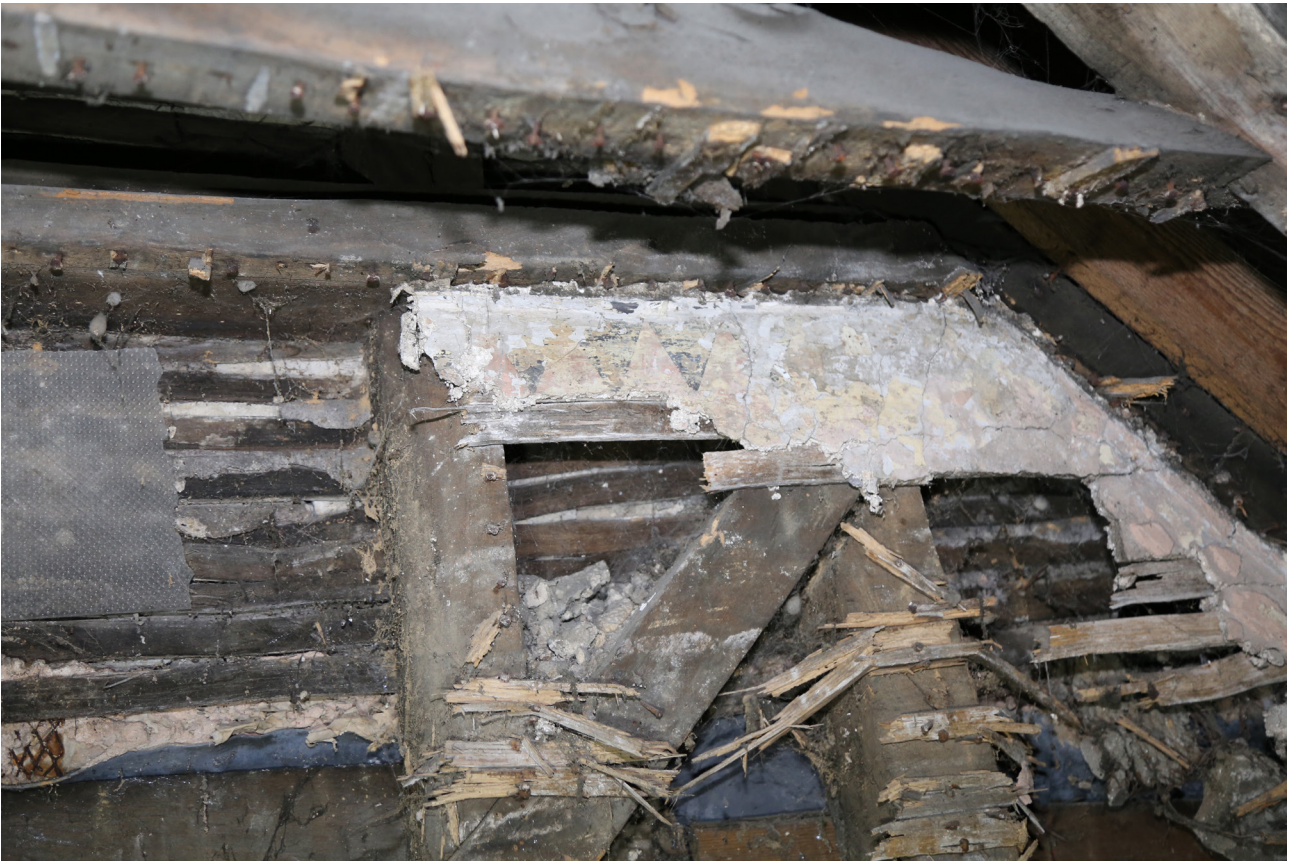
Figure 57: Fragment of wall plaster left in attic room over west bay of the front range (No. 41), showing a painted motif of triangles along the top edge of the plaster, immediately under the ceiling level, looking north-west. [© Andrea Kirkham. Reproduced with permission]

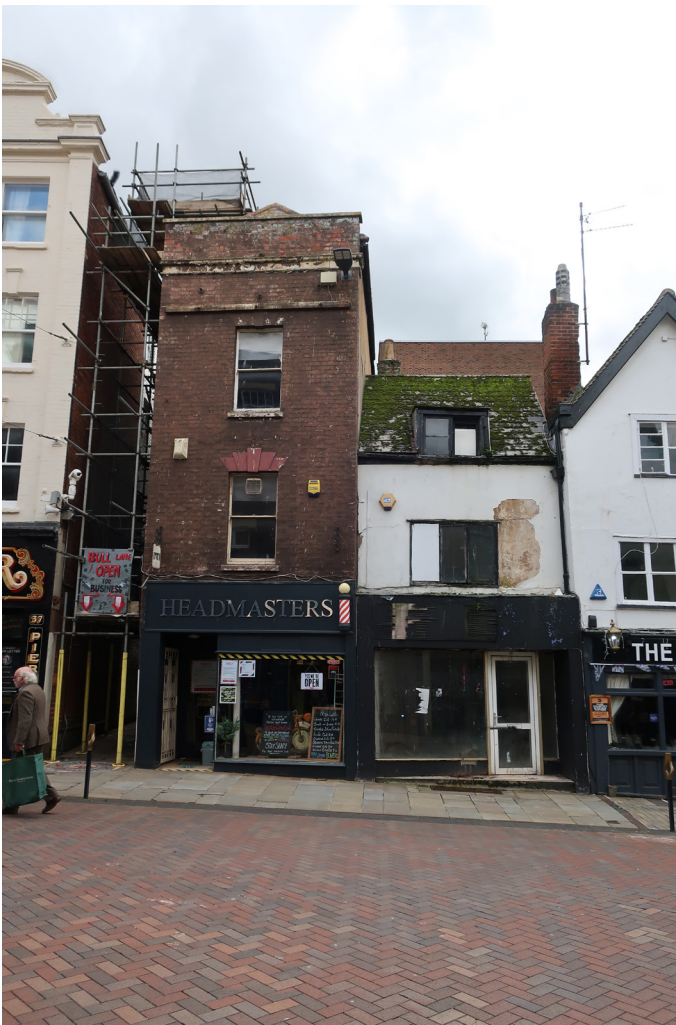
Figure 58: North elevation of Nos 39-41, prior to the recent restoration work, showing the eastern bay of the front range (No. 39) as rebuilt sometime between 1824 and 1834, looking south. [Rebecca Lane © Historic England]

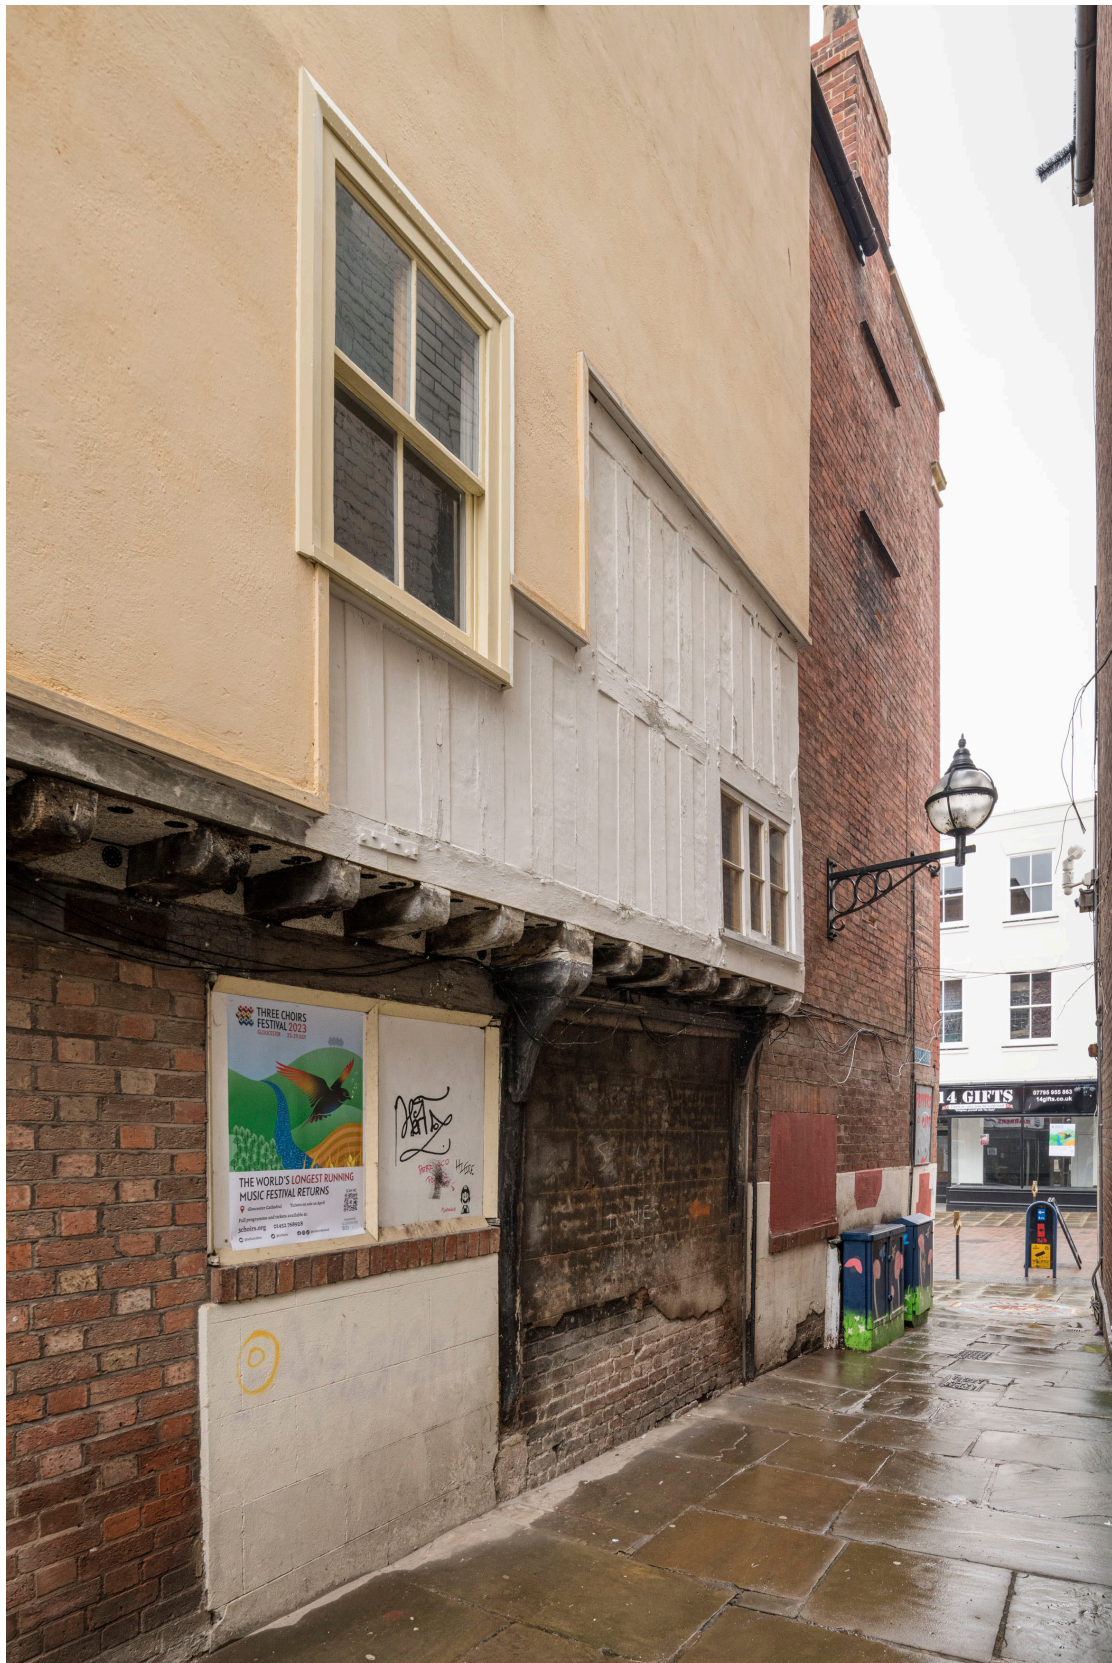
Figure 59: East elevation of the rear range of No. 39 at ground-floor level showing brick infill around the original timber posts, looking north. [Steve Baker © HEA DP464261]

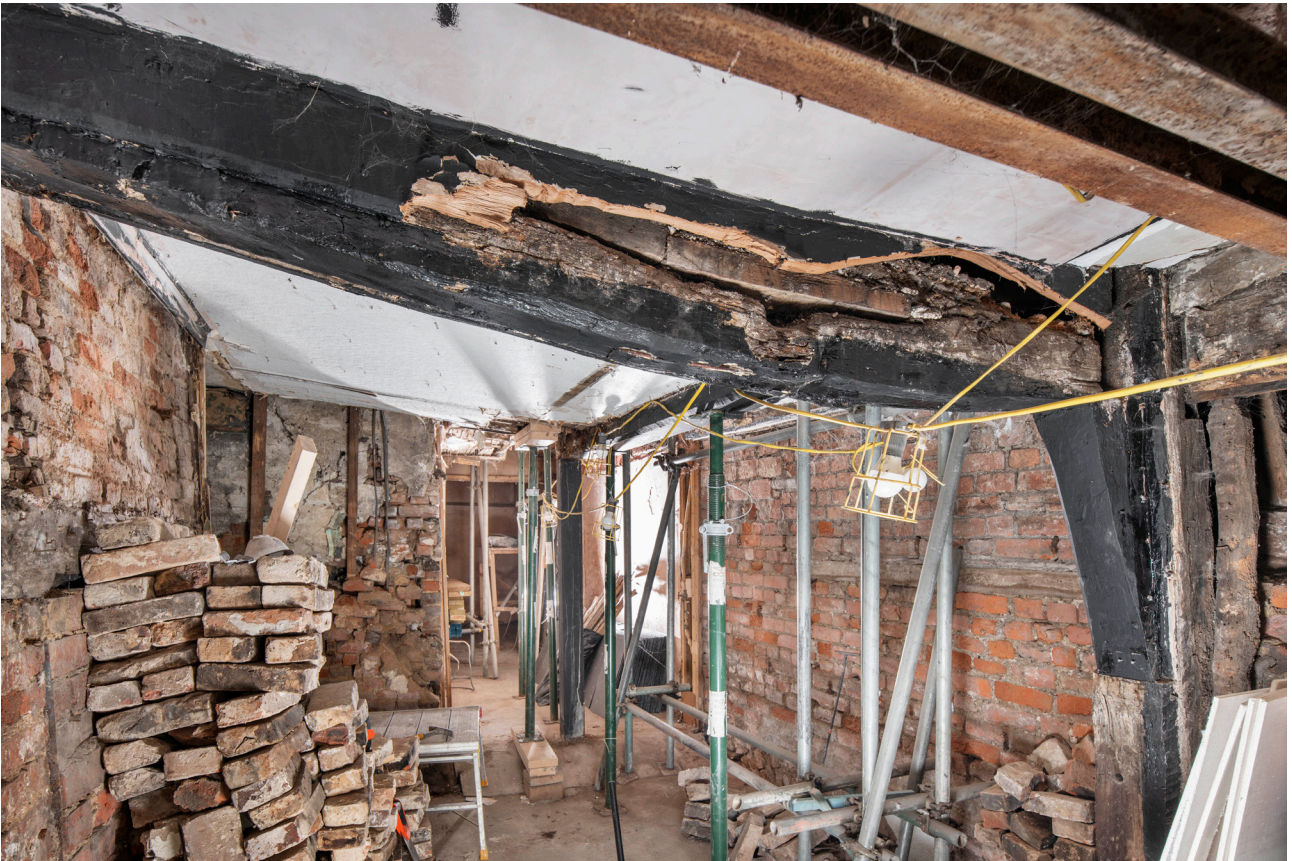
Figure 60: Rear range of No. 41, showing the later timber beam (now supported on acroprops) inserted to allow the removal of the ground-floor timber framing of the west elevation, running off the south girding beam of the front range, looking south-west. [James O. Davies © HEA DP435512]

Perhaps as a response to the loss of space in the south-east corner of the rear range of No. 41, it seems that further adaptations were made to the western side of the range, removing the narrow passageway which ran along the western side of the rear range. The timber framing of the western elevation was removed at ground-floor level, although left intact above. The northern part of the cross beam of the elevation was supported on an inserted timber (Figure 60; see Figure 46). To the south this timber was supported on a timber post, and to the north this was fixed against the rear girding beam of the front range, with a metal strap used to reinforce the junction between the two timbers. This arrangement seems to have further exacerbated the structural problems in the south-west corner of the front range, which had perhaps already caused some subsidence of this side of the property. The point at which the inserted beam joins the girding beam has seen significant splitting in the girding beam. Initially this expansion into the passageway appears to have been at ground-floor level only, with an upper sloping grille still in place representing some form of lean-to roof covering (see Figure 46).

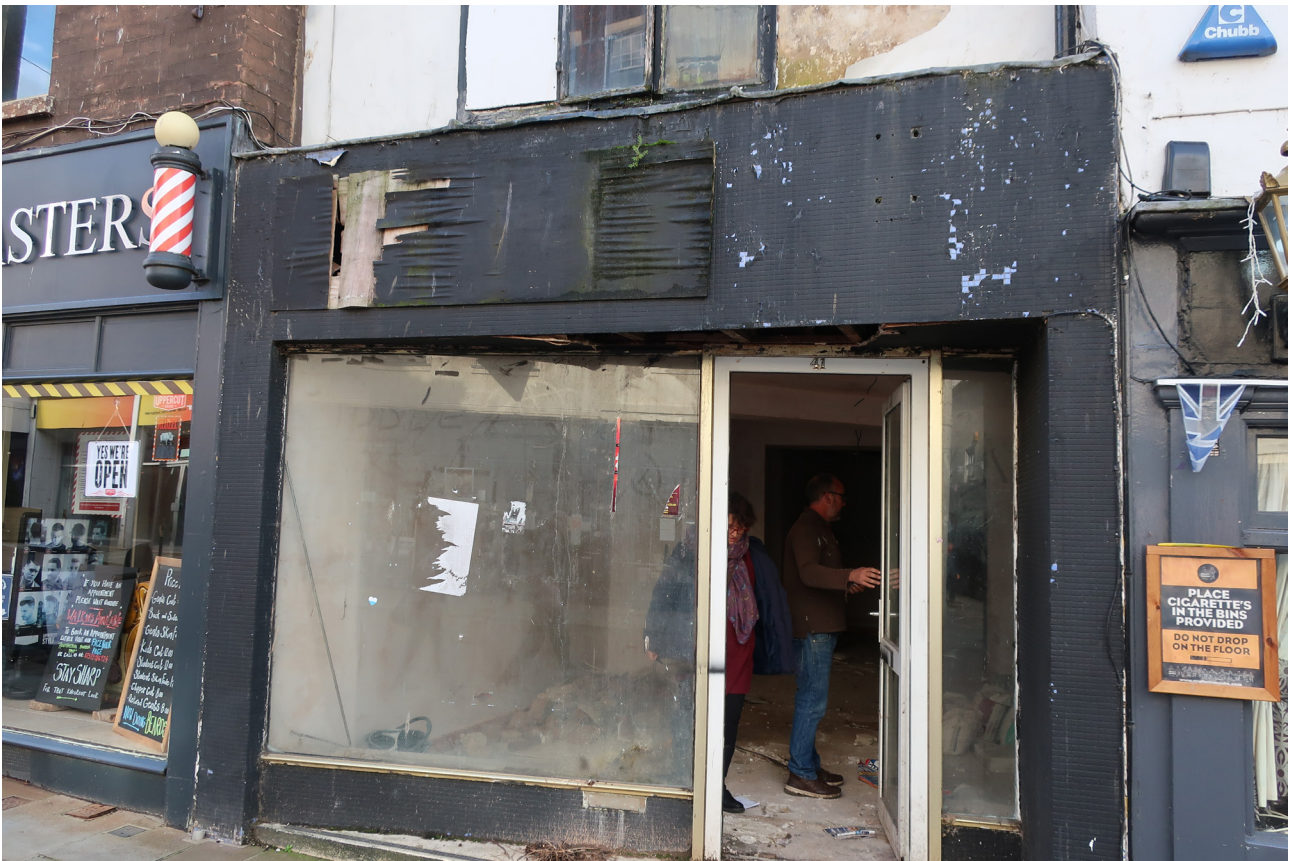
Figure 61: Shopfront inserted into the north elevation of No. 41 in the 20th century, looking south. [Rebecca Lane © Historic England]
