# The Tudor House Hotel, 52-3 High Street, Tewkesbury, Gloucestershire

Historic Building Assessment

Johanna Roethe

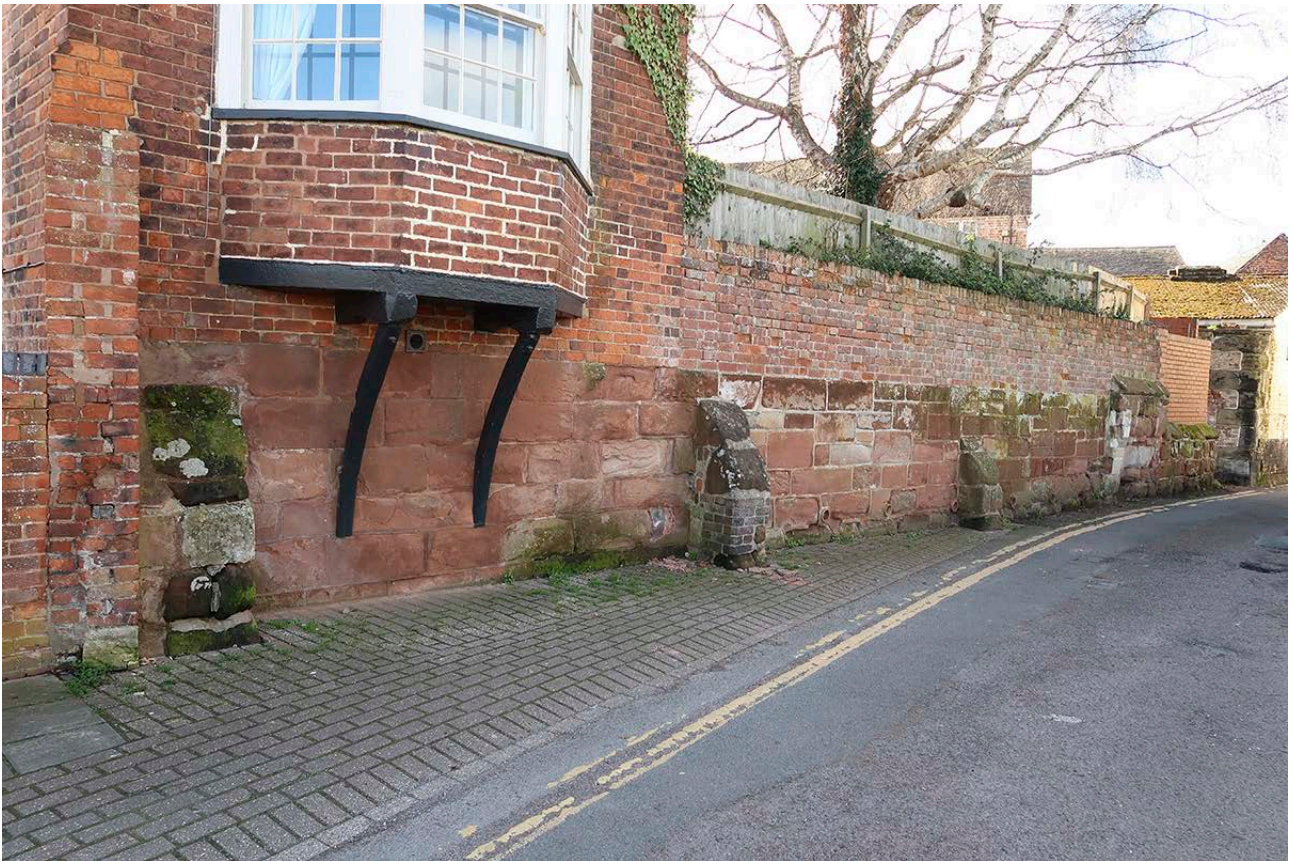
Figure 3: The medieval wall in Red Lane to the west of 50 and 51 High Street. [Abigail Lloyd © Historic England]

It seems likely that the plot of the present Tudor House had been built up during the medieval period. To the rear (west) of 50 and 51 High Street, along the edge of Red Lane, is a stretch of boundary wall of red sandstone which has been dated to the 14th or 15th centuries (Figure 3).<sup>23</sup> The wall is constructed of squared ashlar blocks, with small sandstone buttresses on the western side, towards Red Lane. This may have been a quay wall facing the Mill Avon, although if so the route of the original Red Lane must have run slightly further to the east.<sup>24</sup> It is perhaps more likely that this represents a property boundary, dividing the plot from the public lane. Until the second half of the 20th century this wall continued north along the western boundary of the Tudor House.<sup>25</sup> The presence of this wall indicates that the area was well developed in the late medieval period, with defined plot boundaries. The form of the wall also indicates considerable expenditure on the feature, suggesting the plots had some status, consistent with their prime location.

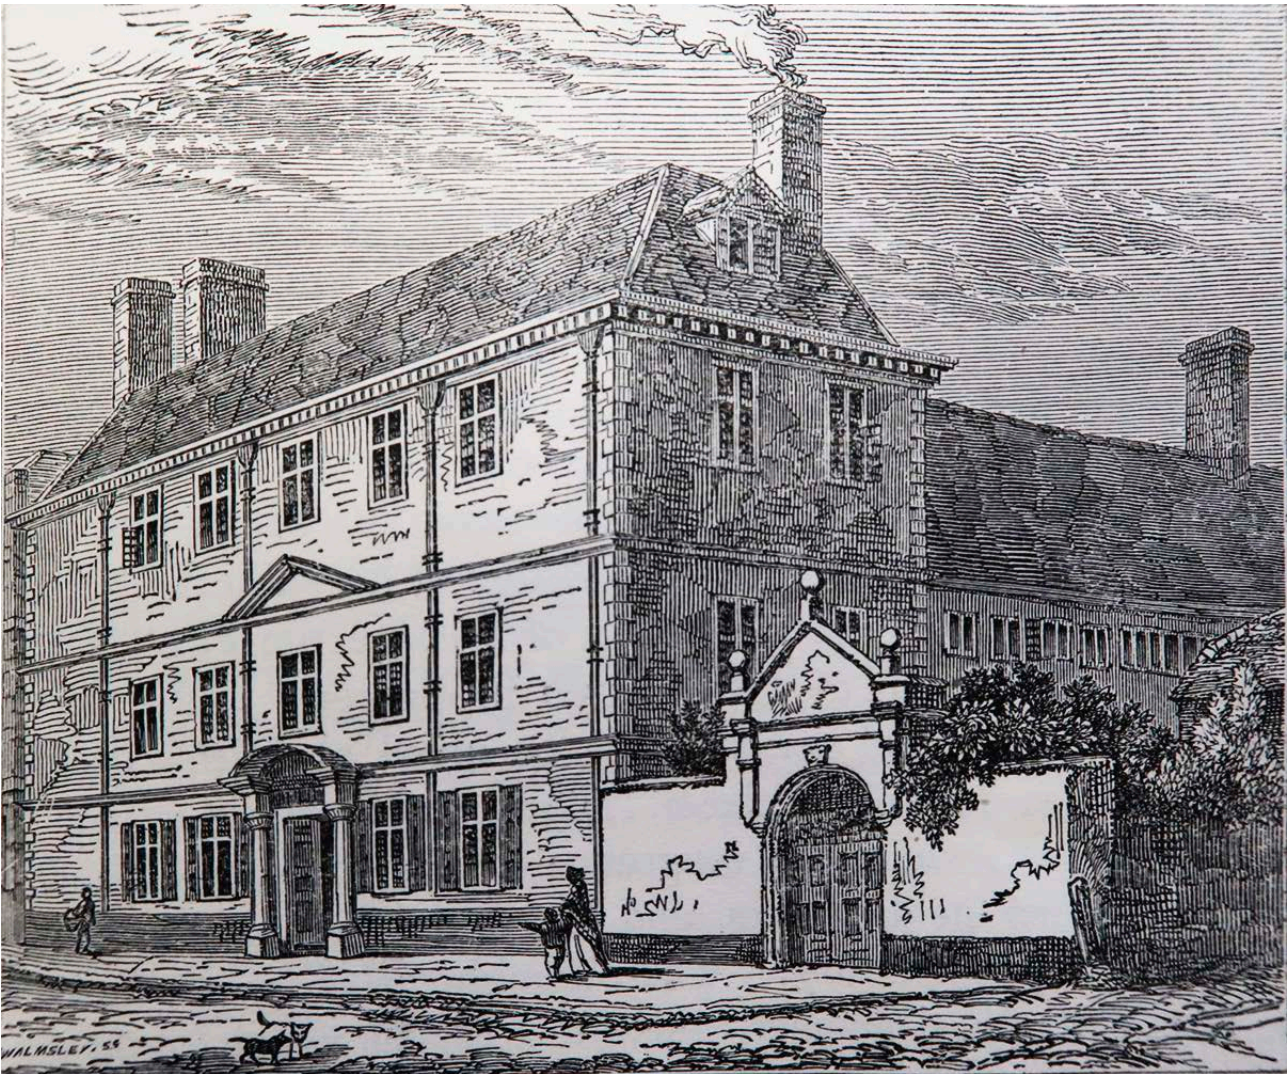
Figure 4: Engraving of 1850 by Mr Walmsley showing the Tudor House after the remodelling of 1701. [Bennet 1850, 441; reproduced with permission of Tewkesbury Library]

The earliest known depiction of the Tudor House is an engraving published in 1850 (see Figure 4).<sup>73</sup> The viewpoint is from the north, with the gateway to the corner courtyard in the foreground – the most popular depiction of the building in the 19th and 20th centuries. It shows the building as remodelled in the early 18th century. By that date the building on the plot to the north had been demolished and an arched gateway erected. However, the tiled roof of a building slightly further west is just visible in the engraving. This might have been a service building which was only demolished in about 1910.

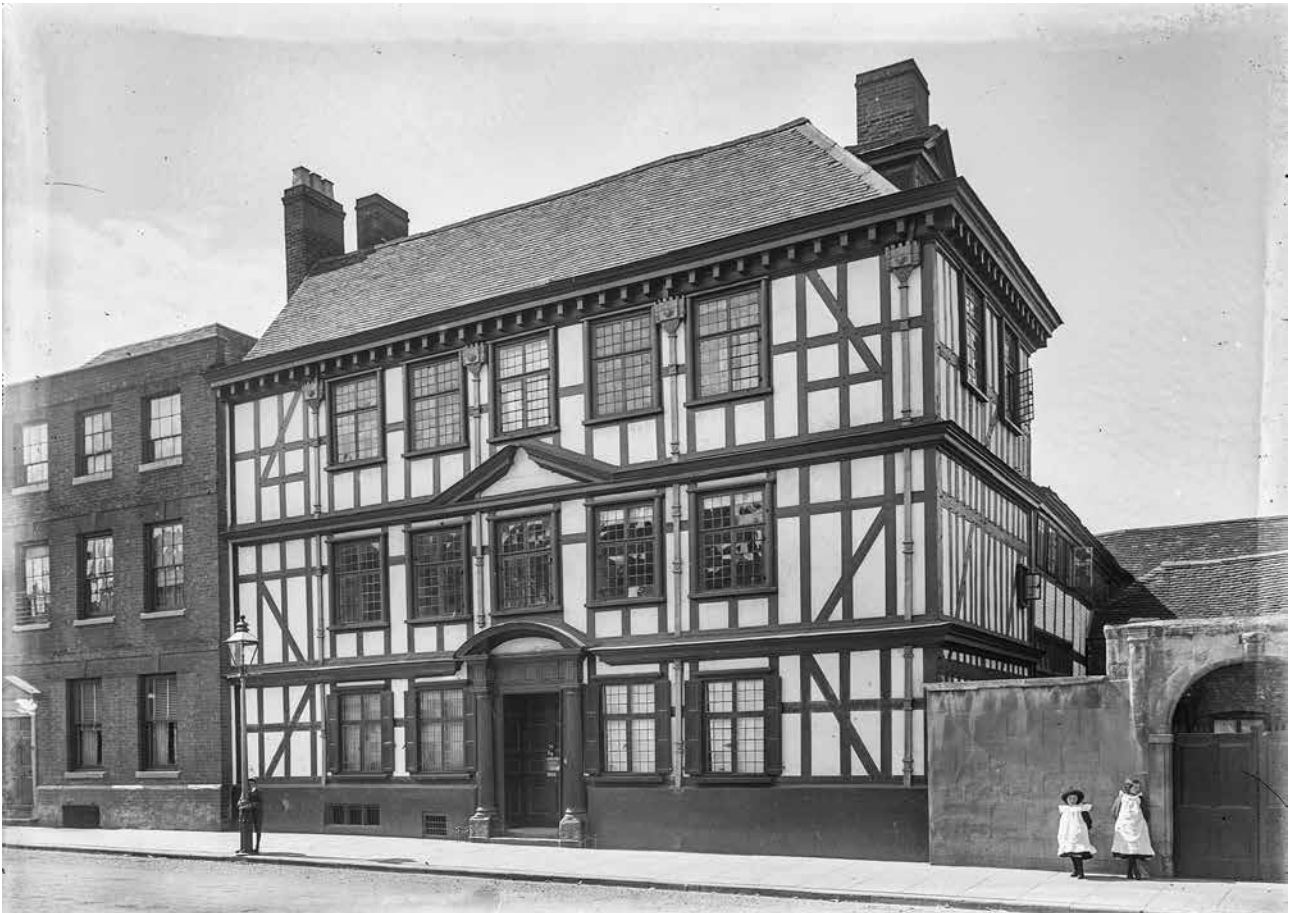
Figure 7: A photograph of the Tudor House, taken at some point between the 1890s and 1910. [Source: Historic England Archive, BB67/08939]

To the west of 53 High Street and the corner courtyard, a large building had been erected which by 1895 was in use as a malthouse. This butted up against the small service building (by 1895 a coach house and a stable), which on the plan is shown as part of the same block as the malthouse. This service building is still extant adjacent to the courtyard. The map shows a further range which runs parallel with this, within the courtyard. The roofline of this building is just visible in the 1850 illustration of the site (see Figure 4) and in a photograph taken at some point between the 1890s and 1910 (Figure 7). This range is shown on the 1885 Town Plan as subdivided into two spaces

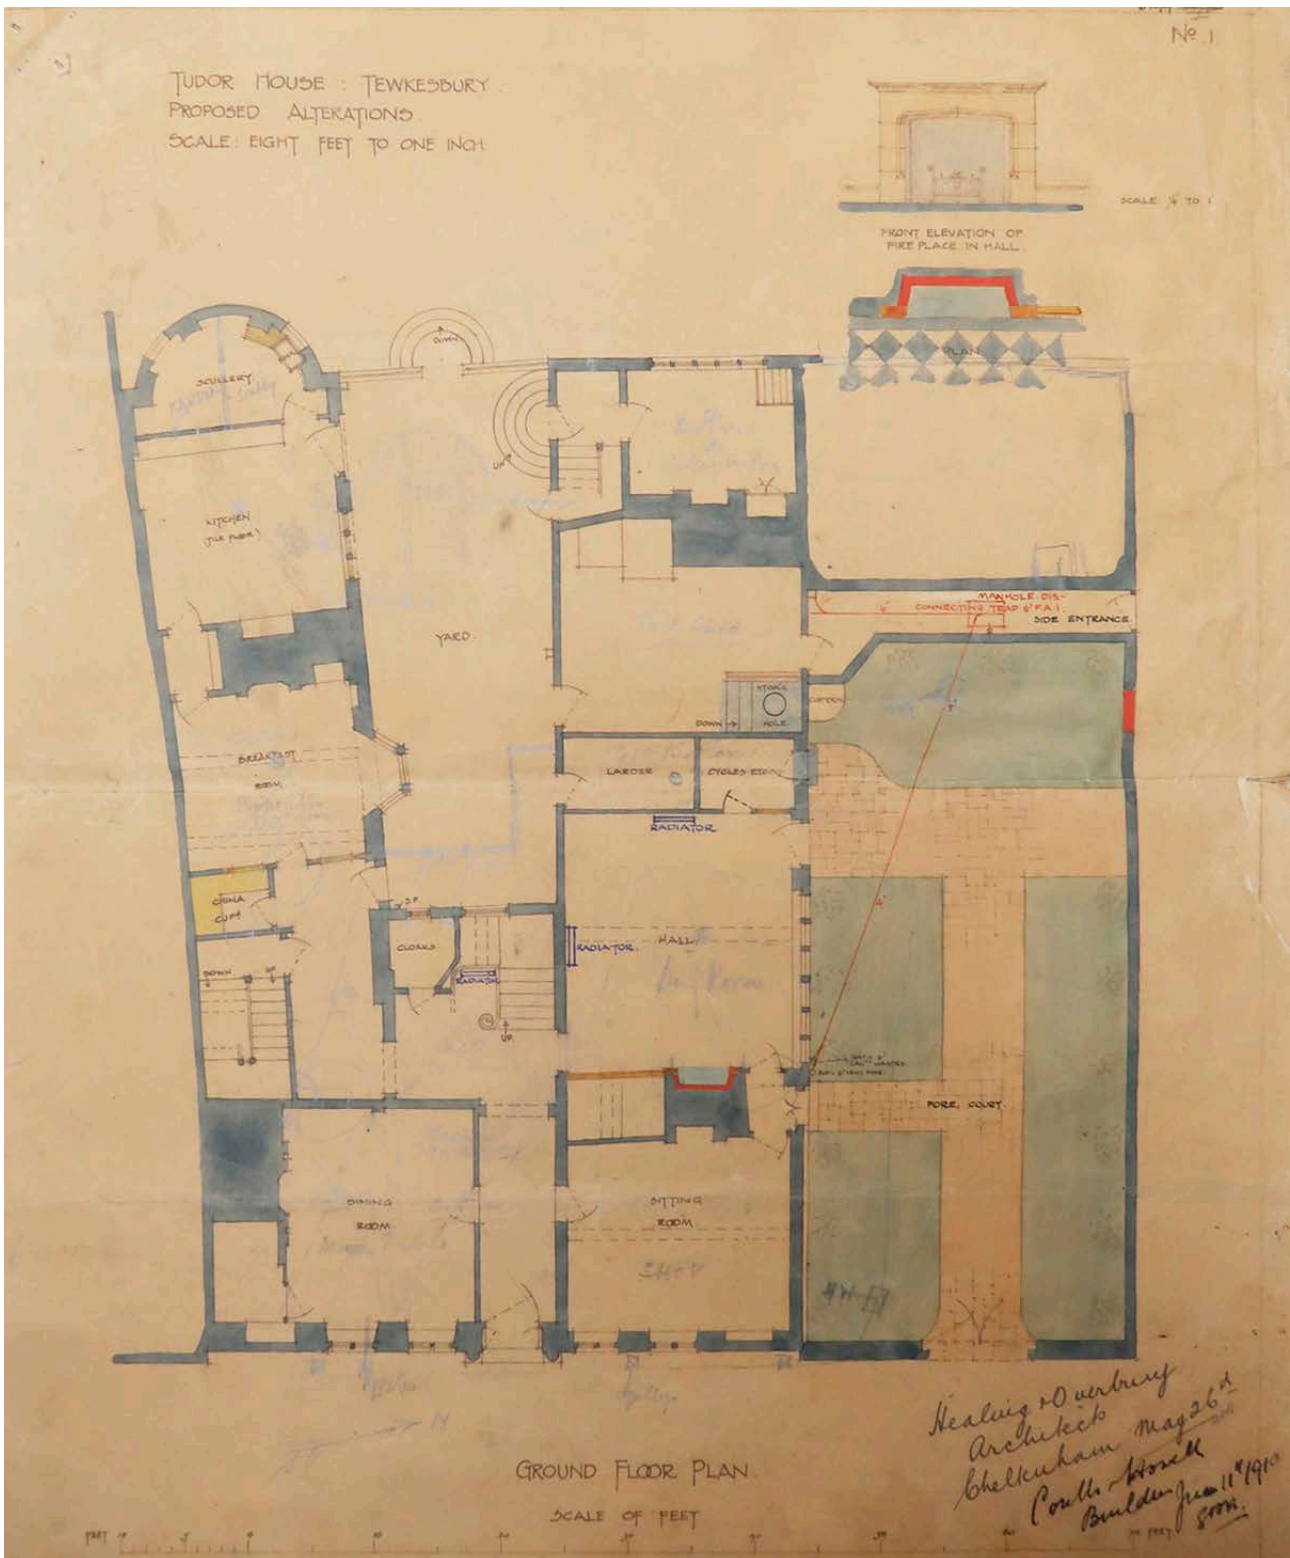
Figure 10: Contract drawing of the ground floor as proposed, by Healing & Overbury, May 1910. The room names in pencil were those used by the hotel in 1934. North is to the right. [Gloucestershire Archives, D5587/box9627, item 13/27]

Most of the proposed works amounted to the refurbishment and repair of the interior but some works were more substantial. All gas pipes were removed and electricity installed. In the south wing, on the ground floor, a new china pantry was created just east of the breakfast room, which had new borrowed lights to the passage. A bathroom was installed, on the first floor of the north wing, together with a W.C. These spaces were lit by the reopening of existing but blocked windows. The kitchen and scullery at the west end of the corner courtyard, which are shown on the 1885 OS Town Plan (see Figure 6), were demolished.

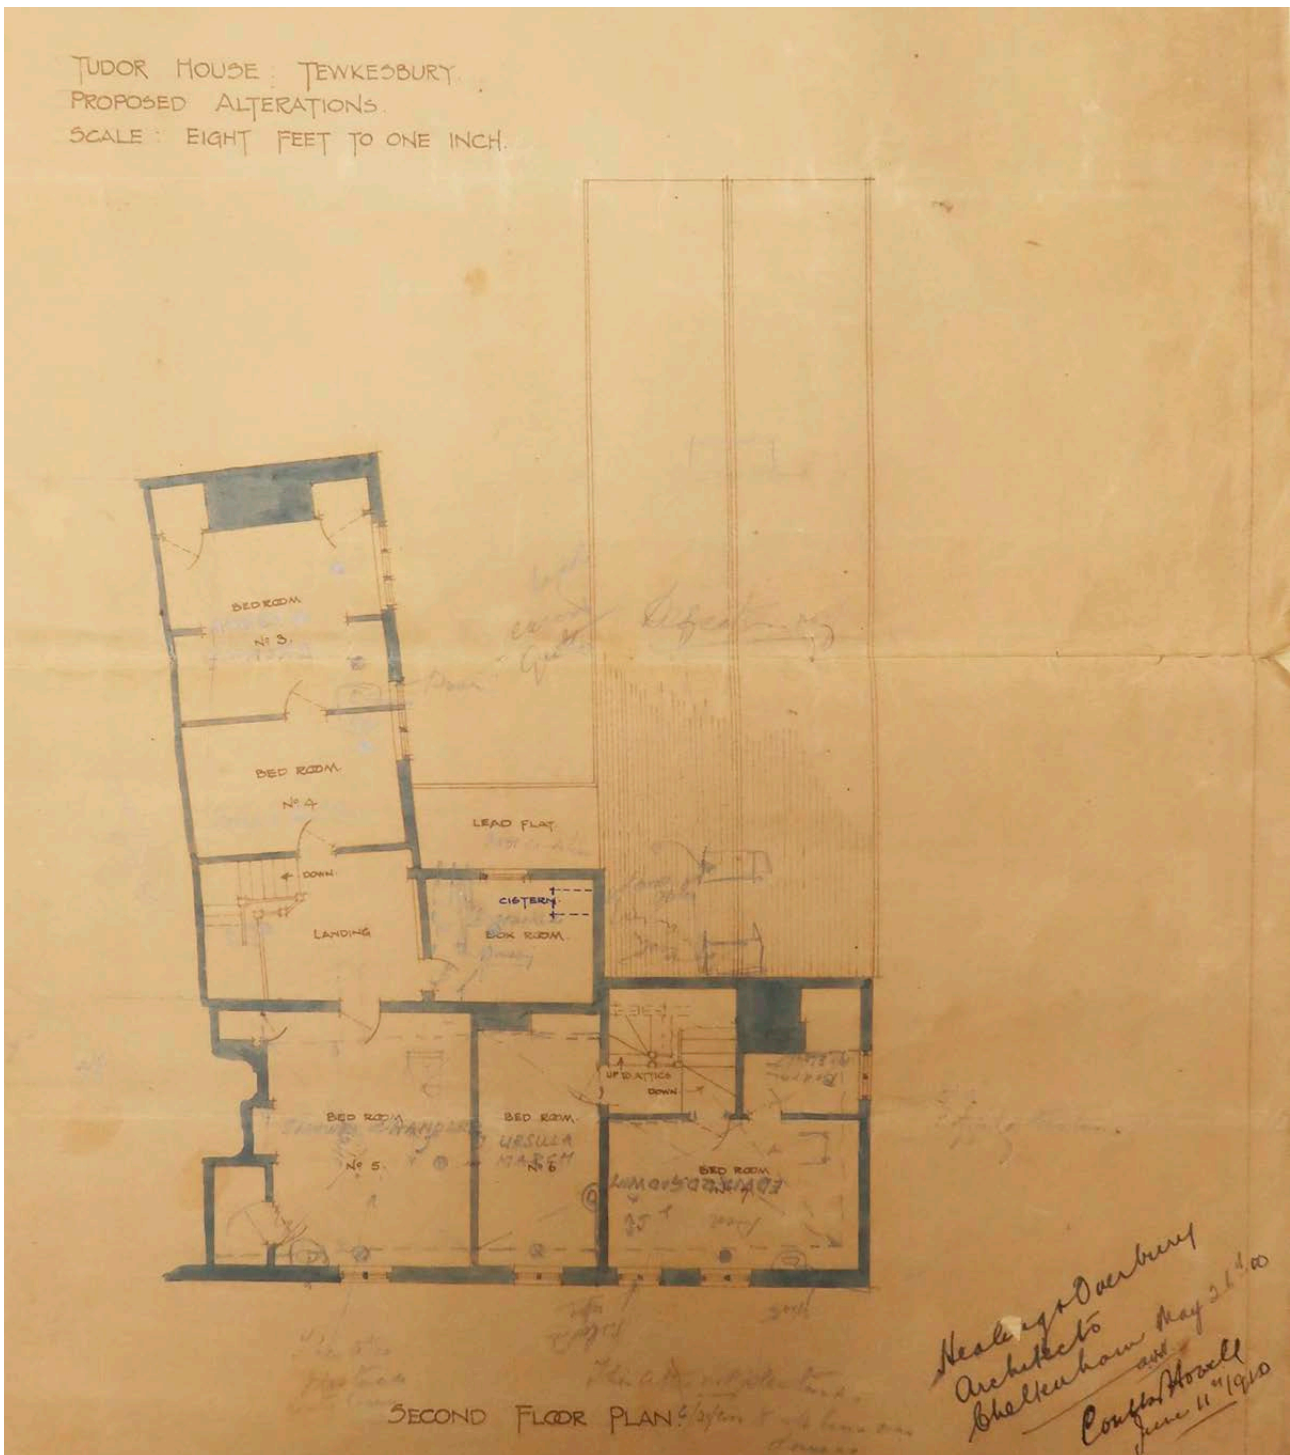
Figure 12: Contract drawing of the second floor as proposed, by Healing & Overbury, May 1910. The room names in pencil were those used by the hotel in 1934. North is to the right. [Gloucestershire Archives, D5587/box9627, item 13/27]

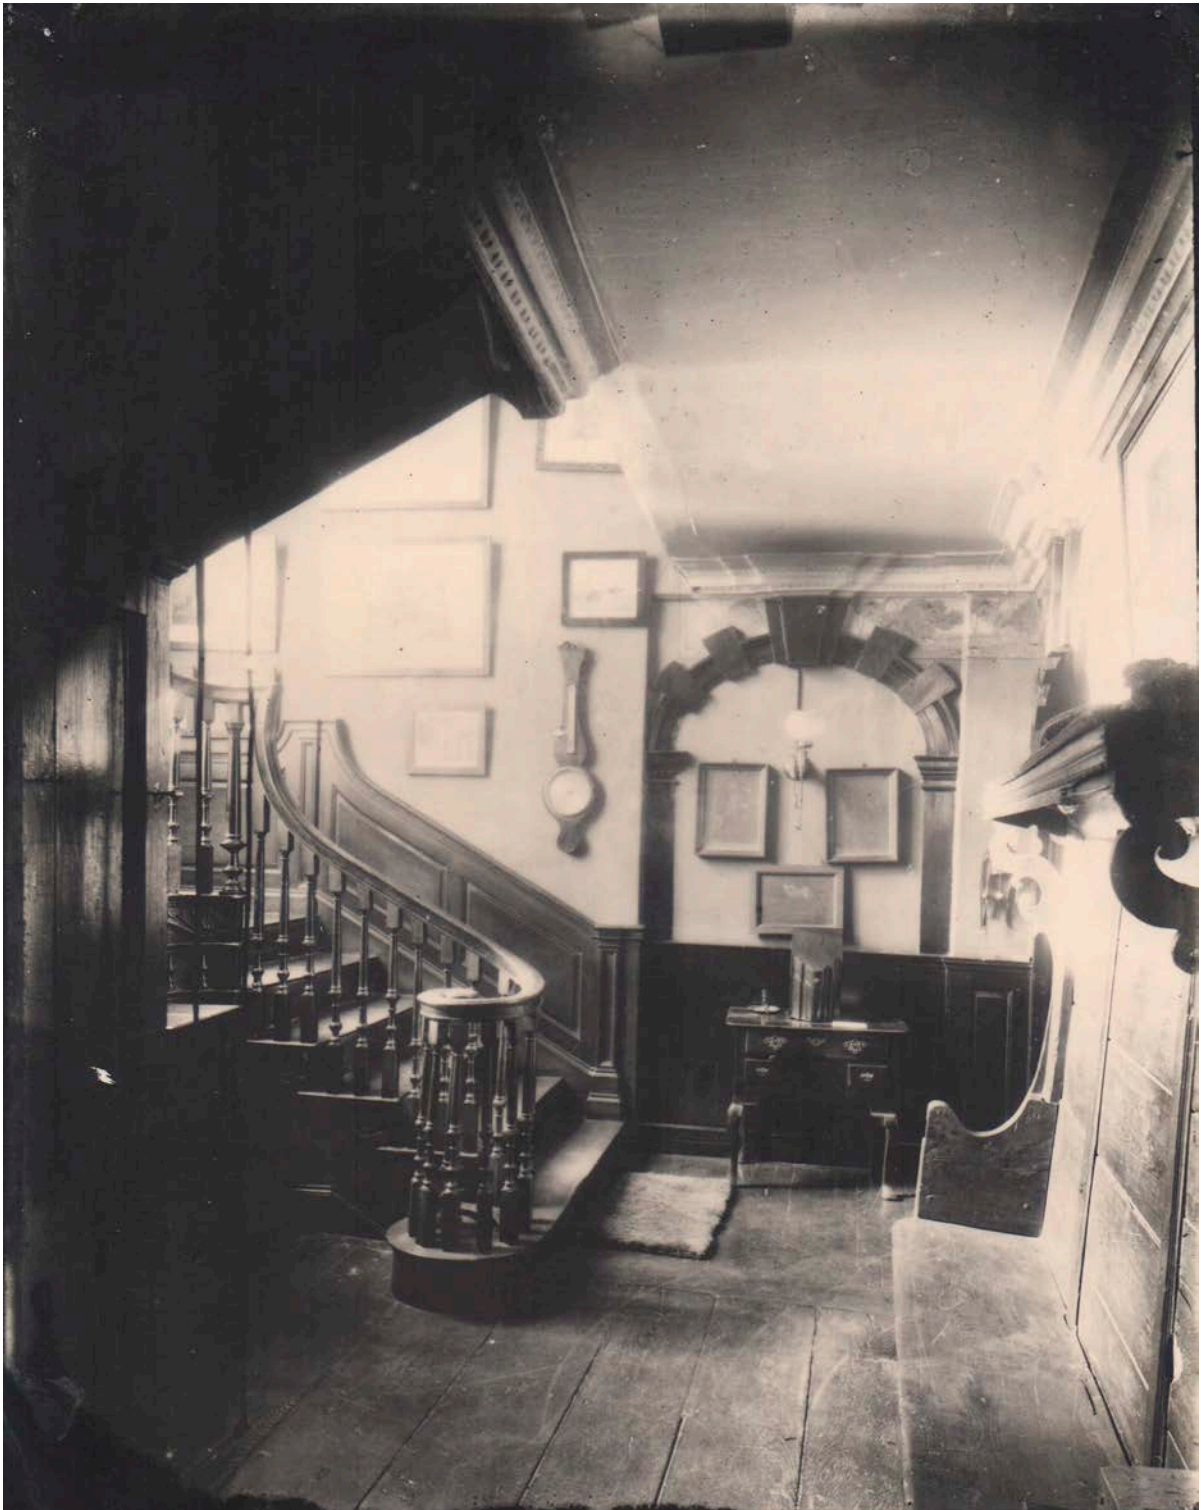
Figure 13: The stairwell in the front range, looking towards the blocked door into the hall in the north wing. The photograph was probably taken in around 1910, before the alterations for the Moore family. [The John Moore Society; reproduced with permission]

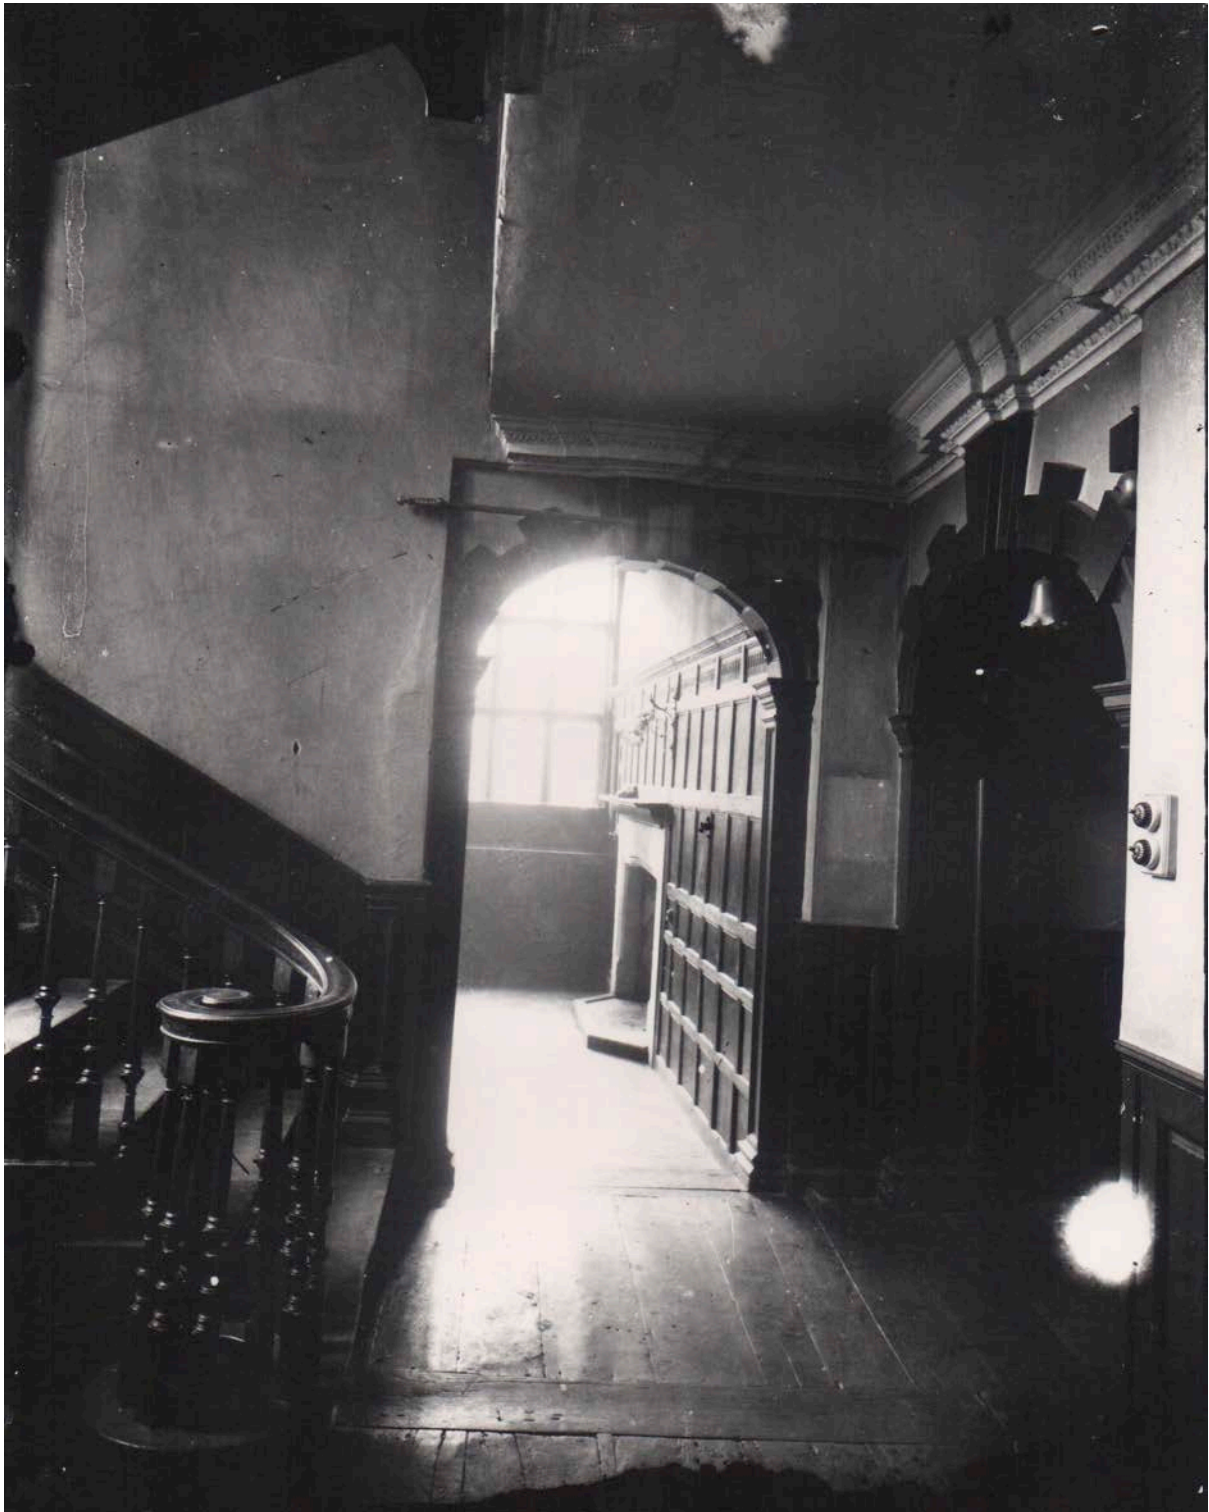
Figure 14: A similar view taken after the alterations of 1910-11. [The John Moore Society; reproduced with permission]

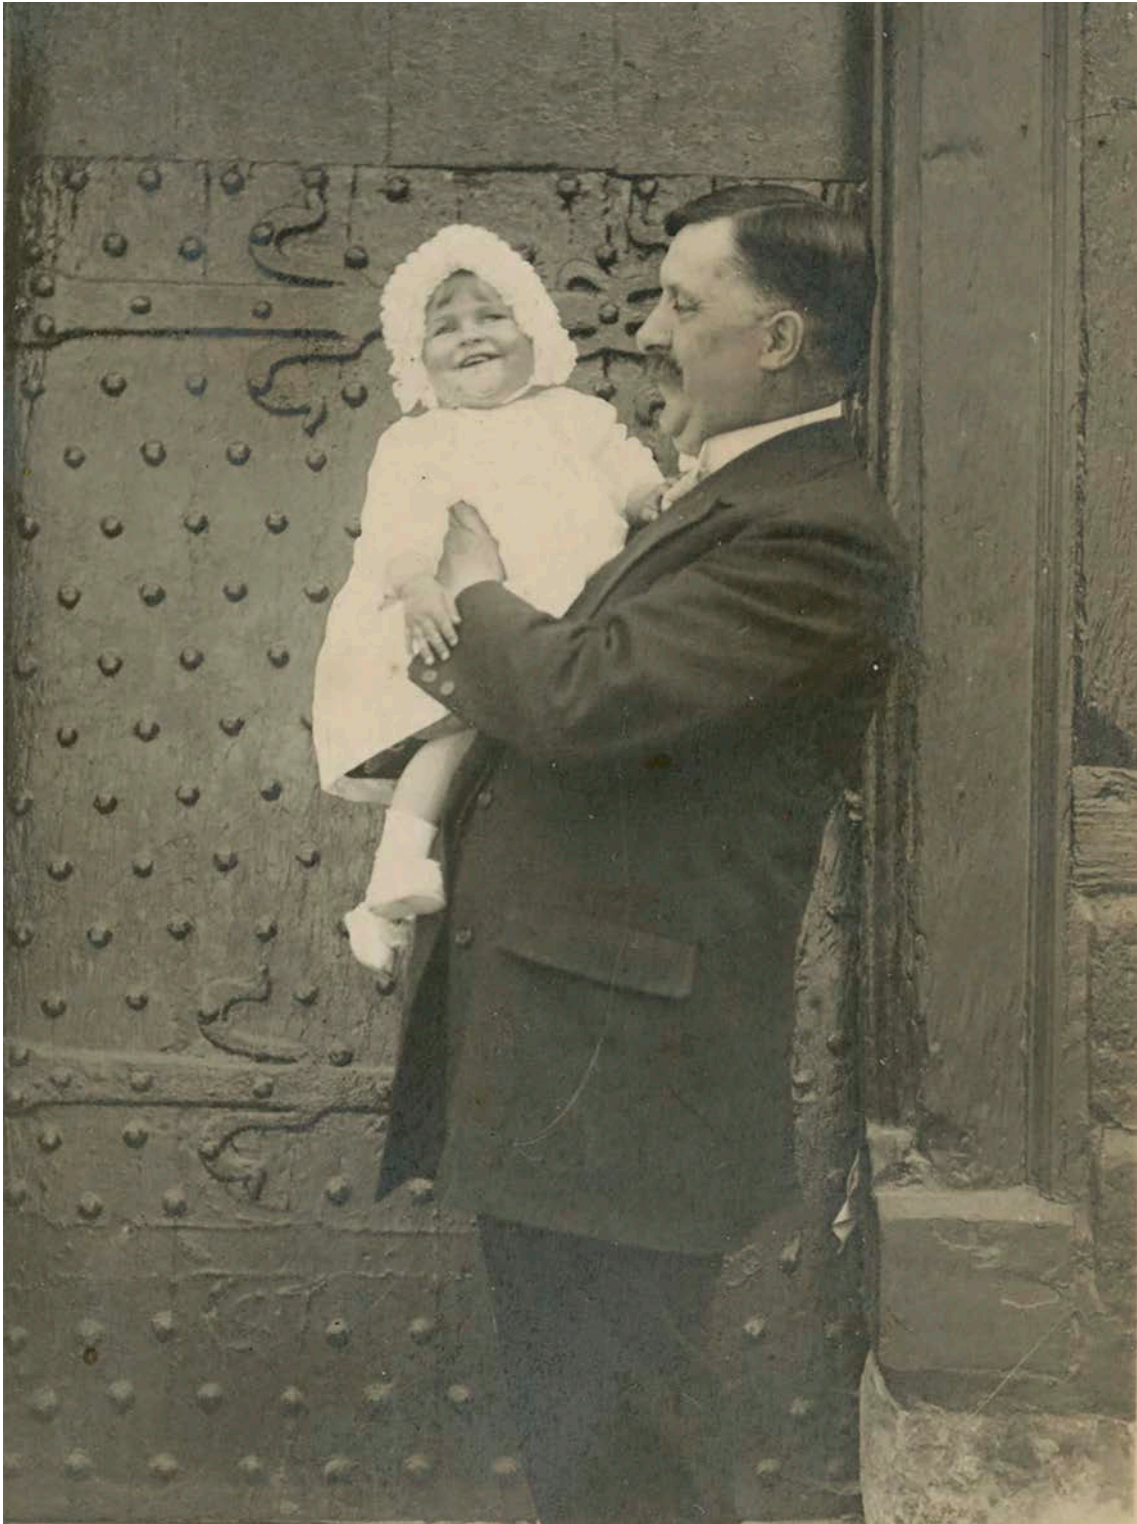
Figure 15: Undated photograph of around 1911, showing Cecil Moore holding his daughter Daphne in front of the side door. [Gloucestershire Archives, D8451/1/15/2; The John Moore Society, reproduced with permission]

A few photographs survive showing the building during the Moores' time. One such image shows Cecil Moore holding his daughter Daphne in front of the nail-studded and axe-scarred side door into the corner courtyard (Figure 15). This picture shows a paint scar on the door, which indicates that the lower hinge was at some point moved further up.

The top plank appears to be a modern repair or replacement. On the inside of the door frame there are signs that the location of pintles has changed over time. One of the two hinges has also been moved slightly further up the door; this had been done shortly after 1910 when a scar in the paintwork is still visible on a historic photograph (see Figure 15), and is still visible now as there is an absence of the original nail pattern in the area

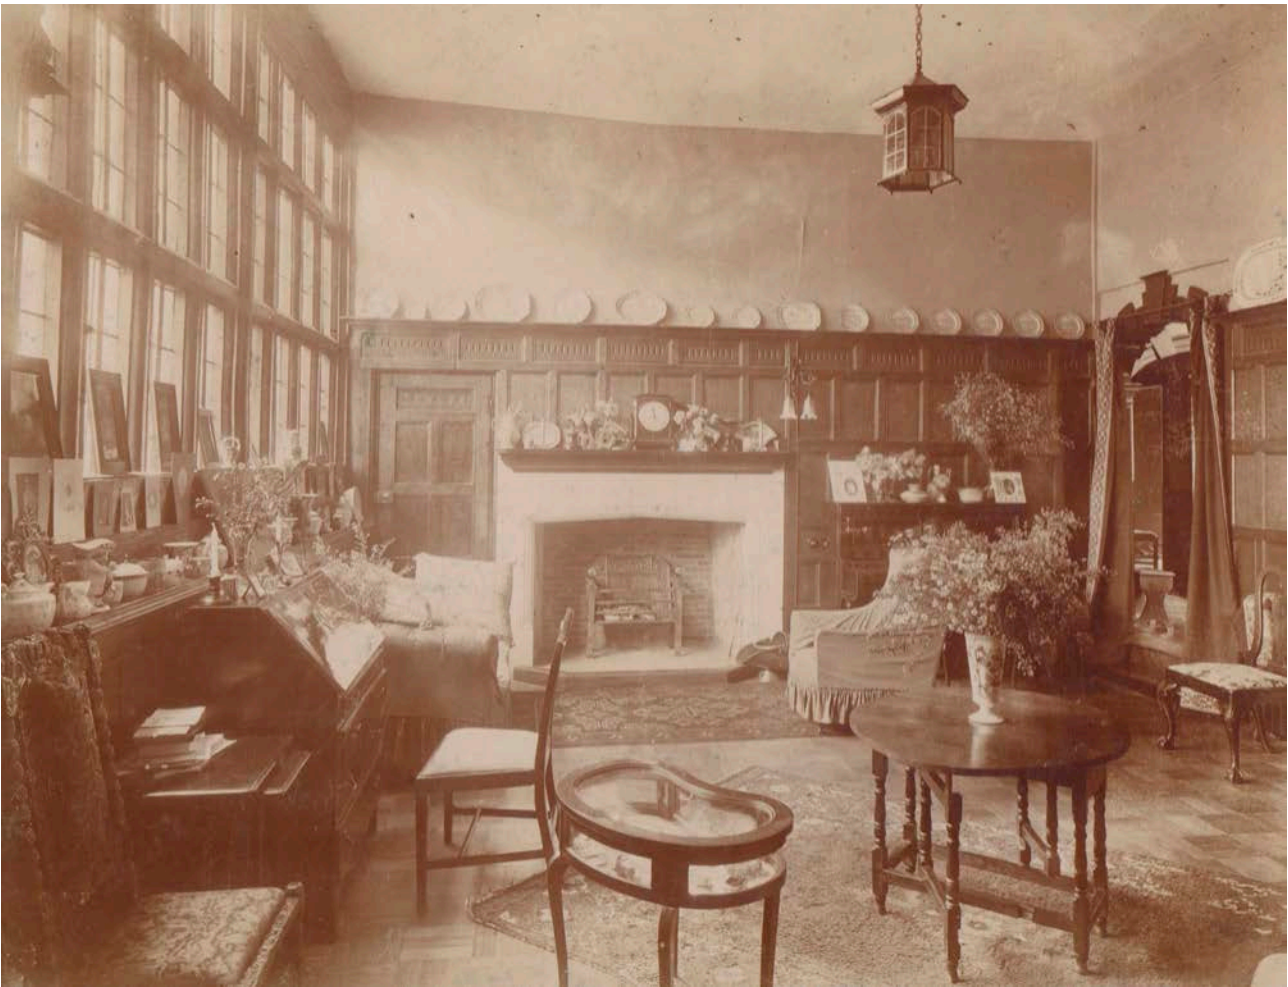
Figure 16: Undated photograph of the hall during the Moore family's residence, between about 1911 and 1918, looking east. [The John Moore Society; reproduced with permission]

Two interior pictures show the newly panelled hall in the north wing (Figures 16, 17). It appears largely as now but without the later plaster cornice. Another three photographs show the southern front room, which was the dining room during the Moores' residence (Figures 18-20). This room had a large, carved Jacobean overmantel featuring the Stuart royal arms. The remainder of the room was panelled with pilasters and a frieze carved with intertwining ornament and strapwork. The Jacobean overmantel was clearly considered a valuable feature of the house. In 1911, Cecil Moore insured it for £100 and the rest of the house for £1,500.<sup>120</sup>

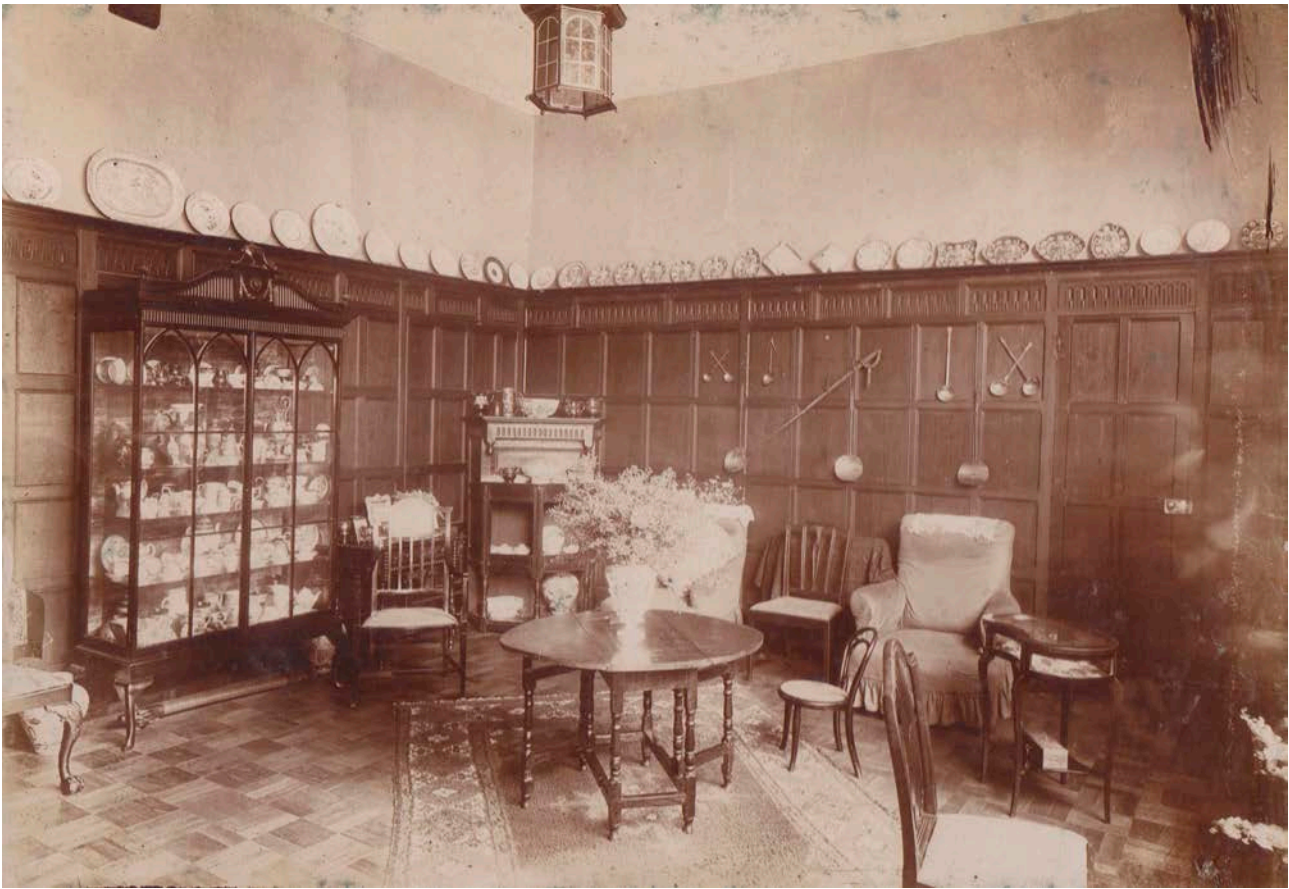
Figure 17: Undated photograph of the hall during the Moore family's residence, between about 1911 and 1918, looking south-west. [The John Moore Society; reproduced with permission]

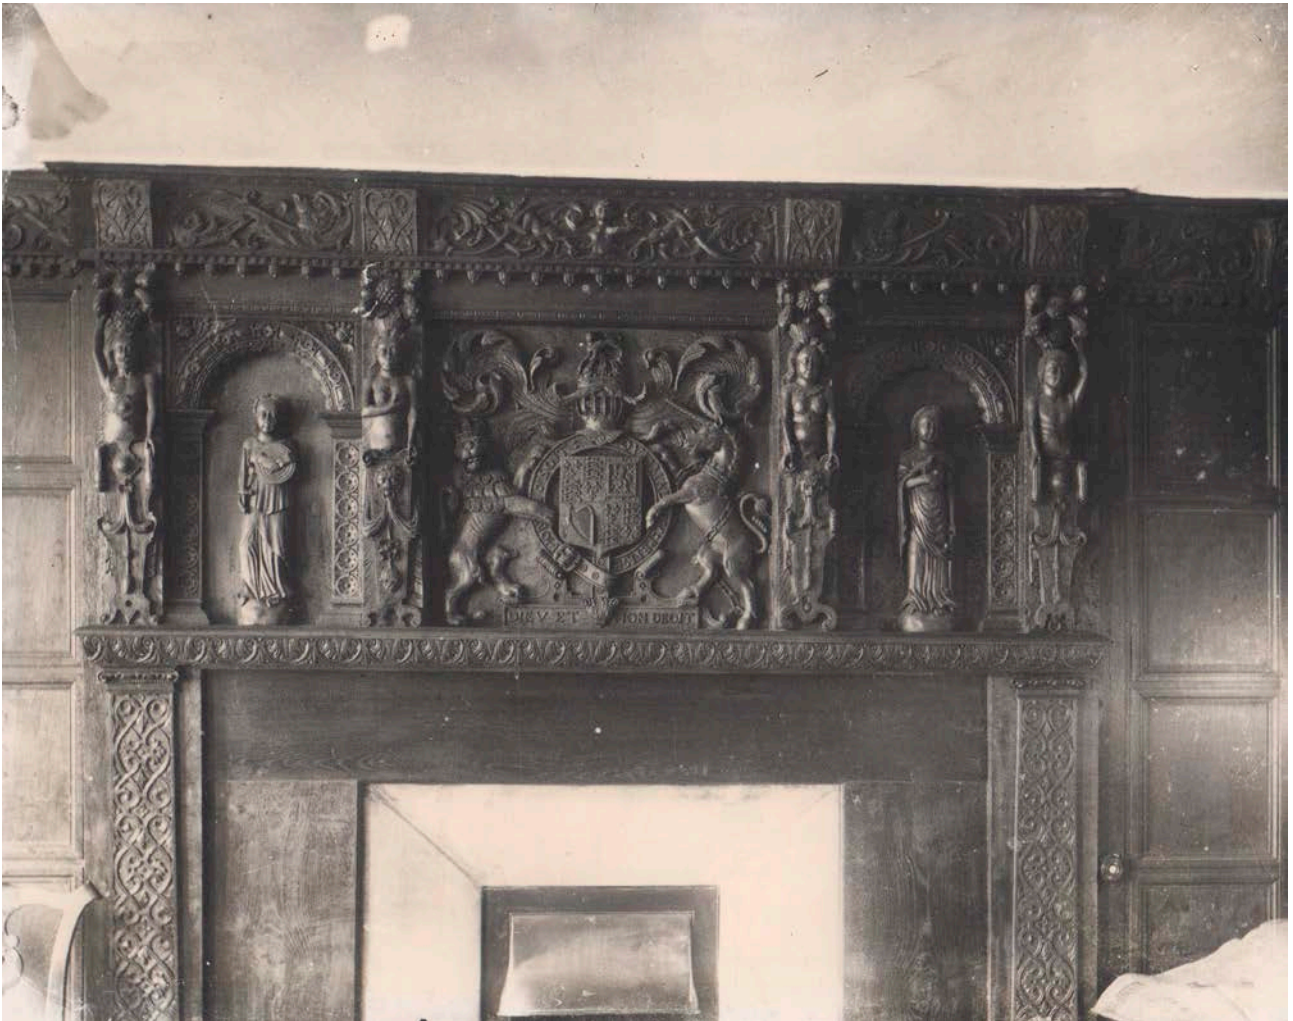
Figure 20: Detail of the overmantel in the southern ground-floor room in the front range, taken during the Moore family's residence between about 1911 and 1918. [The John Moore Society; reproduced with permission]

At some point after 1921 the Jacobean overmantel and its marble chimneypiece were removed and reportedly sold to America.<sup>146</sup> It seems likely that this sale included much of the original panelling of the room as the present panelling does not have any pilasters or

the carved frieze which continued around the room (see Figures 18-20). It was certainly gone by about 1930-34 when a booklet published by hotelier Mrs Fothergill shows the room without it.<sup>147</sup>

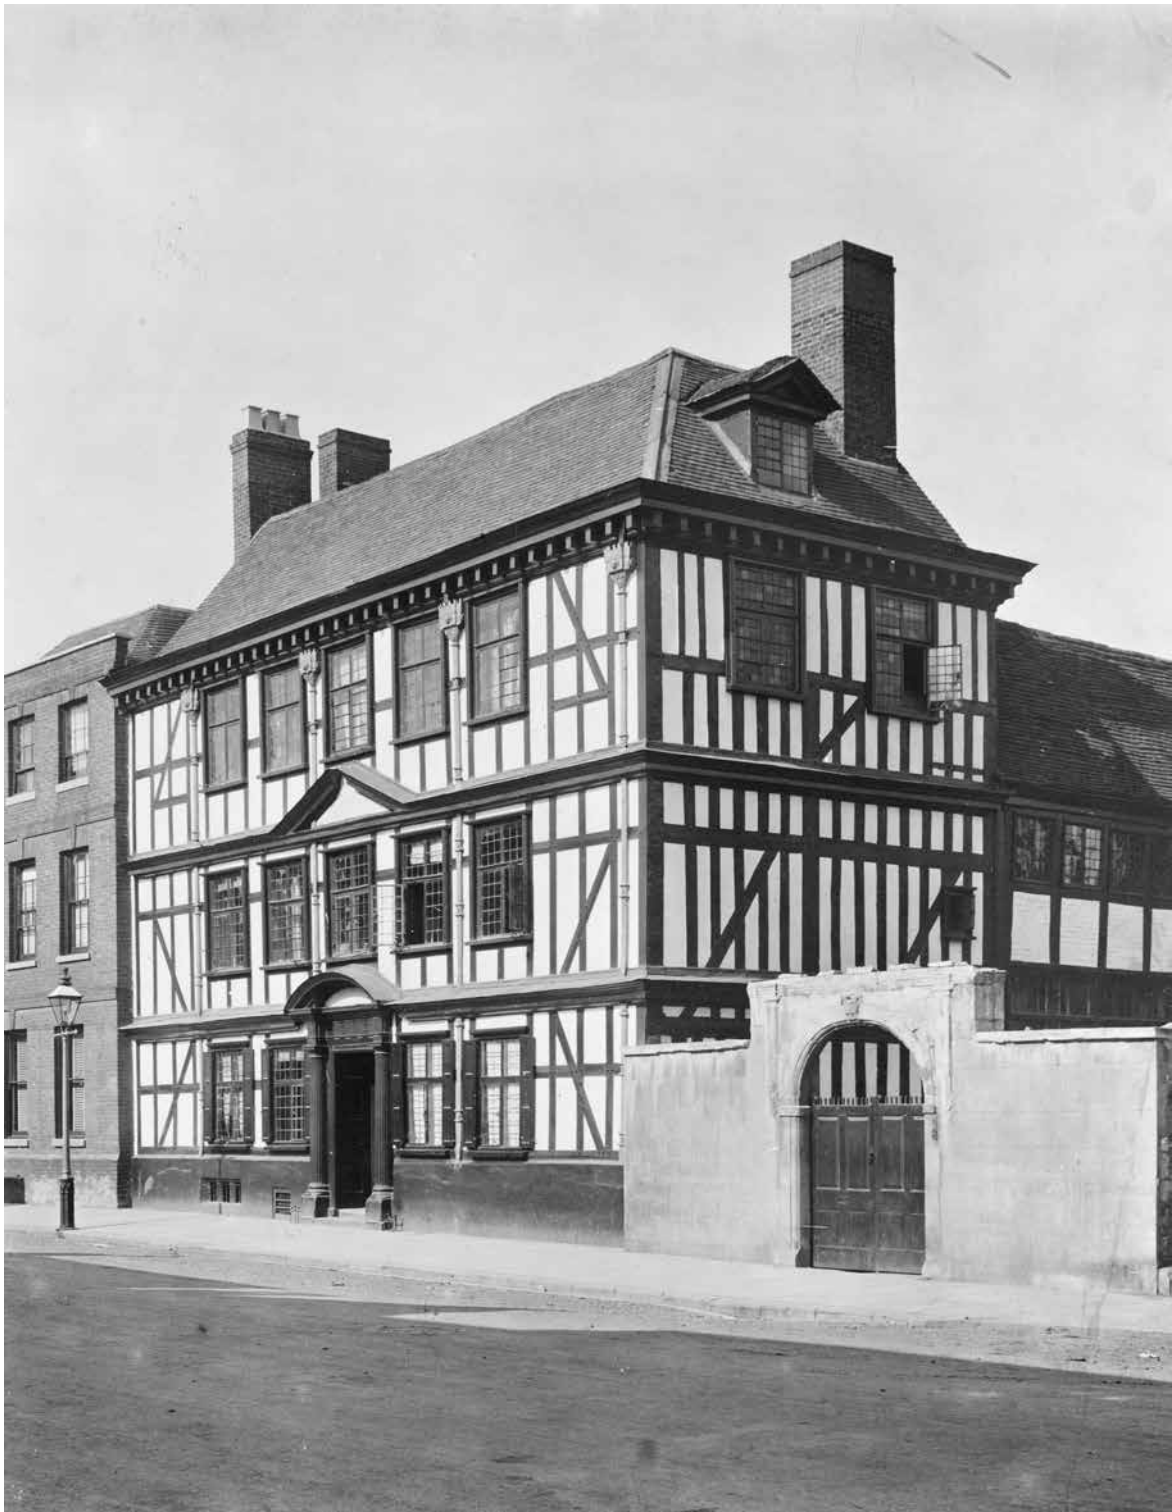
Figure 21: The Tudor House in a photograph that was probably taken in the 1920s. [Source: Historic England Archive, OP36168]

In July 1921 the Royal Institute of Archaeology and the Bristol and Gloucestershire Archaeological Society held a joint summer meeting which included a visit to Tewkesbury, which included the Tudor House.<sup>143</sup> The published account mentions the building's two main staircases, a room with plaster decoration in the style of the Adam brothers, and the south front room with the royal arms in its overmantel and panelling 'with pilasters carved with interlaced strapwork of the Jacobean period'.<sup>144</sup> It also noted that the stone gateway to the corner courtyard was 'now partly destroyed', which presumably refers to the removal of the pediment which had taken place by then (Figure 21).<sup>145</sup>

In 1930 the building had changed hands again. In March that year Edith Emily Fothergill bought the property from Mayo for £1,550.<sup>156</sup> In 1932 the two four-panelled doors in the gateway to the corner courtyard were replaced with a two-leaf gate with diamond timber mullions (Figure 23 and see Figure 21). It has the inscription ‘Where antiquity walks hand in hand with time and still retains its dignity – there is peace. 1540/1932’. The stone gateway itself is said to have been restored at that time.<sup>157</sup> It seems likely that the ball finials of the gateway’s pediment were placed on its entablature around this time; they were in place by 1938 (see Figure 23). Also during the early 1930s, a larger canopy was erected over the building’s front entrance (see Figure 23).

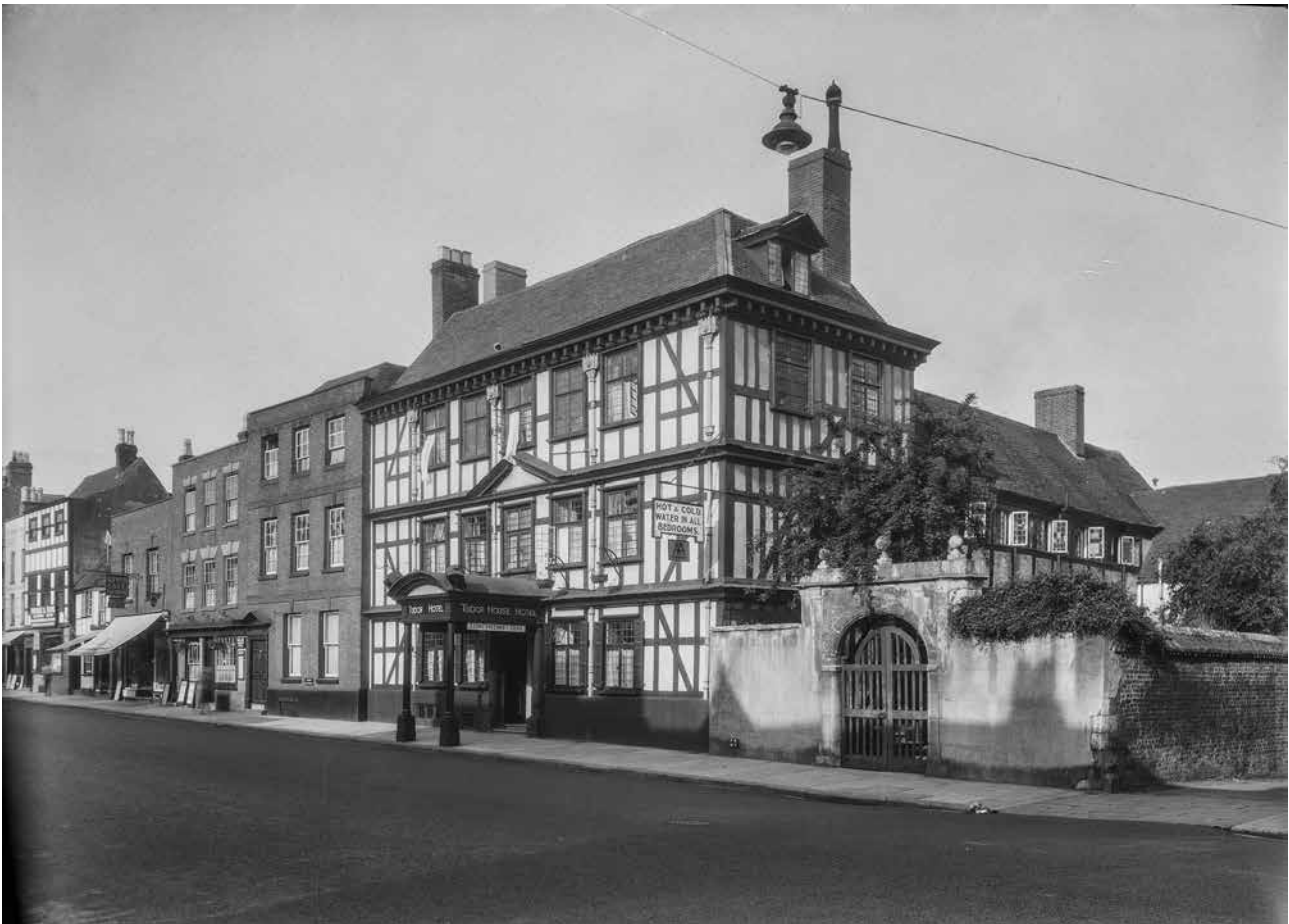
Figure 23: Tudor House Hotel in 1938. [Source: Historic England Archive, WSA01/01/AA0570]
