# The Tudor House Hotel, 52-3 High Street, Tewkesbury, Gloucestershire

Historic Building Assessment

Johanna Roethe

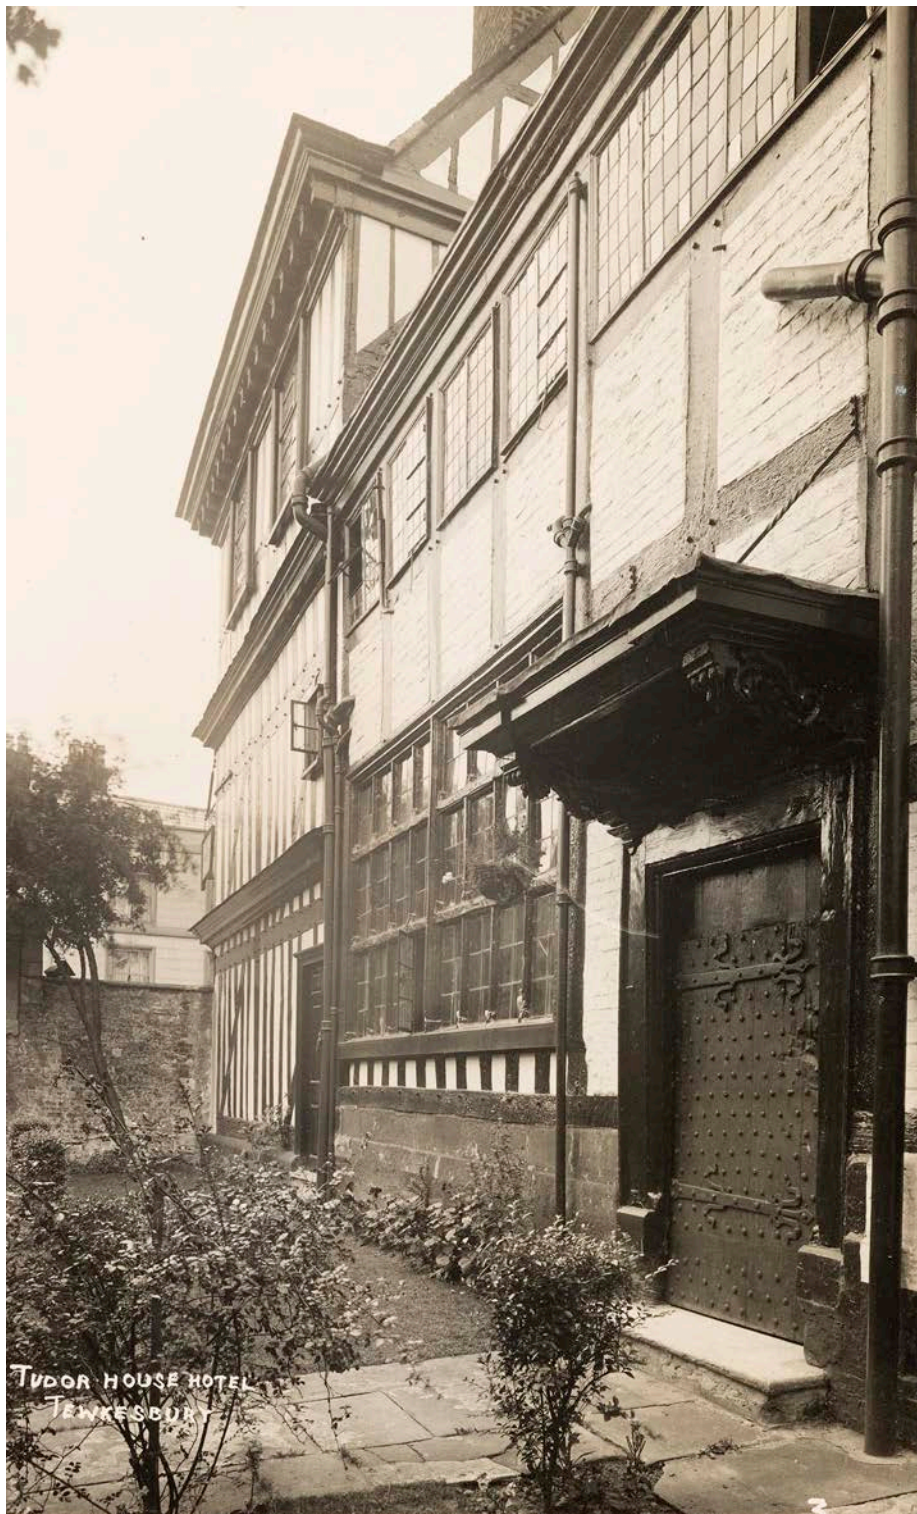
Figure 26: Photographic postcard showing the north elevation of the front range (left) and the north wing (centre and right), probably in the early 1930s. [Source: Historic England Archive, PC62003]

In the second bay to the east is a door frame adjacent to the post at the western side of the bay. The mid-rail in this bay is higher, to accommodate the door, and it is pegged into the post (Figure 71). The broad door frame is defined by two jambs and a lintel all of which have an ovolo-chamfer moulding around the edge of the opening with stops. Due to thick layers of paint and damage, the form of the stops is unclear but historic photographs shows them as scroll stops (see Figures 15, 26). The degree of later patching and overpainting makes the precise relationship between the doorway and the surrounding framing unclear. To the west the western jamb sits against the wall post, but any pegging is not currently visible. The pegged mid-rail however appears to prove that there was always a doorway in this position. There is a slight gap between the top of the door frame and the bottom of the lintel; this was formerly filled by a door canopy on decoratively carved, scrolled brackets (see Figure 26).

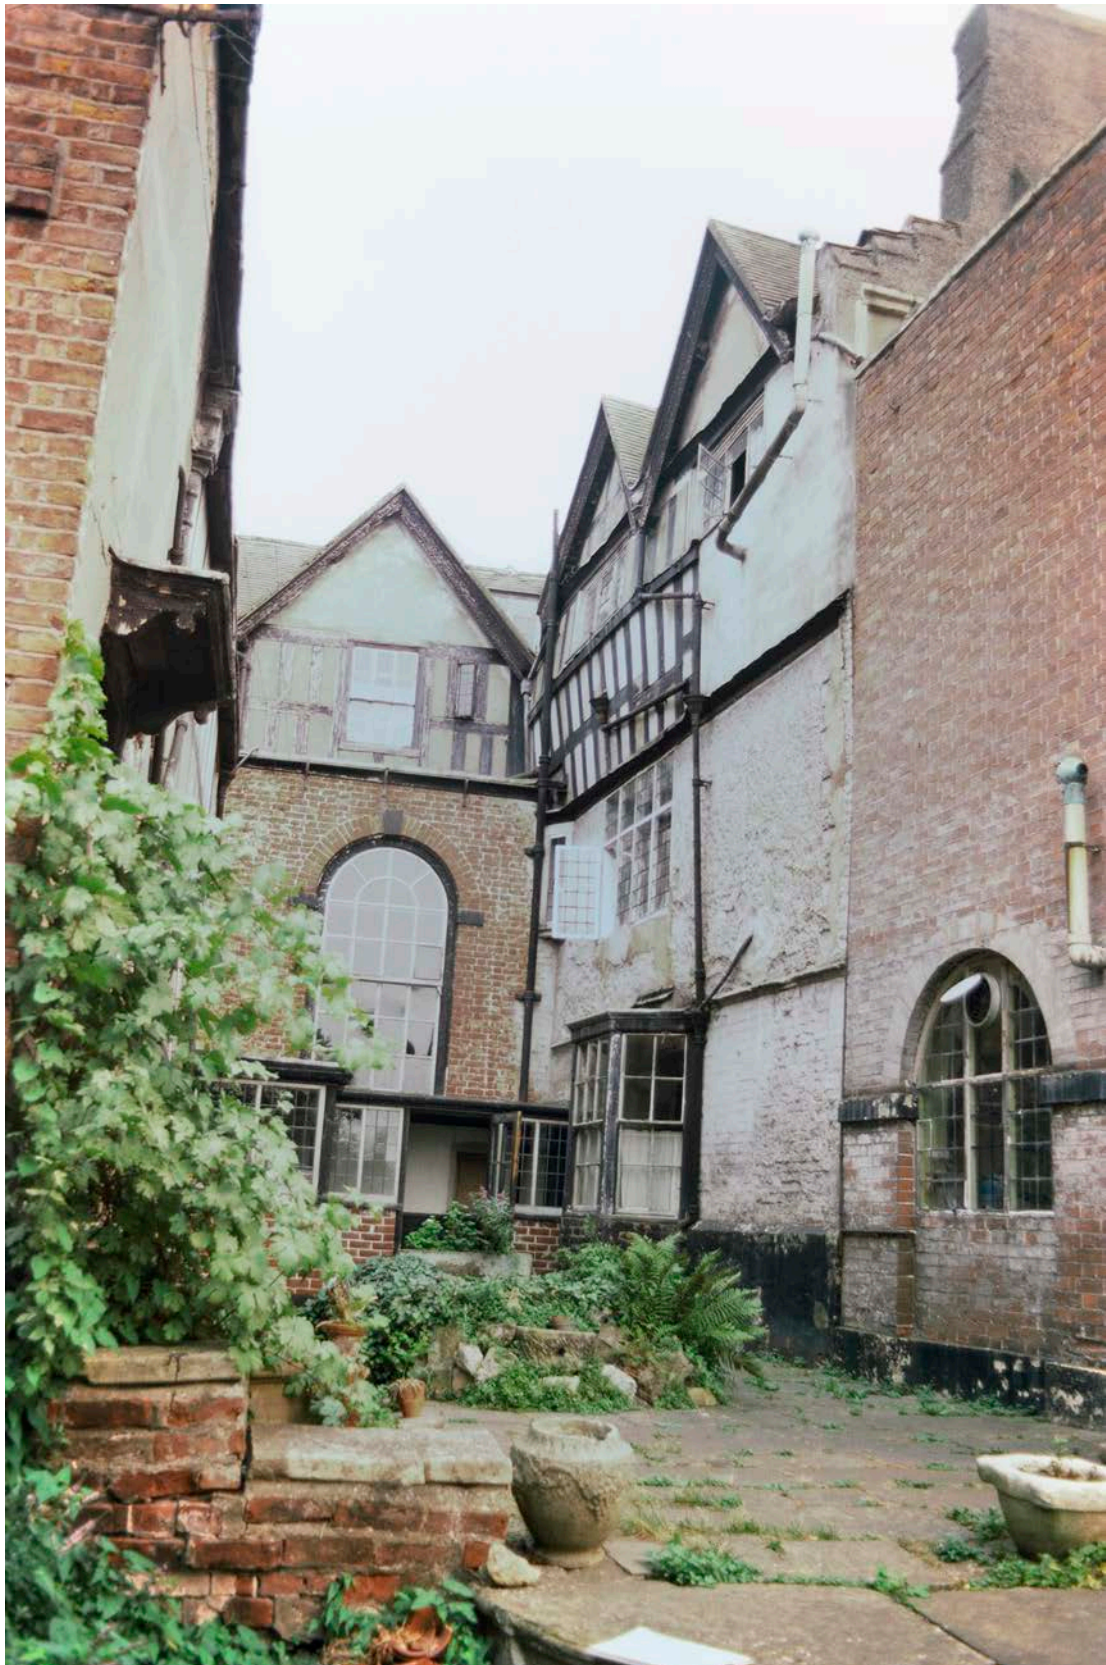
Figure 28: A photograph of the rear (west) elevation taken by Stanley Jones in about 1967-8. [© Historic England Archive, SJC01/03/0014]

The south wing has a gable-end chimneystack at its west end. Although it has been partially rebuilt in the late 20th century, a photograph of the stack in the 1960s shows that originally it had a stepped gabled end with stone coping, and a small stone window on its northern side (see Figure 28). At attic level the stack occupies nearly the whole width of the wing. This stepped form is typical of the late 17th century. Whether it is contemporary with the construction of the wing, or a slightly later modification is unclear. Brickwork of this type has not been identified elsewhere in Tewkesbury but is typical of modifications often seen in relatively high-status buildings in the 17th century.

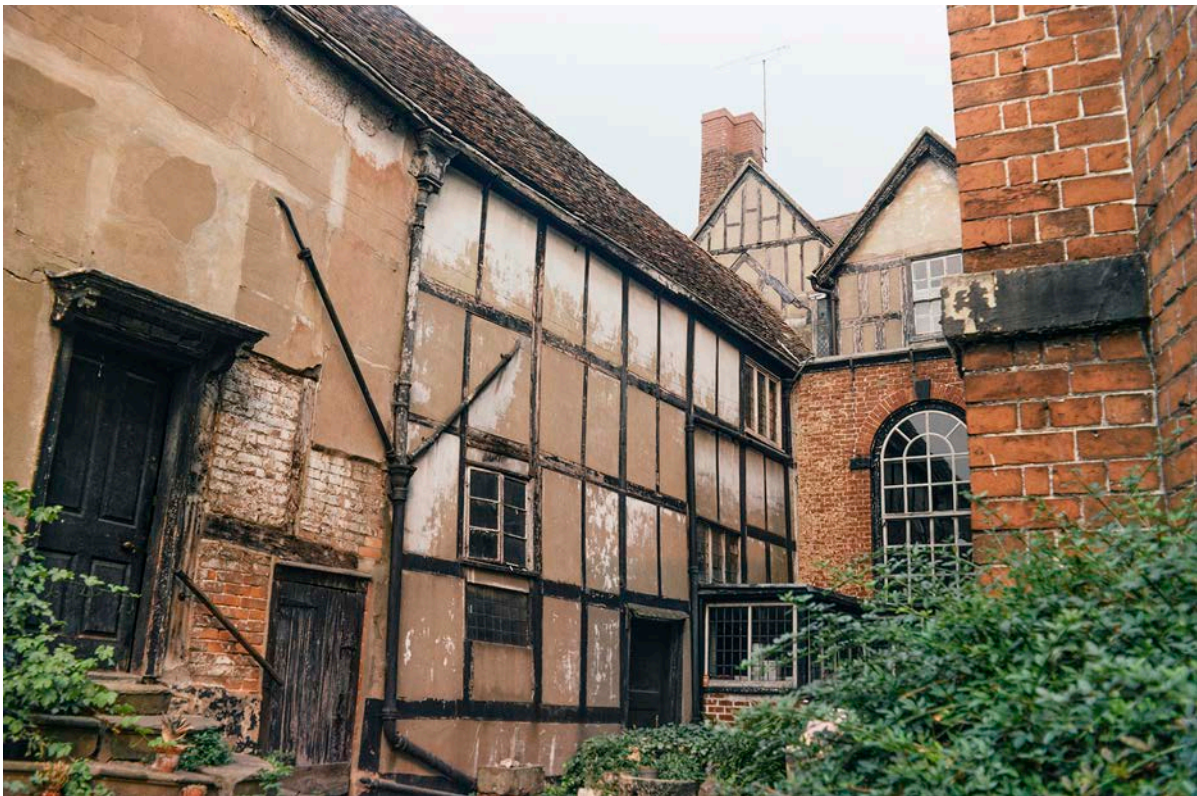
Figure 29: A photograph of the west elevation of the front range and the south elevation of the north wing (left) taken by Stanley Jones in about 1967-8. [© Historic England Archive, SJC01/03/0015]

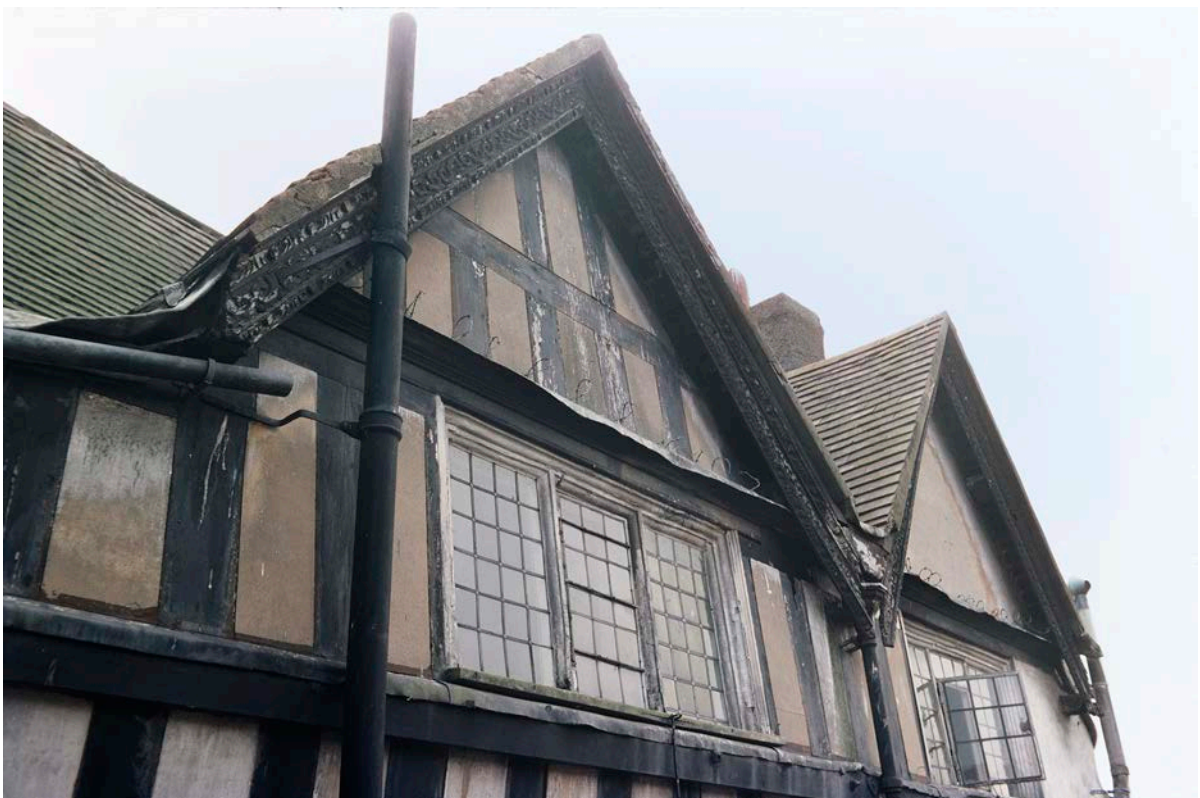
Figure 30: A photograph of the two north gables of the south wing taken by Stanley Jones in about 1967-8. [© Historic England Archive, SJC01/03/0009]

The south wing has two storeys and attics. As constructed the wing consisted of four bays, defined by five frames. The westernmost bay incorporates a brick gable chimney, beyond which is now a late 18th-century brick extension. Only the framing of the north elevation is visible externally (Figure 42). It is box-framed but with quite closely spaced studs. The ground-floor wall has been rebuilt in brick and much of the timber on the upper floors was replaced in the 1970s-80s, not always reflecting the original arrangement (see Figure 28). In the 1960s the two attic windows still had ovolo-moulded windows with timber mullions (see Figure 30).

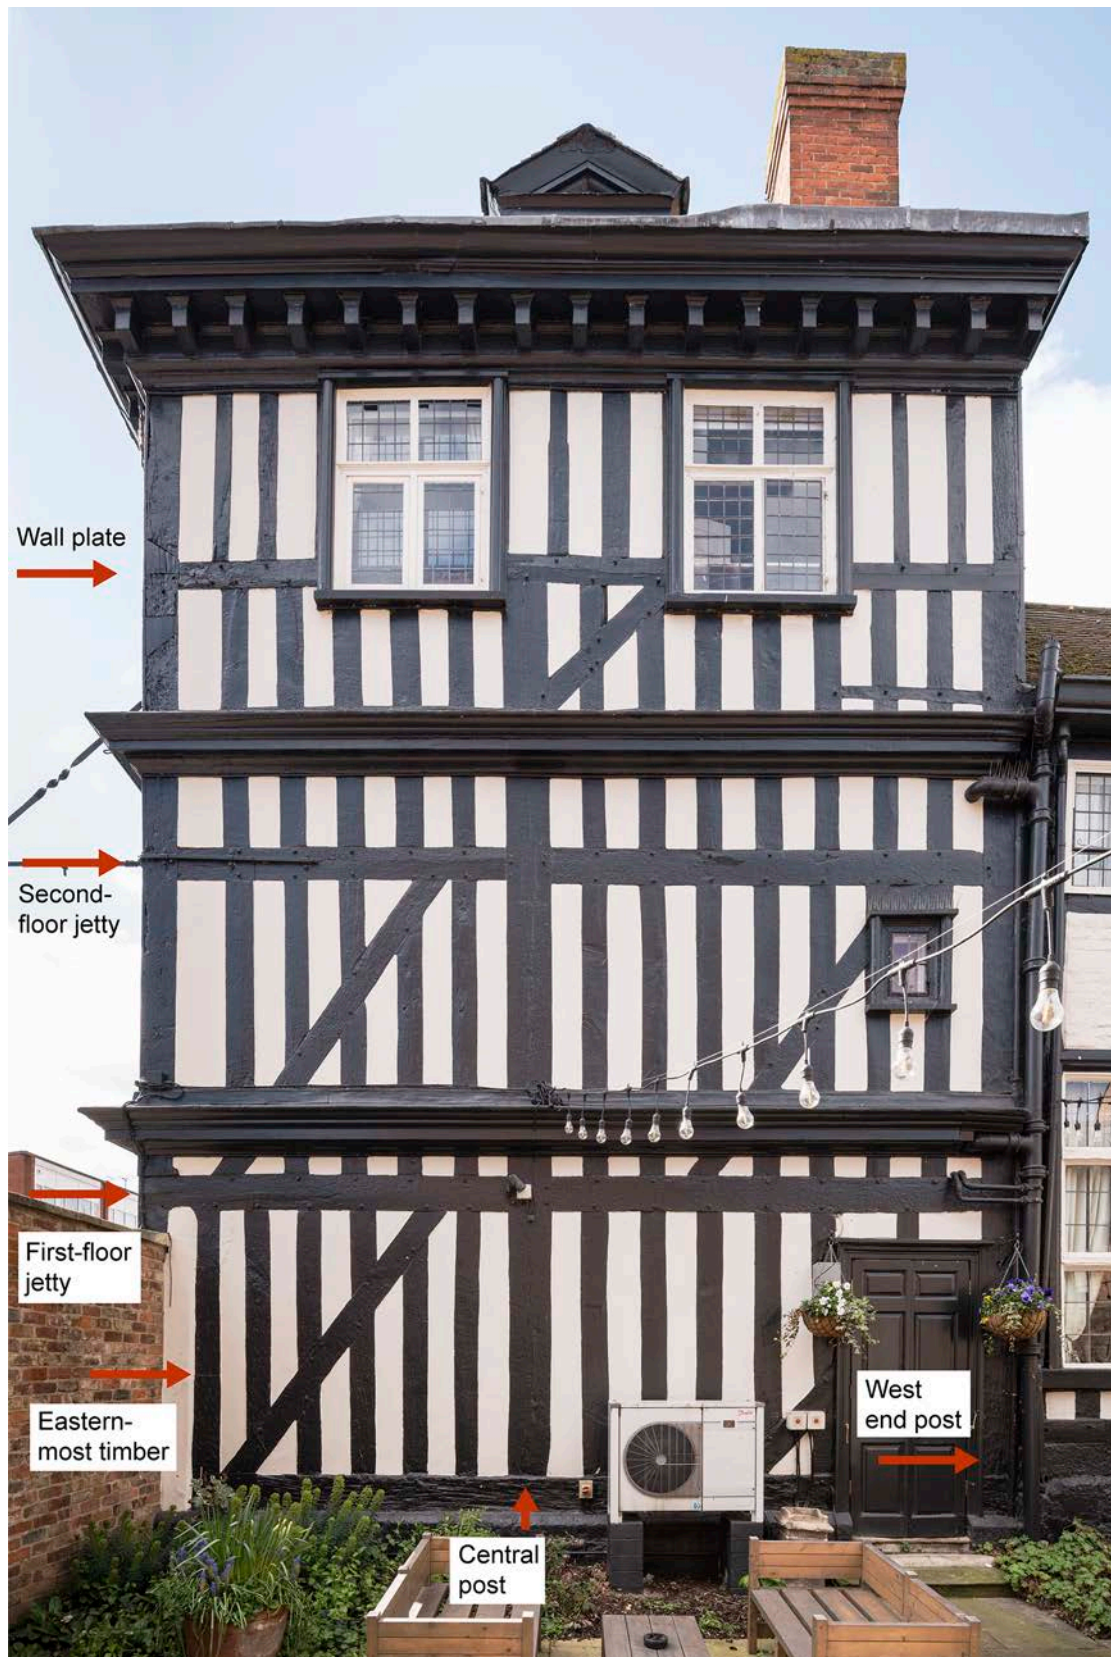
Figure 36: The north elevation of the front range, annotated with key original features. [Steven Baker © Historic England Archive, DP325759]

Between the main structural posts and the central post are the girding beams at the original floor levels. As noted above, they are lower than the 18th-century moulded cornices or the current internal floor levels. The remainder of the framing of the elevation is of close studding, with largely the same pattern over the three original storeys. The only area where the pattern now deviates is on the ground floor, above the later door to the west, where two original studs were later replaced by one above the door but the two original peg holes are still visible. Several studs have carpenter's marks and appear to have been numbered from the west end post to the east front (Figure 37). For example, the stud with the number XII (12) is the twelfth vertical timber from the west, including the west post and the two removed studs in the location of the door.

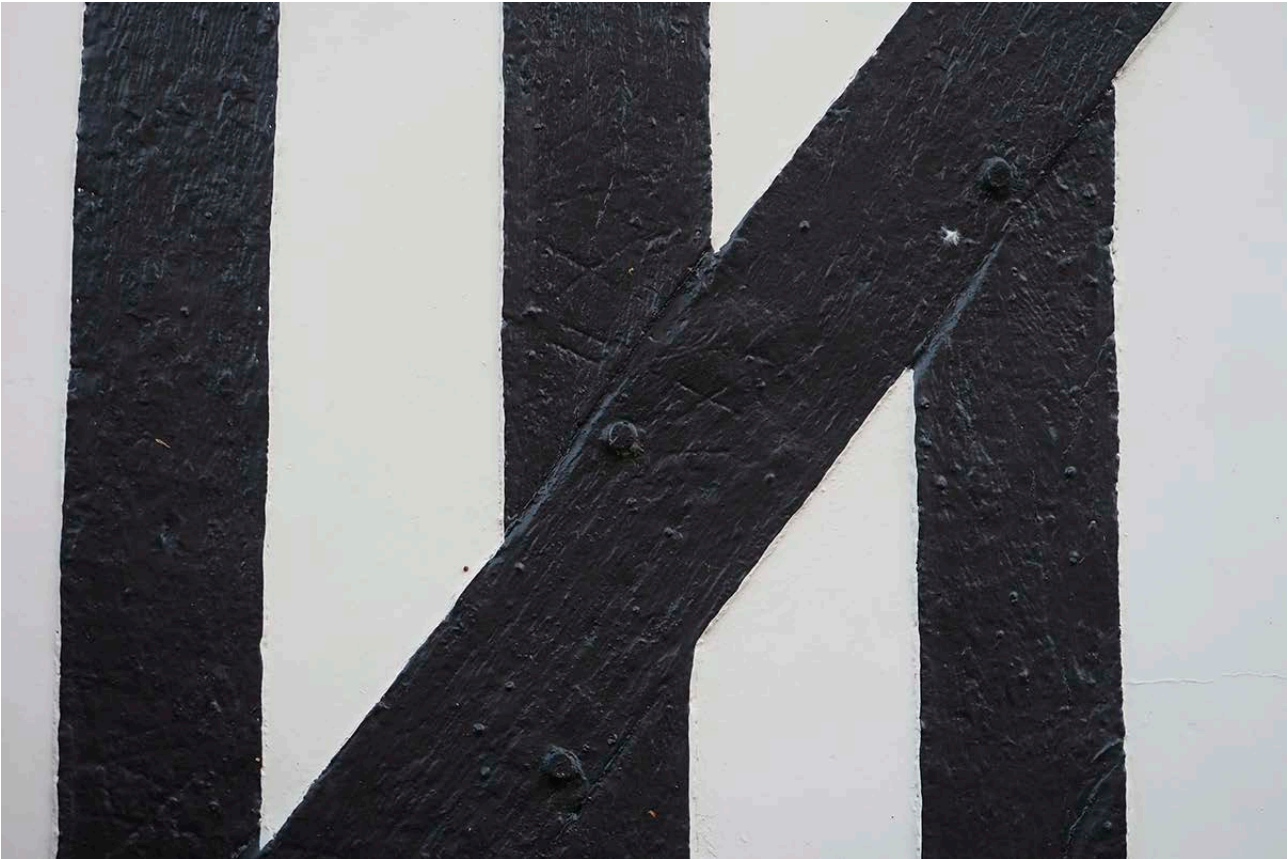
Figure 37: Detail of the framing in the eastern half of the north elevation, showing carpenter's marks with the number XII (for 12) on a stud and brace. [Abigail Lloyd © Historic England]

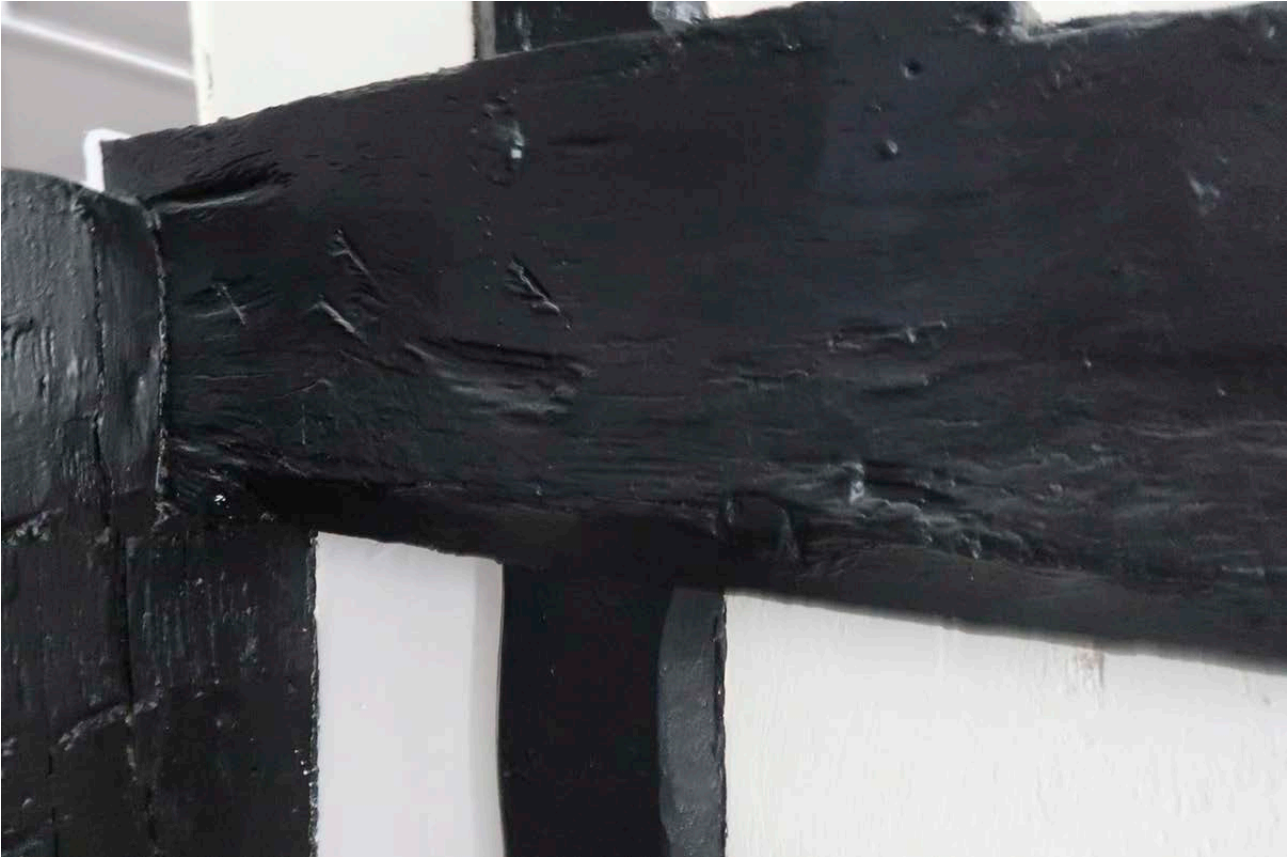
Figure 38: Chamfer, straight stop and peg hole on the underside of the wallplate at the north-east corner of the front range, indicating the possible location of an original window. [Johanna Roethe © Historic England]

At the west end of the original second floor is a thin rail which is pegged into the west end post and the three studs to the east. This is probably the sill to a former window opening. No further evidence is visible externally as part of the wall plate directly above has been obscured with nailed-on thin sections of timber. The area below the rail is

obscured by the 18th-century cornice. Internally, a chamfer with a straight stop on the wall plate and a peg hole for a mullion appear to confirm that this was indeed a window (Figure 38).

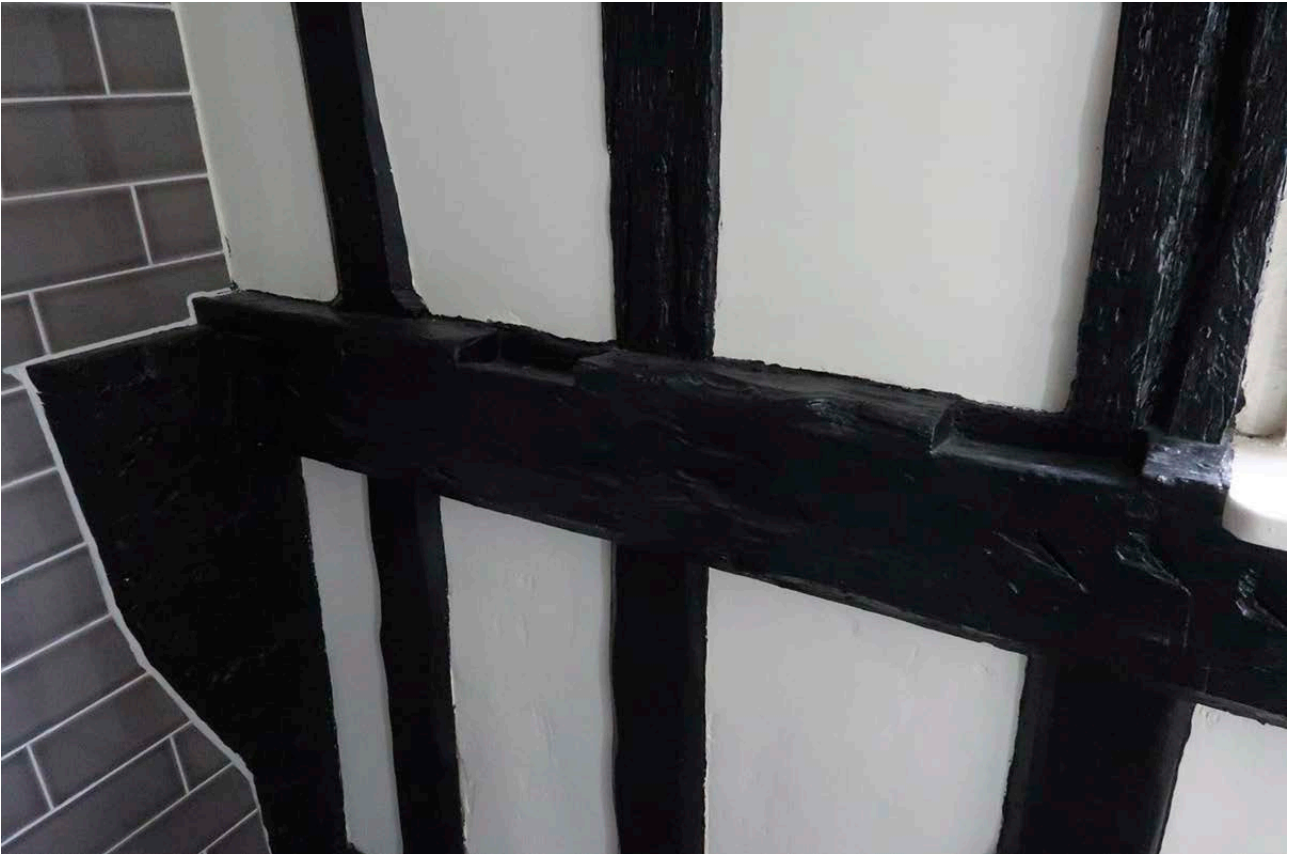
Figure 39: The former wall plate and jowled west post of the north elevation at the modern second-floor level. [Johanna Roethe © Historic England]

Internally, nothing of this framing is visible at ground-floor level. The first-floor room was not inspected but in the second-floor room the wall plate, some of the close studding of the original second floor, and the jowled head of the west post of the north elevation are visible (Figure 39). The wall plate has empty notches for the original rafter feet and is chamfered on the soffit.

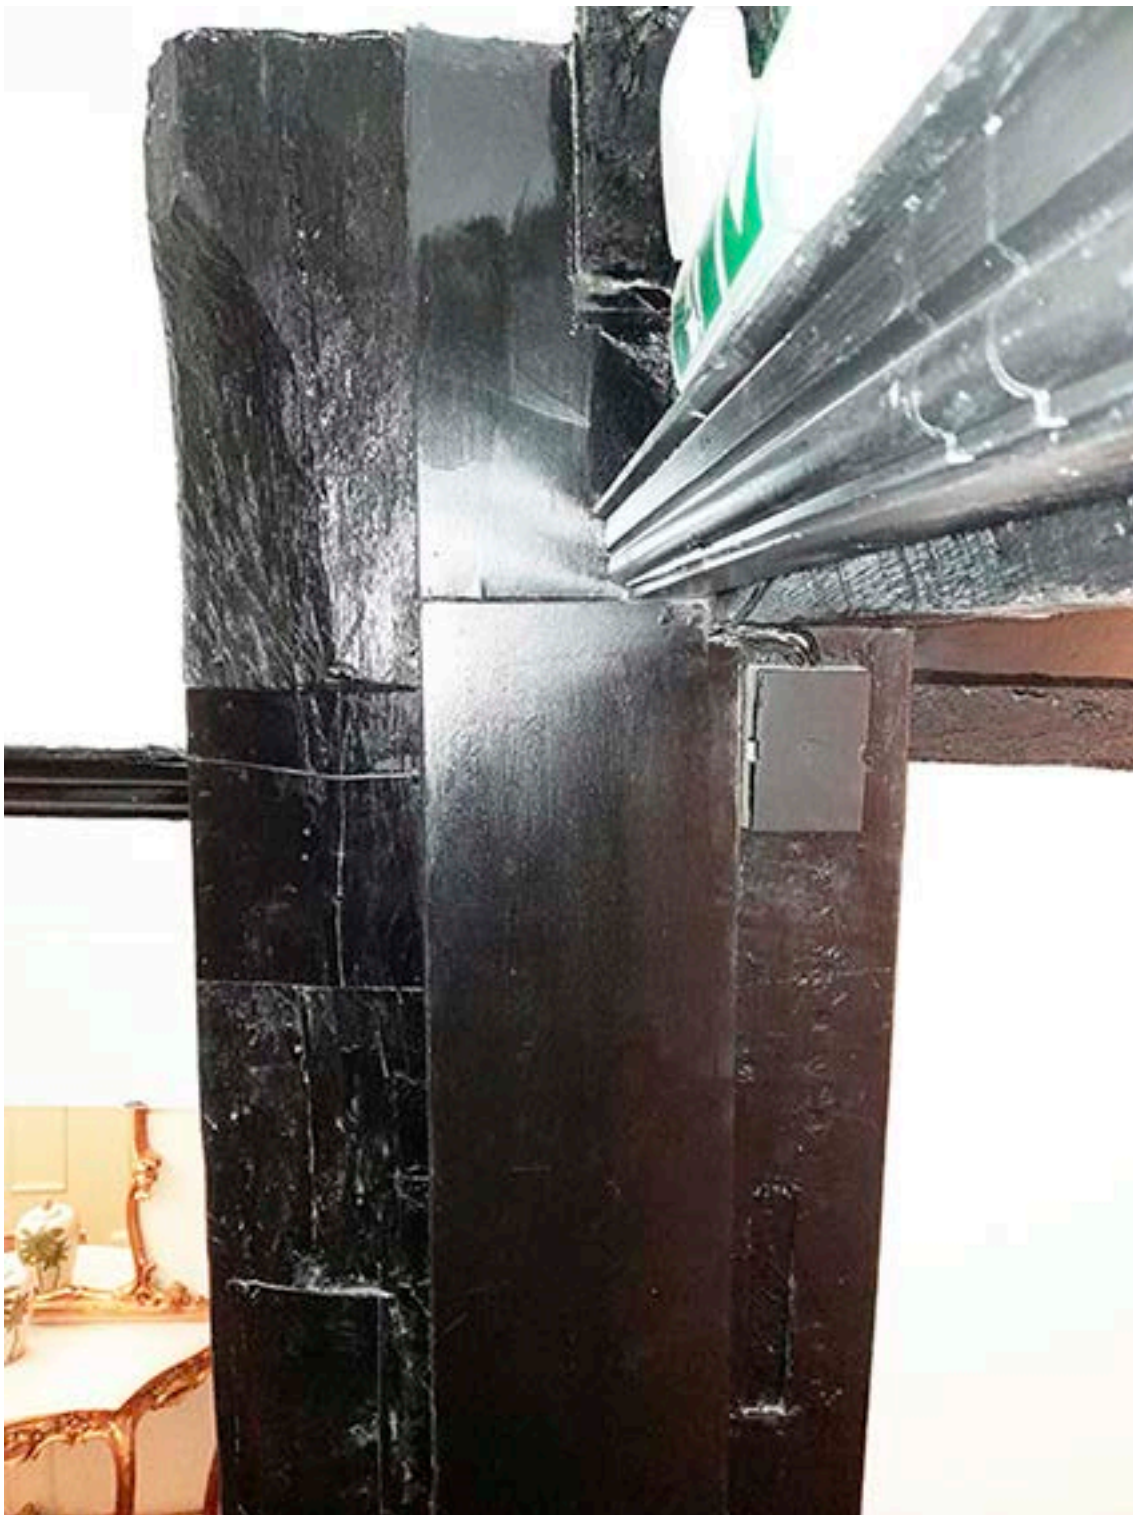
Figure 40: The south corner of the junction of the front range (left) and the north wing, seen at the first floor. The north wing's south-east corner post is to the right and a post belonging to the front range to the left. Their junction is obscured by a modern piece of timber. [Johanna Roethe © Historic England]

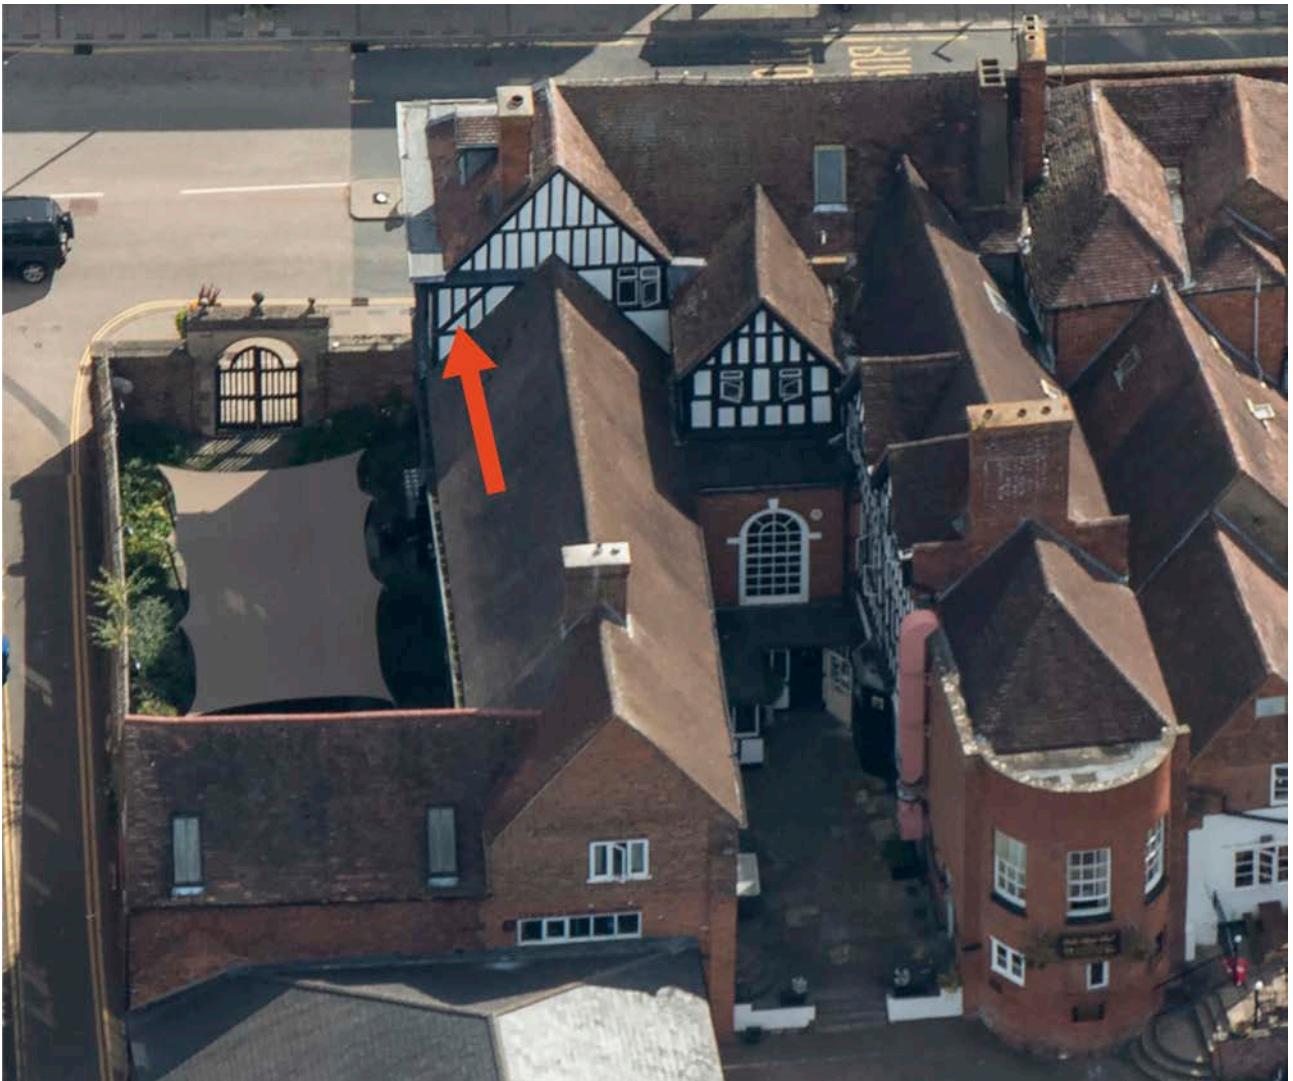
Figure 41: Aerial photograph of the Tudor House Hotel from the north-west. The red arrow indicates the remaining timber from the original, lower gable. [Damian Grady © Historic England Archive, 35124\_023]

The original roof structure was replaced when the building was raised, but some evidence survives to indicate its original form. At the northern end of the range, adjacent to the later north wing, traces of a gable end at the original, lower roof line are still visible, in the form of a residual section of the northern principal rafter (Figure 41). Photographs from the 1960s indicate that at this date the full residual gable end was still in situ (see Figure 29). The form of the rest of the roof is unclear. It may have formed an L-shape as it does now at a higher level (see Figure 41), with the majority of the roof therefore running parallel to the street front. Alternatively, the residual rear gable

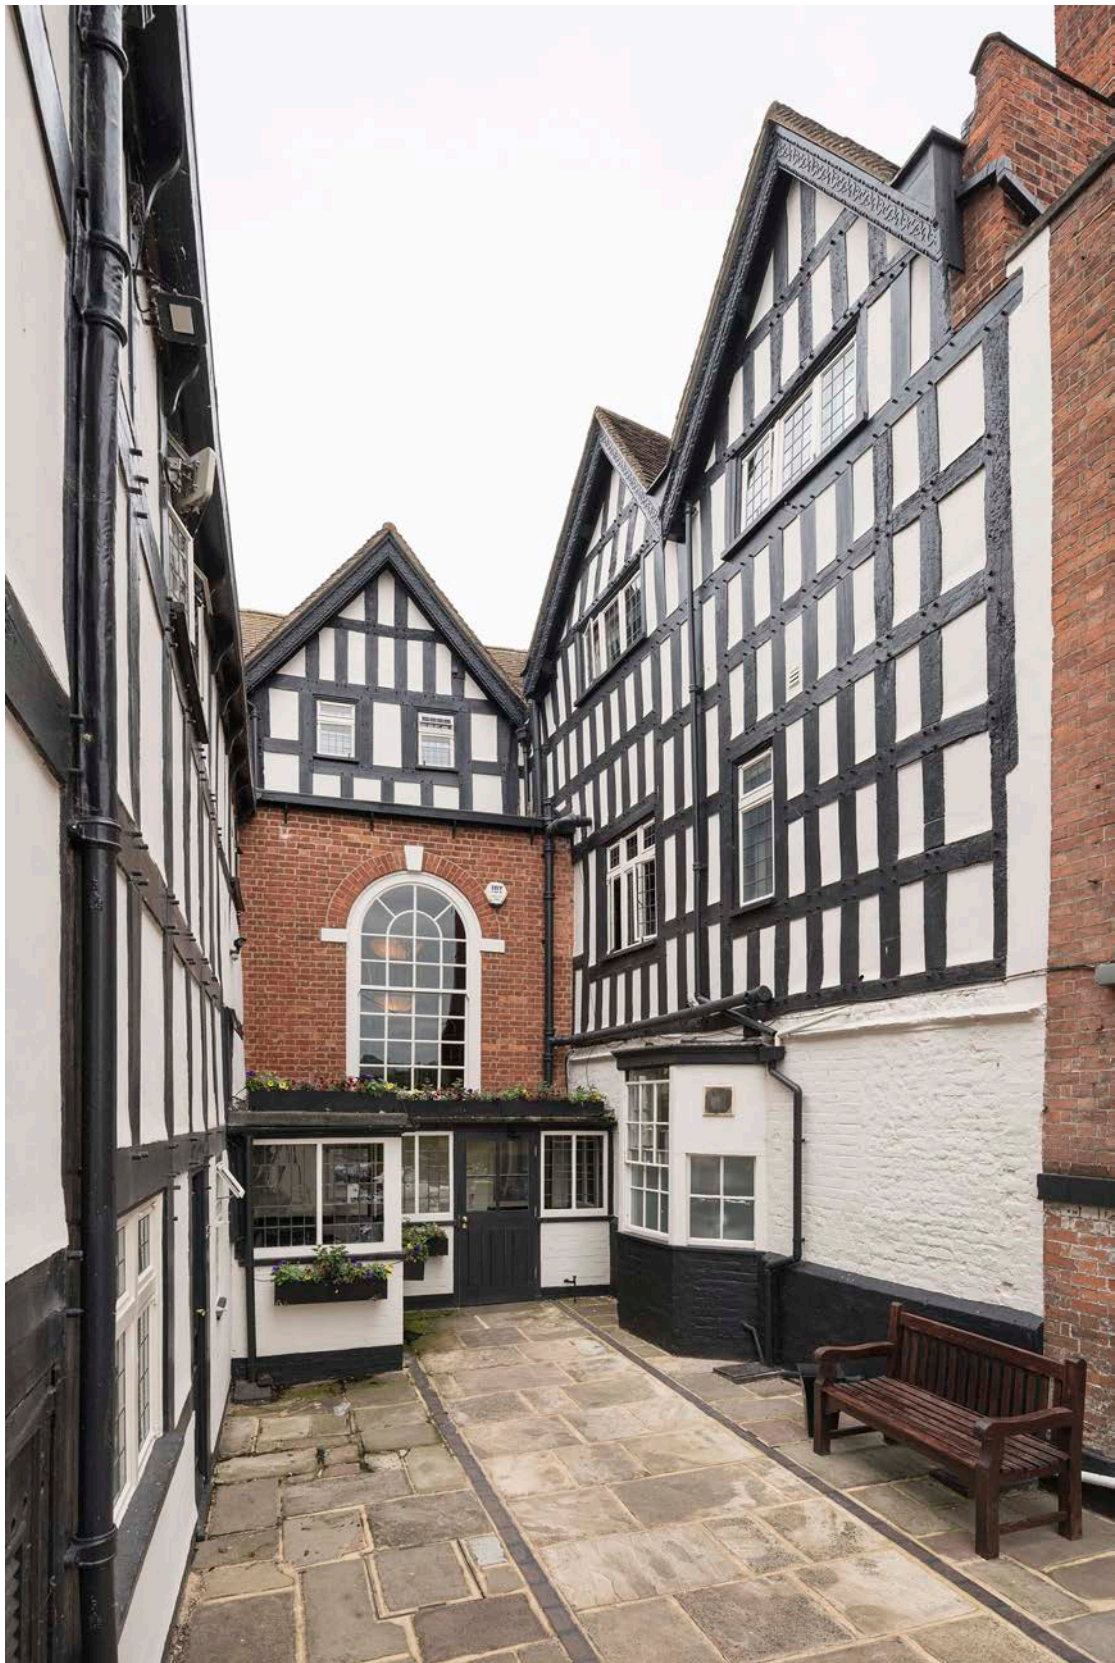
Figure 42: The courtyard to the rear (west) of the front range, with the north elevation of the south wing to the right. [Steven Baker © Historic England Archive, DP325764]

The original form of the westernmost truss is unclear, and the western end of the building may always have been partly supported by the stack. The northern post of the westernmost truss may be the weathered post visible externally today rising close to the western stack externally (see Figure 42). It is not visible internally at attic level. Although

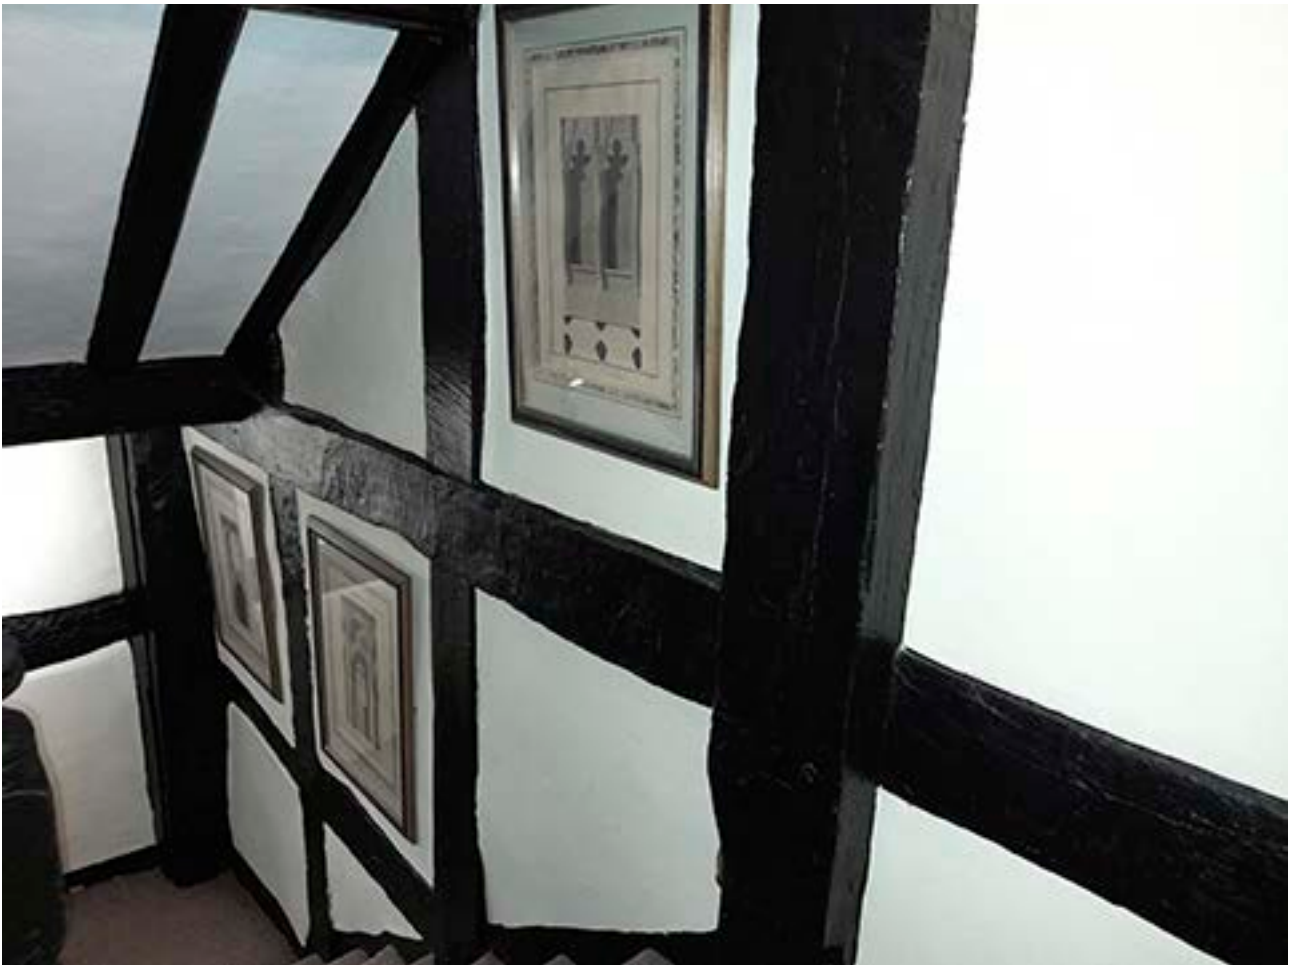
Figure 43: The south wall in the staircase looking down from the first-floor landing. [Johanna Roethe © Historic England]

The south wall is also box-framed and is visible internally at the south-east corner of the south wing. At ground-floor level there is a tall stone plinth on which rests the sill plate into which posts and studs are pegged. At first- and second-floor level the regular box-framed pattern is visible (Figure 43). There is no indication of any window openings on the south elevation, which may suggest that the building was built up against an earlier neighbouring building.

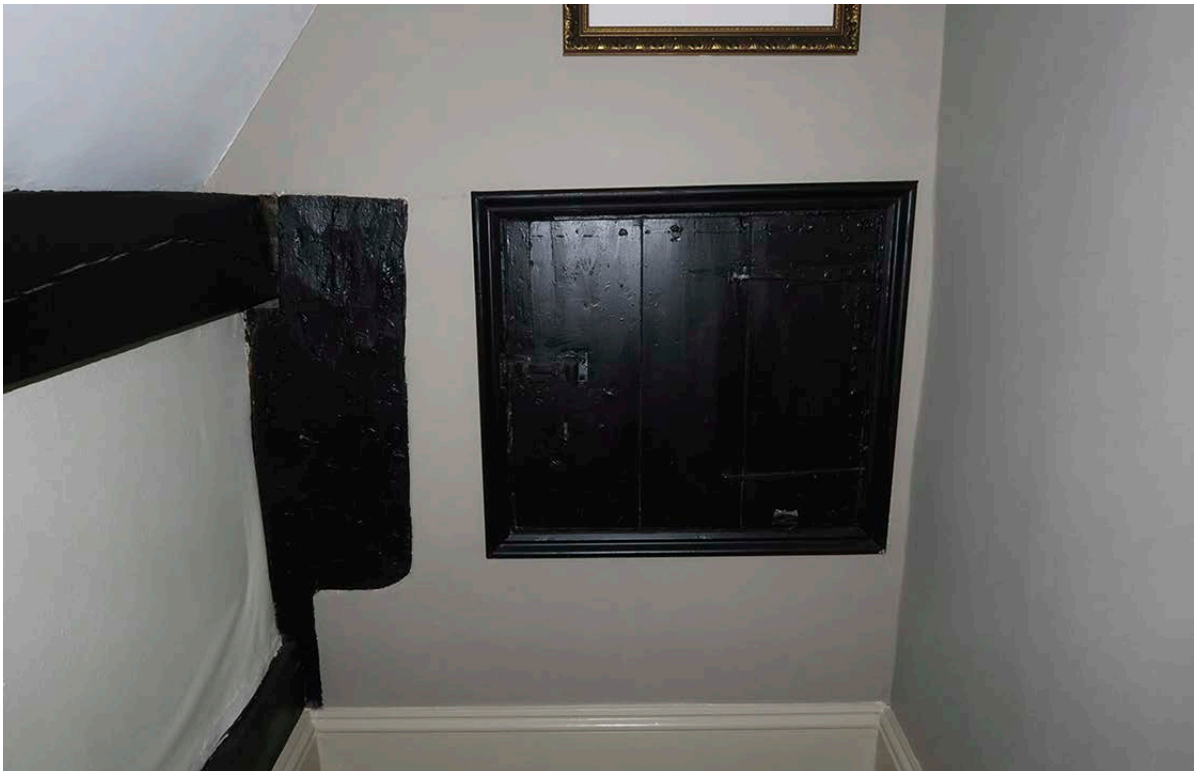
Figure 45: The south-west corner of the south wing at attic level. The south corner post of the westernmost frame is to the left and the chimneystack is to the right. [Johanna Roethe © Historic England]

it is slightly further west than the chimneystack this tallies with the location of the south post of the same truss, which is visible internally and is also located slightly further west than the deep stack (Figure 45).

A small cupboard has been built into the wall to the south of the deep stack, with slender strap hinges terminating in a round end, typical of the late 17th century (see Figure 45). The rooms with the stack on the lower two floors were not accessible for this project. There is said to be a further ovolo-moulded doorway on the ground floor, just to the south of the chimneybreast.<sup>199</sup>

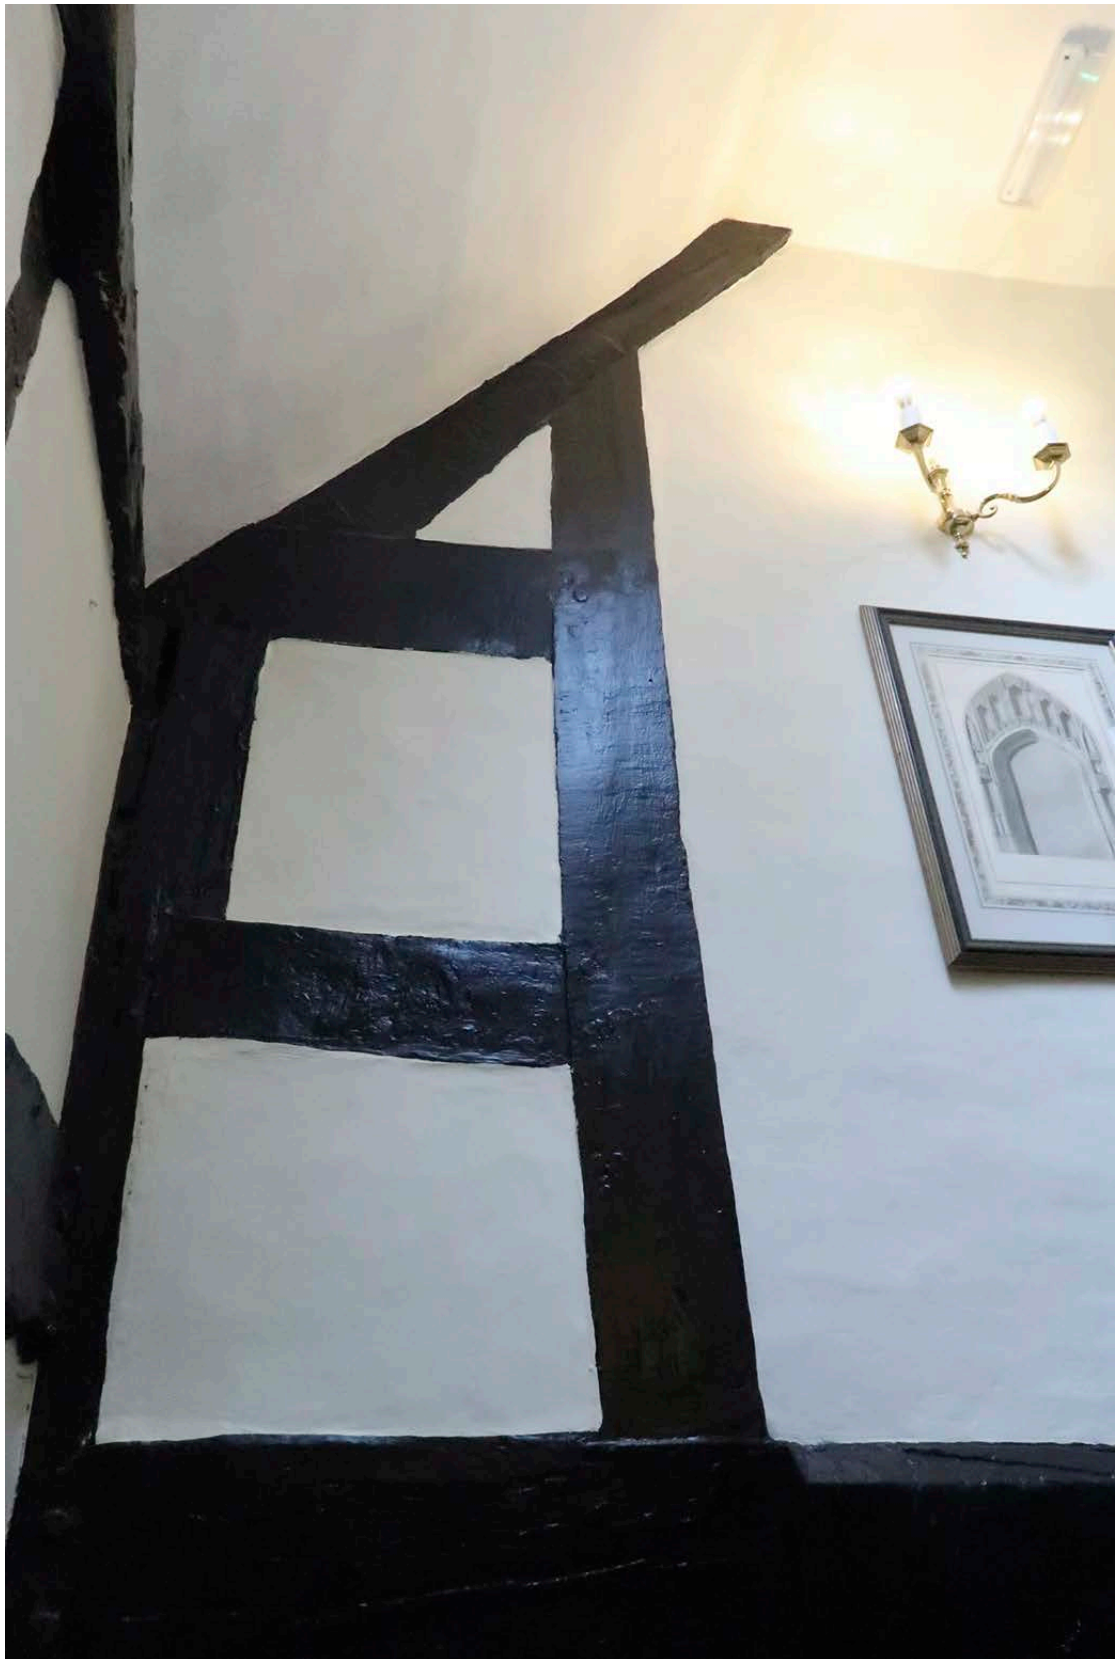
Figure 47: The south side of the fourth truss from the west. [Johanna Roethe © Historic England]
