# The Tudor House Hotel, 52-3 High Street, Tewkesbury, Gloucestershire

Historic Building Assessment

Johanna Roethe

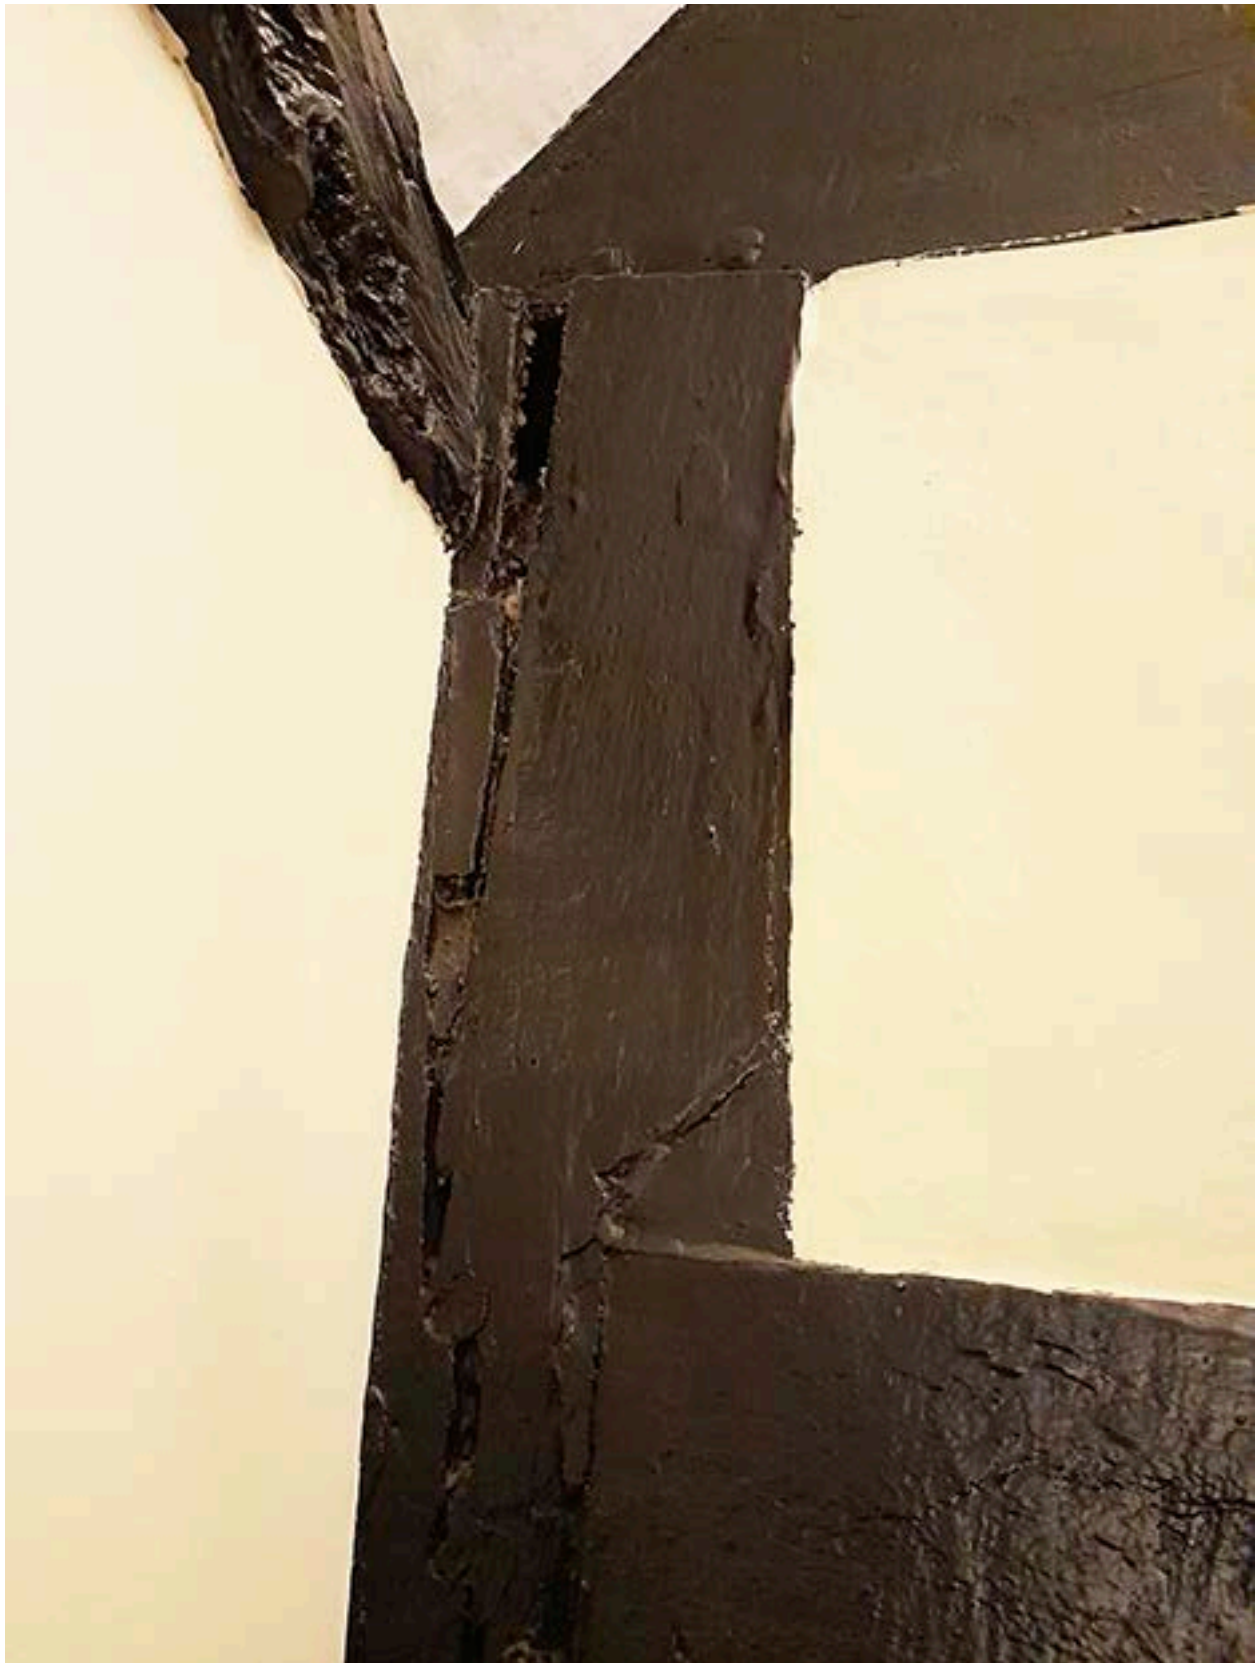
Figure 48: The southern wall post and wall plate (top left) in the fourth truss from the west.  
[Johanna Roethe © Historic England]

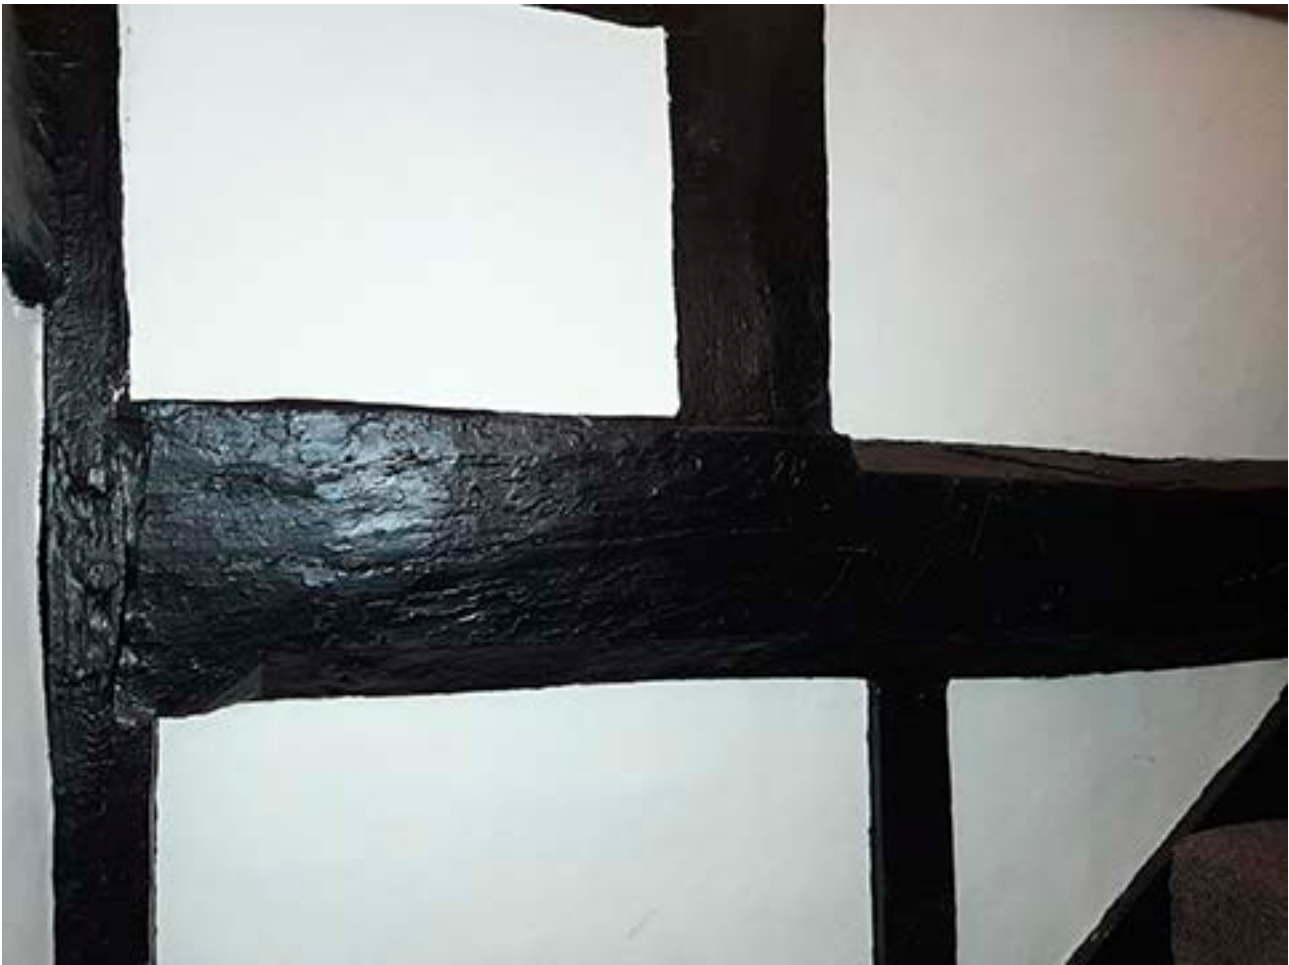
Figure 49: The chamfered girthing beam of the fourth truss from the west, just west of the stairwell. [Johanna Roethe © Historic England]

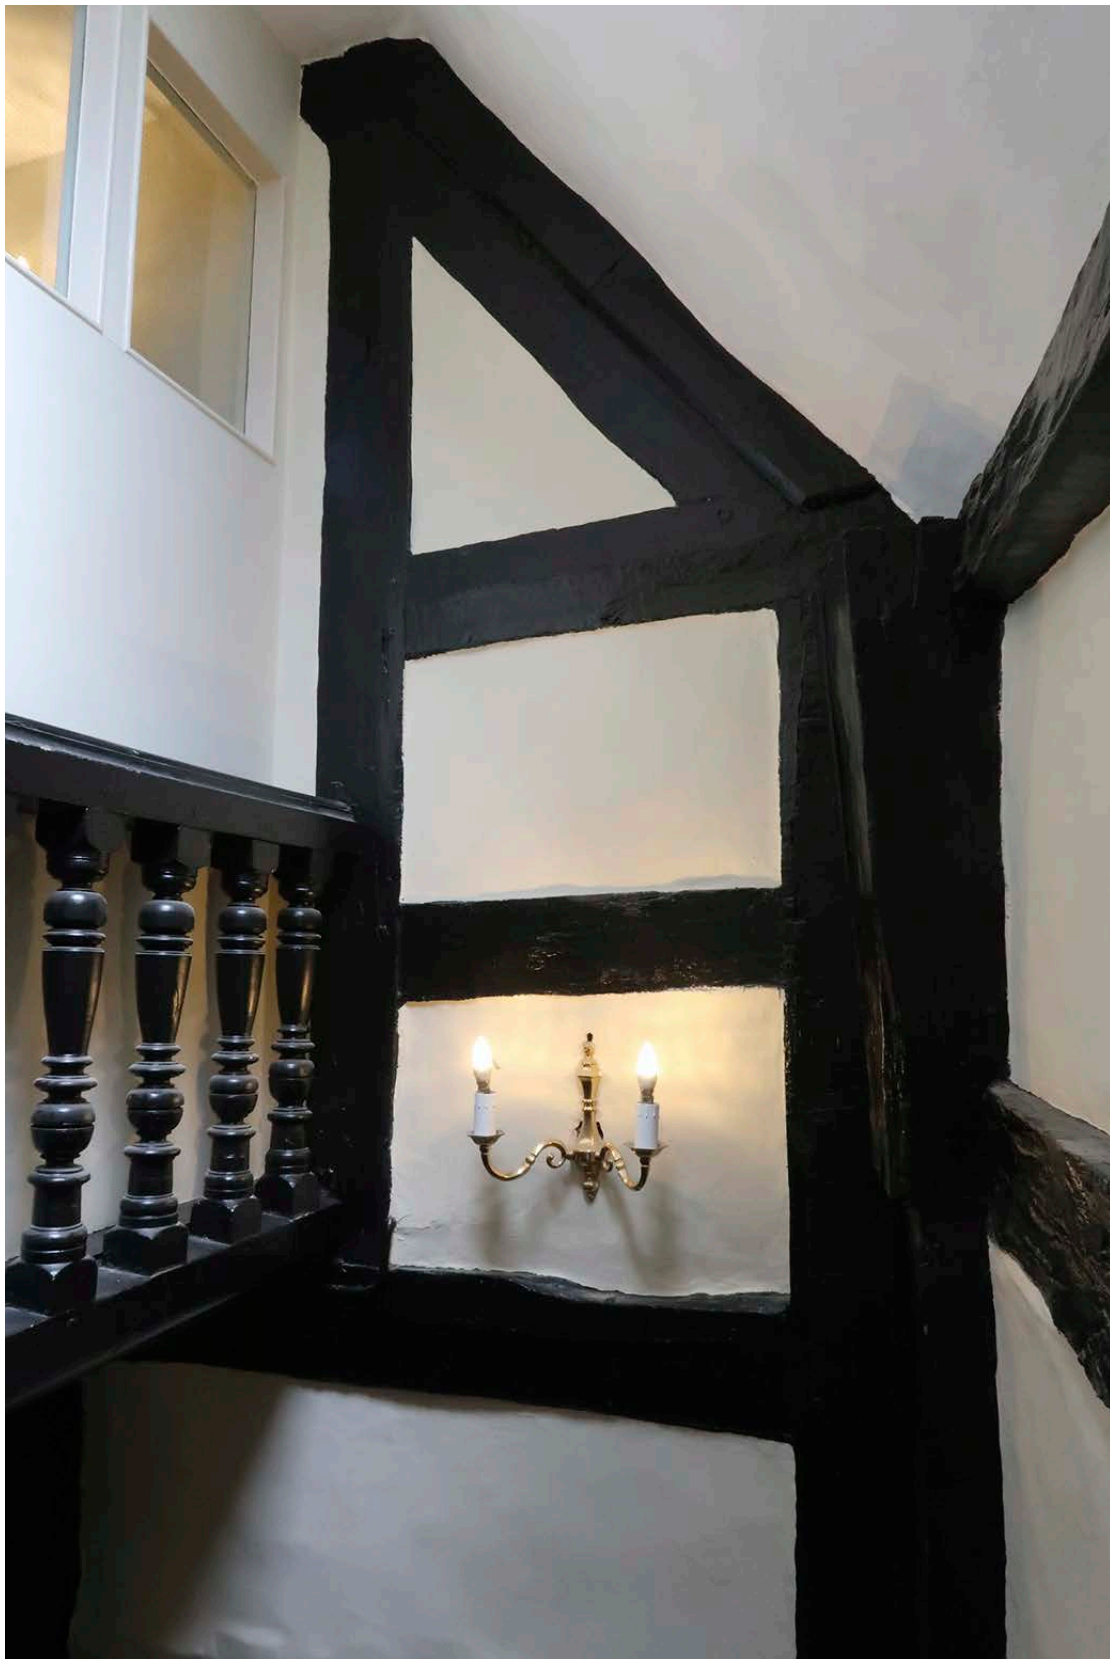
Figure 51: The south end of the easternmost truss of the south wing at attic level. [Johanna Roethe © Historic England]

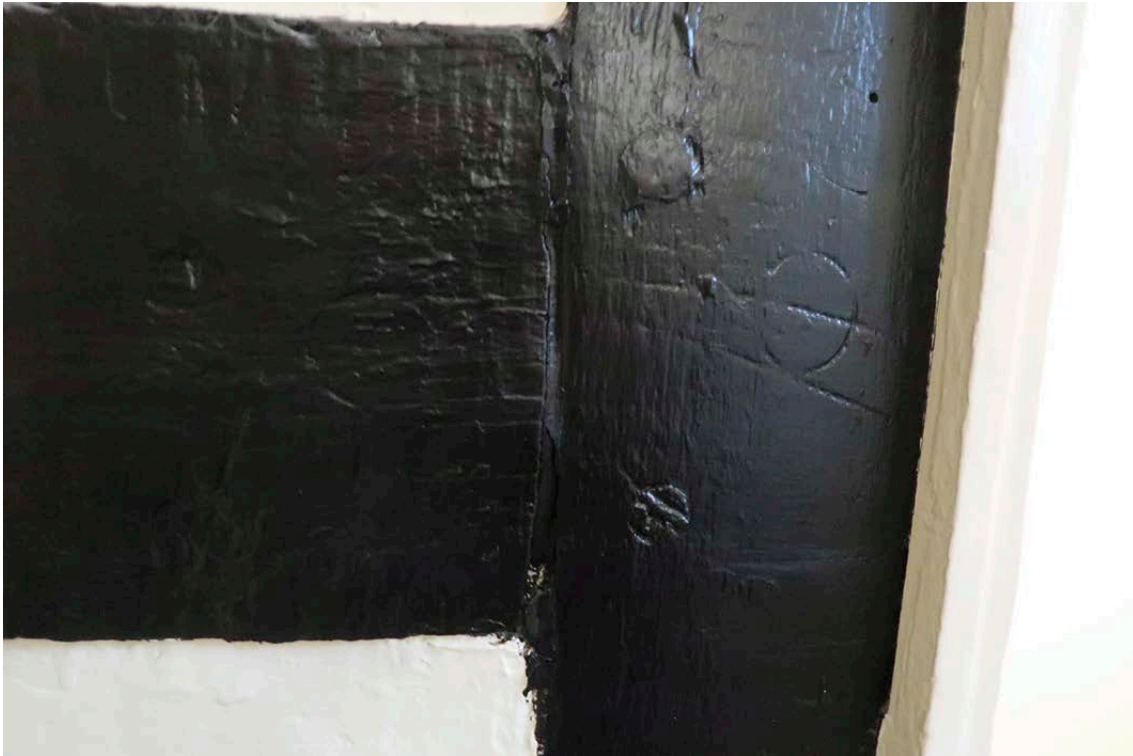
Figure 52: Carpenter's marks on the north end of the easternmost truss with the number 2 on both the mid-rail (left) and the strut (right). [Johanna Roethe © Historic England]

This easternmost truss also has a surviving set of carpenters' assembly marks visible on the western face of the truss's north end. Although later paint makes some of the marks unclear, there appear to be marks relating to the assembly of that particular frame (Figure 52). This numbering system uses a circle with a line through it for 1. An additional line denotes 2 and another line 3.

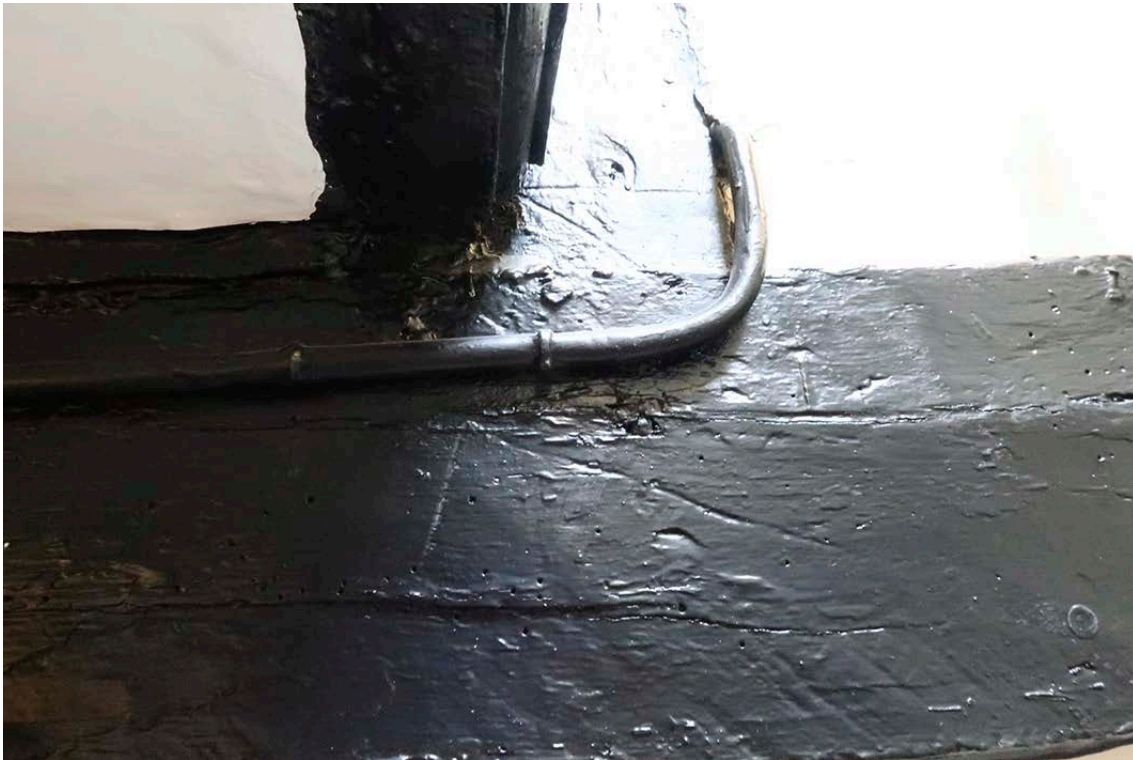
Figure 53: Carpenter's marks (possibly V for 5) on the south end of the south wing's easternmost truss, the fifth from the west. [Johanna Roethe © Historic England]

At the south end of the same frame, there are two carpenter's marks where the inner strut meets the girding beam (Figure 53). Both strut and beam have what looks like a V for 5. These do not have associated circles, and may relate to the overall frame/truss arrangement – with the V indicating that this was the fifth truss. This would correspond with the known form of the wing, with the frames therefore being numbered 1 to 5 from west to east. On the floors below, the east wall is box-framed, presumably because it abutted the staircase and there was no provision for access between the front range and the stair.

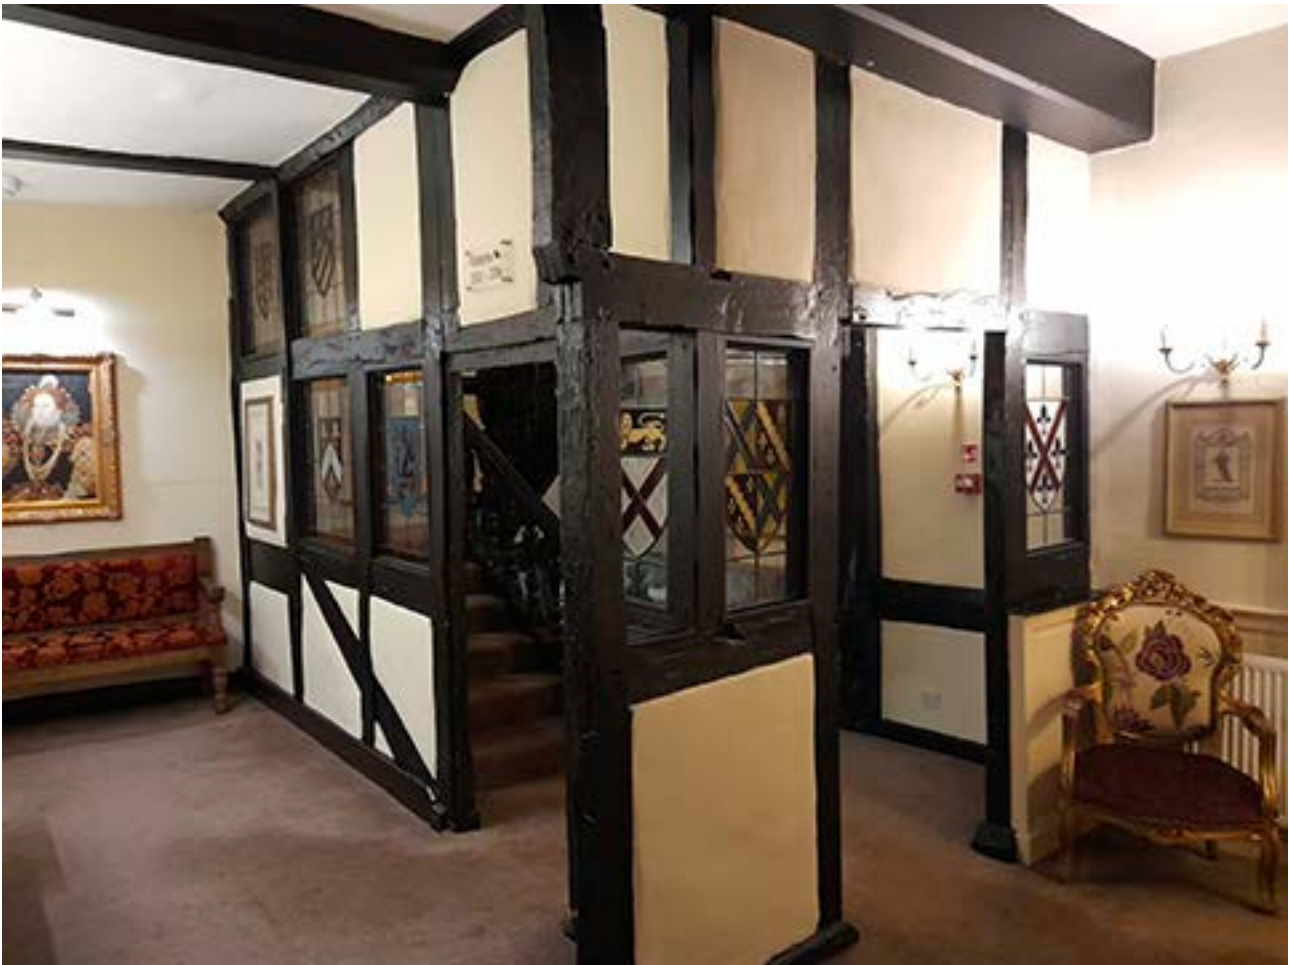
Figure 54: The box-framed stairwell at first-floor level. [Johanna Roethe © Historic England]

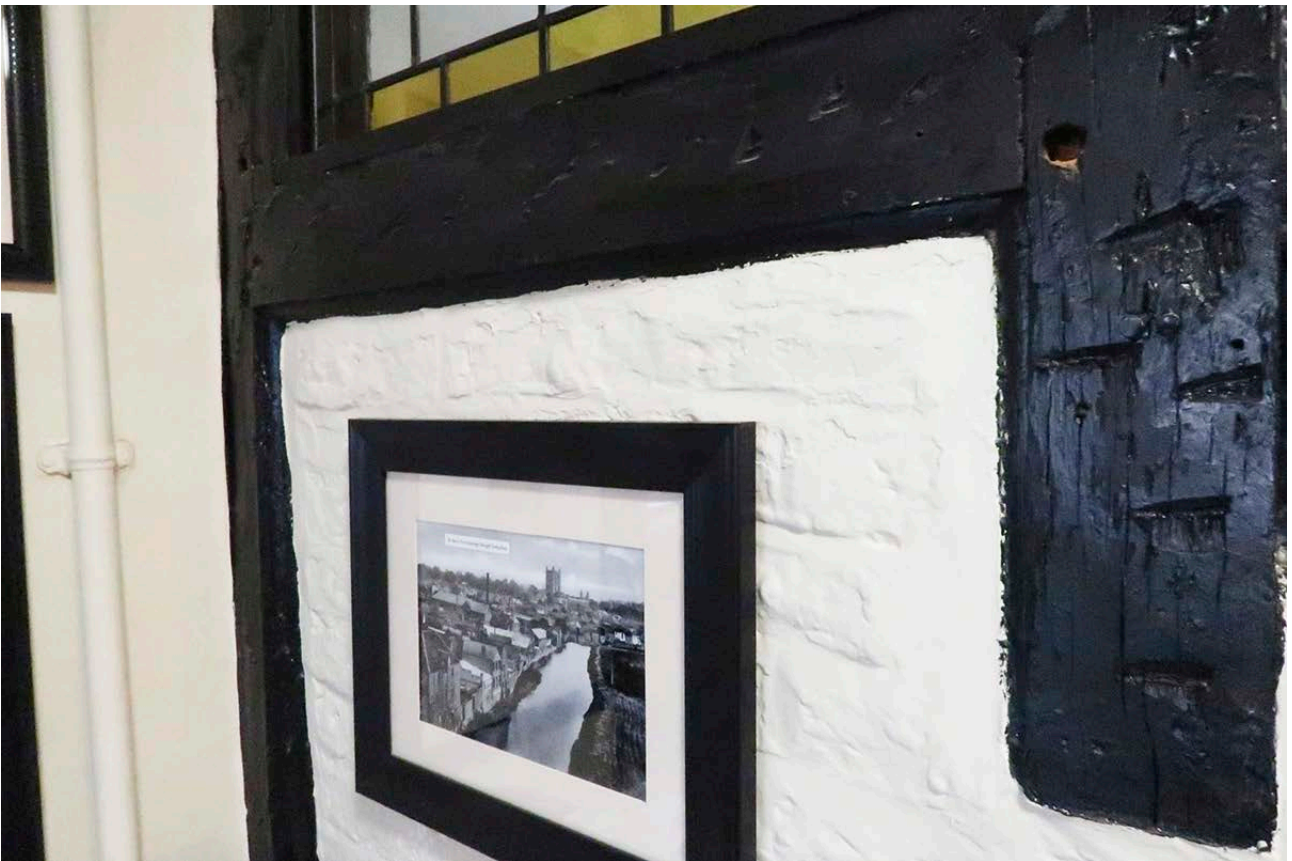
Figure 55: The moulded door frame at the east end of the stairwell's north wall, at ground-floor level, with later brick infill. [Johanna Roethe © Historic England]

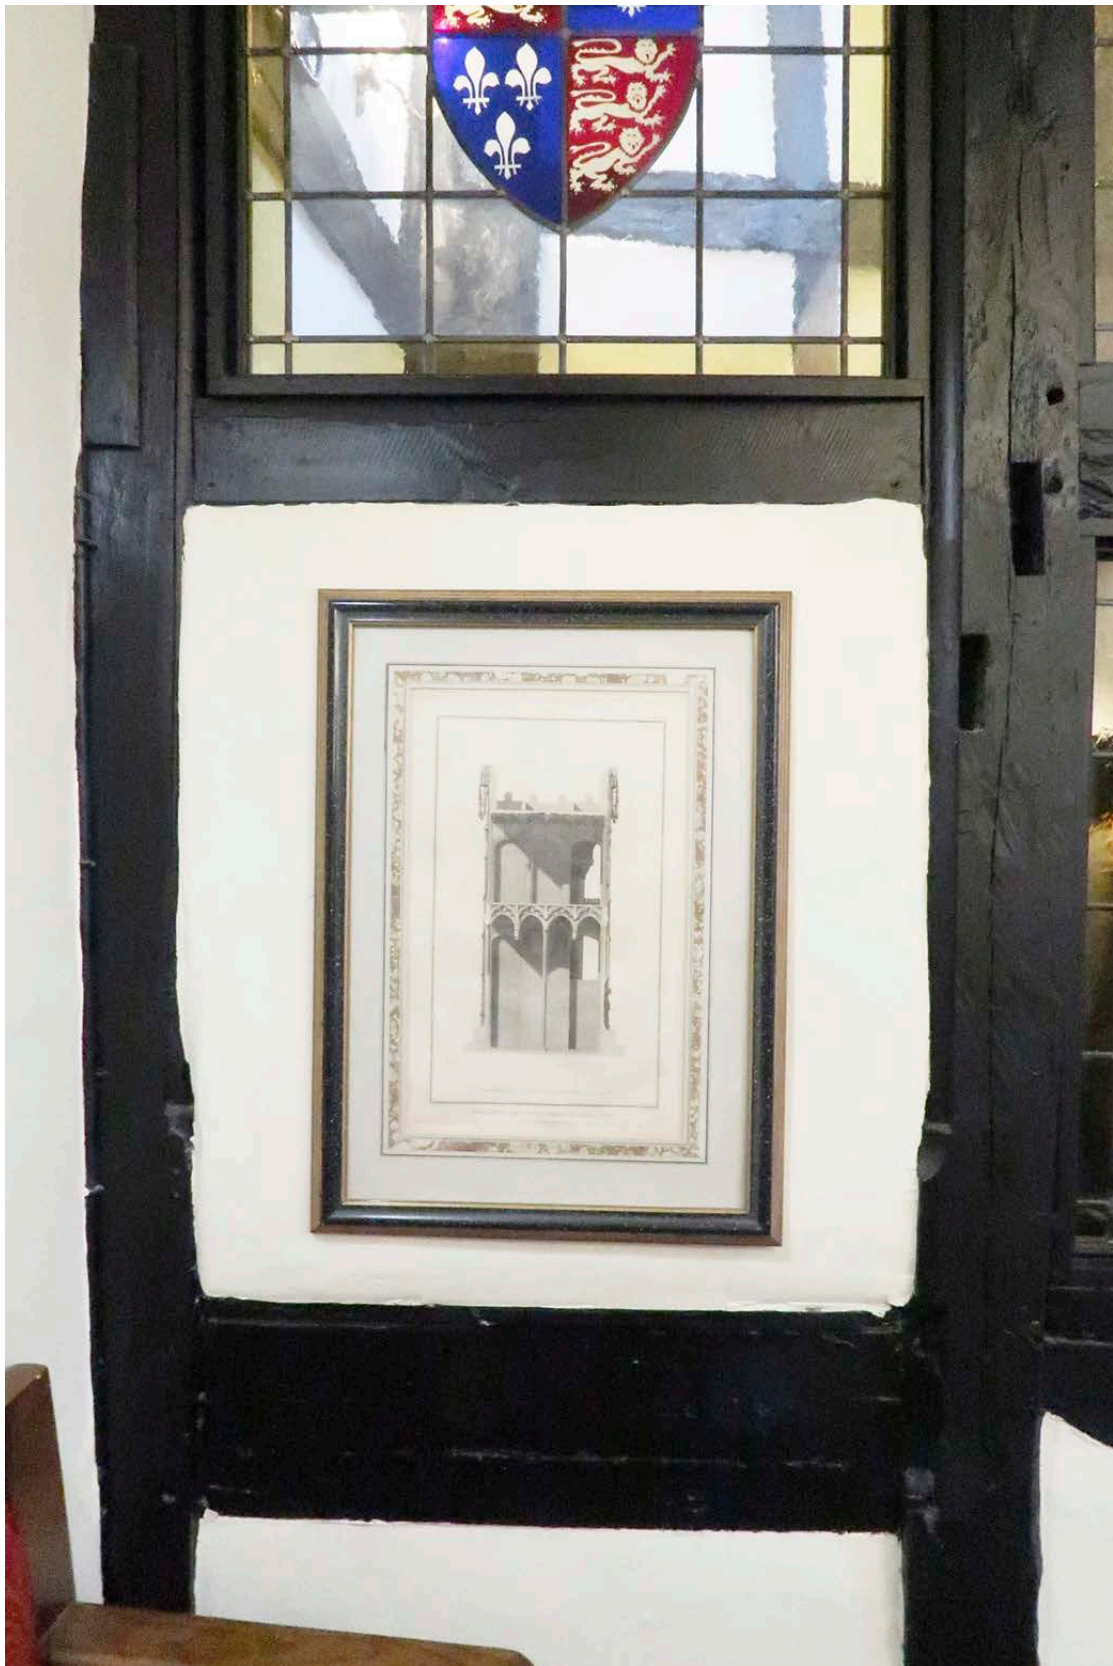
Figure 56: The lower part of the chamfered and stopped doorway on the first floor, with later infilling [Johanna Roethe © Historic England]

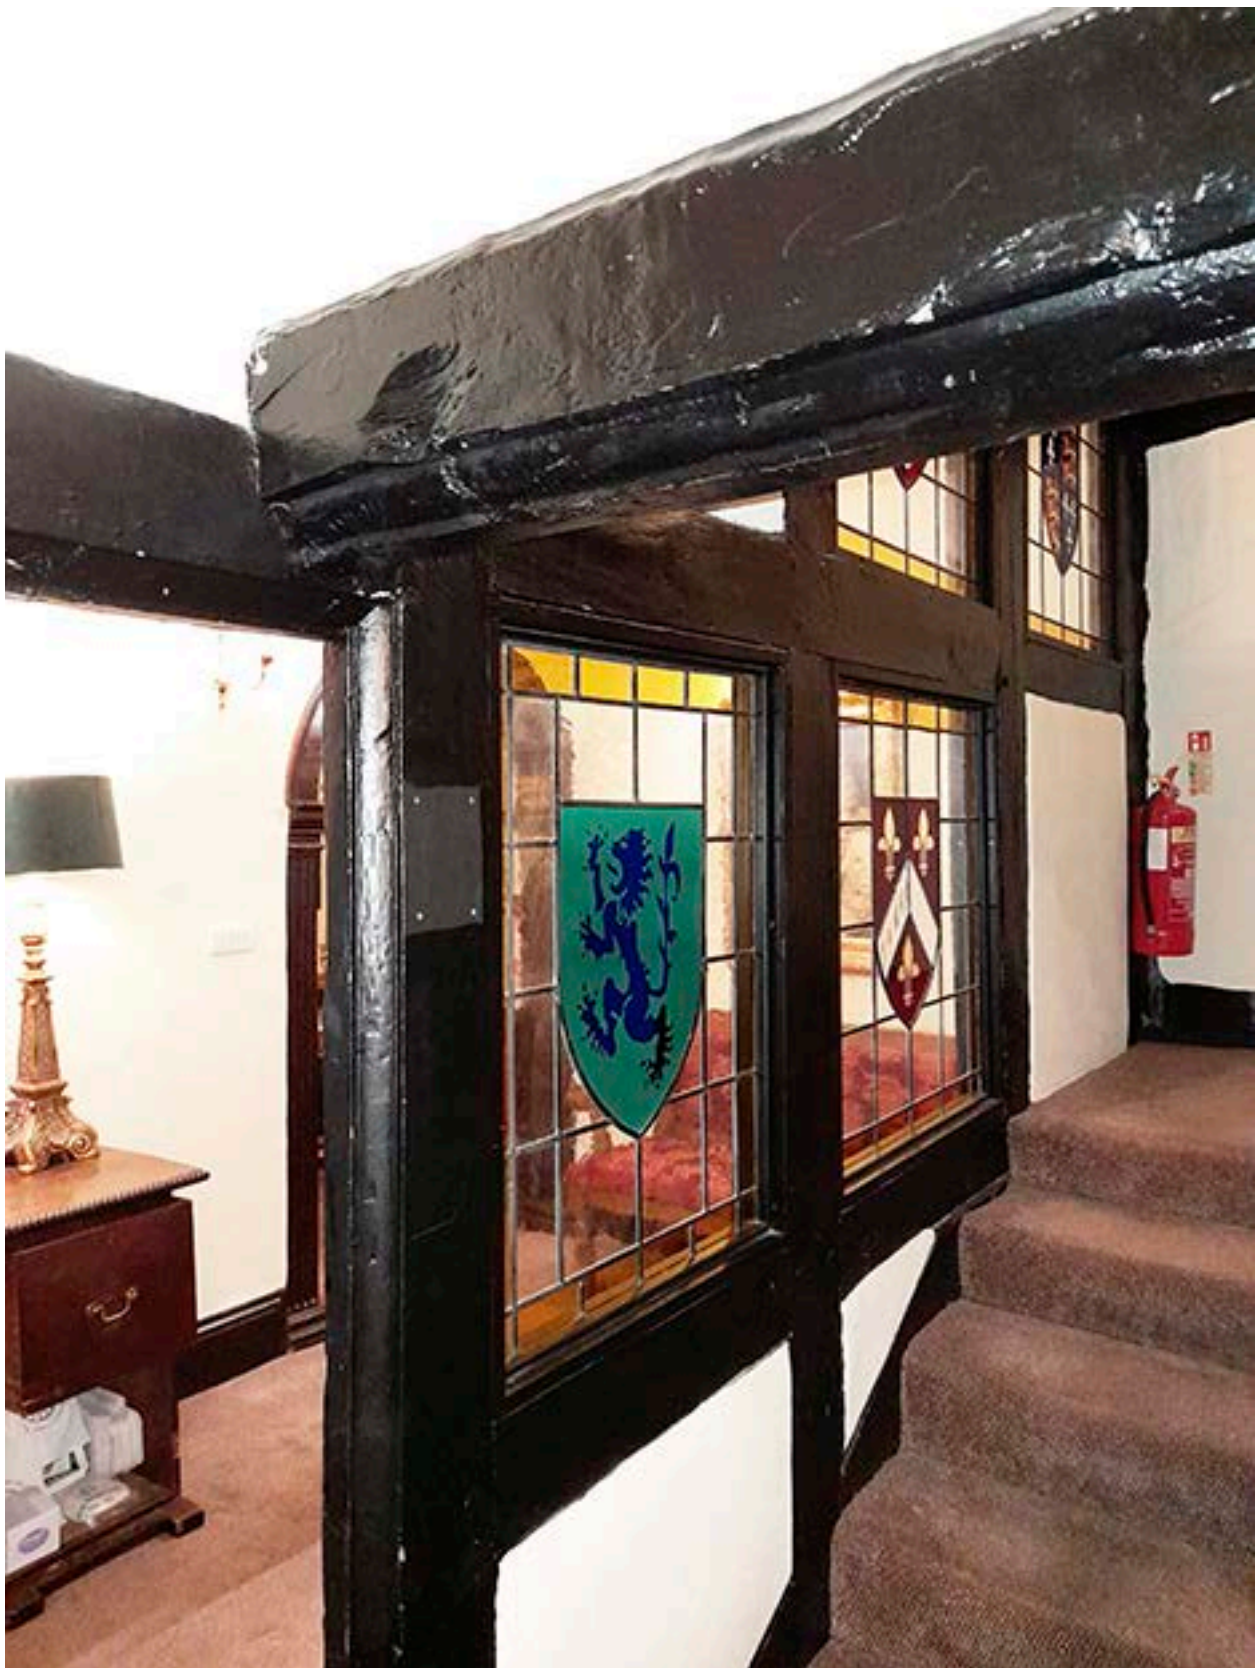
Figure 57: The north wall of the stairwell at first-floor level, with the blocked door to the half-landing at the far end. [Johanna Roethe © Historic England]

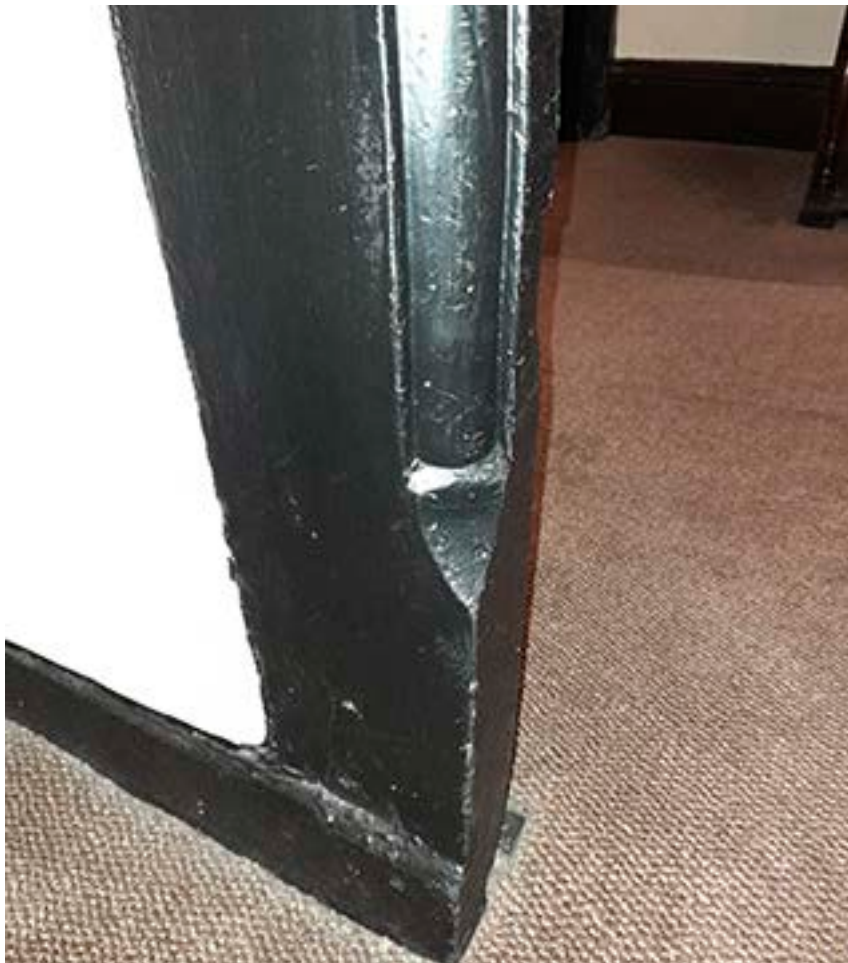
Figure 58: Detail of the ovolo-moulded door frame with scroll chamfer at first-floor level. [Johanna Roethe © Historic England]

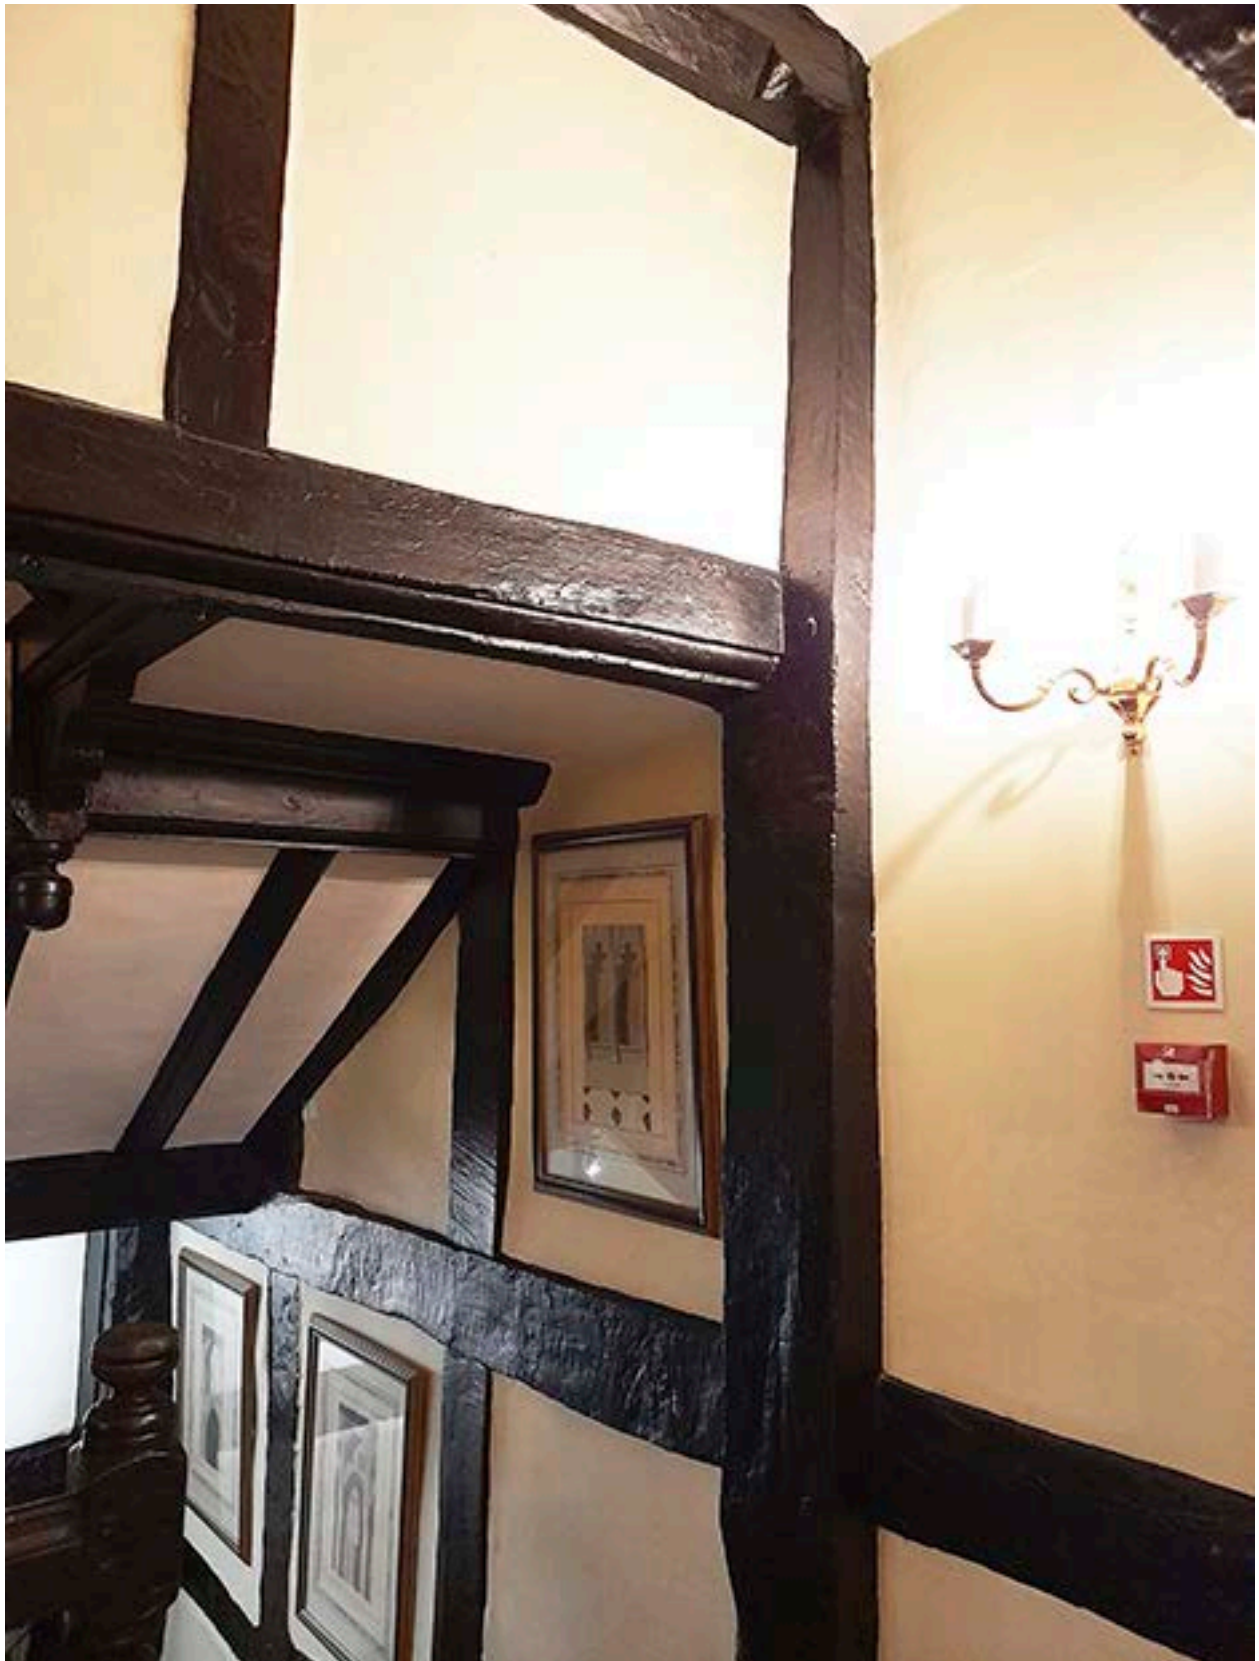
Figure 61: The ovolo-moulded trimmer at first-floor level. [Johanna Roethe © Historic England]

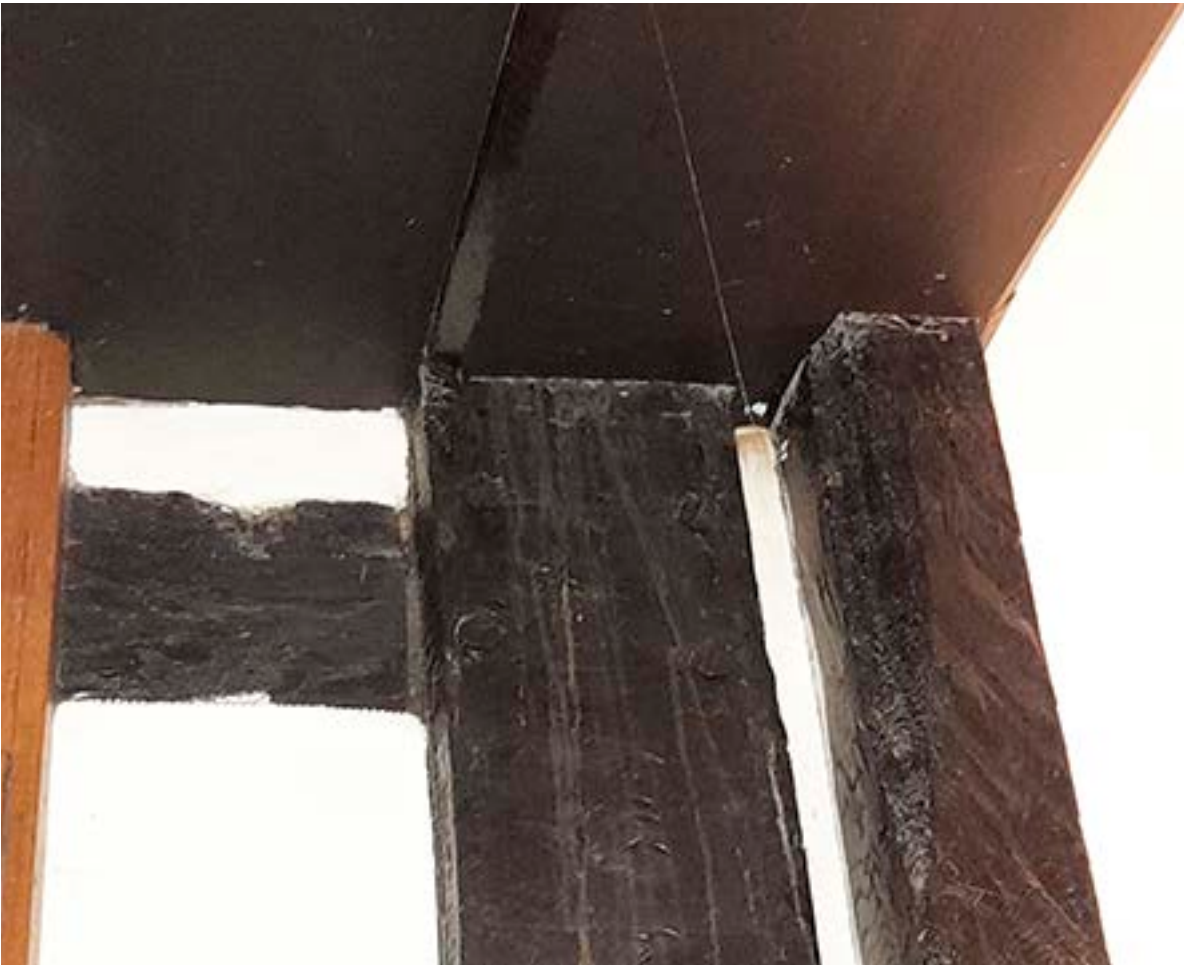
Figure 63: A wall post (centre) in the north wall of the south wing, at first-floor level, with the post relating to the stairwell enclosure to the right. Above is a boxed-in beam and to the left a later window frame. [Johanna Roethe © Historic England]

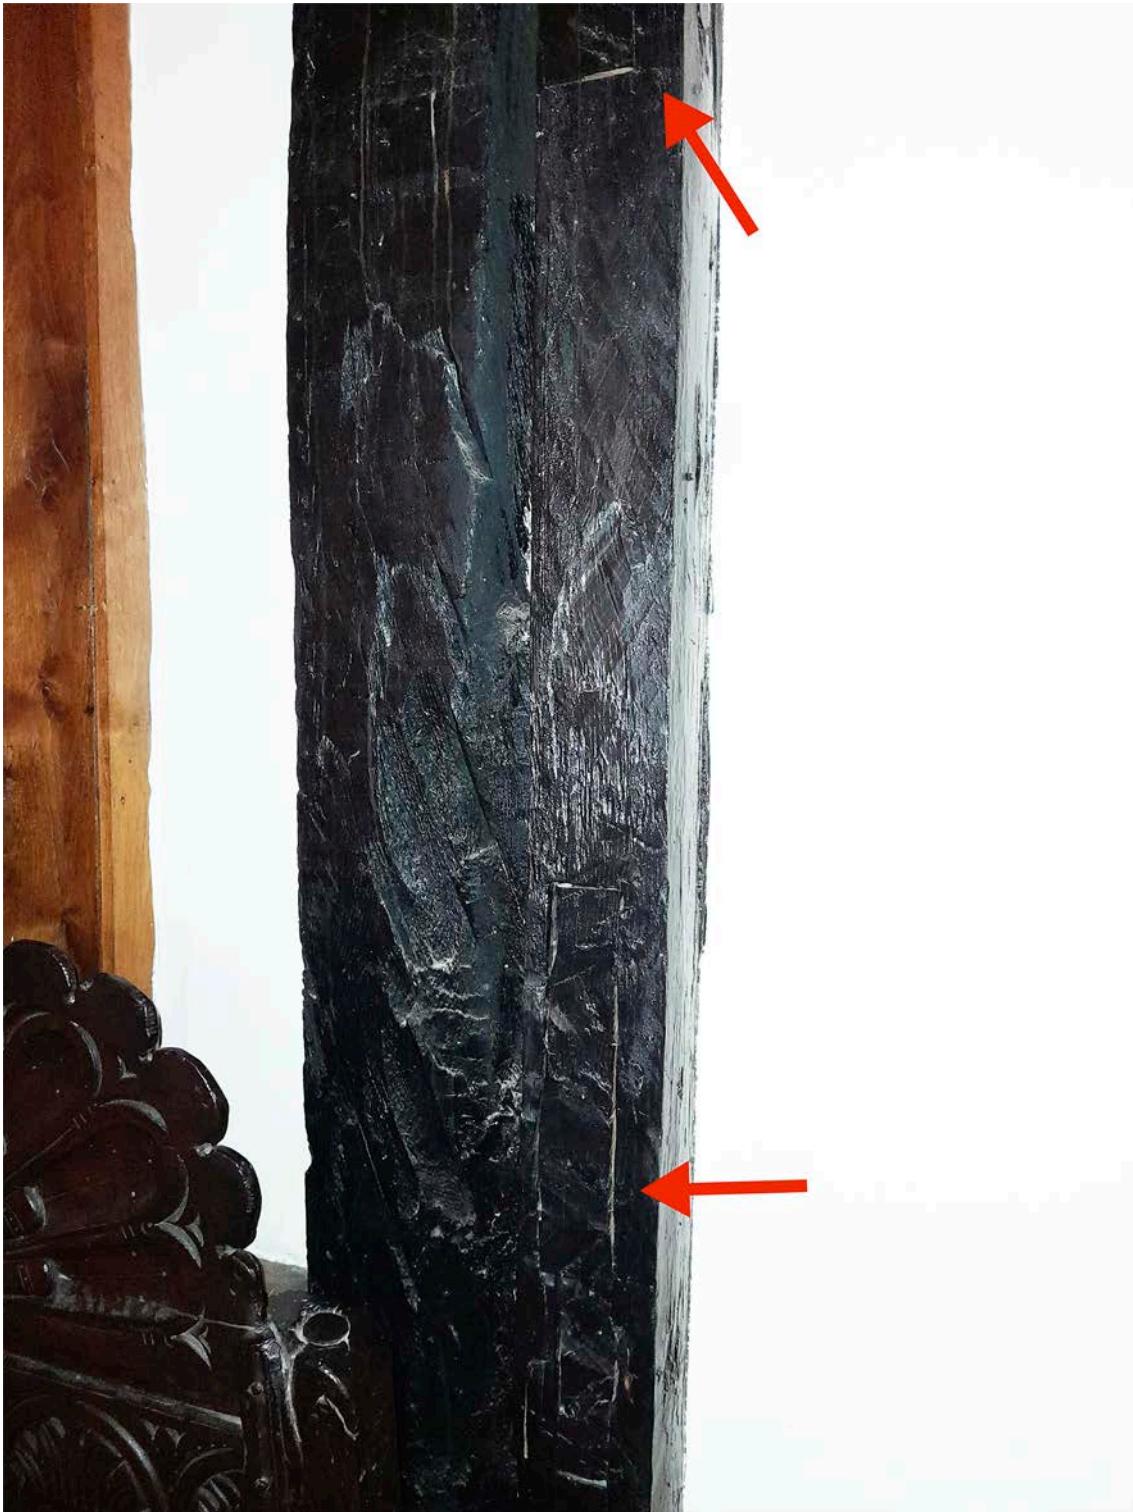
Figure 64: The mortices in the wall post just north of the stair enclosure's projecting partition at first-floor level. [Johanna Roethe © Historic England]

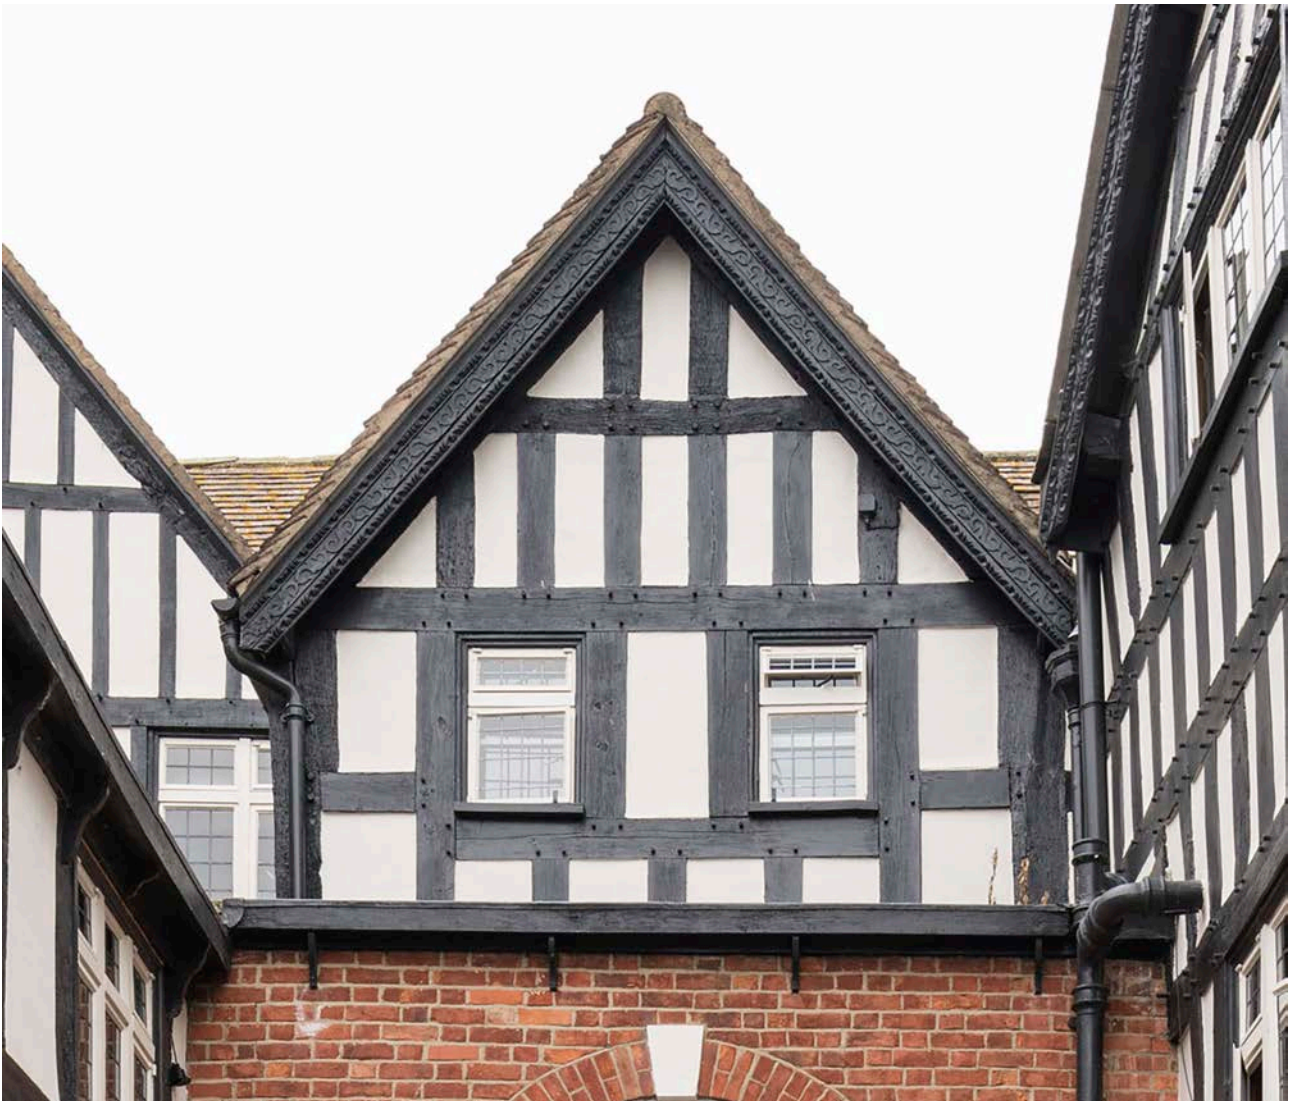
Figure 65: The gable of the central wing. [Steven Baker © Historic England, DP325763]

Immediately north of the south wing, the central wing, which now houses a later stair, appears also to have formed part of the extensions to the complex in the 17th century. This has been much modified and extended further west, but the original extent of the wing is indicated by the gable end rising above the later brickwork of the west elevation (Figure 65). It was clearly originally fully timber framed, with the same framing pattern as the south range. Only the second floor and gable of this arrangement appears to survive, however. As constructed, this clearly provided three floor levels. As noted above, the matching style of the decorative bargeboards on the central wing and south wing suggest they are contemporary – i.e. both of the mid- to late 17th century. The higher level of the northern wallplate of the south wing also suggests that the central wing and the south wing were built around the same time.
