# The Tudor House Hotel, 52-3 High Street, Tewkesbury, Gloucestershire

Historic Building Assessment

Johanna Roethe

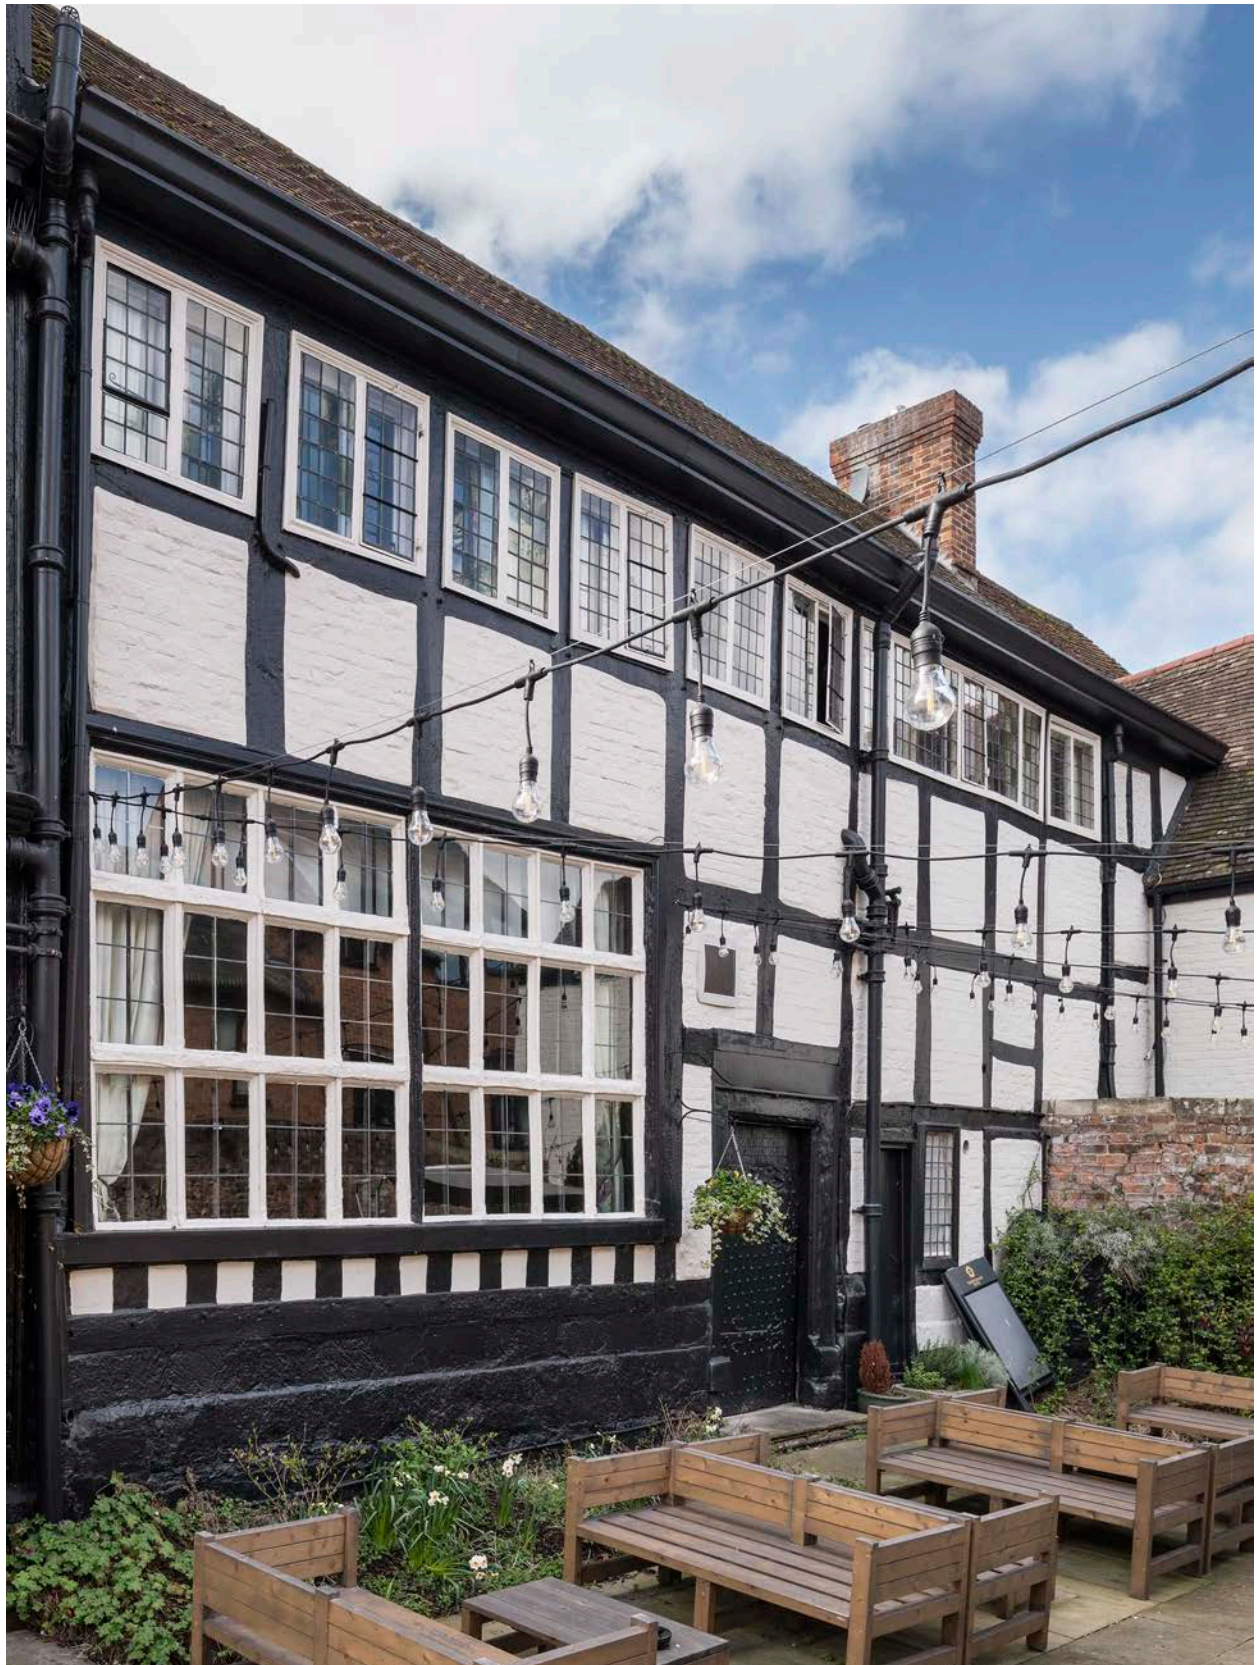
Figure 66: The north elevation of the north wing from the north-east. [Steven Baker © Historic England Archive, DP325760]

As constructed, the north wing comprised a four-bay, two-storey range. The original western end appears to be defined by the (later) brick stack which still divides this wing from the later extension of the range to the west. The framing on the north elevation is similar to that of the south wing, but with more widely spaced panels, and is somewhat plainer in its overall styling, apart from the architectural emphasis given to the large ground-floor room (Figure 66). This occupies the eastern two bays of the range at ground-floor level. West of this was a further ground-floor room, or rooms, possibly with a service function, which this part of the range appears to have had consistently in later periods in its history. At first-floor level the original plan form is unclear. There is now a continuous line of windows on the north elevation, which may reflect the original arrangement. Whether this lit a corridor or a series of rooms is unclear.

The north elevation is box-framed with later brick infill to the panels which would probably originally have been filled with wattle-and-daub (see Figure 66). The sill plate rests on a stone plinth, formed of cut ashlar stonework of three courses with diagonal chisel marks. At the east end is a full-height post, which forms the eastern extent of the wing. The corresponding post at the western end is not visible as the stable range was later built up against that end of the wing. The box framing is largely of a regular pattern, although there has been some later modification, and the size of the ground-floor window necessitated a slightly higher girding beam in the eastern two bays of the wing (corresponding to the 'hall' area). Although later insertions have masked the original bay pattern, it seems that there was originally a regular arrangement of posts, defining four bays, each of which contained further full height studs, dividing the bay into three box panels horizontally; the girding beam and mid-rails delineated four panels in height.

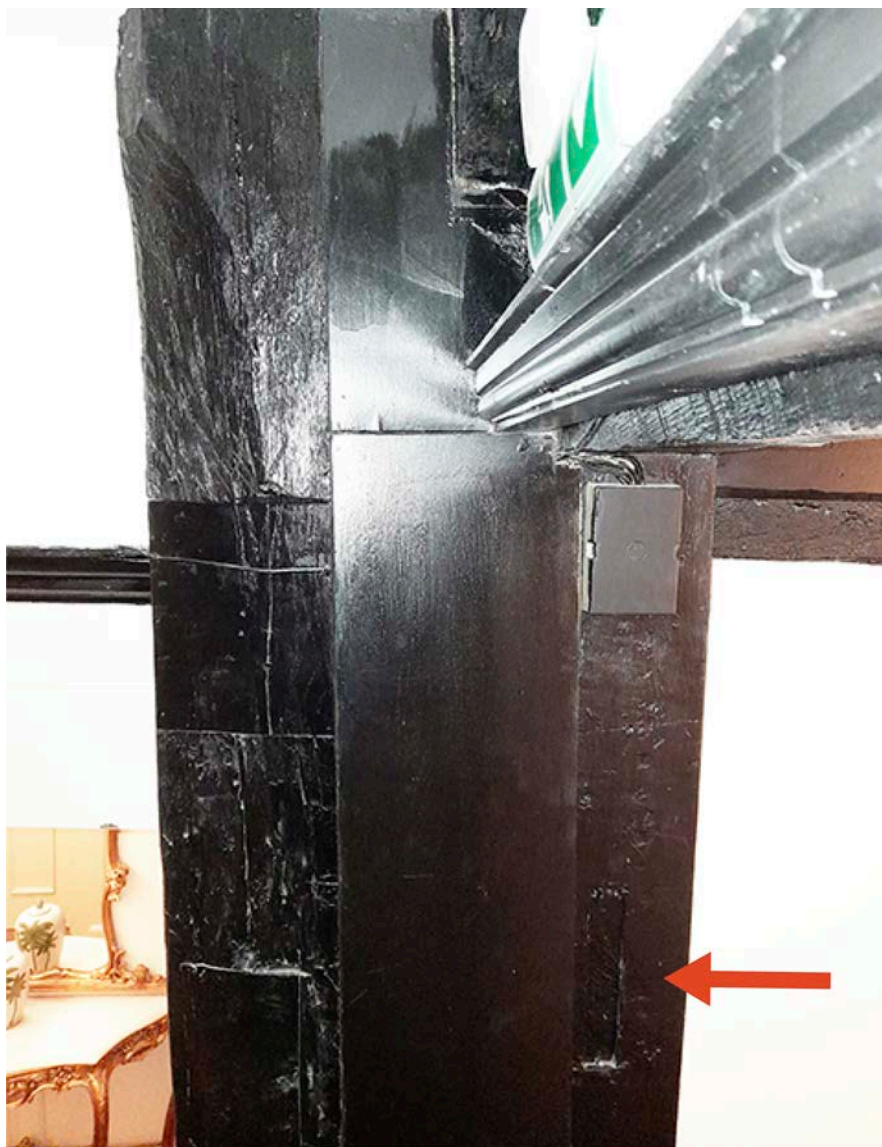
Figure 67: The junction of the front range's west elevation and the south-east corner of the north wing, seen at first-floor level. The north wing's south-east corner post is to the right, a modern timber at the centre, and a post belonging to the front range to the left. The arrow indicates the location of a mortice. [Johanna Roethe © Historic England]

The wing's eastern frame abuts the west elevation of the front range. The north-eastern corner post is visible externally (see Figure 36), the south-eastern one internally (Figure 67). The latter has an empty mortice in its northern face and empty peg holes on its west side. There is a matching mortice with peg holes on the underside of the tiebeam (Figure 68). Together, these indicate the former existence of a diagonal up-brace in this location. There were originally similar braces in the main frames of this wing (see discussion below) and a brace in this location does not necessarily indicate that the eastern truss was originally closed. Above first-floor level the east gable of the north wing is closed with studs which are pegged into the tiebeam (Figure 69). This suggests that the attics of the front range and the north wing were not in contiguous use.

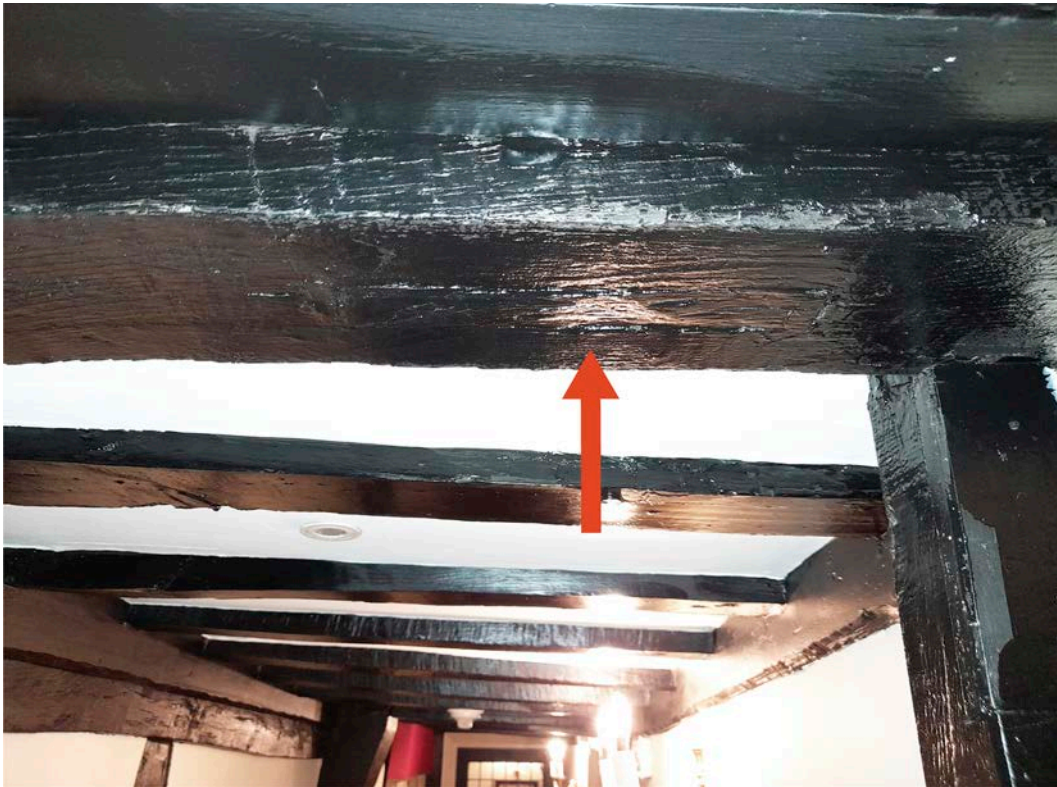
Figure 68: The mortice for an up-brace in the tiebeam at the east end of the north wing, with two off-centre peg holes above. [Johanna Roethe © Historic England]

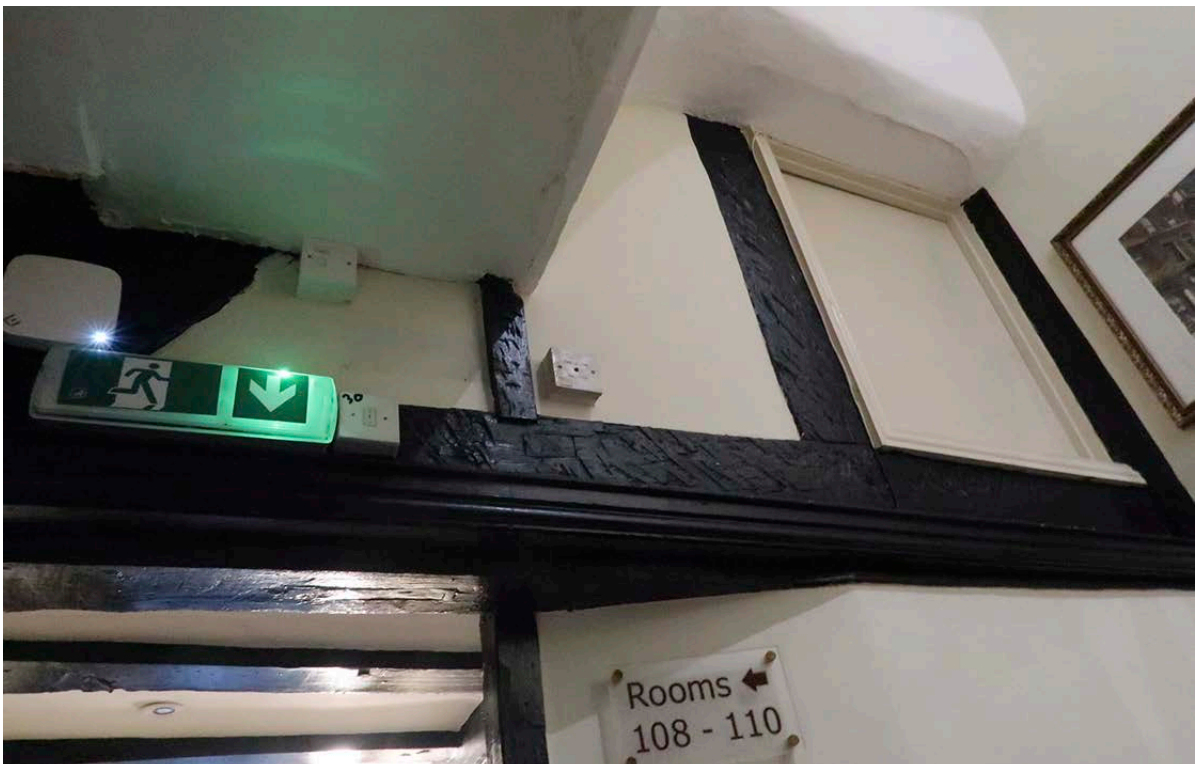
Figure 69: The east gable of the north wing, seen from the front range. [Johanna Roethe © Historic England]

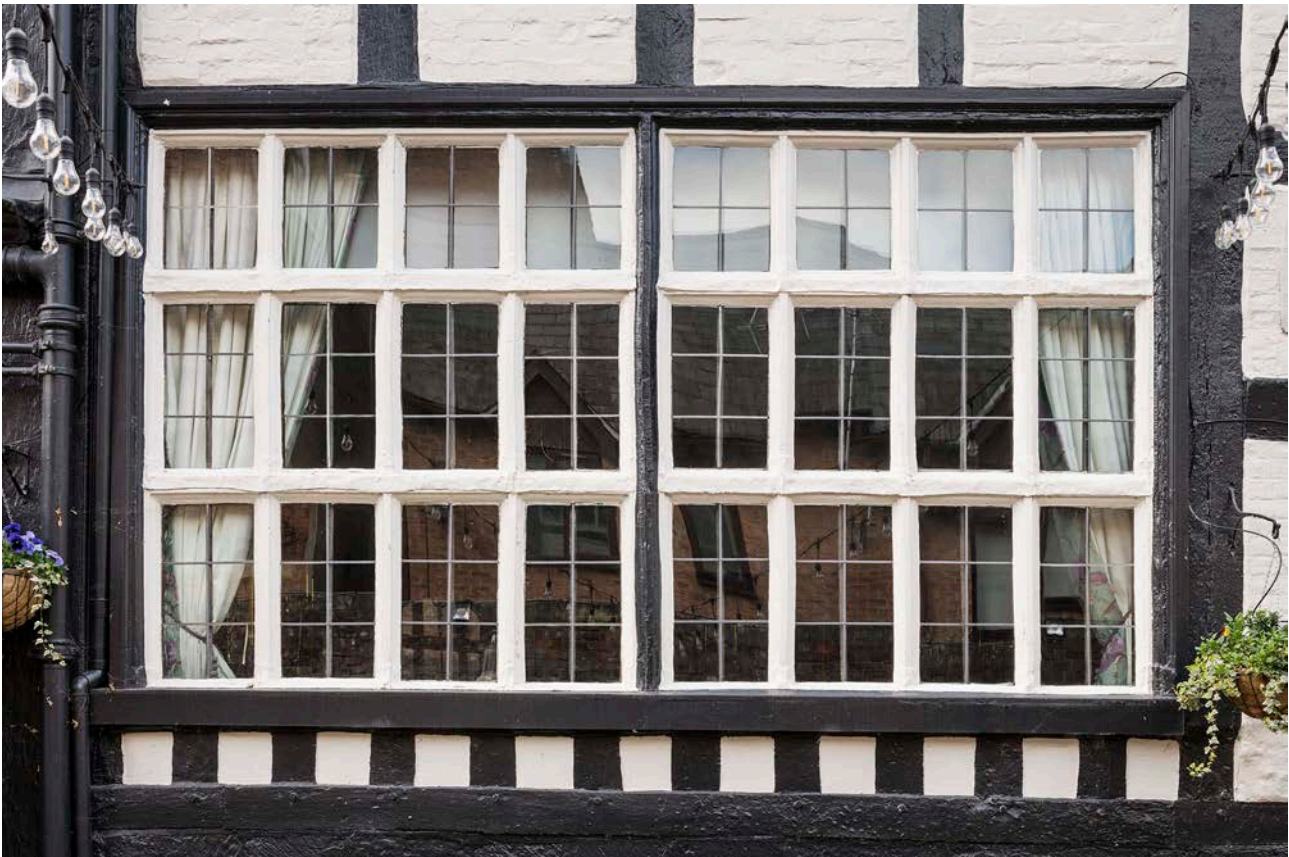
Figure 70: The large window in the north elevation of the north wing. [Steven Baker © Historic England Archive, DP325761]

At ground-floor level to the east is a large mullioned window with a central king mullion, double transoms and 24 lights in total (Figure 70). The mullions and frame all have ovolo mouldings externally and internally. Above the window is the girding beam; below the windowsill is a short area of close studding which is pegged into the sill plate. The use of close studding is not seen elsewhere in the wing, but the studs are all pegged into the sill beam. They may have been considered necessary to support the weight of the window, which must have been glazed when constructed and an expensive and high-status feature.

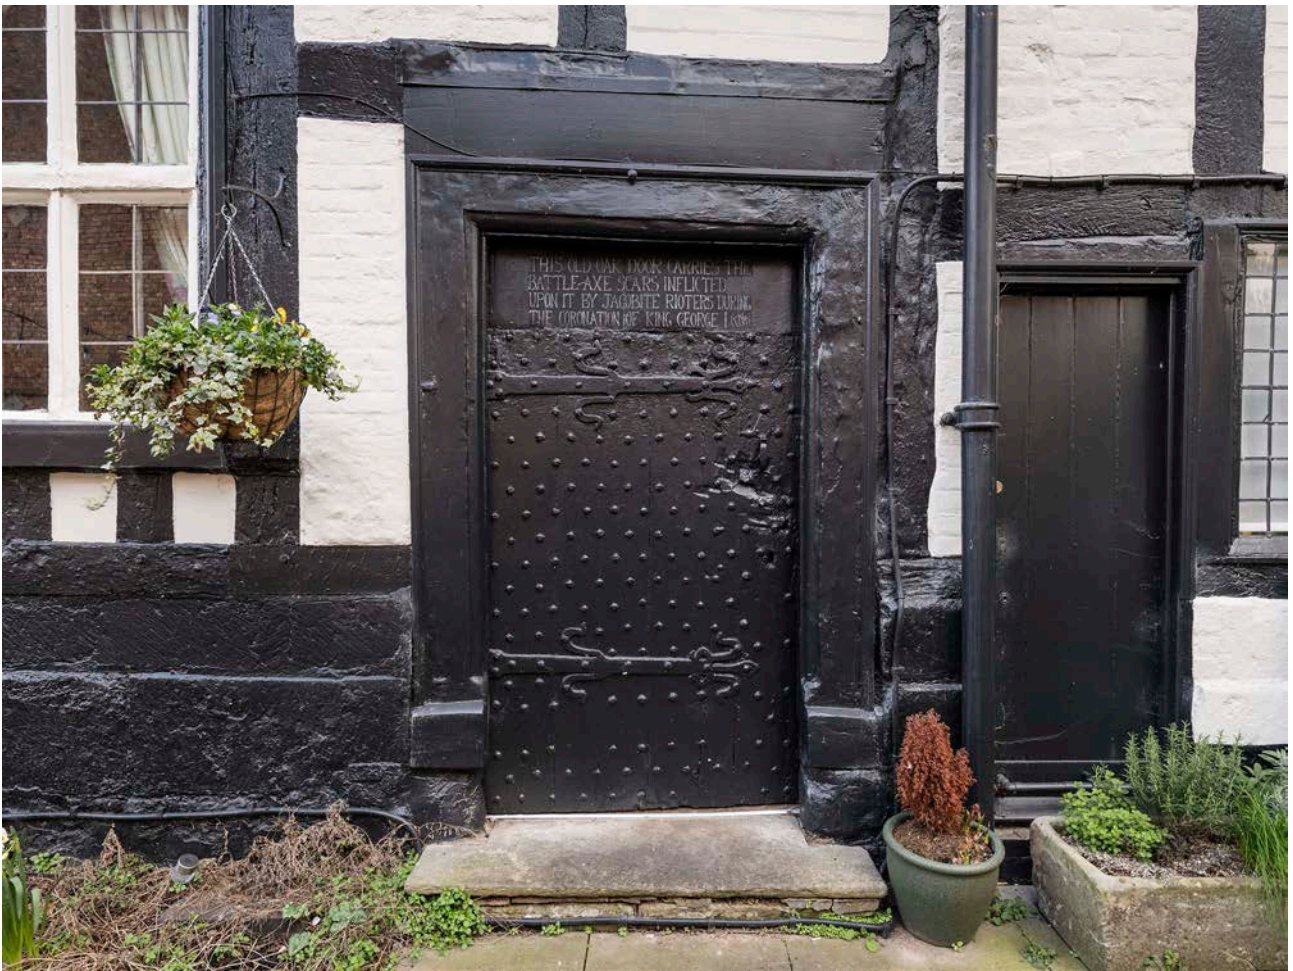
Figure 71: The main door in the north wing's north elevation. [Steven Baker © Historic England Archive, DP325762]

In the second bay to the east is a door frame adjacent to the post at the western side of the bay. The mid-rail in this bay is higher, to accommodate the door, and it is pegged into the post (Figure 71). The broad door frame is defined by two jambs and a lintel all of which have an ovolo-chamfer moulding around the edge of the opening with stops. Due to thick layers of paint and damage, the form of the stops is unclear but historic photographs shows them as scroll stops (see Figures 15, 26). The degree of later patching and overpainting makes the precise relationship between the doorway and the surrounding framing unclear. To the west the western jamb sits against the wall post, but any pegging is not currently visible. The pegged mid-rail however appears to prove that there was always a doorway in this position. There is a slight gap between the top of the door frame and the bottom of the lintel; this was formerly filled by a door canopy on decoratively carved, scrolled brackets (see Figure 26).

The top plank appears to be a modern repair or replacement. On the inside of the door frame there are signs that the location of pintles has changed over time. One of the two hinges has also been moved slightly further up the door; this had been done shortly after 1910 when a scar in the paintwork is still visible on a historic photograph (see Figure 15), and is still visible now as there is an absence of the original nail pattern in the area

Externally, there are deep scars in the area of the lock, which according to a modern inscription in the added panel at the top were caused by the rioters of 1714. The scars are partly covered by an 18th-century upright door handle with leaf-shaped ends.<sup>205</sup>

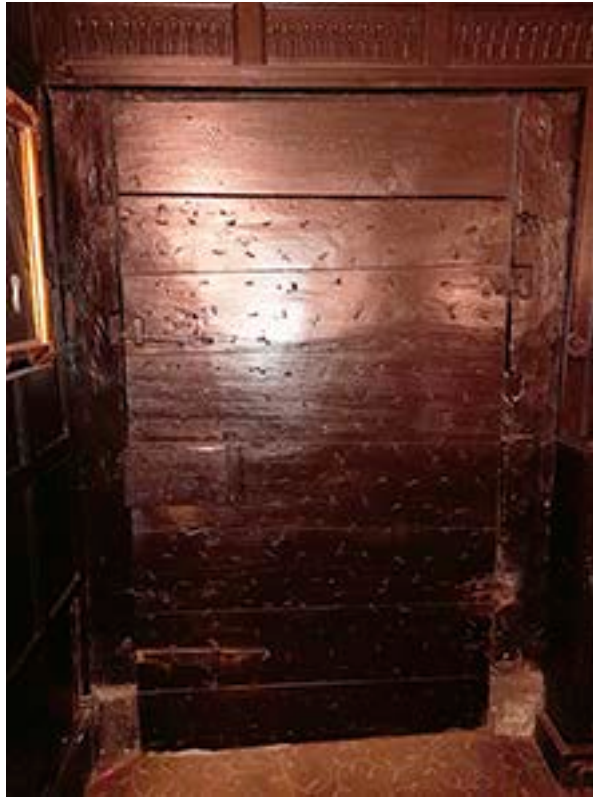
This is a double-thickness door, with two layers of planking. It consists externally of four vertical planks and internally of seven original horizontal planks with one modern plank at the top (Figure 72, see Figure 71).<sup>203</sup> It has a regular pattern of studs and two highly decorative external hinges with variations on the fleur-de-lis motif which was popular between the 1620s and 1670s.<sup>204</sup> The iron latch and the lock case are relatively plain.

Figure 72: The inside of the door in the north wing's north elevation. [Johanna Roethe © Historic England]

where the hinge was formerly placed. It is possible that the door is not original to this position but it seems most likely that it is in situ as it fits the overall height and width of the door frame.

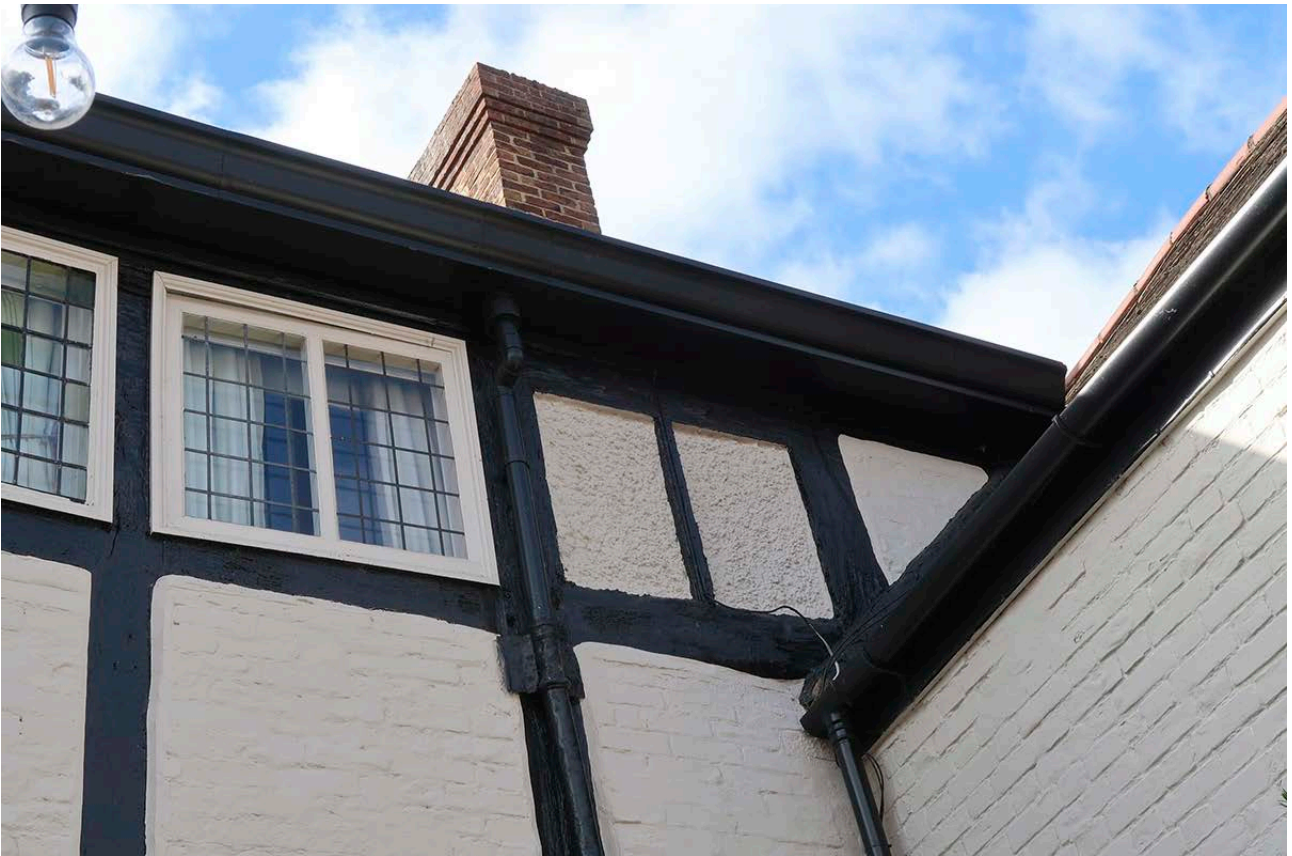
For the last century or more, the western two bays of the north wing have been in use for various services and the ground floor has been much altered with the insertion and removal of additional entrance doors. On the north elevation in the third bay from the east is a small rail double-pegged into the studs, about halfway between the mid-rail and girding beam. The fact that this is pegged suggests it is an original feature. The rail may have formed the lintel to a doorway below or the sill to a small window above, although its position is quite high for a doorway. The first-floor girding beam has been replaced in the westernmost bay with later rails at slightly different levels; however, redundant peg holes indicate that the beam originally ran at the same level as that to the west. As noted above, the leaded casement windows on the first floor are later insertions, possibly in the location of original windows, but an example of an original window survives in the westernmost bay of the elevation (Figure 73). This has a moulded timber mullion set into the box-framed panel, which is now blocked up.

Figure 73: The original window at the west end of the north elevation of the north wing, with a moulded mullion surviving in the centre of the panel. [Johanna Roethe © Historic England]

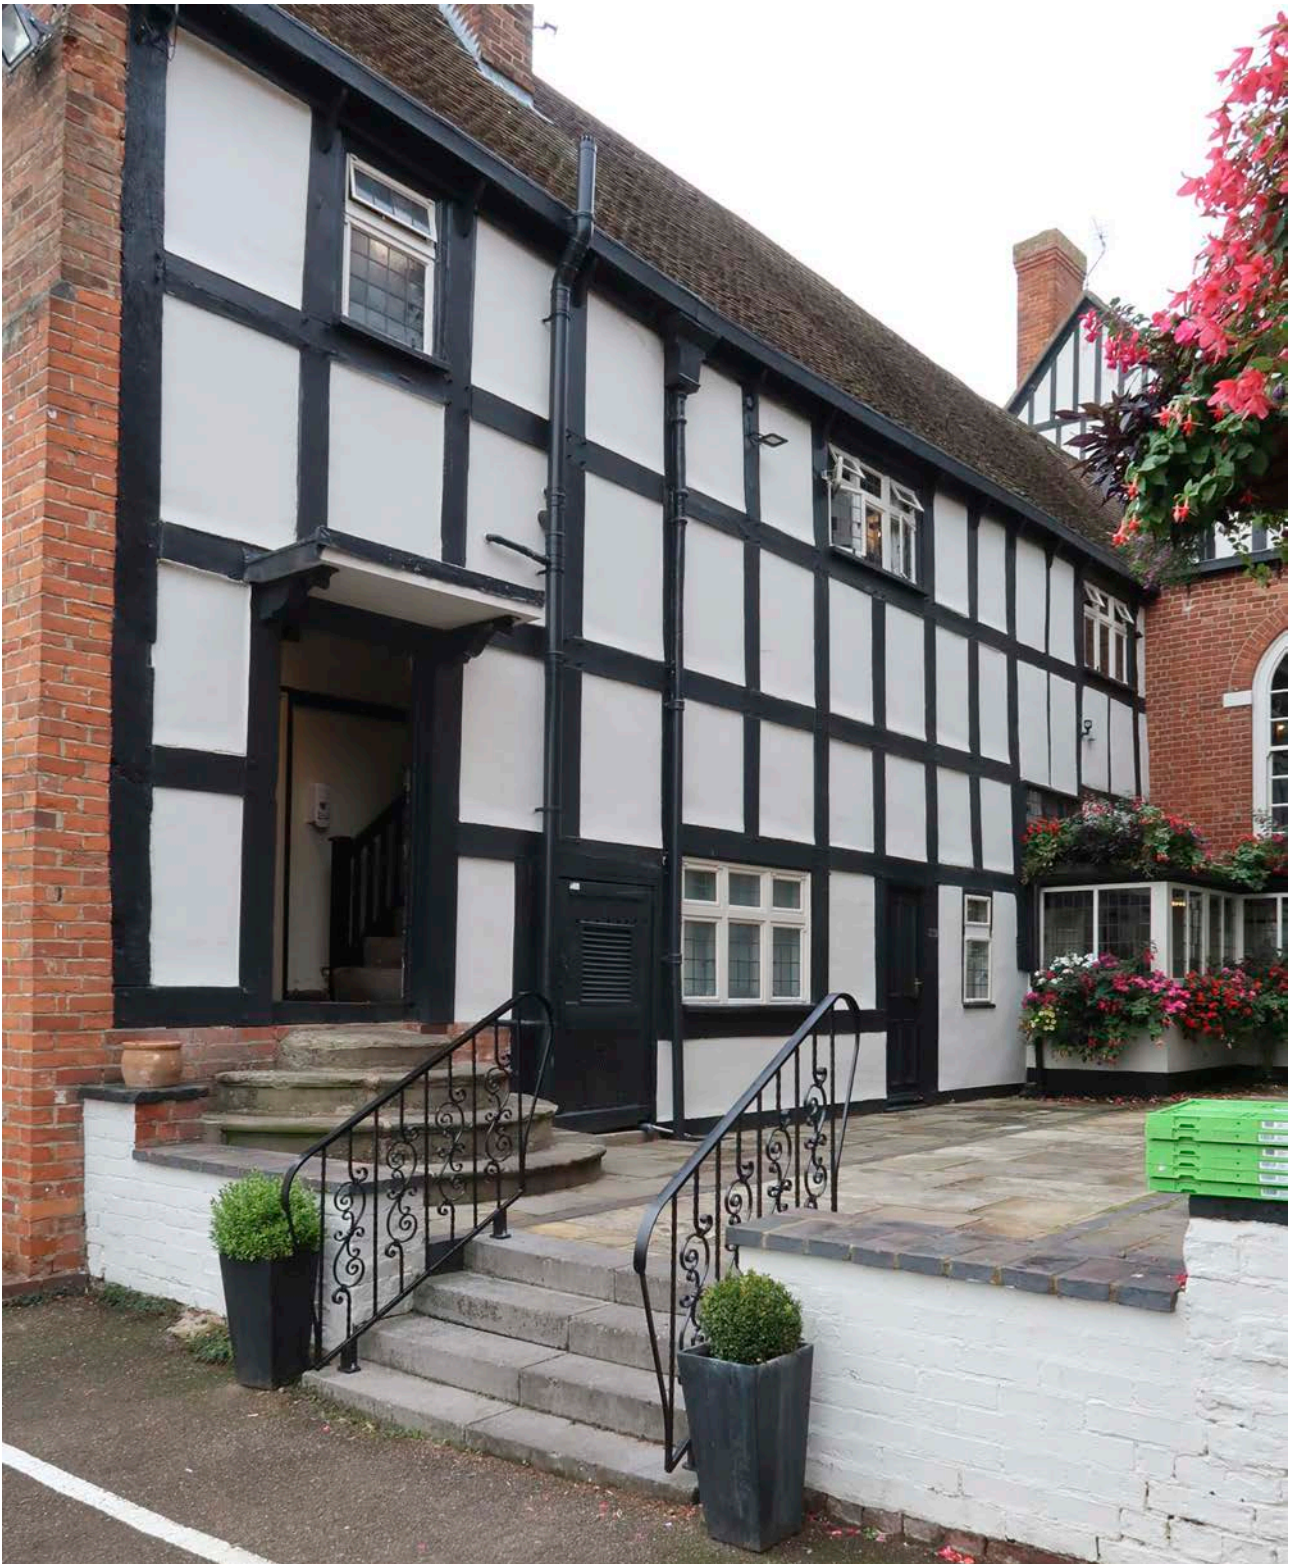
The timbers of the south elevation of the north wing have been largely renewed in the 1970s-80s and in the process the box-framing has been much regularised and several door and window openings changed (Figure 74). Stanley Jones's photograph shows that in the 1960s studs were alternating with posts, so forming a different box framing pattern to the north elevation (see Figure 29). By that date the studs between the posts were much thinner, suggesting some alterations had taken place, possibly when the brick infill panels were inserted. Today, the only historic timbers visible externally on this elevation appear to be the section closest to the junction with the front range, as the timbers are weathered and one post (marking the third frame from the east) retains a scotch mark which relates to the assembly of the frame (Figure 75).

Figure 74: The south elevation of the north wing, from the south-west. [Johanna Roethe © Historic England]

The front range was raised in height by half a storey to create taller internal storeys at all three levels (see Figure 36). The previous jettied arrangement on the cross wing at the northern end was removed at this time: the first-floor jetty was underbuilt and the second-floor jetty removed, creating a flat façade. The east elevation was then remodelled according to the classical Queen Anne style and the timber framing was hidden behind rendering. Stucco quoins were added to the corners (see Figure 4). A timber modillion cornice, string courses and a triangular pediment were added, with the cornices and string courses surviving despite the subsequent alterations to the façade. Square lead downpipes and decorative lead hoppers with cherub's heads and the date 1701 were installed to the east elevation (Figure 79). A plainer, early 18th-century rainwater hopper survives on the north wing's south elevation (see Figure 74).

A major phase of restoration and alterations took place between about 1978 and 1983. The roofs were to be retiled with handmade tiles and several timber-framed walls 'reinstated' using 'properly seasoned oak with brick panel infill'.<sup>218</sup> There seems to be no recording of the building before the works took place and no detailed record of the works undertaken. Based on fabric analysis and a comparison with Stanley Jones's 1960s photographs the replacement of timber framing was extensive in the elevations facing the west courtyard (see Figures 28-9, 42, 74).

The timber framing of the south elevation of the north wing was also restored and largely replaced, although the historic pattern was mostly followed, with the addition of several new window openings (see Figures 29 and 74). It seems likely that the canopy over the westernmost door of the north wing and its corbels were replaced at this time. The west elevation of the north wing appears to have been rebuilt in brick with an additional corner buttress.

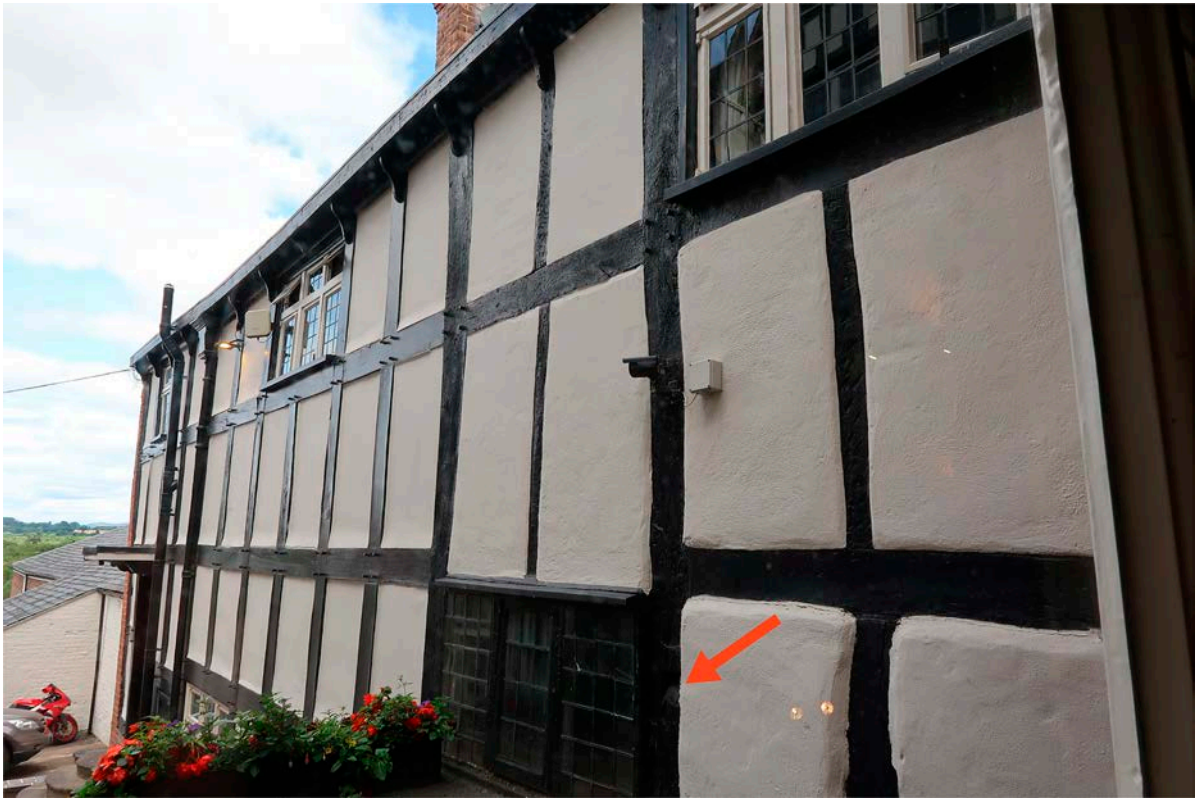
Figure 75: The south elevation of the north wing, seen from the stair west of the front range. The arrow indicates the location of the scotch. [Johanna Roethe © Historic England]

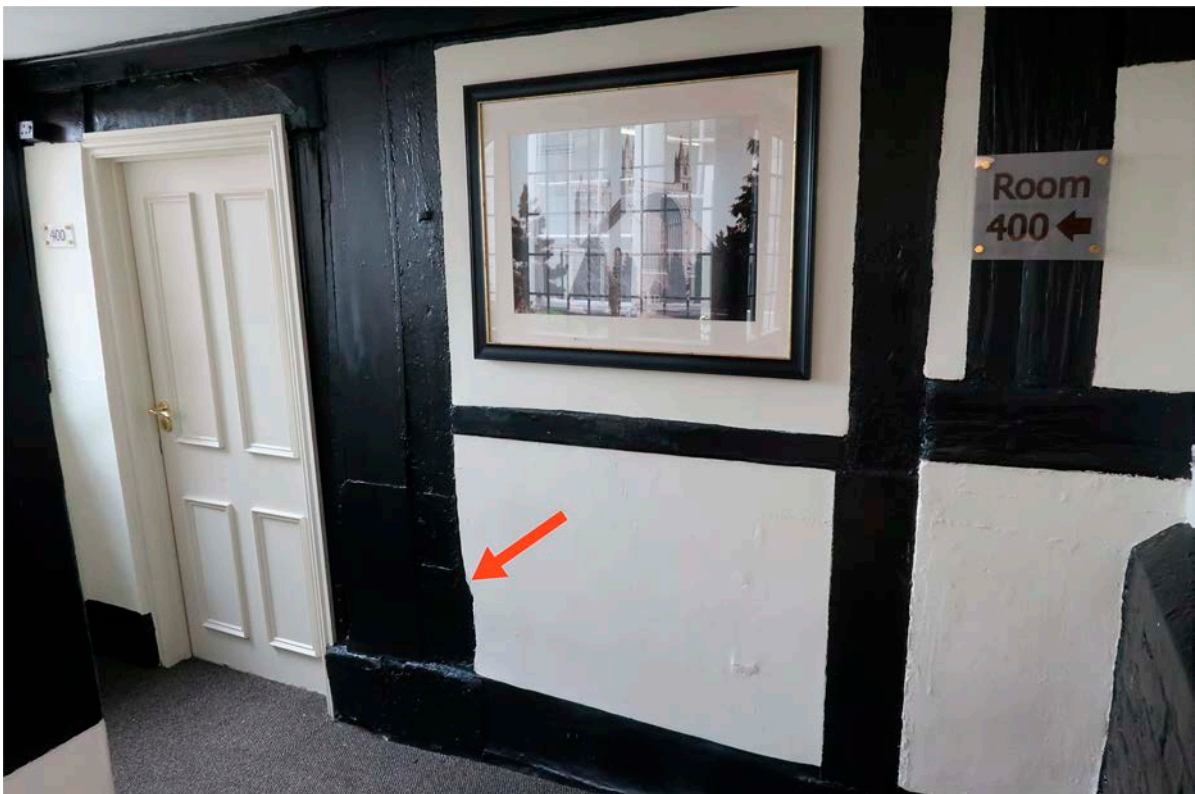
Figure 76: The location of the former doorway at the east end of the north wing's south elevation. The arrow indicates the potential chamfer stop. [Johanna Roethe © Historic England]

Within the range, the large ground-floor room still occupies the eastern two bays of the wing. As discussed above, this was accessed via a cross passage arrangement at the western end of the room. The south door opening is no longer visible from within the room as it is hidden by panelling. Apart from the north door and window, most features of the hall date from the 1910-11 alterations, although it is possible that some parts of the panelling were original to the room and retained in the panelling scheme of 1910-11. There is a later fireplace in the east wall, which may represent a replacement for an original feature in this position, although this is unproven. During the alterations of 1910-11, the architects found historic black and white stone paving in the hall.<sup>206</sup> It seems possible that this was the original flooring as decorative paving using coloured stone or marble was popular in the 17th century. Examples survive today in high-status buildings such as the floor in the Great Hall in the Queen's House in Greenwich, South London.

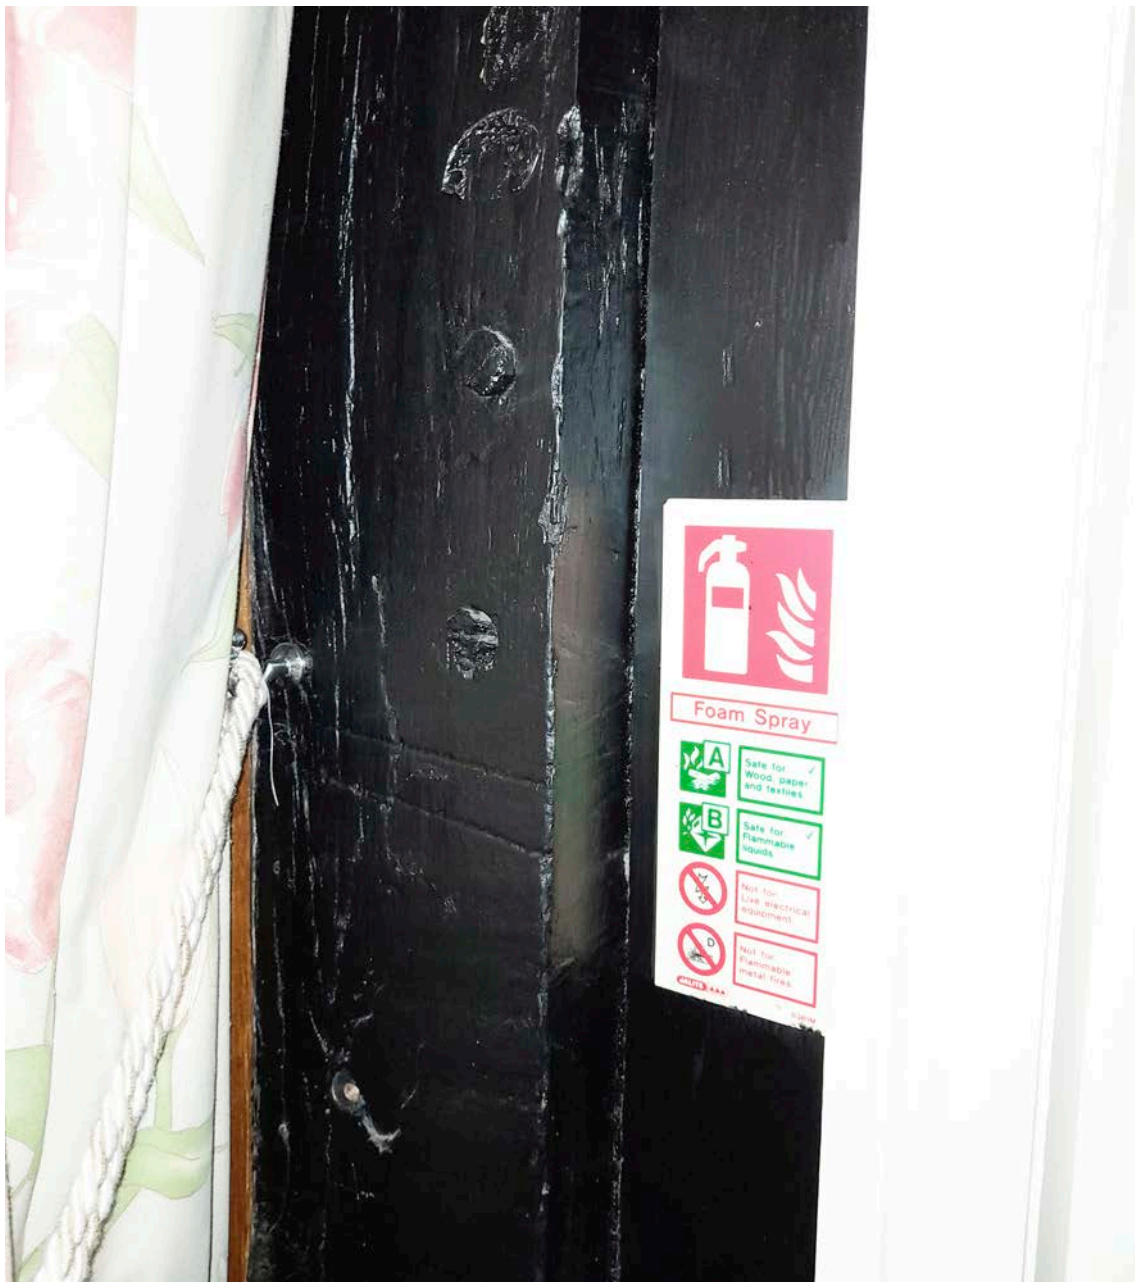
Figure 77: The redundant peg holes and possible carpenter’s mark in the third post from the east on the north wing’s south side, at first-floor level. [Johanna Roethe © Historic England]

At first-floor level, the posts of the wing's south elevation now have jowls. The third post from the east – now part of a modern partition – has redundant peg holes in a similar position to those in the south-east corner post (as described above; Figure 77, see Figure 67). Below the peg holes is what may be a scribed carpenter's mark, indicating II (for 2). The underside of the tiebeam is not visible to confirm a receiving mortice but presumably there was a diagonal up-brace here, similar to that at the eastern frame. The next post to the west (the fourth from the east) is a modern replacement but the tiebeam it supports has another empty mortice for a diagonal brace (Figure 78). The presence of such braces along the south side of the wing suggest that the current arrangement of a corridor along the south side is modern, as the braces would have blocked such an arrangement. The posts on the northern side could not be inspected for this project. If they are lacking up-braces in the same positions this might suggest an original corridor arrangement on the northern side, which the continuous glazing on the north elevation might also indicate.

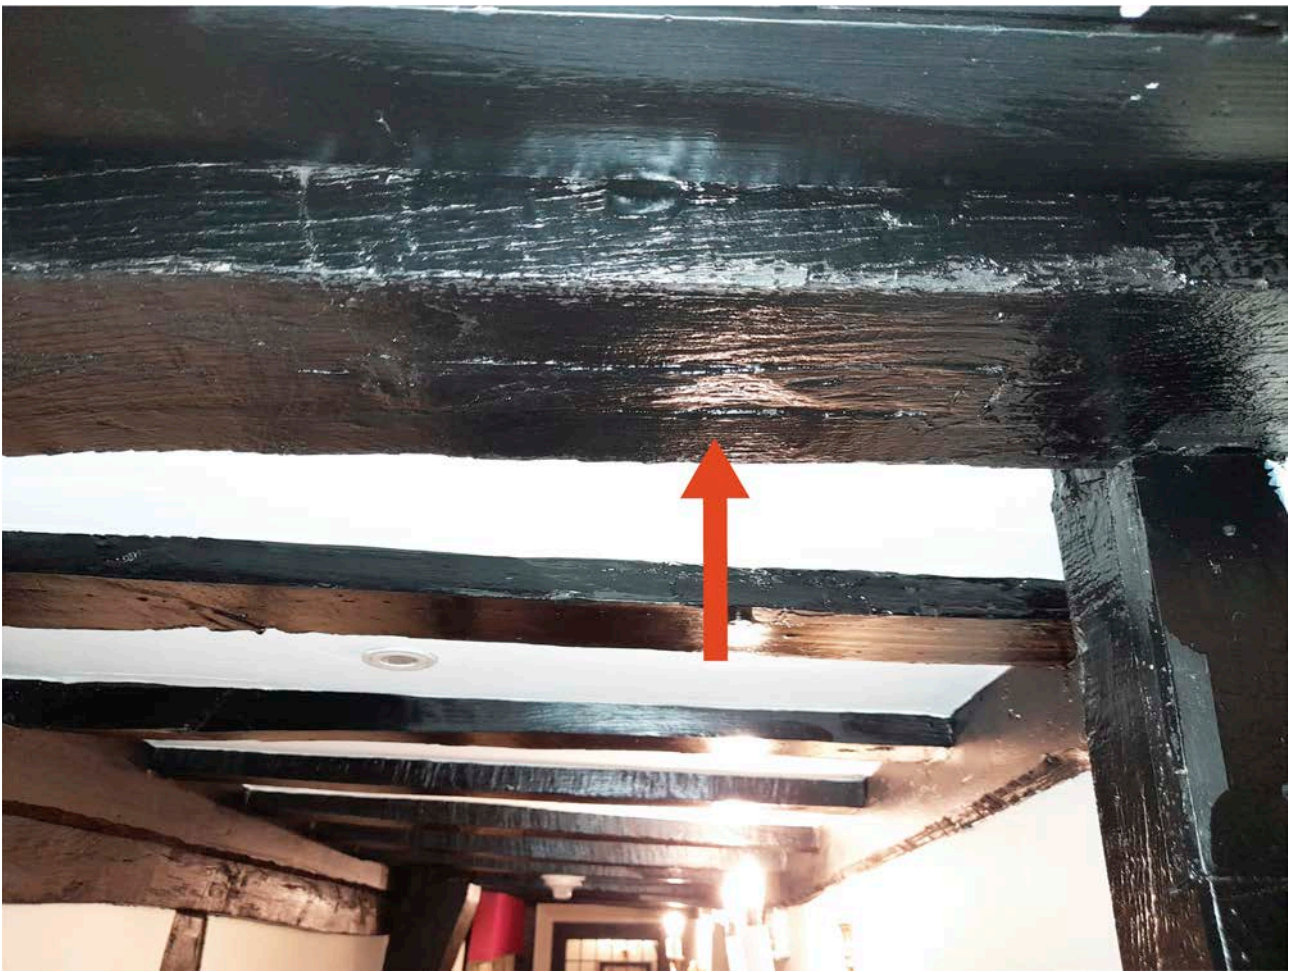
Figure 78: The modern post (left) in the location of the fourth post from the east in the north wing. The arrow indicates the empty mortise in the tie beam for a diagonal up-brace with two peg holes above. [Johanna Roethe © Historic England]

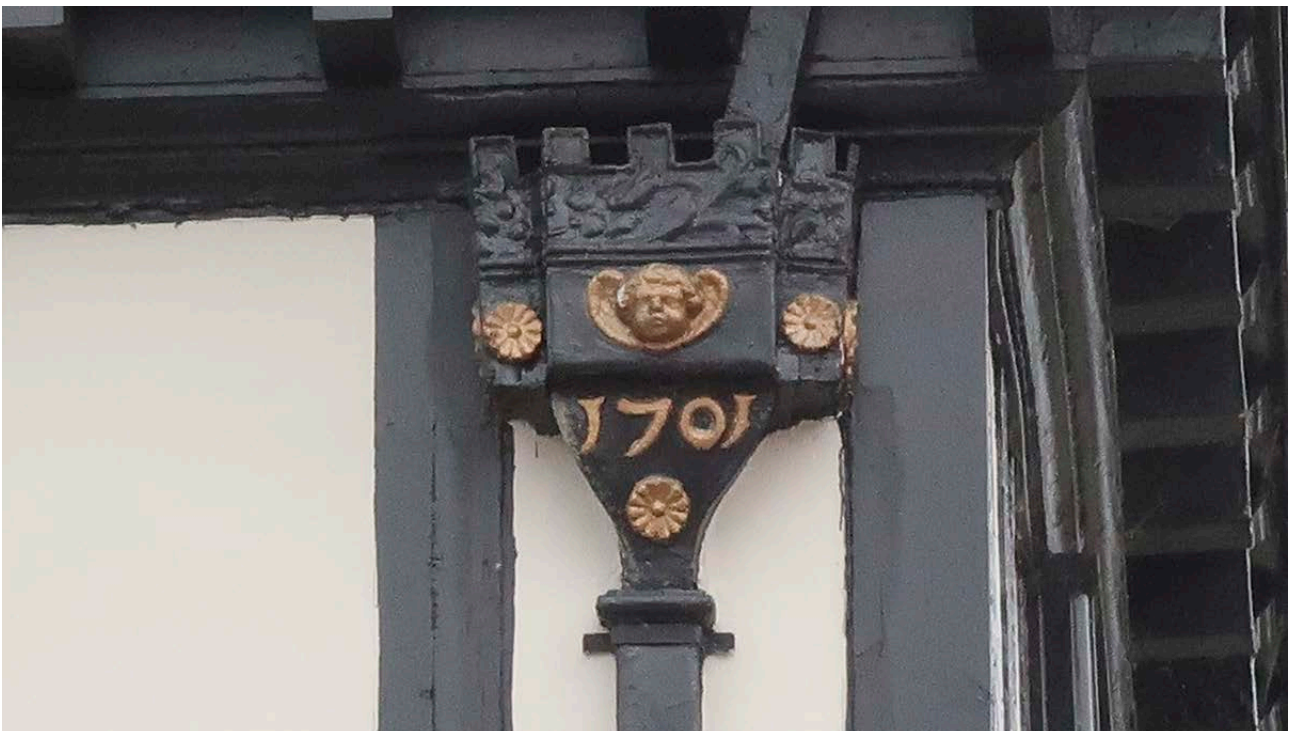
Figure 79: One of the 1701 rainwater hoppers. [Johanna Roethe © Historic England]

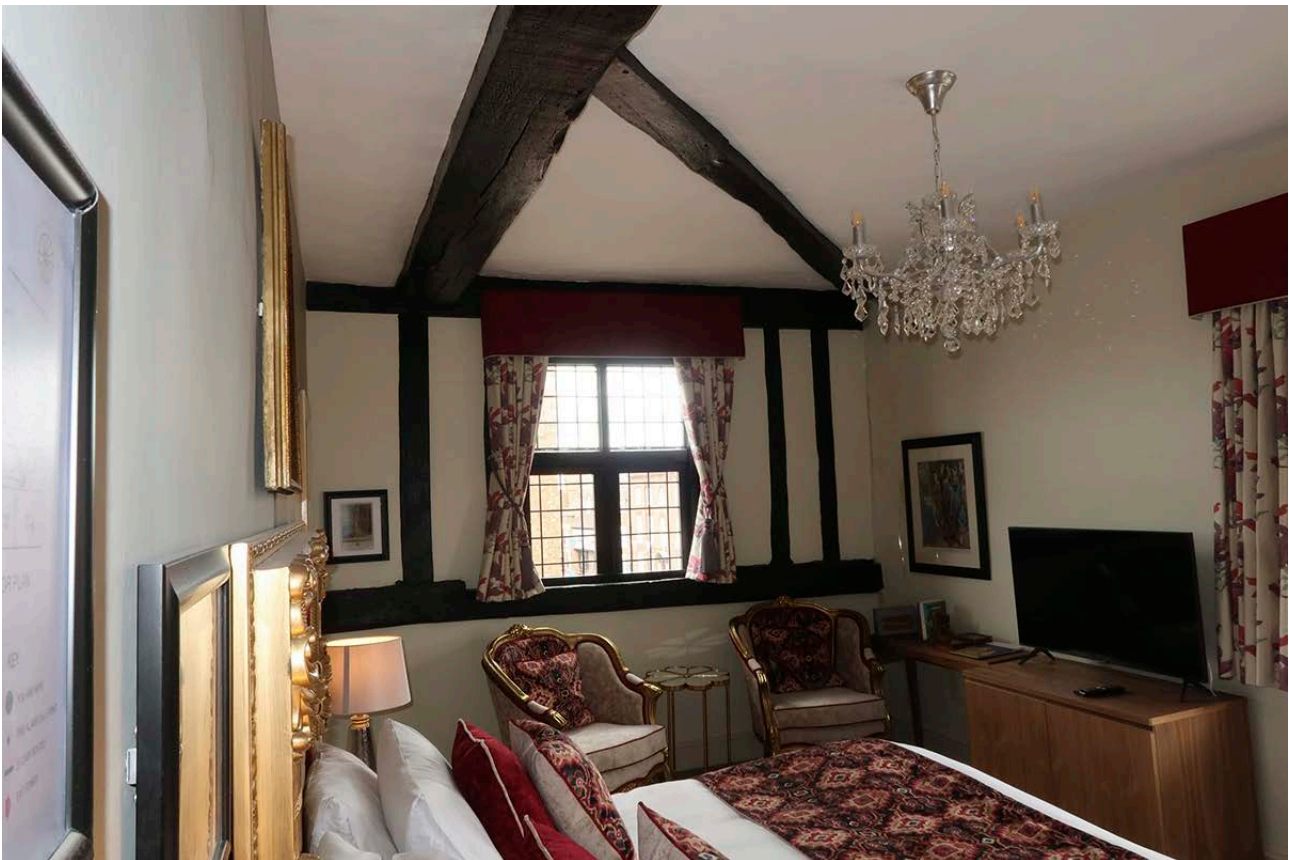
The attic spaces of the front range could not be accessed for this project but the second-floor rooms have ceiling beams which must relate to the raising of the roof. Some of them are clearly re-used with redundant peg holes so may have come from the earlier roof and been repurposed. The north-east room on the second floor has a diagonal ceiling beam running out to the north-east corner but there is no suggestion that this once was a dragon beam (i.e. the diagonal beam used when there are jetties on two sides of a building) (Figure 80). Diagonal beams are drawn on the second-floor plan of 1910 for the entire second floor and may have been a way of supporting the hipped roof (see Figure 12).

Figure 80: The second-floor room at the north-east corner of the front range. [Johanna Roethe © Historic England]

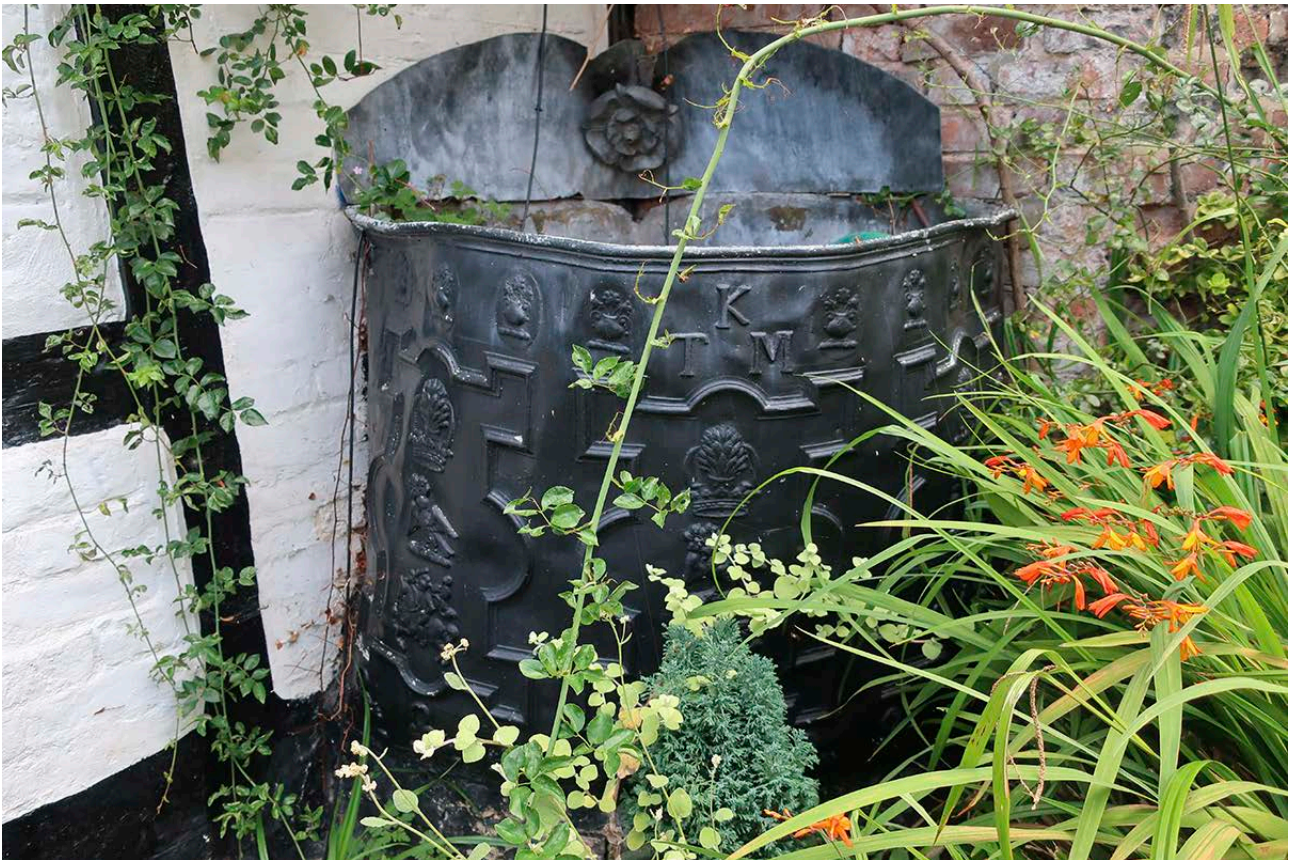
Figure 81: The lead water cistern in the courtyard. [Johanna Roethe © Historic England]

The date '1741' and the initials of Thomas Kemble (1701-76) and his wife Margaret (1716-1800) can be found on a lead cistern in the courtyard of Tudor House. After Thomas's death in 1776, Margaret continued to live there until her own death in 1800. She bequeathed her property to her niece Judith Bland.<sup>58</sup>
