# The Tudor House Hotel, 52-3 High Street, Tewkesbury, Gloucestershire

Historic Building Assessment

Johanna Roethe

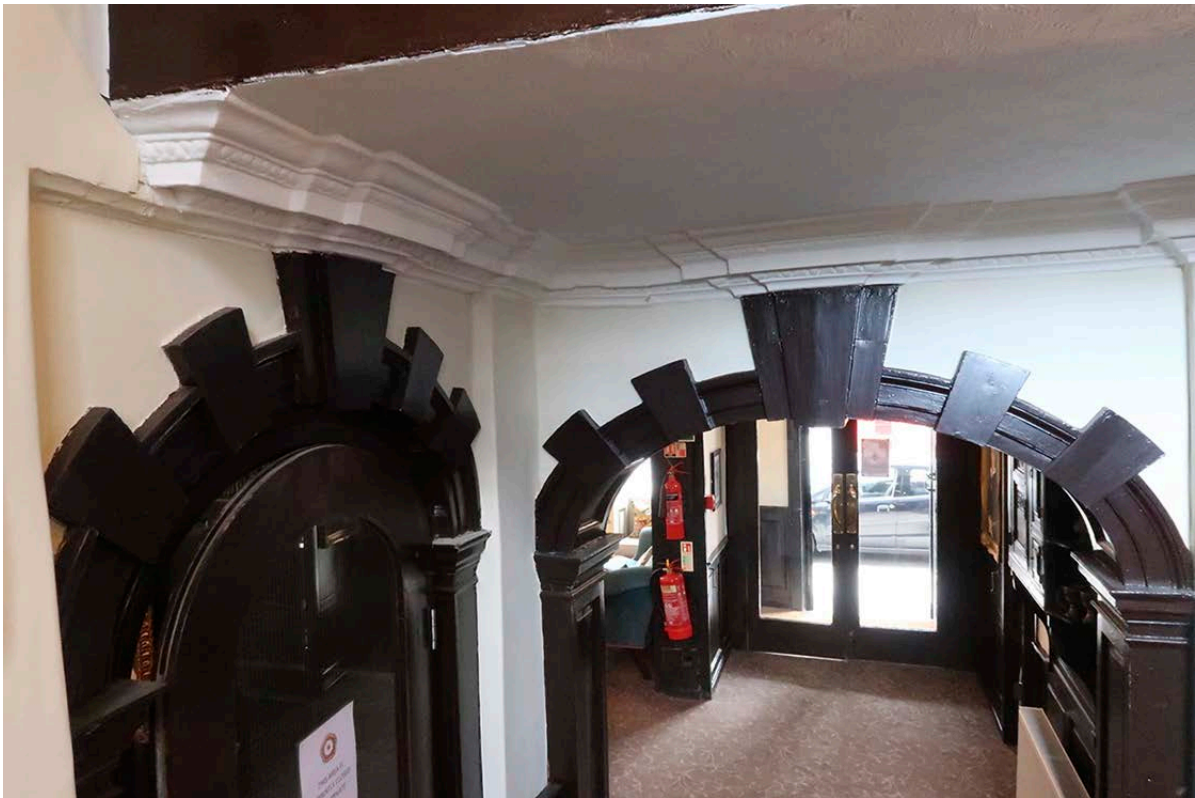
Four elliptical timber arches with moulded architraves, projecting keystones and voussoirs and panelled pilasters were probably added to the doorway and window openings in the central wing at the same time. One is on the inside of the staircase window, one leads from the stairwell to the ground-floor entrance corridor, another from the stairwell into the hall in the north wing and another one from the stairwell to the south wing (Figure 83). Two further arches lead from the first-floor landing to the central corridor and the south wing; these have fluted pilasters and a moulded architrave with a central keystone. The plasterwork cornices of the ground and first floors are similarly differentiated according to classical conventions: on the ground floor the stairwell has a moulded cornice with egg-and-dart (Figure 84) and on the first floor a modillion cornice which extends into the first-floor corridor between the two central rooms (Figure 85).

Figure 84: The timber arches on the ground floor, seen from the stair. [Johanna Roethe © Historic England]

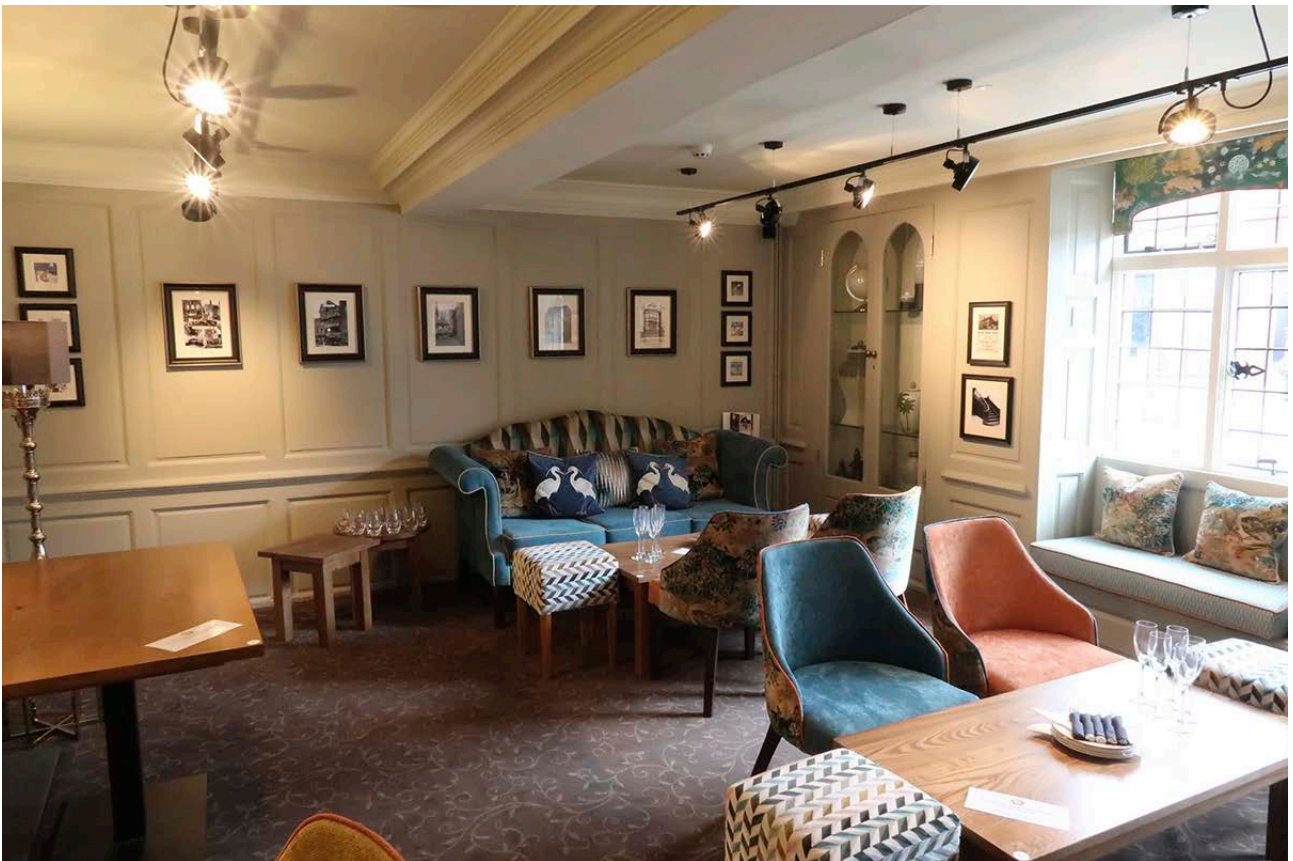
During the first half of the 18th century, the infill of the timber-framed panels throughout the building was probably replaced by brick and the lower floor of the south wing's north elevation rebuilt in brick. Other, minor alterations during the 18th century included the insertion of some sash windows, for example those formerly in the gable of the central wing (see Figure 28). The panelling in the ground-floor room at the north end of the front range probably also dates from this period (Figure 87).

Figure 87: The ground-floor room at the north end of the front range, looking north-east. [Johanna Roethe © Historic England]

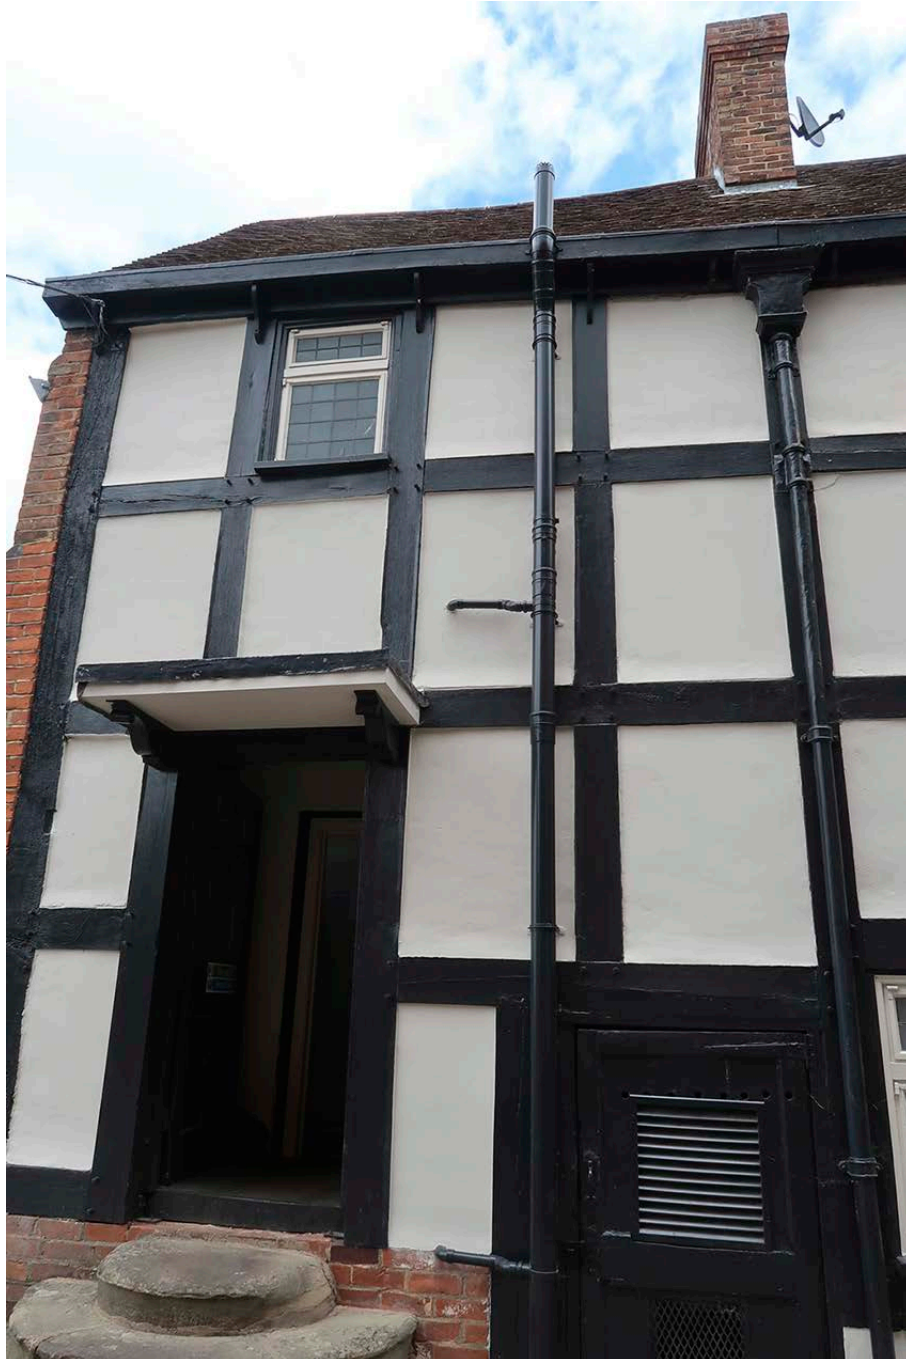
Figure 88: The west end of the north wing's south elevation. The later replacement of the timber framing masks the change in phase, which is marked by the downpipe with an early hopper. [Johanna Roethe © Historic England]

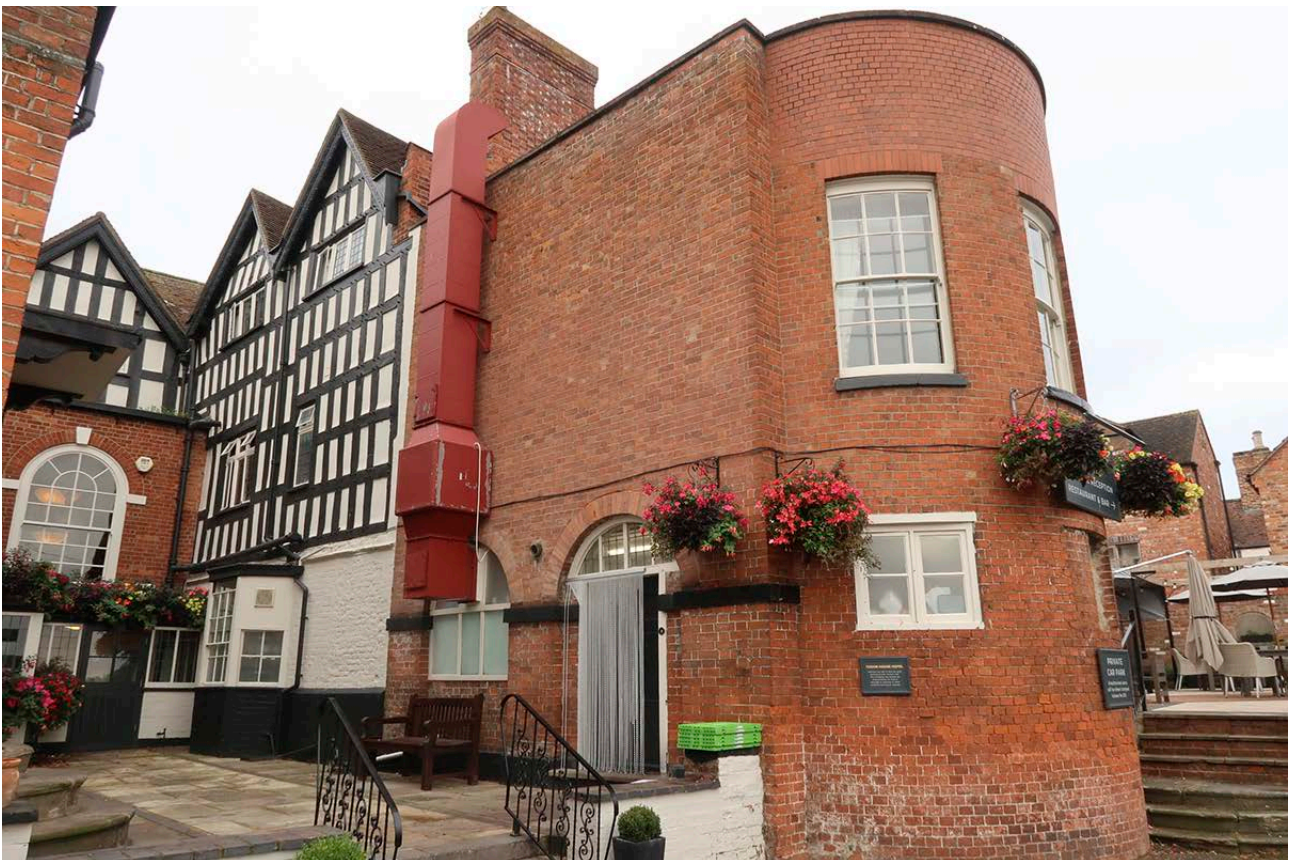
In the late 18th century or the early 19th century, the south wing was also extended further west (Figure 89). The extension was built in brick laid in Flemish bond and header bond, and terminates in a bow window with three sash windows on the first floor. It now has a hipped and tiled roof which stops short of the (now flat-roofed) bow. For the past century or so, the ground-floor space in this extension has been in use as a kitchen and the room above, featuring Adamesque plasterwork, in a higher status use, such as a drawing room in 1910 and now a bedroom. The original use of this extension is likely to have been similar, with a more utilitarian use below and a higher status use above.

Figure 89: The south wing extension from the north-west. [Johanna Roethe © Historic England]

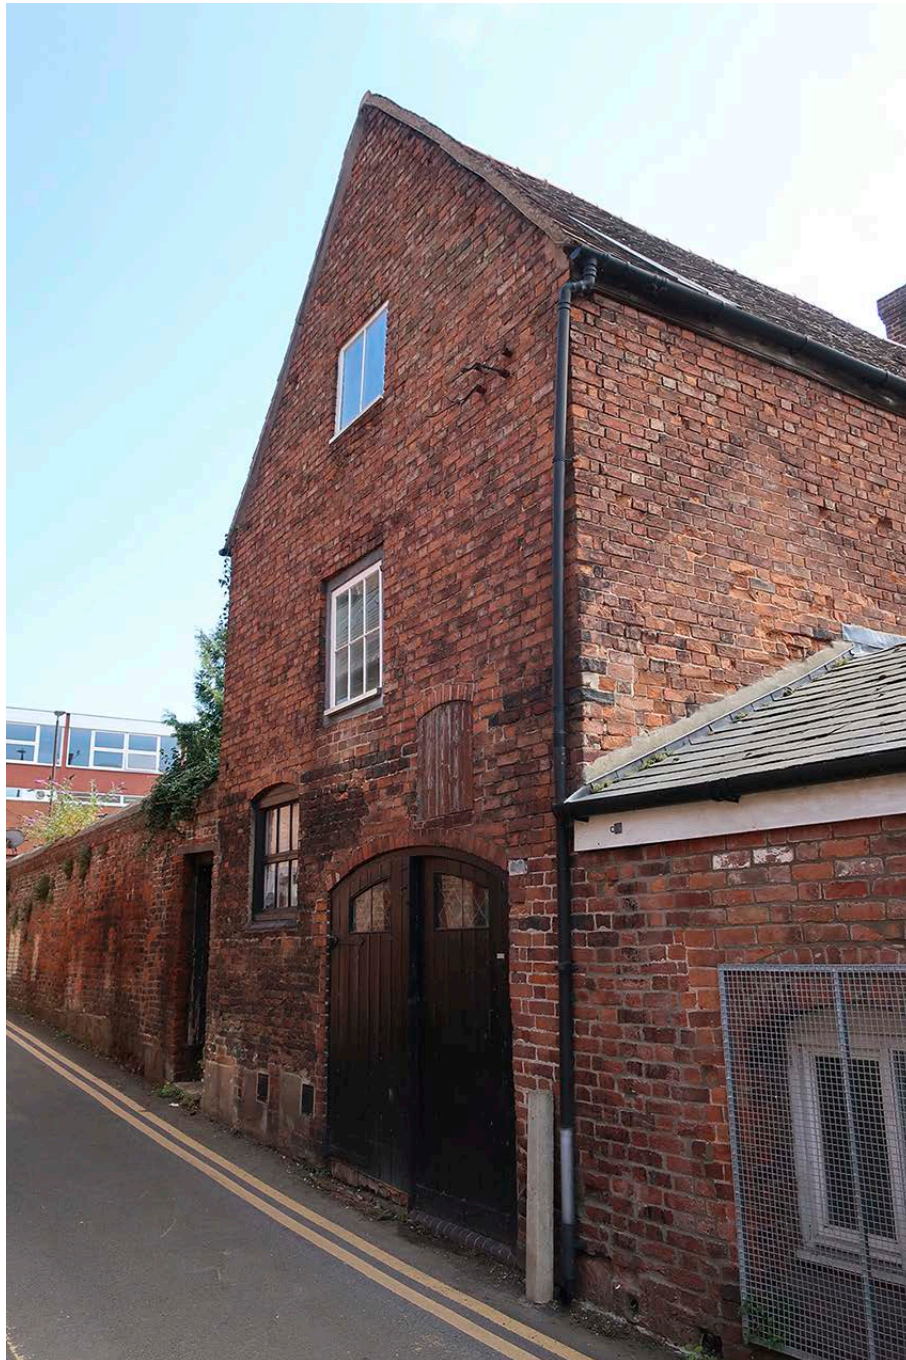
Probably in the early 19th century, a brick range was erected to the west of what is now the corner courtyard and attached, but sitting at right angles, to the north wing. It was extant by the 1880s (see Figure 6) and in use as a stable and coach house by 1895. The interior has not been inspected. It is of red brick laid in Flemish bond. Several of its window and door openings have been altered but others retain simple brick arches of a single row of headers which are consistent with an early 19th-century date. The north elevation has a two-leaf carriage door towards Red Lane with a small hayloft opening above and a window to one side (Figure 90). At first-floor level on the east elevation is a

Figure 90: The north elevation of the stable block from Red Lane, seen from the north-west. [Johanna Roethe © Historic England]

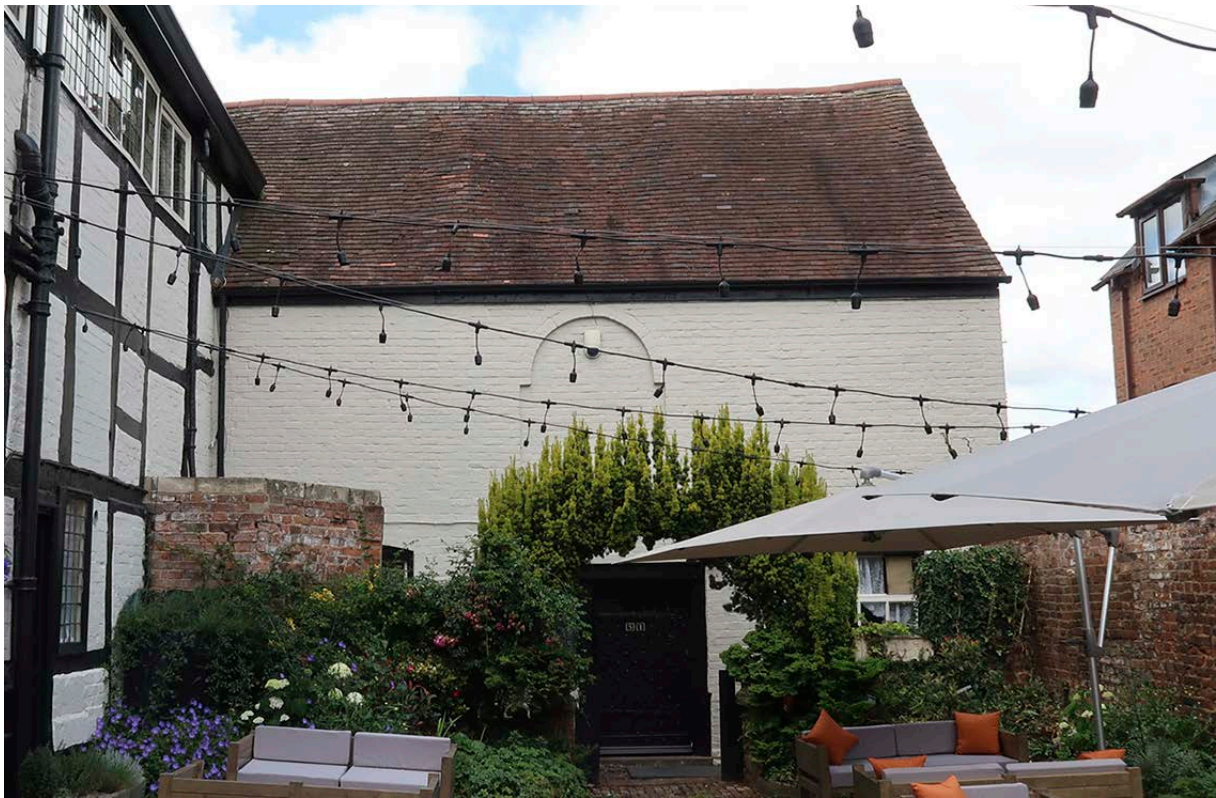
blocked central arched opening or decorative feature (Figure 91). Directly below on the ground floor, a later timber-framed door frame and a small window are set into a shallow and wide recess, which may originally have been another wide door opening. Set within the later door frame is a door of three wide vertical planks with fleur-de-lis hinges and nails, which is similar in form to the 17th-century door to the north wing. It is not in situ and may have come from elsewhere in the complex (Figure 92).

Figure 91: The east elevation of the stable block. [Johanna Roethe © Historic England]

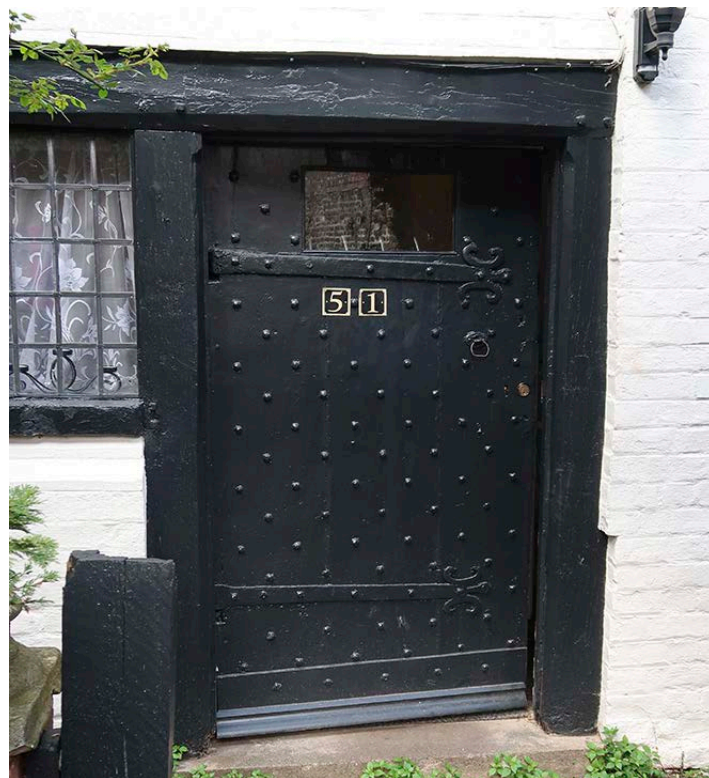
Figure 92: The door in the east elevation of the stable block. [Abigail Lloyd © Historic England]

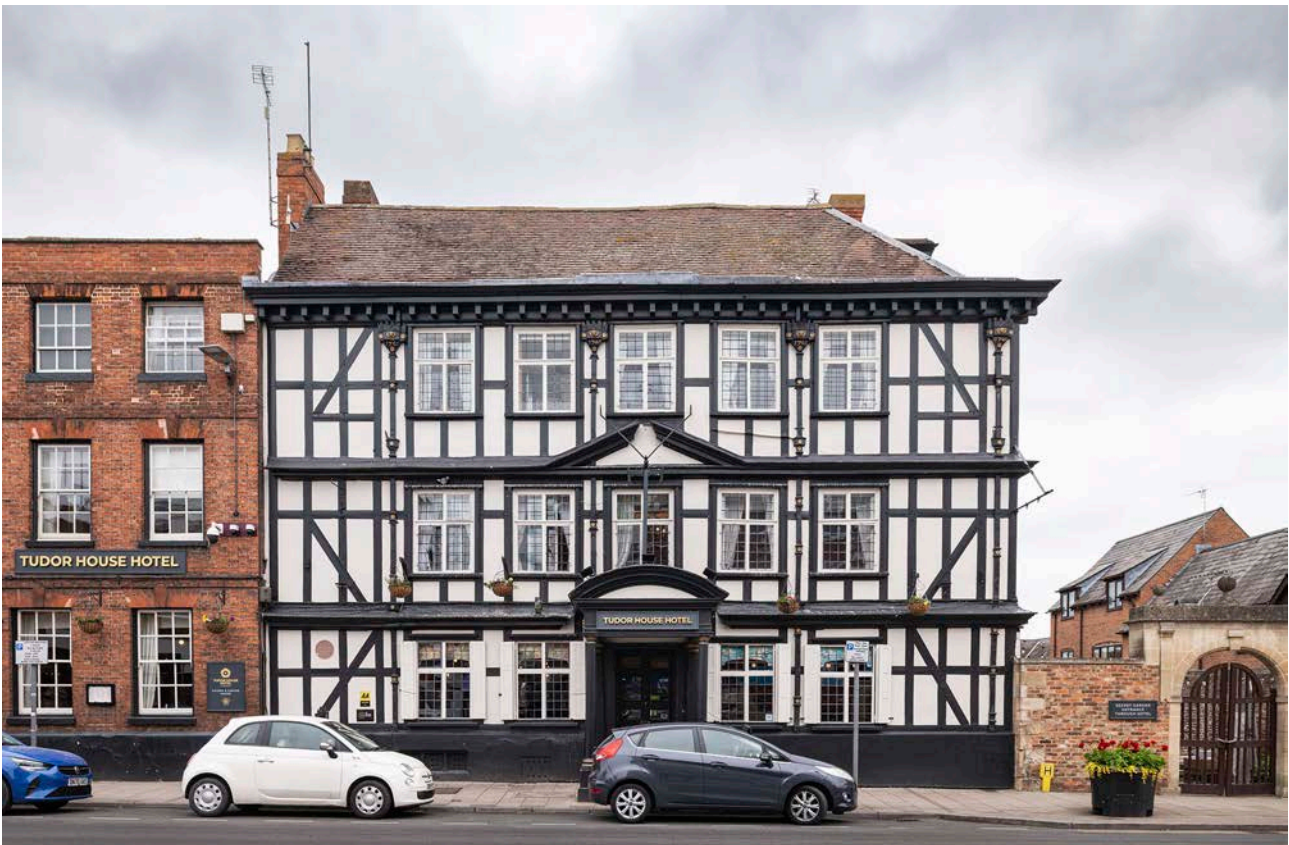
Most changes in the mid- to late 19th century were incremental. The most significant alteration during this period was the refronting of the east elevation of the front range with new 'mock' timber framing (Figure 93). Few details are known about this phase of work. According to an early 20th-century account by Healing & Overbury the building underwent 'very considerable structural renovation' in the late 19th century when the rough-cast of the front elevation was removed and the false timber framing installed.<sup>216</sup> Some of the early 18th-century details were retained, including the downpipes and hoppers, the string courses, the cornice and the Doric door case. The triangular pediment above the entrance – shown as complete on the 1850 print – seems to have been changed in form to a broken pediment (see Figure 4).

Figure 93: The east elevation in 2023. [Steven Baker © Historic England Archive, DP325757]

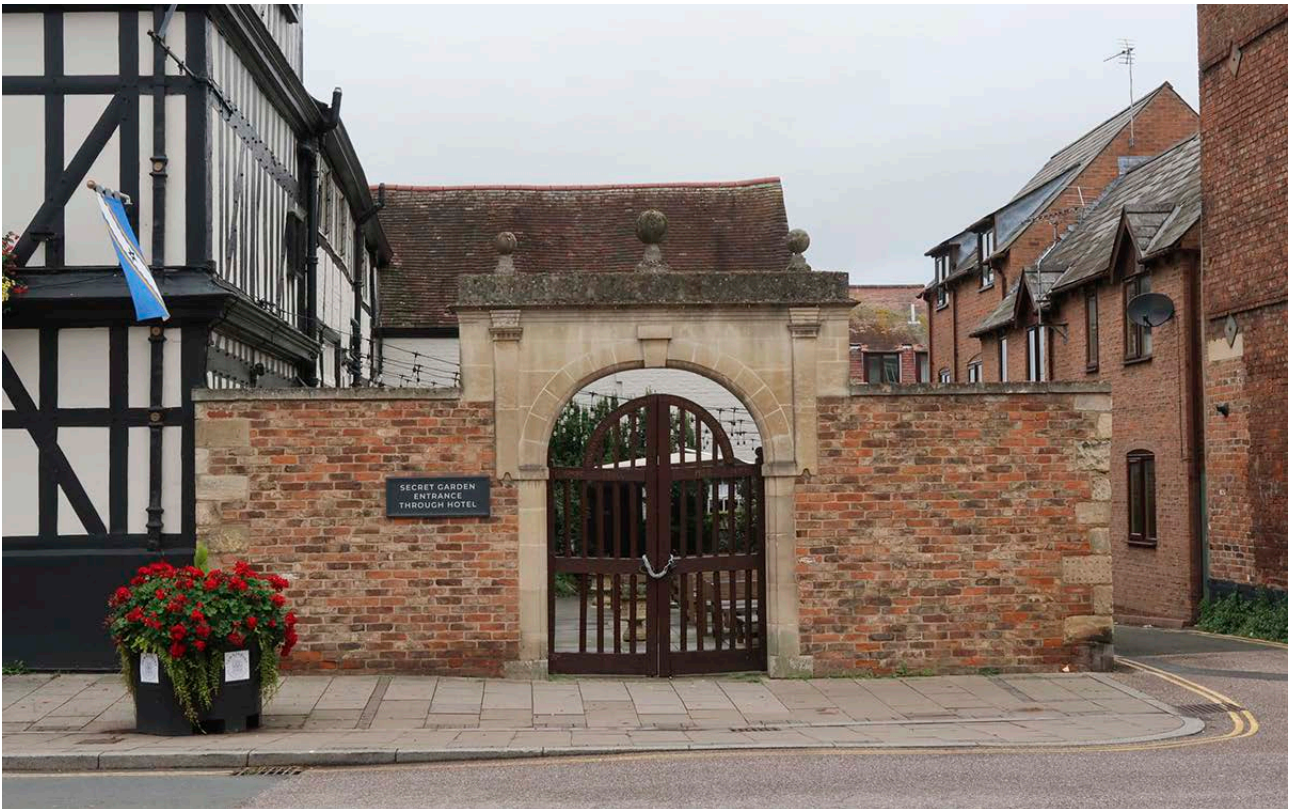
The stone gateway into the corner courtyard was rebuilt in replica, copying the details of the much-eroded historic stonework as extant in early 1979 as far as possible (Figure 95). The original pediment which had been removed by 1921 was not recreated. The brick walls on either side were rebuilt in reclaimed and second-hand brick.

Figure 95: The arched gateway in 2023. [Johanna Roethe © Historic England]

If the house at the corner was only demolished in the first half of the 19th century, the gateway in its originally 17th-century form was not in situ. It might have been a genuine 17th-century feature relocated here from elsewhere, perhaps even from another part of the Tudor House plot. Alternatively, it might have been a creation of the first half of the 19th century, possibly replicating the gateway to the Manor House at Bredon's Norton, Worcestershire, which it closely resembled (Figure 96).<sup>239</sup> Bredon's Norton is located only 8km from Tewkesbury. Both gateways have stopped strap pilasters framing a central arch, which terminate in a three-lobed pendant. At both the pilasters supported a full entablature of architrave, fluted frieze and dentilled cornice and a triangular pediment above. The gateway at Bredon's Norton is dated to the 17th century on stylistic grounds.<sup>240</sup> The motif of two strap pilasters framing a gateway also appears on the porch of Woollas Hall, a house of 1611, in Eckington, Worcestershire, near Bredon's Norton.<sup>241</sup>

In the absence of further evidence, the date and origin of the gateway formerly at the Tudor House remain uncertain and given the total rebuilding it is unlikely that the question will be resolved.

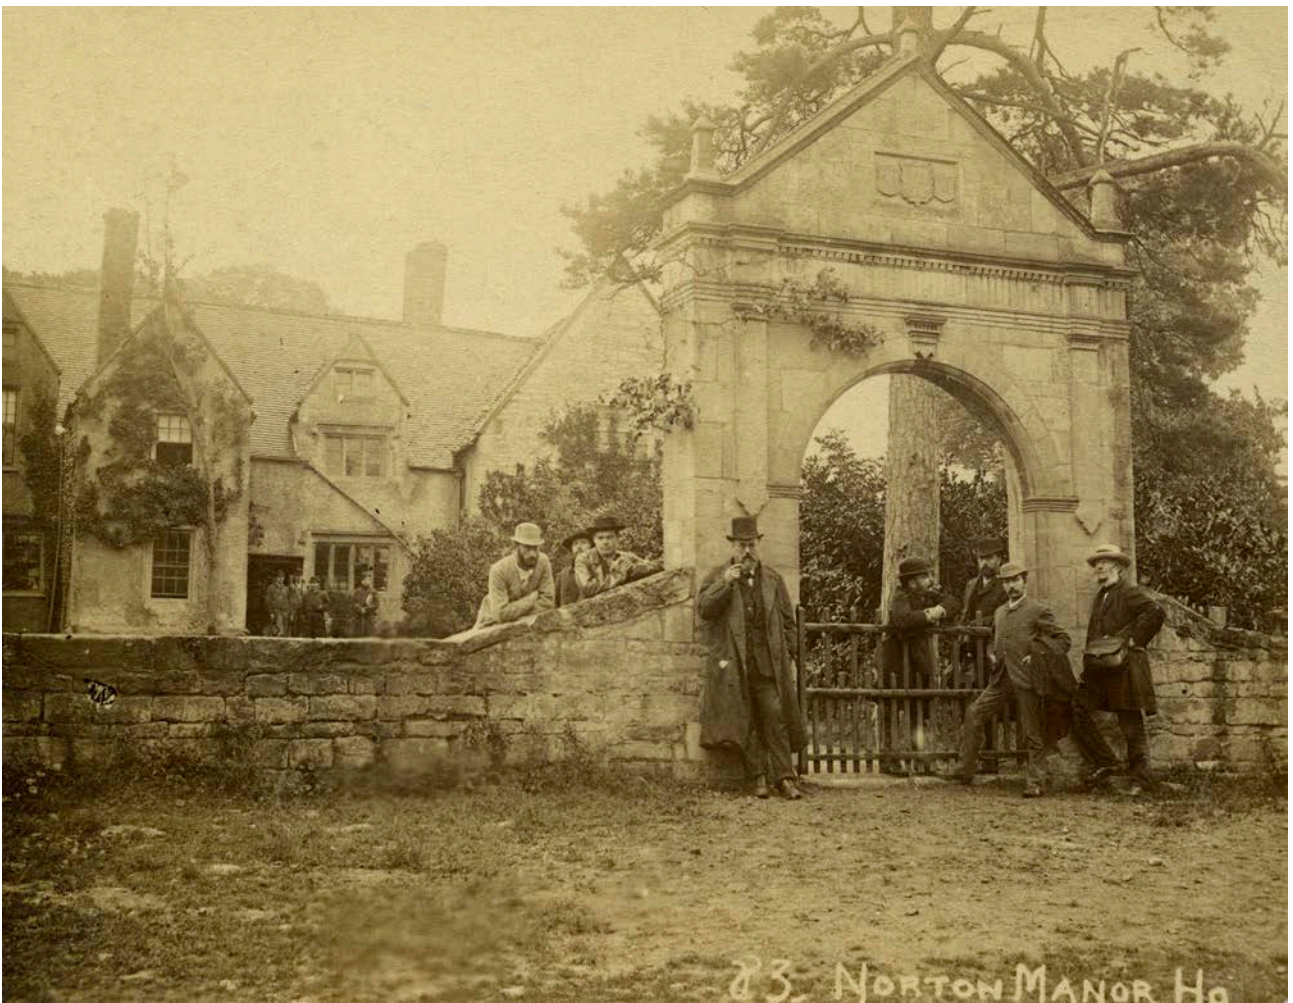
Figure 96: The gateway at Bredon's Norton Manor House, Worcestershire, before the insertion of a datestone in the 1880s. [Source: Historic England Archive, OP06657]
