Ravenglass Roman Bath House, Muncaster, Cumbria

Report on Geophysical Surveys, January 2024

Megan Clements and Neil Linford

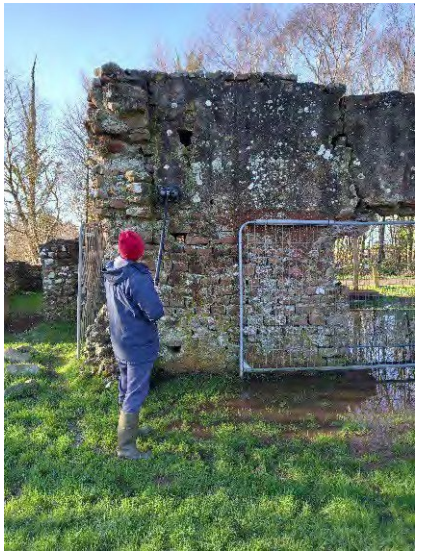
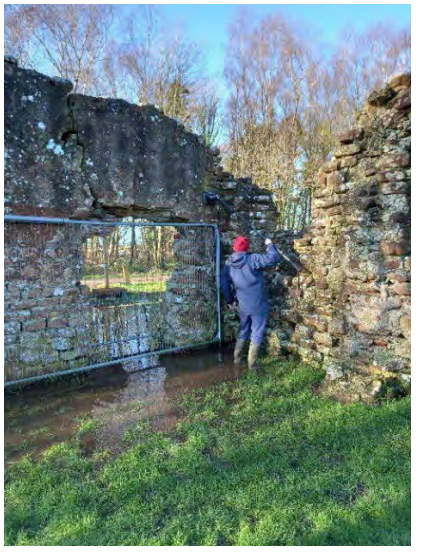
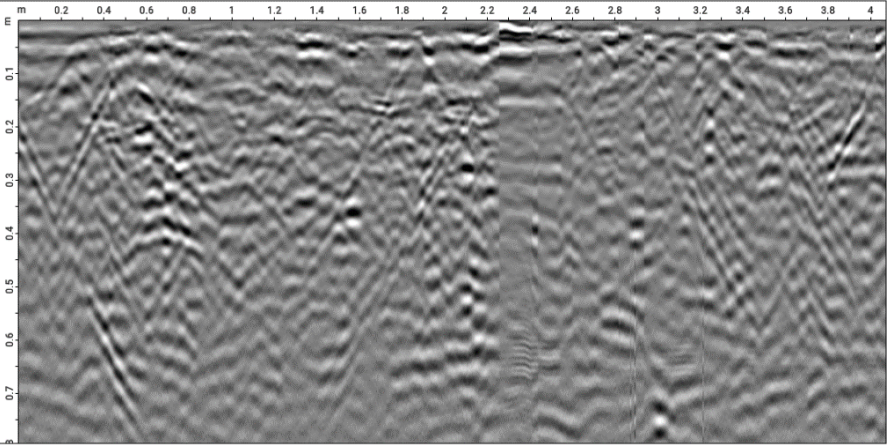
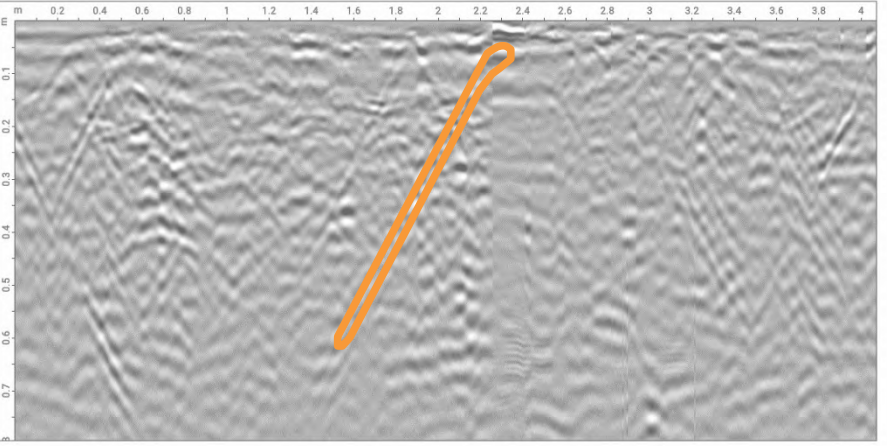
Ravenglass_e3**	Beginning	End	Data	Interpretation
<p>01</p> <ul style="list-style-type: none"> e301_1 = crack

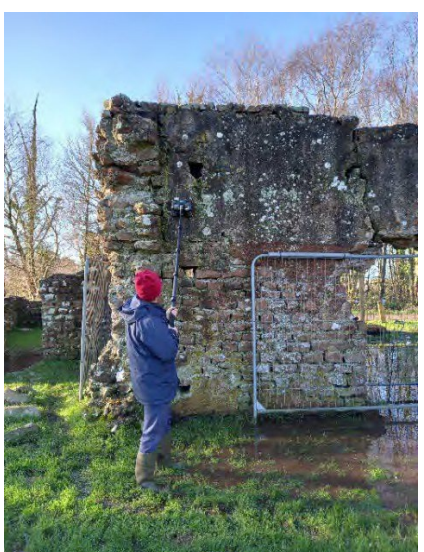
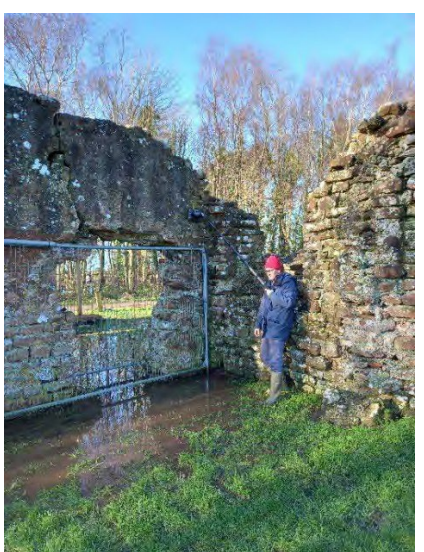
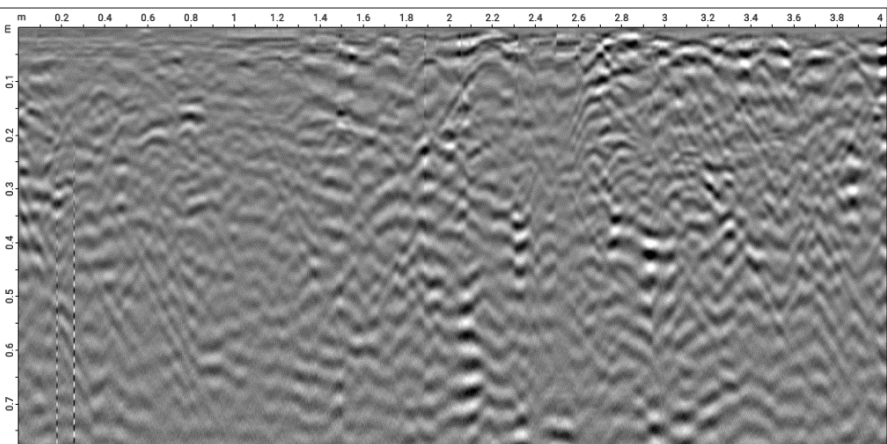
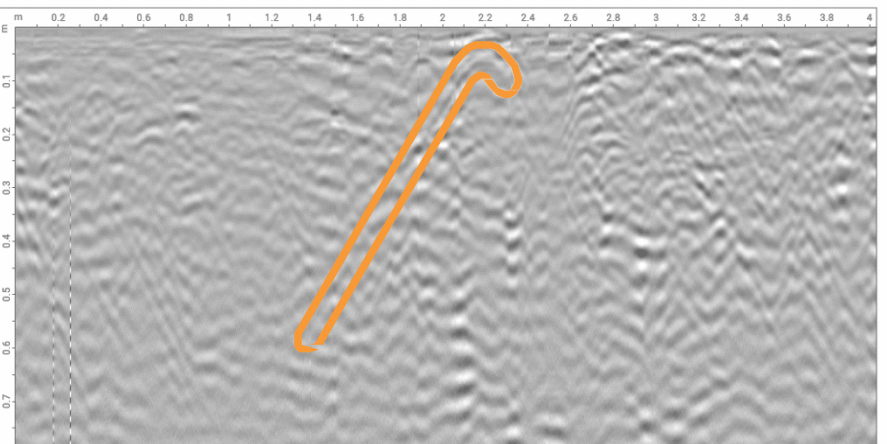
<p>Line: Ravenglass_e301</p>
<p>02</p> <ul style="list-style-type: none"> e302_1 = crack

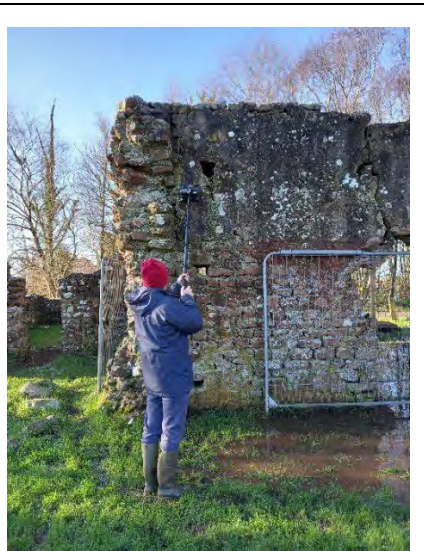
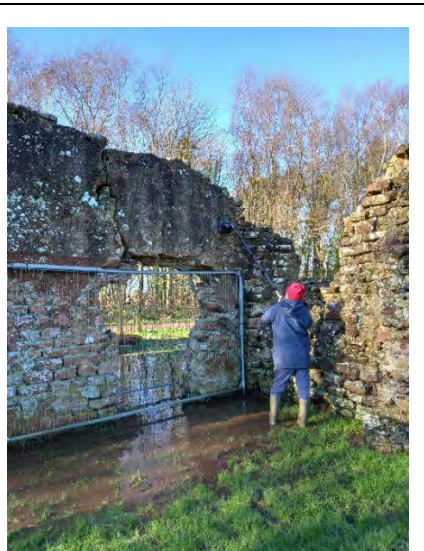
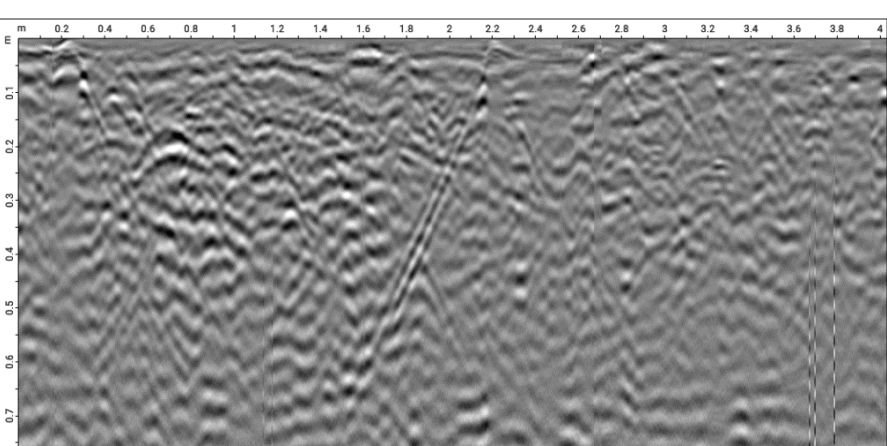
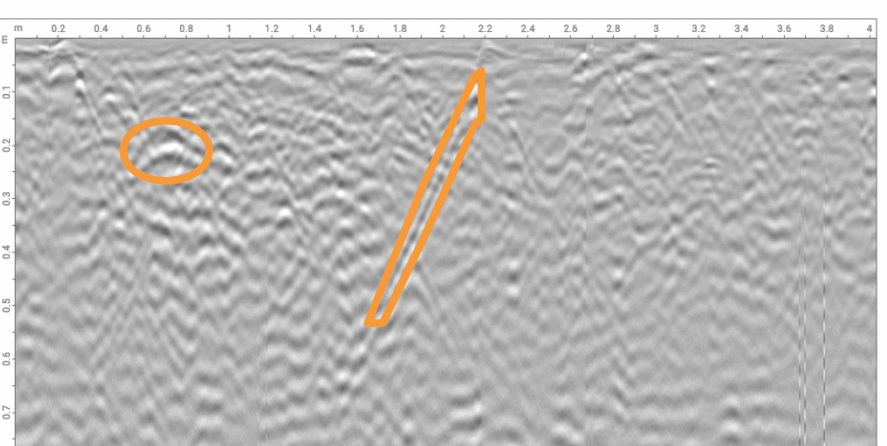
<p>Line: Ravenglass_e302</p>
<p>03</p> <ul style="list-style-type: none"> e303_1 = internal voiding e303_2 = crack

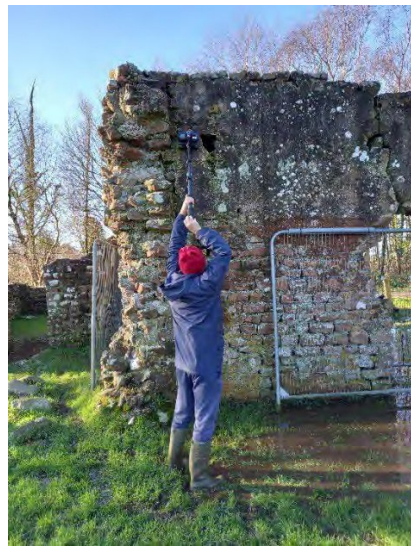
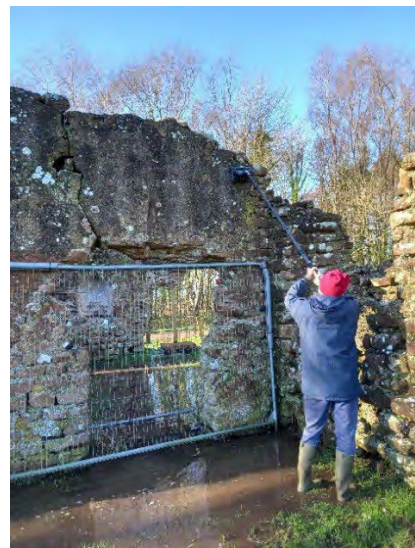
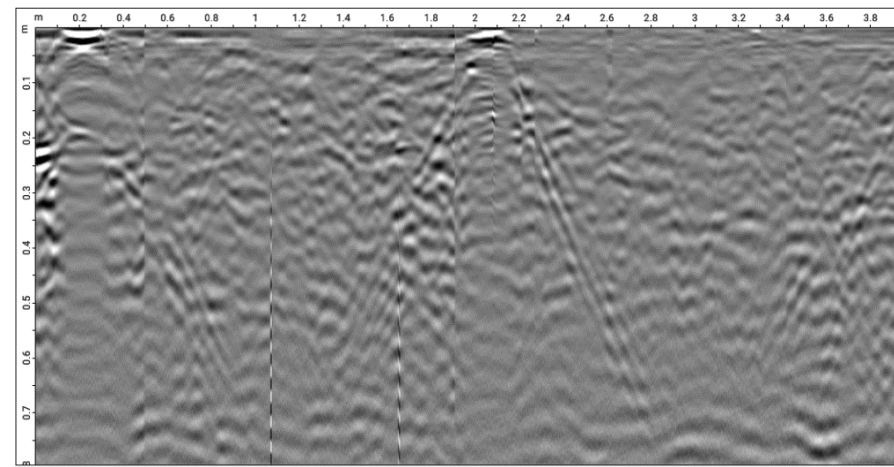
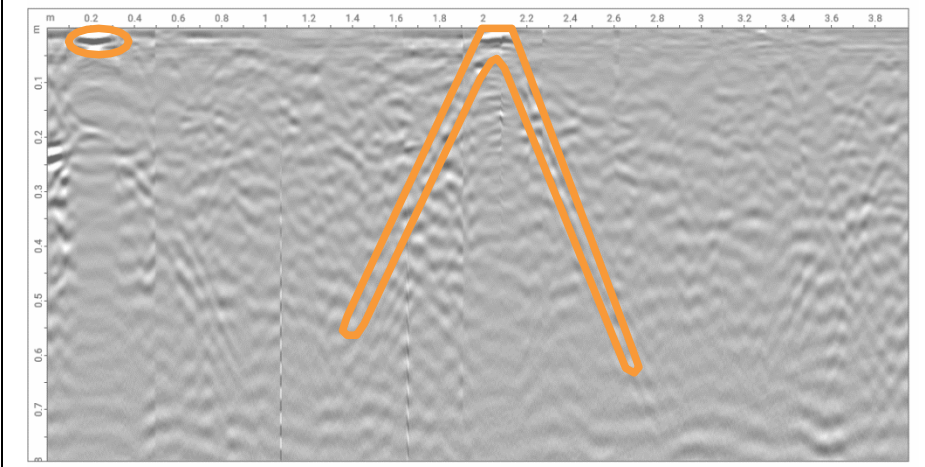
04

- e304_1 = hole
- e304_2 = hole in middle of crack

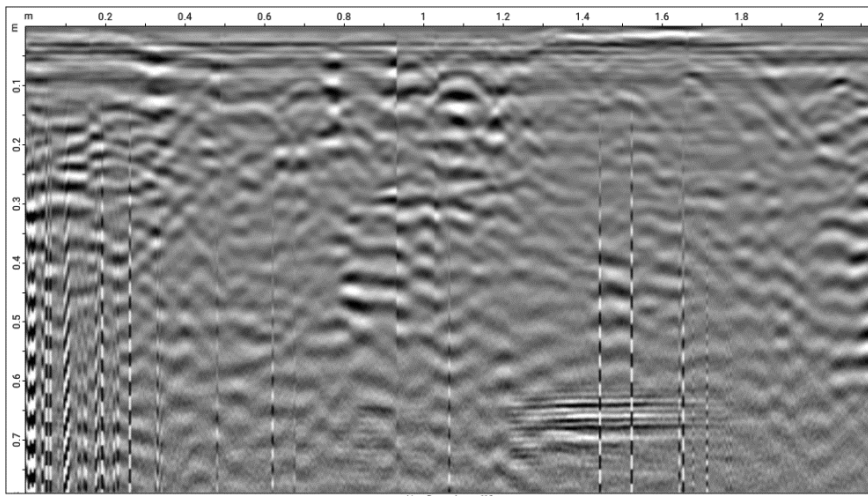
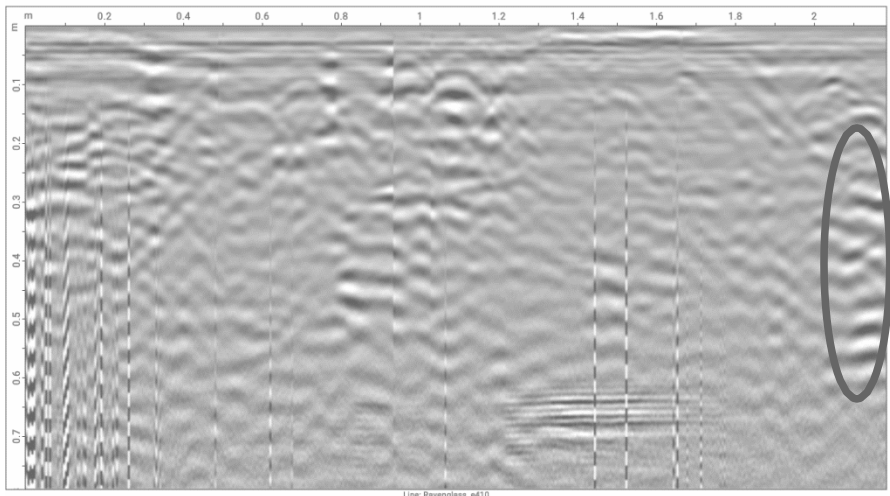
<p>10</p> <ul style="list-style-type: none"> e410_1 = airwave reflection from overhang

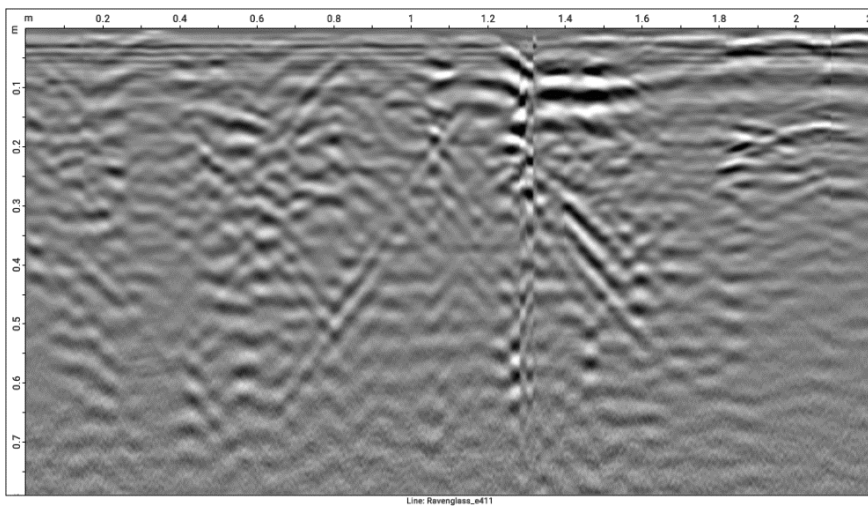
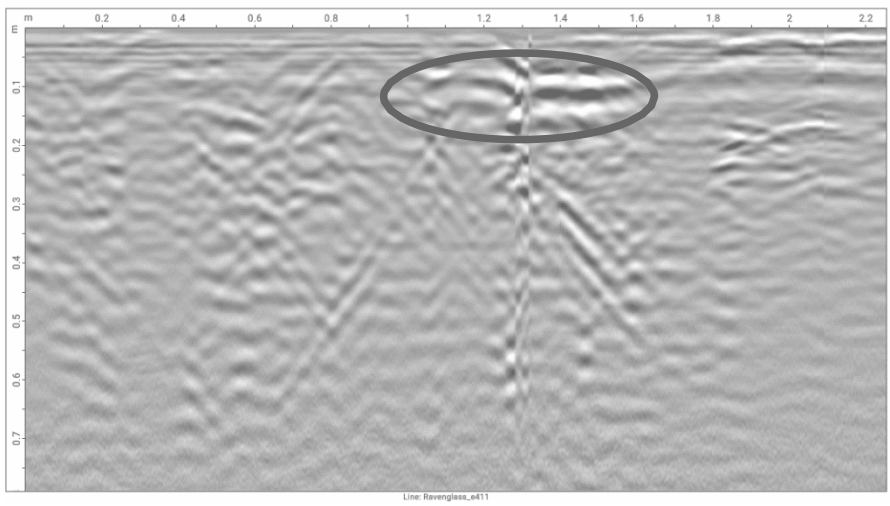
<p>11</p> <ul style="list-style-type: none"> e411_1 = data artefact

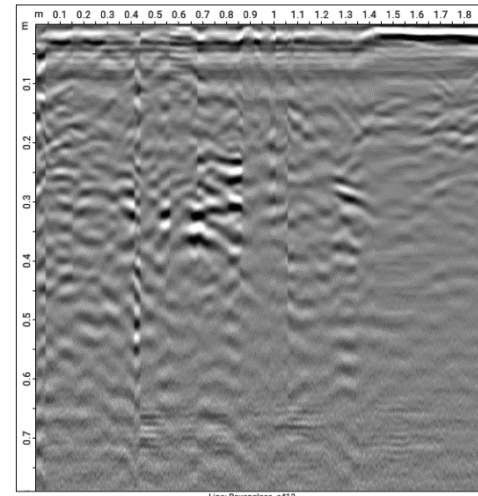
13

- e413_1 = change in building material or direction of masonry

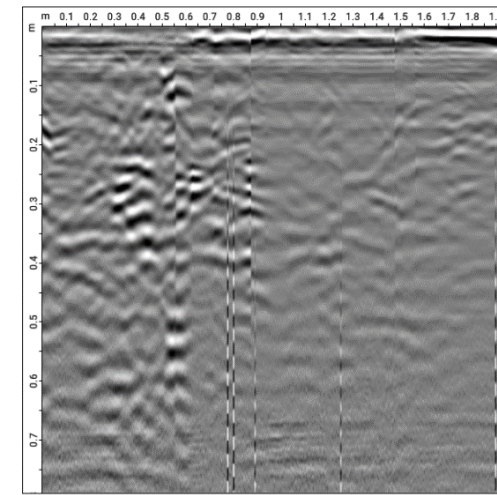
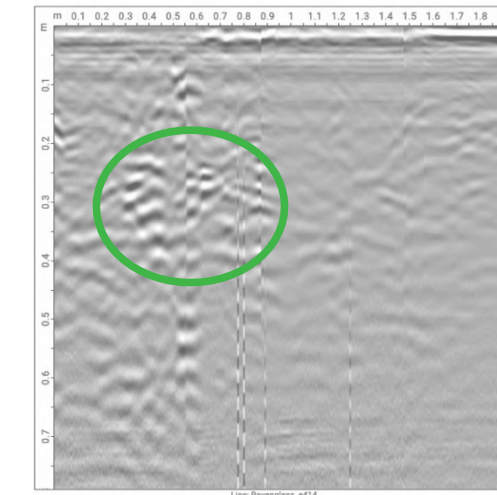
14

- e414_1 = change in building material or direction of masonry

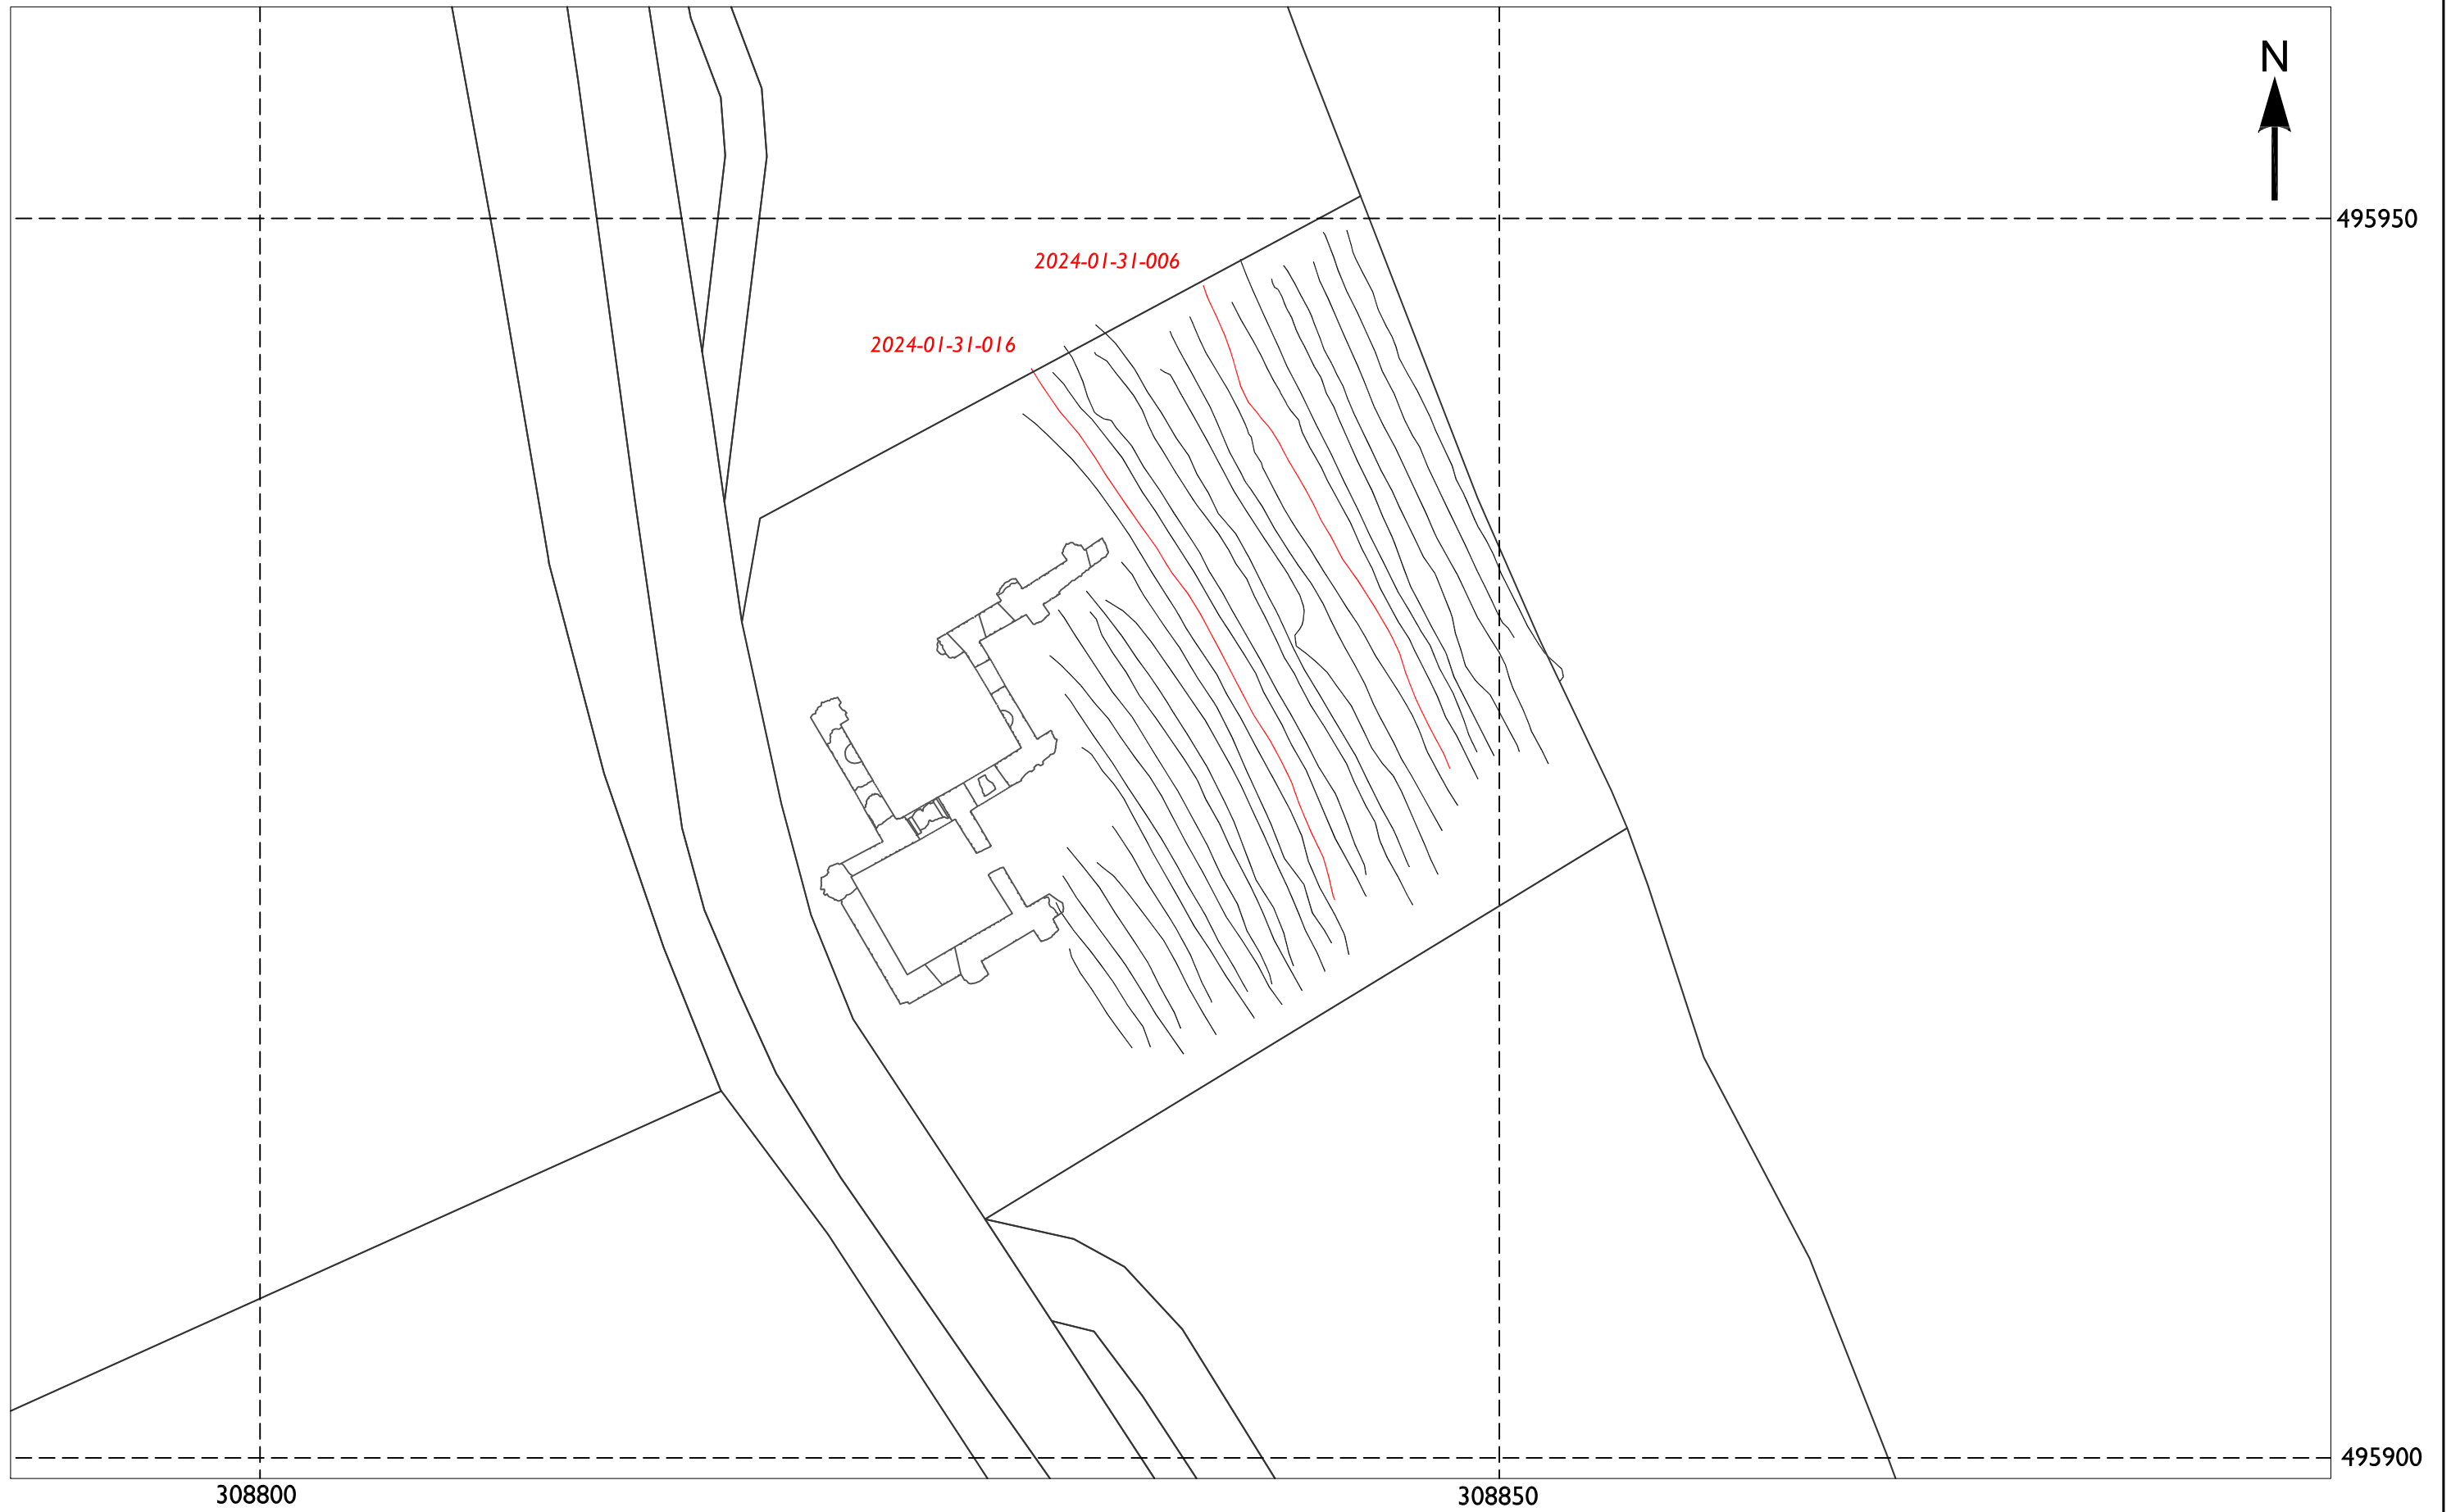
Location of GPR instrument survey swaths with measured survey plan of the Bath House

- Figure 1: Location of GPR instrument survey swaths superimposed over the base OS mapping data and an outline from a measured survey of the Bath House (1:250).

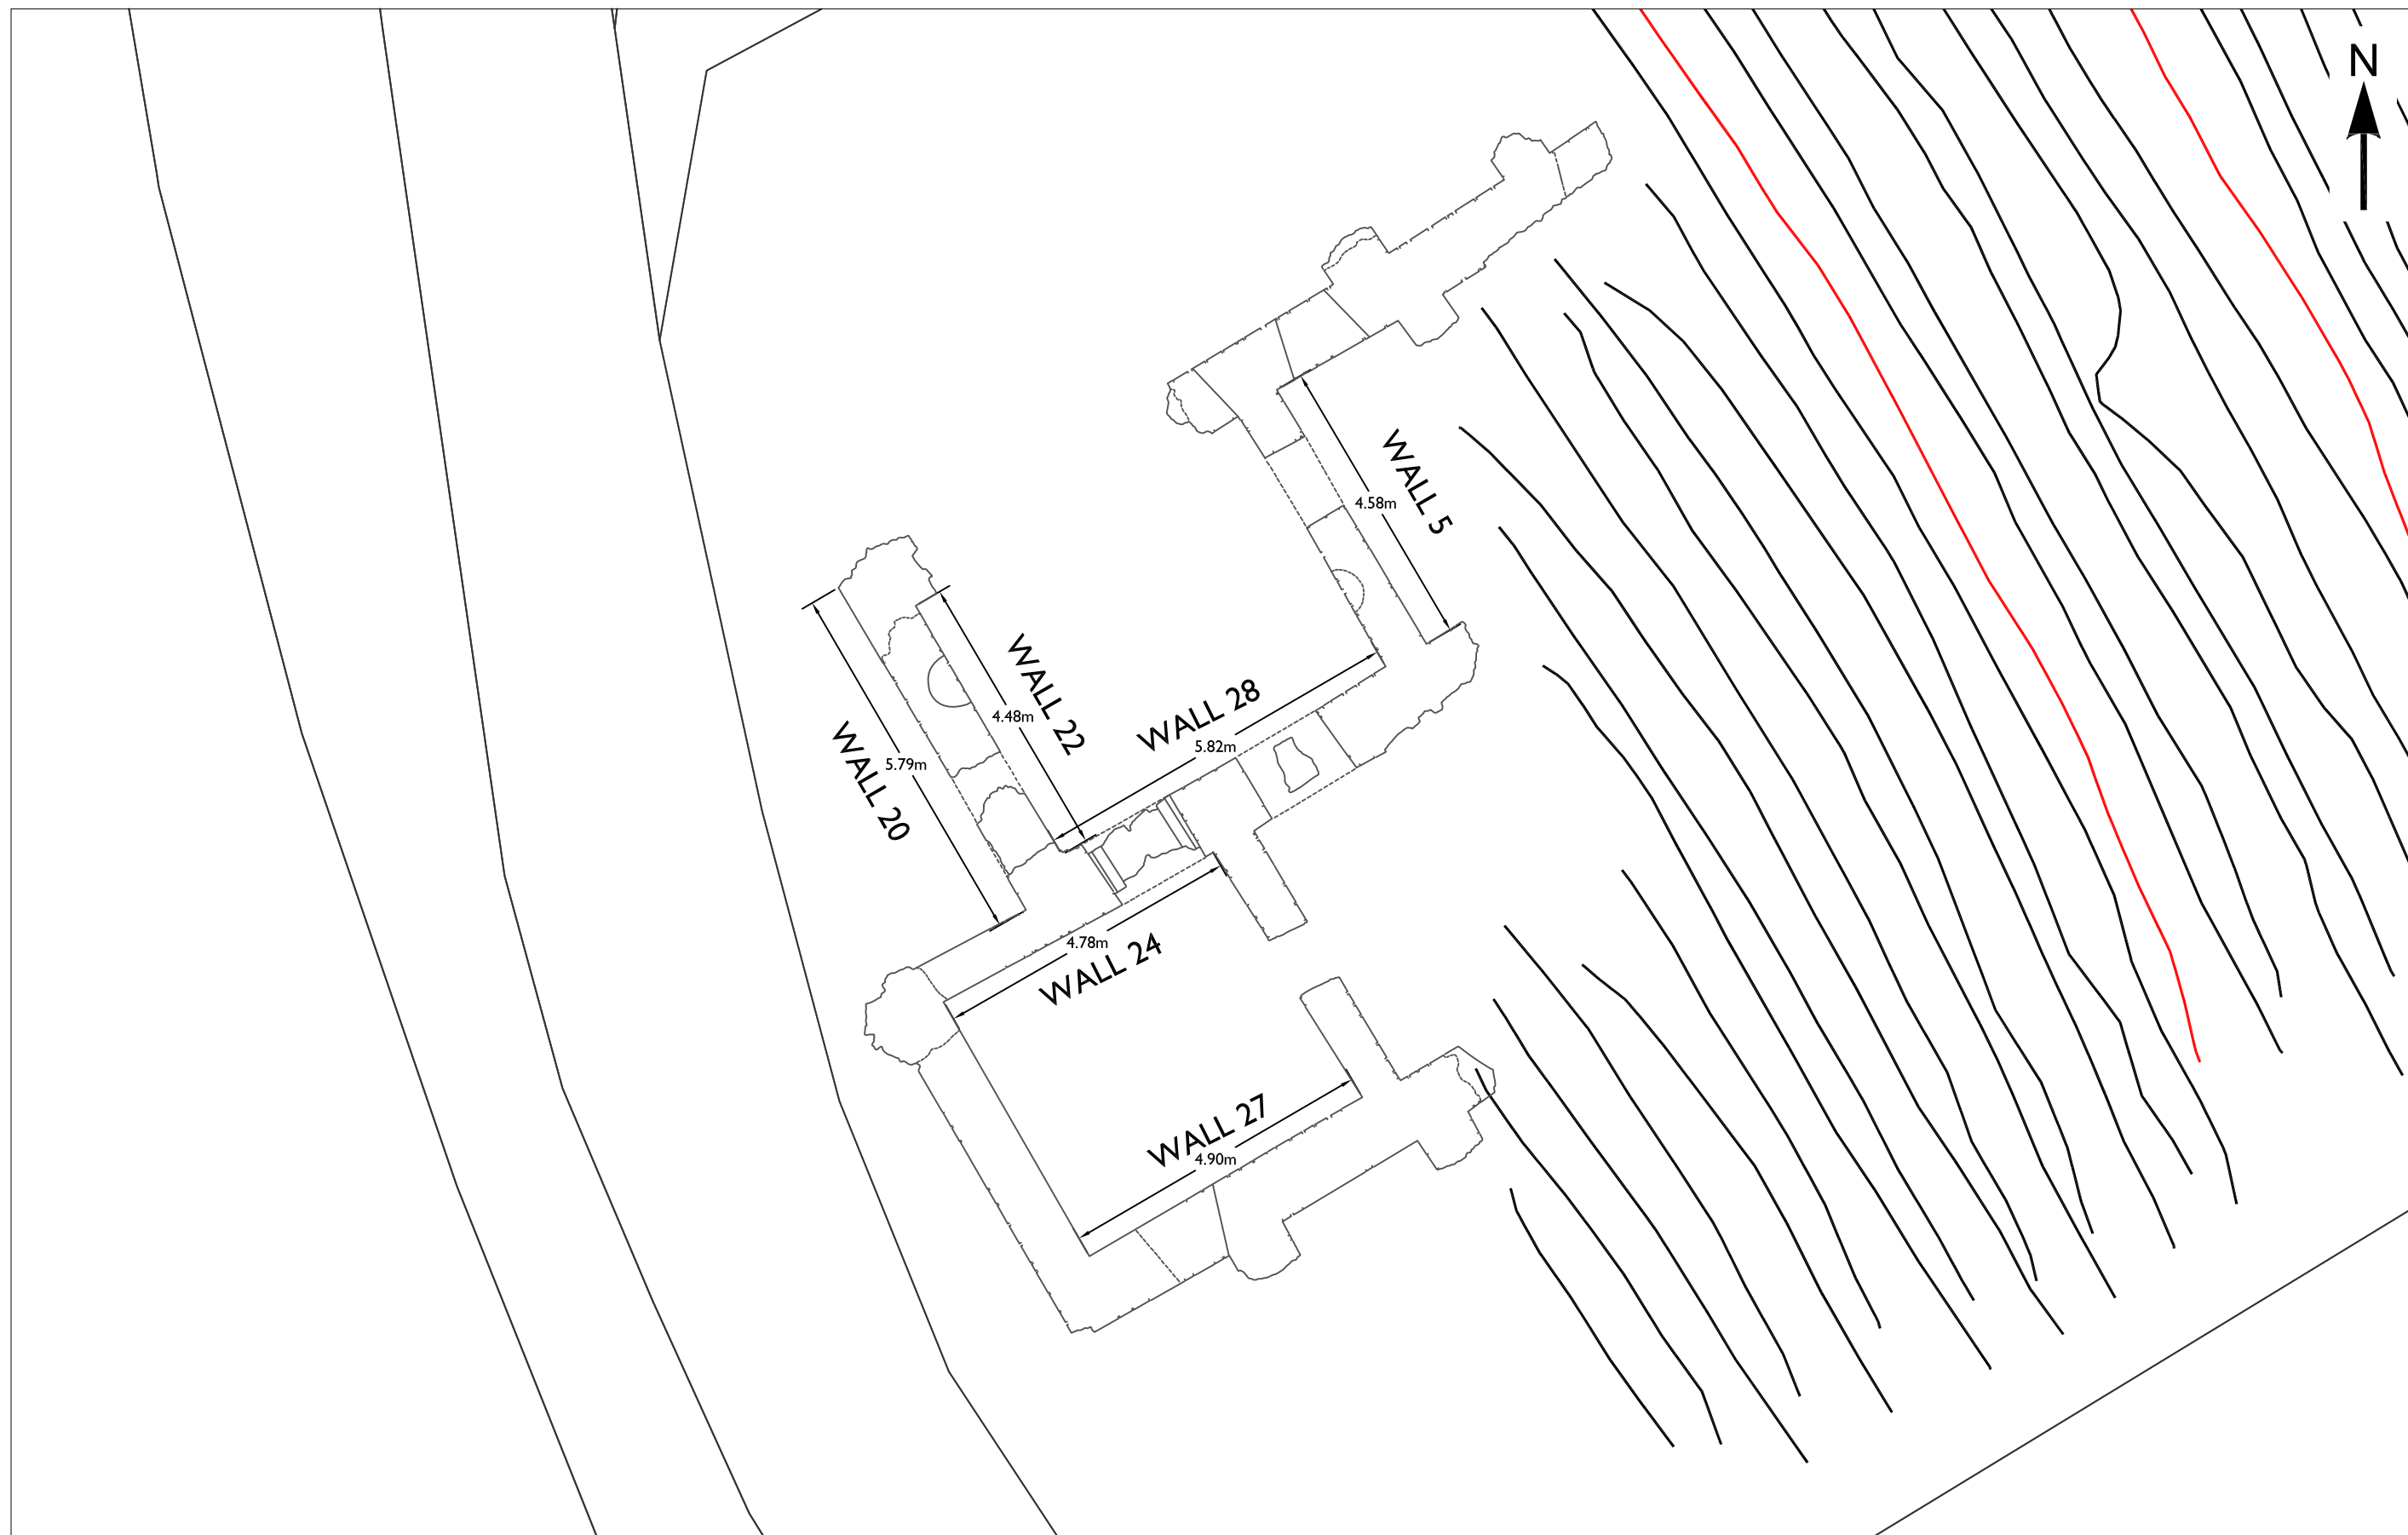
Labelled measured survey plan of the Bath House

The names of the walls have been taken from previous measured drawings and a labelled view of the Bath House is displayed in Figure 2. Figures 3 to 10 display the location of the profiles against the measured drawings of the walls. Profiles have been named as Ravenglass_elevationprofilenumber (e.g. Ravenglass_e101 shortened to e101 in most cases and occasionally 01 where space is limited). The name of each profile traverse is displayed at the starting position. Profiles shown in red on Figures 3 to 10 were acquired vertically, while profiles shown in blue collected horizontally across the wall elevation. An attempt was made to acquire profiles in a sequential order across each elevation, however sometimes this was not always the case (Figure 7). Videos rather than still photographs were taken to record the location of profiles e224, e225 and e226.

- Figure 2: Labelled diagram of the Bath House (1:100).
- Figure 3: Location of GPR profiles collected from Elevations 1 and 2: Wall 22.
- Figure 4: GPR amplitude time slice between 3.0 and 4.0ns (0.12 to 0.16m) superimposed over Elevation 2: Wall 22

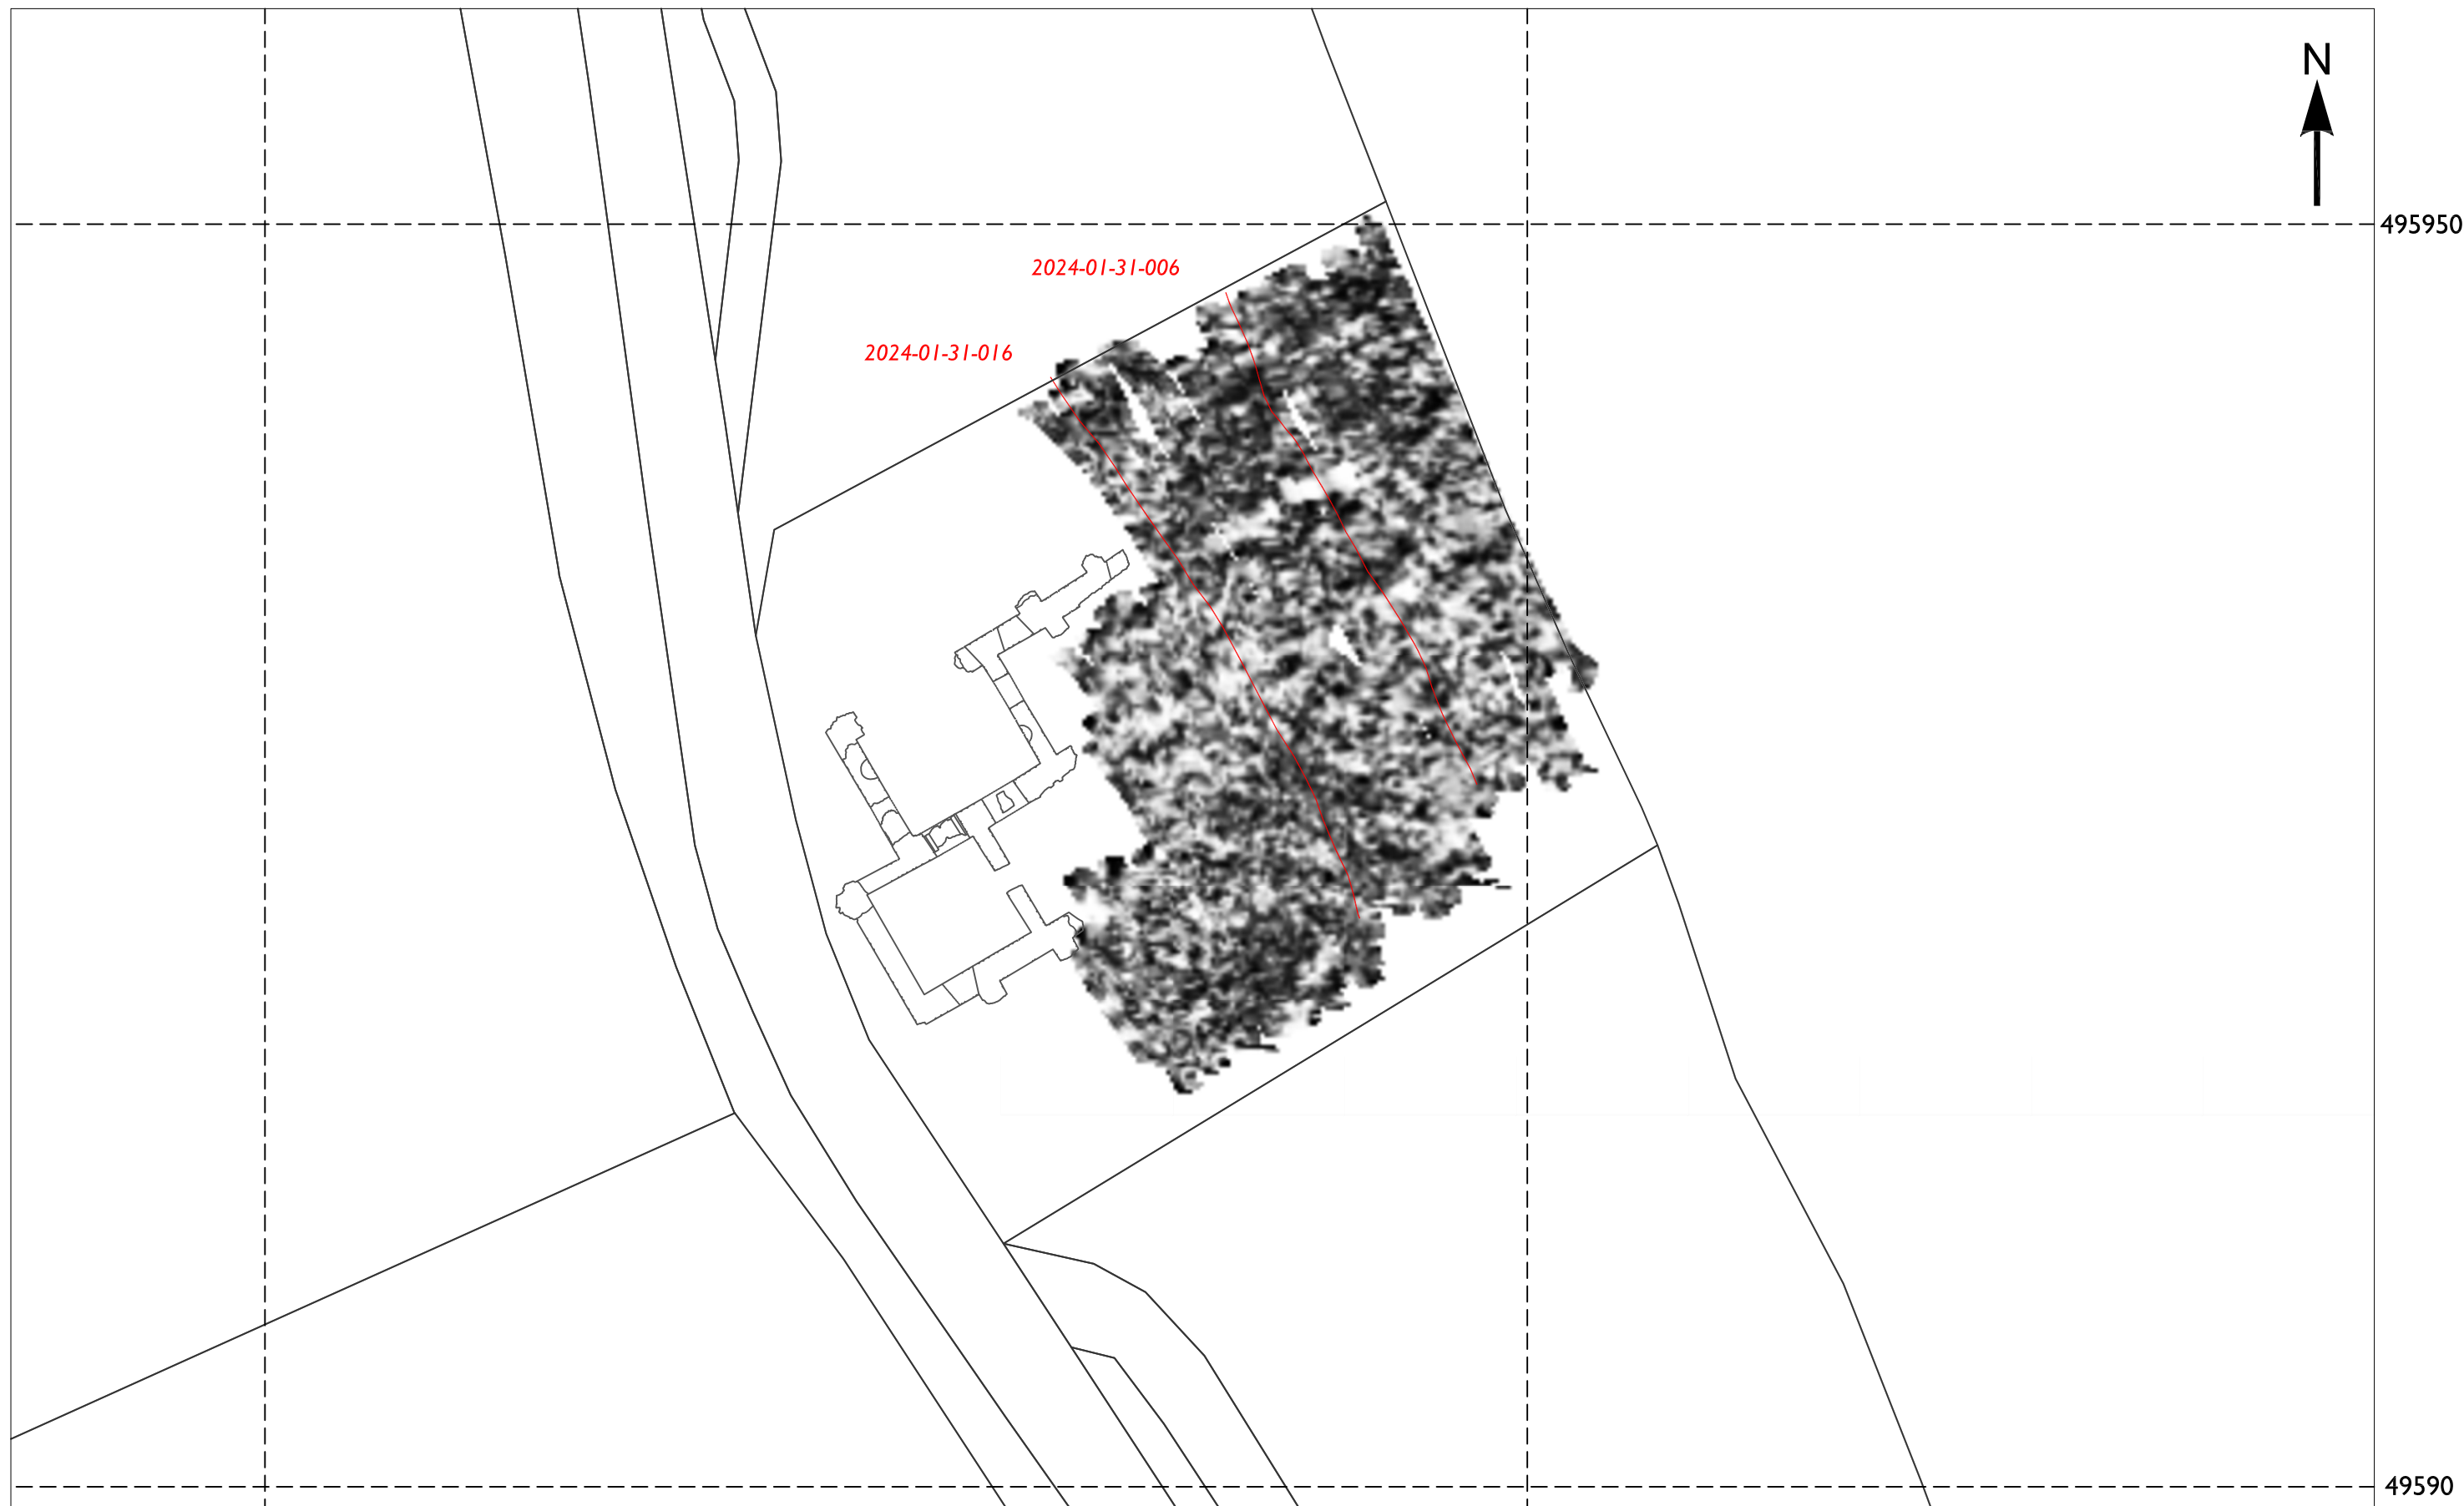
- Figure 11: GPR amplitude time slice between 25.0 and 27.5ns (1.32 to 1.46m) superimposed over the base OS mapping data (1:250).
- Figure 12: Representative topographically corrected profiles from the GPR survey shown as greyscale images with annotation denoting significant anomalies. The location of the selected profiles can be found on Figures 1, 11 and 15.

— Location of selected
2024-01-31-016 GPR profiles shown
on Figure 12

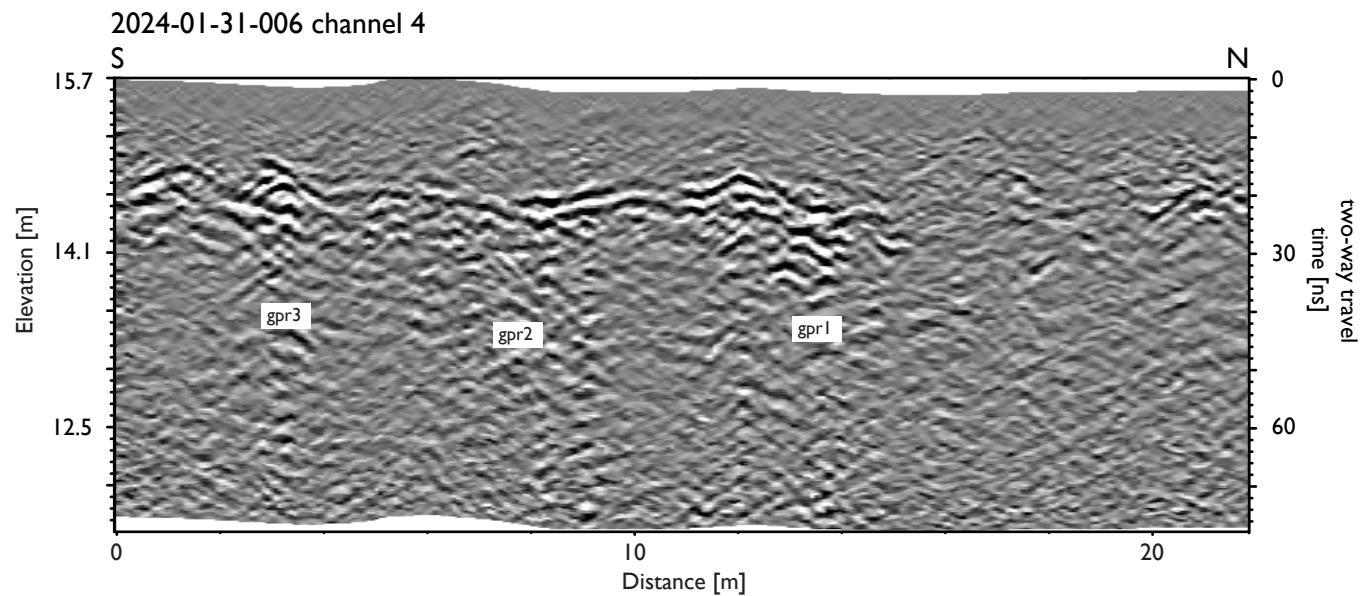
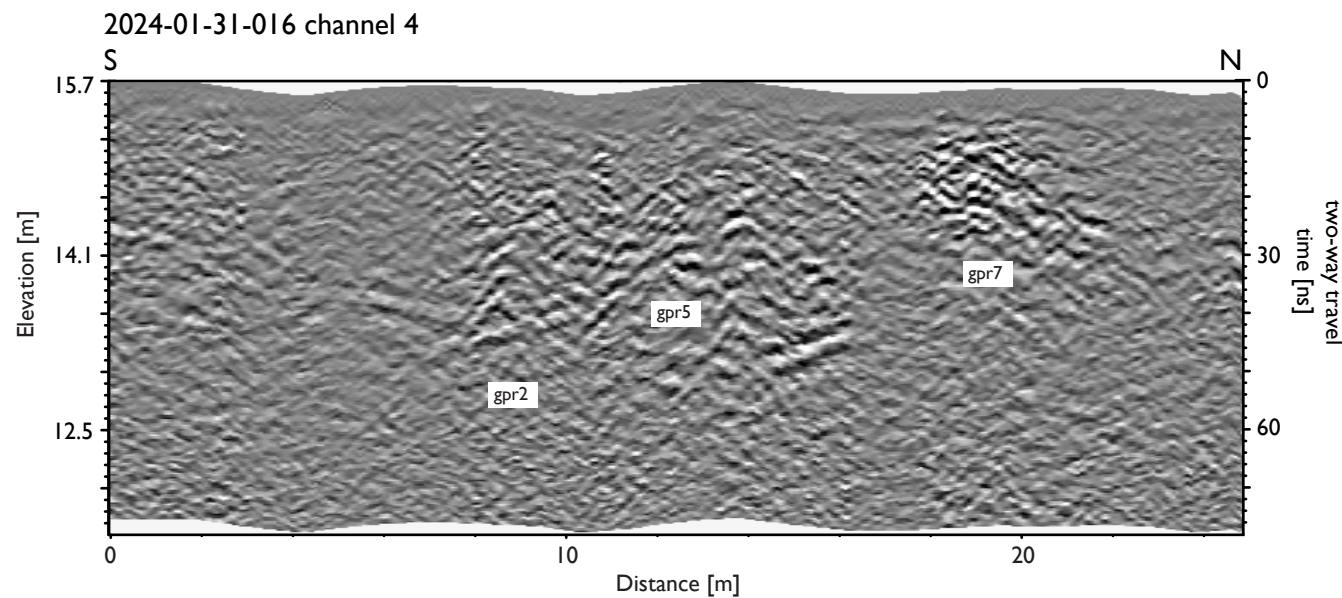
Figure 12

Representative profiles from the full GPR survey data set are shown on Figure 12. To aid visualisation amplitude time slices were created from the entire data set by averaging data within successive 2.5ns (two-way travel time) windows (e.g. Linford 2004). An average sub-surface velocity of 0.106m/ns was assumed following constant velocity tests on the data and was used as the velocity field for the time to estimated depth conversion. Each of the resulting time slices therefore represents the variation of reflection strength through successive ~0.13m intervals from the ground surface, shown as individual greyscale images in Figures 13 and 14. Further details of both the frequency and time domain algorithms developed for processing this data can be found in Sala and Linford (2012).

Representative topographically corrected GPR profiles, January 2024
