1 High Street, Stratford-upon-Avon, Warwickshire

Tree-ring Analysis of Oak Timbers

Martin Bridge and Cathy Tyers

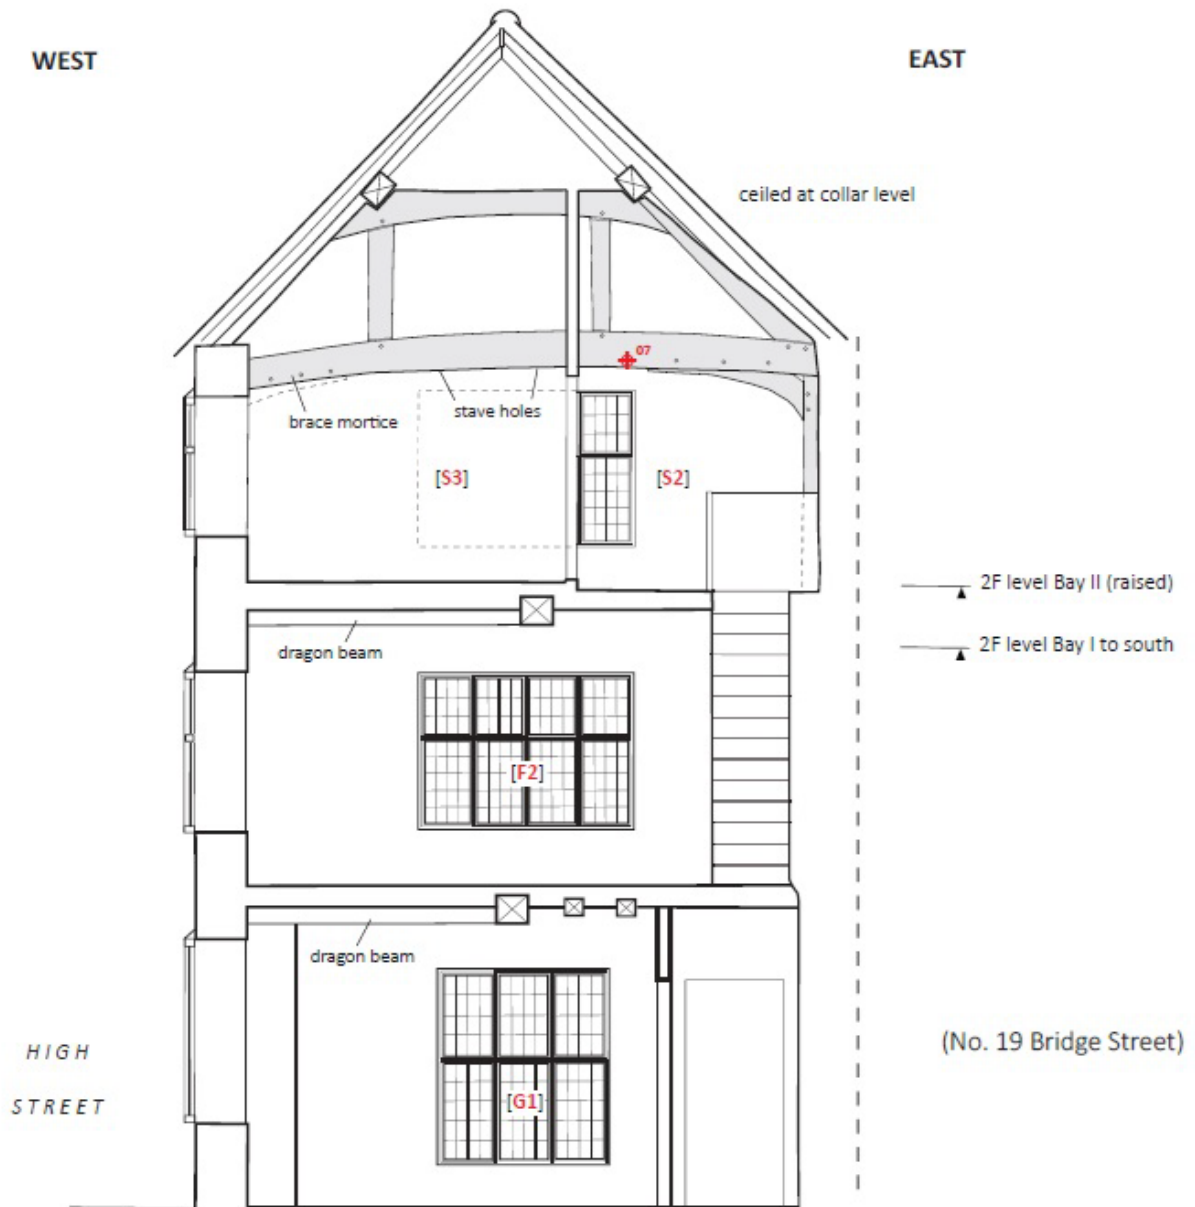
Figure 3: Section through truss one (T1) showing the location of sample 07 [adapted from an original drawing by Ric Tyler]

Details of the samples taken, all oak (*Quercus* spp), are shown in Table 1, with their location in the building illustrated in Figures 2–5. One sample (strh06) had too few rings to be considered for further analysis. The ring-width measurements for the measured samples are given in Appendix 1.

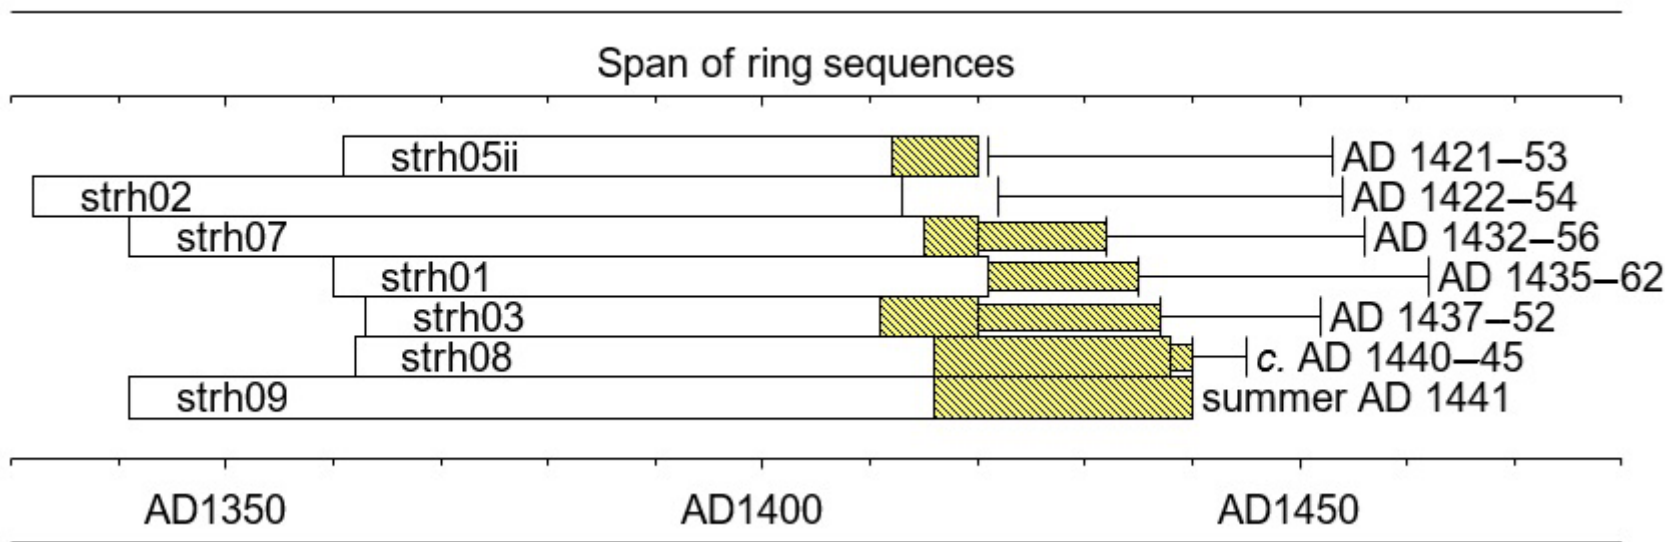
Figure 6: Bar diagram showing the relative positions of overlap of the dated timbers from 1 High Street, Stratford-upon-Avon. White sections represent heartwood rings, yellow hatched bars represent sapwood rings, with narrow sections representing additional unmeasured rings

The seven dated timbers are from the three levels of the building sampled and appear to form a coherent group, most likely all felled at the same time (Table 1 and Fig 6). One sample, strh09, has provided a felling date of summer AD 1441. Whilst another sample, strh08, was noted at the time of sampling as to having lost a couple of millimetres from the complete sapwood during coring, and has thus been allotted a 5-year likely felling date range.
