Conserving Stained Glass Windows Using Tracery and Partial Environmental Protective Glazing

A comparative study on the efficacy of tracery, partial and full environmental protective glazing

Tobit Curteis

2024

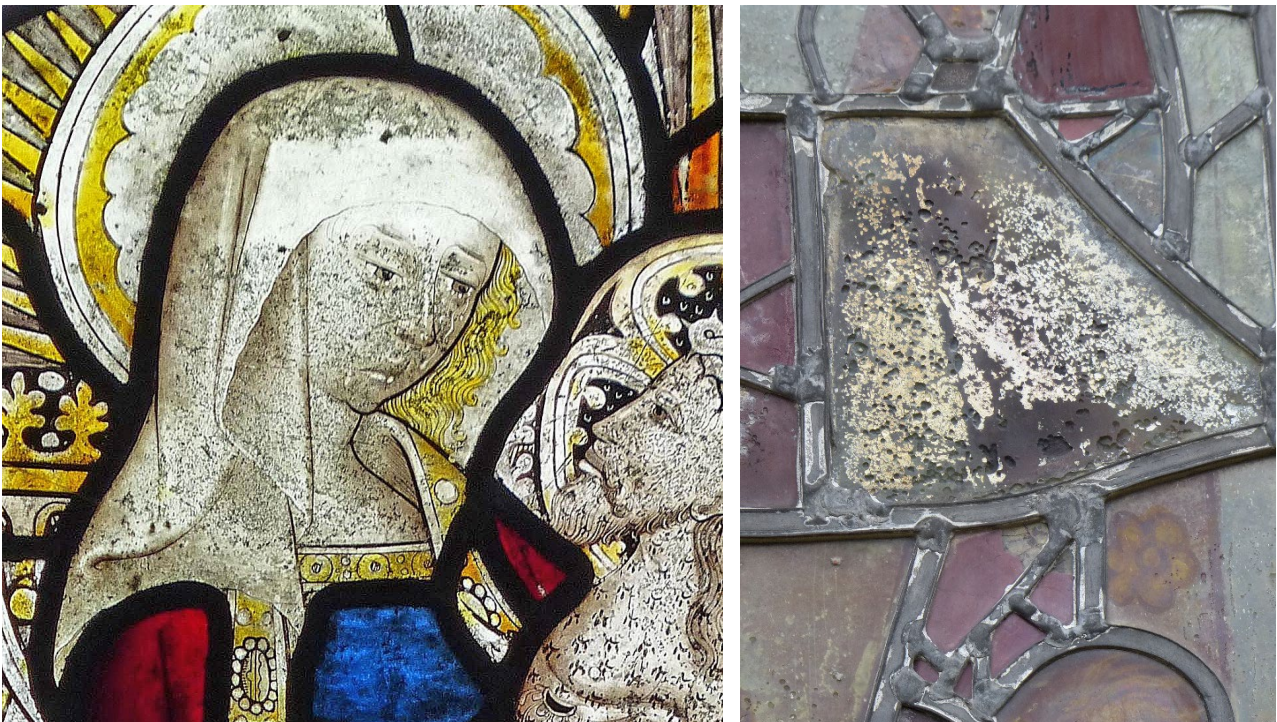
Figures 1 and 2: Microbiological growth disfiguring and causing damage to the glass paint (left) and loss of body glass due to dissolution on the exterior surface of the glass (right).

Glass can suffer considerable deterioration but show little visible change from a distance. However, at a certain point, artistic detail is lost and, eventually, structural integrity fails. It is then no longer able to provide the functional element of the building envelope for which it was designed.¹

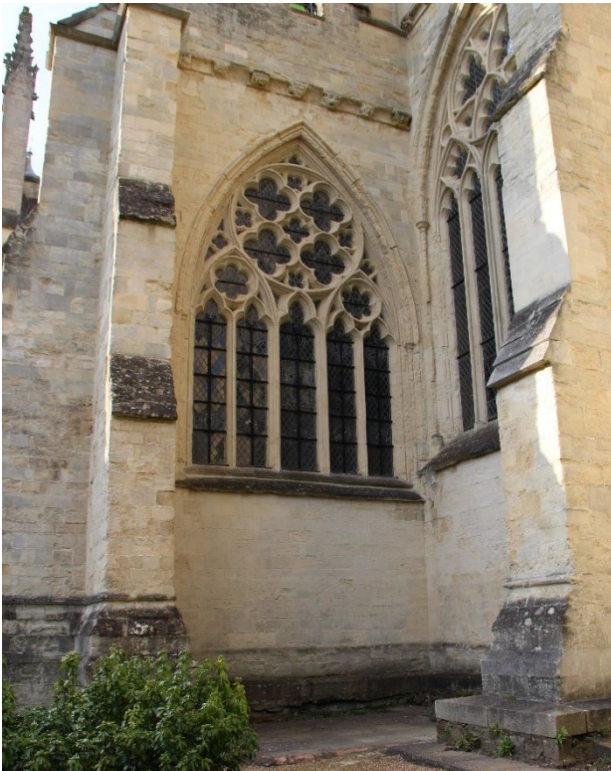
Figures 3 and 4: Plan showing the location of the Chapel of St Gabriel and the external view of the east window. [Figure 4 Drawing © Acanthus Clews Architects]

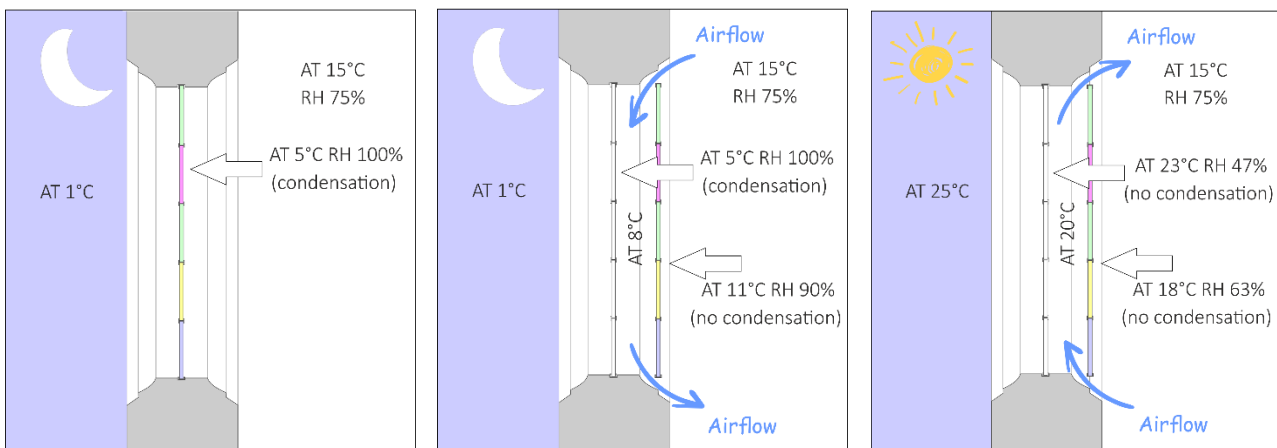
Figures 5 to 7: Diagrams showing the basic method by which EPG controls condensation.

Installing EPG involves the addition of a layer of modern glass to the outside of historic glazing. An air gap is left between the two panels, which is generally ventilated at the top and bottom to the inside. This increases thermal buffering between internal and external conditions. When the external conditions are colder than those inside, this air gap stops the minimum temperature of the historic glass dropping to a level where condensation might occur. This risk is, instead, transferred to the EPG panel, which acts as the new interface with the external environment.

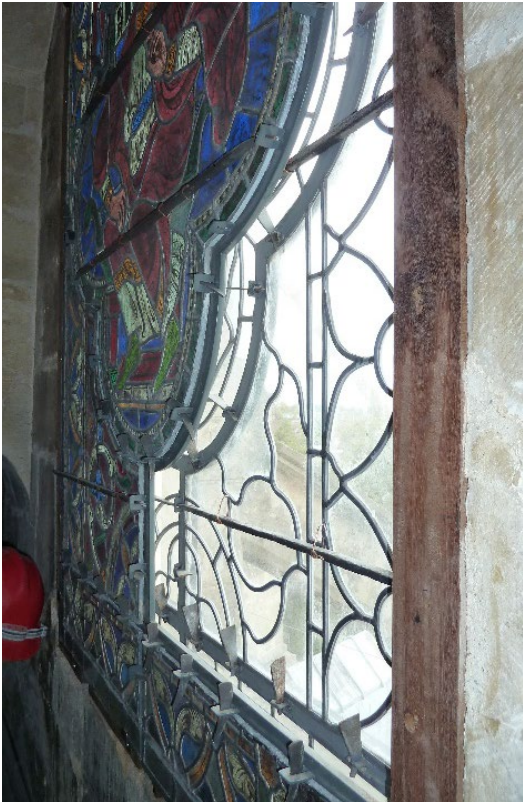
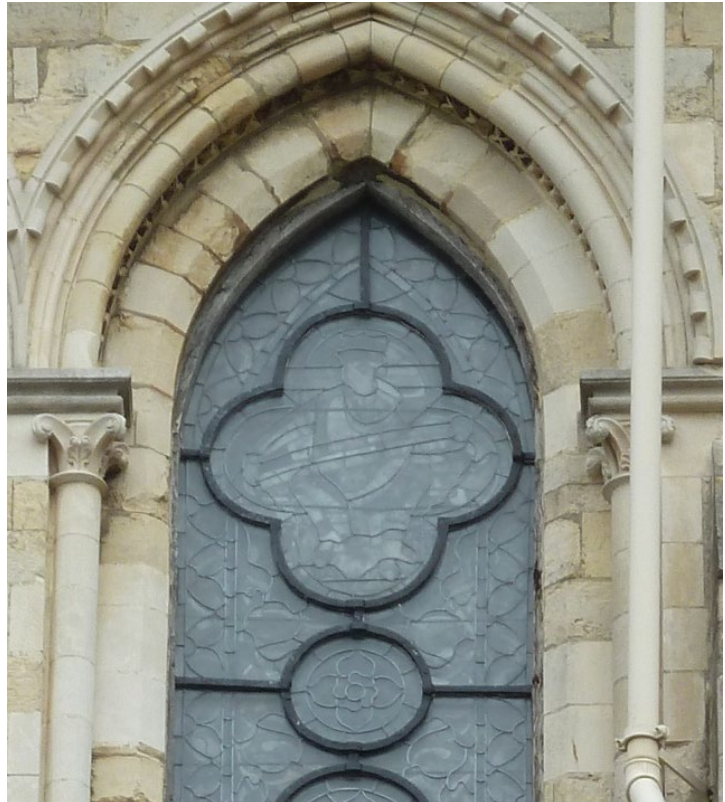
Figures 8 to 11: Internally ventilated EPG, with the new glass in the original glazing grooves and the historic glass moved forward into the building. [Figures 10 and 11 © Historic England]

A number of ventilation systems have been used since secondary glazing was first introduced, but most common today is the internally ventilated design. In this system, the historic glass is moved inside the building, usually on a frame, with ventilation gaps at the top and bottom. Protective glazing is then placed in the original glazing grooves, thereby allowing internal air to circulate between the two layers.

When the air in the interspace is warmer and more buoyant than the air in the building (when external conditions are significantly warmer than internal ones), the air flows upwards, drawing in more air through the bottom vent and expelling it through the top vent. This mechanism is commonly known as 'stack effect'. When the air in the interspace is cooler and less buoyant (when external conditions are colder than internal ones), the opposite flow pattern occurs.

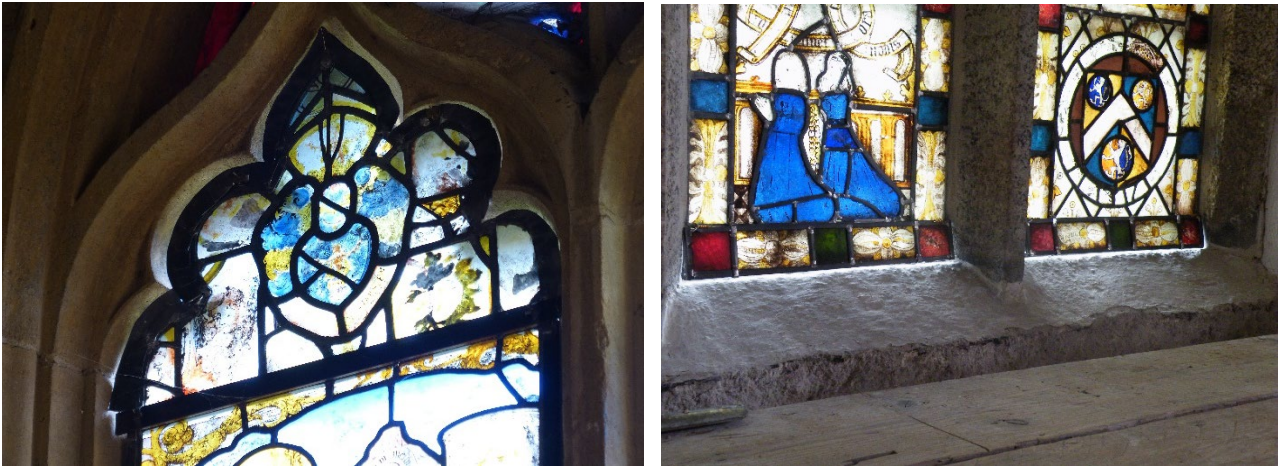
Figures 12 to 15: Internally ventilated EPG, with the historic glass remaining in the glazing grooves and the new glass mounted externally within the depth of the tracery. Images and illustrations show a number of different approaches to creating ventilation openings. [Figures 14 and 15 © Historic England]

If the historic glass is too delicate to be moved, the stained glass can sometimes remain in the original glazing grooves, with modern glazing added to the exterior within the depth of the tracery, with a lead skirt dressed tightly to the stonework to minimise air leakage. Openings are made in the historic glazing, or sections are tilted forward, to allow airflow through the interspace.

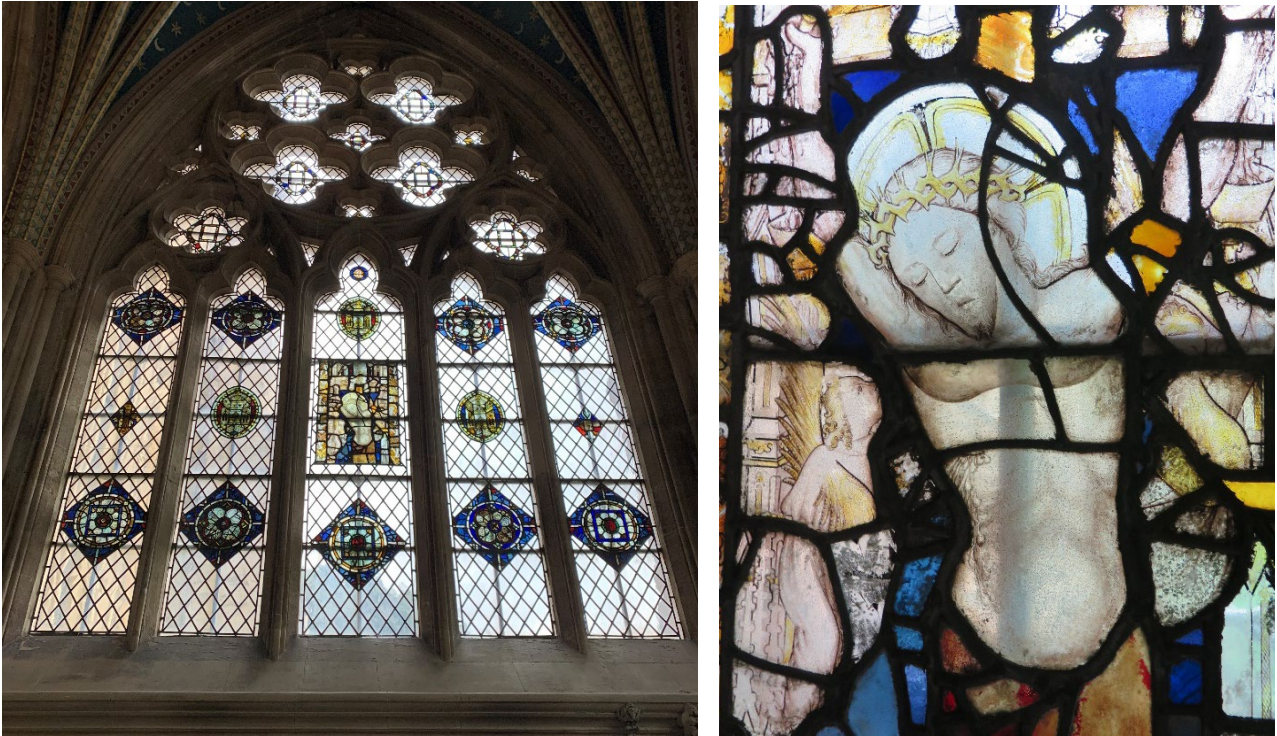
Figures 16 and 17: The east window of the Chapel of St Gabriel at Exeter Cathedral.

Constructed in the late 13th century, the east window of the Chapel of St Gabriel at Exeter Cathedral has five principal lancet lights. Above these, there are ornate tracery lights, including quatrefoils and sexfoils, separated by small triangular sections.

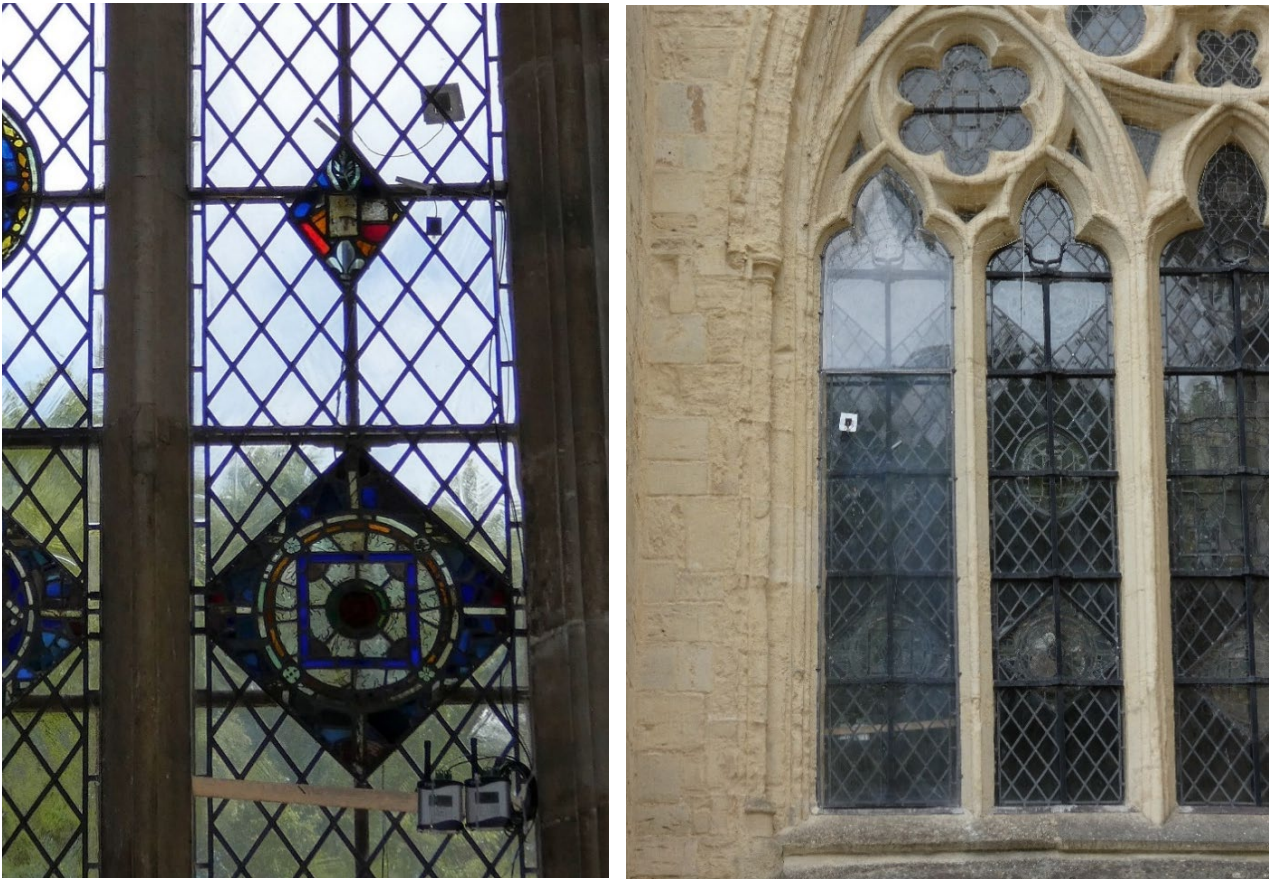
Figures 20 and 21: Layout of the full EPG control trial.

The full lancet installation had ventilation gaps at the top and bottom formed by the removal of small sections of clear glazing, and a 50mm interspace. The historic glass remained in the original grooves, with a Perspex glazing panel mounted on the outside and a lead skirt dressed back to the stonework to minimise air leakage. The Perspex EPG was installed only for the period of the trials and was subsequently removed.

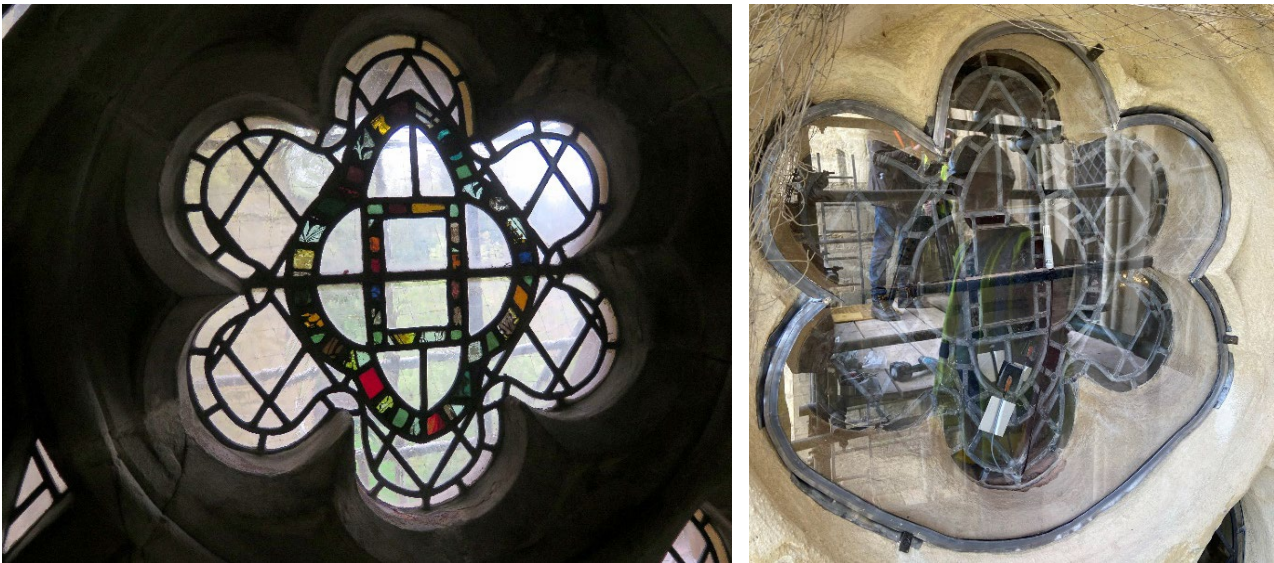
Figures 24 and 25: Layout for the tracery EPG trial.

For the tracery EPG installation, some of the clear glass pieces at the top and bottom edges of the historic glazing were removed to allow ventilation. The Perspex glazing was mounted on the outside, leaving a <50mm interspace, with a lead skirt dressed back to the stonework to minimise air leakage. The Perspex EPG was installed only for the period of the trials and was subsequently removed.

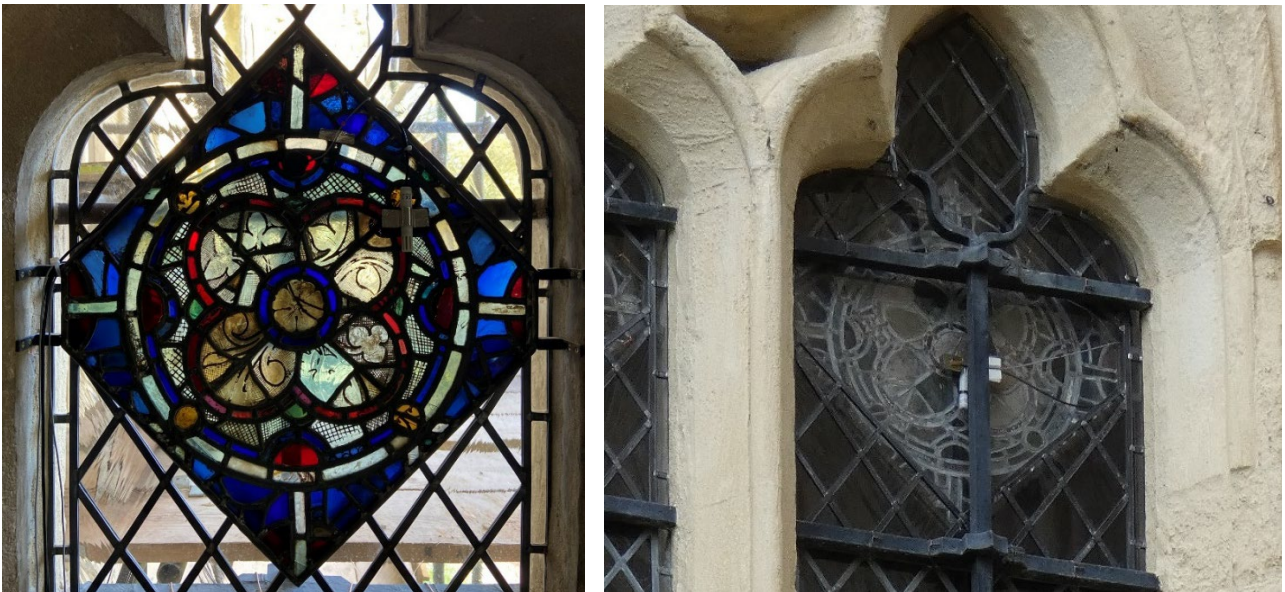
Figures 28 and 29: Layout for the partial EPG trial.

For the partial EPG installation (small stained-glass panels within plain glazing) the historic glass was removed from the quarry glazing and set forward on a bronze frame, with the resulting opening filled with a section of modern glazing. The bronze-framed historic glass had open sides, to allow internal ventilation, and a <math><20\text{mm}</math> interspace. The EPG glazing system for the panels was a permanent installation.

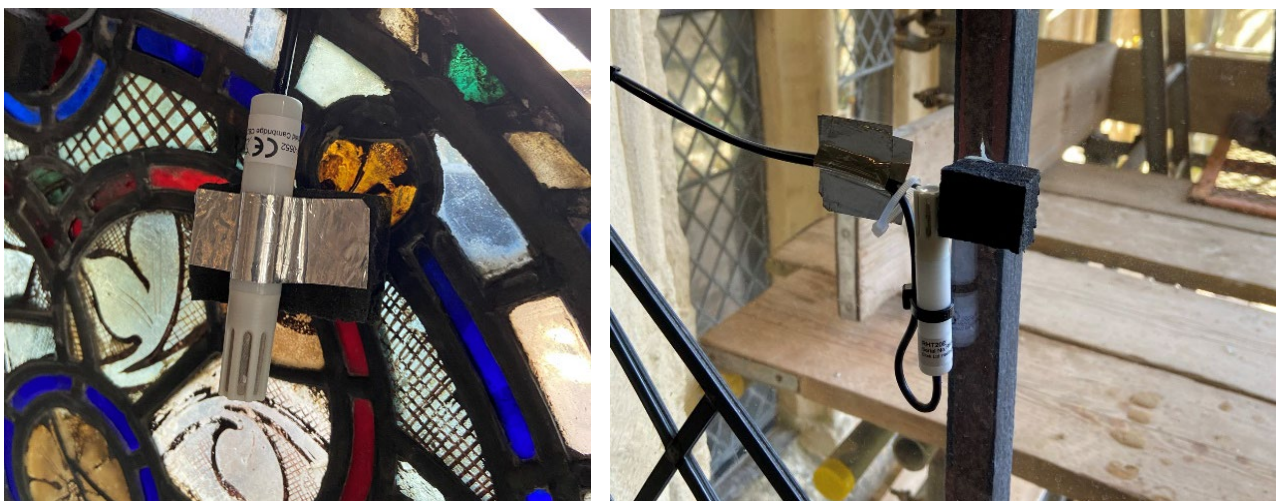
Figures 35 and 36: Relative humidity/ambient temperature and surface temperature sensors, attached to the stained glass (left) and modern glazing (right).

Internal RH/AT probes were suspended from available fixing points on the ferramenta. Surface temperature probes on the historic glass were attached to the surface using Paraloid B-72 adhesive. A block of Plastazote foam was used to thermally insulate the back of the sensors. Surface temperature probes on the Perspex and modern glazing were attached using epoxy resin.

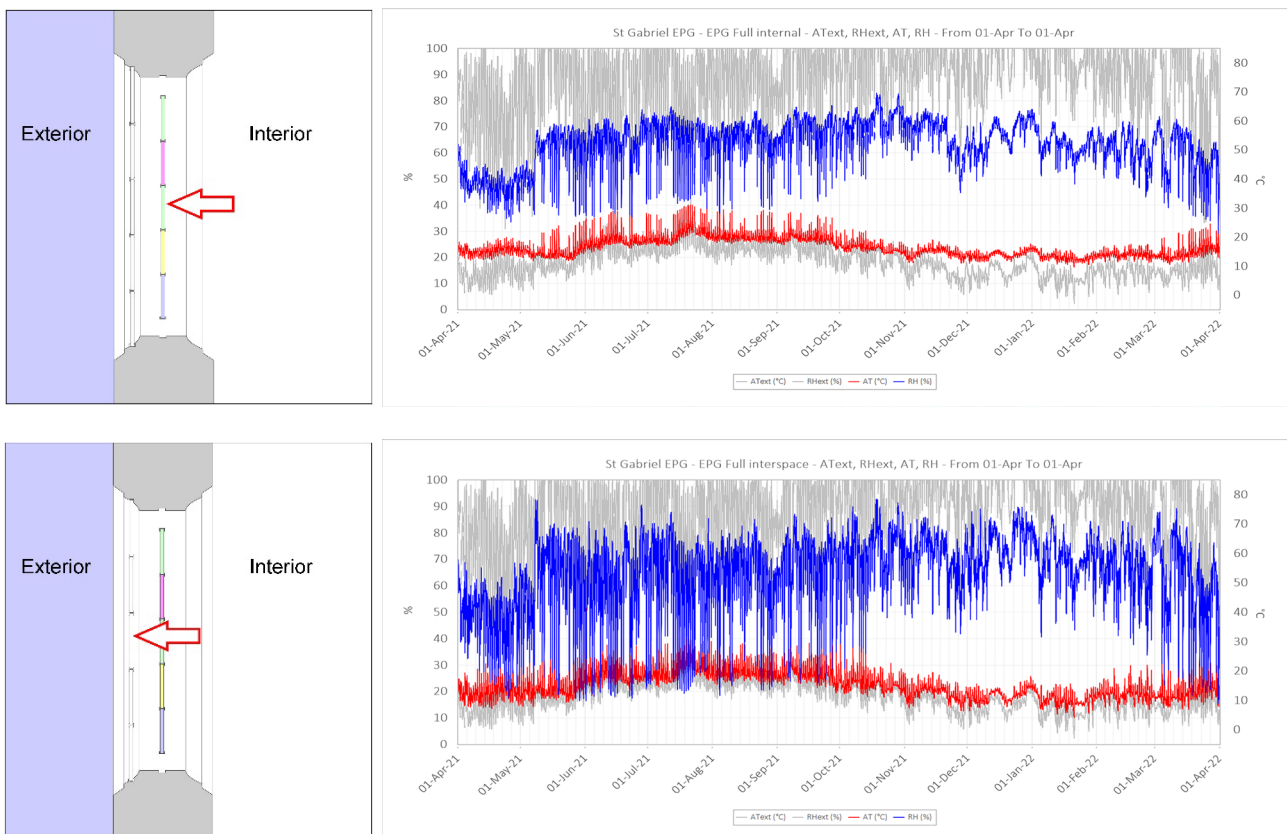
Figures 37 to 40: Charts showing the RH/AT conditions on the historic glass (top) and in the interspace (bottom).

Data from the full EPG test demonstrated that the conditions by the east window were typically unstable due to the limited thermal buffering provided by the glazing (in comparison to masonry) and, in particular, the effect of solar gain when the window was exposed to direct sunlight in the mornings.

As a result, the AT and ST fluctuated sharply, with temperature increases (in the summer months) of more than 10°C. These were reflected by decreases in RH of more than 30% over a period of four hours, before the sun moved to the south and the window fell into shade. Conditions in the interspace were even more unstable. Temperatures increased by more than 25°C, resulting in decreases in RH of more than 50%.

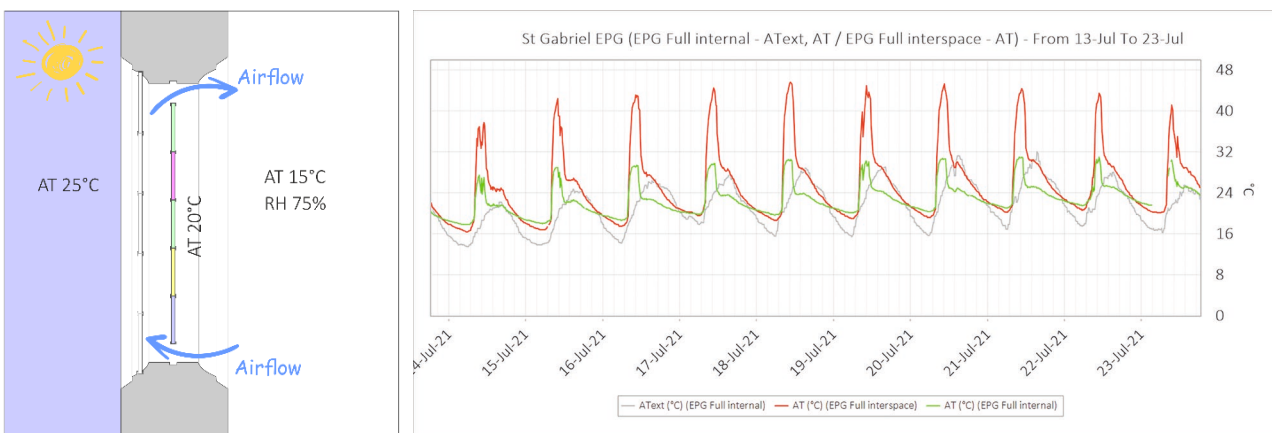
Figures 41 and 42: During the summer, the interspace temperature (red) is far higher than the internal temperature (green), causing air to rise.

During the daytime, in the summer, when the external air was hotter than the internal air, and when the window was exposed to direct sun, the temperature of the air in the interspace was higher than that inside the chapel. The resulting buoyancy would have caused the air to rise, escaping the interspace via the top vent and drawing in internal air via the vent at the base.
