Overhall Grove Moated Site and Mound, Cambridgeshire

Archaeological Investigation

Moated site, Overhall Grove, Boxworth Cambridgeshire, and
Mound, Knapwell, Cambridgeshire

NGR: TL 338 631

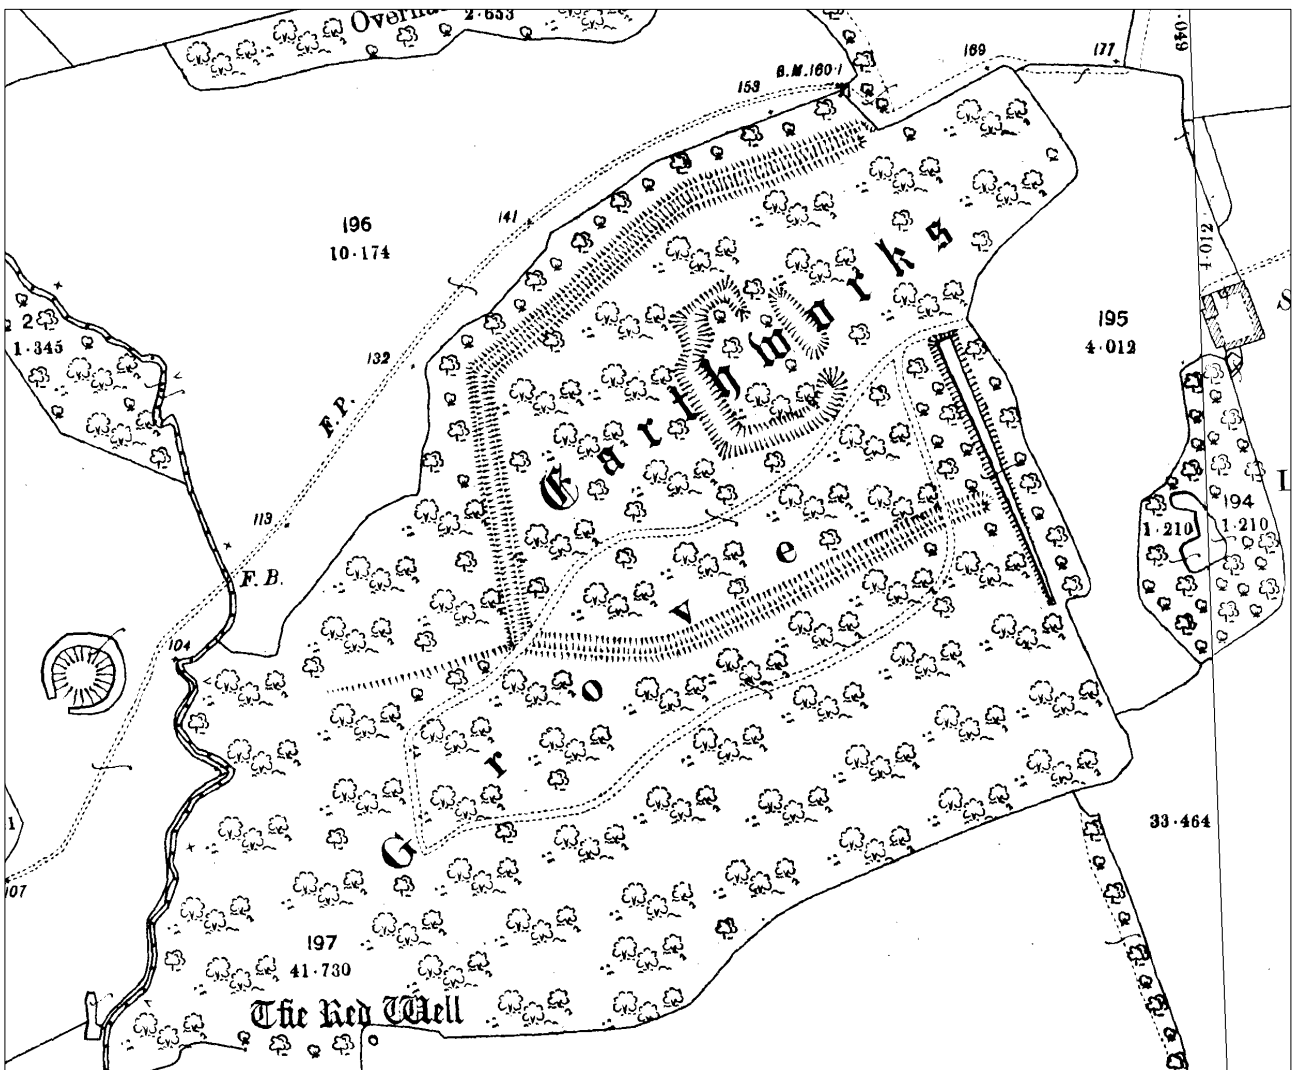
Figure 2 – Second edition 1:2,500 Ordnance Survey map published 1902
 Not to scale (Historic England corporate GIS, © and database right Crown Copyright and Landmark Information Group Ltd (All rights reserved 2024). Licence numbers 000394 and TP0024)

The moated site appears to have first been surveyed for the second edition 1:2,500 map published in 1902 (Figure 2). This shows the moat's north, west and south arms, with most of the east arm as an isolated oval hollow. The north and west arms of the outer enclosure are depicted as two banks, and the south arm as a ditch with an outer bank. A slight, south facing scarp runs WSW from the outer enclosure's south-west corner. The linear pond remains, though the small pond to the north has gone. On the subsequent pre-Second World War Ordnance Survey maps the depiction of the earthworks changed little.

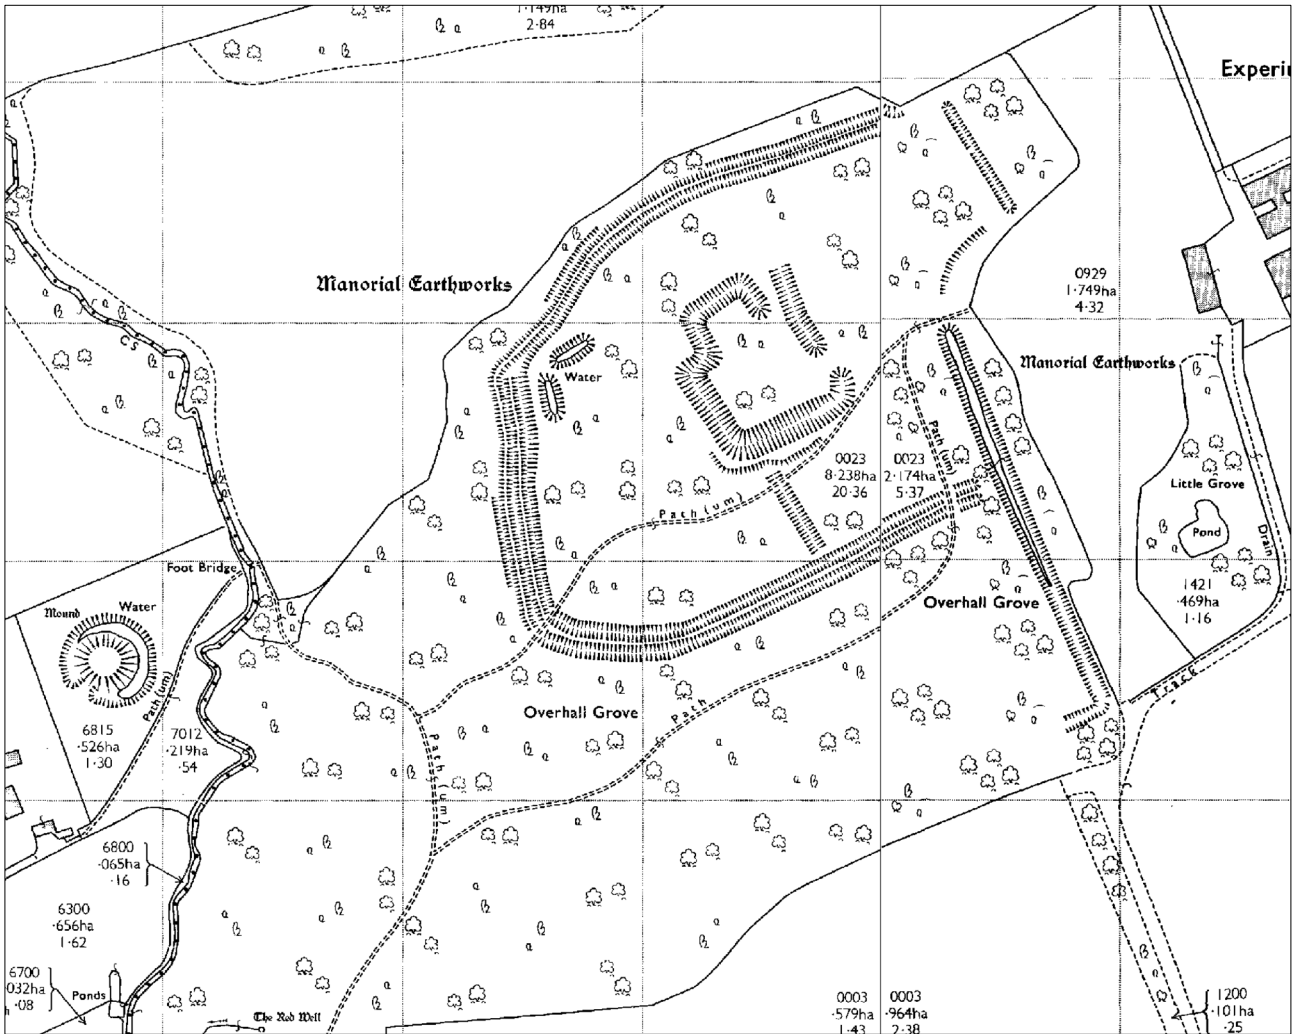
Figure 3 – First National Grid edition 1:2,500 Ordnance Survey map published 1975 Not to scale (Historic England corporate GIS, © and database right Crown Copyright and Landmark Information Group Ltd (All rights reserved 2024). Licence numbers 000394 and TP0024)

The post-war editions show more detail (Figure 3). The moat is much the same, but the east arm extends further to the north and the terrace to the south is shown. The north arm of the outer enclosure's outer ditch is shown as intermittent, the western as somewhat elaborated, and the southern as a double ditch. The linear features running from the

enclosure's south-west corner are not depicted. Within the enclosure, the ponds to the north-west are shown as are the ditch to the south of the moat and that to the north-east, as well as fragments of the woodland boundary in the same area. The long pond is also shown but with a dry extension to the south, with a return to the west at its south end.

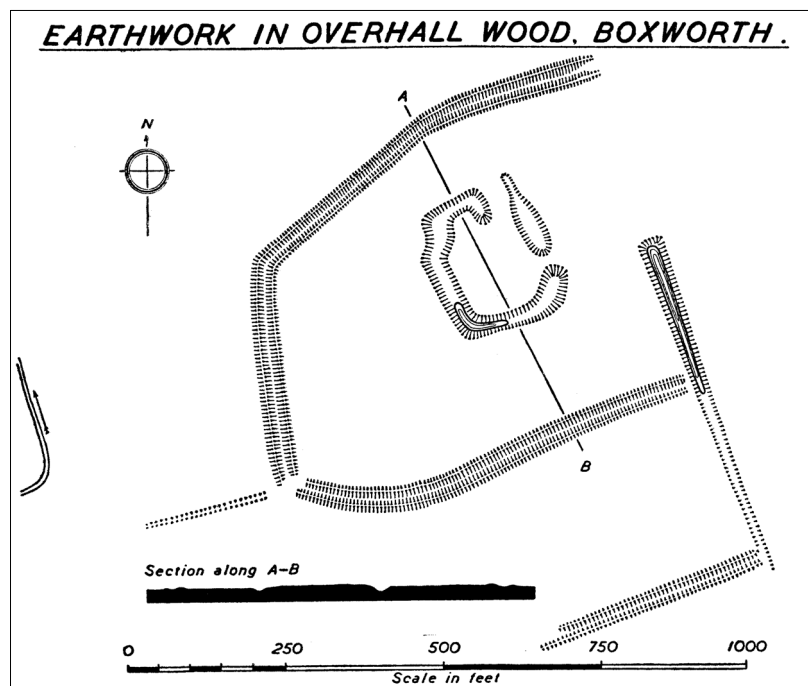
Figure 4 – Earthwork plan
(Salzman 1948, 17. Reproduced with permission from *The Victoria History of the County of Cambridge and the Isle of Ely, Volume 2* (London, 1948), Victoria County History © University of London)

In 1948 a survey of the moat earthworks was published in the second volume of the Cambridgeshire VCH (Salzman 1948, 17; Figure 4) along with a description of the site. The plan is similar to the pre-war OS maps, though the VCH shows a gully running off from the north end of the east moat arm, the south side of the outer enclosure as a double bank, and the scarp running off from the south-west corner of the outer enclosure as a gully. It also shows the linear pond to the east with less water but with its earthworks extending further south and meeting two gullies running off to the WSW. Although published in 1948, most of the volume was already in print by the summer of 1939 (ibid,

VCH (Figure 4) where the pond is shorter and the double ditches at the southern end follow a line to the north. The VCH appears to be the more accurate here (below).

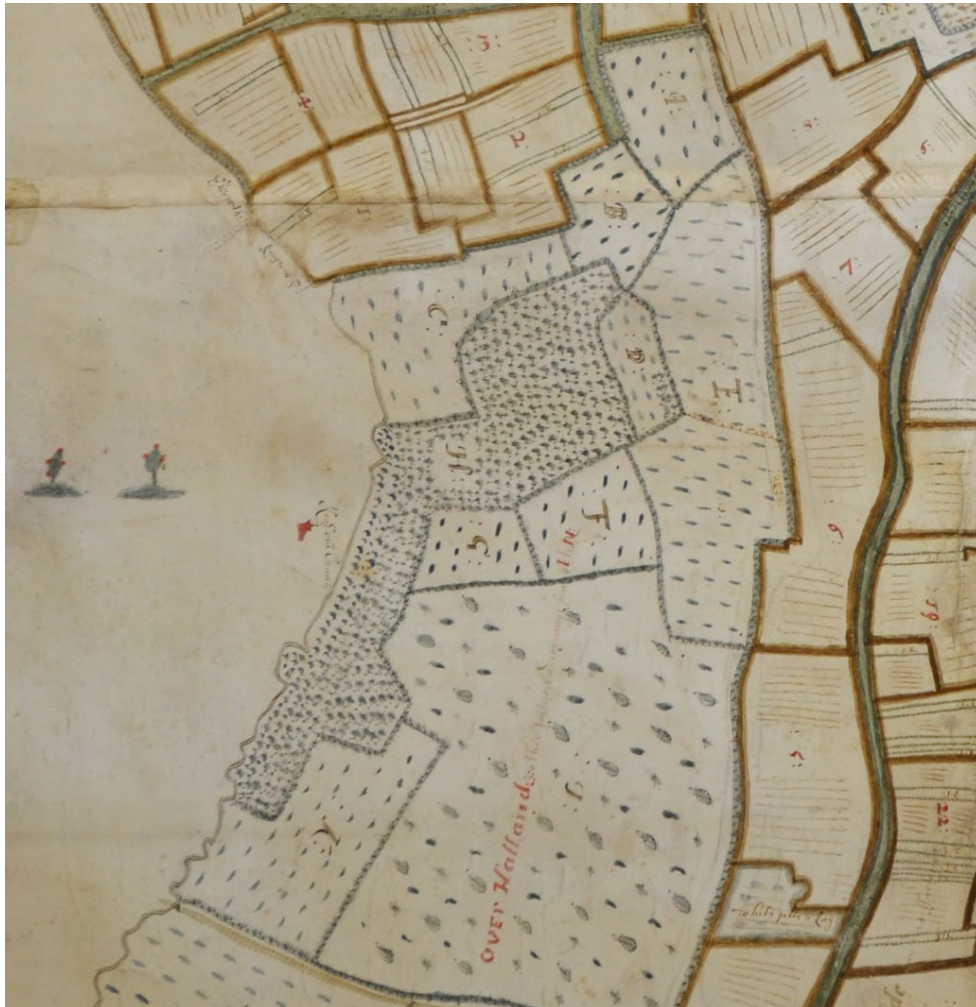
Figure 6 – Detail of the source map for Figure 5 showing the Overhall Grove area 'The Plott, or Description of Boxworth in Cambridgeshire being parte of the demeanes of the Lady Ann Cutts', surveyed by Matthew Hayward, 1650 (image: Matthew Bristow, © Historic England, source: with permission Huntingdonshire Archives, 148/1571/LR23/367)

xiii) so any visit or survey must pre-date this. The mound was also described but not illustrated (ibid, 34). The history of the parishes in Papworth Hundred were dealt with in more detail in volume 9 of the Cambridgeshire VCH (Wright and Lewis 1989). This included a plan of Boxworth dated by the VCH to about 1660 (Figure 5), but apparently based upon a manuscript map of 1650 (see Figure 6).

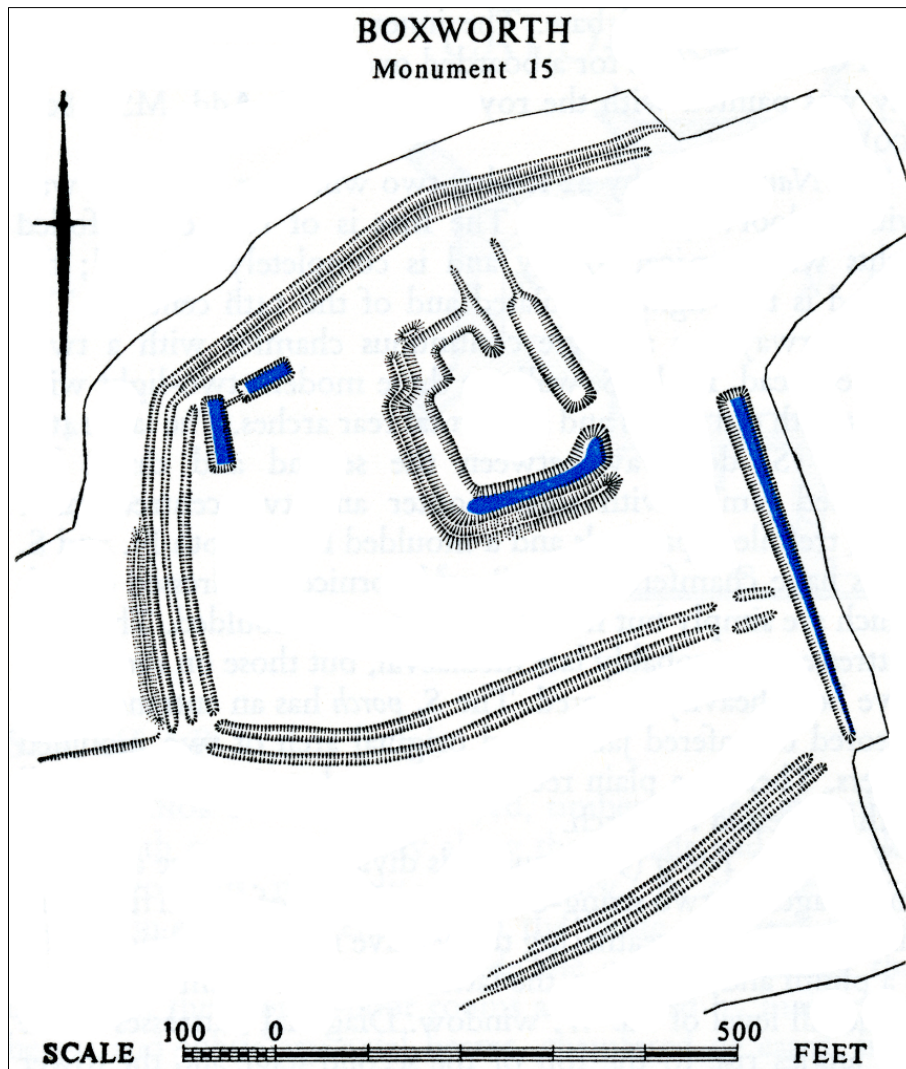
Figure 7 – Earthwork plan from the RCHME inventory (RCHME 1968, 31)

In 1968 a survey and description of the moat earthworks was published in the first volume of the RCHME Inventory of Cambridgeshire (RCHME 1968, 30-1). The plan (Figure 7) depicts the moat and outer enclosure earthworks in more detail than previous sources. It shows two small gullies running off from the north-east corner of the moat, a small hollow outside the north-west corner of the moat and an outer bank on the west and south sides. The outer enclosure is depicted as double ditched to the north. These ditches continue around to the west where there is an additional internal ditch and an external bank. The two ponds in the north-west corner of the outer enclosure are shown and a single scarp running west from the south-west corner is depicted. The south side of the enclosure is shown as a double bank. Once again, the north/south pond is depicted as water filled along its full length with double ditches running away to the south-west from near the south end of this pond, but the depiction of these features is rather different to that shown by the

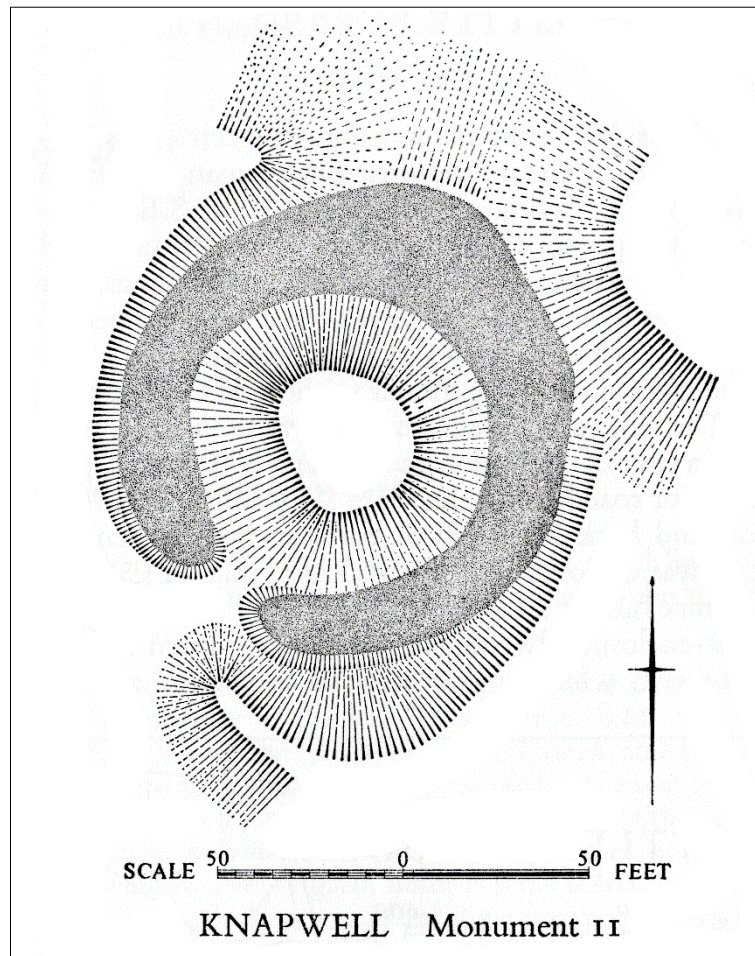
Figure 9 – The mound
(RCHME 1968, 163)

The circular mound in Knapwell is shown on plans of the whole village (Figure 8), and in a large-scale plan of the mound alone (Figure 9), accompanied by a detailed description. This suggests that the mound may have been 'a small Norman motte' and records 'Finds made during an unpublished excavation in 1929 include St. Neots ware from 2 ft. to 3ft. below surface of the mound' (RCHME 1968, 163).

The overall form of the mound, encircling ditch and causeway appear to be much as shown (Figure 9) and described by the RCHME (1968, 163):

The mound is circular, 6ft. [1.8m] high and 80 ft. [24.4m] in diameter with a flat top 30 ft. to 40 ft. [9.1-12.2m] across. The wet ditch is 30ft. [9.1m] wide on the N.E. and 20ft [6.1m] wide on the S.W. and holds about 2½ ft. [0.75m] of water. On the S.W. the ditch is crossed by a flat causeway 10 ft. [3.0m] wide which, in view of the cupped ends of the ditch on either side, is probably original.

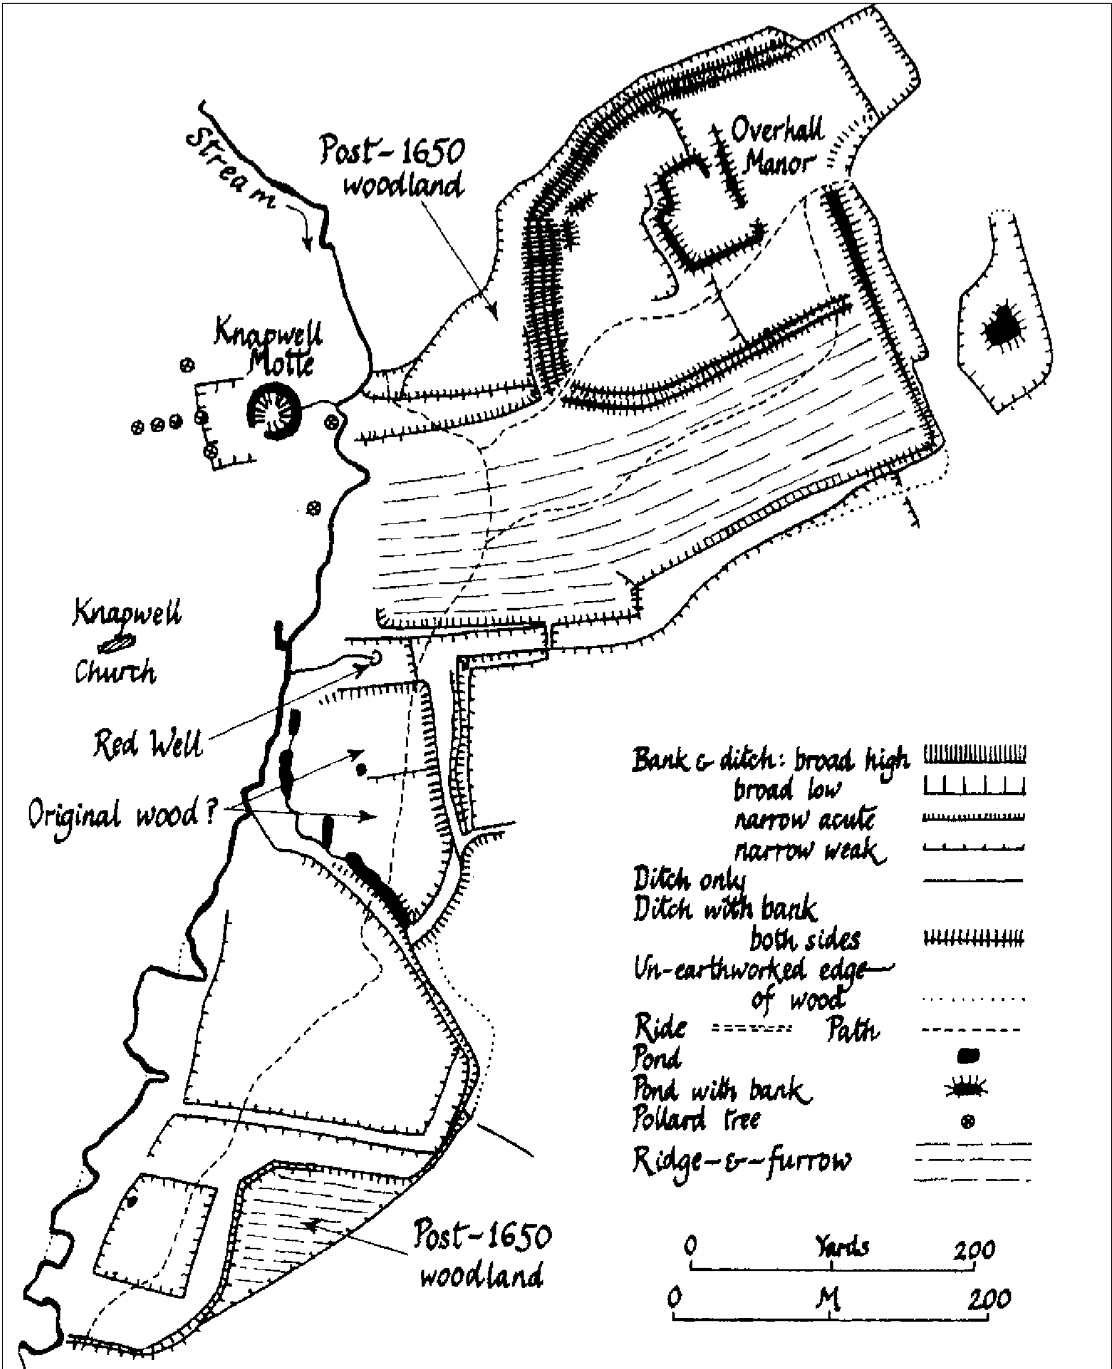
Figure 12 – Overhall Grove (Rackham 1990, fig 27, 137, with publisher’s permission)

In the late 1980s Rackham (1990, 136-8) examined the whole of Overhall Grove and presented a map of the key historic features he identified (Figure 12). The source of this map is not given, but must have contained information from his own survey, presumably based on earlier depictions. Whilst stylised it combines the accuracy of the VCH plan with the detail of the RCHME plan and adds information not depicted in any other sources.

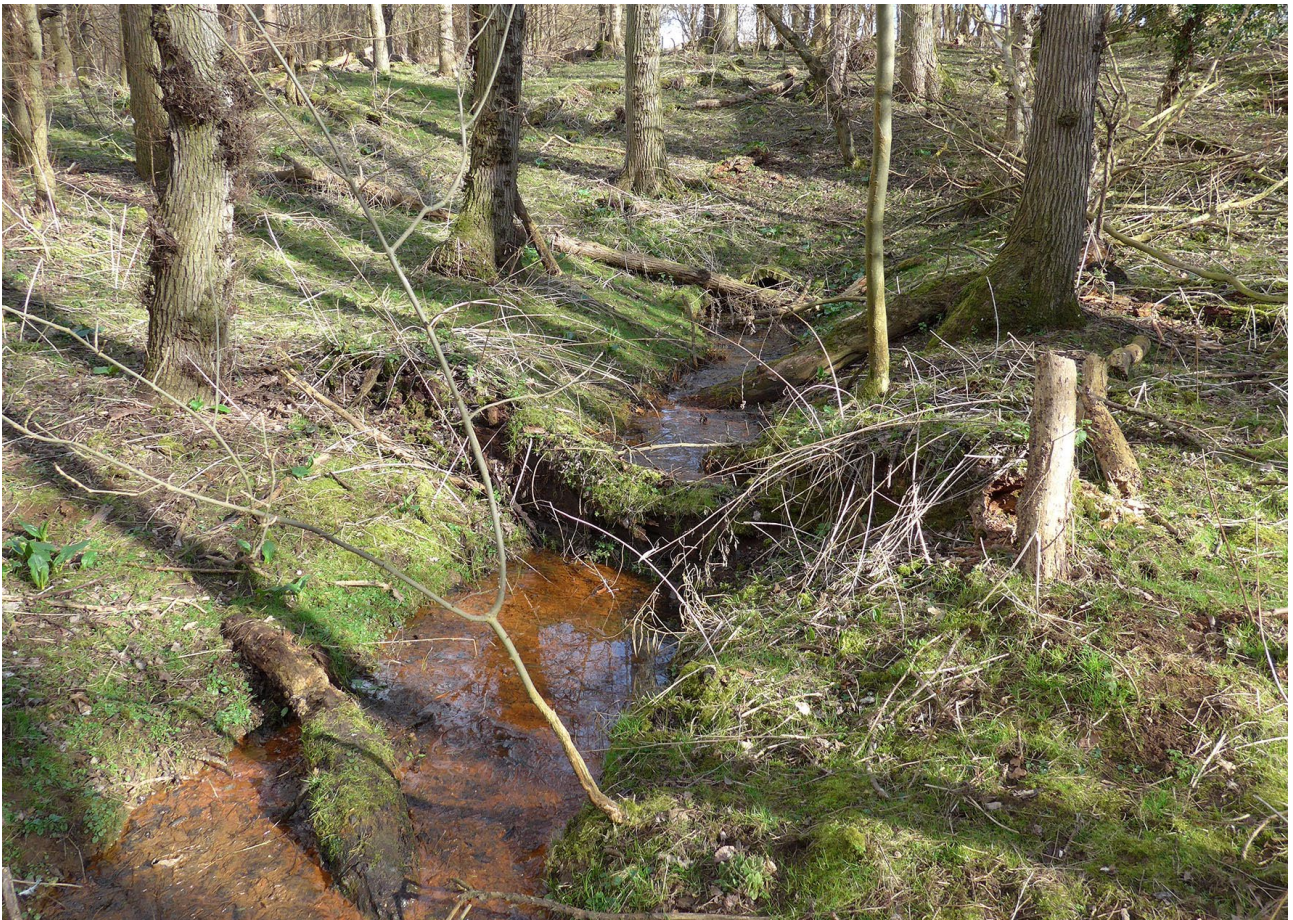
RW. The Red Well lies in the south-west of the area surveyed, rising in a short side valley joining the main stream 60m to the west. It still flows steadily today producing brownish water that leaves rust-coloured deposits (Figure 14). The north and east sides of the side valley are well defined, steepening towards the bottom, and may have been deliberately cut back. The south side has been modified by the north facing scarp of ditch [55].

Figure 14 – The Red Well from the west
(Magnus Alexander, March 2015, © Historic England)

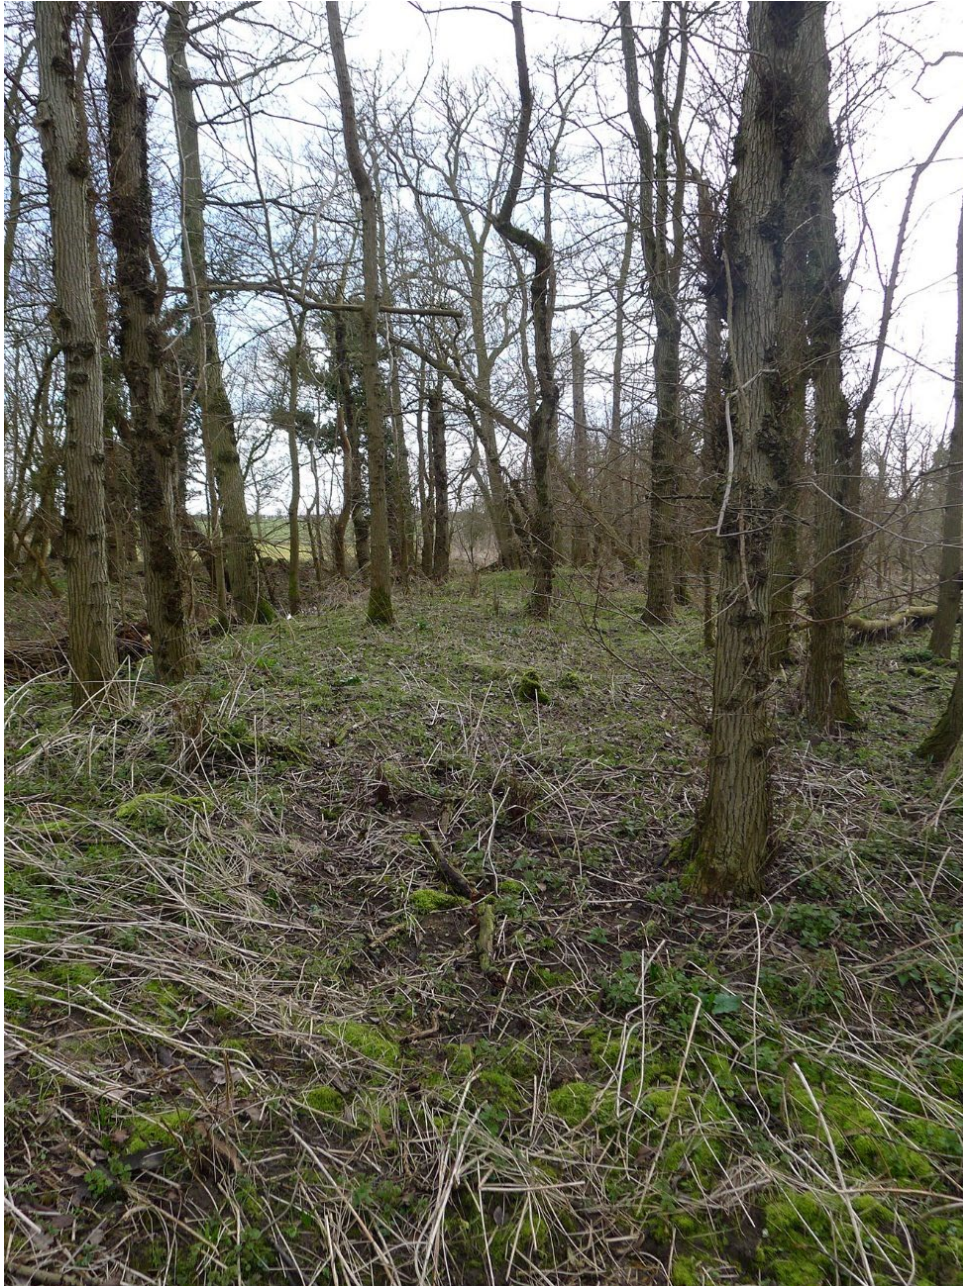
varies in width from around 4.5m to 12m and appears to be cut by the moat's outer enclosure and wood banks and more certainly by the long pond [42].

Figure 15 – Terrace to the west of the long pond
Seen from the north, the long pond can be seen through the trees to the left (Sarah Newsome, February 2015, © Historic England)

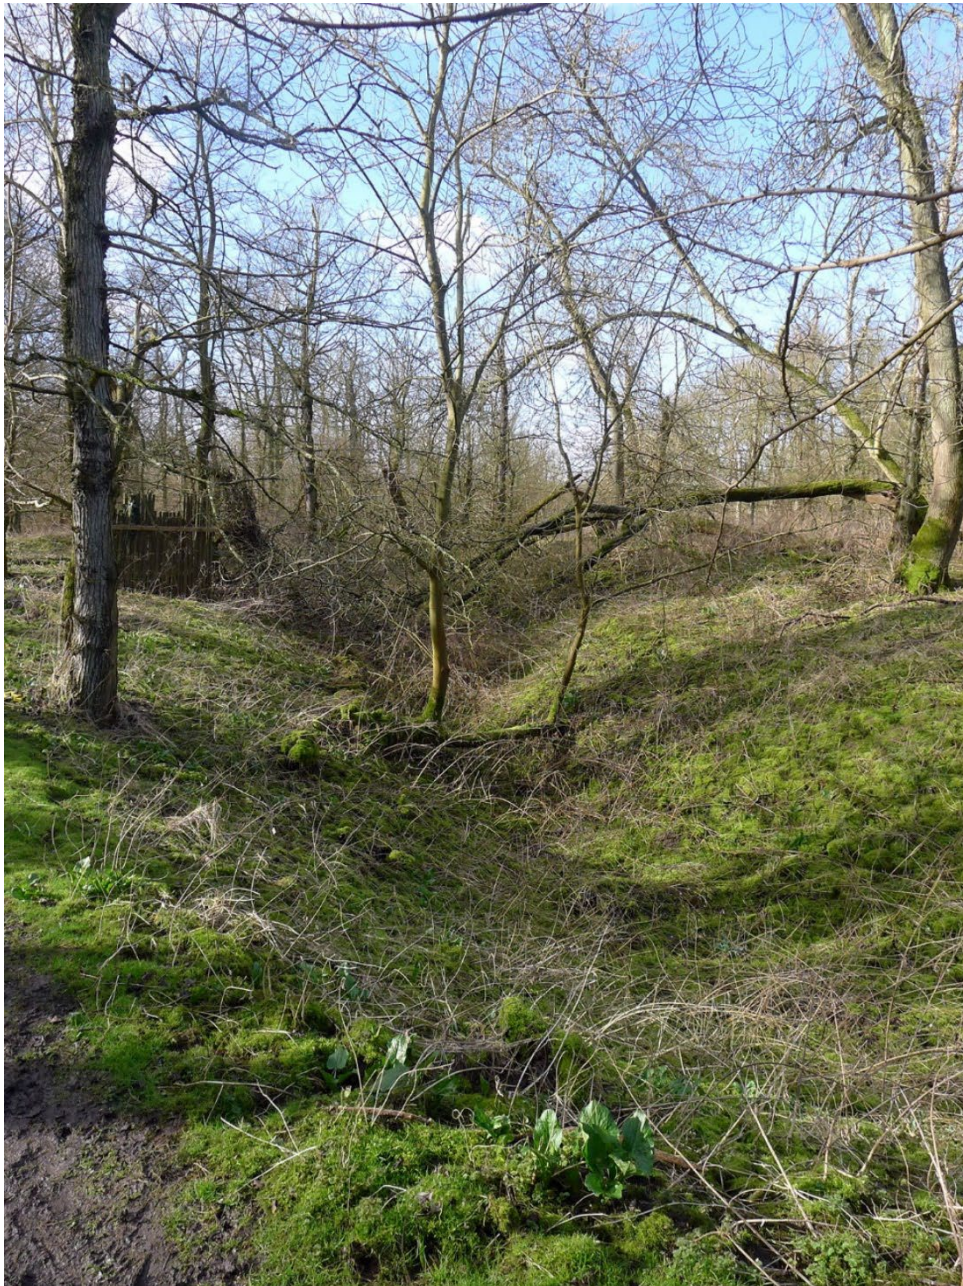
Figure 16 – The south side of the moat
Seen from the east, note the enclosed badger viewing platform to the left (Sarah Newsome, February 2015, © Historic England)

7. The moat is located within the north-east corner of Overhall Grove just below the brow of the hill. It varies between 8m and 10m in width and between approximately 0.9m and 2.4m in depth. The moat ditch is deepest at the south-east corner (2.3m) and along its southern side (Figure 16) but it is not clear if this is related to the topography or reflects a deliberate intention to emphasise this side of the moated

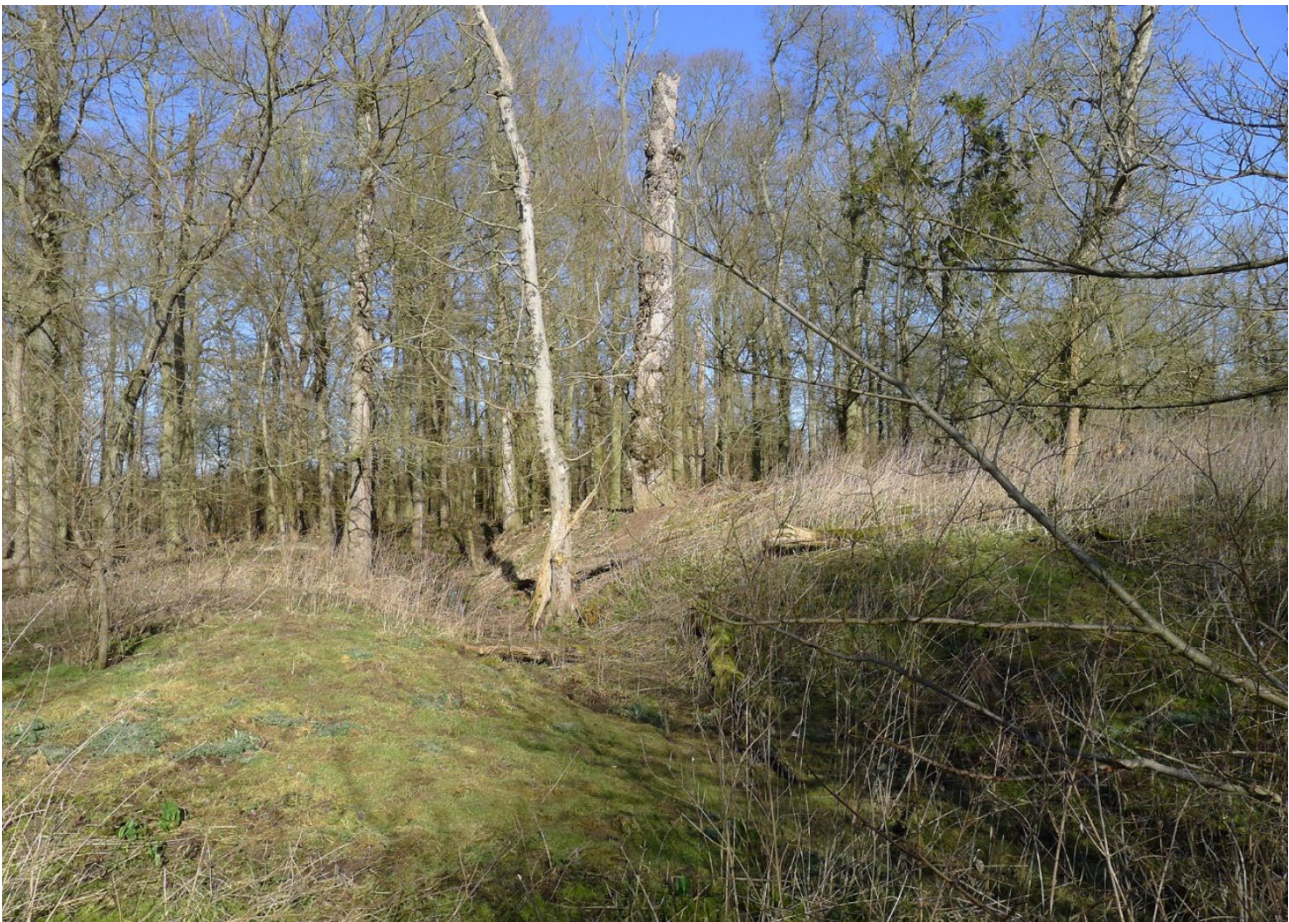
platform, perhaps the more visible on approach. The moat is 1.3m deep on the northern side and on the western side the ditch is 2m deep relative to the internal platform but only 0.9m to the outside of the moat, emphasising its mid-slope position (Figure 17). The moat defines a rectangular platform, roughly 43m east/west by 30m north/south with a smaller sub-square area 19m east/west by 21m north/south on its northern side. The moat platform has been heavily disturbed by tree throws and badger setts which have obscured any subtle earthwork evidence.

Figure 17 – The west side of the moat
Looking north, showing the fall from the moat island (right) to the outer enclosure (left) (Sarah Newsome, February 2015, © Historic England)

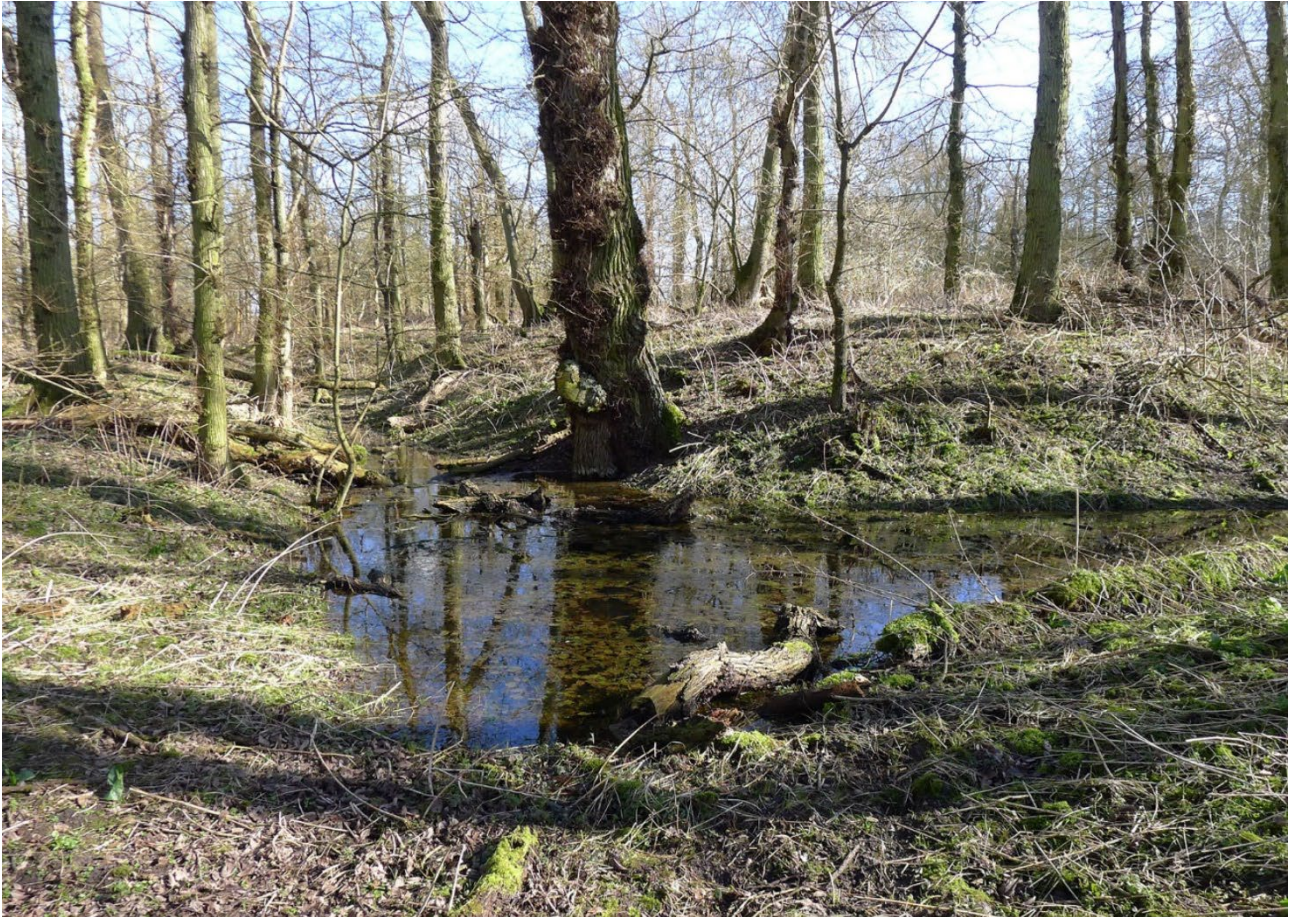
Figure 18 – The north-west corner of the moat
From the west (Sarah Newsome, February 2015, © Historic England)

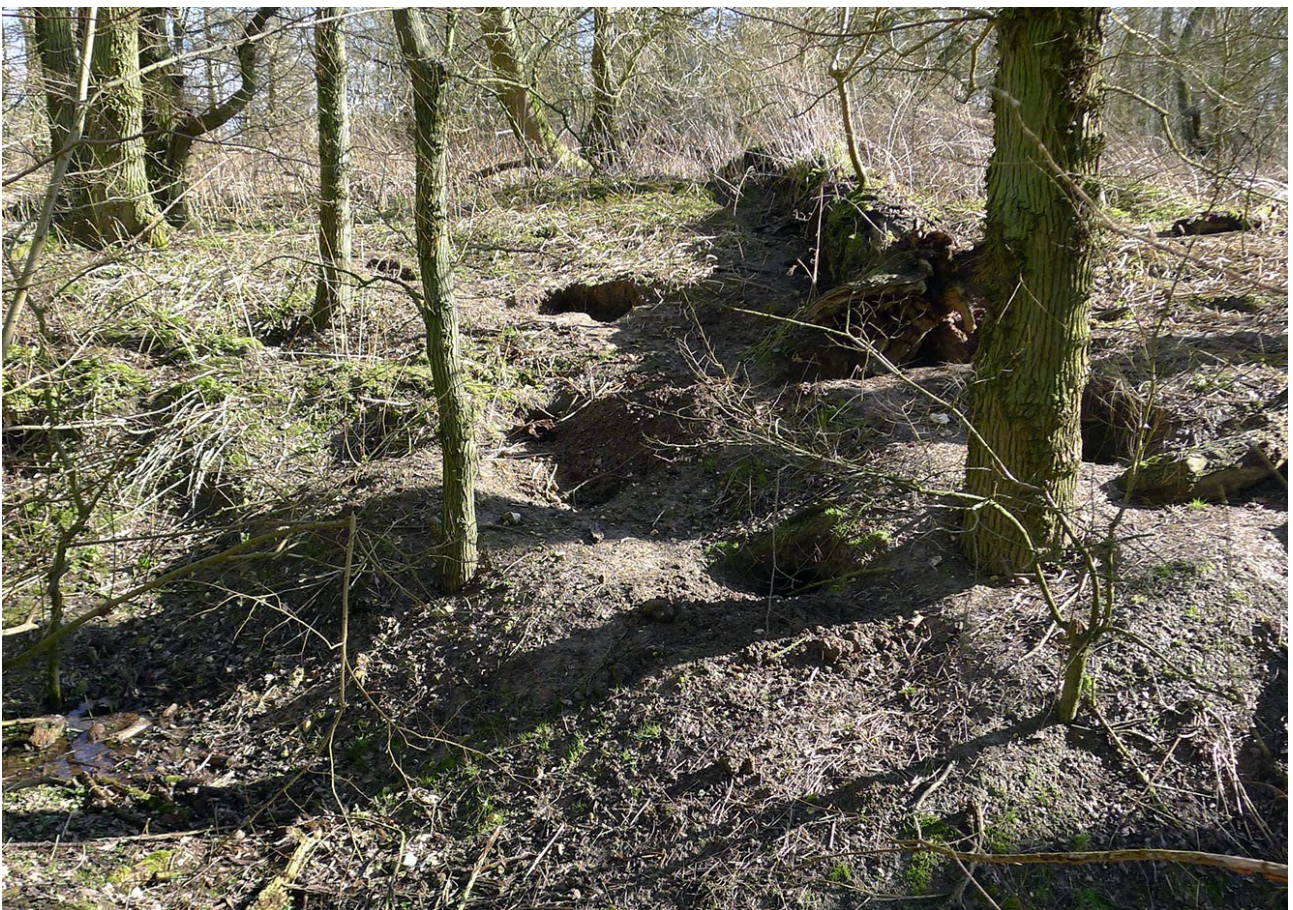
Figure 19 – Badger damage at the north-west corner of the moat island
From the west (Sarah Newsome, February 2015, © Historic England)

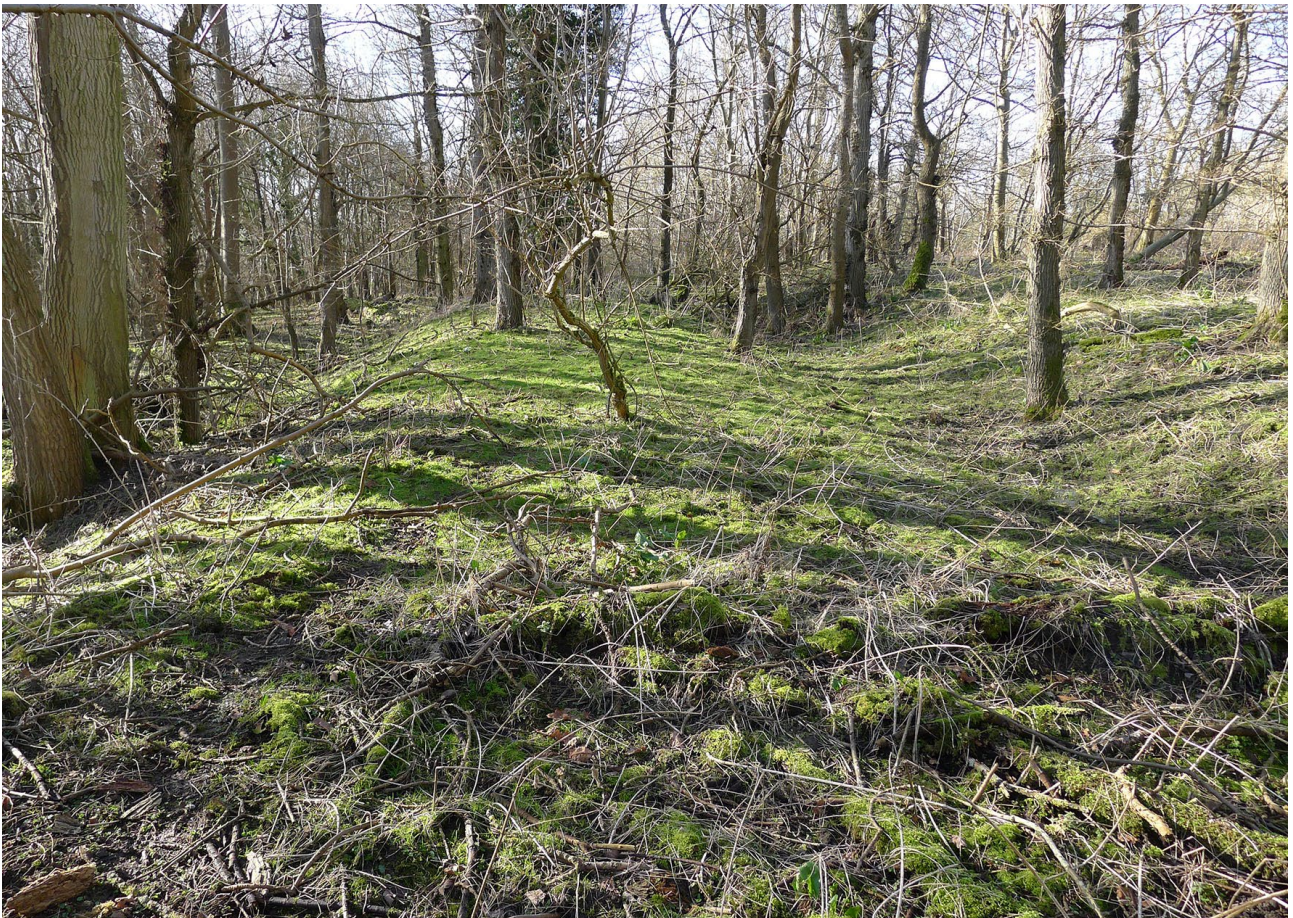
19. The southern side of the enclosure consists of two parallel ditches with a broad flat-topped bank between them and an overall width of around 15m (Figure 20).

Figure 20 – The south side of the outer enclosure.
Looking west towards its south-west corner (Sarah Newsome, February 2015, © Historic England)

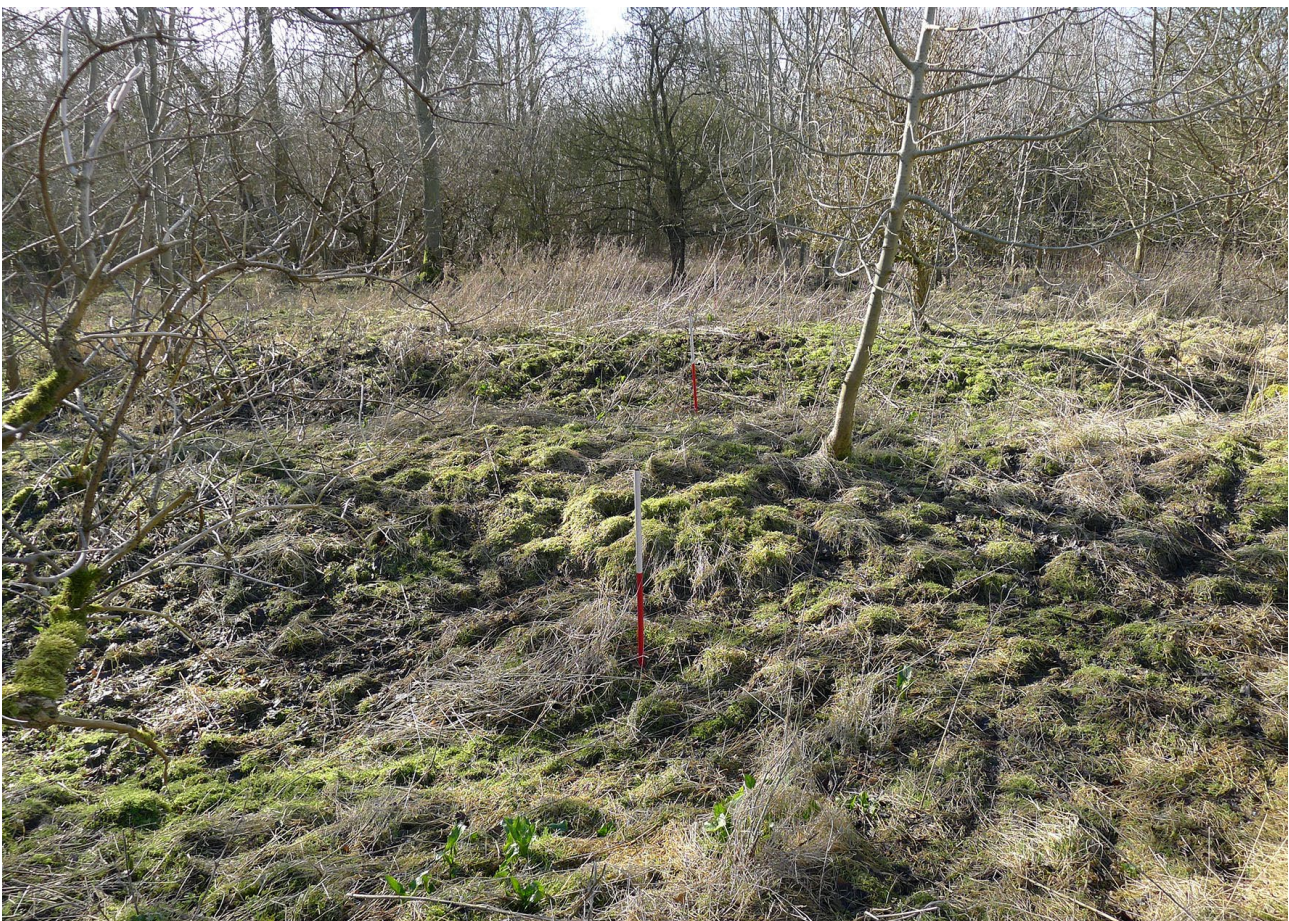
20. The western side of the enclosure is more elaborate than the southern side and consists of three parallel ditches with two banks between, and an overall width of 17m (Figure 21). The inner ditch and bank are the most substantial, the middle ditch and outer bank less so and the outermost ditch is noticeably shallower than the inner ones. A slight west-facing scarp beyond these ditches [37] runs on a slightly different alignment and may not be directly related. At the south-west corner of the enclosure, the double ditches of the south side curve north to align with the inner two ditches on the west side, implying that the outer ditch was added later.

Figure 21 – The west side of the outer enclosure. Looking west. The ranging rods mark the inner (nearer) and central ditches (Sarah Newsome, February 2015, © Historic England)

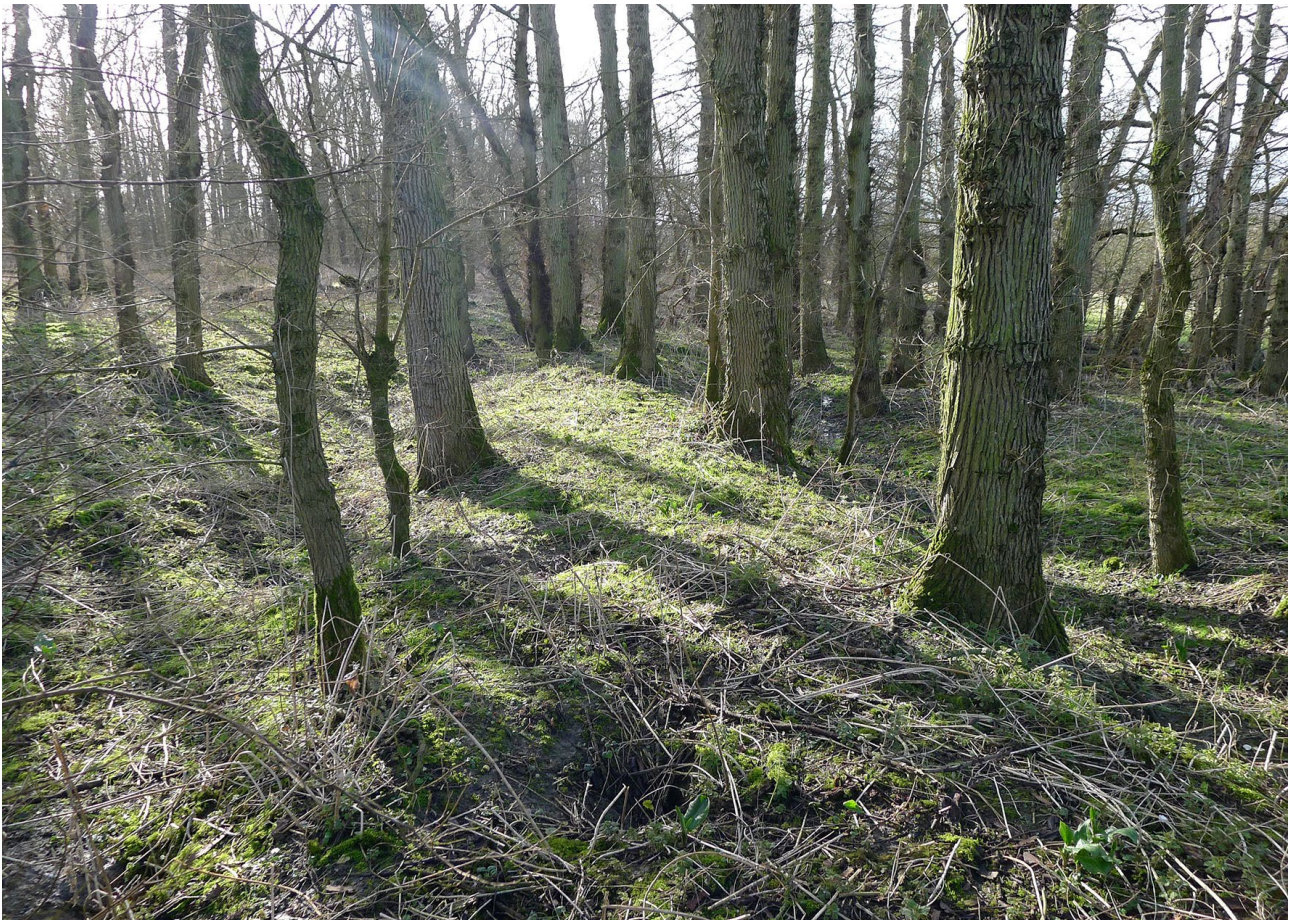
21. The north side of the enclosure consists of parallel double ditches with a total width of roughly 13m, similar to the southern side [19], though the central bank is narrower (Figure 22). There is also a more marked difference between the more substantial inner, and slighter outer, ditches, and the steeper inner faces of both relative to the outer. To the west the outer ditch is very slight, but it strengthens to the east where there are hints of an outer counterscarp forming a very low bank (not surveyable). The variation along these ditches, and between this and the southern arm, appeared to be largely topographically determined as the ground falls away more steeply here than to the south.

Figure 22 – The eastern part of the northern outer enclosure earthworks. Looking west, with the central bank illuminated by sunlight and the ditches visible to either side (Sarah Newsome, February 2015, © Historic England)

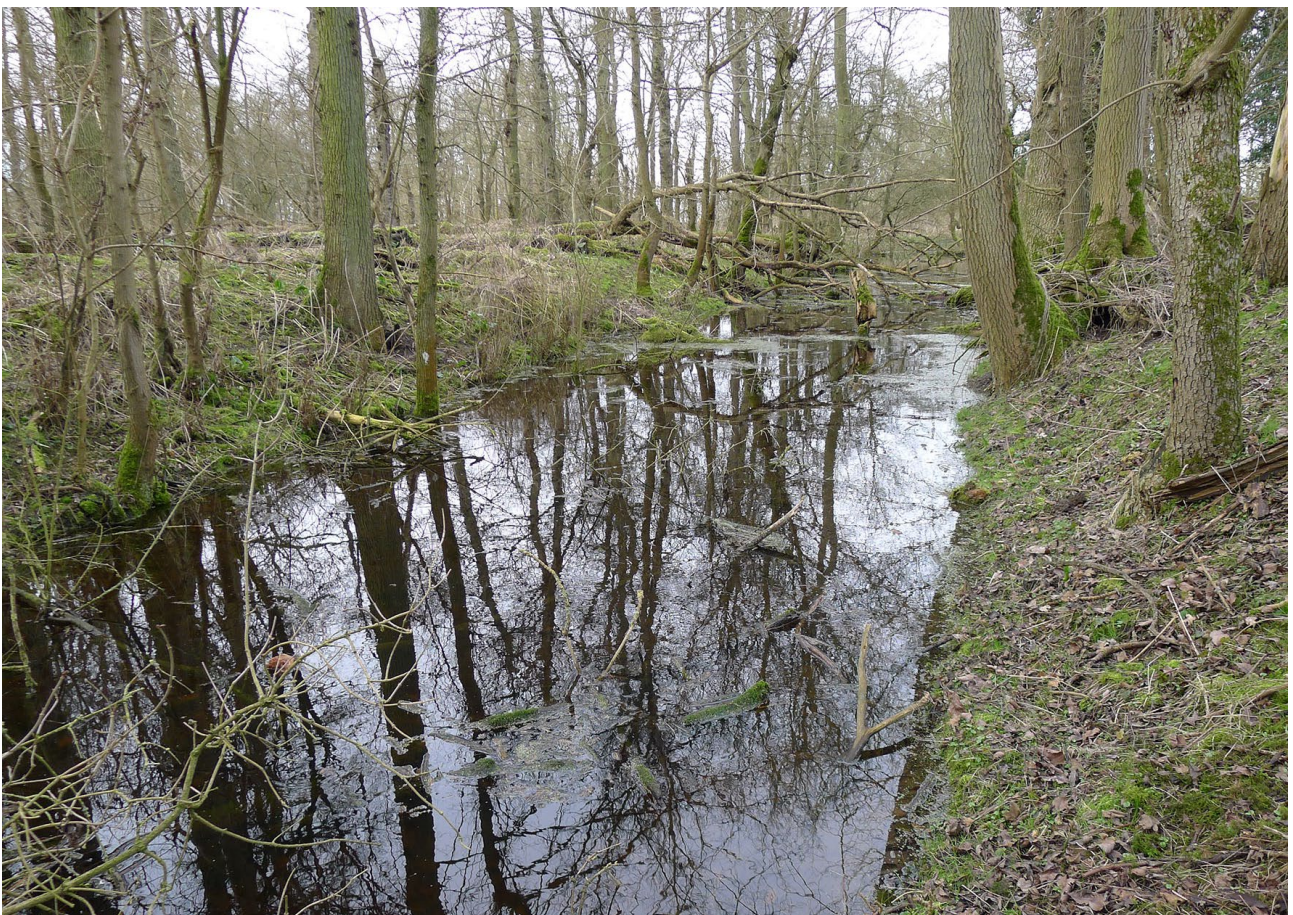
Figure 23 – The linear pond.
From the south (Sarah Newsome, February 2015, © Historic England).

The linear pond appears to be a late creation post-dating the wood boundaries of the 17th century. It is first depicted on the 1887 first edition OS maps and its length appears to have varied over the years but this is likely to simply be due to the conditions at the time of survey leading to variations in water level, rather than any changes to its form. It may be of two phases, but it is equally likely that its noted change in width/orientation, is the result of it having been based upon two separate features.
