Overhall Grove Moated Site and Mound, Cambridgeshire

Archaeological Investigation

Moated site, Overhall Grove, Boxworth Cambridgeshire, and
Mound, Knapwell, Cambridgeshire

NGR: TL 338 631

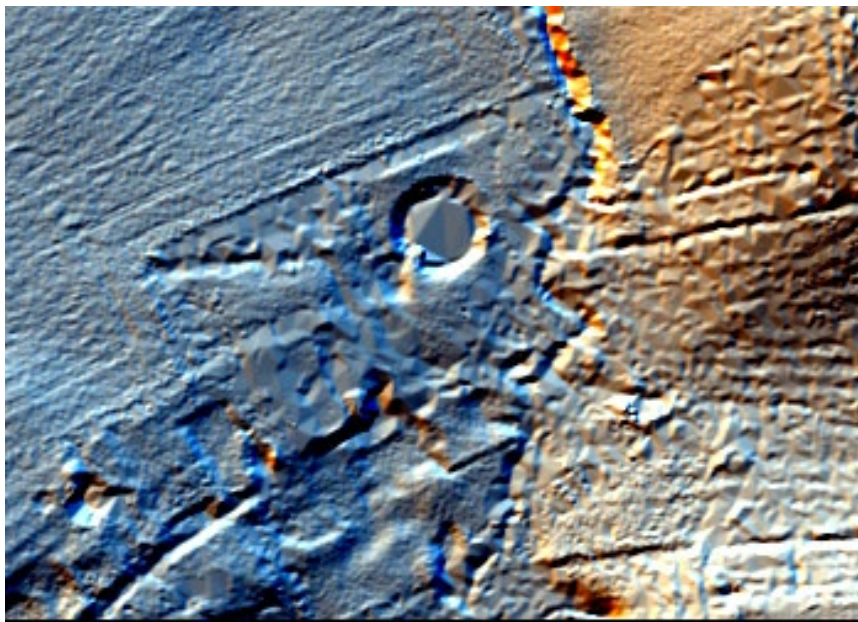
Figure 24 – Lidar DTM of the mound area with the mound above centre. For details see the front cover caption. Note how the over-processed areas are visible by their ‘faceted’ appearance - they include the mound itself, the field boundary to the north and the area around the house to the south-west.

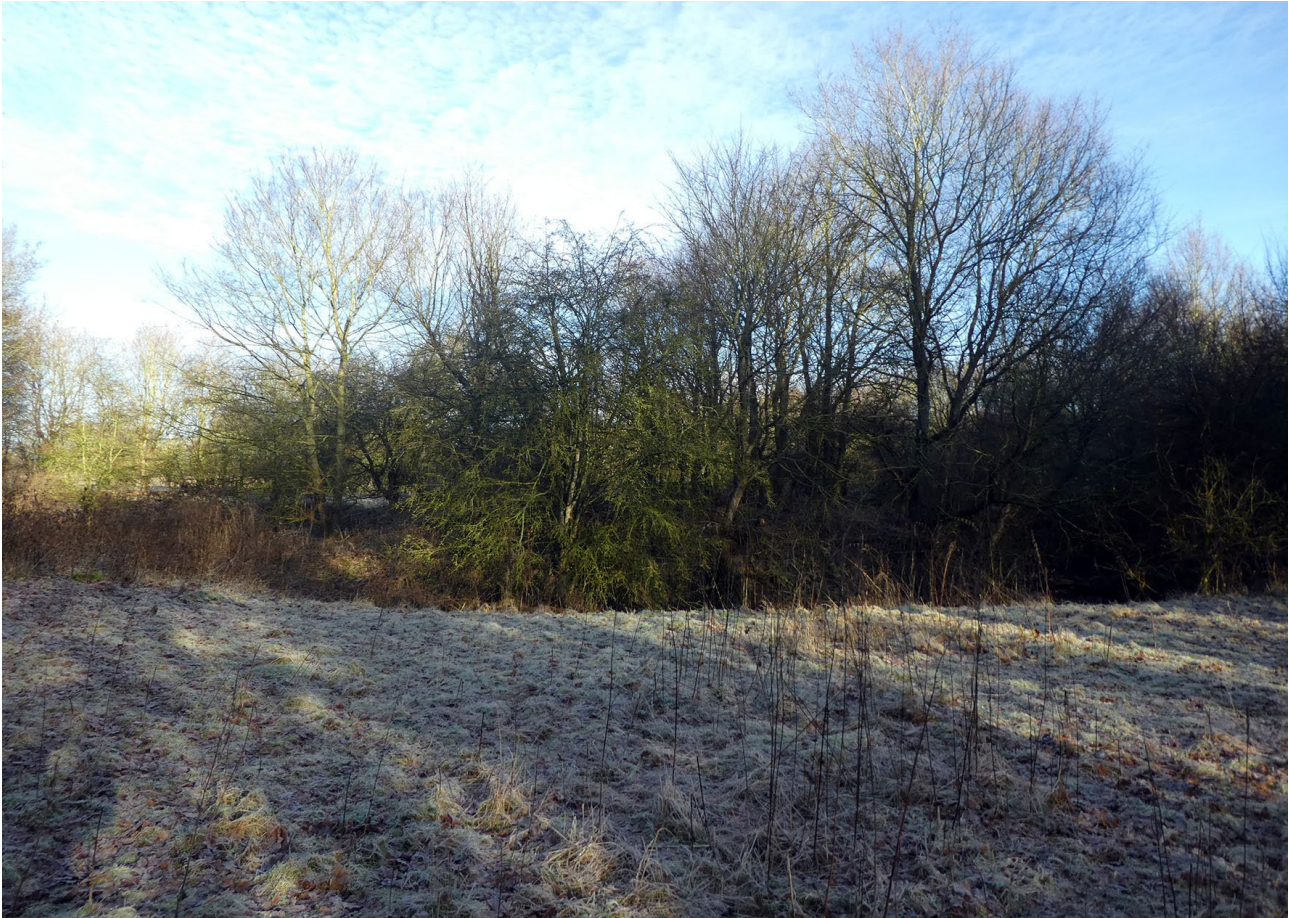
Figure 25 – The mound from the south, the highest adjacent ground lies to the left (Sarah Newsome, January 2022, © Historic England)

A fall onto the causeway suggests that, contrary to the RCHME, this may not be original. A broad, low and slightly irregular hollow to the immediate south-west may have been the source of the material for the causeway, but had perhaps been exaggerated by traffic onto the mound over the years. This hollow is shown on Figure 8 but as rather elongated southwards compared to that seen on lidar, which has been interpreted as having a very shallow broad gully curving south-west and west in this area.

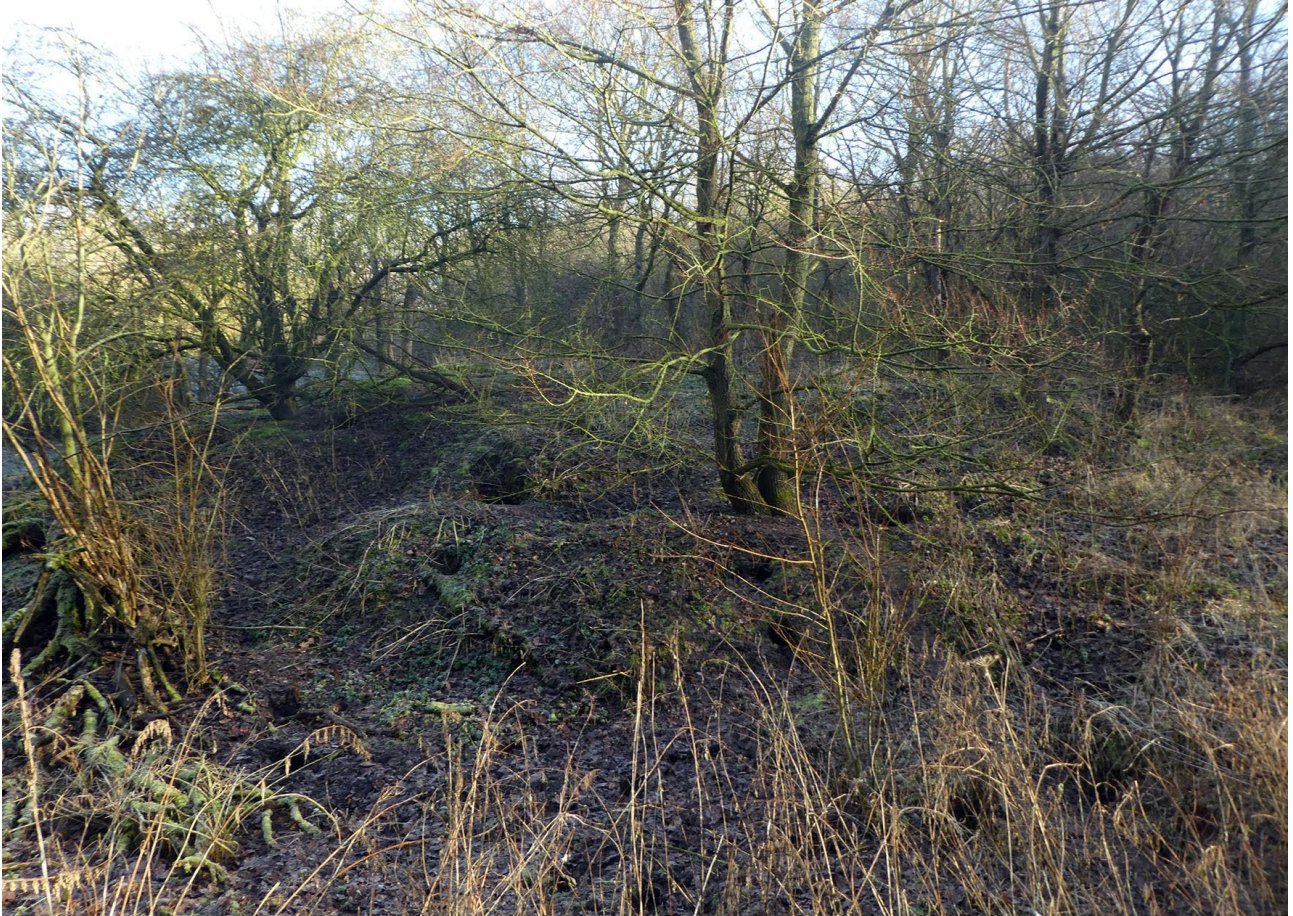
Figure 26 – The mound from the north-west, note its disturbed condition (Sarah Newsome, January 2022, © Historic England)

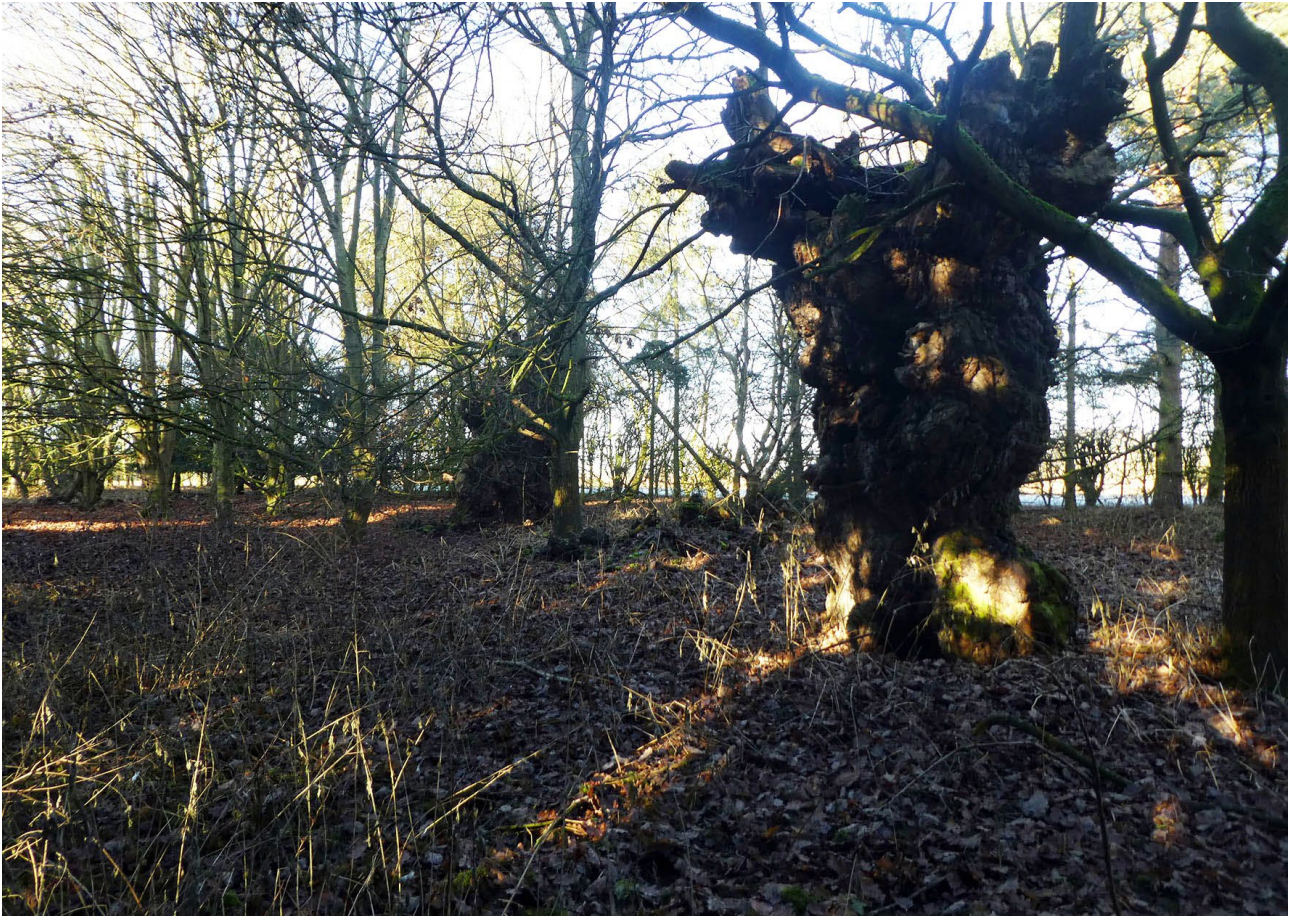
To the west of the hollow a ditch is visible in the lidar running approximately SSE to NNW for a short distance before turning to run to the west. The north/south section cannot be seen on the ground, probably due to heavy vegetation and gardening activity. That to the west is clear however, and had a prominent bank to the north, not shown on the lidar, presumably due to processing (Figure 27). Substantial trees, probably oaks, stand on this bank indicating it is of some age. This feature is also shown by the RCHME (Figure 8) to be part of a boundary system extending some way to the north and west. To the south lay east/west ridge and furrow but to the north it ran north/south, suggesting that this was a furlong boundary and that this ditch originated in a medieval open field system.

Figure 27 – The east/west boundary described above
Seen from the WSW, showing the large trees on the bank to the north (right) of the ditch (Sarah Newsome, January 2022, © Historic England)

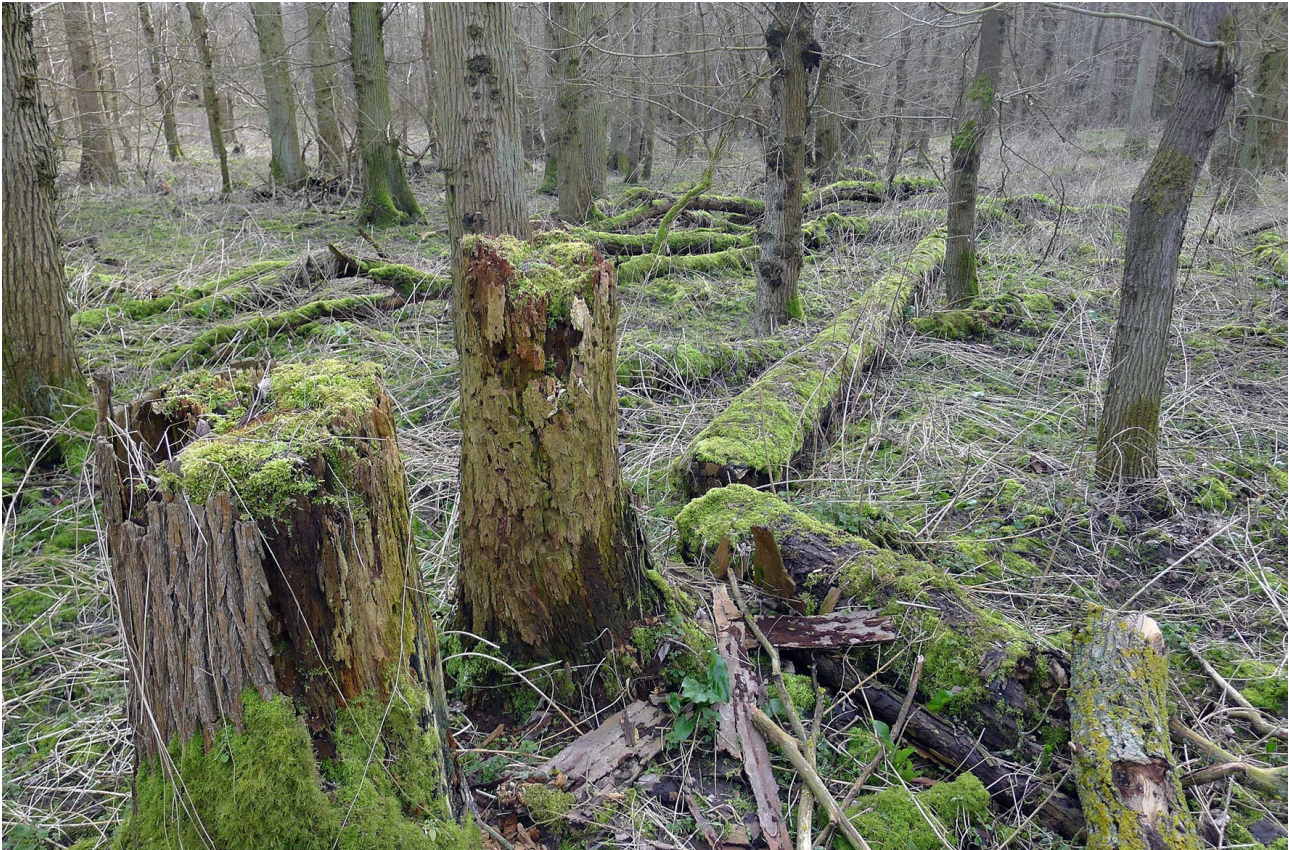
Figure 28 – Fallen trees within the south-west of the outer enclosure. They have disrupted the DTM and made it impossible to trace a low, spread bank [1] (Sarah Newsome, February 2015, © Historic England)

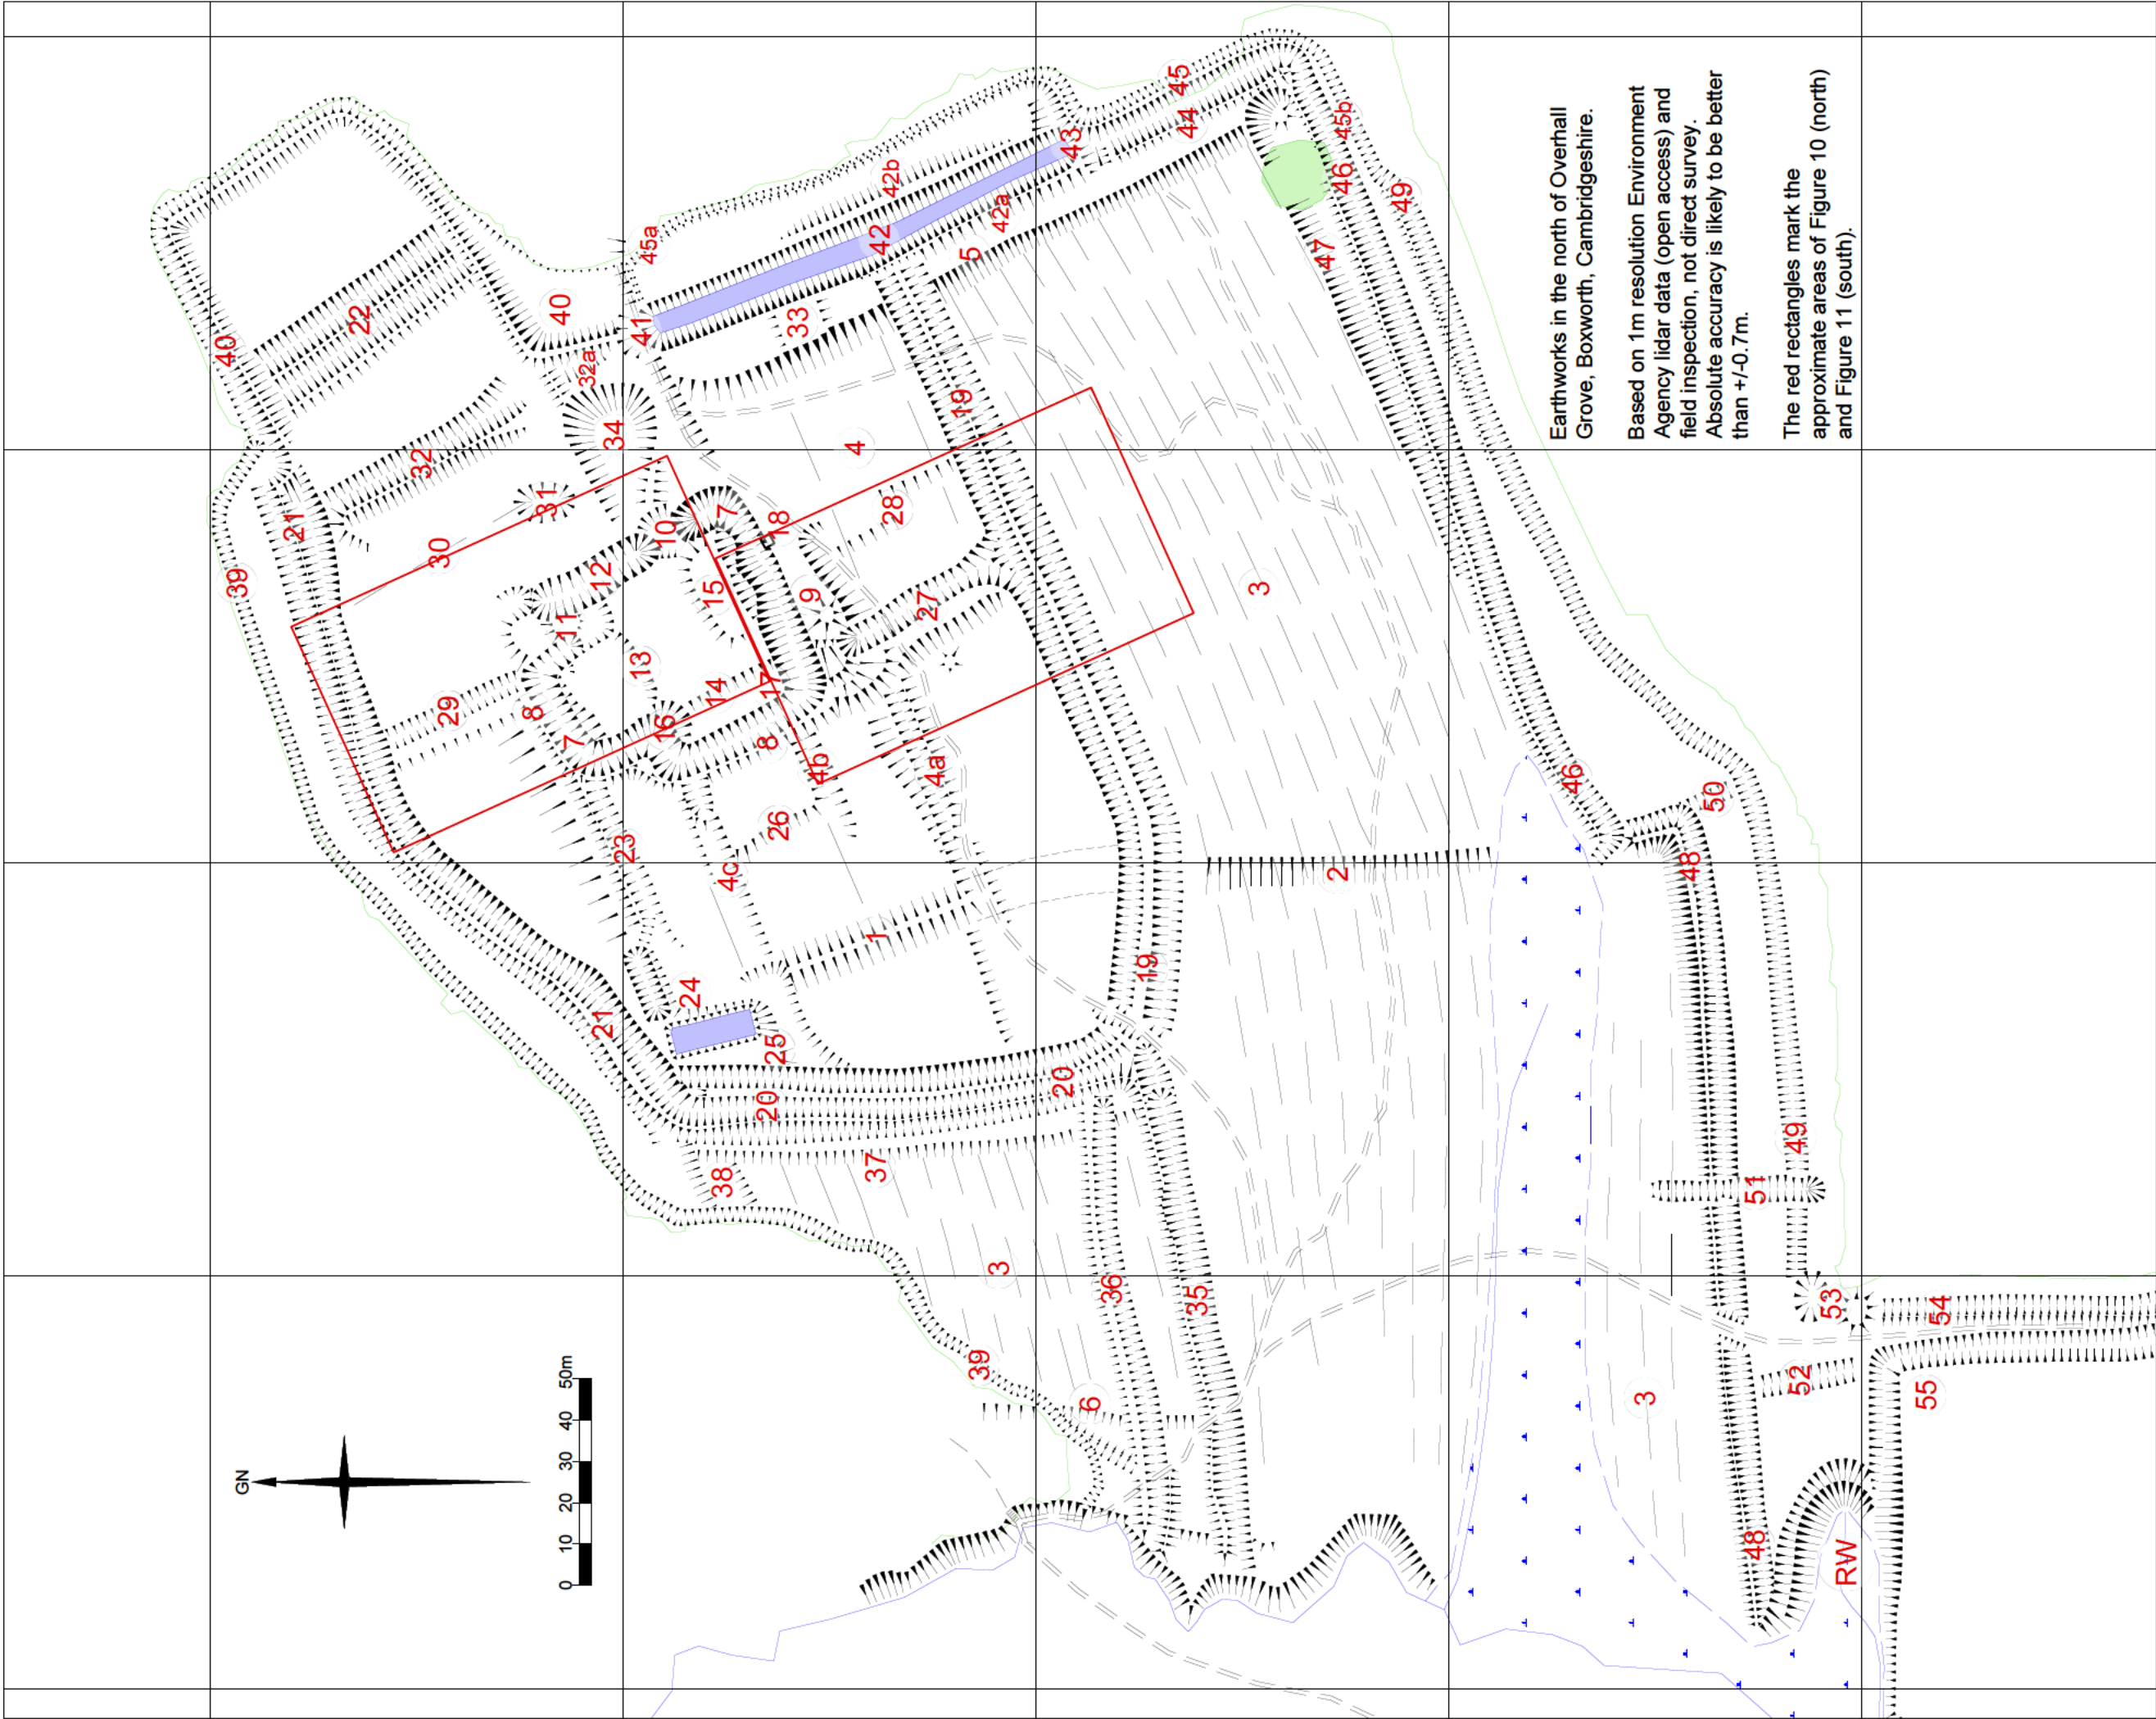
Figure 29 – Plan of the earthworks, 1:1500 at A3 (overleaf).

Most of the earthworks described below lie in the northern part of Overhall Grove (Figure 13). The Red Well lies in the south-west of this area, the manorial earthworks, comprising the moat and outer enclosure in the north and east. Ridge and furrow is preserved in much of the area between the two. Most of the remaining earthworks discussed lie near the edge of the woodland. The mound lies on the other side of the valley to the WSW of the moat. The paragraph numbering, and numbers in square brackets within each paragraph, refer to the figures on the earthwork plan (Figure 29); the latter are also intended to provide cross-references within the description text.
