Clifford's Tower, York

Excavations 2014-2016

2023

This report collates the results of excavations carried out by Historic England at Clifford's Tower, York, over a total of 6 weeks, between November 2014 and May 2016. There is a summary of the excavation archive and some assessment and analysis of the results.

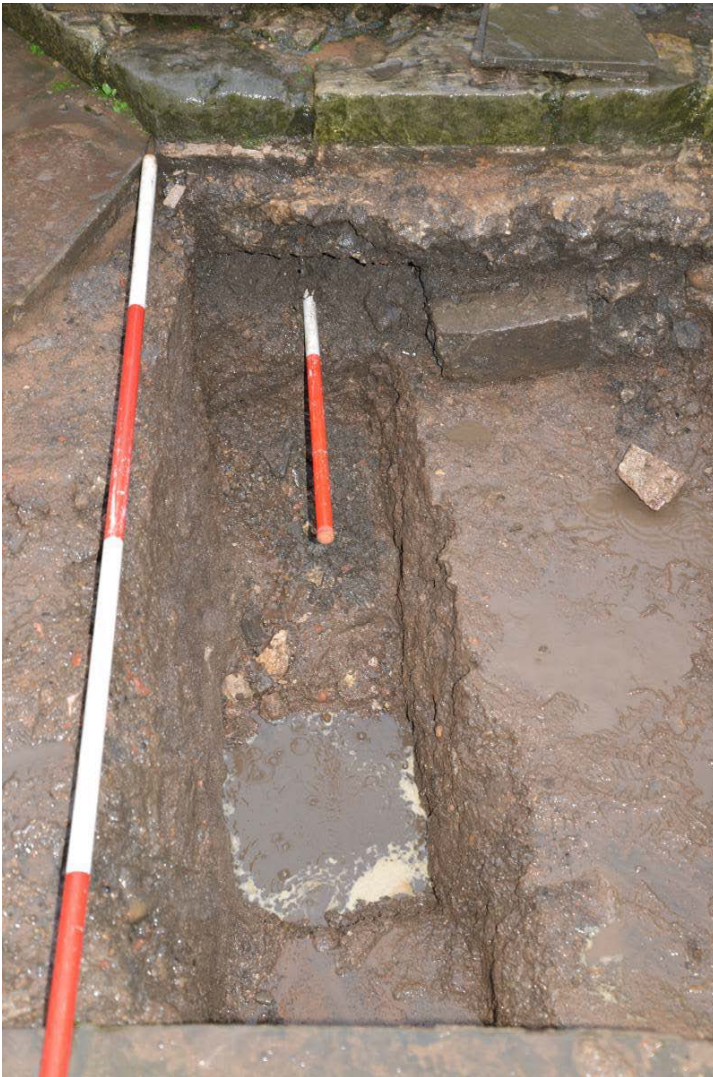
Figure 2 Foundations of octagonal feature. [Source © Historic England, Pr7166-7167]

The octagonal feature laid out on the surface of the courtyard had little in the way of foundations, resting on no more than a shallow layer of small stones bonded together in concrete (photograph 7167). It was possible to drive a two-metre ranging pole deep into the clay layer below the feature; clearly more substantial foundations do not survive at this level.

The octagonal feature has been used to support interpretations that the tower had an all-over roof, although the evidence that it marks an earlier column is slight (Ashbee 2003, 19-20). It remains possible that foundations were seen at a lower level during Office of Works consolidations between 1919 and 1922, but Test Pit 1 produced no evidence to support this.

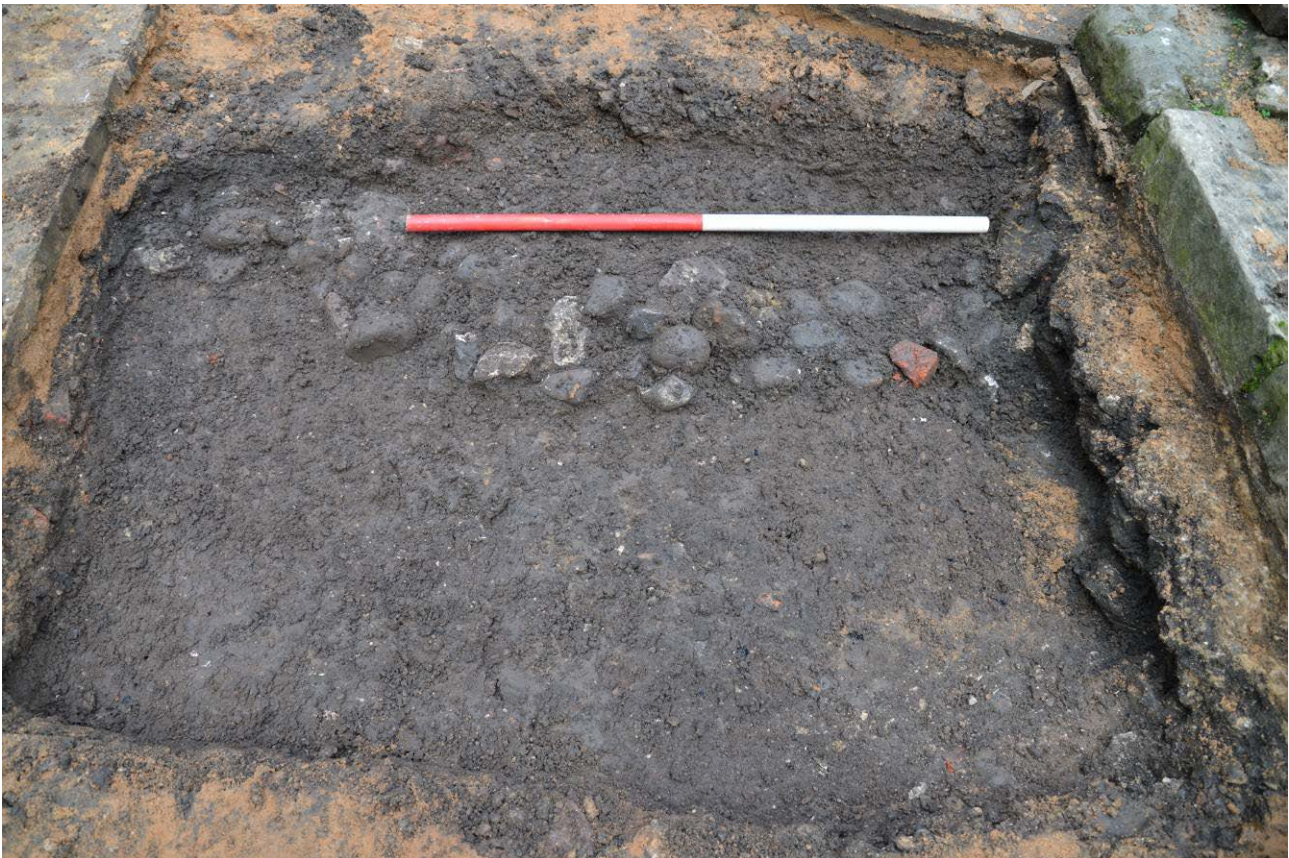
Figure 3 Cobble feature 90104. Source © Historic England, Pr7166-7146

Two clay layers were seen in this test pit. The uppermost (90103) contained a range of material, some quite modern. Separating the two layers a linear spread of water worn cobbles (90104) lay on the surface of the lower dark orangey brown clay (90105). The cobbles ran west to east across the length of the test pit exiting beneath the octagonal feature (photograph 7146). A tentative suggestion is that this represents a French drain soak away.

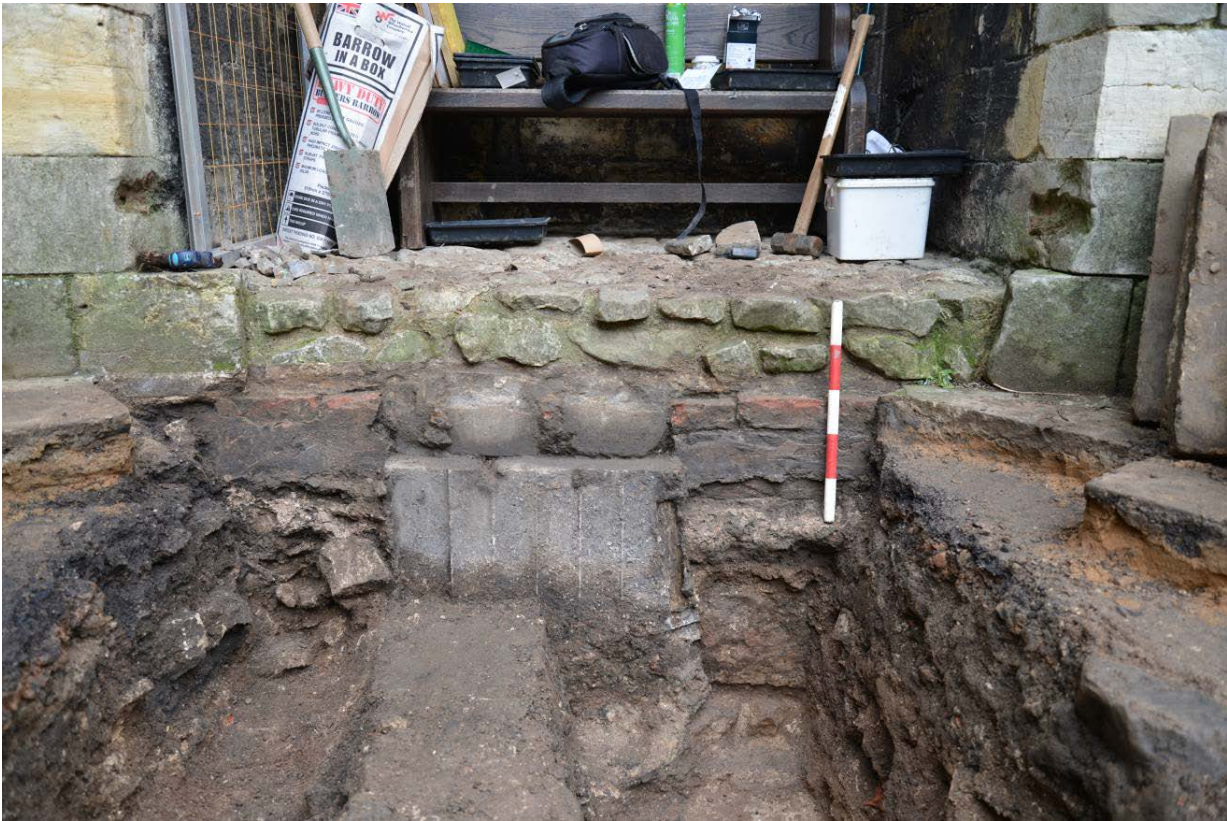
Toward the base of layer 90213 (0.8m below ground surface) the frequency of brick fragments increased and the layer rested on the remnants of a C17th brick floor (90214) set on a mortar base (90220).

Figure 4 Brick floor 90214 and mortar base 90220. Source © Historic England, Pr7166-7159

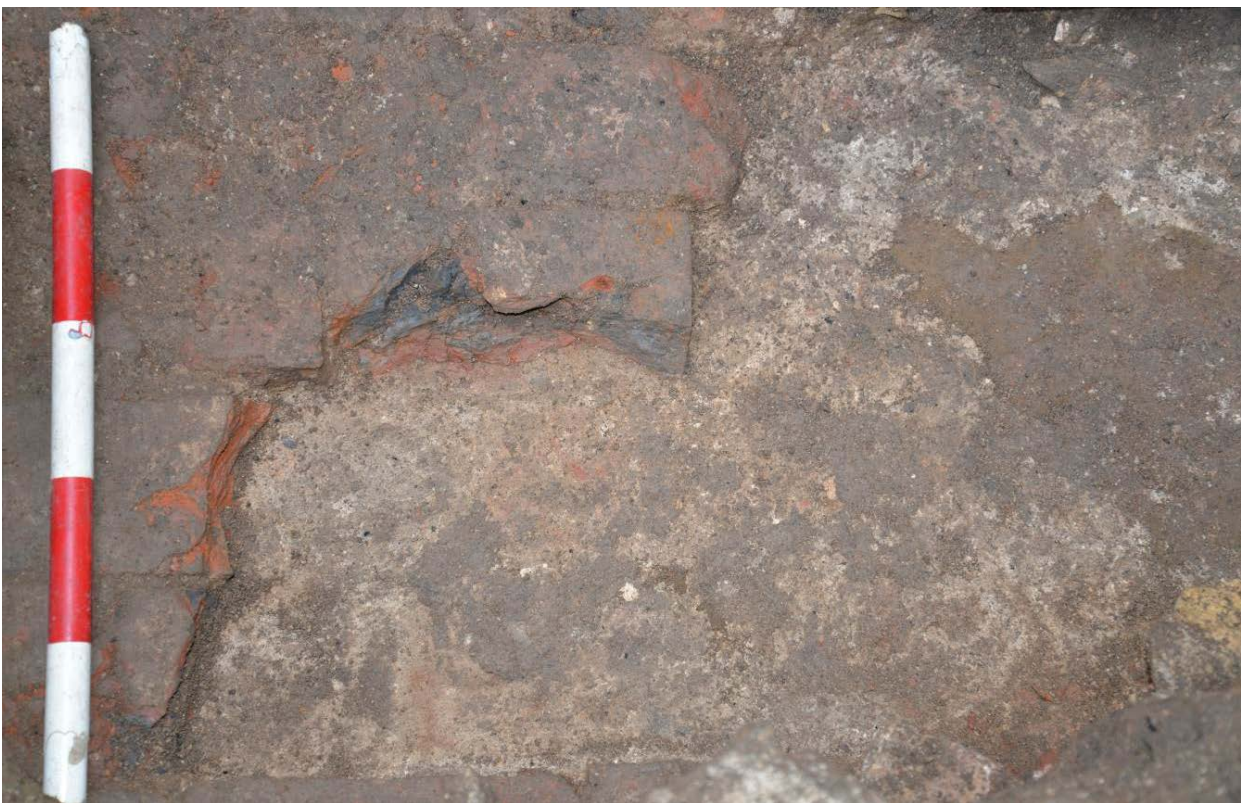
Figure 5 Northwest section of Test Pit 2. Source © Historic England, Pr7166-7161

Beneath the foundations of the embrasure, O'Hara thought it was possible to deduce the imprint of steps leading up from the floor (Photographs 7161, 7162). He suggested the floor (90214) related to work undertaken by Henrietta Maria in 1643 in defence of the Royalist cause and that this 'subterranean' level possibly afforded protection against ordnance from incoming fire. This is a persuasive theory, although the interpretation of

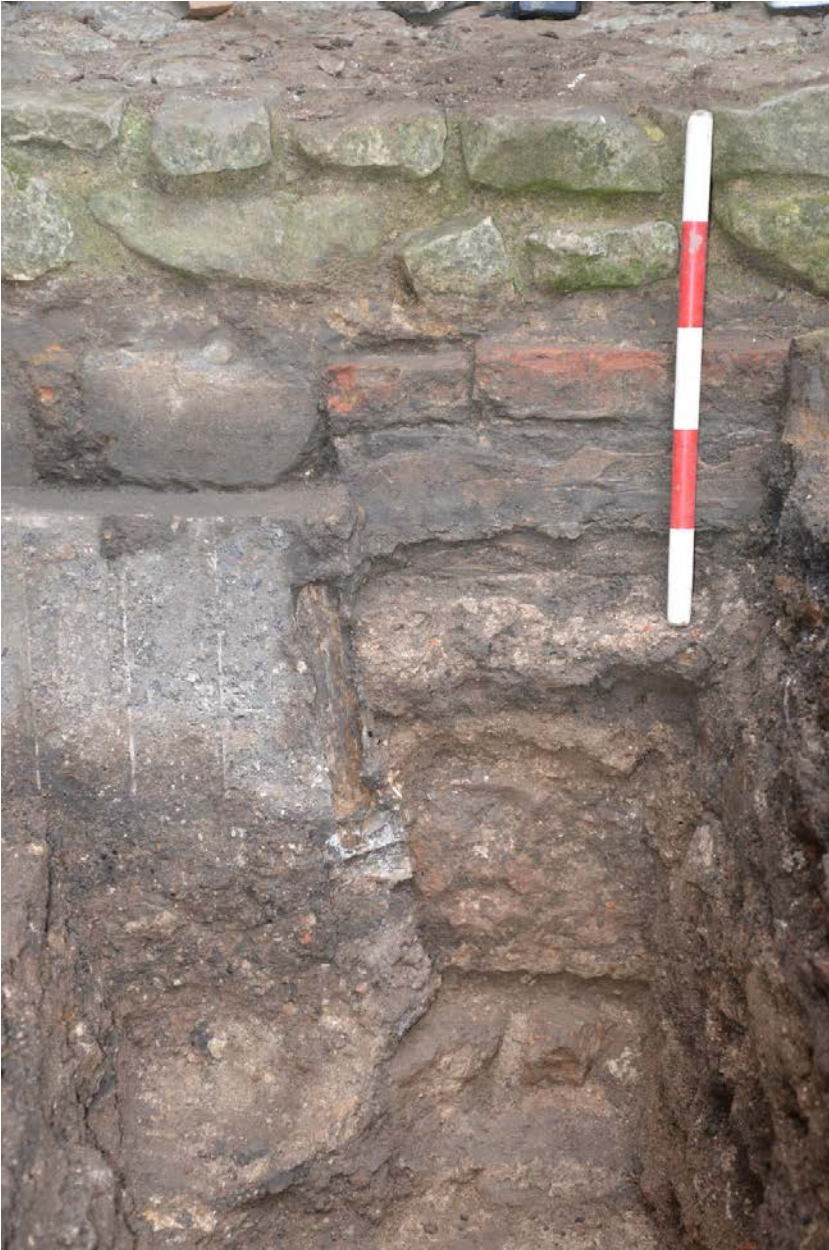
Figure 6 Mortar floor 90218 and wall footing 90219 cut by pit 90209. Source © Historic England, Pr7166-7162.

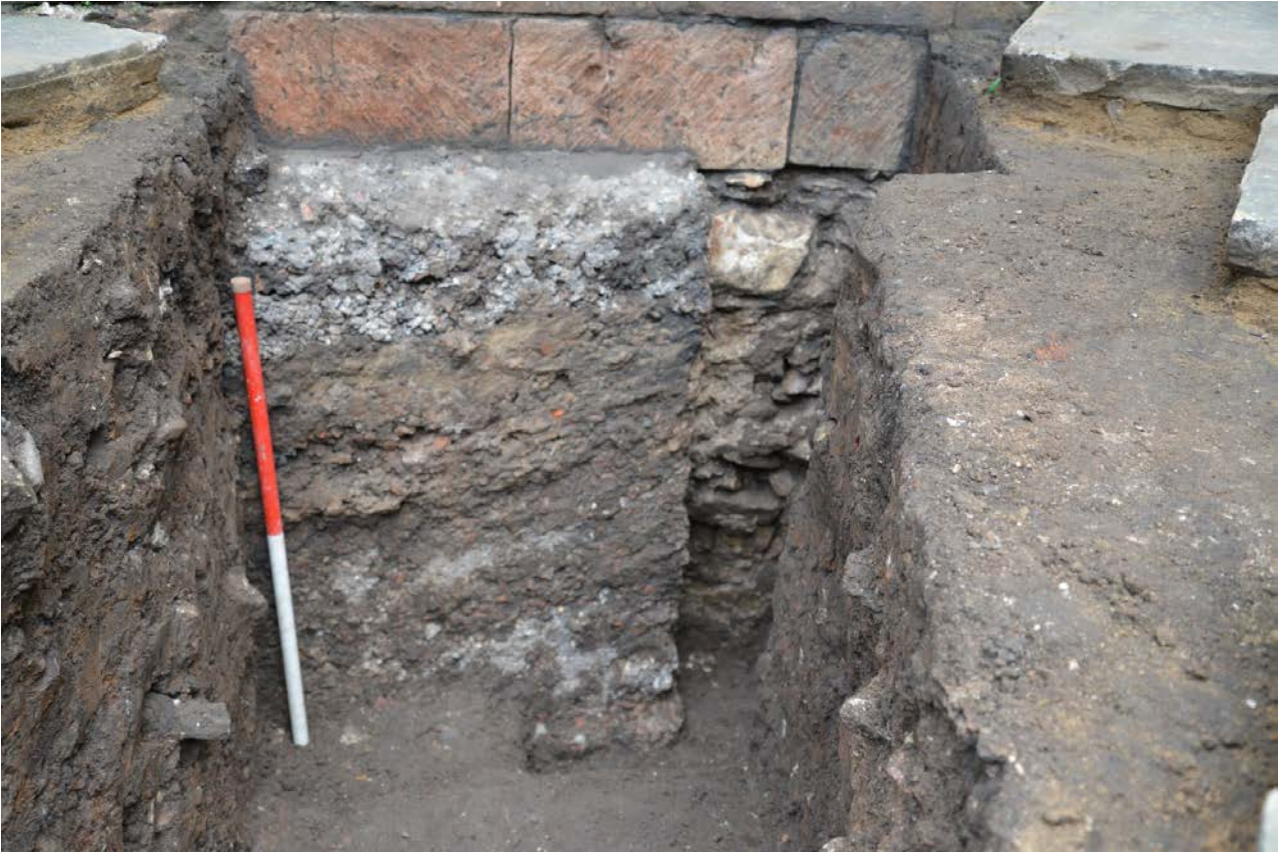
An Office of Works campaign used ashlar blocks to stitch together the crack that had developed up the side of the SE corner of the tower; one course of three blocks (90307) are visible in the side of the trench immediately below the level of the flagstone. O’Hara’s report described these as sitting on contemporaneous concrete foundations. However, the site records (and photograph 7016) indicate that the concrete butted against the base of the course.

The concrete extended 0.25 forwards from the wall. It is not clear that it extended under the ashlar blocks, and as shown in the photographs (7016-7018) the southern blocks visible lay directly on the rubble footing for the tower wall (90308). The concrete buttressing was at least 1.5m deep and extended below the level at which excavation stopped.

Figure 7 Northeast section of Test Pit 3 showing ashlar blocks 90307, concrete buttressing 90306 and the rubble wall footing 90308. Source © Historic England, Pr7166-7016.

On balance it seems likeliest that the ashlar stitching, concrete buttressing and pit (90309) and its fill (90305) relate to a single twentieth century intervention, Office of Works consolidations in the 1920s. If Mott's external wall buttressing (seen in Test Pit 6 on the outside of the wall) had extended into the courtyard, it would probably have been visible at 1.5m deep; it was not and probing a further 0.7m with a road iron did not locate it.

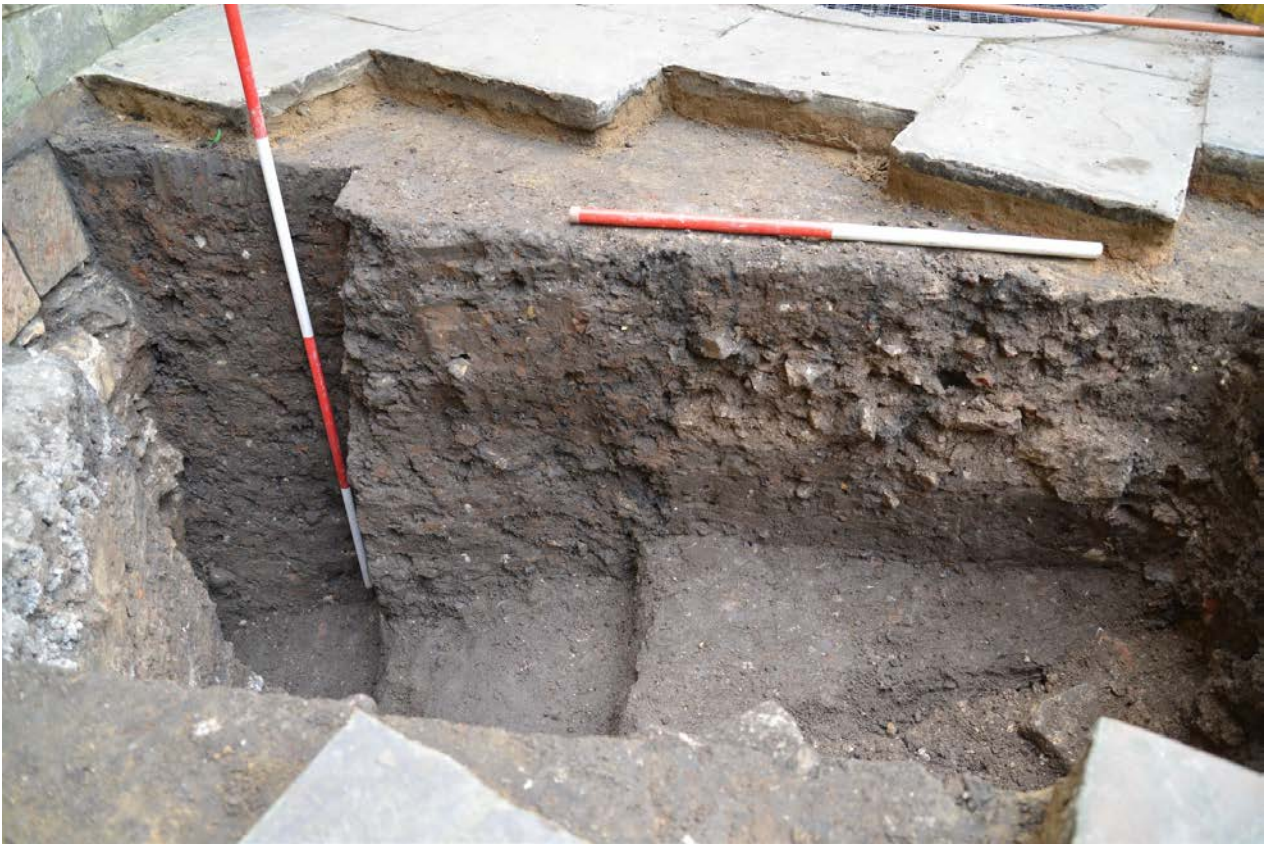
Figure 8 North facing section of Test Pit 3 showing cut 90309. Source © Historic England, Pr7166-7019.

O'Hara suggests the pit may have been associated with the sweeping away of ruinous structures when the tower was incorporated into the prison during the nineteenth century. Similar pits were excavated in Trench 20 (95034, 95036, 95039).

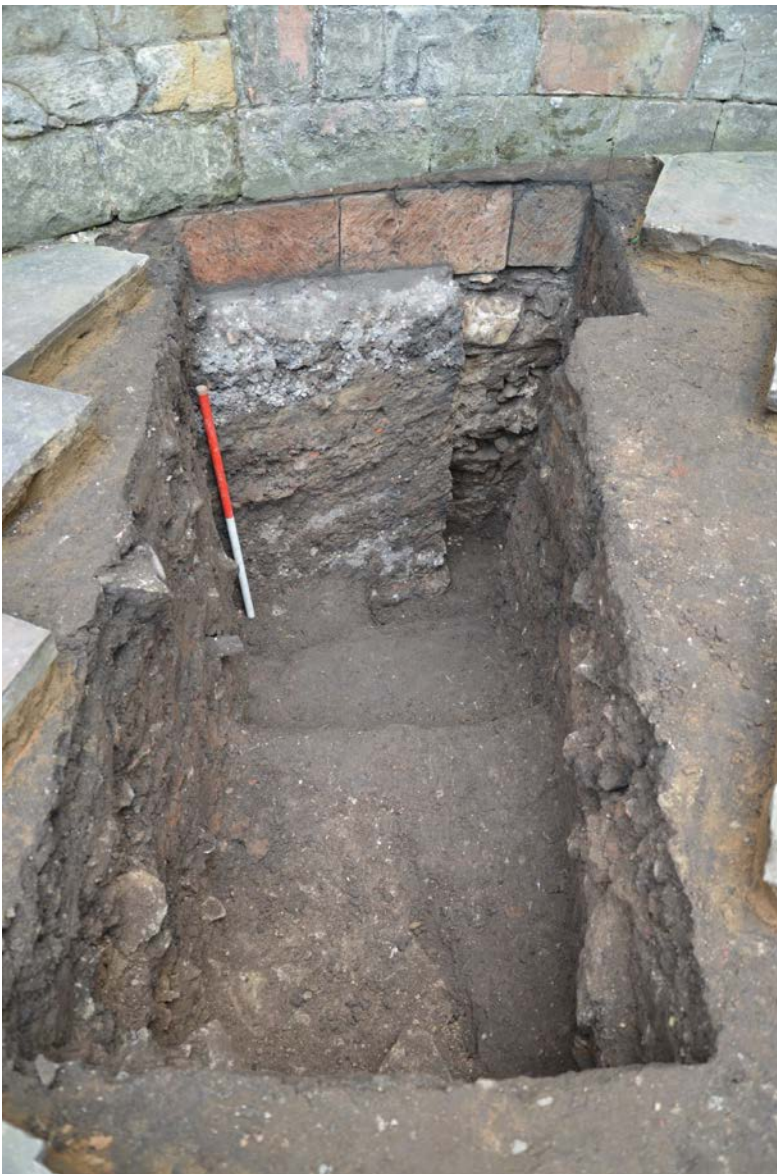
Figure 10 Test Pit 3 after excavation Source © Historic England, Pr7166-7017.

The western end of the trench was occupied by a layer (90304) of light yellow-brown sandy silt loam with frequent large angular limestone fragments and smaller stones. Towards the end of excavating Test Pit 3 it was recognized that 90304 was the fill of a pit (90310) which cut layer 903011 (90311 had not been noted earlier because of its similarity to 90305, the fill of 90310). 90304 was cut by 90309 (the cut for the early C20th repairs). These layers are shown on photographs 7017 and 7018, and context sheet sketch HE7166-90304.

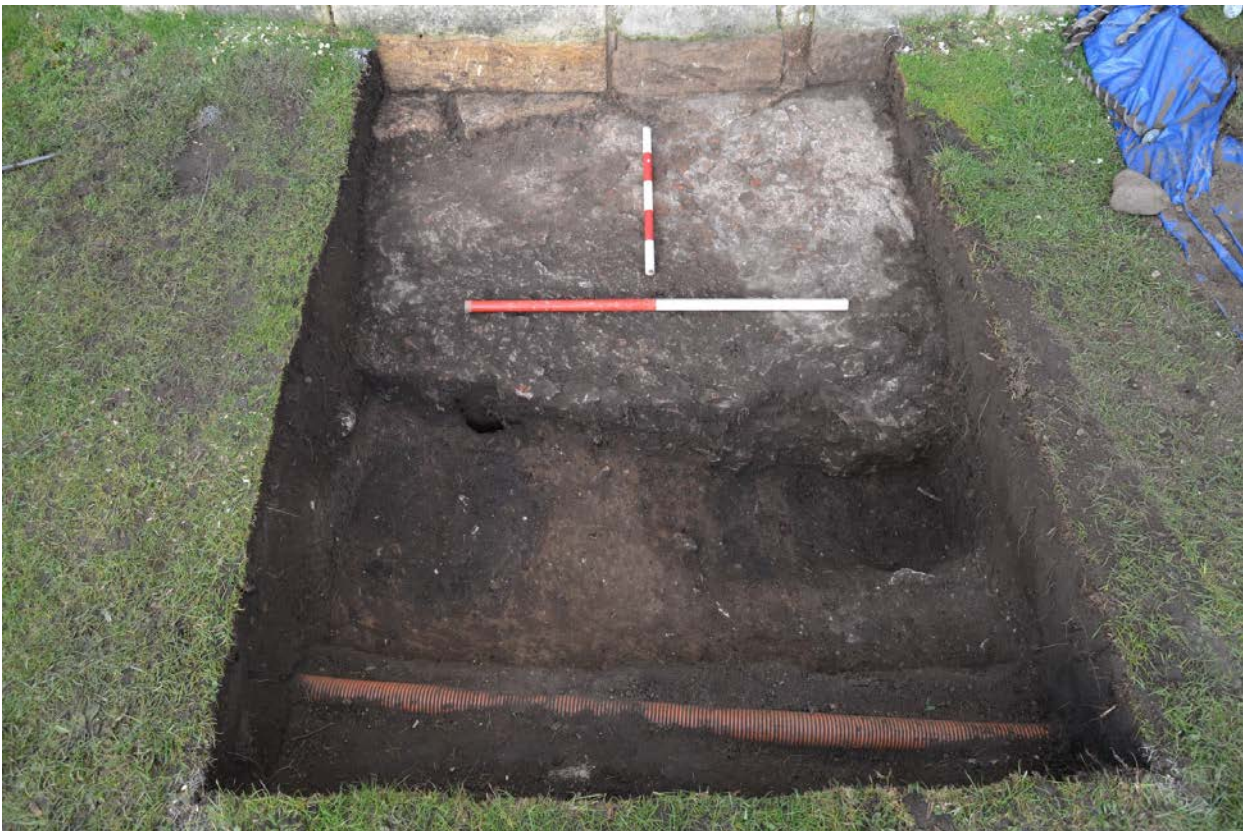
Figure 11 Test Pit 4 showing concrete raft 90402. Source © Historic England, Pr7166-7101.

Beneath the turf line three limestone slabs (90408) forming part of the wall foundations protrude from the face of the wall. At a depth of 0.2m these slabs and the rest of the face of the wall below ground level were enveloped in a raft of poured concrete (90402). The upper surface had a hard capping of brick fragments cemented together below this

capping the repair was of a more consistent and uniform mix of concrete. This underpinning raft occupies the width of the test pit and extended away from the wall face for 1m, being considerably greater by volume than the concrete features encountered in either Test Pit 3 or Test Pit 6. It was excavated and probed to a depth of 1m, but it was not possible to determine the depth of the underpinning. It is clear that this C20th raft supports the contemporary masonry above and is assumed to be part of the same Office of Works campaign seen in Test Pits 3 and 6.

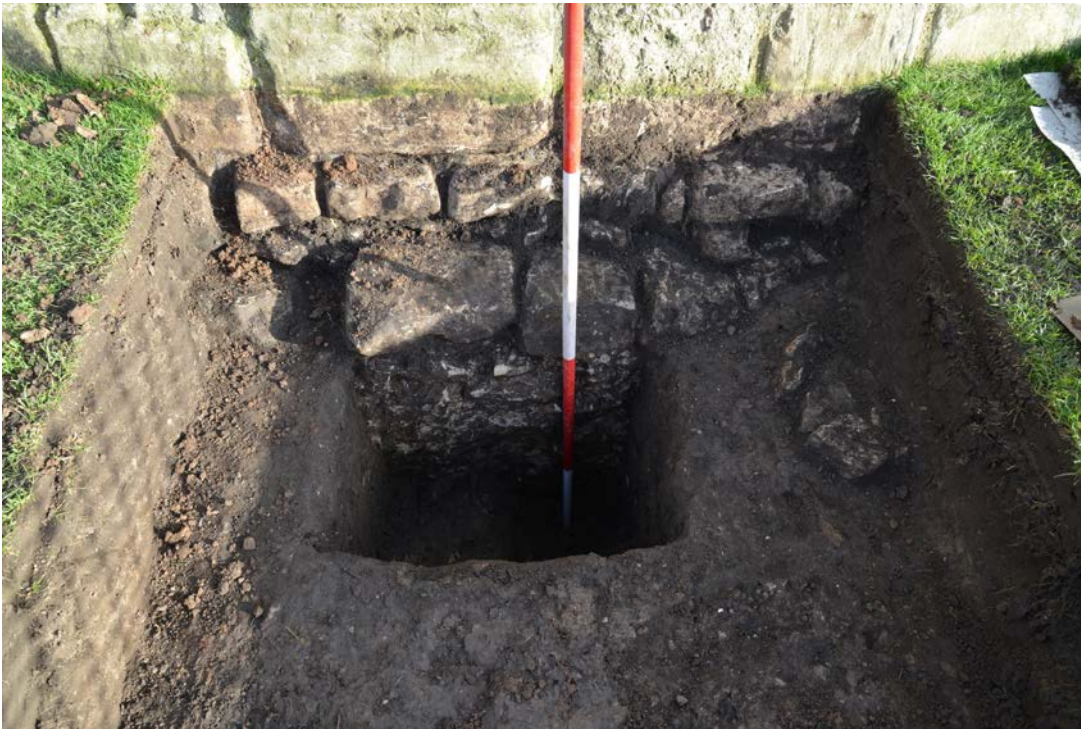
The tower wall foundations were seen at a depth of 0.2m below ground surface. The top course of the foundations stepped out from the wall face 0.15m. At a depth of 0.25m a thin layer of consistently sized small water worn pebbles (90502) formed what appeared to be a narrow path parallel to the wall face (photograph 7133) and may date to C18th, when the motte and tower were used as a folly or belvedere within the garden walls of a large house to the east (Clark 2010, 36). When this path was in use the motte must have been lowered, exposing to view a course or more of the foundations (90505).

Figure 12 Tower wall foundations 90505 and pebble path 90502. Source © Historic England, Pr7166-7133.

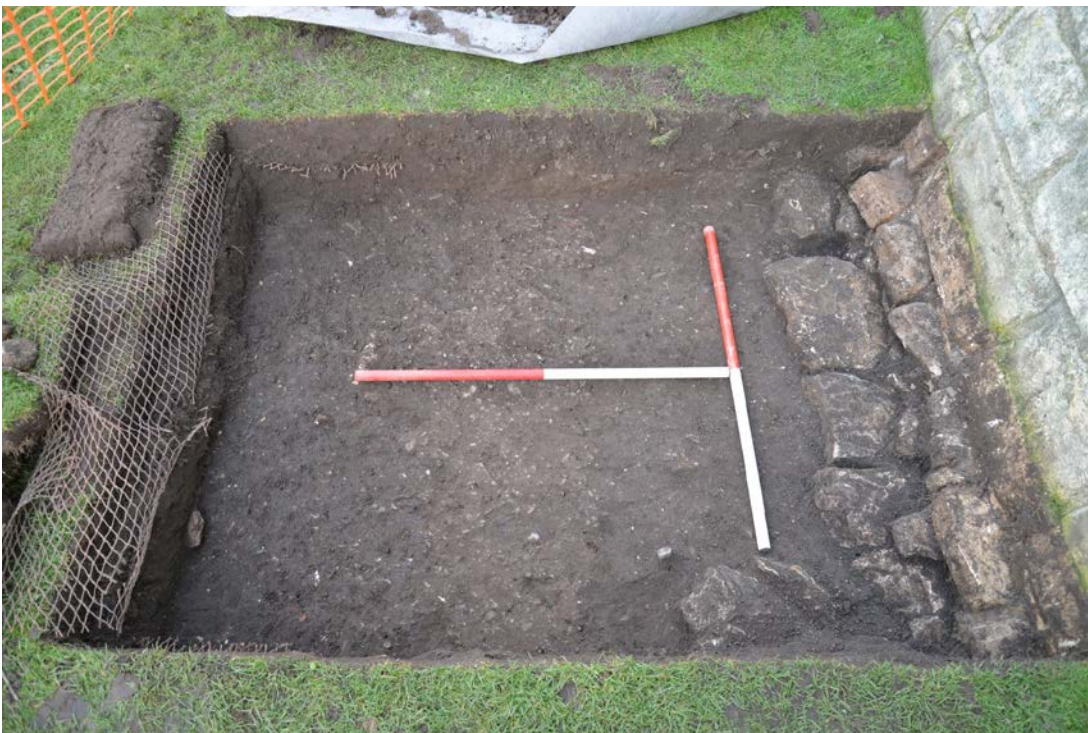
Further excavation against the wall face revealed a second larger course of foundation stones stepping out a further 0.2m. A square sondage (photograph 7145) was excavated to a greater depth; the rubble foundation (90505) dropped vertically below the masonry courses, terminating at a depth of 1.6m below ground surface.

Figure 13 Wall foundations 90405 and sondage. Source © Historic England, Pr7166-7145.

The lower rubble part of the foundations (90505) probably occupied a cut (90506) about 1.0m deep into layer 90504. This cut was inferred rather than observed - “foundations were trench built up to the edge of the cut” although “loose mortar [was] seen b/w foundation stones and edge of cut”.

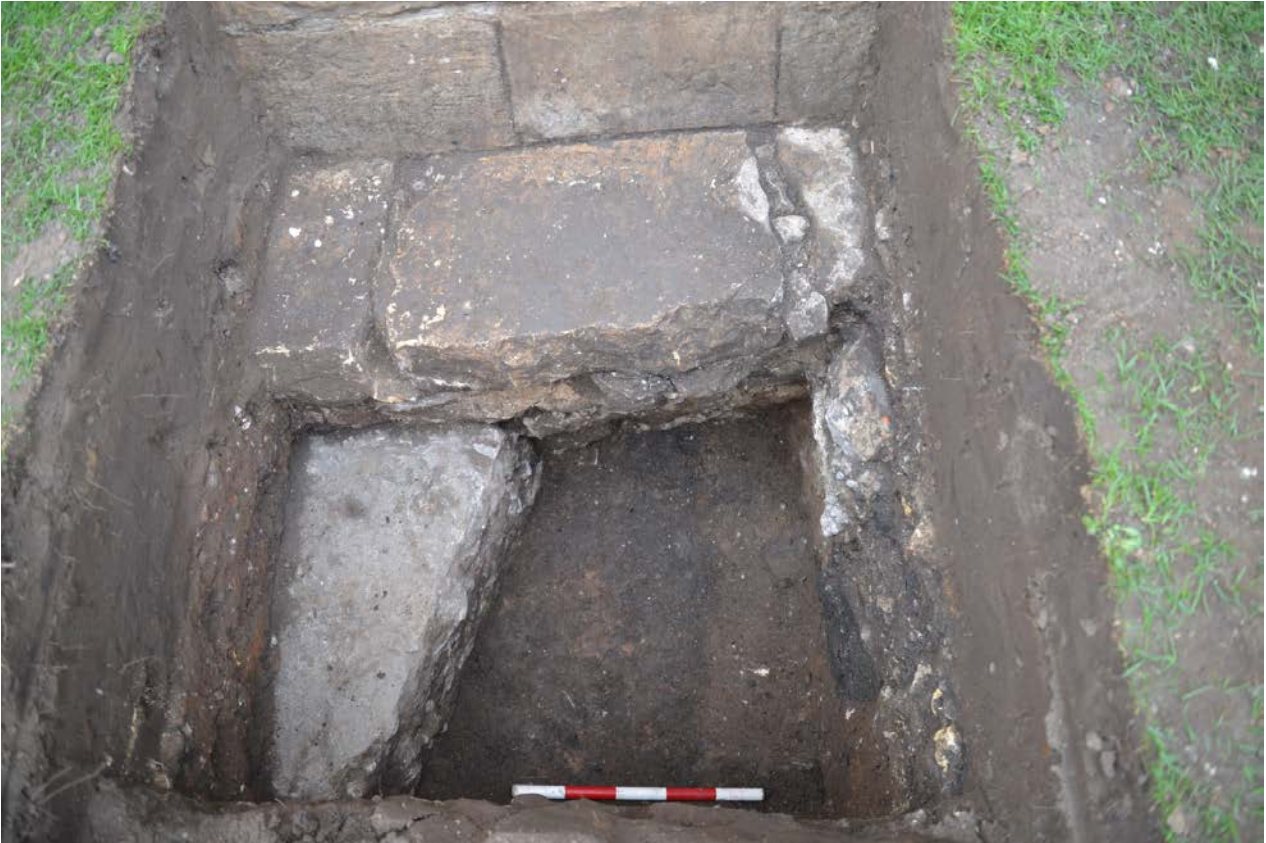
Basil Mott’s 1903 work to remedy the structural instability of the tower is seen in this test pit as the dense mass of concrete (90608) that butts against the medieval foundations (90605a). It occupies cut 90608; 90610 and 90603 are packing and backfill deposits.

Counting anti-clockwise from the south, this is the fifth of five concrete ribs that rise up to clasp and stabilise the foundations of the southeast of the tower and its fore-building.

Figure 14 Mott's concrete buttress 90608 and wall foundations 90605a. Source © Historic England, Pr7166-7086.

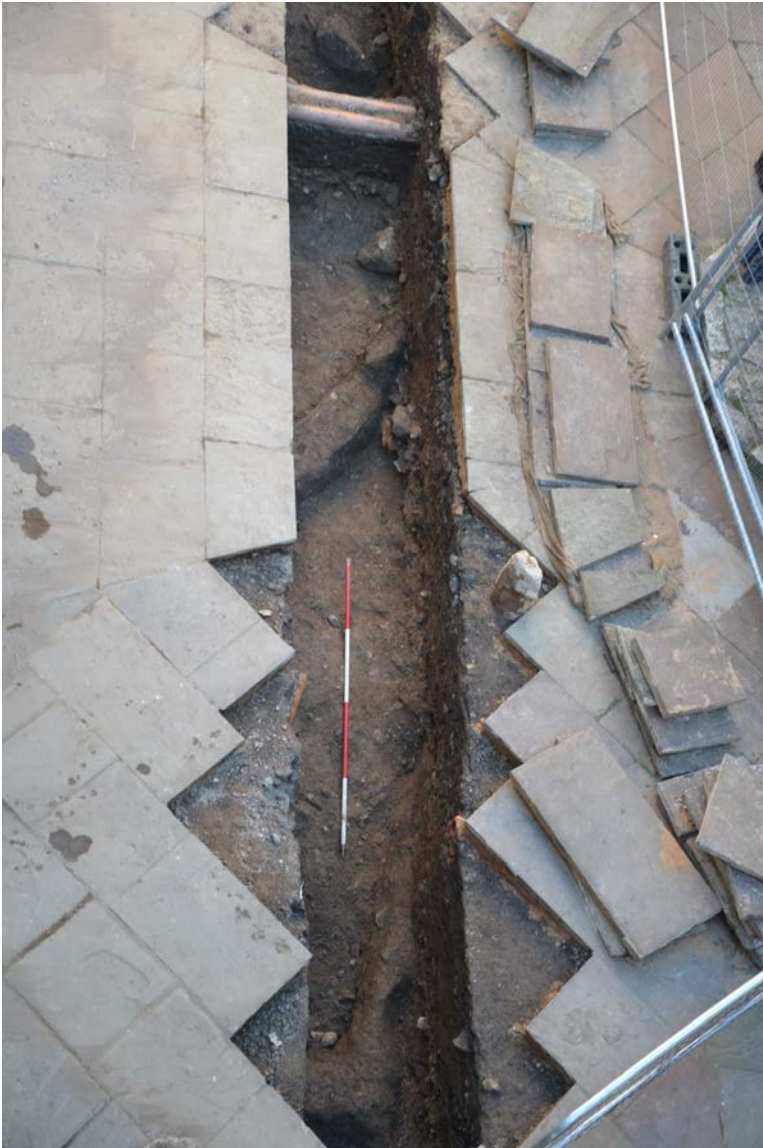
Figure 15 Trench 20 after excavation. Source © Historic England, Pr7166-7804

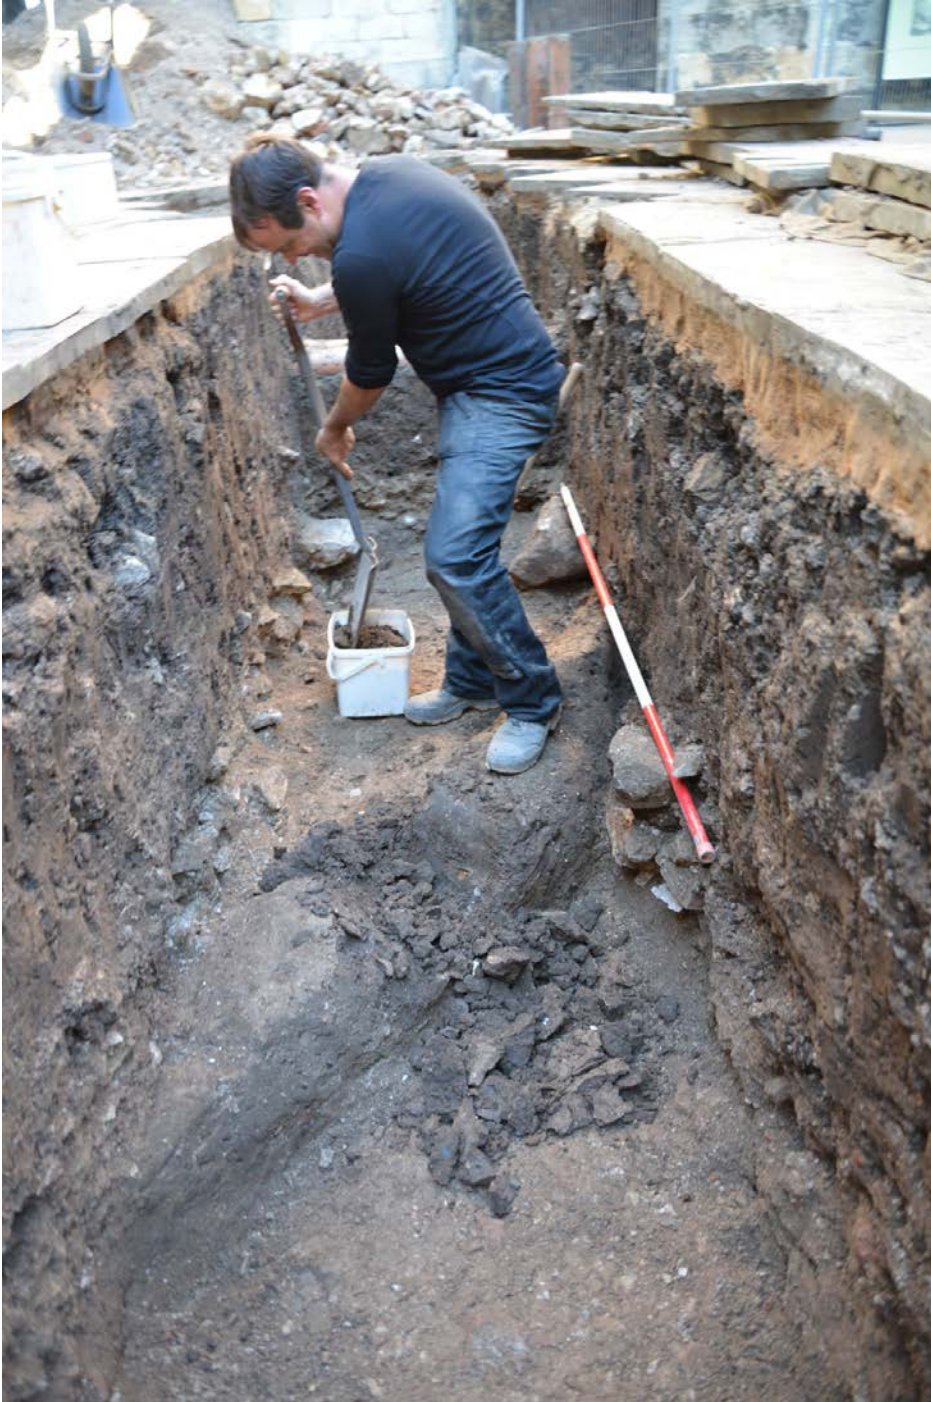
Figure 16 Taking sample 5012 from motte material 95037. Source © Historic England Pr7166-7808.

The motte material (95037) was sampled in three locations along the trench (Samples 5012- 5014, 20 litres each) to continue the sampling strategy begun in the first season of

excavation. This was to compare the material found across the motte as a large quantity of fish bone, charcoal and other small finds were found. Pottery fragments from the samples were medieval or Romano-British. The samples were taken from below the exposed surface to ensure the motte material was as undisturbed as possible.

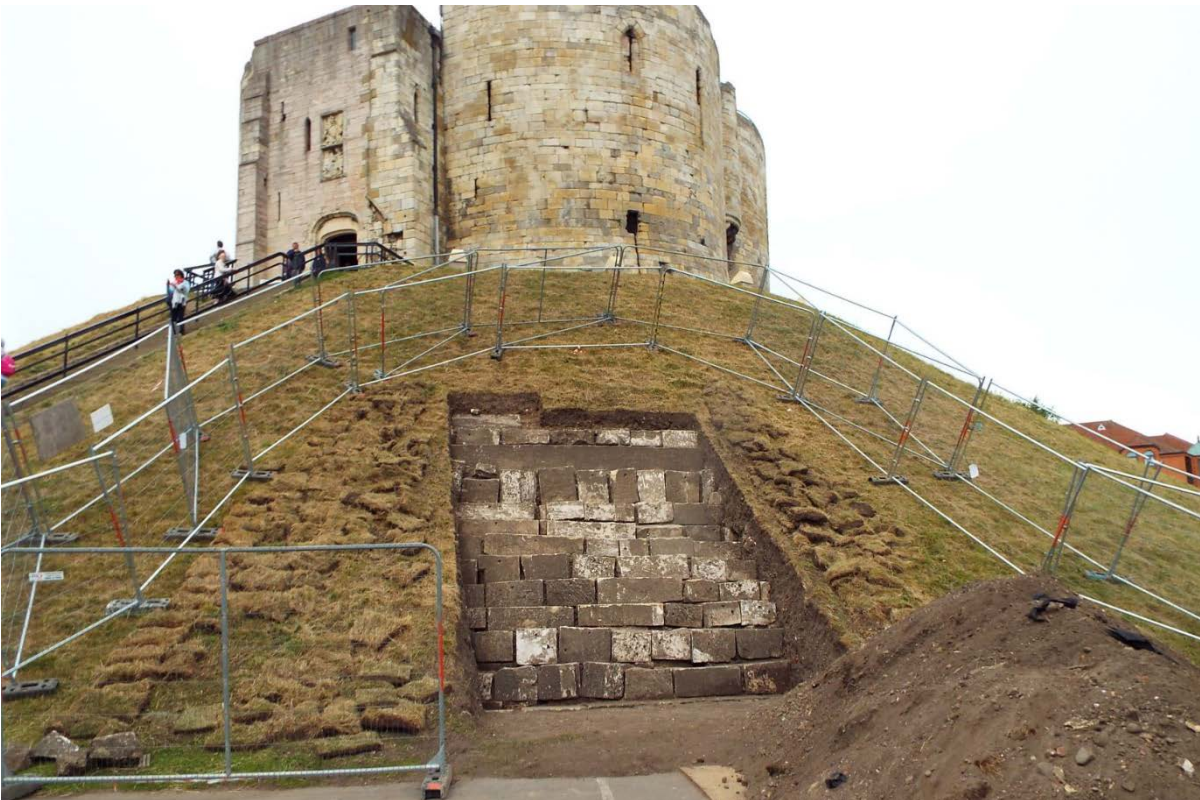
Figure 18 Stepped masonry blocks in Test Pit 9. Source © Historic England Pr7166-7926.

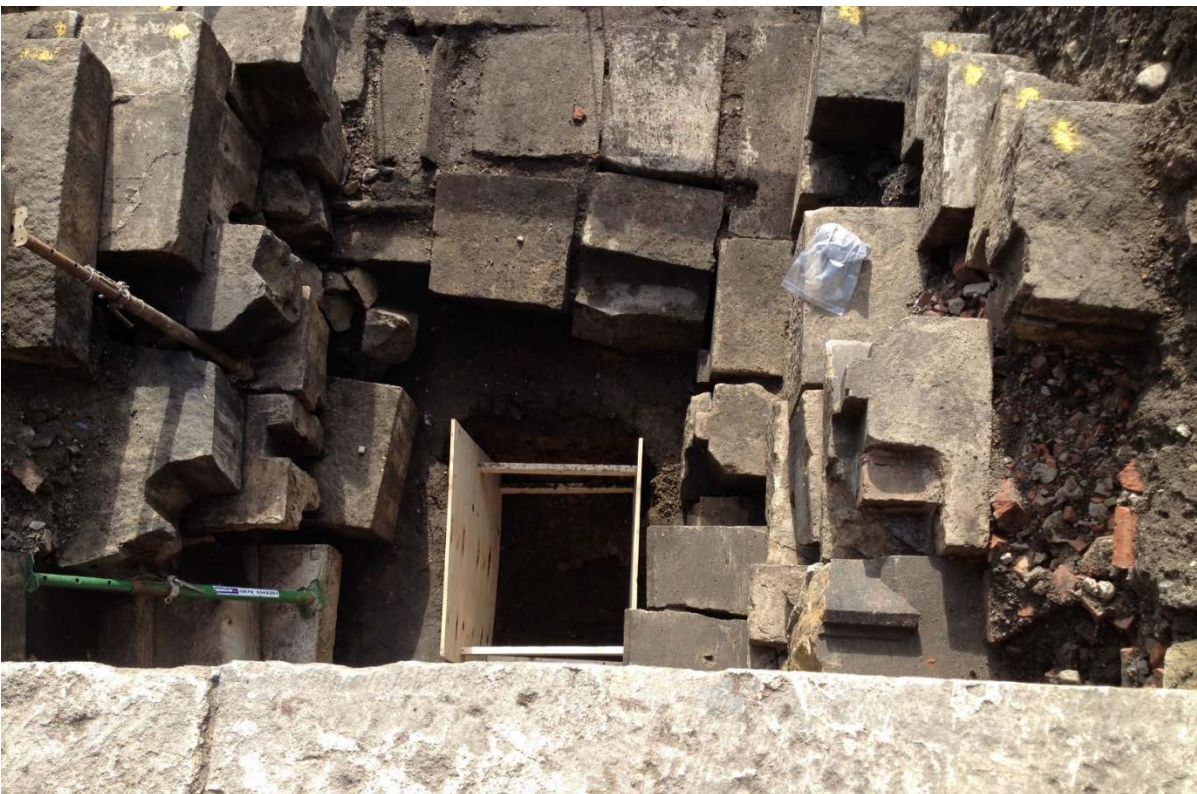
Figure 19 Excavation box from top of prison wall. Source © Historic England Pr7166-7937.

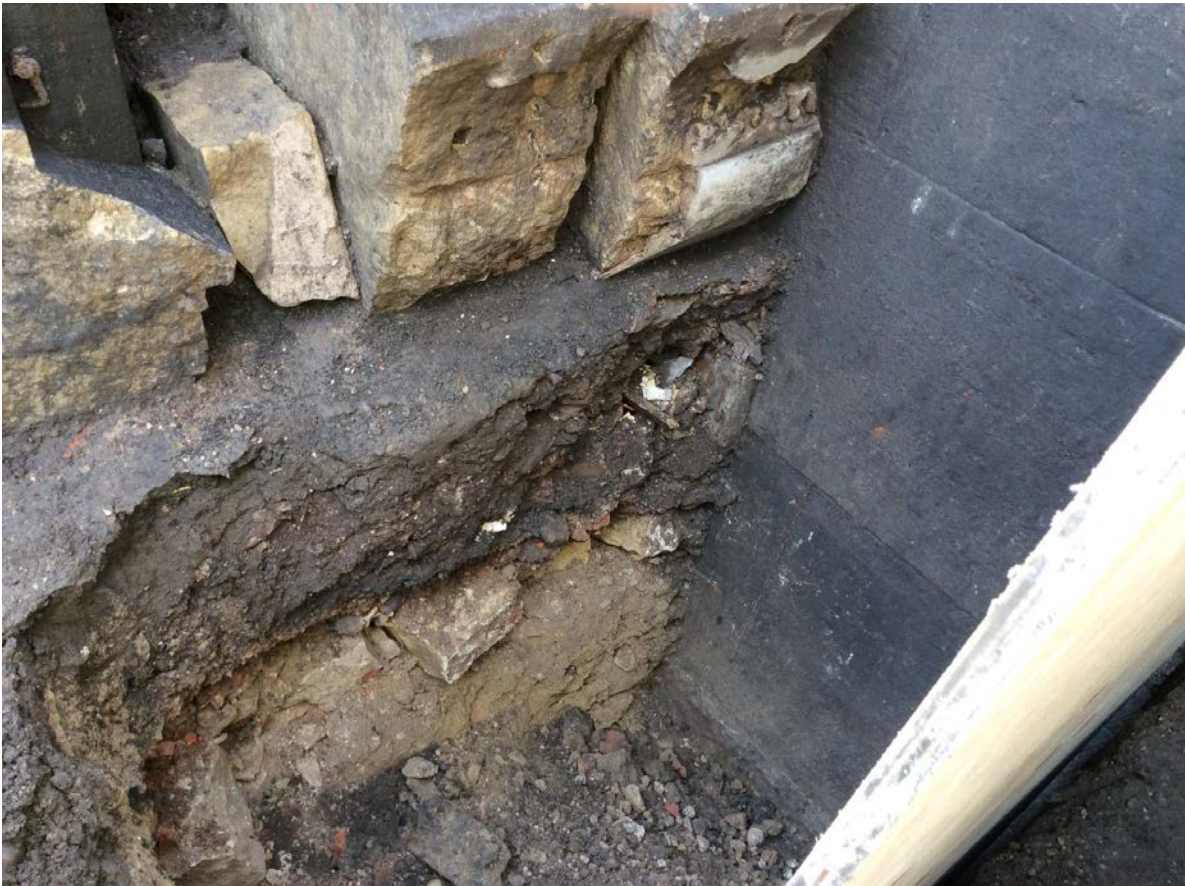
Figure 20 Section through modern backfill against wall. Source © Historic England Pr7166- 7932.

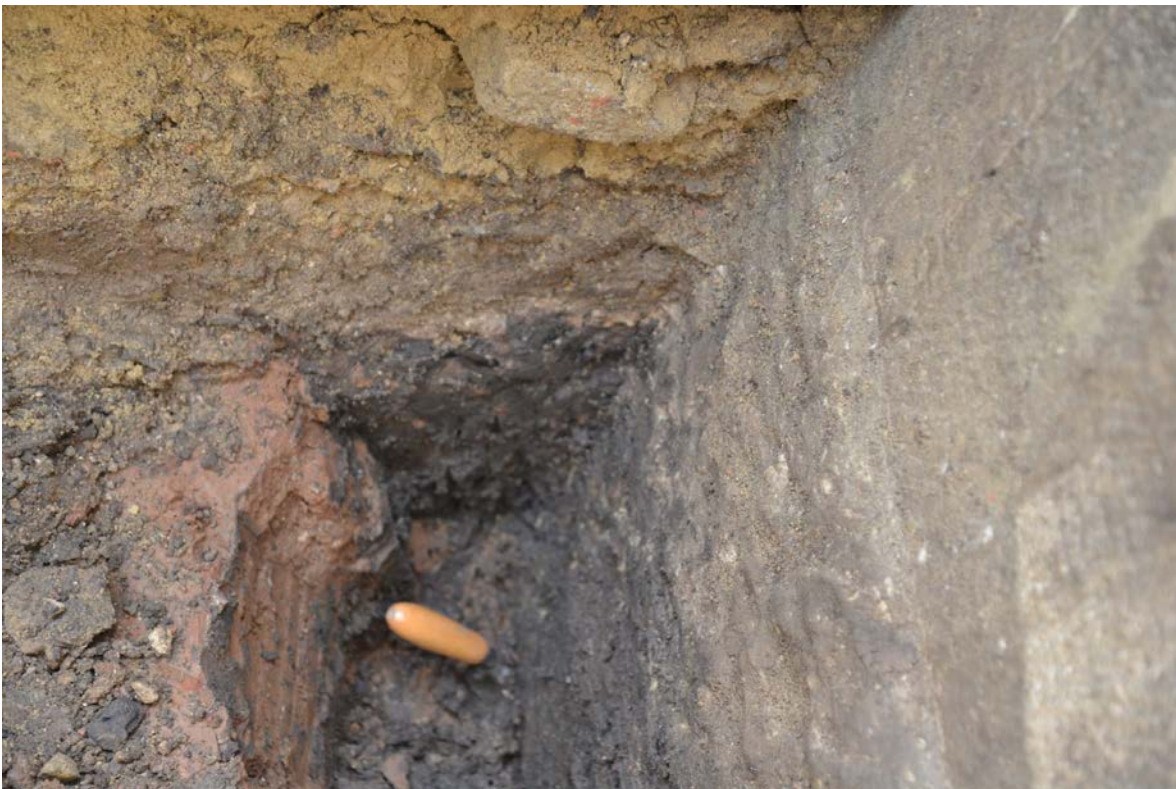
The battered ashlar wall face gave way to a single course of rough-hewn masonry set in a trench cut through stiff pink clay natural. The pink clay is likely to either be alluvial material or the natural York Formation clays. Any earlier archaeological remains appear to have been truncated either by the construction of the prison wall or by the later re-instatement.

Figure 21 Wall foundation and pink clay subsoil. Source © Historic England Pr7166-7947.

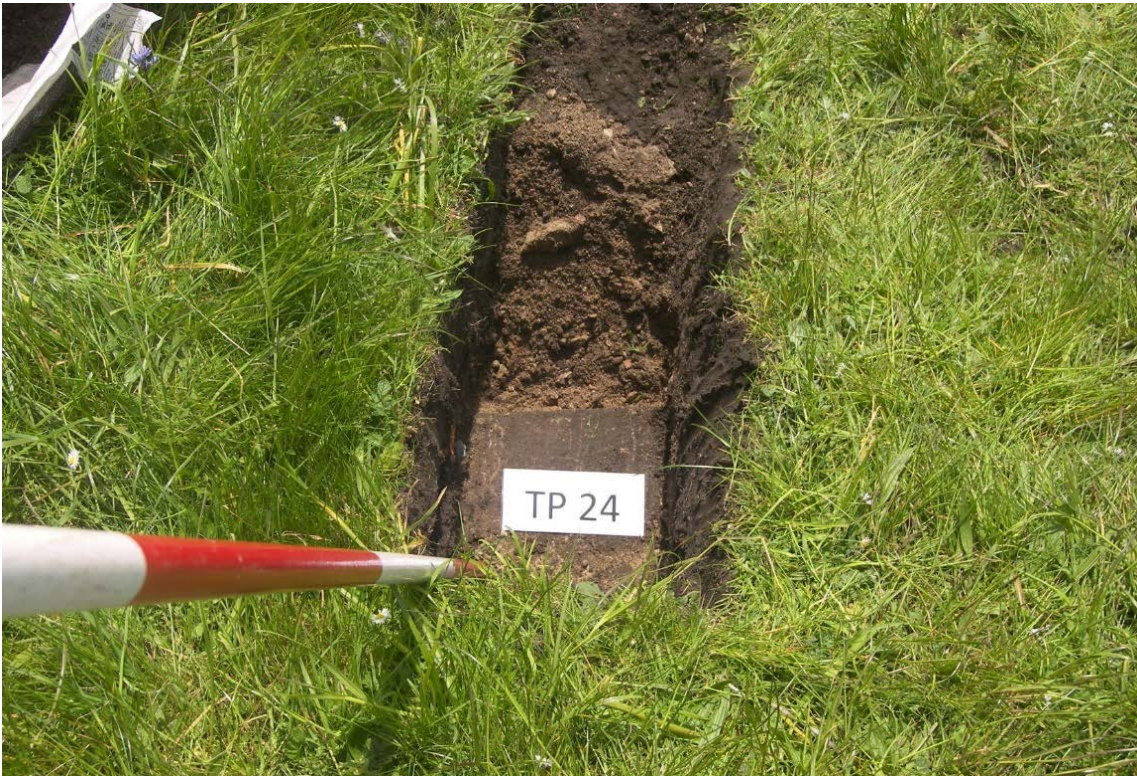
Figure 24 Top of retaining wall 92401 in Test Pit 24. Source © Historic England Pr7166-7912.

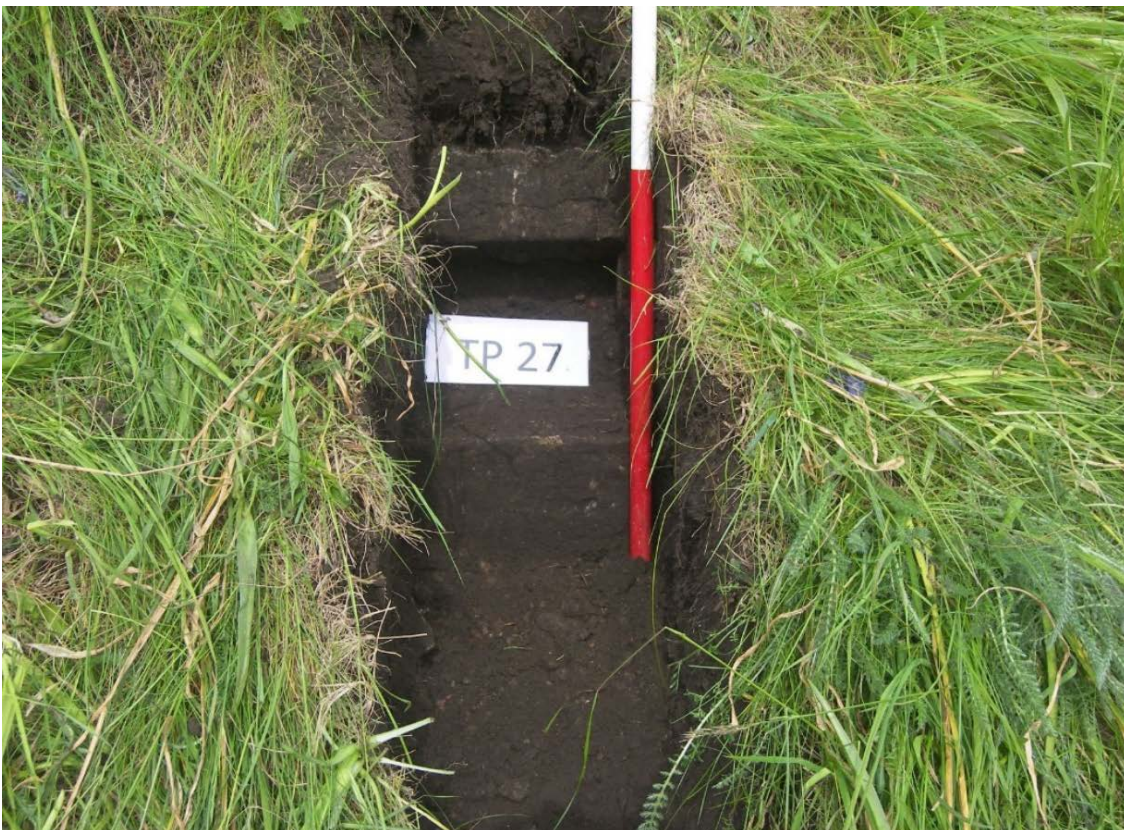
Figure 25 Retaining wall 92071 in Test Pit 27. Source © Historic England Pr7166-7918.
