Clifford's Tower, York

Excavations 2014-2016

2023

This report collates the results of excavations carried out by Historic England at Clifford's Tower, York, over a total of 6 weeks, between November 2014 and May 2016. There is a summary of the excavation archive and some assessment and analysis of the results.

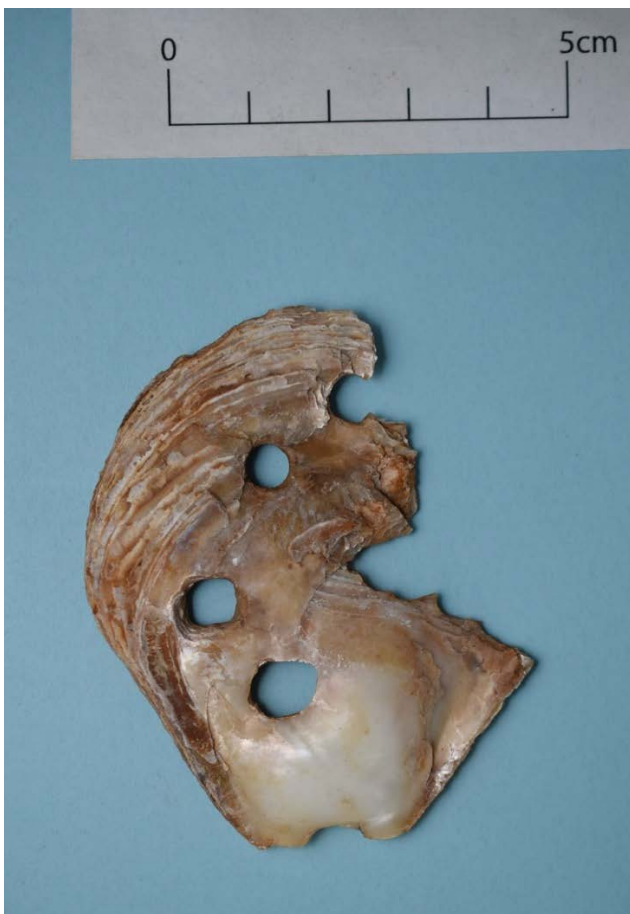
Two right (flat) valves of common or native oyster, *Ostrea edulis* L., the larger valve (68 x 63mm) badly broken (the lower rearward edge missing) and pierced by five roughly equally spaced holes set in from the shell edge, forming an irregular ring (Fig. 26, photograph 7960); the two holes nearest the hinge are larger and sub-rectangular, the two furthest from the hinge smaller and circular (the hole opposite the hinge is incomplete due to the break), and the fifth hole just survives as an indentation on the top edge of the rearward break. The holes' edges are as polished as can be expected in such a flaky kind of shell.

Figure 26 Pierced oyster shell 3001. Source © Historic England Pr7166-7960, Greg Campbell.

The exact function of these objects cannot now be determined with certainty. The suggestion that these are button-making or inlay-waste is very improbable because the holes are convincingly wear-polished, and buttons or inlay as small as these holes would crumble in such flaky shell; true oysters do not produce the tough highly polishable nacre or mother-of-pearl used to make buttons and inlays (good sources of nacre are the subtropical pearl-oysters *Pinctada* sp., the native British ormer *Haliotis tuberculata* and perhaps the very largest of the British freshwater *Unio* mussels).

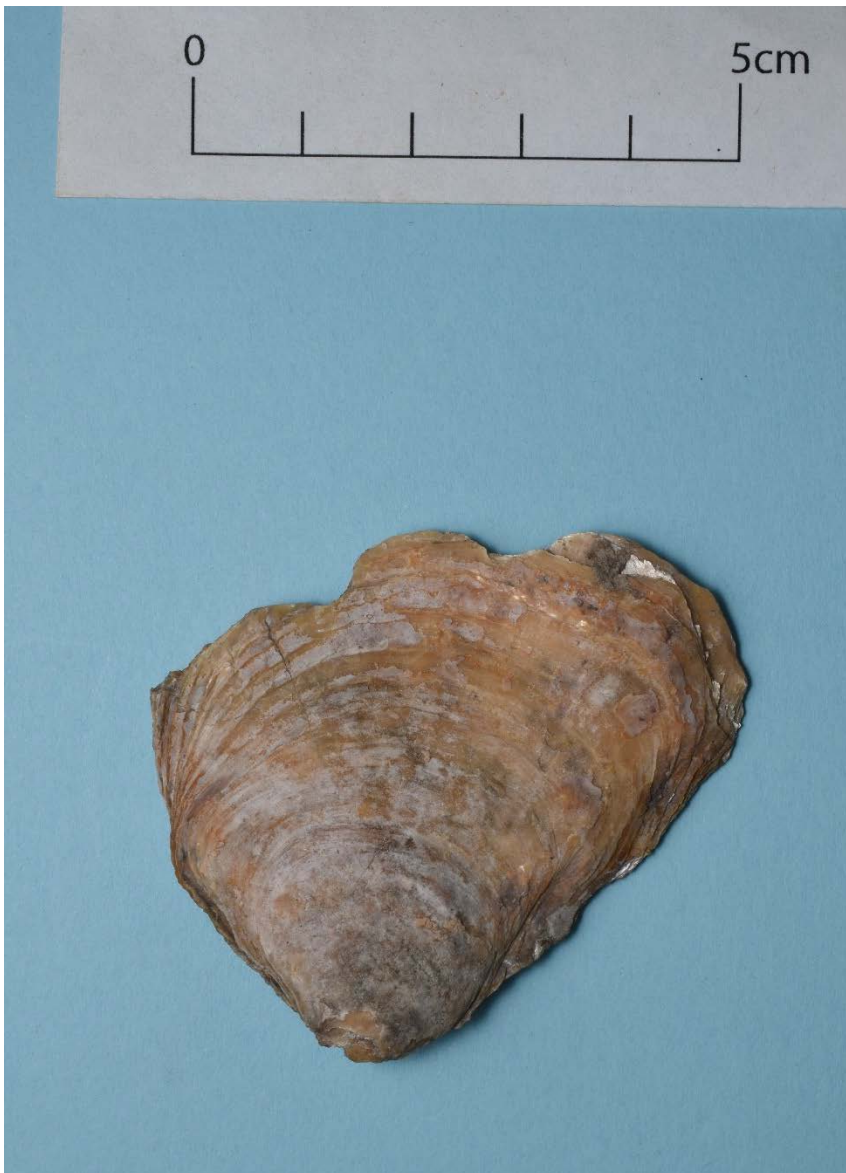
The smaller valve (49 x 54mm) is reduced from its original size by the loss of its lower forward edge (Fig. 27, photograph 7961), this edge polished by wear and bearing two semi-circular indentations, also polished; the indentations align exactly with two holes on the larger valve (Fig. 28, photograph 7962).

Figure 27 Pierced oyster shell 3052. [Source © Historic England Pr7166-7961, Greg Campbell]

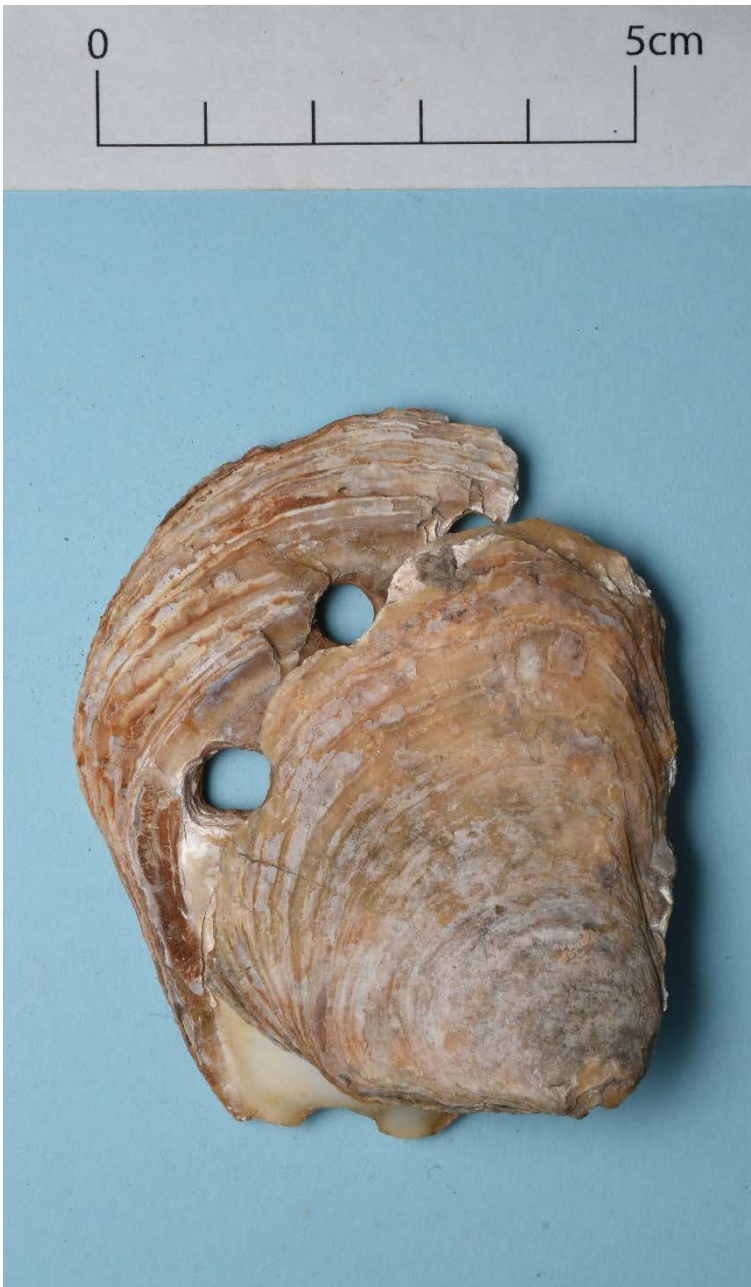
Figure 28 Shells 3001 and 3052 superimposed. [Source © Historic England Pr7166-7962, Greg Campbell]
