Priory Gardens, Dunstable, Central Bedfordshire: An Analytical Earthwork Survey

Research Report Series 11-2022

An Analytical Earthwork Survey

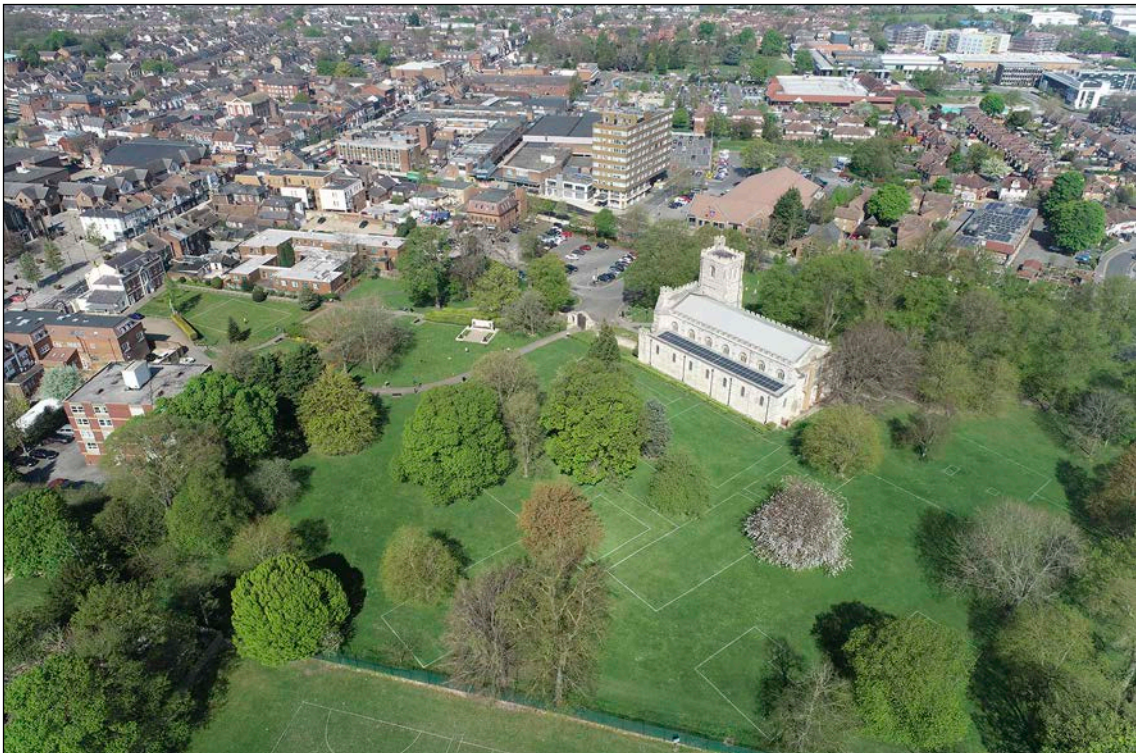
Figure 1: Priory Gardens (looking north) with the Priory Church of St Peter (centre right) and Priory House (centre left). The white lines painted on the grass are an interpretation of the probable positions of the priory buildings based on geophysical surveys. Photograph: Matthew Bristow 21-APR-2022

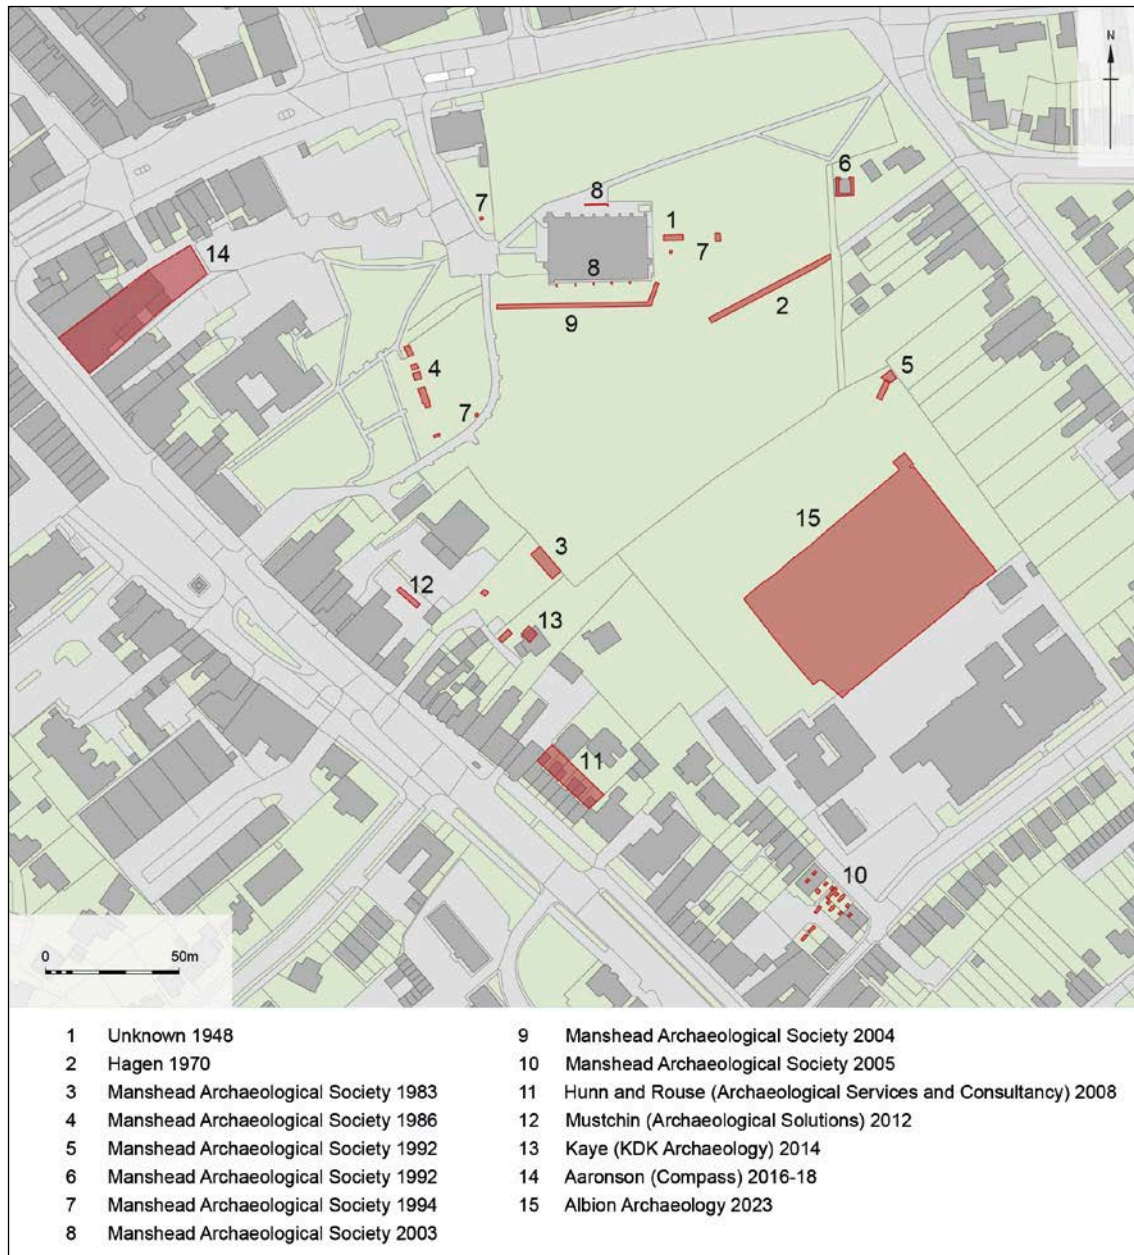
Figure 8: Previous 20th- and 21st-century archaeological interventions in and around Priory Gardens mentioned in the text (where location information is available). © Historic England. Background mapping © Crown Copyright and database right 2023. All rights reserved. Ordnance Survey Licence number 100024900.

Priory Gardens and the wider vicinity has seen a significant amount of archaeological research through the 20th and into the 21st century which is summarised below (Fig. 8). Earlier interventions are poorly recorded but appear to have included digging around the buried eastern end of the monastic church and the discovery of stone coffins (Lamborn 1859, 135-6). Some of these diggings

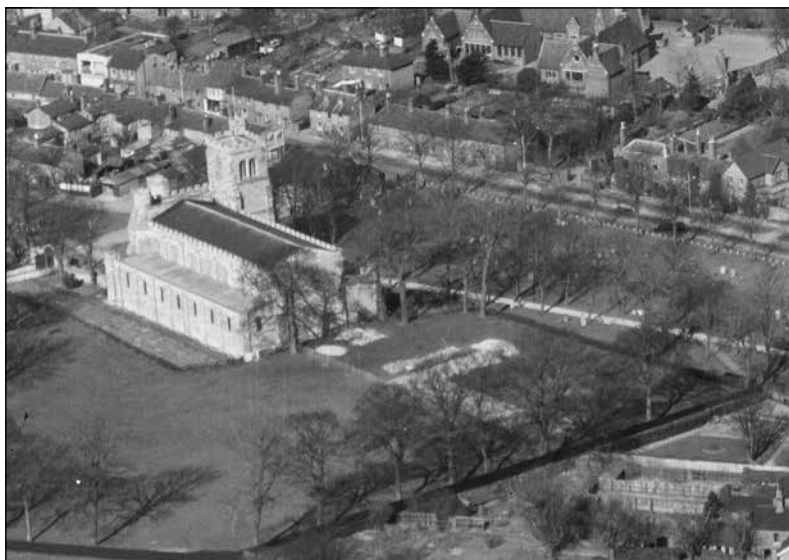
Figure 9: A detail of an aerial photograph taken in 1949 which appears to show the archaeological excavation trenches opened the previous year. HEA RAF/PFFO/540/173/0016 26-MAR-1949 (Historic England Archive: RAF Photography)

In 1948 two trenches were excavated immediately to the east of the church which revealed one of the columns from the original crossing and another wall to the east (Hitchcock 1993, 13; 1993a, 2-3). Low level aerial photographs taken in 1949 (Fig. 9) appear to show ground disturbance and spoil heaps relating to this activity, though the spoil and disturbance, especially to the east, appears to be much more extensive than the diagram published by the Manshead Archaeological Society 45 years later (Hitchcock 1993, 13).

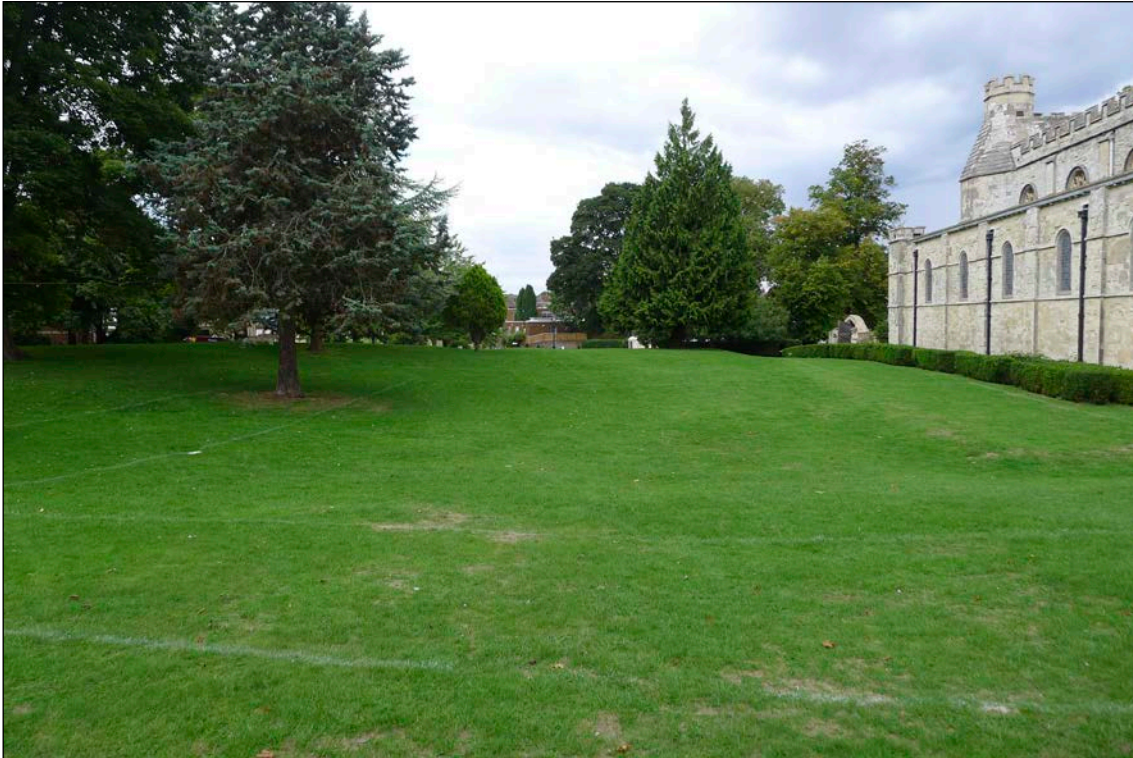
Figure 15: The sub-square hollow [2] indicating the former location of the cloister to the south of the church, view looking west. 12-SEP-2022. © Historic England

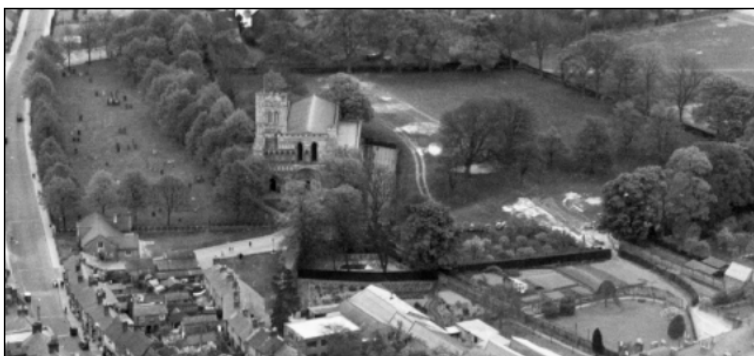
Figure 19: Extract from a 1938 aerial photograph showing the insertion of a service pipe across Priory Gardens, looking east. EPW056929 26-APR-1938 (Historic England Archive: Aerofilms Collection)

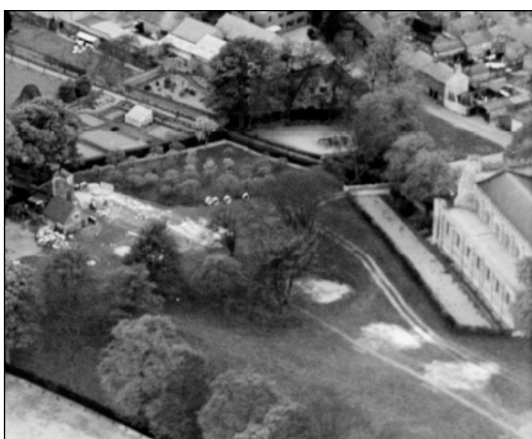
Figure 20: Extract from a 1938 aerial photograph, looking north-west, showing the service pipe sections and ground disturbance from the associated works. EPW056927 26-APR-1938 (Historic England Archive: Aerofilms Collection)

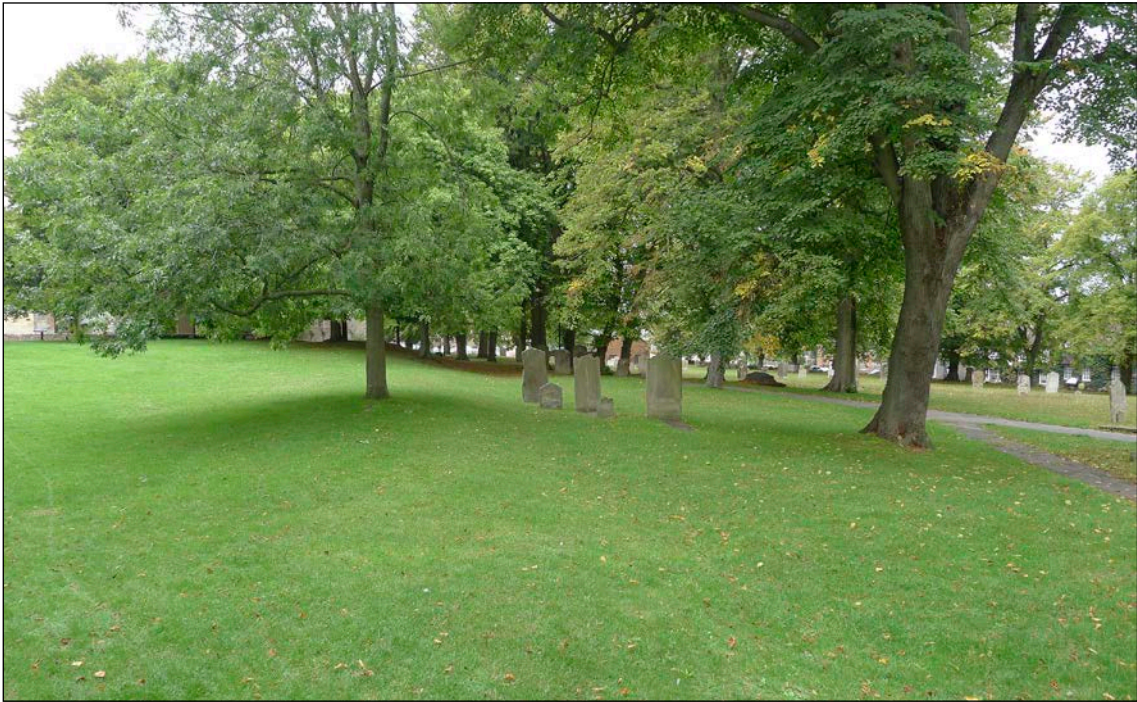
Figure 21: View looking west along the northern boundary bank towards the church with the churchyard to the north (right). 12-SEP-2022. © Historic England

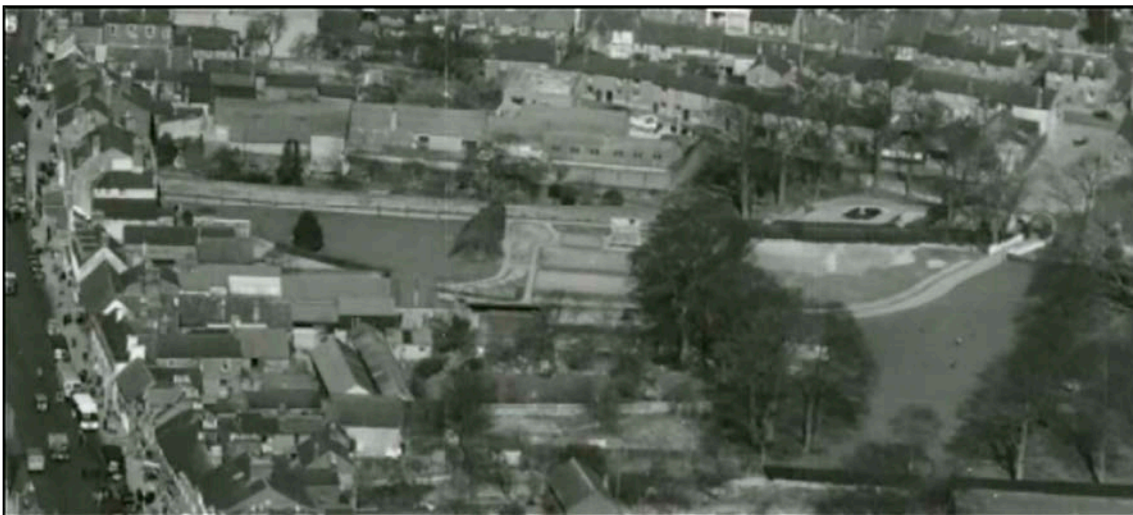
Figure 23: Extract from an aerial photograph taken in 1949 showing the orchard area cleared of trees prior to the installation of the war memorial. Looking north, with High Street South to the left and Priory Church just out of shot to the right. RAF/SFFO/540/173/0036 26-MAR-1949. (Historic England Archive: RAF Photography)

A possible former orchard, characterised by trees planted in well-spaced rows, is visible on numerous aerial photographs from 1928 through to 1949 (e.g. Figs 24 – 25), by which date the trees had been cleared, possibly to create an appropriate setting for the war memorial which was installed around 1952 (Fig. 23). Though trees are shown on earlier maps the area is not enclosed and depicted as orchard until the 25-inch 2nd edition OS map of 1909. An orchard is mentioned on the site in a probate will at the end of the 17th century and pleasure and kitchen gardens are mentioned from 1780 onwards (Henderson et al. 2022, 6-7).

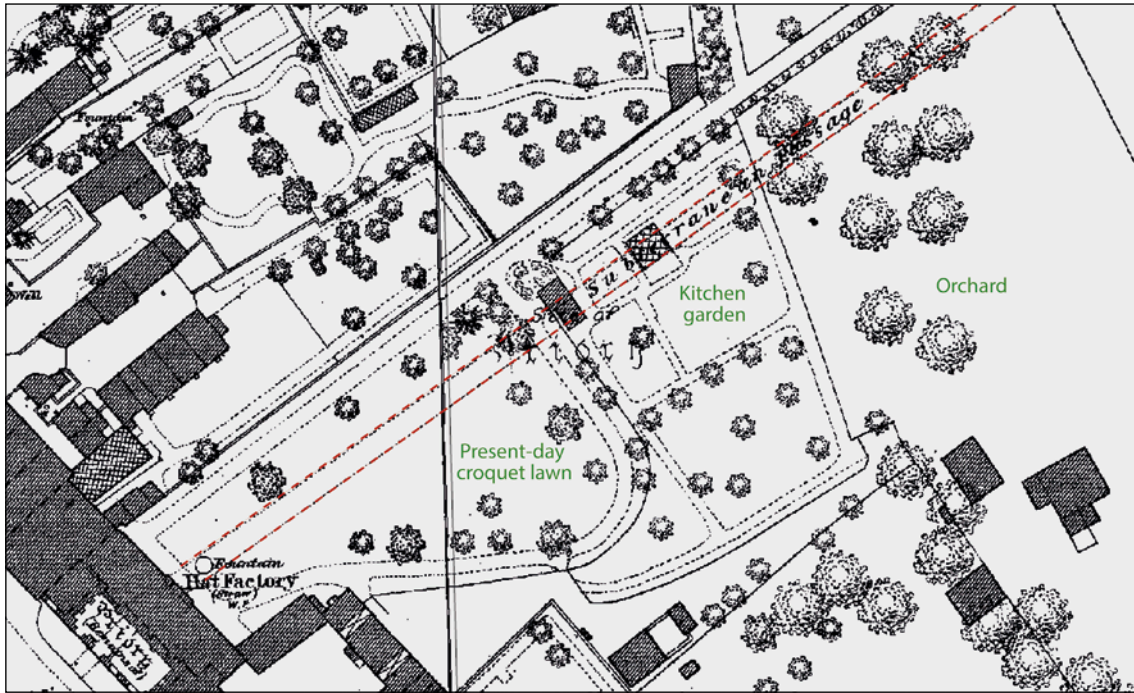
Figure 24: An extract from the Ordnance Survey 1:500 Town Plan published in 1880 showing the kitchen garden, orchard area and the present-day location of the croquet lawn. The fountain can be seen at the end of the so-called 'subterranean passage' (marked with parallel dashed lines) © Historic England. Background mapping © and database right Crown Copyright and Landmark Information Group Ltd (All rights reserved 2023). Licence numbers 000394 and TP0024. Not to scale.

marked on the 1:500 OS Town Plan published in 1880 and may be related to whatever this passage is in reality, whether it be some form of monastic culvert or drain, or something related to the later activities of the hat factory at Priory House (see Fig. 24).

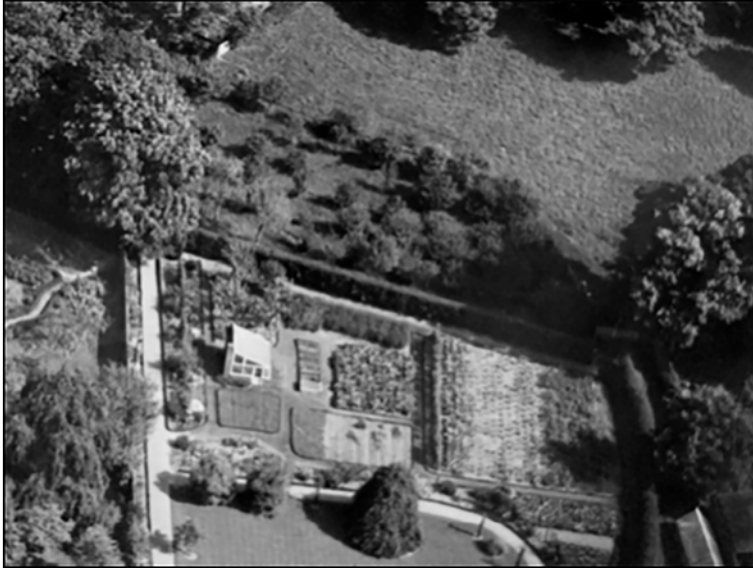
Figure 25: Detail from a 1928 aerial photograph of the kitchen garden area and orchard beyond, looking north-east. EPW023862 01-SEP-1928 (Historic England Archive: Aerofilms Collection)

The section of gardens between the croquet lawn and what was the orchard area was formerly a kitchen garden. It is shown on the 1:500 OS Town Plan published in 1880 and is very little changed in the Aerofilms aerial photograph taken in 1928 (Fig. 25). It was probably the creation of Arthur Munt who lived at Priory House from 1909 until 1927 and who has been described as a 'keen gardener' (Curran 2008, 22). Though it appears that the area was no longer in use as a kitchen garden by 1952 (TL0221/1 CAP9057/42 07-JUN-1952), the main elements of the late 19th-century layout survived into the 1960s but had subsequently been removed by 1969 (OS/69/110/039 14-APR-1969). It is worth noting that when the layout was changed, before or in 1969, the path to the east of the kitchen garden was realigned to the west of its former position, making the surviving area smaller than it was in the 19th century. A pair of very slight curving scarps in the northern section of the garden appear to mark the curved corners of former vegetable beds [60] and a number of other surviving scarps [61] may also mark the edges of beds. These are clearly identifiable on the drone-derived digital elevation model (see Fig. 28). A very slight ridge, just under 13m in length, seen partly as an earthwork and on the digital elevation model, may also represent the edge of these formal beds [62], though this is also in line with anomaly [gpr48] (Fig. A2) and may mark the position of an extension of the feature traditionally known as the 'subterranean tunnel' evident on the croquet lawn to the west [63].

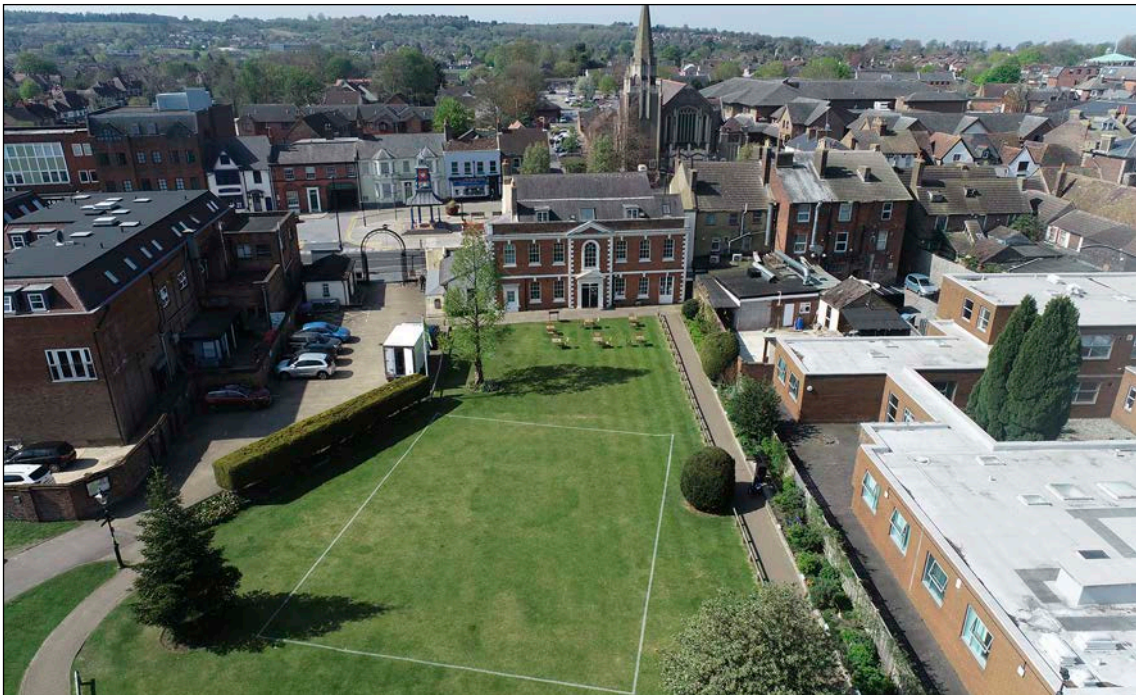
Figure 26: The croquet lawn with Priory House beyond, looking south-west. 21-APR-2022. (Photo: Matt Bristow) © Historic England

The lawn immediately east of Priory House, now known as the croquet lawn, has changed little through the 20th and into the 21st century (Fig. 26). The oldest feature recorded here may be the very low ridge, 23m long and just over 3m wide, which runs parallel to the path on the north-western side of the lawn [63]. This coincides with linear anomaly [gpr46] (Fig. A2) which is thought to represent a drain or a culvert. This feature appears to line up with the ‘subterranean passage’

A number of slight scarps in this area [67] probably relate to minor changes to the shape of the garden throughout the 20th century and the substantial scarp that crosses the croquet lawn from north-west to south-east [68] (and the adjacent scarp that runs parallel to the north-western path) is clearly related to the levelling of the area to its east in order to create a suitable, flat, surface, presumably for croquet. It is not clear from the aerial photographs when this levelling was undertaken but a slight circular feature, 6.8m in diameter, visible as an earthwork and on the digital elevation model, must pre-date the creation of the croquet lawn and is perhaps a former flower-bed [69]. The digital elevation model suggests that the feature consists of a circular ditch enclosing an area roughly 5.25m in diameter (see Fig. 28). It can also be seen as a mark in the grass on Figure 26.

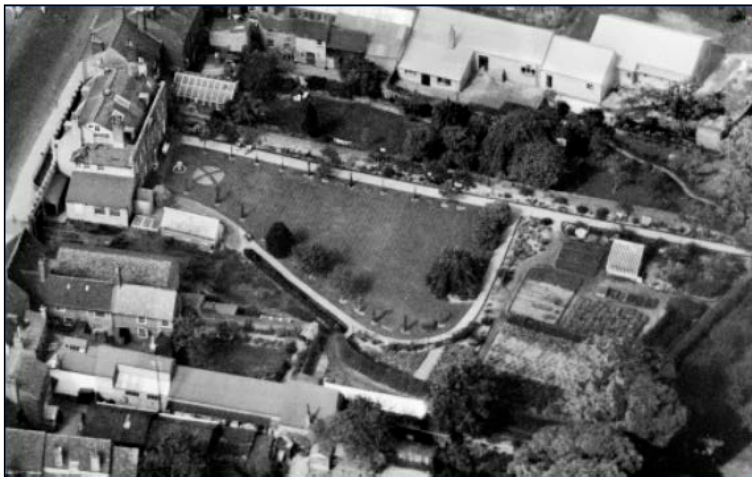
Figure 27: Detail from a 1928 aerial photograph showing the area now known as the croquet lawn behind Priory House laid out as formal gardens, looking north-west. EPW023860 01-SEP-1928 (Historic England Archive: Aerofilms Collection)

On the line of the linear bank mentioned above, and closer to Priory House, is a small platform around 2m square, defined by a very shallow ditch on average 1.7m in width [64]. This is probably the site of the fountain or possibly bird bath shown on the Aerofilms photographs from 1928 (Fig. 27), perhaps the same one marked on the 1:500 1880 OS Town Plan. However, the earthwork does appear to be further away from the front of Priory House than the fountain and may relate to the cross feature shown on the aerial photograph to the east. A number of vegetation hollows recorded along the north-western and, what would have been, the southern edge of the croquet lawn mark the position of ornamental shrubs as seen on the 1928 aerial photograph [65]. A slight irregular shaped mound at the eastern end of the croquet lawn [66] marks the former position of a tree shown on the 1928 photograph (Fig. 27).

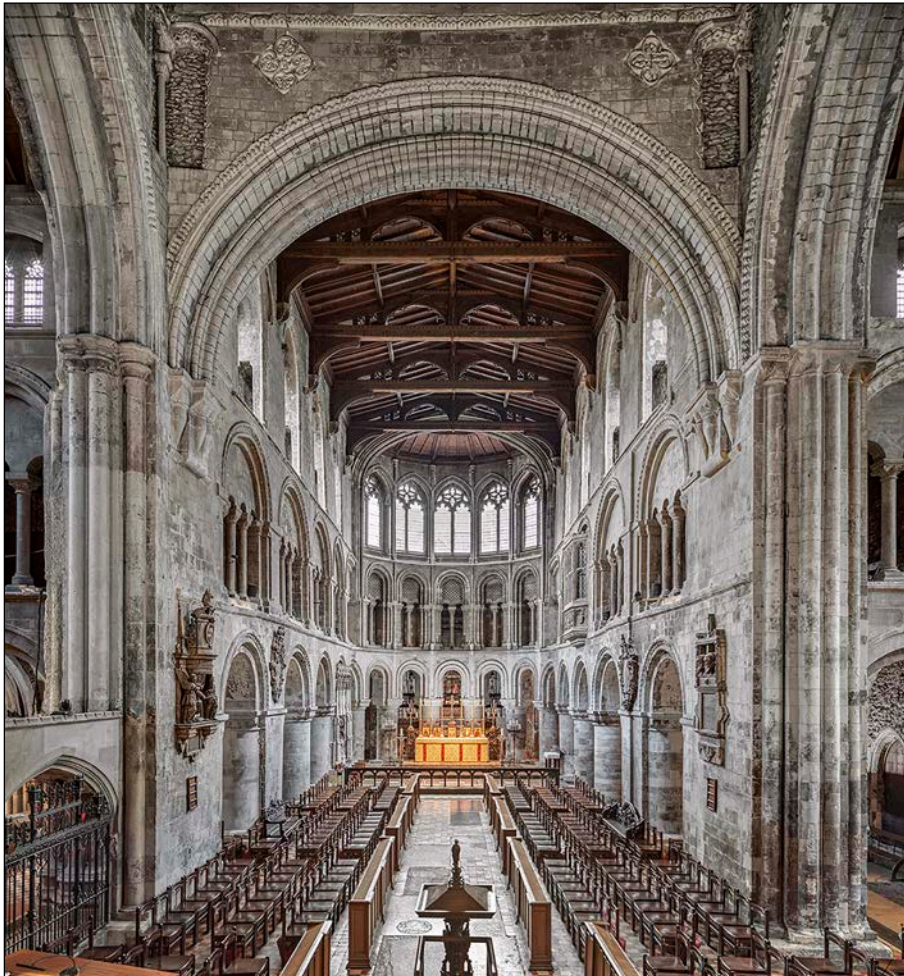
Figure 29: The eastern end of St Bartholomew the Great, Farringdon, London, with rounded apsidal end and arcaded ambulatory. Image: Chris Redgrave DP462404 © Historic England Archive.

The Ground Penetrating Radar (GPR) survey and, to a certain extent the analytical earthwork survey, have revealed new information about the layout of the priory church's east end, in the form of a buried curving ditch and parallel section of wall. These appear to indicate an apsidal or rounded presbytery with an arcaded ambulatory (passageway), similar to that of the 12th-century Augustinian presbytery which survives in the church of St Bartholomew the Great, Farringdon, London (Fig. 29), or as suggested by excavations and GPR survey undertaken at the Priory Church of Saints Peter and Paul at Leominster (Fig. 30), or St Augustine's Abbey at Canterbury (Freeman 1853, 111; Barker and Rarity 2003; Coppack 1990, 40). Aside from the clear evidence of the Lady Chapel, located immediately to the east of the presbytery, there are hints in the GPR of separate chapels that could be accessed from the ambulatory and transepts, but the evidence is far from conclusive.

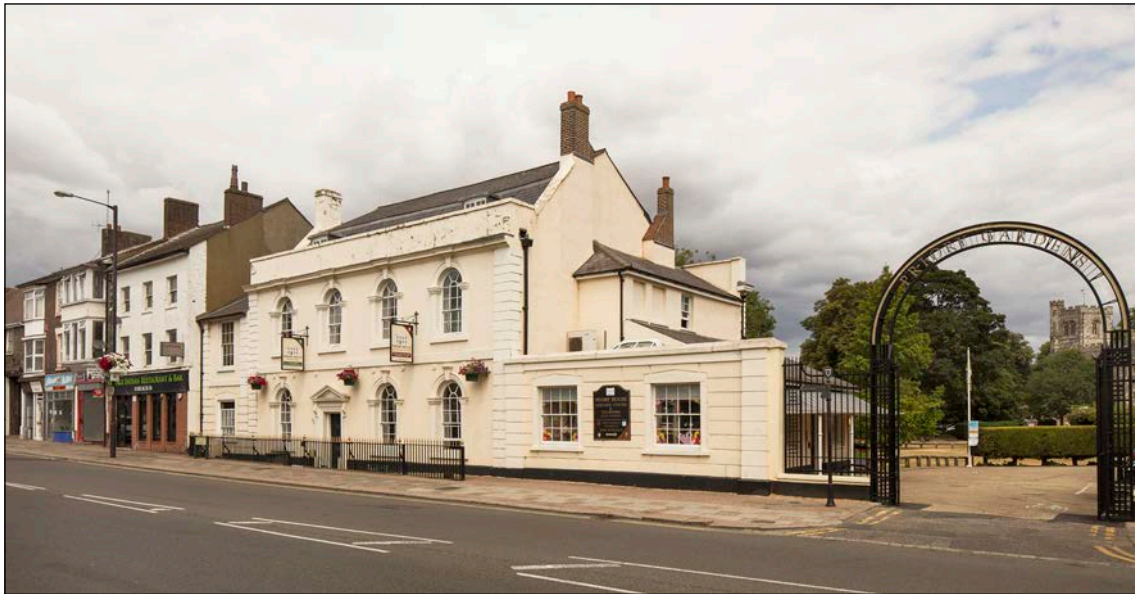
Figure 35: Priory House, looking north-east from High Street South, with Priory Church and Priory Gardens visible in the distance beyond the building. Photograph: Patricia Payne 18-JUL-2018 DP232302 © Historic England Archive

Hall (2021, 2) describes the medieval core of Priory House as ‘a rare near-complete survival of a small early 13th-century stone undercroft, with hall over’ (Fig. 35). This interpretation aligns with that of Henderson et al. (2022, 21; 37) whose investigations also suggest that it was a two-storey building (with a presumed external stair) constructed in the first half of the 13th century. Recent radiocarbon dating has confirmed that the vault was likely to have been constructed between 1217-1269 (Bayliss et al. 2024). There have been many different interpretations of the original function of the medieval building and its relationship with the priory. The most common interpretation is that it was the guest house (or hospitium) for the priory (e.g. Rushton 2003, 27), though Curran (n.d., 37) has suggested that it may have been a private merchant’s house and notes other interpretations through the years including as a canons refectory, school house or market hall. It has also been referred to as a ‘hostelry’ that lay outside the priory precinct (O’Brien and Pevsner 2014, 152). Henderson et al. (2022, 42) suggest that the lack of evidence for internal division, opposing entrances and fireplaces that definitely belong to the first phase of construction make it hard at present to interpret the building as ‘purely domestic’. It should be noted that at the time of writing Priory House is undergoing further

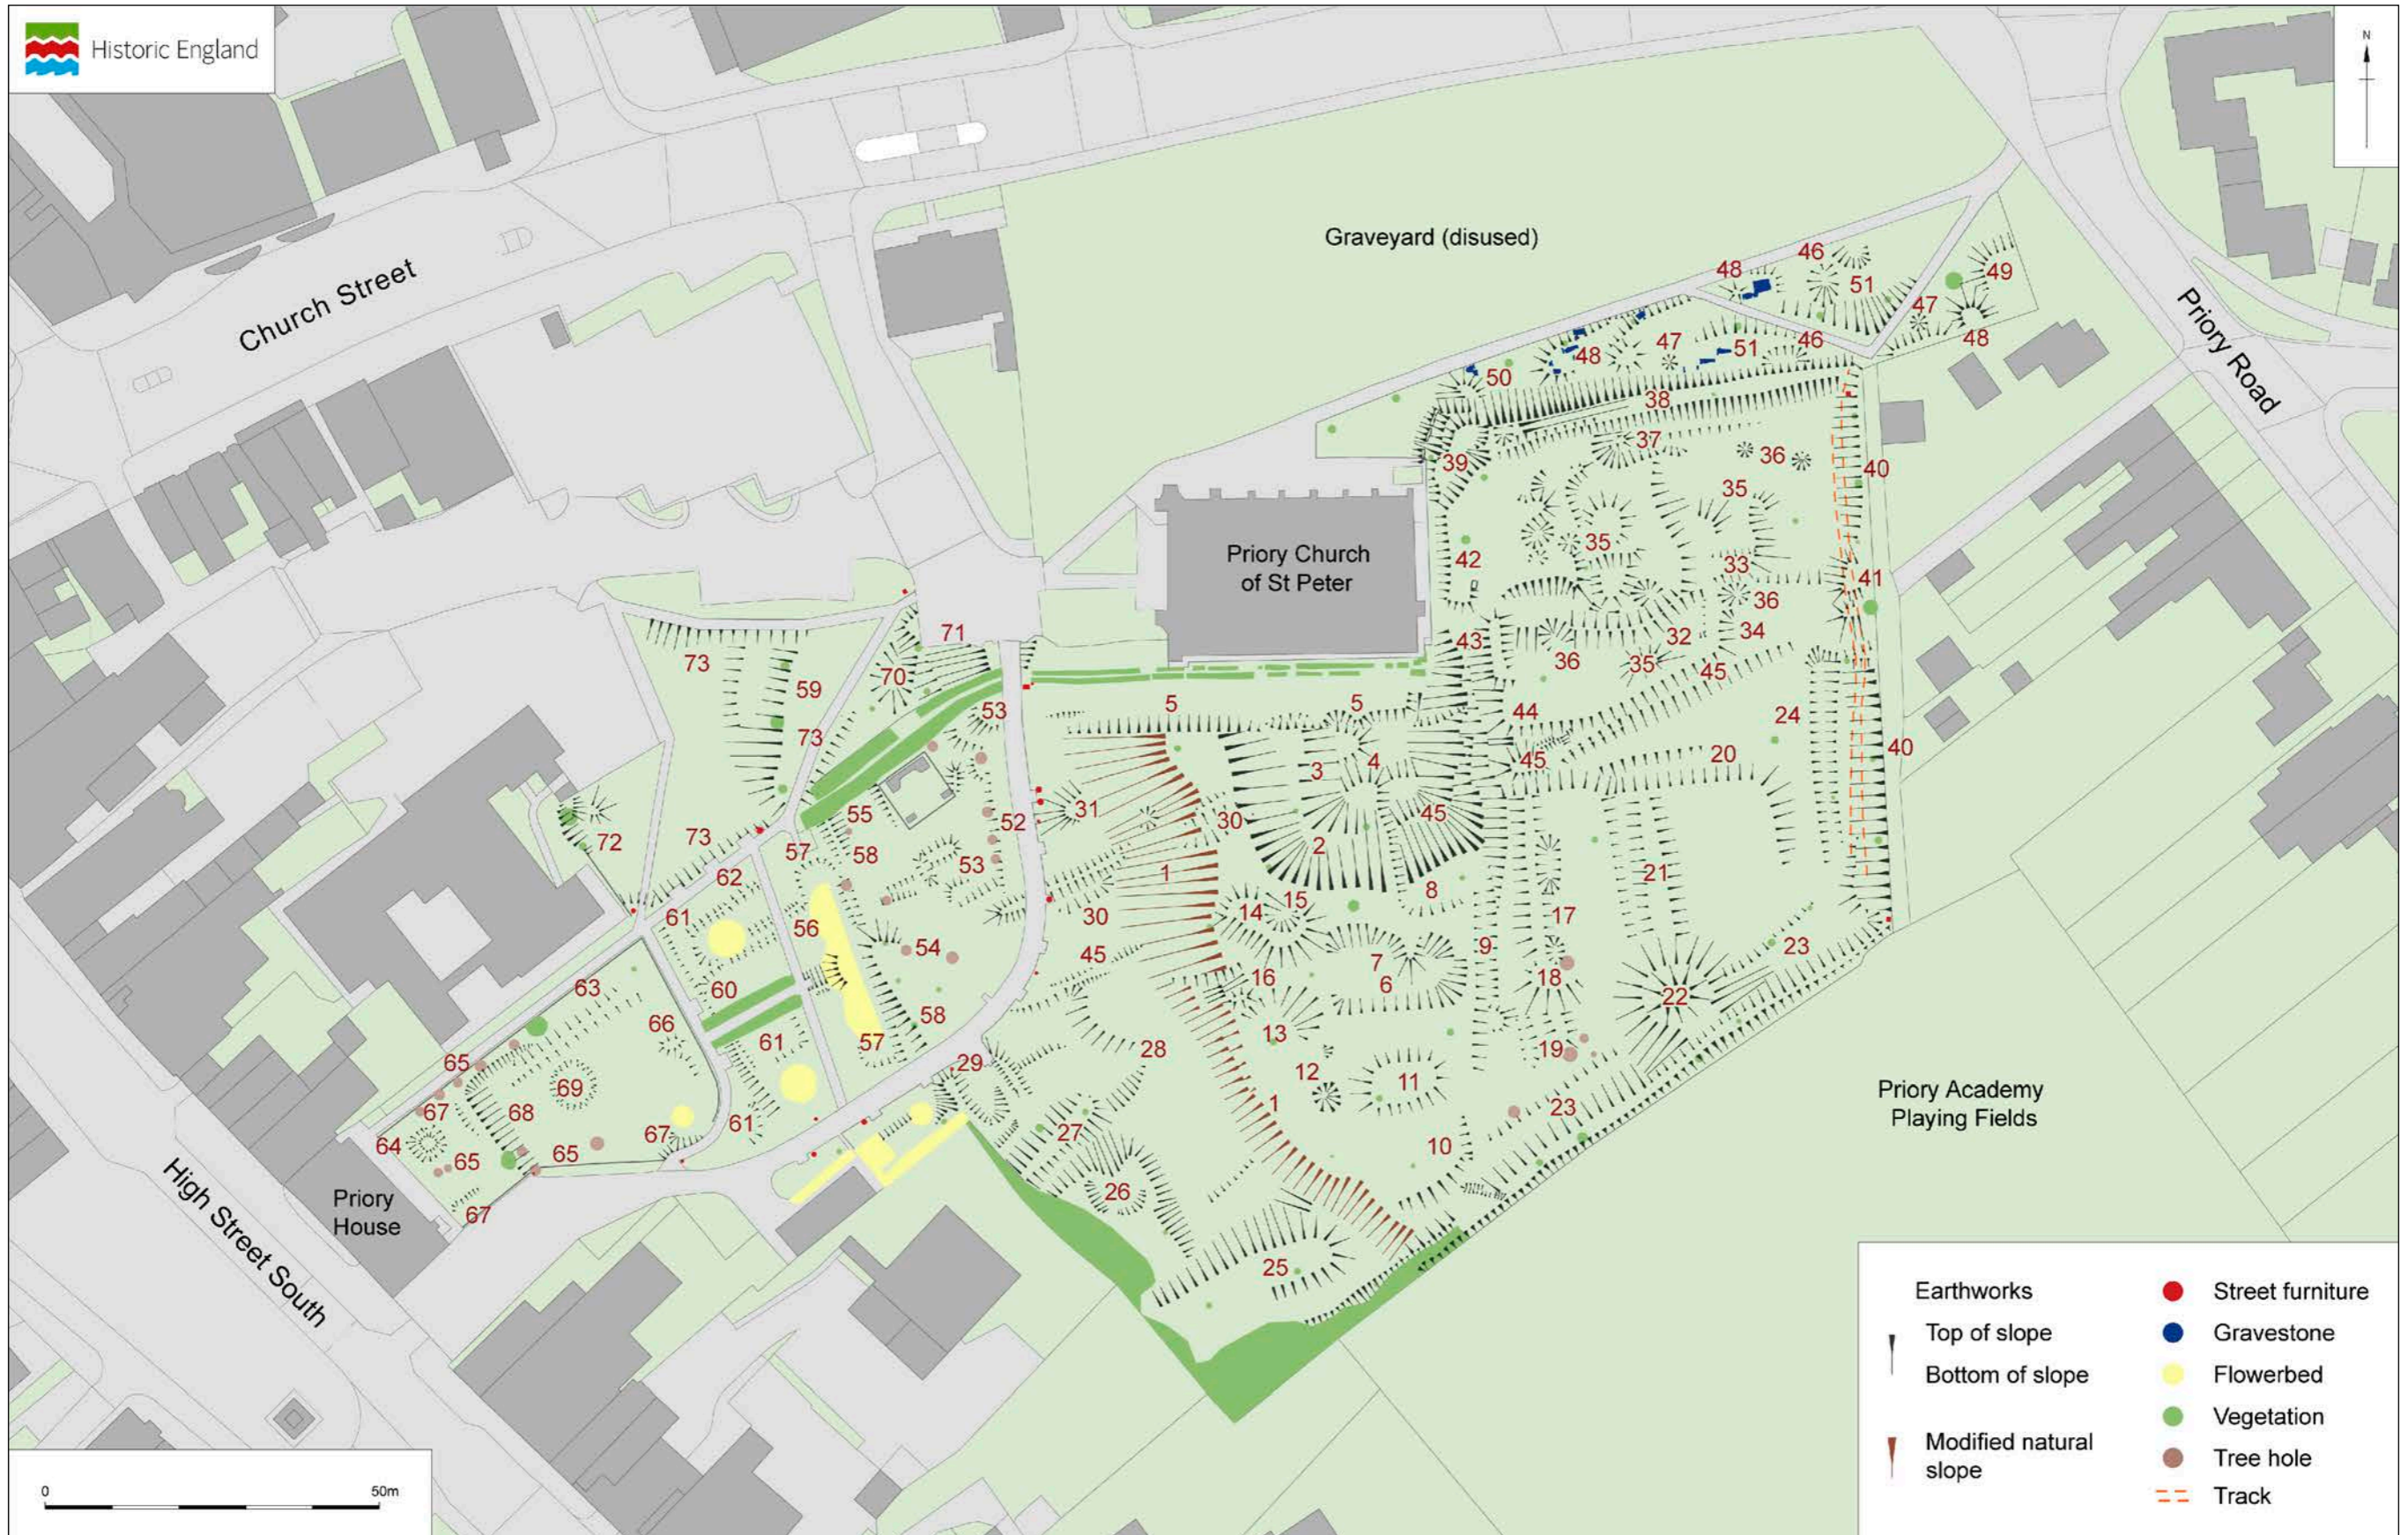
Figure A3: The analytical earthwork survey of Priory Gardens, Dunstable (1:1000 scale) with labels referring to the numbers in square brackets used in the text. © Historic England. (Background mapping © Crown Copyright and database right 2023. All rights reserved. Ordnance Survey Licence number 100024900)

NB Feature numbers given in square-brackets throughout the description text and on extracts from the survey drawing (Figs 13, 17 and 22) are to aid reader orientation. A full, numbered, 1:1000 scale, A3 version of the analytical earthwork survey plan can be found at the back of this report (Fig. A3) alongside an unnumbered version (Fig. A4).

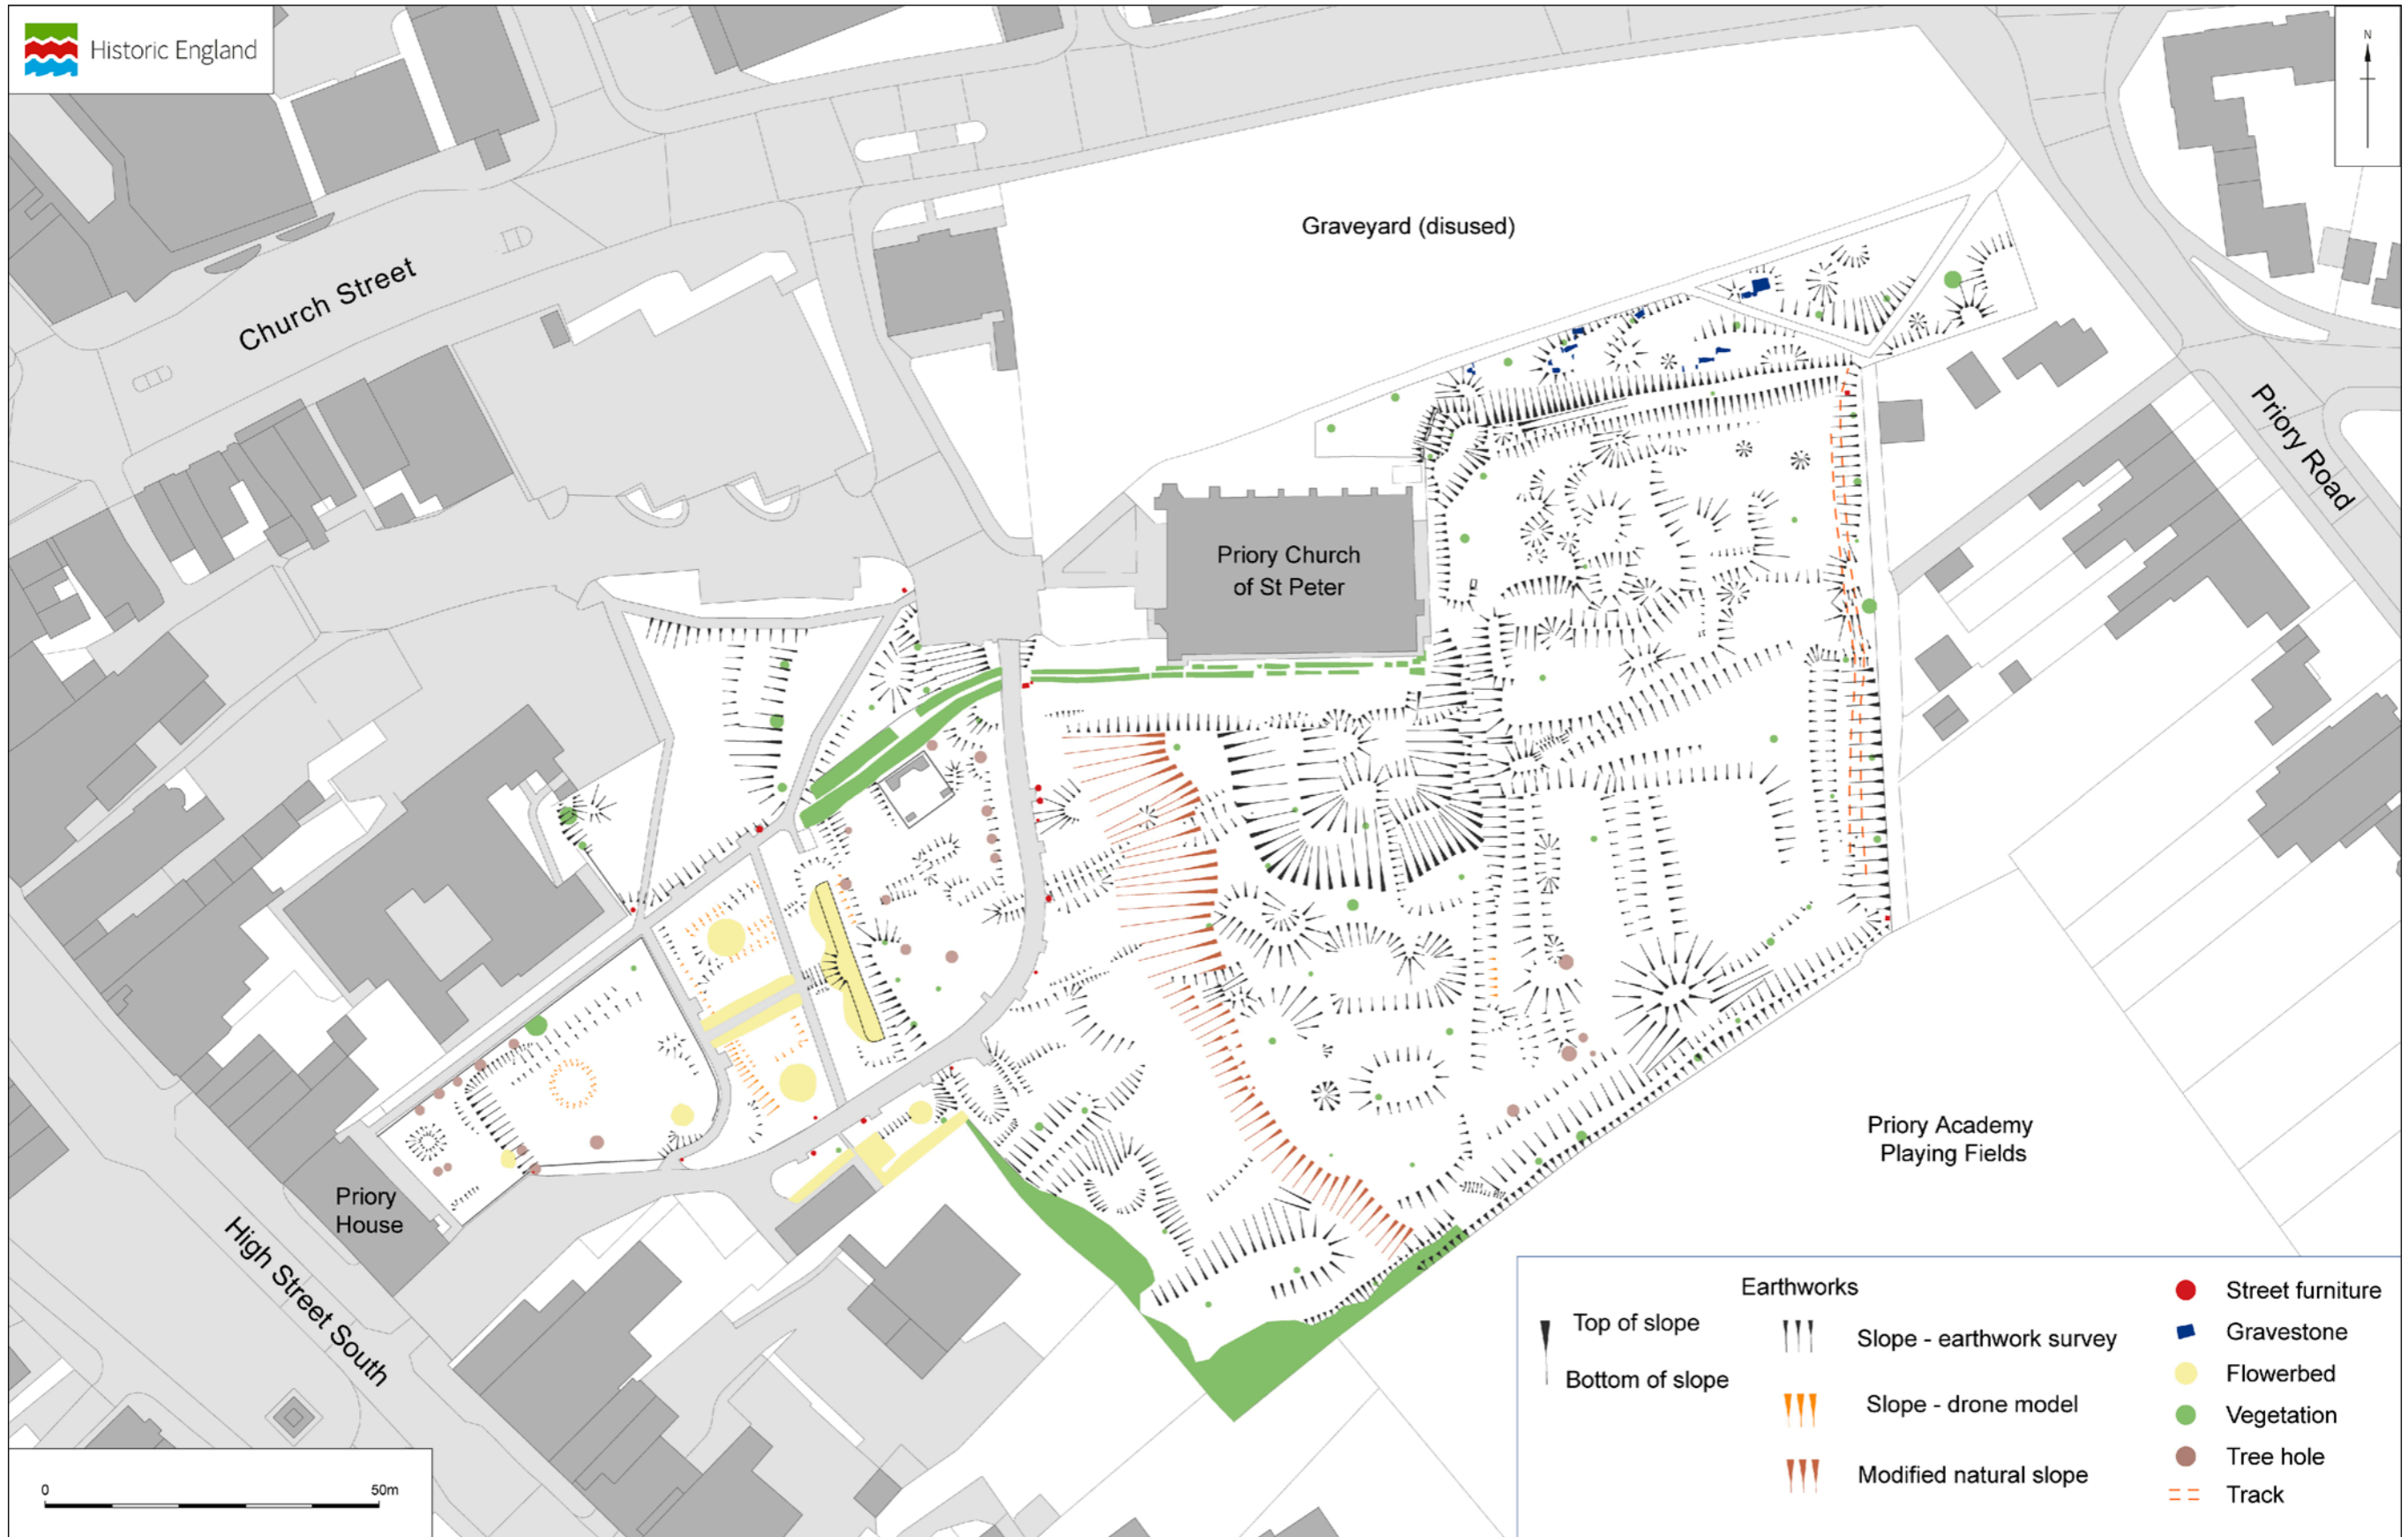
Figure A4: The analytical earthwork survey of Priory Gardens, Dunstable (1:1000 scale) © Historic England. (Background mapping © Crown Copyright and database right 2023. All rights reserved. Ordnance Survey Licence number 100024900)
