# HOPE MILL

## MANCHESTER

*Architectural Investigation*  
Reports and Papers B/047/2002

ENGLISH HERITAGE

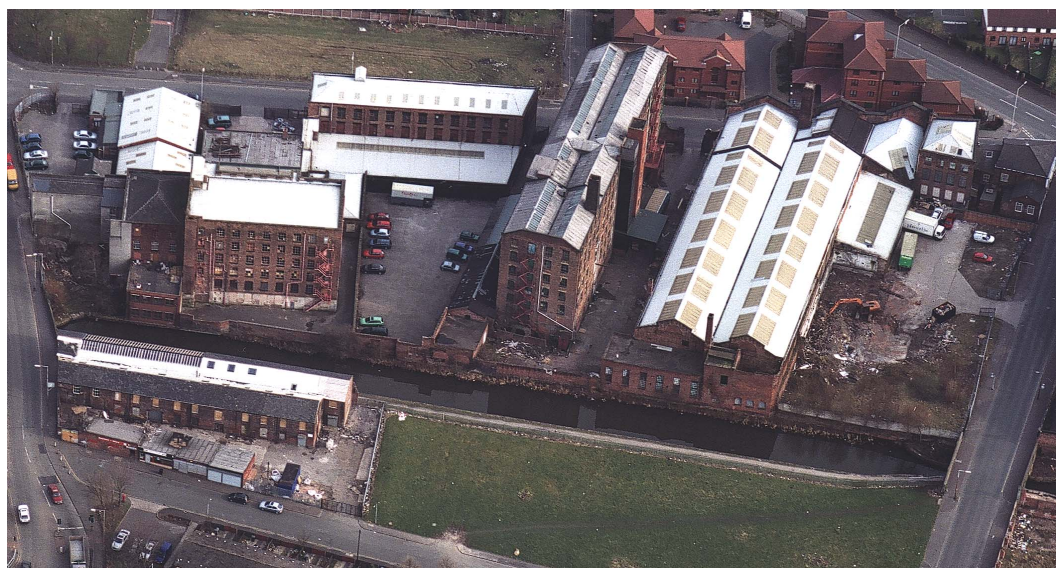
*Figure 1. Hope Mill (centre) from the north, NMR 21151-12.*

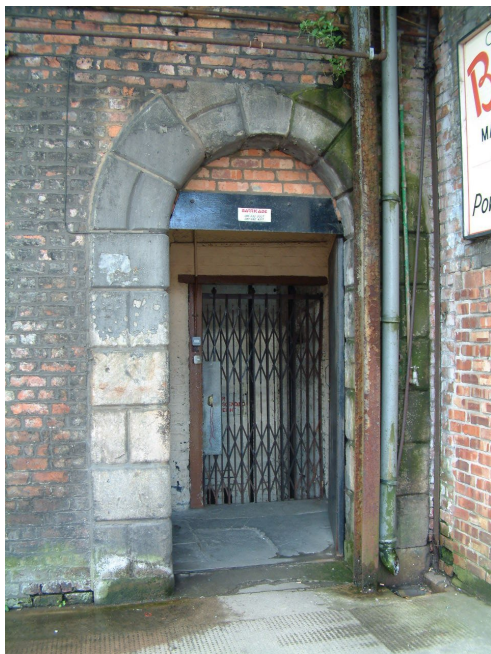
***Figure 2. The main entrance to the stair and hoist tower.***

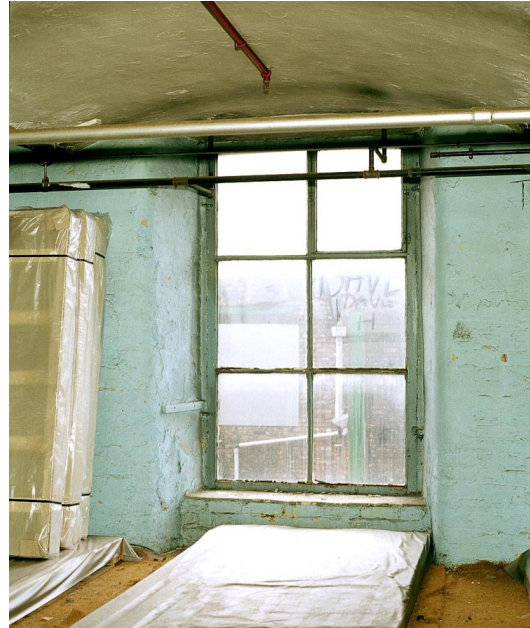
The walls of Hope Mill are a type of “pier and panel” construction, with splayed step-in bays separated by thicker piers which vary in depth from about 33 inches in the ground floor to about 24 inches in the upper floors (Fig.3). Walls of this type had been adopted for fireproof mills by c1820, and may be a forerunner of the use of load-bearing pilastered walls in later multi-storeyed buildings. The cast-iron columns and beams are notably similar to those of other early 19th-century fireproof mills in the Manchester area, which suggests that the ironwork of some of the extant mills might have been produced in the same foundry. The cylindrical columns are similar to those of Sedgwick Mill in the Rochdale Canal area of Ancoats, built 1818-20 (NBR 53328). They range from seven and a half inches diameter in

*Figure 3. A typical step-in window bay in one of the upper stories.*

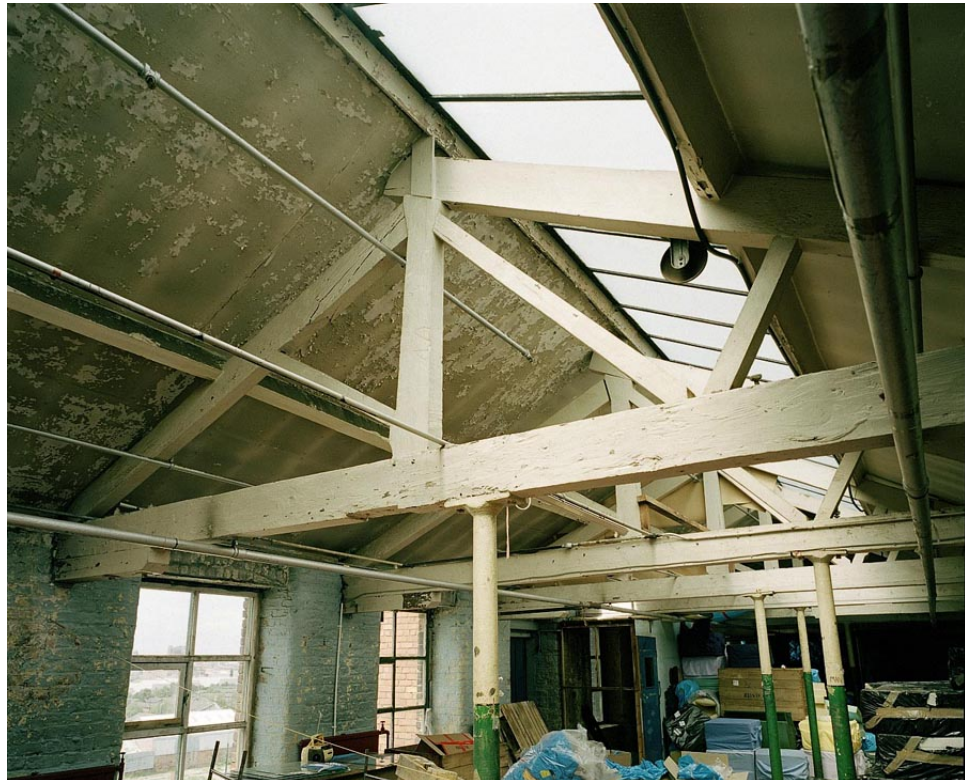
by just two columns flanking the valley gutter. The inner principals, facing the valley gutter, are longer than the outer principals and support continuous skylights extending the full length of the roof. They are crudely mounted on top of the king-posts, suggesting that they may be a later modification (Fig.4). The skylights are of wired glass and are not original, but may replace earlier glazing in the same position. The king-posts are tapered with an expanded head and base, and support the outer principals with a single angled strut; the inner principals are supported by a V-shaped arrangement of struts mounted on the tie-beam.

*Figure 4. The west side of the timber roof.*

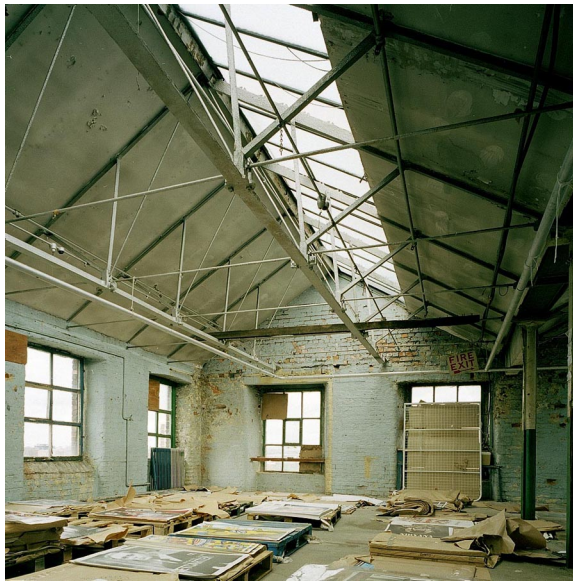
*Figure 5. The west side of the iron roof.*

horizontal and angled tie-rods (Fig.5). The roof originally did not have purlins and the trusses were located longitudinally mainly by iron laths, most of which have been removed. It was later modified with the unusual addition of longitudinal cast-iron beams linking the bases of the angled struts, possibly to reinforce the structure after most of the laths had been removed.

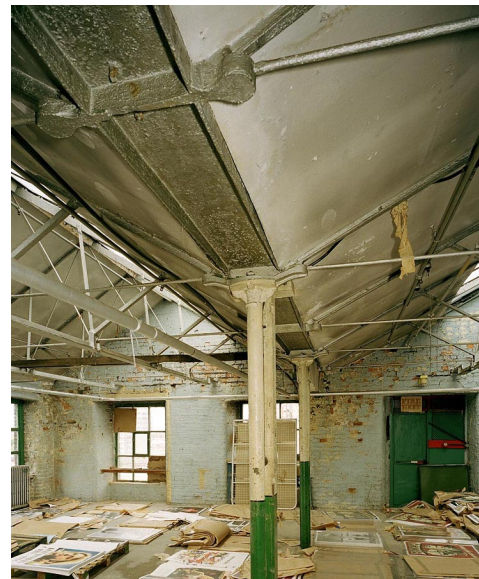
The roof comprises nine pairs of trusses aligned with the five north end bays, including intermediate trusses in the centre of each bay. The valley gutter is offset to the west of the centre line of the building and is supported by a row of four columns; the gutter and the columns are roughly in-line with the columns in the boiler house in the ground floor. The pairs of trusses are thus of unequal size, those to the east having a wider span. Additional columns supporting the roof were added later (see below). The valley gutter is mounted on distinctive cast-iron Y brackets on the four original columns. The ends of these brackets project beyond the sides of the gutter to provide base plates which support both the principals and the ends of the horizontal tie-rods. The design of the base plates enables the foot of the principal to lock the horizontal tie-rods in place (Drawing 4b). The valley gutter is bolted together in sections and has been carefully designed to support the roof (Fig.6). Its underside is strengthened with longitudinal fish-bellied webs, similar to those seen in early T-section cast-iron floor beams. Base plates to support the intermediate principals

*Figure 6. Detail of valley gutter, columns and Y-brackets.*

project from the sides of the valley gutters, mid-way between the columns, and are at the same height and of identical design to those on the Y brackets. The underside of the gutter is strengthened with additional transverse webs between the projecting base plates. Similar base plates are embedded in the walls to support the outer ends of the principals and the horizontal tie-rods.

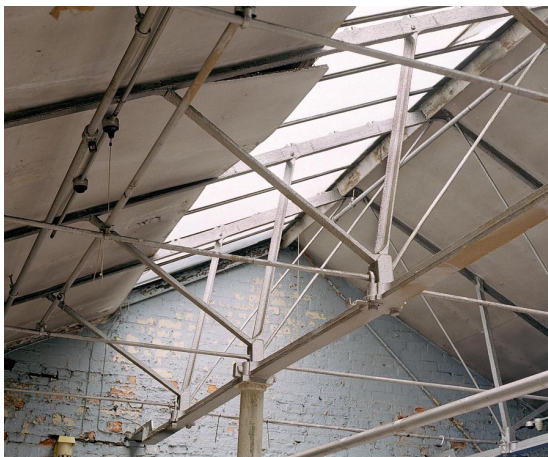
**Figure 7. Angled struts, strut housings and inserted longitudinal beams.**

The top ends of the angled struts are bolted to the webs of the principals and the lower ends have tenons which fit into a separate housing suspended by the tie-rods (Fig.7). The top ends are also shaped to locate against lugs which project from the underside of the principals. The housings at the base of the struts are rectangular cast-iron blocks containing mortices for both the struts and the horizontal and angled tie-rods. The latter are forged with T-shaped ends which engage with mortices in the apex of

In what appears to be a later modification, additional cast-iron beams or purlins have been fitted to add longitudinal stability to the trusses (Drawing 5c). The beams are bolted together in sections, each about one bay long, and are of inverted T cross-section. They have clearly been designed for this purpose, incorporating square recesses to accept the base of the strut housings, and are supported by long bolts which are looped over the horizontal tie-rods. At the north end of the attic the beams are stepped upwards to clear the window heads in the end wall. They may have been added after the removal of the laths from the upper part of the roof, although the form of the castings suggests that they are unlikely to date from later than the mid-19th-century. In the wider eastern half of the roof the longitudinal beams are supported by additional columns inserted beneath the strut housings.

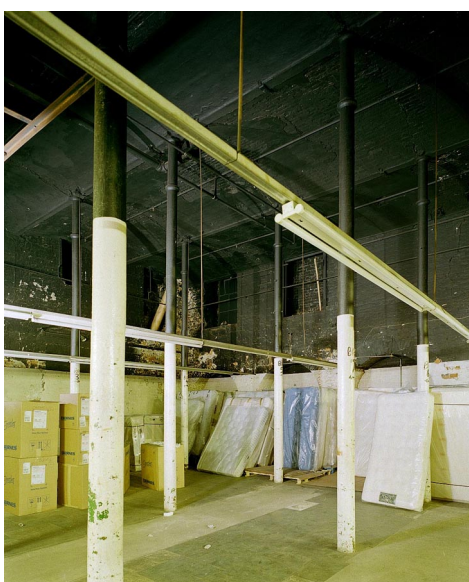
*Figure 8. The internal boiler house.*

The original internal boiler house in the four north end bays is intact except for the brickwork associated with the boilers themselves (Fig.8). It is a rare example of a type that seems to have been in use for a brief period in the early 19th century, with a tall ceiling to accommodate the Boulton and Watt vertical damper pipes.<sup>17</sup> Blocked arched openings in the north end wall and the asymmetrical spacing of the columns confirm that the arrangement of boilers was very similar to that shown in the 1824 drawings. The west elevation contains the smaller blocked arched openings of additional former windows or ventilators. The north end of the boiler

house has blocked windows above the wide-arched boiler openings, and the east elevation retains evidence of the installation of a later steam power system (see below). Externally, the north end of the boiler house has massive cast-iron ribbed plates bolted to the brick piers between the original boiler openings.
