Property Flood Resilience

Outliers study: a historic building

Dr Edward Barsley, Joanne Williams

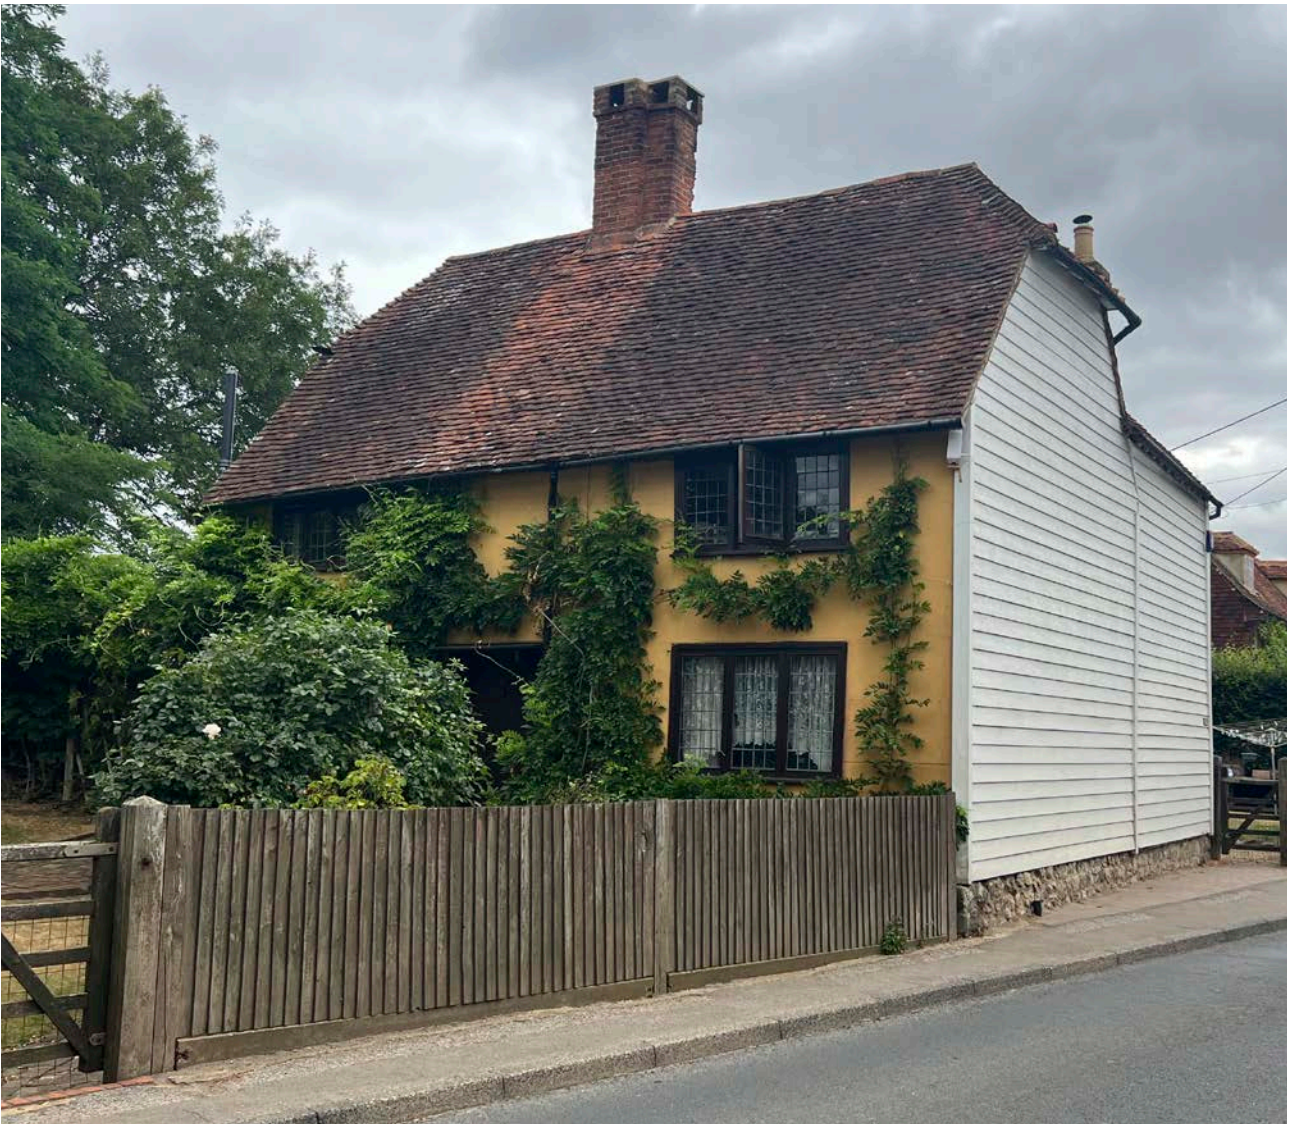
Figure 4: Lees Cottage, view from the street © The Environmental Design Studio

The building was excluded from the Middle Medway Flood Resilience (MMFR) scheme as it did not align with Environment Agency's (EA) PFR supplier standard questionnaire.

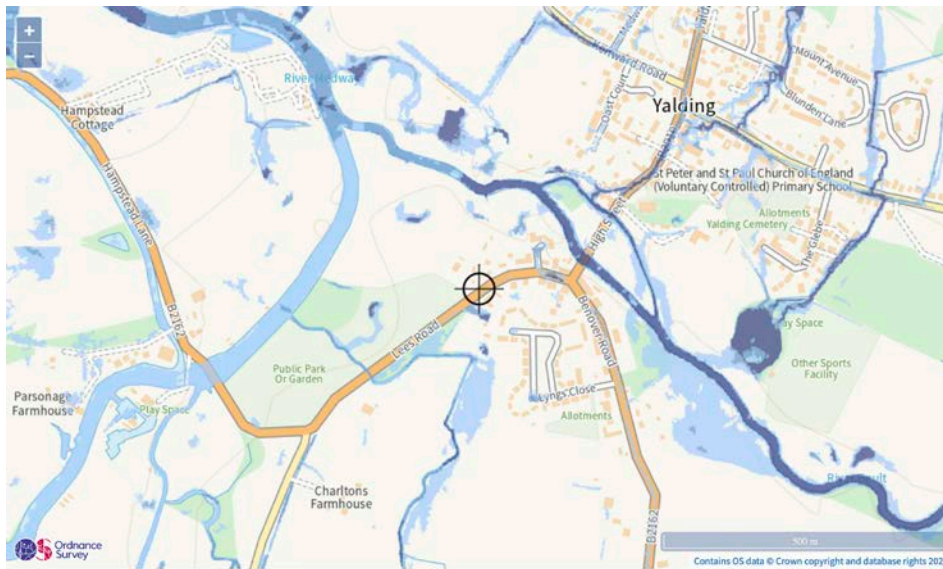
Figure 6:
EA Flood Maps
© Environment Agency

Extent of flooding from rivers or the sea ● High ● Medium ● Low ● Very low ⊕ Location you selected

Extent of flooding from surface water ● High ● Medium ● Low ● Very low ⊕ Location you selected

Maximum extent of flooding from reservoirs: ● when river levels are normal ● when there is also flooding from rivers ⊕ Location you selected

Figure 6 shows the EA flood maps for flood risk from rivers and the sea, surface water and reservoir flooding. Lees cottage is at risk of each of these but to varying degrees and shown in figure 7 and 8.

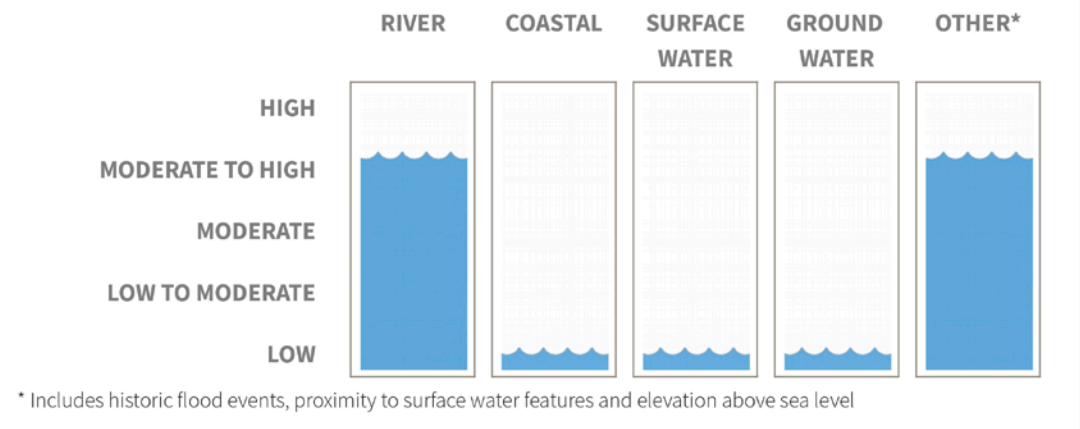
The gauges below detail the level and type of individual flood risks at the property. If flood defences are present, the gauges presume these are operational.

Figure 7: Flood Risk Assessment © Landmark Information

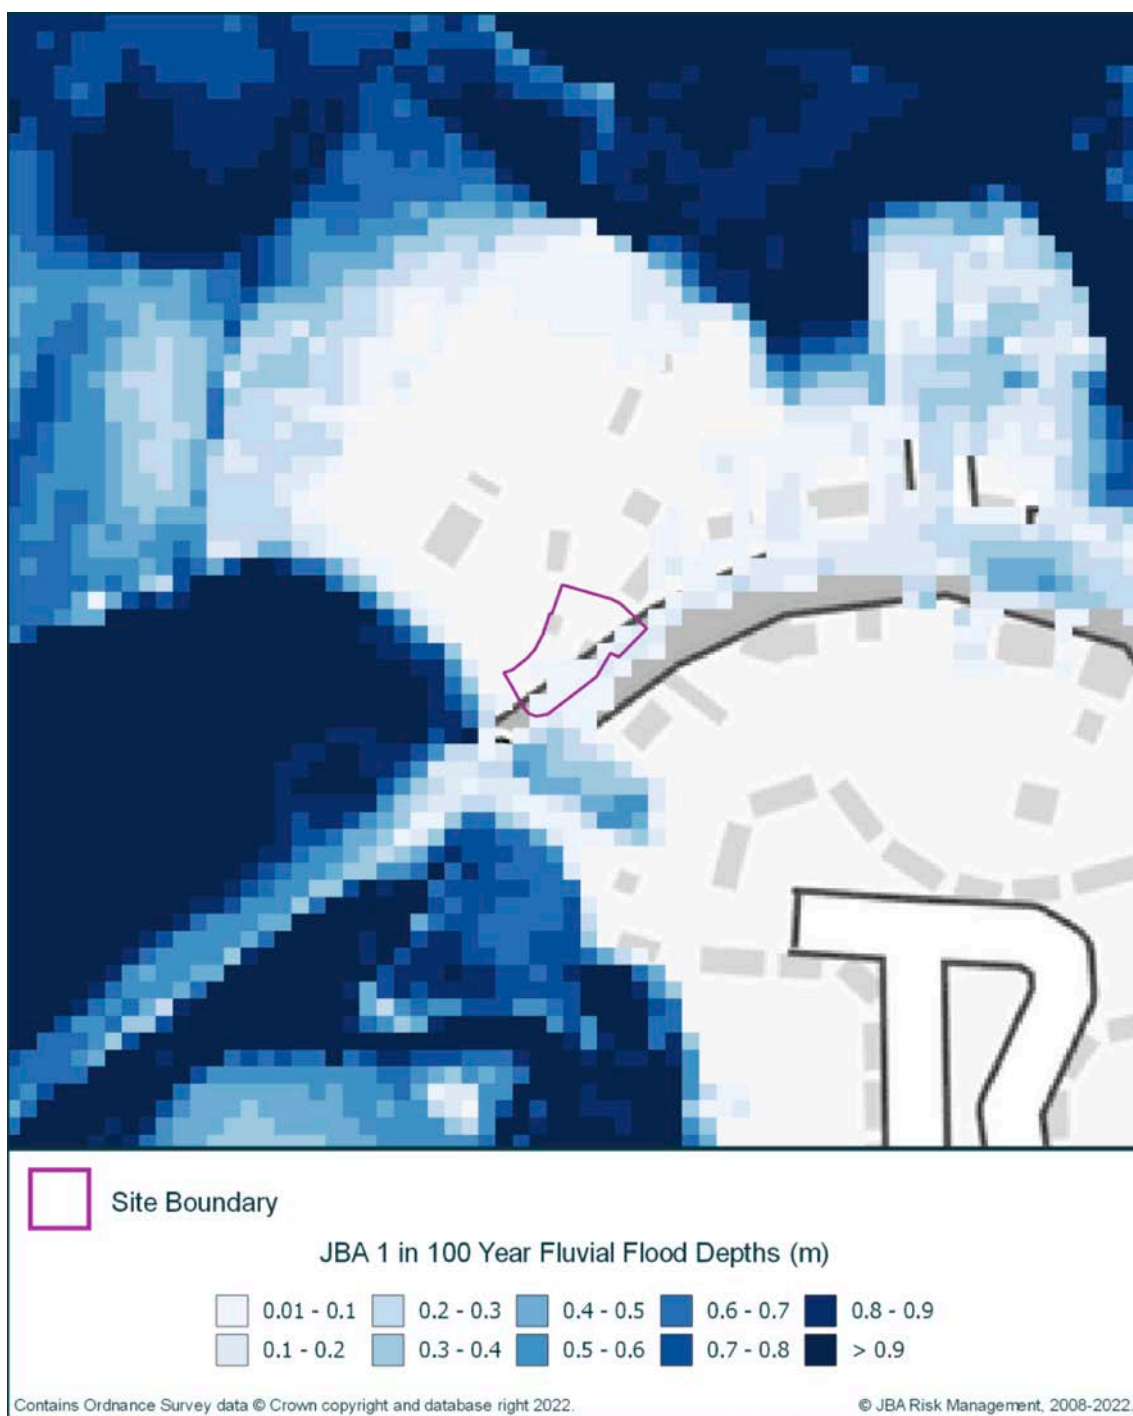
Figure 8: JBA Flood Risk Map © Landmark Information & JBA

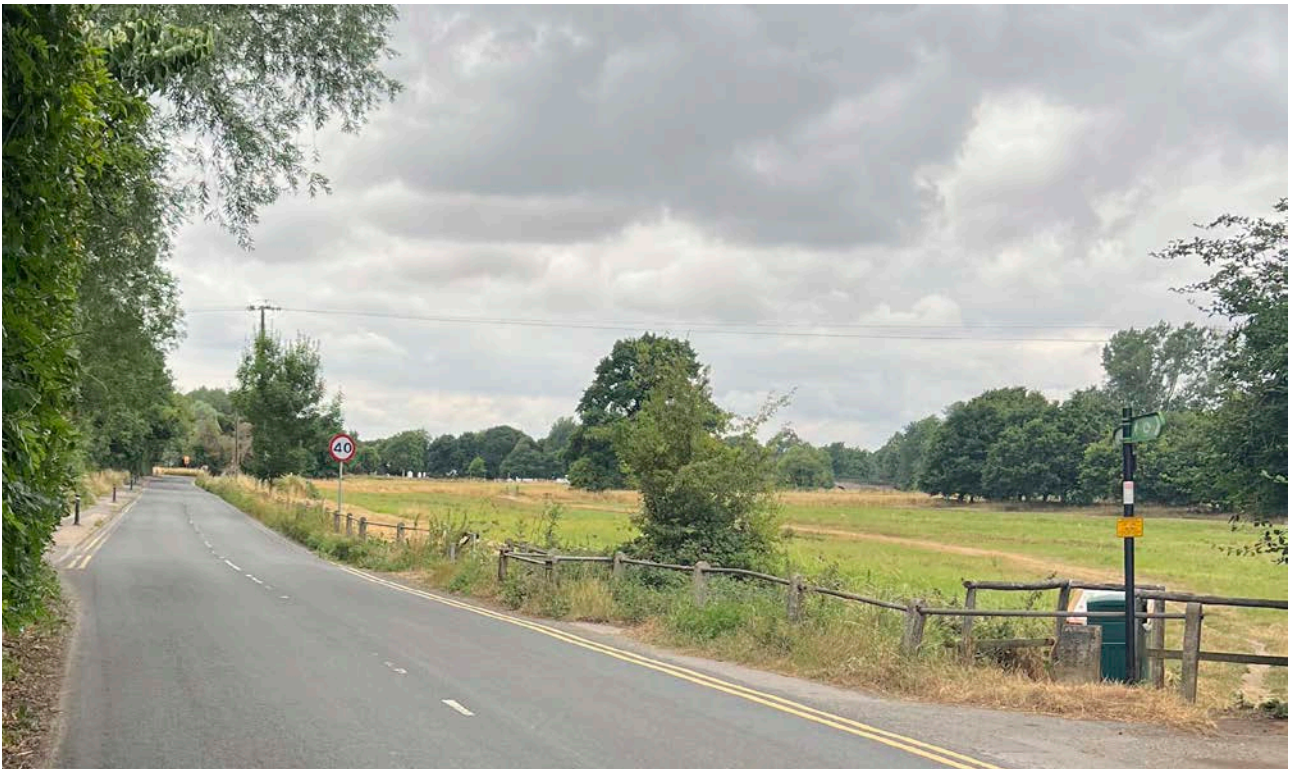
Figure 9: Yalding Floodplain Meadows © The Environmental Design Studio

Lees cottage sits alongside a floodplain meadow. Desktop research by Landmark Information revealed the site has flooded four times in the past. These events have extended across the entire site. They were all fluvial events and occurred in:

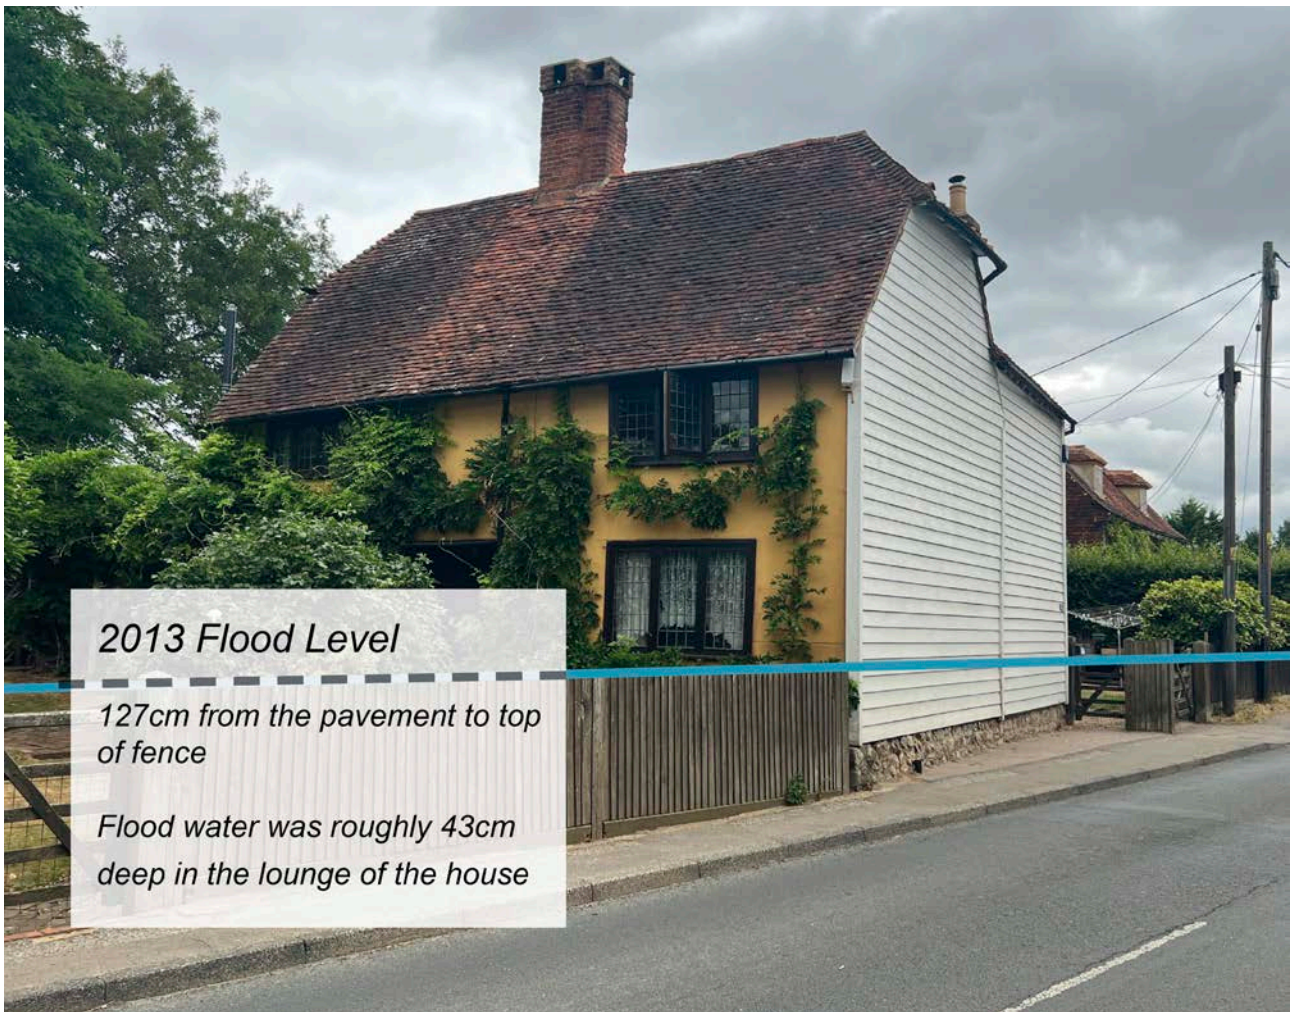
Figure 10: 2013 Flood height in relation to the property © The Environmental Design Studio

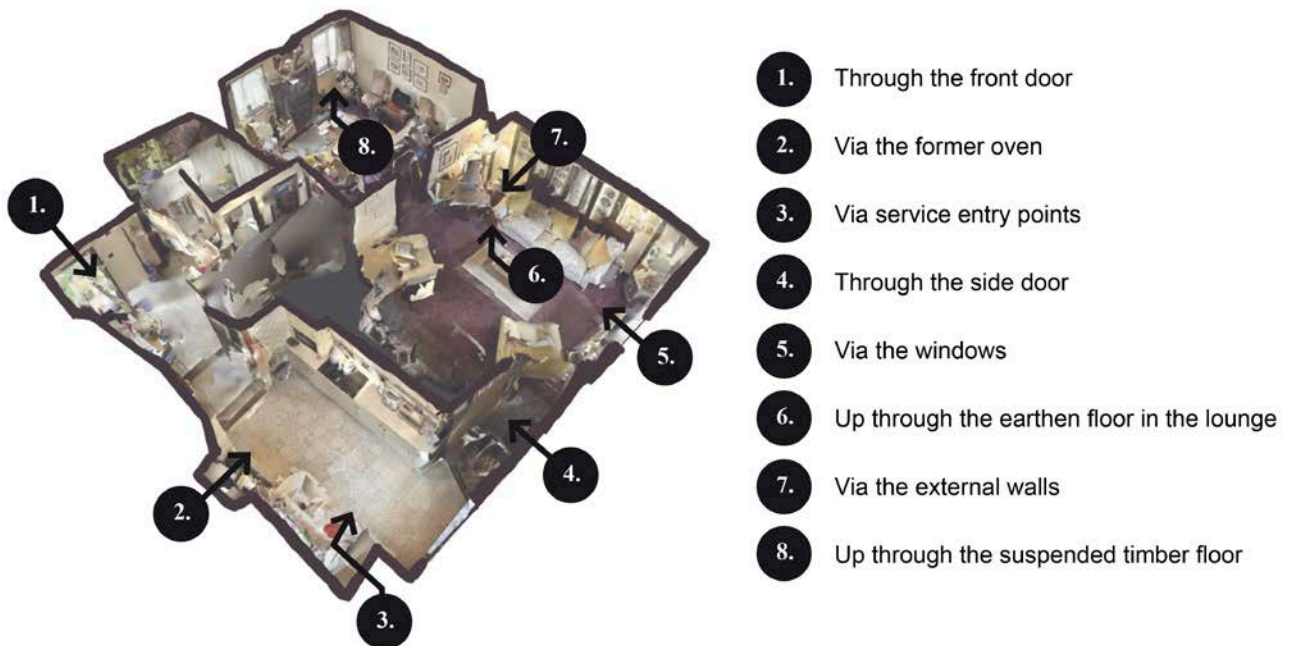
Figure 11: Floodwater entry points © The Environmental Design Studio

There are a range of flood water entry points to the property (see figure 11) and these were recognised as key factors for consideration when reviews PFR options.

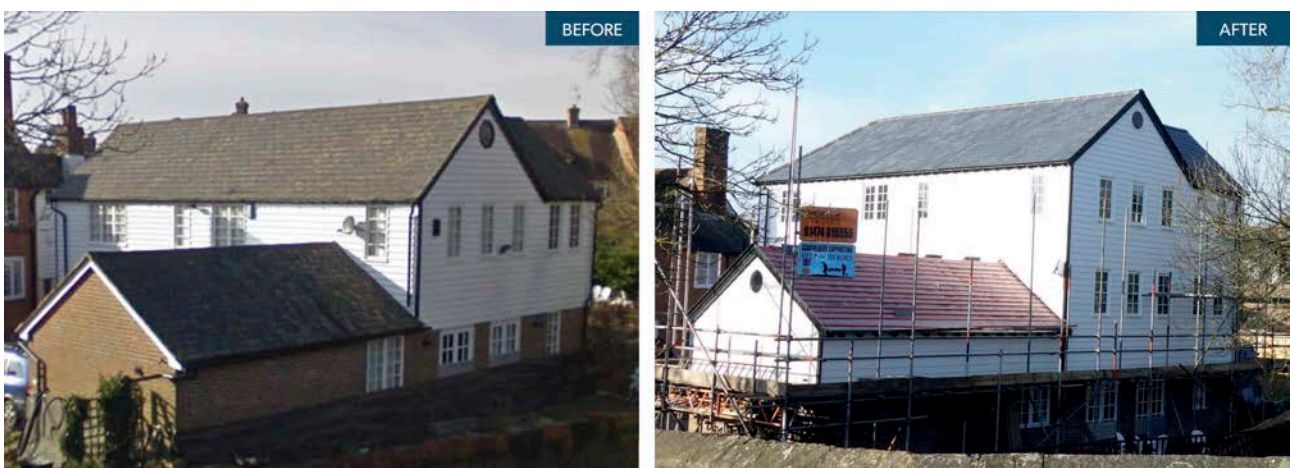
Figure 12: Vertical adaptation in Yalding © The Environmental Design Studio

Avoidance-based approaches to PFR have already been undertaken in the village of Yalding. Figure 12 shows an example of a property which, after flooding had an extra storey added to it and living areas reconfigured. This approach to vertical adaptation was employed as the previous resistance-based approach of flood barriers and a flood skirt (protecting up to 1.2m) were overtopped. The barriers are still used to limit damage from small to medium flood events but for more severe floods (as was experienced in 2013/14) the raised living areas and backup power provide more safety, security and enable a quicker recovery and a greater degree of maintained occupancy and inhabitation.

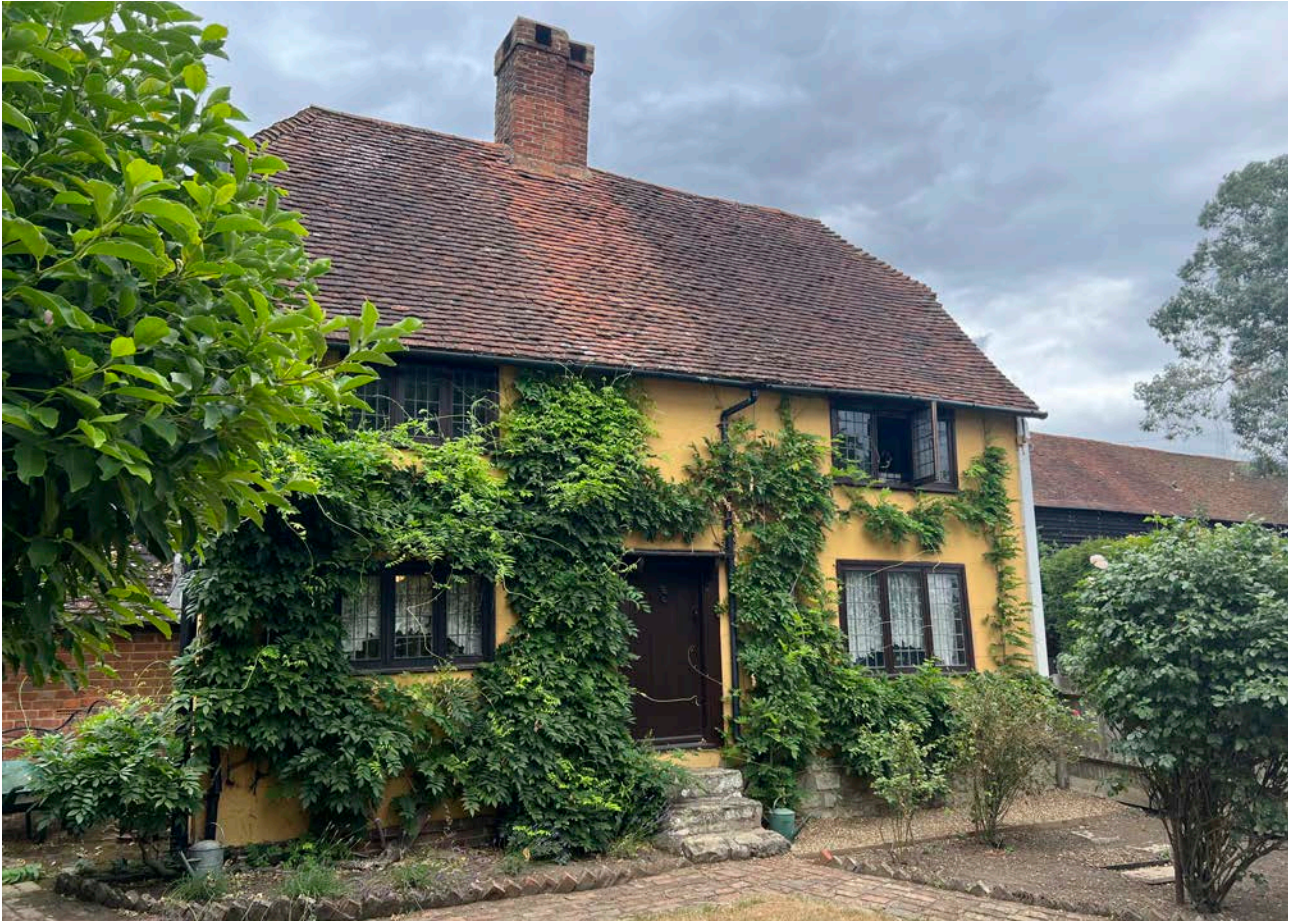
Figure 13: Lees Cottage © The Environmental Design Studio

Lees Cottage is Grade II listed within Yalding conservation area and was constructed C18 or earlier. The construction of the building was originally timber framed, but its frame is now concealed thus the percentage of timber remaining and its condition is unknown without intrusive works. In addition, it was not possible to confirm the material of any infill panels. A more comprehensive timber and damp survey would be beneficial to understand its condition and would inform how the building is responding to flood events and how it should be dried. The front elevation and left gable end are clad with channelled render. The right gable end and wing are weather boarded and have been replaced in 1989 and again in 2000. Conversations with the owner identified that during these works two different structural oak timbers were replaced due to the damage caused by flooding. It is unknown if the damage to the oak timbers was because of impeded or inaccurate drying of the structure after the flood or whether other issues had caused the deterioration of the oak structure. In 2015, it was proposed to replace the weatherboard with Cedral weatherboarding, which is constructed of fibre cement. This application was denied.

The house was built at right-angles to the road and faces west. It's 2 storeys and has a plain tile roof with a projecting red and grey brick stack towards rear of left gable end, and multiple brick ridge stack to left of centre. The house has had several new extensions since its original construction, which has included the introduction of concrete foundations, underpinning and modern materials in conjunction with the original traditional constructed elements.

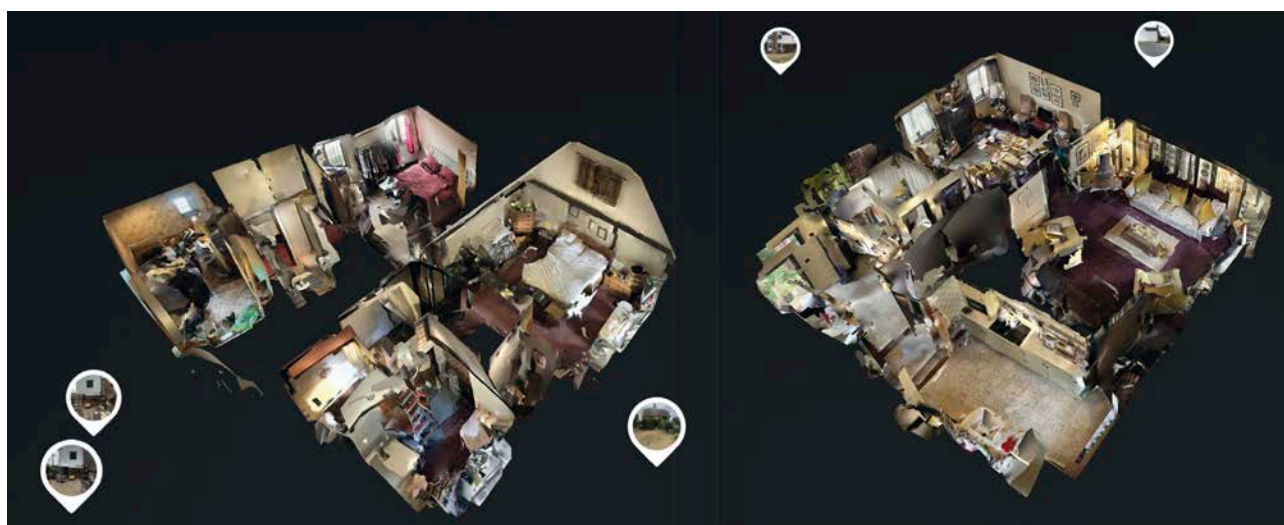
Figure 14: Matterport Scan of Lees Cottage © The Environmental Design Studio

Figure 14 shows a 3D scan of the building via Matterport.

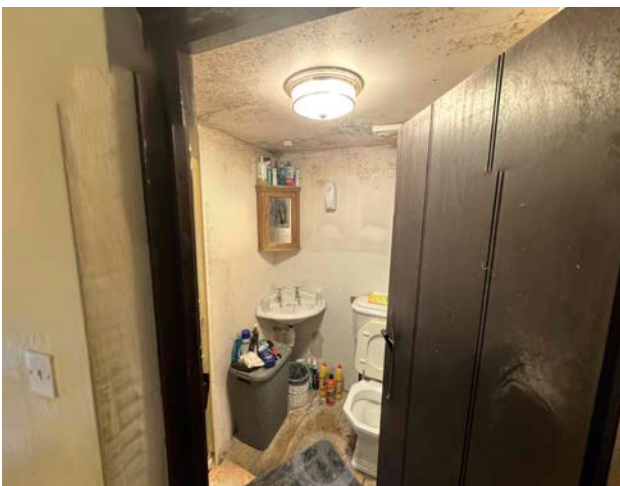
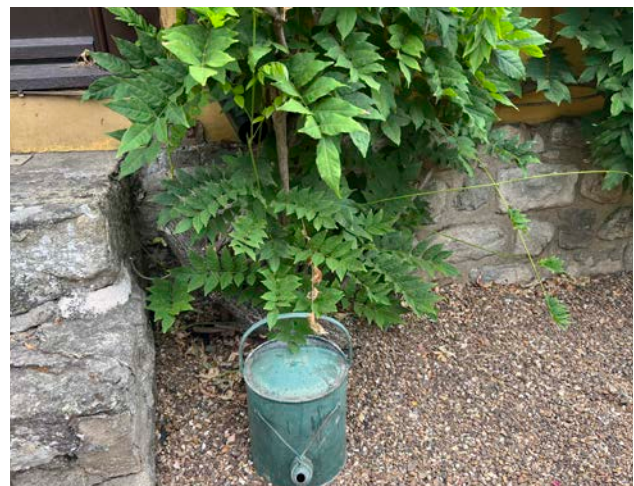
The building has seen some movement on its west corner which was evident externally and from the gradient of one of the first-floor bedrooms floor and ceiling. The suspected cause is a failed rainwater pipe on the same corner, that is concentrating water at the footing of the building. A structural engineer was recommended to the owner of the property during the survey to undertake an assessment as to whether the movement was historic or continuous and to advise on any remedial work required.

Figure 15: Building defects © The Environmental Design Studio

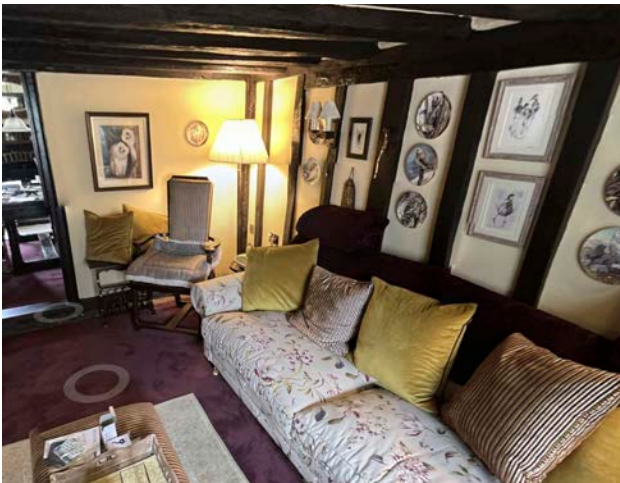
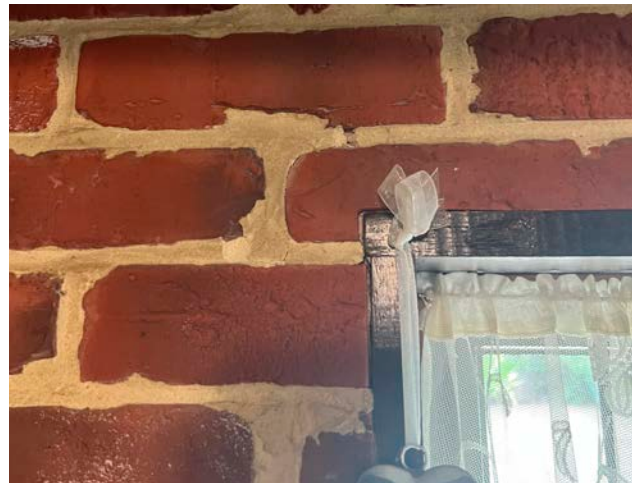
The walls are known to be a mixture of historic timber framed with unknown infill panels, and areas of modern brick. In the kitchen, the walls have been covered in faux brick tiles and porcelain tiles. These tiles have been bedded using tile adhesive and may be trapping moisture after a flood occurs and has reduced the hygroscopic area, which is likely to be impacting the equilibrium of moisture and vapour.

In the other downstairs rooms, the owner informed us that the plaster had been repaired with lime, but the type of lime used, and its mix is unknown, as is the finish. Review of the paint whilst on site, determined it was unlikely to be lime wash. It is known that where impermeable materials are used in flood zones, they will trap moisture and it's likely the covering will fail, or cause damp, mould and condensation.

On the outside, it was unclear what render or mortar mix had been used but it is assumed from prior experience to likely be cementitious. As the mortar could be seen to be having an impact on the surrounding masonry. Taking samples of the mortar, render and yellow paint would be beneficial to ascertain if the buildings permeability has been compromised.

Figure 16: Wall materials in Lees Cottage © The Environmental Design Studio

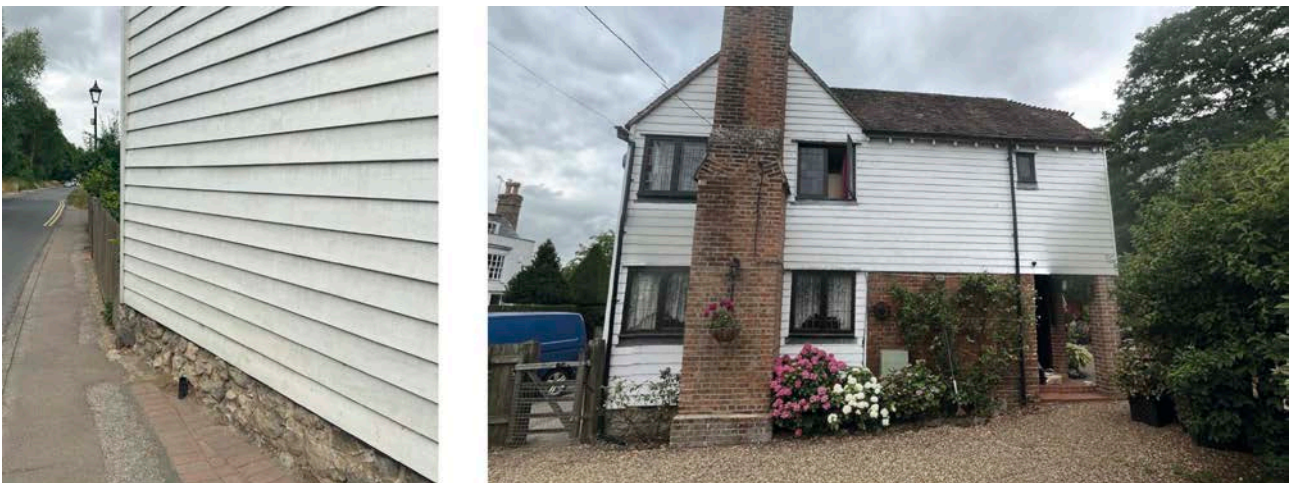
In 2015 permission was sought to replace the weatherboarding with Cedar, which was denied. Across the road another home has removed the lower metre of their weatherboard. Which could be an option that Lee Cottage could seek to discuss with the council but it would be important to establish whether this would benefit or hinder the property during another flood.

Figure 17: Cladding on Lees Cottage © The Environmental Design Studio

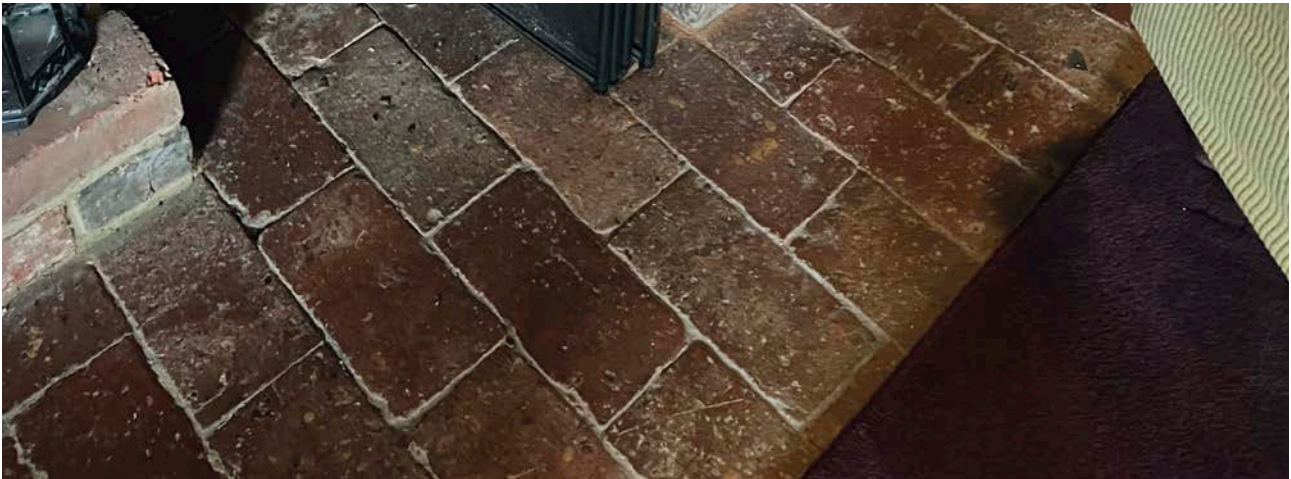
The dining room is the original timber suspended floor. It is constructed higher than the living room floor and has not yet been submerged during a flood. The timbers would be vulnerable to a flood if appropriate repair and drying was not undertaken swiftly.

The other floors in the rest of the building are all concrete slabs with tiled finishes. This means that they are easier to clean after a flood event but will still take longer to dry due to the concrete.

Figure 18: Living room floor © The Environmental Design Studio

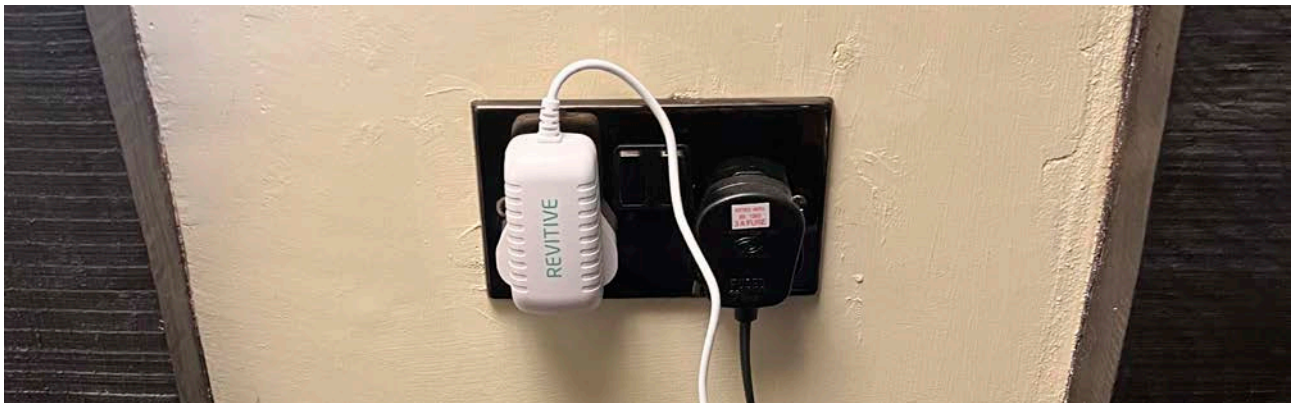
Even though the property has flooded in the past the electric sockets are still relatively low. Upon the next rewire or flood event it would be recommended to install these higher with an upper ring main.

Figure 19: Electrical sockets © The Environmental Design Studio

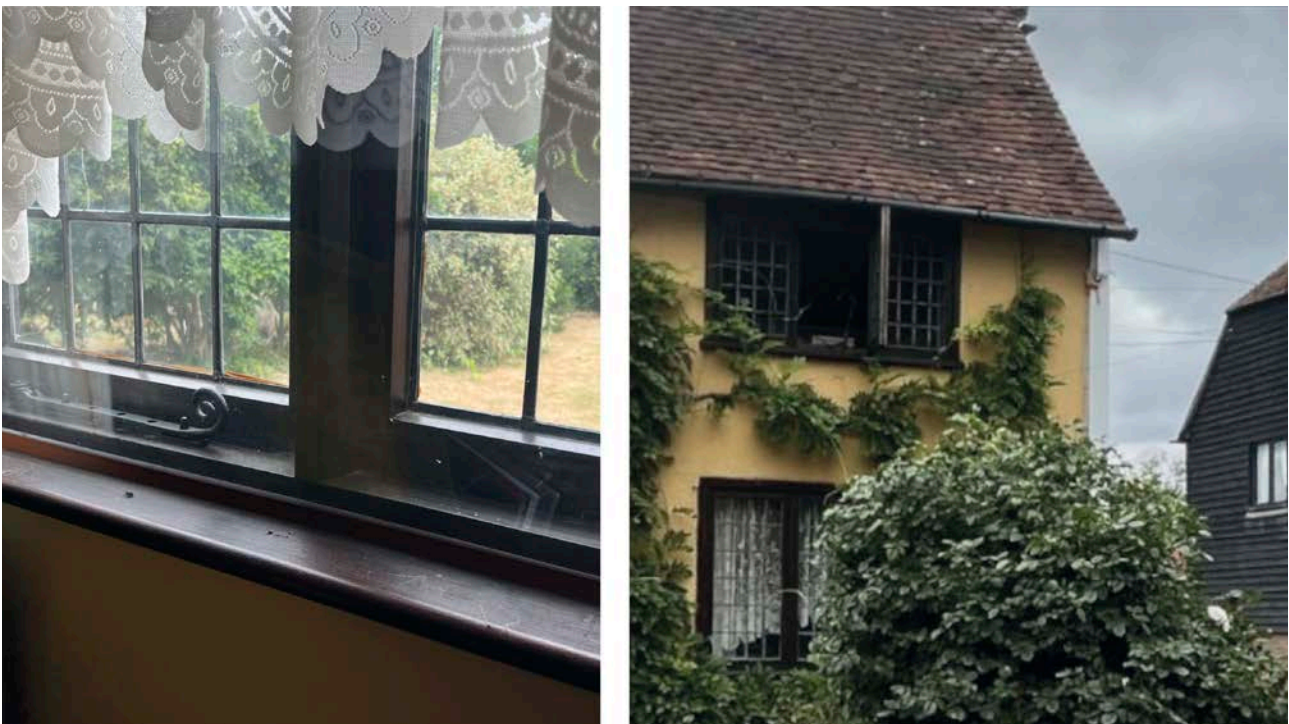
If the flood levels were to increase dramatically it is possible that flood water would be able to enter between the sill and the frame and that the hydrostatic pressure of the flood water might break the single glazing and warp the lead. There is some secondary glazing throughout the property that might prevent water ingress but would not protect the windows.

Figure 20: Windows at Lees Cottage © The Environmental Design Studio

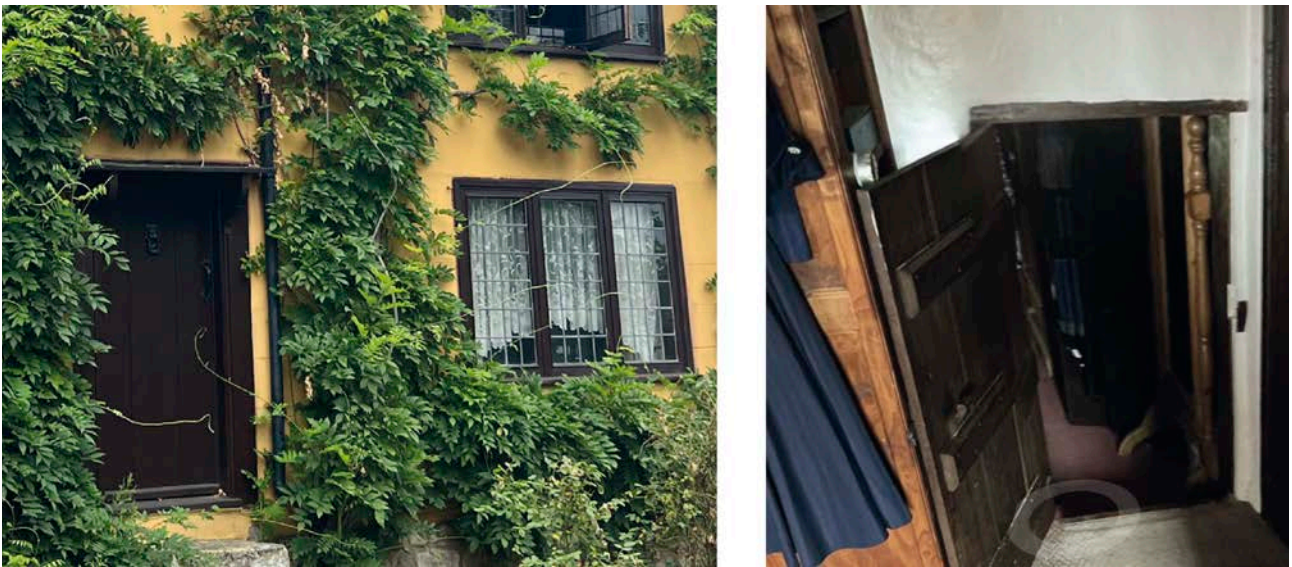
The front door is in good condition and constructed of oak. However, it is not sitting flush within the frame and there is obvious gaps that causes draughts and would allow flood water to enter between the door and frame.

Figure 21: Front door at Lees Cottage © The Environmental Design Studio

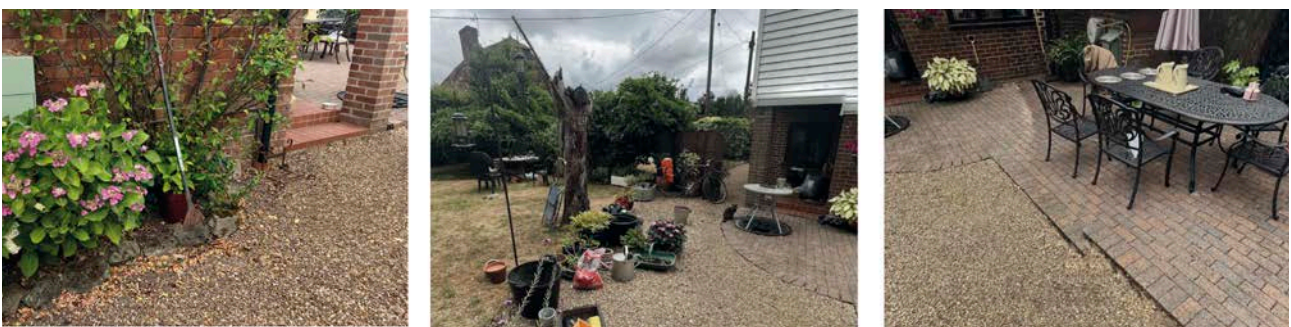
It would be beneficial to lower the ground levels and to introduce more permeable surfaces. The area is largely clay and as a result, post flood the ground remains saturated for long periods of time which in turn impacts the rate of drying to adjacent building elements.

Figure 22: The landscape around Lees Cottage © The Environmental Design Studio

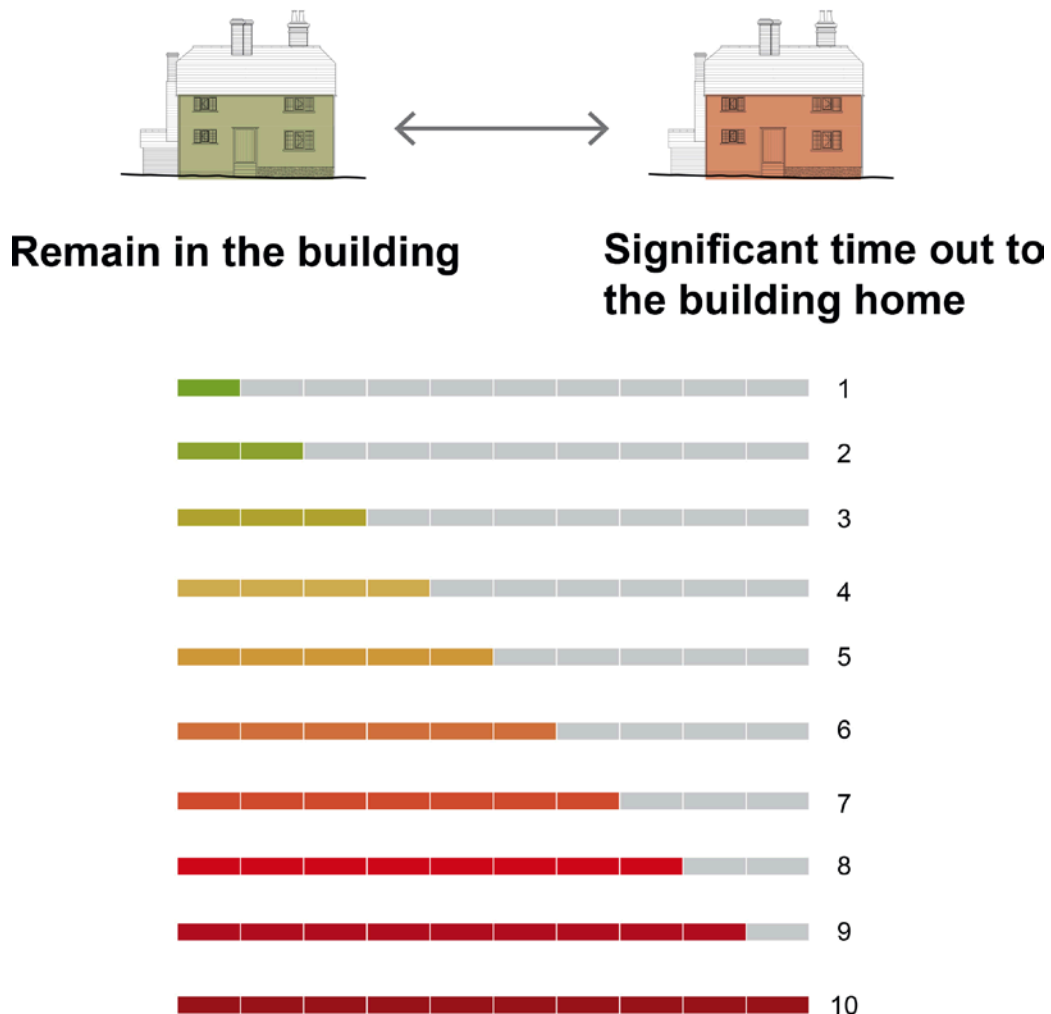
Conversely, a 'high' consequence score of 10 would indicate that there would be severe consequences from flood event and that it is likely that there would be significant disruption to the occupant's lives and that it would take substantial time, effort and cost to fully reinstate the property

Figure 23: Consequences rating © The Environmental Design Studio

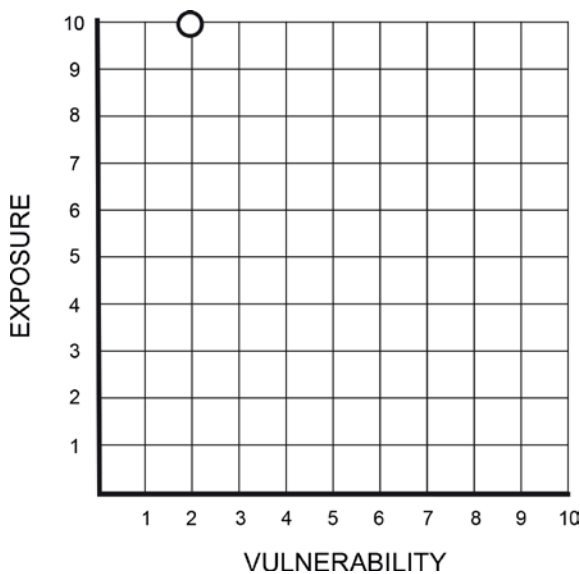
Figure 24: A houseboat scored in the Exposure vs Vulnerability Matrix
© The Environmental Design Studio

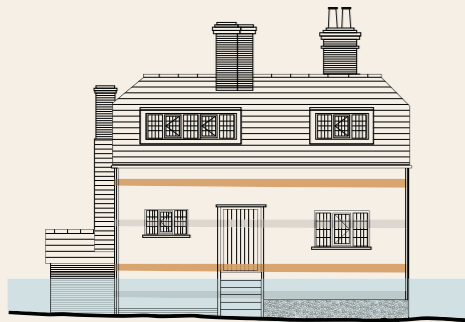
Figure 40: Scenario #07 © The Environmental Design Studio

Scenario 07

Reconfigure floor levels

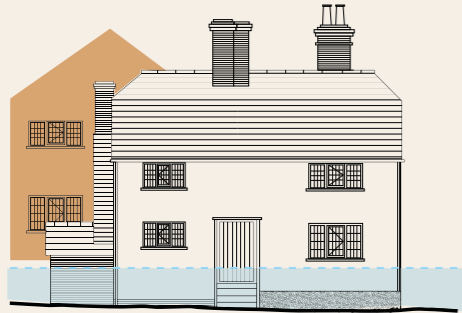
Figure 44: Scenario #9 © The Environmental Design Studio

Scenario 09

Add an extension

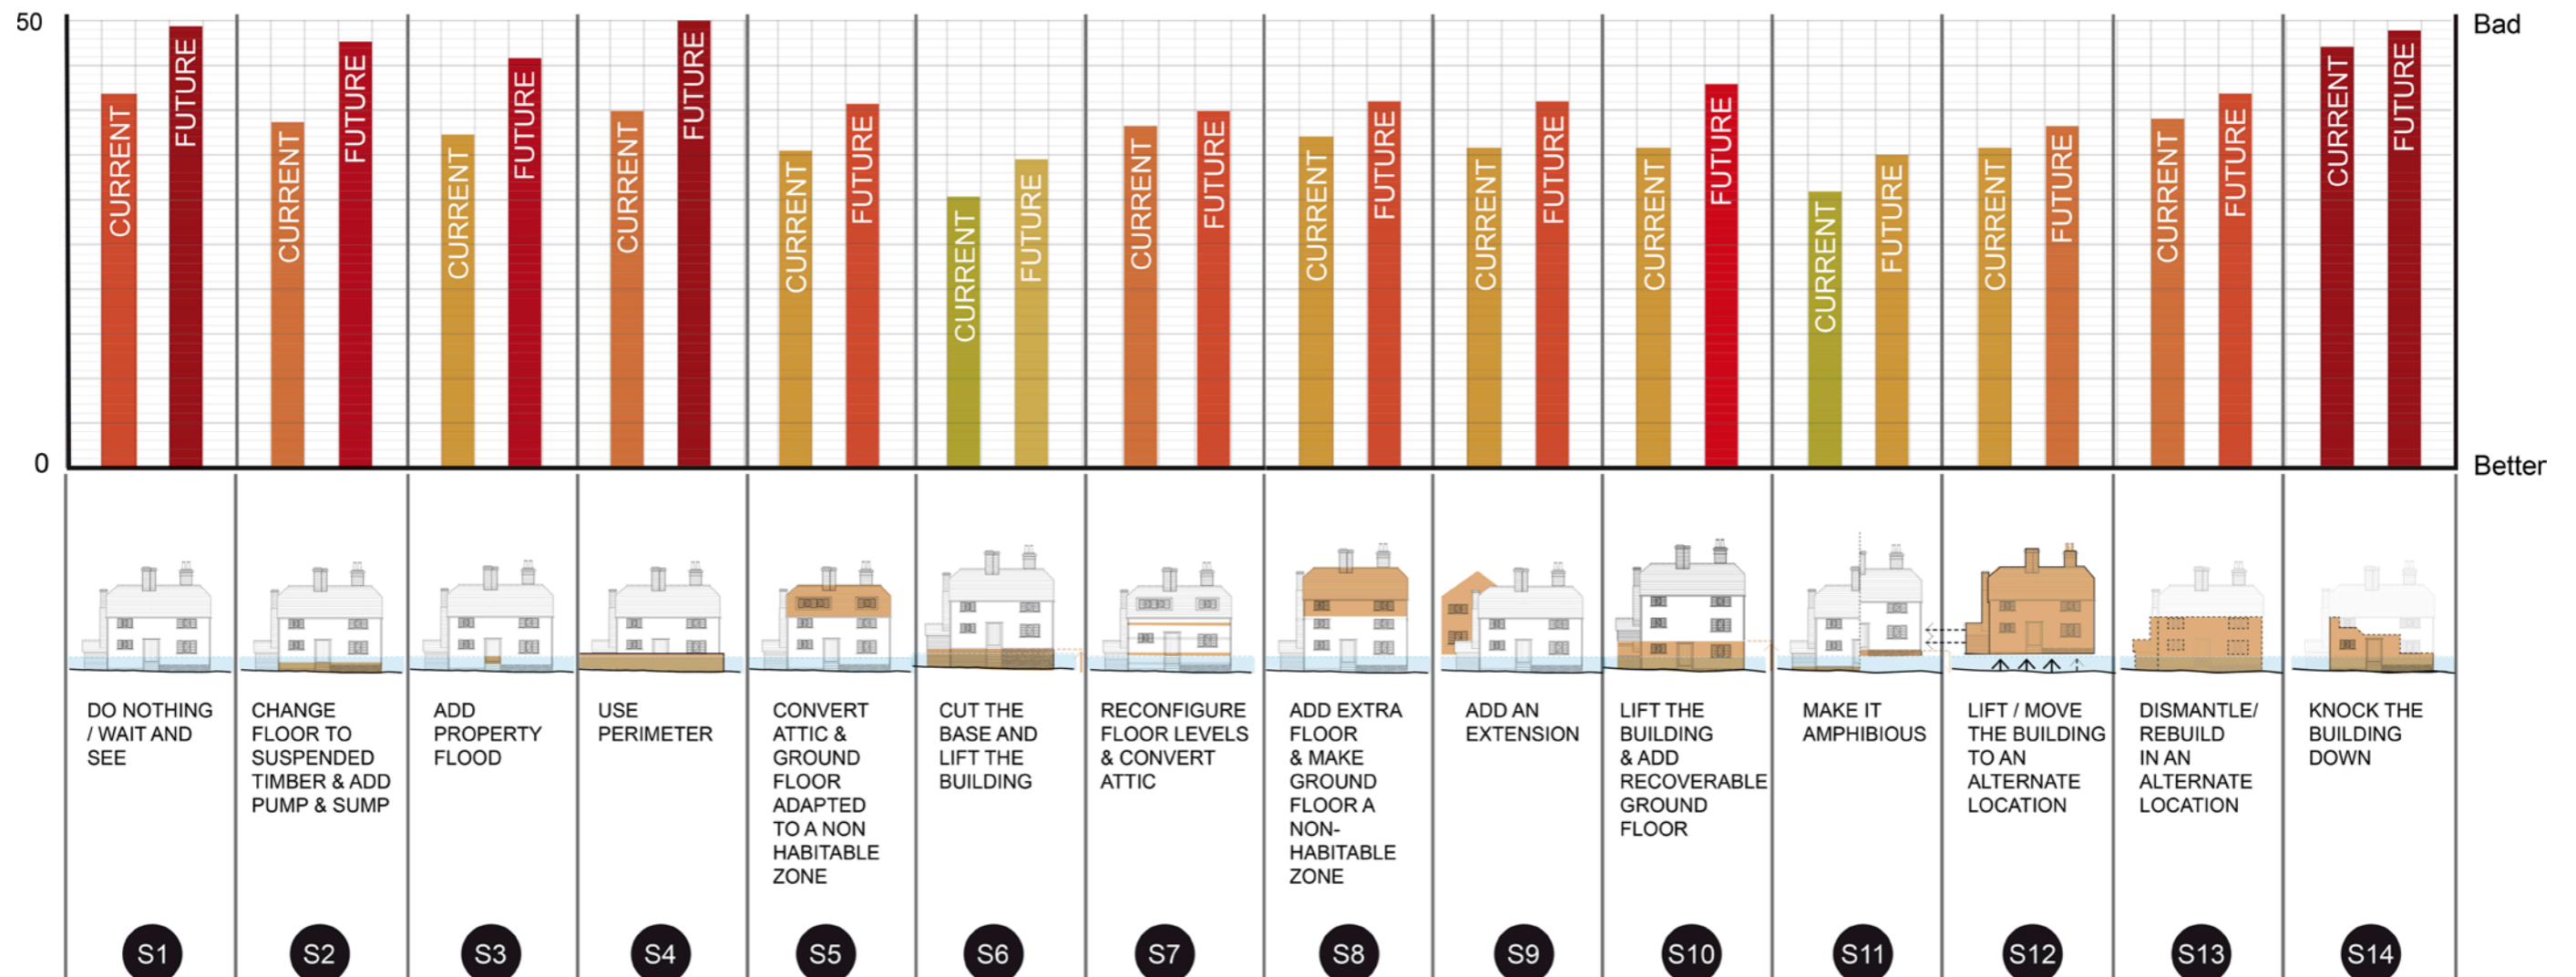
Figure 55: MCA scenarios scores © The Environmental Design Studio

The scores shown in Figure 55 should however not be considered in isolation. When considered in relation to specific criteria such as heritage values or consequences, the results are even more revealing.
