Property Flood Resilience

Outliers study: a historic building

Dr Edward Barsley, Joanne Williams

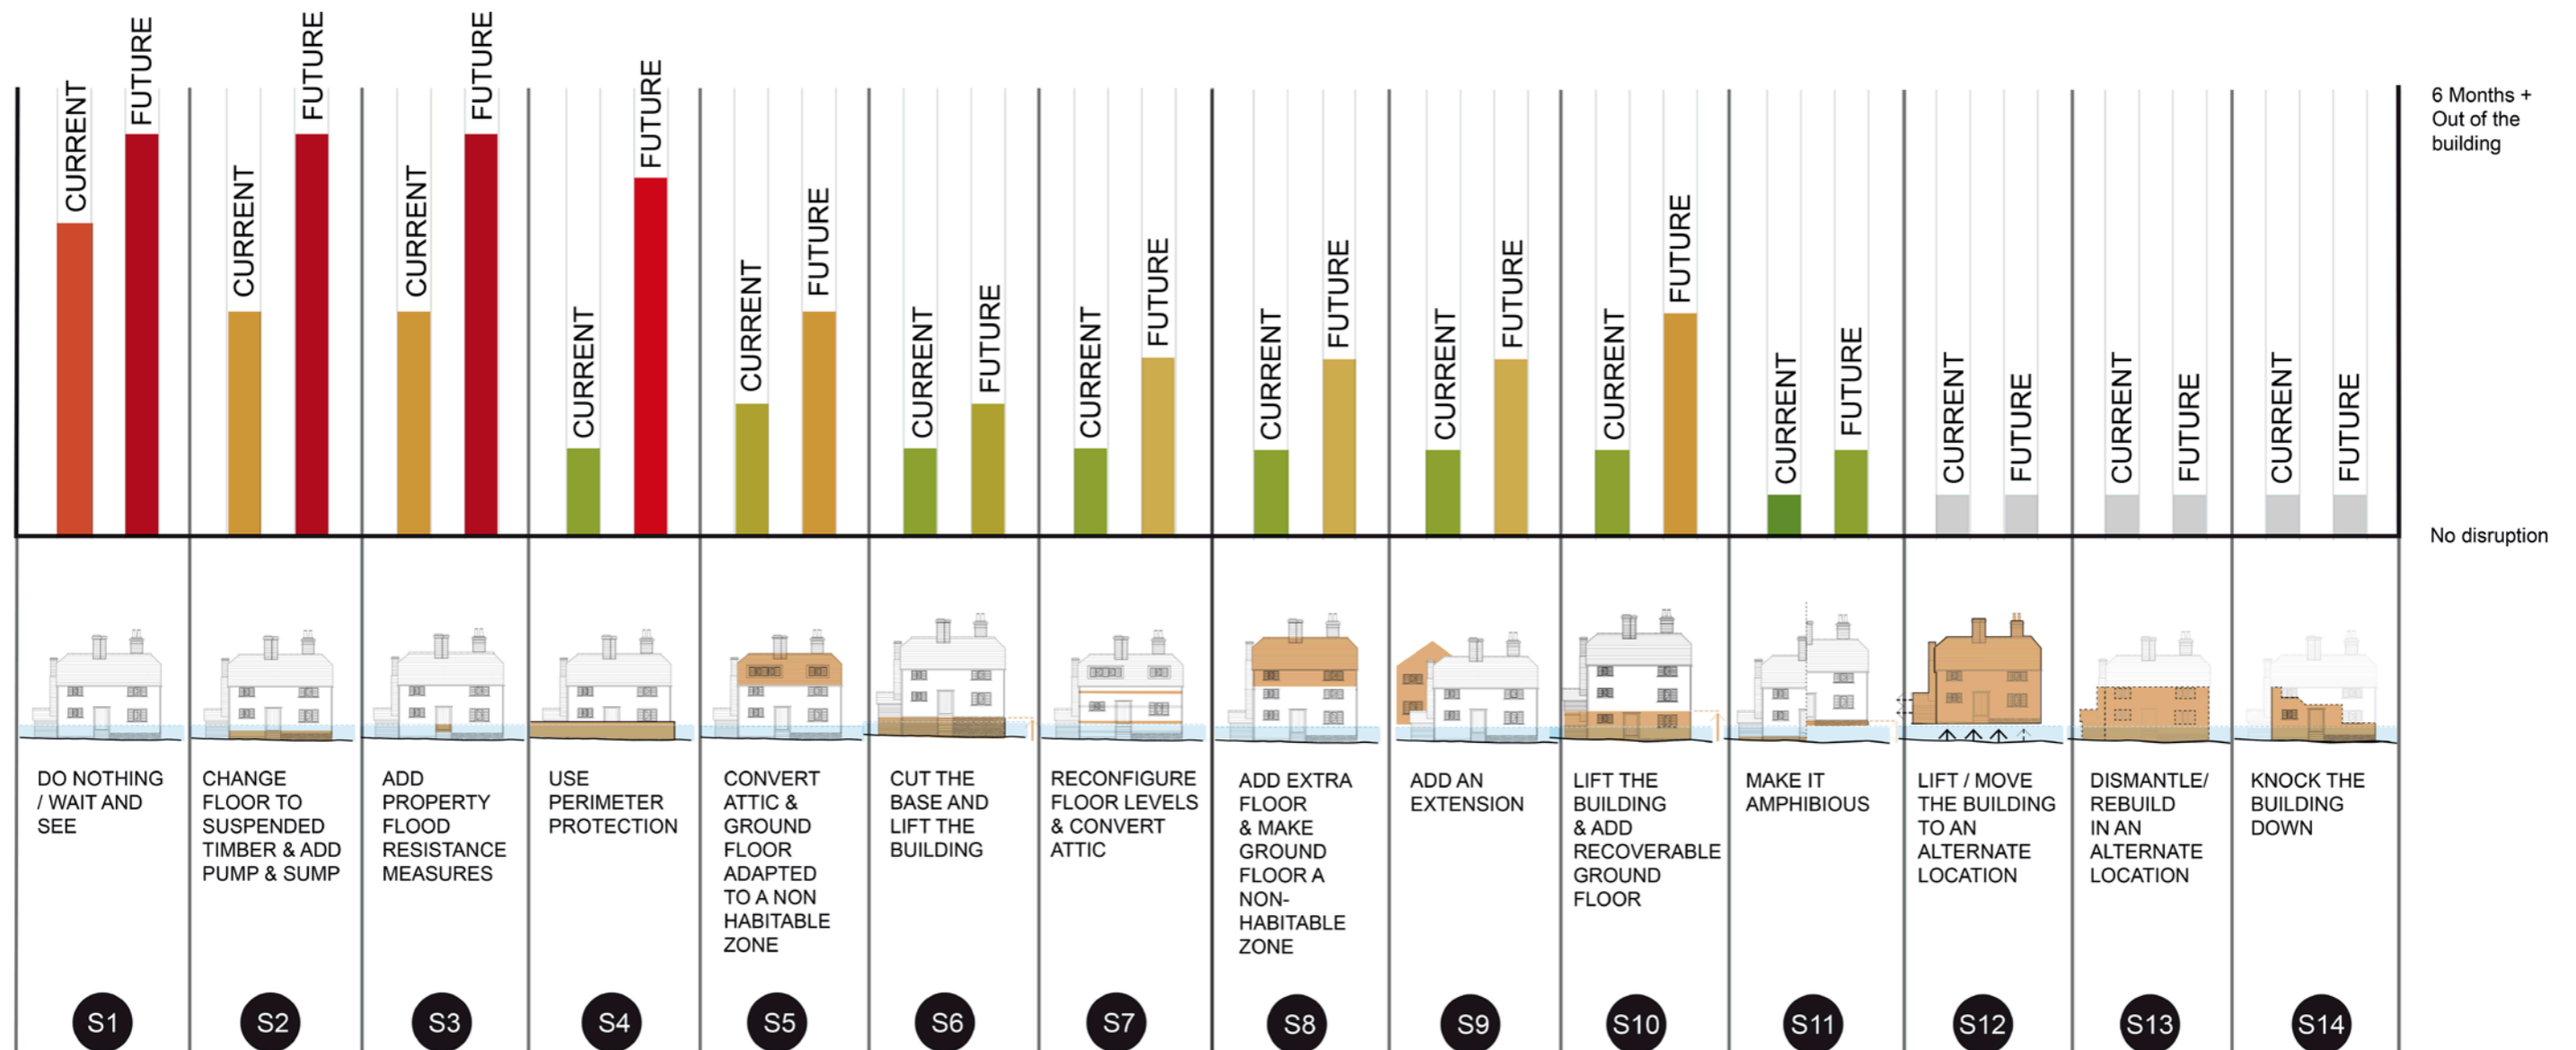
For scenarios 12, 13 and 14 which show a relocation/removal of the building score low in the consequence as the building is no longer there to flood. They have been set to grey as the considering consequence in these cases is distinctly different. The family would have moved and whilst there may be reduced risk of flooding in the new location, but ultimately the consequence has been relocation.

Figure 56: Comparison of scenario consequence scores © The Environmental Design Studio

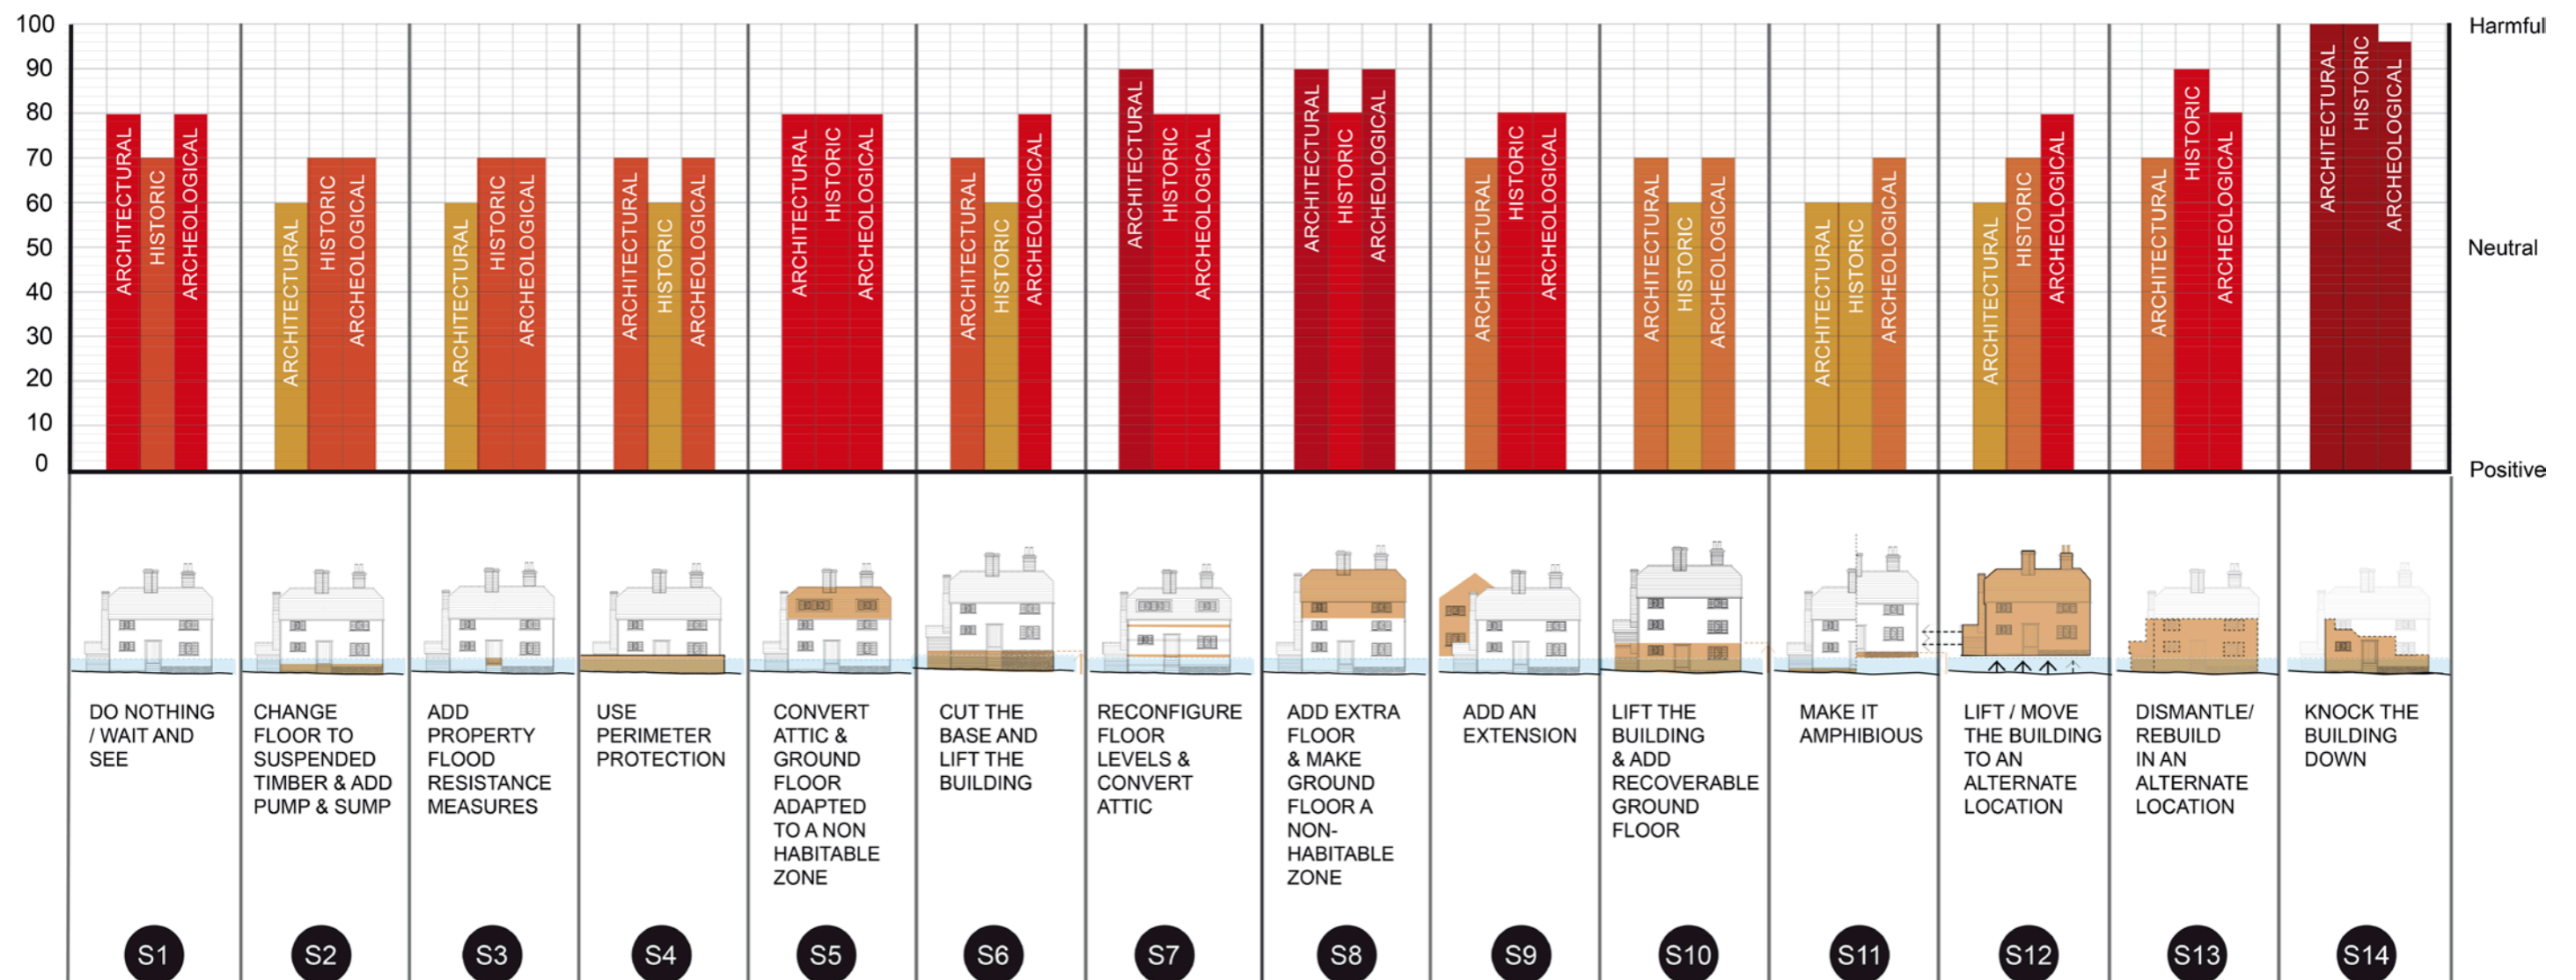
A strategy such as scenario 5 (convert the attic) scored well in the overall MCDA ratings but is shown in its score to be more harmful in terms of the impact on significance and heritage values as it would require a major change to the built form and its historic setup. This approach for cross-comparison of factors opens a dialogue to help us consider these often-disparate topics and themes.

Figure 57: Comparison of scenario heritage value scores © The Environmental Design Studio
