## HMS B2

Archaeological Report

### HMS B2 DOVER APPROACHES

#### ARCHAEOLOGICAL REPORT

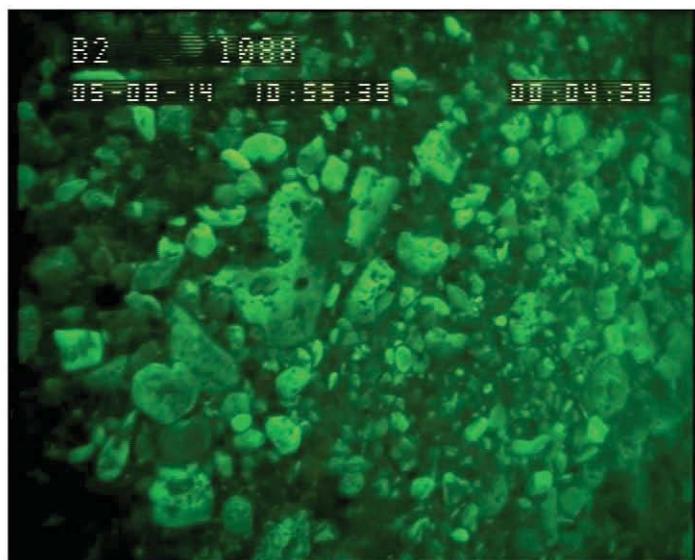
Plate 1: WA1139

- 4.6.1 The seabed consists of exposed chalk bedrock (**Plate 1**) and derived chalk gravel and cobbles interspersed with large patches of gravelly sand, shells and sedimentary rock fragments. Around the wreck deposits of well sorted middle grained sand build up against the site. Scouring is visible on the portside particularly at the bow where the structure appears to be undercut whilst the section towards the stern immediately aft the conning tower is covered by sandy substrate of several centimetres. The propeller and steering mechanism are exposed.

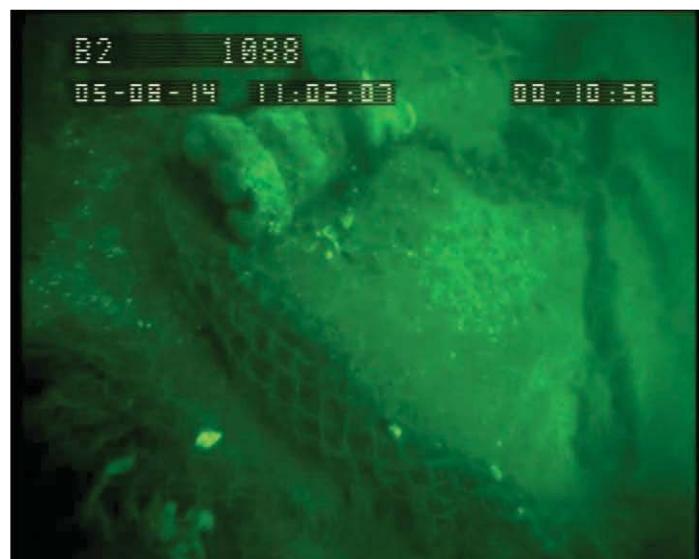
Plate 6: WA1187

- 4.7.27 Nets are present aft of the conning tower and up to c. 4 meters in a northerly direction over the port side. At c. 1.5m from the port side of the submarine a cylindrical feature (300mm diameter x 1.5m length) with toothed indentations on one end seems to be entangled in the fishing gear (**Plate 6, WA1187**). The nature of this feature is unclear.
