# Plymouth Civic Centre

## Feasibility Study

Final Report June 2010

AVANTI  
ARCHITECTS

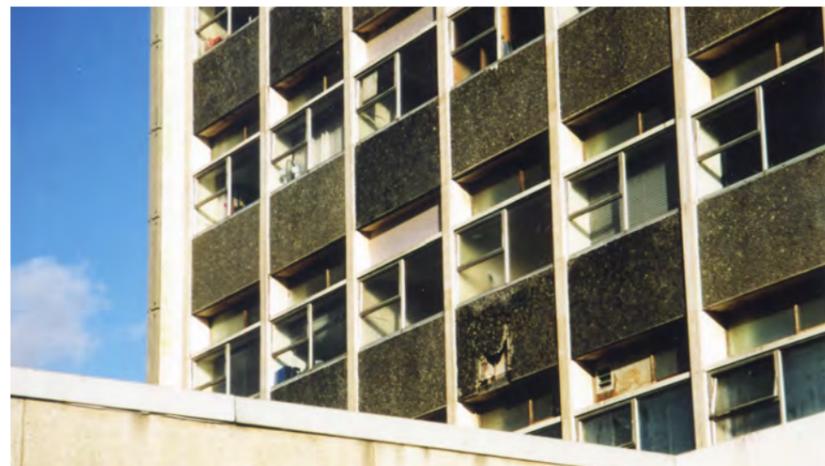
Close up of window details, current

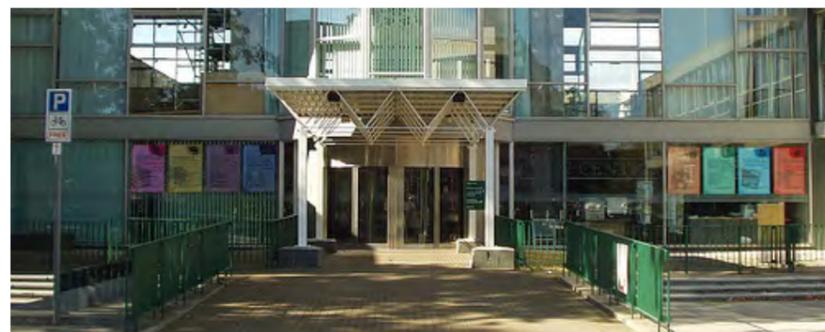
Amended entrance, 1995

already been extended from the main east facing doors. This intervention, undertaken in 1995, clumsily detailed and corrupting the tower soffit line, also involved the removal of an etched City Coat of Arms by artist Alan Collins in the original glass entrance screen. The original separate means of entry into the north office block (to the Housing and Children Departments) also appears to have been closed off as part of the above alterations – all visitors now being channelled through the reception system in the main foyer. (The ply covering currently conceals these sides of the entrance re-entrant.)

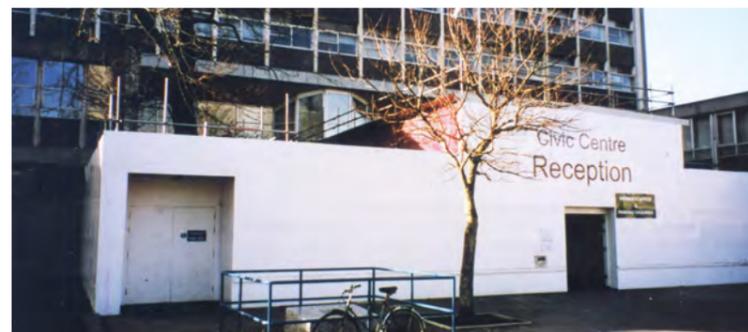
At low level a large plywood construction has been erected in front of the entrance, intended to protect visitors entering the building from the possible risk of loose fragments of concrete falling from above. This temporary enclosure detracts very considerably from the original entrance experience. Prior to its erection a projecting glass porch and entrance canopy had

Entrance enclosure now

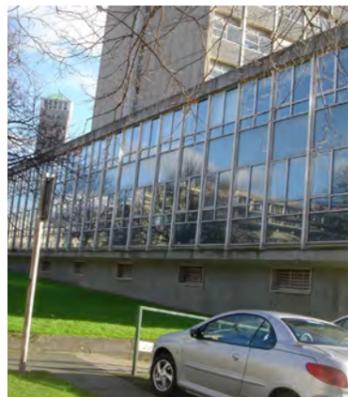
In addition, the north-facing façade of the north block has been replaced with a conventional curtain wall, losing the rhythmic treatment of the original fenestration.

North block façade, current

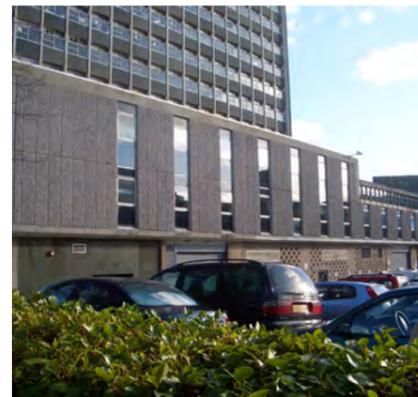
Additional tranches of office accommodation have been developed on the west side of the original plan below the tower, which extend the original block southwards, in a spur of 2 storeys on the outer edge becoming a single storey and infilling the western courtyard up to first floor level. These extensions, though providing significant additional accommodation, completely obscure the transparency of the ground floor entrance hall and detract from the legibility of the original plan form. The extension envelope is nonetheless constructed in a matching style, joining seamlessly with the original west facing flank wall. The single storey portion runs out in a wide flight of external steps which connect the first floor level with the main ground platform. A further consequence of this intervention was the removal of one of the two external concrete spiral staircases which connected the platform with the lower ground level on the west.

North west corner, as amended

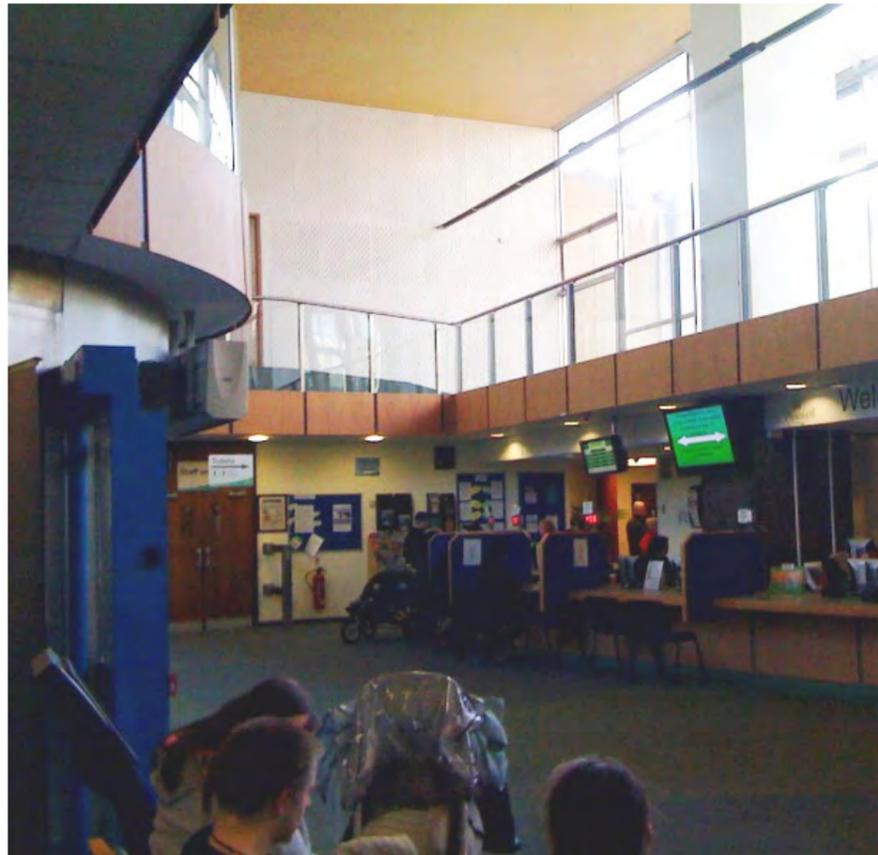
Having reached the foyer itself there are further alterations following a major refurbishment in 1995. The original information kiosk has been replaced by an extensive reception counter, and the fine terrazzo/marble floor has been overlaid with carpet. The quantity of seating has been increased to create large waiting zones, with various information screens and associated paraphernalia replacing the distinctly minimal look of the original photographs. The Ashburton marble column facings have been replaced

Entrance foyer, current

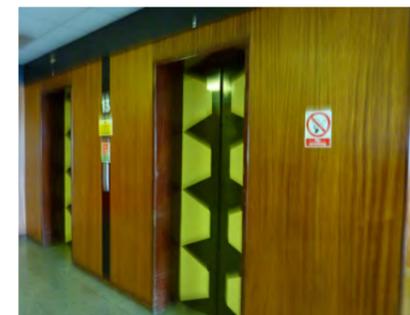
Lift hall, current

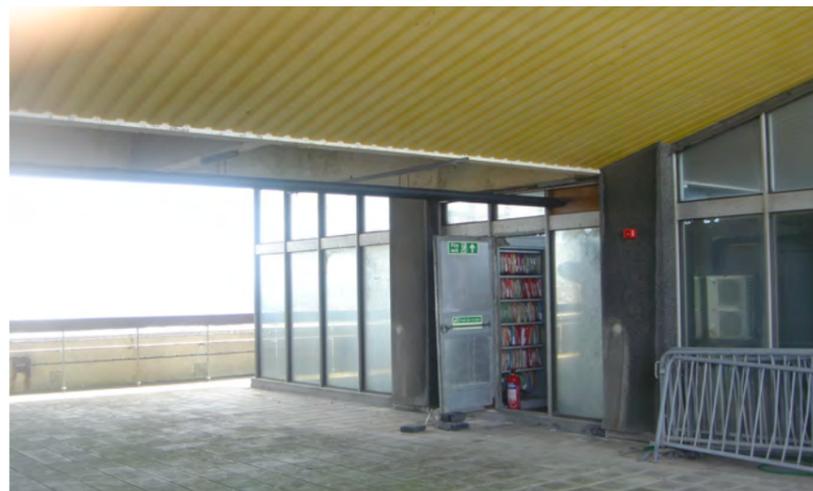
Roof terrace, current

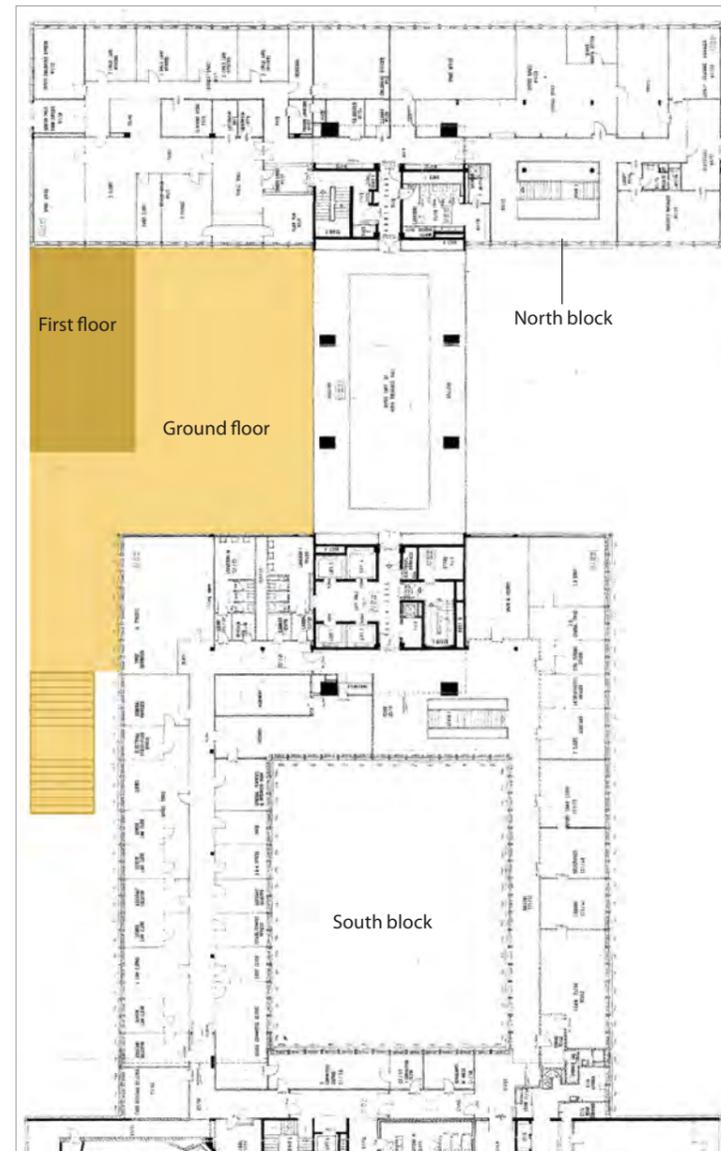
First floor north and south admin blocks 1959, shaded tones indicating plan alteration

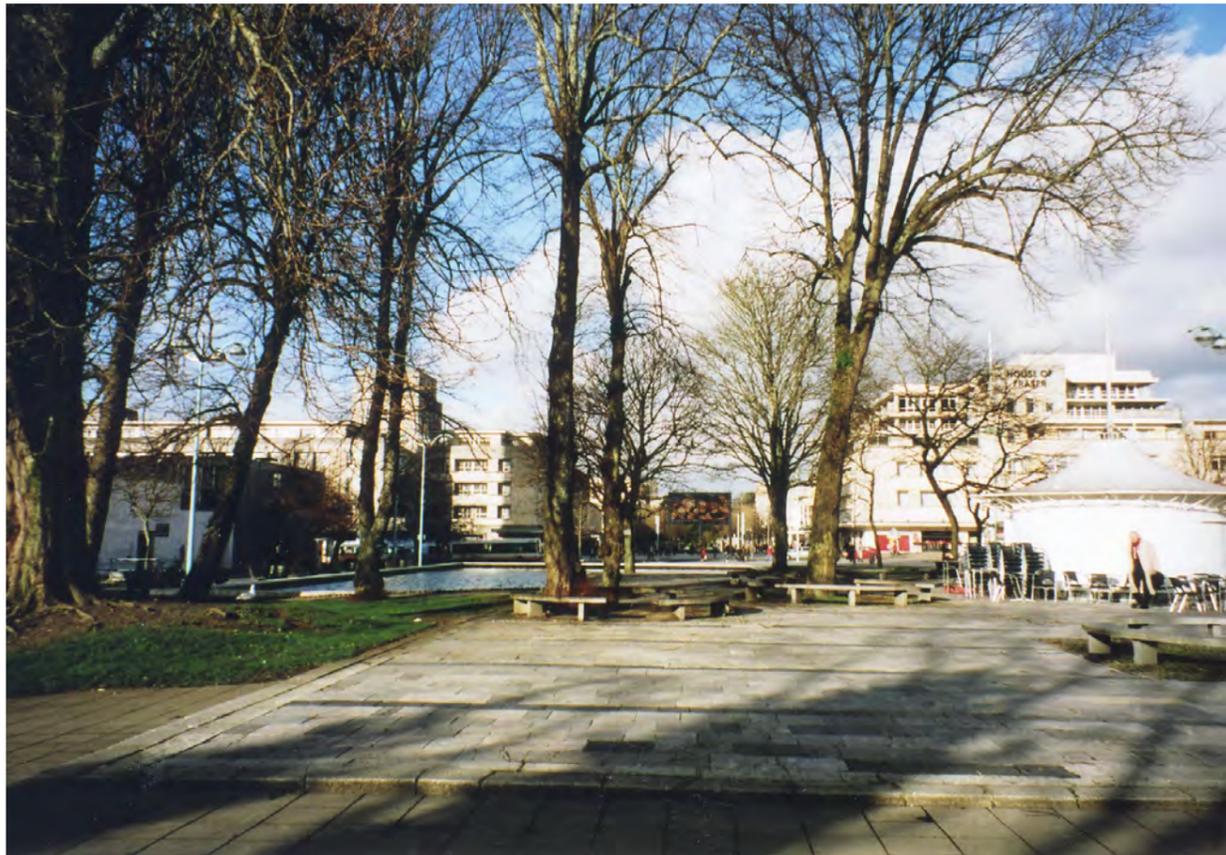
View north towards The Great Square, current, showing 'tentform' cafe, right

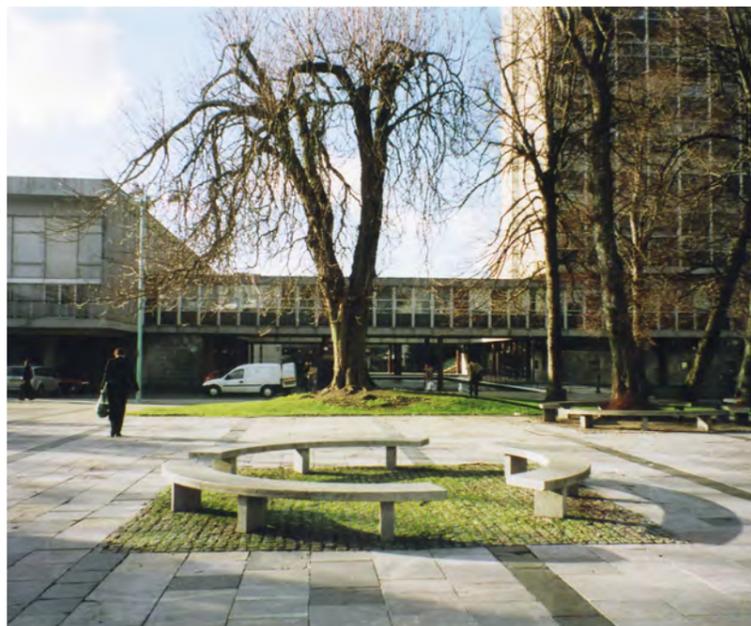
Seating in the square (supports altered from original tapered design)

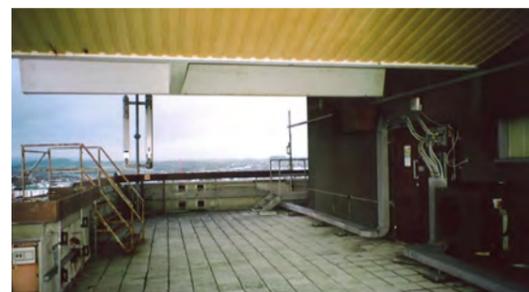
The terrace is finished in concrete paviors which appear to be in sound condition. The parapet walls are capped in (non-original) pressed aluminium copings. The inside face of parapet walls are exposed concrete which show a degree of wear and tear, also refer to Structural Survey by SW.

There are a number of antennae and associated cabling and ducting attached to the parapet walls at the four corners, the cable routes are connected to the main structure across the terraces via localized steel gantries creating obstacles.

The condition, build-up and age of the waterproofing membrane below concrete paviors is unknown.

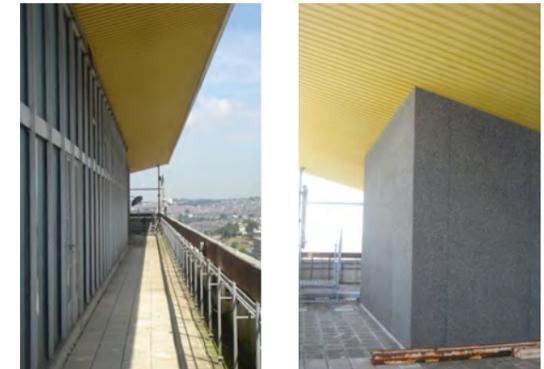
#### Façades to fourteenth floor

The southern portion of the enclosure façade to 14th floor is predominantly constructed of aluminium framed full height glazing with associated opening lights and doors. The system is basic, does not comply with current standards and shows a degree of wear and tear.

The northern enclosure is clad in exposed aggregate precast concrete panels which appear to be in good visual order.

Access/escape doors, hatches and associated ironmongery are dated and in need of maintenance attention or upgrade.

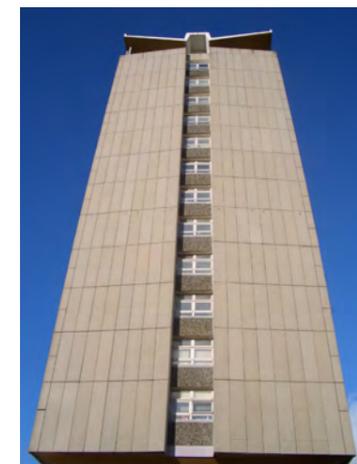
Prefabricated concrete panels (which have been replaced) and insitu soffits were visually examined from ground level. Some deterioration and spalling were detected within the façade panels. It appeared that the condition was superior to panels on the east and west façades. Also refer to structural survey by SW.

Aluminium framed window ensembles were visually inspected from ground level and from inside. Not all windows were examined but assemblies inspected were generally in working order, although not compliant with current standards.

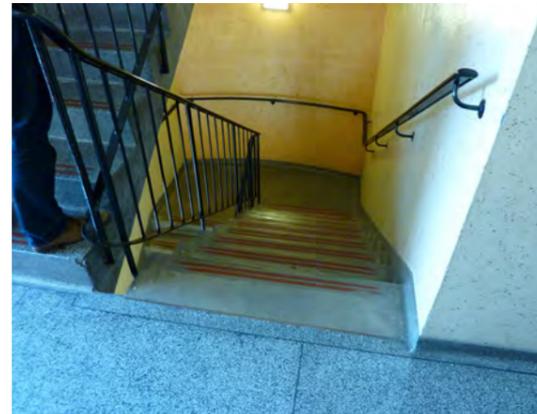
**South core to fourteenth floor and services mezzanine above**

South core continues to fourteenth floor and the service mezzanine via the escape stairs, the lifts do not serve fourteenth floor. Dumb waiter originally arrived at this level but its condition or serviceability is unknown. Escape stairs continue up to service mezzanine. Generally the staircase and walls seem in good order.

The doors to escape stair lobbies are original and many of them carry original ironmongery, the serviceability of these doors with regards to smoke and fire containment is unknown.

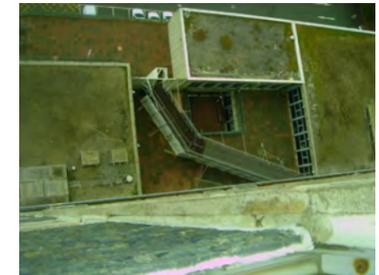
The roof was visually inspected from high level windows of the Tower. There is evidence of moss growth and some ponding. The exact condition, build up and age of the roofing membrane is unknown, but it can be assumed that replacement of the covering with enhanced insulation and drainage gradient would be included in a general refurbishment project.

The roof lights are currently under protective boarding. The condition of these roof lights is unknown.

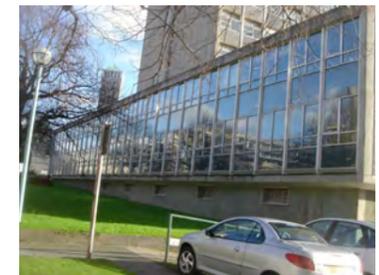
**North façade**

The north façade is composed of double height window assemblies (curtain walling) with precast stone full height separating mullions. The façade is clad in precast concrete sections to the parapet, sides, and the continuous cill at ground level. Visual inspection shows these to be in better condition than those of the tower, also refer structural survey by SW.

The exposed wall to basement service areas, to the west of the façade is in brickwork in fair condition. The wall also includes a regular pattern of ventilation grills to various accommodation behind.

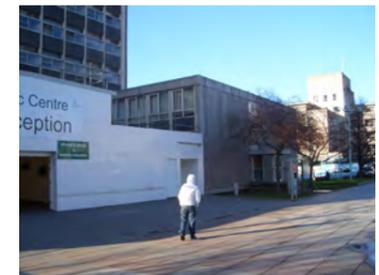
**South façade**

As the eastern portion of south façade is currently covered in protective hoardings, it has not been possible to visually inspect this façade.

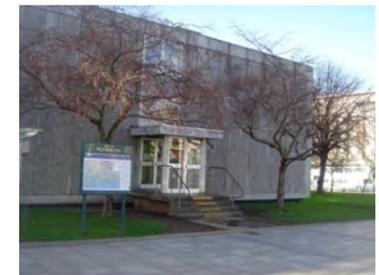
**East and west façades**

East façade is faced with exposed aggregate precast units with a two storey height window assembly approximately in the centre. The ground floor portion of the window has been replaced by a new entrance arrangement with an external glazed lobby accessed via steps and ramps from the pedestrian areas to the east. The date of this entrance is unknown. The precast concrete panels appear in fair condition and generally better than those of the Tower, also see structural survey by SW.

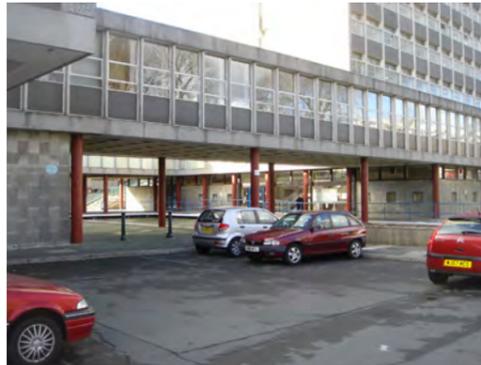
<p><b>East, west, north and south elevation to ground floor section (GL 30-20 N/S)</b></p> <p>Ground floor façades are generally clad with riven-face slabs of Delabole slate. With rectangular aluminium windows at high level and punched square ones at mid level. The condition of cladding and windows is generally fair. Some of slate panels have been pinned back due to delamination.</p> <p>The south façade between grid lines M and T is fully glazed with an access controlled glazed double door, staff entrance, the glazed screen is in good visual order but does not comply with current standards.</p>

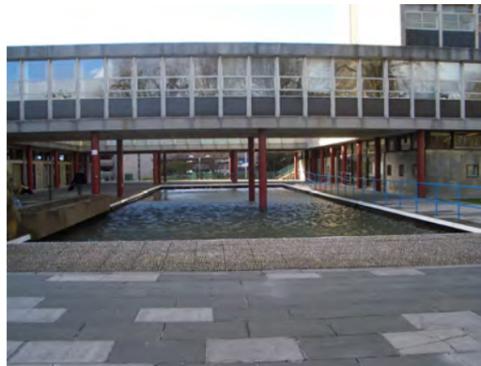
<p><b>East, west, north and south elevations to first floor</b></p> <p>East and west elevations are composed of single storey window assemblies (curtain walling) with precast stone full height separating mullions. The façade is framed in precast concrete sections to the parapet, sides, and the continuous sill at first floor slab. Visual inspection shows these to be in better condition than those of the tower, also refer structural survey by SW.</p> <p>North elevation is composed of exposed aggregate precast concrete panels. Visual inspection shows these to be in better condition than those of the tower, also refer structural survey by SW.</p>

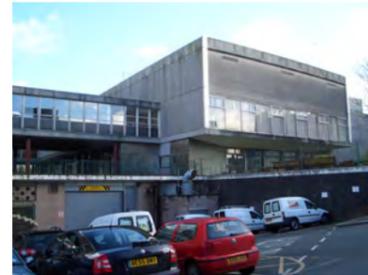
The reconstituted stone/concrete cladding at first floor and above is stained and weathered but otherwise appears to be in good order.

The soffit to the first floor overhang is in good condition with the exception of one patch repair to the north west corner.

The slate cladding to the walls at ground floor has suffered modest staining and weathering but is generally in good order. There are isolated patches of damaged slate and some poorly executed repairs have been carried out.

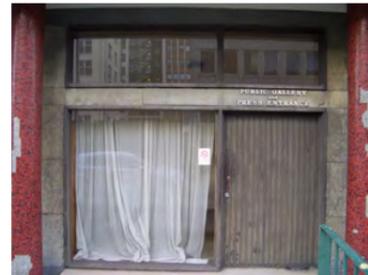
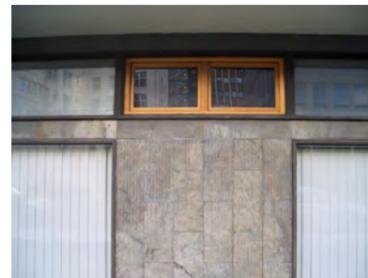
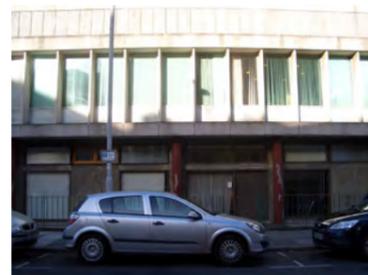
A number of the original windows to the Mayor's parlour at first floor have been replaced with new windows that do not match the originals.

The spandrel panels beneath the windows at first floor are stained but otherwise appear in good order.

The reconstituted stone/concrete cladding at first floor and above is stained and weathered but otherwise appears to be in good order. Some of the panels appear to have been dislodged and have suffered damage (refer to the Structural Survey by Scott Wilson).

The soffit to the first floor overhang is in good condition but requires cleaning and redecoration.

The slate cladding to the walls at ground floor has suffered modest staining and weathering but is generally in good order. There are isolated patches of damaged slate and some poorly executed repairs have been carried out.

Large areas of original mosaic tiles are missing from the columns at ground floor, evidently as a result of malicious damage.

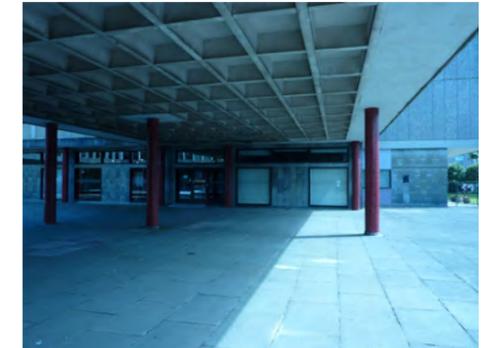
#### North elevation

The spandrel panels beneath the windows at first floor are stained but otherwise appear in good order.

The reconstituted stone/concrete cladding at first floor and above is stained and weathered but otherwise appears to be in good order.

The soffit to the first floor overhang is generally in good condition.

The slate cladding to the walls at ground floor has suffered modest staining and weathering but is generally in good order. There are isolated patches of damaged slate and some poorly executed repairs have been carried out.

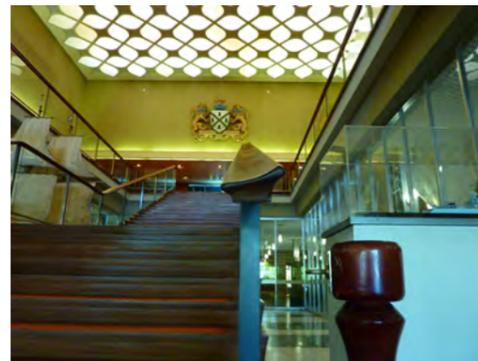
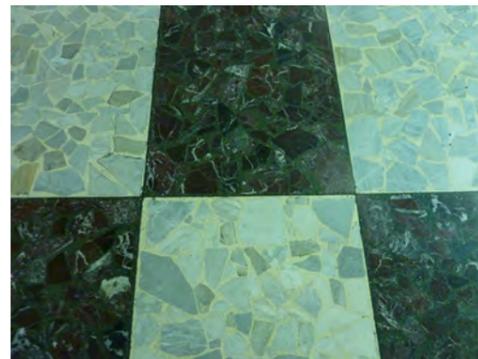
The original embossed ceiling tiles are largely intact and in good condition with isolated areas of modest damage and adjustments made for retro-fit items such as smoke detectors. The internal column cladding of Ashburton marble and white Sicilian marble is undamaged and in good condition.

The south wall to first floor foyer at high level has previously been refurbished due to collapse of the plaster behind decorative wall paper, thought to be caused by vibration from the centrifugal fans in rooms behind. The north wall shows signs of plaster delamination, behind decorative wall paper, this area will need to be further examined and investigated.

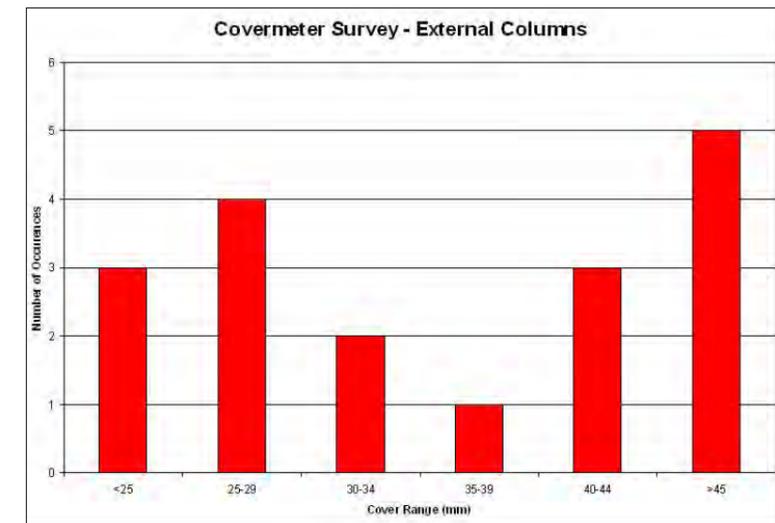
Reinforcement cover on the externally exposed areas of the concrete columns was measured between 22mm and 61mm, which is reasonable in comparison with the recorded design cover of 11/2" (38mm). Refer to the following chart. The cover meter depths were taken on the side faces of the columns due to the presence of reconstituted stone cladding pilasters covering the outer faces.

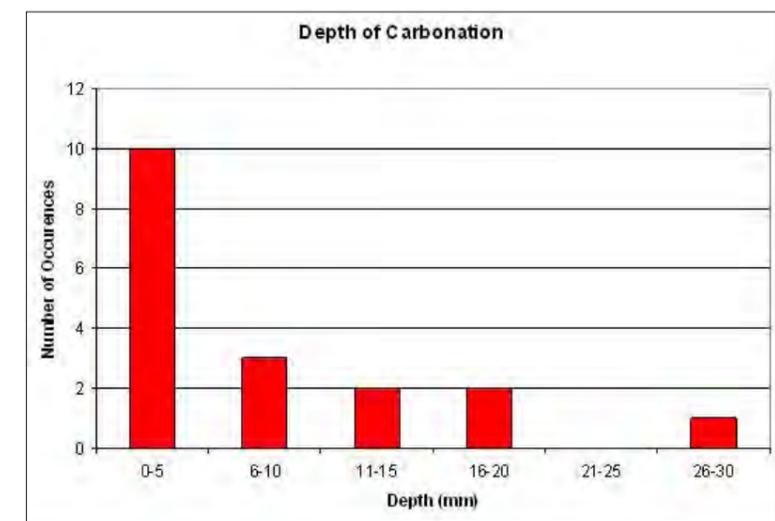
Carbonation depths were found to be in the range of 1mm to 30mm, with a significant proportion higher than the anticipated maximum value of 5mm. Low carbonation ingress is usually found in structures set in a maritime environment such as this, because the weather conditions tend to keep the concrete sufficiently wet to prevent carbonation occurring. Nevertheless, when the carbonation and cover depths are correlated, the test data indicates that only 10% of the reinforcement is at risk of reinforcement corrosion due to carbonation.

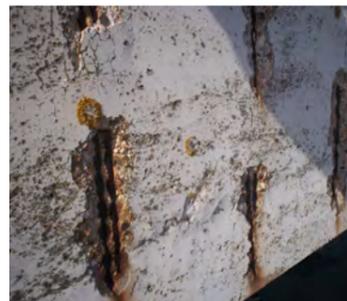
Reinforcement corrosion to gull wing roof edge

A moderate amount of cracking, and a small amount of concrete spalling was found to be present. Typically the cover was low. On the roof edge the cover was measured between 5mm and 34mm. The ribbed soffits could be seen to have very low concrete cover of between 2mm and 3mm. The reinforcement appears to have been placed on the formwork during casting in some areas.

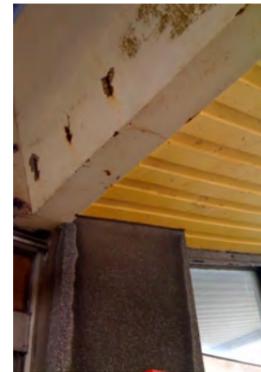
Corrosion in parapet at movement joint. Side view (right). Top view (left).

The measured carbonation depths were typically only 1mm to 2mm with a single abnormally high value of 12mm, although coupled with the low cover this would indicate a high risk of carbonation-induced corrosion.

Chloride contents were not excessively high, but were typically sufficient at the level of the reinforcement to introduce a risk of corrosion (>0.3% by weight of cement).

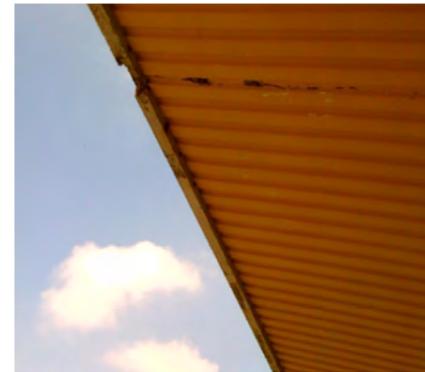
Corrosion in gull wing roof soffit

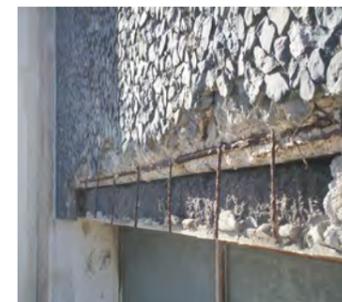
Dilapidated spandrel cladding panels

As stated in our previous report, low level spandrel panels appear to differ in colour, which could be due to the presence of a clear coating, possibly an anti-carbonation coating. It would seem doubtful that a coating was applied at the time of construction, and would more likely have been applied some time later. It is also unclear how many panels would have been coated, but it would acknowledge that spandrel panel corrosion has been known about for some time, and that previous efforts have been made to address the issue.

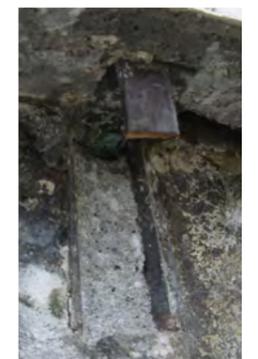
Non-ferrous metal pilaster restraint fixing

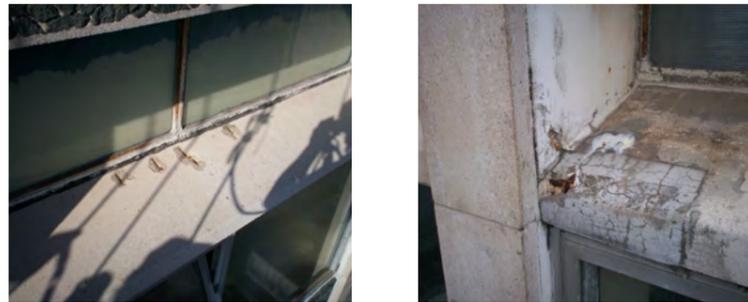
The upper and lower windows of each bay of the façade are separated by pre-cast concrete transom cills, many of which exhibit signs of reinforcement corrosion and previous patch repairs.

Samples of concrete taken from the transom cills revealed high levels of chloride content, indicating the reinforcement corrosion to be chloride induced. In this instance the exposure to chloride ions is increased not only through direct exposure to a maritime environment, but also from rain running-off the windows above.

Pre-cast concrete transom cills

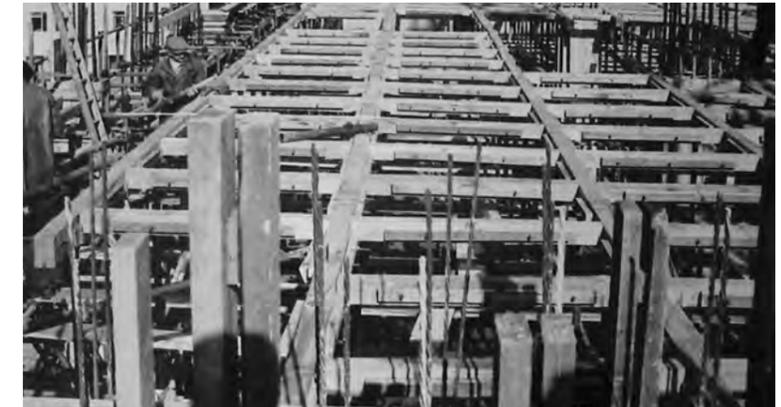
- ▶ Photographic records indicate sufficient continuity of reinforcement in the vertical ties (columns) by virtue of the reinforcement laps visible between floors

Column reinforcement projecting above slab. Continuous between floors

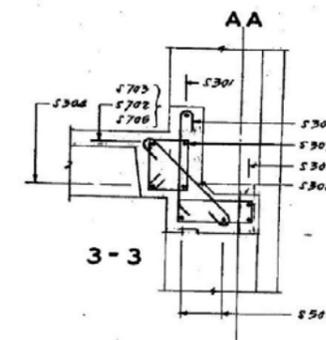
- ▶ Columns are adequately tied to the slabs through mechanical interlock of column reinforcement with the perimeter edge beam reinforcement and its subsequent mechanical interlock with the slab reinforcement.

Perimeter column anchored to slab by mechanical interlock with perimeter beam reinforcement
