Ancient Monuments Laboratory  
Report 47/93

DOVER BRONZE-AGE BOAT:  
ASSESSMENT FOR CONSERVATION

Jacqui Watson

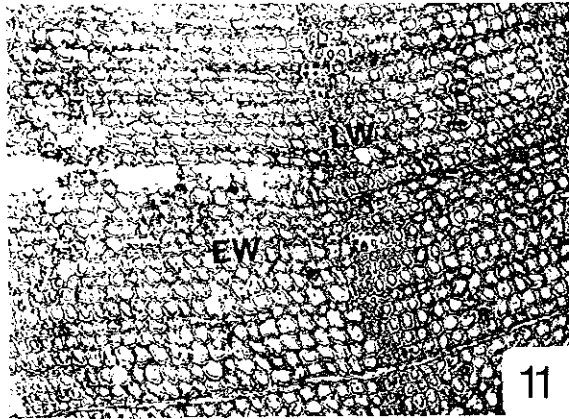
Figures 11-16. Light (LM) and scanning electron micrographs (SEM) of transverse sections of yew sample 15, withy 108.

11. LM showing the gradual transition from earlywood (EW) to latewood (LW). x47

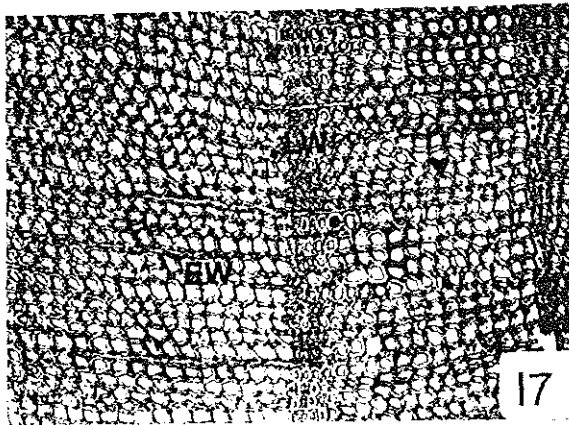
Figures 17-22. Scanning electron micrographs of yew sample 15, withy 108.

17. Sound early (EW) and latewood (LW) with most of the cell wall still intact. x320
