Centre for Archaeology Report 73/2001

# **Report on the Excavation and Survey of Two of the Bomb Craters at Fort Cumberland**

David Fellows

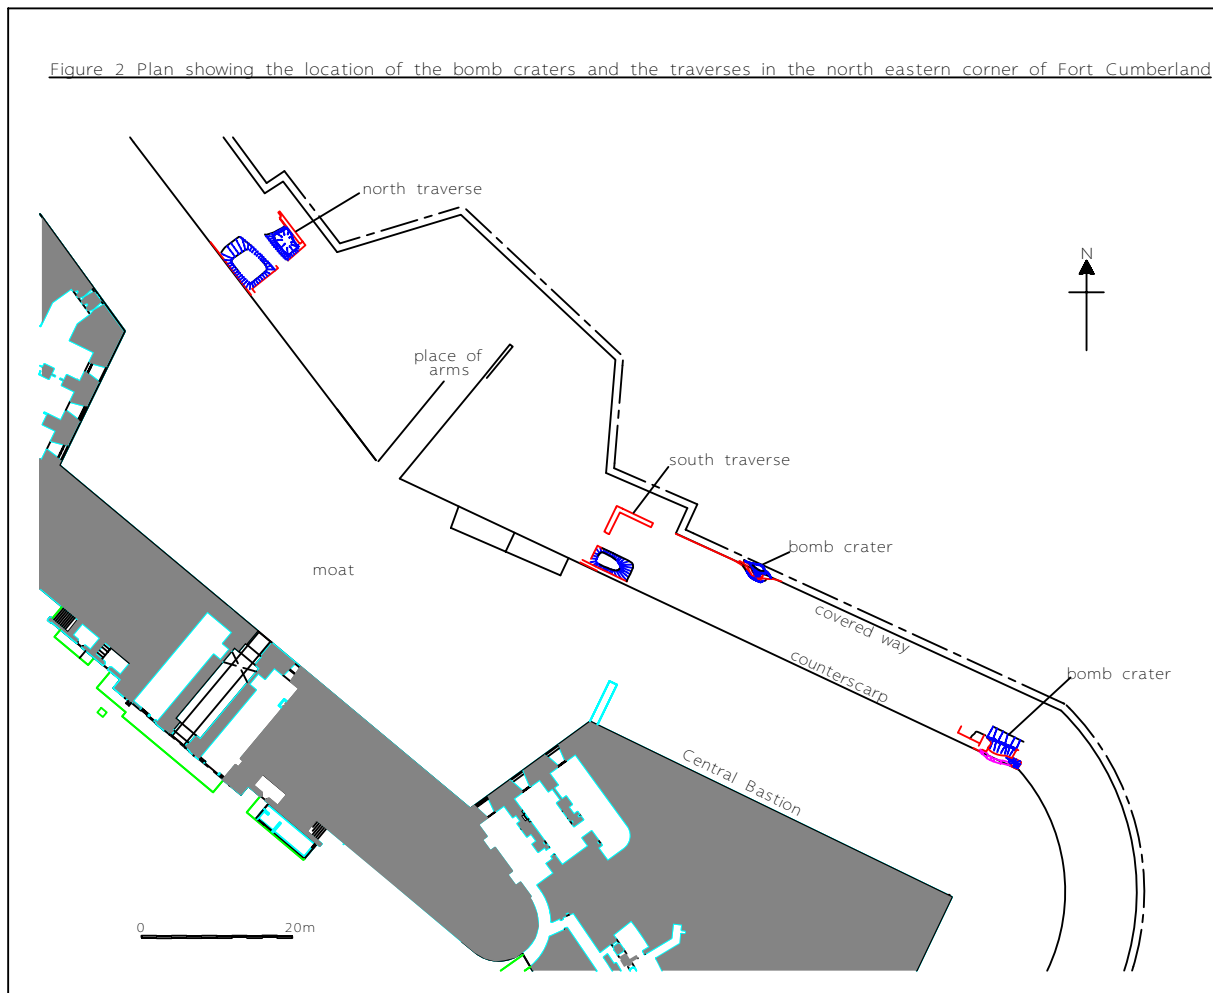
Figure 2 Plan showing the location of the bomb craters and the traverses in the north eastern corner of Fort Cumberland

Removal of vegetation and general clearance of overlying debris during the consolidation works at Fort Cumberland revealed the full extent of the damage of two of the bomb craters dating from the aerial bombardment experienced on the evening of the 26th August 1940. The craters are located to the north-east of the Fort, one causing a breach of the counterscarp wall directly to the north of the apex of the central bastion, the other breaching the parapet wall of the covered way to the north-west of the central bastion (*see figure 2* for location plan).
