Centre for Archaeology Report 75/2001

## **Report on the Survey of the Hospital Complex at Fort Cumberland**

David Fellows and Patrick O'Hara

### **Summary**

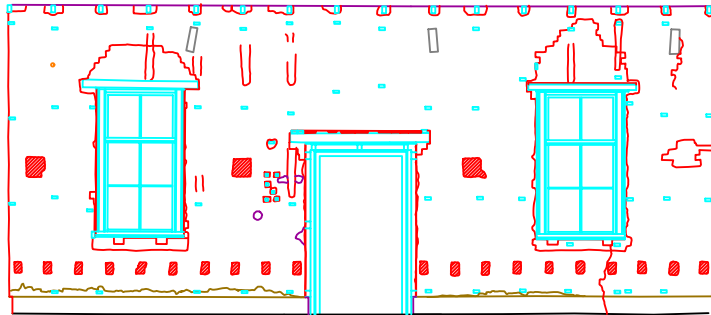
south elevation

Internally the wall has a rendered plinth that is 0.20m high (8") above the poured concrete floor and c.0.06m (2½") proud of the wall face (see **figure 7**). The plinth stops on either side of the door and does not appear to have been cut through for its insertion, suggesting the plinth to be either contemporary with or post-dating the insertion of the door. It is thought that the door and windows were inserted into this elevation during the second phase of works early in the 19th century when the North Office was added. The addition of the North Office would have created a rectangular building, with central doorways flanked by windows in the north and south elevations.

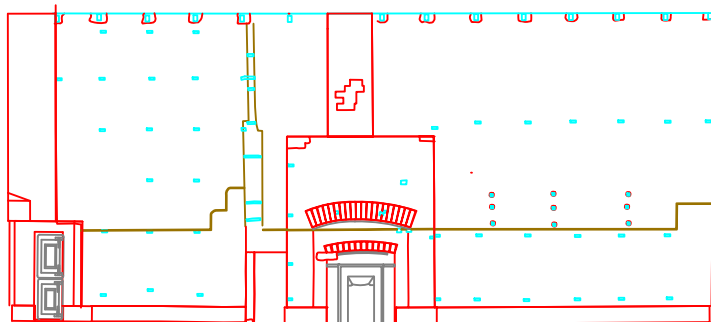
north elevation

The northern wall of the Storehouse survives little altered from its original form, although evidence for the varying uses of the building can be seen on the internal face (see **figure 7**). The final decorative scheme in the Storehouse consisted of dry-lining, with the wall surfaces covered by hardboard attached to timber battens. This has recently been removed to expose the brickwork, and the elevation retains much of the final paint scheme of the room.

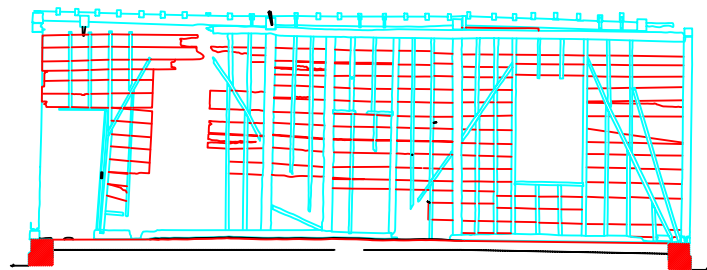
south elevation

The southern elevation of the timber-framed structure was recorded by HPSE prior to the restoration works being undertaken, and the survey results are shown on **figure 10**.

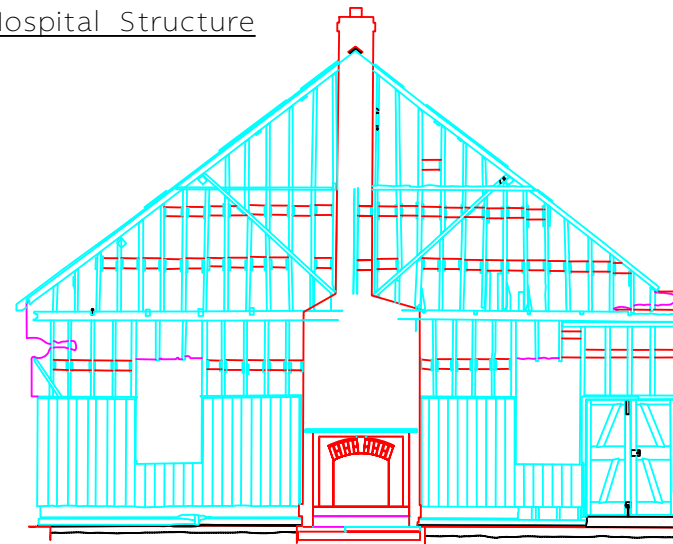
west elevation

The western elevation of the timber-framed structure was recorded by HPSE prior to the restoration works being undertaken, and the survey results are shown on **figure 10**.

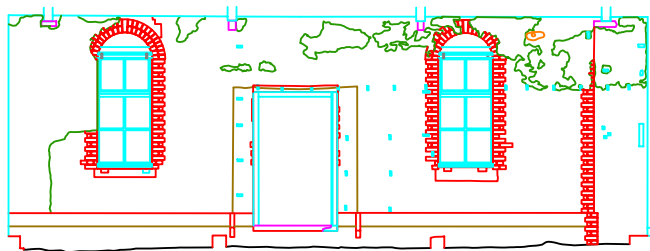
north elevation

The northern wall of the timber-framed Hospital building is the external elevation of the southern wall of the 1747 Storehouse building. It is constructed of red brickwork laid in English Bond. The elevation currently contains two window openings and a central doorway (see **figure 10**, with an isometric view of the 3D wire-framed model of the internal Hospital elevations shown on **figure 11**). The windows and door have been inserted through the brickwork prior to the construction of the timber structure of the Hospital building. At the eastern end of the wall there is the vertical joint between the original south-eastern quoin of the building and the more recent Flemish bonded brickwork (1850s) of the eastern range (see **figure 10** showing the survey results of the north wall).

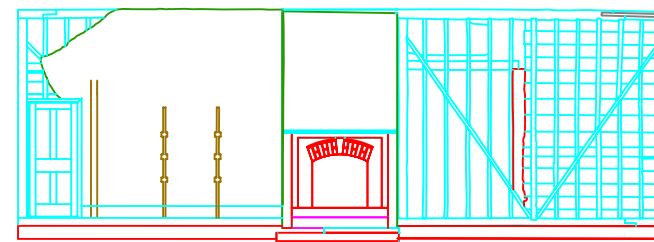
east elevation

Although the northern wall of the hospital extension is brickwork (as it is part of the earlier Storehouse building), the rest of the structure is predominantly timber-framed. The eastern wall can be treated as being in three sections, two sections of timber framing separated by a centrally positioned brick fireplace and chimney (see **figure 10** showing the survey results of the east wall).

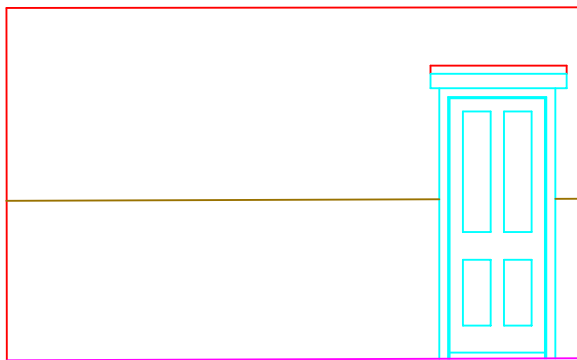
south elevation

inserted four panelled door at the western end of the southern elevation leading to the next room in the range, the Barber's Shop (see **figure 13**).

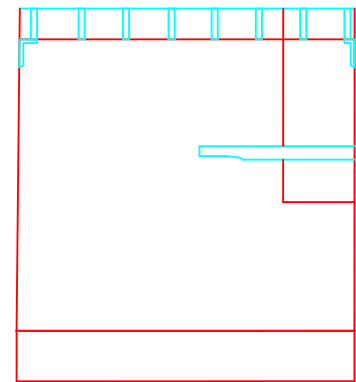
west elevation

The western elevation of the South Store shows evidence for the external face of the east elevation of the Storehouse. The brick plinth can be seen, as can the southern jamb and the sill of the window opening, although the opening has subsequently been blocked with brickwork (see **figure 15**).
