RESEARCH REPORT SERIES no. 19-2013

APETHORPE HALL, APETHORPE, NORTHAMPTONSHIRE DOVECOTE ROOF

HISTORIC BUILDING REPORT

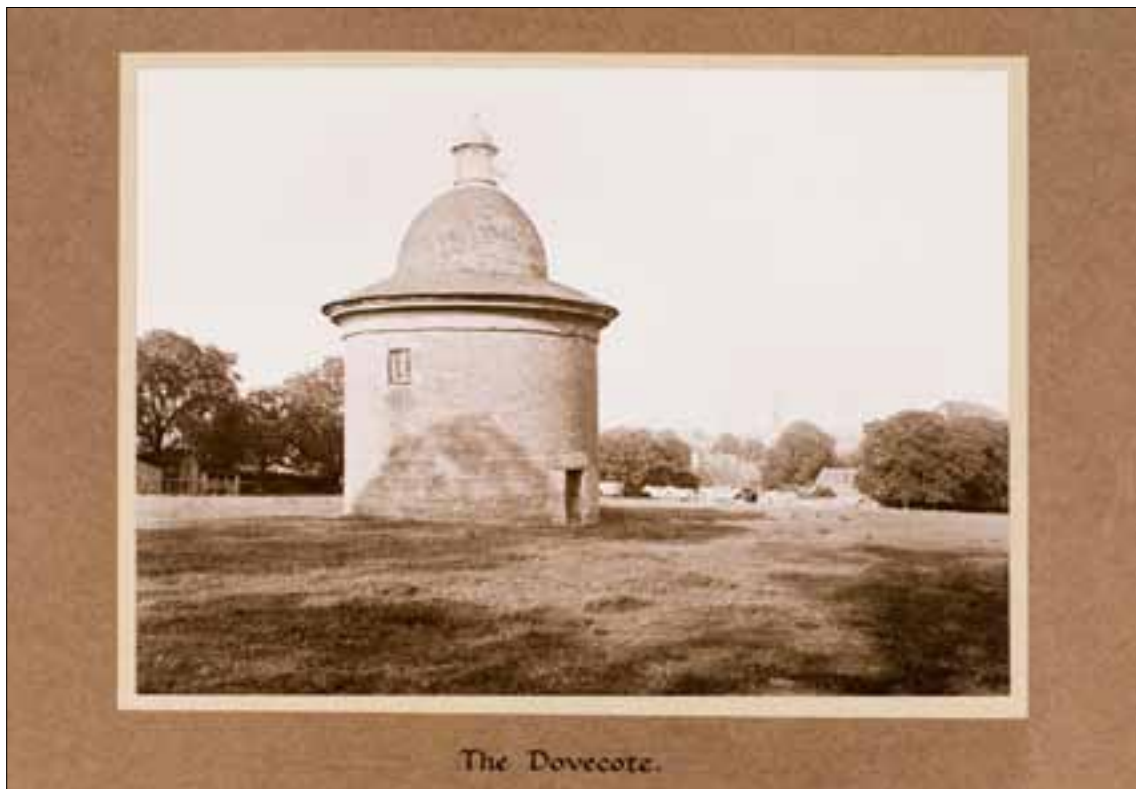
Fig 3 The west side of the Dovecote in 1922. The Dovecote had recently been fitted with a water tank inside and a new glazed lantern. Courtesy of Lord Brassey.

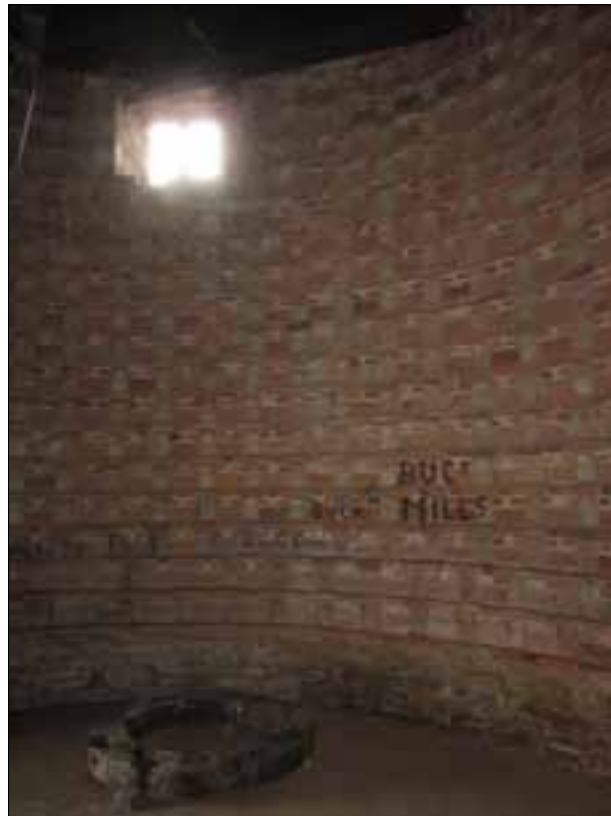
Fig 4 The interior of the Dovecote, with bricked-up nesting boxes.

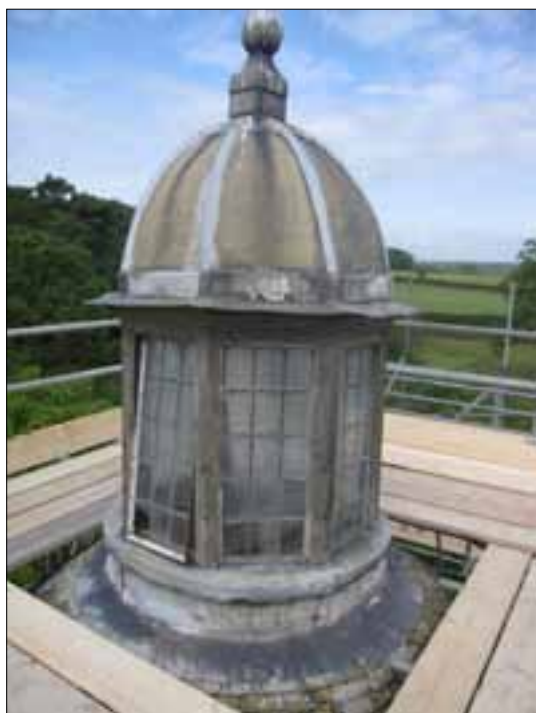
Fig 5 The early 20th-century glazed lantern and original leaded cupola.

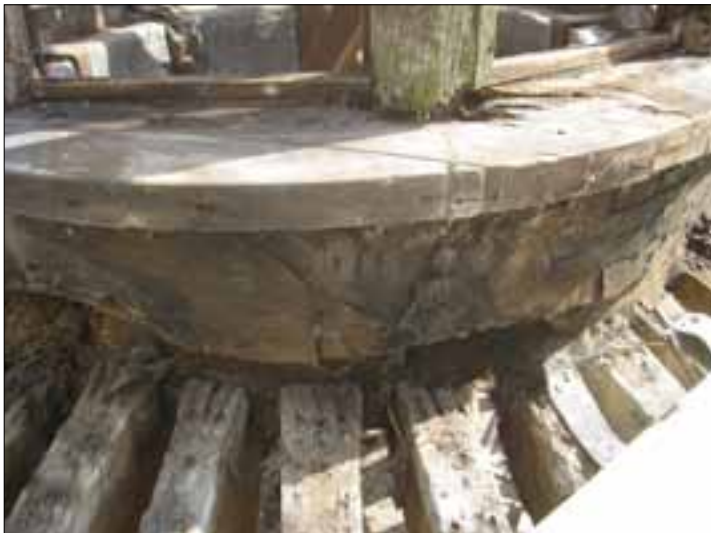
Fig 11 Detail of the upper ring-beam, with early 20th-century applied softwood cill, carpenter's mark 'IIII' and oak peg which fixed the tenon of the original Glover post.

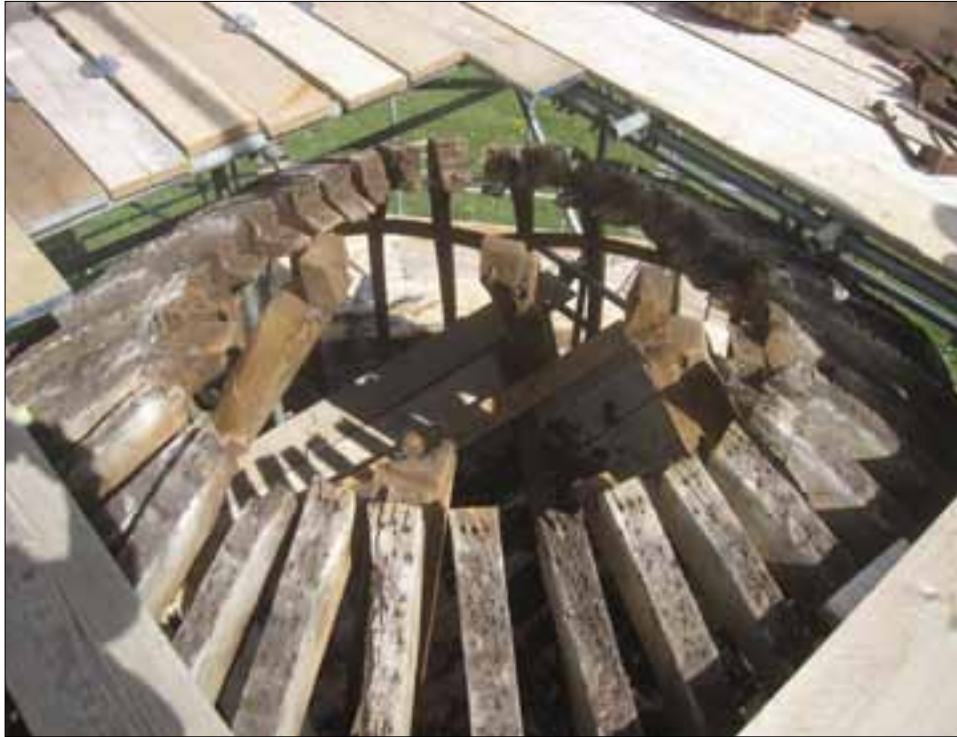
The dome ribs are of carefully shaped oak (c.140mm by 70mm), tenoned and nailed to the dome base beam at the foot, with a nailed birds-mouth joint to the lower ring beam at the top (figs 14-15). Five of the ribs were formed of two sections, an open tenon joint. It was clearly a challenge to obtain enough timber to produce the long, curved ribs in a single piece. There are 32 ribs, with a set of chisel-cut carpenter's marks to the foot, all in sequential order – eg 'XXVII' (fig 17).

Fig 14 The tops of the main dome ribs, after removal of the ring-beams. The tops of the four straight principal rafters can also be seen.

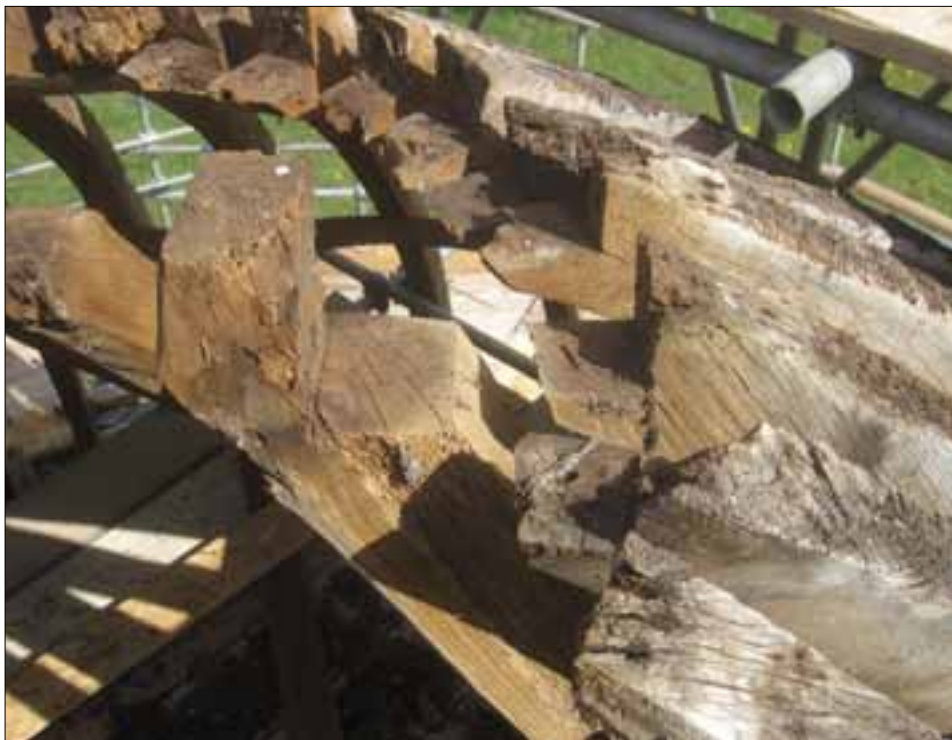
Fig 15 Detail of the birds-mouth joint to the ribs and principal rafters, which fitted against the underside of the lower ring-beam.

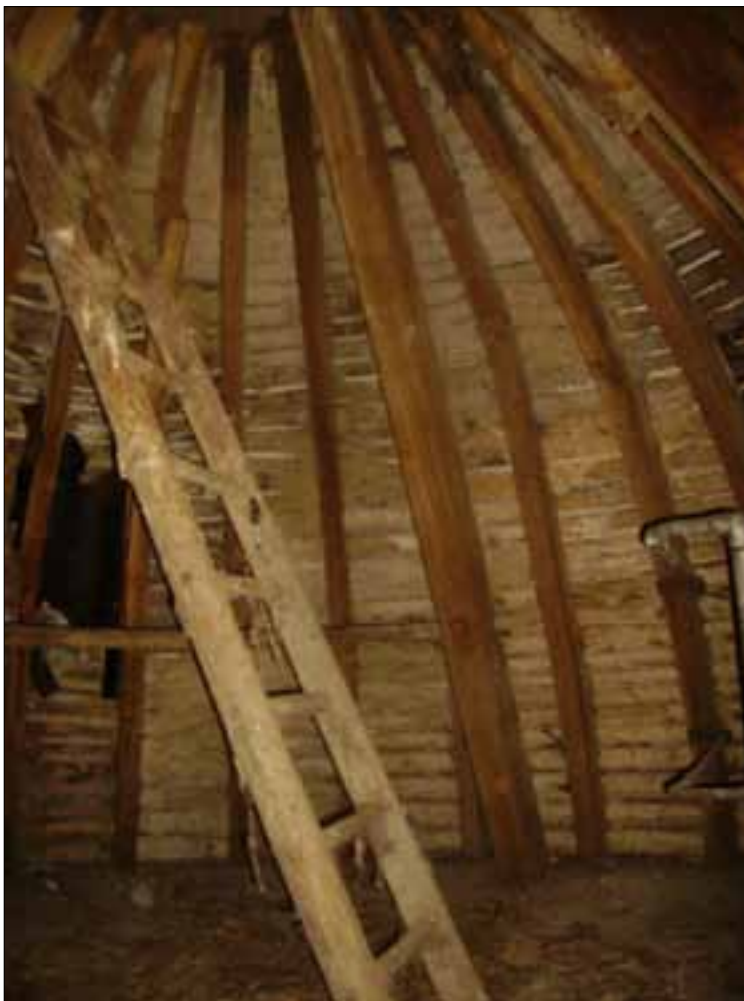
Fig 17 The interior of the main dome before roof stripping. As well as the curved ribs, one of the straight principal rafters is visible.

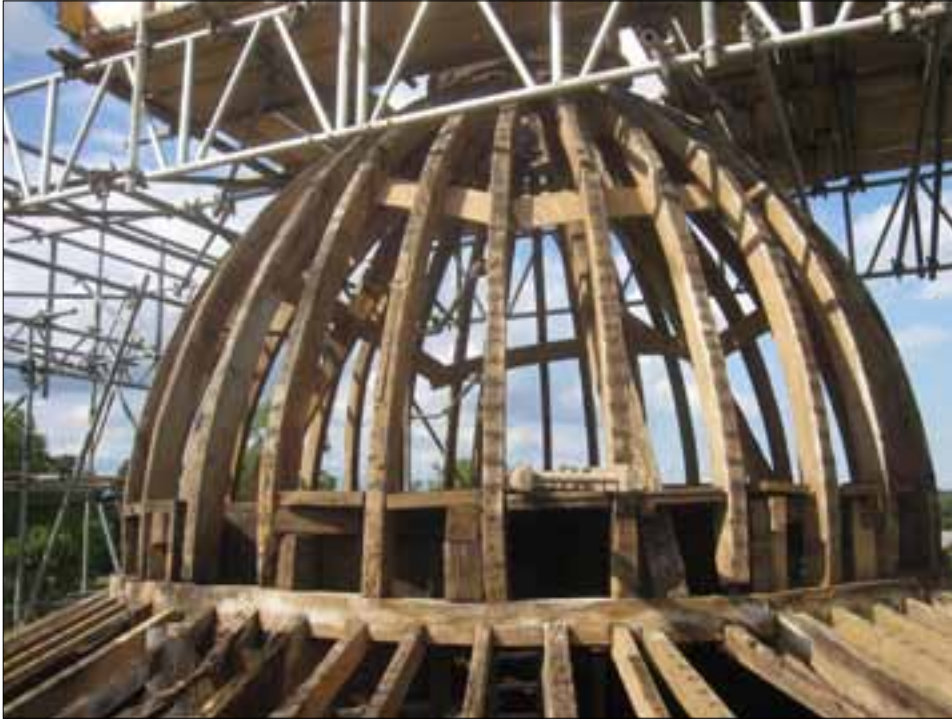
Fig 18 The ribs of the main dome are supported on the dome base plate, which is in turn supported by the lower 'skirt' structure. Some of the straight principal rafters to the dome can also be seen, as well as joist ends of the inserted floor.

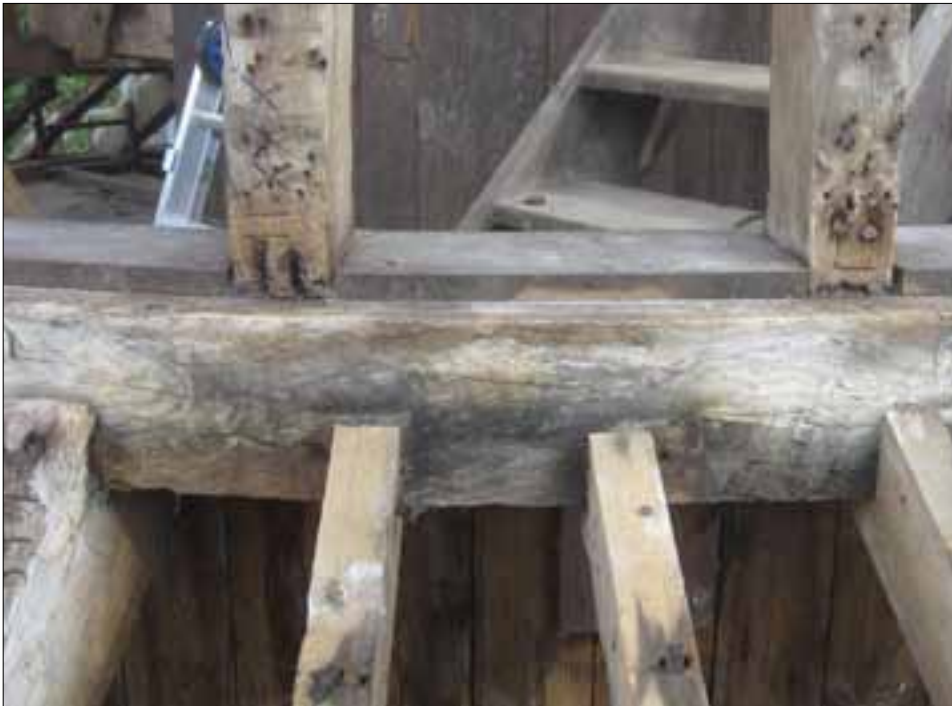
The dome base beam is circular, with an outside diameter of 4.7m (fig 19). It is formed of six curved sections (180mm by 150mm), with half-lap joints, fixed with a forelock bolt. Some chisel-cut carpenter's marks were seen to the beam sections eg 'IIII'.

Fig 19 Detail of the dome base plate, with the first and last dome ribs – marked 'I' and 'XXXII'.

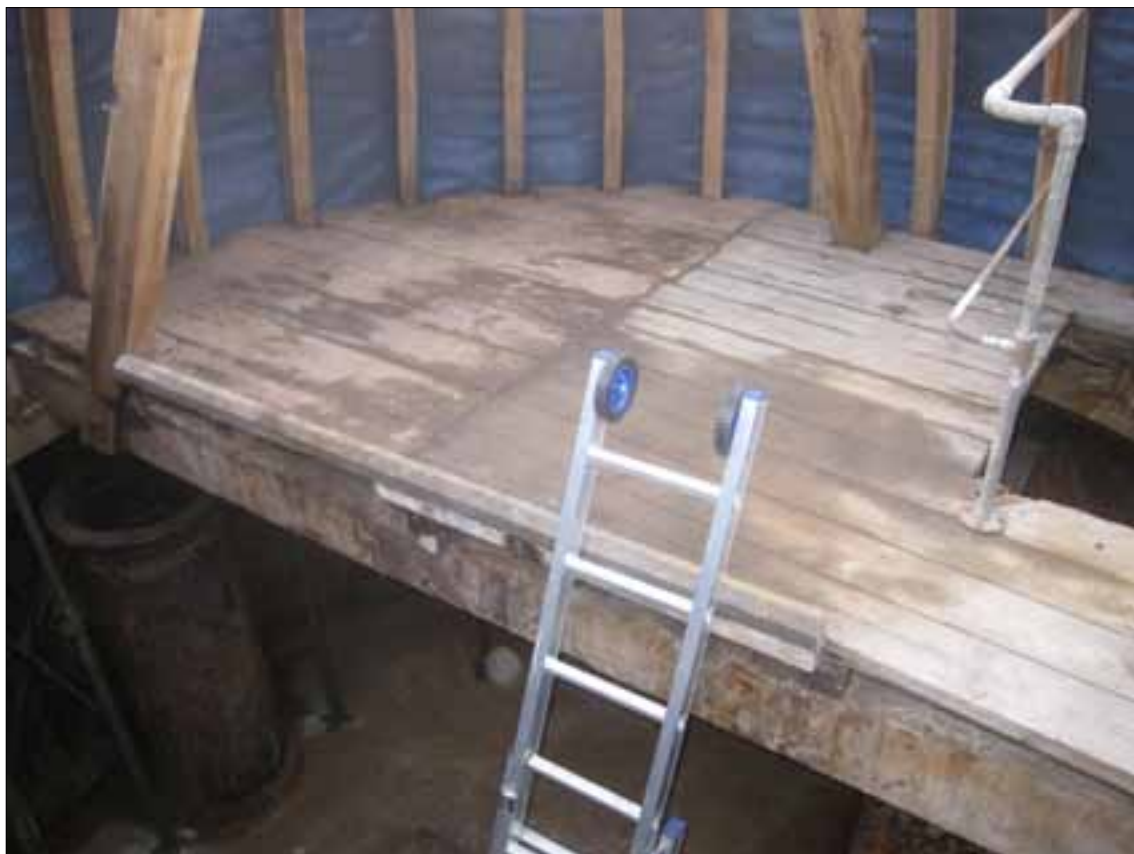
The structure of the dome is braced by four principal rafters, straight not curved, and of c.140mm x 135mm in section. Two of these rafters are secured to a horizontal tie-beam, with a lap-dovetail joint, fixed with a forelock bolt and a large nail (figs 20-21). The tie-beam is seated on top of the dome base beam, and is fixed to this with a lap dovetail joint and forelock bolt (fig 22). The other two principal rafters have no tie-beam, and are simply birds-mouth jointed to the dome base beam and fixed with large nails. At the top, all four principal rafters have a birds-mouth joint to the lower ring-beam, through-fixed with a forelock bolt. When the iron water tank was fitted, softwood joists and boarding were added above the tie-beam, to form a partial floor.

Fig 20 Lower part of a dome principal rafter and the tie-beam – partly covered by the water tank floor.

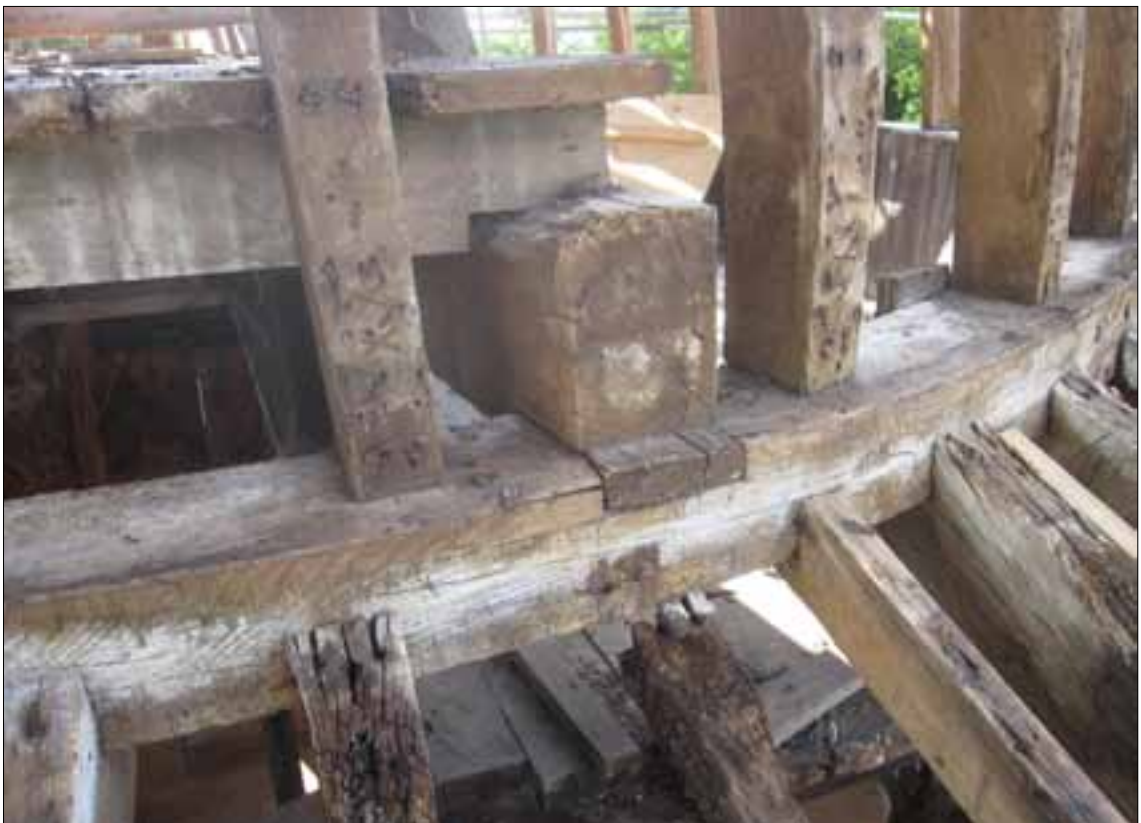
Fig 22 Detail of the dome tie-beam end, with dovetail-lap seating onto the dome base plate.

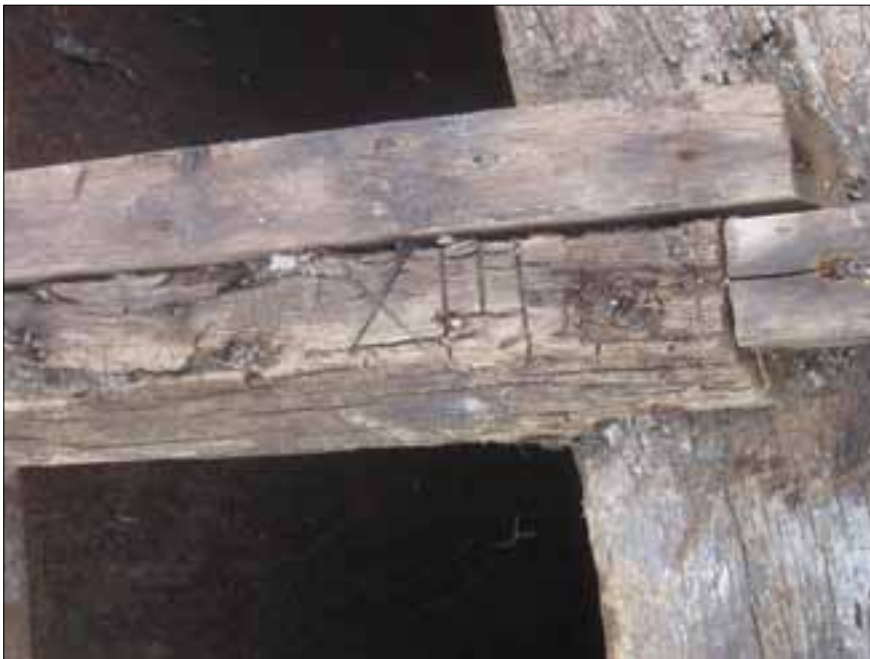
The circular wallplate, resting on the inner face of the stone walls, is formed of eight, curving sections, c.200mm wide by 250mm high. The sections were jointed originally with open, bridle joints with slightly dovetail-shaped tenons, and fixed with a forelock bolt (fig 26). Although designed to resist the outwards force from the 'skirt' rafters, the joints had failed to perform and in most cases had pulled apart, by up to 50mm. A flat iron strap had been bolted to the outer face of the wallplate across the joints to prevent further outwards spreading. This strap was fixed with threaded bolts and square nuts, not forelock bolts, and may date from the early 20th-century repairs, or a previous repair programme. The outer feet of the common rafters rest simply on the masonry wall top, with no evidence for an original outer wallplate.

Fig 26 The foot of one of the 'skirt' principal rafters, with carpenter's mark 'XIII'.

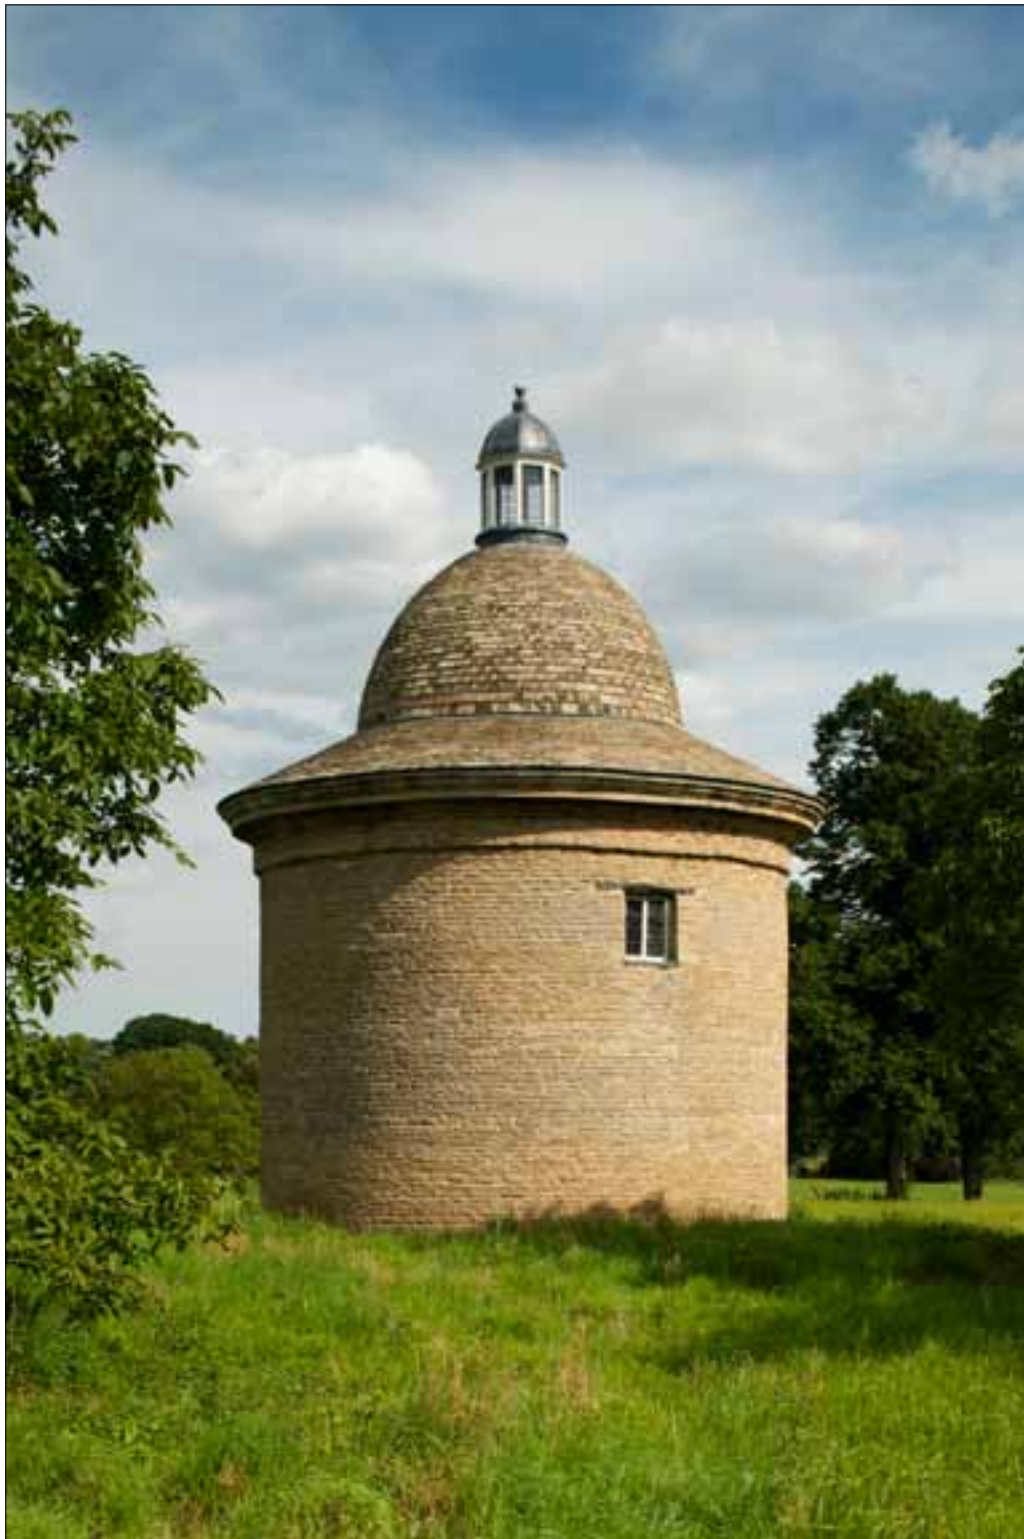
Fig 28 The Dovecote after repair, in 2012 (Pat Payne, DPO152841)

During the recent repairs, the cupola roof structure to the lantern was retained largely intact, including most of the original roof boarding (figs 27-28). The timber of the early 20th-century lantern structure was fully replaced, with the two iron pivot windows and leaded-light glazing reinstated. Both the upper and lower ring-beams had to be fully replaced, though the intact upper ring-beam has been left inside the building, together with a number of forelock bolts. The main dome ribs and base plate required only minor repair and re-fixing. Quite extensive repairs were needed to the lower 'skirt', but the majority of the wallplate and principal rafters remain in situ. The Collyweston slates and leadwork were fully stripped and reinstated. The water tank structure has been retained, and provides vital support to the dome base beam via added props.
