GRASSINGTON LEAD MINES,
NORTH YORKSHIRE
A RAPID ASSESSMENT OF THE
THREATS POSED BY ROAD
MANAGEMENT AND EROSION
AN ARCHAEOLOGICAL INVESTIGATION

A rapid assessment of threats posed by road management and erosion

NGR: SE 0250 6650

Field survey August 2008 – September 2008; aerial photographs November 2008

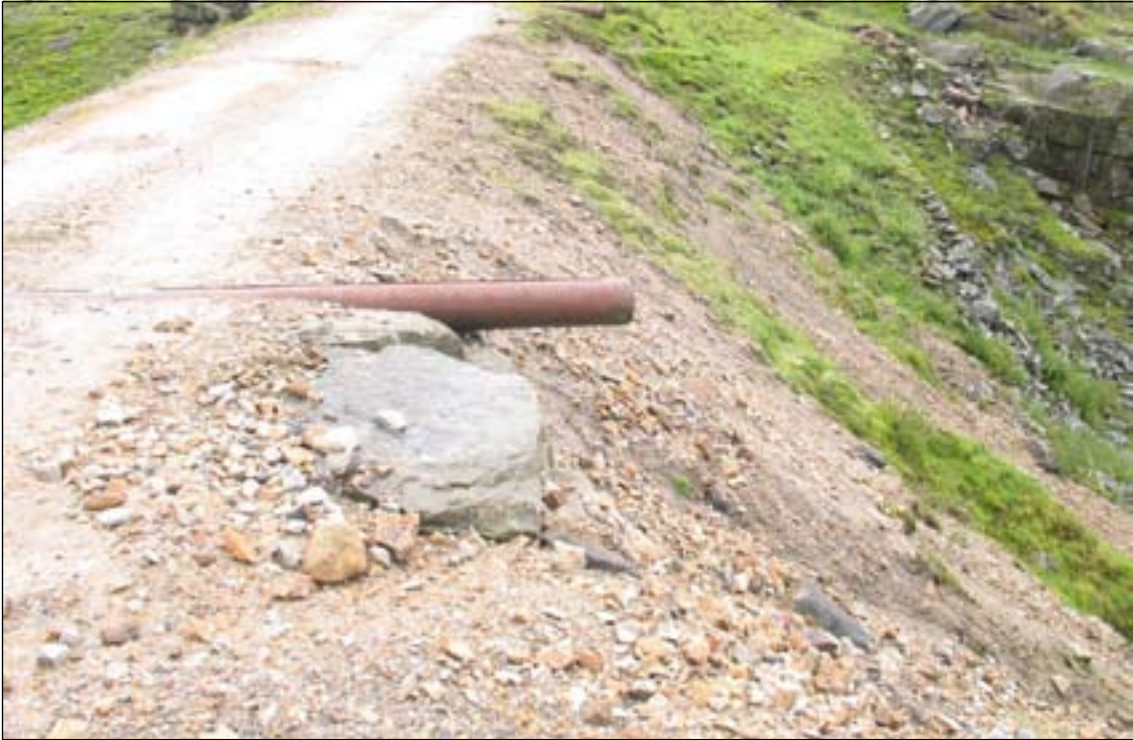
Figure 12: Example of Category 1c: metal-pipe drain along Road 1 (70).

Ic: Metal-pipe drain (Figure 12). Potentially, these drains can handle larger volumes of water than the similar deflection drains and wooden-trough drains (Types Ia and Id), but are evidently liable to clogging. Of the 3 metal-pipe drains recorded, 2 (67%) fall in the Low Risk category and 1 (33%) is classified as High Risk (7). The outfall from this pipe may actually be creating a longer term, more serious erosion issue further down the embankment upon which it is located.

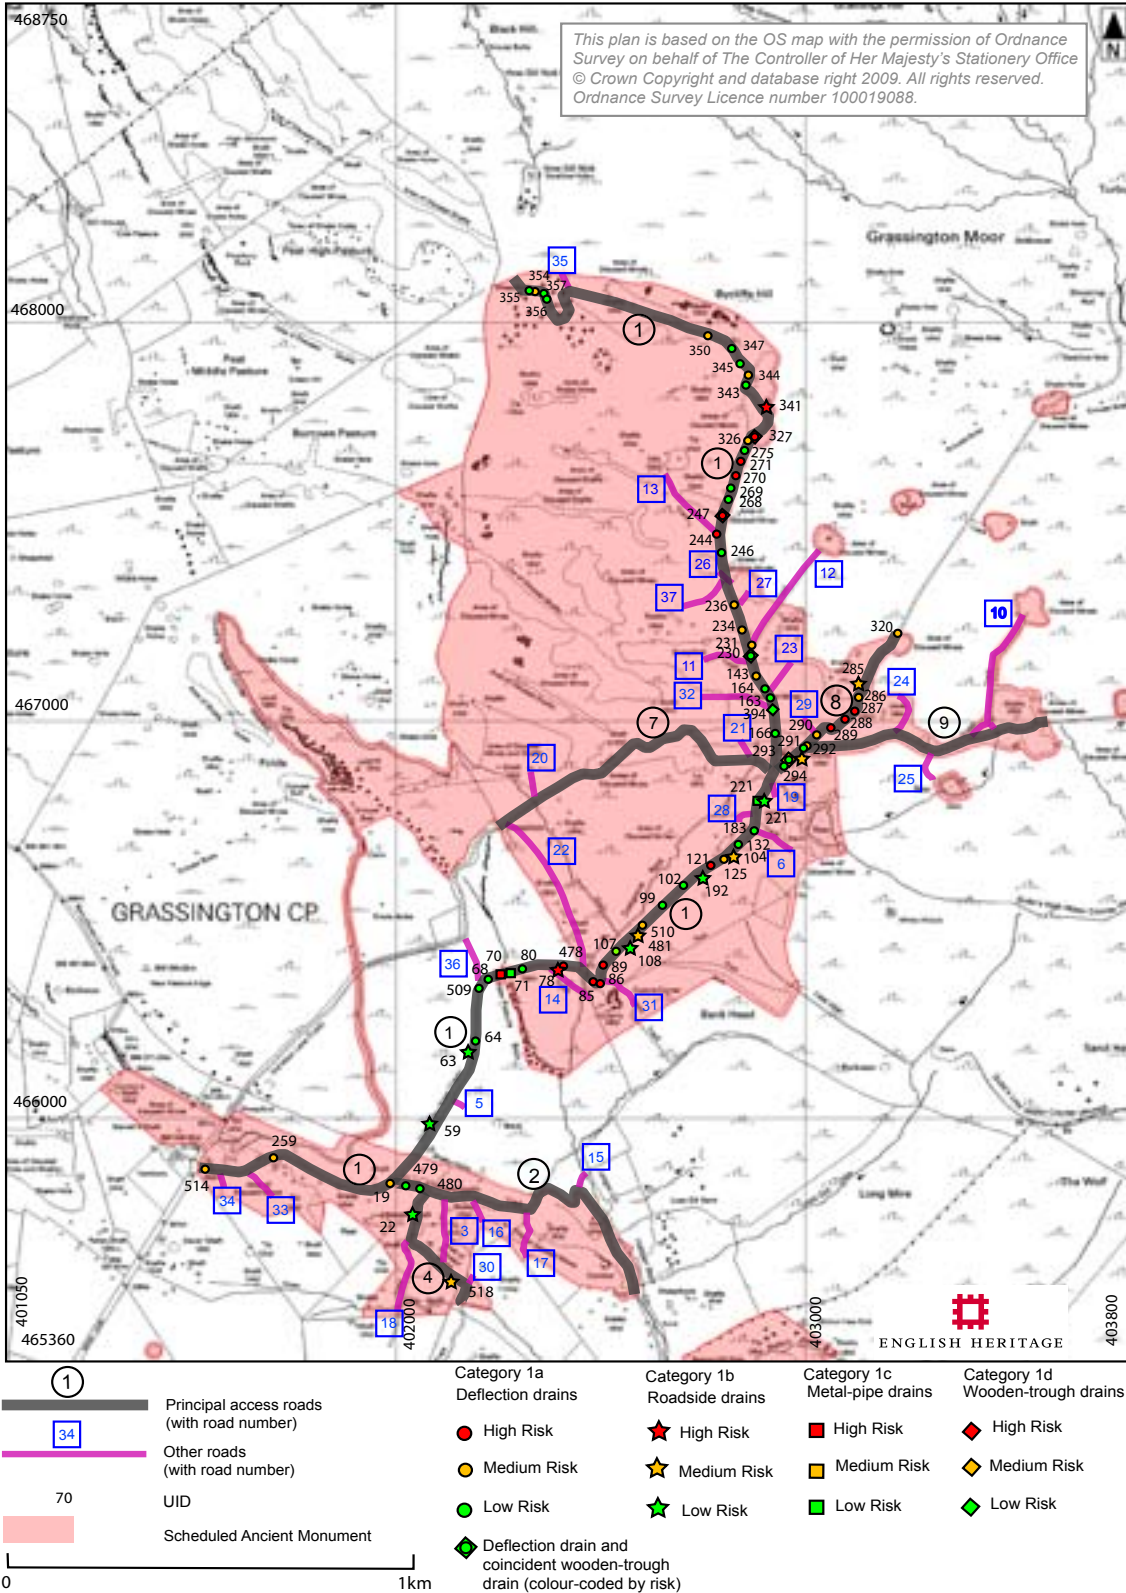
Figure 14: Category 1: modern drainage. Based on OS 2008a, reduced from 1:10 000 scale.

Ib: Roadside drain (Figure 11). A total of 13 instances of this type of drain were recorded. Of these, 6 (46%) are considered to be Low Risk, while 5 (39%) are Medium Risk and 2 (15%) are High Risk. Although the two High Risk instances (78; 341) have an impact on archaeological features, this method of drainage alongside the roads was one of the solutions favoured for management of water run-off when the mines were operating. The potential conservation benefits of re-activating this historic collection and distribution mechanism as part of a long-term management plan requires consideration (this is discussed further below).

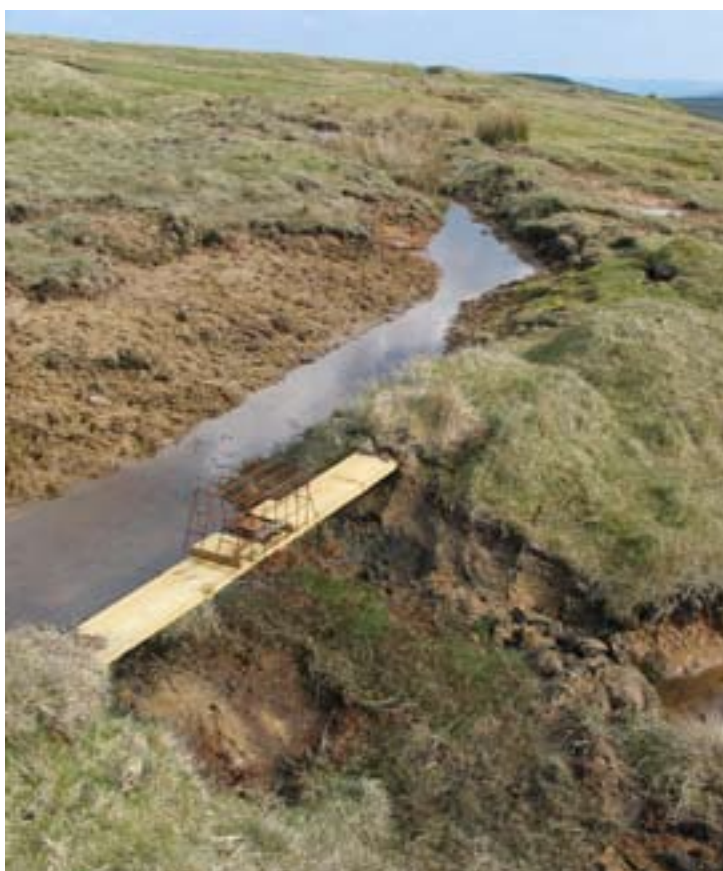
Ie: Artificial watercourse (Figure 15). A number of long drainage channels contemporary in origin with the mining operations exist alongside the road network (for example, 104; 296). Part of their original function was evidently to drain the road surfaces, in some cases perhaps making use of the run-off as a source of water, as well as to manage the supply of water to waterwheels and dressing floors. Many of these historic watercourses are now truncated or blocked, causing them to overflow, in some cases with damaging

*Figure 15:
Example of Category Ie:
artificial watercourse
(298 – Duke's Water Course).
Here a breach in the retaining
bank has been dug (or an
existing breach modified) to
accommodate an animal trap.*

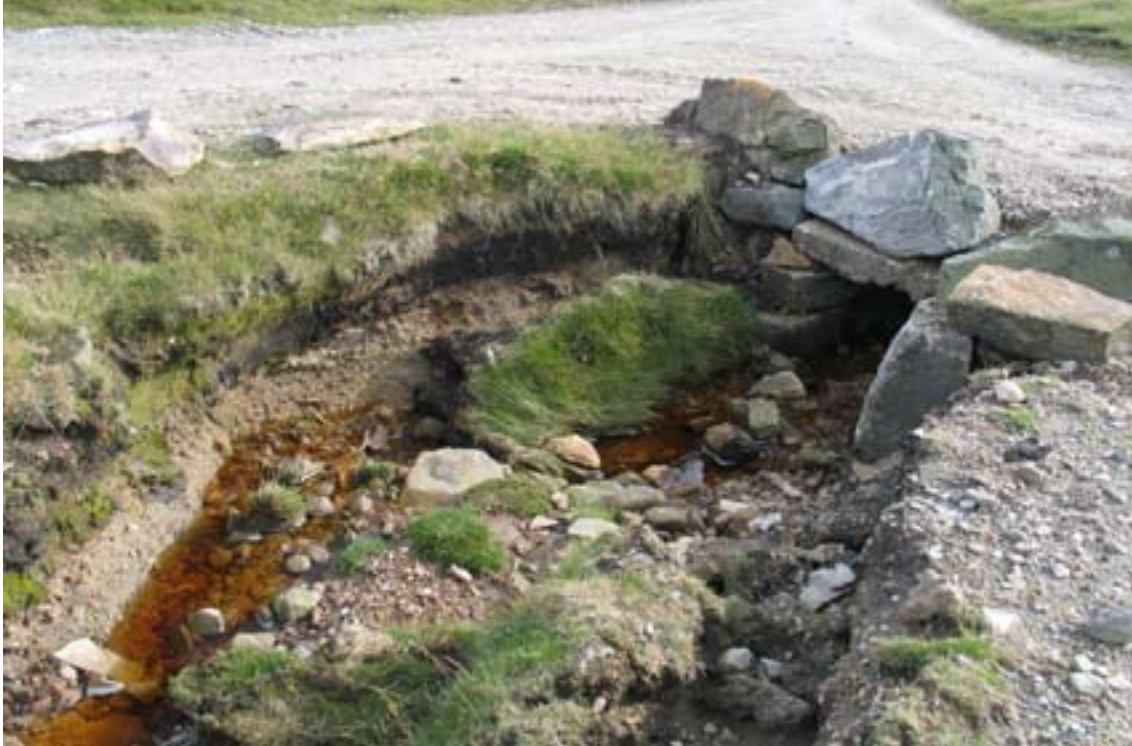
Figure 16: Example of Category 1f: culvert (170). An attempt has been made to arrest erosion by placement of boulders and stones around the historic culvert.

If: Culvert (Figure 16). Of the 27 culverts recorded (more may be masked by later activity), some may have been re-cut or piped at various stages, but none appear to have been specifically constructed as part of modern road maintenance. Many are still functioning, although some are blocked. 20 (74%) are classified as Low Risk and 3 (11%) as Medium Risk. Of the 4 (15%) categorised as High Risk, 2 (170; 390) have already suffered some degree of collapse. In the case of culvert (170), attempts have been made to arrest the erosion by placement of boulders to form a crude revetment; whilst this may have alleviated the problem in the short term, it is considered that erosion will continue, since this channel carries a large volume of water from natural and redundant artificial watercourses. In addition, the manner in which these boulders have been obtained raises separate issues (see Section 6.2.3 Category 3h).

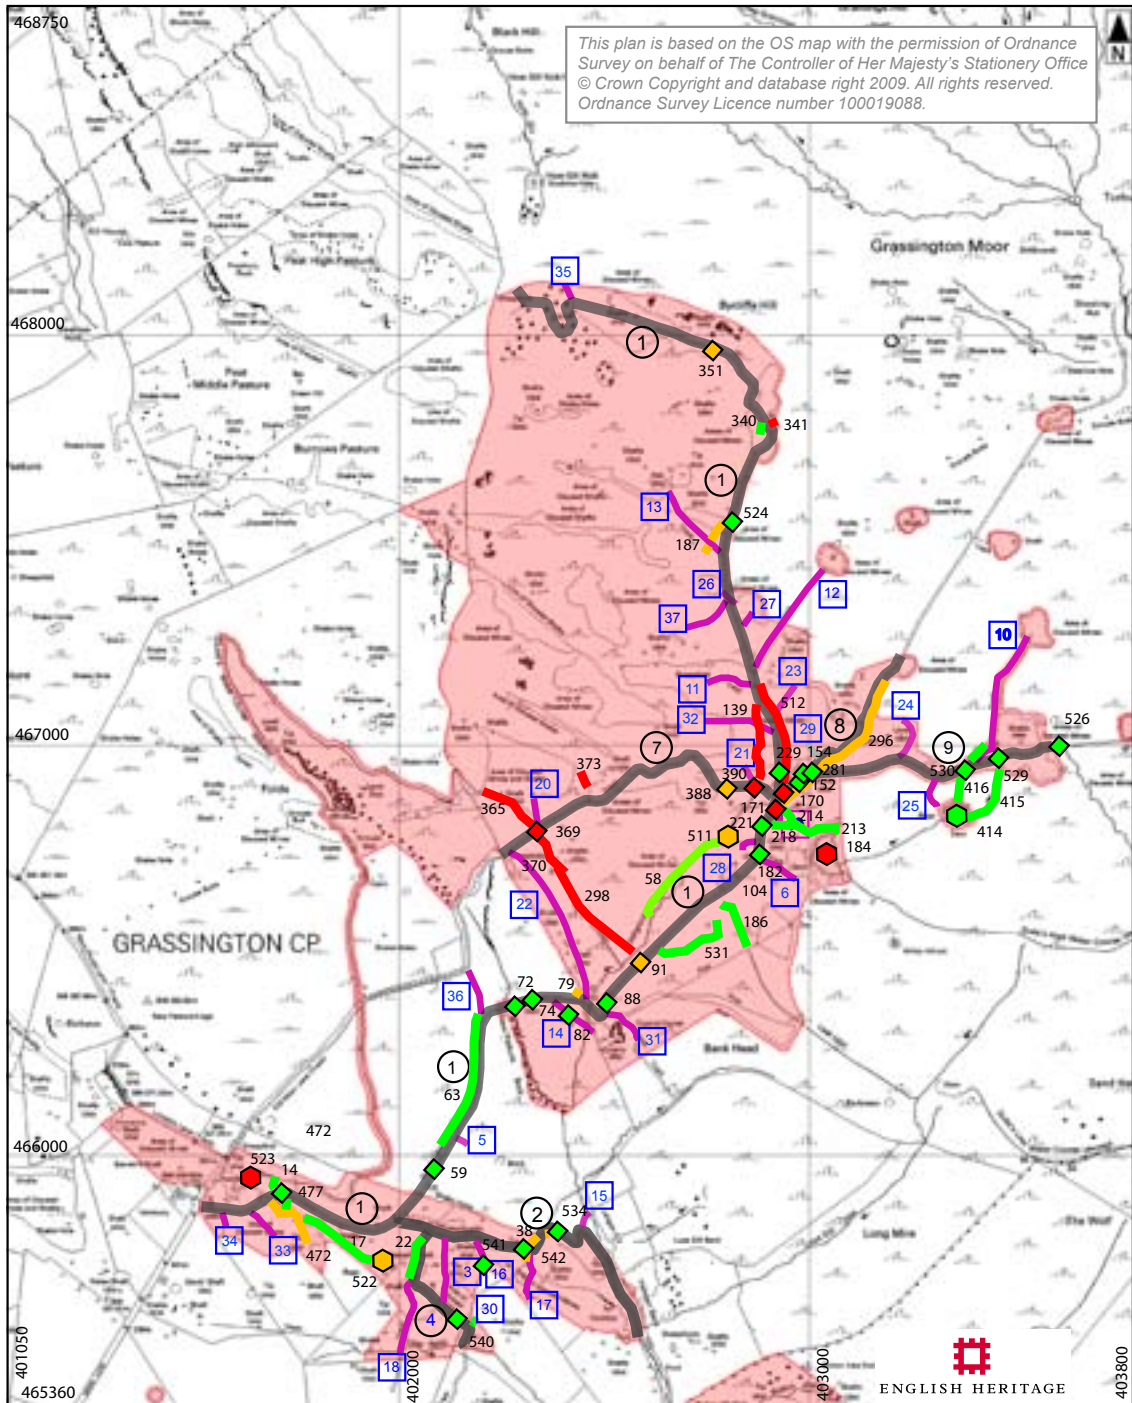
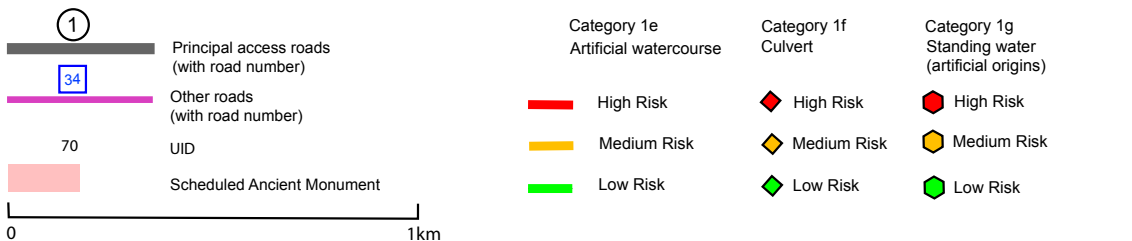
Figure 18: Category I: historic drainage and water management. Based on OS 2008a, reduced from 1:10 000 scale.

where breaches in the dams have occurred. Thus erosion originating at these sources becomes focussed into the highly sensitive processing and dressing areas they formerly supplied. Two of the reservoirs (184; 523) within the road corridors have an impact on routes in terms of direct overflow (Roads 1a and 6). Of the 5 instances noted, 2 (40%) fall within the High Risk category, 2 (40%) being Medium Risk, and 1 (20%) is Low Risk.

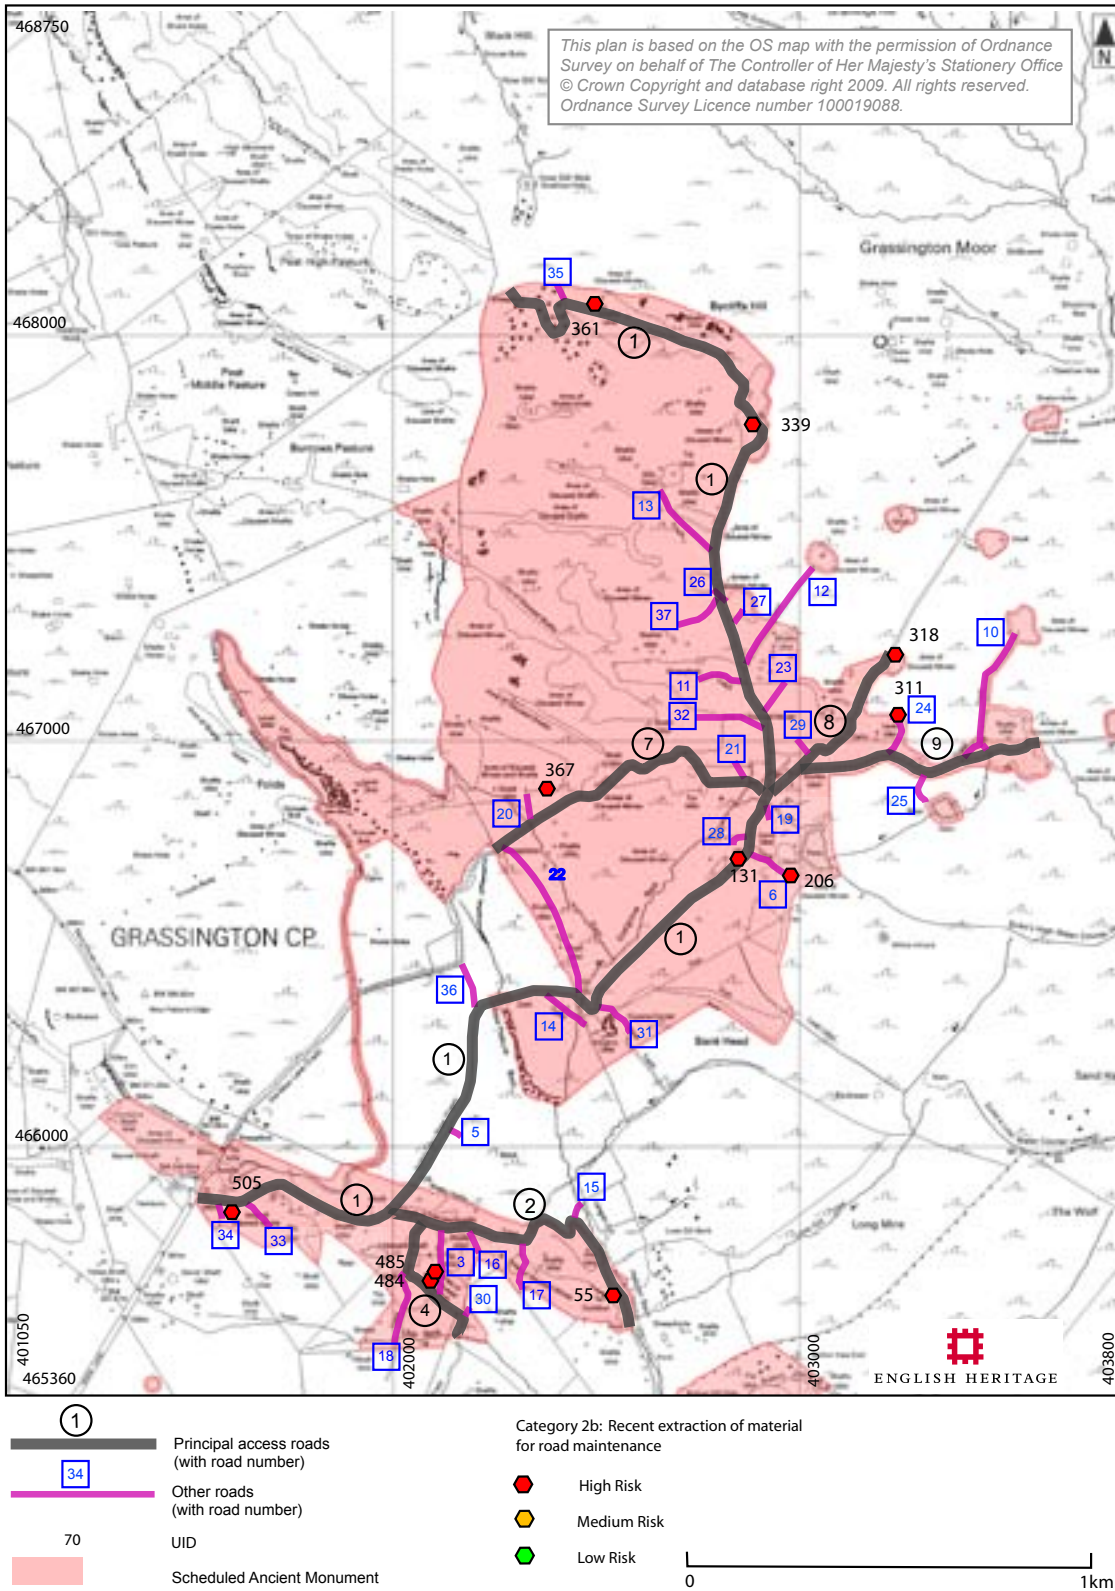
Figure 23: Category 2: works and features relating to the removal of material from spoil mounds. Based on OS 2008a, reduced from 1:10 000 scale.

2b. Recent extraction of material for road maintenance (Figure 22). In 11 locations, there is evidence of the removal of mine waste that cannot unambiguously be attributed to mining-related activity such as mineral re-working. The spoil mounds have been targeted as these are the most obvious sources of material, and all are close to the road network. At this stage, it is assumed that the material has been either removed for re-surfacing the

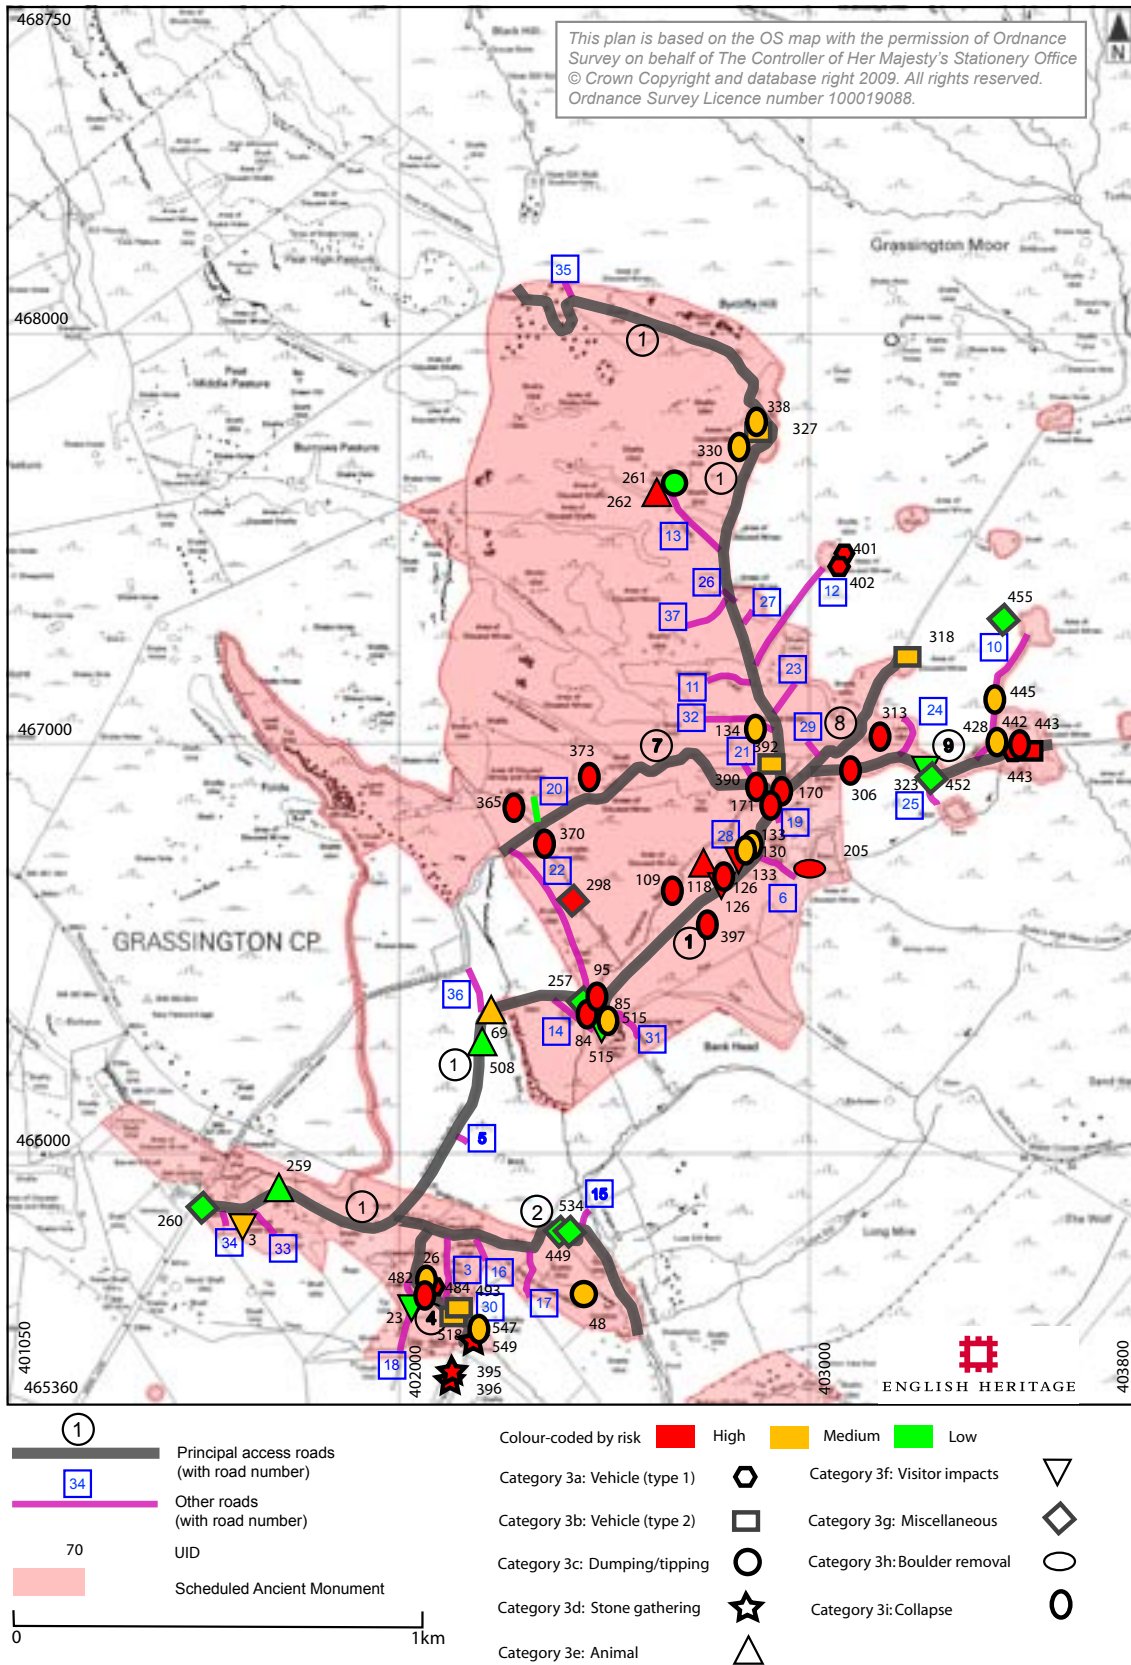
Figure 37: Category 3a-i: other modern works and features affecting the site. Based on OS 2008a, reduced from 1:10 000 scale.

problem in their placing. Four instances occur within the Scheduled area where the line of an underground gas pipeline (41) crosses a road. In one case (452), the unconsolidated restoration of the road surface may be exacerbating erosion damage caused by water run-off. Of more serious concern is the damage to the Duke's Water Course (298) caused by digging into the retaining bank for a bridged vermin trap (noted on a later field visit – see Figure 15). Of the 7 recorded instances in this category, 6 (85%) are considered to be Low Risk and 1 (15%) is High Risk.

3i: Collapse (Figure 36). In 25 places along the road corridors, mining-related structures have suffered some degree of collapse; 15 (60%) are categorised as High Risk. In the majority of cases, the collapse is being caused and exacerbated by erosion brought about by water run-off from the moor (for example, 95) combined with neglect. Although other natural factors are undoubtedly contributing to collapse, particularly frost action on standing remains, this issue could be addressed through careful management of the hydrological pathways. Of the remaining 10 instances, 1 (4%) is classified as Low Risk and 9 (36%) as Medium Risk.

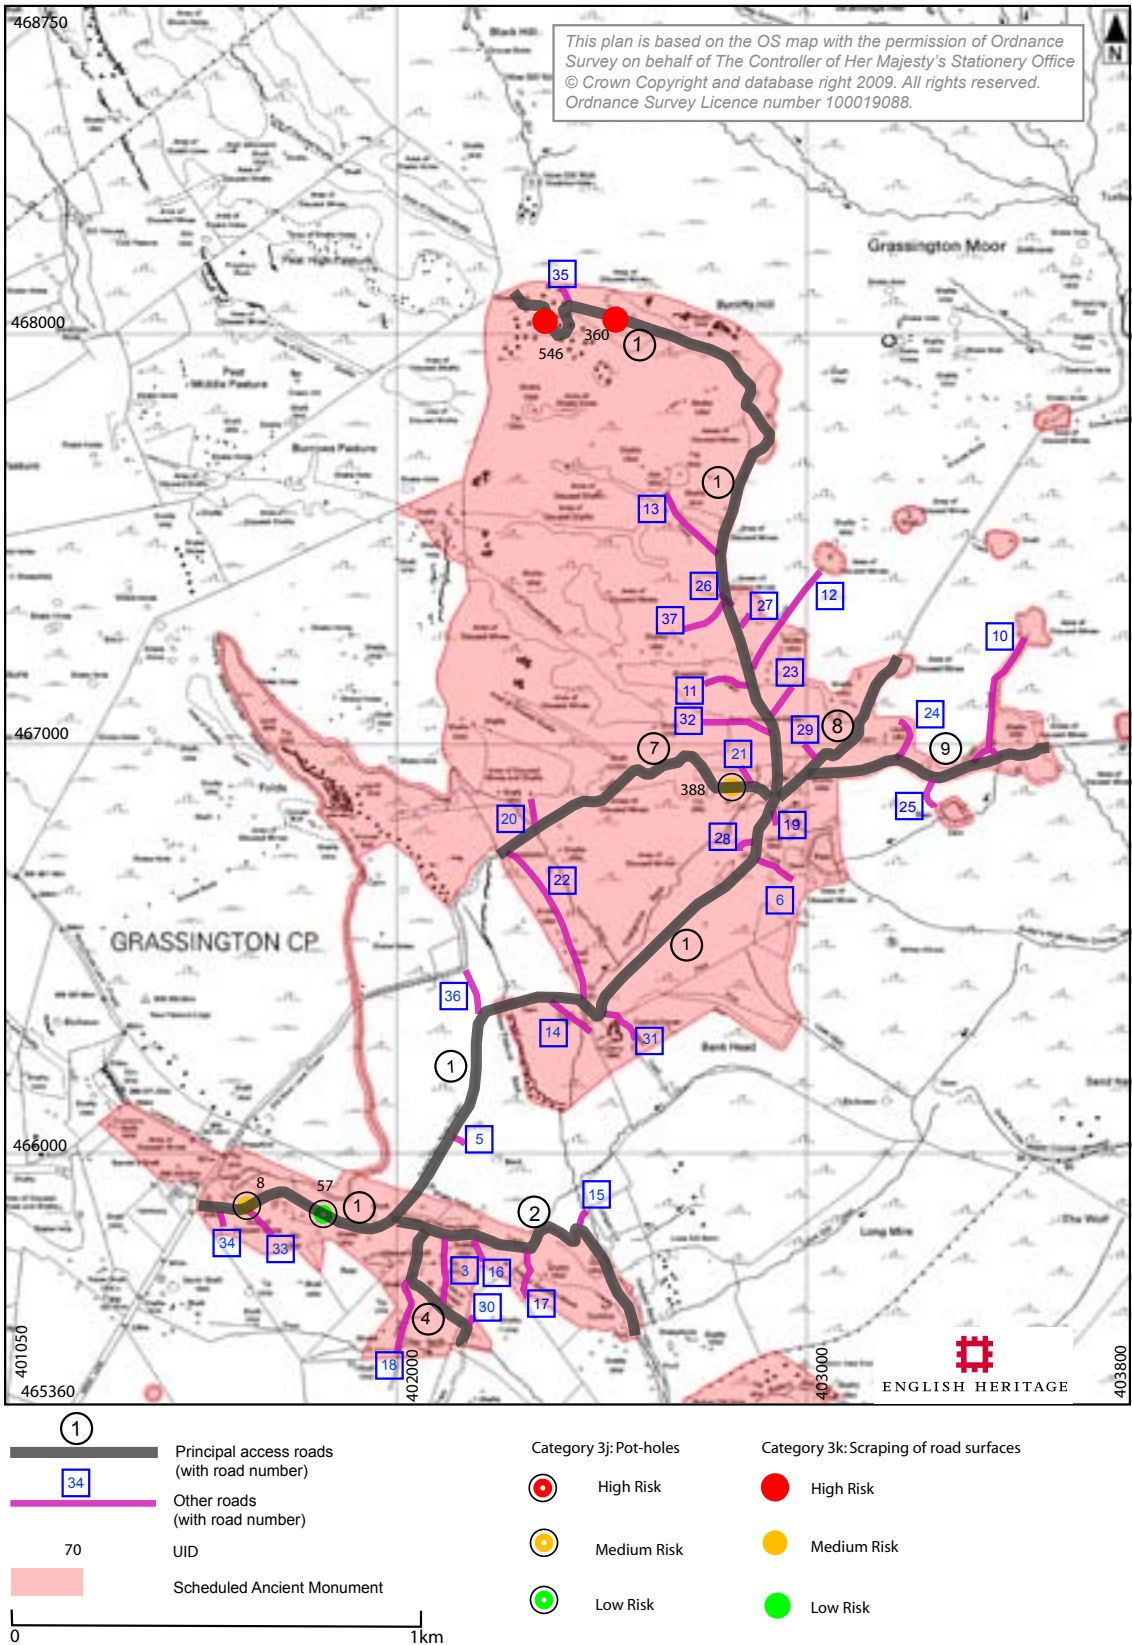
Figure 40: Category 3j-k: other modern works and features affecting the site. Based on OS 2008a, reduced from 1:10 000 scale.

3k: *Scraping of road surfaces (Figure 39)*. This work was pointed to by the farmer and the representative of the shooting estate as having a beneficial impact on the condition of the road (see Section 4ii). The potential impacts of this activity have to be understood in the context of the complex development of the mine roads, involving different construction techniques, materials and phases of activity, from at least the mid-18th century to the mid-20th century. The majority of the mine roads are built up above the natural surface on a platform of rubble to provide solid foundations for heavy traffic, particularly over boggy areas. Road 1a is typical of the 19th-century mine roads which have experienced later re-use. In places, the original rubble bedding and surface is visible, while in others this is buried beneath re-surfacing layers of dressing waste compacted into the earlier surface. Other roads are structurally more complex: for example, those which have been terraced into slopes to ease the gradient are often revetted by drystone walls on the downslope side. In several places, mine roads were evidently cut through pre-existing spoil mounds (for example, 20) so that their surfaces comprise *in situ* compacted spoil. Elsewhere, it is clear that a network of hollow ways pre-dated the built roads (for example, parts of Road 7); many probably gave access to the earliest mining sites, but some may have originated before the mining. In areas where mineral re-working is known to have taken place in the mid-20th century, there has evidently been repeated levelling, consolidation and patching of the road surfaces, probably to allow access by heavy vehicles. In some cases (for example, Road 29), new roads appear to have been constructed as part of the re-working to facilitate access to the spoil mounds.

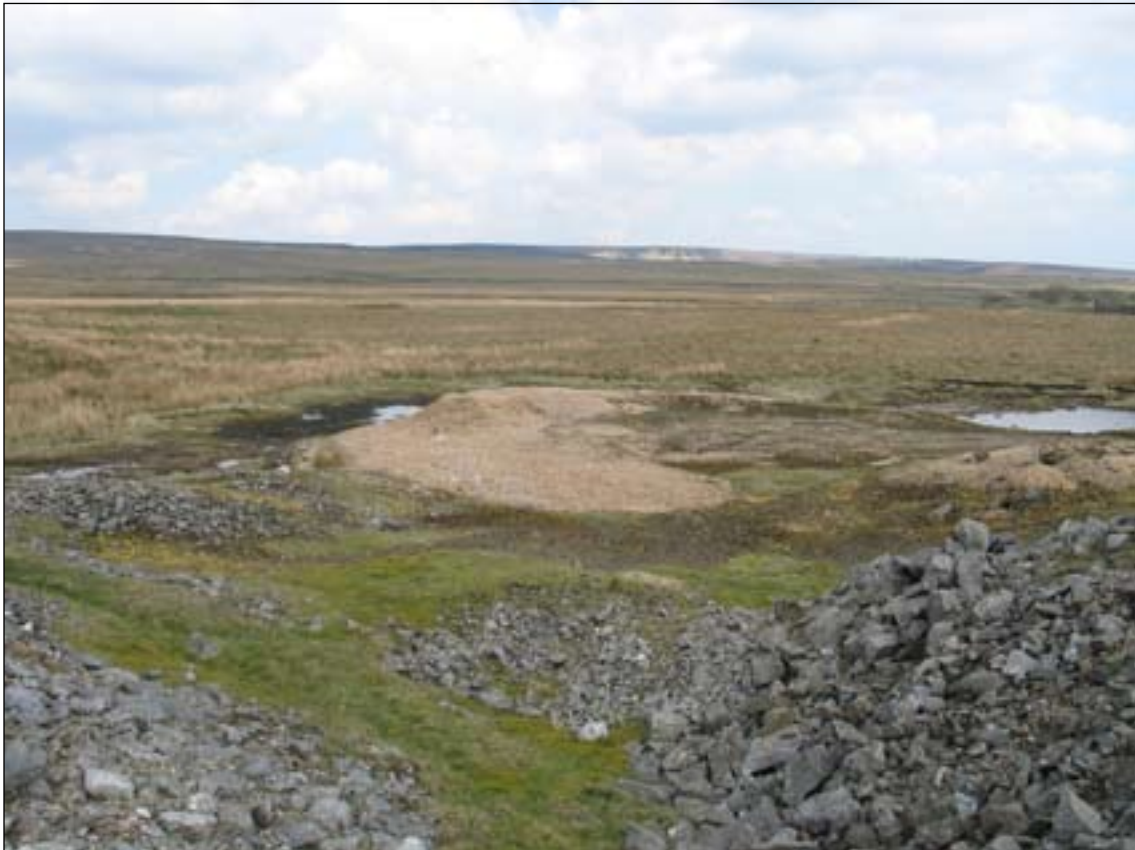
Figure 41: Light-coloured spoil mound in the centre of the photograph (311).

Of the 117 spoil mounds and spoil areas examined (including re-worked areas), only two small mounds (311; 507) within larger spoil dumps might be regarded as having so little significance that they might potentially be used as sources of material for road repairs. However, both are so small that they could not serve more than very limited needs for material to fill pot-holes. English Heritage's policy on mineral extraction and use includes the statement that 'archaeological remains, historic buildings, sites and landscapes relating to the extractive industries, whether designated or not, should be protected and preserved wherever practical through land management plans and initiatives' (English Heritage 2008e, 16). The presumption is therefore that identifying an alternative source for hardcore other than these two mounds should be considered as the first choice. Even if a Scheduled Monument Consent (SMC) application was to be considered for their removal, the cost of the archaeological recording necessary might be prohibitive compared to their value. It seems clear that a continuing programme of erosion control along the road corridors will be necessary, and therefore the volume of material actually necessary to maintain the road surfaces over the long term may increase. It is also clear that the volume required (even for short-term repair at its present levels) is likely to be significantly greater than could be provided by the two small mounds. The evidence would suggest that the best solution to addressing both the long and short-term management needs would be to import suitable material from an appropriate source off-site when necessary, and that the material used should be of a size which is not easily displaceable through the effects of Hydrological Erosion Types 1-4. The ideal material is considered to be walnut-sized limestone chippings rammed or pressed into the surface.

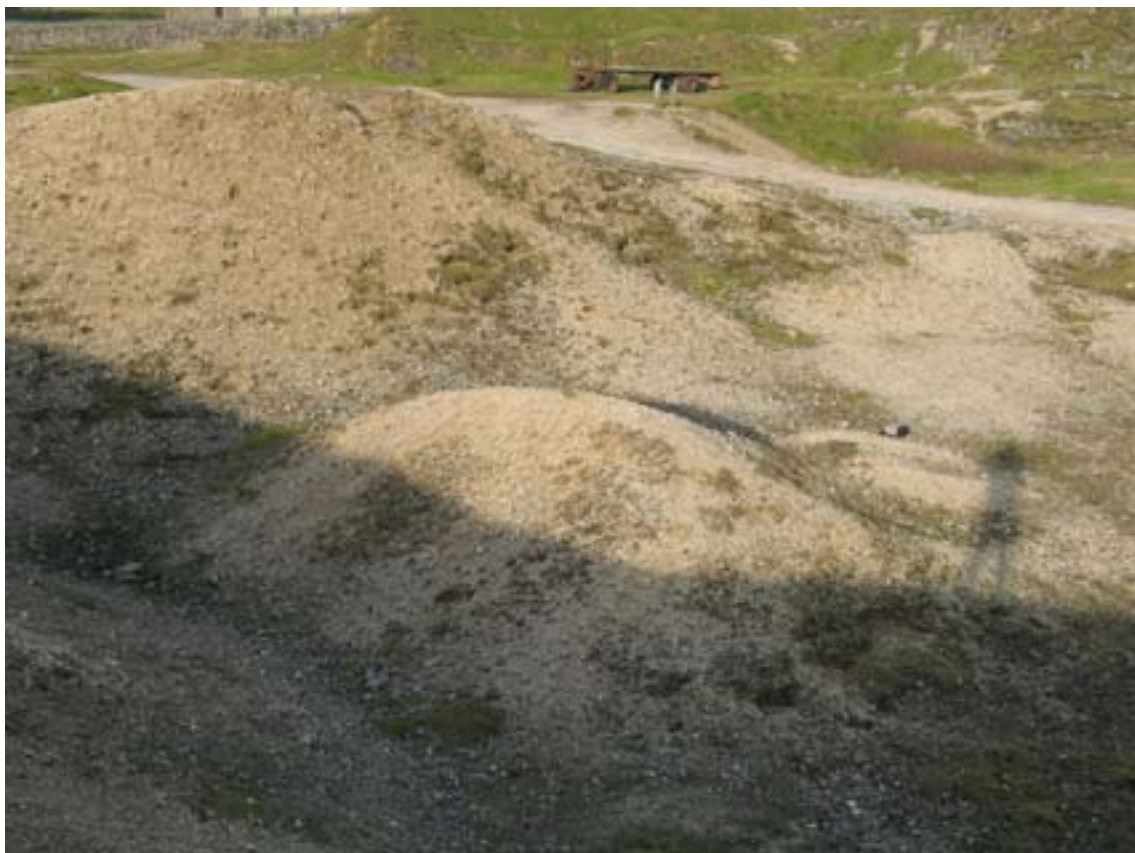
Figure 42: Small spoil mound immediately to the left of the photographer's shadow (507).

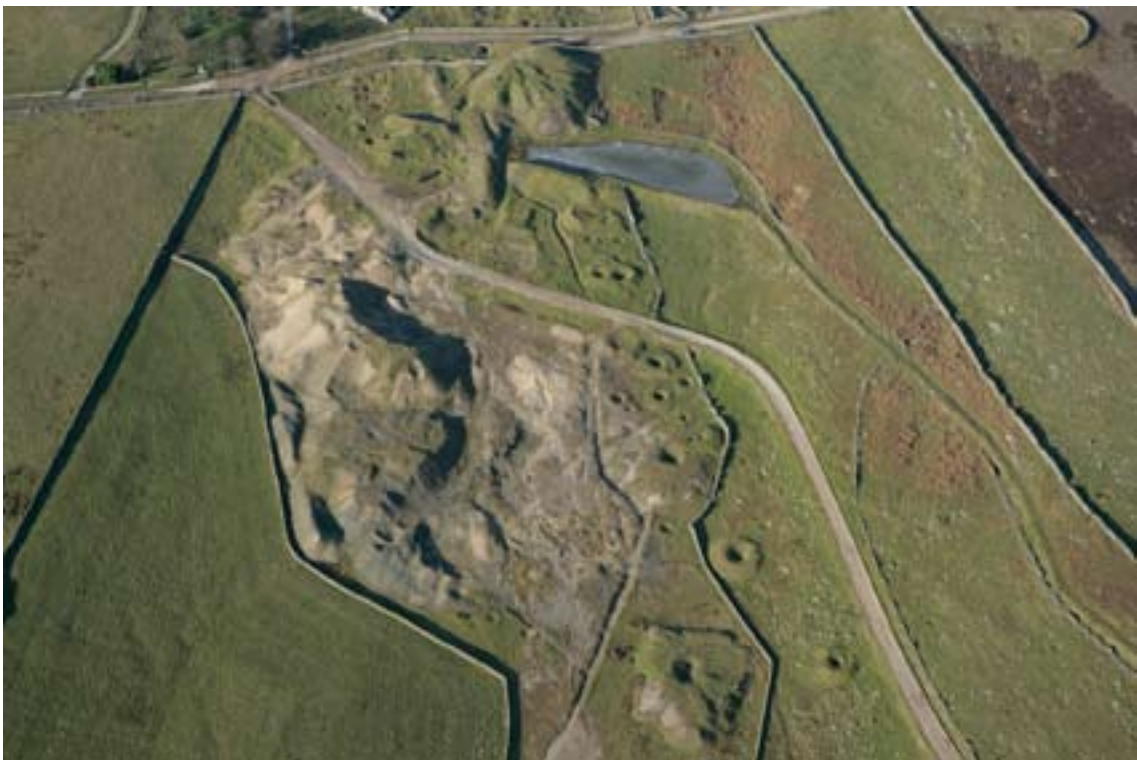
Zone A (Figure 50)

The most significant threat to this road corridor stems from the early development of gully erosion (8) along Road 1a, close to Low Grinding Mill (10). Although road drains have been introduced here in recent years, there is one area of Road 1a which slopes down to the south-east where this type of erosion has the potential to cause damage due to run-off and outwash fans from the gullies spreading into archaeologically sensitive areas to the south. If this is left unchecked, flows will become more concentrated and damaging over time and will further contribute to the loss of archaeological surfaces and structures in the dressing floors further to the south-east, where extensive channel/rill erosion is already developing. This will also have an impact in due course on structural remains and may result in the movement of slimes residues further downslope. As the gateway/cattle-grid (260) from Old Moor Lane at the west is the main point of access onto the moor, unrestricted vehicle access could be better controlled at this point by use

Figure 50: Zone A. Oblique aerial photograph from the east in 2008. Road 1 runs from top-left to bottom-right. NMR 20844/016/25-NOV-2008. © English Heritage. NMR.

of a locked gate (although this may raise issues regarding routine vehicle access to New Hall), with a stile for pedestrian access. This may alleviate some of the problems related to vehicle damage elsewhere within the Scheduled area. As this is the area closest to Old Moor Lane, this is also the area within which most pedestrian visitors concentrate. Thus any artefacts exposed by the removal of hardcore (505) are most at risk of being removed, especially because there is easy access for vehicles for the transportation of larger items.

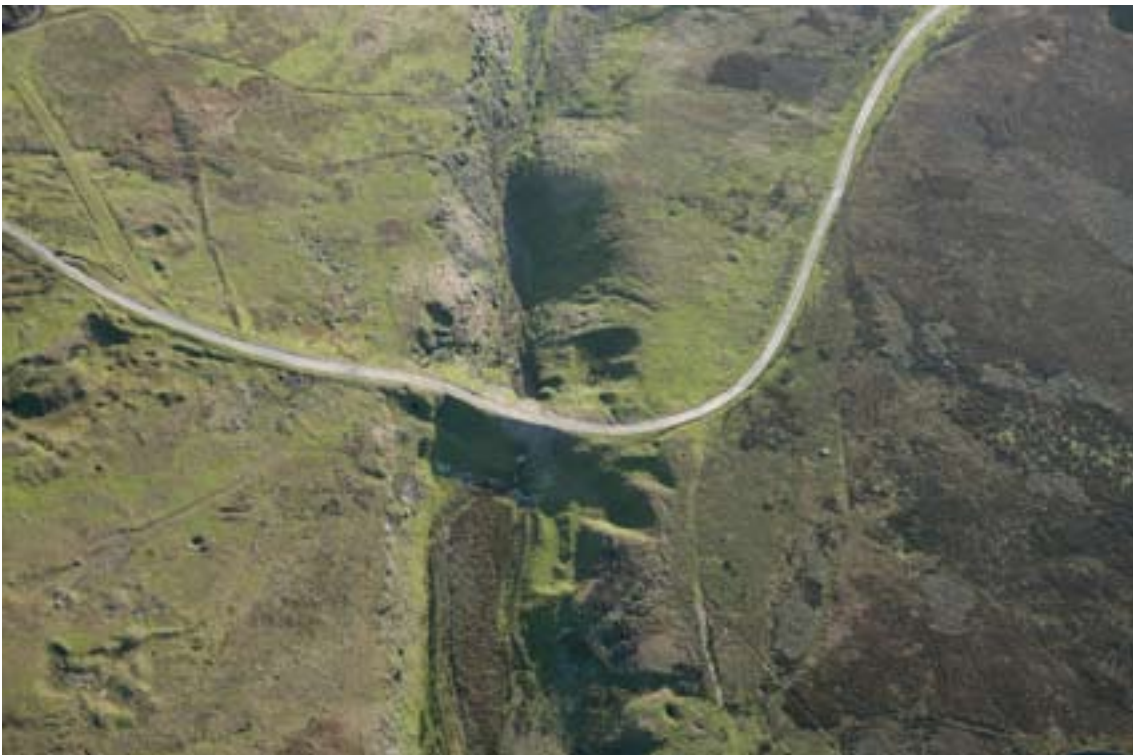
Zone B (Figure 51)

Where Road 1a crosses the valley of the New Pasture Beck, the slopes steepen toward the embankment which carries the road. This has the effect of concentrating run-off toward the line of the embankment from both sides. Although drains have been placed here in recent years to address this problem, the use of metal-pipe drains on the embankment may need to be reconsidered, as the outfall from one (70) may impact on the stability of this embankment and may also be actively contributing to further erosion downslope. This embankment has suffered collapse in the past and was substantially re-built in 1977. Although the Beck itself is now carried under the embankment in a large pipe, there is a risk that the outfall from the metal-pipe drain, which is certainly causing gully erosion on the slopes, may ultimately compromise the stability of the re-built section of the embankment, leading to another catastrophic collapse after heavy precipitation.

Figure 51: Zone B. Oblique aerial photograph from the south in 2008. Road 1 runs from left-centre to top-right. NMR 20844/043/25-NOV-2008. © English Heritage. NMR.

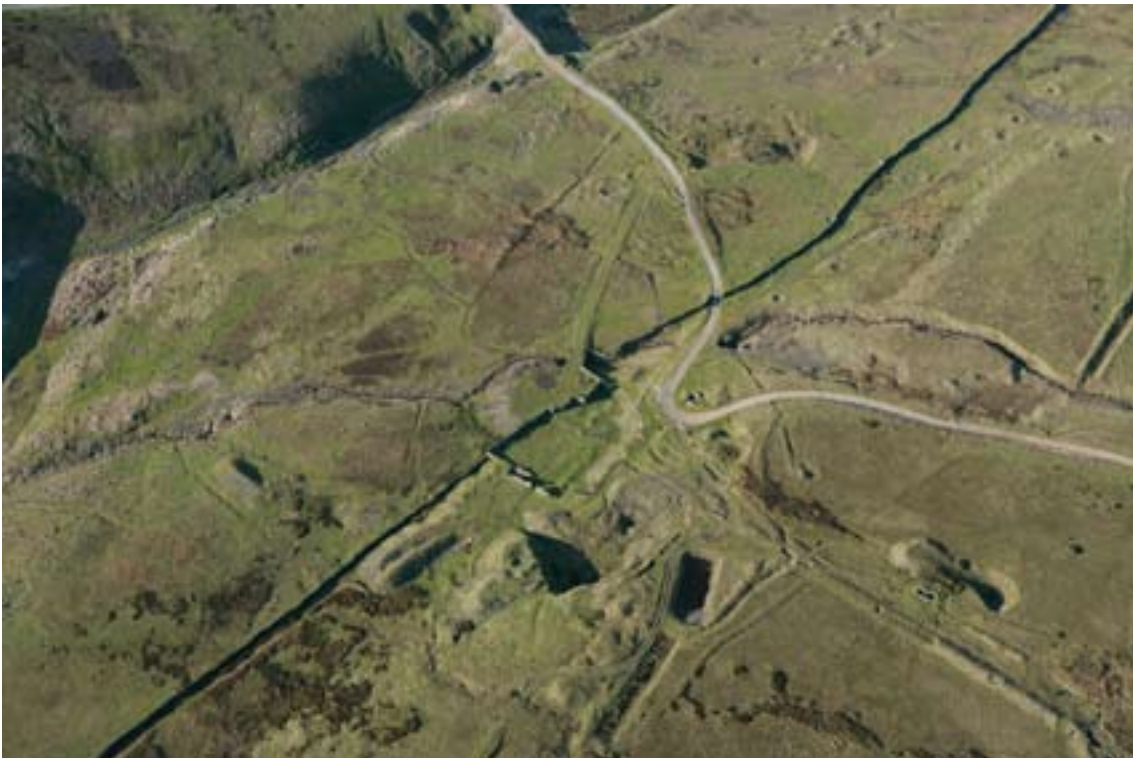
Zone C (Figure 52)

In the area of the Cupola Smelt Mill (515), significant erosion of standing fabric is taking place along one of the most sensitive archaeological areas on the moor. In the area immediately north-east of the point where Road 1a crosses the Coalgrove Beck, stream erosion (95) has led to the collapse of walling and revetments. As well as the obvious walls, more ephemeral features and collapsed wall-faces are exposed, and at the south a stone-lined culvert probably marks the exit of a tail race returning into the Beck. All these features, together with the bridges carrying Roads 1a and 14, are potentially at risk of collapse in the longer term. This area may also be the site of High Mill, which dates back to 1637 (Gill, 1993, 117) and therefore this area may contain particularly rare and important evidence for activity predating the Industrial Revolution. Further collapse and erosion is occurring to the south of the road within the Cupola Smelt Mill complex, where, after precipitation, uncontrolled torrents of water from the higher ground to the north-east are channelling through the complex, compounded by the run-off from modern deflection drains from the road. This whole section of stream and the archaeological remains close to it may be at risk in the long term due to the volume of water which flows through and into this corridor. In this zone, more consideration may need to be given to the placing of drains, particularly with regard to the direction and impact of run-off from them.

Figure 52: Zone C. Oblique aerial photograph from the east in 2008. Road 1 runs from top-centre to right-centre. NMR 20844/035/25-NOV-2008. © English Heritage. NMR.

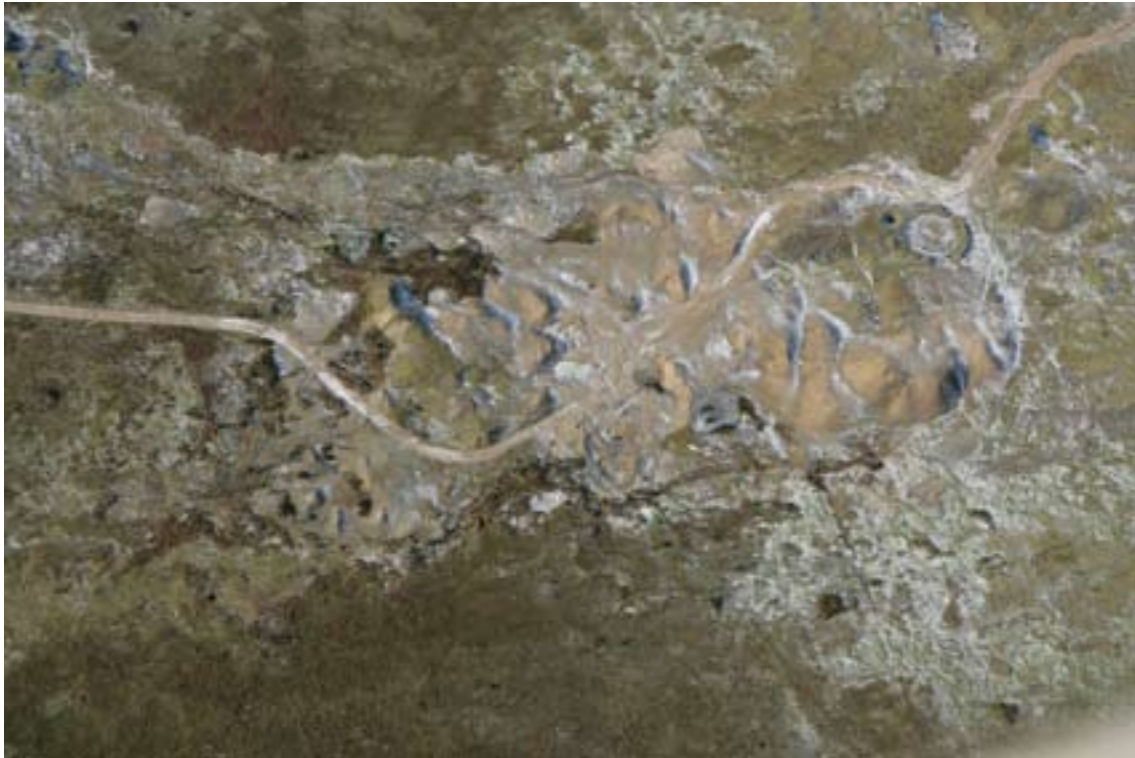
Zone E (Figure 54)

The course of Road 1b through this area may not be the original route and it now cuts through a number of archaeological features related to Byeclyffe Mine, including settling ponds, structures and dressing floors. This area is particularly susceptible to

Figure 54: Zone E. Oblique aerial photograph from the east in 2008 with a light dusting of snow. Road 1 runs from left-centre to top-right. NMR 20843/001/25-NOV-2008. © English Heritage. NMR.

fluvial erosion, as a series of ponds and disused leats (335; 337; 340) still channel water towards the road itself, which cuts through one of the leats. The situation is complicated by a roadside drain (341) which has been dug parallel to the road to take away excess water from this leat system but which then discharges into dressing floors below, causing significant outwash and erosion problems. Close by, a deflection drain (327), which has a choked wooden trough, discharges into former mineral re-working areas, depositing a fan of outwash material. The drainage here is further complicated by waterlogging resulting from the abandonment of the former pond and dam system (335), with consequent increased potential for the development of channel/rill erosion through this area. Pools of water are forming episodically on the road itself as a result of these circumstances and attempts have been made to alleviate this with the insertion of deflection drains (326; 327). Whilst these have dispersed water from the road surface, their outflows may be contributing to further problems downslope. Other disturbances contribute to the overall threat level in this zone, including vehicle tracks across the waste areas, and the possible digging of spoil material for road repair (339). A meerstone (336) which is recumbent near the road could easily be accidentally or maliciously broken or removed. At the northern end of this zone are the well-preserved remains of a gin circle, a shaft, and a crushing mill (331; 333; 334). The road runs very close to the gin circle and while no immediate threat is apparent at this time, the road cannot be allowed to migrate at the bend or damage will occur. A deflection drain (344) which has been cut near the gin circle is creating an outwash fan on the west (opposite) side of the road, but is currently ensuring that water is directed away from the gin circle.

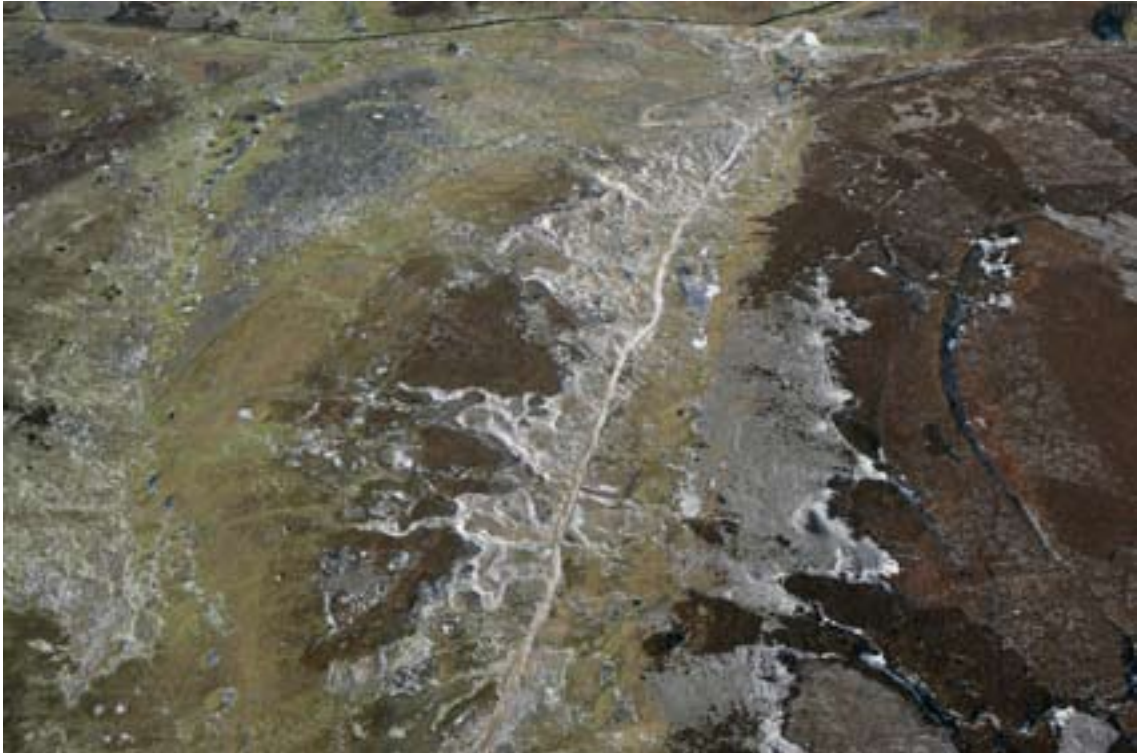
Zone F (Figure 55)

Figure 55: Zone F. Oblique aerial photograph from the east in 2008 with a light dusting of snow. Road 1 runs from bottom-centre to top-right. NMR 20843/021/25-NOV-2008. © English Heritage. NMR.

The construction of Road 1b and 1c below Byeclyffe Hill is relatively late (not directly associated with the mining operations) and has cut through and damaged an extensive area of multi-period mining remains, including shafts, dressing floors and built structures (360). Historic water-management features north of the road, including ponds and leats, as well as the natural drainage from the moor itself, are causing significant erosion problems for the dressing floors (501) south of the road, where exposed paved floors and timbers can be seen. An unvegetated expanse marks the extent of slimes and tailings. As well as the damage caused by the construction of the road, what appears to be recent digging into a waste mound, possibly for hardcore material, has exposed possible archaeological stratigraphy (361). There is no evidence of modern drainage along most of this section of road, although on the slopes to the west deflection drains have been inserted (354-357). Only one of these (354) has any negative impact on archaeological features. South of the road are small dressing mounds, and some unusual, small cleared areas and mounds within the clutter on the slopes (359), which may relate to early periods of agricultural or mining activity.
