GRASSINGTON LEAD MINES,
NORTH YORKSHIRE
A RAPID ASSESSMENT OF THE
THREATS POSED BY ROAD
MANAGEMENT AND EROSION
AN ARCHAEOLOGICAL INVESTIGATION

A rapid assessment of threats posed by road management and erosion

NGR: SE 0250 6650

Field survey August 2008 – September 2008; aerial photographs November 2008

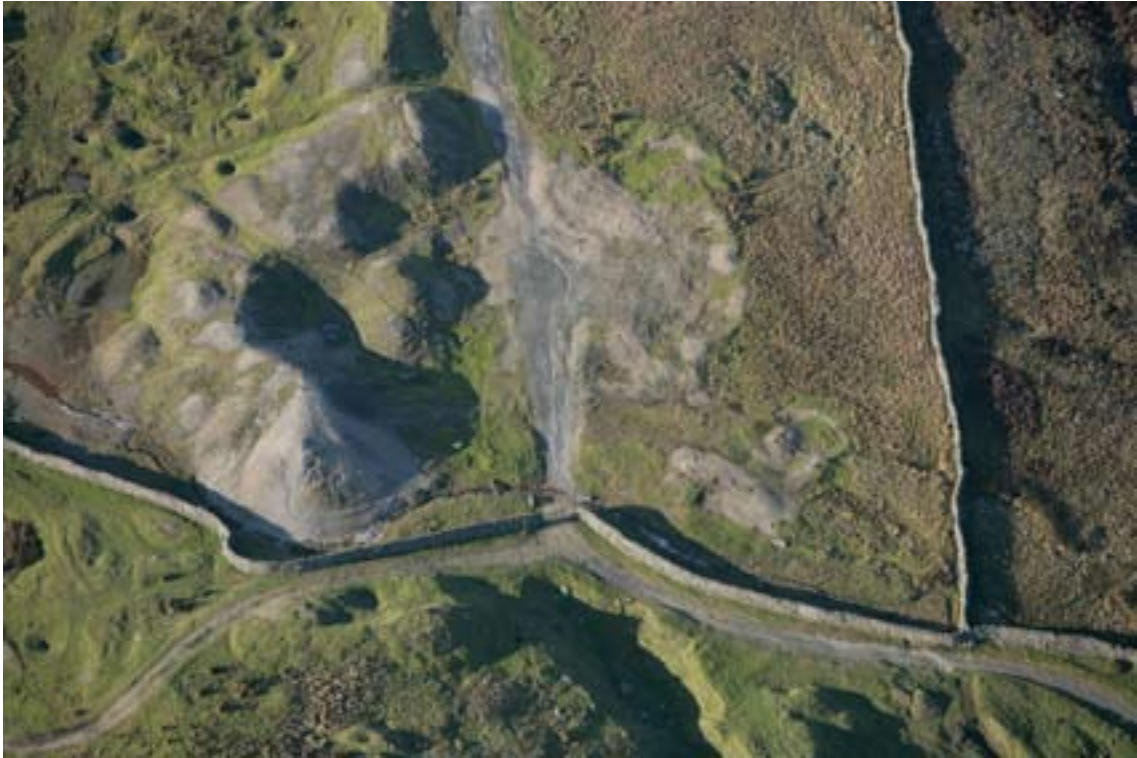
Zone G (Figure 56)

Where Road 2 passes immediately east of Cockbur Mine (37), run-off from abandoned leats and ponds and from the road itself converges along the drystone wall and flows

Figure 56: Zone G. Oblique aerial photograph from the east in 2008. Road 2 runs from top-centre to bottom-right. NMR 20844/046/25-NOV-2008. © English Heritage. NMR.

down toward the valley of the Hebden Beck. Flows run through former dressing floors (502), threatening exposed remains there. There has been some modern maintenance of the historic leat (38) which flows alongside the wall but this area acts as a 'pinch-point' for drainage and may therefore attract more remedial work in the future.

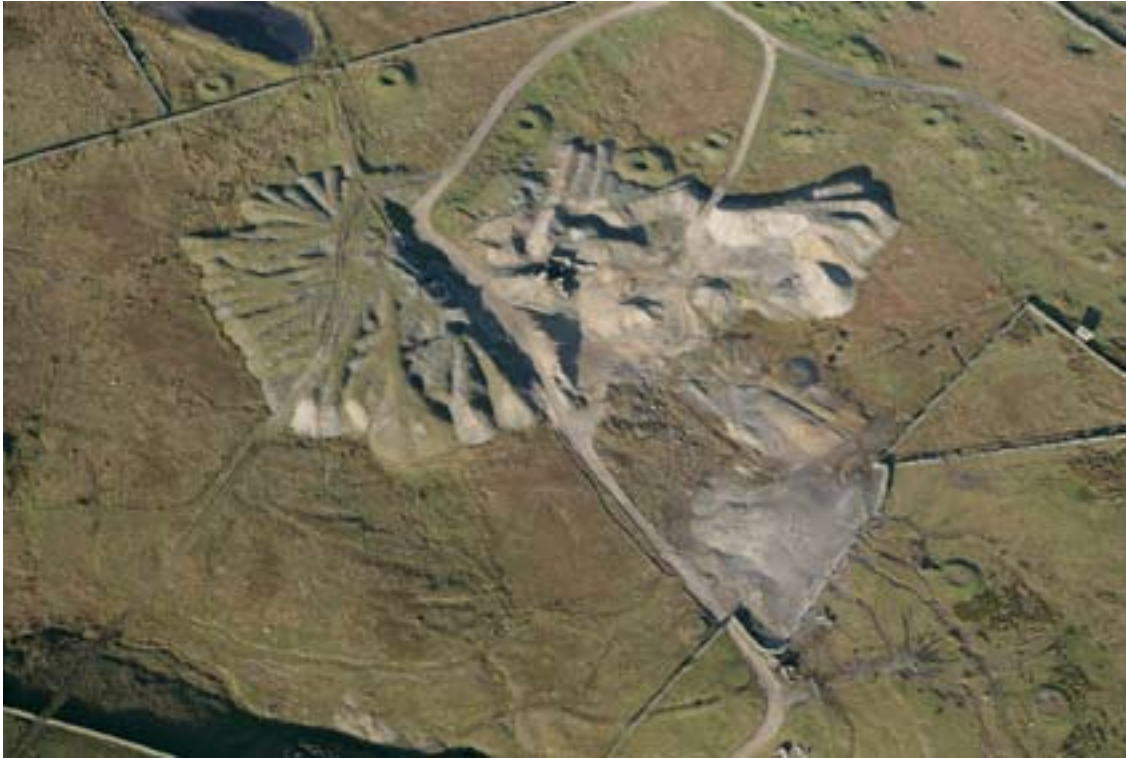
Zone H (Figure 57)

Where Road 4 runs through the Beaver's Mine complex (23), close to the bouse-teems (482), gully erosion is developing on the slopes to the north (483). This feeds down into dressing floors below and, if left unchecked, will regress towards the bouse-teems and road. To the east, water floods through an arrangement of dressing floors, with its system of ponds, buddles, stone drains, stone-lined tanks and leats (491-498), all of which are consequently being eroded, mostly by channel/rills. In places, artefacts have been exposed. At the east, there is an extensive, unvegetated area of slimes which is currently retained by a drystone wall, possibly built on an earlier dam, but leakage is passing into the field to the east and down to the Eller Beck. The run-off is compounded by flows from the abandoned historic water-management system of leats and stone drains, which drains unchecked into this area. There has also been damage from the possible removal of spoil for road repair (485), which has exposed artefacts, and possible unauthorised 4x4 activity (484). The cutting of a roadside drain (518) is helping to reduce run-off into the dressing floors but this has cut through two historic leats (24) and a shaft mound (31). The turning of heavy vehicles has also impacted on the dressing areas to the north (493). The bouse-teems (482) and mill (23) have both suffered from varying levels of collapse.

Figure 57: Zone H. Oblique aerial photograph from the south-east in 2008. Road 4 runs from top-centre to bottom-centre. NMR 20844/030/25-NOV-2008. © English Heritage. NMR.

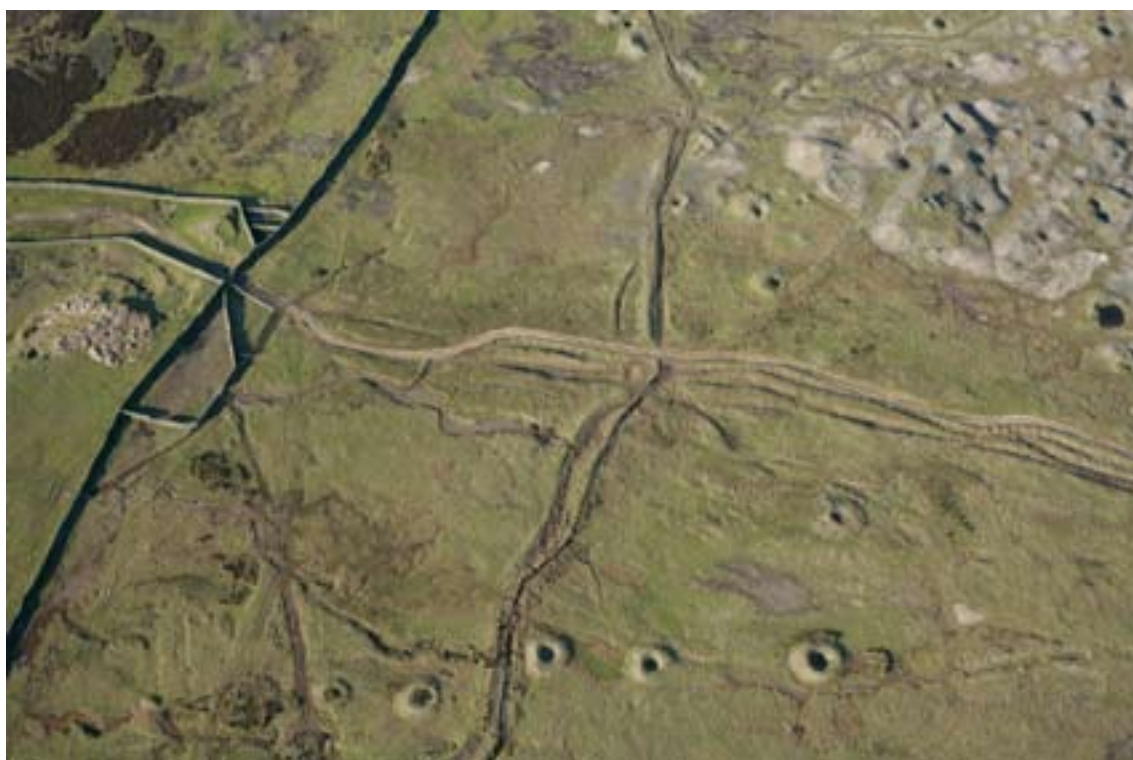
Zone K (Figure 59)

Problems stemming from gully erosion, similar to those noted in Zone J, are occurring further down the slope on Road 7d, where, again, no attempt has been made in recent years to remedy the situation through modern drainage works. This section of the road, however, does not appear to cut through complex mining remains, because it is of relatively early origin, having probably been the main access route into the mining areas since at least the 17th century. Thus, the well-marked hollow ways, which themselves

Figure 59: Zones K and N. Oblique aerial photograph from the east in 2008. Road 7 runs from right-centre to left-centre. Road 22 runs from bottom-left to join Road 7. NMR 20844/026/25-NOV-2008. © English Heritage. NMR.

concentrate and channel run-off, may be part of some of the earliest mining-related routes on Grassington Moor. In this area, the problems are compounded by breaches in the Duke's Water Course (for example, 370), which are contributing to both channel/rill and gully erosion further downslope. These concentrate flow into the area around the gate through the Moor Wall, feeding into animal pens close by and ultimately into the New Pasture Beck.

Serious erosion is taking place along the northern end of Road 22, which has not been subject to any modern drainage works. The erosion is mostly caused by run-off from the slopes above, mainly emanating from Zone J and leakages from the Duke's Water Course (298), which acts as a linear reservoir. The road itself has been little disturbed by activity related to mineral re-working between c. 1956 and 1964 and it may represent one of the earliest routes to the Cupola Smelt Mill complex (515). A section of the road has been eroded away, and although this is not intensively used today, recent vehicle tracks suggest it may still be in occasional use.

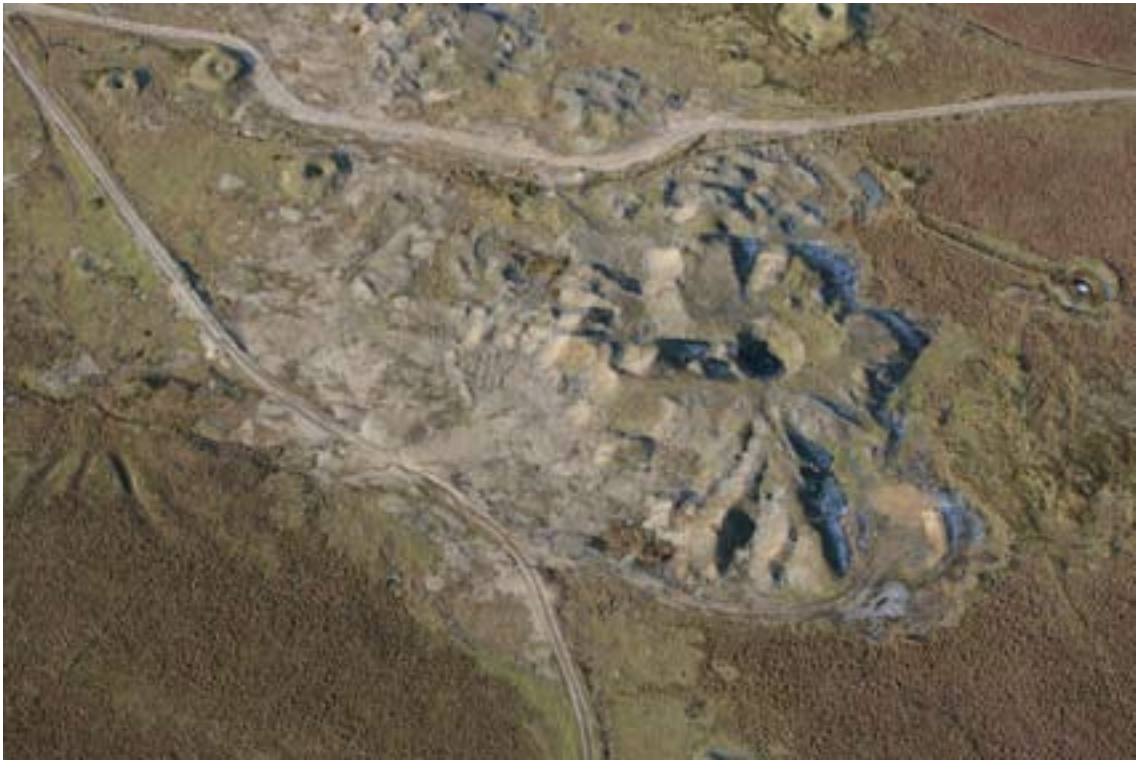
Zone L (Figure 60)

Along a short section of Road 9 below Coalgrove Head Mine, unmanaged gully erosion is impacting on dressing areas south of the road, which are relatively well-preserved having remained largely unaffected by the re-working for barytes between c. 1956 and 1964. Also at risk in this area are the raised causeway (306) and surviving stone channels where the road was carried over the rod-tracks of the pumping and winding mechanisms which linked Coalgrove Head to the motive power at the Brake House to the south. Some of the revetments of this impressive and rare feature have already collapsed. Stumps of timber supports for the rod-tracks also survive in the area to the north (307) and more may survive in the boggy areas to the south; these and associated linear earthworks are at risk from erosion.

Figure 60: Zone L . Oblique aerial photograph from the east in 2008. Road 9 runs from bottom-centre to left-top. NMR 20846/042/25-NOV-2008. © English Heritage. NMR.
