The Use of Multi-Image Photogrammetry to Record At-Risk Archaeological Material from the Wreck of *Invincible*

Dan Pascoe, Ben Jones and Grant Cox

**PROJECT REPORT
2017**

May 2017

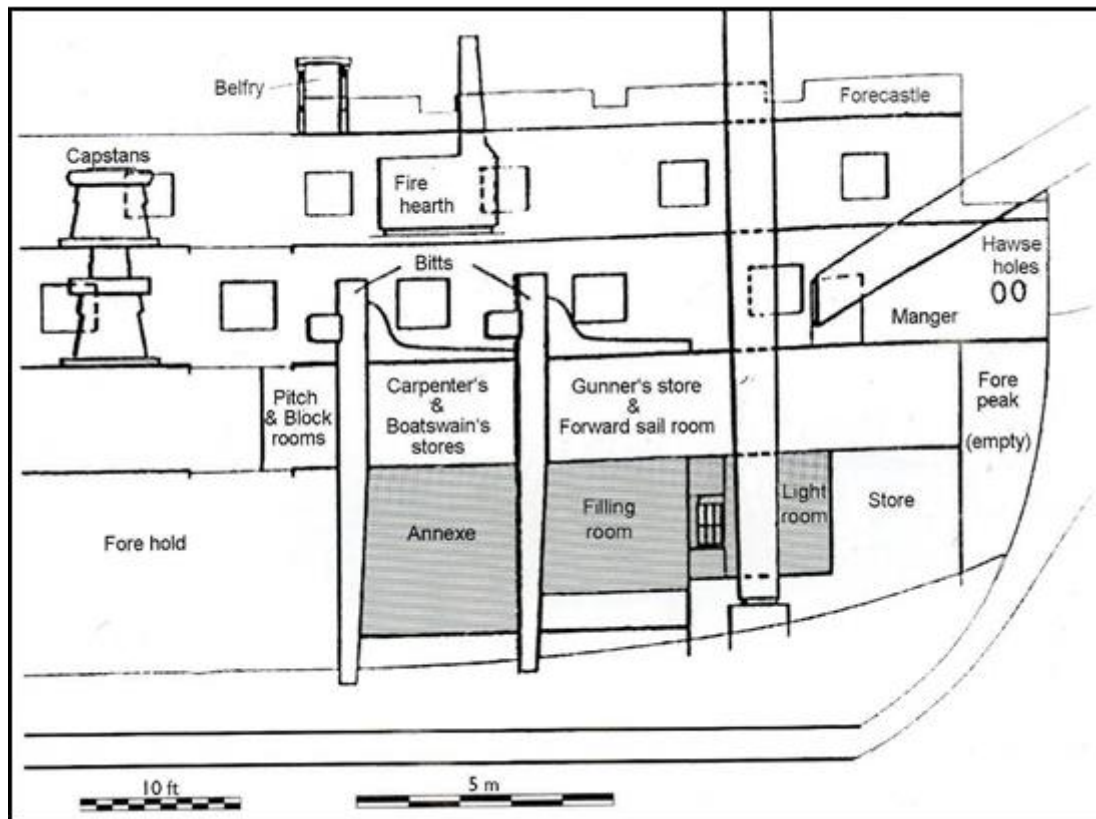
Figure 7: *Invincible's* forward arrangements. Drawing John Betwell

- 5.2.1. At the bottom of the forward hold are exposed floor timbers and futtocks and immediately above these large timbers are the remains of frames and planking of a slighter construction. These most likely represent the floor of a storeroom which was suspended above the ceiling of the hold (Figures 7-9).
- 5.2.2. From studying the internal forward plan of *Invincible* in Bingeman's 2010 publication following her major refit in 1752-56, this internal structure could be related to the light room or filling room (Figure 7). Above the light room and filling room was the gunner's store. On the seabed, scattered on the planks of this floor structure, are musket shot, probably originating from the gunner's store.

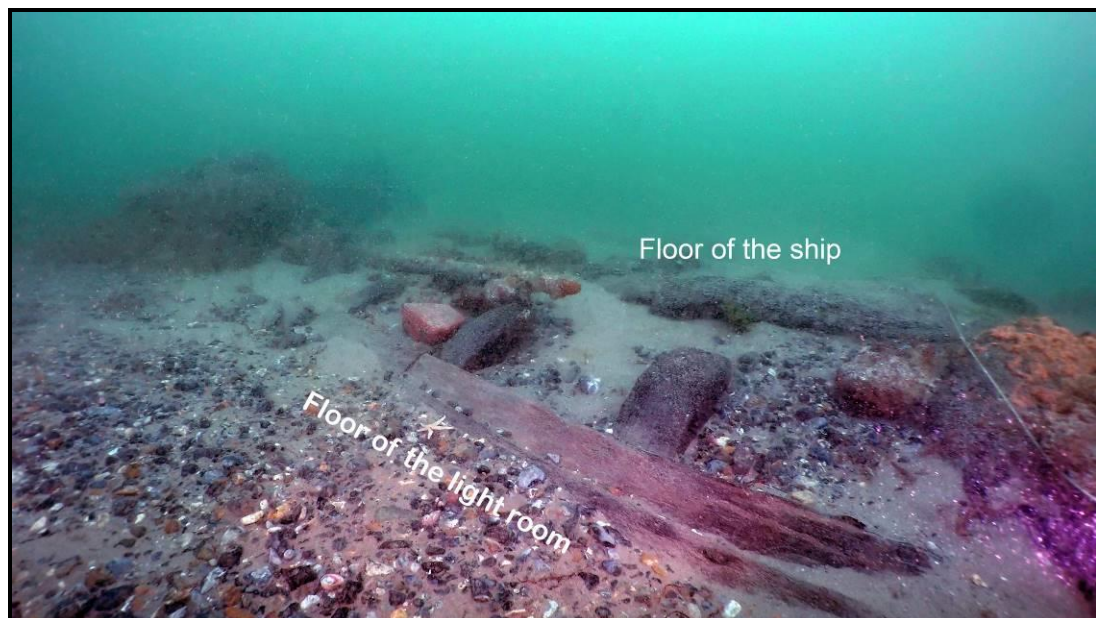
Figure 8: Internal floor of a compartment above the ceiling of the forward hold, possibly the light room © PAS

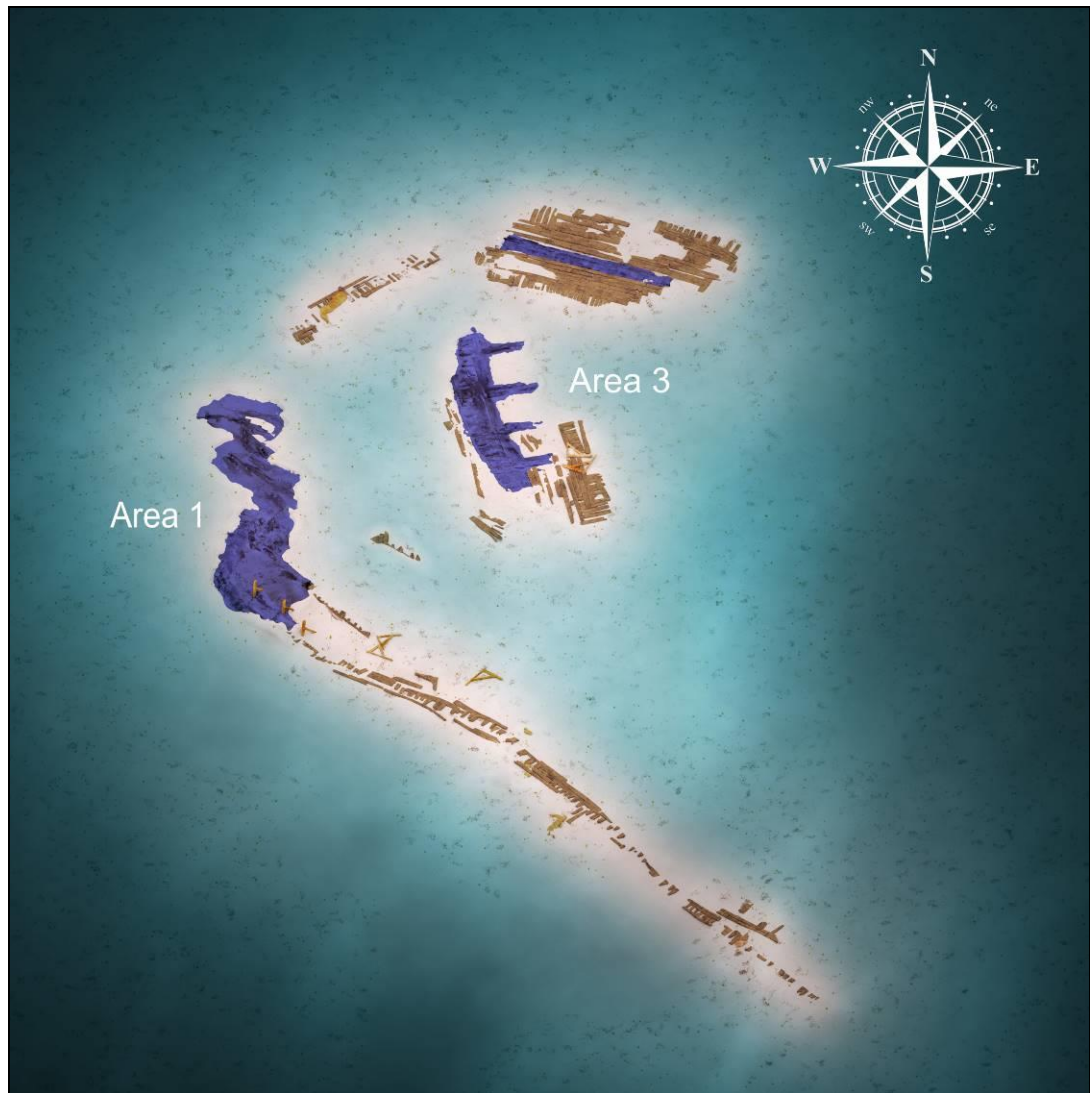
Figure 10: This is a reconstructed plan of the site, the purple shaded areas represent the areas which have been recorded photogrammetrically. Area 1 and 3 are sections recorded in 2016 © PAS.

- 5.3.1. **Area 3** is located 15m NE of the main site and roughly 2m south of **Area 2** (Figure 10). It is a large coherent section of starboard side structure relating to the hold and orlop. It consists of riders, inner and outer planking, frames and wooden and iron knees. This whole section is roughly 14m long by 5m wide.

- 5.3.3. As intended the west and central section of Area 3 were successfully photogrammetrically surveyed (Figure 10). The survey recorded the large pairs of riders fastened over the ceiling planking and frames of this section of starboard side lower hull structure. Although the survey of the eastern side of Area 3 was not originally in the project design, it was hoped this could have been carried out because of the exposure of new features. However, as previously mentioned, the underwater conditions slowed the progress of the survey and there was insufficient time to complete the whole of Area 3.

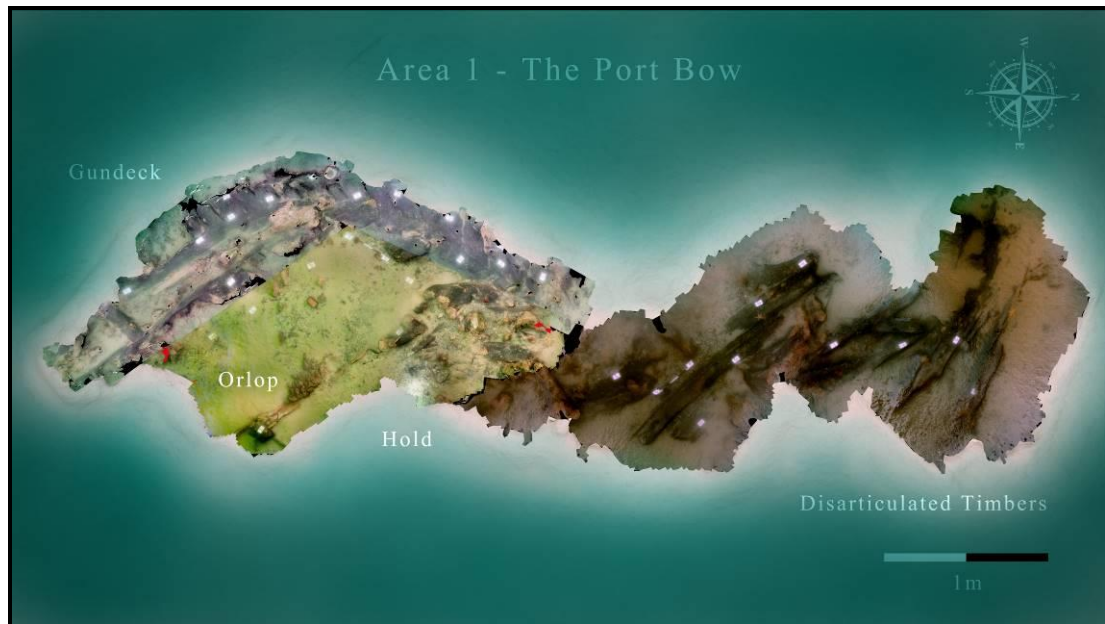
- 5.2.5. The results from Area 1 derive from three data-sets, taken from three individual dives. The first data-set includes the gundeck and the sweep of the bow. The second data-set includes the orlop and a section of the forward hold. The third data-set includes an area of disarticulated timbers outside the coherent port structure. These individual data-sets can be clearly seen in Figure 11. Differences in colour have occurred in the data-sets due to changes in ambient light. Subtle changes in light occur depending on the height of the tide, angle of the sun, whether it is a cloudy or sunny day and the clarity of the water. Underwater conditions are constantly changing throughout the day and this influences the appearance of the data.

Figure 11: Image showing the original photogrammetry model of Area 1 with Photoscans targets. This image also identifies the three separate data sets, which have been merged to form Area 1 © PAS.

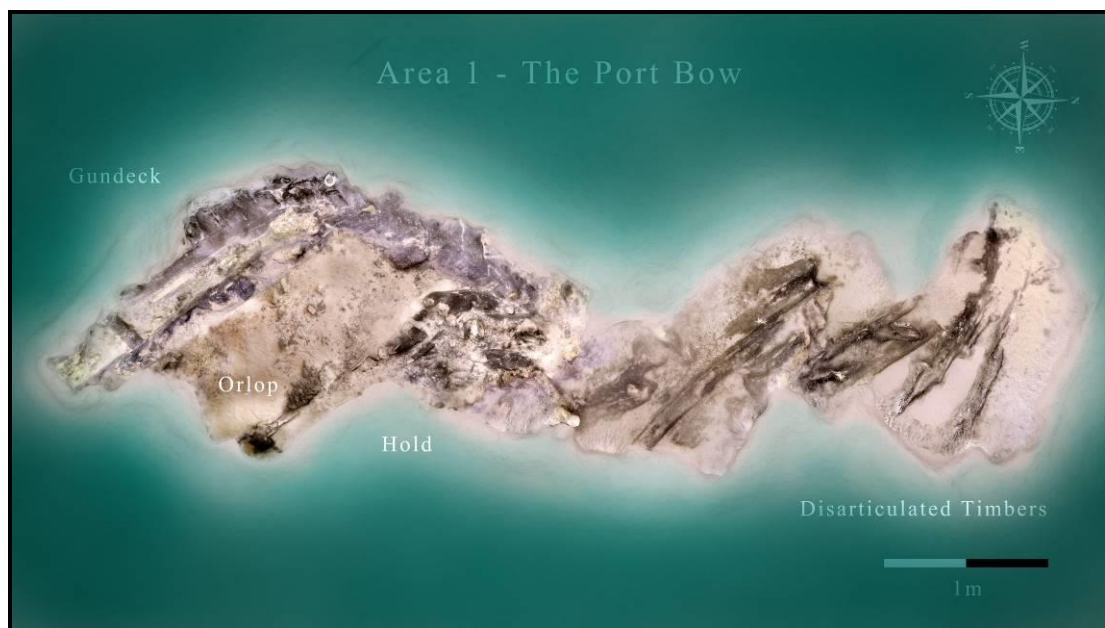
Figure 12: Image showing the reworked and colour corrected model of Area 1 without Photoscans targets © PAS.

- 5.2.8. Below the gundeck are the remains of the orlop. The line of the orlop deck can be seen emerging from the sand, parallel to the remains of the gun deck. On top of the deck is a coil of exposed anchor cable. The cable is lying directly on top of the deck which is clad with pine. At the forward end of the orlop, halfway between the decks, are the remains of a wooden breast hook fastened to the inside of the hull. Below the deck of the orlop there are the exposed ends of deck beams and ledges (Figure 12).

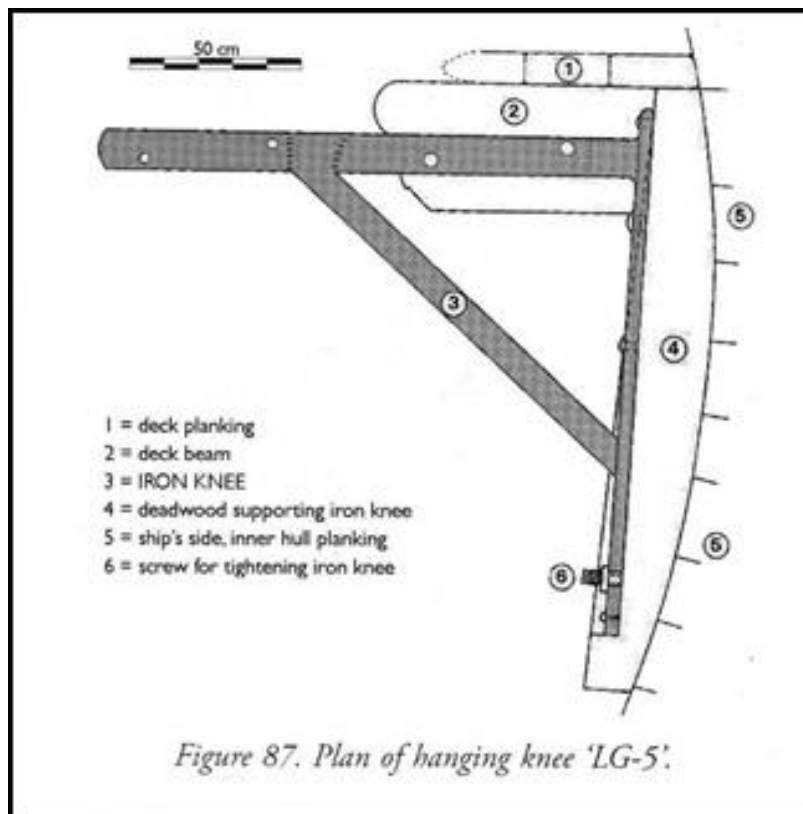
Figure 16: Plan of how the iron knees fitted to the inside of the hull (Bingeman 2009, 73).

- 5.3.2. Further exposure over the winter led to the identification of structural features relating to the support of the decks. An in-situ lodging knee marks the line between the hold and the orlop. Above each end of the lodging knee is a section of deadwood known as an oak pad piece. This is where the iron knees were counter sunk into the pad piece and then bolted through the hull (Figures 16-18). The iron knees are missing from this particular location but there are a number surviving in locations either side. Although some iron knees have survived they are no longer in the upright position as found in Area 1 of the coherent port bow.

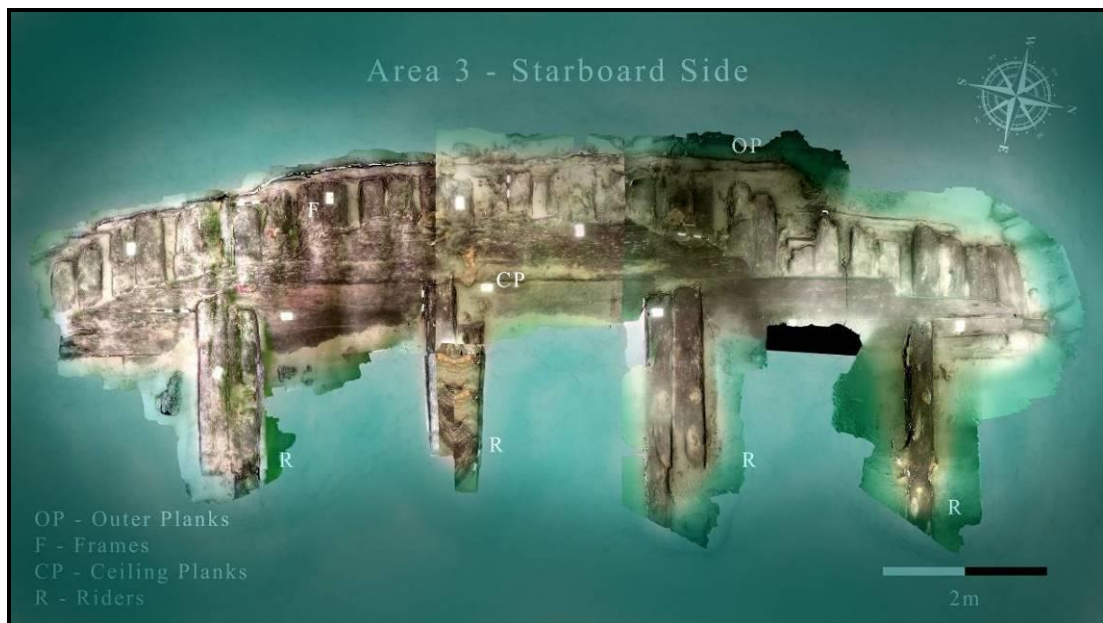
- 5.3.4. The results of the photogrammetry survey of Area 3 come from three individual data-sets which can be seen in Figure 19. The first data-set is at the south end and includes the first 6.5 pairs of frames or 13 individual frames. The second data-set is in the middle and includes six individual frames. The third data-set includes 6.5 pairs of frames or 13 individual frames from the north end. The three data-sets represent three individual dives that were made to complete the survey.

Figure 19: Image showing original processed photogrammetry model of Area 3 with Photoscan targets. The image also shows Area 3 is made from three data sets © PAS.

- 5.3.3. The photogrammetry survey also clearly shows the framing pattern in the construction of *Invincible*. She has been constructed with frames fastened in pairs followed by a space before the next pair. The model identifies that the space between the frames is not always uniform (Figures 19, 20 and 22).
- 5.3.4. Where the frames join is also obvious and it is clear to see from the model that this section of the starboard side broke at the joins of the framing timbers (Figure 22), which was a clear weak point.

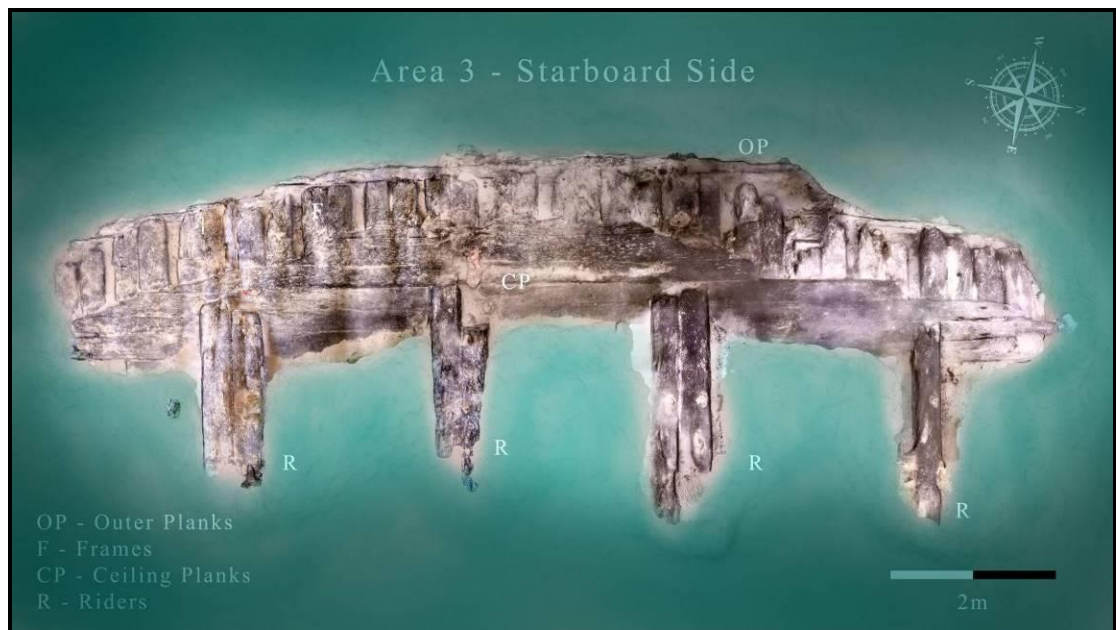
- 5.3.5. The three data-sets have been merged together to form one model representing the total area surveyed. Figure 20 represents the colour-corrected version of the same model. The two models represent the inside of a section of the starboard side hold.

Figure 20: Image showing the colour corrected model of Area 3 © PAS.

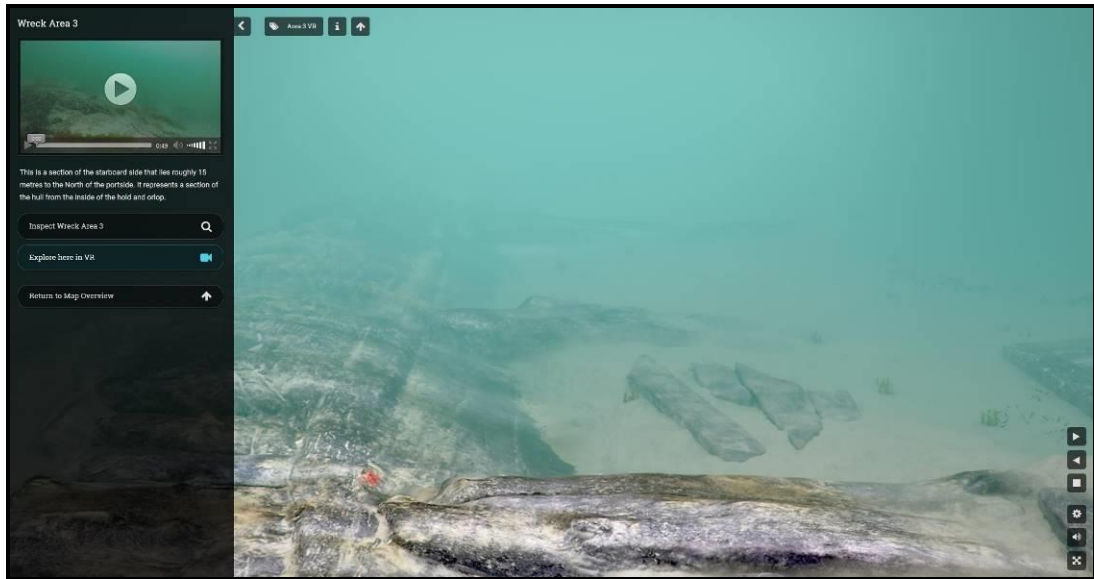
Figure 27: The 3D animation sequence of Area 3 © PAS.
