Historic England

# A Preliminary Study of Flood Remediation in Hebden Bridge and Appleby

March 2017

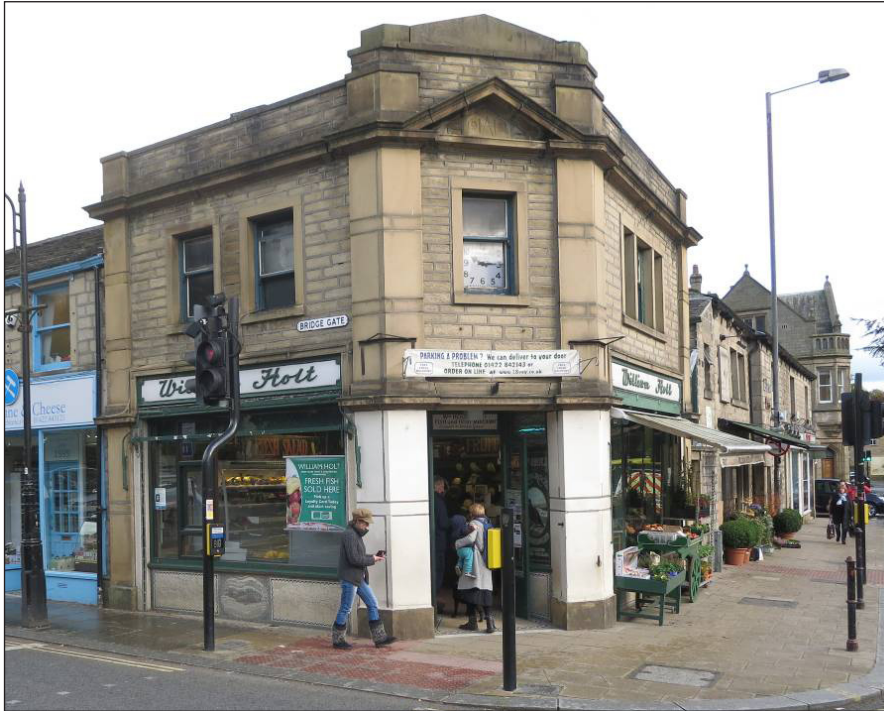
Cleaned out mud and swabbed walls and floor with an agricultural disinfectant. Three dehumidifiers used over a 3-week period. (Back rooms have un-plastered stone walls. All rooms have solid floors).

*Figure 2: Shopfront of William Holt, greengrocer.*

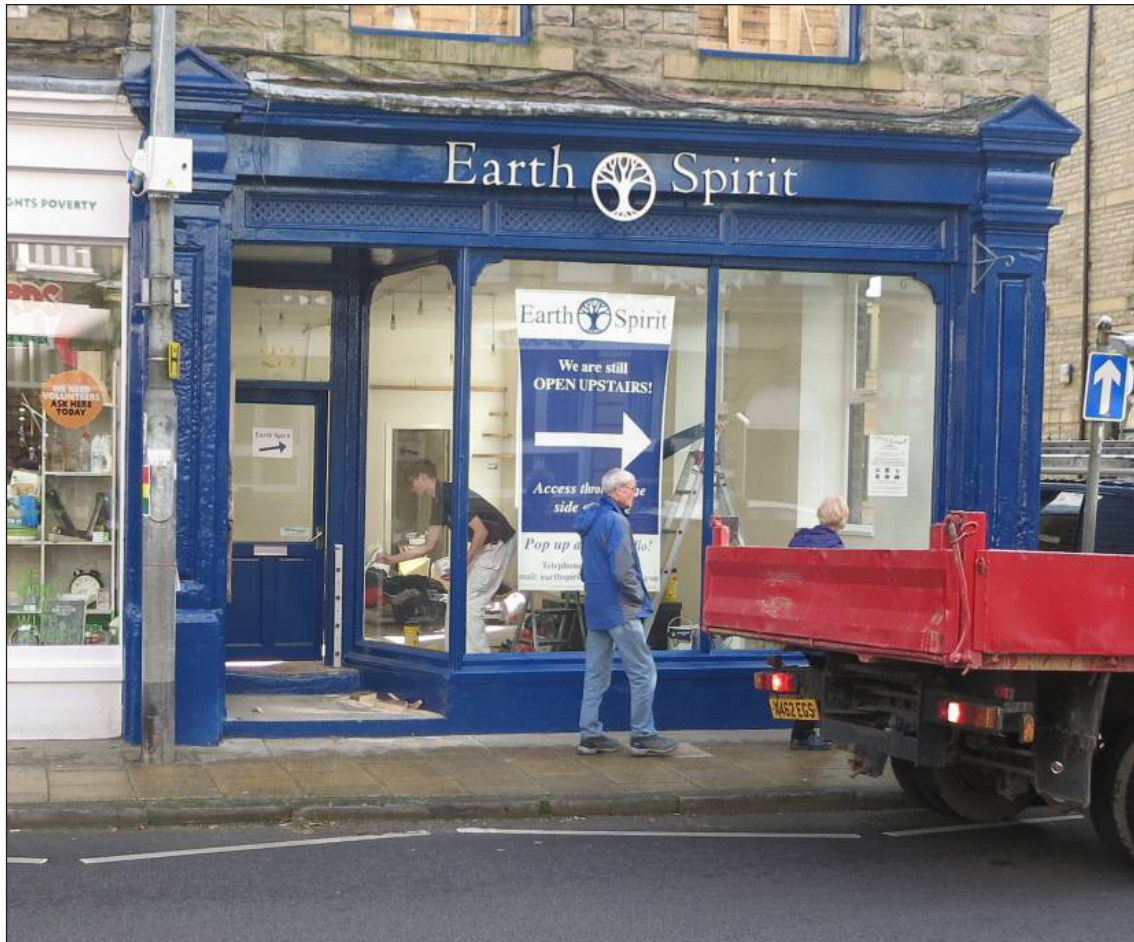
*What remedial actions were taken? (e.g. Cleaning: how? Disinfecting: with what? Details of any heating, ventilation or dehumidification provided at this time).*  
Mud cleared and surfaces disinfected. Laminated floor finish had floated and was easily removed. Dehumidifiers used. (Walls were replastered with a 'waterproof' plaster (?) after the previous flood in 2012).

*What heating, ventilation (and dehumidification, if any) has been in operation since reopening?*  
Not clear, but probably none because air fresheners needed to disguise damp smell.

*Figure 4: Shopfront of Earth Spirit, gallery.*

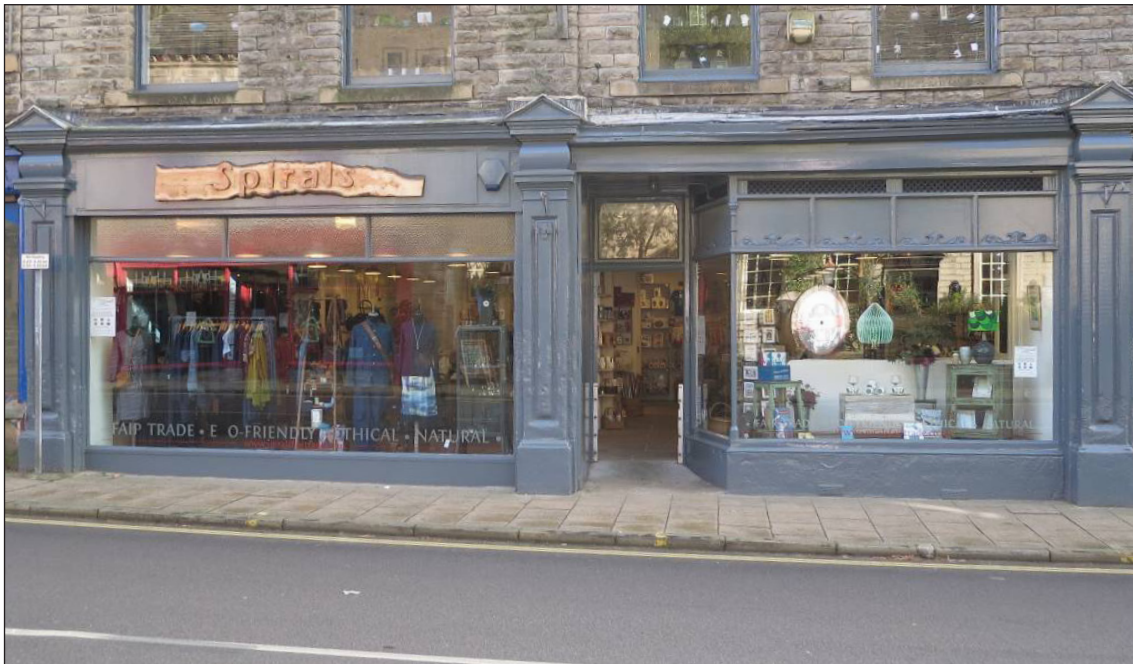
Professional drying. Heaters and dehumidifiers used. The timber floor was removed and replaced with stone flags on a concrete slab (Figure 6) and plaster was hacked from the walls to a height of 1.5m.

*Figure 5: The shopfront of Spirals.*

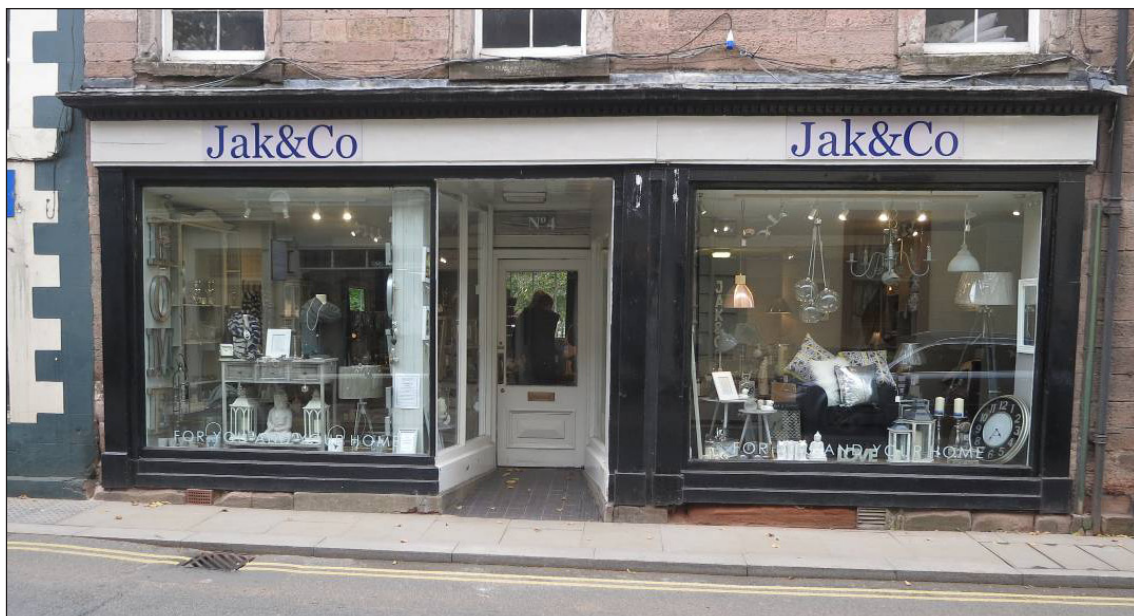
*Figure 11: The shopfront of Jak & Co.*

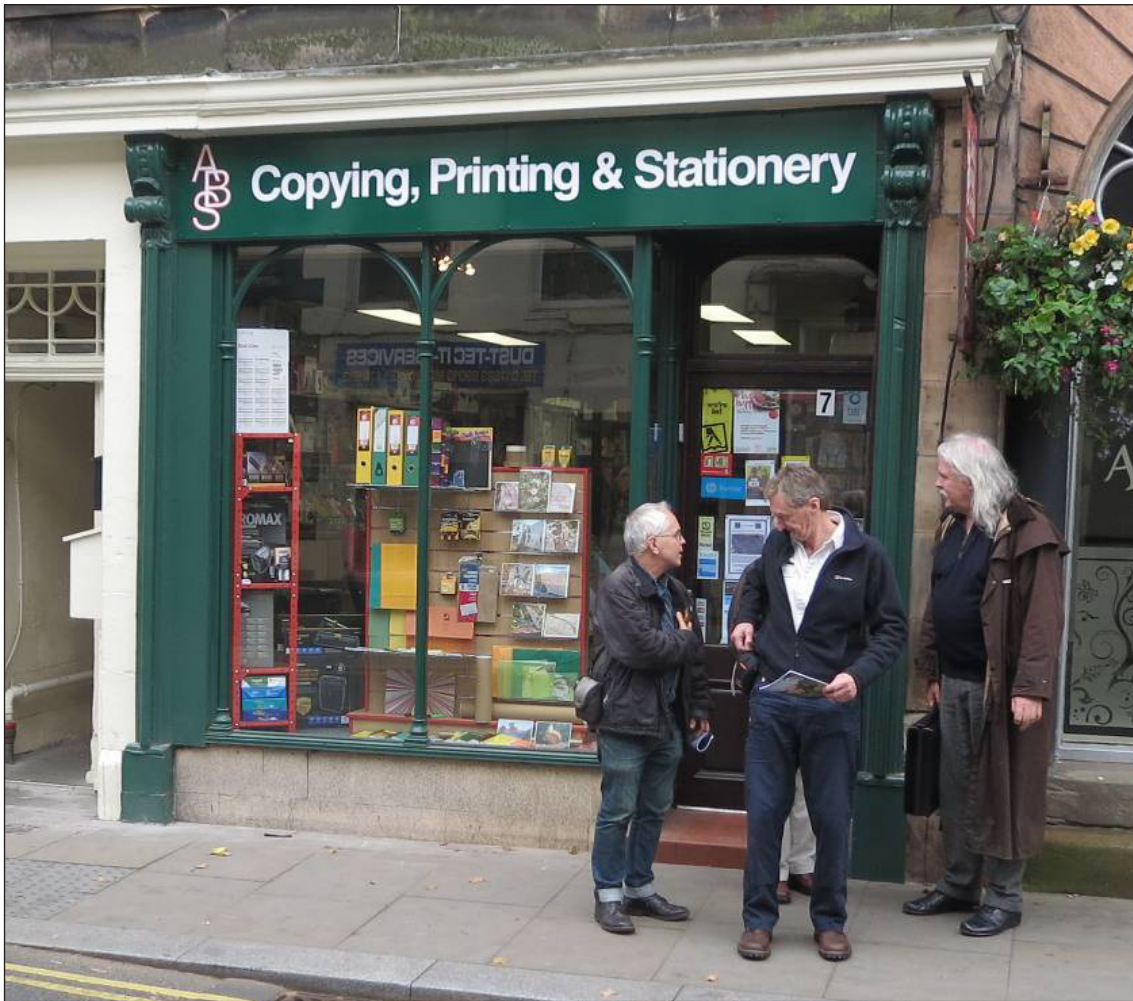
*Figure 14: The shopfront of Copying, Printing & Stationery.*
