ARCHAEOLOGICAL SERVICES IN RELATION TO MARINE DESIGNATION

UB-109, off Folkestone, Kent

ARCHAEOLOGICAL REPORT

January 2015

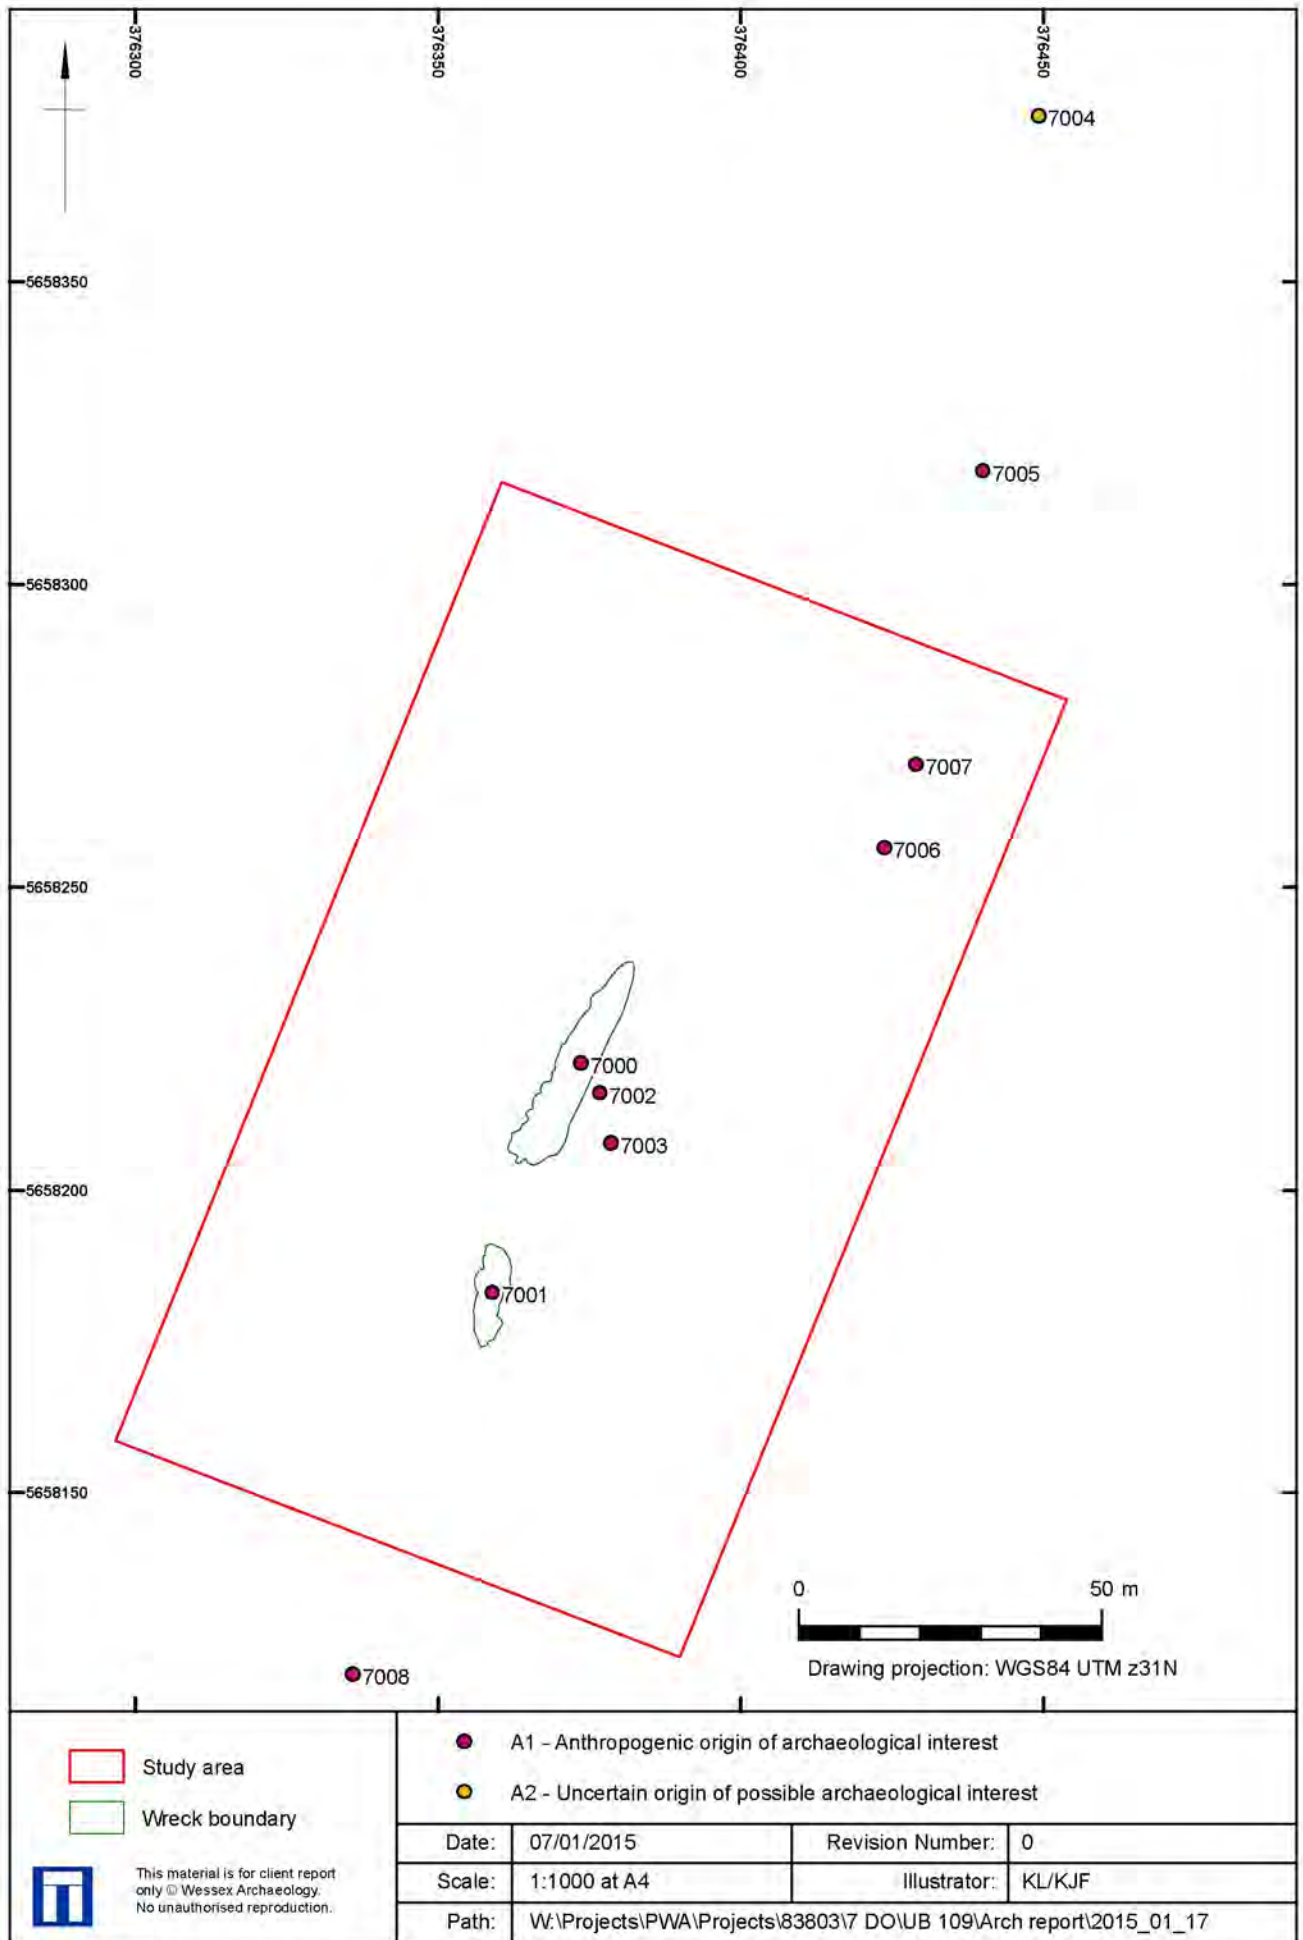
Figure 2

- 4.4.1 The geophysical survey identified a total of nine features of archaeological potential, including the two sections of the wreck, two items of debris and five magnetic anomalies (WA 2014; **Figure 2**). The geophysical survey results are reported on separately but have been incorporated in this report (WA 2014). **Figures 3-4** summarises the geophysical survey results.

Geophysical survey anomalies of potential archaeological interest

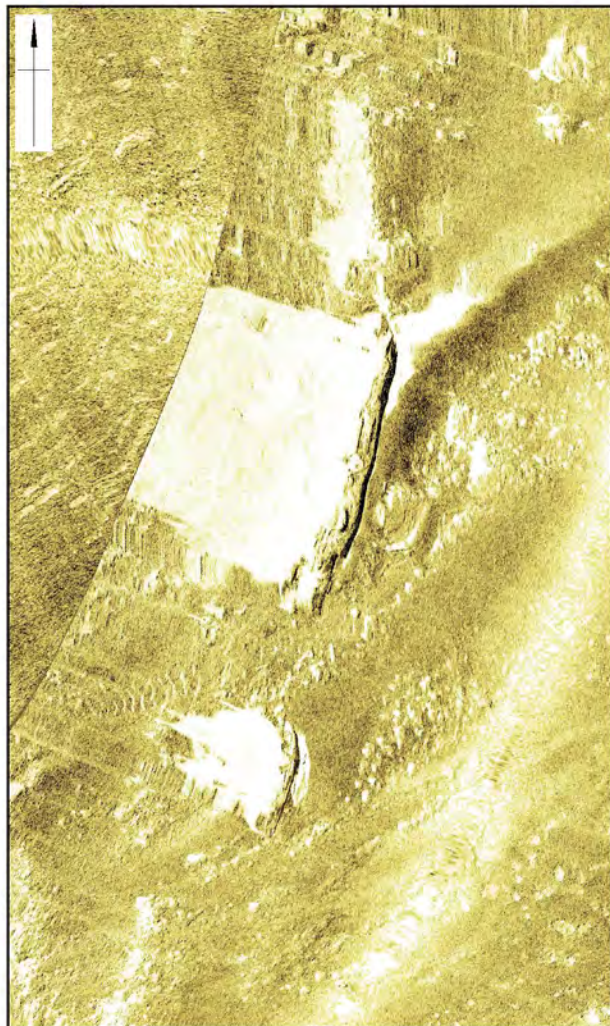
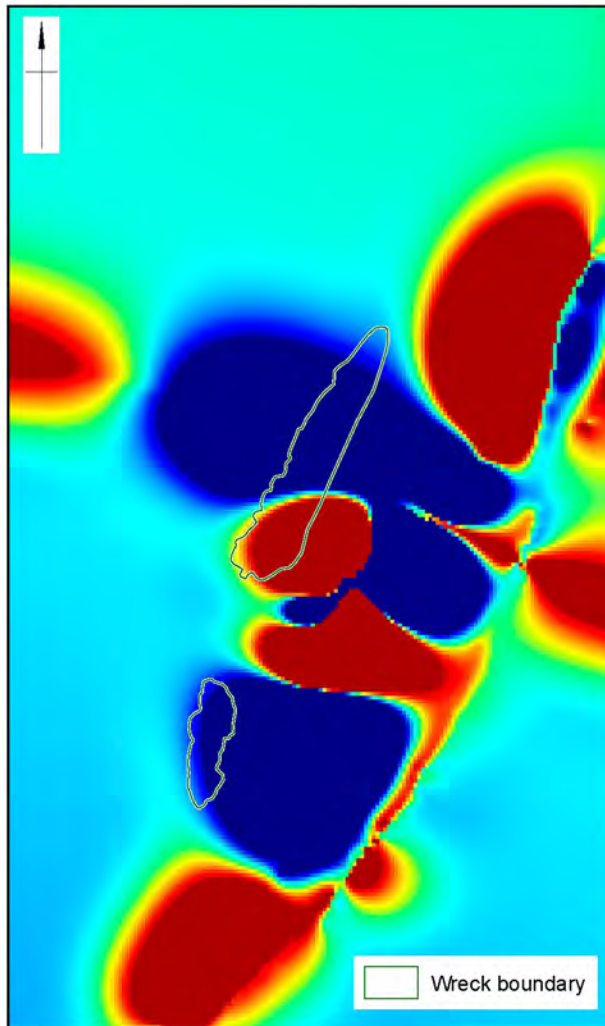
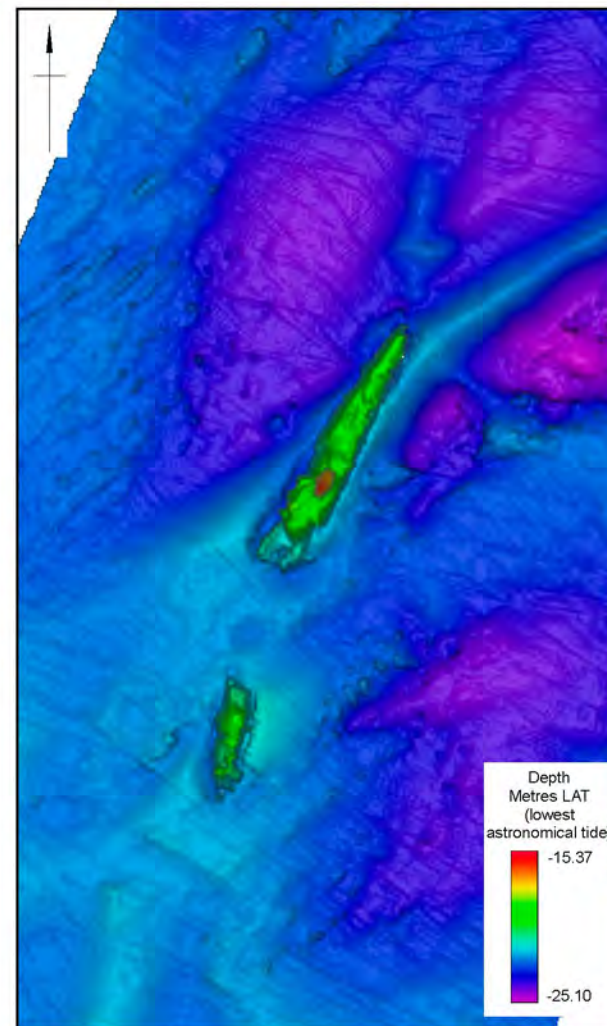
- 4.5.6 The smaller section (7001), comprising the hull aft of and including part of the engine room lies approximately 16m to the south-west at an orientation of 10/185°, approximately N/S (**Figure 3**). It is inverted, with the props pointing towards the main section. This section is 16m long and has a maximum width of approximately 5m. Maximum height above the seabed is 4.5m (**Figure 6**).

A. Sidescan sonar mosaic

B. Gridded magnetometer data ($\pm 35\text{nT}$)

C. Multibeam bathymetry

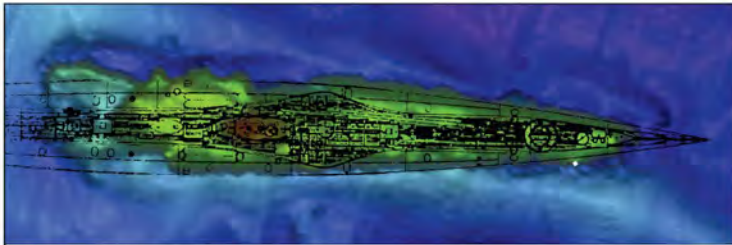
7000: Multibeam bathymetry with plan

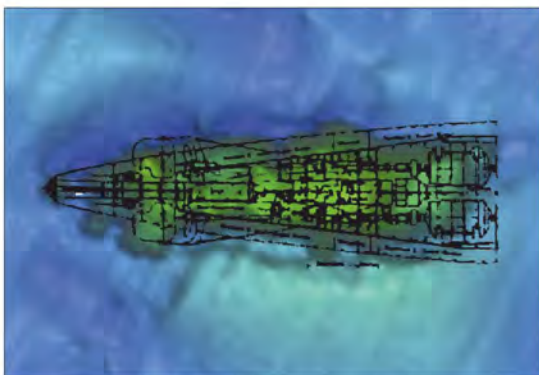
7001: Multibeam bathymetry with plan
