Goodwin Sands and the Downs: Multi-Beam Surveys of the Designated Wrecks

Multi-Beam Surveys of the Designated Wrecks on the Goodwin Sands and the Downs

July 2017

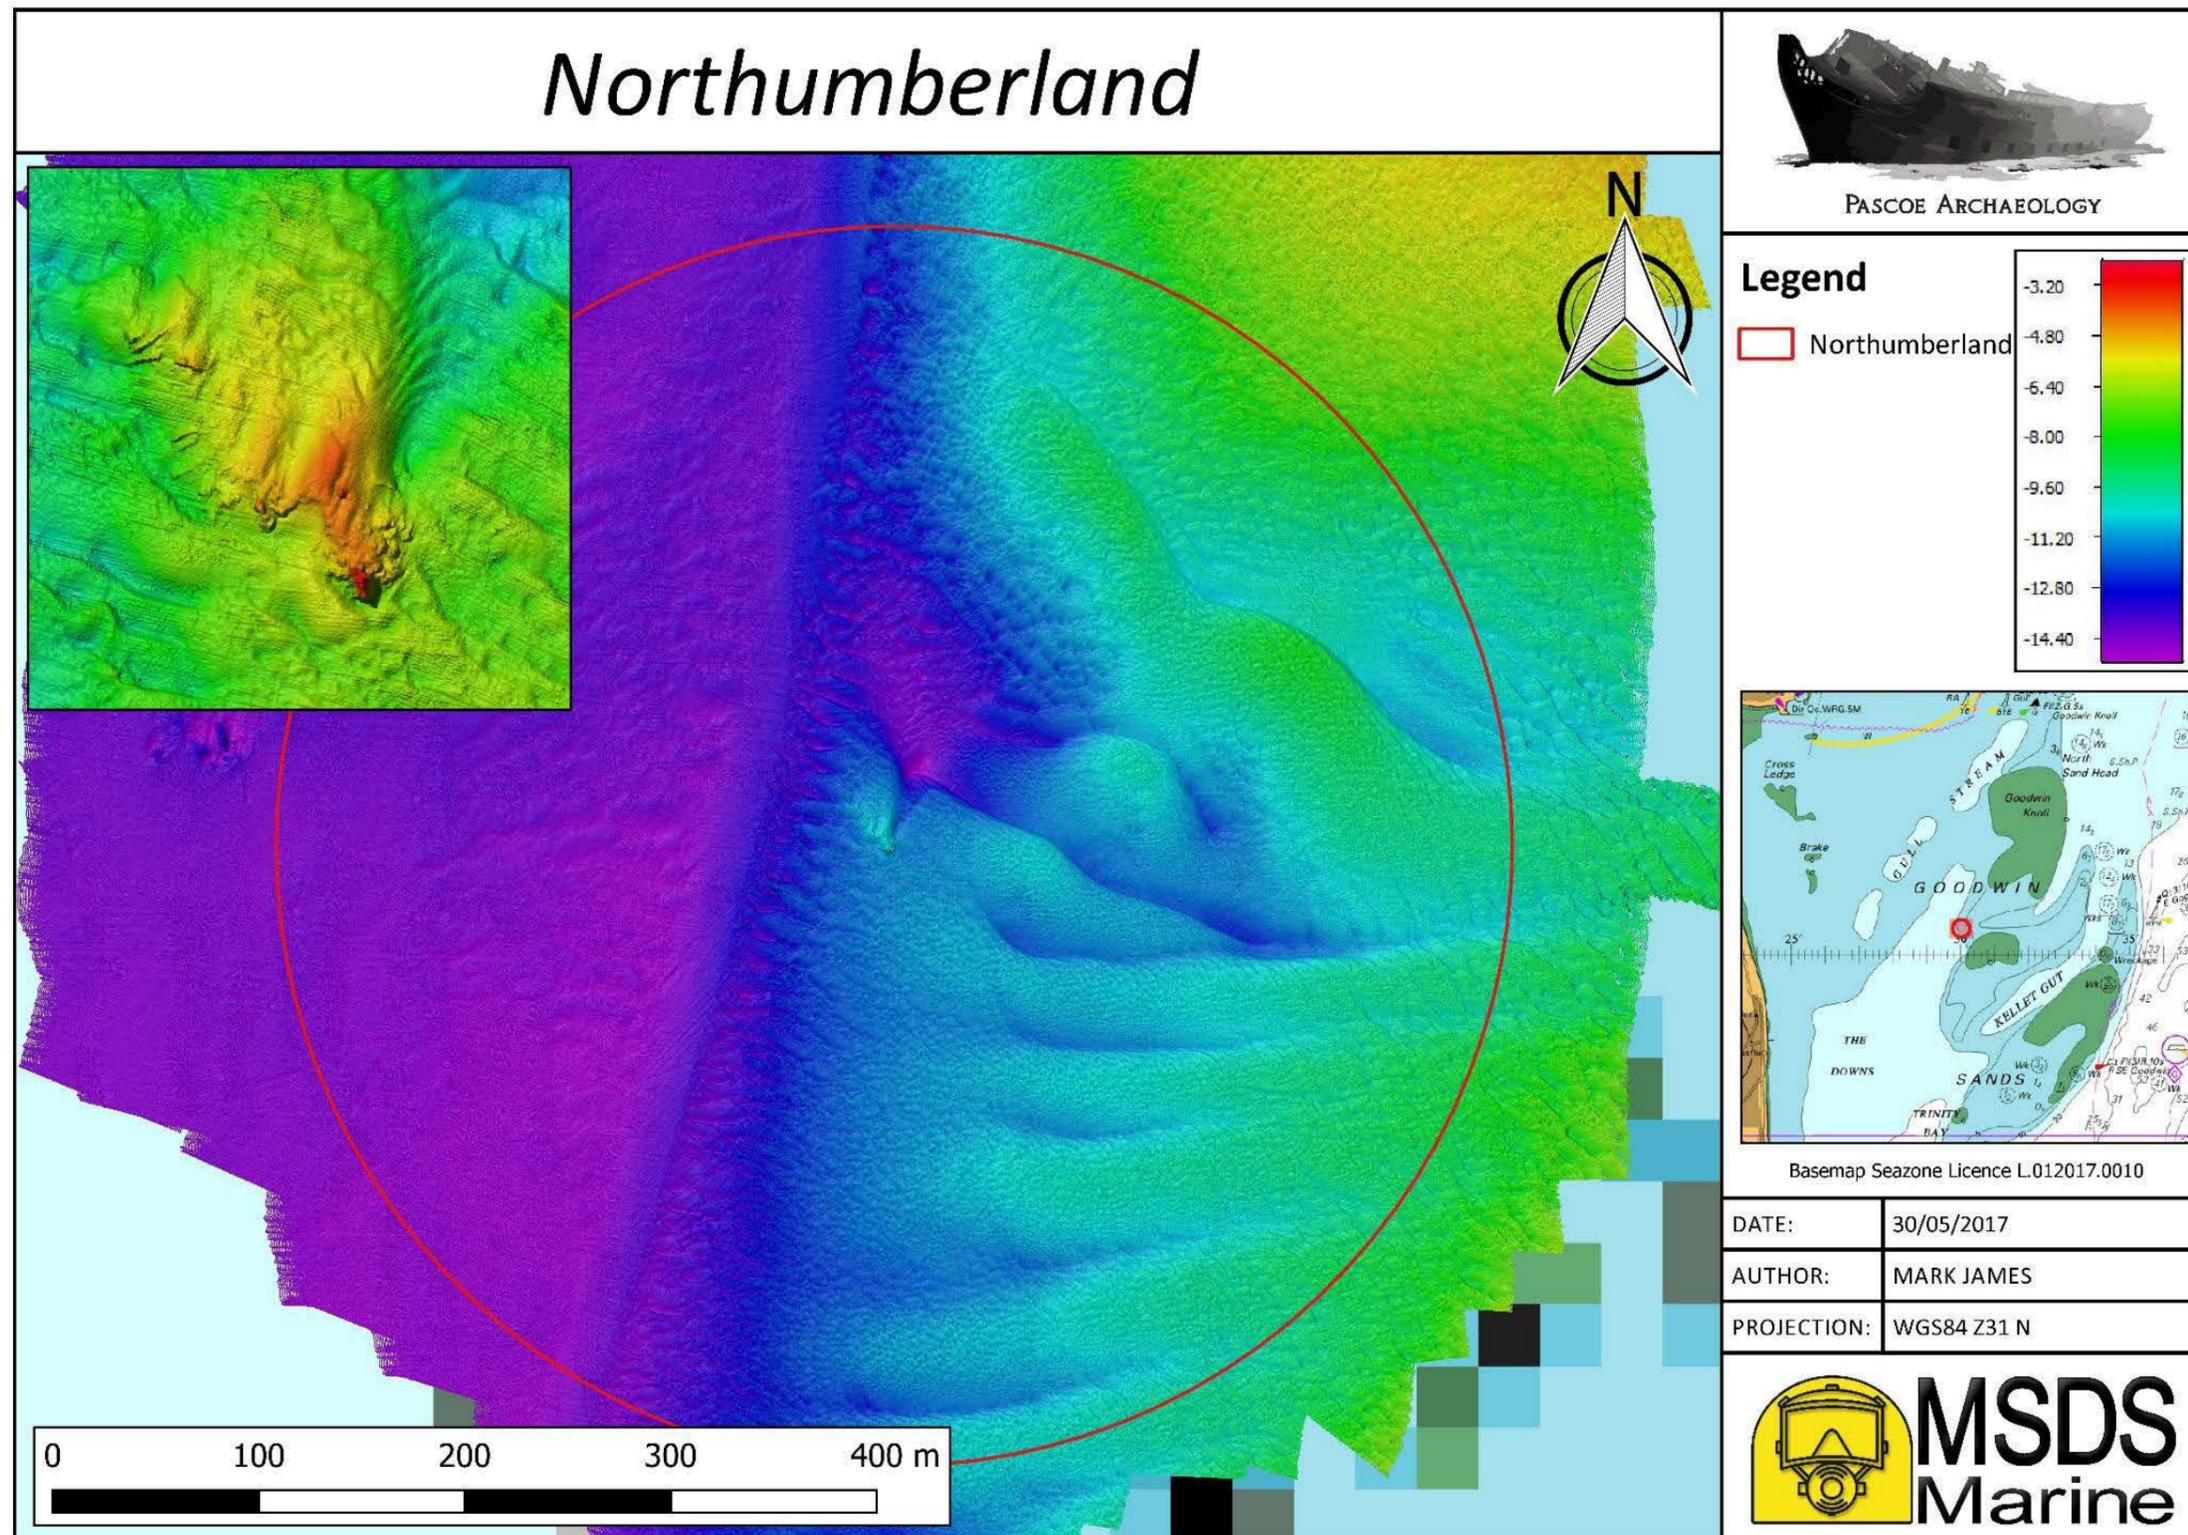
Fig. 10: The *Northumberland* and designated area.

- 4.3.4 The 2017 MBES data shows there is a greater slope to the mound on the west side which extends from the northern limits to the southern limits of the site. There is also a distinct scour on the east side of the mound that extends 30m to the north. The mound flattens out to the north (Figures 10–12). There is also a potential for buried archaeological material around the north as many of the guns previously observed on the site were found along the northern parts of the site (Pascoe *et al* 2015, 134).

- 4.3.5 There is a large upstanding feature 3m long by 2m wide by 2m high. This is the highest point of the wreck and is part of a large concretion thought to be the forward shot locker (Pascoe *et al* 2015, 134). Therefore, the southeast end of the site is believed to be the forward end with the stern towards the northwest end. The upstanding feature has a distinct scour around its base on the southern side. To the north it appears to be part of a much larger area of exposed features which roughly covers an area of 10 x 8m (Figures 10–12).

- 4.3.11 317m to the west of the *Northumberland* is another exposed wreck which lies on a sandy seabed. This wreck is not significantly deeper than the *Northumberland* but the 2017 data identifies it to be significantly exposed. It identifies the risk to the site of the *Northumberland* should the edge of the sand bank continue to migrate eastwards (Figure 10).

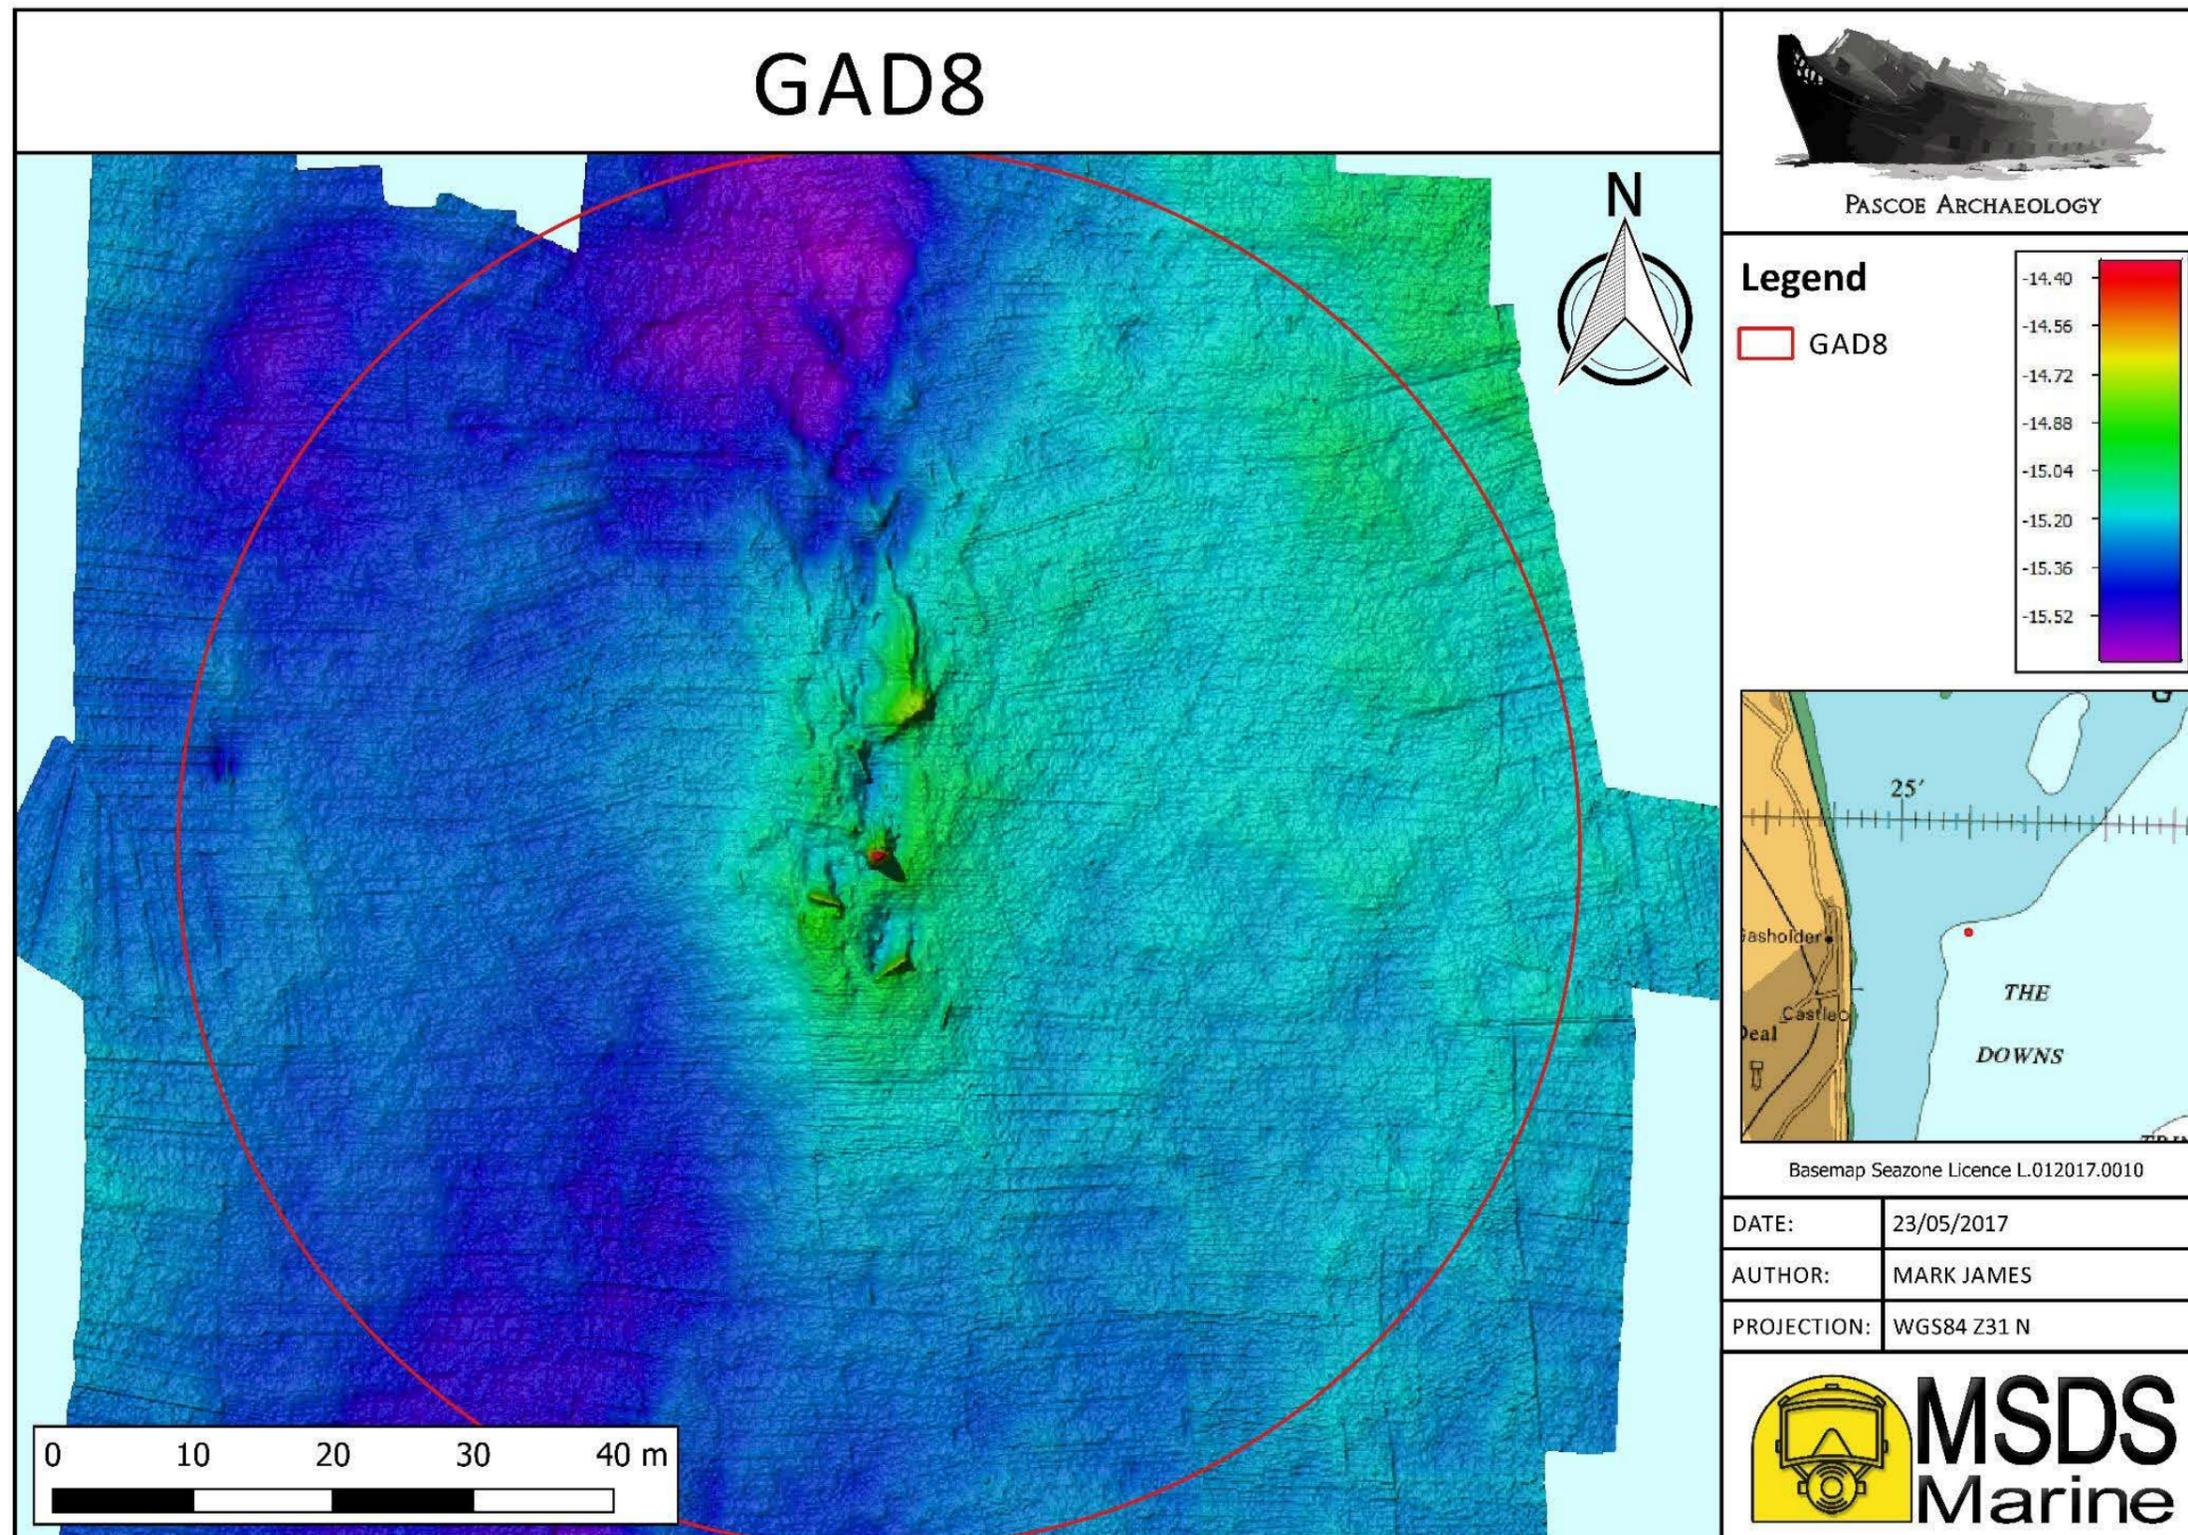
Fig. 17: GAD 8 and the designated area.

4.7.2 The 2017 MBES survey shows the site is currently 39m long by 18m wide at its widest. The site is orientated north–south. Despite the overall spread of material there are not a vast number of exposed features. The majority of the features that are exposed are fairly low lying (Figure 17–18).

4.7.5 Also identified on the 2017 MBES survey are two anomalies outside the main wreck site. The first is a linear anomaly 31.5m south of the central concretion mound. It is 1.3m long and approximately 0.4m wide and appears almost flush with the seabed (Figure 17). The second anomaly is 46.7m west of the central concretion mound. It is circular with a diameter of 1m and it has a shallow scour around its northern edges (Figure 17).

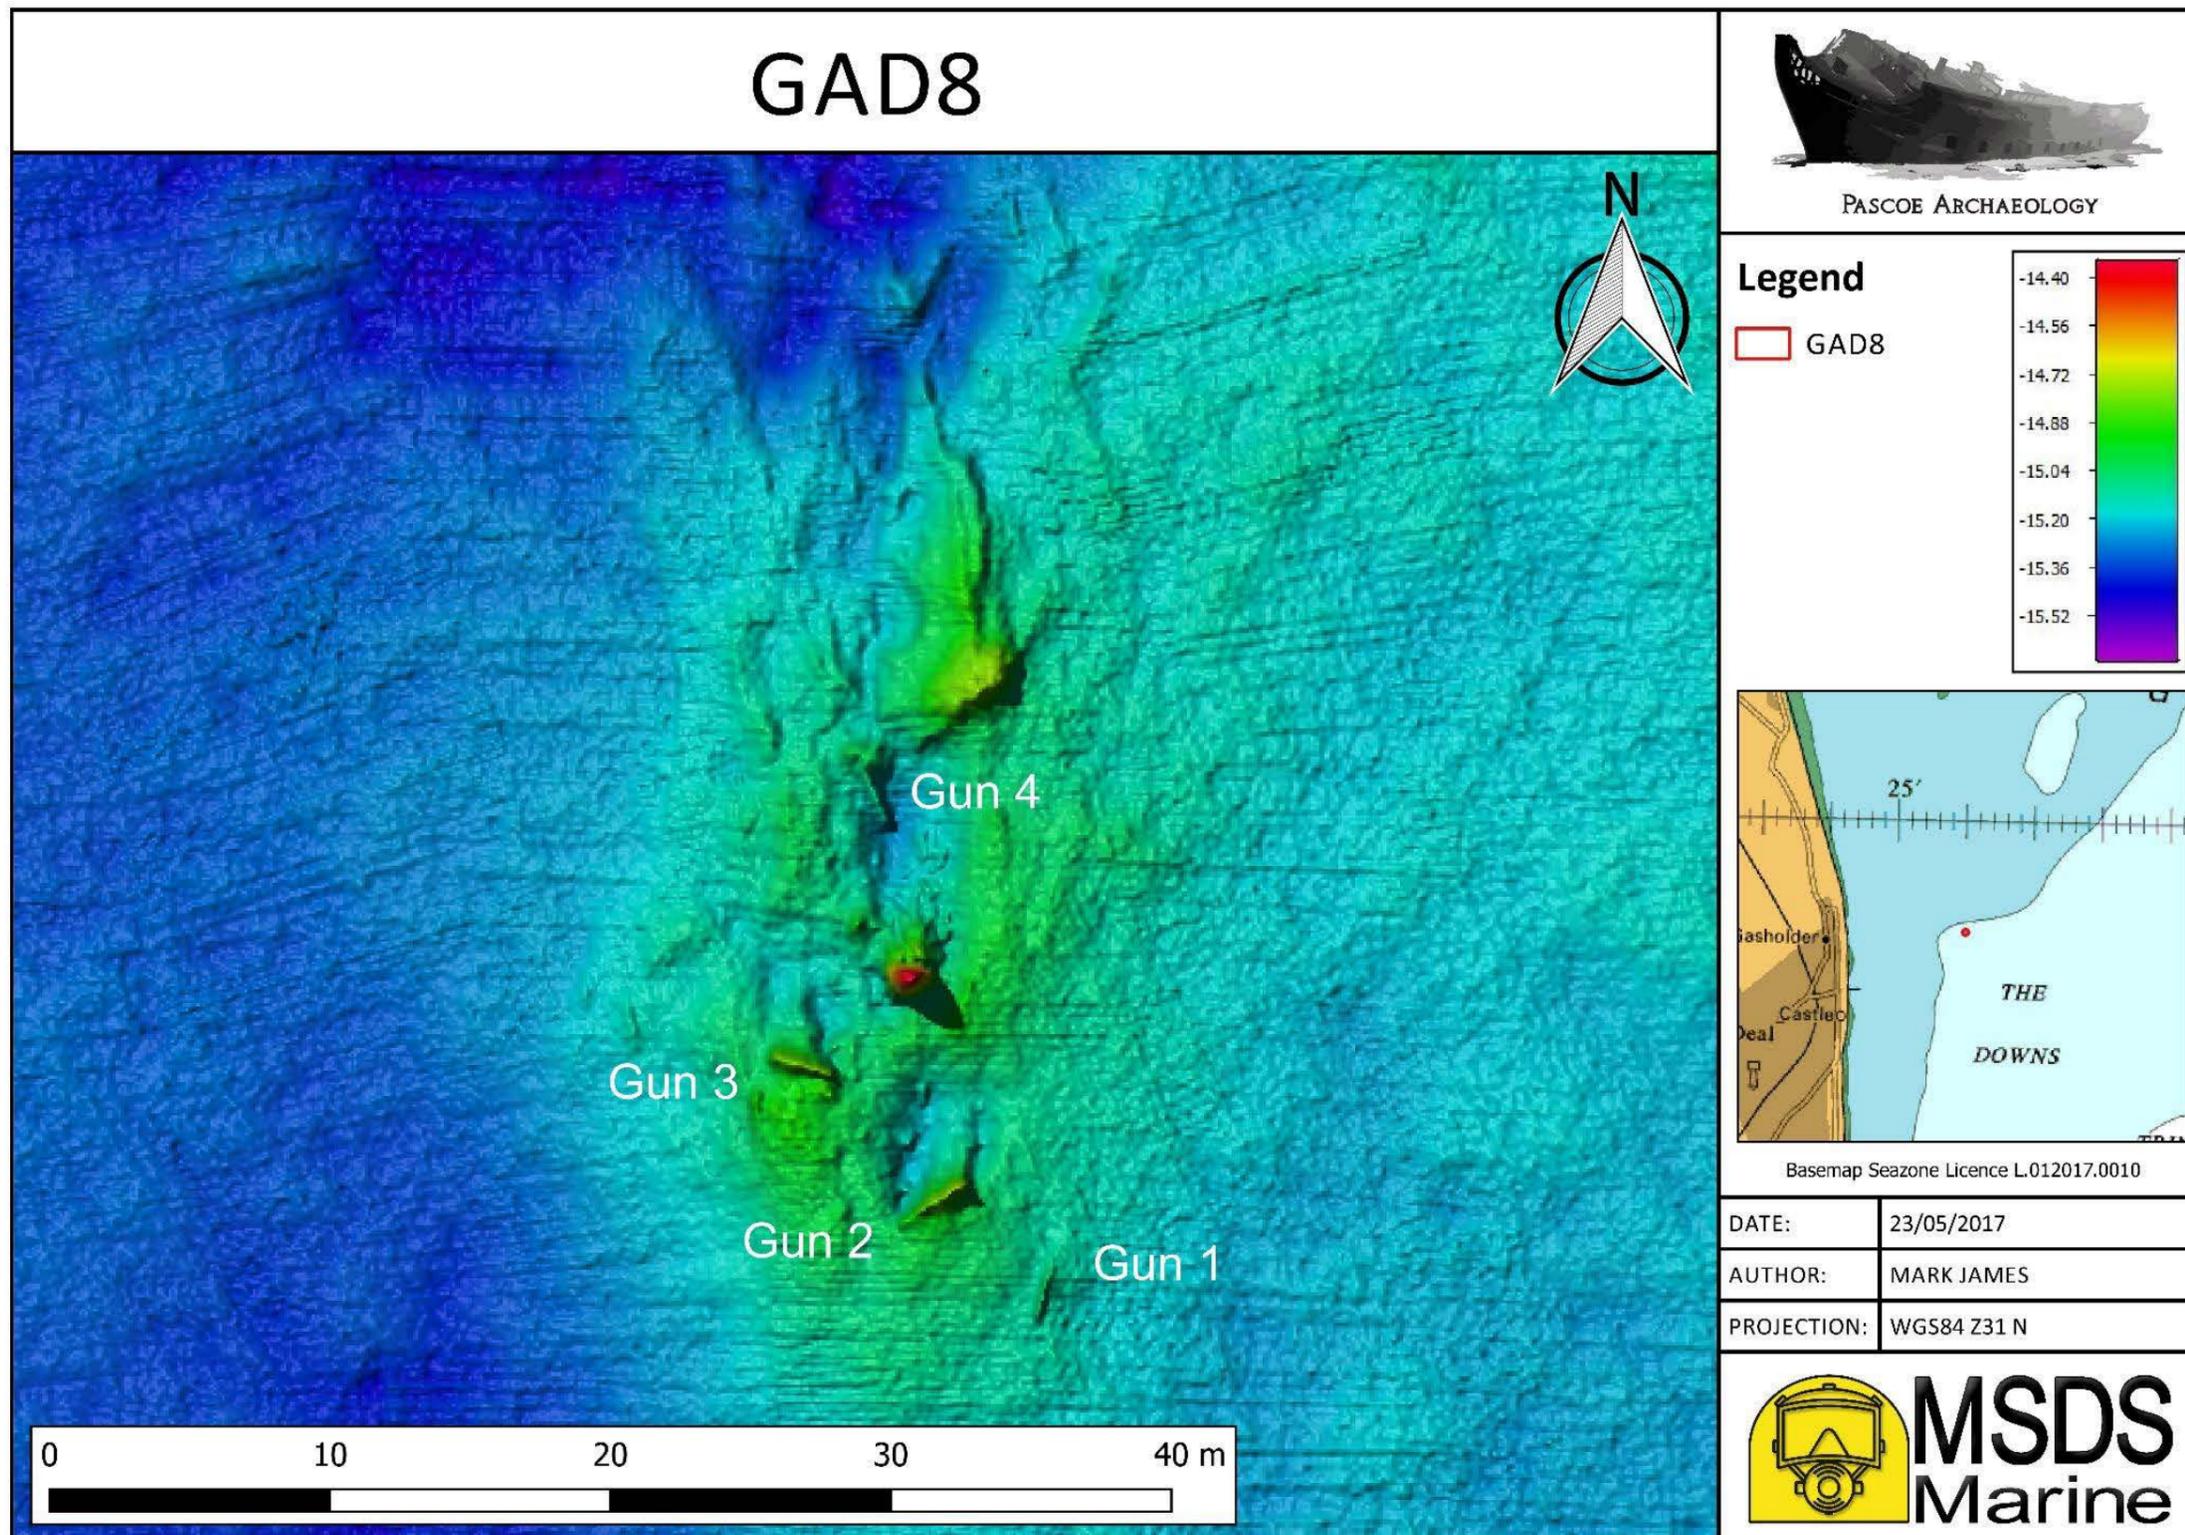
Fig. 18: Close-up of GAD 8.

4.7.3 There are four linear features that match the positions of four of a total of seven guns, which have been recorded on a WA site plan (WA 2011). Three of these are towards the south end of the site. Gun 1 is 2.2m long and orientated NNE/SSW. It is lying almost flush with the seabed, therefore apparently partially buried. Gun 2 is 2.7m long and orientated northeast–southwest. It appears slightly raised above the seabed with a shallow scour along its north side. Gun 3 is 2.5m long and orientated east–west and is lying flat on the seabed. The fourth gun is 4.5m north of an upstanding feature, which is the highest point of the wreck. Gun 4 is 2.2m long and orientated NNW/SSE. It appears slightly raised at its northern end and has a scour along its east side and south end (Figure 18).

concretion mound to another feature which is slightly raised above the general seabed. This feature has an edge 5m long and orientated northeast–southwest. Immediately beyond the edge of the feature is a mound-like feature with an area of sedimentation extending 8.8m to the north. The identification of a distinct edge to this feature could represent a possible section of ship’s structure (Figure 18).
