# An Assessment of a Second World War Hangar Structure at Tollerton Airfield, Rushcliffe, Nottinghamshire

AN ASSESSMENT OF A SECOND WORLD WAR HANGAR  
STRUCTURE AT TOLLERTON AIRFIELD,  
NOTTINGHAMSHIRE

NGR: SK 61544 36017

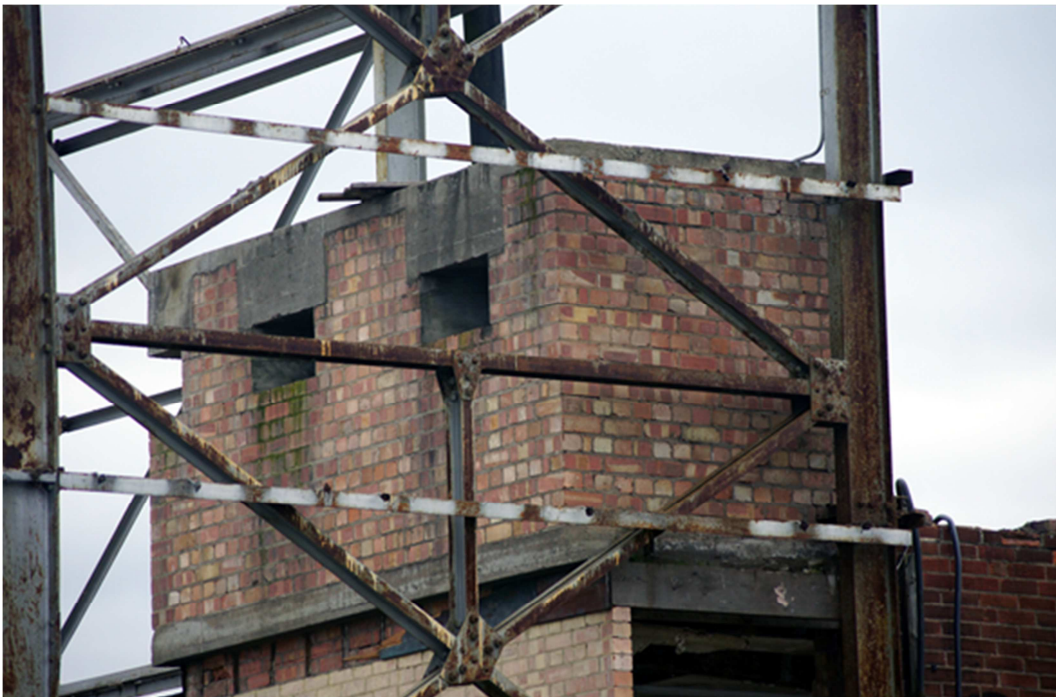
*Figure 13: View from the hangar's interior of the fire watcher's shelter. [Paul Francis 5 December 2017]*

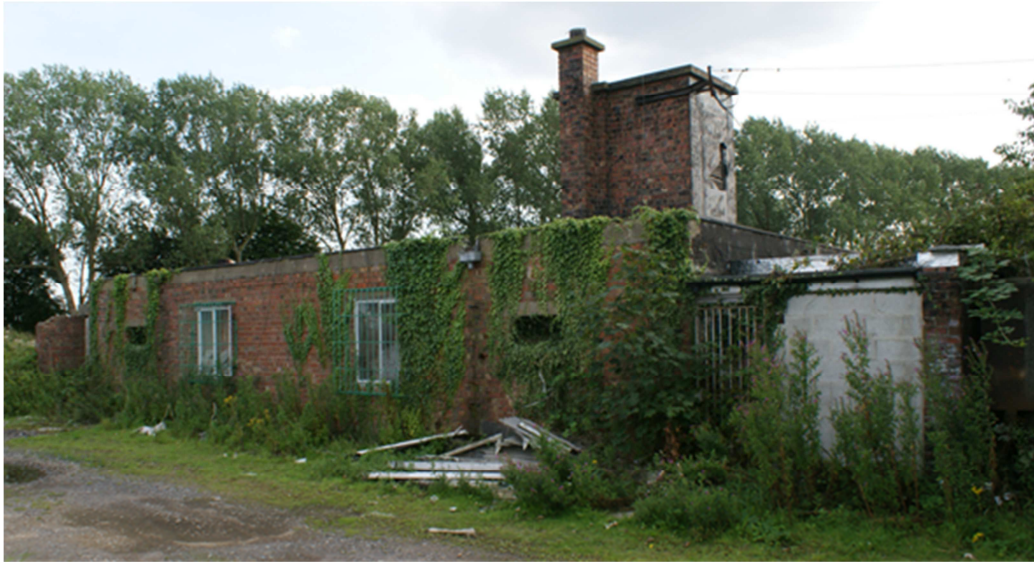
*Figure 16: Cleansing (decontamination) and first-aid post (Bldg.48), view looking SE, now demolished. [Paul Francis 07-08-2009]*

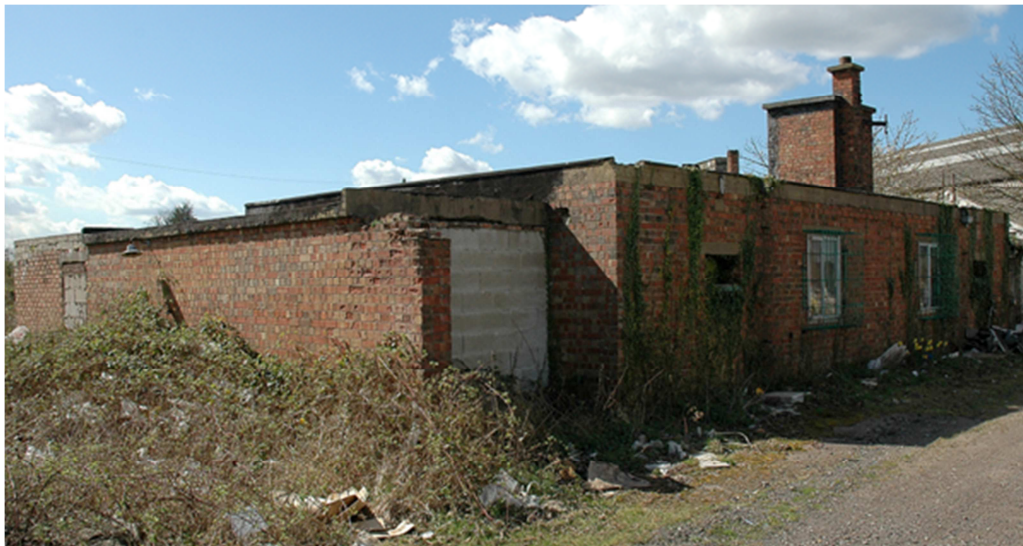
*Figure 17: Cleansing (decontamination) and first-aid post (Bldg.48) – a view looking NW, now demolished. [Richard Flagg 07-08-2009]*

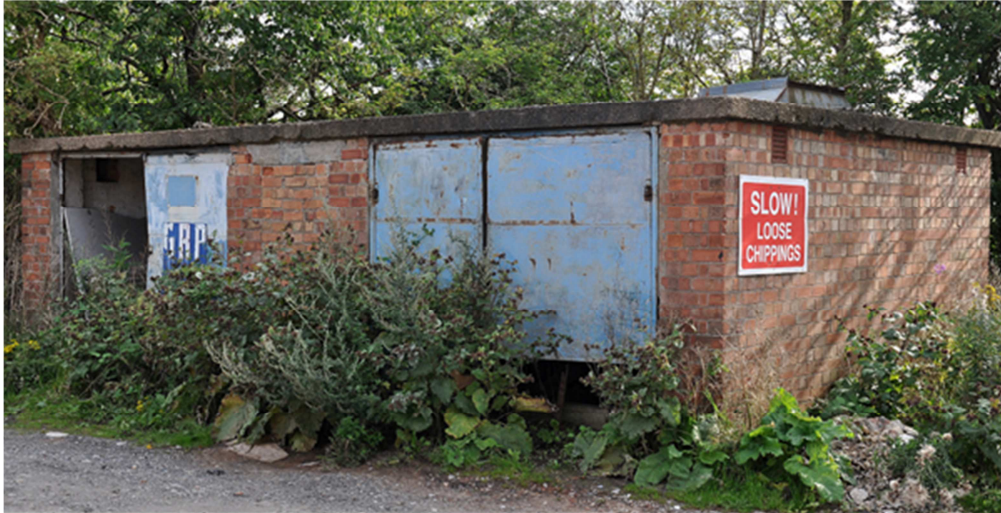
The building illustrated below was an air-raid shelter that post-war was converted into a metal store and was identified on the 1950 site plan as a 'store' (Figures 18 & 19) As originally built it would have had two shelter rooms (with separate entrances) separated by a shared central emergency exit. The evidence in support of this being an air-raid shelter is as follows:

*Figure 18: Air-raid shelter front (modified) elevation (Bldg.47). [Richard Flagg 07-08-2009]*

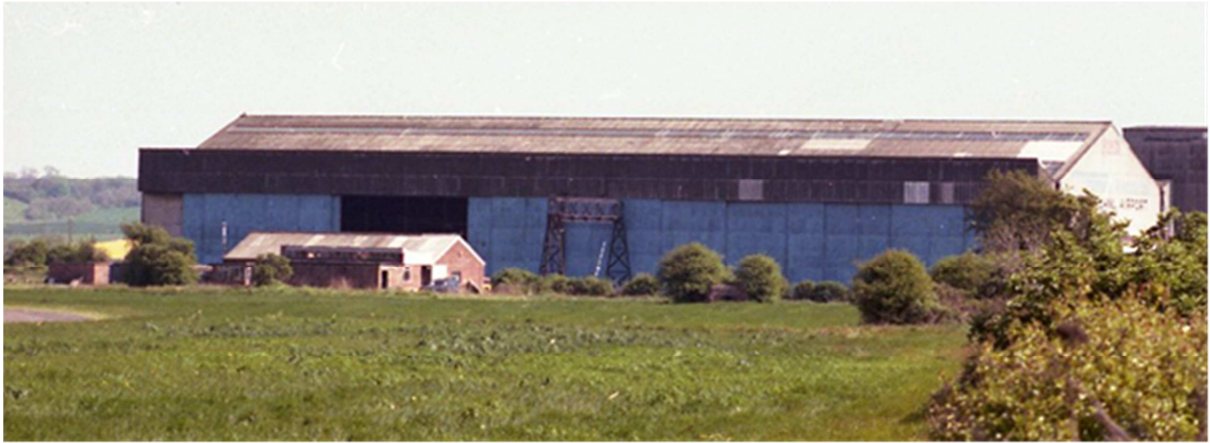
*Figure 27: Main hangar (Bldg.43) with engine gantry. [Paul Francis 1987]*
