SPAB Building Performance Survey 2013

Interim Report
October 2013

Dr Caroline Rye, Cameron Scott and Diane Hubbard
Society for the Protection of Ancient Buildings
Supported by Historic England

THE SPAB RESEARCH REPORT 2

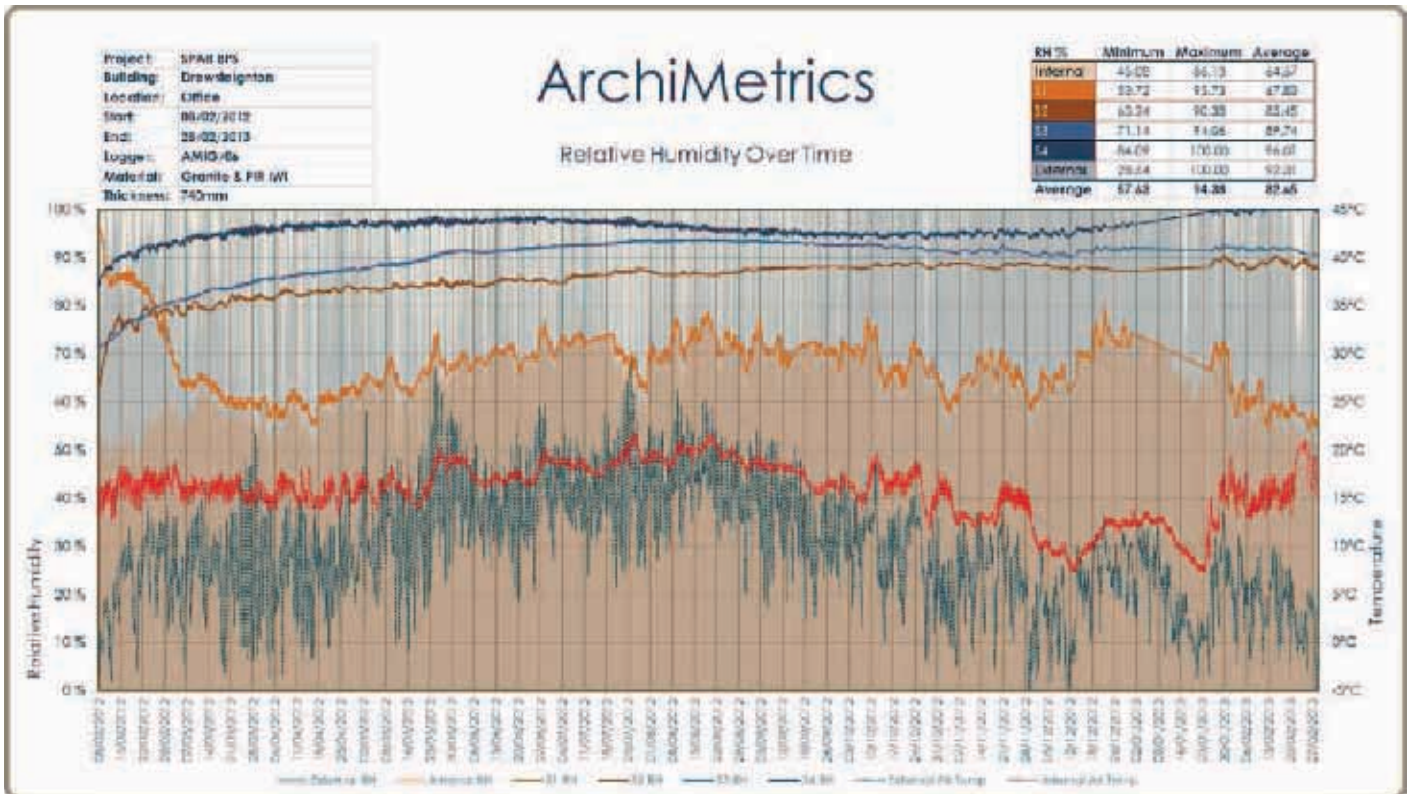
Figure 8: Relative Humidity over time, Mill House, Drewsteignton 2012 - 2013.

The walls at Drewsteignton and Riddlecombe (Figures 8 and 9) also share another feature, that is both these locations exhibit a trend of rising %RH over the reported monitoring period (12 months for Drewsteignton, 6 month at Riddlecombe). This is particularly clear in Figure 9 when measurements of %RH at sensor 4, the sensor closest to the external side of the wall at Riddlecombe, reaches 100% RH within a matter of weeks from the commencement of the graph and is followed, sixteen weeks later by sensor 3 and all four gradients have a mostly upward trajectory for the entire duration of the graph. At Drewsteignton, Figure 8, the trend is less obvious and there is also a period of time over the summer where measurements of %RH decline at sensors 3 and 4, however, over the full reporting period the predominate trend is one of increasing %RH with the exception of measurement from sensor 1 positioned in the air gap behind the plasterboard drylining of this wall which tracks internal room %RH conditions. Towards the end of the graph for Drewsteignton, in January 2013, sensor 4 reaches 100% RH. There is however a significant difference between these two walls in that peaks of %RH occur in opposing seasons suggesting two different and possibly opposing driving forces for this behaviour. By and large, and this can be seen in the other walls in this study (Figures 6 and 7) %RH increases and peaks during the winter when colder external temperatures cause the %RH to rise particularly within the colder, external side of the wall leaf. However, at Riddlecombe the rising trend, including peaks at 100%, occurs over the warmer summer months and it is thought that this may be due to vaporisation or sweating behaviour from the cob material that has a high moisture content due to the failing external cement render that previously covered the building and water introduced into the wall as part of the re-rendering process. (This phenomenon is explored in more detail in the individual report on Riddlecombe in Appendix A, pps. 102-121). Continued measurements of this wall into the winter period, 2013-14, should be able to shed more light on the high %RH measured in this wall and whether this is a seasonal and ultimately diminishing trend or a cause for concern over the longer term. However, measurements of %RH at Drewsteignton reveal a trend of rising %RH that occurs over a 12 month period, when normally perhaps one might expect any rise in %RH as a result of colder temperatures to be reversed during the warm summer. Both Drewsteignton and Riddlecombe also show higher interstitial %RH values where average %RH values measured at sensors 2-4 in both walls all exceed 80% the value often quoted as the threshold for mould growth conditions. In contrast, only measurements from sensor 4 exceed 80% RH in the walls at Shrewsbury and Skipton, averaging 83.49% and 81.43 respectively whereas averages for sensor 4 are much higher at Drewsteignton, 96.01% and at Riddlecombe, 99.82%.

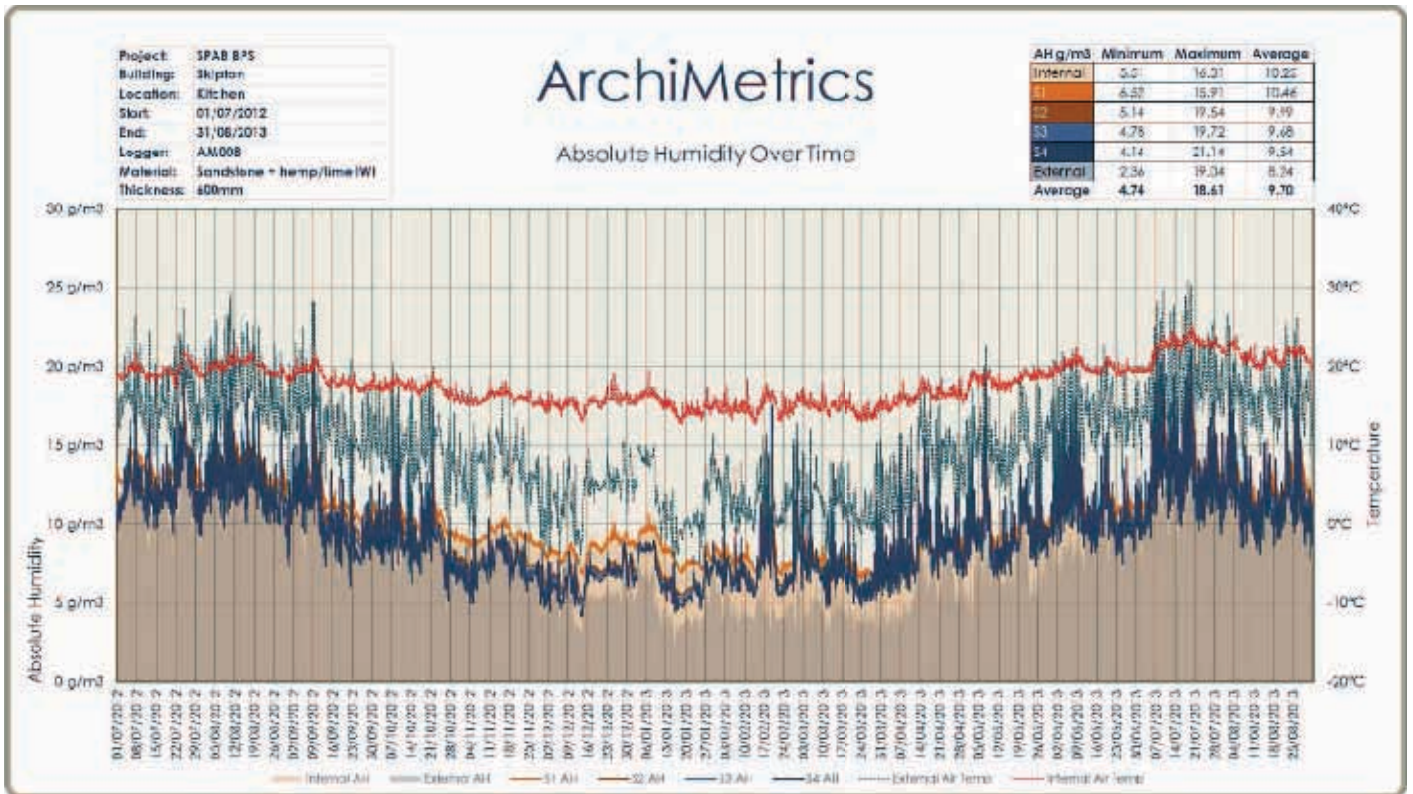
Figure 11: Absolute Humidity over time, Sensors 1 - 4, White House Farm, Skipton, 2012 -13.

All four Figures (10-13) show the same general pattern of behaviour, that is to say that as atmospheric absolute humidity increases in the warmer summer months (due to the ability of warmer air to contain more vapour) a similar rise in absolute humidity occurs within wall fabric. Following this logic we can also see that weights of vapour within the walls are at their highest in proximity to a source of heat. During the summer the highest weights are recorded towards the exterior side of the wall, at sensor 4 and diminish in proximity to this heat but in winter this hierarchy is reversed and with the onset of central heating sensor 1 tops the range of absolute humidity readings through the wall section. This behaviour is particularly visible in the walls at Shrewsbury and Skipton (Figures 10 and 11) but less defined at Drewsteignton, Figure 12,

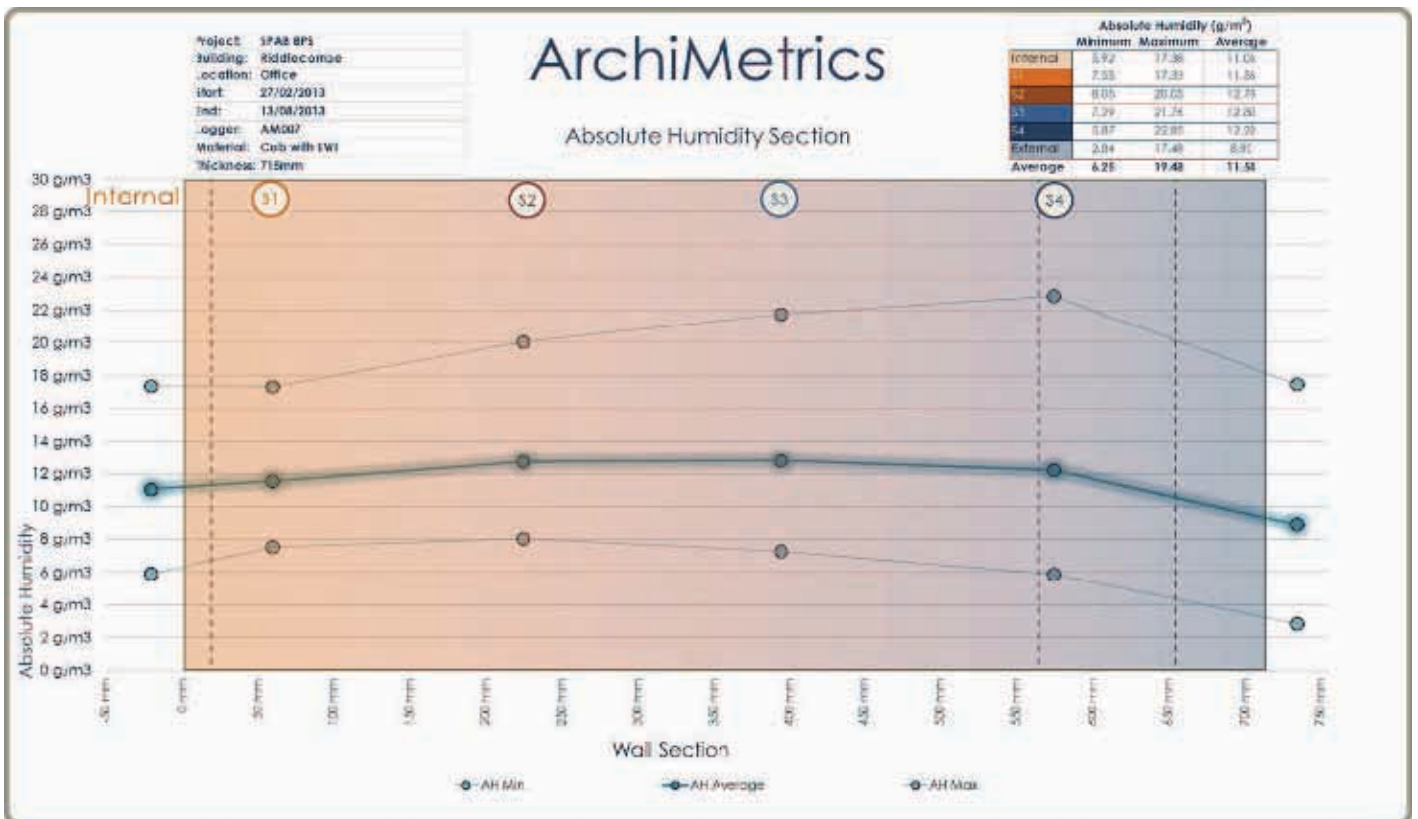
Figure 17: Absolute Humidity Section, The Firs, Riddlecombe February - August 2013.

In Figures 14-17 the average absolute humidity values through and either side of the four wall sections under study have been plotted along with the maximum and minimum values recorded over the reported monitoring period. These result in more or less flat gradients, showing more or less similar quantities of vapour through the wall sections with the exception of Riddlecombe, Figure 17.

As can be seen from the compilation of data given in Table 4, on average the walls at Skipton and Riddlecombe contain the highest weights of vapour g/m³, although the weight of vapour in Riddlecombe far exceeds that of Skipton in relation to the other two walls in the study, being approximately 38% greater than that of the walls at Shrewsbury and Drewsteignton, as oppose to just 11% greater in the wall at Skipton. The walls at Drewsteignton and Shrewsbury bear very similar averaged quantities of vapour, and these in turn closely match averages calculated for the walls which also include internal and external absolute humidities. This suggests that there is a close relationship between the ambient vapour conditions surrounding these walls and the vapour behaviour within the wall itself. In Table 4 the highest averaged measurements of weight of vapour through each wall section is marked in bold, this shows that for the walls at Shrewsbury and Drewsteignton the highest averaged weight of vapour is found at sensor 4, at the exterior side of the walls, but for Skipton this is located at sensor 1 close to the internal wall face. It is suggested that this is a reflection of the wet hemp/lime finishes which are in the process of drying during the reported monitoring period and that this in turn influences the overall average weight of interstitial vapour recorded for this wall and explains why this is raised in relation to the average which takes account of internal and external conditions. However, the discrepancy between the average interstitial absolute humidity recorded at Riddlecombe and this same quantity including internal and external conditions is less easily explained unless, as is suggested elsewhere, there is an additional source of vapour that influences this wall, possibly in the form of additional moisture bound within the cob.

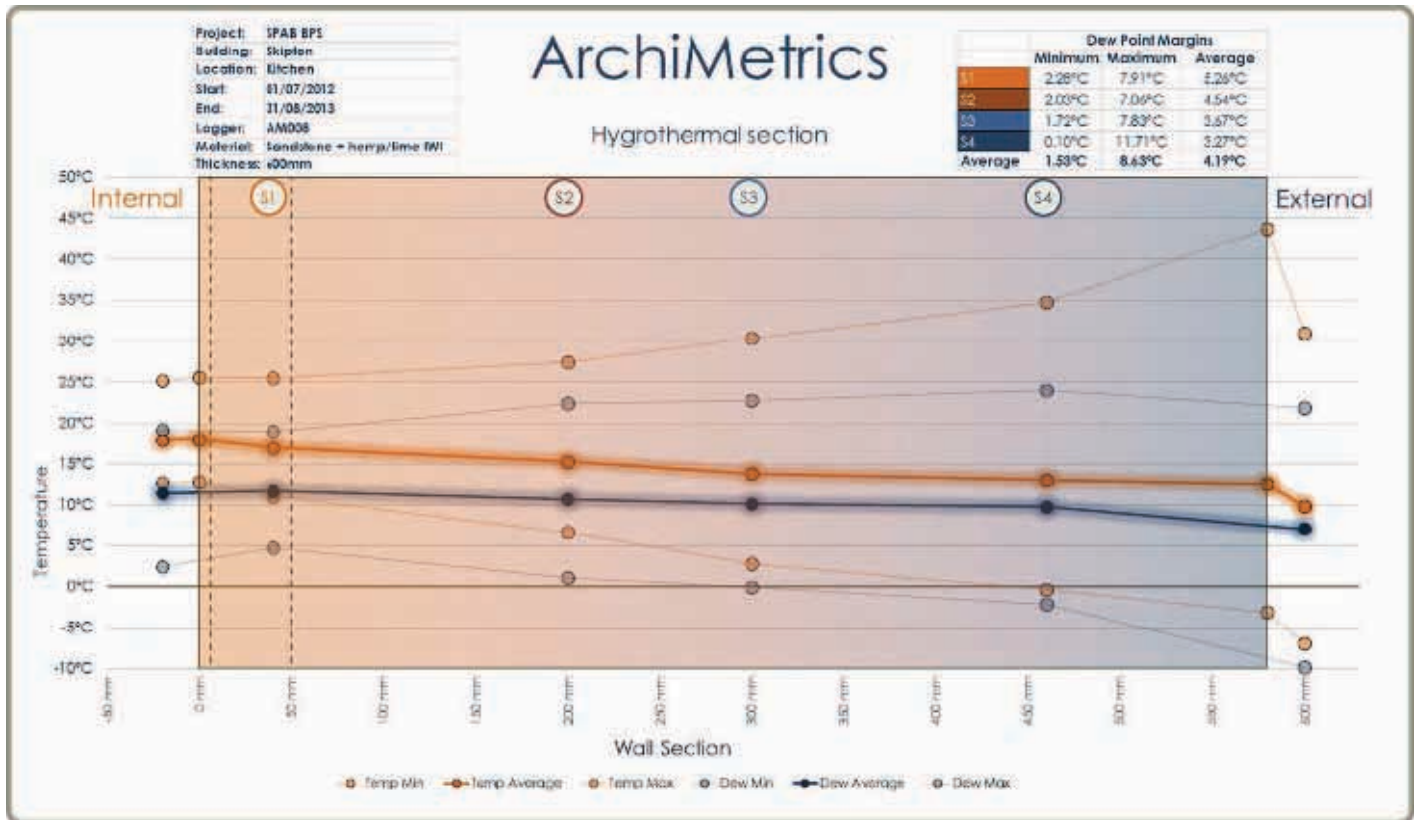
Figure 19: Hygrothermal Section, White House Farm, Skipton, July 2012 - August 2013.

Figures 18-21 provide plots of temperature and dewpoint gradients for the four wall sections under examination in this report. In the temperature gradients for the walls that have been insulated internally (Shrewsbury, Skipton and Drewsteignton) it is possible to see the different thermal resistance of this layer, compared with that of the masonry part of the wall, reflected in the steeper gradient which passes through the insulation. The pitch of this gradient reflects the degree of impact this insulating layer has had on the overall U-value of the wall post-refurbishment i.e. it is at its steepest at Drewsteignton, Figure 20, where the addition of 100mm PIR resulted in an measured 87% decrease in heat loss through this wall. The gradients are less pronounced at Shrewsbury and Skipton where the thinner 40mm addition of IWI resulted in reductions of 69% and 38% respectively. Beyond this insulating layer these internally insulated walls all share another characteristic which is a flattening of the temperature gradient as it passes through the remaining masonry part of the wall, here walls at Drewsteignton and Shrewsbury only seem to have a 1-2°C temperature difference across their masonry sections, whereas the wall at Skipton looks to have a slightly greater difference of between 4-5 °C, once again as a reflection of the different proportions of heat loss reduction that have occurred in these walls. The temperature gradient within the masonry section at Skipton also differs from that of Drewsteignton and Shrewsbury in that at these locations the flattened gradient also follows the same pitch between sensor positions indicating a similar rate of heat loss throughout this part of the wall section. As has been observed elsewhere the wall at Skipton is a rubble core construction and as such is more diverse in its materials and contains considerable voiding particularly at the centre of the wall. In pre-refurbishment measurements the affect of this rubble core and alterations in thermal conductivity/resistivity as a result of the wall's disparate construction was seen in changes of pitch between measurement points particularly the measurement that straddled the rubble core. This characteristic is still visible, if somewhat muted by the flattened temperature gradient, in Figure 19 post-refurbishment.

dewpoint gradient narrows towards the colder external side of the wall as colder temperatures cause an increase in %RH. However, in Figures 18 and 19, Shrewsbury and Skipton, there is a gap between these two gradients showing that, over an annual cycle, on average, a temperature drop of roughly 3°C is required before saturation point is reached at sensor 4. Therefore possibly there is no significant risk of extended periods of condensation within these two walls. This is in contrast to the wall at Drewsteignton, Figure 20, where temperature and dewpoint gradients at sensor 4 are seen to be in close proximity to one another, the margin of difference being 0.57°C. As well as the wall at Riddlecombe, Figure 21, where at sensor 4 and sensor 3 they are affectively coincidental with margins of 0.03°C and 0.54°C respectively. This would seem to suggest that these walls, which were also found to both exhibit the trend of rising %RH, may be at greater threat from condensation over the long term.

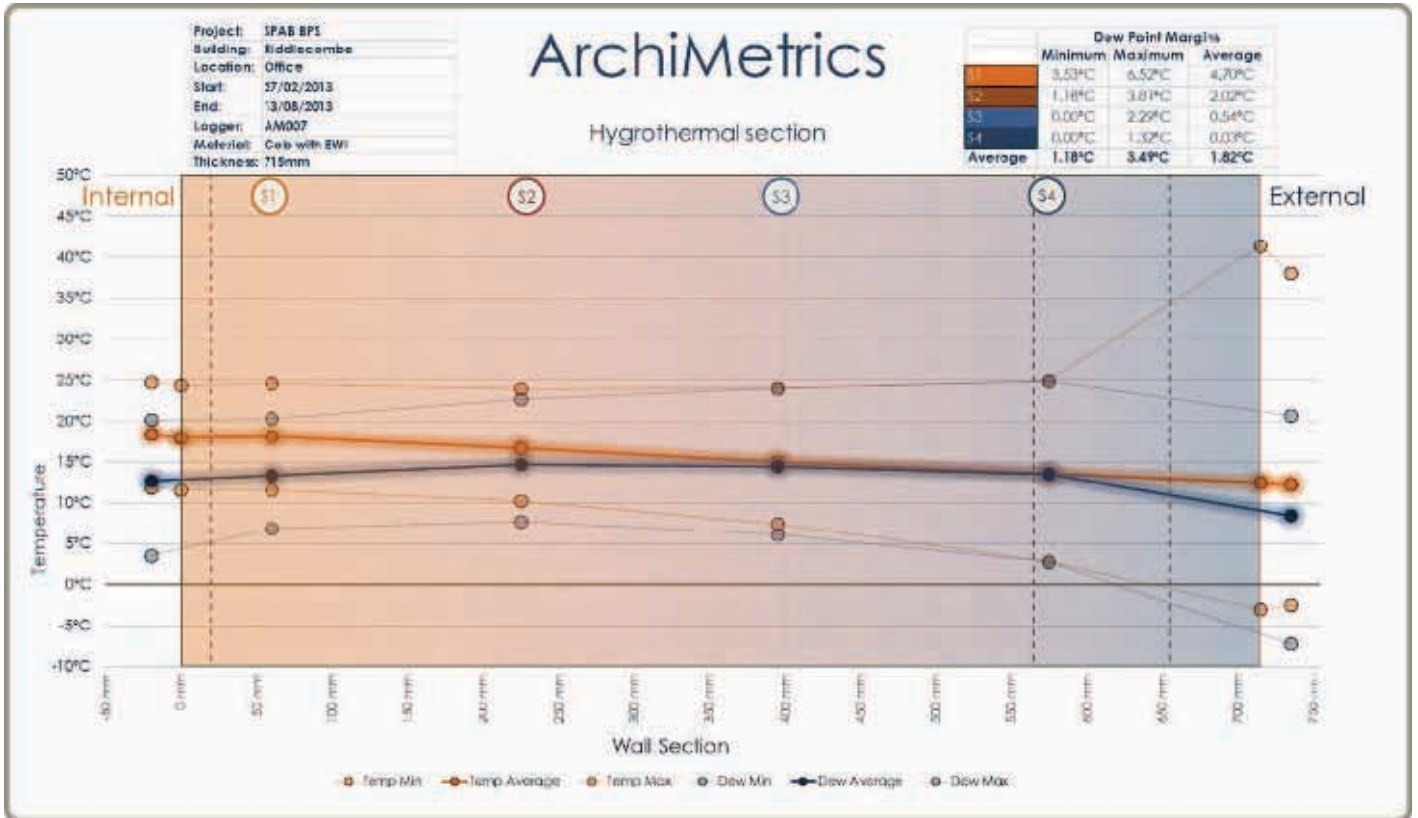
Figure 21: Hygrothermal Section, The Firs, Riddlecombe February - August 2013.

The dewpoint gradients plotted for these walls derive from measurements of %RH and show the nominal temperature drop required for dewpoint to occur at certain points within the wall. For Shrewsbury, Skipton and Drewsteignton these gradients are, more or less, flat and sit around 10°C. At Riddlecombe, which is found to have higher levels of vapour within its structure, the average dewpoint gradient is raised above 10°C and is convexed and peaks within the centre of the wall echoing the section plot of average absolute humidity found in Figure 17. For all four walls the margin between the temperature gradient and the

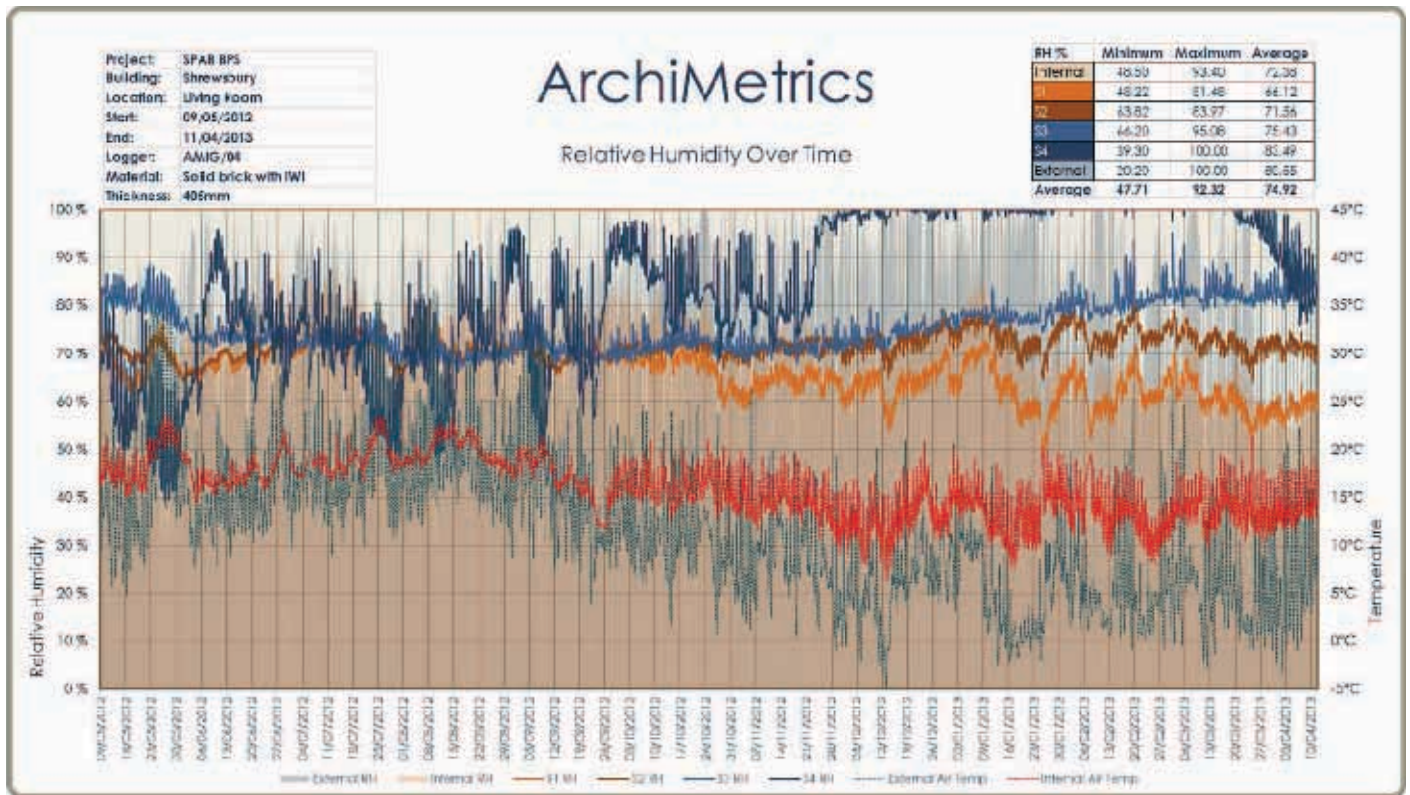
Figure 6: Relative Humidity over time, Abbeyforegate, Shrewsbury 2012 - 2013.

With the exception of sensor 4, %RH responses throughout the wall section are very steady despite the open and porous nature of the wall and on average remain below 80%, the threshold often given for the formation of mould fungus. Neither do they, overall, exhibit a rising trend of %RH throughout the wall section as a whole, unlike those measured at Drewsteignton and Riddlecombe. Readings from sensor 2, installed between the woodfibre insulation and the brickwork are particularly interesting in this regard as these are particularly stable, only varying between 63.82 - 83.97 %RH throughout the whole period, with an average value of 71.56%. It might be suggested that this steady %RH response may be as a

consequence of the hygroscopic properties of the woodfibre board which, via its moisture buffering capabilities, might serve to even out fluctuating humidity responses in this part of the wall.

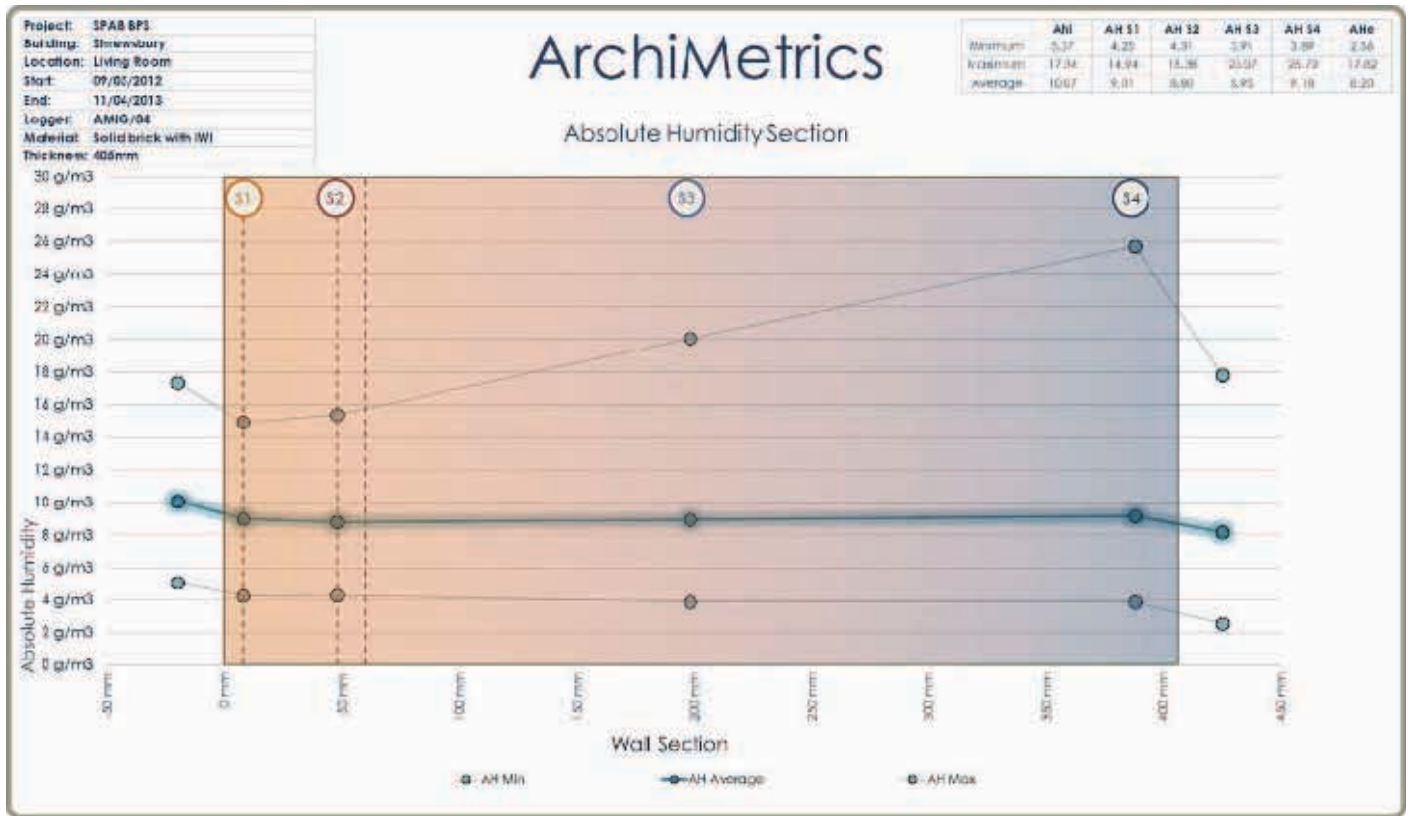
Figure 14: Absolute Humidity Section, Abbeyforegate, Shrewsbury 2012 - 2013

The absolute humidity section for Shrewsbury, Figure 14, provides an indication of the average g/m^3 of vapour either side of and through the wall section at Shrewsbury over the period 9th May 2012 - 11th April 2013. The graph presents a virtually flat line through the wall and an examination of the average values calculated for sensors 2, 3 and 4 (given in the table in the top right corner of Figure 14) shows a slight increase in average quantities of vapour towards the external wall leaf. This may suggest that, despite the distribution of vapour seen for the winter months in Figure 10, where vapour was higher at the internal wall leaf, the predominant condition of the wall over the reporting period is one of slightly increased weights of vapour towards the exterior side of the wall.

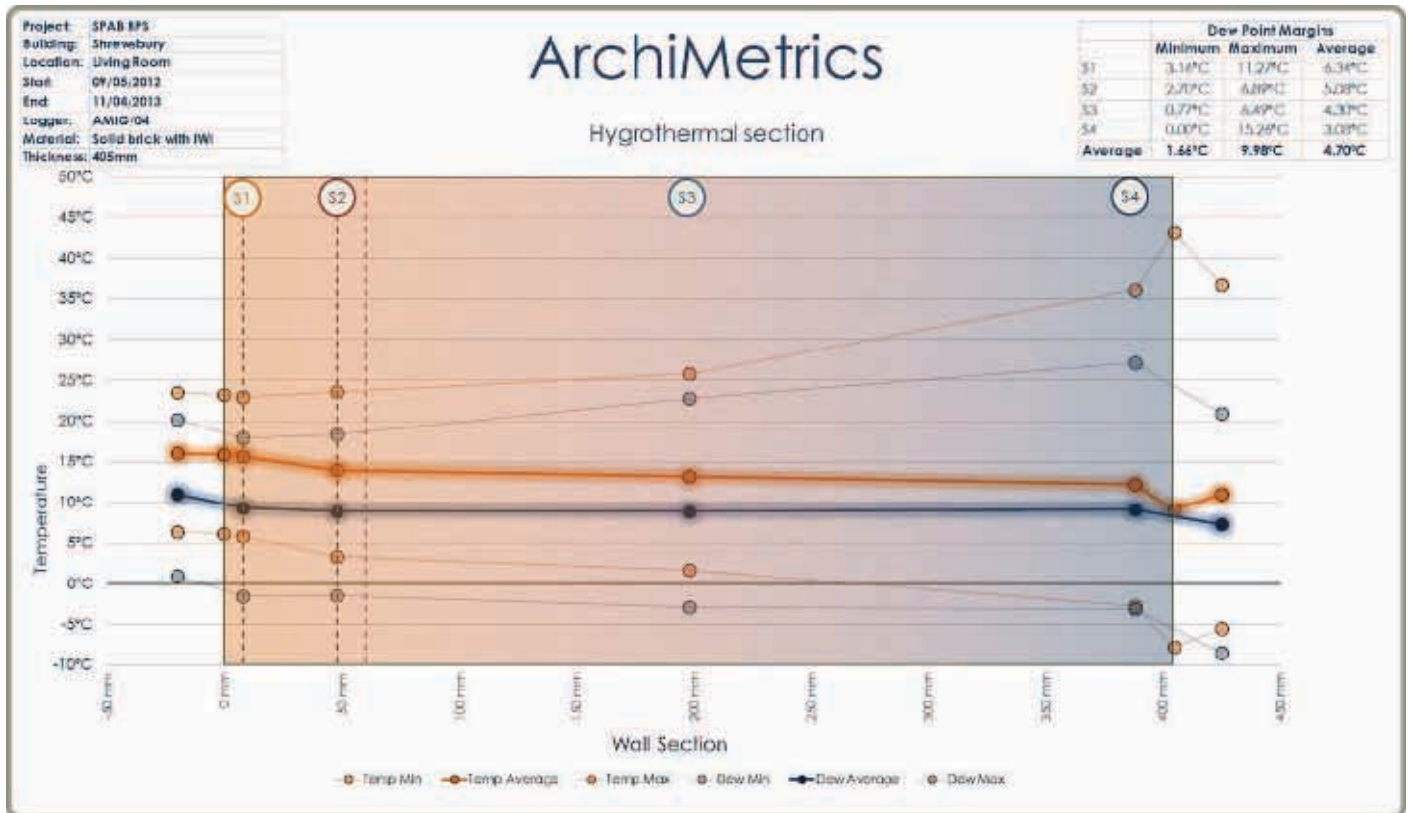
Figure 18: Hygrothermal Section, Abbeyforegate, Shrewsbury 2012 - 2013.

The dewpoint behaviour of the wall averaged over the reporting period is illustrated in Figure 18. This shows that the narrowest dewpoint margin (that is the temperature drop required for dewpoint to occur at a certain point) is understandably located towards the coldest part of the wall element at sensor 4, the average °C margin here being 3.06°C. The average dewpoint margin calculated from data from all four sensors in the wall for this period is 4.70°C. Prior to refurbishment, the average dewpoint margin for the wall section was 5.49°C and 3.96°C specifically at the 4th sensor. Therefore, the addition of 40mm of woodfibre internal wall insulation has not resulted in a significant reduction in these dewpoint margins despite lowering the quantity of heat transferred into the wall during the cold winter heating season. The plots of maximum temperatures recorded over the period are also of interest. These show the affect of solar radiation on the south-facing wall resulting in periods of reverse heat flow in the wall fabric. This reverse heat flow will be of benefit on sunny days during the winter heating season as the transmission of heat from the interior to the exterior will be slowed by the warming of the external fabric by solar radiation.

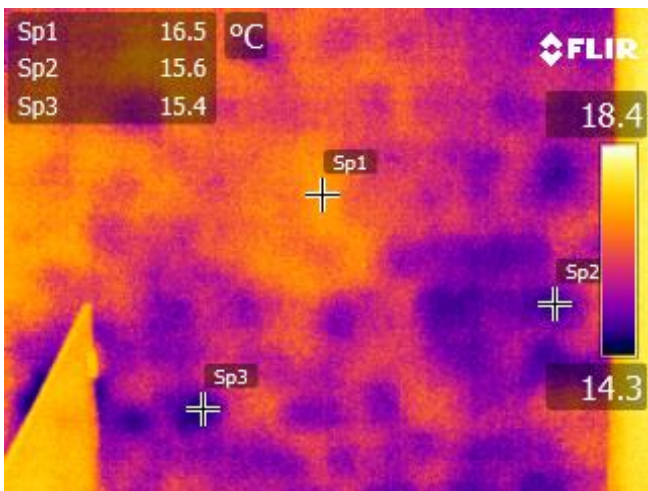
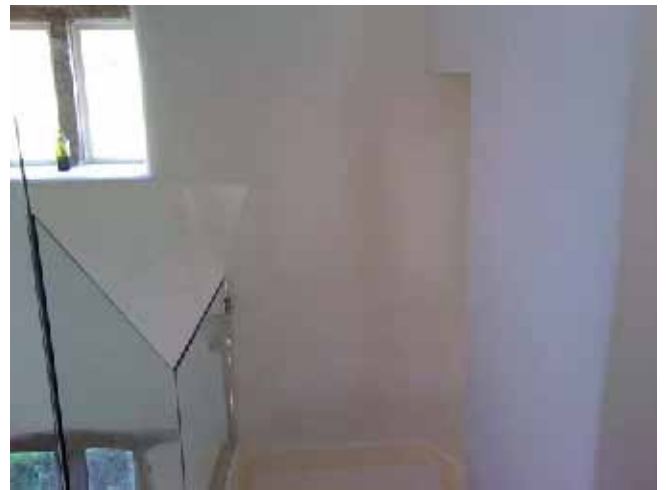
Examining the older building fabric, it is possible to see the underlying external wall structure (Figure 46). It should be noted there is approx. 1°C temperature difference between the coolest and warmest parts of this wall area.

Figure 46. White House Farm, Stirton, Skipton – North exterior wall on staircase.

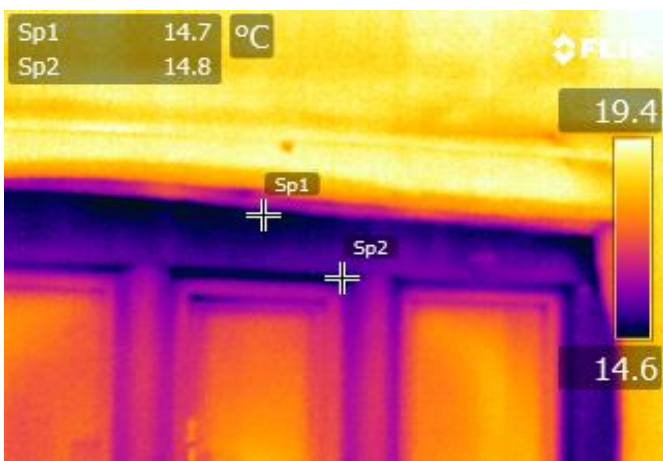
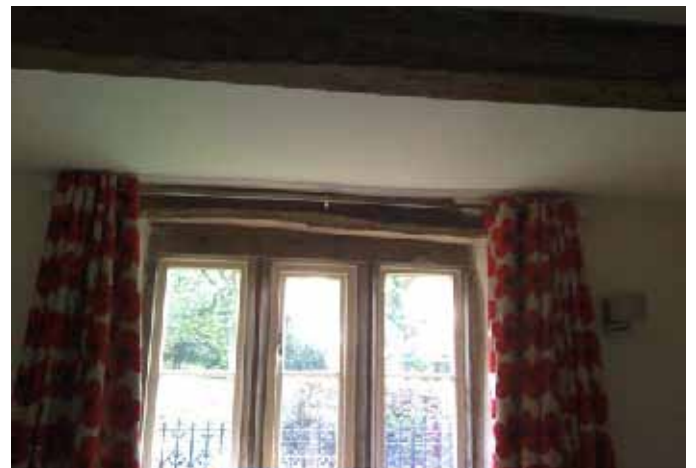
The stone mullions show they are the main thermal bridges and the key leakage points displayed in the older portion of the dwelling are around beams, missing pointing at sills and around window / roof light casements (Figures 47 - 49). In some areas, where floor coverings are not fitted, ingress can be seen between floorboards (e.g. on the staircase).

Figure 47. White House Farm, Stirton, Skipton – Thermal bridging on mullion and air ingress around lintel (NB. lower portion of window mullions are subject to solar gain).

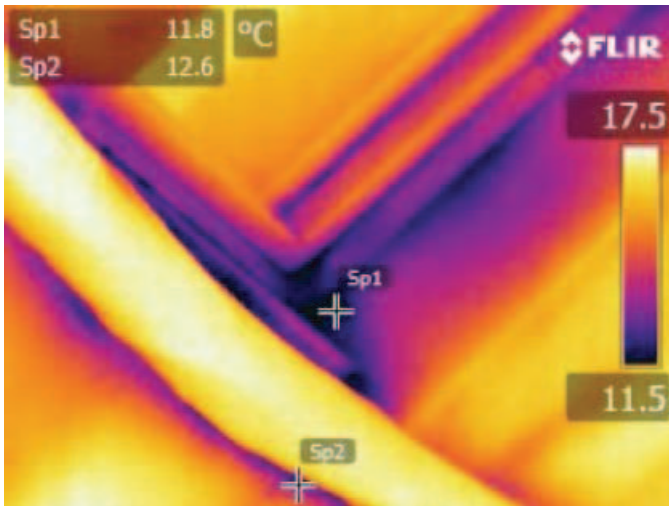
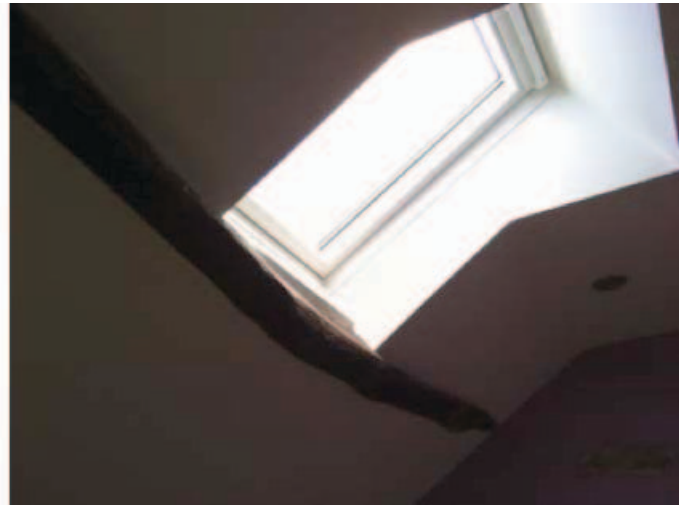
Figure 48. White House Farm, Stirton, Skipton □ north facing ceiling in bathroom air ingress around roof light and beam.

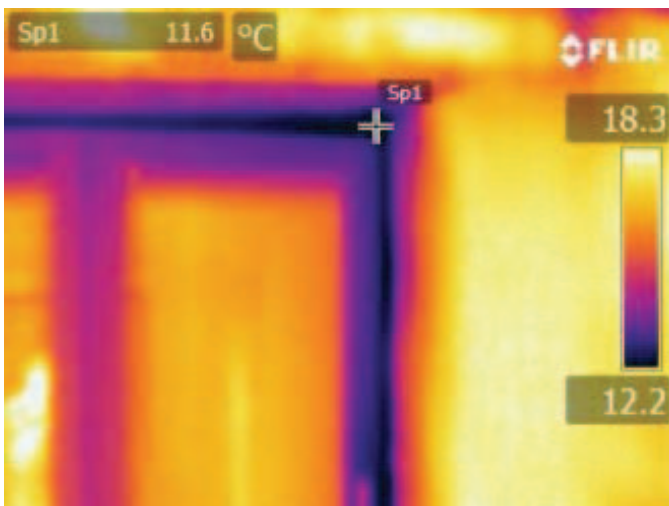
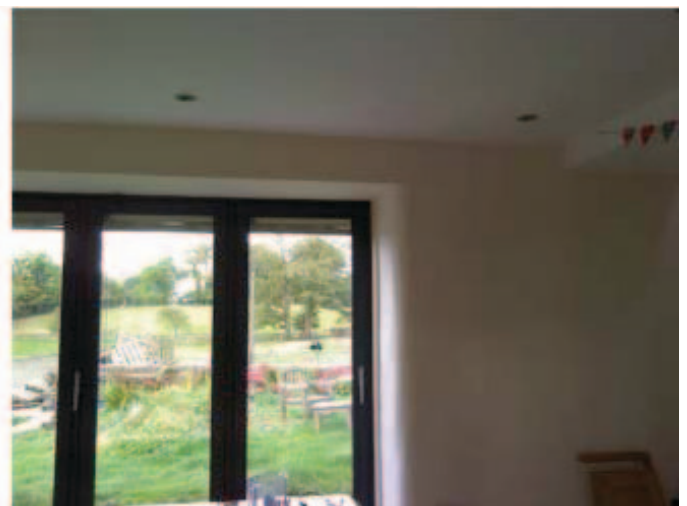
Figure 49. White House Farm, Stirton, Skipton □ north wall in kitchen showing ingress around new door casement

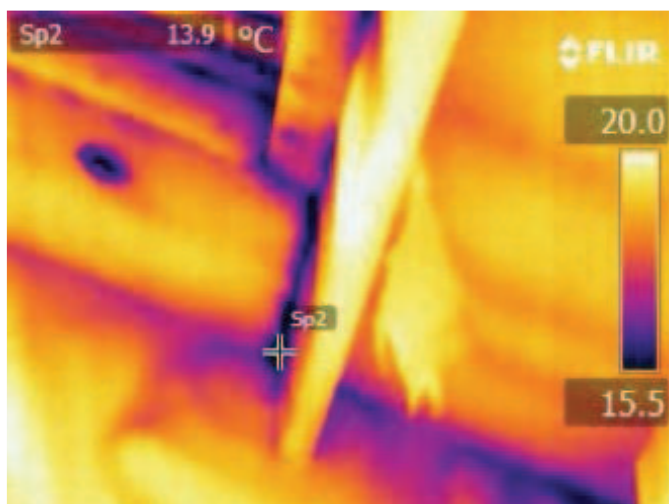
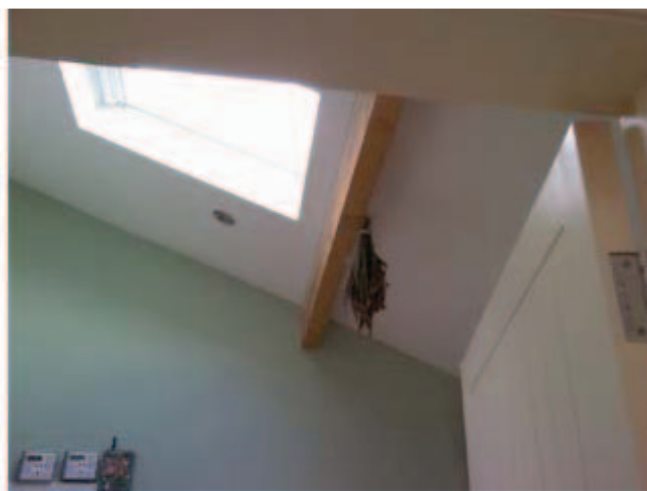
Ingress around beams and window frames is evident in the extension (Figure 51) with the window in the first floor bedroom showing ingress through its opening sections (Figure 52).

Figure 51. White House Farm, Stirton, Skipton □ ingress around roof light casement, beam, wall joint and light fitting in Utility Room.

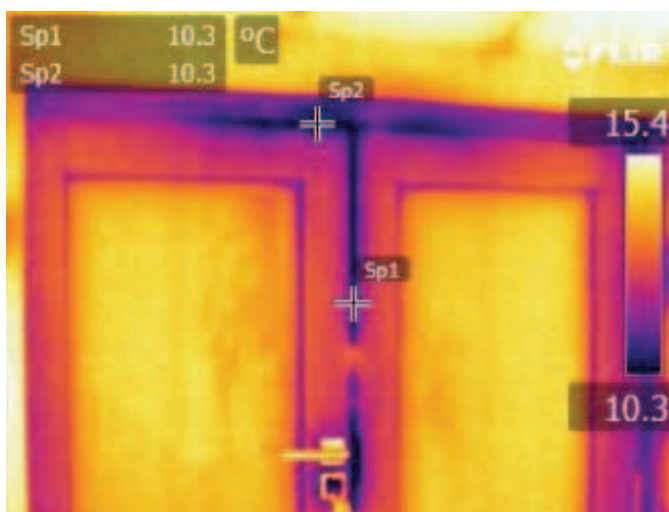
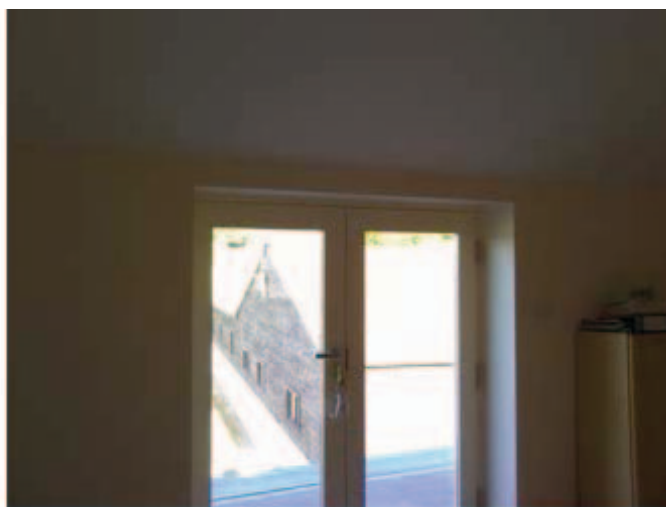
Figure 52. White House Farm, Stirton, Skipton □ ingress through opening section of north facing window in first floor bedroom in addition.

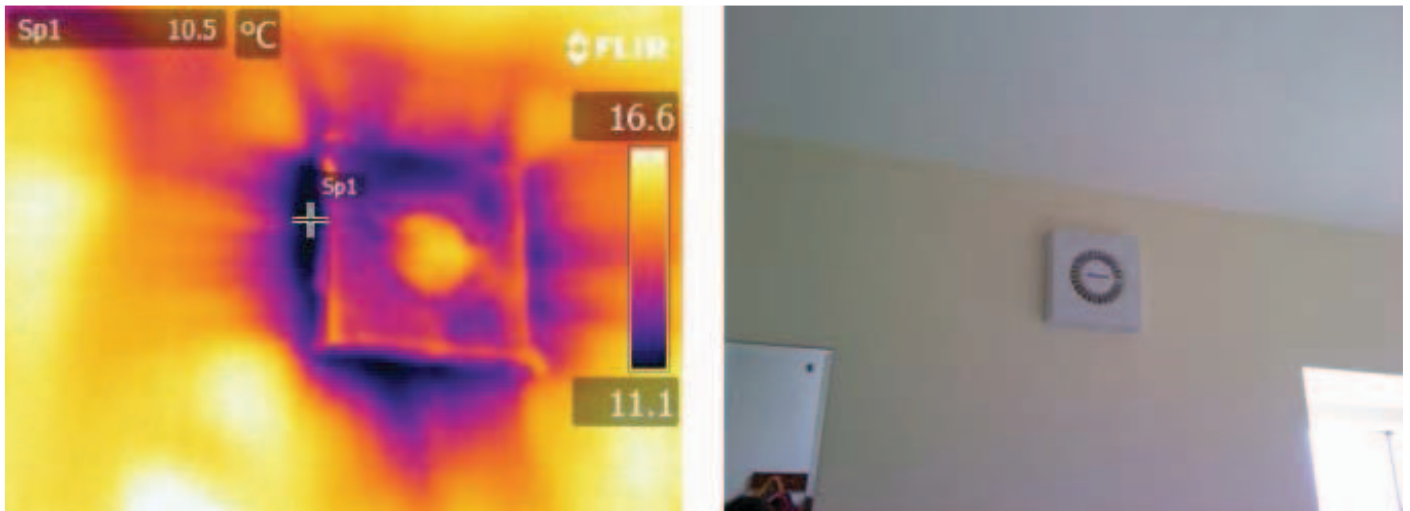
- Though extract fans are taped over during the test, every installed fan showed a poor connection between the base of the cover plate and wall, Figure 55. There are 5 extract fans fitted in the property.

Figure 55. White House Farm, Stirton, Skipton. Ground floor cloakroom extractor fan showing poor connection between the base of the cover plate and wall.

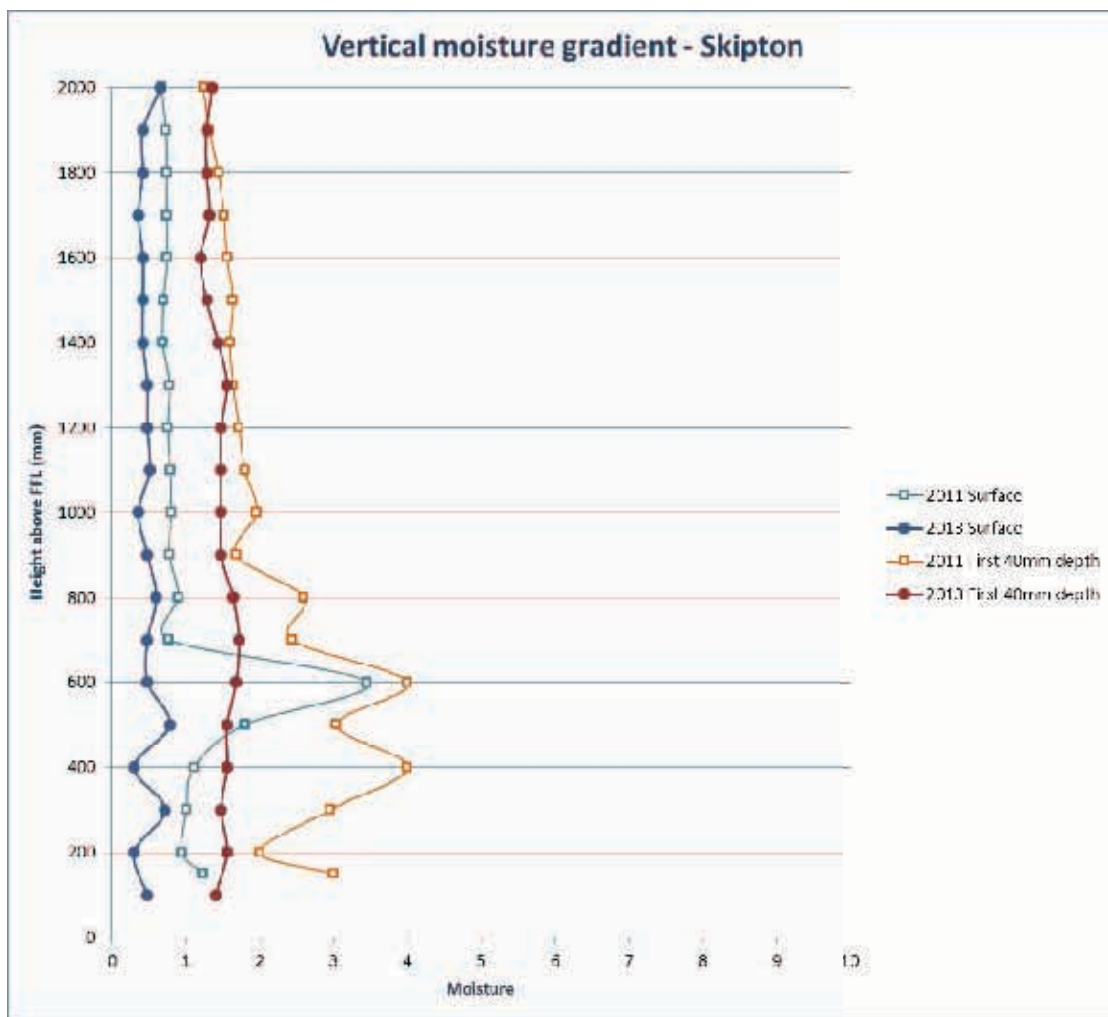
The 2011 moisture profiles show fluctuating levels of moisture both at the surface and sub-surface of the wall below the height of 1000mm - 1200mm. There is a particularly severe deformation of the surface moisture gradient recorded at 600mm above finished floor level which coincides with the bottom of the window cill leading to speculation that moisture may be tracking from the exterior to the interior wall face, beneath the stone window cill leading to a concentration of moisture at this location. Or this may be the affect of the cill creating a thermal bridge and therefore cooling the interior wall face at this point leading to increased surface and sub-surface humidity. It is interesting to note that this affect seems to have completely disappeared in the 2013 set of measurements. In 2013 both the surface and sub-surface measurements have moved towards the 'drier' end of the moisture scale and whilst, quite low down, the surface of the wall shows a slightly erratic profile in general both gradients are more stable. This apparent reduction and stabilisation in the surface and sub-surface moisture profile for the wall may be due to the addition of 40mm of lime and hemp/lime plaster to the interior wall face. Measurements only penetrate approximately 40mm into the wall therefore this new layer moves the zone of measurement away from the stone wall itself and so the presence of moisture within the masonry of the wall is no longer being directly measured. It may also be that the hemp and lime as relatively vapour permeable and hygroscopic materials have a beneficial affect with regard to humidity levels and that the surface and sub-surface of the wall appears drier in 2013 as these materials, given appropriate internal conditions, promote evaporation from the internal wall surface. This may also help to explain the disappearance of the 'cill affect' in the measurements from the refurbished wall in that the internal finish encourages the evaporation of any penetrating moisture or this may simply be because the zone of measurement zone no longer penetrates as far as the masonry.

Figure 4. Pre and post refurbishment measurements of surface & sub-surface moisture at White House Farm, Skipton 2011 & 2013.

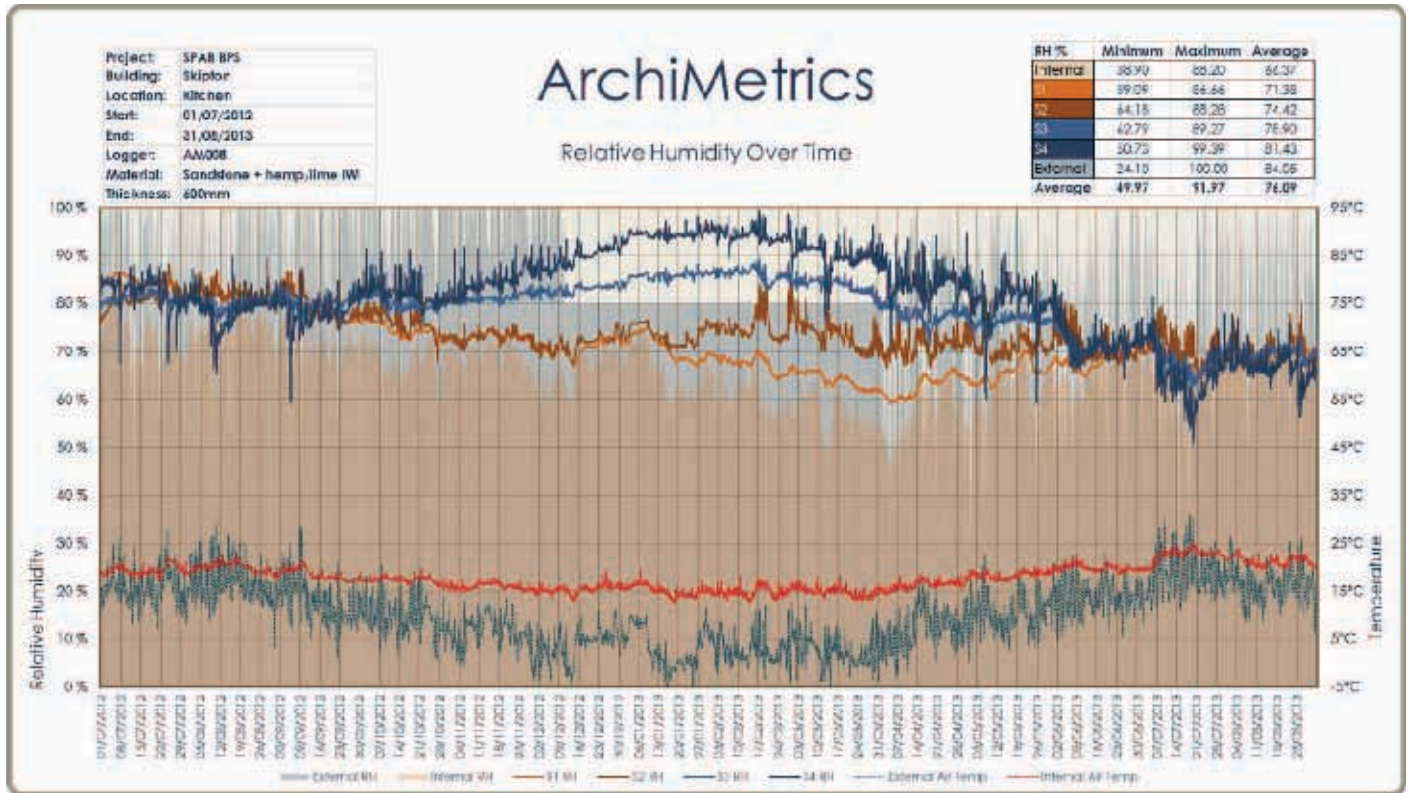
There are a number of other features of the %RH over time graph for Skipton which are of interest. There is a decreasing trend in %RH over the reporting period July 2012 - August 2013. This may reflect a general improvement in weather conditions between the two years, where 2012 was noted to be a particularly wet and cold year compared with that of 2013. In Figure 7 plots of external temperature and %RH show warmer and drier conditions from spring 2013 onward which in turn most likely lead to reduce %RH within the majority of the wall fabric. However, the %RH profiles of sensor 1 and sensor 2, positioned towards the internal side of the wall, may be less driven by external conditions. Here we also see a decline in %RH through the monitoring period which may be more related to the drying of the hemp and lime plaster internal finishes. The drying of these finishes, from haptic observation, has taken place over an extremely long period of time. It was not possible to carry out certain tests at the property in the winter of 2012 because finishes were still wet and the degree of drying has been noticed during regular visits to the property. The relationship between %RH measured at sensor 1 and sensor 2 also undergoes a change during the week beginning 13th January 2013. Until this date conditions at both sensors seem closely matched, if more volatile at sensor 2, and roughly track internal conditions. However after this date a margin of difference appears between the %RH measurements at sensors 1 and 2. This coincides with a period of extremely low external temperatures where the internal/external temperature difference is at its greatest. This may cause a more differentiated temperature gradient through the wall section and an alteration of the predominant influences on %RH behaviour at sensor 2 which is now more driven by external conditions than internal ones.

A further feature of Figure 7 are the sudden rapid drops of %RH recorded at sensor 4, 120mm back from the external wall face. These occur during periods of low external %RH and indicate that this part of the wall is well coupled with external conditions

Figure 7. Relative Humidity over time, White House Farm, Skipton, 2012 -13.
