SPAB Building Performance Survey 2013

Interim Report
October 2013

Dr Caroline Rye, Cameron Scott and Diane Hubbard
Society for the Protection of Ancient Buildings
Supported by Historic England

THE SPAB RESEARCH REPORT 2

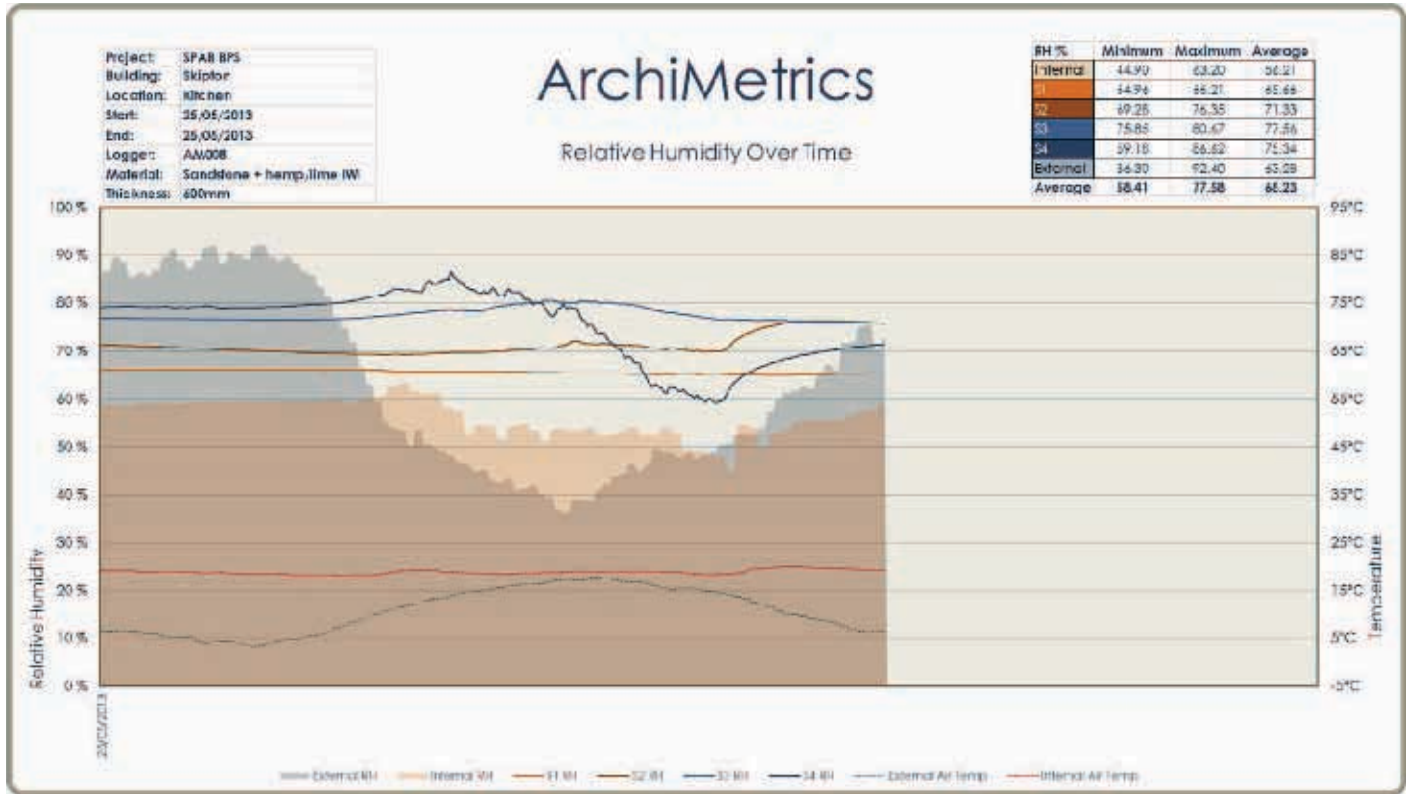
A detailed examination of one of these rapid drops in %RH is provided in Figure 59. As temperature increases through the day the external relative humidity falls and this decline is echoed, albeit with a slight time lag of about two hours, by the %RH conditions measured at sensor 4. Interestingly the same dramatic response is not seen at sensor 3 which sees a gradual rise and decline in %RH replicated in miniature at sensor 2 which then rises quickly to meet the gradient of sensor 3, a trajectory that runs in parallel with sensor 4 at the end of the day. This detailed section may show the competing influence on %RH behaviour within the wall under different conditions. Rises in %RH at sensors 2 and 3 may be in response to increased external temperatures and therefore indicate sweating or vaporisation, similar to that seen at Riddlecombe, taking place at these locations. At the end of the day sensors 4 and 2 seem to share a driving influence which causes %RH to rise, perhaps increasing external %RH and declining external temperatures. Responses at sensors 4 and 2 share a volatile characteristic which is interesting as they are some distance apart from one another within the wall and normally volatility of response declines in proximity to internal conditions whereas here responses at sensor 3, closer to the external wall face, are generally more muted than those at sensor 2. The wall at Skipton is a rubble core construction with many internal voids and fractures, during installation the core of sensor 3 become blocked by dust and rubble as a result of this relatively unstable internal construction, it is proposed that responses at sensor 3

are dampened by this debris whereas the cores of sensor 4 and 2 are more open to the influences of the external environment. What is also clear in Figure 59, however, is that whilst, by and large behaviour in the wall is affected by external conditions, 40mm back from the internal wall face %RH conditions are extremely static and in this way more in line with internal temperature conditions and perhaps reflect a buffering of internal %RH by the presence of hemp within the lime plaster finish.

Figure 59. Relative Humidity over time, 25th May 2013, White House Farm, Skipton.

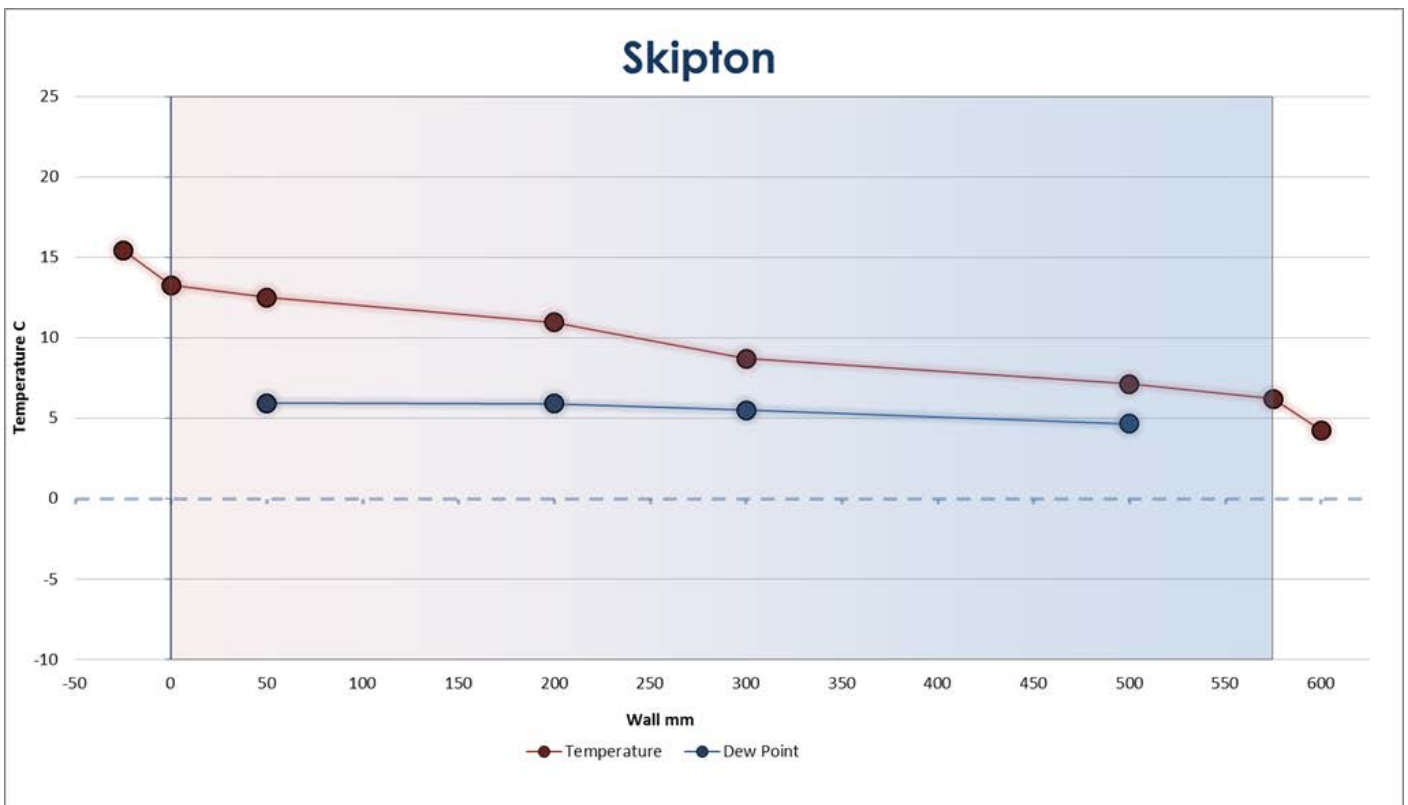
These Figures, 62, 63 and 19, also allow an examination of the average dewpoint margins for the wall at Skipton, that is the nominal temperature drop required at certain locations for condensation to possibly occur. As can be seen in both Figures 62 and 19 there is no instance in which the temperature gradient intersects with the dewpoint suggesting that, on average, there are no significant periods of interstitial condensation risk within the walls either prior to, or post, refurbishment. However, from measurements taken in Feb 2013 alone, Figure 63, does show a narrowing for the dewpoint margin particularly at sensor 4 where the °C margin becomes less than 1°C, 0.87°C. There is also, in Figure 19, a less pronounced narrowing of the dewpoint margin following refurbishment, particularly towards the inner side of the wall. However, this is, once again, mostly a result of the flattened temperature gradient over this extended 13

month time period. In 2011, pre-refurbishment, a dewpoint margin was averaged across all four interstitial sensors of 4.34°C. For the re-furbished wall in 2012 - 2013 this margin in February 2013 has dropped to 3.29°C but when calculated over 13 months has risen to 4.19°C to just below the pre-refurbishment value. However, considering each sensor position individually, there is of course an increased vulnerability with regard to condensation towards the colder, exterior side of the wall where temperatures are lower. And indeed Figure 63, for February 2013, shows a reduced dewpoint margin of 0.87°C at sensor 4, where as in 2011, pre-refurbishment, the margin here was found to be greater, 2.49°C. Figure 63 does not show dewpoint occurring which would of course be indicated by a margin of 0°C however it does suggest that the likelihood of condensation occurring at this point may have now increased. The slightly reduced dewpoint margins found for the wall following refurbishment, Figures 63 and 19, suggest that whilst it seems that there maybe an increased risk of interstitial condensation in the wall at Skipton during the winter months, particularly towards the external leaf the average dewpoint margins over an annual cycle including those for sensor 4 of 3.27°C suggests that significant quantities of condensation are unlikely to be deposited.

Figure 62: Hygrothermal Section, White House Farm, Skipton, 10th - 24th February 2011.

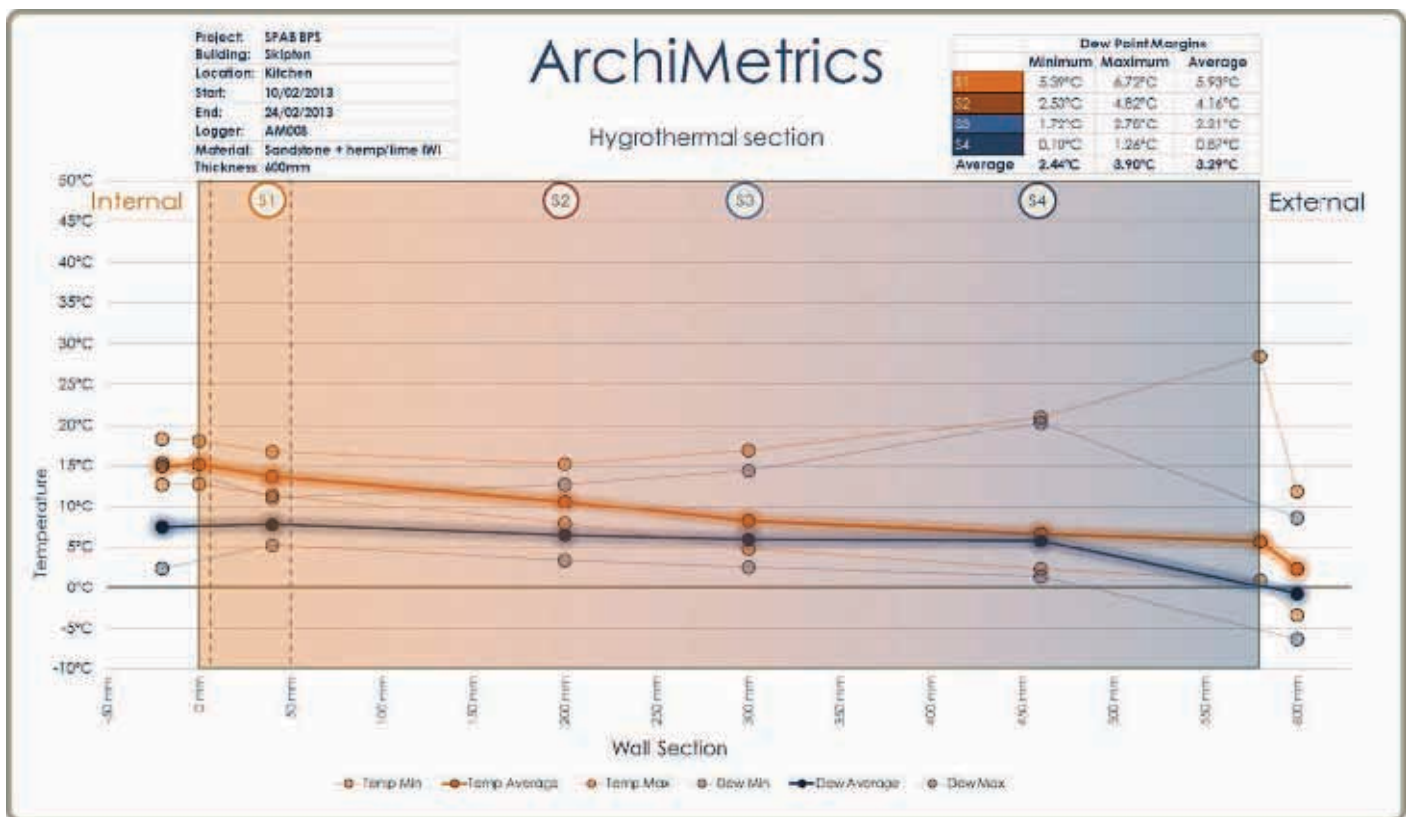
Figure 63: Hygrothermal Section, White House Farm, Skipton, 10th - 24th February 2013.

Figures 62, 63 and 19 show the average values of each sensor graphed as separate temperature and dewpoint gradients from both the pre and post-refurbishment monitoring periods. Data from the extended post-refurbishment monitoring has been graphed in two ways, Figure 63 shows a short time period (10th - 24th February) for comparison purposes with the pre-refurbishment interstitial hygrothermal monitoring shown in Figure 62. Figure 19 provides a section for the longer 13 month monitoring duration at White House Farm. The values derived from the relative humidity sensors have been converted to dewpoints in order to indicate the likelihood of condensation forming within the wall. (The temperature gradient is that much flatter in the long term post-refurbishment graph, Figure 19, because this covers a far greater period of time and includes both summer and winter time temperatures in contrast to the data in Figures 62 and 63 which was gathered over the winter only, between 10th - 24th February 2011/13, and so naturally shows a greater internal/external temperature difference). The 2011 analysis, pre-refurbishment, Figure 62, showed a variety of gradients between the sensor measurement locations indicating a non-homogenous wall with varying degrees of thermal resistivity/conductivity. The character and construction of this wall was ascertained during core drilling to install the interstitial sensors which revealed a variety of stone material types, a rubble core and plenty of voiding all of which would contribute to altering heat flow through the element. In Figure 19, the 2012 - 13 post-refurbishment section this same character is seen, the affect of the rubble core, bracketed between sensors 2 and 3, is still visible although differences in gradient between the sensor points is less pronounced due to the flattened temperature gradient in general. This centre part of the wall contains plenty of air which perhaps acts as a thermal break hence a slightly steeper temperature drop is seen across this part of the construction. The other steeper part of the temperature gradient in Figures 63 and 19 is seen between the measurements of internal surface temperature and sensor 1, either side of the lime and hemp/lime insulating plaster finishes. This indicates, once again, the insulation affect of this layer in the construction, something that is confirmed by the in situ U-values measured, post-refurbishment for this wall (Figures 43 and 44) which showed a 38% reduction in heat loss most likely due to the addition of the insulating hemp/lime plaster.

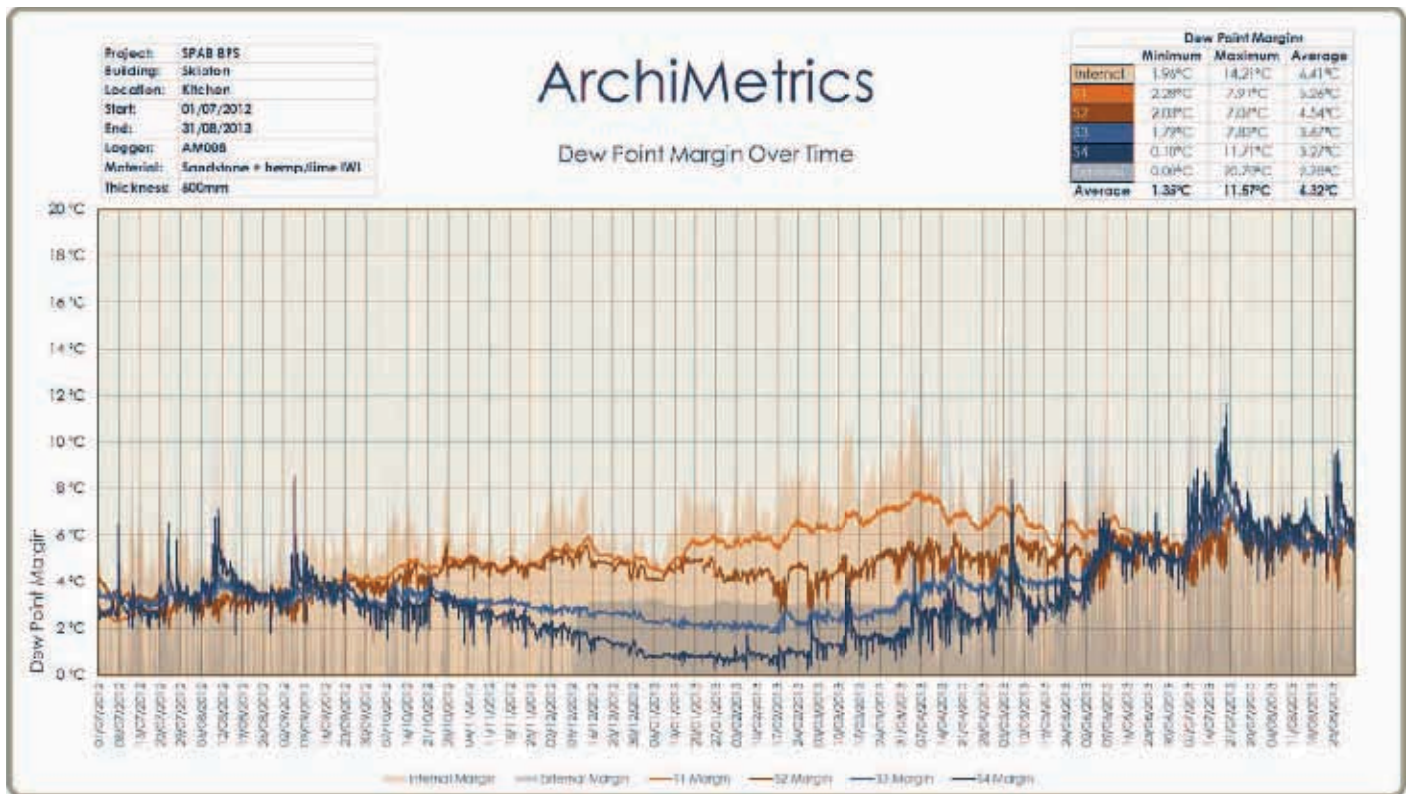
Figure 23: Dewpoint Margin over time, White House Farm, Skipton, 2012 -13.

In Figure 23 the dewpoint margins calculated for the four interstitial sensors in the wall at Skipton are plotted over time. From this it can be seen that the most vulnerable period of time with regard to the potential for condensation occurs not surprisingly during the coldest months of the year around the sensor positioned closest to external conditions, sensor 4. From December 2012 through to March 2013 the dewpoint margin calculated for sensor 4 remains below 2°C and records a minimum value of 0.1°C on or around 17th February 2013. Unlike all the other locations in this study this graph does not find a margin of 0°C, indicating dewpoint and therefore the likely formation of condensation, at any point over the monitoring period for the wall at Skipton. However, it should be noted that the position of sensor 4 is somewhat back into the body of the wall at Skipton, 255 mm away from external conditions, and low external temperatures

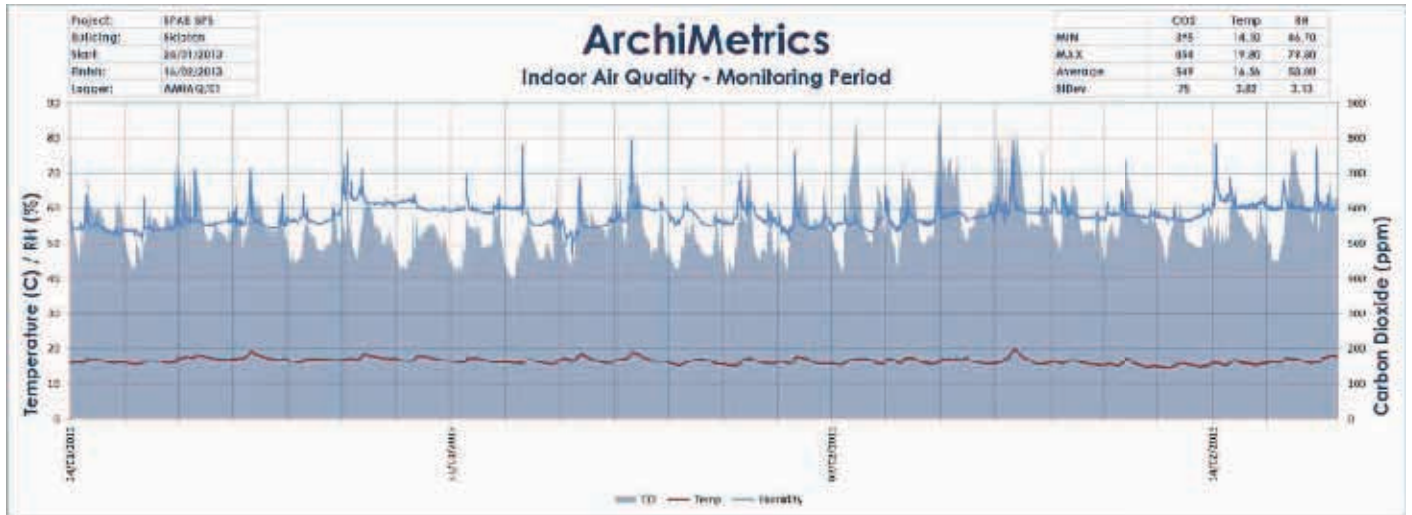
Figure 27. Indoor Air Quality (CO₂, temperature and RH) White House Farm, Skipton 2013.

Figure 27 plots temperature, %RH and CO₂ levels for the kitchen at White House Farm, Skipton, between the period 24th January - 16th February 2013. Table 14 provides a summary of the indoor conditions surveyed within the kitchen on the ground floor at White House Farm pre and post refurbishment, the figures represent average values recorded over the monitoring period 10 - 24th February 2011 and 24th January - 16th February 2013. There seems to be very little change in the conditions within the kitchen pre and post refurbishment, average levels of CO₂ and %RH are very slightly lower, whilst the temperature is slightly warmer. The removal of cement-based wall finishes and the addition of more hygroscopic finishes in the form of lime and hemp/lime insulating plaster may account for a lowering of %RH between 2011 and 2013 where these materials may absorb and thereby buffer water vapour. Underfloor central heating was installed throughout the ground floor at White House Farm but the air temperature within the kitchen does not appear to have altered significantly between the pre and post-refurbishment phases, 16.2°C in 2011 and 16.56°C in 2013. This is interesting as the perception of

comfort in the building has altered and the dwelling is now reported to be appreciable warmer. This is a noted affect of heat delivered via, in this case, the stone floor of a dwelling where the occupant feels warm despite a lower than 'ideal' internal air temperature. During the monitoring period in 2013, peak CO₂ is recorded as 854 ppm which is below the 1000 ppm quantity of CO₂ often used to indicate inadequate ventilation. The average value, 549ppm, is below 600 ppm which is commonly used to indicate 'good' or 'acceptable' levels of CO₂ and is not that much greater than concentrations of CO₂ measured in external air, reckoned to be 350 - 450 ppm.

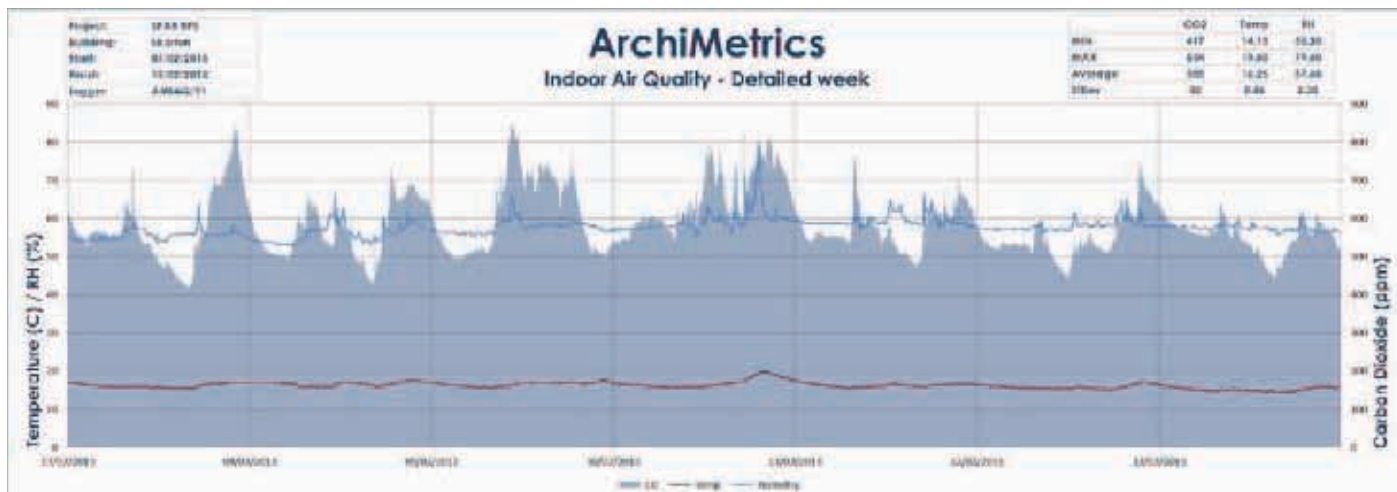
Figure 65. Indoor Air Quality (CO₂, temperature and RH) detail, White House Farm, Skipton 7th - 13th February 2013.

Figure 65 provides a detail from a week of internal conditions monitoring at Skipton in 2013. This shows that whereas by and large peaks in %RH also coincide with peaks in CO₂ indicating occupancy and activity within the kitchen environment, this is not always the case. Peaks of %RH independent of CO₂ can perhaps be explained by cooking activities taking place during the day accompanied by intermittent or low room occupancy.

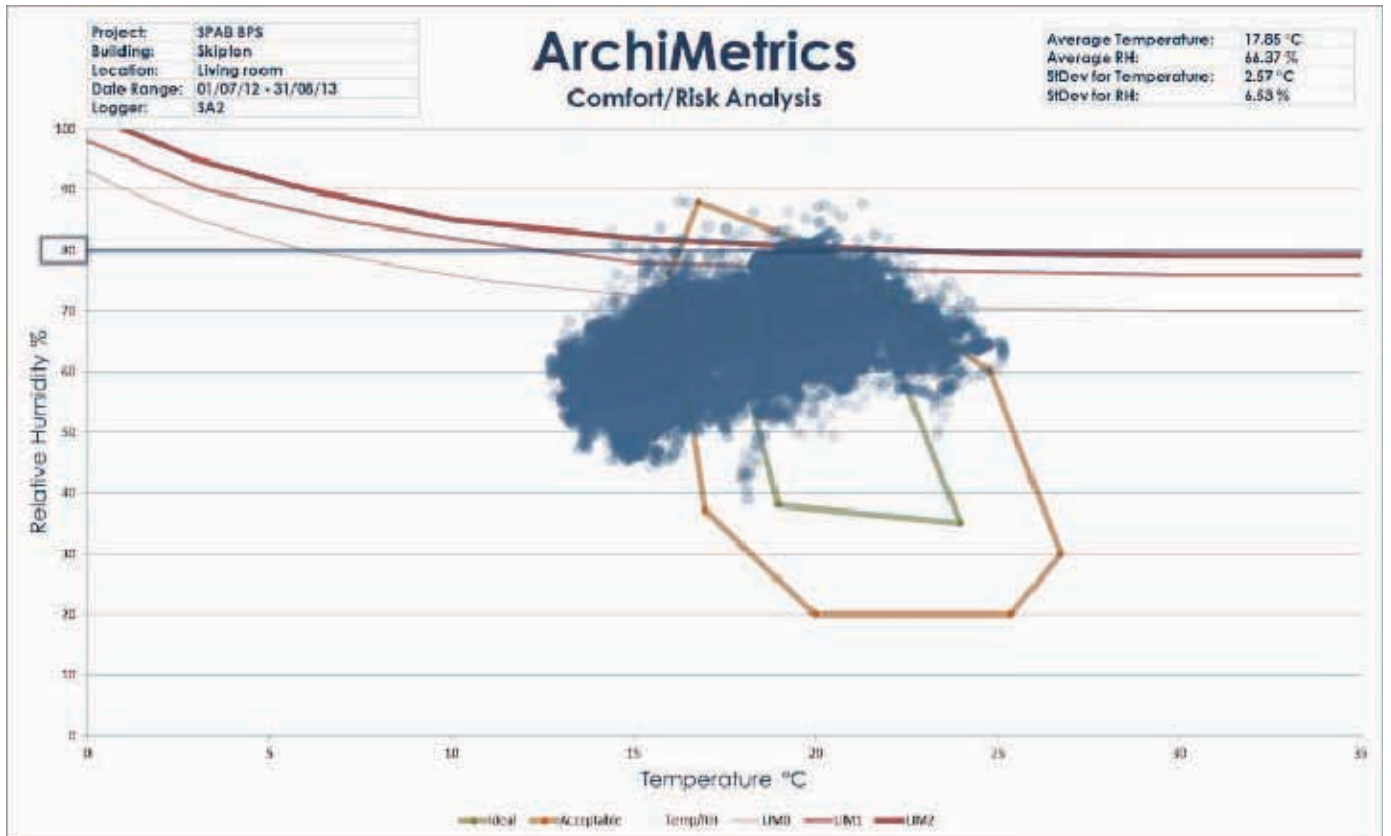
Figure 31. Comfort/Risk Analysis for White House Farm, Sipton, 2012 - 13.

Individual indoor temperature and relative humidity readings have also been plotted against an index of human comfort and fabric risk for the full monitoring period, 1st July 2012 - 31st August 2013, Figure 31. This shows that over the 13 month monitoring period the average air temperature in the kitchen was 17.85°C and %RH was 66.37% (figures that are slightly higher than those gathered over the much shorter time period of the IAQ monitoring, Figure 66). Over the extended year it can be seen that whilst the majority of the temperature measurements sit within the acceptable range of temperature with regard to comfort, a certain proportion of these lie outside this polygon at the lower end of the temperature scale. However, as was noted in the commentary on Indoor Air Quality above, the house is said to be significantly more comfortable and these low air temperatures may be a reflection of the way heat is delivered to the building, via underfloor heating, resulting in relatively lower air temperatures but conditions that are still perceived by occupants as comfortable. Figure 31 also shows a proportion of %RH samples that sit above the gradients which indicate the limiting isopleths for mould growth (LIM) on various, more or less, biologically active substrates; LIM0 being an optimal substrate, LIM1 being biodegradable materials and LIM2 representing porous materials⁹. A small proportion of these %RH points sit above LIMs 1 and 2 suggesting that there is a slight possibility of mould growth formation on the wall surfaces of the kitchen at Skipton although no growth has been noted through observation and may be retarded by the presence of lime-based internal wall finishes.

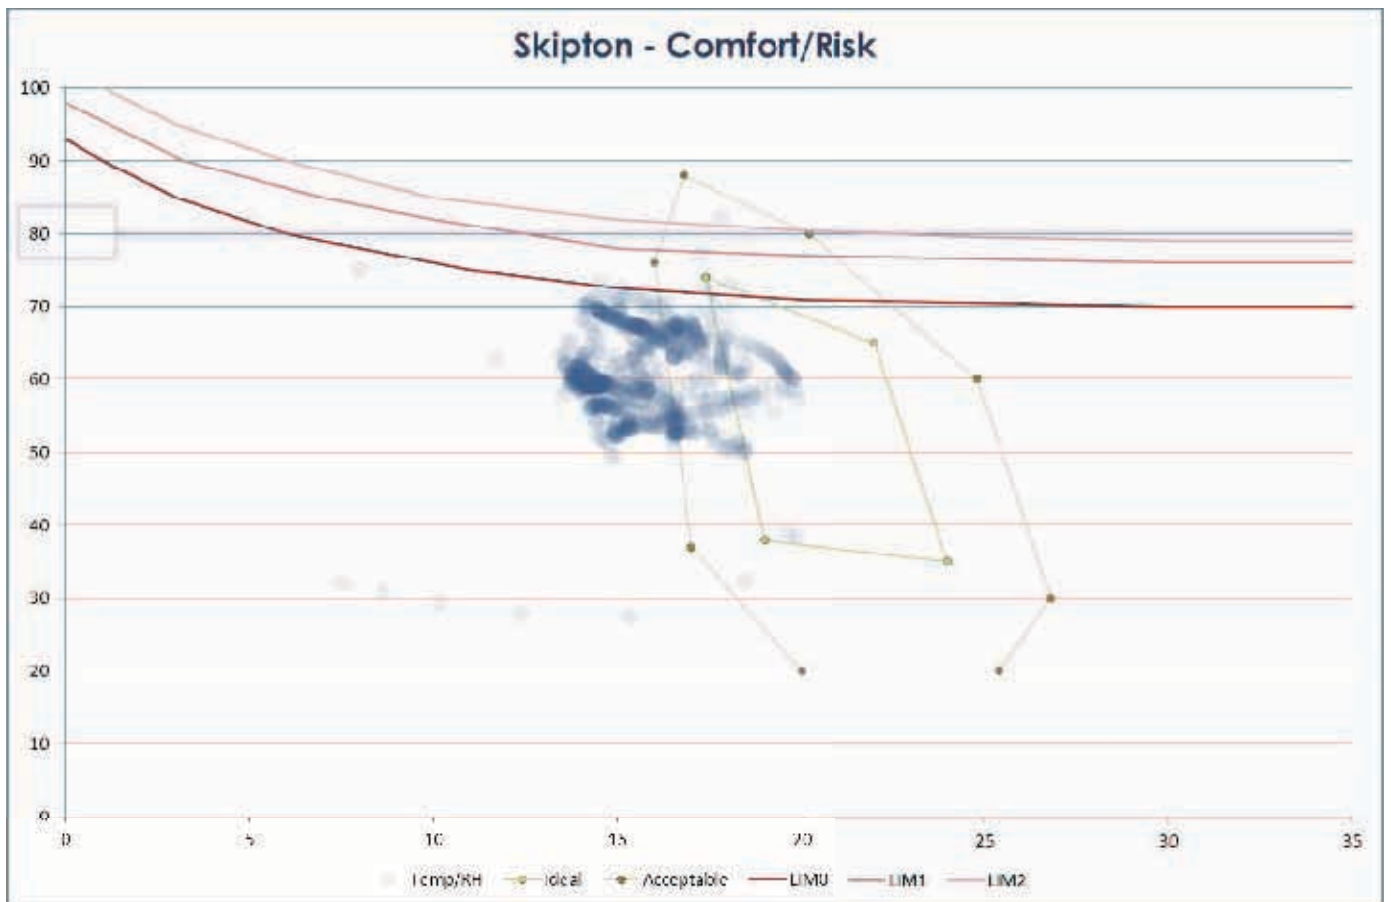
Figure 66. Comfort/Risk Analysis for White House Farm, 19th - 25th February, Sipton, 2011.

To allow some form of comparison with the pre-refurbishment data a comparative graph has been provided, Figure 67, which looks at the same date range as that of 2011 19th - 25th February (Figure 66). The average temperature during this period in 2011 was 15.70°C and the average %RH 60.54%. The post-refurbishment data shows that over the same period in 2013 the average indoor air temperature in the kitchen was 14.87 °C and %RH also slightly lower at 57.58%. The reasons for these reductions are probably similar to those commented on in relation to Figures 27 and Figures 65 concerning the method of heat delivery and volume of the room. The underfloor heating has reportedly improved comfort but lowered air temperatures whilst the lower %RH is may be a reflection of the greater volume now given over to the kitchen/dining as well as the addition of extract ventilation immediately over the cooking area. The distribution of the individual plots of temperature and %RH in Figures 66 and 67 are interesting to compare, measurements from 2011 are much more dispersed perhaps indicating greater air movement within the room compared with a much tighter cluster of data from the 2013 record due to new windows and an effective new air tight layer in the form of the hemp/lime finish.

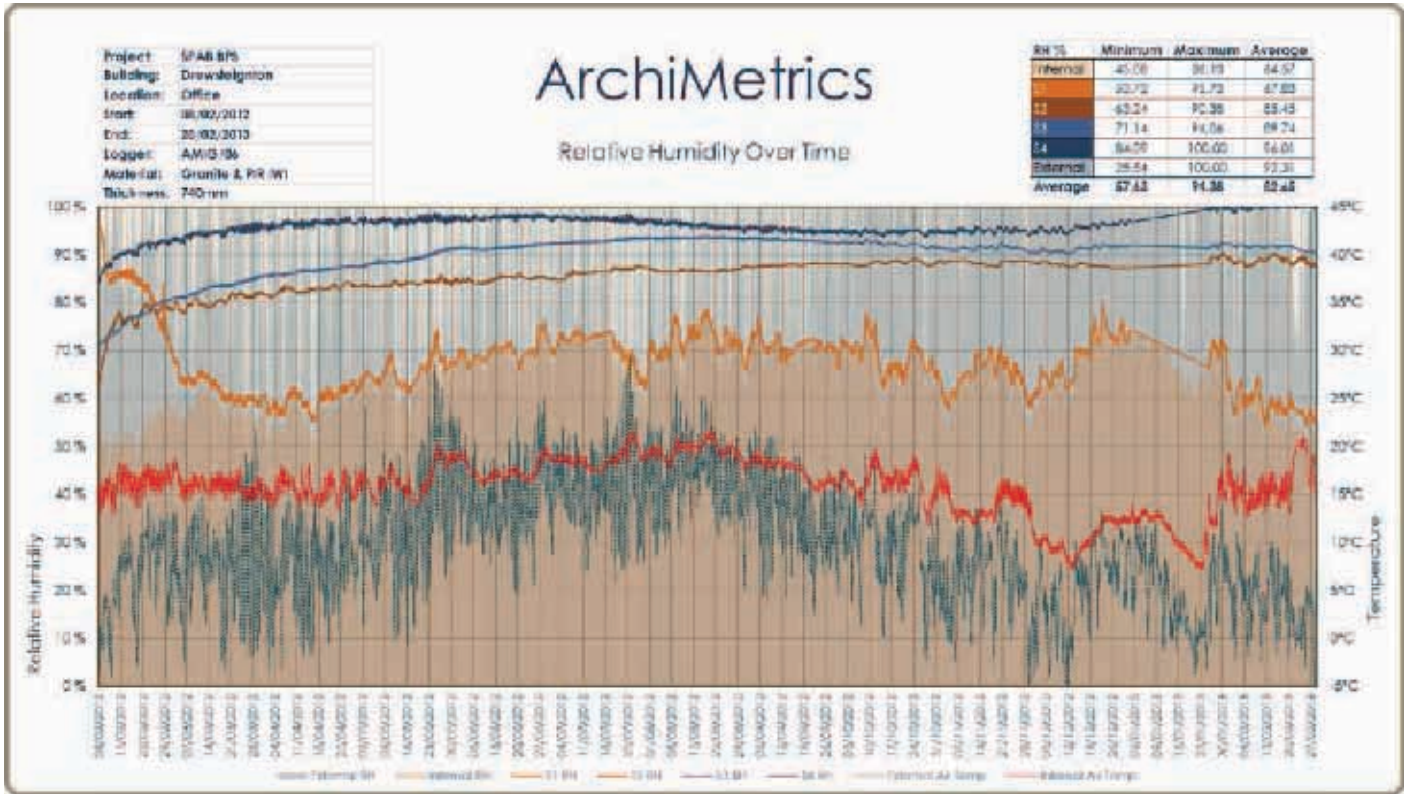
Figure 8: Relative Humidity over time, Mill House, Drewsteignton 2012 - 2013.

Figure 8 plots levels of %RH recorded by the interstitial and internal and external sensors over time, along with internal and external temperature data. The trend of rising %RH at sensors 2, 3 and 4 that was noted in the previous report (*The SPAB Building Performance Survey 2012, Interim Report*) is confirmed by this graph which looks at %RH responses over a full annual cycle. Whilst it is possible to see a small reduction in %RH measured at sensor positions 3 and 4 over the months of July, August and September, once the cold weather recommences %RH begins to rise at these two locations once again. Indeed, at the beginning of February 2013 %RH reaches 100% at the outer sensor (sensor 4, 134mm back from the external wall face) and remains there throughout this month suggesting an increased risk of condensation at this point. Unlike sensors 3 and 4, there is no period in the year where %RH diminishes at sensor 2 which is located immediately behind the PIR insulation at the insulation/masonry interface. Here a steady rise in %RH is measured over the full 13 month reporting period, however, unlike sensor 4 neither sensor 2 or 3 reaches saturation (100% RH) over this time. The average %RH values of the three sensors position on the cold side of the insulation are all above 80%, a threshold commonly used to indicate the possibility of mould growth, and are; sensor 2 = 85%, sensor 3 = 80% and sensor 4 = 96% (see table at top right of Figure 8). Following the installation of insulation at Drewsteignton and the drying of the plasterboard's gypsum plaster skim coat behaviour of %RH at sensor 1 is, as was previously noted, closely coupled to that of the internal room %RH. This suggests that there is a high degree of vapour exchange from the room through the plasterboard to the air gap between the plasterboard and PIR insulation.

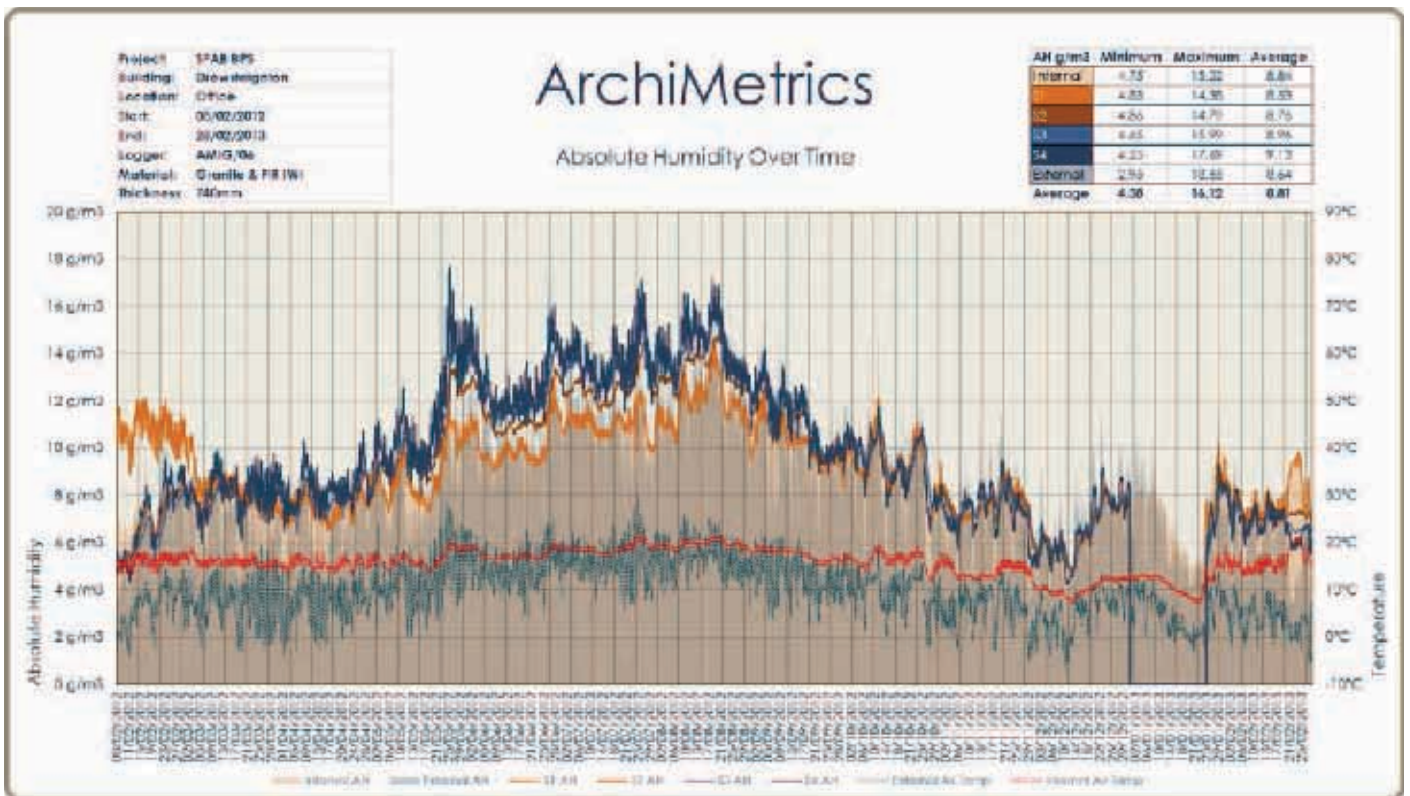
Figure 12: Absolute Humidity over time, Sensors 1 - 4, Mill House, Drewsteigton 2012 - 2013.

Figures 12 and 72 show plots of absolute humidity over time for the insulated granite wall at Drewsteignton (Figure 72 is given for clarity to show plots from sensors 1 - 3 which are obscured by the plot from sensor 4 in Figure 12). These show that humidity rises within the wall over the warmer summer months as warmer temperatures enable more vapour to be held in the air. The pattern for the summer months is also more dispersed, that is to say there is greater variation in the weight of water vapour measured at the four locations through the wall and, in general, this increases in relation to proximity to more humid external conditions. This relationship is clearly seen in Figure 72 for measurements from sensors 1 - 3 but is less defined in Figure 12 where plots from sensor 4, the outer most sensor, are more volatile reflecting more dynamic influences on quantities of water vapour in the immediate atmosphere. The drying of the gypsum plaster skim previously noted in relation to %RH can also be seen in plots of absolute humidity for sensor 1 installed in the air gap behind the plasterboard. Following this drying sensor 1 once again follows internal room conditions and shows the lowest weight of vapour by volume for this part of the wall during the summer. This changes in winter when, in general, quantities of water vapour are lower through the wall section as the colder temperatures are less able to promote evaporation and/or carry water vapour within the air. The quantities of vapour measured at each sensing point are also similar or more closely aligned during the winter period and now there are periods of time when the quantity of vapour is at its highest in proximity to warm, centrally heated, internal conditions. This is most marked in the week beginning 21/02/13 at the end of the reporting period where it

would seem in response to extreme internal and external temperature difference measurements of absolute humidity are unusually dispersed through the wall section and increase in quantity in proximity to internal conditions (the inverse of the summertime pattern). It has been speculated that this behaviour is in response to a very cold but sunny period where the internal room temperature is increased above its usual 18°C to a winter peak of 20°C by solar radiation (entering the building through it's glazing) heating the internal environment and increasing absolute humidity within the room and immediately behind the drylining. This, coupled with cold and dry conditions externally, provides an unusually sharp delineation of quantities of absolute humidity through the wall section.

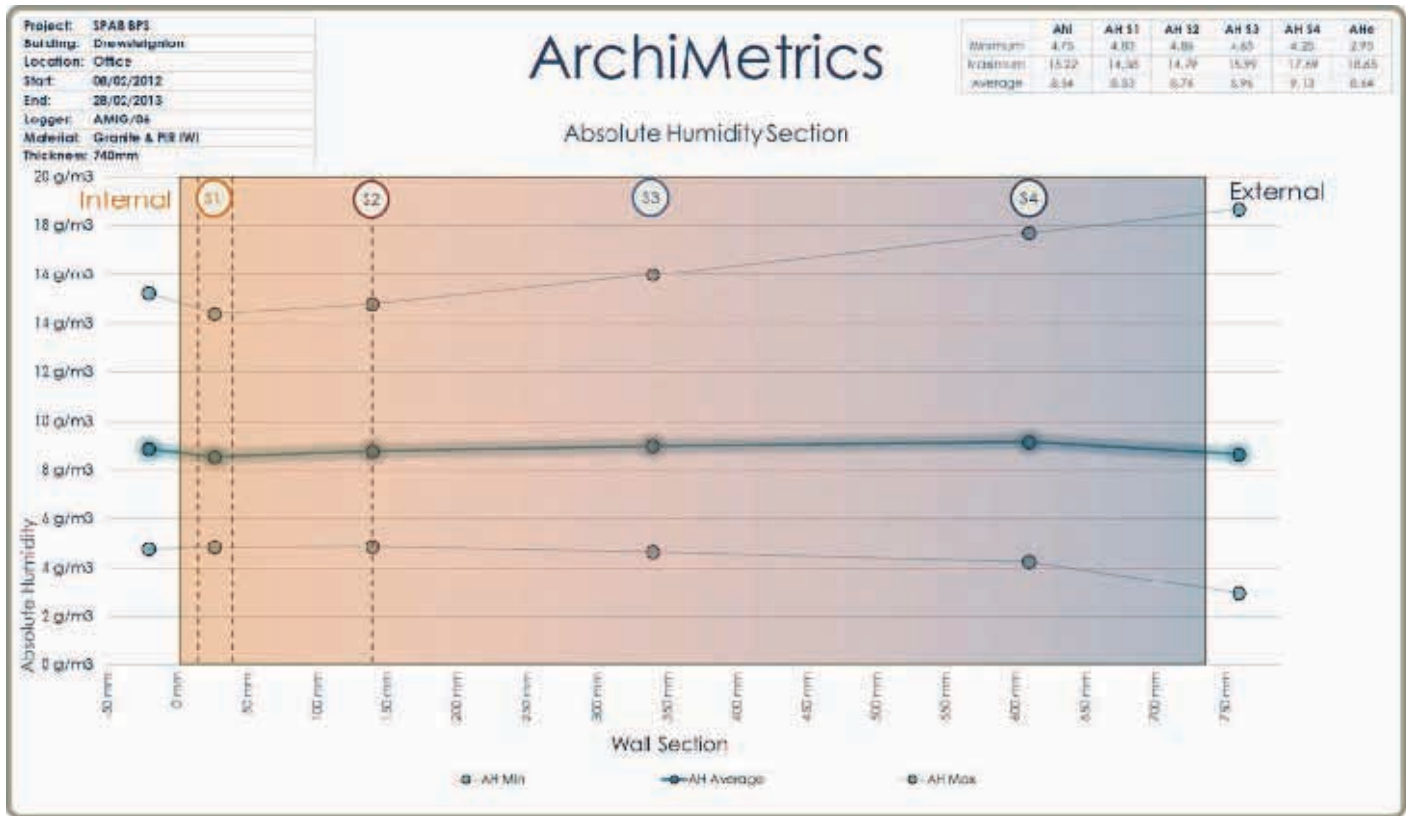
Figure 16: Absolute Humidity Section, Mill House, Drewsteignton 2012 - 2013.

The absolute humidity section for Drewsteignton, Figure 16, provides an indication of the average g/m^3 of water vapour either side of and through the wall section over the period 8th February 2012 - 4th March 2013. From this graph it can be seen that at this location quantities of internal and external water vapour are very similar, 8.84 g/m^3 internally and 8.64 g/m^3 externally, suggesting that by and large conditions with regard to quantities of water vapour are similar both inside and outside the property. The highest average weight of water vapour over the reporting period is recorded within the wall at the sensor 4 position towards the exterior wall face and diminishes in quantity travelling back through the wall section to the interior side. This gradient may be significant with regard to other observations of humidity conditions within the wall as it suggests that vapour movement through the wall may be static or indeed in a reverse direction, that is to say travelling towards the interior side of the wall. As is standard, the PIR insulation is sandwiched between aluminium foil and the joints of these boards are taped with adhesive foil tape upon installation. This foil creates a mostly impermeable layer and resists the passage of water both in a liquid and vapour form. In situations of reverse vapour flow this layer may prevent the progress of vapour through the wall section thus causing humidity to increase within the structure. Therefore perhaps it is possible that the incorporation of this insulation may account for the trend of rising %RH previously noted for this wall (Figure 8).

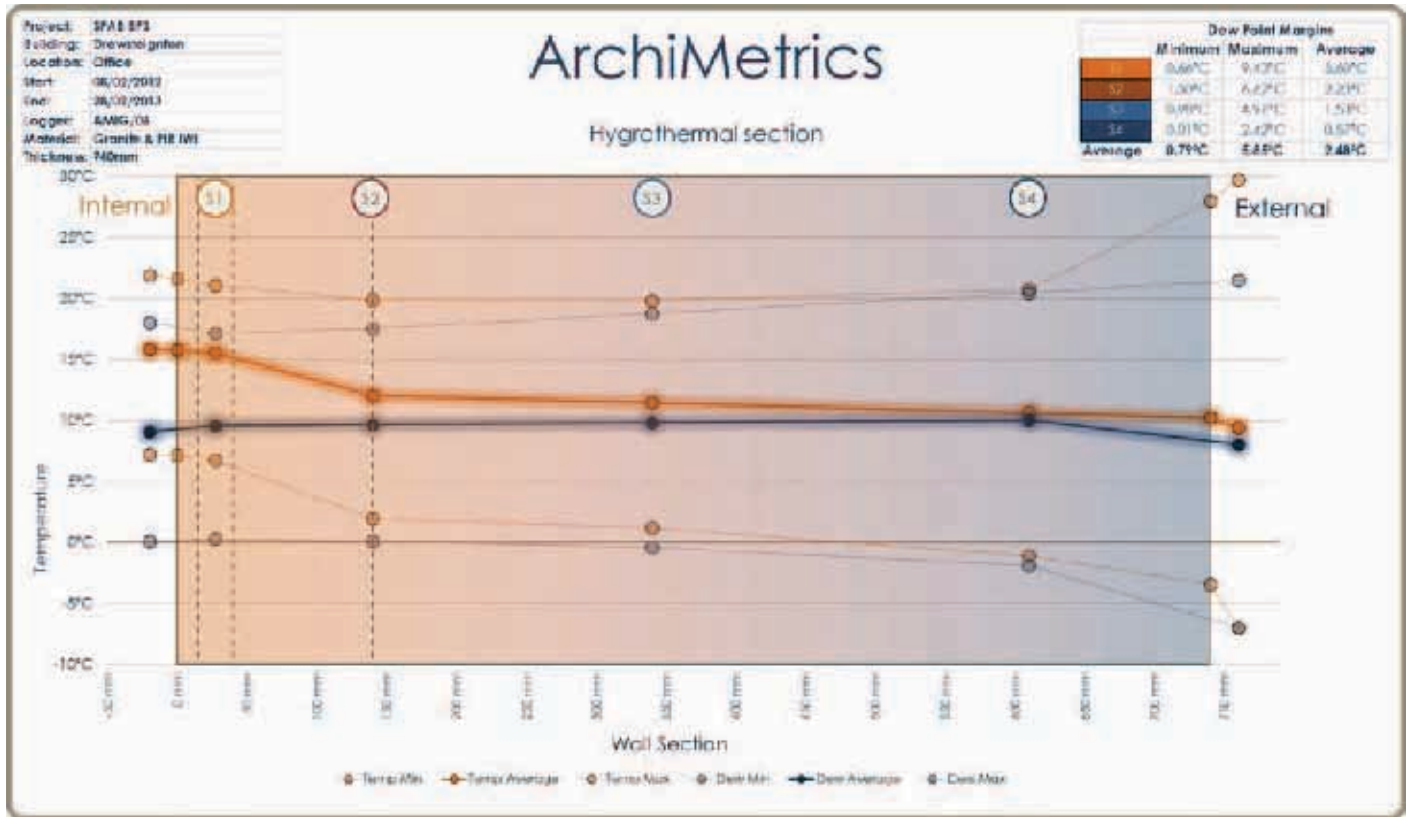
Figure 20: Hygrothermal Section, Mill House, Drewsteignton 2012 - 2013.

Figure 20 allows an examination of temperature and dewpoint gradients through the wall section at Drewsteignton recorded over 13 months, between 8th February 2012 - 4th March 2013. Figure 73 reproduces the graph from the 2012 Interim report which shows plots of these same gradients over a shorter period, spring and summer 2012. The temperature profile through the section remains very similar over the two reporting periods and shows the different thermal resistances of the wall materials. The gradient is steep through the PIR insulating layer section (the addition of 100mm of PIR reduced the wall's measured U-value from 1.20 W/m²K to 0.16 W/m²K) and much more shallow, 1 - 2°C difference, through the original granite masonry of the wall reflecting the reduction of heat travelling through this part of the wall as a result of the internal wall insulation. As is to be expected the dewpoint margin (the temperature drop required for dewpoint to occur at a certain point) is at its narrowest towards the coldest part of the wall. Prior to insulation, in 2011, the dewpoint margin averaged across all four measurement sensors for the wall was 4.01°C, and the average at the most vulnerable outer 4th sensor in isolation was 2.38°C. From the spring/summer 2012 data (Figure 73) the average dewpoint margin across all four sensors was reduced to 2.77°C and 0.64°C for the fourth sensor alone. Now, with a complete annual cycle of data (Figure 20) the margins are found to have reduced slightly once more and are 2.65°C averaged across all four sensors and 0.61°C at sensor 4. This further reduction reflects the addition of colder autumn and

winter temperatures into the data set, cold temperatures inevitably increase %RH and thus moves conditions within the fabric closer towards dewpoint.

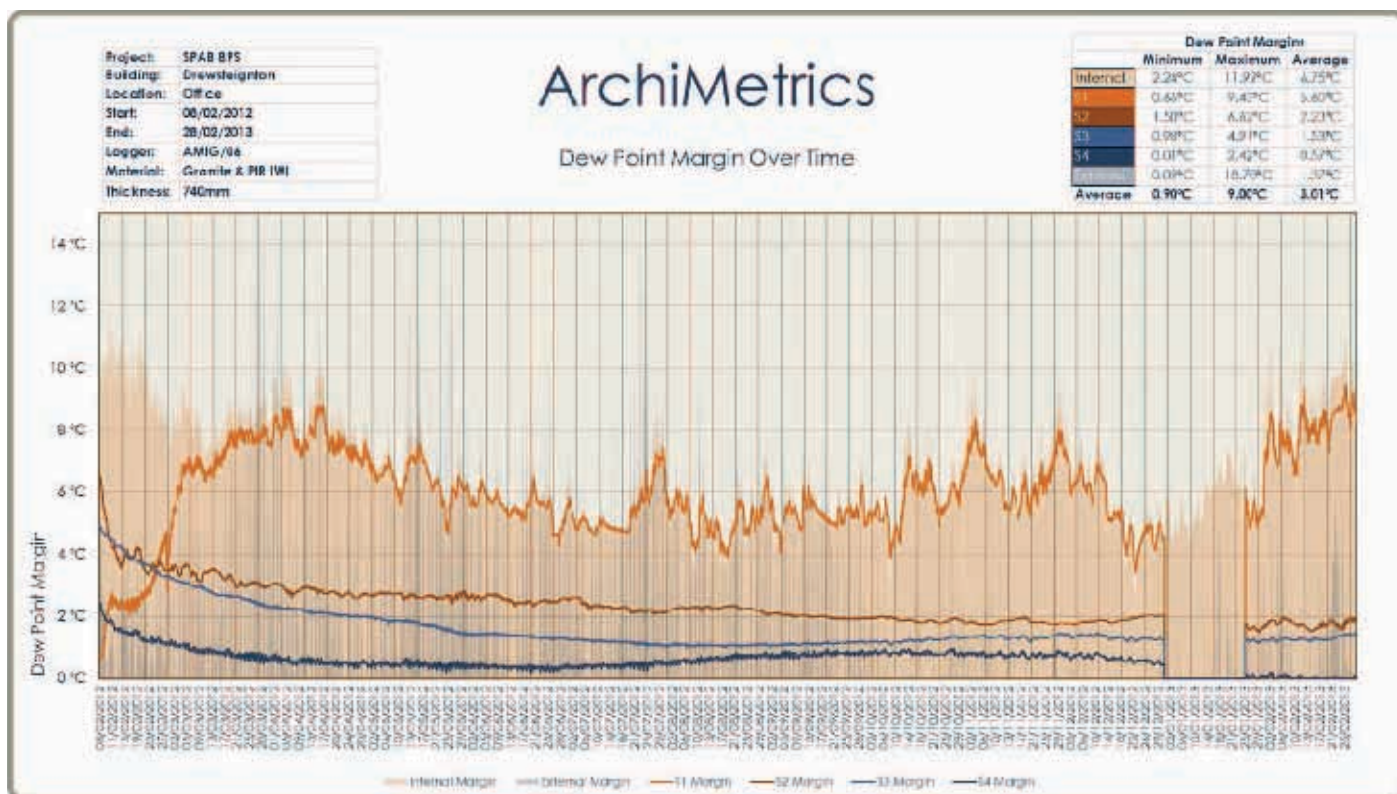
Figure 24: Dewpoint Margin over time, Mill House, Drewsteignton 2012 - 2013.

Figure 24 presents a plot of dewpoint margins over time for the wall at Drewsteignton. Dewpoint is a function of %RH thus, as with the trend of increasing %RH for this wall (Figure 8) an inverse trend of decreasing dewpoint margins is found over the reporting period. Likewise, as with the plots of %RH there is an interruption in this trend at sensors 3 and 4 for a period of time (although not at sensor 2 at the insulation/masonry interface) but following this, entering the coldest months of the year, margins at all three sensors continue to narrow. Indeed, from the end of January 2013 the margin at sensor 4 has reached 0°C, i.e. there is no margin and this location is at 100%RH or saturation. The reduction of dewpoint margins found for the wall at Drewsteignton is similar to that found for other internally insulated walls and is probably at least in part a response to the reduction of heat passing into the original fabric of the wall as the colder temperatures increase %RH. However, the reduction in dewpoint margins at Drewsteignton, particularly at the 4th node (average 0.61°C) are quite extreme and in this sense may be a response to the extreme heat loss reduction that has occurred as a result of the application of 100mm of PIR insulation and also the introduction of a vapour barrier, in the form of the aluminium foil facing either side of the PIR insulation, which prevents the migration of vapour. The addition of insulation reduced the U-value measured for the wall from 1.20 W/m²K to 0.16 W/m²K a reduction in heat loss of 87%. The highly reduced dewpoint margins at Drewsteignton may also be a reflection of the increased presence of vapour within the wall over time as indicated by the overall trend of rising %RH, as vapour accumulates dewpoint is more likely to be reached. In this context however it should be noted that as condensation is a function of both humidity and temperature it is highly dependent upon ambient conditions, particularly external weather conditions and this reporting period covers a year which has been noted for high rainfall and cold winter temperatures. The degree to which the temperature and moisture behaviour of the wall at Drewsteignton is a response to these extremes of weather, rather than the addition of internal wall insulation, is difficult to determine. However, by monitoring the wall over the longer term the drivers of hygrothermal behaviour should become clearer. For example, we may find after a warm and dry summer %RH starts to reduce and falls below 80% once more or that the wall reaches some form of thermal and moisture equilibrium which reflects the affect of significant heat loss reduction over the longer term.

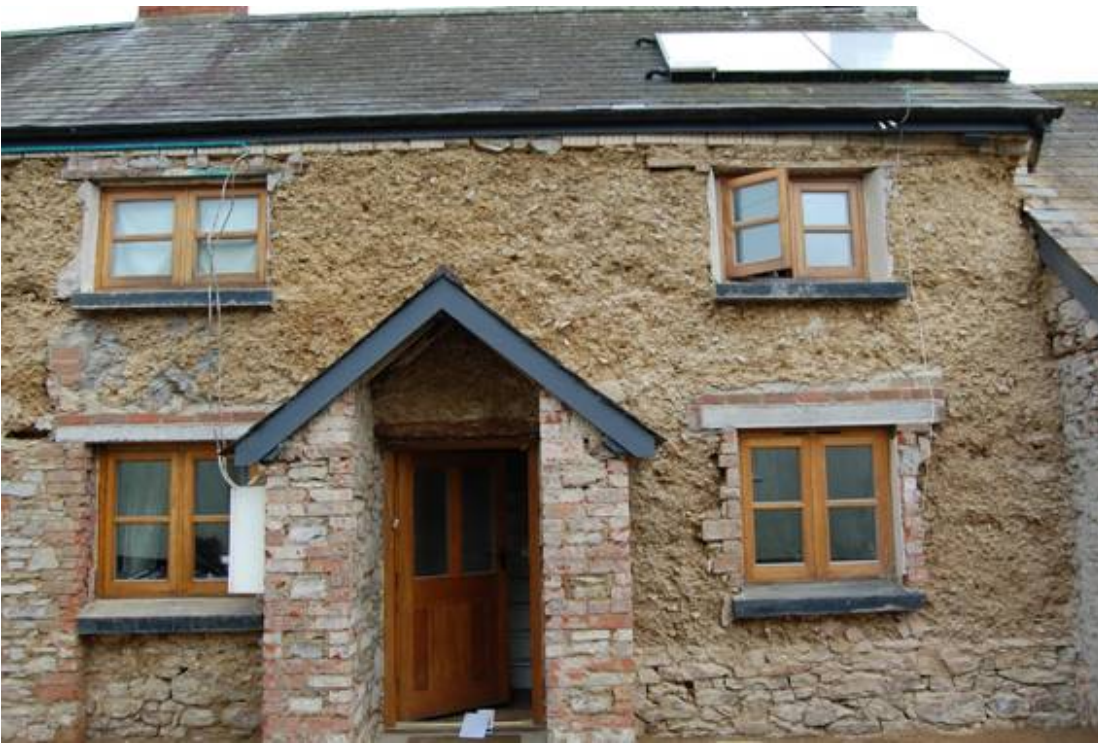
Figure 76. The Firs, Riddlecombe front elevation showing masonry buttress bottom left of frame.

In the summer of 2011, during the re-rendering of the south facing front facade at The Firs, Riddlecombe, it became apparent that the area of the wall under examination in this survey included an external stone buttress that had previously been hidden under the cement render (Figure 76). The addition of this component altered the build up of the wall used for U-value calculation purposes and new U-value calculations were undertaken for both the uninsulated and insulated walls to take account of these differences. These were reported in Table 10 of the 2012 version of the Building Performance Survey report (naturally the measured in situ U-values were unaffected by these changes). Subsequently, during the monitoring that has taken place in 2013, further details of the wall build ups at Riddlecombe have emerged resulting in minor alterations to the dimensions of the individual components that comprise the measured wall section. To reflect these changes new U-values have been calculated once again and details of these calculations and updated wall build ups are given in Table 16 below. The pre and post insulation calculated U-values have altered slightly increasing from 0.93 to 0.95 W/m²K for the uninsulated wall at Riddlecombe, reflecting the greater quantity of more conductive stone within the overall build up and decreasing from 0.6 to 0.56 W/m²K for the same wall post insulation, as a result of an increase in the quantity of insulating render ascribed to this wall.
