SPAB Building Performance Survey 2013

Interim Report
October 2013

Dr Caroline Rye, Cameron Scott and Diane Hubbard
Society for the Protection of Ancient Buildings
Supported by Historic England

THE SPAB RESEARCH REPORT 2

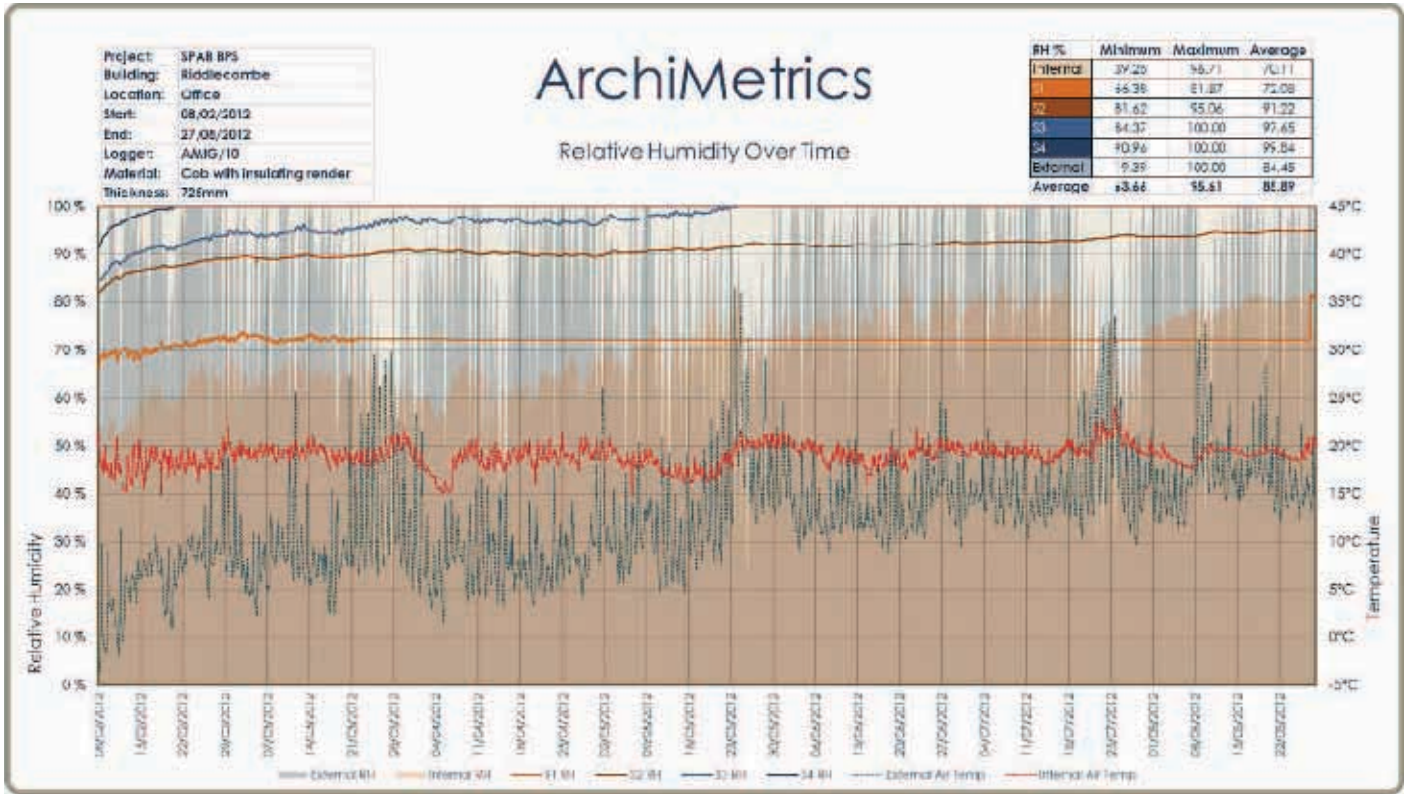
Figure 79. Relative Humidity over time, The Firs, Riddlecombe Feb - Aug 2012.

Over the same period the previous year, February - August 2012, a very similar plot of %RH behaviour over time was produced for the insulated wall at Riddlecombe (Figures 79 & 9). Both graphs show %RH rising within the wall at all four sensor positions over time and levels of %RH reaching 100% indicating saturation and the possibility of condensation, first at sensor four and then later into the summer, further back within the wall at sensor 3. However, there are some slight variations in the plots of %RH recorded during 2013 which may give some cause for optimism given the alarming trend of raised %RH within the wall. At sensor 3, 395mm into the body of the wall, in 2012 %RH rose from 84.37% to 100% over a period of 15 weeks and the average %RH over the whole reporting period, February - August 2012, was 97.65%. In 2013, at the same sensor, %RH rises from 85.6% to 100% over a longer period of time, 18 weeks and the average %RH at sensor 3 over the reporting period Feb - Aug 2013 is slightly lower, 96.57%. Furthermore, unlike the graph for 2012 (Figure 79) in 2013 there is also a hint that levels of %RH at sensor 3 may begin to reduce towards the end of the reporting period, around the week beginning 7th August 2013.

That %RH appears to increase through the wall over the summer months is curious and is a pattern that is repeated over two years following the application of external insulating render. It is also contrary to findings at other locations where, in general, %RH tends to decrease in the summer as the warmer external temperatures lower %RH throughout a wall section. Over the first two weeks of the 2013 reporting period %RH rises on all four sensors, reaching 100% at sensor 4 before diminishing towards the end of the second week. Given conventional %RH behaviour this could be ascribed to the loss of heat experienced by the wall while the occupants were away on holiday (the rise in %RH is mirrored by a decline in internal temperature over the same period). However, looking at the graph over a longer time period, shows that the trend of rising %RH is matched not by declining internal temperatures but by rising external ones and indeed weeks 27th February and 6th March 2013 also saw steep rises in external temperature. It was noted in the previous edition of this report that the rise in relative humidity measured within the wall at Riddlecombe may be driven by raised external temperatures and was illustrated by a detailed graph for the period 15th - 29th May 2012 (Figure 80).

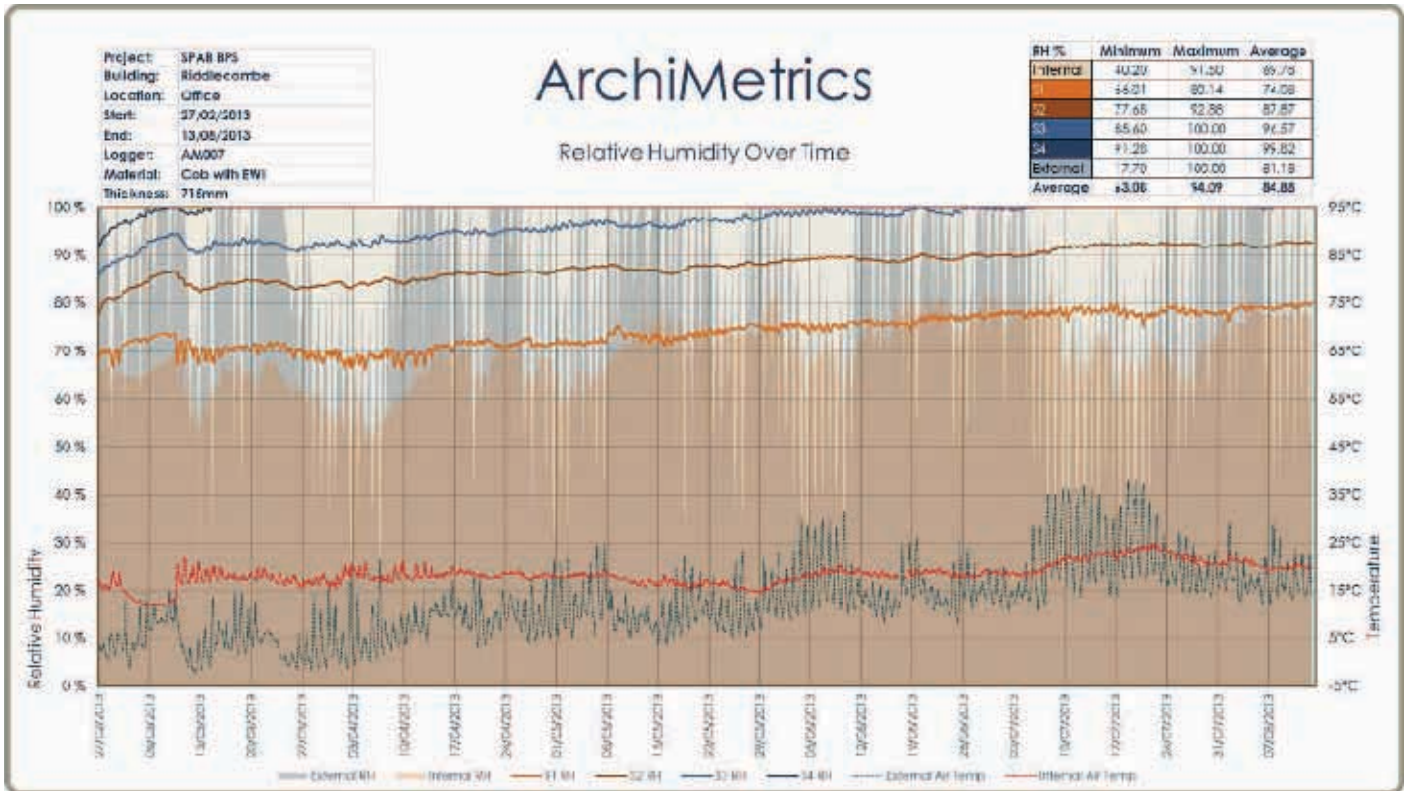
Figure 9: Relative Humidity over time, The Firs, Riddlecombe Feb - Aug 2013.

The walls at Drewsteignton and Riddlecombe (Figures 8 and 9) also share another feature, that is both these locations exhibit a trend of rising %RH over the reported monitoring period (12 months for Drewsteignton, 6 month at Riddlecombe). This is particularly clear in Figure 9 when measurements of %RH at sensor 4, the sensor closest to the external side of the wall at Riddlecombe, reaches 100% RH within a matter of weeks from the commencement of the graph and is followed, sixteen weeks later by sensor 3 and all four gradients have a mostly upward trajectory for the entire duration of the graph. At Drewsteignton, Figure 8, the trend is less obvious and there is also a period of time over the summer where measurements of %RH decline at sensors 3 and 4, however, over the full reporting period the predominate trend is one of increasing %RH with the exception of measurement from sensor 1 positioned in the air gap behind the plasterboard drylining of this wall which tracks internal room %RH conditions. Towards the end of the graph for Drewsteignton, in January 2013, sensor 4 reaches 100% RH. There is however a significant difference between these two walls in that peaks of %RH occur in opposing seasons suggesting two different and possibly opposing driving forces for this behaviour. By and large, and this can be seen in the other walls in this study (Figures 6 and 7) %RH increases and peaks during the winter when colder external temperatures cause the %RH to rise particularly within the colder, external side of the wall leaf. However, at Riddlecombe the rising trend, including peaks at 100%, occurs over the warmer summer months and it is thought that this may be due to vaporisation or sweating behaviour from the cob material that has a high moisture content due to the failing external cement render that previously covered the building and water introduced into the wall as part of the re-rendering process. (This phenomenon is explored in more detail in the individual report on Riddlecombe in Appendix A, pps. 102-121). Continued measurements of this wall into the winter period, 2013-14, should be able to shed more light on the high %RH measured in this wall and whether this is a seasonal and ultimately diminishing trend or a cause for concern over the longer term. However, measurements of %RH at Drewsteignton reveal a trend of rising %RH that occurs over a 12 month period, when normally perhaps one might expect any rise in %RH as a result of colder temperatures to be reversed during the warm summer. Both Drewsteignton and Riddlecombe also show higher interstitial %RH values where average %RH values measured at sensors 2-4 in both walls all exceed 80% the value often quoted as the threshold for mould growth conditions. In contrast, only measurements from sensor 4 exceed 80% RH in the walls at Shrewsbury and Skipton, averaging 83.49% and 81.43 respectively whereas averages for sensor 4 are much higher at Drewsteignton, 96.01% and at Riddlecombe, 99.82%.

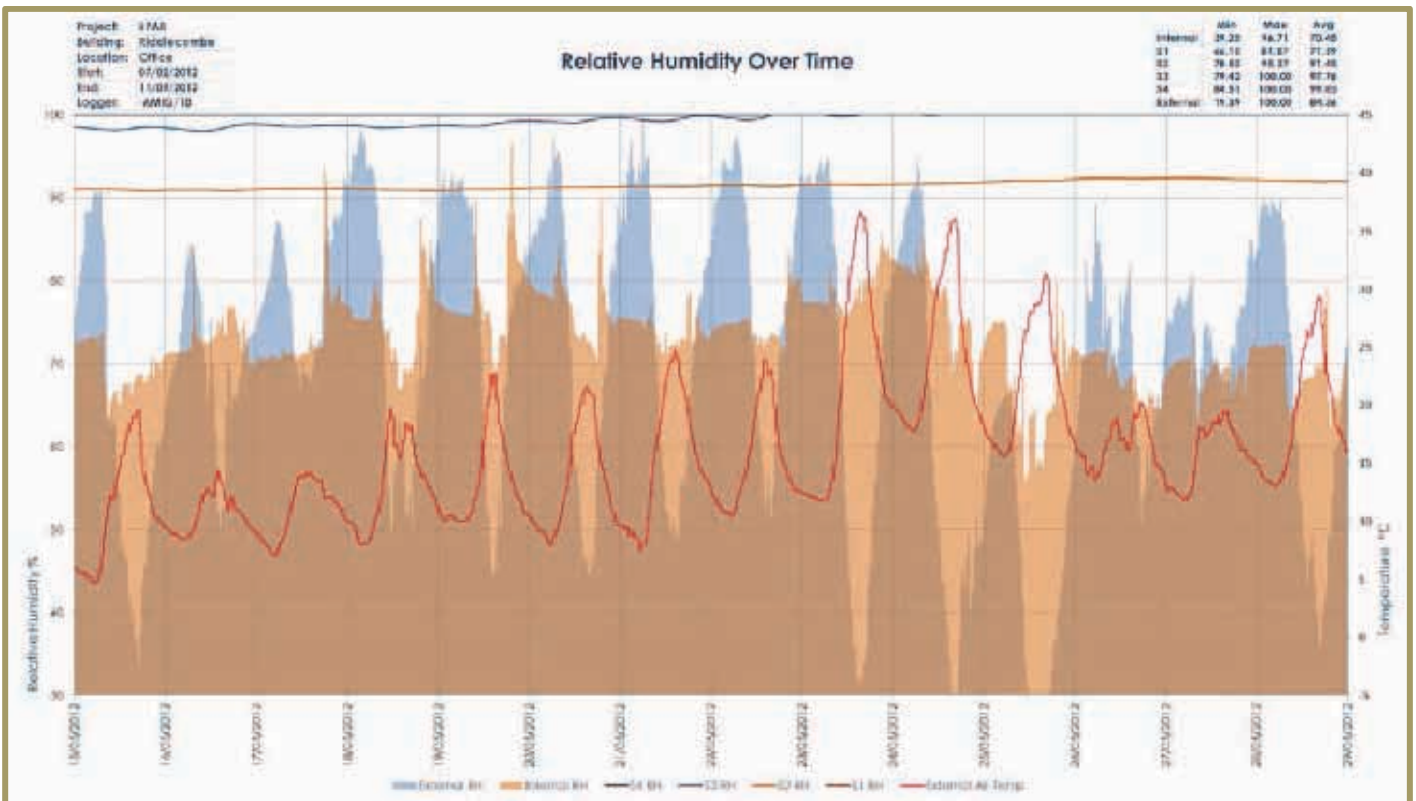
Figure 80. Detail - plots of interstitial RH, internal room RH and external RH and temperature, The Firs, Riddlecombe, 15th - 29th May 2012.

The discussion in the 2012 report stated "Figure 80 shows a detailed plot of the RH values for the wall at Riddlecombe between 15th - 29th May. It is during these two weeks that the level of RH measured at sensor 3 exceeds 100%. It appears that this occurs in parallel with rising external temperatures and a similar although somewhat delayed and less pronounced increase can be seen in sensor 2....In contrast to the wall at Shrewsbury where interstitial RH more or less maps that of external temperature and RH i.e. when temperatures rise interstitial RH falls the opposite appears to be happening in the wall at Riddlecombe. RH increases with external temperature increase and continues to accumulate over time. This leads us to speculate that the raised temperatures are perhaps causing bound construction water to develop into vapour which is in turn slow to migrate out of the wall due to the now in tact and much thicker external render system."

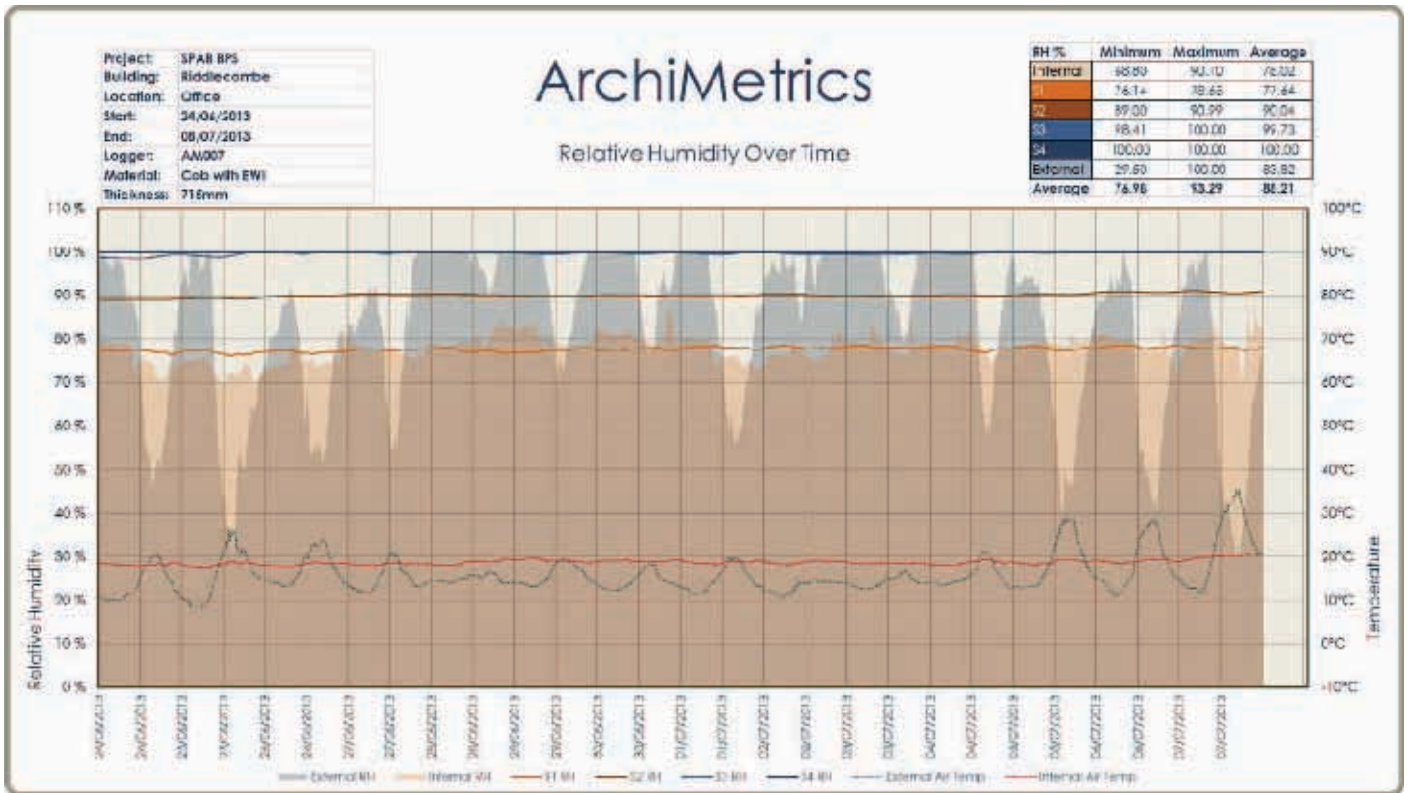
Figure 81. Relative Humidity over time, Sensors 1 - 3, The Firs, Riddlecombe, 24th June - 8th July 2013.

Figure 81 provides a detailed description of %RH behaviour during the two weeks that sensor 3 exceeds 100% this time over the summer of 2013. As with the previous year, this shows that the peak at 100% is achieved just shortly after a peak in external temperature on the 25th June and that, following this, humidity then hovers just below 100% during a period of slightly lower external temperatures but returns to saturation on the 4th July and remains there over the very warm days that follow.

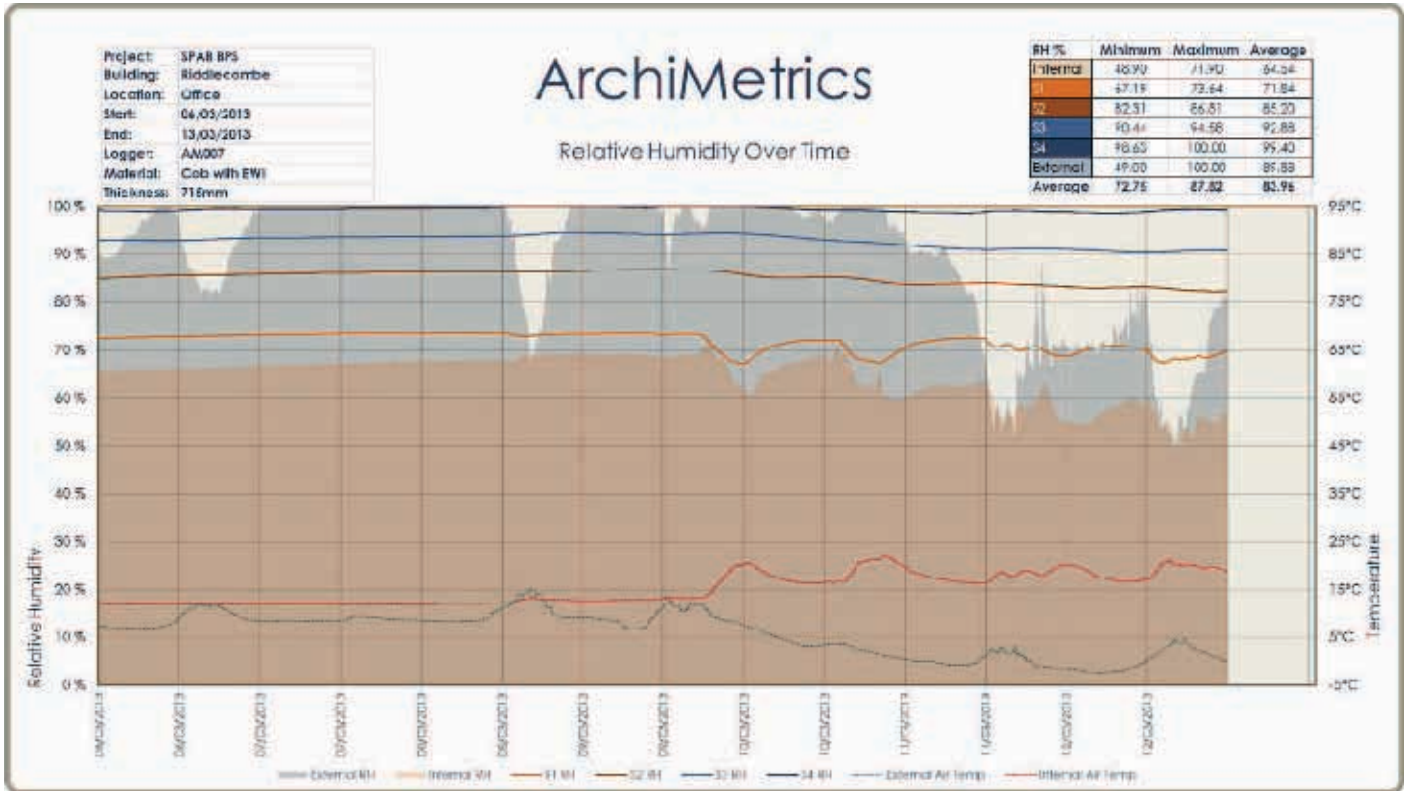
Figure 82: Relative Humidity over time, Sensors 1 - 4, The Firs, Riddlecombe 6th March - 12th March 2013.

A detailed graph for a week earlier in the year also shows some interesting trends regarding %RH behaviour in the cob wall, Figure 82. Week beginning 6th March 2013 coincides with the end of the holiday period previously mentioned and therefore sees quite low internal room temperatures over the early part of this week. After the family has returned heat is once more input into the building and patterns of %RH measured at sensor 1, 60mm back from the internal wall face, immediately respond following the conventional pattern of decreasing %RH during periods of raised internal temperature. However, measurements from the other three sensors seem to be less determined by internal conditions and may be affected, contrary to orthodoxy, by a decline in %RH which follows the decline in external temperatures. Sensor 4, closest to the external wall face, in particular, seems to be responding to external conditions in this contrarian way where %RH peaks close to 100% during periods of slightly warmer temperatures during the days of the 11th and 12th of March.

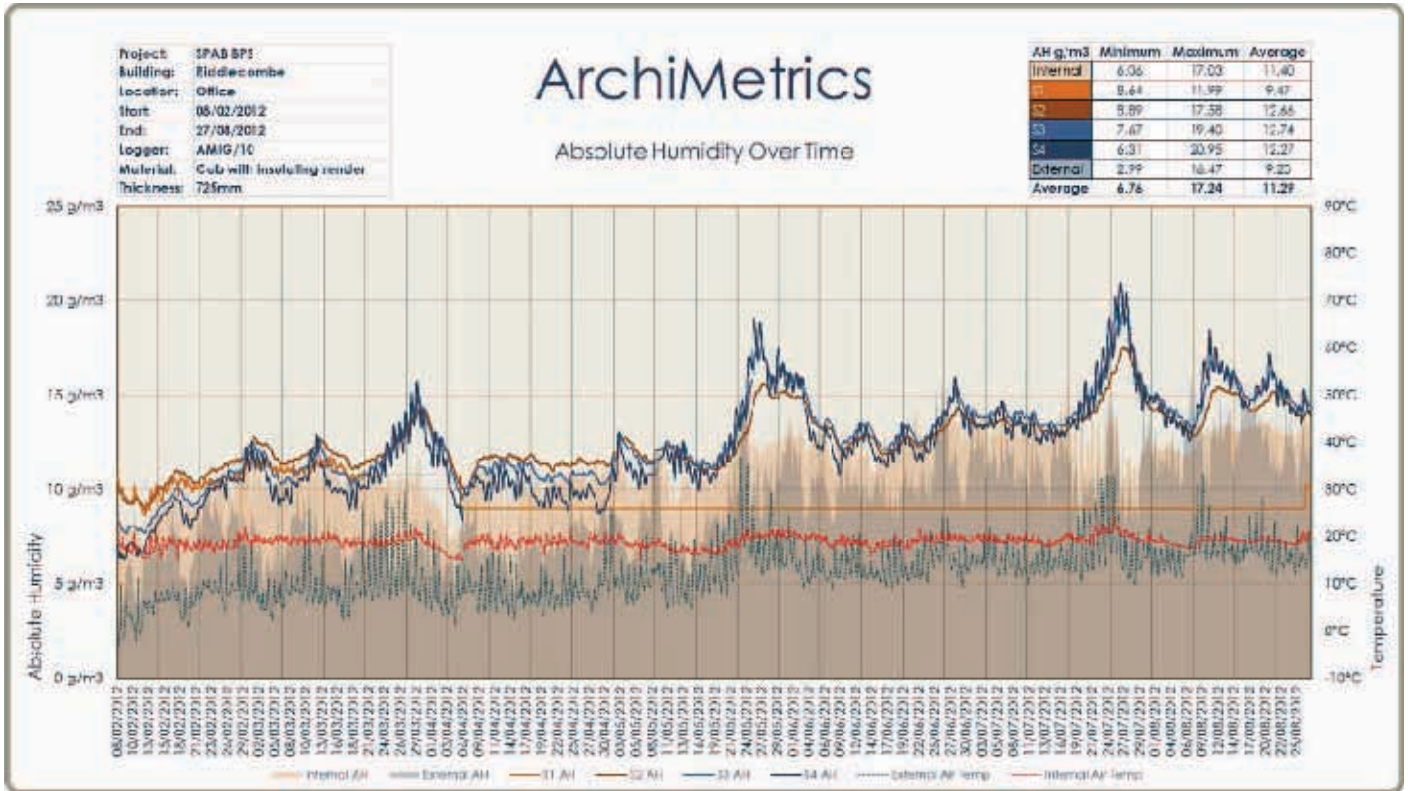
Figure 83: Absolute Humidity over time, Sensors 1 - 4, The Firs, Riddlecombe February - September 2012.

Following on from observations made concerning rising levels of %RH coinciding with warmer temperatures in the wall in Riddlecombe, plots of absolute humidity over time show an increase in vapour in the wall during higher external temperatures. This behaviour can be seen in the plots for both the 2012 spring and summer data (Figure 83) as well as this year's records, Figure 13. In both years the weight of vapour measured within the wall increases and peaks alongside peaks in external air temperature. Furthermore, over both years, these peaks are cumulative, that is quantities of vapour increase over time. In the discussion concerning %RH in the wall at Riddlecombe it was suggested that the increase in %RH measured in the wall over summer could be explained by vaporisation occurring from the wet cob material as a result of the higher temperatures within the wall. The plots of absolute humidity would seem to reinforce this notion as we can see vapour levels increasing during periods of high external air temperature. Once external temperatures diminish however neither absolute nor relative humidity levels return to those found prior to the warm spell. The fact that these levels of vapour appear to be cumulative suggests that once a certain quantity of moisture has vaporised from the cob material it then remains in a vapour form due to the warm temperatures and struggles to migrate out of the wall until such vapour has accumulated for parts of the wall to reach 100% RH despite summer time conditions.

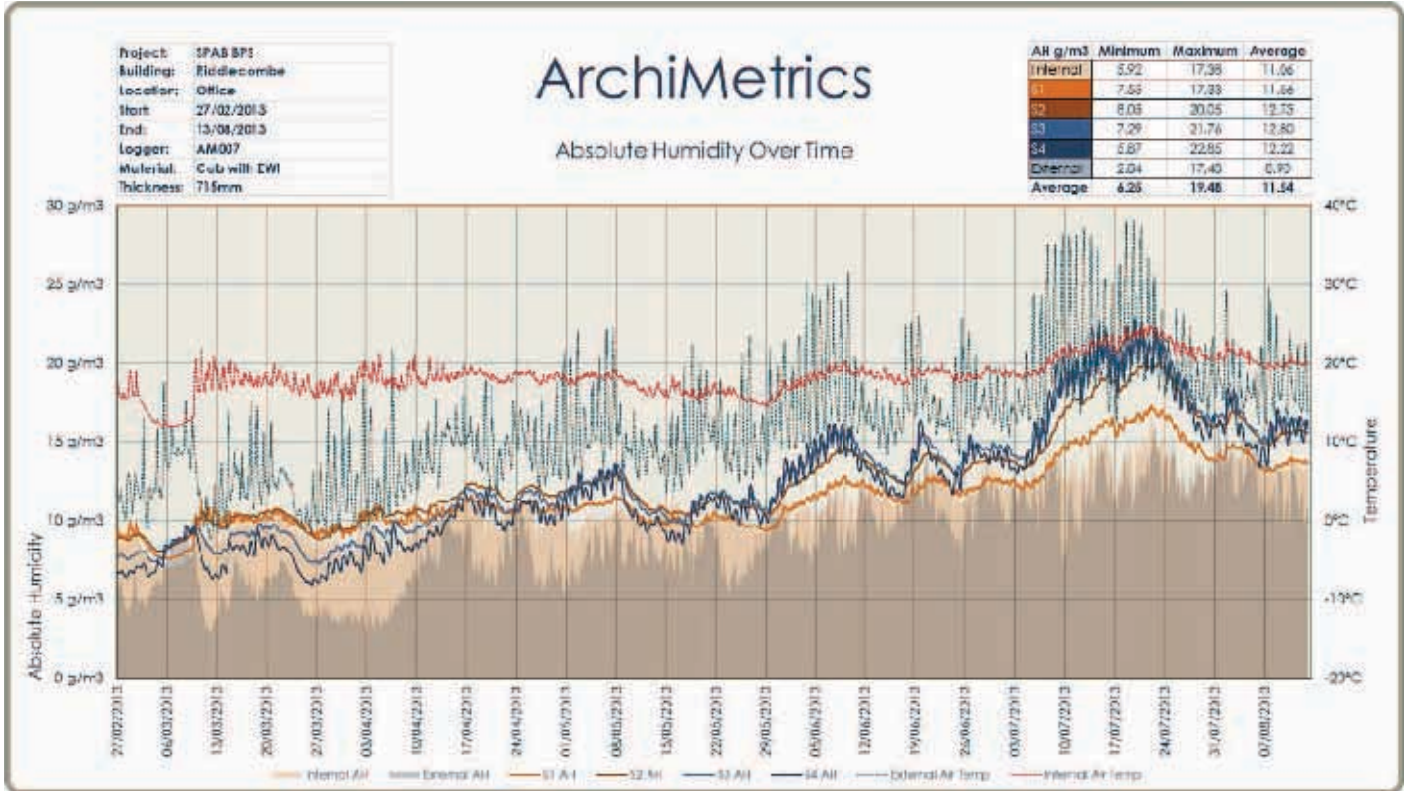
Figure 13: Absolute Humidity over time, Sensors 1 - 4, The Firs, Riddlecombe February - August 2013.

Although the graph for Riddlecombe, Figure 13, covers a shorter time period the increase in absolute humidity here also follows the seasonal pattern and increases with increasing external temperatures/external absolute humidity. There is, however, a significant difference in the plots of absolute humidity for the wall at Riddlecombe compared with those at the other locations. By and large, plots of absolute humidity in the other walls broadly match, sit between or fractionally surmount, those of internal and external levels of absolute humidity showing a close correlation between internal/external and interstitial conditions. At Riddlecombe plots of interstitial absolute humidity are detached from and significantly higher than those of external humidity and also internal absolute humidity from May 2013 onwards. This suggests that there is an additional factor or factors driving quantities of vapour in this cob wall independent of ambient internal and external vapour conditions. In the previous discussion on %RH and in the individual report on Riddlecombe it is suggested that excess moisture is contained within the cob as a result of a past failing external render as well as water added to the wall during the re-rendering process and this is vaporising during periods of warm temperatures as sun falls on the south-facing wall. This might explain the detachment seen between internal and external vapour conditions and those within the wall, as the moisture within the cob material provides an additional and independent source of vapour.

Although the graph for Riddlecombe, Figure 13, covers a shorter time period the increase in absolute humidity here also follows the seasonal pattern and increases with increasing external

temperatures/external absolute humidity. There is, however, a significant difference in the plots of absolute humidity for the wall at Riddlecombe compared with those at the other locations. By and large, plots of absolute humidity in the other walls broadly match, sit between or fractional surmount, those of internal and external levels of absolute humidity showing a close correlation between internal/external and interstitial conditions. At Riddlecombe plots of interstitial absolute humidity are detached from and significantly higher than those of external humidity and also internal absolute humidity from May 2013 onwards. This suggests that there is an additional or additional factors driving quantities of vapour in this cob wall independent of ambient internal and external vapour conditions. In the previous discussion on %RH and in the individual report on Riddlecombe it is suggested that excess moisture is contained within the cob as a result of a past failing external render as well as water added to the wall during the re-rendering process and this is vaporising during periods of warm temperatures as sun falls on the south facing wall. This might explain the detachment seen between internal and external vapour conditions and those within the wall, as the moisture within the cob material provides an additional and independent source of vapour.

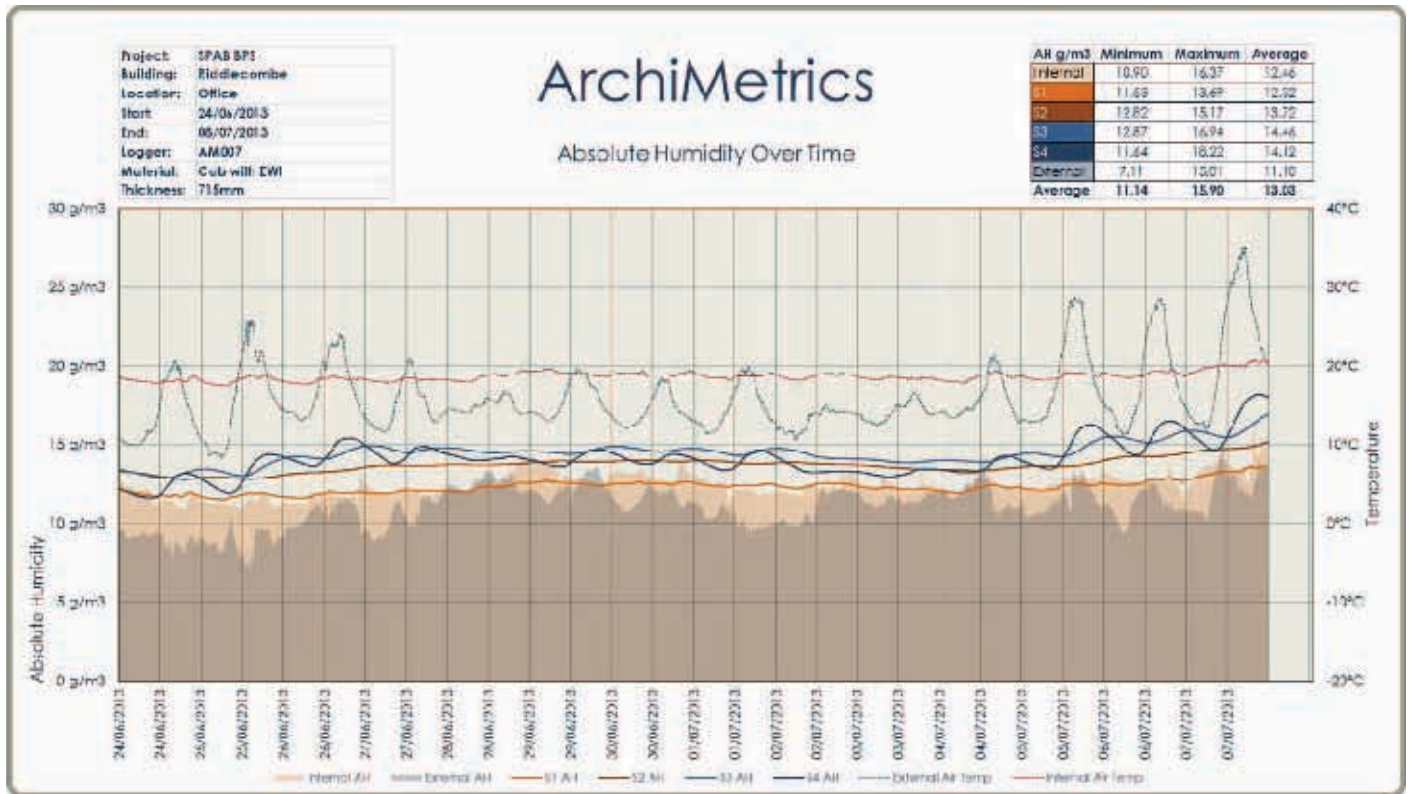
Figure 84: Absolute Humidity over time, Sensors 1 - 4, The Firs, Riddlecombe 24th June - 8th July 2013.

The same detailed weeks discussed in the commentary on %RH above have been graphed to provide a picture of the behaviour within the wall with regard to absolute humidity, Figure 84. Vapour responses at sensor 4 can be clearly seen to map increases in temperature in Figure 84, with similar, if slightly delayed and increasingly muted responses seen for the other three sensors in the wall. The period of time when external temperatures peak above 20°C and then 30°C beginning on the 4th July see an increase vapour throughout the wall section over this time.

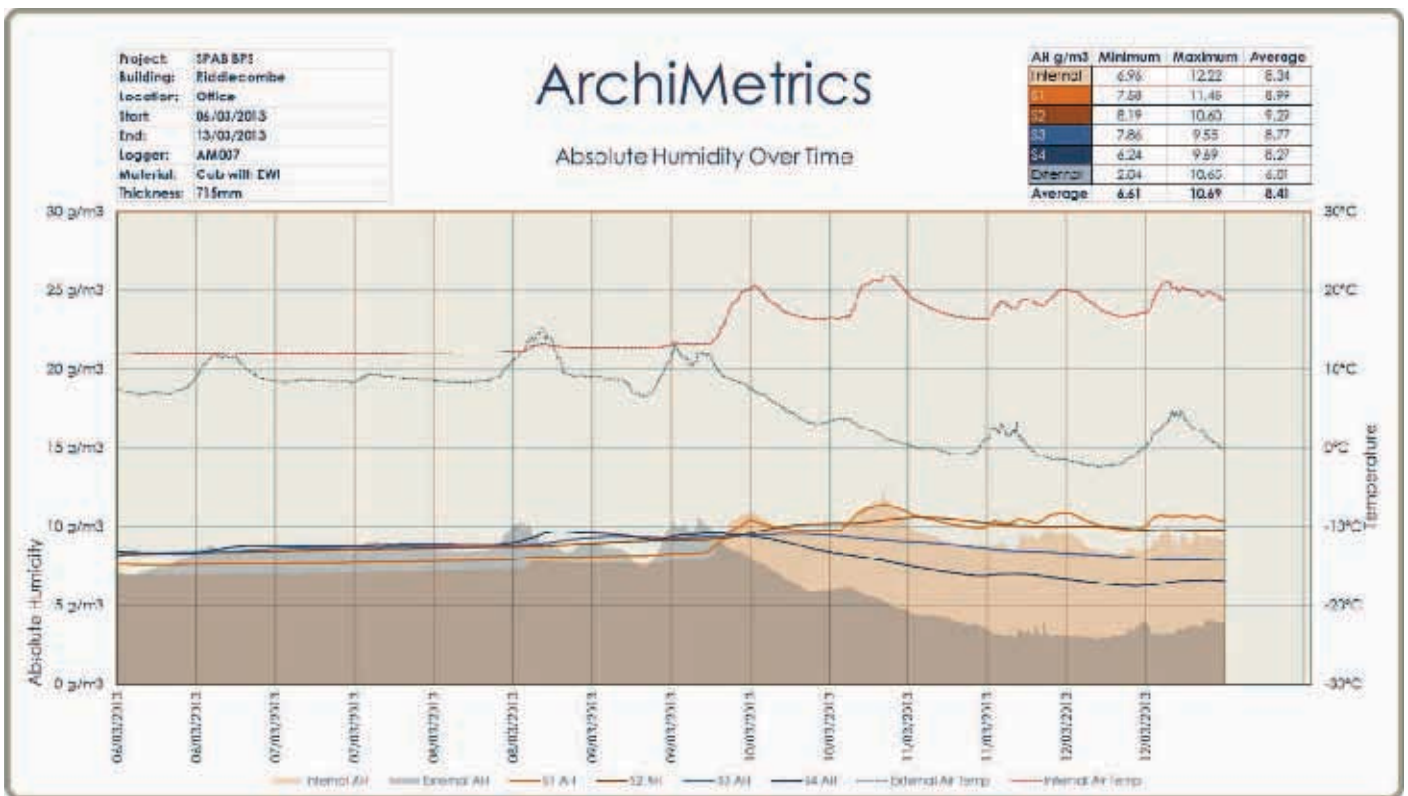
Figure 85: Absolute Humidity over time, Sensors 1 - 4, The Firs, Riddlecombe 6th March - 12th March 2013.

The detailed graph for the earlier week in the 2013 reporting period, Figure 85, shows increases in the g/m^3 of vapour at sensor 1 starting on 9th March which are a response to increases in internal room heat (despite the increase in vapour %RH declines at this location during these periods due to the ability of warm air to hold greater quantities of water as a vapour, Figure 85). Quantities of vapour measured at sensor 2 may, in this early colder period of the year, also be mostly determined by heat originating from inside the building, as, at least initially, following 9th March g/m^3 of vapour increase at this location like that of sensor 1. However, this increase in vapour quantities following the input of interior heat to the wall is not seen further out towards the exterior at sensors 3 and 4, where, contrary to sensors 1 and 2, g/m^3 of vapour decline over this time and show only slight increases (at sensor 4 only) during slightly raised daytime temperatures on 11th and 12th March 2013.

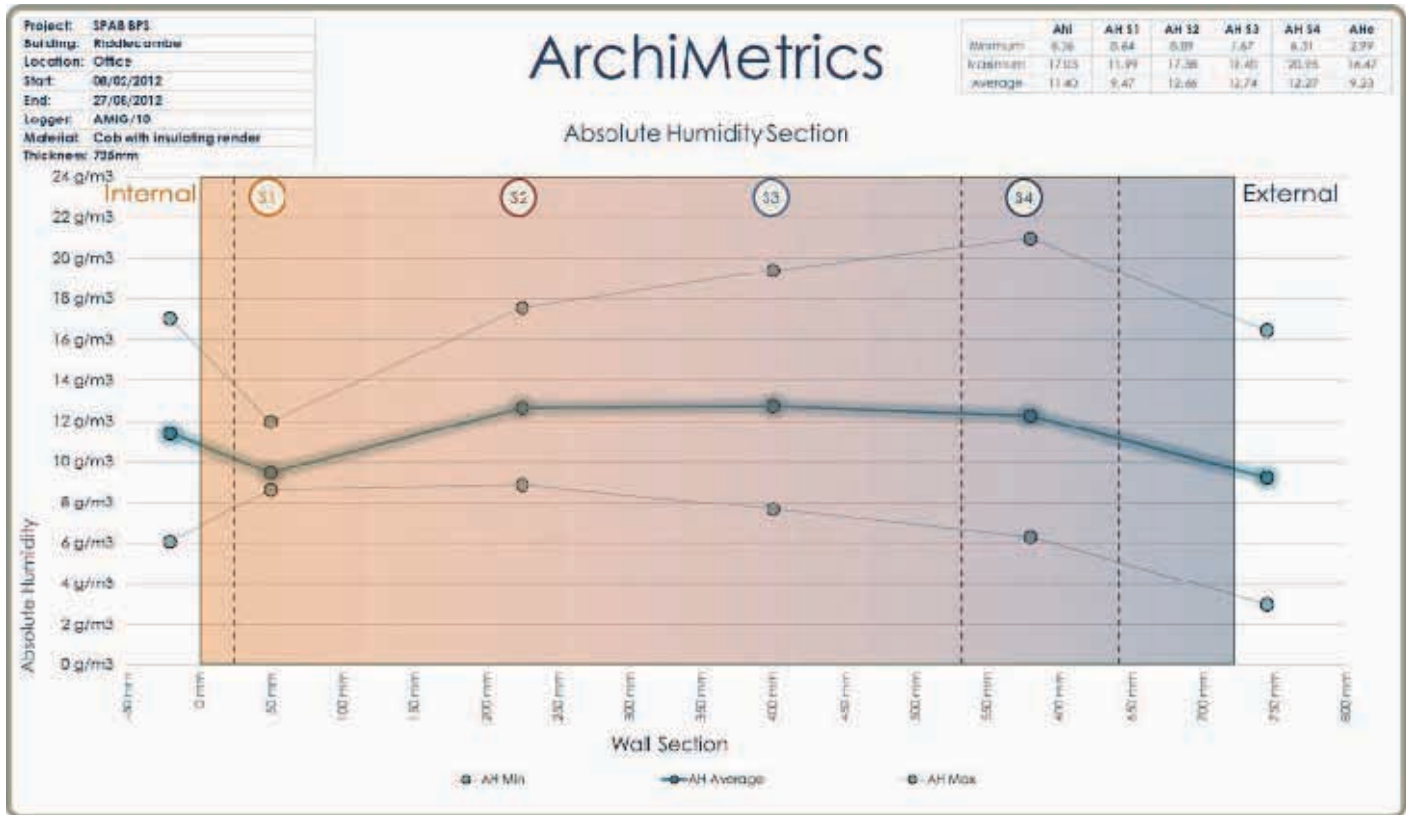
Figure 86: Absolute Humidity Section, The Firs, Riddlecombe February - September 2012.

The absolute humidity profile of the wall at Riddlecombe is also provided in the form of a section graph which plots the average g/m^3 of water vapour either side of and through the wall. Figure 86 shows the section for the 2012 data and Figure 17 the section for 2013. Both the 2012 and 2013 sections finds that of the four sensors in the wall sensor 3 records the highest weight of vapour by volume; 12.74 g/m^3 in 2012 and the slightly higher value of 12.80 g/m^3 in 2013. On average the total weight of vapour in the wall has increased from 47.07 g/m^3 in 2012 to 49.31 g/m^3 in 2013 but comparison of the two years shows that vapour is also distributed slightly more evenly throughout the section in the 2013 readings. This may suggest that whilst vapour still seems to be accumulating in the wall at Riddlecombe that there is also some movement in this vapour outwards from the centre of the wall towards the wall surfaces where, given suitably vapour permeable finishes, there may be some chance of vapour migration to the inside/outside occurring.

The relative and absolute humidity data from Riddlecombe leads us to speculate that we may be watching the damp cob wall at Riddlecombe drying out, or at least beginning to dry out, albeit very slowly. The cob was found to be wet prior to refurbishment, mostly likely as a result of the cracked external cement render. Whilst the replacement of this render took place over 4 weeks in the summer, which provided a short opportunity for drying of the cob, the application of the new insulating external render also involved the significant wetting of the substrate with a water hose. In these circumstances, it may be that the cob at Riddlecombe has a high moisture content; additional measurements, as well as damp insulating material removed from the monitoring wall cores prior to the commencement of refurbishment monitoring, suggest this is the case. Therefore, rather than seeing vapour accumulating within the cob material due to low rates of ventilation and air permeability, high rates of internal humidity and the inhibition of internal to external vapour flows, instead, during periods of high external temperatures, the south-facing wall heats up enough to cause the moisture that is bound within the cob material to vaporise. If, as is suggested by the 2103 absolute humidity section (Figure 17), this vapour then migrates towards internal or external wall surfaces then there is a possibility that it can be dispelled into the atmosphere. Whilst the quantity of vapour appears to have increased over time between 2012 and 2013 this may be a factor of the quantity of moisture held within the cob and the warmer temperatures of the 2013 summer encouraging more vaporisation. However whether this actually leads to lower quantities of moisture overall within the wall relies on the ability of this vapour to travel through the materials to exit the wall. In Figure 9, the %RH over time graph for summer 2013 for this wall, it is possible to see a very slight recovery in %RH measurements at sensor 3, which dip below 100% RH occurring around the week beginning 7th August. This may suggest that vapour is able to successfully migrate through the wall structure and therefore we may see %RH values measured in this wall begin to reduce however, at present, overall vapour quantities appear to still be increasing. Monitoring over the longer term will

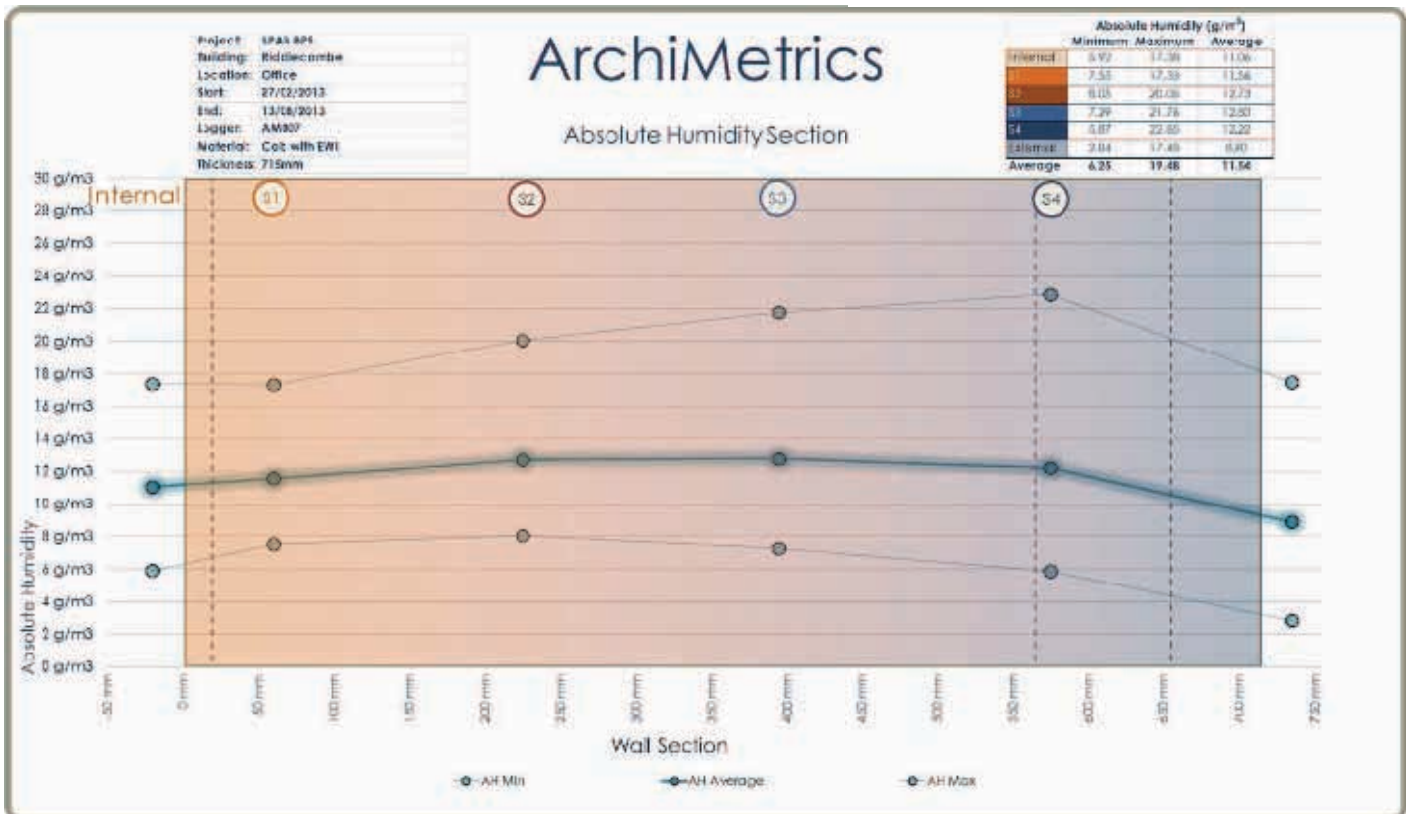
Figure 17: Absolute Humidity Section, The Firs, Riddlecombe February - August 2013.

In Figures 14-17 the average absolute humidity values through and either side of the four wall sections under study have been plotted along with the maximum and minimum values recorded over the reported monitoring period. These result in more or less flat gradients, showing more or less similar quantities of vapour through the wall sections with the exception of Riddlecombe, Figure 17.

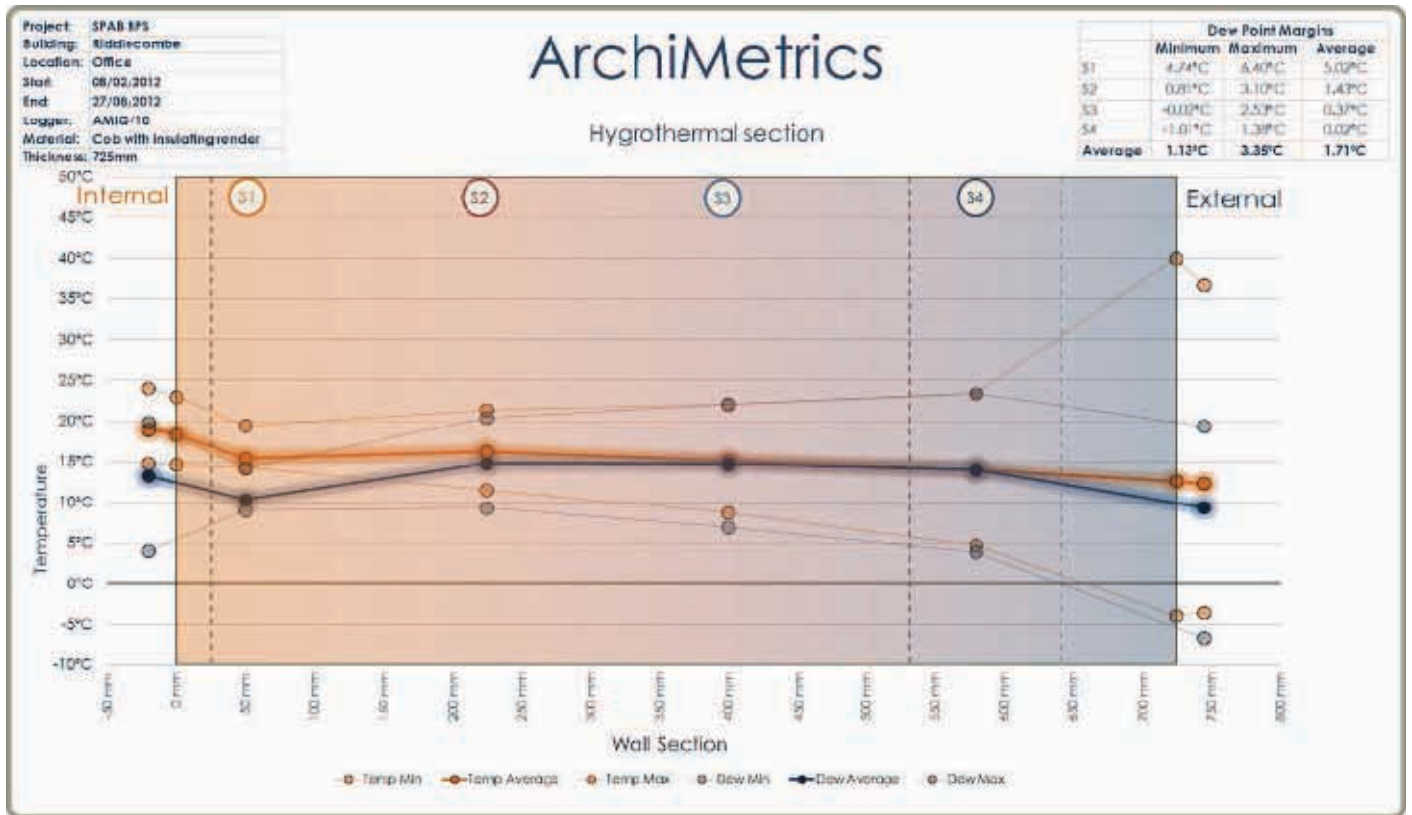
Figure 87: Hygrothermal Section, The Firs, Riddlecombe February - August 2012.

Figures 87 & 21 allow an examination of the temperature and dewpoint gradients through the wall section at Riddlecombe recorded over the periods February - August 2012 and 2013. Ostensibly these look very similar for both years where the temperature and dewpoint margins narrow towards the external side of the wall and are coincidental between sensors 3 and 4. There is a slight difference for the plots of temperature gradient towards the internal side of the wall; in 2012 there is a dip in the temperature/gradient at sensor 1 between the internal surface and sensor 2, whereas in 2013 the temperature recorded at sensor 1 has increased and the gradient begins to decline through the wall from this point. Whilst the temperature at sensor 1 seems to have improved at this location the dewpoint margin (the hypothetical temperature drop required for dewpoint to occur) has, however, decreased from 5.02°C in 2012 to 4.70°C. This narrowing is unexpected as %RH should decrease with increased temperatures and was occasionally found to do so during the early part of the year, see Figure 9. Therefore, this is perhaps a reflection of the increased quantities of vapour found in general over the longer term at this point in the wall in 2013 as compared with 2012, something that is confirmed by records of absolute humidity for 2012 and 2013 at this location (Figures 86 & 17).

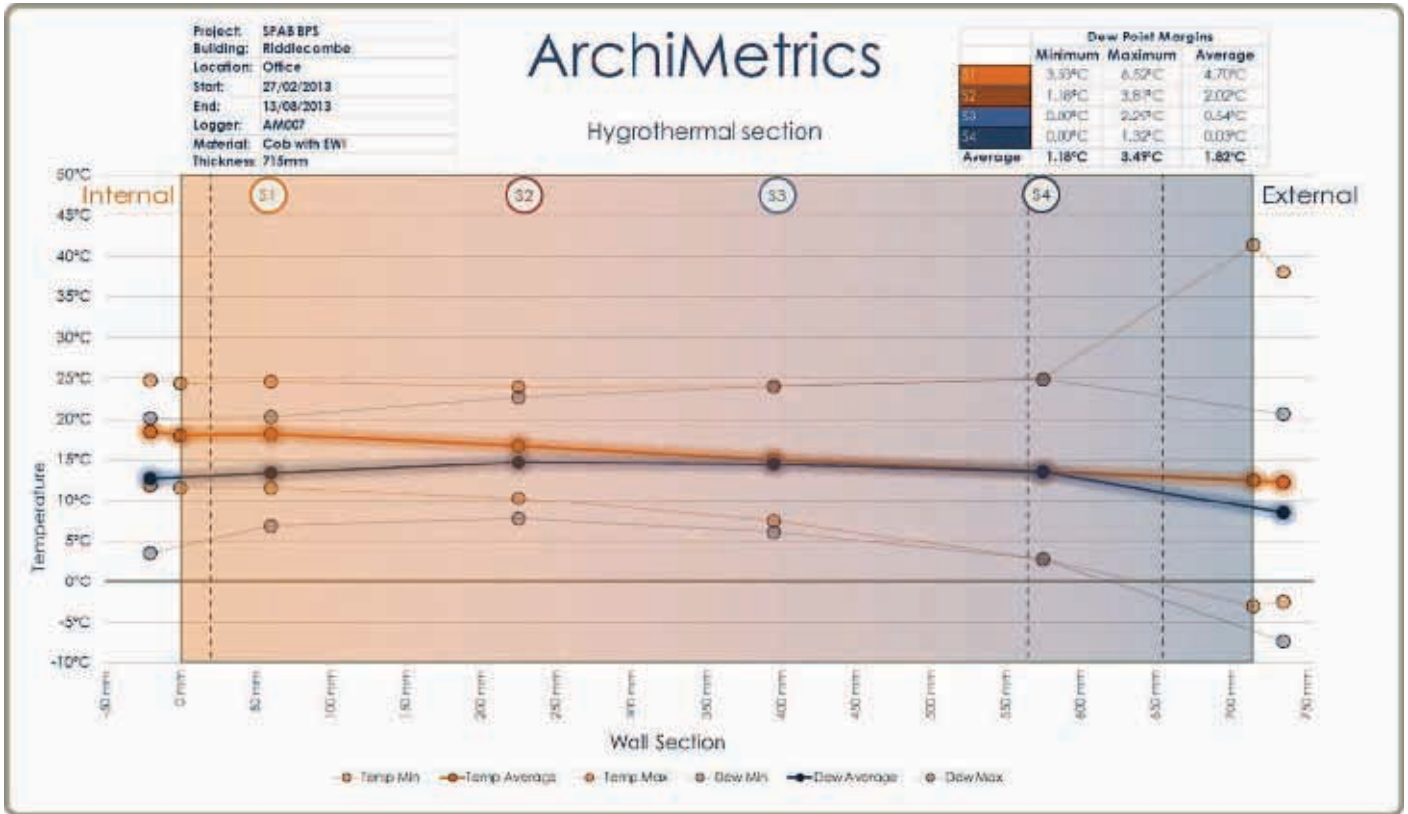
Figure 21: Hygrothermal Section, The Firs, Riddlecombe February - August 2013.

The dewpoint gradients plotted for these walls derive from measurements of %RH and show the nominal temperature drop required for dewpoint to occur at certain points within the wall. For Shrewsbury, Skipton and Drewsteignton these gradients are, more or less, flat and sit around 10°C. At Riddlecombe, which is found to have higher levels of vapour within its structure, the average dewpoint gradient is raised above 10°C and is convexed and peaks within the centre of the wall echoing the section plot of average absolute humidity found in Figure 17. For all four walls the margin between the temperature gradient and the

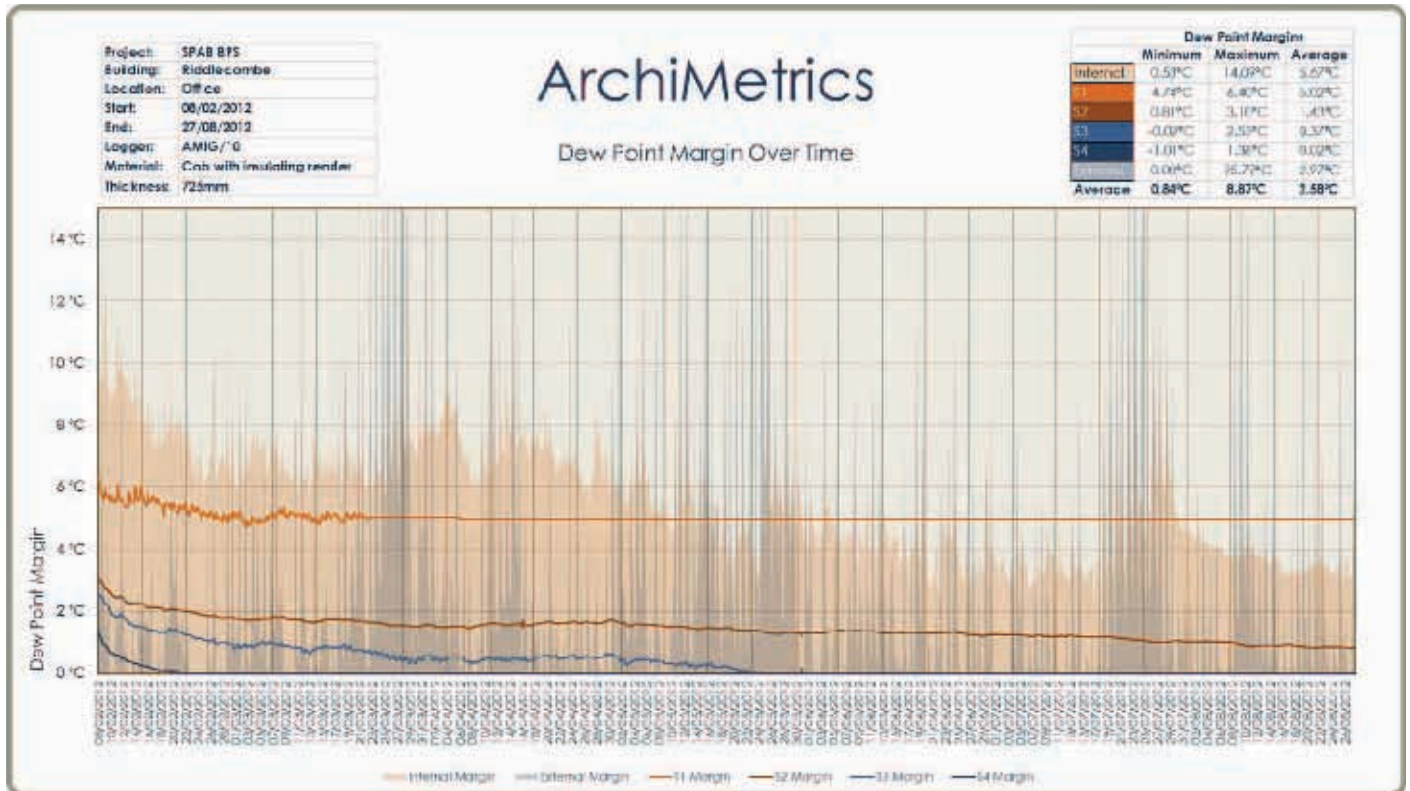
Figure 88: Dewpoint Margin over time, The Firs, Riddlecombe February - August 2012.

The dewpoint margins for the wall at Riddlecombe are also expressed for each sensor plotted over time, Figures 88 and 25. Once again, the graphs for 2012 and 2013 do not appear to be significantly different to one another and both show the same pattern of decreasing dewpoint margins over time. Over the two reporting periods first the margin at sensor 4 reaches a margin of 0°C followed later by sensor 3. However, there are slight differences between the two years and whilst it would appear that saturation is occurring within some parts of the wall, as with the %RH findings (Figure 9) it takes a longer period of time for this to occur at sensor 3 in 2013. But perhaps most significantly, despite a slight increase in quantities of vapour in the wall in 2013 (Figure 17) the overall dewpoint margin for all four sensor positions has also increased very slightly from 1.71°C in 2012 to 1.82°C in 2013. This may reflect the slightly higher temperatures recorded at 3 of the 4 sensor positions for the 2013 period, which, despite high and increasing quantities of vapour, are able to lower the %RH sufficiently to cause this small increase in the overall dewpoint margin for 2013. Indeed records of %RH for the wall overall show a fractional improvement in overall %RH between 2012 and 2013, from 90.20% in 2012 to 89.59% in 2013. Furthermore, as with the 2013 plots of %RH over time (Figure 9) a slight recovery can be seen towards the end of the reporting period in the dewpoint margin at sensor 3. This may indicate the start of an improving situation for the wall where excess material moisture is slowly reducing via cycles of
