SPAB Building Performance Survey 2013

Interim Report
October 2013

Dr Caroline Rye, Cameron Scott and Diane Hubbard
Society for the Protection of Ancient Buildings
Supported by Historic England

THE SPAB RESEARCH REPORT 2

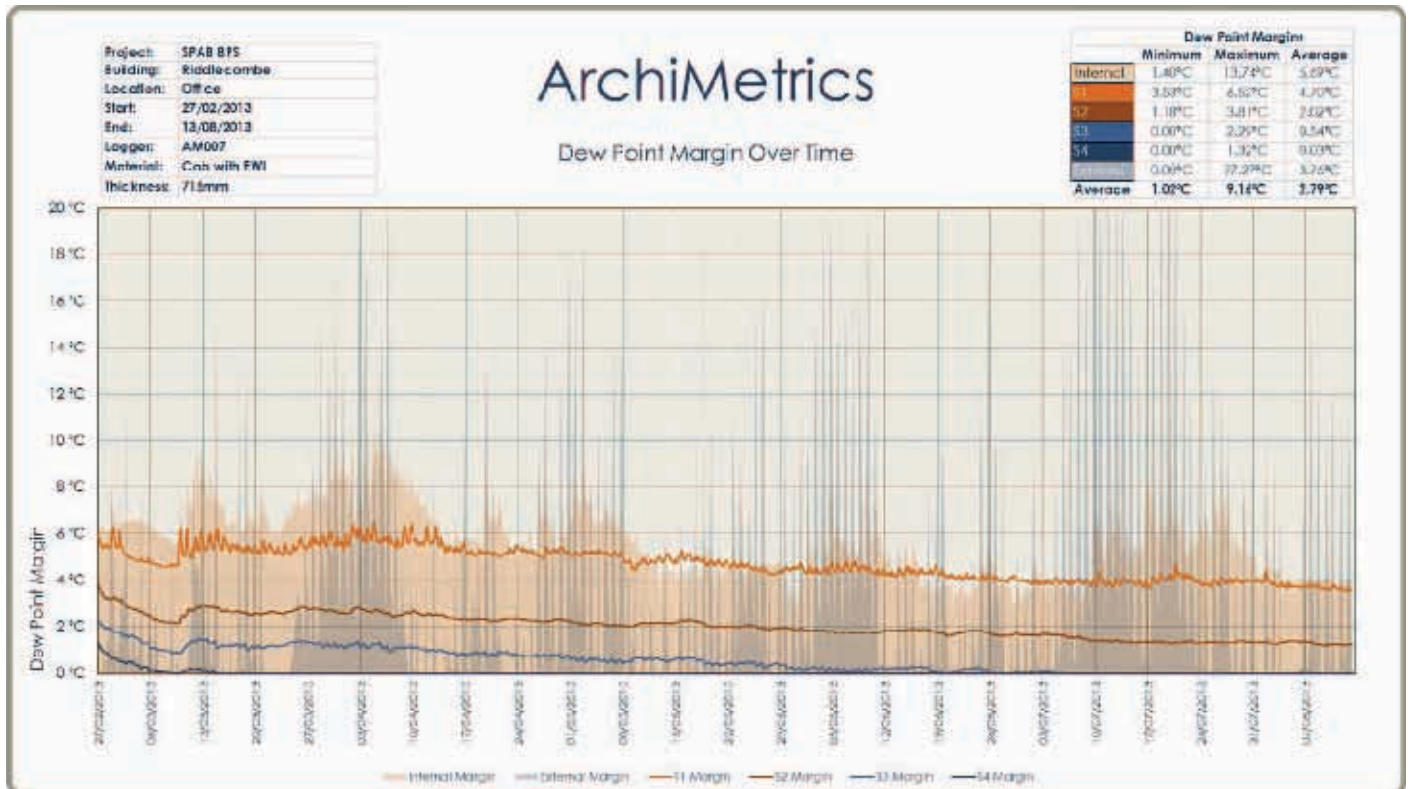
Figure 25: Dewpoint Margin over time, The Firs, Riddlecombe February - August 2013.

The dewpoint margins for the wall at Riddlecombe are also expressed for each sensor plotted over time, Figures 88 and 25. Once again, the graphs for 2012 and 2013 do not appear to be significantly different to one another and both show the same pattern of decreasing dewpoint margins over time. Over the two reporting periods first the margin at sensor 4 reaches a margin of 0°C followed later by sensor 3. However, there are slight differences between the two years and whilst it would appear that saturation is occurring within some parts of the wall, as with the %RH findings (Figure 9) it takes a longer period of time for this to occur at sensor 3 in 2013. But perhaps most significantly, despite a slight increase in quantities of vapour in the wall in 2013 (Figure 17) the overall dewpoint margin for all four sensor positions has also increased very slightly from 1.71°C in 2012 to 1.82°C in 2013. This may reflect the slightly higher temperatures recorded at 3 of the 4 sensor positions for the 2013 period, which, despite high and increasing quantities of vapour, are able to lower the %RH sufficiently to cause this small increase in the overall dewpoint margin for 2013. Indeed records of %RH for the wall overall show a fractional improvement in overall %RH between 2012 and 2013, from 90.20% in 2012 to 89.59% in 2013. Furthermore, as with the 2013 plots of %RH over time (Figure 9) a slight recovery can be seen towards the end of the reporting period in the dewpoint margin at sensor 3. This may indicate the start of an improving situation for the wall where excess material moisture is slowly reducing via cycles of
