Little Toller Farmhouse, Toller Fratrum, Dorset

Building analysis and survey

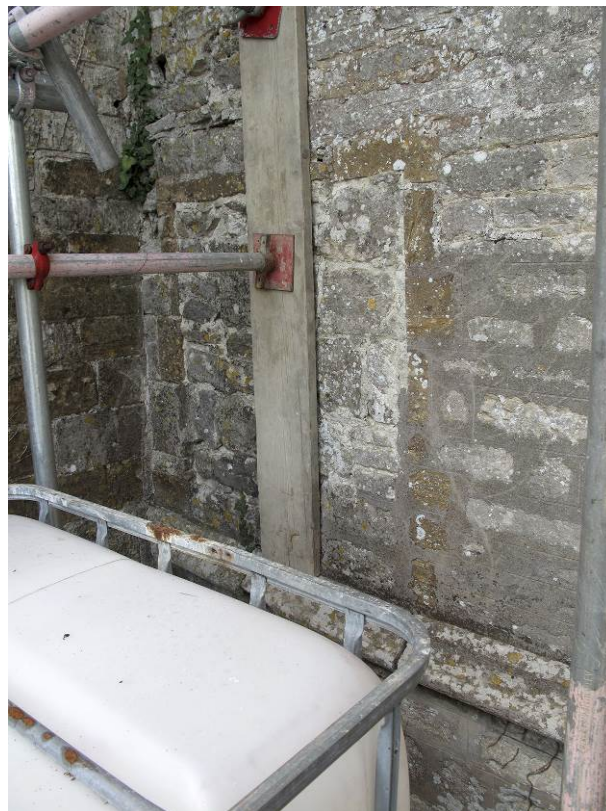
Fig 24 The blocked window on the ground floor where the south elevation of the main range meets the south wing. Photo: Rebecca Lane.

On the south elevation, next to the join with the later south wing, there are two blocked openings on the ground and first floor and it is likely that these were window positions (Fig 24). The blocked ground-floor window has orange-brown stone dressings and the one above has dressings of paler grey stone. The adjacent window to the east on the first floor has been modified but the jambs on the east side are of orange-brown stone and it could be an original opening, later widened to the west. Further west, the south elevation was heavily altered by the later construction of the south wing, so little of the original form can be determined. However an off-set and change in width of the interior south wall of the later kitchen (point E on Fig 9) could indicate the position of an original opening, perhaps for a south-facing window.

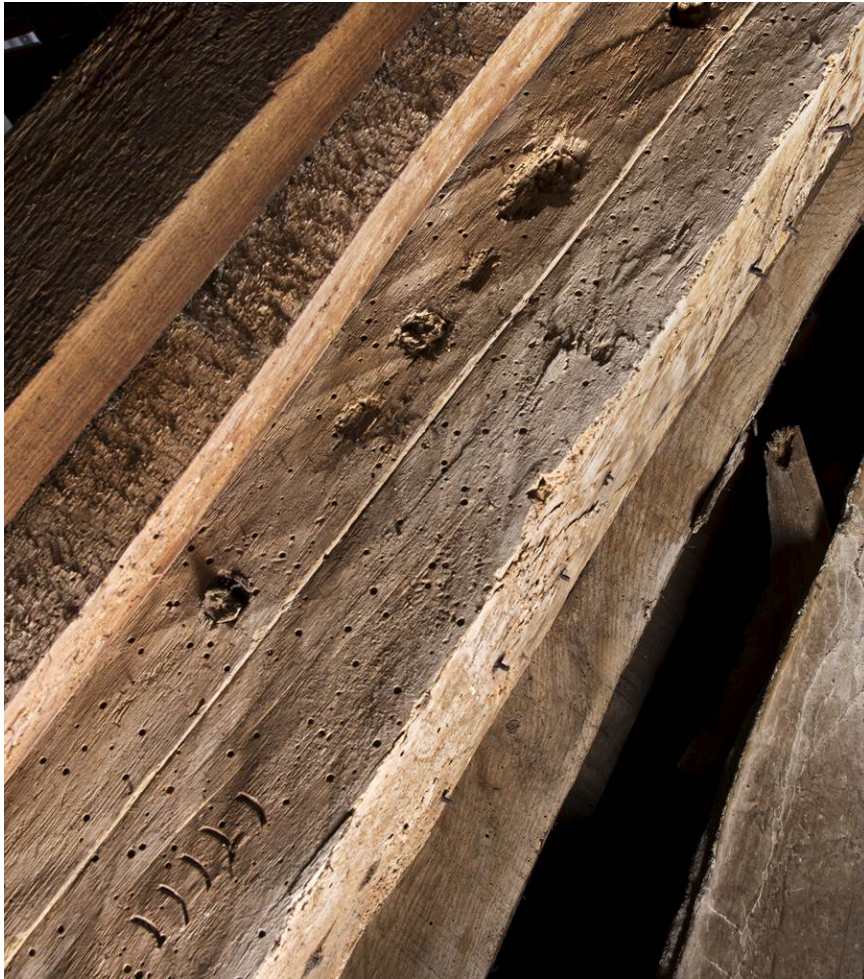
The carpenters' marks on trusses 37-45 comprise gouge stamped short curves on the fair (east) side (Fig 26). These form a sequence from 1 to 9, although none were observed on number 5 in this sequence (truss 42). At the north end of truss 37, the lower brace was marked on the west side, ie the other side for all the other trusses, but the marks are on the east side at the south end of the rafter. From trusses 47-53 the marks are Roman numerals. There were no marks on trusses 54-62 except a 'IIII' on the upper brace, south side, of truss 58. Details of the carpenters' marks are in Appendix 2. Surviving parts of laths and nails show the intention to have a barrel ceiling. The nails are not dissimilar to those at the eastern end of the building so it is possible that they are similar in date.

Fig 26 View of the fair (east) side of truss 41 on the south side of the roof over the main range. HEA DP 196787.

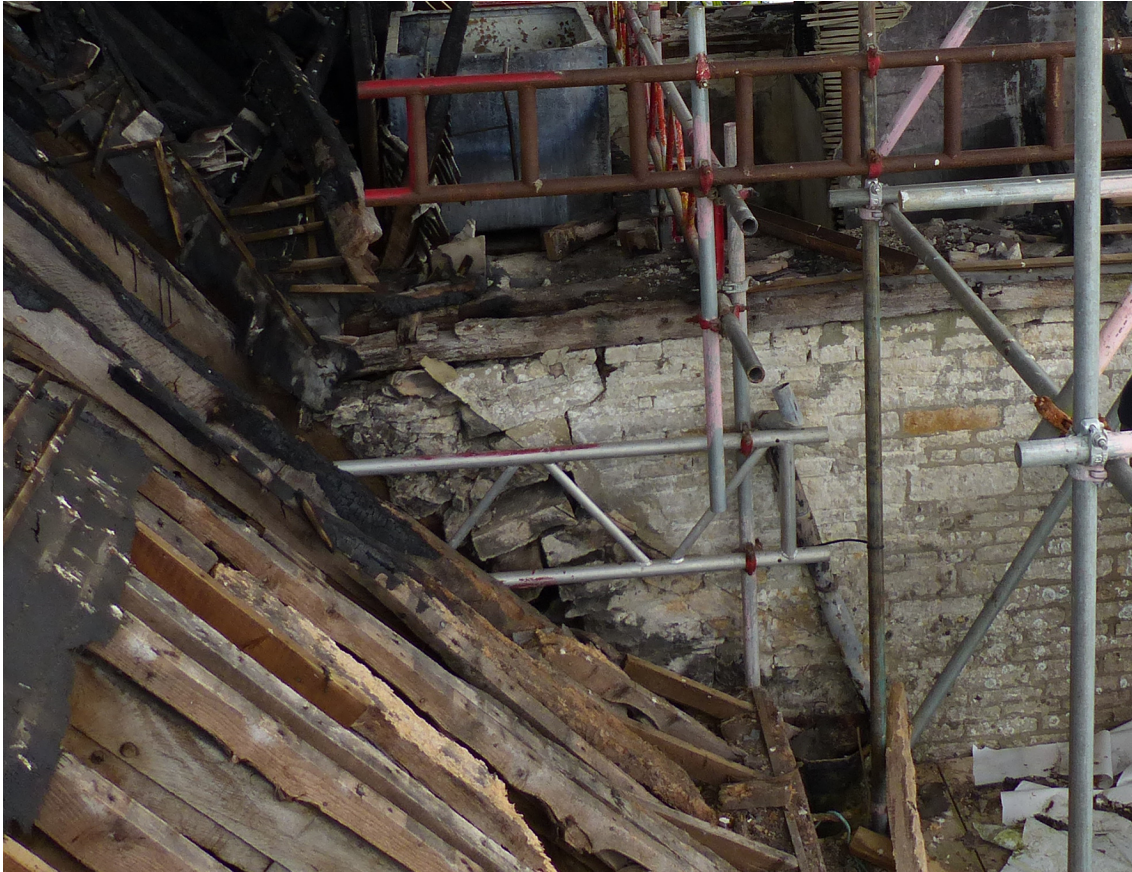
Fig 28 View looking west showing the east wall of the north range resting on the roof of the main range. Photo: Helen Winton.

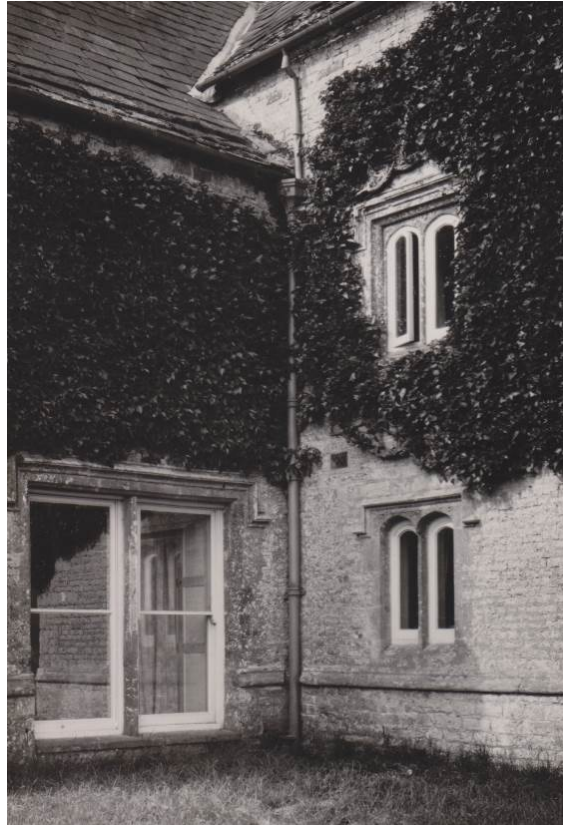
The windows on the east elevation light the ground and first floors (Fig 29). On the west elevation, the lower window towards the north end of the north wing is positioned between the ground and first floors (Fig 30). The upper window (now blocked) is centrally placed in the elevation and is higher than first-floor level. There is a three light window, in the north gable at eaves height, positioned off-centre to the west (Fig 31). Unlike the other windows, this has an ogee moulded surround and dressings in the same pale grey stone as the rest of the gable. There is nothing to suggest that it has been altered or inserted so it seems to be an original feature even though it is in a different style to the other windows.

Fig 29 The north wing east elevation (right of frame). HEA IN00484 DM 1521.

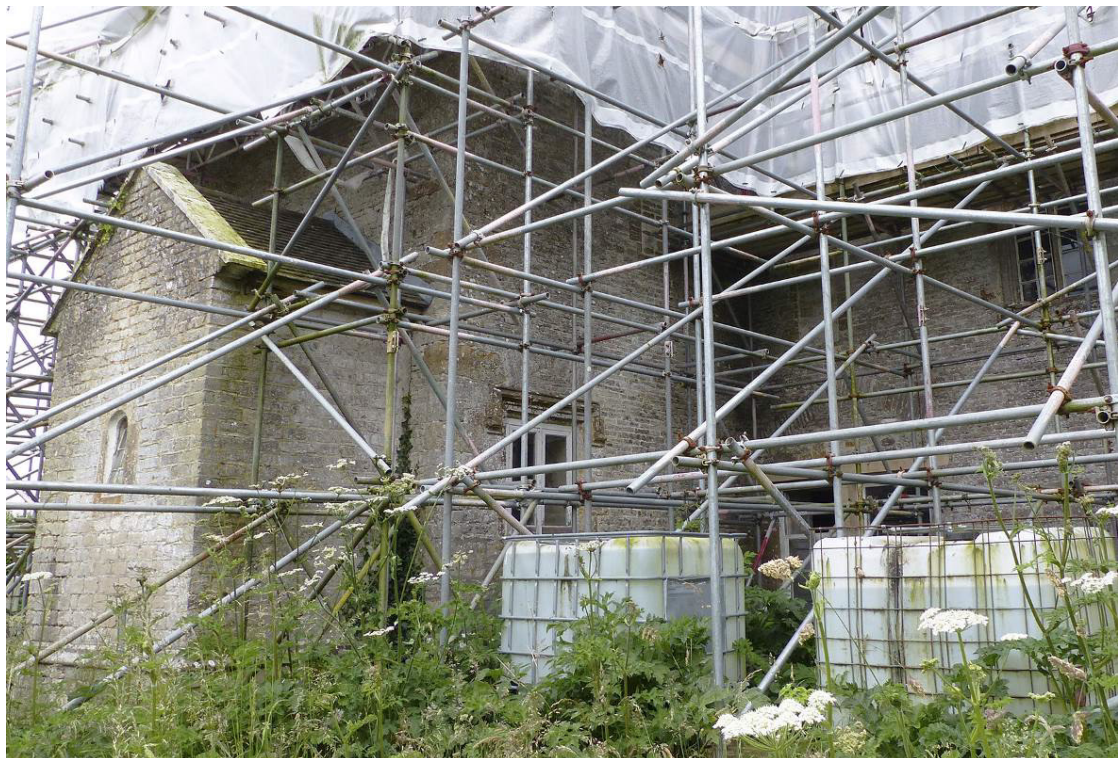
Fig 30 The west elevation of the north wing showing the position of the window between ground and first-floor level. The bottom of the blocked window above first floor level is just visible centre-right near the top of the frame. Photo: Helen Winton.

The original internal layout of the north wing is not entirely clear but the position of the windows, at intermediate heights on the east elevation, suggests there was a stair probably extending up the east side (Fig 30). The interior is relatively large to have contained just a stair. A compact stair would allow for more circulation space on each floor but there could have been a well-stair. However, the single flue chimneystack shows there was a heated room on one of the floors that might be difficult to accommodate if there was originally a large well stair.

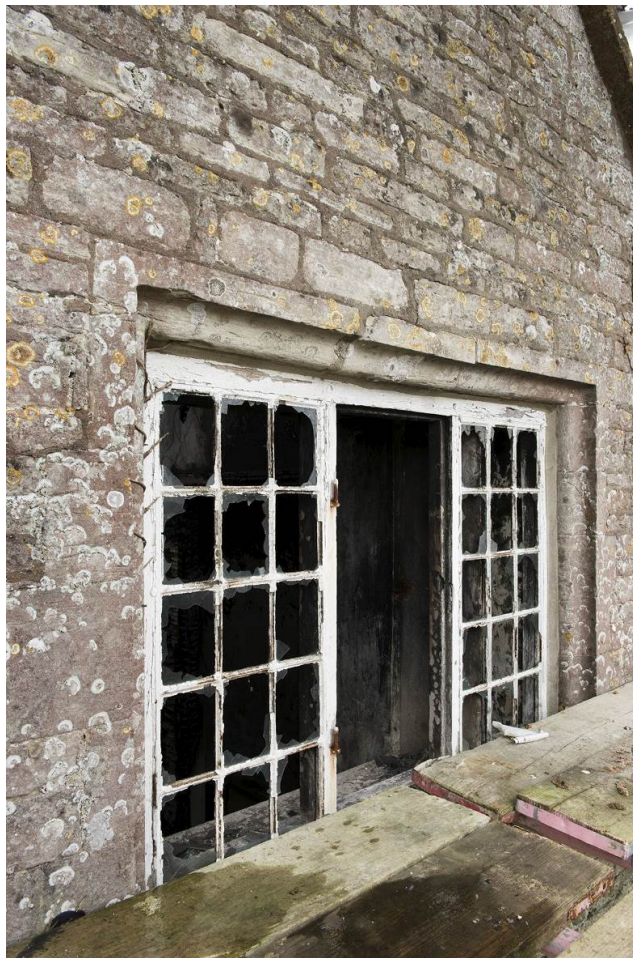
Above first-floor level there was almost certainly a further room at gable height, lit by the three-light window in the north gable (Fig 31). This room was entered via a stair probably in the position of the current, later stair. This would have provided a low chamber at the head of the stair with a barrel-vaulted ceiling above. The window has angled internal splays similar to original openings elsewhere in the house. The off-centre position of the window in the north gable means that it partly lights the head of the stair and the adjacent space.

Fig 31 A view from the north-east of the three-light window on the top floor of the north wing. HEA DP196810.

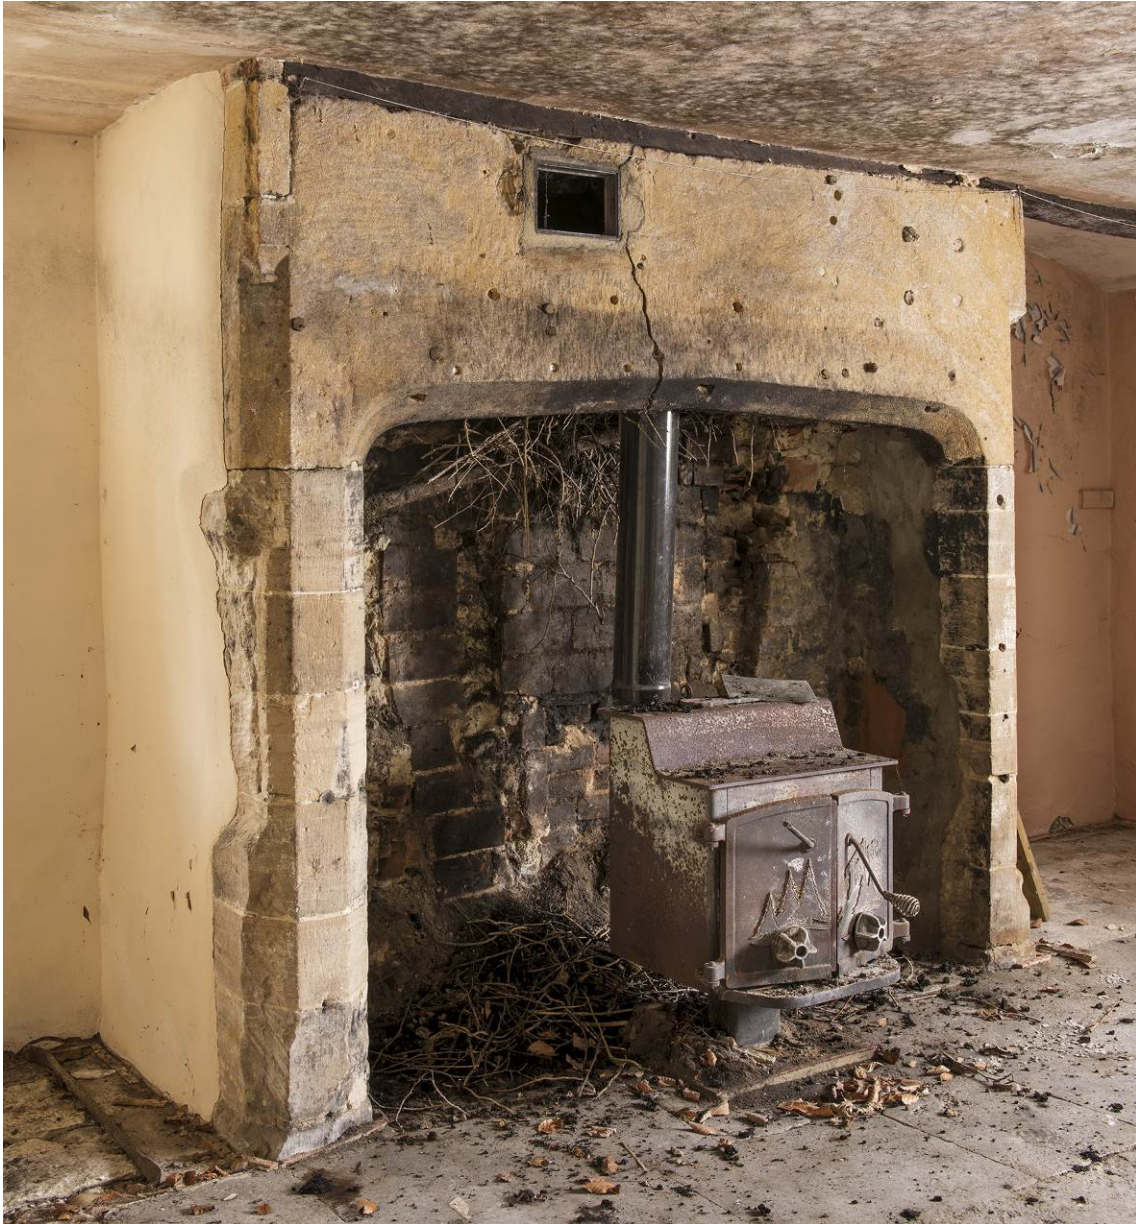
As previously mentioned, the large fireplace on the west gable of the main range does not appear to be in its original position (Fig 32). It is likely that the fireplace was moved when its large scale and style became unfashionable. This could have occurred any time from the late 17th century onwards. The size of the fireplace is similar to the chimneybreast of the lateral stack on the south side of the main range. It is therefore possible that the fireplace was moved from within the house, but there is no direct evidence for this. There is an inserted chimneybreast against the west gable of the house (seen in the roof space) and this may have been constructed when the fireplace was installed in its current position.

Fig 32 The fireplace on the ground floor at the west end of the house. HEA DP196746.

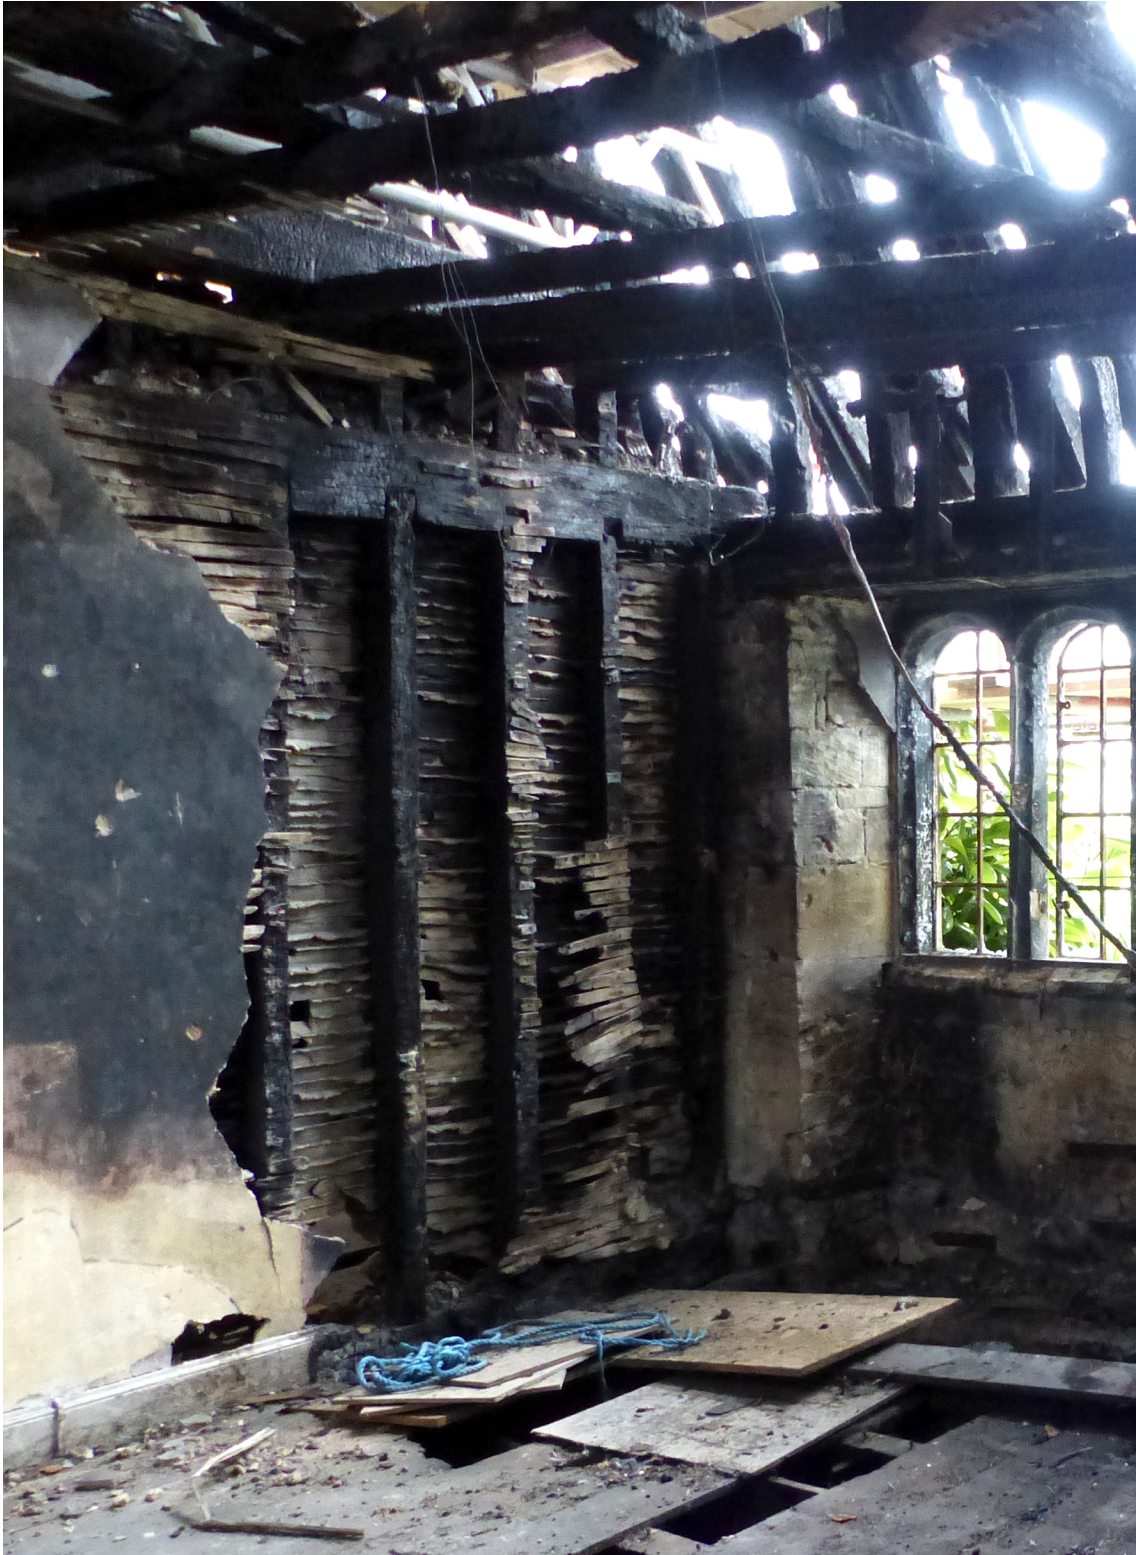
The partition between the two easternmost first-floor rooms (K on Fig 10) appears to be of an earlier phase to the other interior sub-divisions (Fig 33). It extends across the full width of the house and the beam supporting this partition is lapped onto the top of the inner wall plate. The partition comprises a substantial timber frame and laths with plaster laid over. The partition continued into the roof space and is still partially plastered. It has an off-centre opening, allowing movement through the attic space. It is not clear if this opening is an original feature or if it was created by removing a stud. In the roof space, the partition appears to be plastered on the east side only, although it is possible that the fire removed the plaster from the west side.

The fact that the partition extends into the roof space and is plastered at this level, may mean it was inserted while the barrel-vaulted ceiling was still in place in the eastern and central parts of the main range. It is possible that the first floor was gradually altered with a flat ceiling inserted over certain rooms while retaining the barrel vault in others. For example, the easternmost room possibly retained the barrel ceiling, while the room to the west had a flat ceiling installed. This might explain why the partition in the roof was only plastered on the east side. A flat ceiling would certainly have been inserted along the central part of the range before, or at the same time as, the creation of the corridor to the rear of the first floor.

Figure 33 The partition between the two easternmost first-floor rooms (K on Fig 10) viewed from the north west. Photo: Helen Winton

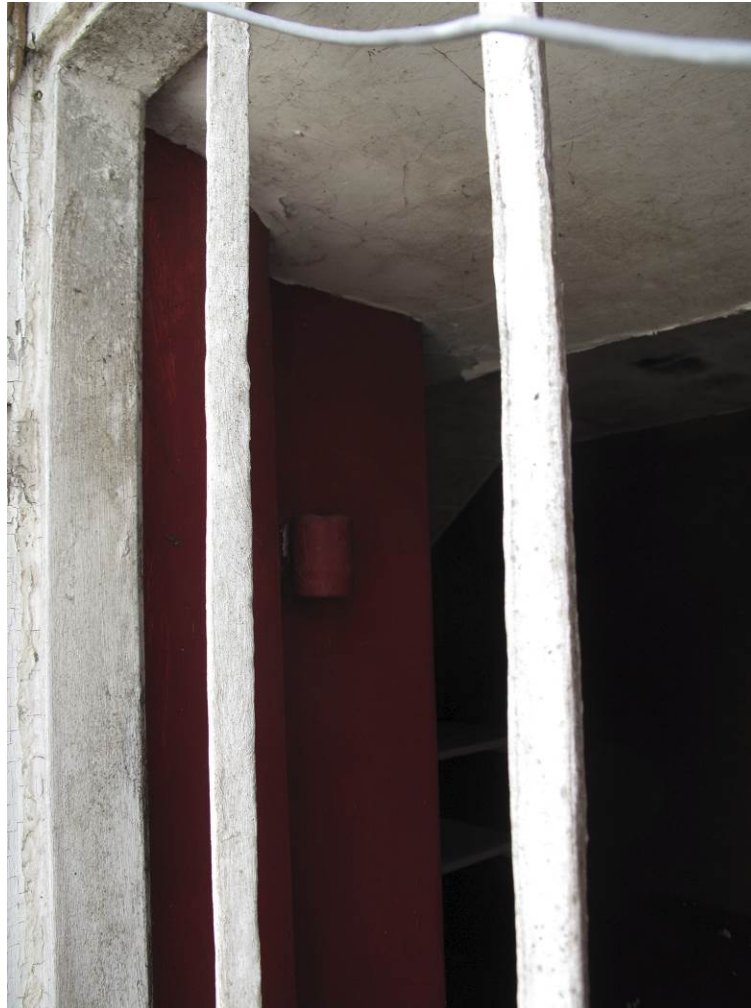
The form of the interior of the window on the ground floor towards the west of the front (south) elevation suggests that this opening was once used as a doorway (Fig 34). Part of a substantial metal hinge just inside the window perhaps once held a door or shutter. This may have been inserted, and then blocked again, during one of the phases of reorganisation of the interior during the 18th or 19th centuries.

Fig 34 The metal hinge behind the window on the ground floor at the west end of the main range. It is possible this was once a doorway. Photo: Rebecca Lane.

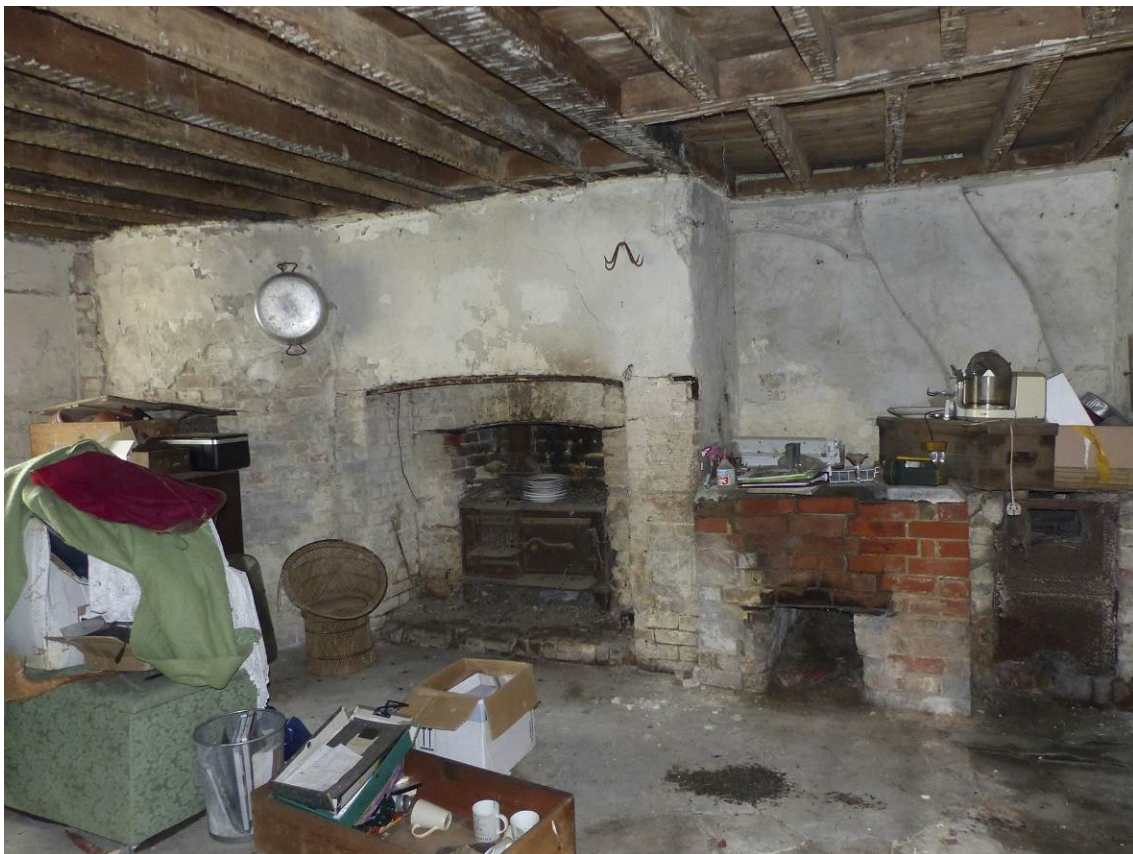
Fig 35 Interior of the ground floor of the south wing, looking south. Photo: Helen Winton.

Internally the ground floor of the wing has 19th-century fixtures and fittings including a centrally placed brick fireplace against the south wall with a cooking range (Fig 35). To the east side of the fireplace there is a curved brick wall, probably for a bread oven. These are both made of pale bricks, unlike those found elsewhere in the house, and appear to be original features further suggesting a 19th-century date for the south wing. To the west of the fireplace, there are two red brick plinths each with a fireplace underneath, one open, the other enclosed. These probably held coppers for washing. An inserted flue, now plastered over, extends up the wall serving the western copper fire. On the first floor of the main range, the wall was cut back to form a curve leading to the doorway through to the south wing. This must be the result of adapting the earlier south wall of the main range to accommodate the join with the wing.

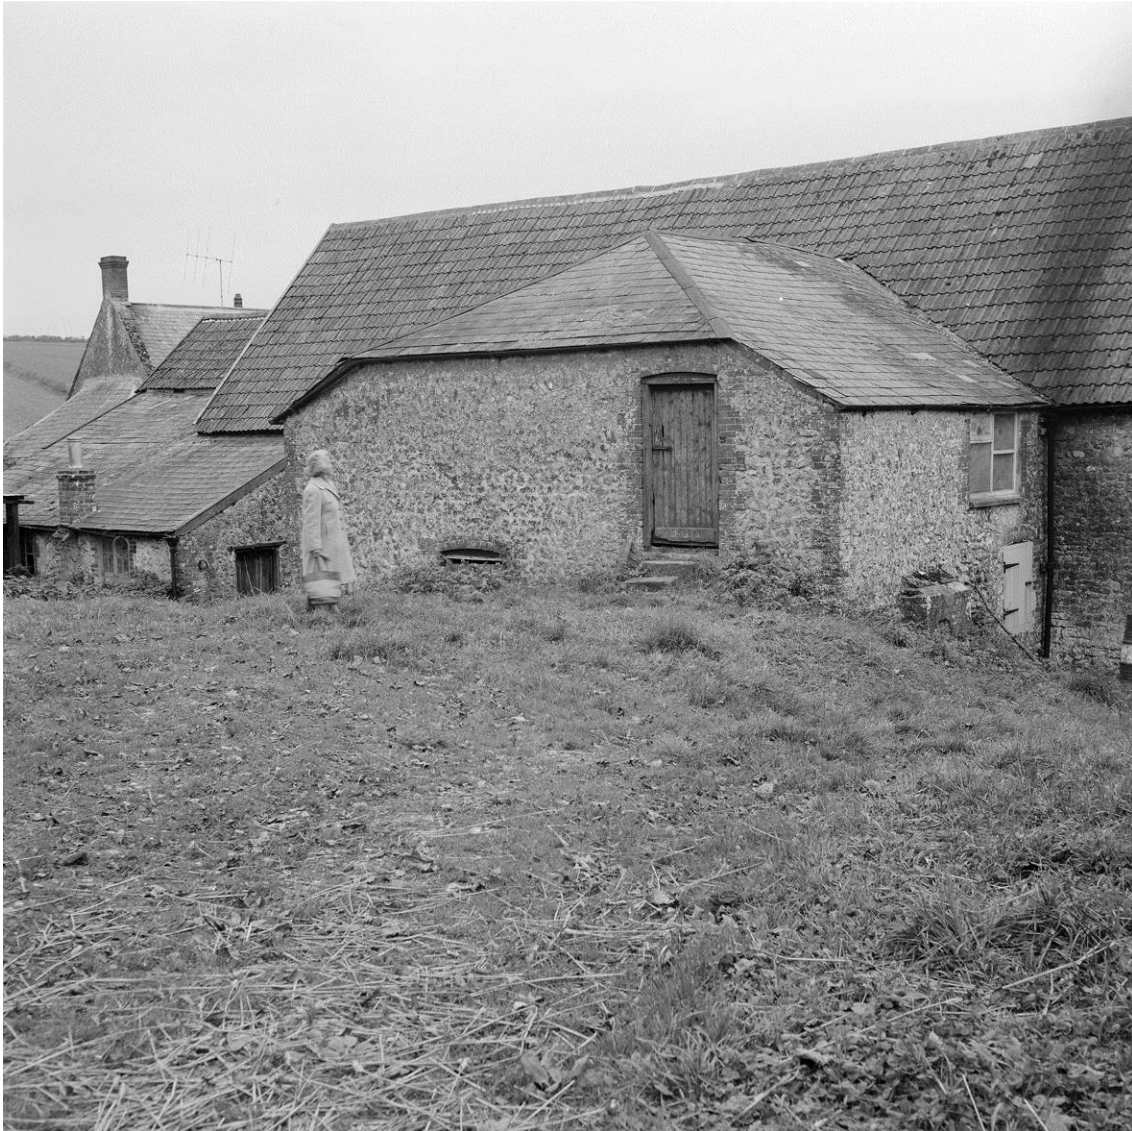
Fig 36 Looking north east towards the back of the barn c1960. The house, with the single storey extension against the west gable, is far left of the frame. HEA AA043154.

The historic maps and the RCHME Inventory notes show the main range extended westwards beyond the south wing. A one-storey lean-to was still there in the 1960s when a photograph was taken to record the rear of the barn (Fig 36). It is not marked on the 1972 1:2500 Ordnance Survey 1:2500 scale map so was probably removed in the late 1960s. It is likely to have been an early 19th century addition to the house, and presumably provided more service rooms associated with the farmhouse.
